StEER
STRUCTURAL
EXTREME EVENTS
RECONNAISSANCE

Hurricane Otis
October 25, 2023
Released: September 18, 2024
NHERI DesignSafe Project ID:
PRJ-4231

EARLY ACCESS RECONNAISSANCE REPORT (EARR)

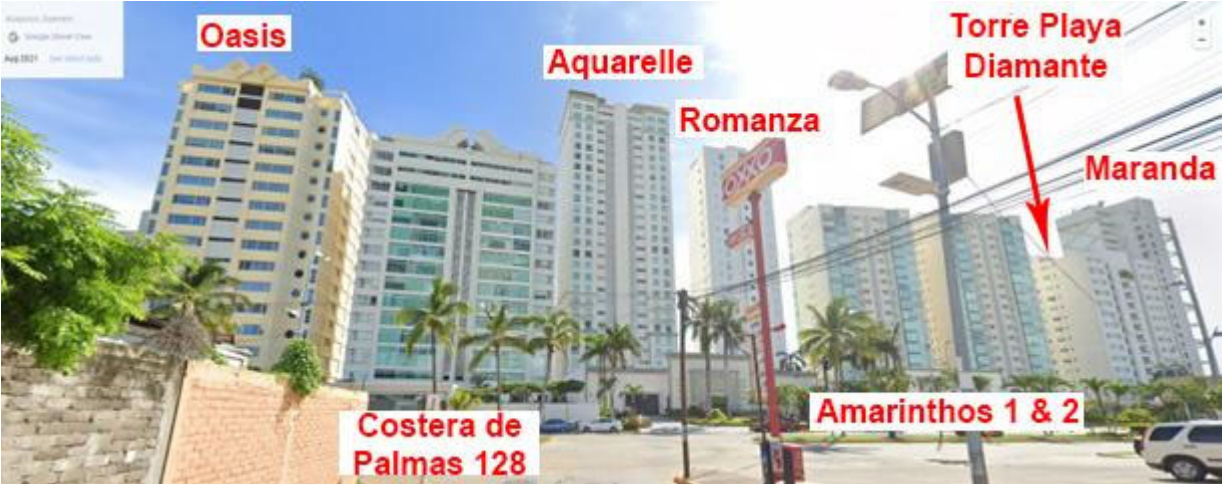
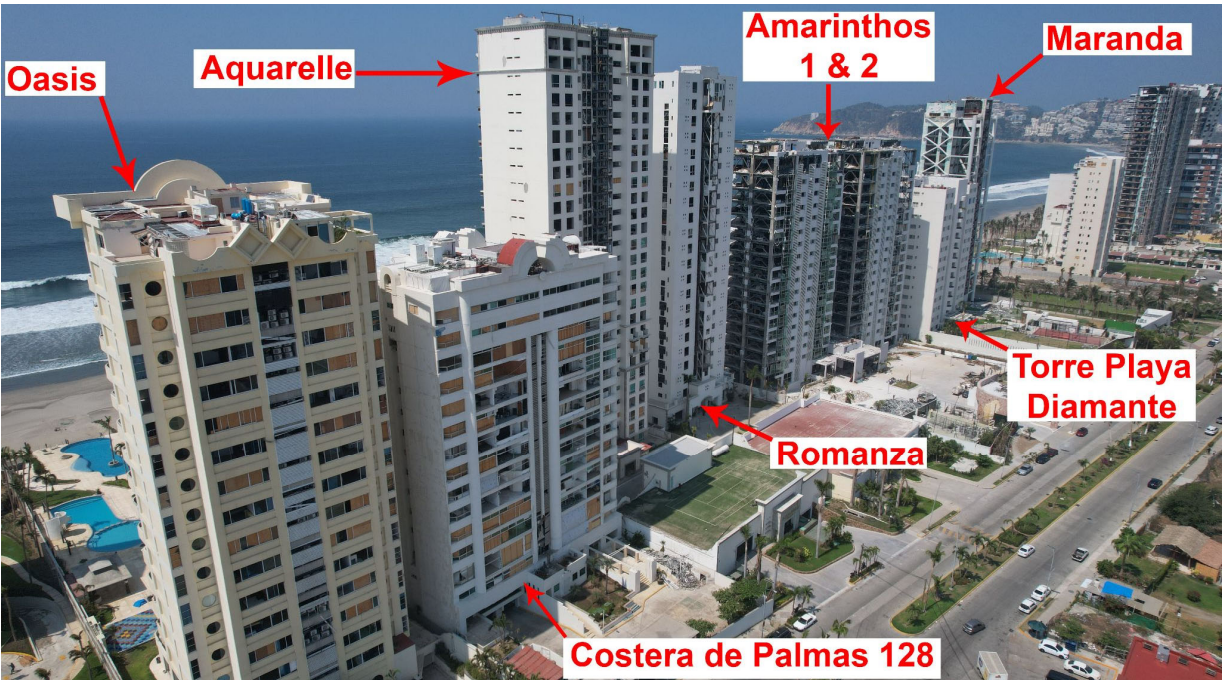
Figure 4.1.5 shows perspective views from the street of the eight towers: Oasis, Costera de las Palmas 128, Aquarelle, Romanza, Amarinthos 1 and 2, Torre Playa Diamante, and Maranda in Cluster 13 pre- and post-Hurricane Otis. Figures 4.1.6 and 4.1.7 together present general views from the beach of the eight towers: Maranda, Torre Playa Diamante, Amarinthos 1 and 2, Romanza, Aquarelle, Costera de las Palmas 128, and Oasis in Cluster 13 pre- and post-Hurricane Otis.

Figure 4.1.5. Cluster 13 NE elevation landward views; (top) before Hurricane Otis (Source: Google Street View) & (bottom) post Hurricane Otis (Source: FAST).

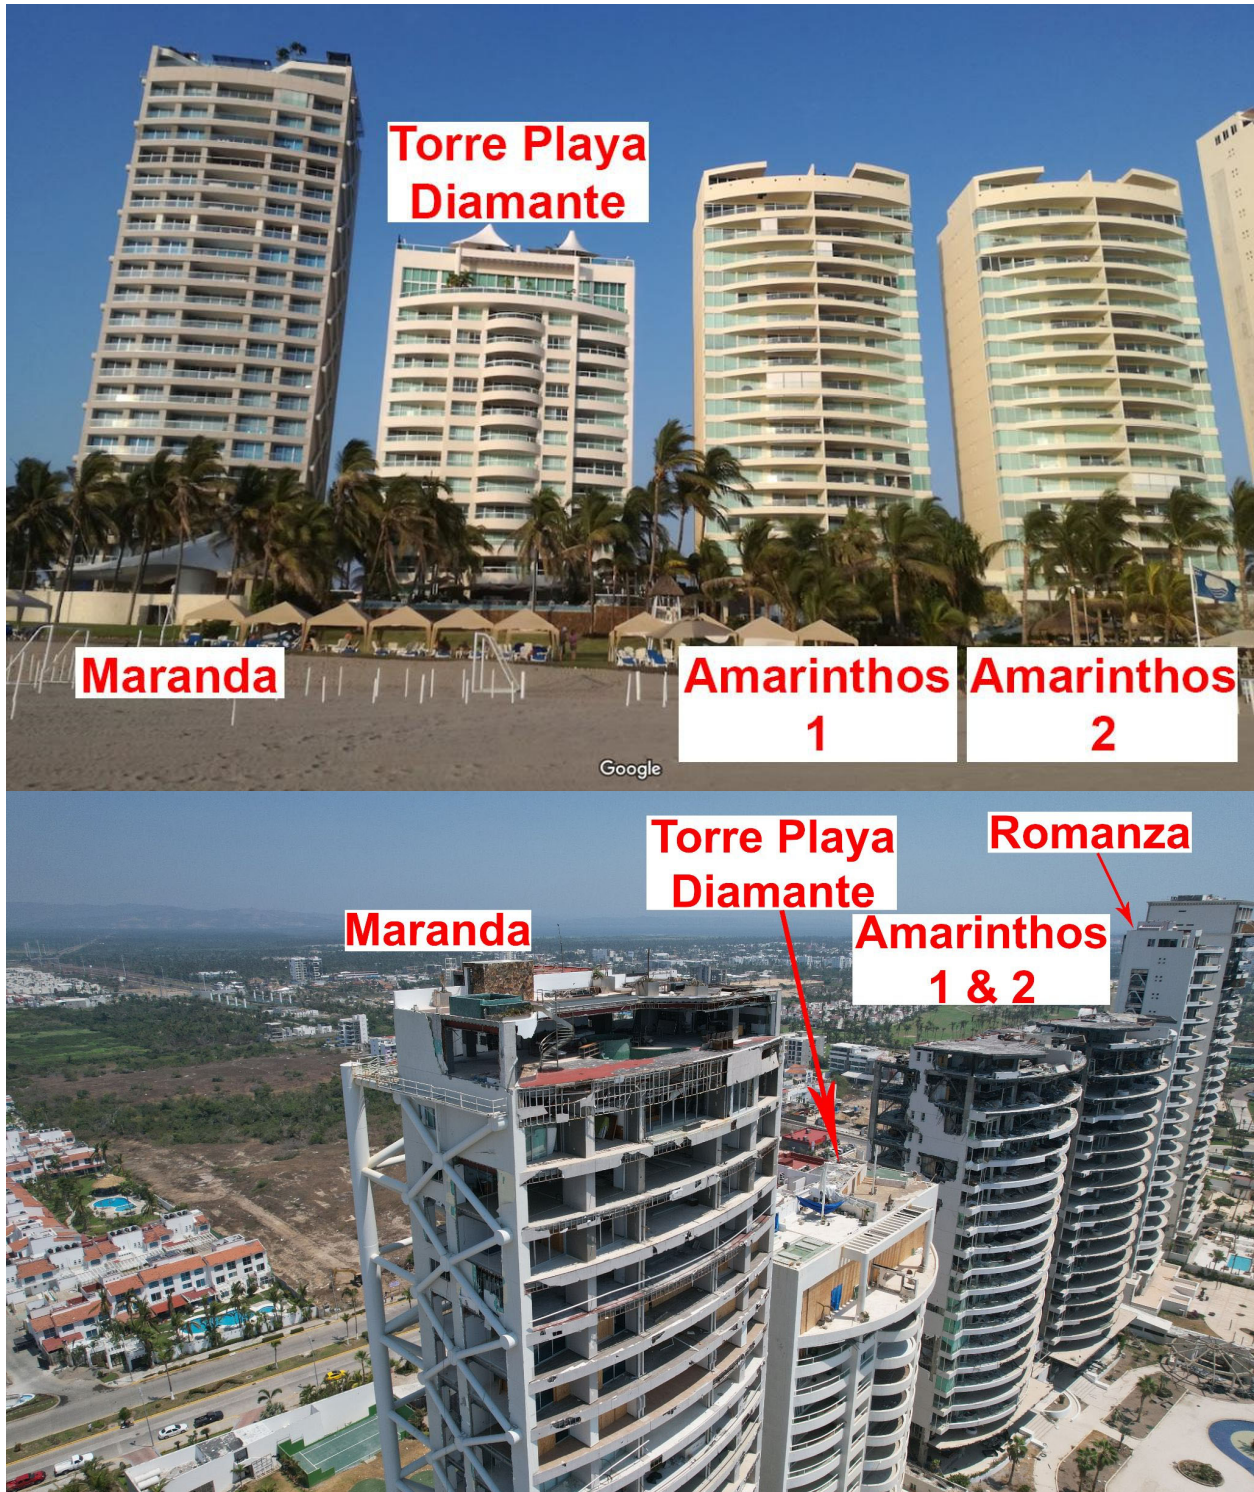
Figure 4.1.6. Cluster 13 SW elevation seaward views; (top) before (Source: Google Street View); (bottom) after Hurricane Otis (Source: FAST).

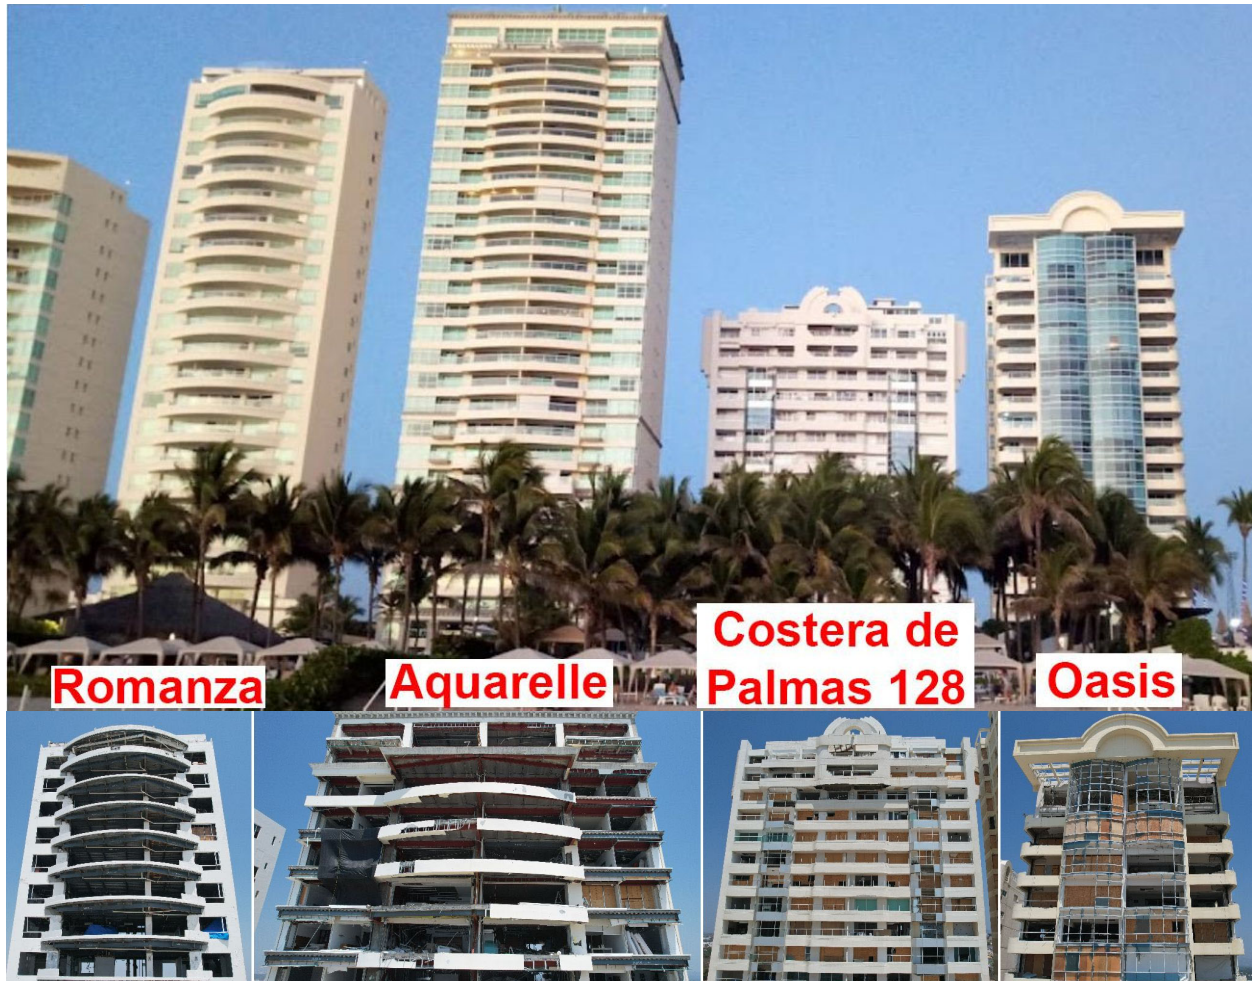
Figure 4.1.7. Cluster 13 SW elevation seaward views; (top) before Hurricane Otis (Source: Google Street View); (bottom) after Hurricane Otis (Source: FAST).

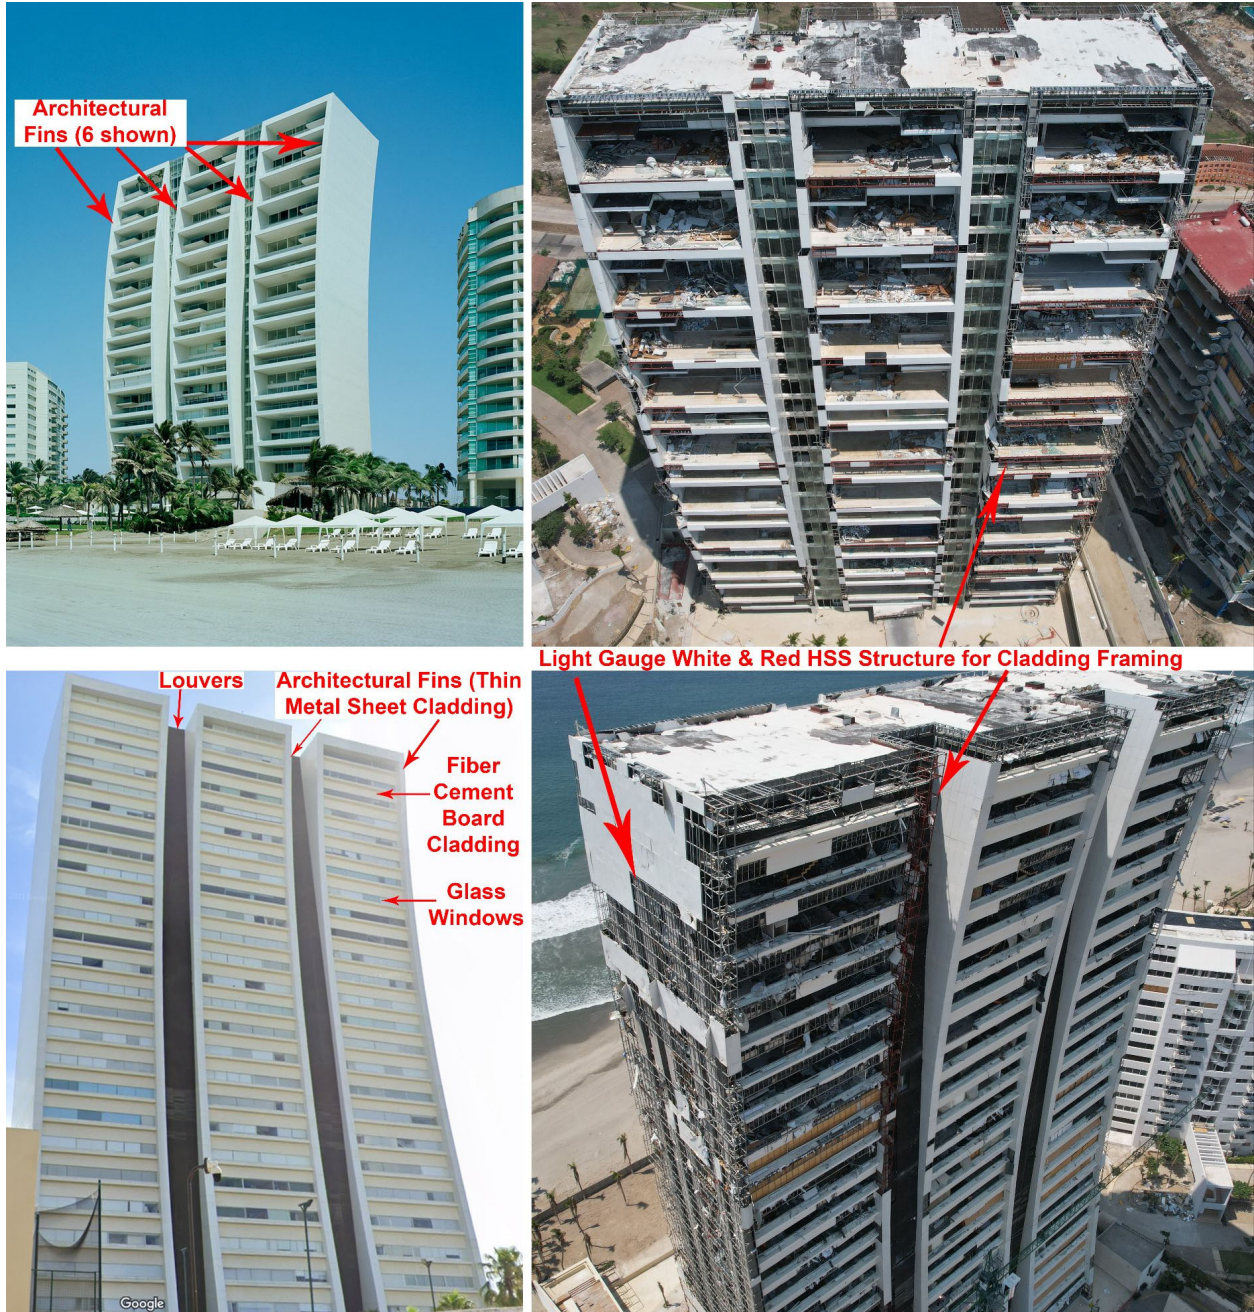
Architectural features of the façade and their supporting secondary structures were destroyed in most mid- and high-rise beach front buildings assessed. These features include aesthetic elements and finishes, shading devices, louvers, and lattice walls. Figure 4.1.8 depicts damage to architectural features and the supporting secondary steel structures of the Marena building in Cluster 15. Marena’s architectural fins (6 thin metal sheet cladding elements supported by light gauge HSS structures) were extensively damaged by wind induced pressures and wind-borne debris. Damage in the field zones of the building’s walls was lower than that in the corner zones.

Figure 4.1.8. Marena (Cluster 15) seaward and landward elevations views; (top, left) before Hurricane Otis view of the seaward SW elevation (Source: Google Street View); (bottom, left) before Hurricane Otis view of the landward NE elevation (Source: Google Street View); (top, right) after Hurricane Otis view of the seaward SW elevation (Source: FAST); (bottom, right) after Hurricane Otis view of the landward NE elevation (Source: FAST).

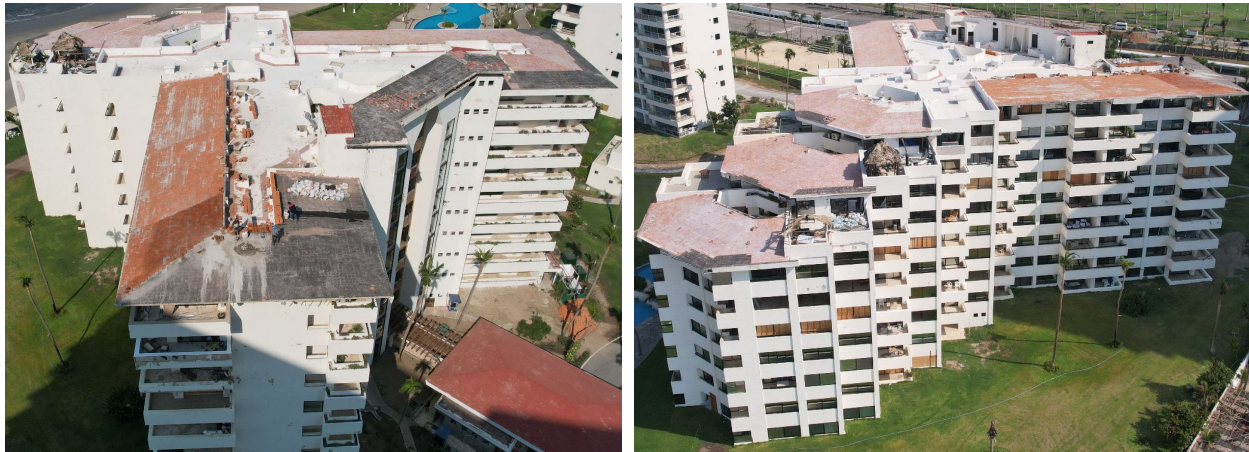
Figure 4.1.9 depicts damage to flat clay roof tile cover. Flat clay roof tile is a typical (traditional) component of roof cover waterproofing systems in low rise building construction in Mexico; nevertheless, it introduces a higher seismic effective weight to the building. Mortar adhesive is used to attach tiles to the roof slab's concrete finished surface. Failure of the tile to slab bond due to tensile uplift forces is depicted in Figure 4.1.9.

Figure 4.1.9. Roof cover (Flat Clay Roofing Tile) damage at Torre Uno Condominio in Cluster 12 (Source: FAST).

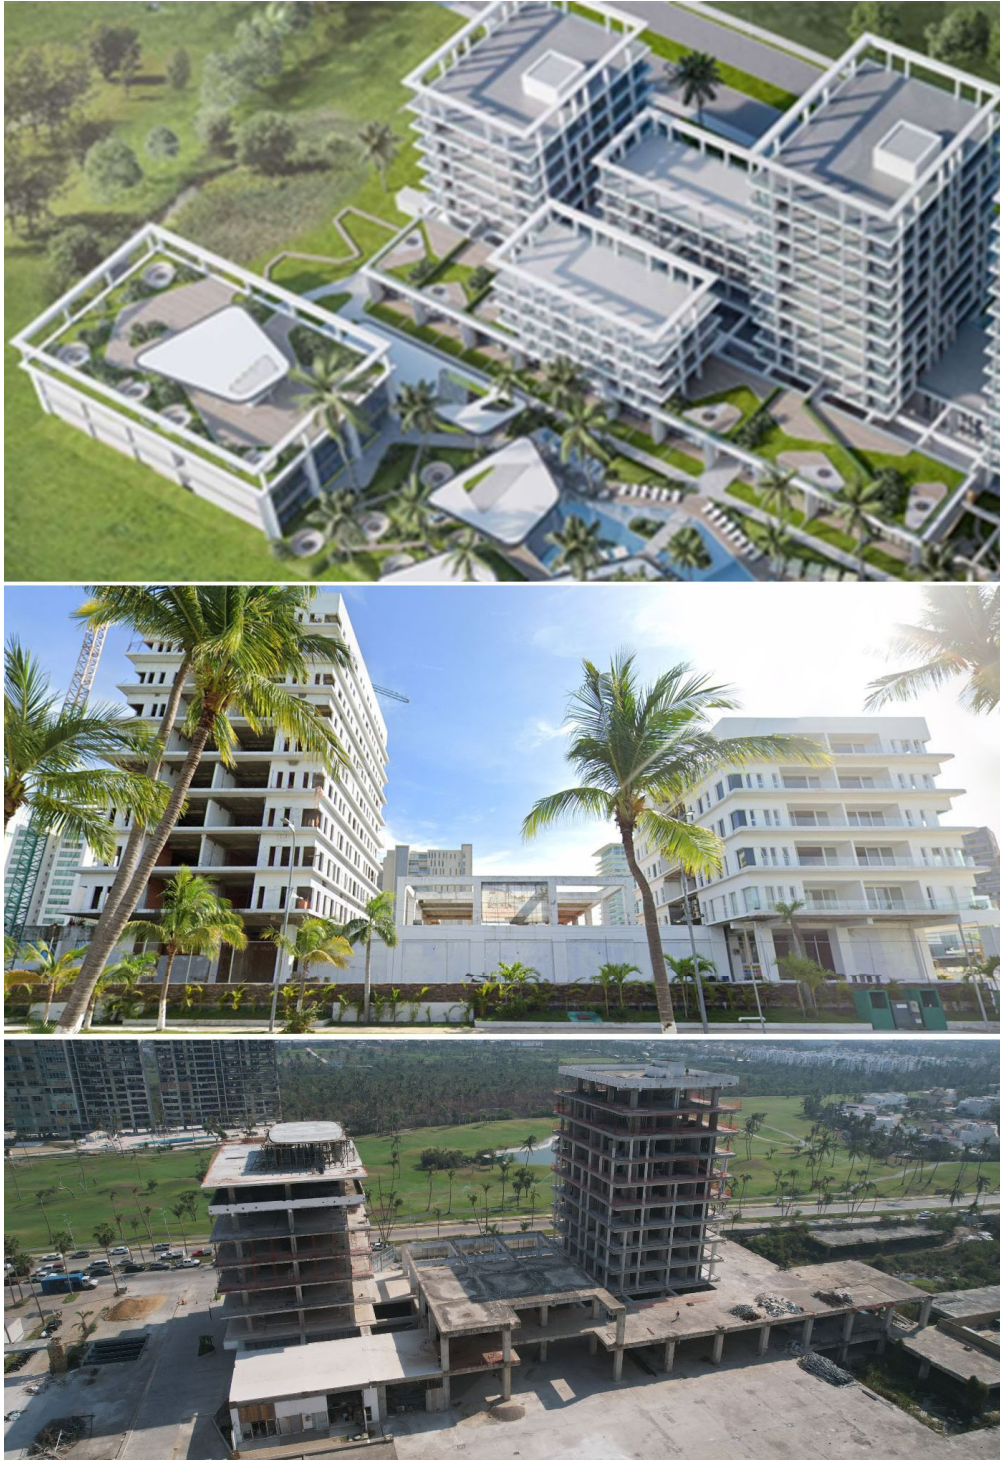
Figures 4.1.10 and 4.1.11 show damage to the wall cladding and building envelopes at Maroa (Cluster 11) and Solar Ocean (Cluster 15), respectively. The damage to the Maroa building was so extensive that the assessment team initially thought the building was still in construction; however, construction of the building had been recently concluded (the most recent photograph of the complex from Google Street view, dated August 2021, shows the buildings in a near completion phase). The damaged elements had clearly been completely removed from the structure in preparation for reconstruction. The pre-Otis image in Figure 4.1.10 is a rendering from the developer's website. Wall assemblies of Solar Ocean and its neighbor Costa Bamboo consisted of double wythe walls with a clay, jumbo format, mechanically extruded brick internal wall and an external wythe of cement board cladding supported over cold formed steel studs. Use of this construction detail in the luxury apartments in these complexes does not reflect prioritizing the minimization of the seismic effective weight to reduce the earthquake-induced inertial loads. Regardless, the double wythe assemblies in Solar Ocean and Costa Bamboo were, respectively, completely destroyed and extensively damaged.

Figure 4.1.10. Maroa (Cluster 11) loss of wall cladding and building envelope; (top) rendering (Source: <https://maroadiamante.mx/>); (middle) before Hurricane Otis on August 2021 view of the NE elevation (Source: Google Street View); (bottom) after hurricane Otis view of the SW elevation, after removal of damaged elements (Source: FAST).

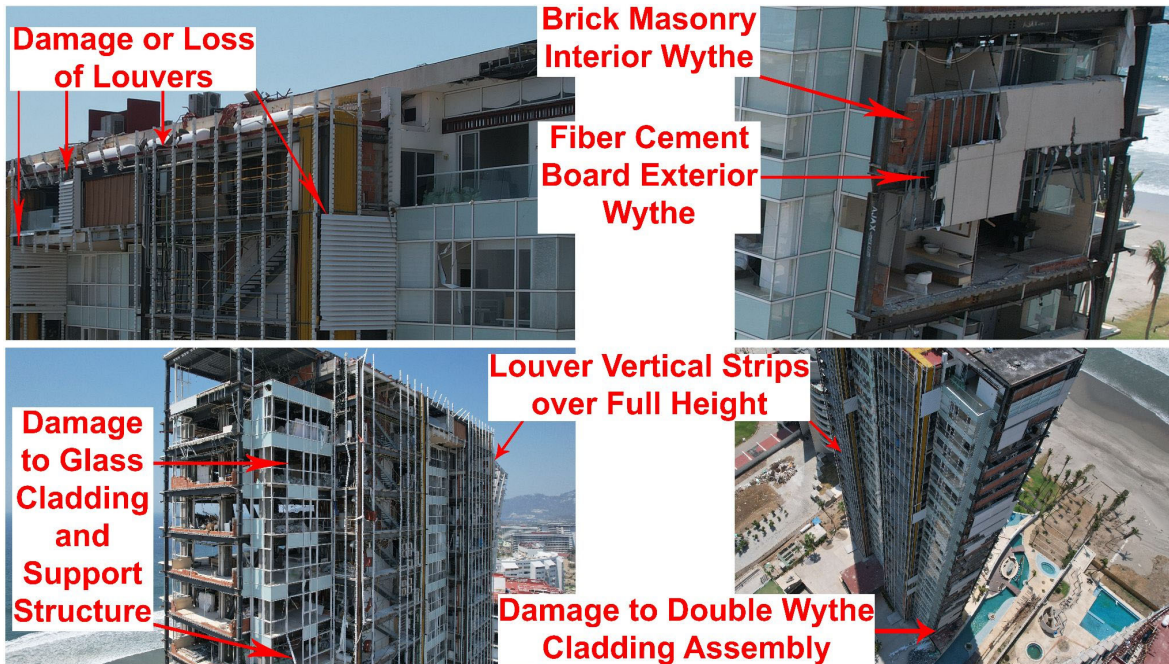
Figure 4.1.11. Wall building envelope damage at Solar Ocean in Cluster 15 (Source: FAST).

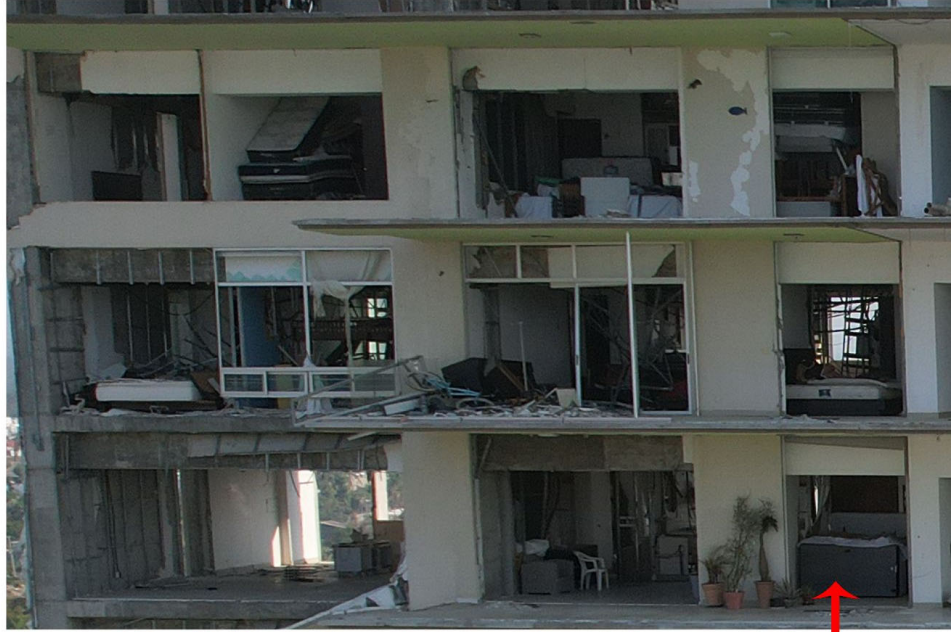
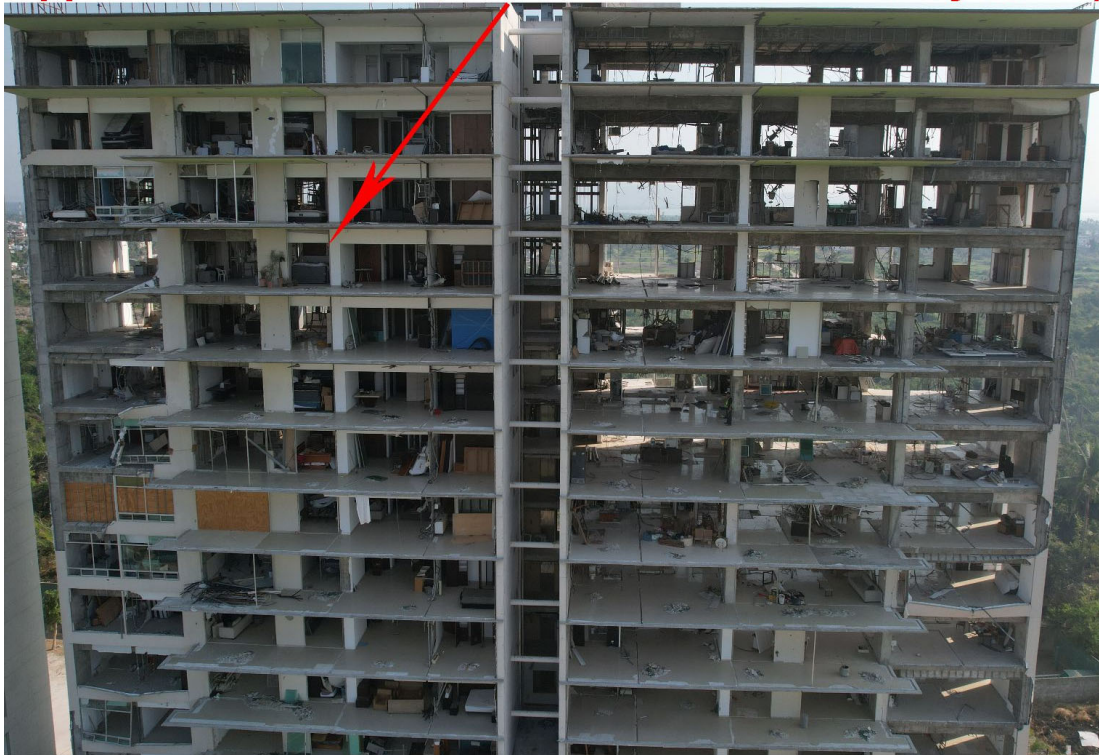
Figure 4.1.12 depicts the damage sustained by the non-structural components and the building's contents of Condominio Laguna Towers (Cluster 11). Wind pressure- and water-induced damage rendered all contents unusable. These observations were recurrent in nearly all buildings assessed.

Loss of Building Contents (Partitions, False Ceiling, Appliances, Furniture, Finishes, MEP & HVAC Systems)

Figure 4.1.12. Damage to Building Contents at Condominio Laguna in Cluster 11, fairway view (Source: FAST).

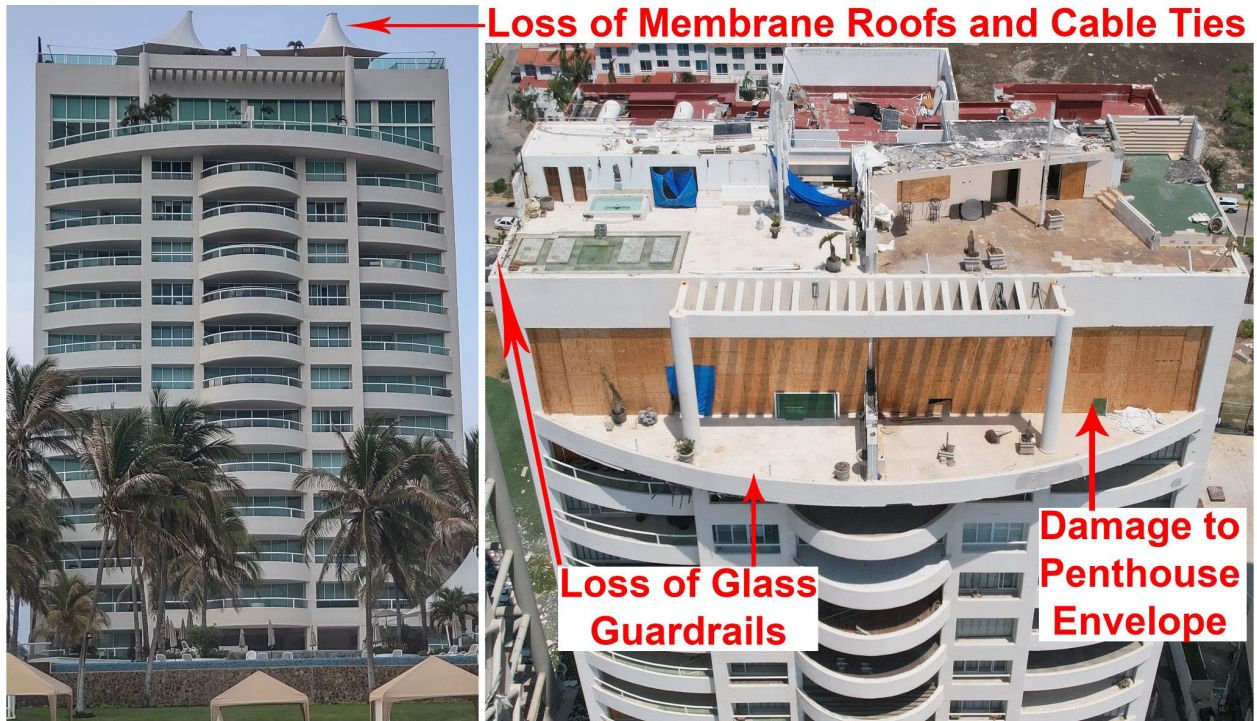
Figure 4.1.13 presents damage to the penthouse, appendages, and canopies of Torre Playa Diamante (Cluster 13). Canopies, appendages, and penthouse components and cladding in the assessed buildings featuring amenities were destroyed. Identifying this type of damage during the FAST was not possible as the team was not aware that there had even been a penthouse; comparison of pre-Hurricane Otis images with those obtained during the FAST was necessary.

Figure 4.1.13. Torre Playa Diamante (Cluster 13) damage to penthouse and appendages, view of the SW, beachfront, elevation; (left) before Hurricane Otis (Source: Google Street View); after Hurricane Otis (Source: FAST).

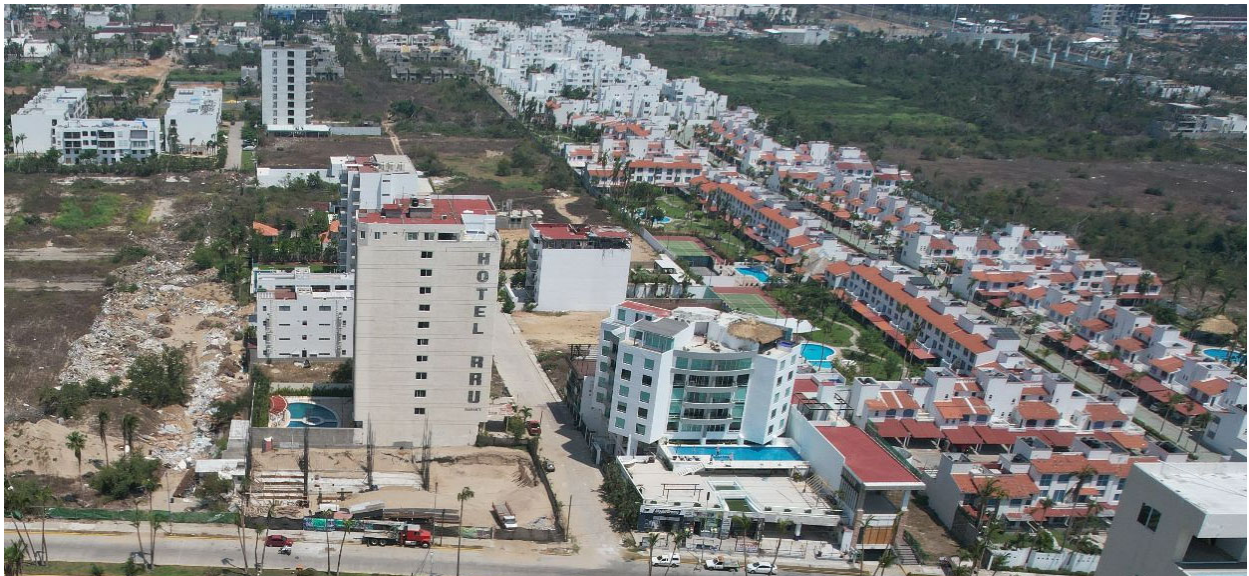
Figure 4.1.14. Overall view of buildings inland from Clusters 13 and 15 (Source: FAST).

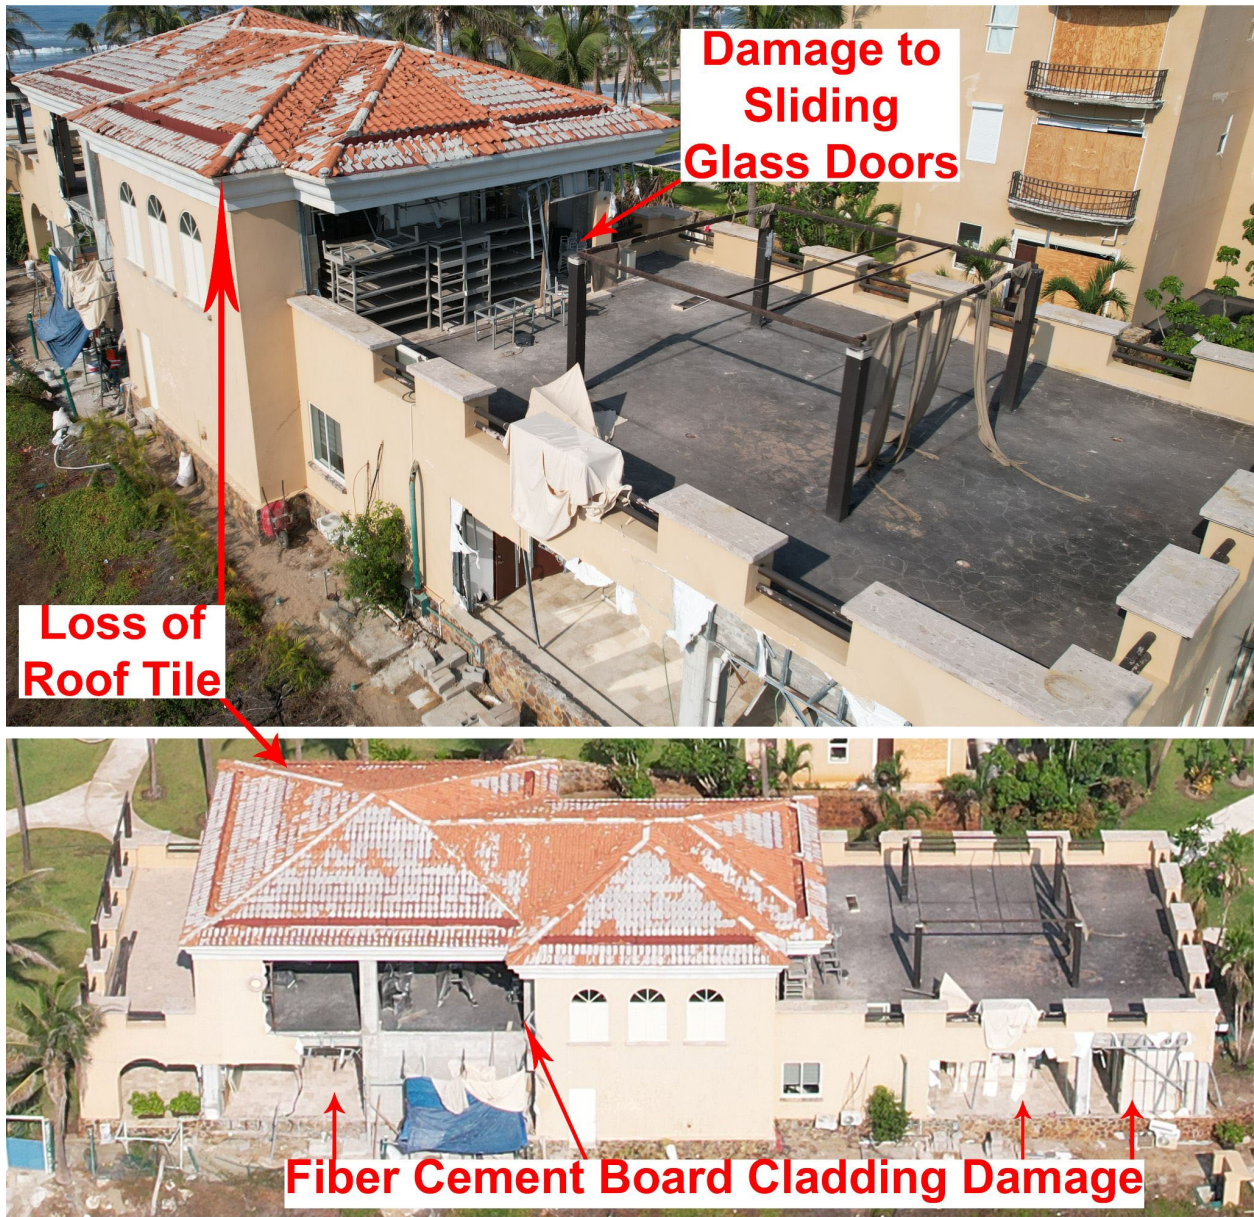
Figure 4.2.1 depicts extensive damage to the building envelope and components & cladding of a 2-story accessory building of the residential complex Del Mar Tres Vidas in Cluster 03. The building envelope system in this building was not part of the LFRS for seismic loads (reinforced concrete moment resisting frames). Observations for this building are consistent with those presented in section 4.1.

Figure 4.2.1. Damage to building envelope and components and cladding of accessory building
 (Source: FAST).

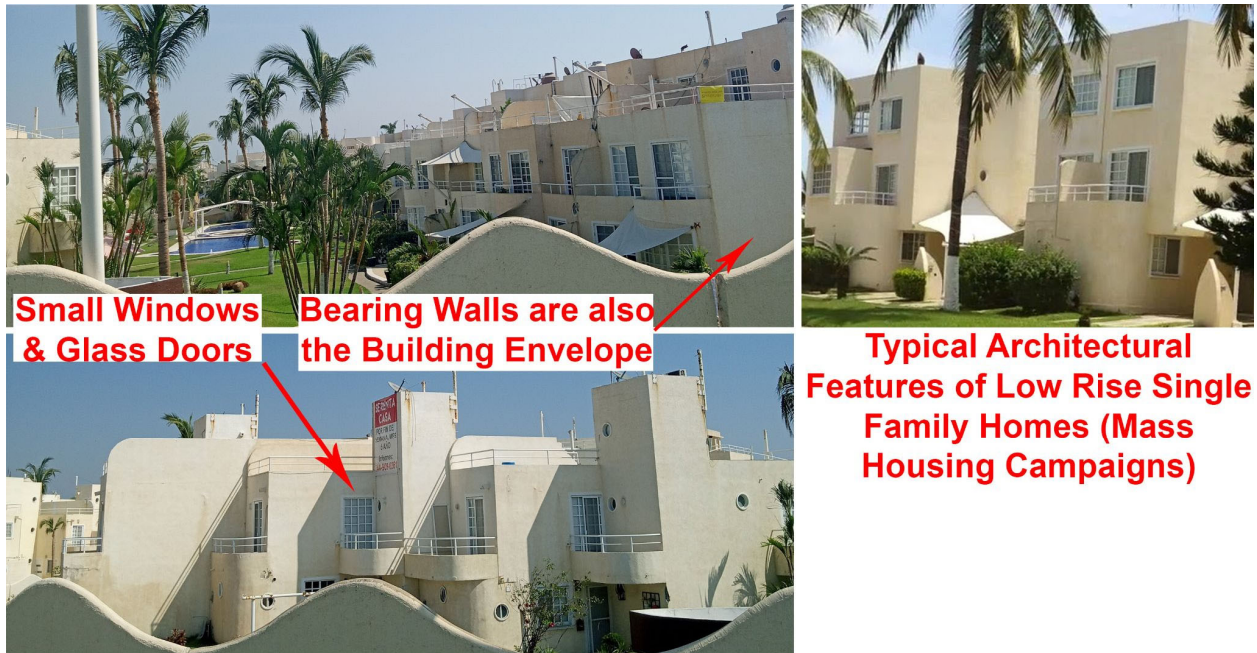
Figure 4.2.2 shows minor damage to the building envelope and components & cladding of the single family engineered homes in the Barra Vieja area. The minor damage was concentrated in the windows (likely due to impact of wind-borne debris) and roof tiles. Construction type and damage to low-rise residential single-family housing in the assessed areas (tourist areas of Diamante and Barra Vieja) is not representative of the lower income areas of the region that were severely affected by the hurricane but not accessible to the FAST. These observations also applied to multi-family low rise residential buildings (2-5 stories) with construction typology similar to that of buildings eligible for government mortgage sponsored programs (e.g., INFONAVIT). INFONAVIT-style construction, either single- or multi-family, implement reusable aluminum formwork to satisfy the demands of mass housing campaigns. The characteristic structural system of cast in place reinforced concrete bearing walls serves as both the LFRS and the building envelope (Figures 4.2.2 and 4.2.3 present examples of multi-family INFONAVIT style complexes with minor damage in the Diamante and Barra Vieja areas).

Figure 4.2.2. Minimum damage to building envelope and components and cladding of single-family homes in the Barra Vieja area; (left) after Hurricane Otis (Source: FAST); (right) before Hurricane Otis showing typical architectural features (Source: Google Street View).

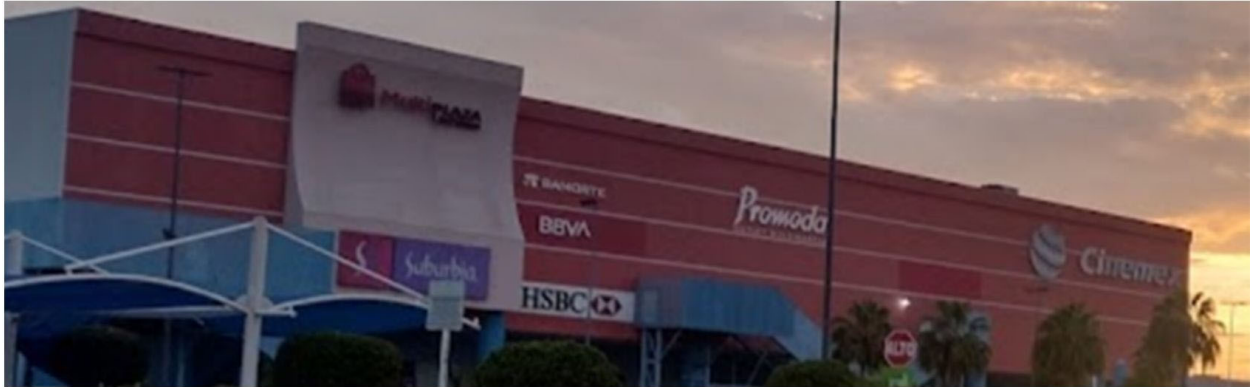
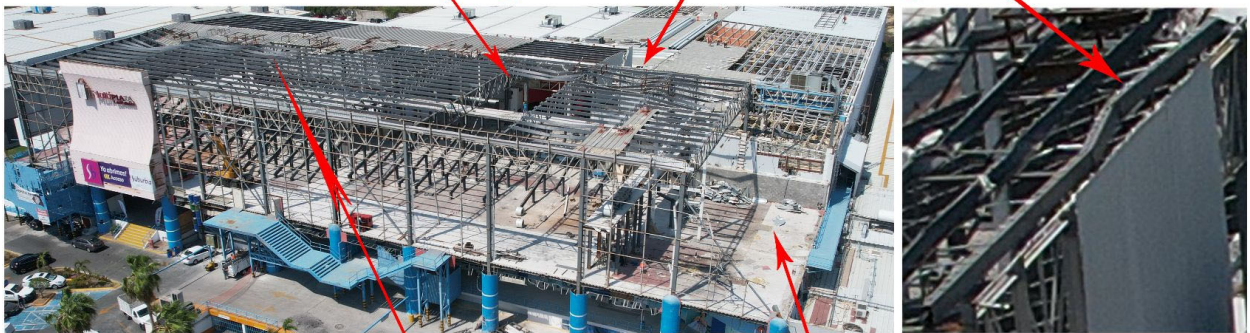
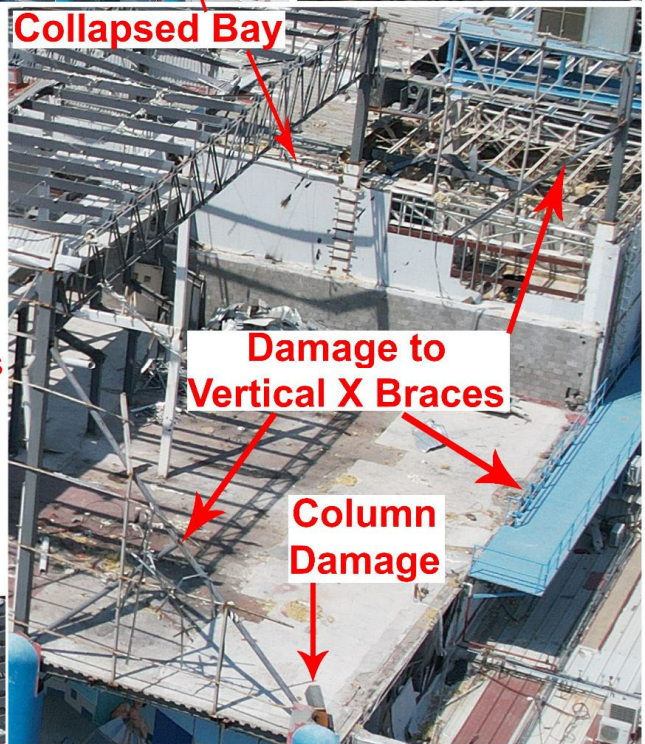
- The KIA car dealership, Multiplaza las Palmas shopping center, and Centro Comercial Harbour in the Diamante area were severely affected (Figures 4.3.1-4.3.3). The Multiplaza las Palmas (Fig. 4.3.1) sustained wind-induced collapse of a section of the main structure, extensive loss of cladding, and failure of the secondary structure (wall girts and roof purlins). A complete bay (purlins, truss, and columns) collapsed in this building (refer to the bottom right corner of Figure 4.3.1). The partial collapse observation represents a brittle failure of the LFRS of the building. The relative magnitudes of seismic- and wind-induced design loads and the differences in the hypothetical bases and objectives of the LFRS design approaches (reduced seismic load inelastic design vs. traditional linear elastic wind design) could have affected the performance of the LFRS in this building. This scenario highlights a disadvantage to the traditional wind elastic design approach: the structural systems were designed with no knowledge of their inelastic behavior (Tabusso et al., 2016). The results were an “unknown post-yield behavior” and an “undesirable collapse scenario”. In addition, the building was subjected to total loss of interior contents; one of the tenants was a cinema theater.

Total Loss of Purlins in Bay Buckled Diaphragm Collector

Loss of Standing Seam Roof Panels (Loss of Membrane and Diaphragm Actions)

Lateral Torsional Buckling of Purlins

Collapsed Bay

Damage to Vertical X Braces

Column Damage

Figure 4.3.1. Damage to Multiplaza las Palmas; (top) before Hurricane Otis (Source: Google Street View); (middle and bottom) after Hurricane Otis (Source: FAST)

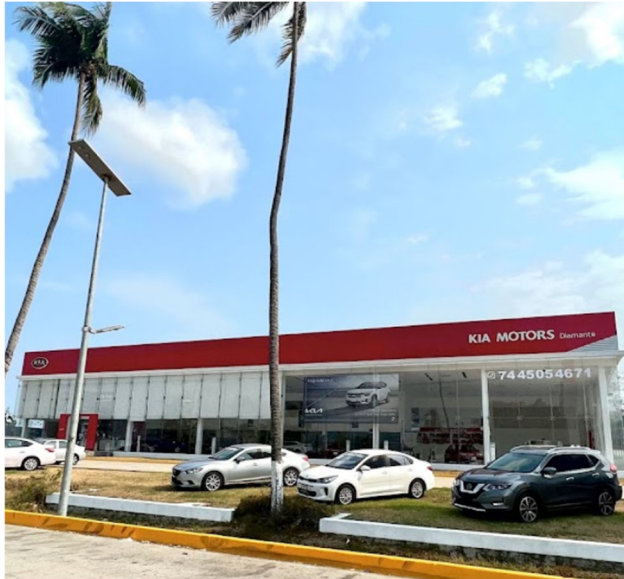
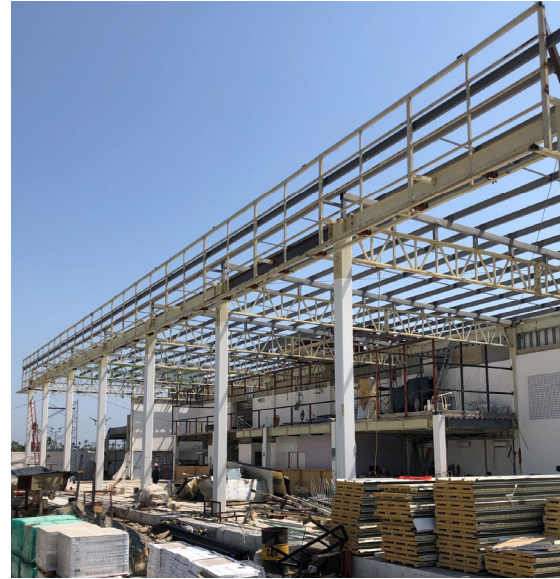
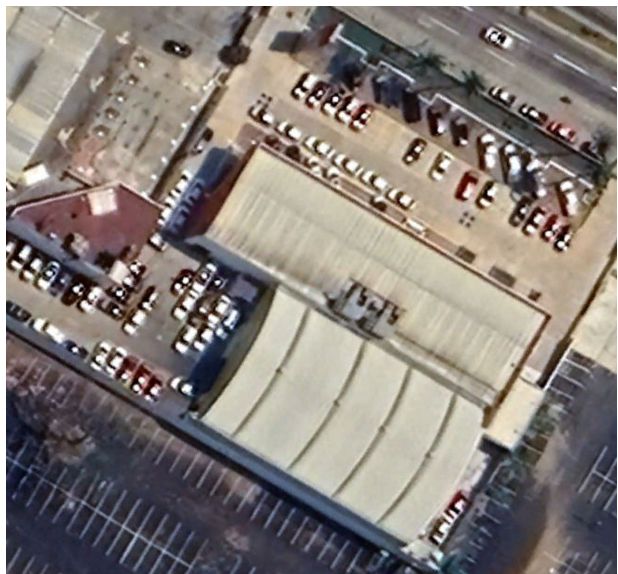
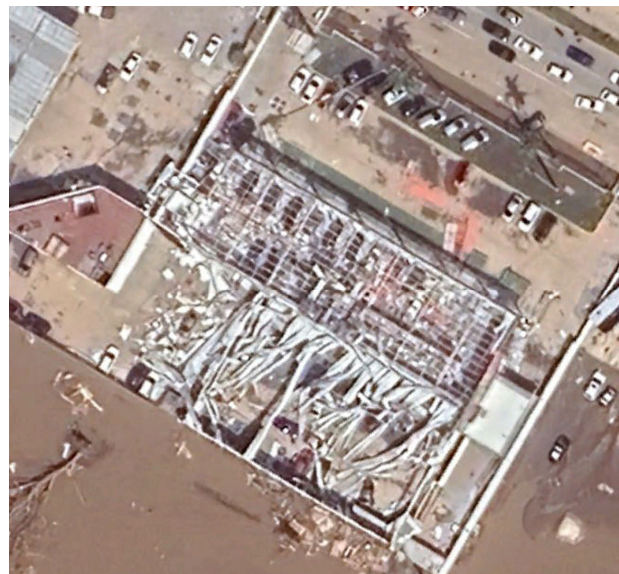
The KIA Diamante Dealership (Fig. 4.3.2) cladding (glass panes, alucobond, and metallic standing seam roof) was destroyed. In addition, components of the secondary steel structures and roof purlins were damaged and all interior contents were lost. The KIA dealership’s accessory building with arched roof was subjected to complete wind-induced collapse. Other car dealerships in the area were subjected to similar cladding damage.

Figure 4.3.2. Damage to KIA Diamante Dealership: (a) Elevation view pre-Hurricane Otis (Source: Google Street View); (b) Elevation View post-Otis (Source: FAST); (c) Aerial view pre-Hurricane Otis (Source: Google Street View); (d) Aerial view Post-Hurricane Otis (Source: Google Earth)

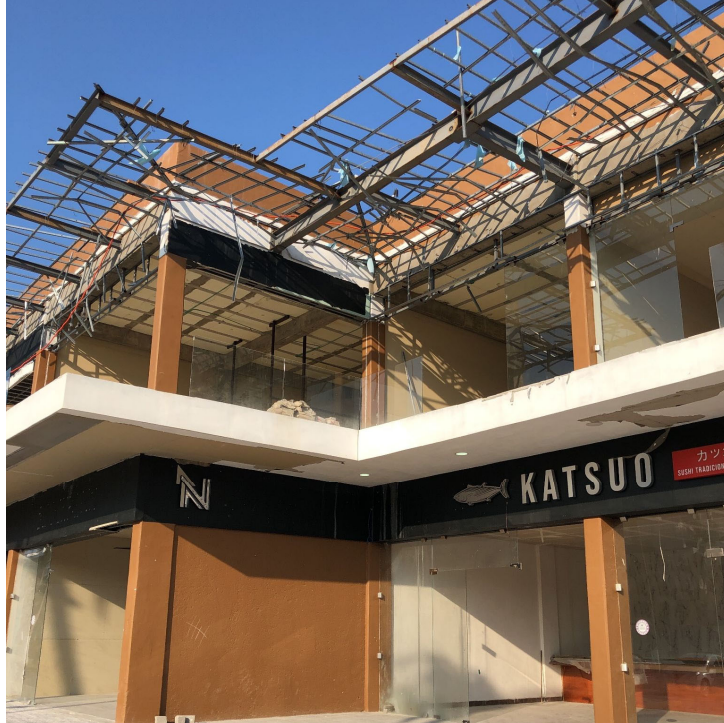
The Centro Commercial Harbour complex consisted of a reinforced concrete structure with selected structural steel assemblies (e.g., canopies, corridor colonnade) and the large shop front glass façade elements characteristic of retail occupancies. Figure 4.3.3 illustrates destruction of the steel canopies, building contents, glass guardrails, and glass cladding/doors.

Figure 4.3.3. Damage to Centro Commercial Harbour (Source: FAST)

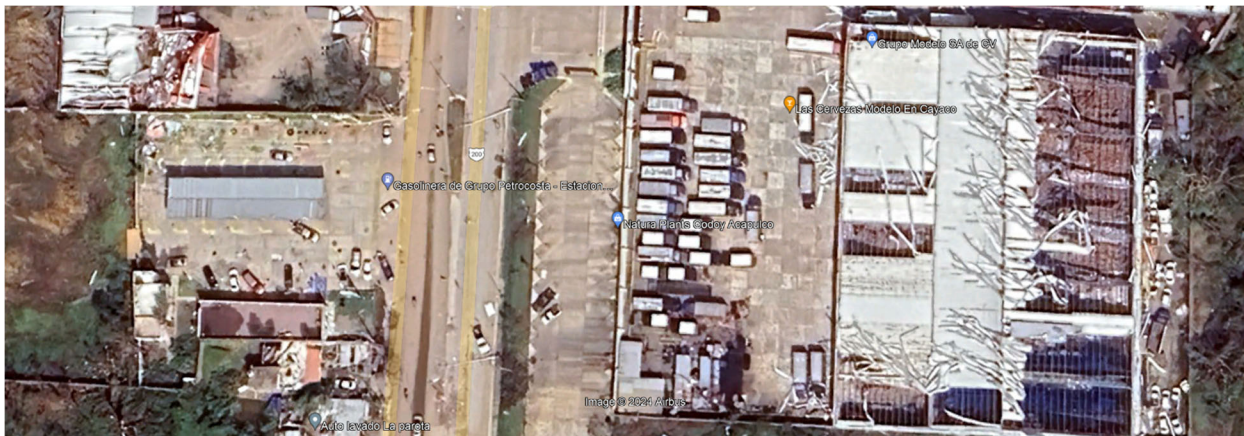
Regular-shaped single-story industrial buildings were severely damaged by Hurricane Otis' winds. The damage includes engineered and non-engineered structures of small businesses and large corporations. Large national (e.g., Bimbo Bread and Grupo Modelo Beer) and international corporations (e.g., Home Depot, WalMart) operate facilities in the region (some in the commercial corridor within Cluster 09). Buildings operated by these corporations are engineered structures designed with recent building code editions. Figures 4.3.4 and 4.3.5 depict roof cladding damage of Grupo Modelo and Bimbo facilities.

Figure 4.3.4. Grupo Modelo in Cayaco (Source: Google Earth)

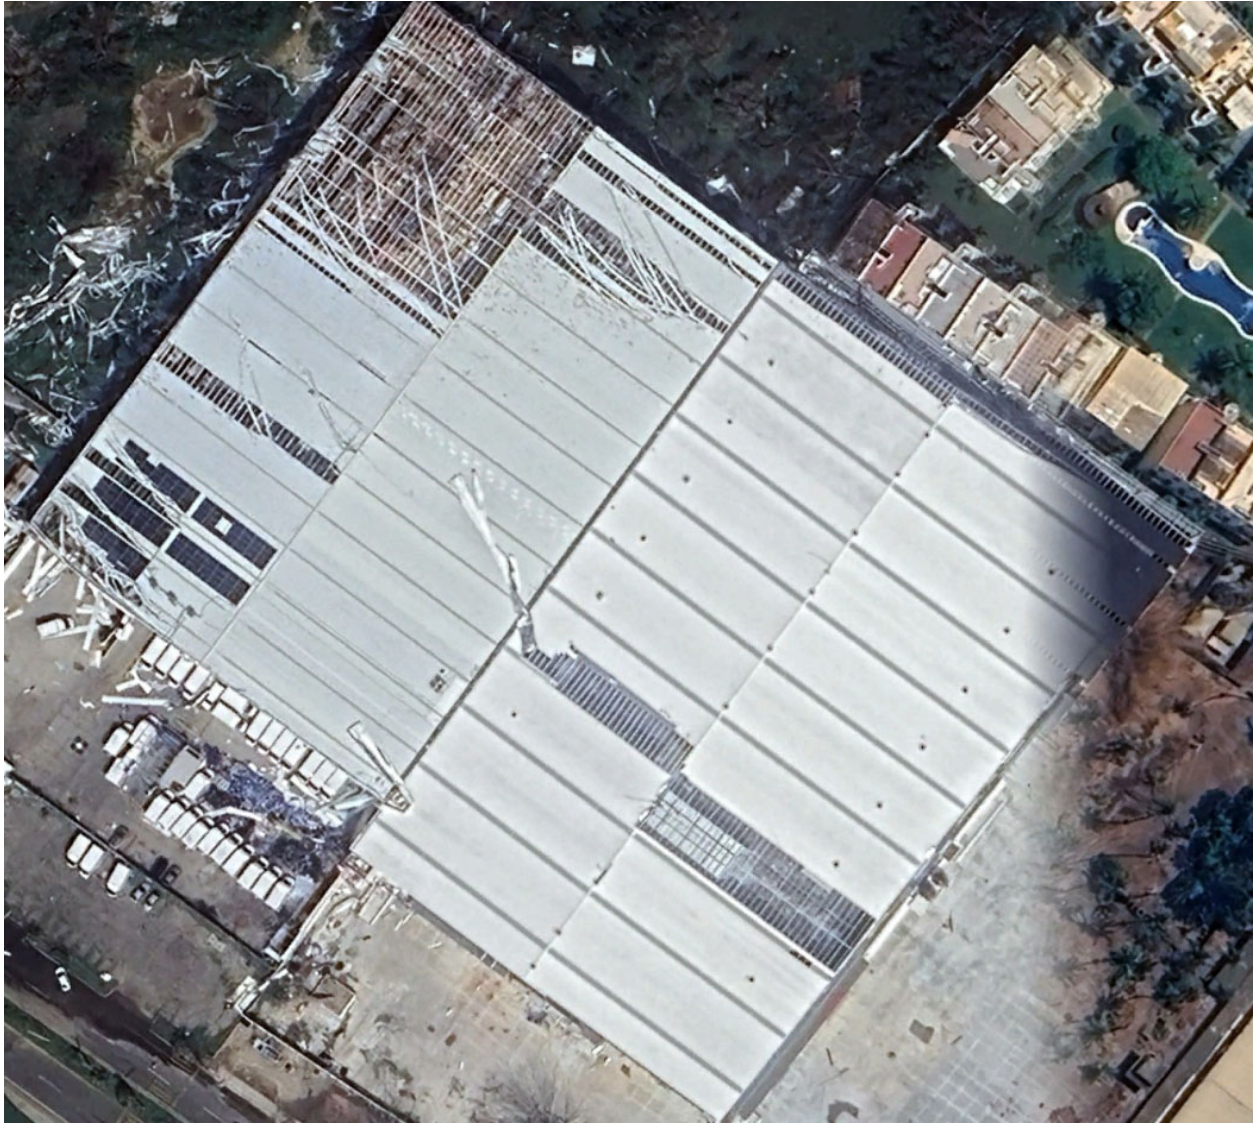
The Bimbo bread distribution center consists of two warehouses (Fig. 4.3.5). Construction of warehouse 1 on the left concluded approximately in 2015 and construction of warehouse 2 on the

right concluded in mid-2023. Warehouse 1 had to be completely reroofed. The buildings don't exhibit any geometric irregularities deviating from the code adopted hypothesis in the wind load quantification procedures.

Figure 4.3.5. Bimbo Distribution Center, including Warehouse 1 on the left and Warehouse 2 on the right (Source: Google Earth).
