StEER
STRUCTURAL
EXTREME EVENTS
RECONNAISSANCE

Hurricane Otis
October 25, 2023
Released: September 18, 2024
NHERI DesignSafe Project ID:
PRJ-4231

EARLY ACCESS RECONNAISSANCE REPORT (EARR)

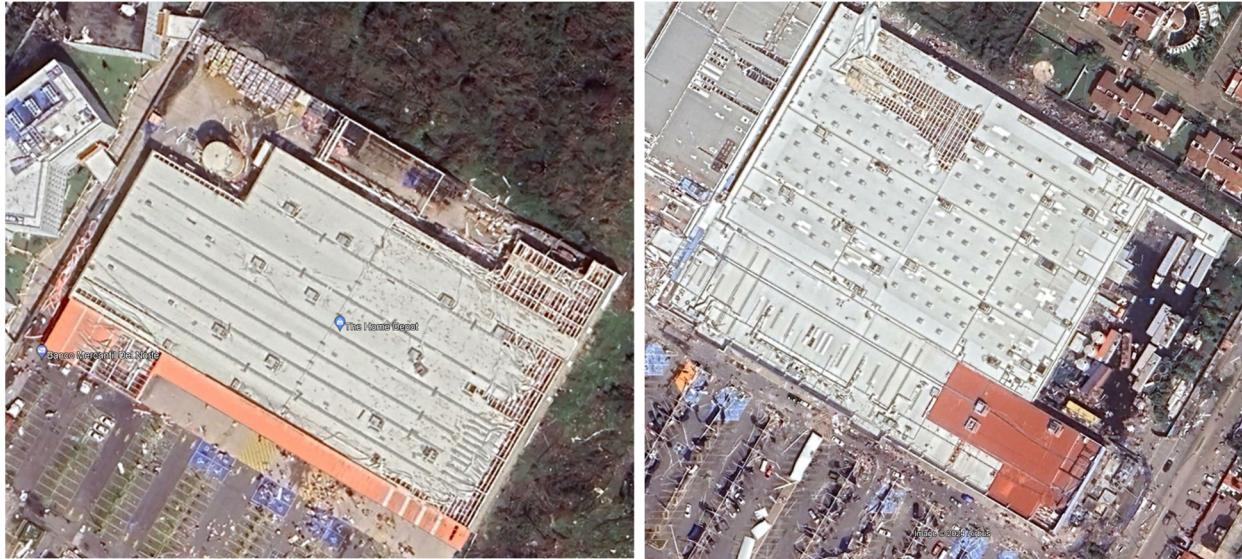
Home Depot and WalMart wholesale stores (Fig. 4.3.6) were subjected to similar damage as that depicted in Figures 4.3.4 and 4.3.5. In addition, all of the carports in their parking lots collapsed. WalMart is adjacent to Multiplaza las Palmas (on the east), Sam's Club is adjacent to Multiplaza las Palmas (on the west), and Home Depot is located about 100 meters to the west of Sam's Club. Figure 4.3.6 depicts the damage to roof cladding experienced by Home Depot (left) and WalMart (right). Damage to carports in the WalMart parking lot is also shown in this figure. Engineered structures in this area were extensively damaged (Soriana wholesale store was

Figure 4.3.6. Damage to Home Depot (left) and WalMart (right) in Cluster 09 (Source: Google Earth).

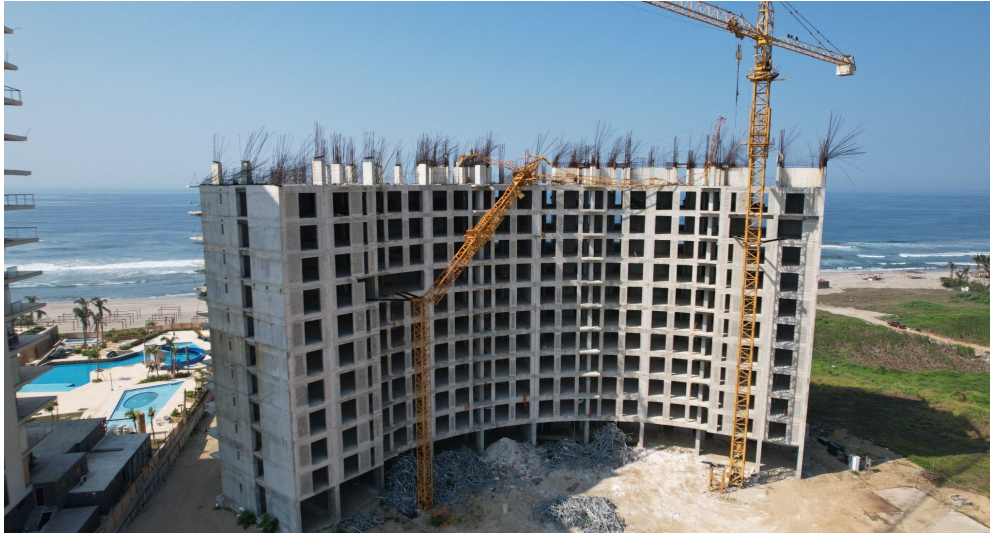
Figure 4.4.1. A tower crane collapsed onto a building under construction (Source: FAST).

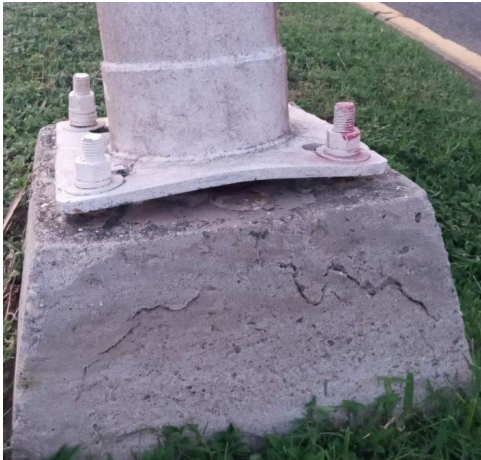
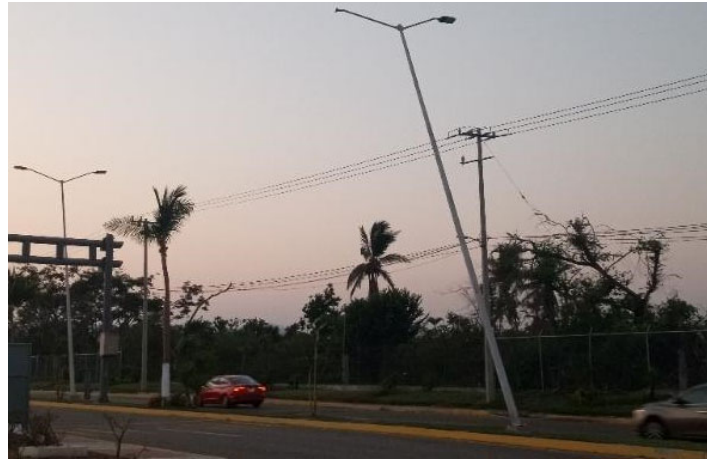
Figure 4.4.2. Brittle damage of public lightning poles, including rotation of foundation and out-of-plane base plate bending (Source: FAST).

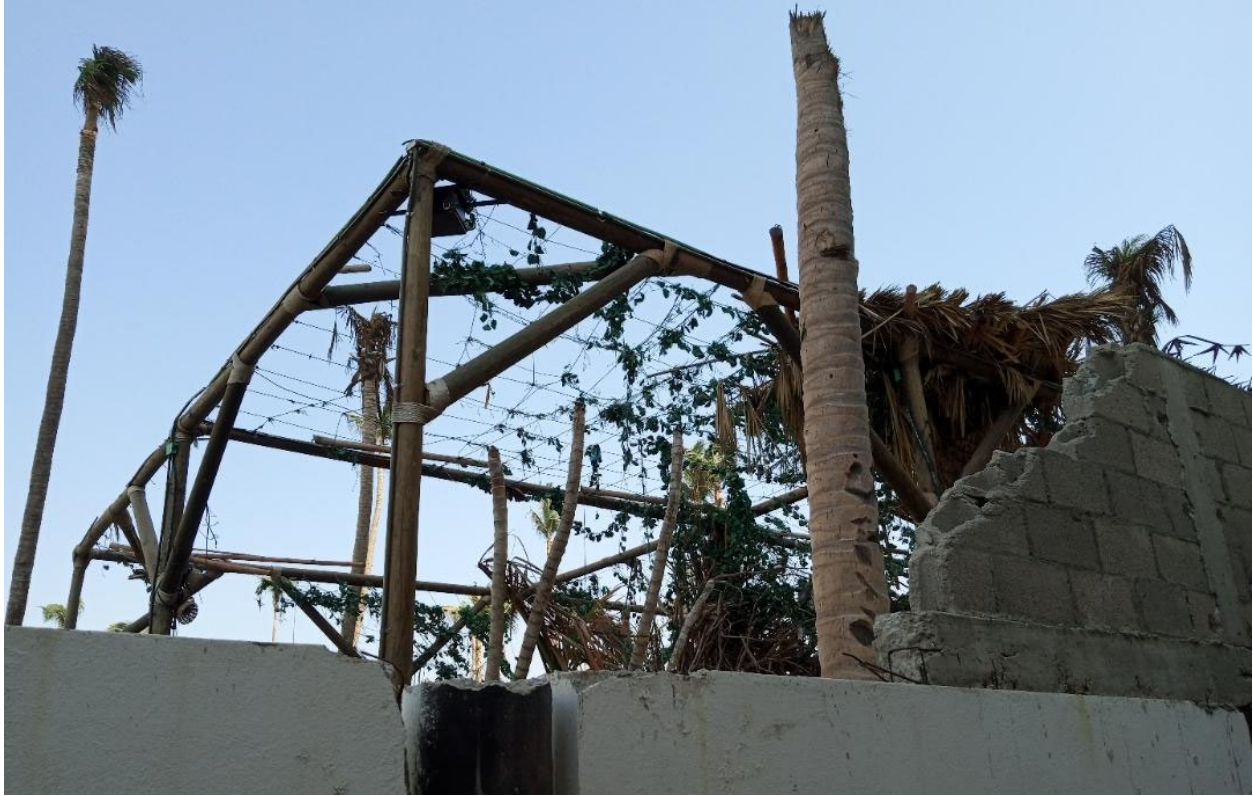
¹ The team did not prioritize photographs of damaged free-standing masonry walls because their failures were consistent and brittle, due to out-of-plane shear in the tie columns at a region of stress transfer either to a plinth beam at the foundation interface or bond beam in an interface with a supporting element.

Figure 4.4.3. Out-of-plane damage to masonry wall (tie element on top of black column sheared off completely) and damage to a palapas, a non-engineered wood structure with palm thatched roof (Source: FAST).
