## Mw 5.6 Indonesia Earthquake

2022 Nov 21

NHERI DesignSafe Project ID:  
PRJ-3781

### PRELIMINARY VIRTUAL RECONNAISSANCE REPORT (PVRR)

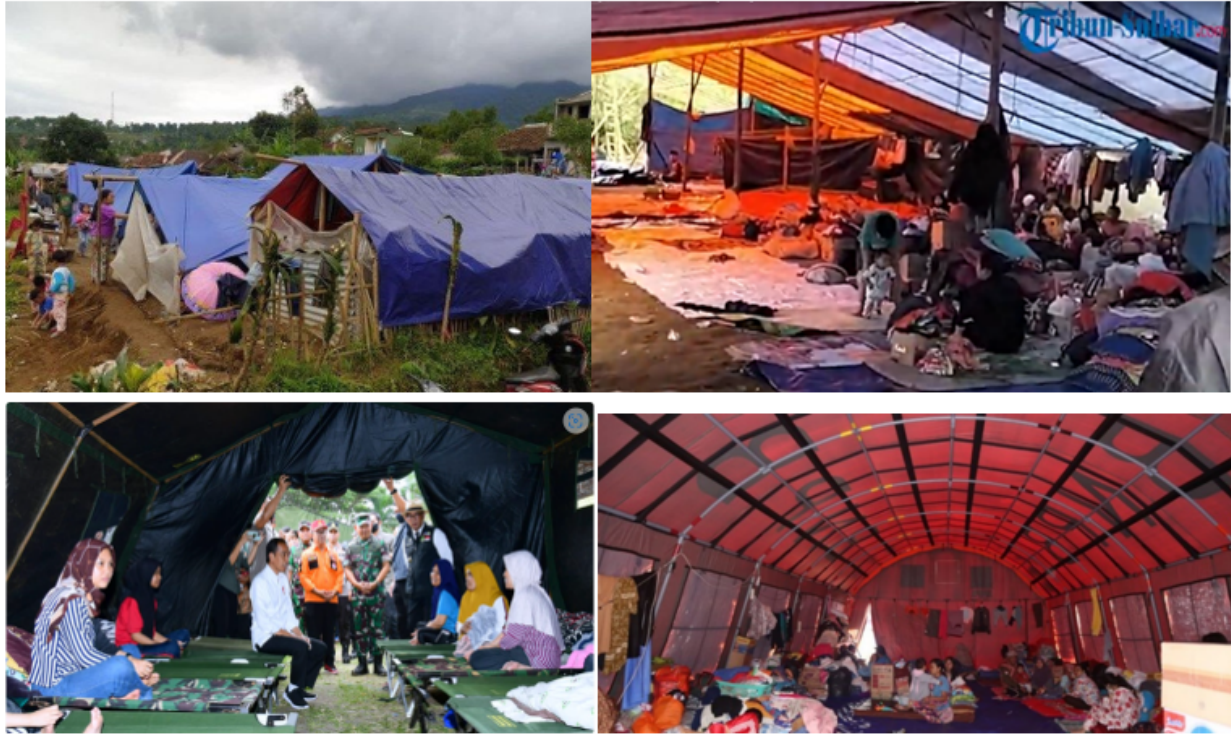
As recently as November 27th, 2022, BNPB recorded 325 locations of displaced residences. Each location has the capacity of maximum 25 people (Yahya, 2022). The displaced residences are housed in emergency tents built by the residents and the volunteers. Those emergency tents are built using a tarpaulin supported by bamboo (see Figure 4.1).

Figure 4.1 – Displaced residences in Cianjur region.

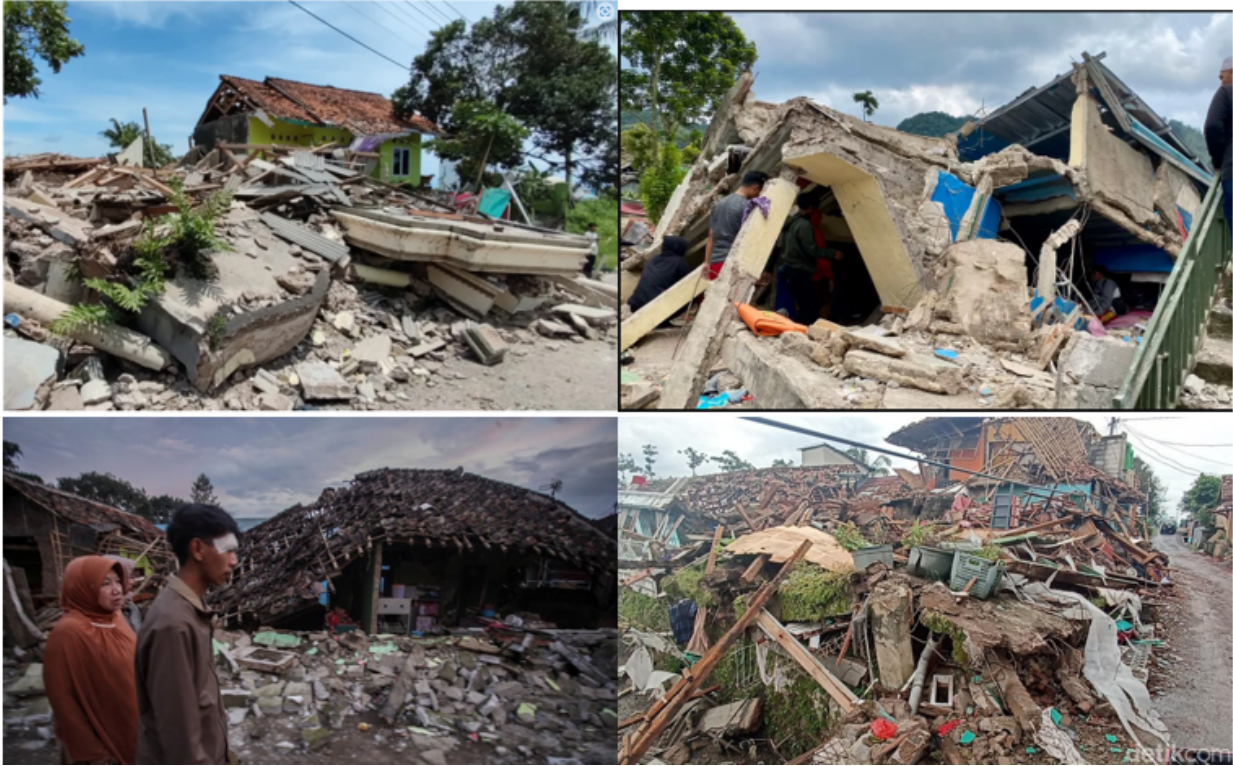
By looking at the post-earthquake photos, the most common damage that occurred on residential buildings are gravity (pancake) collapses and sideways collapses. The gravity collapses might have occurred because of the soft/weak story formations due to the small column dimensions and the presence of openings at the lower stories. Furthermore, axial force capacities of columns could have been exceeded because of the small column sizes and low concrete strength. Large axial force ratios accompanied by shear failures could have led to the observed gravity collapses. Insufficient reinforcement anchorage at beam-column joints might have also triggered collapse (see Figure 4.2, intact column on the top right photo hints to the beam-column joint failures leading to collapse). The sideways collapses happened mostly because the masonry infill or the brick infill were detached completely from the main structures, or they were collapsing out-of-plane. According to common practice in Indonesia, masonry infills and/or concrete brick infills are bonded with unreinforced mortar. Also, they are rarely anchored to the main structures. Therefore,

Figure 4.2 – Pancake collapses (Project Hope, 2022; BBC, 2022a; tirto.id, 2022; Fadhillah, 2022).

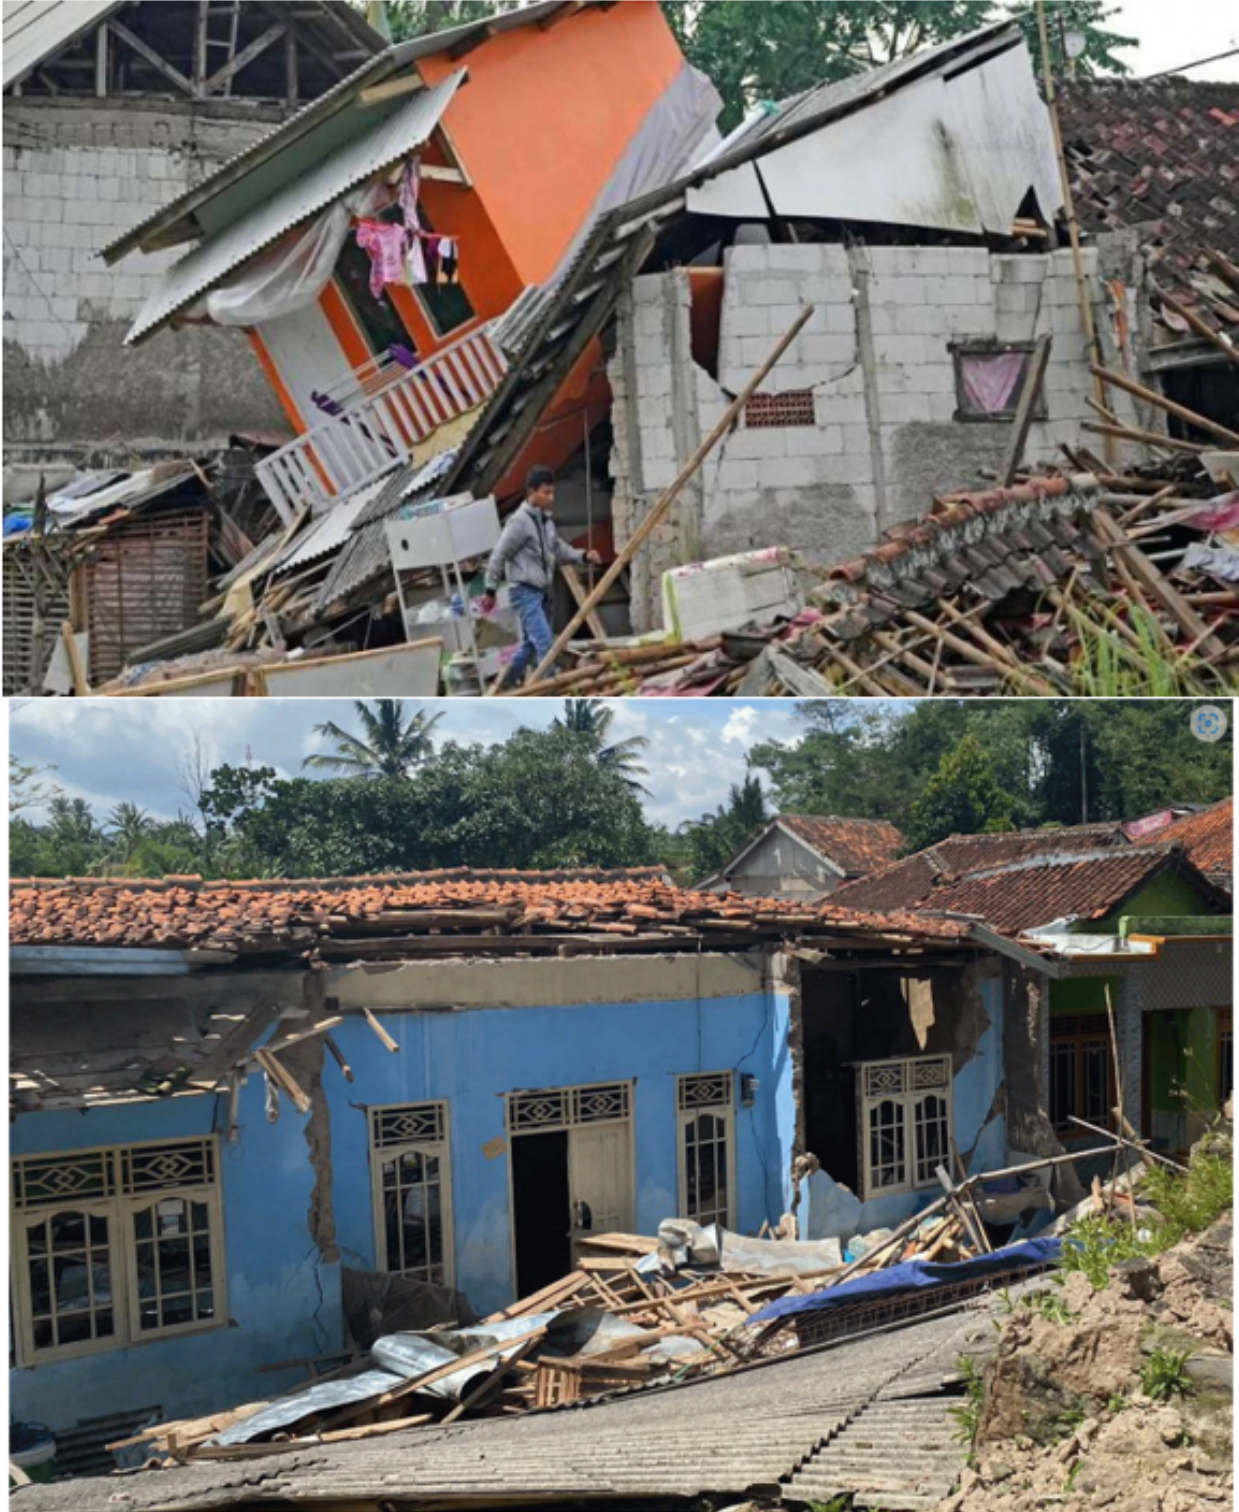
there is not a proper load path to resist the lateral forces (see Figure 4.3). Other pictures of residential building collapses are shown in Figures 4.4 and 4.5.

Figure 4.3 – Damage to masonry and concrete brick infills (Project Hope, 2022; Nugraha and Firdaus, 2022).

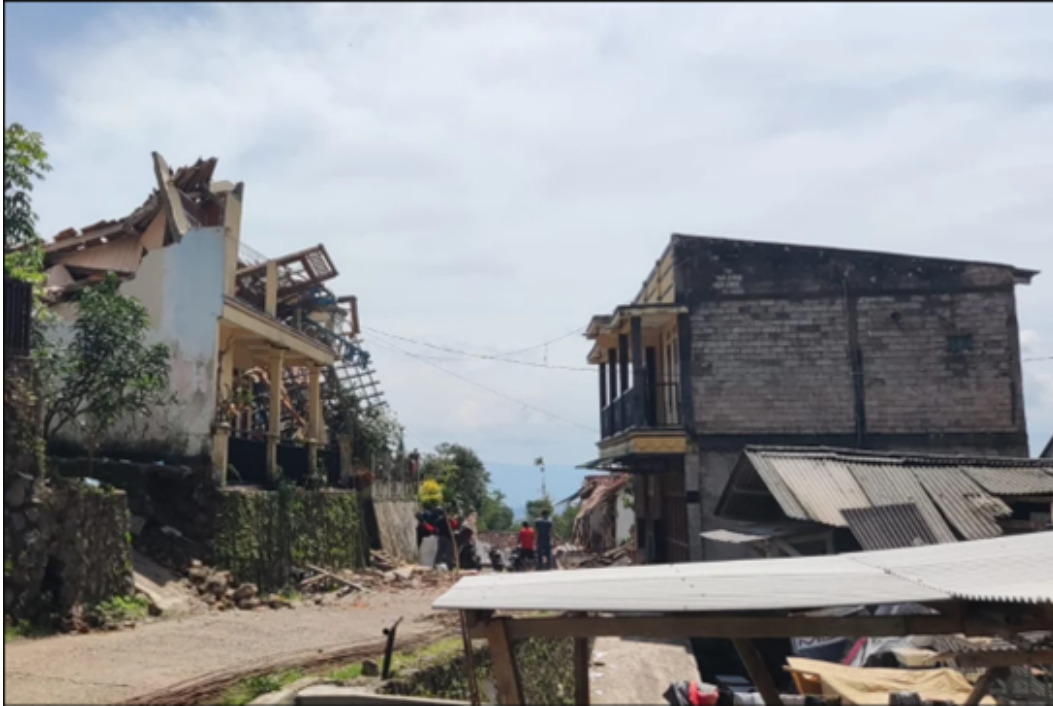
Figure 4.4 – A collapsed building next to a survived building (Project Hope, 2022).

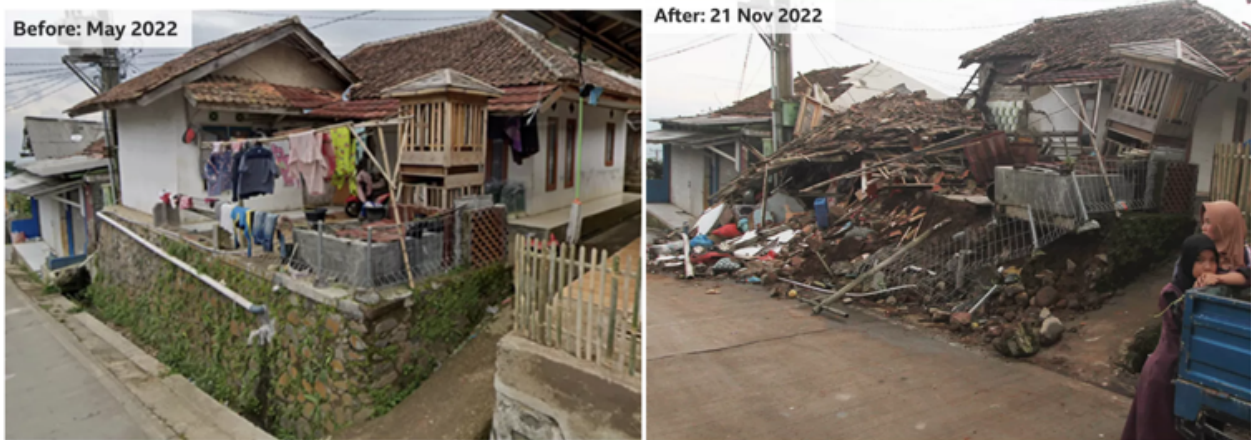
Figure 4.5 – Before and After Picture of Damaged House in Nyalindung Village, Cianjur Region, West Java Province (BBC, 2022a).

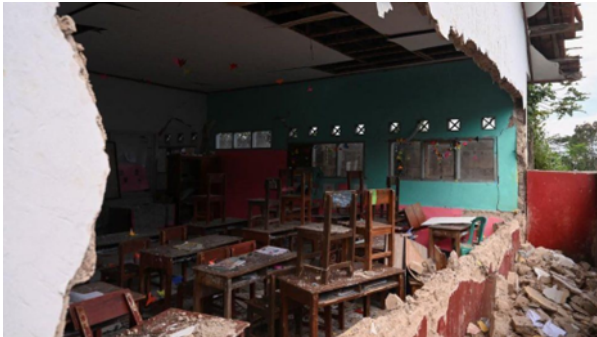
<p>(a) Collapse of Islamic boarding school in Cianjur (BBC, 2022a). Damage appears to be caused by a combination of soft-story, and soil and foundation failures, leading to a pancake collapse</p>	<p>(b) Damaged classroom in concrete masonry building in Cianjur (BBC, 2022b)</p>

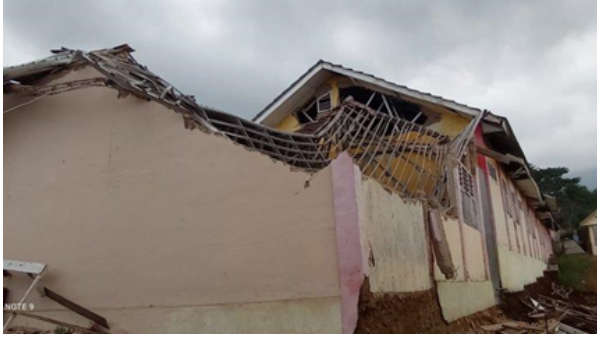
<p>(c) Collapsed school building in Cianjur. The building was constructed with a concrete frame with wood and clay roofing. The concrete frame appears to have collapsed and there was also failure in the wooden roof structure (BBC, 2022b). Presence of observed partial height walls could have led to short columns.</p>	<p>(d) Damage to a school building constructed using concrete masonry infills with wooden roof structure with clay tiles. The wood structure appears to have collapsed and there was heavy damage to the masonry infills. (SuryaMalang, 2022)</p>

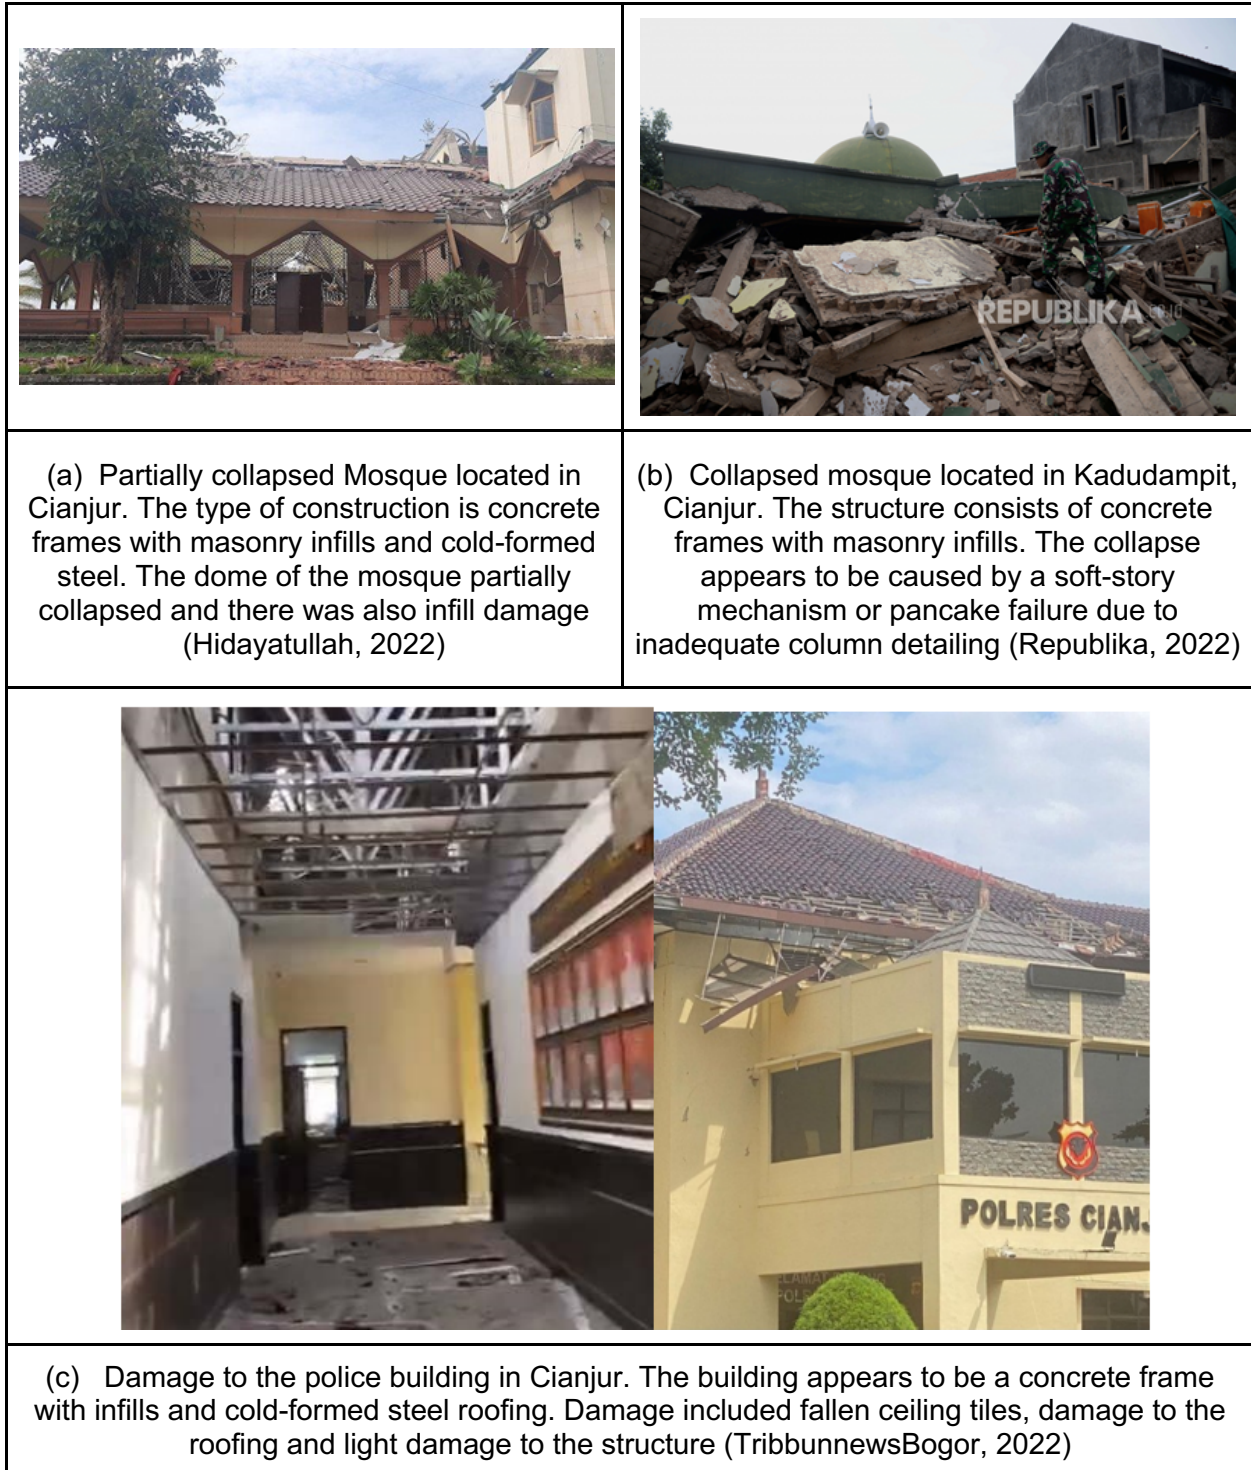
Figure 4.7 – Damage to religious and government buildings.

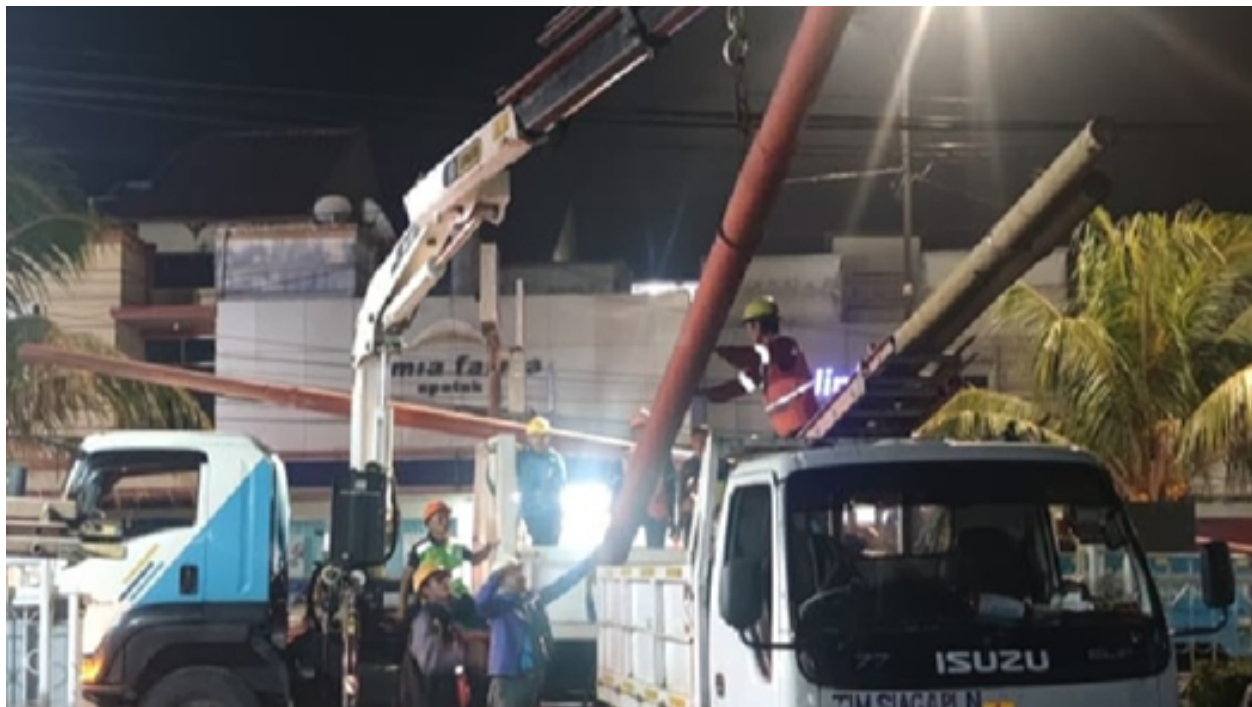
The Cianjur Earthquake caused the disruption of electrical power in the Cianjurto District (CNN Indonesia 2022). Specifically, the earthquake affected 21 customer distributions (power suppliers) and 1957 distribution substations. As a result, 366,675 customers were affected by the power outage. As of the morning of November 22 (18 hours after the earthquake), 17 suppliers and 1802 substations were successfully restored by the local electricity company Perusahaan Listrik Negara (PLN), and the electricity in 89% of the affected area have been restored (Lukihardianti and Murdaningsih2022). Figure 5.1 shows the PLN officials utilizing the heavy equipment to restore the power grid at the Cianjur earthquake disaster site (Budianto 2022).

Figure 5.1 Perusahaan Listrik Negara (PLN) officials are working to restore the power grid at the Cianjur earthquake disaster site (Budianto 2022).

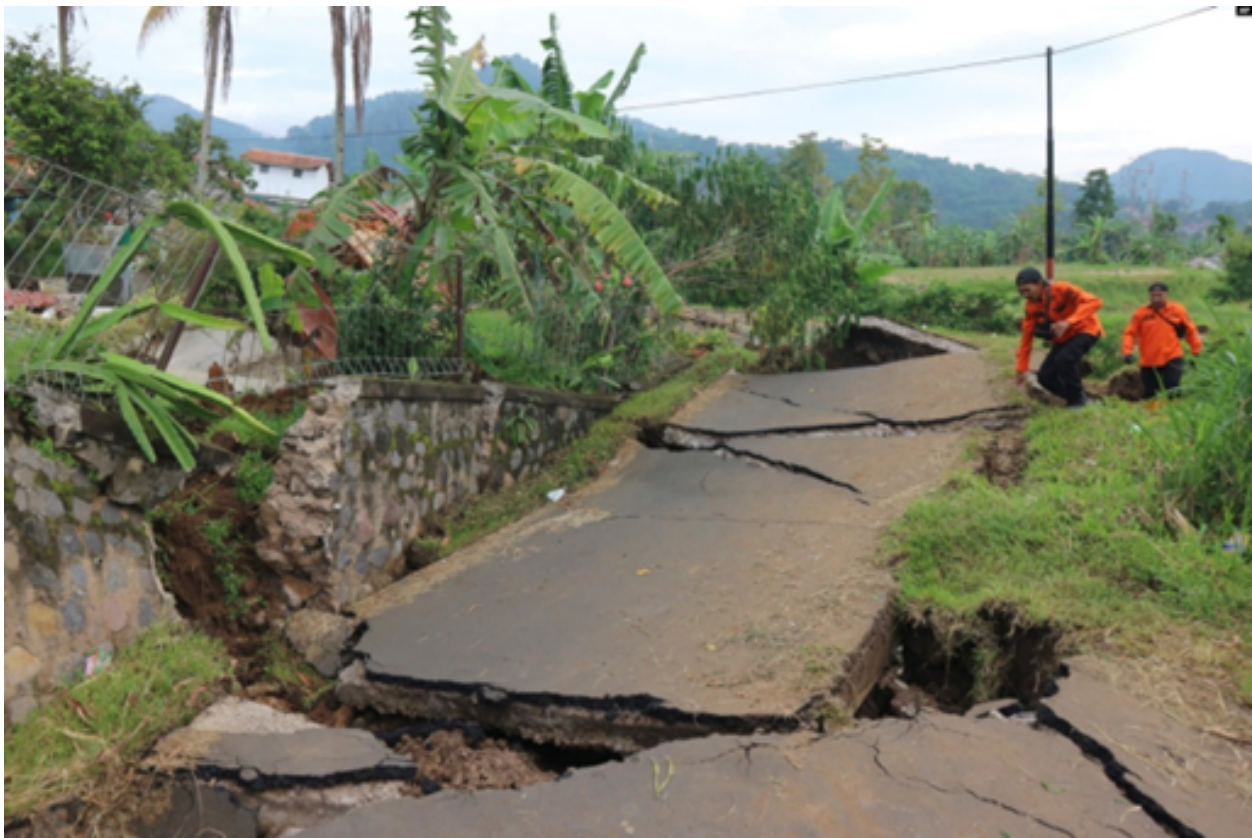
The Cianjur earthquake significantly disrupted the transportation system through two primary patterns. First, the earthquake caused severe damage to the road foundation in many locations. One example of such damage is shown in Figure 5.2, where the road surface was ruptured into multiple segments and was thus not functional for regular traffic. The earthquake also triggered landslides, which further resulted in fallen trees, electricity poles, and soil from cliff avalanches. These fallen objects and soil blocked the road. The Puncak-Cipanas-Cianjur national road was paralyzed because toppled trees completely blocked the road, as shown in Figure 5.3. According to the collected data, the disruption caused by the landslide was more significant than direct damage to the roadways in the Cianjur district. The Ministry of Public Works and Public Housing has sent personnel and heavy equipment to clean up the national road starting from November 21, 2022. However, at the time of the writing of this report, no successful restoration has been reported.

Figure 5.2 Severe road damage caused by the West Java earthquake (VOA News, 2022).

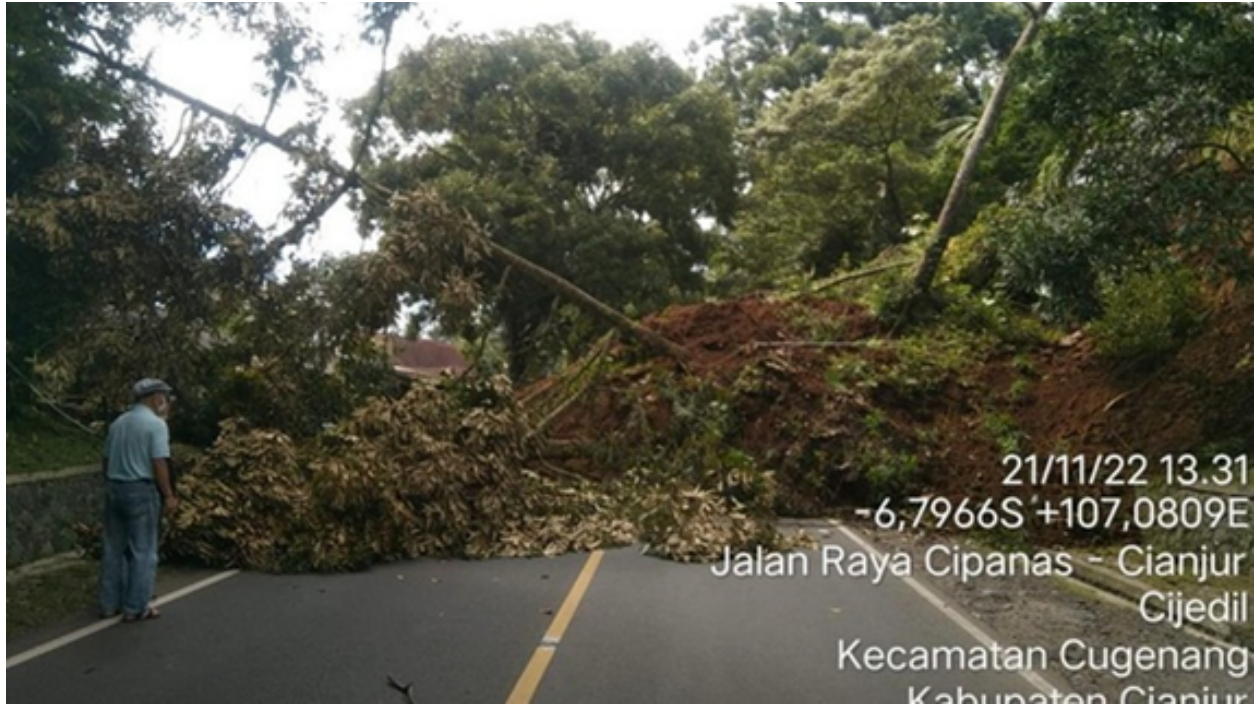
Figure 5.3 The road access from Cianjur to Puncak is blocked because of a landslide and toppled trees (Arini 2022).
