# StEER: Structural Extreme Event Reconnaissance Network

19 JANUARY 2019 TORNADOES IN THE SOUTHEASTERN US: FIELD  
ASSESSMENT TEAM EARLY ACCESS RECONNAISSANCE REPORT (EARR)

**Released:** January 30, 2019  
**NHERI DesignSafe Project ID:** PRJ-2194

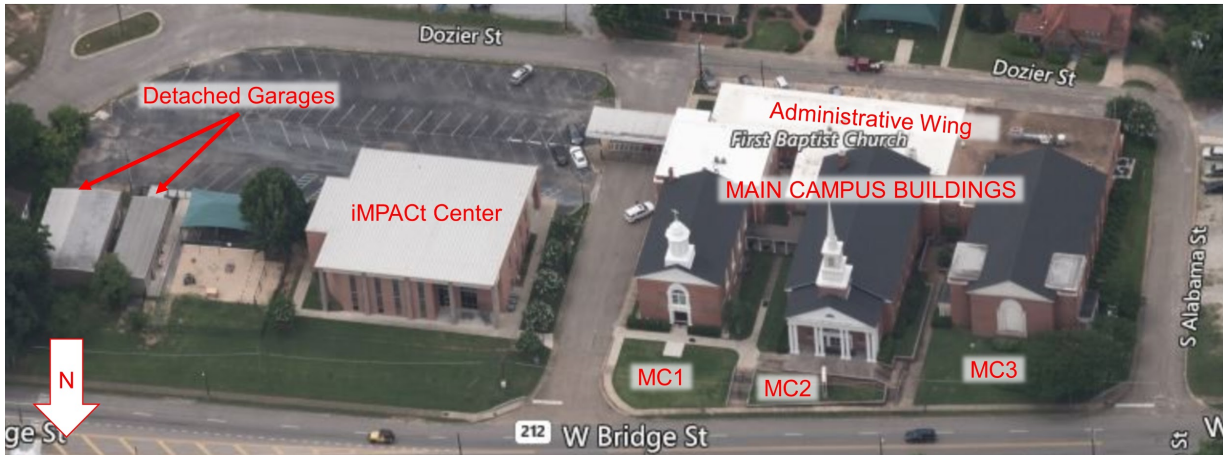
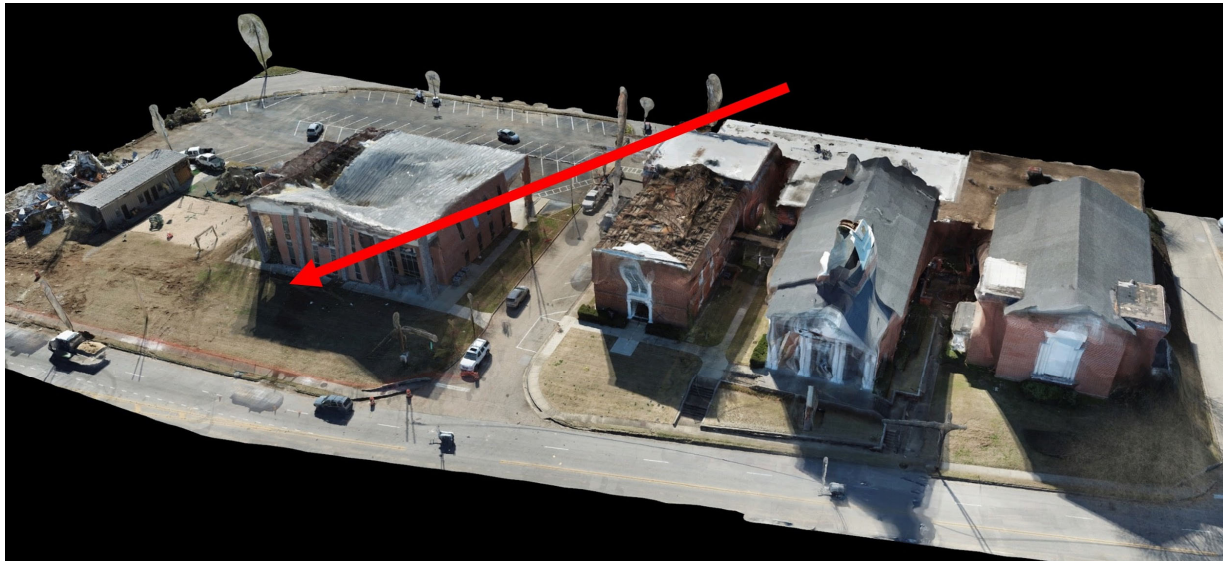
The main campus building MC1 was a 50 ft by 75 ft gable roof building with 30 ft eave height. It was constructed of multi-wythe brick masonry walls (7 wythes thick according to conversations with a member of the church) with heavy timber roof trusses spaced at 10 ft, assembled using mortise and tenon joinery. Spanning the heavy timber roof trusses were dimensional wood planks overlaid with asphalt shingles, which had been installed within the last couple years according to members. The building sustained heavy damage to the roof, with the roof cover and diaphragm completely missing (Figure 5a). Four of the eight heavy timber trusses were fully or partially collapsed/disassembled, with the east slope (closest to the tornado) sustaining the worst of the damage. The large, stained glass windows in the walls did not appear to sustain any damage and the brick walls also lacked significant damage.

**Figure 4.** Pre-tornado birds-eye view of the FBC campus with individual buildings annotated (top); post-tornado birds-eye view of the FBC campus based on preliminary processing of UAV photos using Structure-from-Motion techniques. Approximate direction and location of tornado path centerline is indicated by the red arrow.

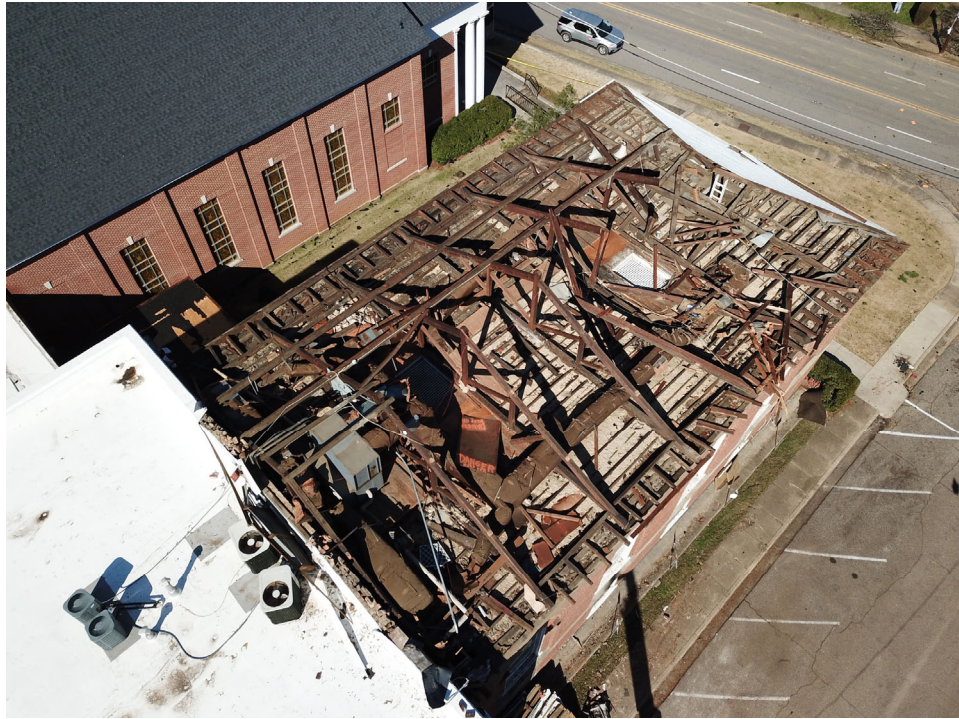
**Figure 5.** (a) Damaged roof structure on main campus building MC1 campus and (b) loss of steeple on main campus building MC2 at the First Baptist Church Wetumpka campus. It is clear the steeple lacked structural connections because the remaining structure is lightly damaged.

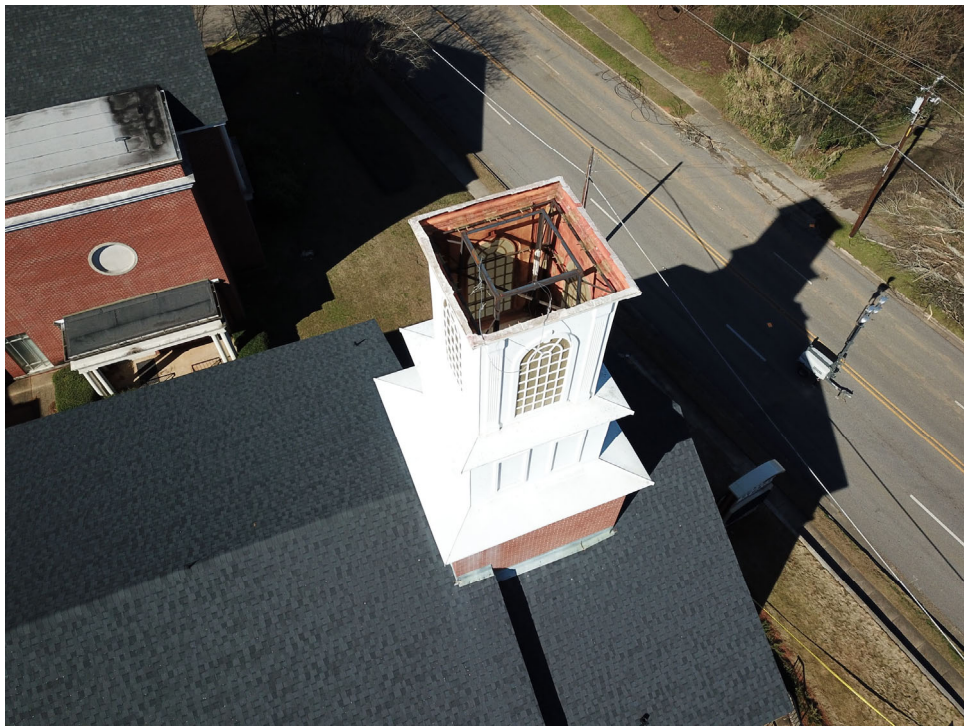
(b)

Main campus buildings MC2 and MC3 did not suffer any obvious structural damage; however, the top half of the steeple on MC2 was lifted off and destroyed (Figure 5b). A few shingles on MC3 were lifted off, all on the west-facing slopes of the roofs, which were subjected to the radial inflow into the tornado vortex. Structural details of these buildings are not available at this time.

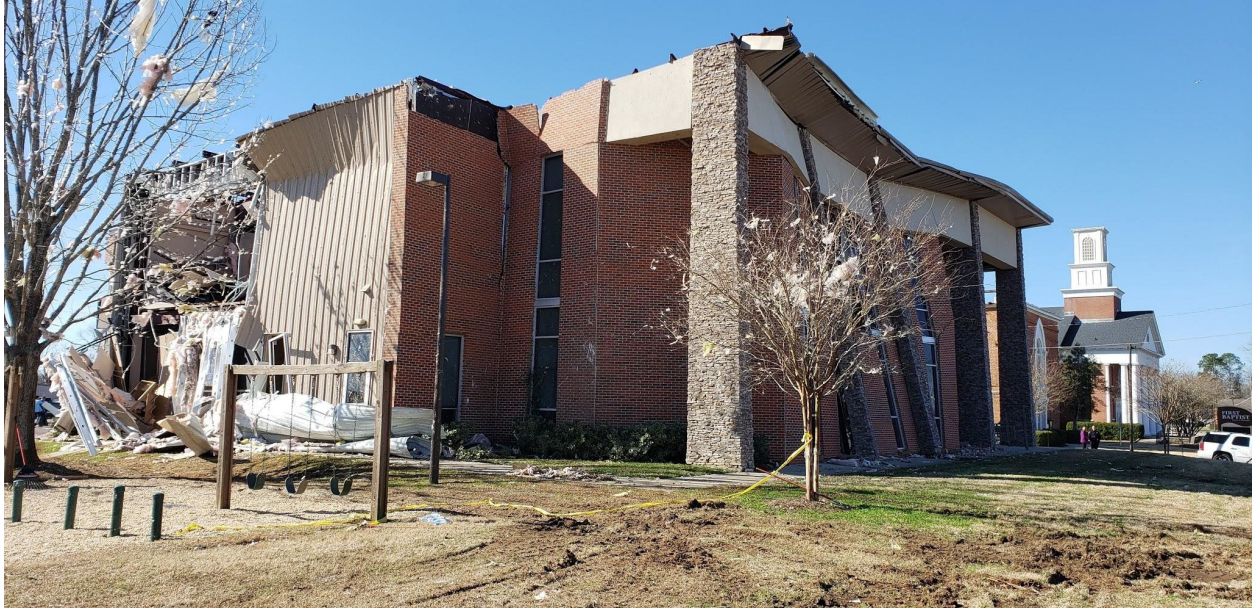
Nearly 50% of the cladding on the east wall was destroyed, and all openings except one window were also destroyed (Figure 6). On the north wall, an overhang collapsed inward into the building, with two of the three center columns underneath the overhang left resting on the building. Structural details of the columns or anchorage were not visible. Multiple windows were broken on all sides of the building. The southwest corner of the building also experienced partial collapse inward towards the center of the building. Many of the roof purlins were also observed to have developed plastic hinges. Approximately 25% of the standing seam metal roof cover was also removed, all on the east side of the building, which would have been the leading edge of the roof relative to the tangential and radial velocity components of the vortex as it approached the building.

**Figure 6.** View from the east of the iMPACt center on the First Baptist Church Wetumpka campus.

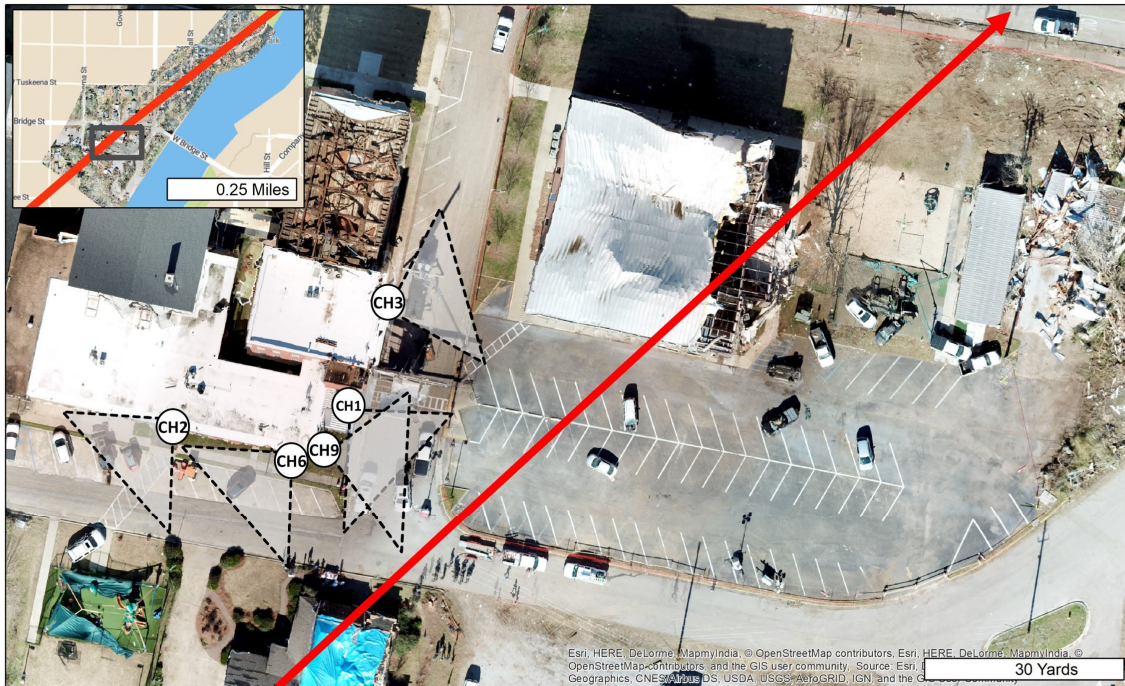
- As the tornado approaches, a glass entry door on the south wall of the administrative building (adjacent to Camera 2 in Figure 7) fails outward, indicative of strong suction forces on the surface of the building facing the oncoming tornado. This could perhaps be indicative of the strong radial component inducing leeward wall pressures on the south wall as the tornado approached.

**Figure 7.** Locations and viewing angles of security camera footage obtained by the FAT overlaid on the post-tornado aerial imagery. Red arrow indicates the approximate centerline of the tornado path based on the damage in this area.

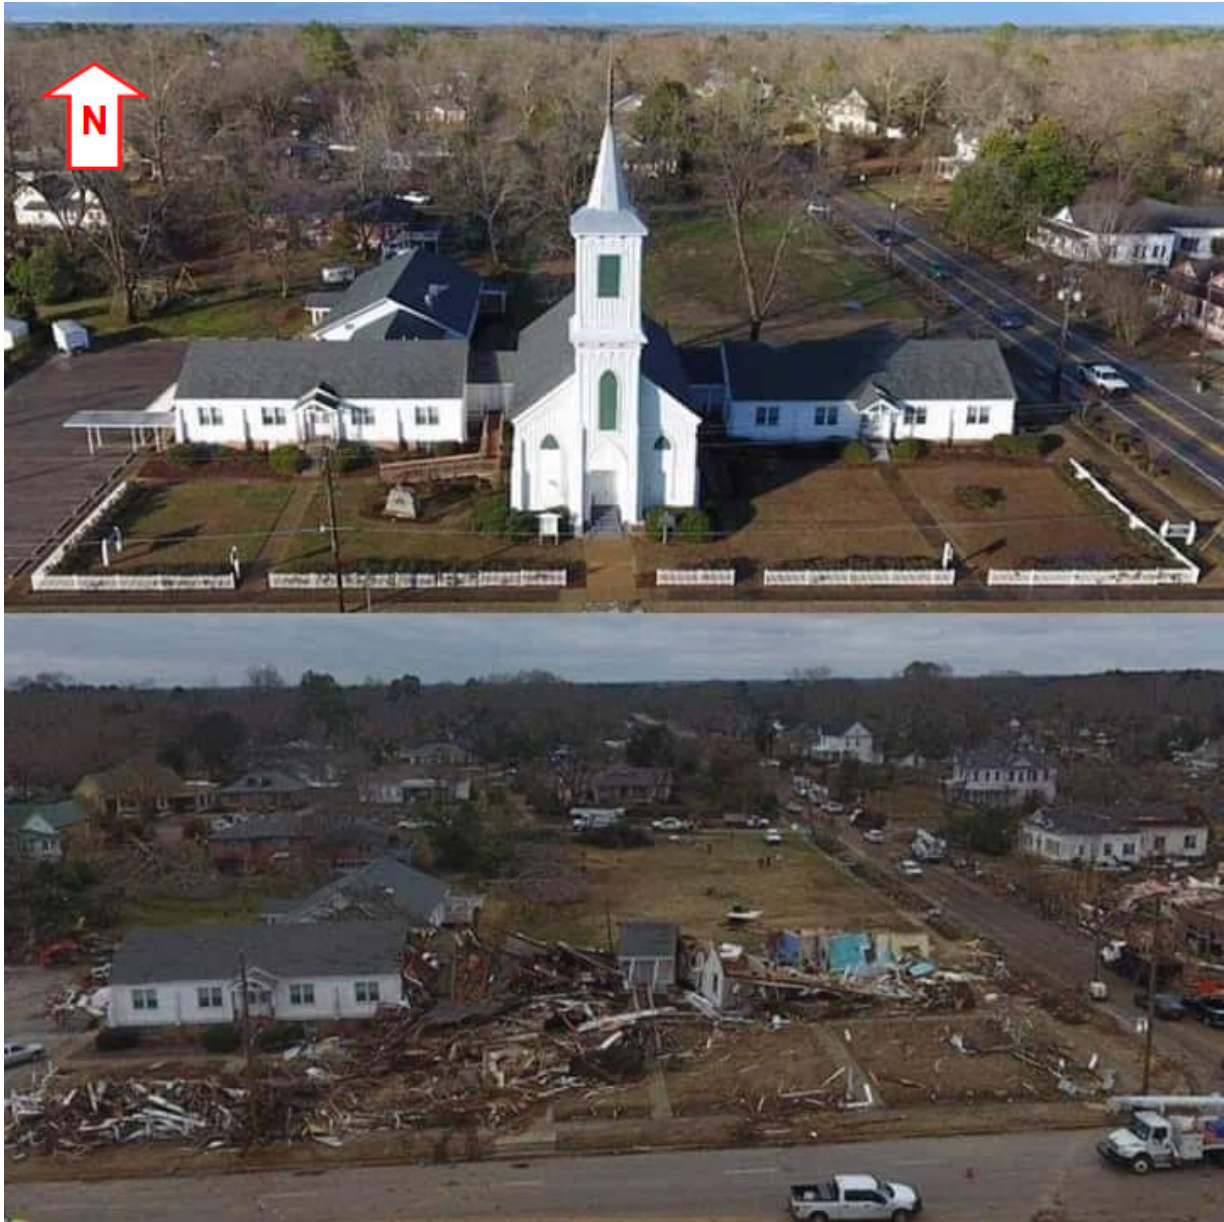
**Figure 8.** Before and after views of the historic First Presbyterian Church in Wetumpka, AL.  
Source: [First Presbyterian Wetumpka](#).

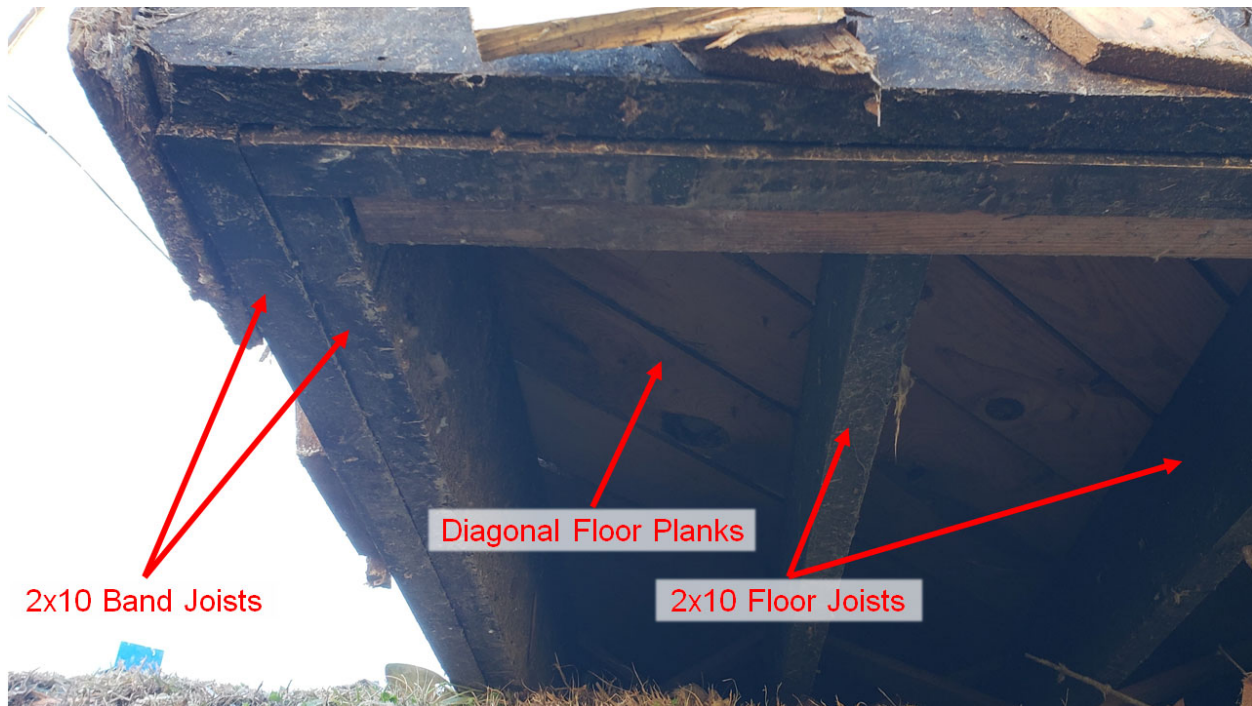
**Figure 9.** Looking upward at the floor structure of the First Presbyterian Church east wing after it had been shifted off the masonry stem wall on which it originally rested.

The roof on the east wing was completely removed and the entire building shifted off the foundation. The west wing generally fared better than the east wing, but still sustained roof damage in several areas. The east wall of the west wing, where a corridor connected to the main sanctuary, was destroyed. The historic sanctuary was completely destroyed. Debris from the bell tower was scattered to the southwest of the original location (Figure 8), generally in the direction of the oncoming tornado (confirmed by early UAV video<sup>14</sup> prior to cleanup).

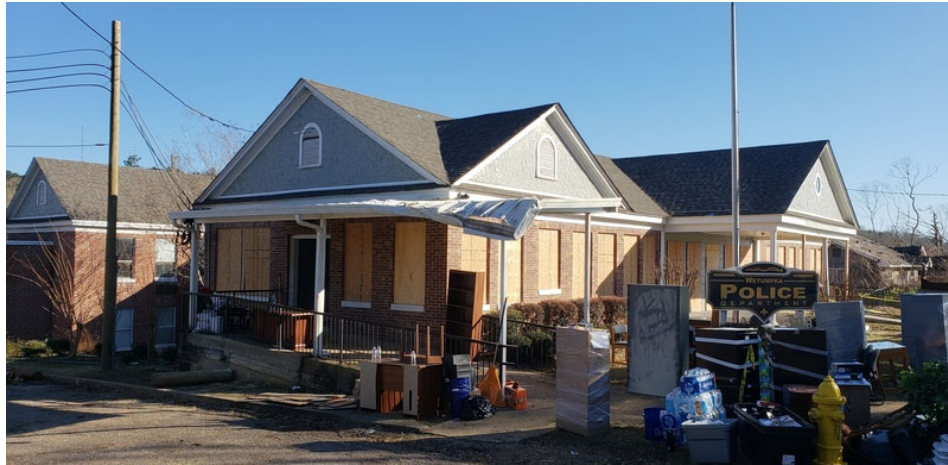
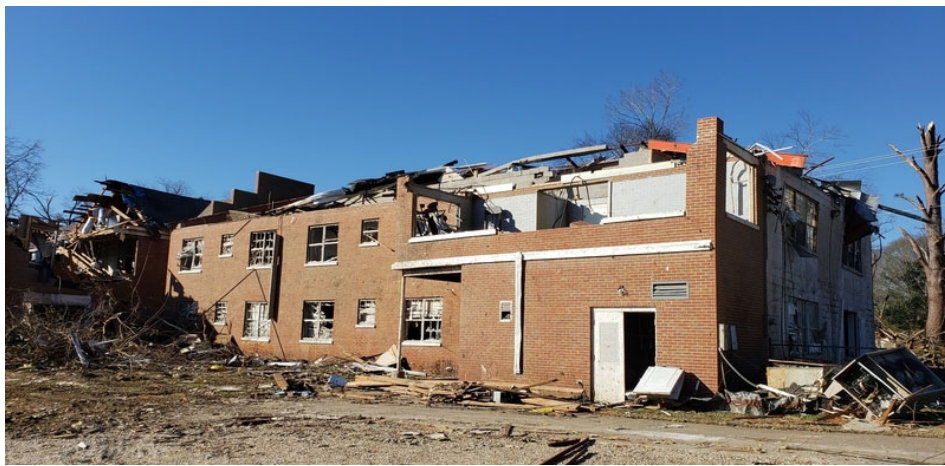
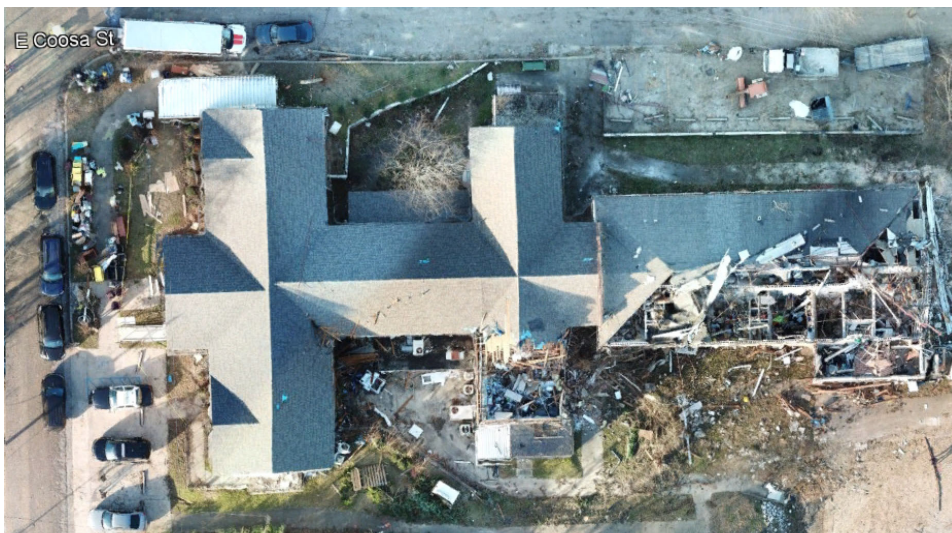
**Figure 10.** View of the Wetumpka police station from the (a) northwest, (b) southeast and (c) overhead (north is up).

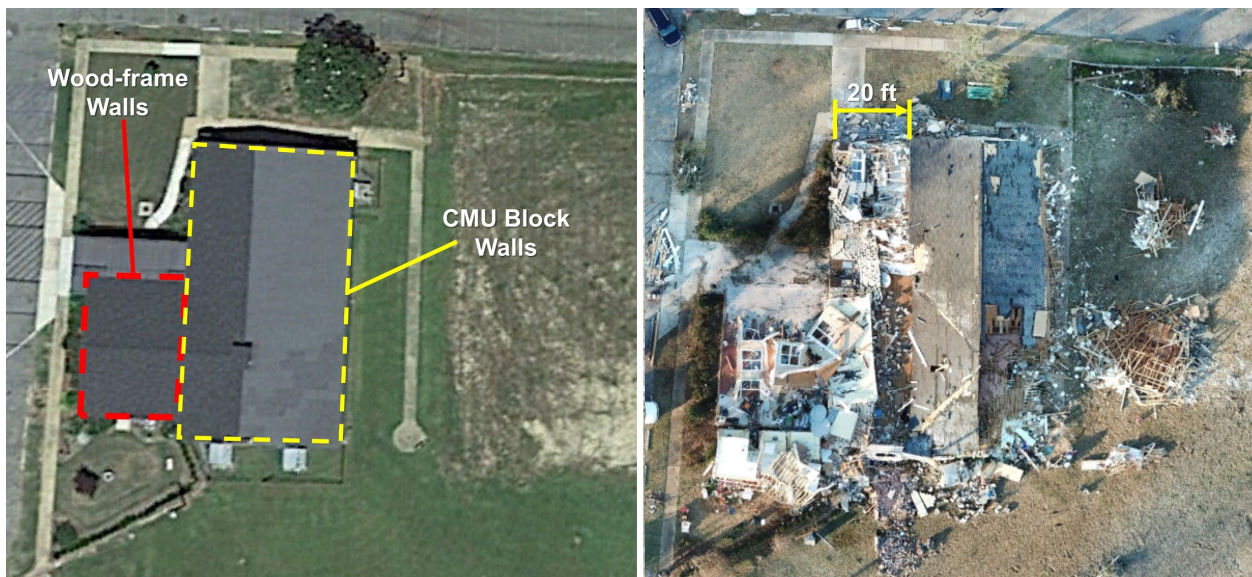
**Figure 11.** Before (left) and right (after) views of the Wetumpka Senior Center showing removal of the gable roof structure on the west wing and collapse (from east to west) of the roof structure over the north-south oriented portion of the building. North is up in both pictures.

The entire center was destroyed by the tornado (Figure 11), with the north-south oriented portion of the building racking and collapsing towards the northeast, following the direction of the tornado movement (Figure 12). The lack of reinforcement in the CMU block wall appeared to be the primary cause of failure. Several of the grouted cells containing the anchor bolts for the roof-to-wall connection simply separated from the remainder of the wall as shown in Figure 13; however, the majority of the roof structure remained largely intact and in place. The roof structure on the north-south oriented portion of the building was displaced 20 ft from west to east, while the roof structure on the west wing of the building was completely lifted off.

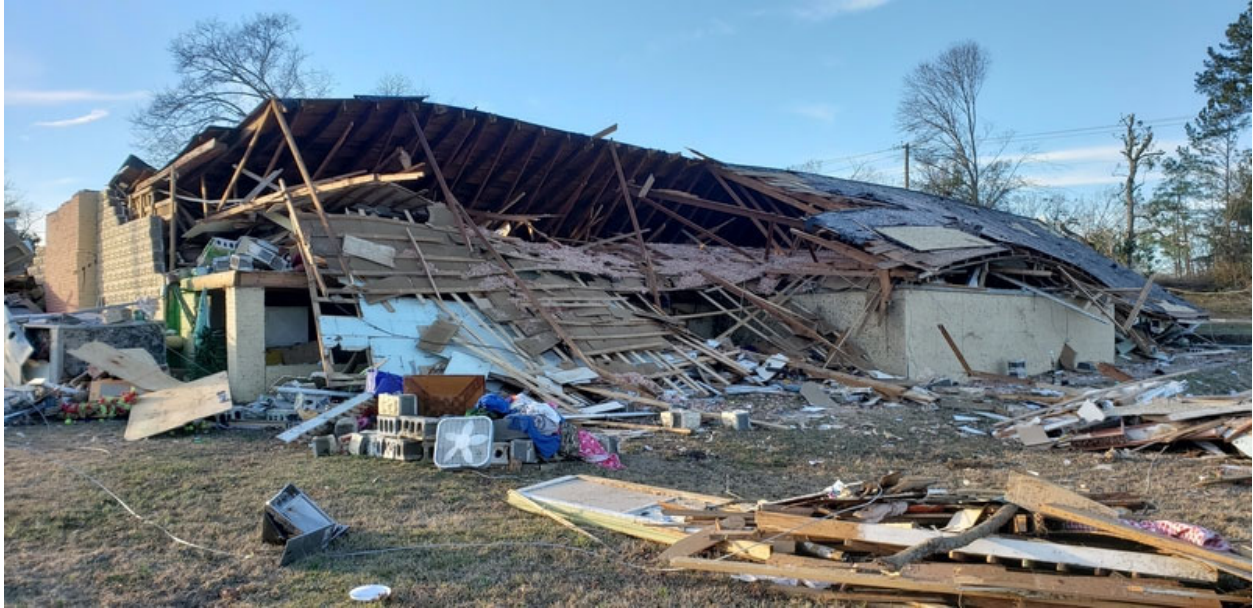
**Figure 12.** View from the back of the building looking northwest showing the collapsed, unreinforced CMU block walls and damage to roof structure.

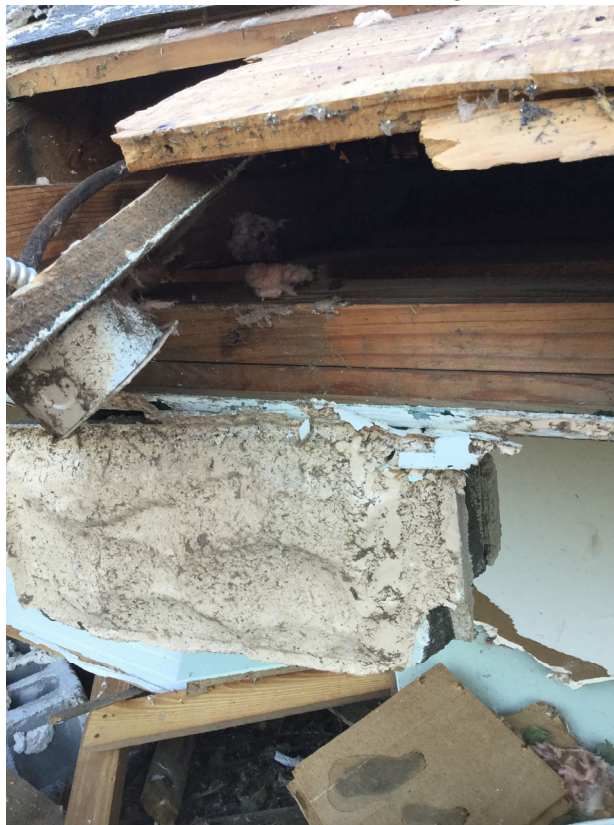
**Figure 13.** Roof-to-wall connection at the Wetumpka Senior Center, showing wood top plate anchored to grouted CMU block with  $\frac{1}{2}$ -inch anchor bolt. Lack of reinforcement in the CMU block wall allowed the grouted cell to easily separate from the rest of the wall structure.

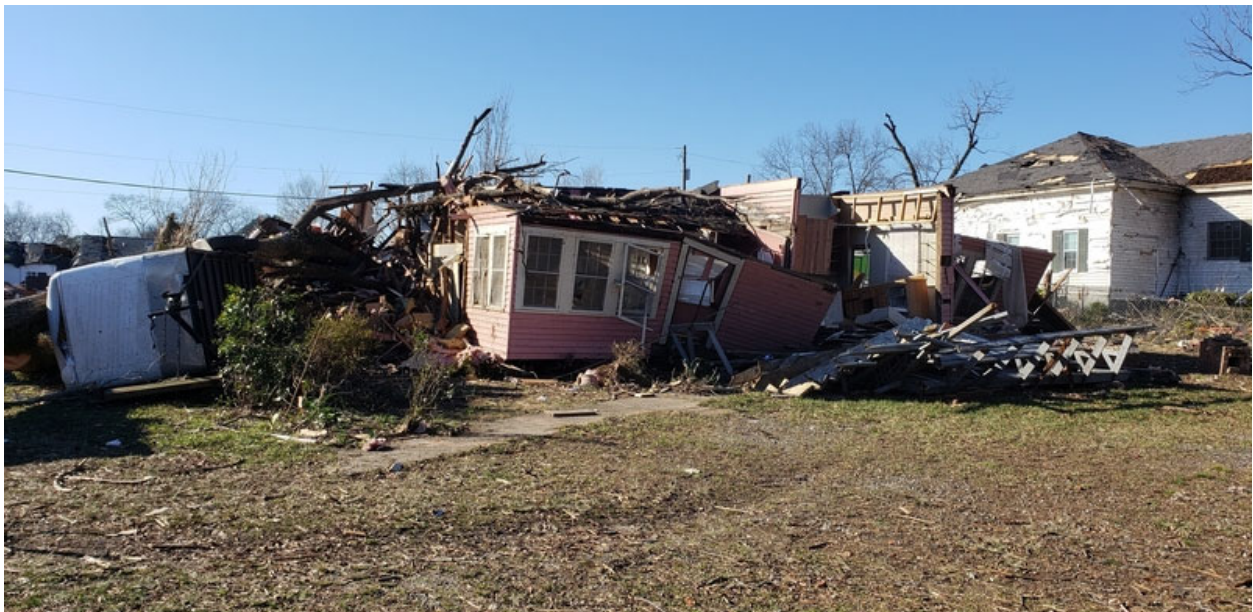
Removal of the complete roof or large sections of the roof was observed in eight buildings, but in all but two the walls remained standing, albeit with significant debris impact such as most windows shattered (Figures 14-15). The frequent use of diagonal planks in the walls and roofs results in a heavier, more rigid diaphragm relative to modern homes<sup>15</sup>, which may have prevented wall collapse in several homes that lost most sections of their roof. Tree-fall was also a primary source of damage in a number of the homes investigated (Figure 16).

**Figure 14.** Partially collapsed single family home in Wetumpka, AL.

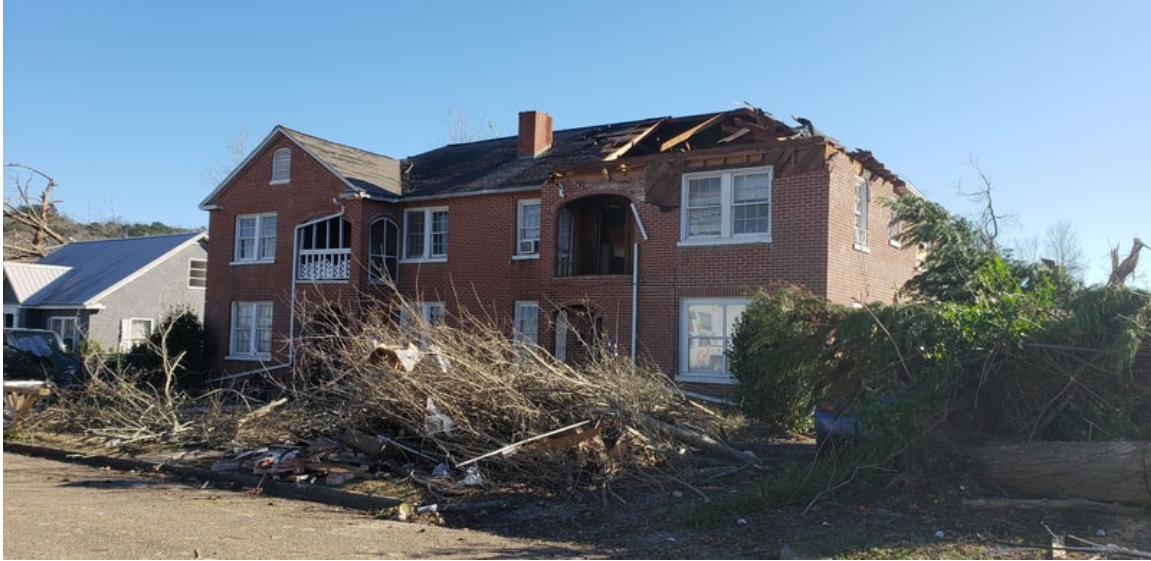
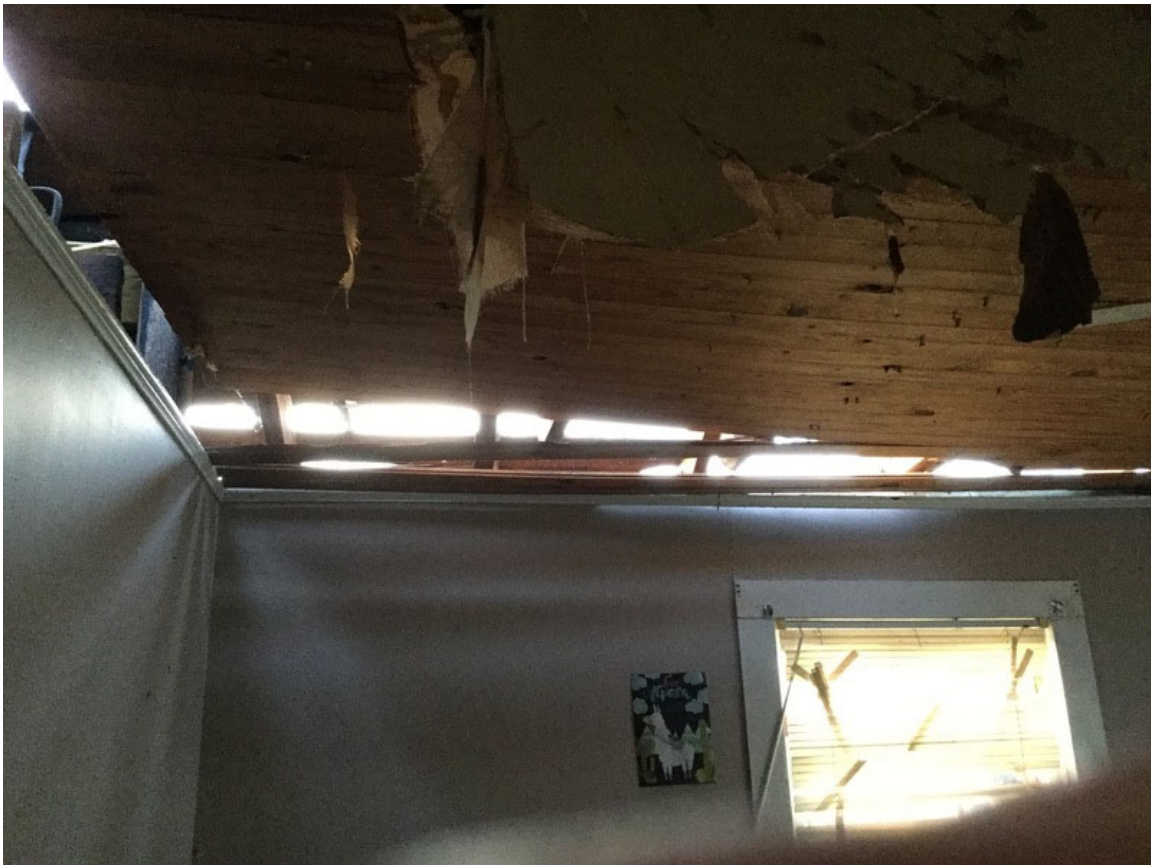
**Figure 15.** Multi-family residential structure with failure of the roof structure on the west-facing slope of the exterior hip roof, and partial uplift of the ceiling joists as viewed from inside the structure. The additional dead weight of the roof from the wood plank ceilings and wood plank roof diaphragm may have prevented complete lift-off of the roof structure.

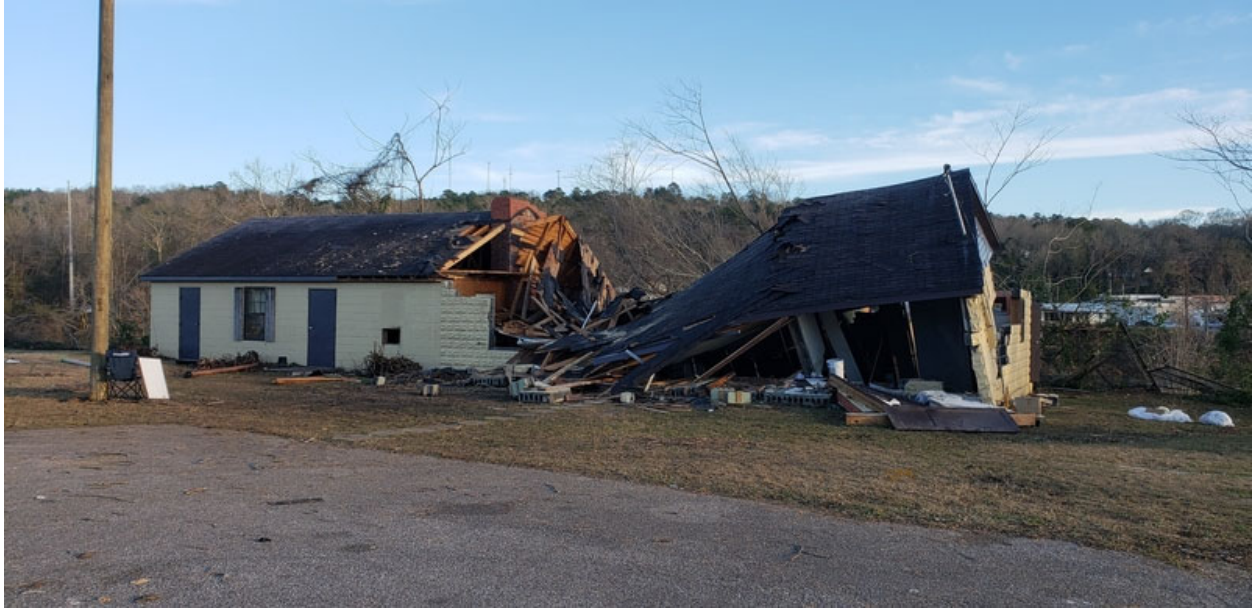
**Figure 16.** Tree damage (removed before photo was taken) to a facility nearby the Wetumpka Senior Center.

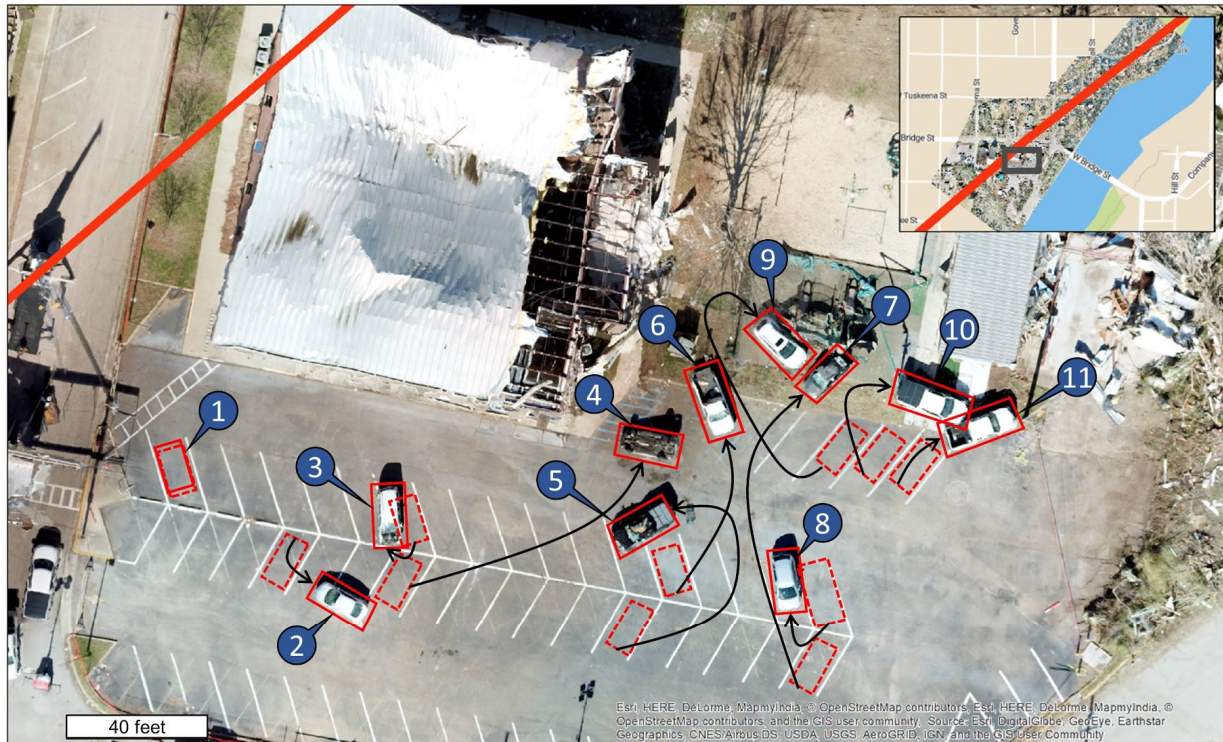
A number of vehicles were encountered during the damage assessment, but the only vehicles that were obviously moved by the tornado were those in the FBC parking lot. According to church members present on-site, a group of church members had left on the morning of 19 January in a bus, leaving their vehicles in the parking lot. Figure 17 shows the original location of the vehicles as best estimated from the security camera footage, along with the final resting place after the tornado. One car was flipped and nine vehicles were shifted laterally (Figure 18). One SUV (Vehicle 8 in Figure 17) only shifted a few feet laterally, but timber debris pierced through the car doors in multiple places (including where a child safety seat was located) and pierced through both walls of one tire (Figure 19).

**Figure 17.** Vehicle movements in the First Baptist Church parking lot. Pre-tornado vehicle locations (dashed polygons) are estimated from security camera footage. Vehicle 1 was removed before the aerial imagery was acquired.

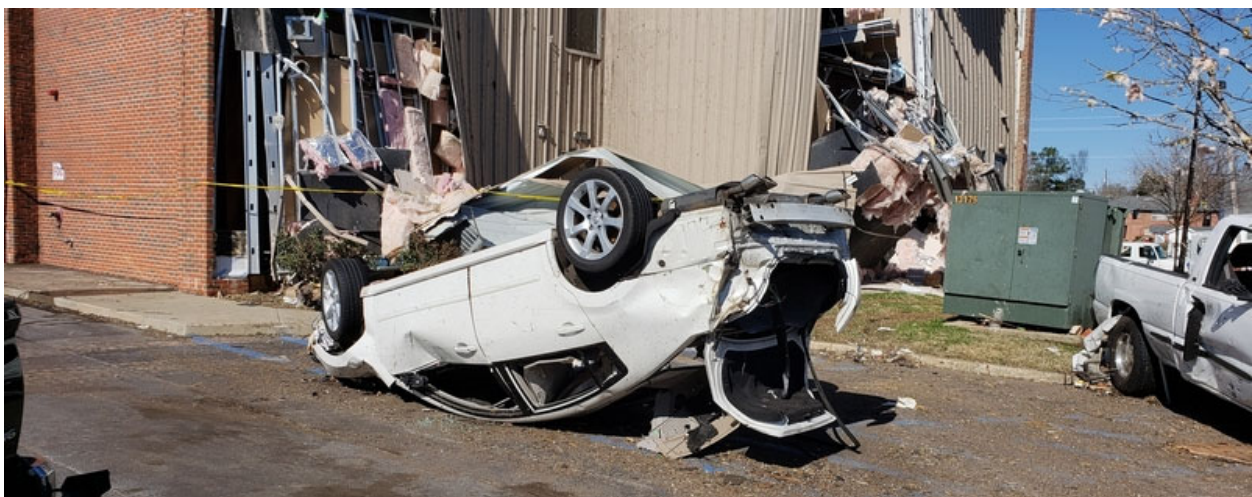
**Figure 18.** Nissan Sentra (Vehicle 4 in Figure 17) flipped by the tornado. Final resting location was approximately 80 ft from origination point in the direction the tornado traveled.

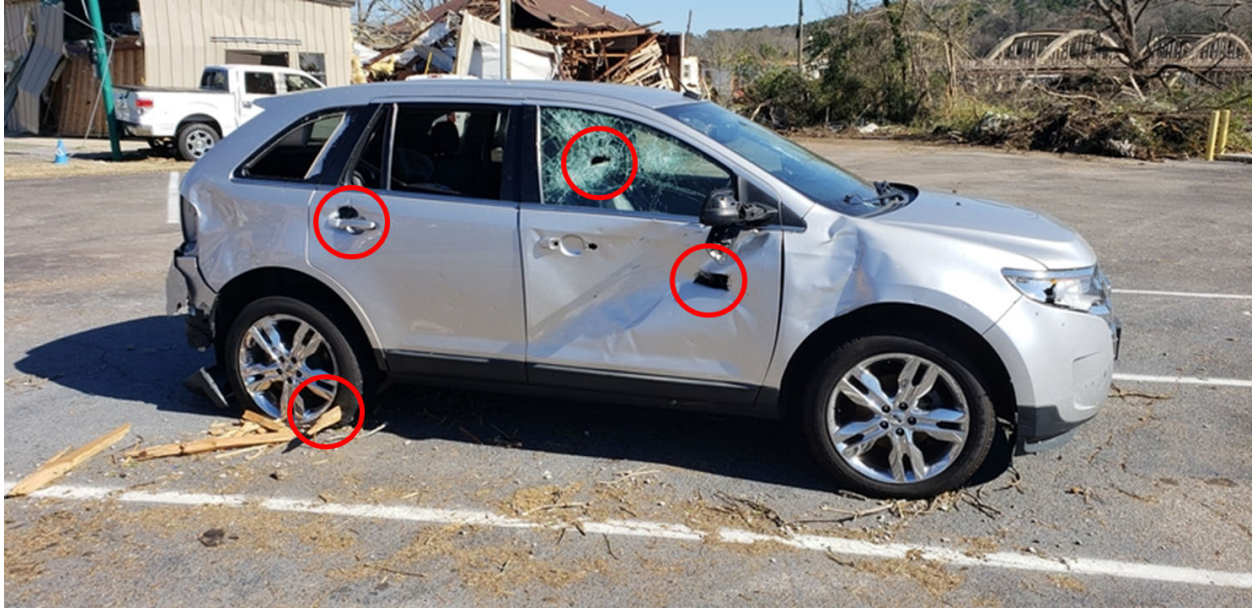
**Figure 19.** Wind-borne debris pierced doors and windows of this midsize SUV in multiple places.

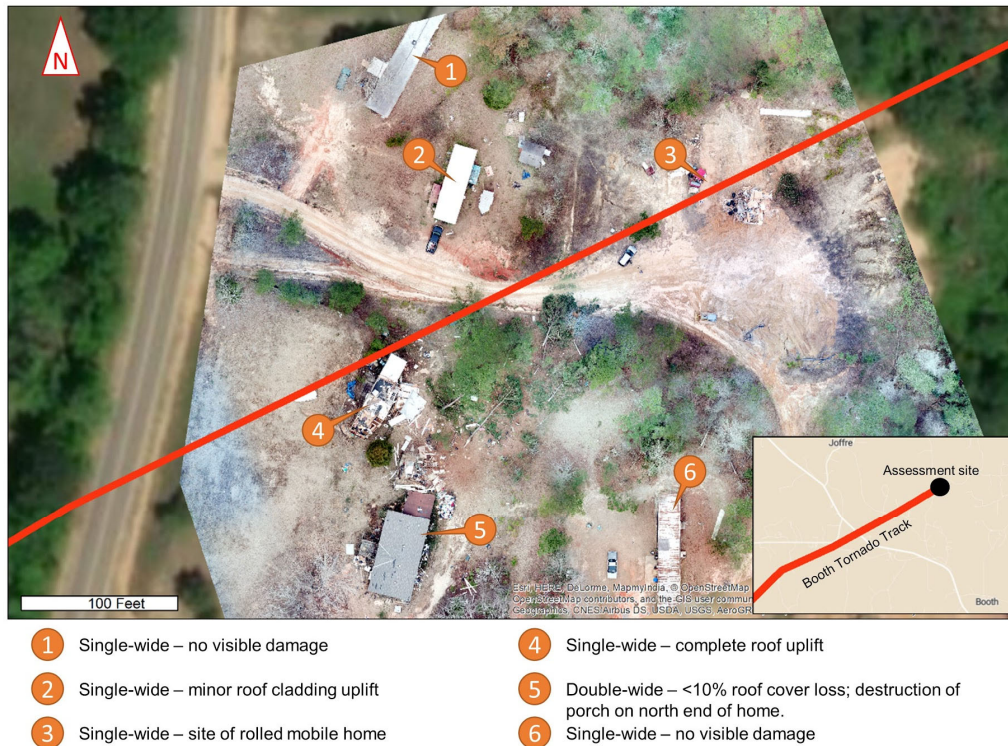
**Figure 21.** Orthomosaic of the tornado path through a mobile home community just north of Booth, AL. The tornado path appears to have been only a few yards wide at this point.

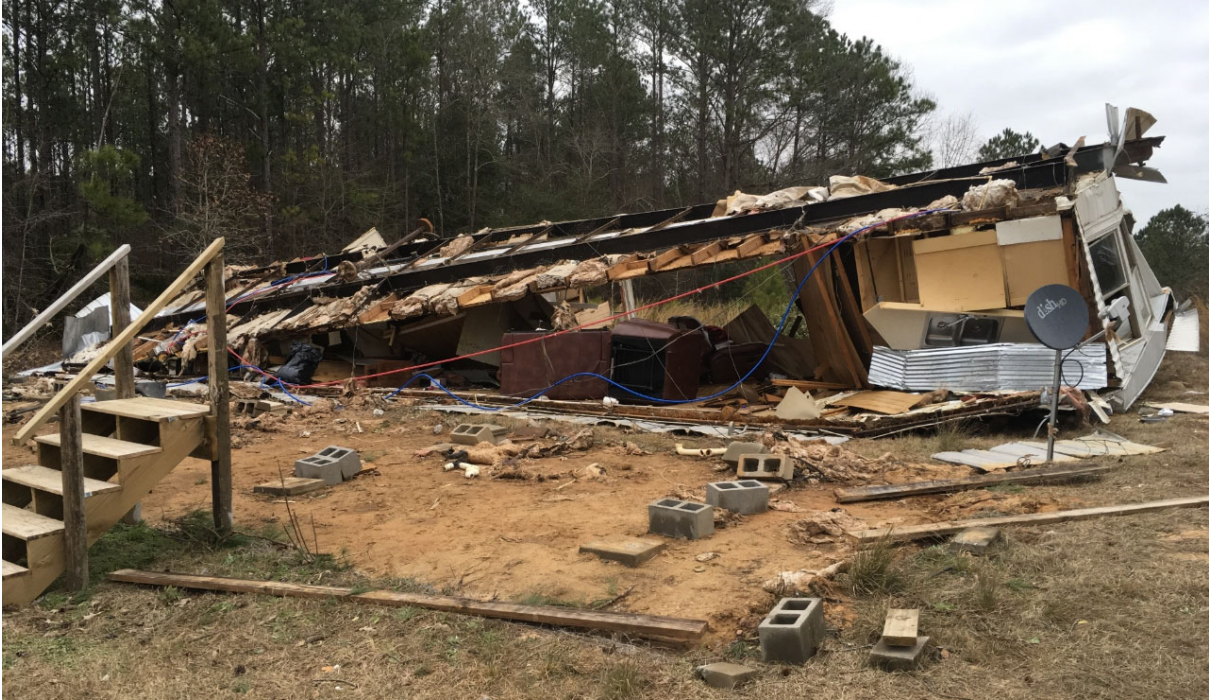
In total, at least 7 homes experienced minor to moderate roof and siding damage, several outbuildings were destroyed, and 2 additional mobile homes were destroyed. One of the mobile homes was rolled over, as seen in Figure 22 below, and the two residents inside were injured. The other mobile home, less than 100 yds away from the home that rolled and also in the direct path of the tornado, had its roof ripped off and part of the leeward wall collapsed outwardly with the roof (Figure 23). The mobile home that rolled was already bulldozed into a pile of debris by the time of the FAT-1 assessment, but the NWS assessment team (personal communication) observed no straps or anchors present in this mobile home. The other mobile home that only lost the roof did have anchor straps consisting of helical anchors (unknown depth, spaced 8-9 ft on center) with 12 inch stabilizer plates attached to galvanized steel straps (2-inch width). At least one strap was detached from the ground anchor due to corrosion. Both mobile homes were built in the mid-1970s according to the property manager. FAT-1 also assessed a single-family residence near the tornado's path, southwest of the mobile homes mentioned above, that sustained only minor roof damage. The roof lost approximately 15-20% of its shingles, but sustained no other damage. According to the owner, the roof was installed in 2006. Another mobile home approximately 150 yds northeast of the single-family residence appeared to be undamaged. No ground anchors were visible in a limited inspection of this mobile home, which was located in a small dell relative to the single-family site-built home to the southwest and the rolled mobile home to the northeast.

The inconsistent anchorage observed in this small, rural community of mobile homes is concerning, and work is ongoing to identify whether this is a trend in existing manufactured homes in rural settings. Rural mobile home residents typically have few if any safe options for shelter in advance of a tornado given the abbreviated warning lead times, and obvious structural deficiencies such as a complete lack of anchorage or missing anchorage elements enhance the vulnerability of what is already a highly vulnerable shelter option. Inspection of the mobile homes in the path of the Booth, AL tornado indicates that contributing factors to the heightened vulnerability of mobile homes include, amongst others, the aforementioned inconsistencies in ground anchorage, the reduced weight of the structure due to use of smaller structural members, the height-to-breadth aspect ratio (higher ratios induce larger overturning moments), and the lack of debris impact-resistant cladding materials. Moreover, for those residents who have no option but to shelter in a mobile home, it is not apparent what the best available refuge area is given the lack of interior rooms in such structures. Research is ongoing in efforts to further improve our understanding of the social and physical vulnerabilities of mobile home residents to tornadoes<sup>18</sup>. State regulations regarding the anchorage and installation of mobile homes is detailed in Chapter 535-X-13 of the Alabama Manufactured Housing Commission Administrative Code<sup>19</sup>.

**Figure 22.** Single-wide mobile home rolled over due to tornado, injuring 2 people.  
(Source: [https://www.weather.gov/bmx/event\\_01192019booth](https://www.weather.gov/bmx/event_01192019booth))

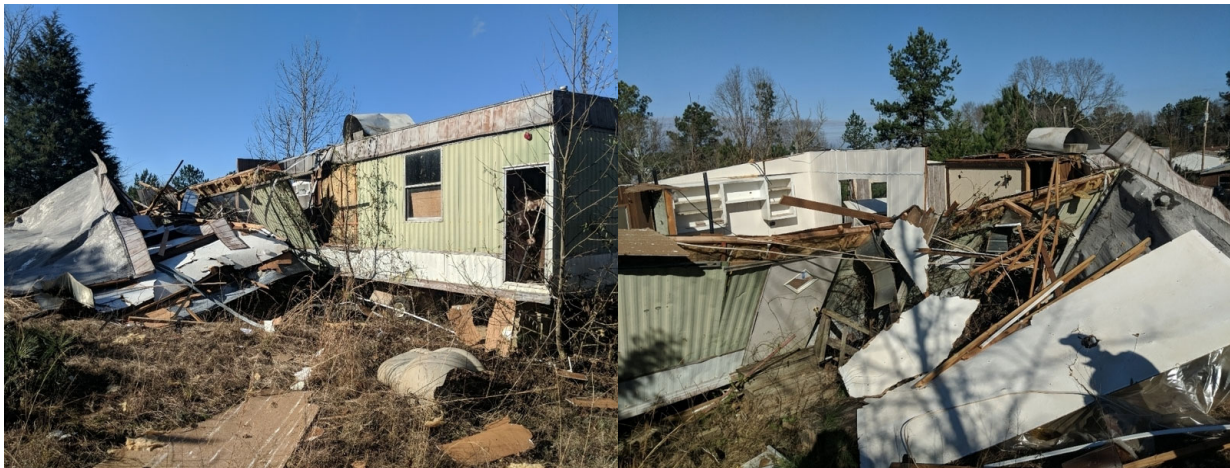
**Figure 23.** Single-wide mobile home that lost the majority of its roof.

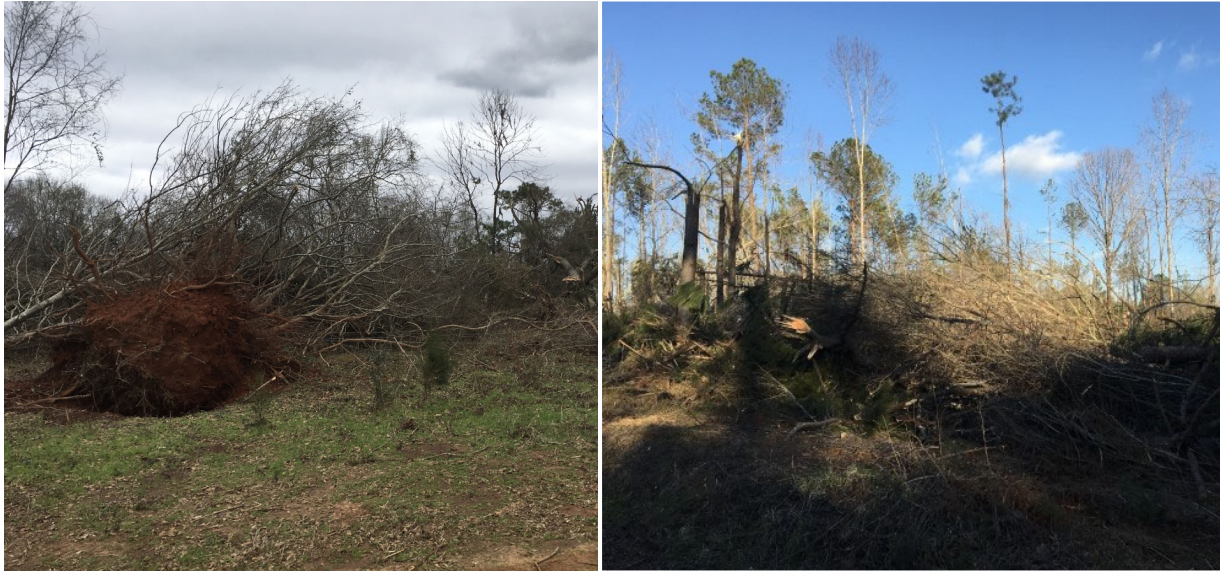
The Tyler Tornado, rated an EF-1, touched down northwest of Tyler, AL, at County Road 74. It traveled northeast for about 6 miles before lifting off the ground just past the Alabama River. It was an estimated 75 yds wide at its widest point and had estimated maximum wind speeds of 100 mph (per the National Weather Service). There were no injuries and no buildings were damaged, but many trees were snapped and farm equipment was damaged (Figure 24).

The Coosa County Road 101 Tornado, was also rated an EF-1, but was only briefly on the ground. It touched down near County Road 101 and moved northeast along the road for 1.8 miles before lifting. According to the National Weather Service, the maximum width was 112 yds and the estimated maximum wind speeds were 100 mph. There were no injuries or buildings damaged, but as with the Tyler Tornado, several trees were knocked down (Figure 24).

**Figure 24.** Left: Trees uprooted by the Tyler Tornado; Right: Trees snapped and uprooted by the Coosa County Road 101 Tornado. (Source: [https://www.weather.gov/bmx/event\\_01192019](https://www.weather.gov/bmx/event_01192019))

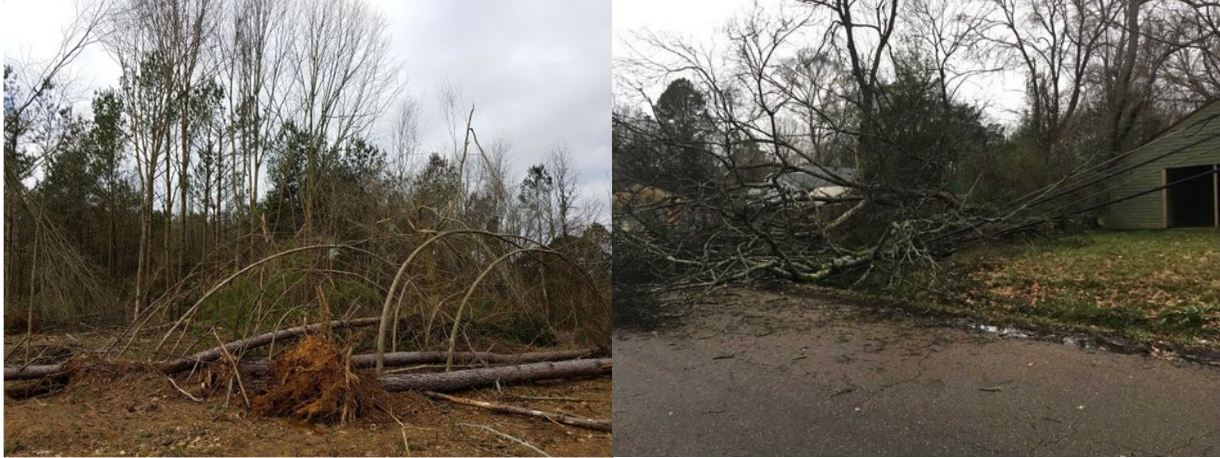
The Leake Tornado, rated an EF-1, touched down northeast of Redwater, MS, south of Barnes Rd. It traveled north for about 1.4 miles until lifting just north of Duncan Rd. At its widest, the tornado was estimated to be 250 yds wide with maximum wind speeds of 90 mph (National Weather Service). There were no injuries, but 4 chicken coops were turned over and several trees were knocked over (Figure 25).

**Figure 25.** Left: Trees uprooted by the Leake Tornado (Source: National Weather Service, Jackson, MS WFO); Right: Trees uprooted by the EF-1 Rankin County Tornado, causing damage to houses and power lines (Source: <https://www.wkrg.com/news/local-news>)
