# StEER: Structural Extreme Event Reconnaissance Network

19 JANUARY 2019 TORNADOES IN THE SOUTHEASTERN US: FIELD  
ASSESSMENT TEAM EARLY ACCESS RECONNAISSANCE REPORT (EARR)

**Released:** January 30, 2019  
**NHERI DesignSafe Project ID:** PRJ-2194

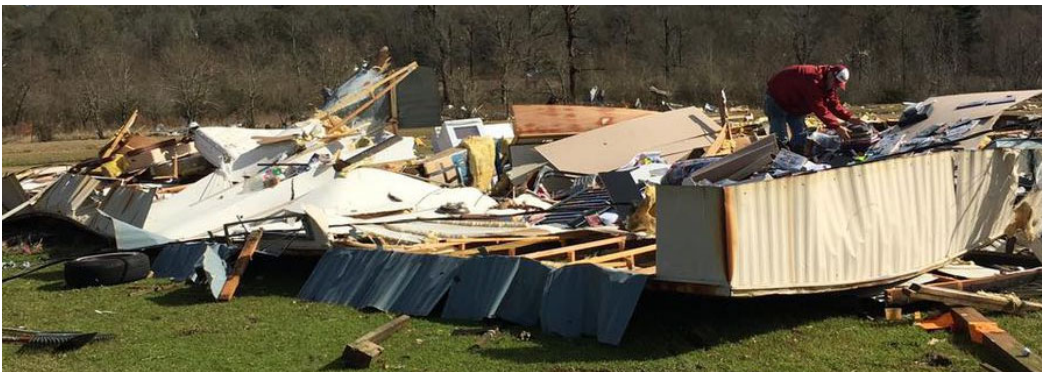
The Washington Parish Tornado, rated an EF-1, touched down near Franklinton, LA, west of Buford Creek Rd. It traveled northeast for 1.2 miles before lifting near T.C Brunfield Rd. The estimated maximum width of the tornado was 75 yds and the maximum wind speeds were 105 mph. No injuries were reported, but one house lost its roof and a mobile home was destroyed (Figure 26), according to the National Weather Service. The tornado also downed several trees and flipped a truck over.

**Figure 26.** Mobile home that was destroyed by the Washington Parish Tornado (Source: <https://www.wdsu.com/>)

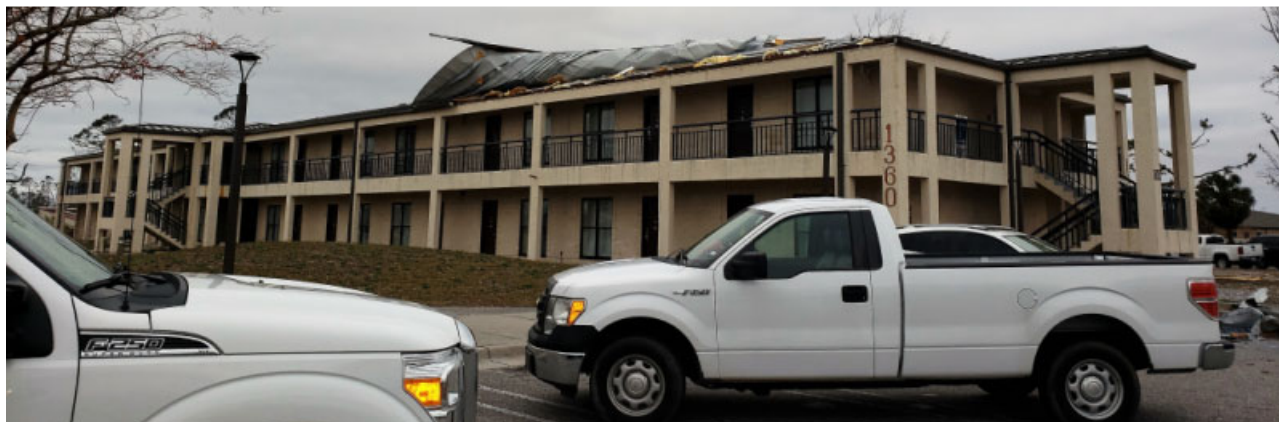
The Tyndall Air Force Base in Florida also experienced an EF-1 tornado, just months after being hit by Hurricane Michael. The tornado touched down near Suwannee Rd. on the base and traveled northeast for approximately 0.8 miles. It was 50 yds wide with estimated maximum wind speeds of 90 mph. There were no injuries, but the winds damaged a portion of a new roof on a barracks

(Figure 27), damaged, moved a car (Figure 28), and flipped dumpsters (NWS). It is unknown at this time whether the roof had been replaced before or after Hurricane Michael. Either way the damage deserves further scrutiny, as either 1) a new roof that should have been designed to 135 mph or greater was damaged in an apparent 100 mph tornado, or 2) a roof that survived the 135+ mph wind speeds of Hurricane Michael failed in a relatively weak tornado. More details are being sought.

**Figure 27.** New roof of a barracks peeled back due to tornado winds on the Tyndall AFB (Source: National Weather Service, Tallahassee, FL WFO)

5. Investigate further the failed roof system on the Tyndall Air Force barracks building. It would appear that the roof system failed well below design, but it is unclear whether installation deficiencies may be to blame, or whether this is evidence of the enhanced wind loads that tornadoes may induce at localized scales, whether accumulated damage in previous storm events (i.e., Hurricane Michael) led to premature failure, or if this roof was only temporary replacement for a roof damaged in Hurricane Michael.

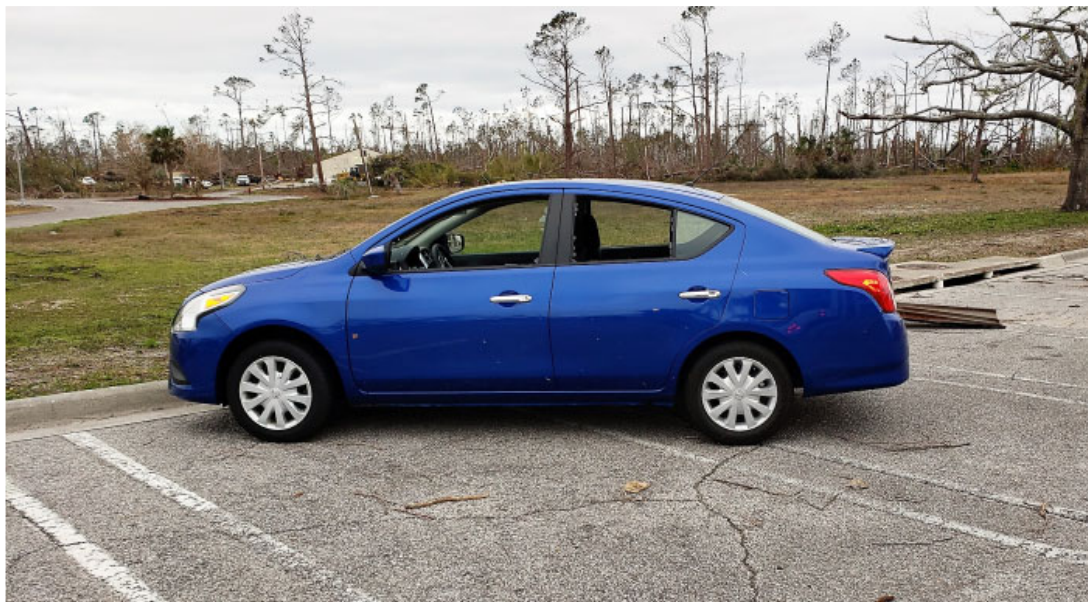
**Figure 28.** Car was moved and the windows were shattered due to the tornado on the Tyndall AFB (Source: National Weather Service, Tallahassee, FL WFO)
