StEER
STRUCTURAL
 EXTREME EVENTS
 RECONNAISSANCE

22 May 2019 JEFFERSON CITY, MO TORNADO: FIELD
 ASSESSMENT STRUCTURAL TEAM 1 (FAST-1)
 EARLY ACCESS RECONNAISSANCE REPORT (EARR)

Released: 06/10/2019 | NHERI DesignSafe Project ID: PRJ-2406

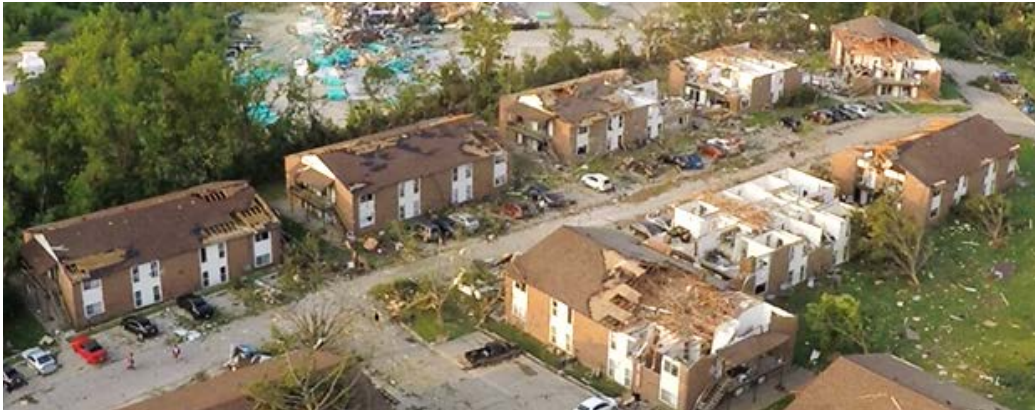
(Top) Damaged Hawthorne Park Apartment Complex (Source: UAV video from FAST-1).
 (Bottom) Members of FAST-1 from the Missouri University of Science and Technology and the
 Wind Hazard Assessment and Mitigation Team (WHAM).

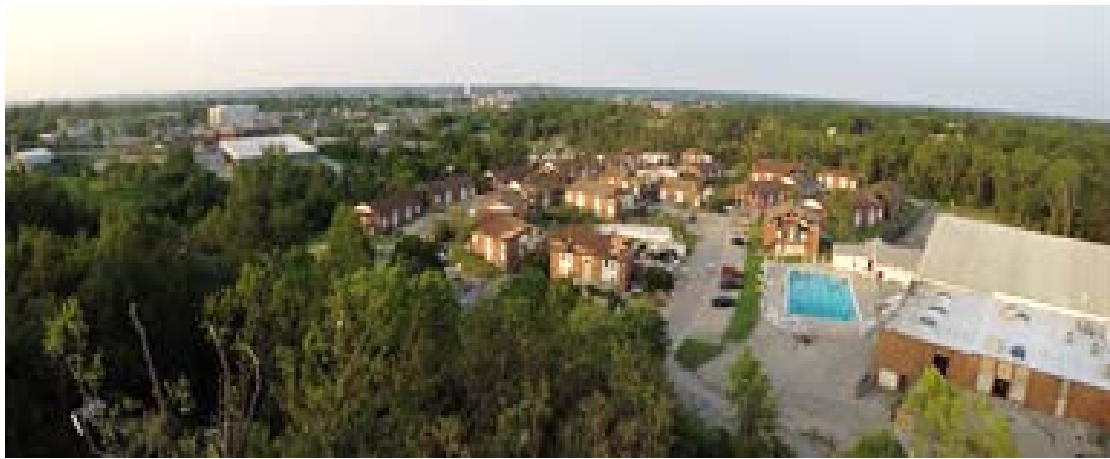
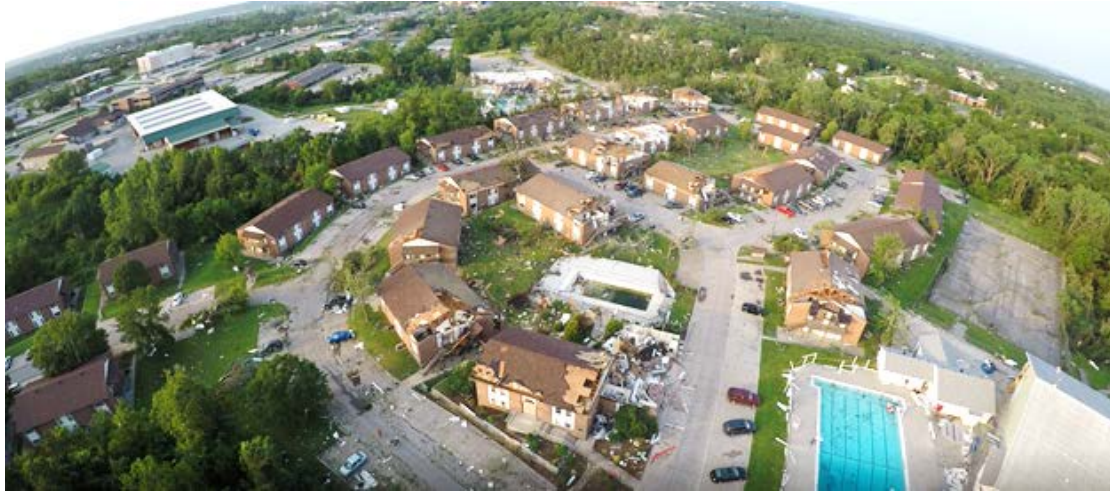
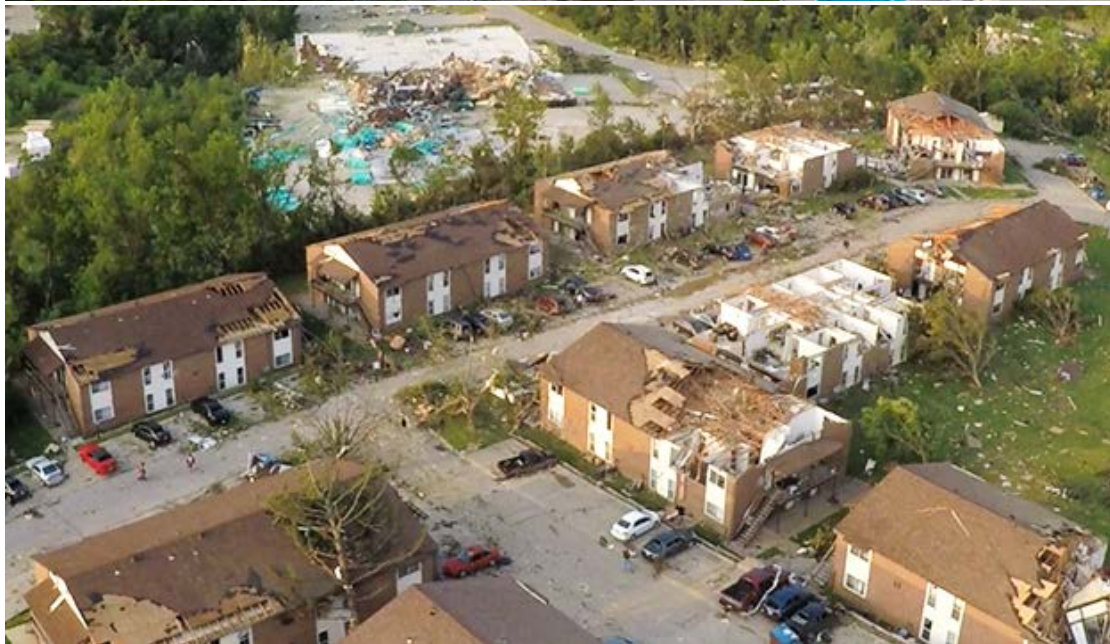
Fig. 1 Drone photos of the Hawthorne Park Apartment Complex.

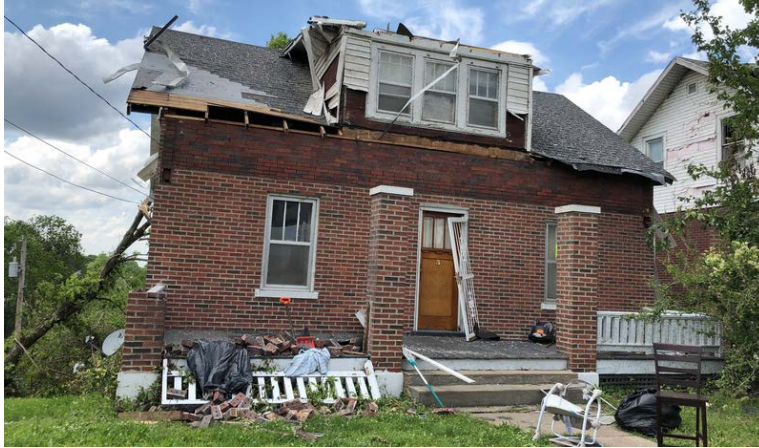
Sixty five single-family residential buildings were surveyed in the D2D assessment; those sustaining damage had preliminary overall wind damage ranging from moderate to destroyed depending upon the proximity to the tornado path. Although it is of note that several homes that were in the tornado path avoided damage. Preliminary analysis of D2D data in the sampled clusters indicates damage predominantly driven by wind and windborne debris and largely windows and roofs were damaged. The building in Figure 7 appears to be a slab on grade building with two stories. The exterior is brick, whether it is veneer or not is hard to determine. The upper story has damage to the roof over the upstairs windows, which suggests a failure of the separate roof over the gable window roof system and not the main truss system.

Fig. 7: Typical single-family residence with damage to windows and the roof.

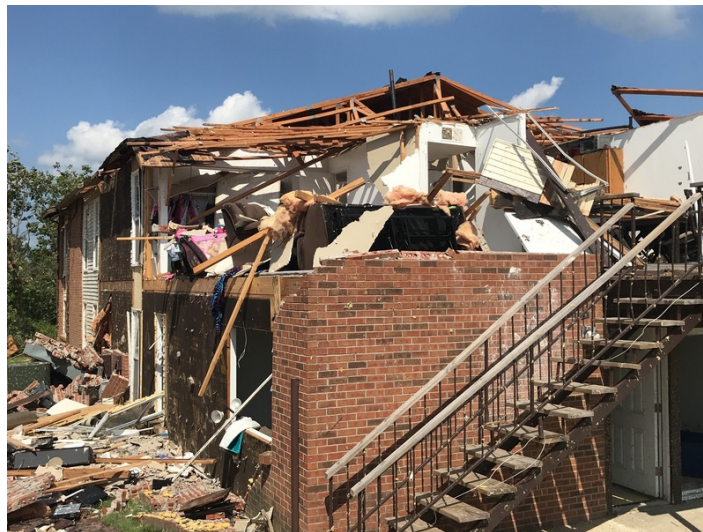
Twenty apartment buildings were surveyed in the D2D assessment; those sustaining damage had preliminary overall wind damage ratings of severe to destruction. Preliminary analysis of D2D data in the sampled clusters indicates damage predominantly driven by wind and windborne debris and largely the brick veneer and roof/truss/wall systems were destroyed or damaged. Figure 8 is a multi-family residential building that has complete destruction of the upper nearest apartment. The exterior is brick veneer. The veneer failed on this structure in the un-collapsed wall of the lower apartment. The building is slab on grade.

Fig. 8: Multi-family residence with total destruction of the second floor apartment.

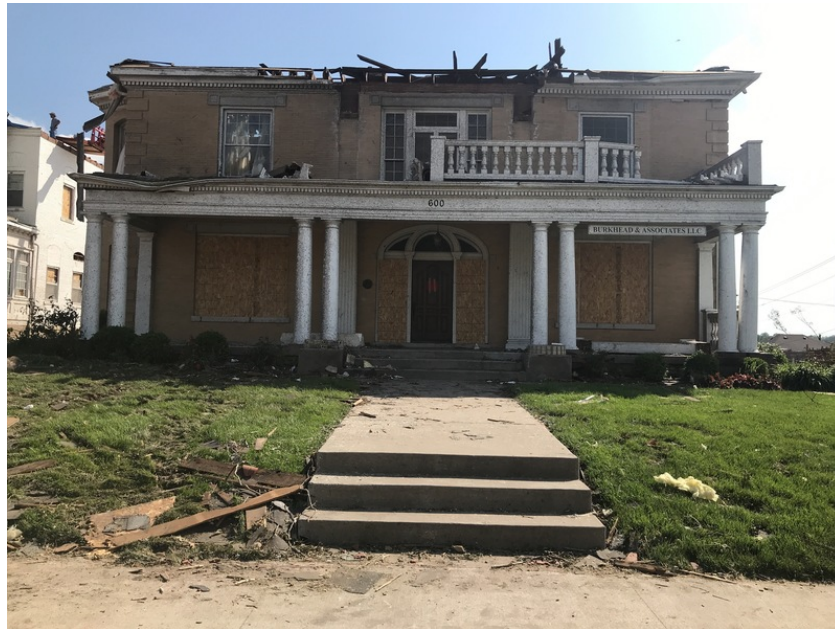
predominantly driven by wind and windborne debris and largely roof damage is present. Figure 9 shows a historical building with a column supported second story balcony. The balcony appears to be intact, however the entire roof has collapsed into the second story of the building.

Fig. 9: Historical building that was used as an office. Total roof collapse visible from street.

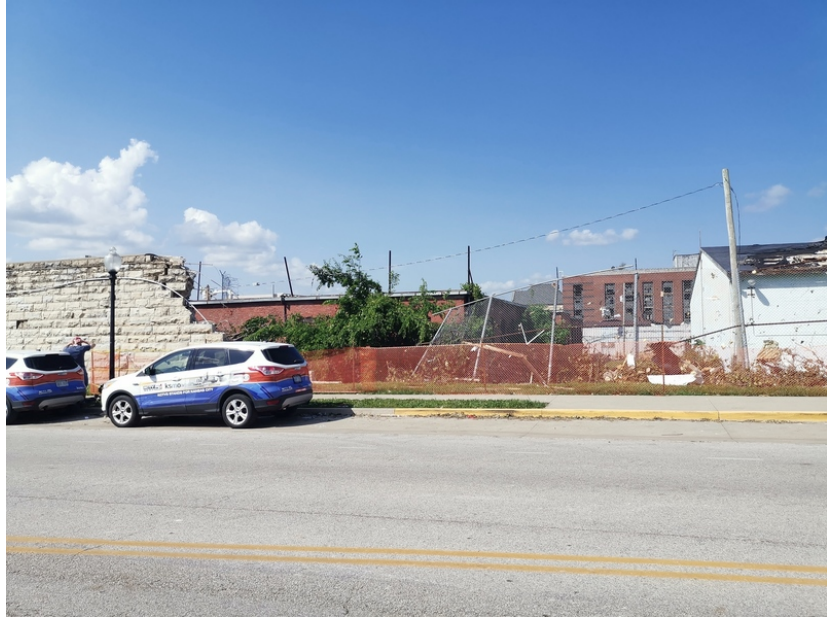
Two professional/government buildings were surveyed in the D2D assessment; those sustaining damage had preliminary overall wind damage ratings of severe to destroyed. Preliminary analysis of D2D data in the sampled clusters indicates damage predominantly driven by wind and largely wall and window damage was present. Figure 10 shows an exterior wall for the old State Penitentiary that has blown over. The wall is one foot thick, and appears to be constructed of heavy stone and mortar.

Fig. 10: State Penitentiary wall was blown over by wind.

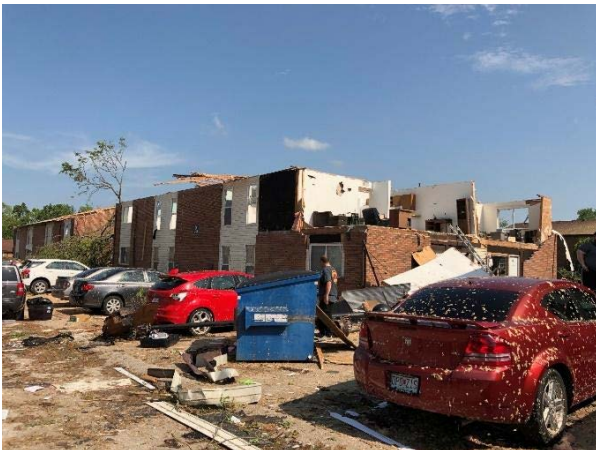
Fig. A1 Entire roof was blown away; wall collapsed; brick veneer fell off.

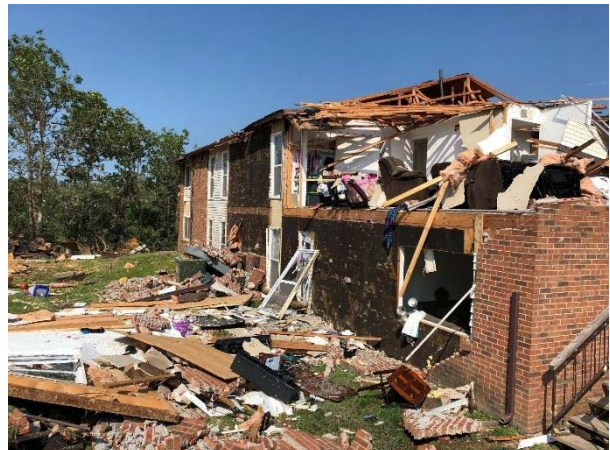
Fig. A2 Partial roof was blown away; wall collapsed; brick veneer fell off.

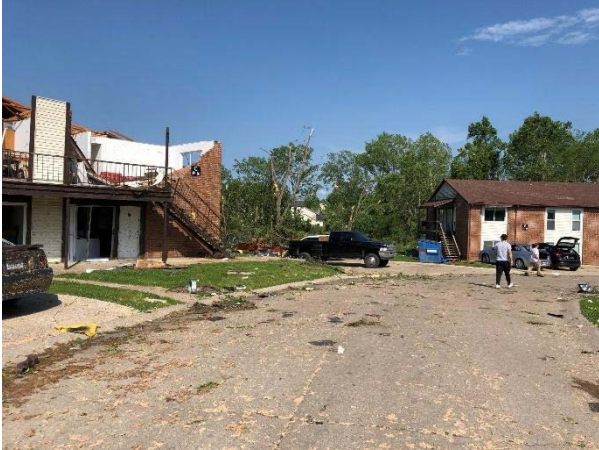
Fig. A3 Partial roof was blown away; wall fell off.

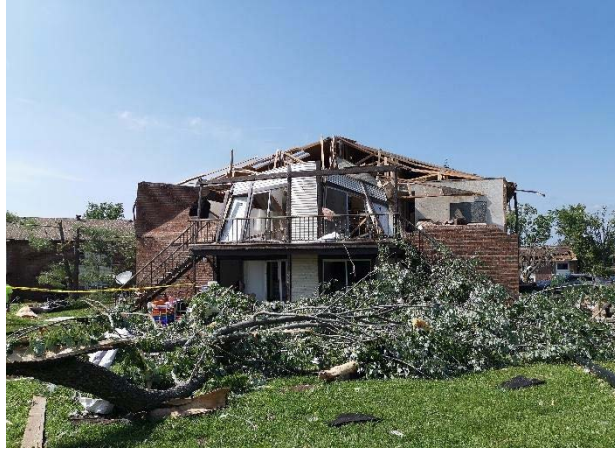
Fig. A4 Partial roof truss was severely; wall collapsed.

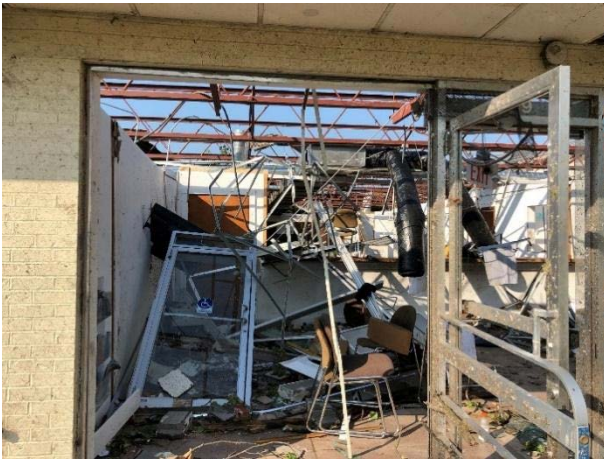
Fig. A5 Entire roof was severely damage; glass door is destroyed.

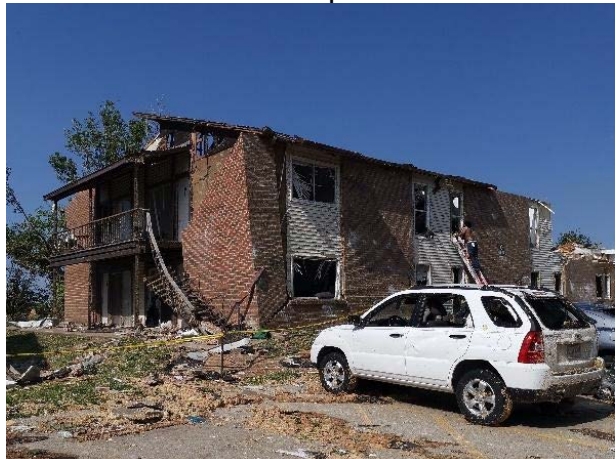
Fig. A6 Partial roof was blown off; brick veneer fell off.

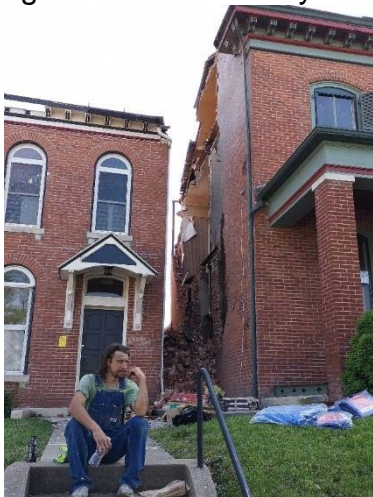
Fig. A7 Side wall collapsed.

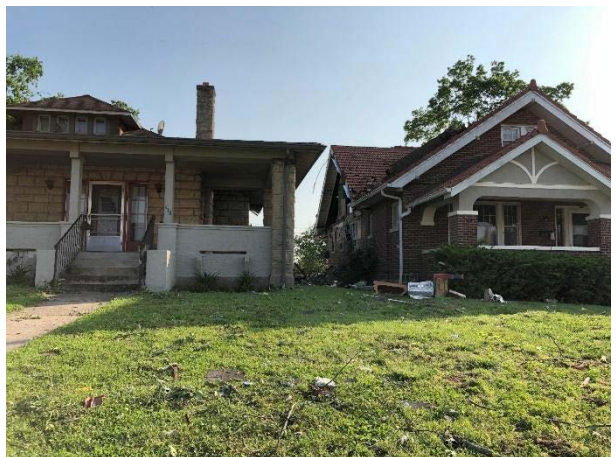
Fig. A8 Side wall collapsed.

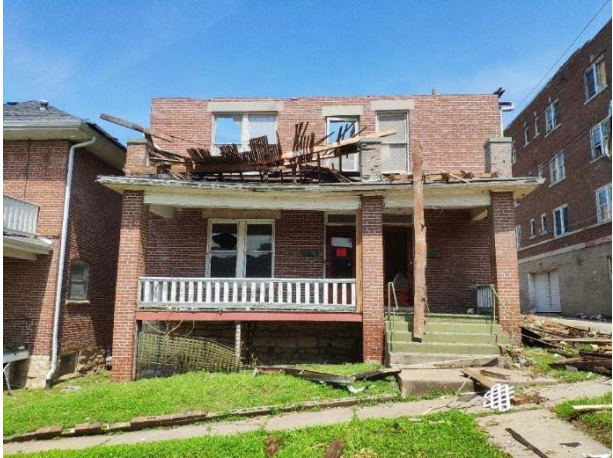
Fig. A9 Entire roof was blown away.

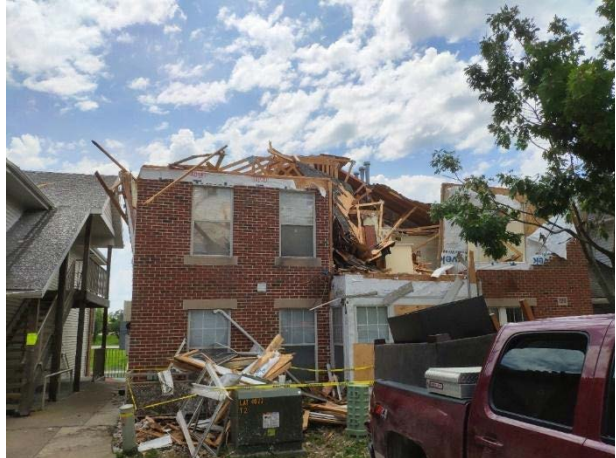
Fig. A10 Entire roof was severely damaged; wall fell off.

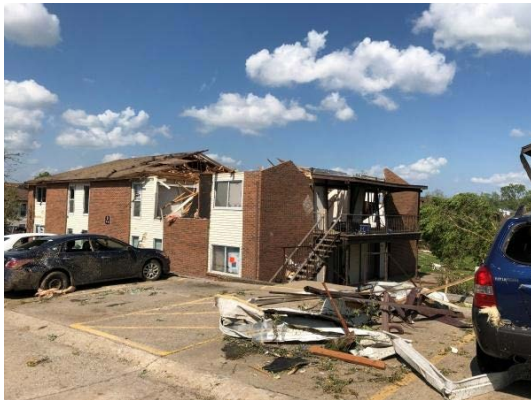
Fig. A11 Partial roof was blown away; brick veneer fell off.

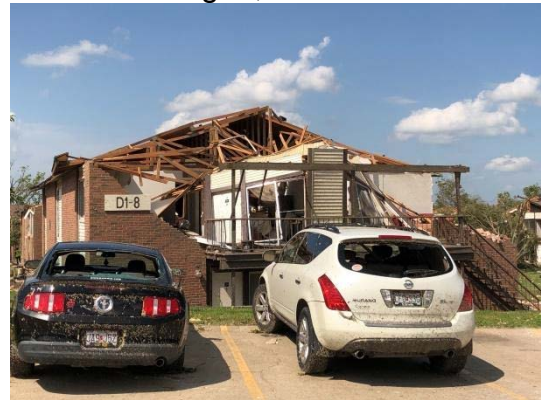
Fig. A12 Partial roof was blown away; wall collapsed; brick veneer fell off.

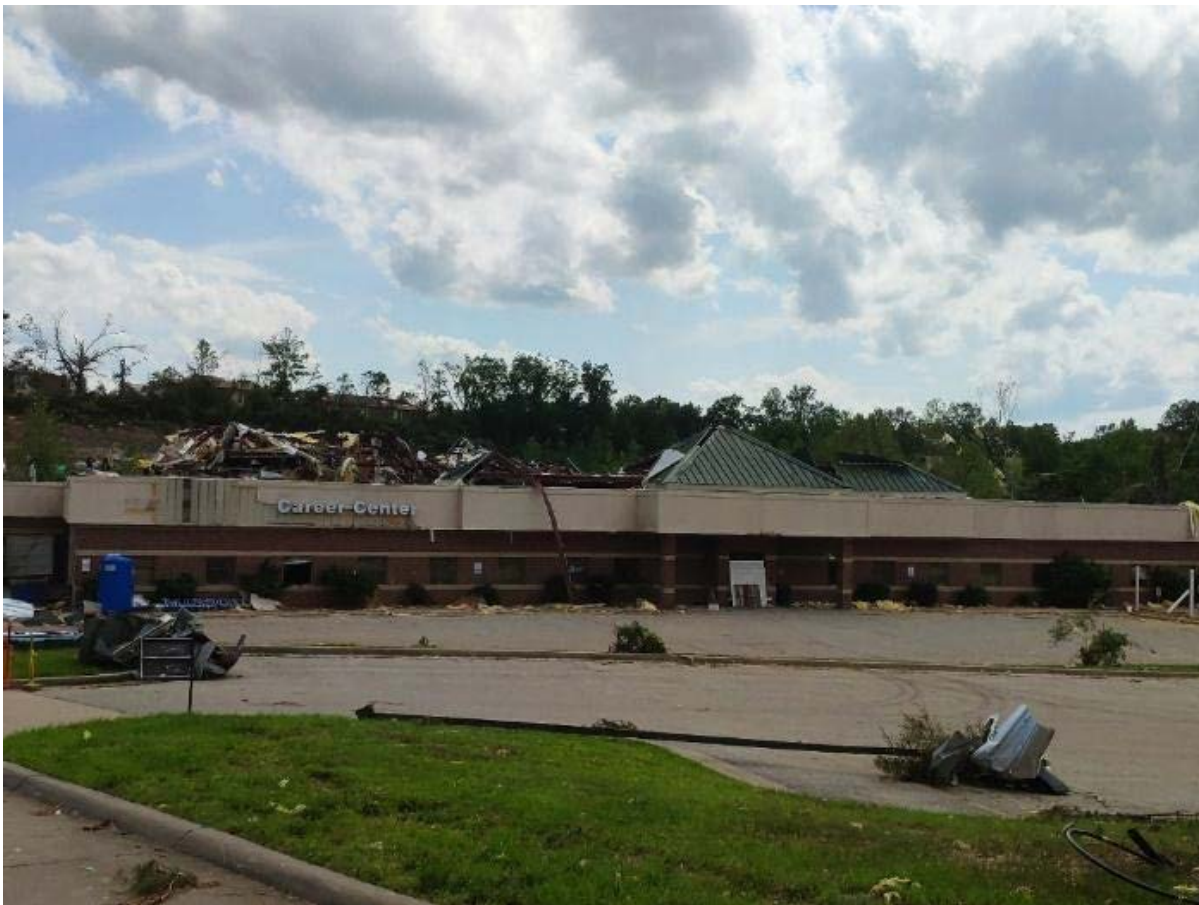
Fig. A13 Steel roof was severely damaged.

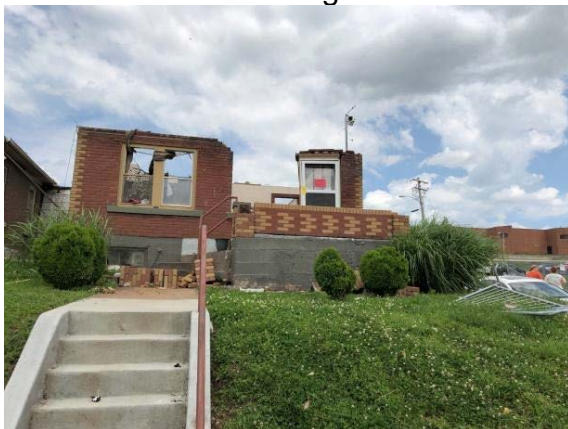
Fig. A14 Entire roof was blown away; wall collapsed; brick veneer fell off.

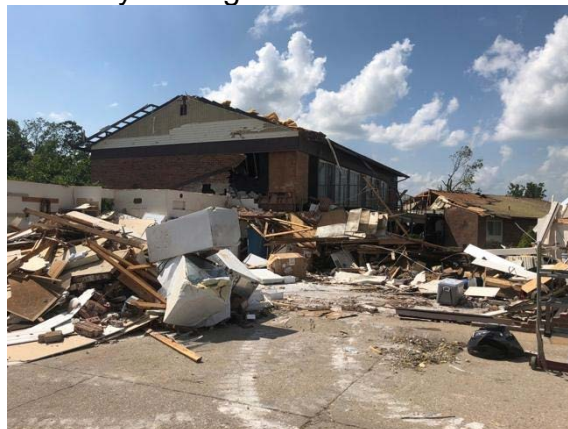
Fig. A15 Partial roof was blown away; wall collapsed; brick veneer fell off.

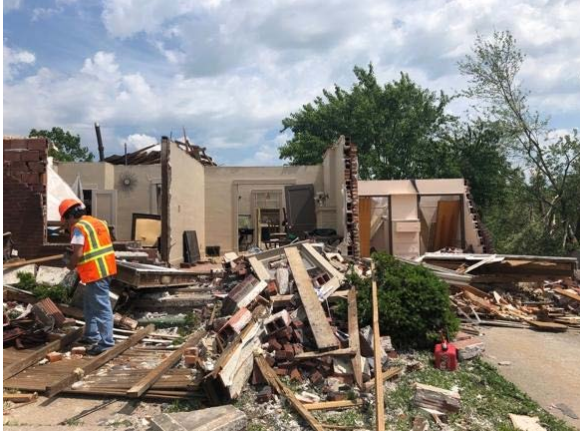
Fig. 16 Entire roof was blown away; wall collapsed; brick veneer fell off.

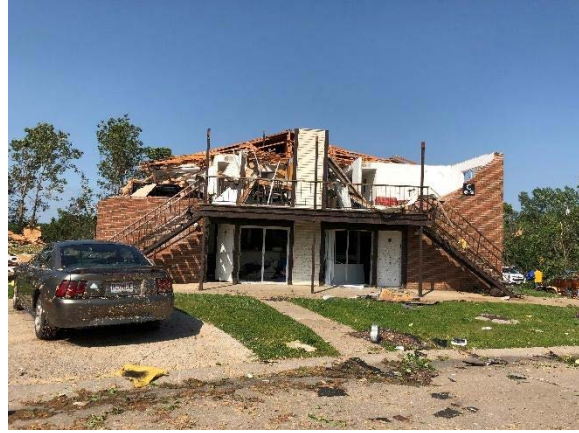
Fig. 17 Partial roof was blown away; wall collapsed; brick veneer fell off.

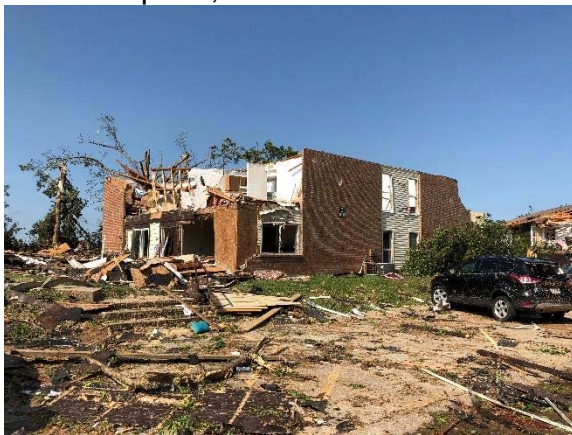
Fig. 18 Entire roof was blown away; wall collapsed; brick veneer fell off; glass was broken.

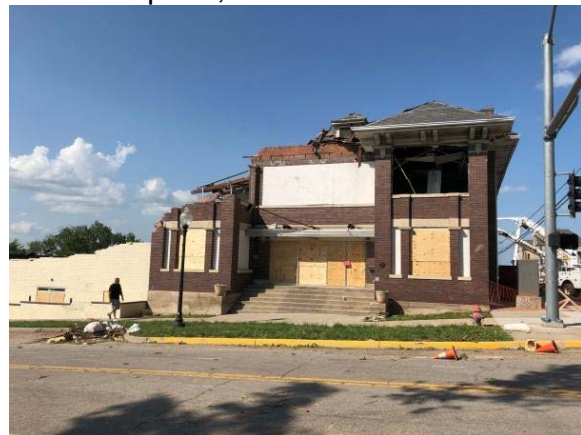
Fig. 19 Partial roof was blown away; wall collapsed; glass was broken.
