<b>StEER</b> <b>STRUCTURAL</b> EXTREME EVENTS RECONNAISSANCE	<b>EVENT BRIEFING</b>		
	Event:	Hurricane Sally	
	Region:	Gulf Coast (Gulf Shores, AL)	
FAST Authors:	John Cleary, University of South Alabama Henry Lester, University of South Alabama Justin D. Marshall, Auburn University David Roueche, Auburn University Stephanie M. Smallegan, University of South Alabama		
VAST Authors:	Irina Afanasyeva, University of Florida Wilfrid DJIMA, Independent Consultant Dmitrii Golovichev, University of Florida Tracy Kijewski-Correa, University of Notre Dame Oscar Lafontaine, University of Florida Stephen Strader, Villanova University		
Editors:	David O. Prevatt, University of Florida		
DesignSafe Project #	PRJ-2914	Release Date:	September 24, 2020

### Event Briefing

Hurricane Sally | Released September 24, 2020

DesignSafe Project: PRJ-2914

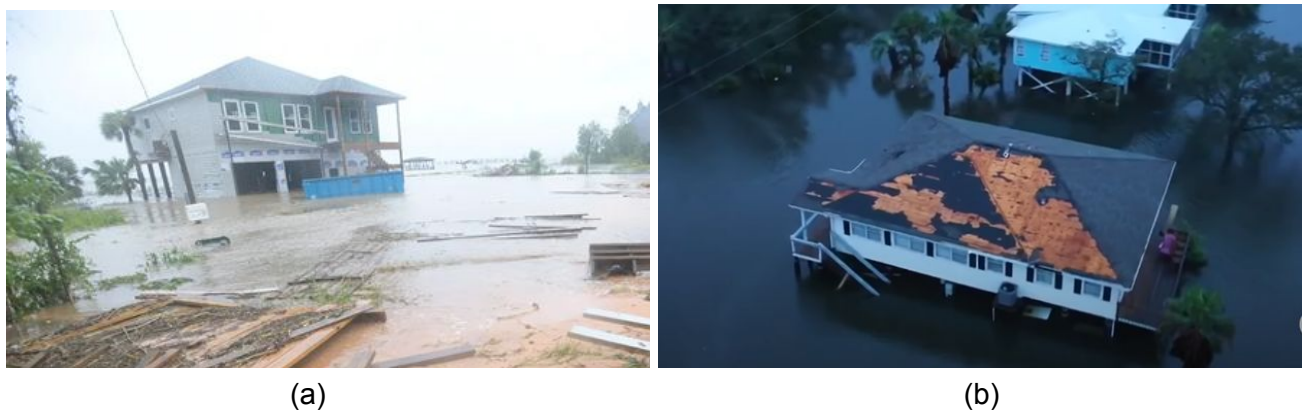
- **Envelope damage:** limited reports from minor to moderate envelope damage, with loss of roof and wall cover (Figs. 3.1-3.2); isolated reports of significant curtain wall damage (Figs. 3.3-3.4)
- **System-level failures:** isolated reports of significant structural roof damages (Figs. 3.5-3.6), in some cases propagating into partial or complete failure of walls (Figs. 3.7-3.9). Major collapses were infrequent and largely confined to wood-framed construction. Several severe structural failures to homes were reported in Fort Morgan, AL (see drone footage from [WXChasing](#)), including complete destruction of the second story.
- **Tree Falls:** damage was due to fallen trees was also widespread and did cause structural damage in some cases (Fig. 3.10). Significant tree loss throughout the region blocked roadways and damaged the power distribution network.

**Figure 3.1.** Envelope damage in Sally: (a) siding loss on a house in Pensacola, FL; (b) roof cover loss on a house in Gulf Shores, AL. (Sources: (a) [www.pnj.com](http://www.pnj.com), (b) [abcnews.go.com](http://abcnews.go.com))

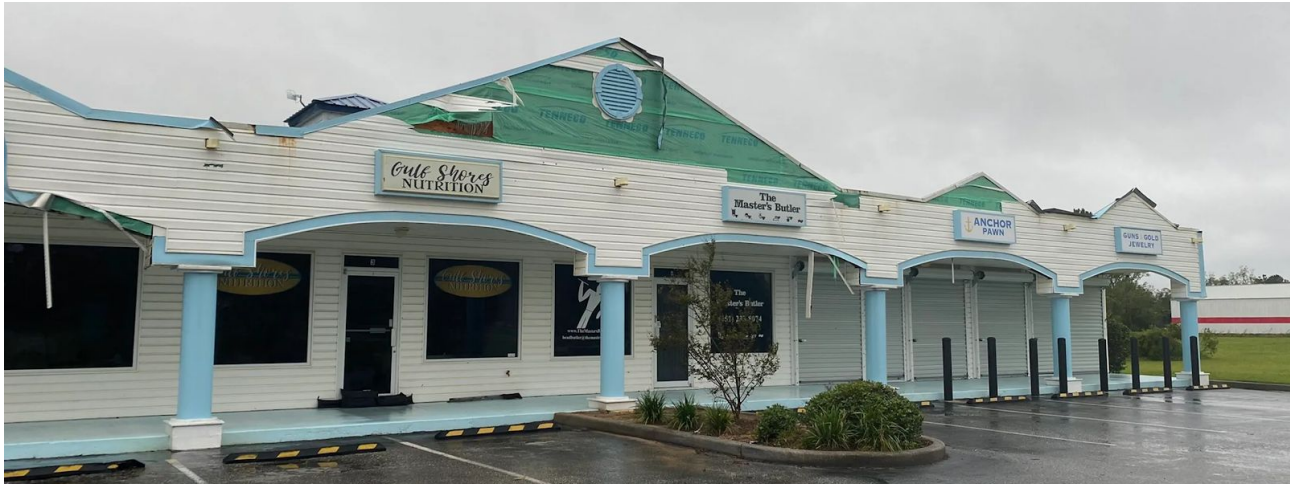
**Figure 3.2.** Loss of siding on strip mall in Gulf Shores, AL (Source: <https://globalnews.ca/>)

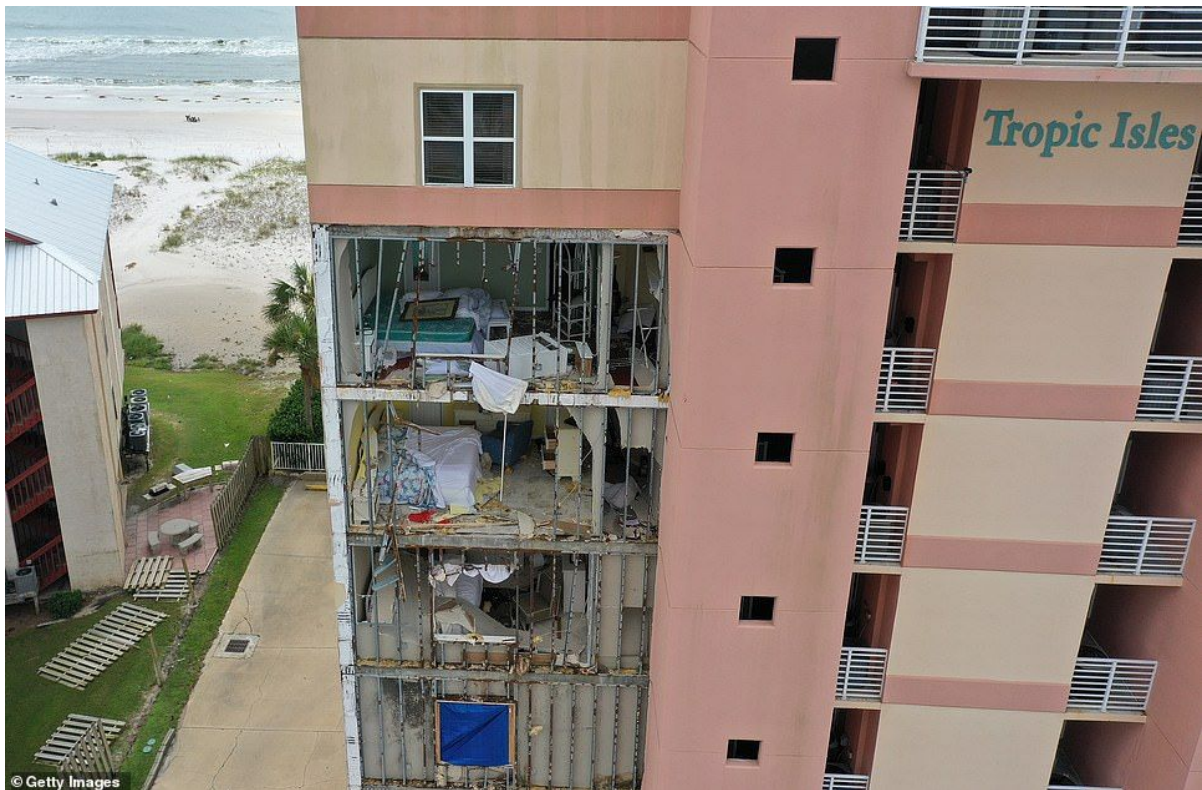
**Figure 3.3.** Aerial image (by drone) capturing failure of curtain wall on the 9-story Tropic Isles complex building in Gulf Shores, AL (Source: [www.dailymail.co.uk](http://www.dailymail.co.uk))

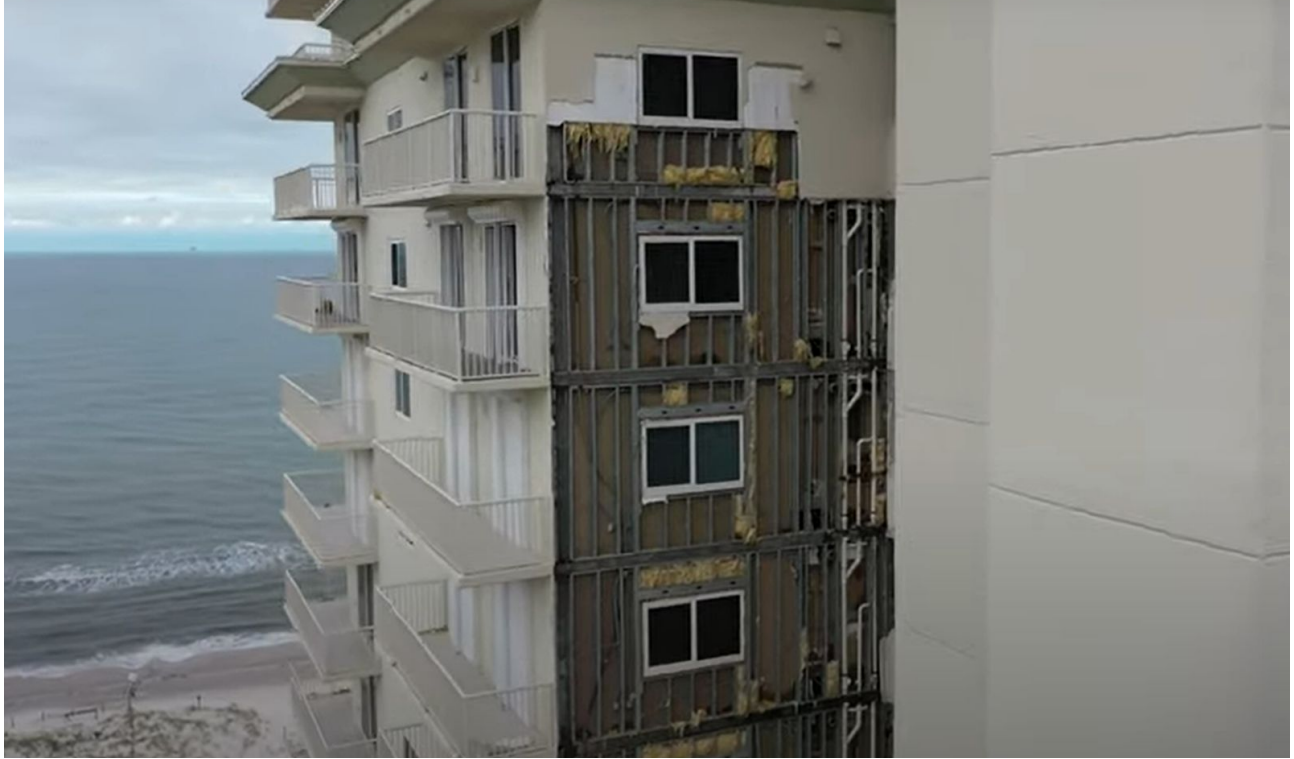
**Figure 3.4.** Aerial image (by drone) shows loss of curtain wall on high-rise building in Fort Morgan, AL (Source: [WXChasing www.youtube.com](https://www.youtube.com/watch?v=WXChasing))

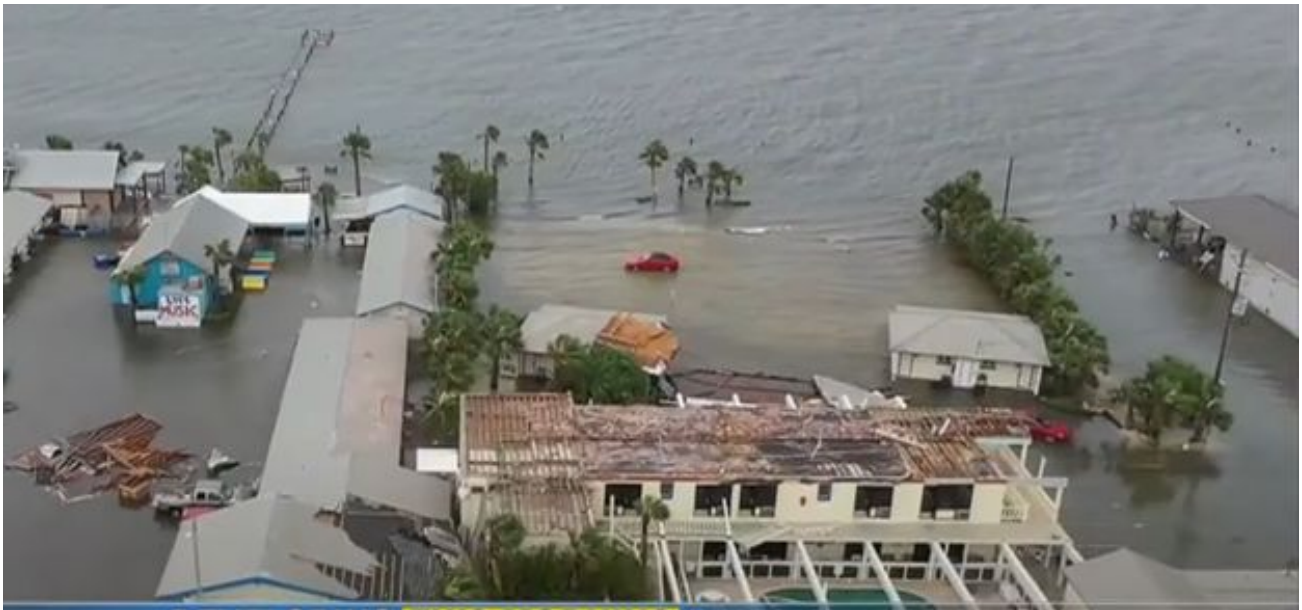
**Figure 3.5.** Structural roof damage at the Paradise Inn hotel in Pensacola, FL (Source: [CBS This Morning www.youtube.com](https://www.youtube.com/watch?v=CBSThisMorning))

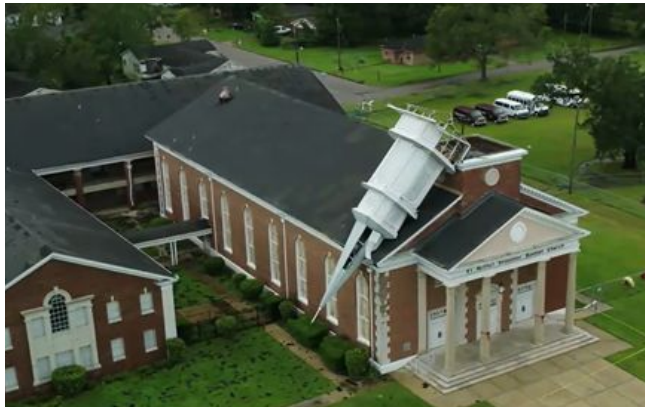
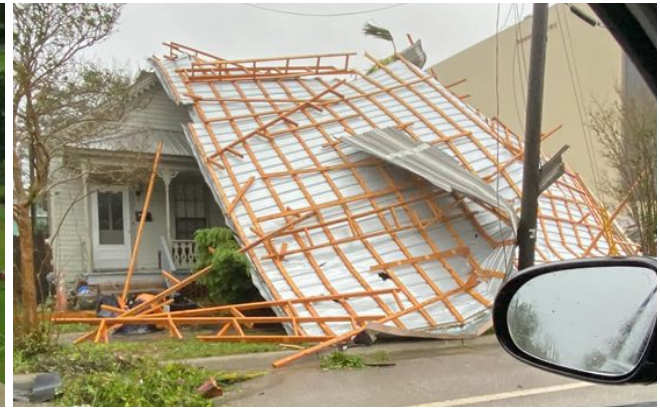
**Figure 3.6.** Roof to wall connection failures in Sally: (a) church steeple toppled in Mobile, AL; (b) failure of roof system on a commercial building, splayed over adjacent single-family building. (Sources: (a) [abcnews.go.com](http://abcnews.go.com), (b) [www.usatoday.com](http://www.usatoday.com))

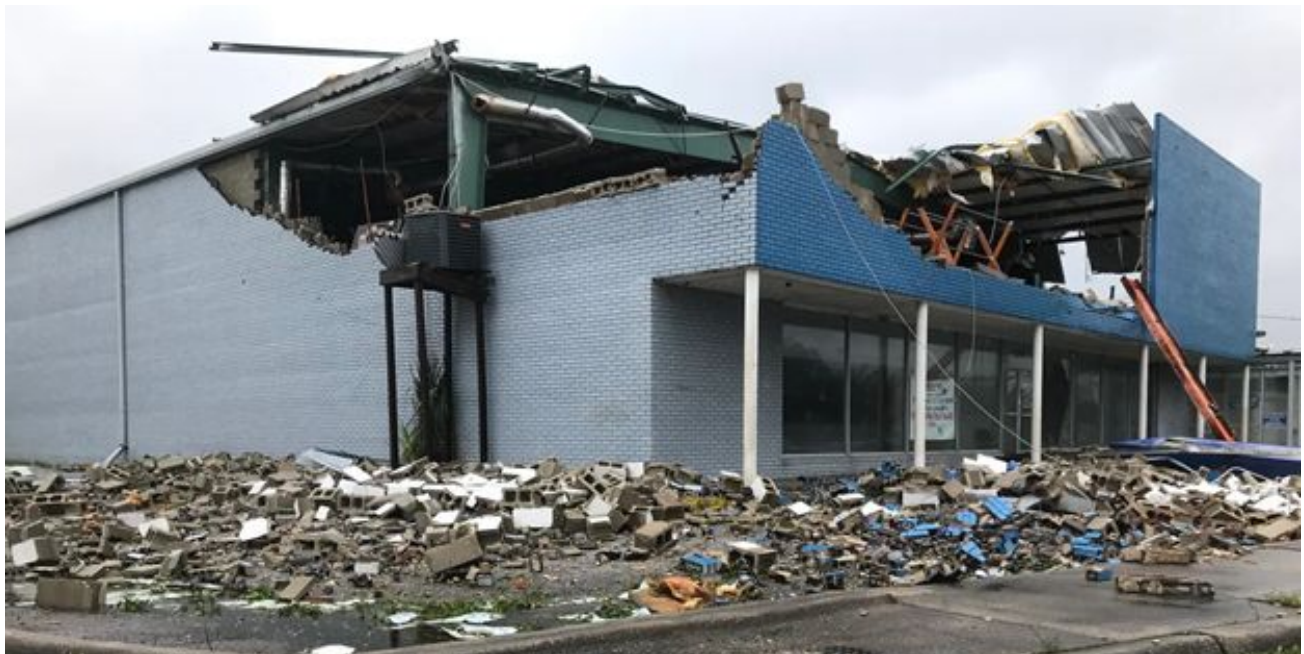
**Figure 3.7.** Roof damage at a commercial building in Brownsville (West Pensacola) causing failure of infill masonry walls and brick veneer. (Source: [www.pnj.com](http://www.pnj.com))

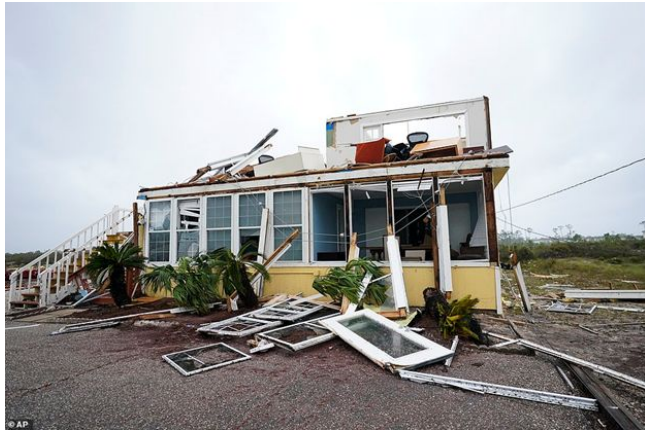
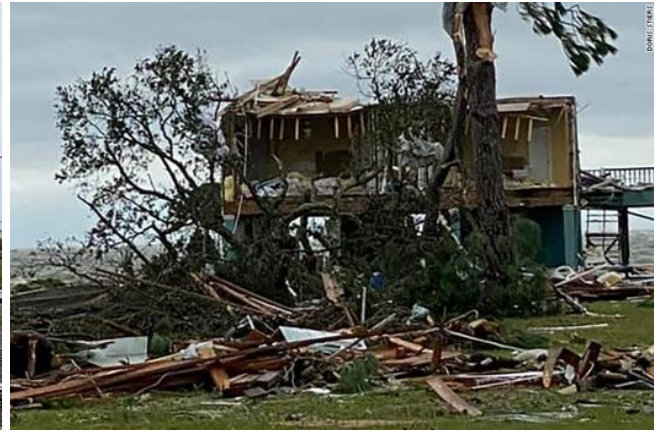
**Figure 3.8.** Major structural damages in Sally: (a) complete loss of second floor of a mixed use building in Perdido Key, FL; (b) Extensive roof and wall damage of house on shoreline of Fort Morgan, AL (Sources: (a) [www.dailymail.co.uk](http://www.dailymail.co.uk) , (b) [www.cnn.com](http://www.cnn.com))

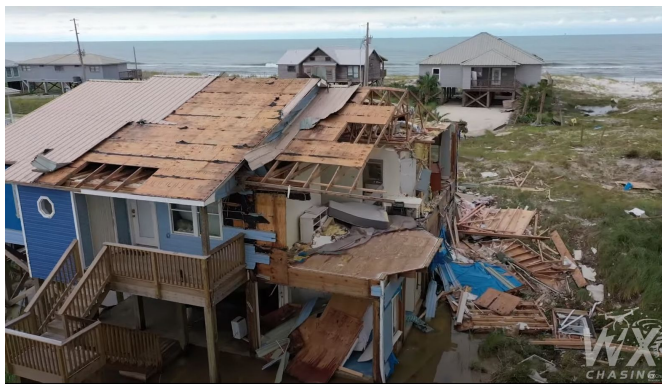
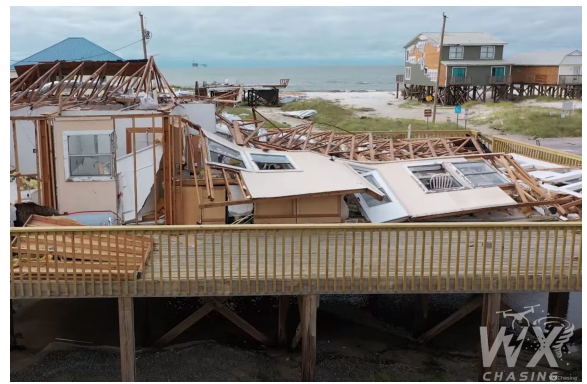
**Figure 3.9.** Structural damage in Sally: (a) end wall collapse of an elevated, wood-frame home in Fort Morgan, AL with well-performing homes in the background; (b) roof and wall collapse of a wood-frame home in Fort Morgan, AL (Sources: [WXChasing](http://WXChasing.com)).

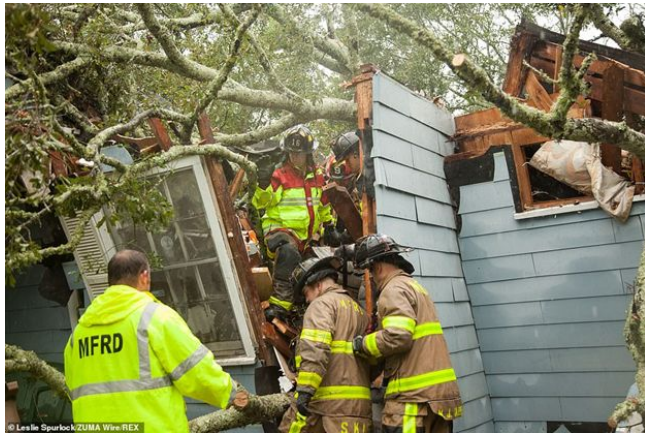
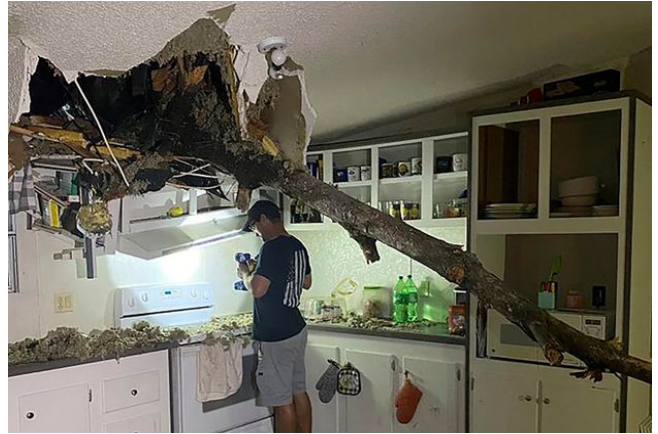
**Figure 3.10.** Tree fall damage at single family homes: (a) rescue of trapped resident in Mobile, AL; (b) tree limb penetrating ceiling of house in Guyton, GA (b). (Sources: (a) [www.dailymail.co.uk](http://www.dailymail.co.uk), (b) [www.dailymail.co.uk](http://www.dailymail.co.uk))

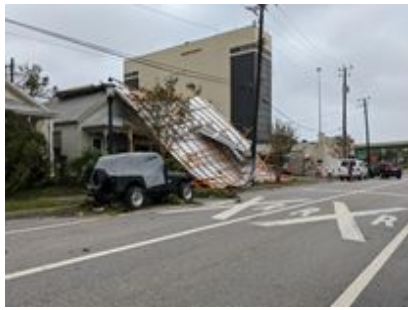
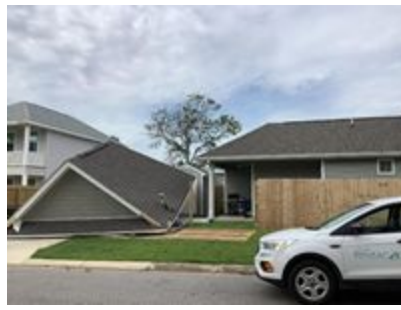
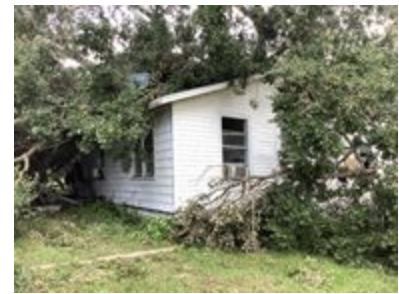
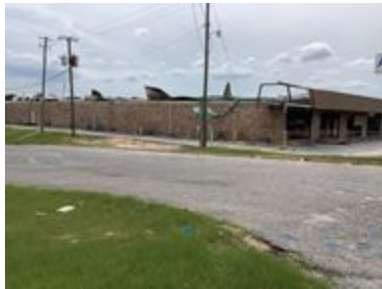
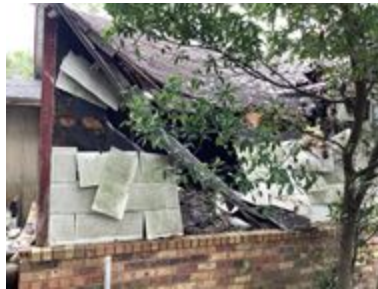
**Figure 3.12.** Illustrative damage in Pensacola sourced from the City of Pensacola: (A) roof damage, year built unknown; (B) carport collapse, built 1947; (C) damage by tree fall, built 1987; (D) commercial roof damage, year built unknown; (E) collapsed roof and wall, built 1938; (F) flood damage (~4ft); built 1953 (City of Pensacola, 2020).

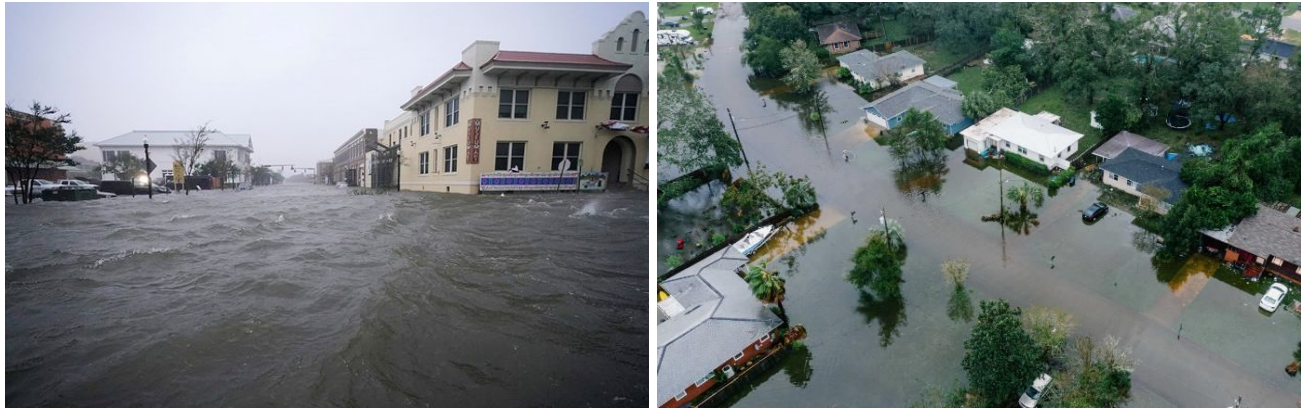
While acknowledging these instances of wind-induced damage, preliminary reports suggest that flooding was the primary driver of losses over a significant area, with high storm surge as major driver in this slow-moving hurricane. This coupled with high rainfall totals over 20 inches led to food waters up to 3 feet in some areas, most notably in Pensacola (Fig. 3.13).

**Figure 3.13.** Examples of flooding in Sally: (a) flooded streets of Pensacola downtown, FL; (b) flooding in West Pensacola, FL near the Bayou Grove and Mulworth neighborhoods (Source: (a) [www.dailymail.co.uk](http://www.dailymail.co.uk), (b) [weather.com](http://weather.com))

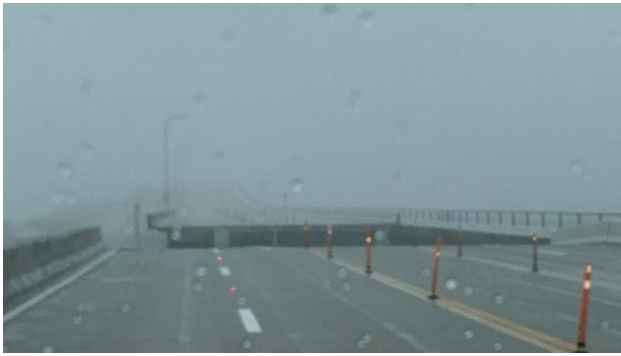
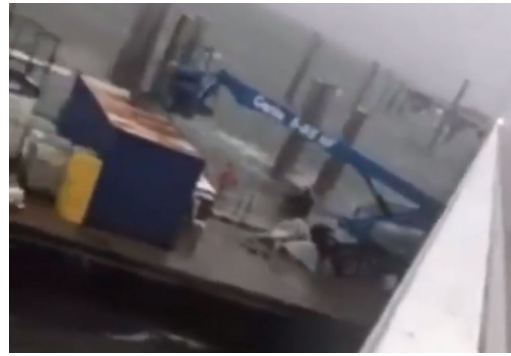
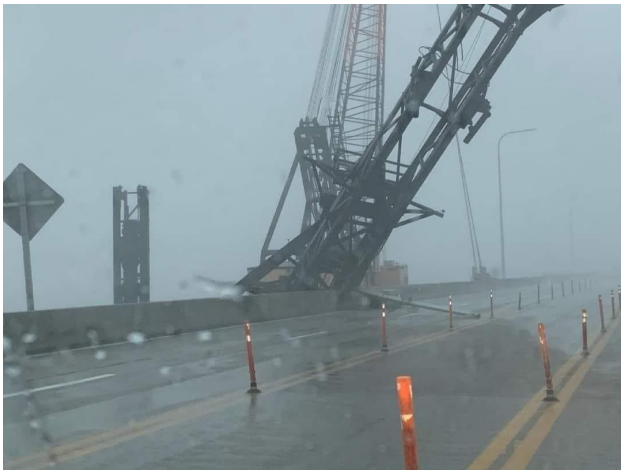
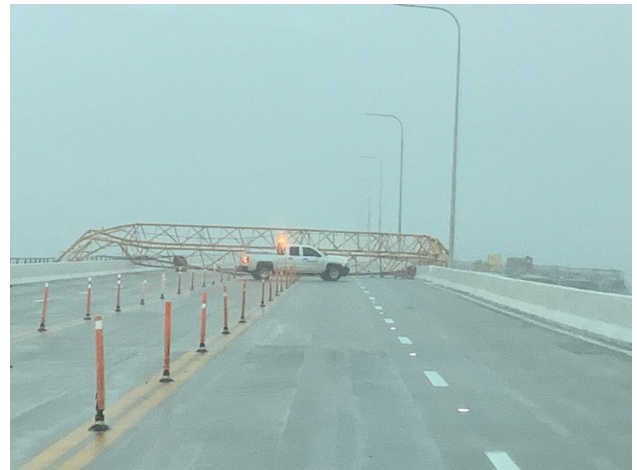
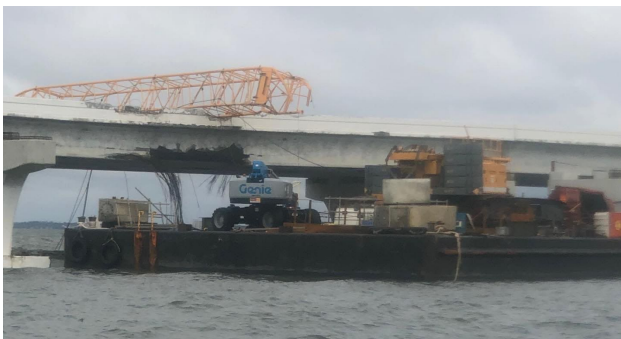
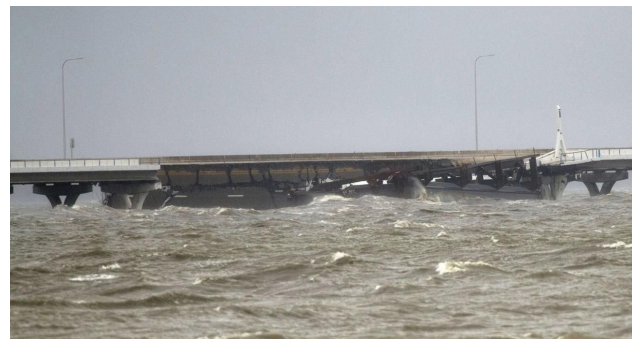
Over 440,000 residents were left without power across the Gulf Coast, with at least 234,103 in Alabama, 204,410 in Florida and 5,406 in Mississippi (Impelli, 2020). In addition to widespread power outages, the initial assessments of damage to roads, bridges and public buildings total nearly \$29 million of damage in Escambia County and the City of Pensacola (Little, 2020). The most notable structural damage to infrastructure reported in public media is a collapsed section of the newly built Pensacola Bay Bridge between Gulf Breeze and Pensacola, FL, known to locals as the Three Mile Bridge (Fig. 3.14) (Kaur and Burnside, 2020). Reports suggest that the bridge's partial collapse resulted from the impacts of two loose barges: one barge wedged under the bridge (Fig. 3.14b), cranes from the other barge rammed against the bridge deck, damaging one section (Fig. 3.14c-e). The recently renovated Gulf State Park Pier in Gulf Shores, AL also lost several sections in the storm (Fig. 3.15). Marinas also sustained significant damage from the storm surge (Fig. 3.16), leading to debris, in the form of marooned boats, impacting the surrounding areas (Fig. 3.17).

**Figure 3.14.** Damaged Pensacola Bay Bridge between Gulf Breeze and Pensacola, Florida: (a) view from deck of lost section, (b) photo of barge wedged under bridge, (c)-(d) crane of second barge damages bridge deck, (e) side view of damage caused by barge/crane impact, and (f) side view of collapsed bridge segment battered by rising waters (Sources: (a) <https://weartv.com>, (b) [Destin-Fort Walton Beach, Florida](https://www.destinfortwaltonbeach.com), (c) [City of Gulf Breeze](https://www.cityofgulfbreeze.com), (d) [Fight the Blight](https://www.fighttheblight.com), (e) <https://twitter.com/wxkaitlin>, (f) <https://www.moultonadvertiser.com>)

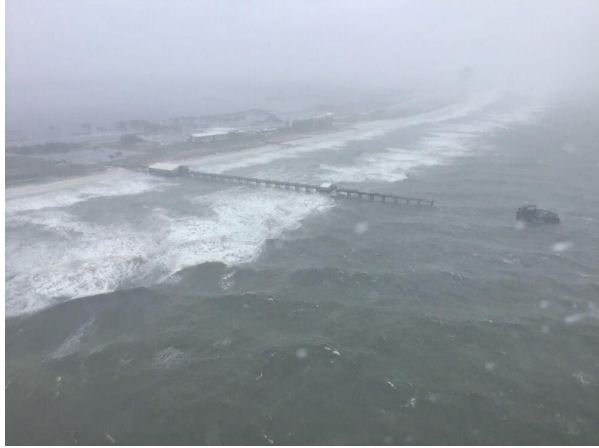
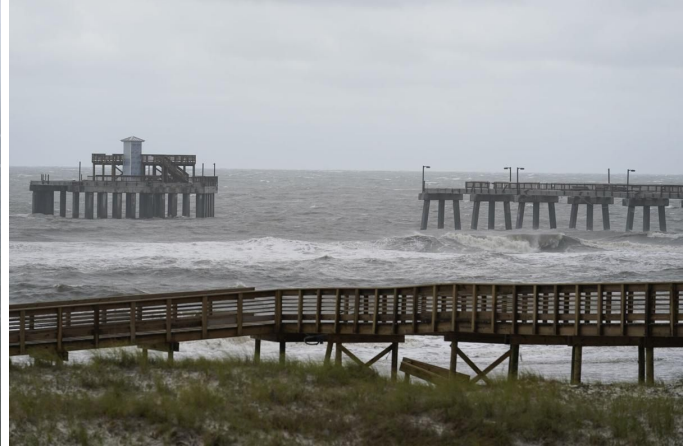
**Figure 3.15.** Damaged pier at Gulf State Park in Gulf Shores, AL (Source: (a) <https://www.fox10tv.com>, (b) <https://www.moultonadvertiser.com>)

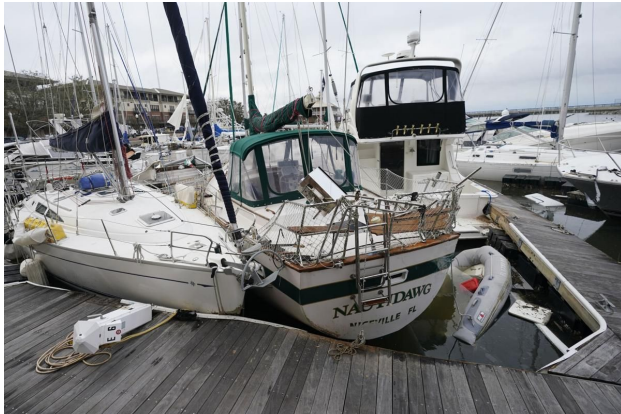
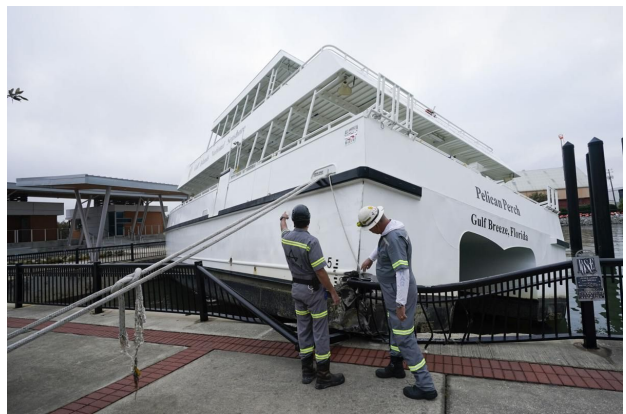
**Figure 3.16.** (a) Damaged boats and (b) ferry in Pensacola, FL (Source: <https://www.moultonadvertiser.com>)

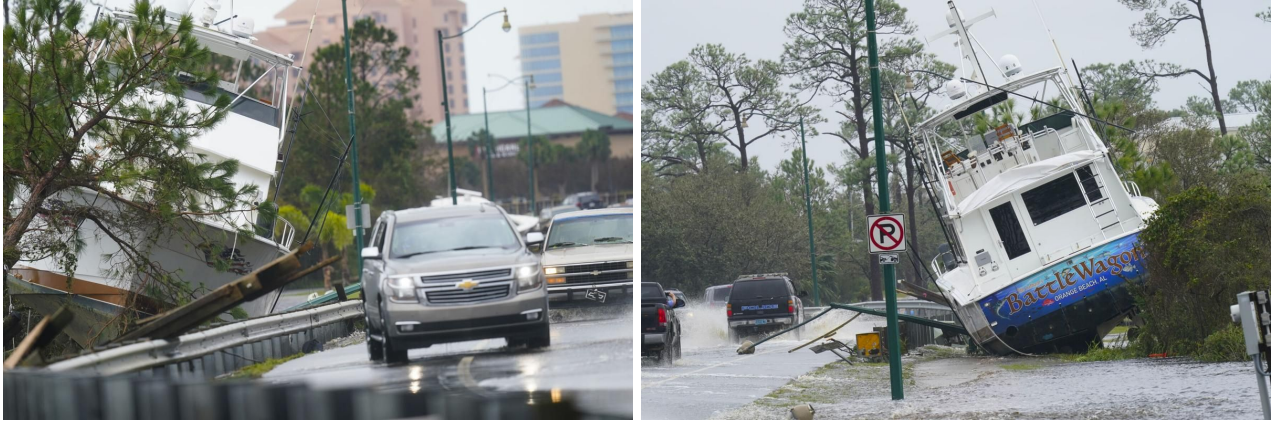
**Figure 3.17.** Flooded roads with boats washed ashore in Orange Beach, AL (Source: <https://www.moultonadvertiser.com>)

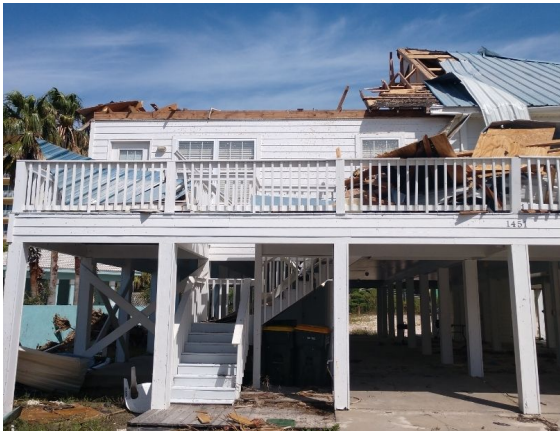
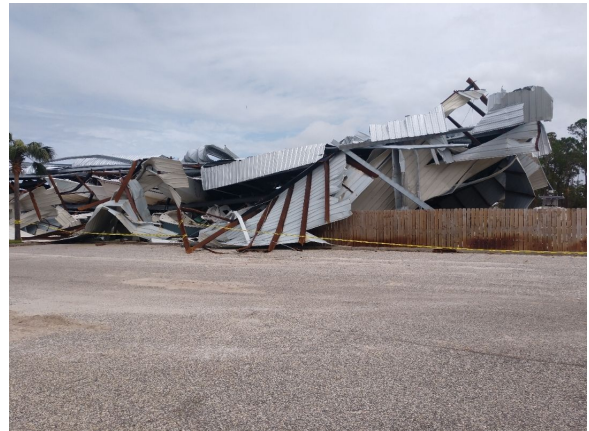
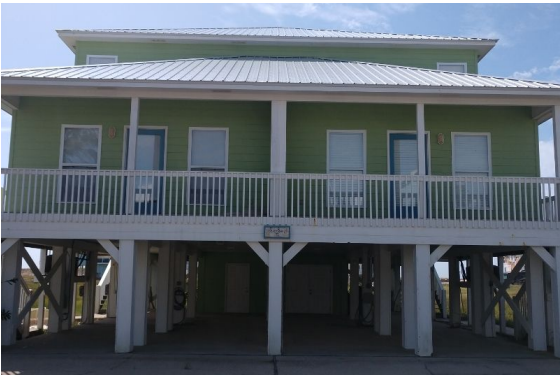
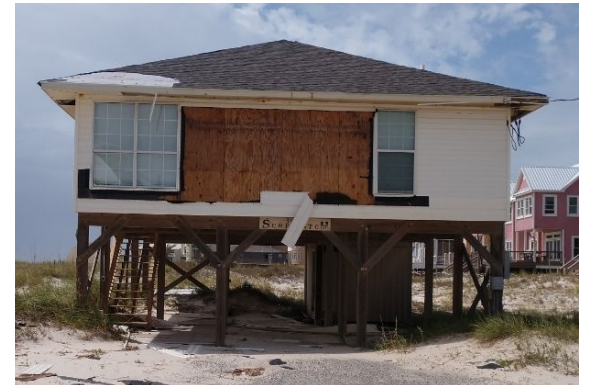
FAST was able to access Fort Morgan, a small unincorporated community west of Gulf Shores, on 23 September and conducted assessments to mostly residential buildings that were present. Most buildings were wood-frame and elevated at least 4 ft above ground. A few multi-story condominium buildings are also present in Fort Morgan, along with a marina. A review of historical aerial imagery showed the majority of buildings in Fort Morgan have been in existence since the early 2000s, although some new construction is also present. Performance varied widely, from no visible evidence of damage to complete destruction. Structural damage up to loss of roof structure and collapse of some walls was observed in a few older buildings (Fig. 4.2a,b), but not all older buildings performed poorly, as shown in Fig. 4.2c,d.

**Figure 4.2.** Illustrative damage observed by FAST in Fort Morgan, AL, including (a) loss of the roof structure in an elevated, one-story wood-frame home constructed in 1998; (b) collapse of a metal marina building constructed between 1997 and 2006; (c) no visible damage to an elevated 2-story home constructed in 2000, located adjacent to (a); no permits exist on file since original construction other than a roof replacement in 2018; (d) loss of vinyl siding and some roof cover in a one-story, wood-frame home constructed in 1992.

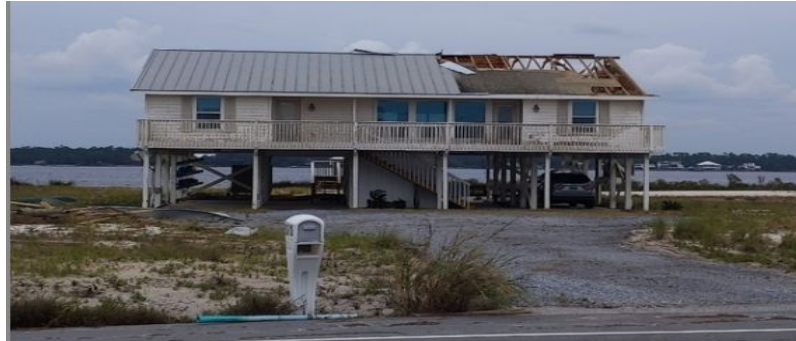
Observations in Gulf Shores were performed primarily on AL 180 (Fr. Morgan Road) and AL 182 (West Beach Blvd) west of AL 59. The most significant impacts in the area were due to storm surge/flooding and tree falls. There were several instances of observed facade and/or roof damage. Typical damage was minor, however, there were several structures that sustained loss of roof sheathing (Fig. 4.3). Damage was primarily observed on older residential structures, with nearby structures undamaged (Fig. 4.4).

**Figure 4.3.** Atypical damage to a residential roof in Gulf Shores with loss of roof sheathing.

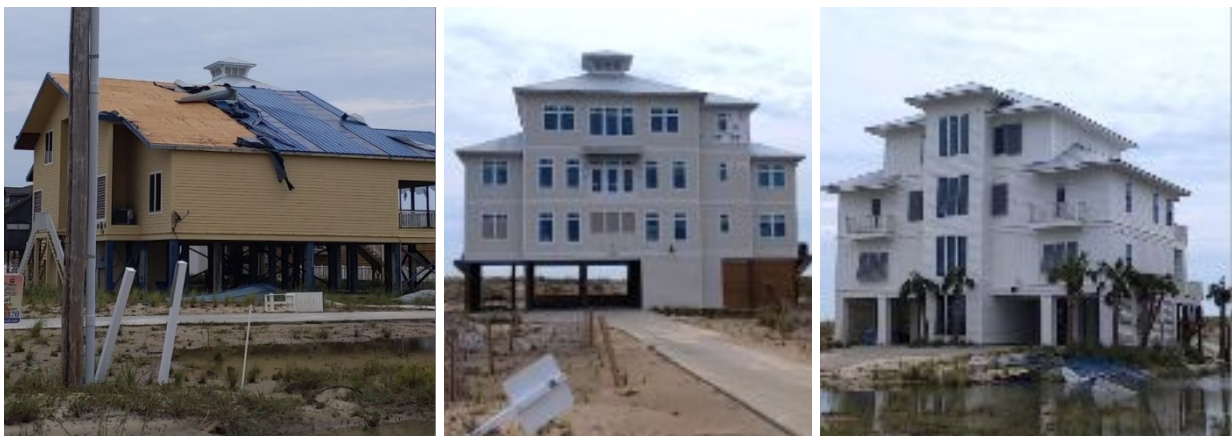
**Figure 4.4.** Typical damage observed in Gulf Shores: (a) significant loss of roof cover; (b) no loss of roof cover, but minor loss of cladding; (c) no observed damage.

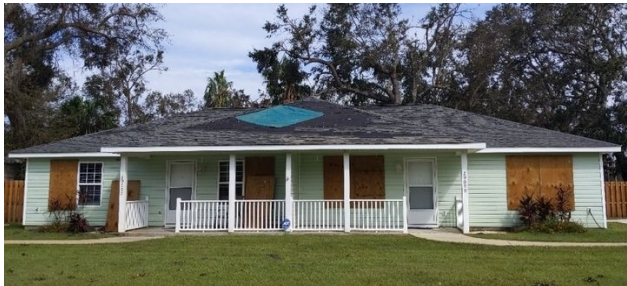
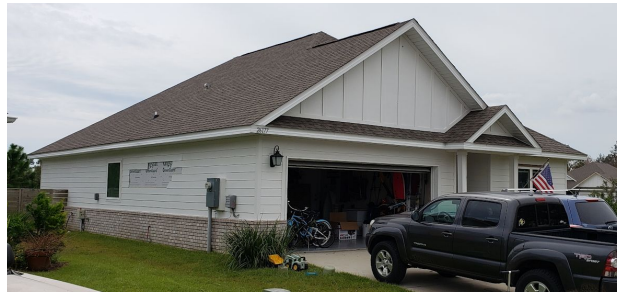
The primary areas evaluated in Orange Beach were along AL 180 (commonly referred to as Canal Road) east of the Foley Beach Expressway (i.e., the Wharf). There was one cluster evaluated in a neighborhood off AL 161 as well. Damage in Orange Beach was similar to Gulf Shores with the primary damage being tree falls and some minor roof damage (Fig. 4.5). Evidence of 2-3 ft of surge and flooding was also observed (Fig. 4.6). A neighborhood of modern residential construction off AL 161, including one FORTIFIED Gold home, performed well overall with no observed structural failures or roof cover damage (laminated asphalt shingles), but did suffer consistent minor loss of fiber-cement board cladding (Fig. 4.5b).

**Figure 4.5.** Damage observed in Orange Beach: (a) typical roof damage; (b) minor loss of fiber cement cladding in a FORTIFIED Gold home, but no other observed damage and no water ingress.

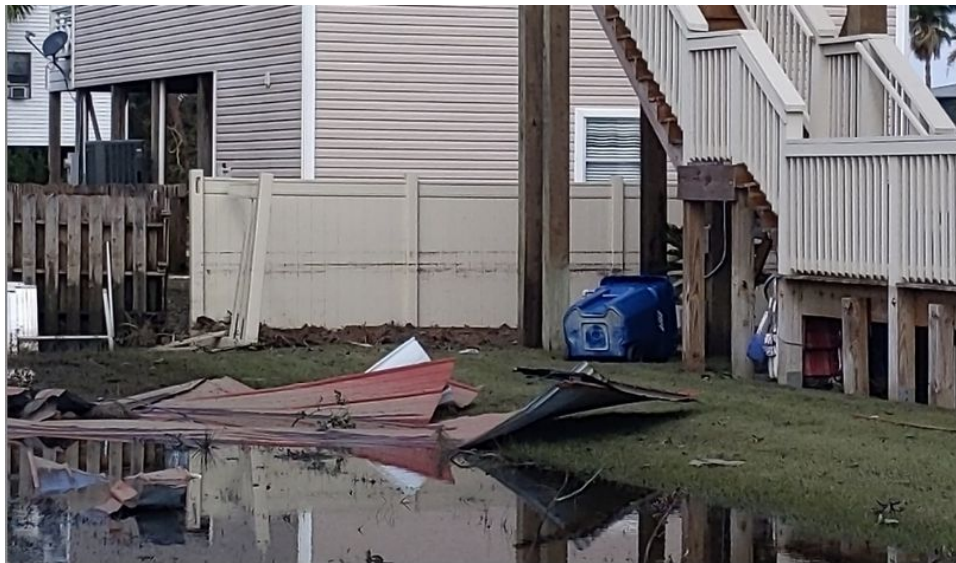
**Figure 4.6.** High water mark (HWM) observed in Bear Point (east end of Orange Beach). Measurements have not yet been taken of observed HWMs.

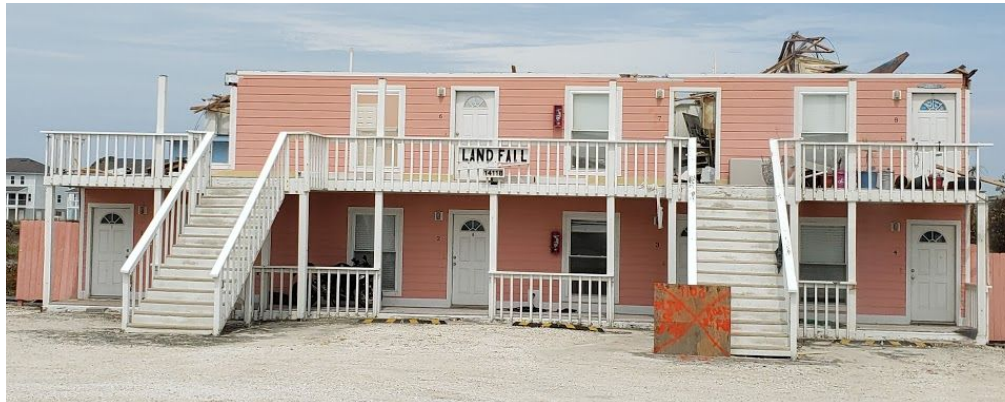
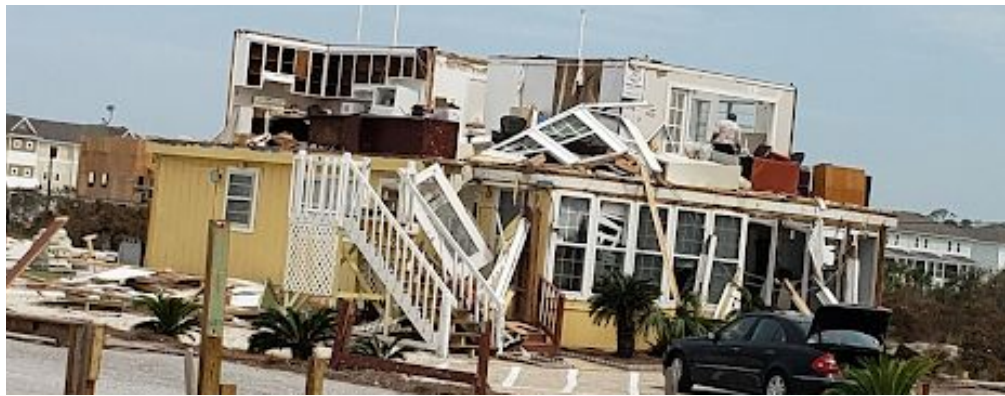
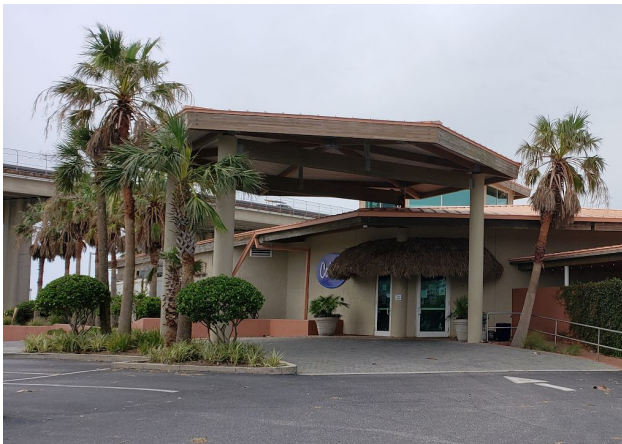
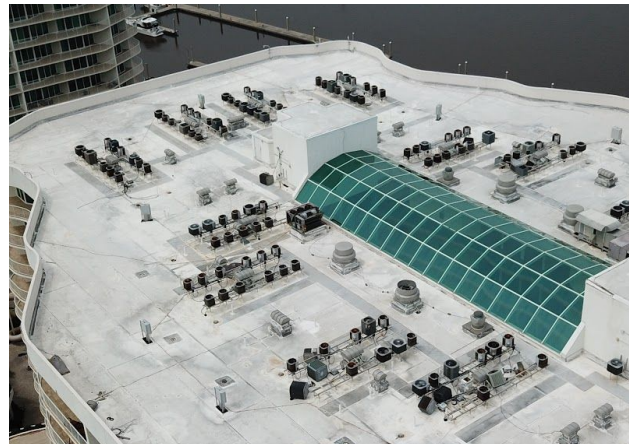
Most observations in Perdido Key were made along FL SR 292. Structural damage of any kind was isolated. The heaviest damage observed was to a two-story, wood-frame condo constructed in 1986, and a real estate office constructed in 1978, both shown in Figure 4.7. The condo building did not appear to have any hurricane straps or other high-wind connections; connections could not be observed in the real estate office. Overall, most buildings suffered little to no damage, and those that were damaged typically only sustained minor loss of roof cover or loss of a few wall cladding elements (e.g., fascia, fiber cement boards, vinyl siding). FAST members Roueche and Marshall conducted a few more detailed assessments near Perdido Pass (the location of the 120 mph gust measurement), but found little evidence of damage in the few structures located in close proximity, which included two 1-story commercial buildings (constructed in 2009 and 2011) and three 13-story resort buildings constructed between 1999 and 2006. The only observed damage was a partial gutter failure in one of the 1-story buildings, and a few toppled rooftop HVAC units in the 13-story condos. The owner of the resort buildings indicated there were no widespread issues with rainwater ingress.

**Figure 4.7.** Illustrative damage in Perdido Key, including (a) a destroyed two-story condominium constructed in 1986; (b) a destroyed real-estate building constructed in 1978; (c) minimal damage to a restaurant near Perdido Pass constructed in 2009; and (d) a few toppled roof top units as the only evidence of damage to 13-story resort buildings near Perdido Pass (constructed between 1999 and 2006).

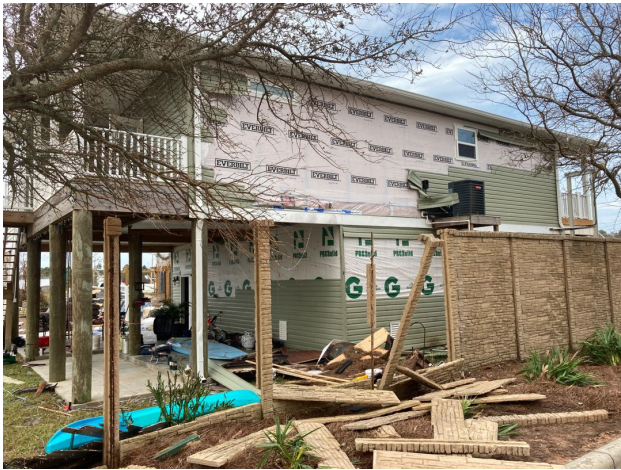
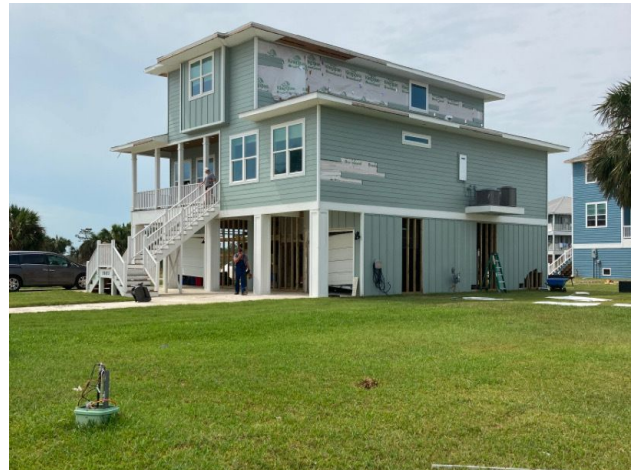
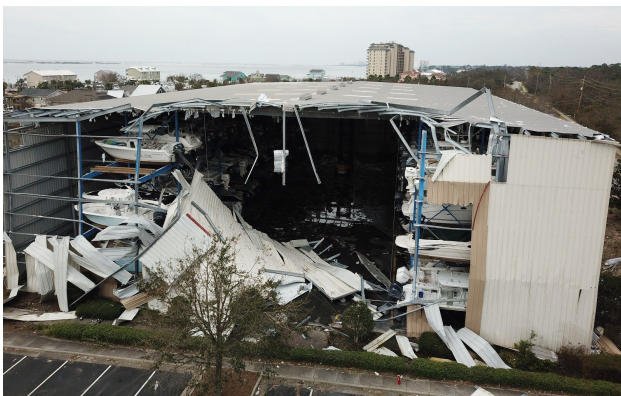
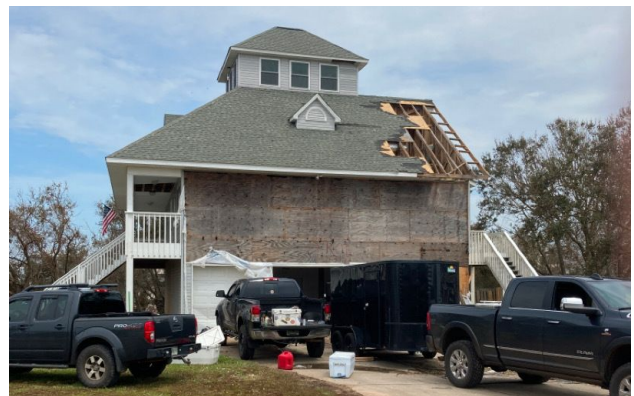
The Big Lagoon included sites located between the Pensacola Naval Air Station to the east and Perdido Key to the west. Damage here was heavier and more consistent than was observed elsewhere, perhaps in part due to the geography of the region. Modern buildings still performed well overall, but were more likely to experience moderate wind damage than other regions. Figure 4.8 illustrates the damage observed in this area.

**Figure 4.8.** Illustrative damage in the Big Lagoon region: (a) loss of wind rated vinyl siding to a home constructed in 2016. The home also suffered loss of ~25% of its laminated shingle roof; (b) loss of fiber cement board cladding to a 2018 home; (c) collapsed end wall (windward wall) of a steel-frame marina constructed in 2003; (d) roof sheathing loss in a single family home constructed in 1990.

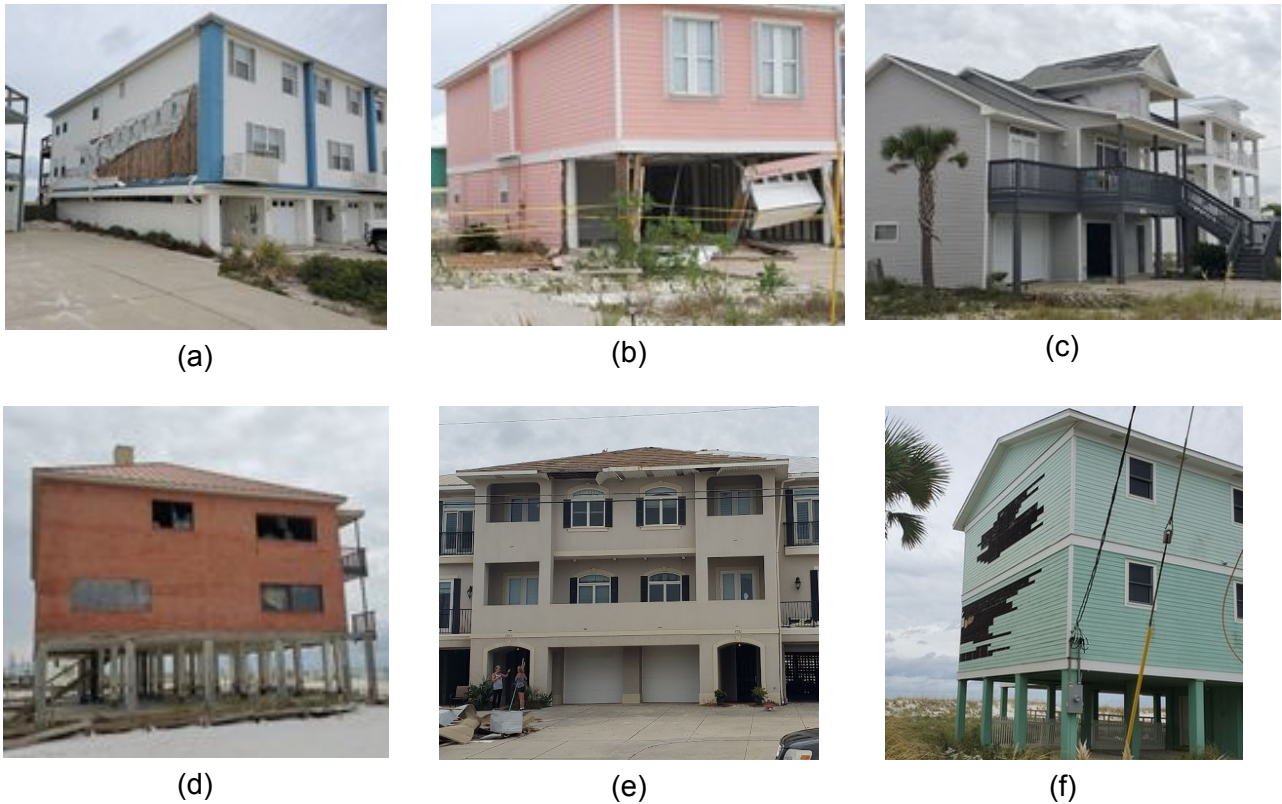
**Figure 4.9.** Illustrative wind damage on Santa Rosa Island: (a) siding damage, built 1999; (b) collapsed garage, built 2001; (c) roof damage - water intrusion, built 2000; (d) wind-borne debris impacts, year built unknown; (e) metal roof damage, built 2003; (f) siding damage, built 2000.

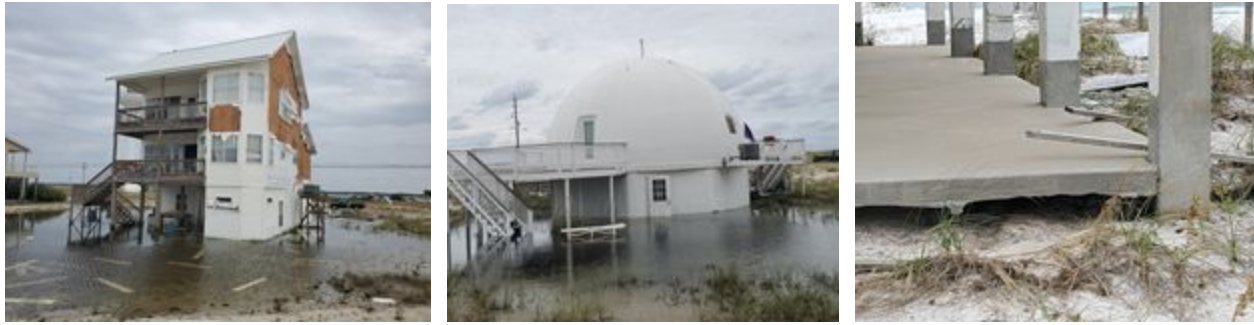
**Figure 4.10.** Illustrative surge damage on Santa Rosa Island: (left) ground floor damage and siding (wind), built 1992; (middle) ground floor damage, built 1982; (right) scouring damage, year built unknown.

The damage and frequency of damage were both greater in Pensacola Beach than in Navarre Beach. Structures closest to the Santa Rosa Sound experienced more surge damage, and structures closest to the Gulf of Mexico experienced more wind damage. While several structures had damage on the island, collectively the damage appears minor. Asphalt shingle roofs and siding appear to account the majority of the wind damage. While the surge appears approximately 2-4 ft, elevated structures with breakaway walls seemed to have mitigated the impact of the surge damage. The surge did shift large amounts of sand, covering roadways and parking lots, and collecting against building structures, particularly in Pensacola Beach.

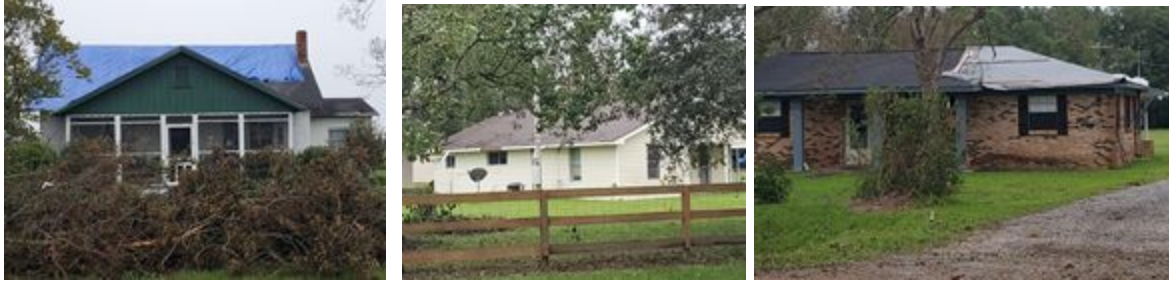
The FAST performed a few assessments throughout interior Baldwin County, including Foley, Elsanor, and Magnolia Springs. Observations in Elsanor were made along US Hwy 90. The observations indicate minimal wind damage and no indication of flooding damage (Fig. 4.11). The only wind damage detected was intermittent minor siding and asphalt shingle roof damage. Elsanor has 5,786 housing units built between 1936 to present, with 1992 as the median year built.

**Figure 4.11.** Illustrative damage in Elsanor: (left) roof damage, built 1955; (middle) roof damage, year built unknown; (right) roof & siding damage, year built unknown.

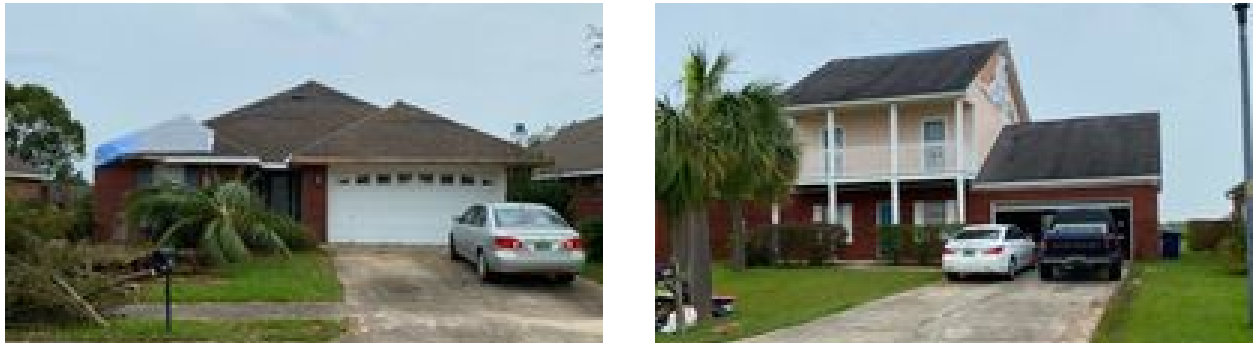
Observations were made primarily along County Rd 12 in Magnolia Springs and Foley, and in subdivisions south of Coastal Gateway Blvd and west of the Foley Beach Express. Minimal wind damage was observed. Typical damage consisted of missing shingles, siding, and soffit (Fig 4.12). Most newer homes (~2010+), notably those with FORTIFIED ratings, sustained no damage. Some homeowners described water damage either due to missing shingles or flooding from overflowed retention ponds. Overall impressions were that damage was more common and more severe in older (~<2010) homes. The most severe failure was a collapsed concrete masonry block structure (constructed in 1982). The tenant of the structure attributed the damage to a tornado and pointed to a possible tornado path in the forest behind the structure, rather than the hurricane (Fig 4.13). A metal building southeast of Foley constructed in 2004 suffered an endwall collapse (Fig. 4.14). Many

**Figure 4.12.** Typical damage in Foley, AL included missing shingles, siding, and soffit.
