<b>StEER</b> <b>STRUCTURAL</b> EXTREME EVENTS RECONNAISSANCE	<b>EVENT BRIEFING</b>		
	Event:	Hurricane Sally	
	Region:	Gulf Coast (Gulf Shores, AL)	
FAST Authors:	John Cleary, University of South Alabama Henry Lester, University of South Alabama Justin D. Marshall, Auburn University David Roueche, Auburn University Stephanie M. Smallegan, University of South Alabama		
VAST Authors:	Irina Afanasyeva, University of Florida Wilfrid DJIMA, Independent Consultant Dmitrii Golovichev, University of Florida Tracy Kijewski-Correa, University of Notre Dame Oscar Lafontaine, University of Florida Stephen Strader, Villanova University		
Editors:	David O. Prevatt, University of Florida		
DesignSafe Project #	PRJ-2914	Release Date:	September 24, 2020

### Event Briefing

Hurricane Sally | Released September 24, 2020

DesignSafe Project: PRJ-2914

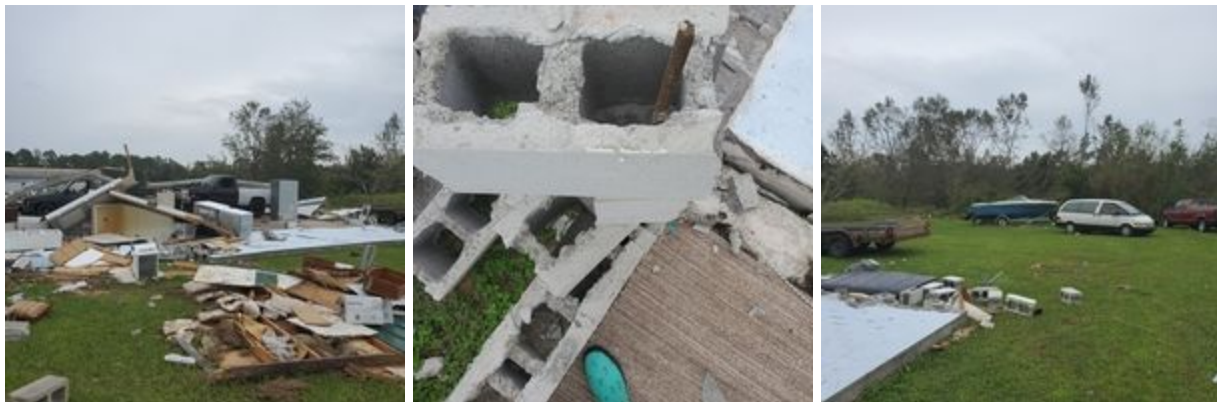
**Figure 4.13.** An unreinforced masonry block structure in Foley, AL was destroyed.

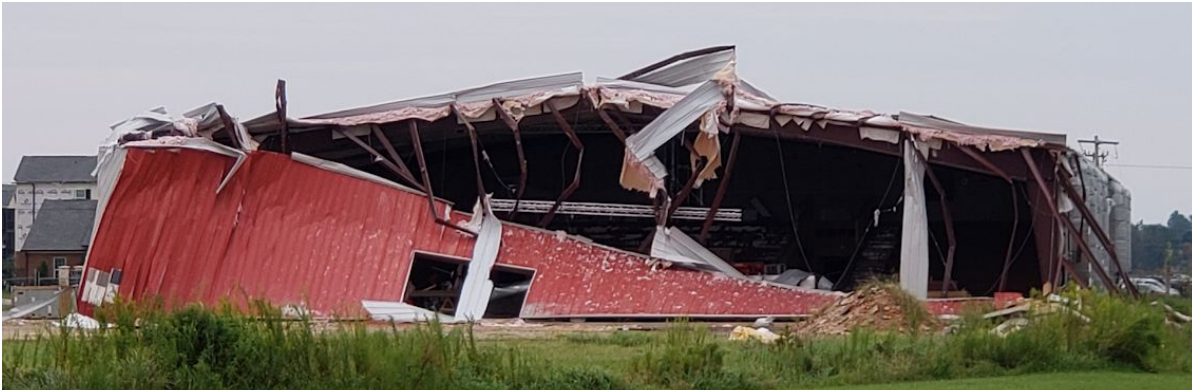
**Figure 4.14.** Endwall collapse (north-facing wall) of a metal building near Foley, AL (GPS: 30.356369, -87.659019).

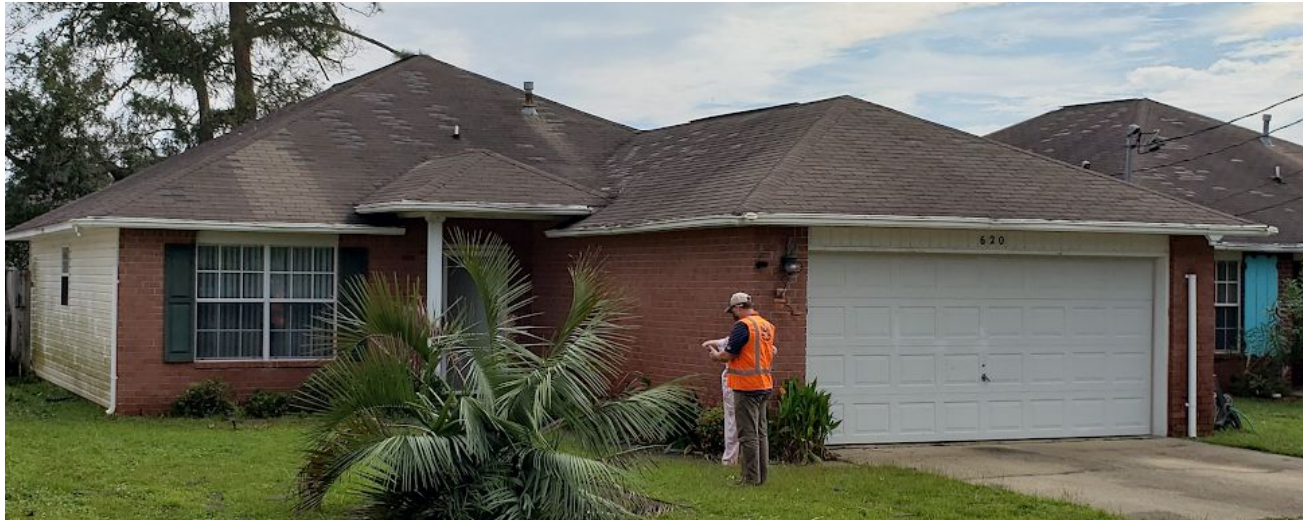
FAST directly observed a few FORTIFIED properties in eastern Pensacola, one of which experienced partial failure of a single vinyl siding panel but was otherwise undamaged, and the other had no visible exterior damage. FAST also sampled a neighborhood in West Pensacola along Generation Ave that seemed to be the furthest east with consistent roof cover damage visible along FL 292. Most homes assessed within the cluster lost between 5-10% of the 3-tab asphalt shingles (Fig. 4.15). The damage was visible in person, but is not visible in the [NOAA aerials](#). The homes were all wood frame with hip roofs, constructed in 2001, and most shingles appeared to be the original installed roofs.

**Figure 4.15.** Typical shingle loss in a neighborhood of single-family homes in West Pensacola constructed in 2001.
