StEER
STRUCTURAL
EXTREME EVENTS
RECONNAISSANCE

2023 Türkiye Earthquake Sequence

NHERI DesignSafe Project ID: PRJ-3824

JOINT PRELIMINARY VIRTUAL RECONNAISSANCE REPORT (PVRR)

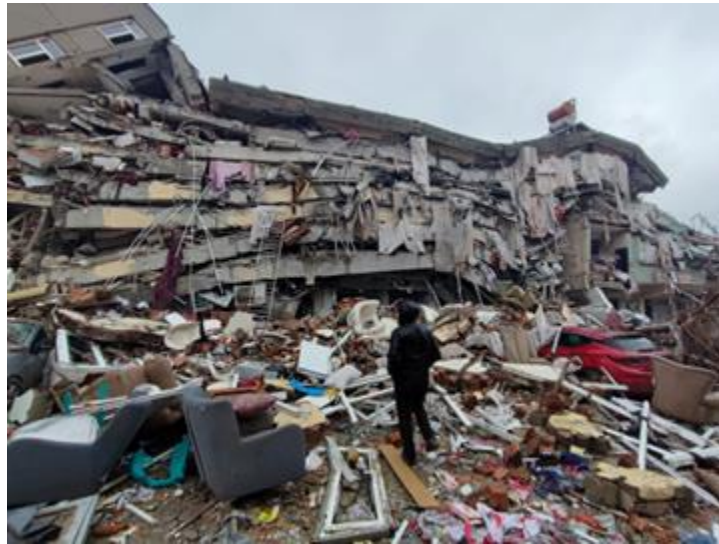
Figure 1.5. Collapsed multi-family residential building in Kahramanmaraş. The photograph illustrates how observed collapse scenarios lead to complete loss of contents and the inability to recover personal possessions (Source: [Reuters via CNN](#)).

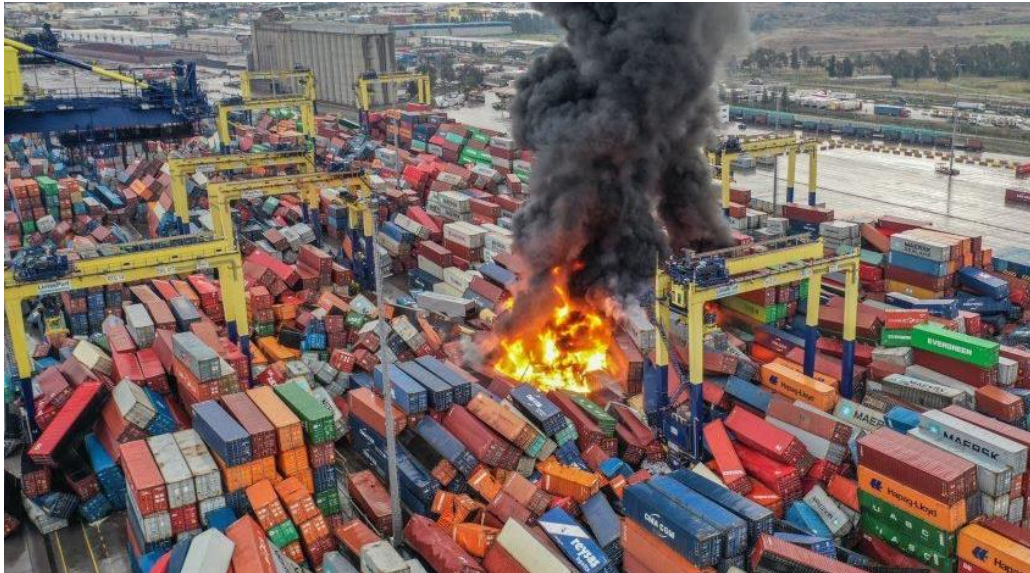
Figure 1.6. While gantry cranes appear unaffected by the earthquake, primary and secondary effects from fire after the earthquake compounded losses and downtime at the Iskenderun Port (Source: [Odessa Journal](#)).

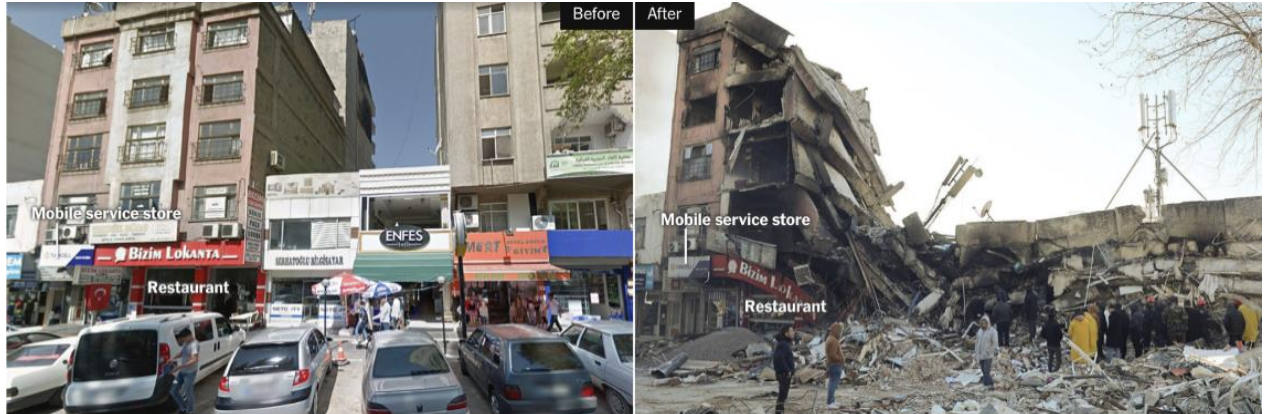
Figure 4.6. Collapse of buildings due to weak/soft story & pounding. The short 2-story building located between two mid-rise buildings, without adequate seismic separation, likely led to pounding between the roof slab of the 2-story building and the mid-height of the adjacent buildings. This has resulted in partial collapse of the building on the left and total collapse of the building on the right along with collapse of the 2-story (Source: [New York Times](#) 2023).

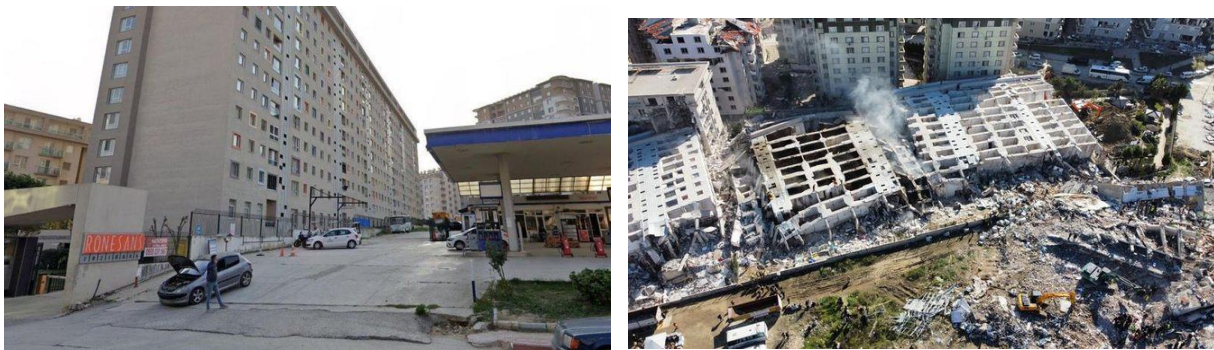
Figure 4.17. Potential sidesway collapse of the Rönesans residence, Hatay (Source: [AFP via Middle East Eye](#)).

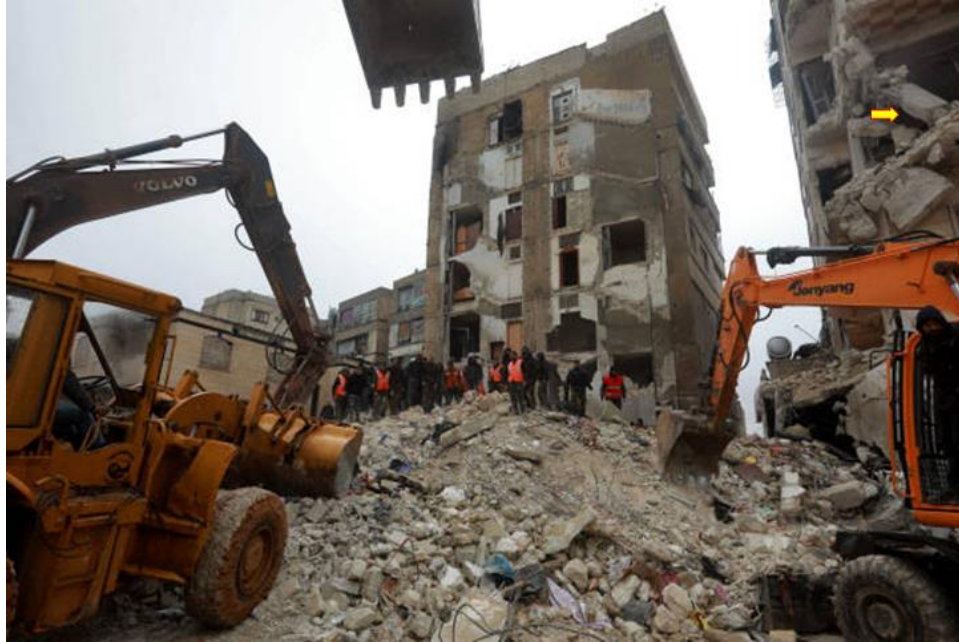
Figure 4.24. Ruins of a collapsed building with severely damaged RC columns (shown with arrows) in the adjacent building, Hama (Source: [LOUAI BESHARA/AFP, Getty Images](#)).

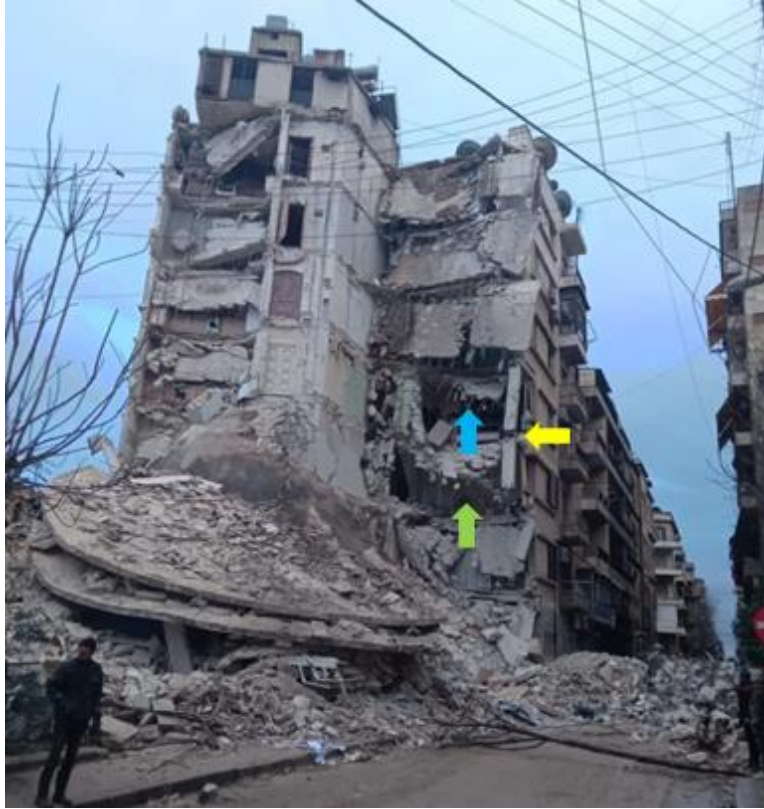
Figure 4.27. A partially collapsed building in Syria. Notice light column reinforcement (yellow arrow), the absence of beams and slab integrity steel (blue arrow), and poor reinforcing bars anchorage (green arrow) (Source: <https://yle.fi/a/74-20016582>).

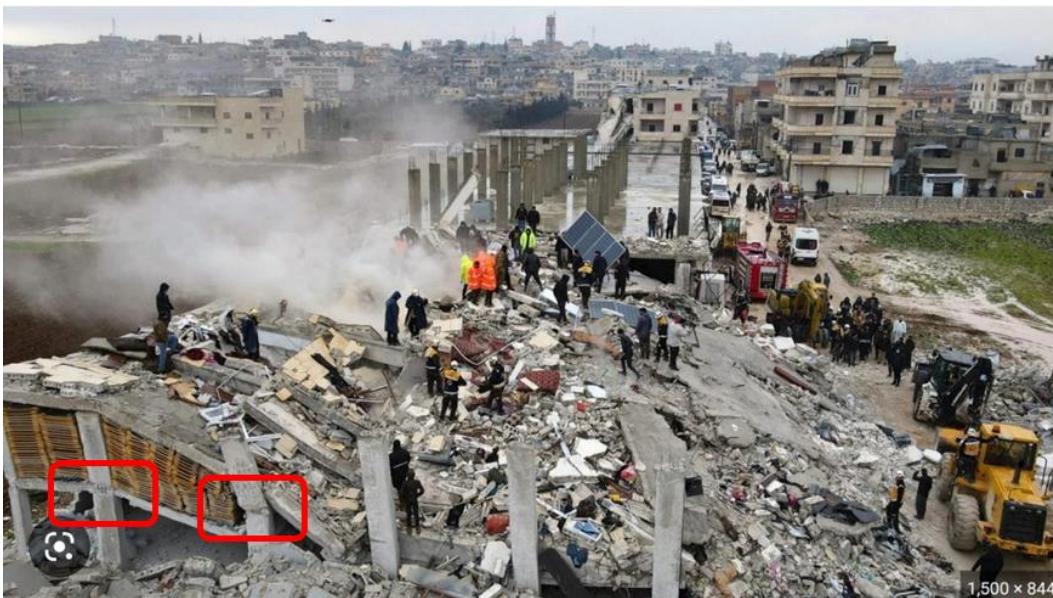
Figure 4.29. A collapsed building in Samada, Northern Syria (Source: [Reuters](#)). Notice the light column reinforcement and separation of slab from columns (in red rectangles) in the collapsed building.

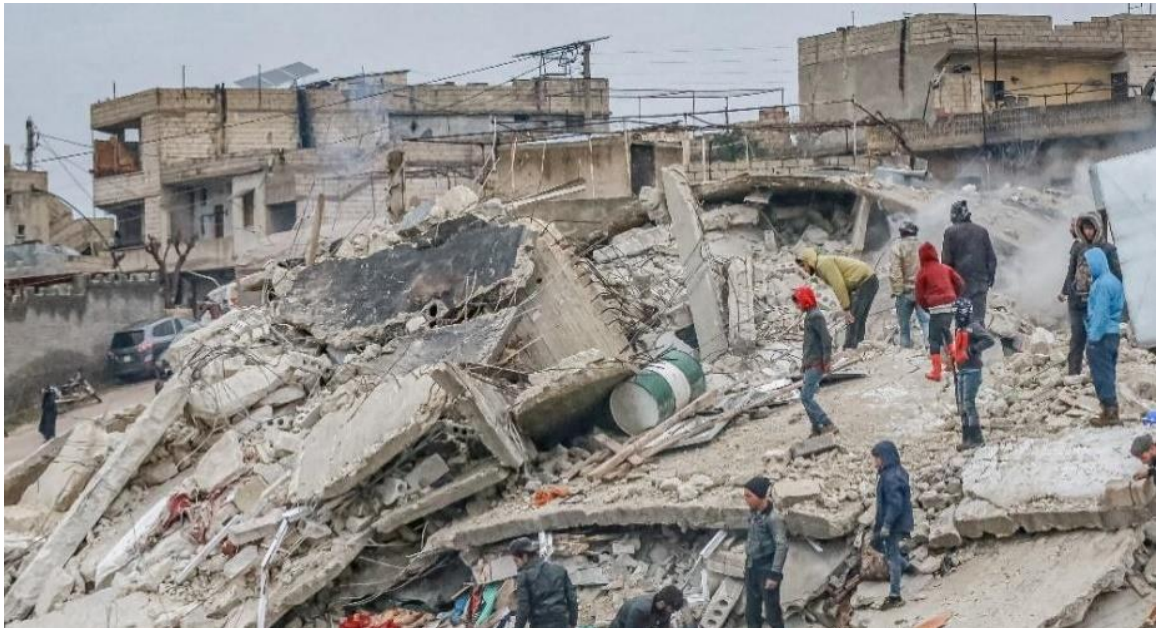
Figure 4.35. Collapsed concrete building near Idlib, Northern Syria. Notice the poor reinforcement of the columns (Source: [AFP](#)).

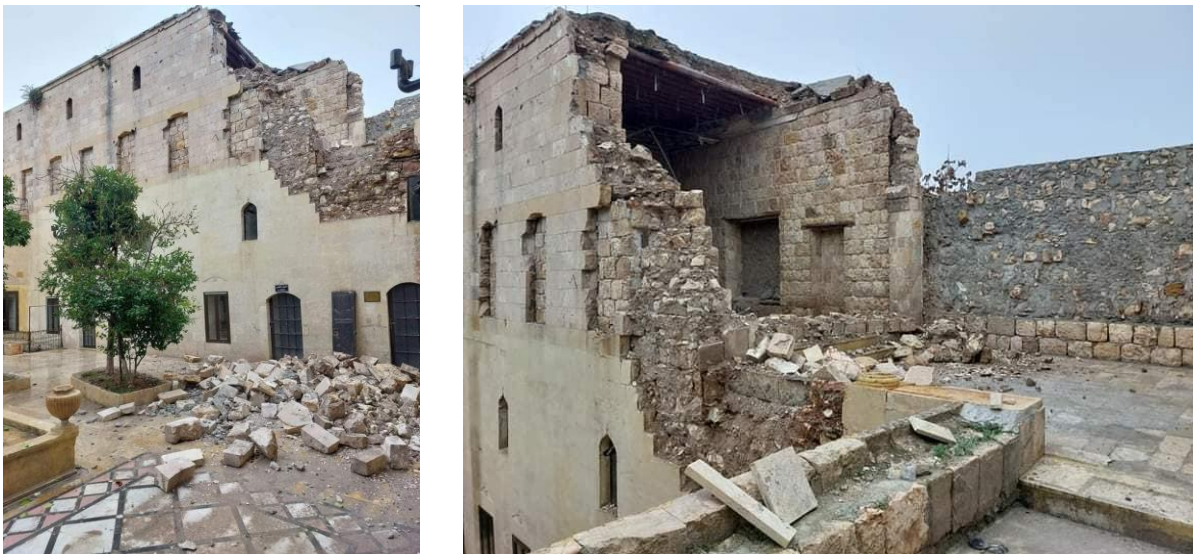
Figure 4.46. Damage at a Cilician Armenian high school of Aleppo, 36.2082°N, 37.1559°E (Source: [Massis Post](#)).

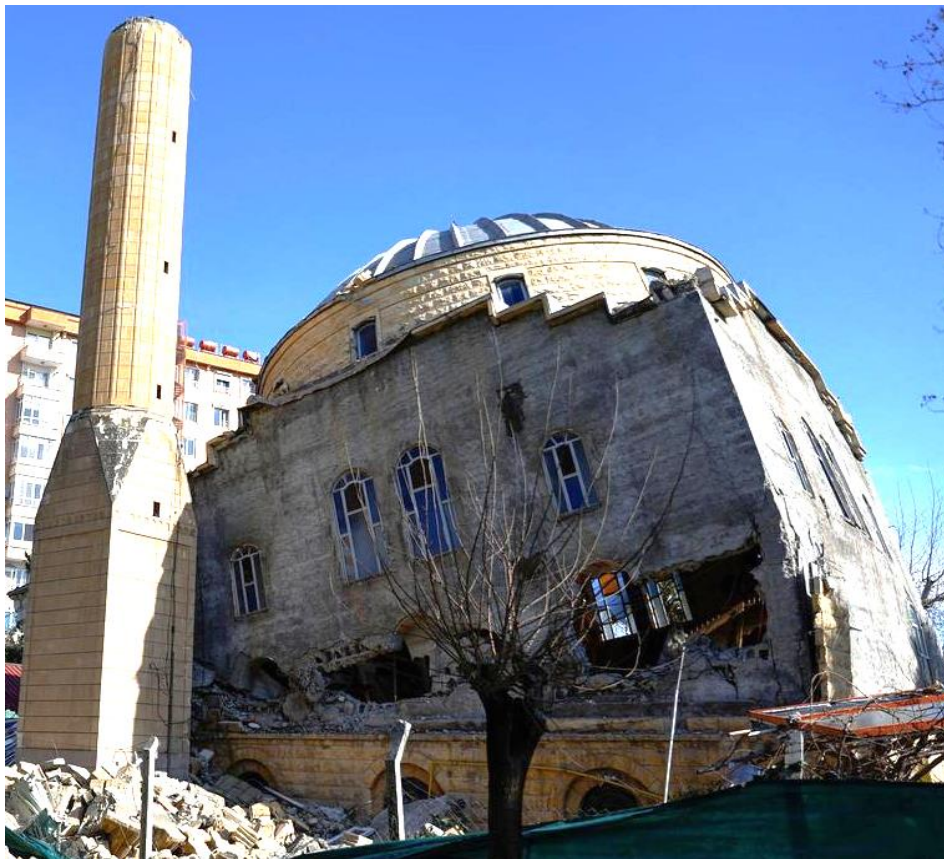
Figure 4.68. Partial collapse of an exterior wall of a mosque in Kahramanmaraş, Türkiye, while the domed roof remained intact (Source: Reuters via the [Independent](#) 2023).

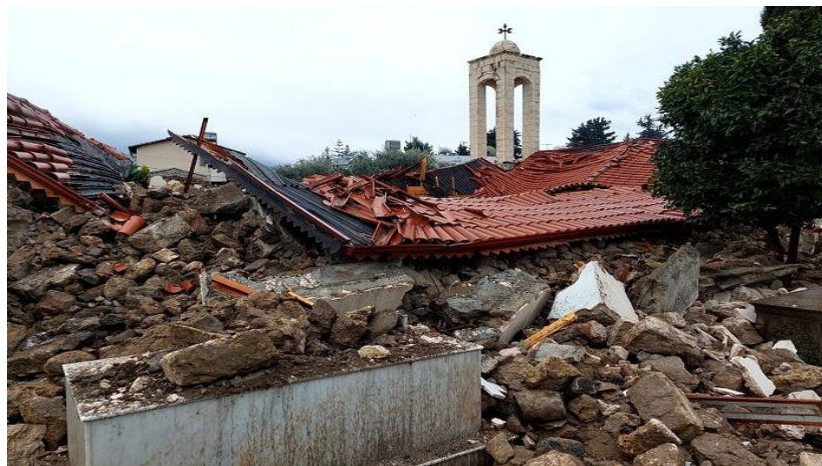
Figure 4.70. Collapsed Mar Yuhanna Orthodox Church in Arsuz where walls were constructed of unreinforced stone masonry (36.4120N 35.8849E) (Source: [haber.sat7turk.com](#) 2023).

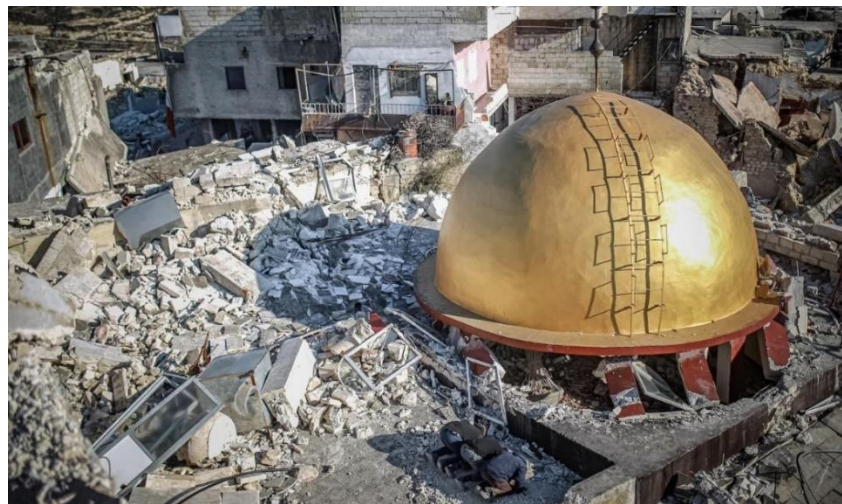
Figure 4.72 Collapsed mosque in Idlib, Northwest Syria (Source: Getty Images via [Foreign Policy](#), 2023). The heavy dome roof appears to have been supported on a long-span roof supported by rectangular reinforced concrete columns with inadequate reinforcement.

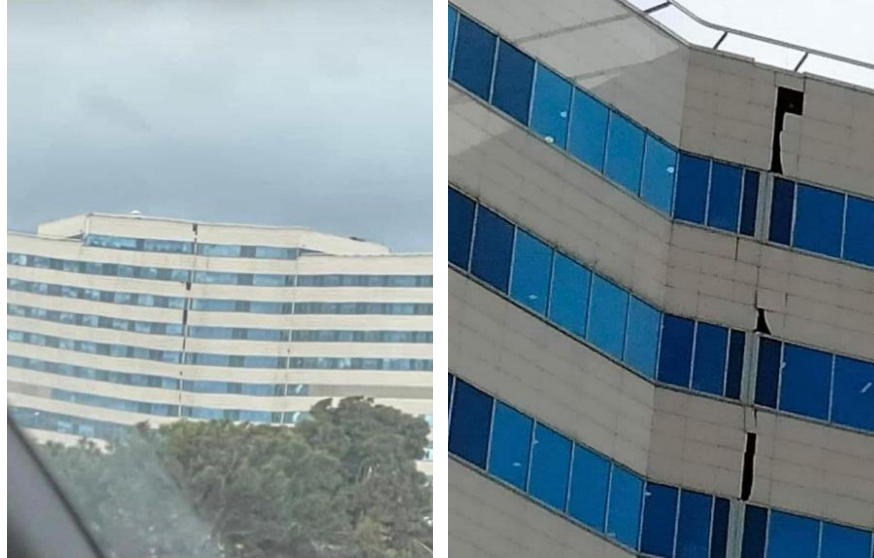
Figure 4.74. Damage to Mersin City Hospital, Türkiye (Source: [Twitter](#)).

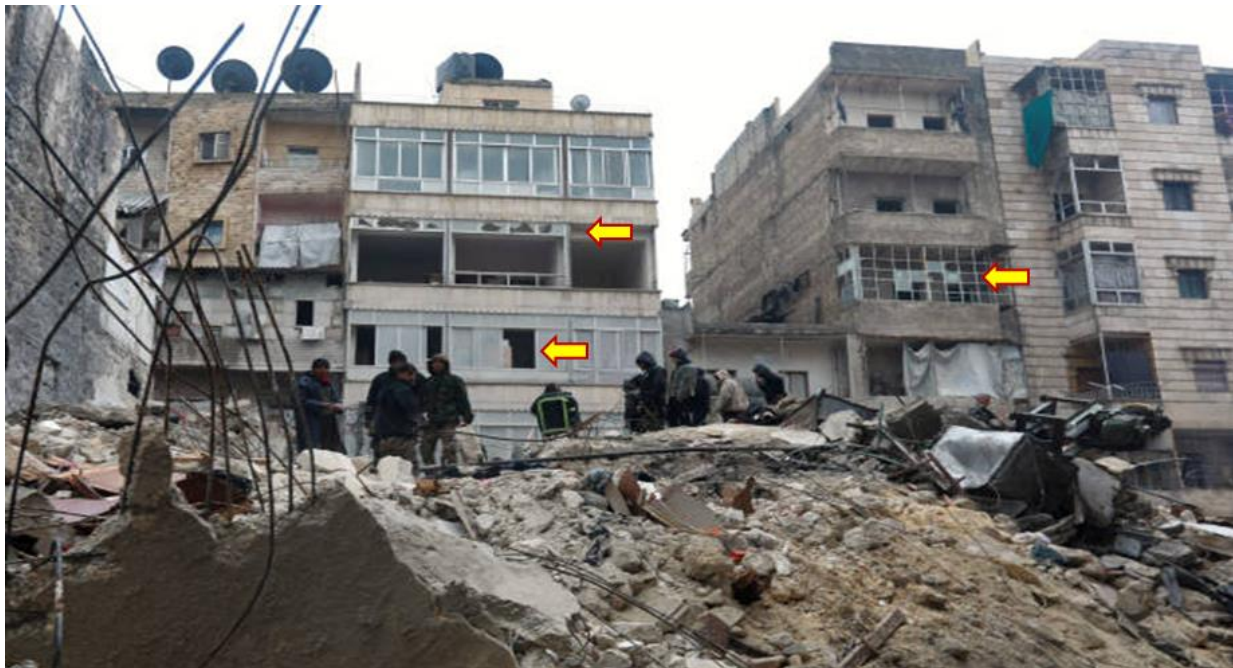
Figure 4.77. Broken window panes, Aleppo, Syria (Source: [LOUAI BESHARA/AFP via Getty Images](#) 2023).

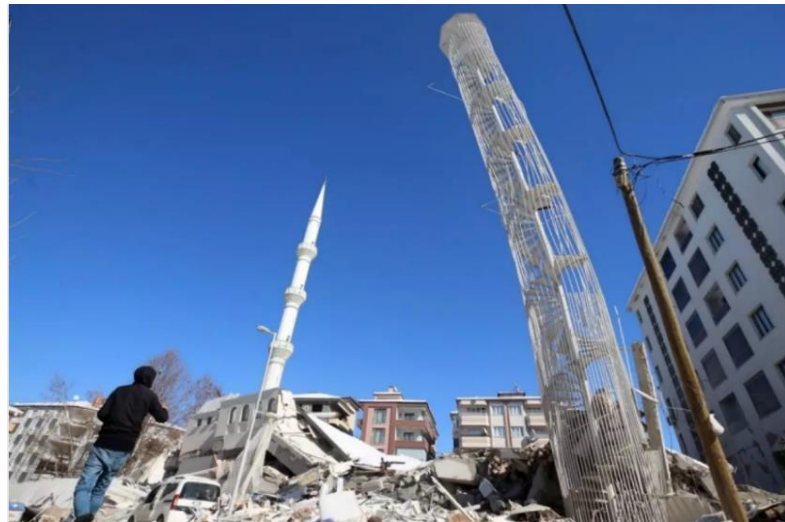
Figure 4.80. A 5-story RC building collapsed, but the steel stair stood alone, Malatya, Türkiye (Source: [TRHaber](https://www.TRHaber.com) 2023).

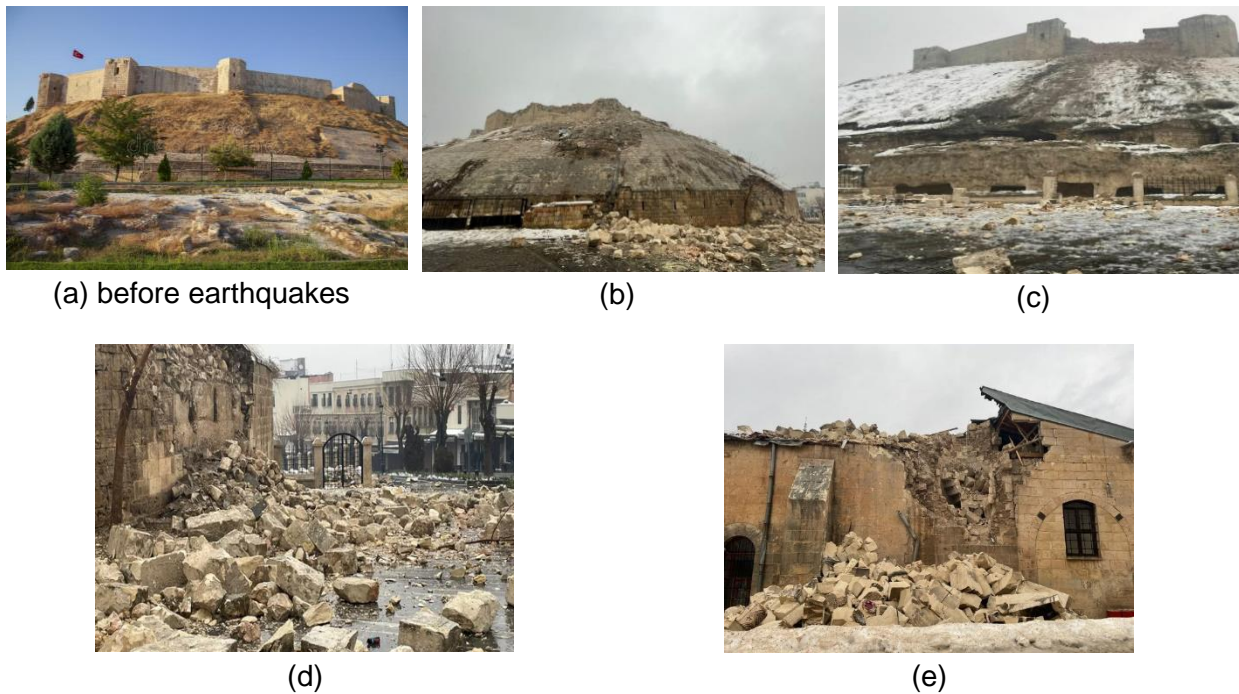
Figure 4.81. Gaziantep Castle damage (Source: (a) and (b) Thomas van Linge via [Twitter](#), (c) and (d) Getty Images via [TheGuardian.com](#), (e) Getty Images via [Smithsonian](#) 2023).

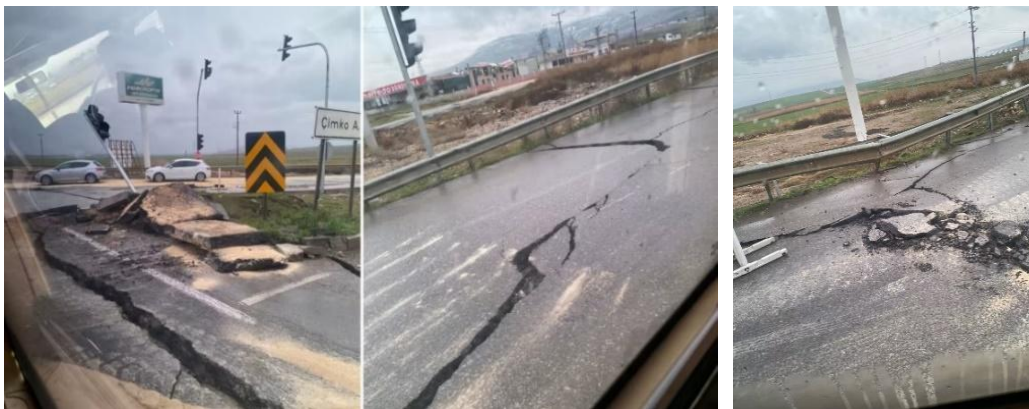
Figure 5.2. Surface failure of roadway (Source: [Channel News Asia](#)).

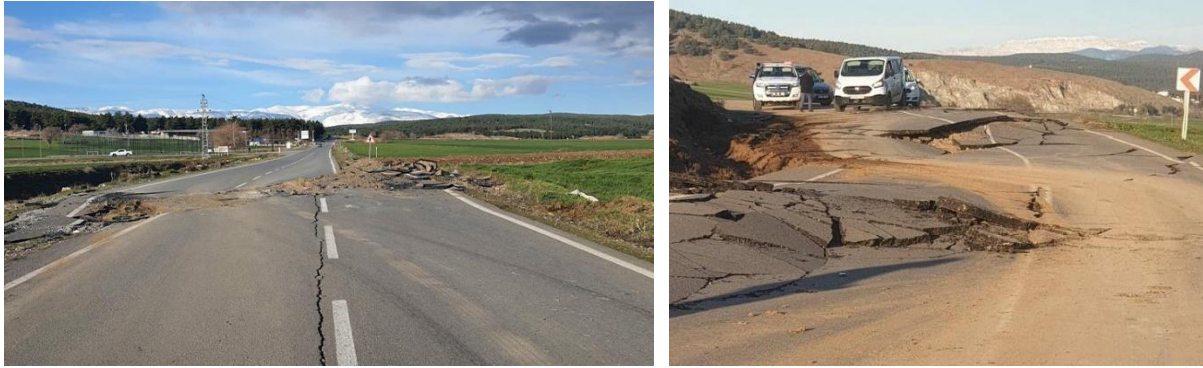
Figure 5.3. Shifting (differential movement) of the roadway near the Tevekkelli village (Source: [Veryansin TV](#)).

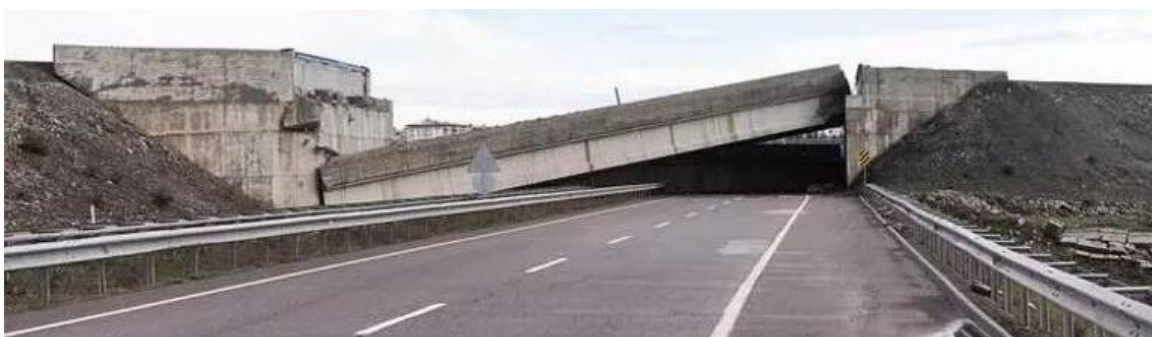
Figure 5.6. Unseating failure of an overpass in Gaziantep Nurdağı (Source: [hurriyet.com](https://www.hurriyet.com)).

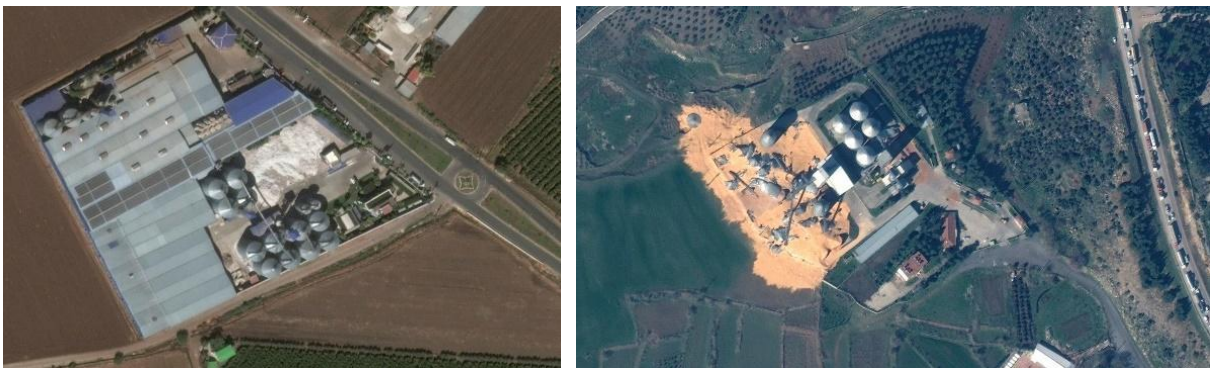
Figure 5.12. Aerial views of the damage of grain silos near Kırıkhan (Left) and near Nurdağı (Right) (Source: [CNN](#)).

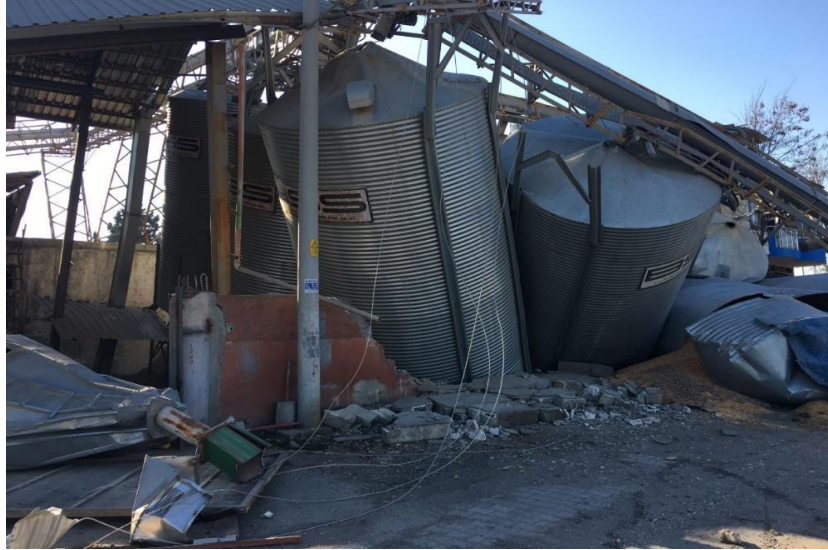
Figure 5.13. Steel storage containers damaged during the earthquake sequence due to failure of roof (Source: [Mustafa Kerem Koçkar via LinkedIn](#)).

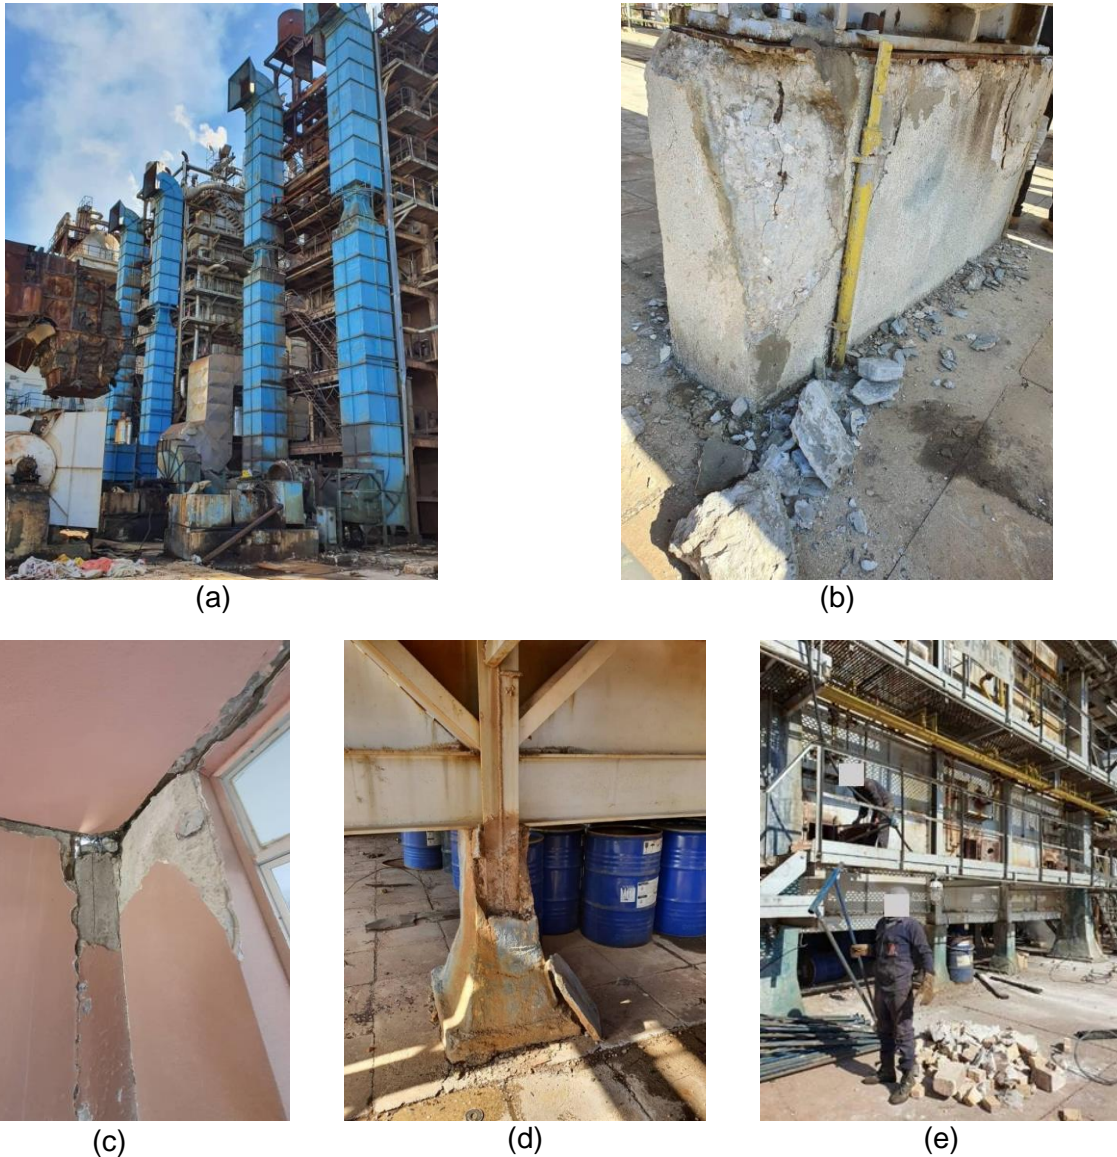
Figure 5.15. Damage of Baniyas Oil Refinery in Syria (Source: [Syrian Ministry of Oil and Mineral Resources](#)).

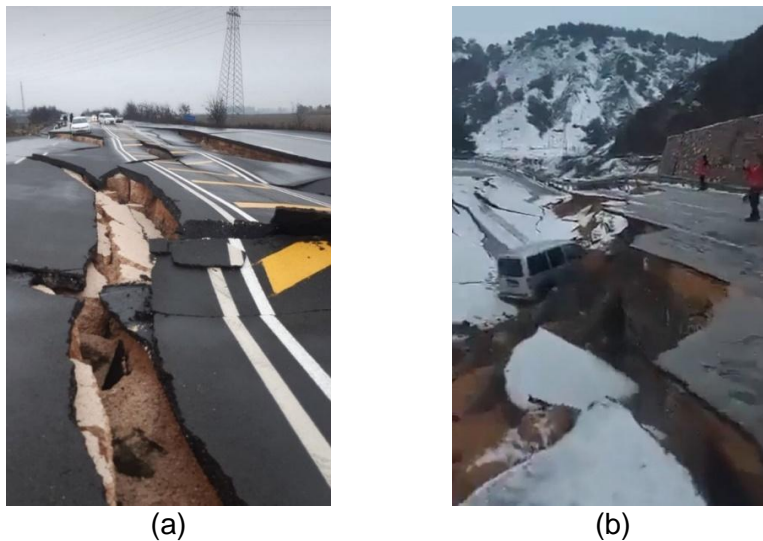
Figure 6.9. (a) Potential lateral spread failure (Source: [Reuters via National Post](#)). (b) Landslide & lateral spreading failure (Source: Extracted from [Sokagin Sesi Gazetesi, Twitter](#)).

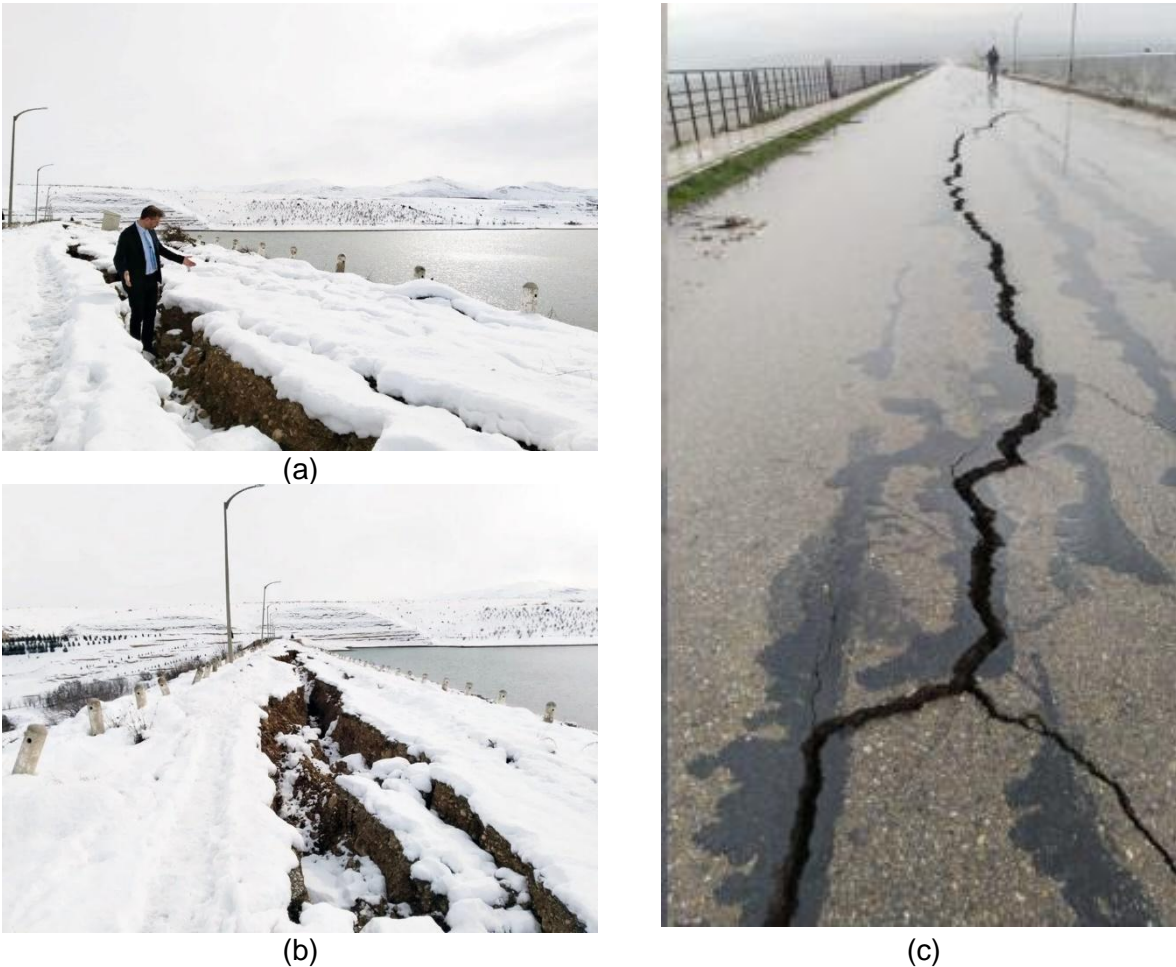
Figure 6.10. (a-b) Sultansuyu Dam with cracks along its central axis (Source: ntv.com) and (c) longitudinal and transverse cracks in the Afrin dam (Source: Syrian Television via misbar.com).
