StEER
STRUCTURAL
 EXTREME EVENTS
 RECONNAISSANCE

**Crucecitas, Mexico Mw 7.4
 Earthquake**

June 23, 2020

PRELIMINARY VIRTUAL RECONNAISSANCE REPORT (PVRR)

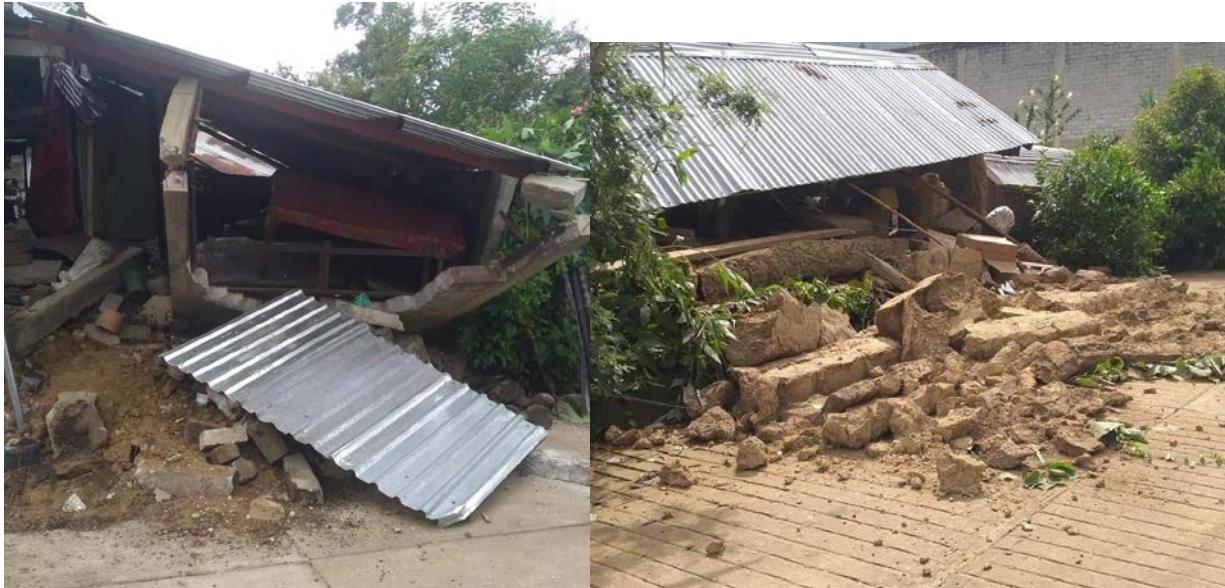
Figure 7.1. Out-of-plane collapsed walls in single family buildings. Left, Ozolotepec municipality in Oaxaca (Twitter, 2020c), and right, Santa Catarina Xanaguía, San Juan Ozolotepec, Oaxaca (Twitter, 2020d).

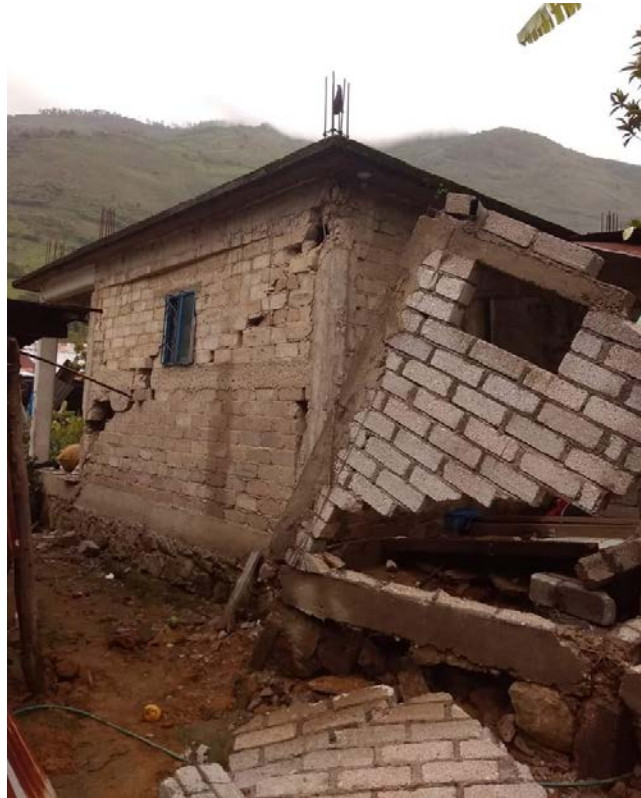
Figure 7.2. Top: Out-of-plane collapse of a boundary wall in an adobe residential construction, Oaxaca (Twitter, 2020e); Bottom: collapse of a confined masonry wall in a residential building, Santa Cruz Ozolotepec (Facebook, 2020a).

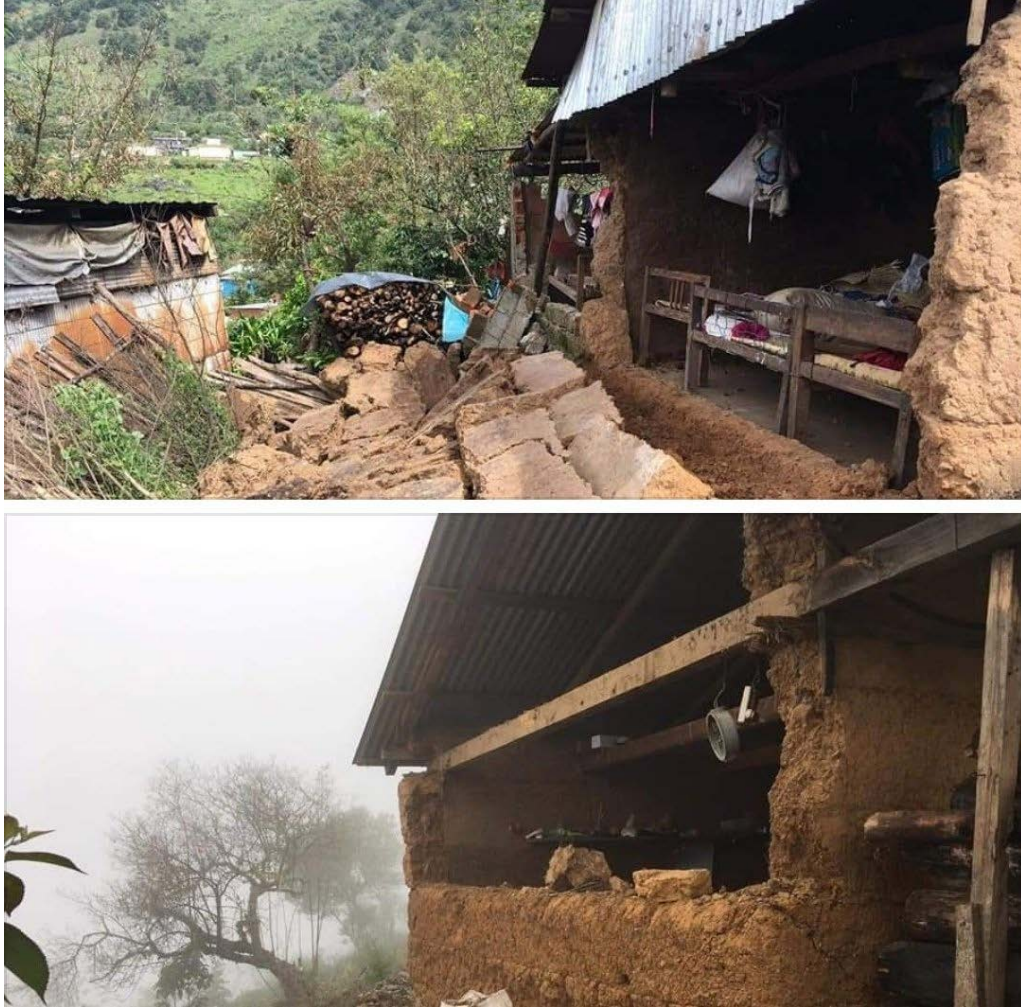
Figure 7.3. Out-of-plane collapse of the upper portion of a wall in an adobe residential construction, Oaxaca (Twitter, 2020f).

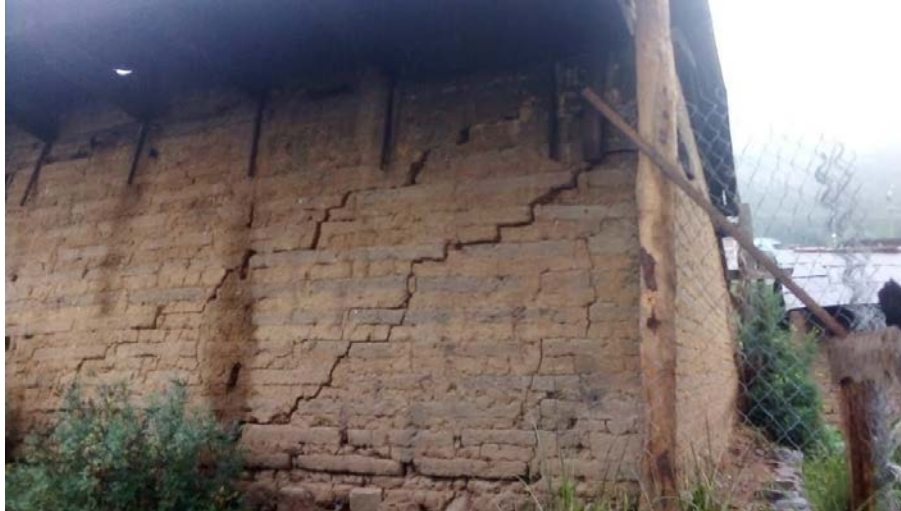
Figure 7.4. Severe diagonal tension cracking in a wall of an adobe house, Oaxaca (Its going down, 2020).

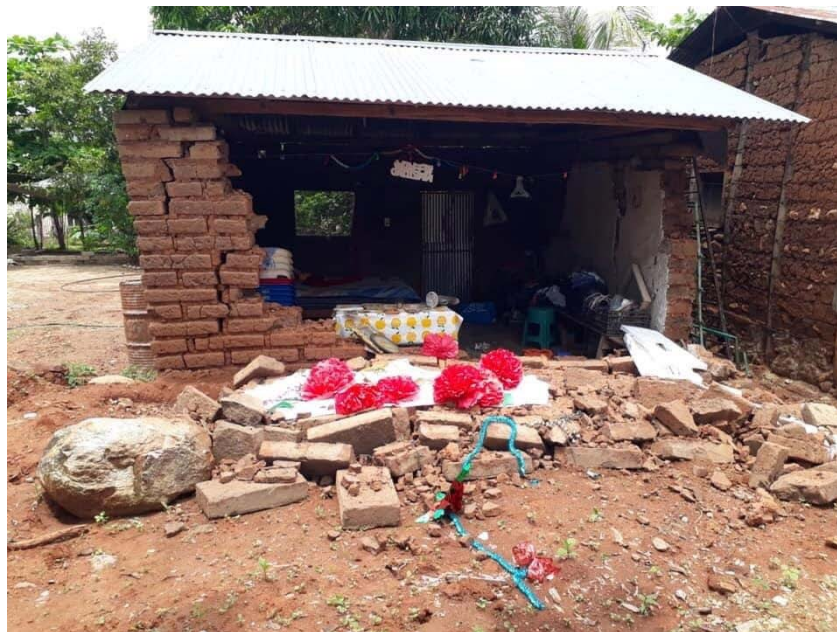
Figure 7.5. Out-of-plane collapse of a wall in an adobe house (Twitter, 2020g).

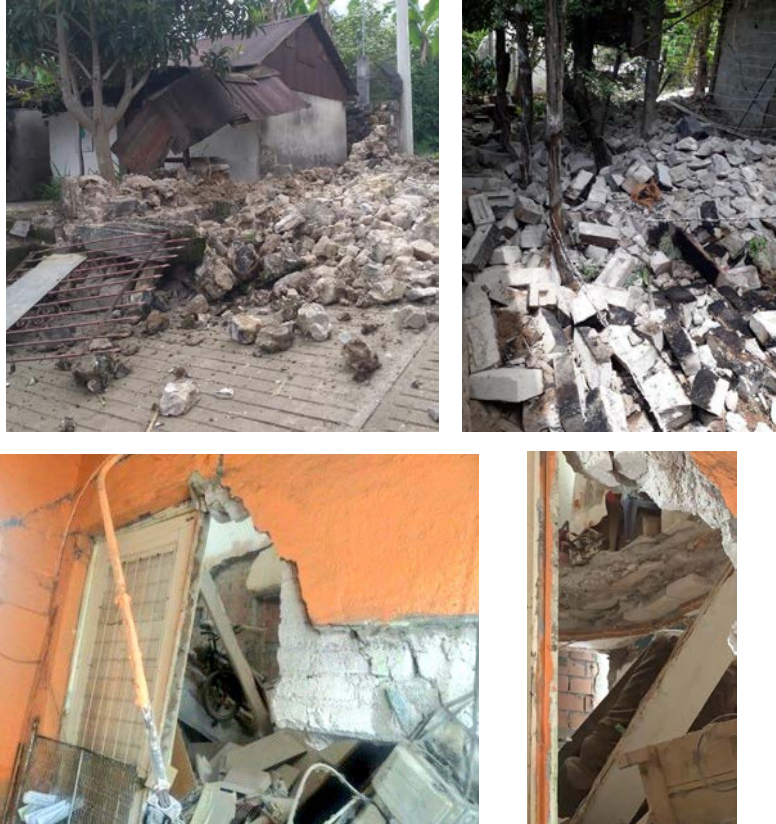
Figure 7.6. Examples of unreinforced masonry building collapse
Top left: San Juan Ozolotepect (Zona Roja, 2020) and Top right: San Miguel del Puerto
(Twitter, 2020h) Bottom: Bolivar Colonia Obrera in Cuauhtémoc (Integral Risk
Management Secretariat via Twitter, 2020t).

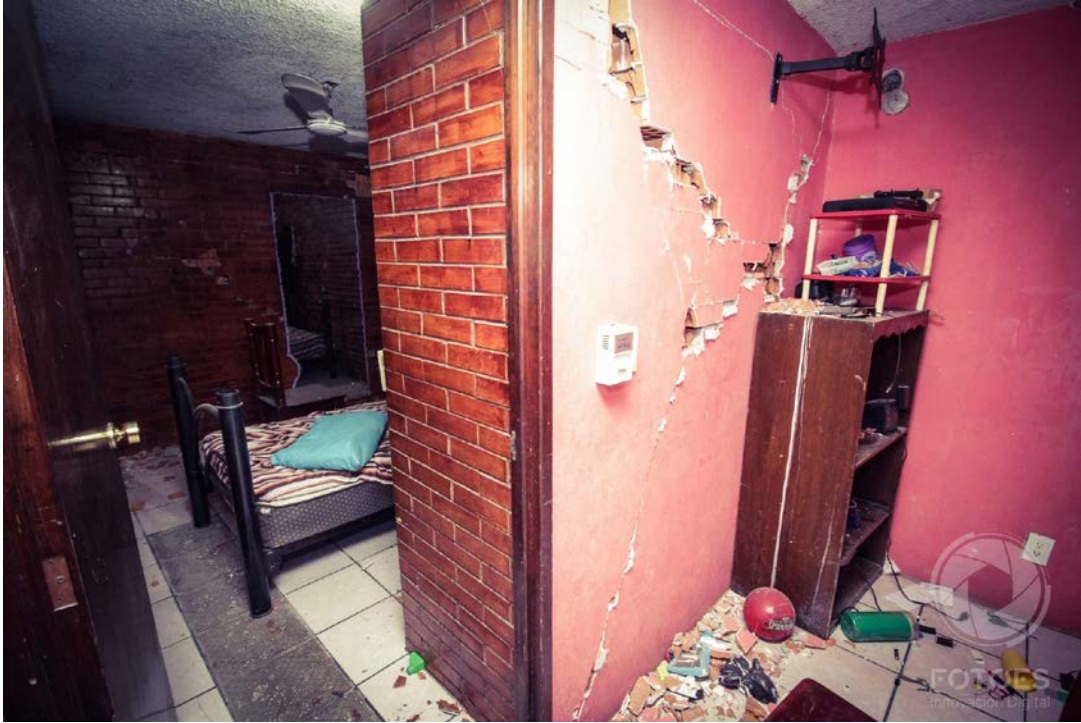
Figure 7.9. Diagonal cracking in the first story of an unreinforced masonry residence (Diario Marca, 2020a).

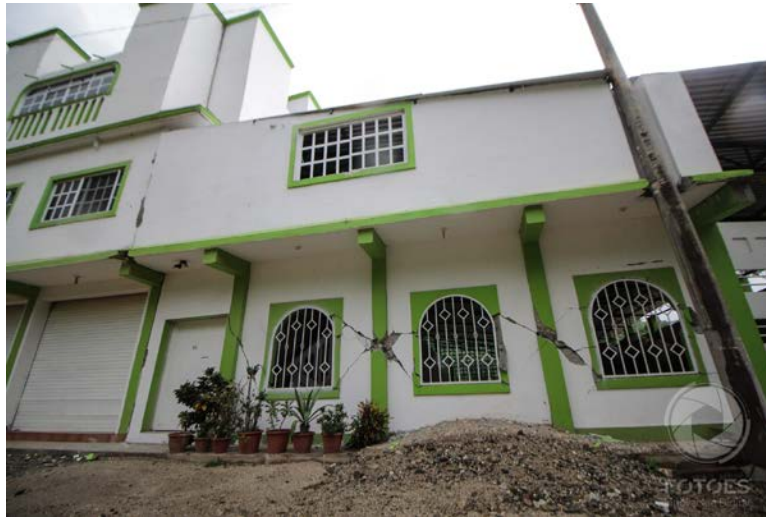
Figure 7.10. Masonry wall facade damage in a multi-family building. Damage is heavily concentrated in the first story (Diario Marca, 2020b).

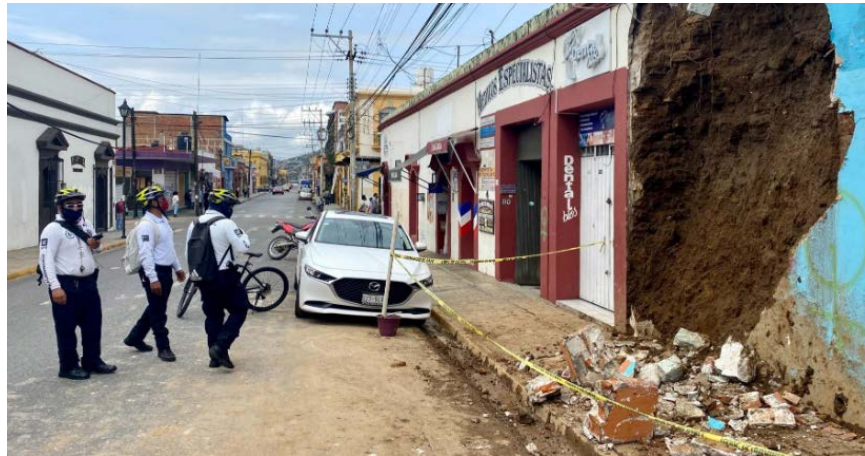
Figure 7.12. Failure of adobe walls in single-story commercial building (Animal Politico, 2020).

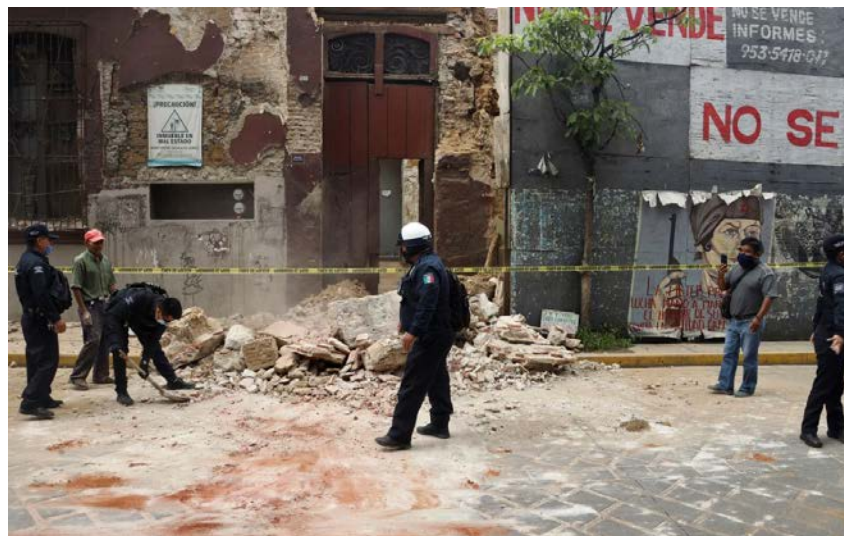
Figure 7.13. Failure of adobe walls in single-story buildings in Oaxaca. (New York Post, 2020).

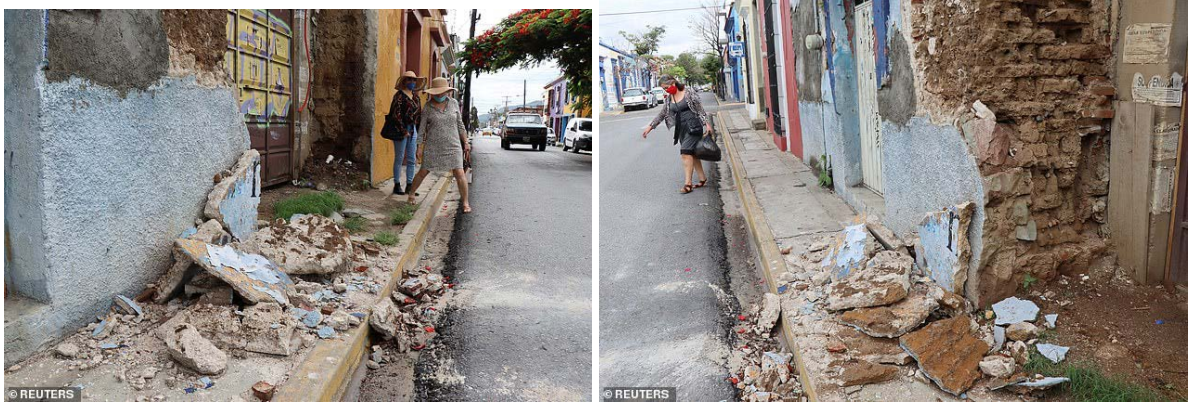
Figure 7.15. Failure of masonry walls and spalling of plaster in Oaxaca (Distinct Today, 2020).

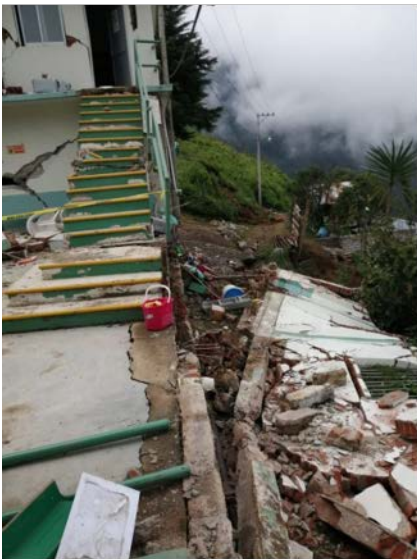
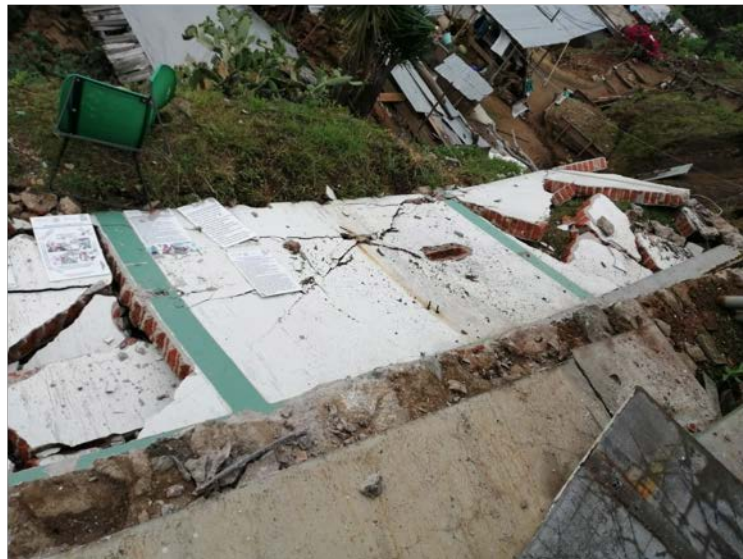
It has been reported that at least 15 hospitals and medical facilities in the Mexican States of Oaxaca, Veracruz, and Morelos suffered some type of structural damage and in particular one medical facility exhibited severe structural damage as a consequence of the earthquake. According to the Government of Oaxaca, the hospitals located at the coast region near the epicenter were among those that reported some cracking. Particularly, the medical facility located at San Juan Ozolotepec in the State of Oaxaca will need to be demolished due to the

severity of the damage as shown in Figure 7.18. Similarly, the Regional Specialty Hospital of Oaxaca in San Bartolo Coyotepec showed cracking at the exterior walls as shown in Figure 7.19. Additionally, it was reported that the Subzone General Hospital of Huatulco and Family Medical Unit 41, near the epicenter, was evacuated since it requires an in-depth structural evaluation (El Universal, 2020a and El Universal, 2020b). Other medical facilities that experienced damage at the facades were reported by Espinosa (2020b) including the Oaxacan Children's Hospital in San Bartolo Coyotepec and the General Hospital in San Pedro Pochutla experienced minor cracking. Although some hospitals needed to be evacuated in Mexico City, there are no reports of structural damage there.

Figure 7.18. Failure of unreinforced masonry wall of the medical unit located at Santa Catarina Xanaguía in the San Juan Ozolotepec municipality, Oaxaca (Twitter, 2020I).

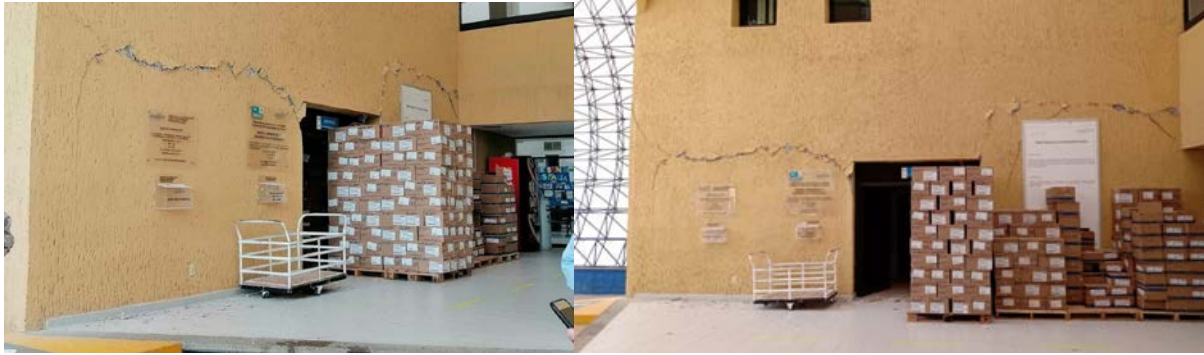
Figure 7.19. Damage to the regional Speciality hospital of Oaxaca located at San Bartolo Coyotepec, Oaxaca (Facebook, 2020b).

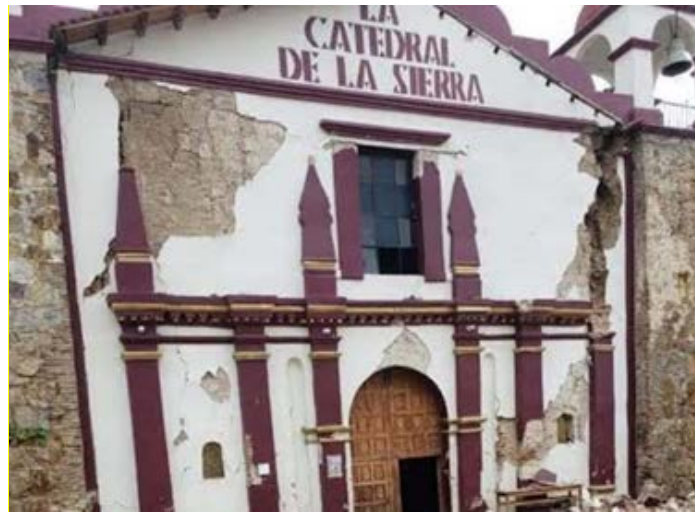
Figure 7.23. Damage to the La Catedral de la Sierra church at San Juan Ozolotepec, Oaxaca (Excelsior, 2020a).

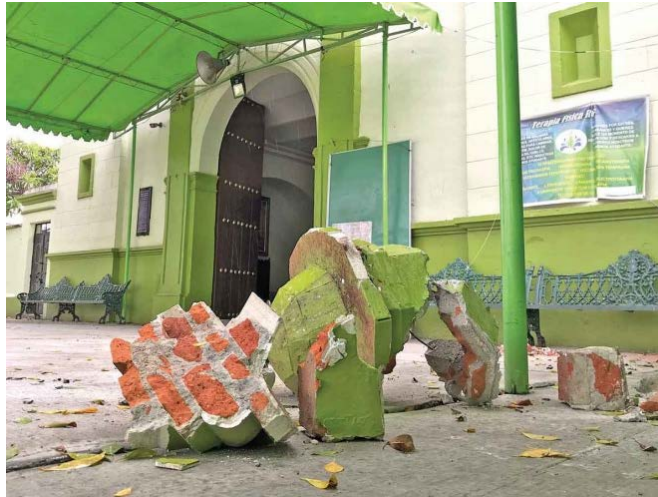
Figure 7.25. Collapse of parapet ornamentation in the church of Santísima Trinidad de las Huertas, City of Oaxaca. (Excelsior, 2020b).

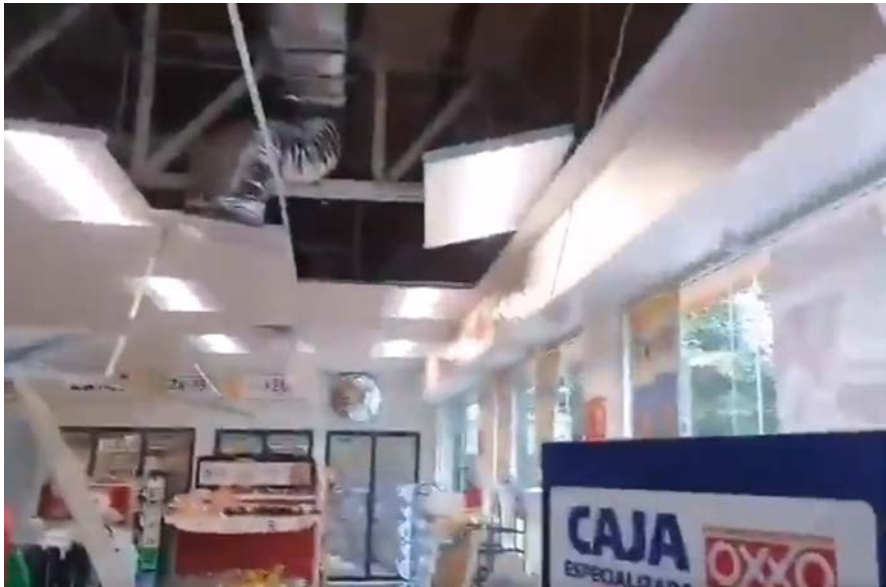
Figure 7.29. Non-structural damage in a store in Oaxaca (Twitter, 2020m).

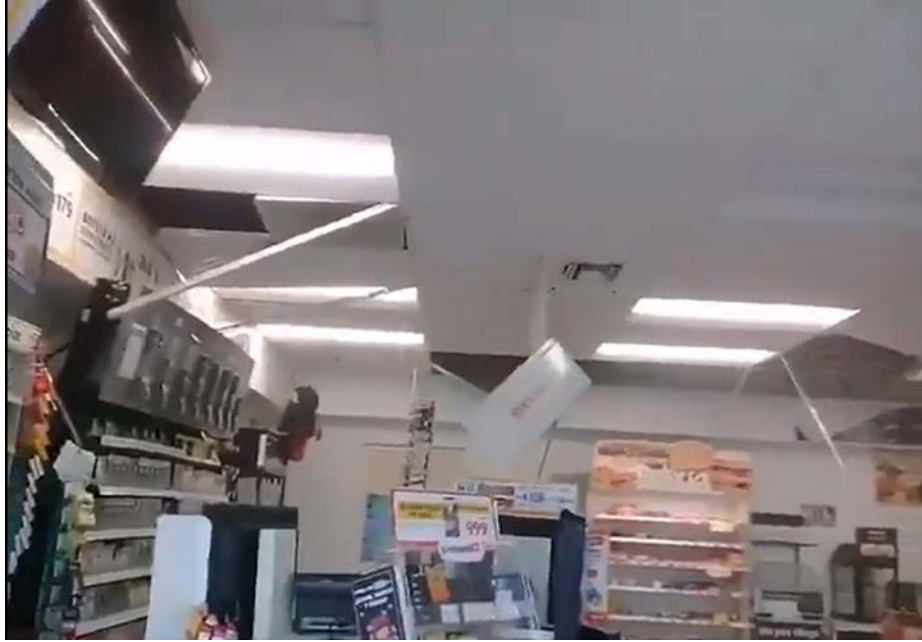
Figure 7.30. Non-structural damage in a store in Oaxaca (Twitter, 2020m).

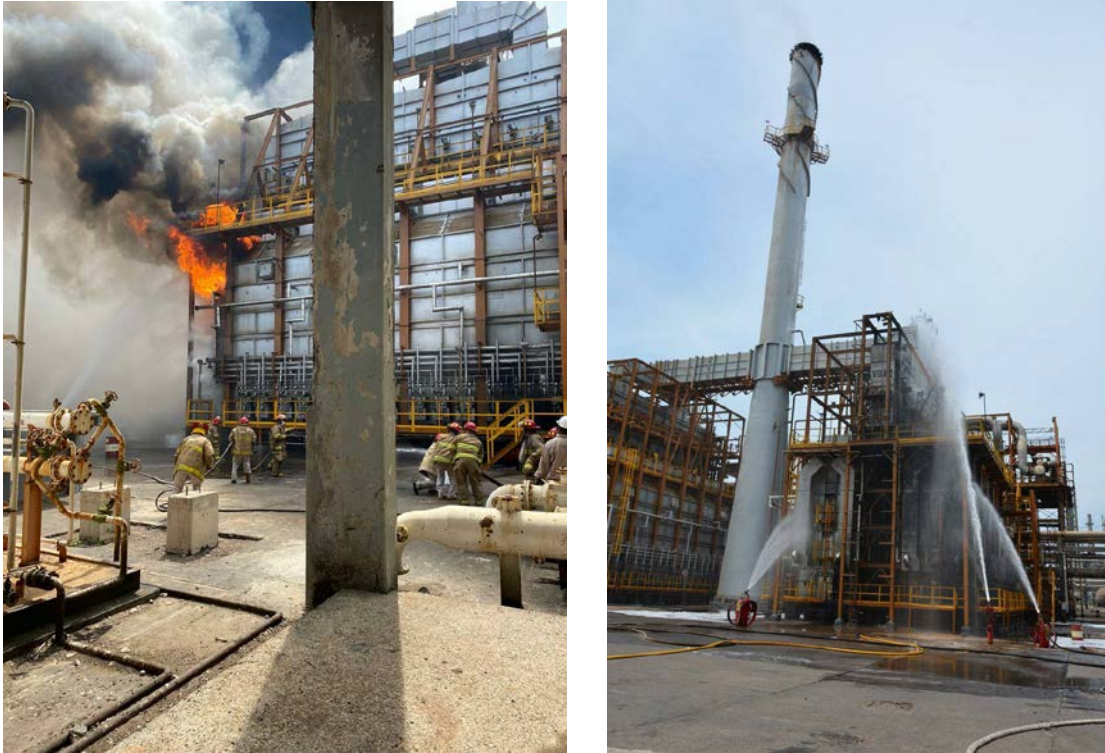
Figure 7.34. Fire incident in the Antonio Dovalí Jaime refinery in Salina Cruz, Oaxaca (Twitter, 2020o).

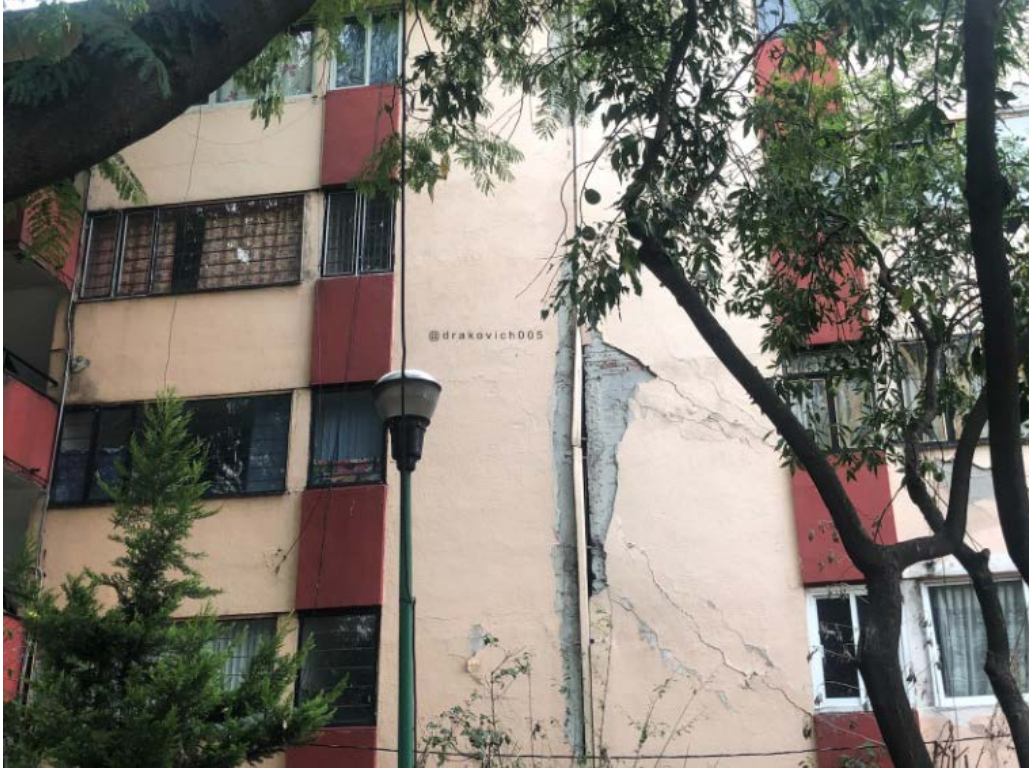
Figure 8.2. Apartment building tilted at Unidad Habitacional Lindavista-Vallejo in Mexico City.

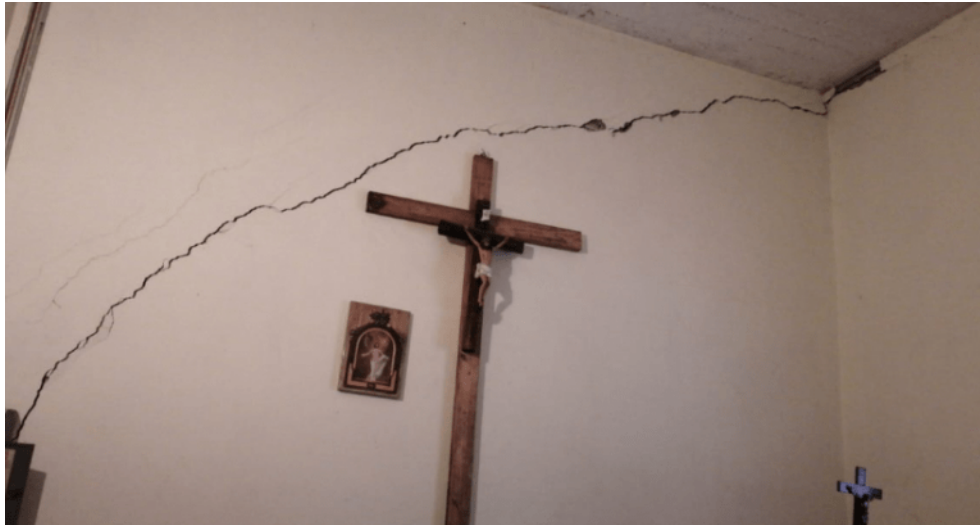
Figure 8.5. Cracks in interior walls at a religious building in Mexico City. (Espinosa, 2020a).
