EVENT BRIEFING

Event: 22/23 April, 2019 Philippines Earthquakes

Authors: Selim Gunay, Pacific Earthquake Engineering Research Center, University of California, Berkeley
Khalid M. Mosalam, Pacific Earthquake Engineering Research Center, University of California, Berkeley
Tracy Kijewski-Correa, University of Notre Dame

Released: June 4, 2019 (DesignSafe Project: PRJ-2195)

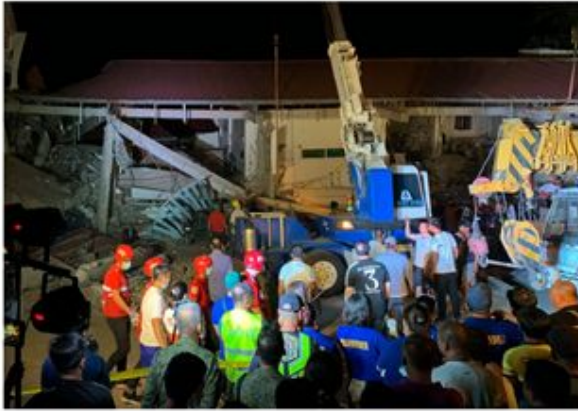
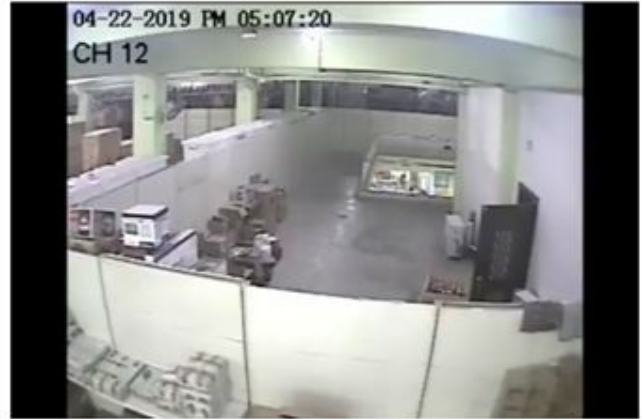
The province of Zambales, the epicenter of the earthquake, had been spared from the earthquake destruction, while the neighboring province of Pampanga suffered damage to 29 structures/buildings and was the area most affected by the earthquake due to the presence of soft sediment and alluvial soil sites. Several structures in the province were damaged by the quake, including a 4-story supermarket in Porac, Fig. 4 (CNN, 2019), the Bataan-Pampanga boundary arch and the main terminal of Clark International Airport. Damage was observed in historical churches in Lubao and Porac, where the stone bell tower of the 19th-century Santa Catalina de Alejandria Church collapsed (Fig. 5). Considering the relatively moderate level of shaking with the fact that collapse and similar damage was not observed in nearby structures, it can be stated that the collapse of the 4-story supermarket is due to the structural deficiencies such as short columns and deficient beam-column joints, Fig. 4.

Figure 4. Collapsed four story structure: (left) photo after collapse, (right) snapshot from the video footage just before collapse showing the presence of short columns.

Similar to many previous earthquakes, the Philippines quake highlighted the vulnerability of non-ductile reinforced concrete structures and historical masonry structures indicating the immediate need for retrofit to avoid such damages in the future. In that regard, research should continue to develop proper retrofit techniques for these types of structures, while maintaining the cultural value and distinctive architecture of historical structures.

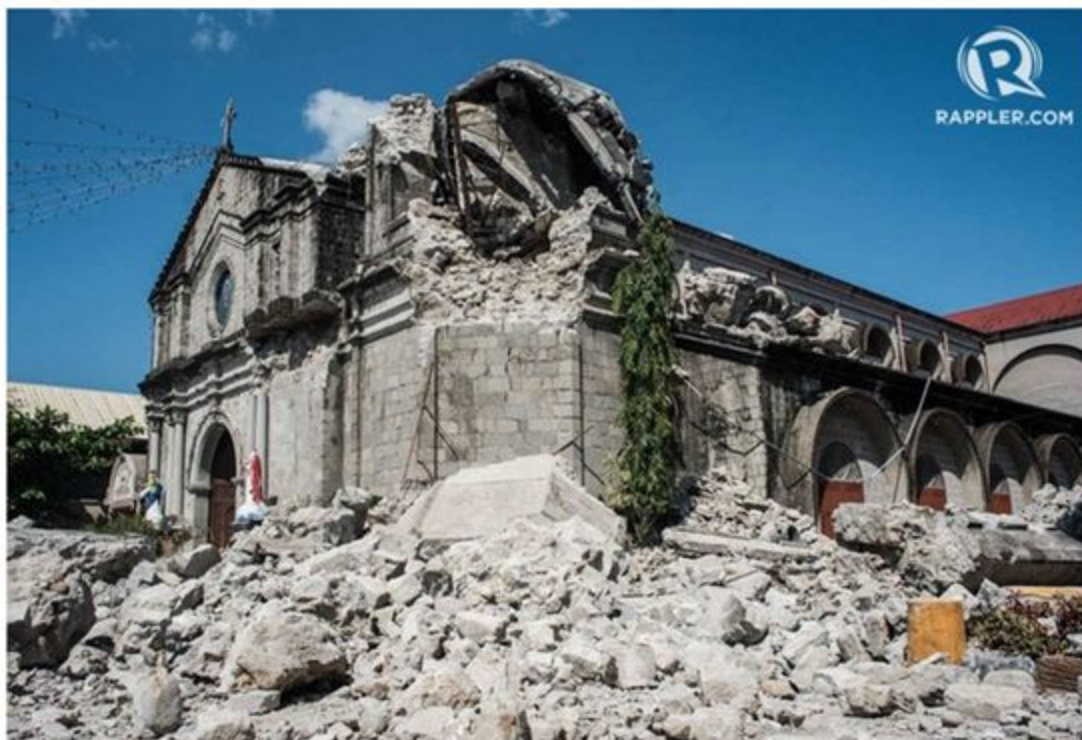
Figure 5. Collapsed stone bell tower of the 19th-century Santa Catalina de Alejandria Church

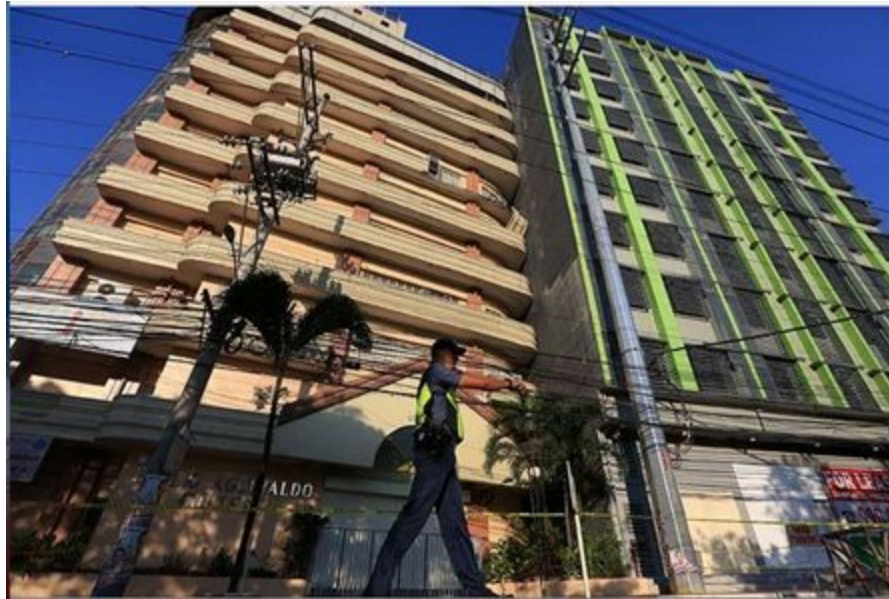
A 10-story school building in Manila (Emilio Aguinaldo College) was reported to have tilted and leaned onto the adjacent building (Fig. 6). Soil liquefaction underneath the building was indicated as the probable cause. This tilting demonstrates the effect of far field ground motions and the ground motion amplification due to local soil conditions, considering that the distance between the epicenter of the earthquake and Manila is around 60 km. Furthermore, the structure being a school building increases the severity of the situation.

Figure 6. Tilted 10 story school building in Manila
