StEER
STRUCTURAL
 EXTREME EVENTS
 RECONNAISSANCE

**2024 Noto Peninsula
 Earthquake**
 Initiated 5 January 2024
 Released: 05 June 2024
 NHERI DesignSafe Project ID: PRJ-4769

PRELIMINARY VIRTUAL RECONNAISSANCE REPORT (PVRR)

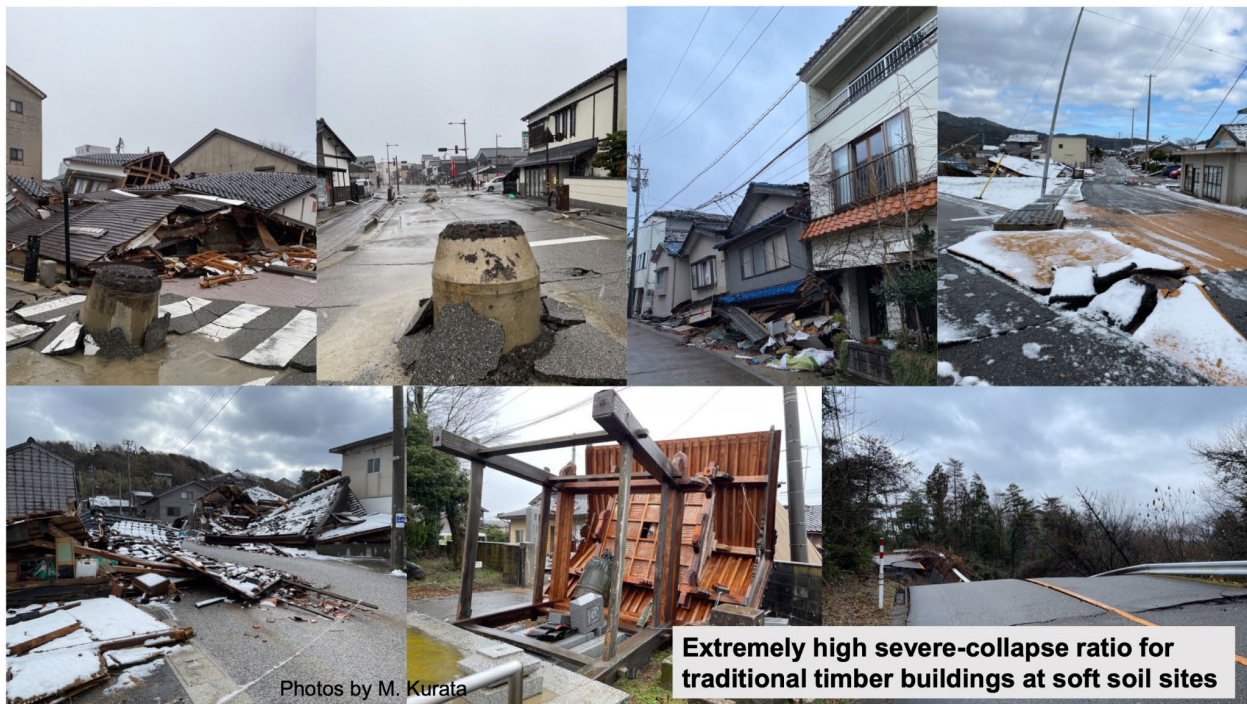
According to previous studies (e.g., Sakai, 2013), the 1-2 second components in ground motions correlate with damage to houses and low-rise buildings whose equivalent period after yielding corresponds to this period range. When these structures are subjected to severe damage, response amplification by resonance does not occur since hysteretic damping becomes large, and the maximum responses are known to occur with one pulse input. Figure 4.4 shows an illustration of a typical traditional timber house in a rural area of Japan. The traditional construction does not use hole-down anchors at the base and metal joints at the connections. As a result, the connections are semi-rigid, and the period of the building elongates significantly after the initial yield, reaching the 1-2 second period range.

Figure 4.3. Traditional building damage at the affected sites (Credit: Kurata and Yamada).

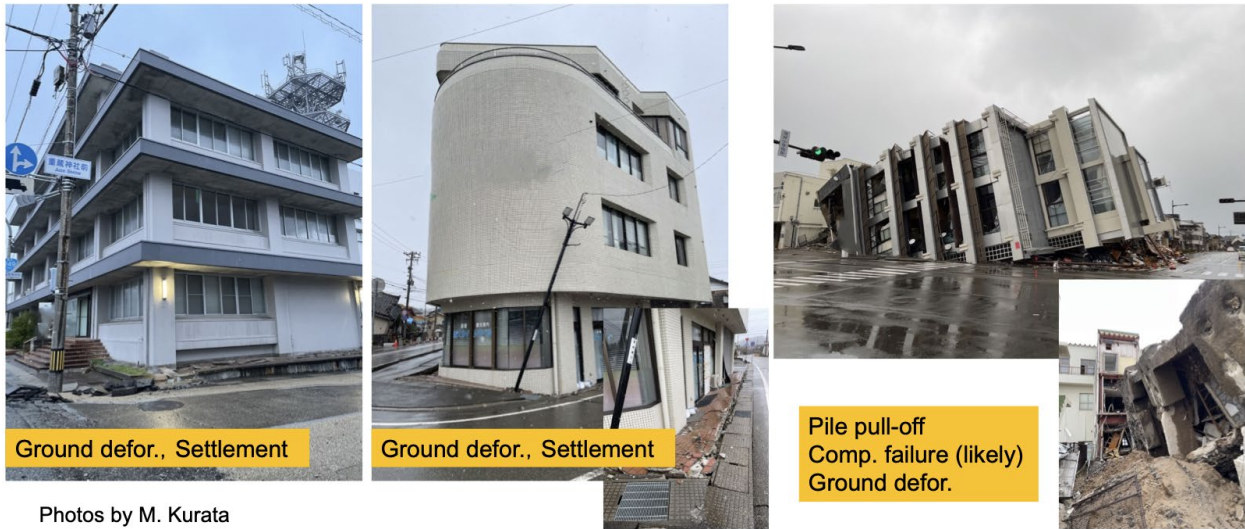
Figure 4.5. Damage to low-mid-rise RC buildings (Credit: M. Kurata).

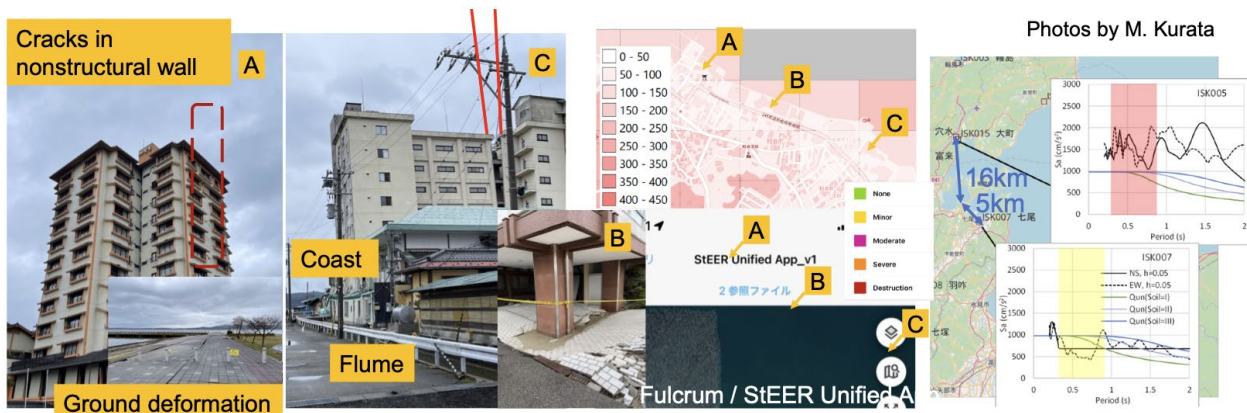
Figure 4.6. Damage to mid-high-rise RC buildings in Wakura-onsen town (Credit: M. Kurata).

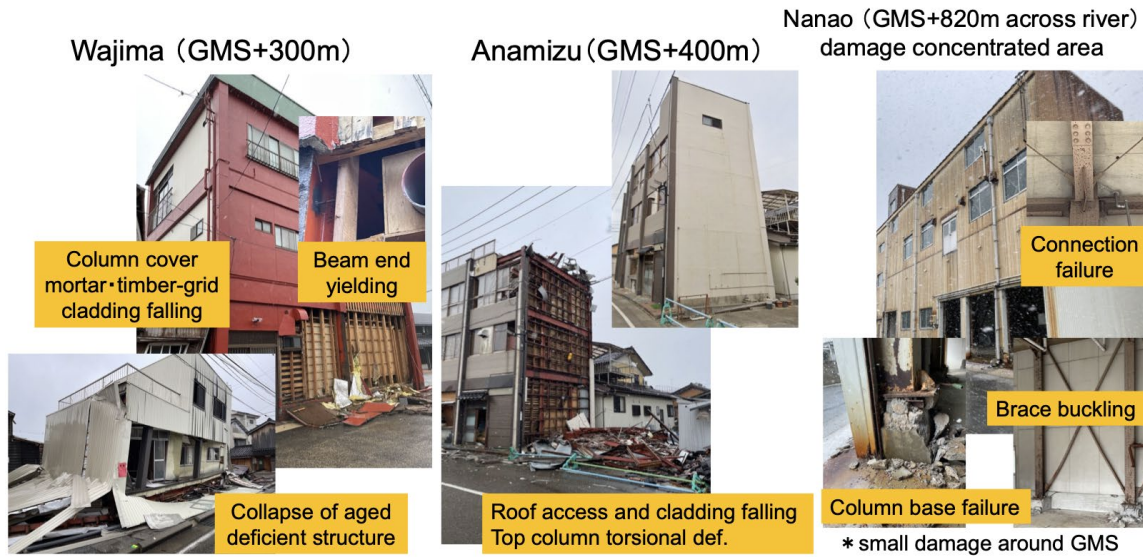
Figure 4.7. Damage to low-mid-rise steel buildings (Credit: M. Kurata).

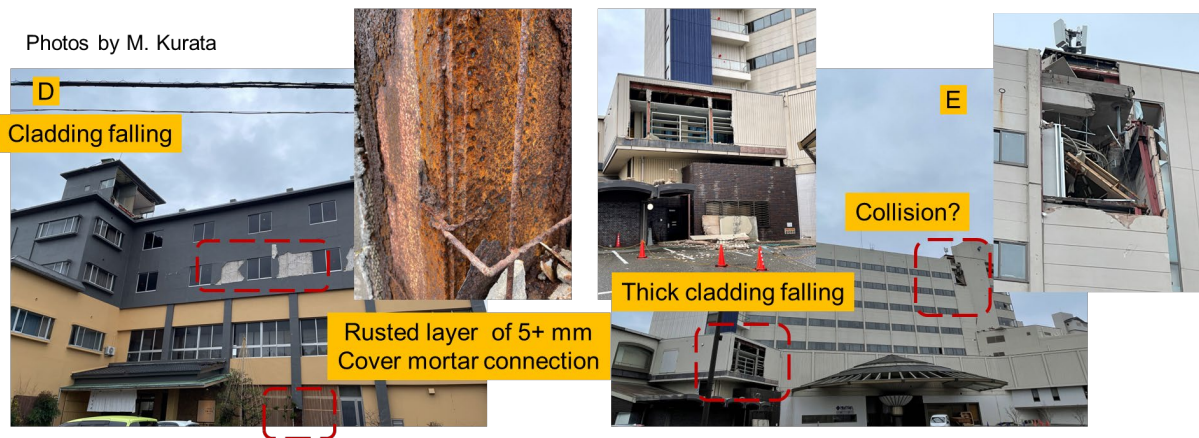
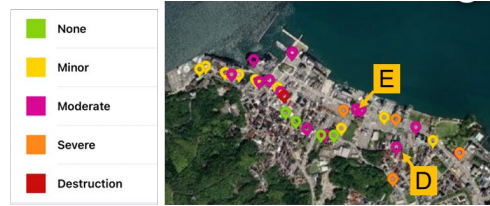
Hotels @ Hot Spring: Steel

- Cladding and column cover falling
- Collisions, severe rusting

Figure 4.8. Damage to mid-rise steel buildings (Credit: M. Kurata).

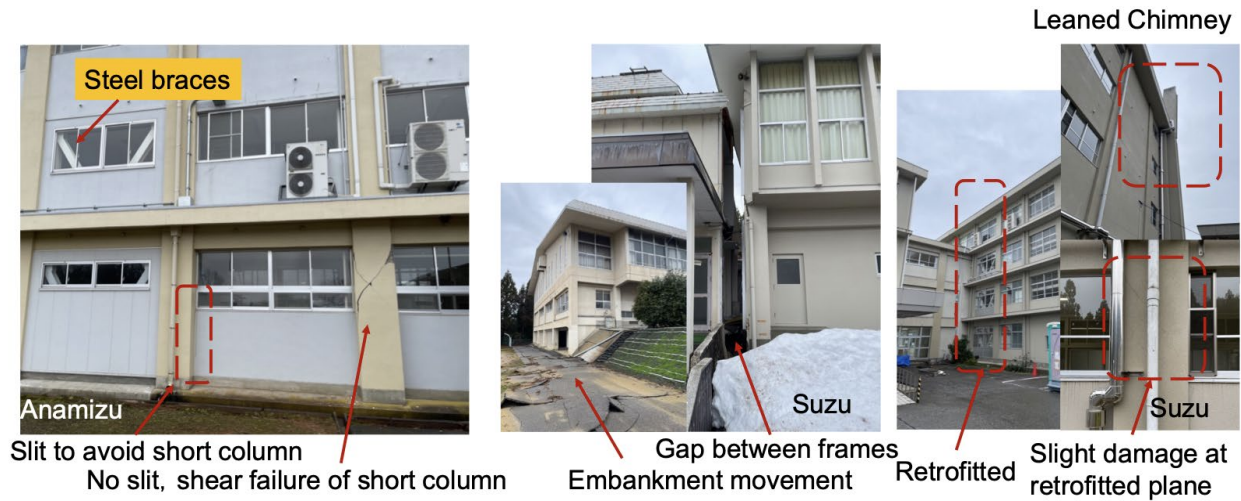
(a) RC building

During the on-site survey, no collapsed school buildings were observed. In fact, most RC school buildings had some structural sections with steel brace retrofit systems (Figure 4.9). Some columns sustained shear failure due to poor detailing and damage to the expansion joint/joint region, which were notable for many buildings. Still, structural integrity was sustained. Landfill deformation around the foundation and embankment failure were severe at the surveyed sites, which had loose soil and poor landfill.

Figure 4.9. Damage to school buildings (Credit: M. Kurata).

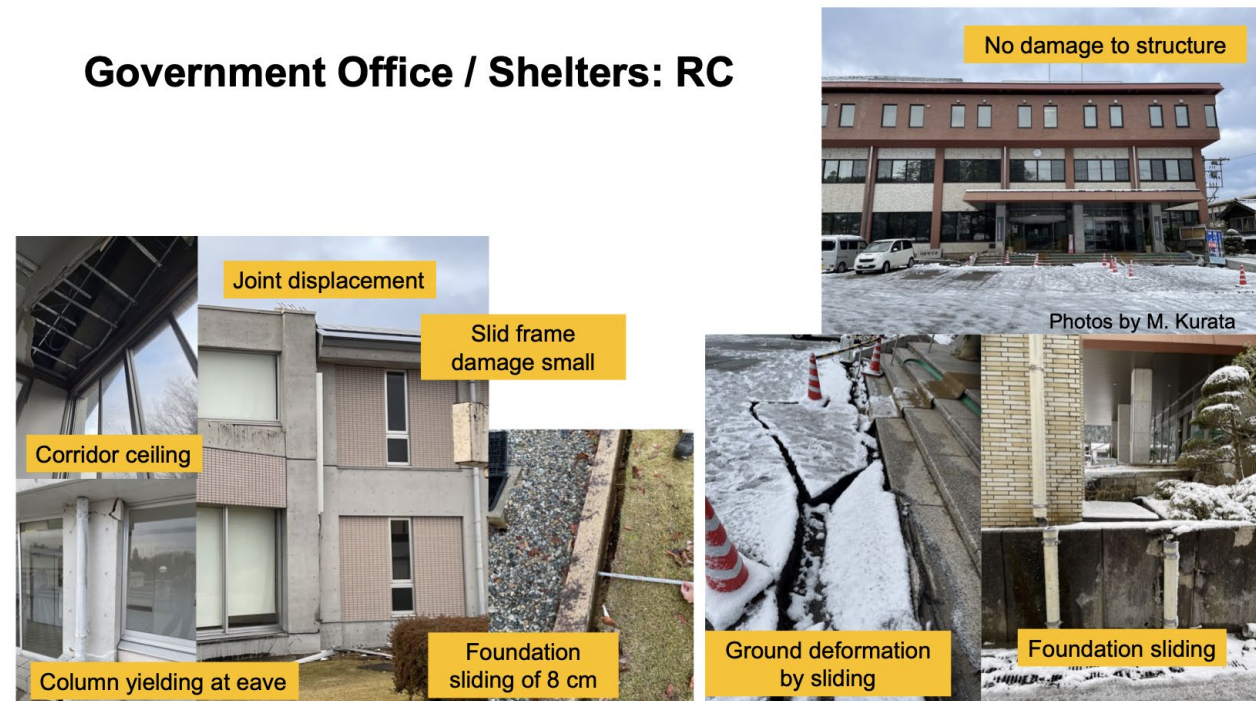
Some government buildings had steel parking lot facilities. Damages such as beam-end yielding, column base failure, and buckled braces were found at aged facilities. Gymnasiums attached to welfare facilities typically have steel-trussed roofs and supporting structures. These structures sit either on steel or concrete columns. A ceiling with an area of more than 200 m² is classified as a specified ceiling (Tokutei tenjo). It requires earthquake-resistance or retrofit (Figure 4.11). In one facility, the ceiling with a light-formed panel suffered damage, and steel wire meshes and bracing failed.

Figure 4.10. Government building and welfare facility (Credit: M. Kurata).

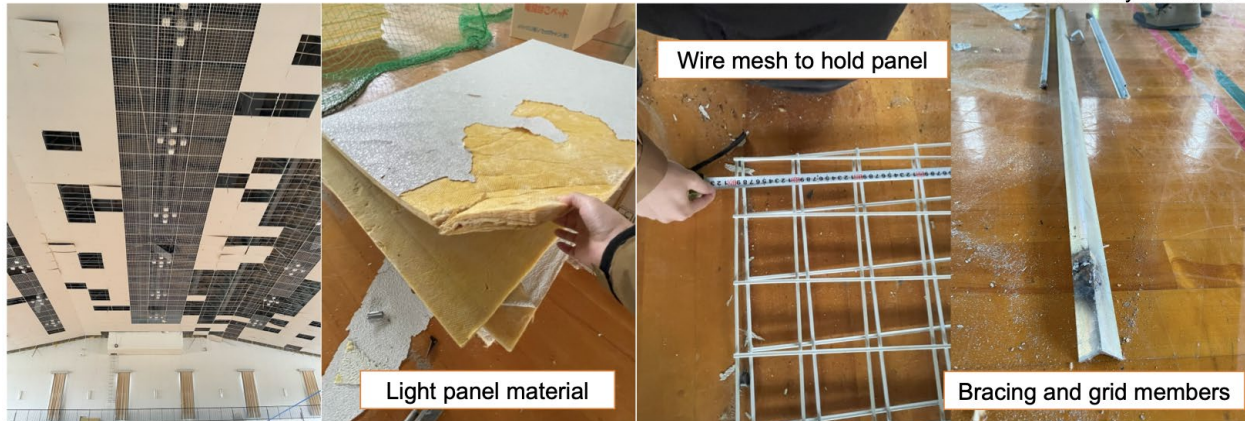
Figure 4.11. Gymnasium at a welfare facility (Credit: M. Kurata).

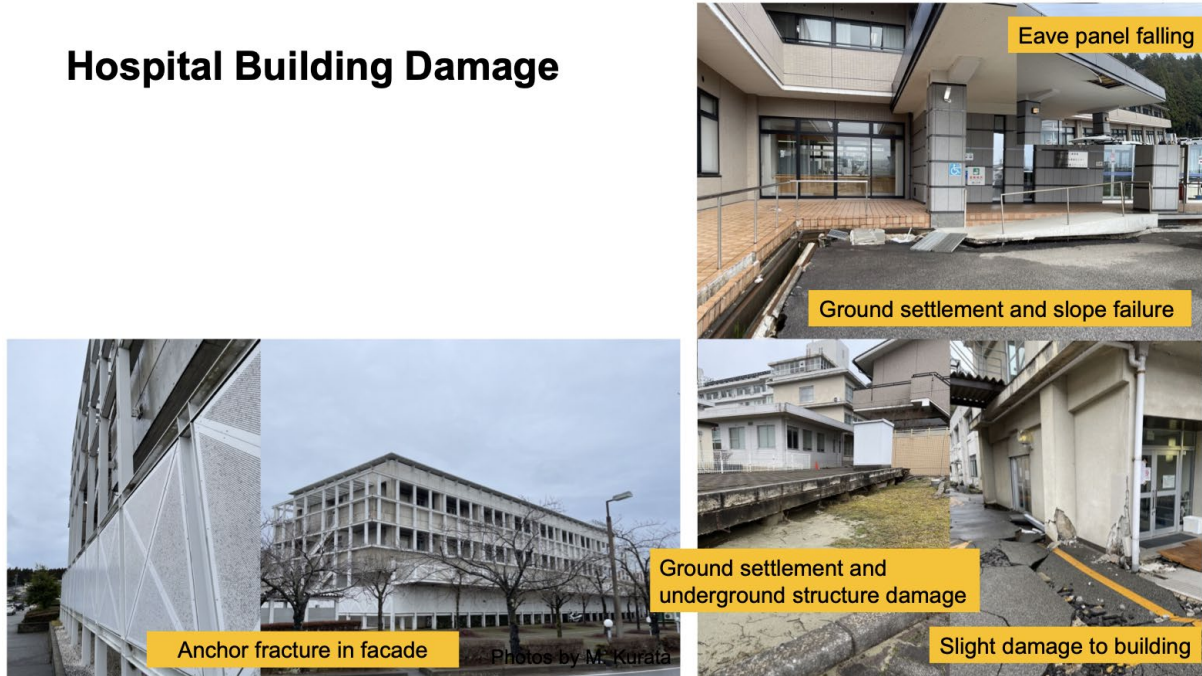
Figure 4.12. Visual survey of hospitals (Credit: M. Kurata).

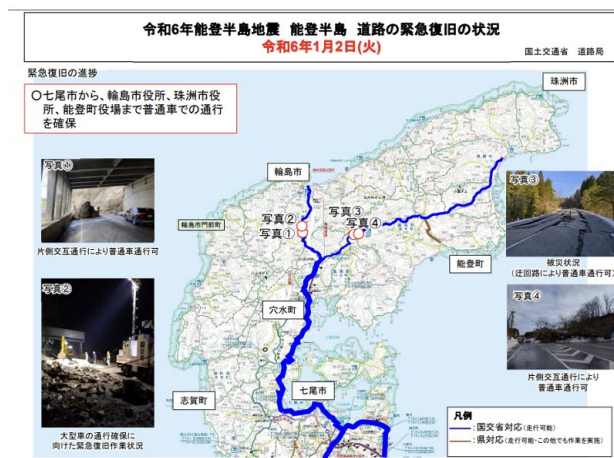
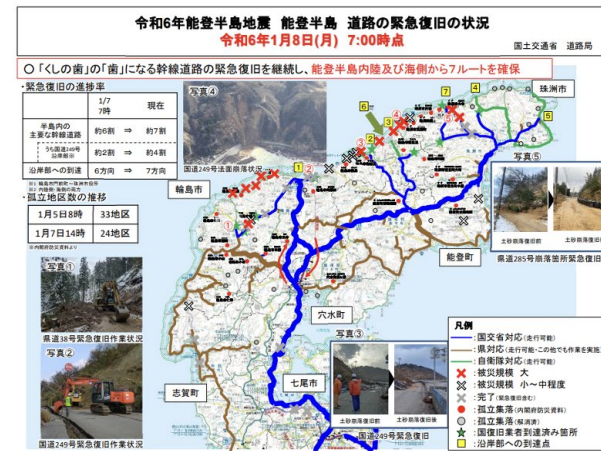
Figure 5.1 shows the damage and emergency restoration of major access roads to the severely affected areas in the Noto Peninsula (MLIT, 2024a). The Noetsu Express highway was damaged severely, and the southbound flow has been closed for months. The national routes were closed at 40 locations, with 80% restored as of April 5. The prefectural routes were closed at 145 locations in Ishikawa, Niigata, and Toyama, while 70% were restored as of April 5. The railway system also suffered from damage. The Nanao line of JR West was closed until February 15, and the Noto railway was closed until April 6. The facilities and runway of the Noto airport were also severely damaged. The runway was reopened to the defense force on January 12 and opened to the public on January 27.

Figure 5.1. Road failure by landslides and tsunami (Road Bureau, MLIT, 2024a).

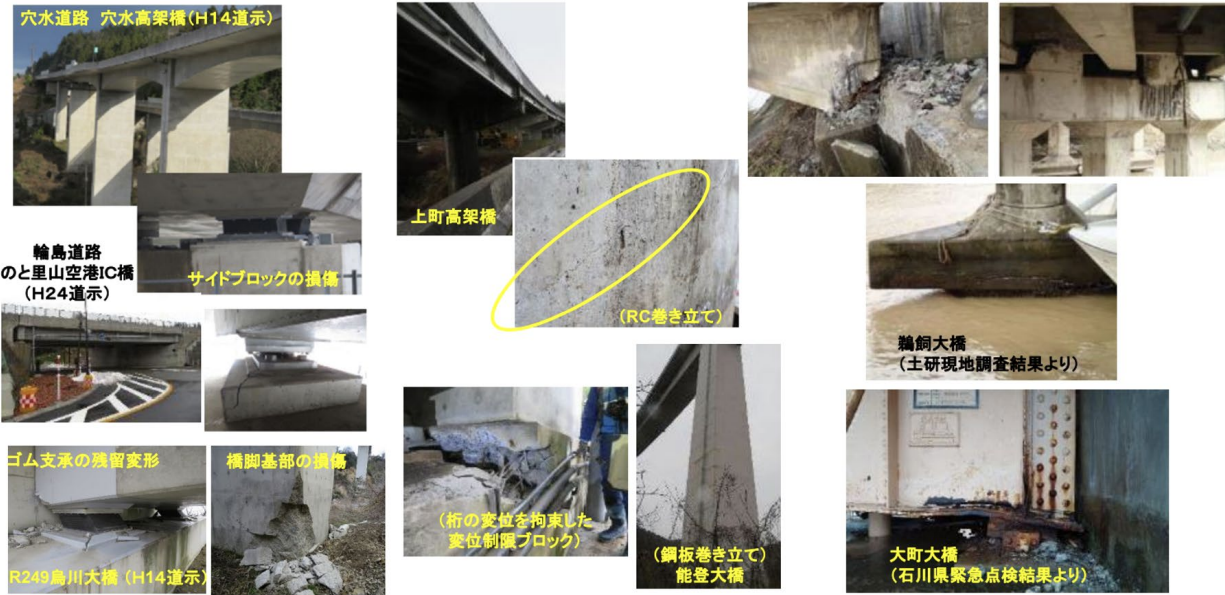
(a) New code conforming bridges (b) Seismically-retrofitted bridges (c) Unretrofitted bridges

Figure 5.2. Bridge damage in piers and supports in Ishikawa Prefecture (MLIT, 2024c).

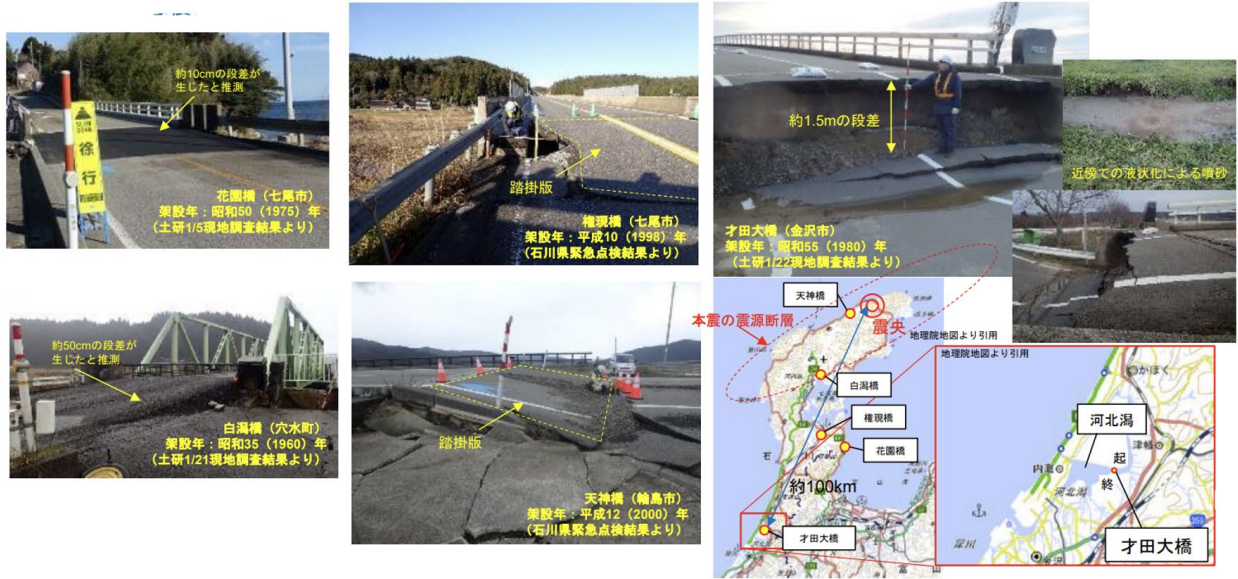
The 1996 specifications for road bridges stipulate that it is desirable to install step slabs, and the 2012 specifications for road bridges stipulate requirements for the structure of the rear abutment approach. The effects of these regulations were observed (Figure 5.3): emergency restoration of 10-50 cm step slabs in Nanao City and Anamizu Town; confirmed effectiveness of step slabs in Nanao City and Wajima City. On the other hand, there is a bridge in Kanazawa City that suffered from the liquefaction-induced ground subsidence of 1.5 m.

(a) Emergency restoration (b) Step slabs effective (c) Large step by liquefaction

Figure 5.3. Bridge damage with step slab in Ishikawa Prefecture (MLIT, 2024c).

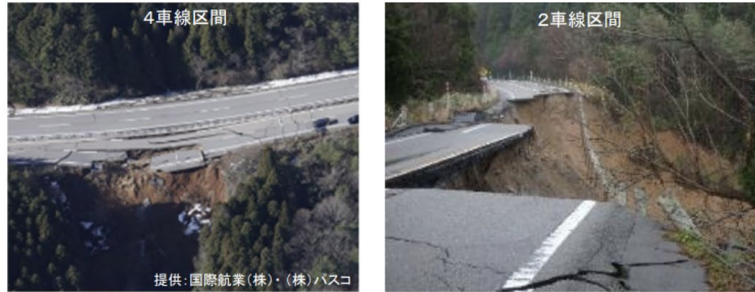
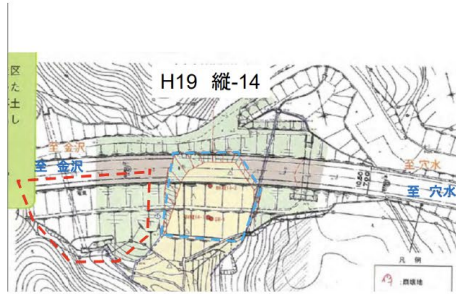
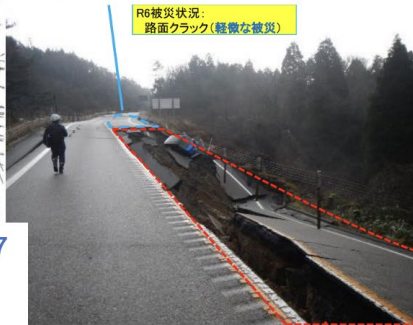
No damage in 2007
Severe damage in 2024

R6被災状況:
盛土高約15mの谷埋め盛土
で大規模崩壊(重傷の被災)

(c) Restored section after the 2007 earthquake and new failure

Figure 5.4. Embankment failure in Noto-satoyama Kaido (MLIT, 2024c).

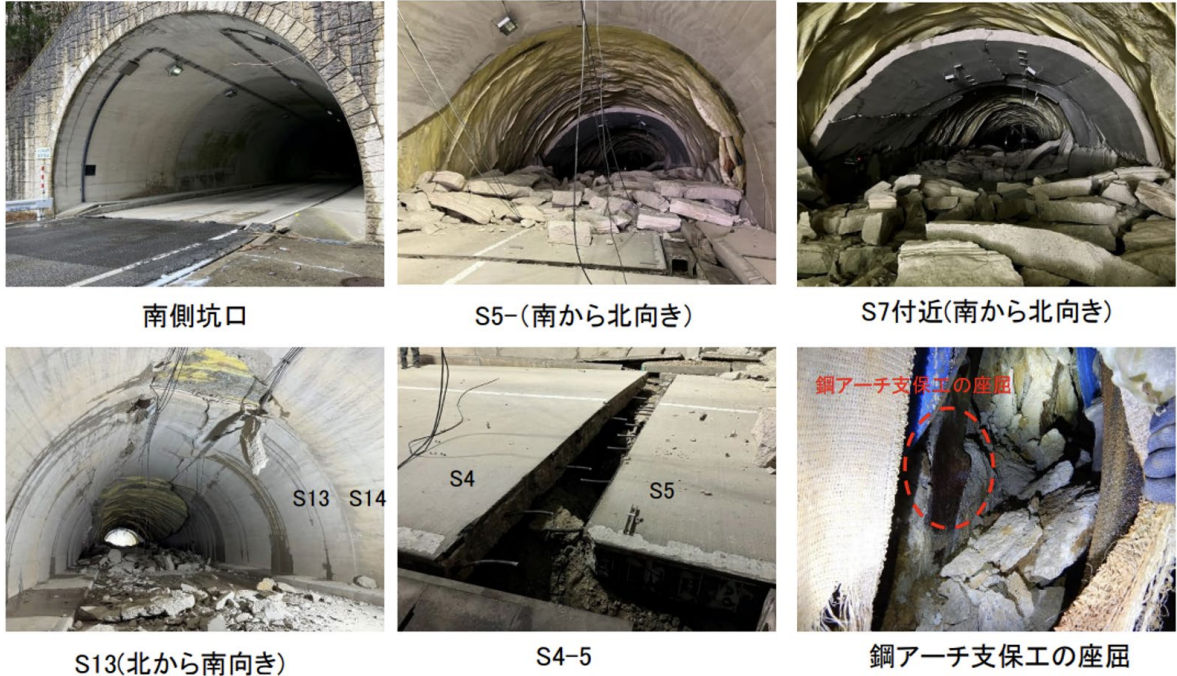
(a) Oya Tunnel

In a wide area between Suzu City and Wajima City, several road tunnels were found to have deformations presumably caused by the earthquake. The most extensive were the Oya and Nakaya tunnels (both constructed by NATM), where the tunnel lining collapsed. However, the ground itself did not collapse, and the tunnel space was not blocked. The mechanism of the damage needs further analysis, but it is assumed that one of the factors is that the earthquake caused large-scale ground deformations.

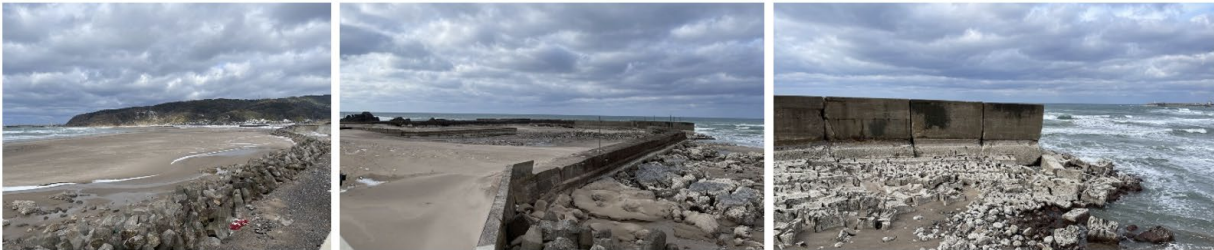
According to a prefectural survey, crustal deformation caused damage to 60 of the 69 fishing ports in Ishikawa Prefecture (86.9%), including ground uplift, breakwaters, quays, and port roads. Many of the prefecture's 12 ports, used by cargo carriers and work vessels in addition to fishing vessels, were also damaged. Figure 5.6 shows photos of the Kuroshima port south of Wajima. The port structure remains without structural damage, but no water exists inside the port. The ocean front line receded around 200 m from the original coastline.

Figure 5.6. Kuroshima port south of Wajima (Credit: M. Kurata).

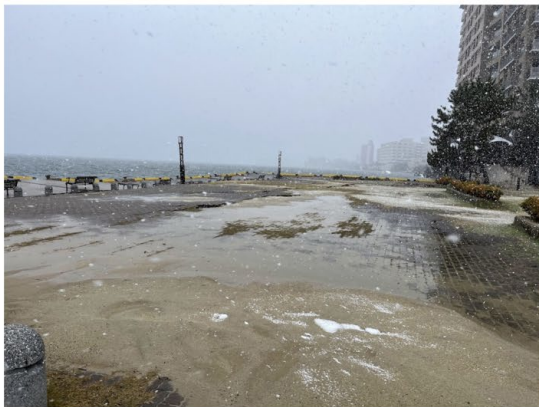
Figure 6.2 illustrates liquefaction damage at Wakura Port in Nanao City, Ishikawa Prefecture. According to the strong-motion seismograph network of the NIED, a maximum acceleration of 374 gal was recorded at an observation station located in Nanao City (K-NET ISK007). As depicted in Figure 6.2(a), cracks and sand boiling were observed in the ground behind the quay wall due to this intense shaking. Additionally, lateral spreading in the ground caused the quay wall to bulge towards the sea, leading to ground settlement, as illustrated in Figure 6.2(b). Wakura Port also experienced liquefaction damage during the 2007 Noto Peninsula earthquake (with a maximum acceleration of 202 gal recorded at K-NET ISK007), and the extent of damage shown in Figure 6.2 from the 2024 earthquake surpassed that of 2007. The recurrence of liquefaction at the same location 17 years later highlights a significant issue when considering liquefaction mitigation measures for future earthquakes. In the 2024 earthquake, similar damage due to reliquefaction was also observed at Nanao Port in Nanao City, Ishikawa Prefecture, and Himi Fishing Port in Himi City, Toyama Prefecture.

(a) Sand boiling and cracks in the ground

Figure 6.2. Liquefaction damage at Wakura Port in Nanao City, Ishikawa Prefecture (Credit: K. Ueda).

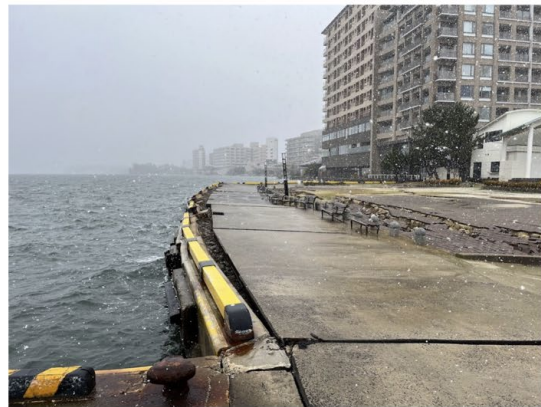
(b) Horizontal displacement of the quay wall

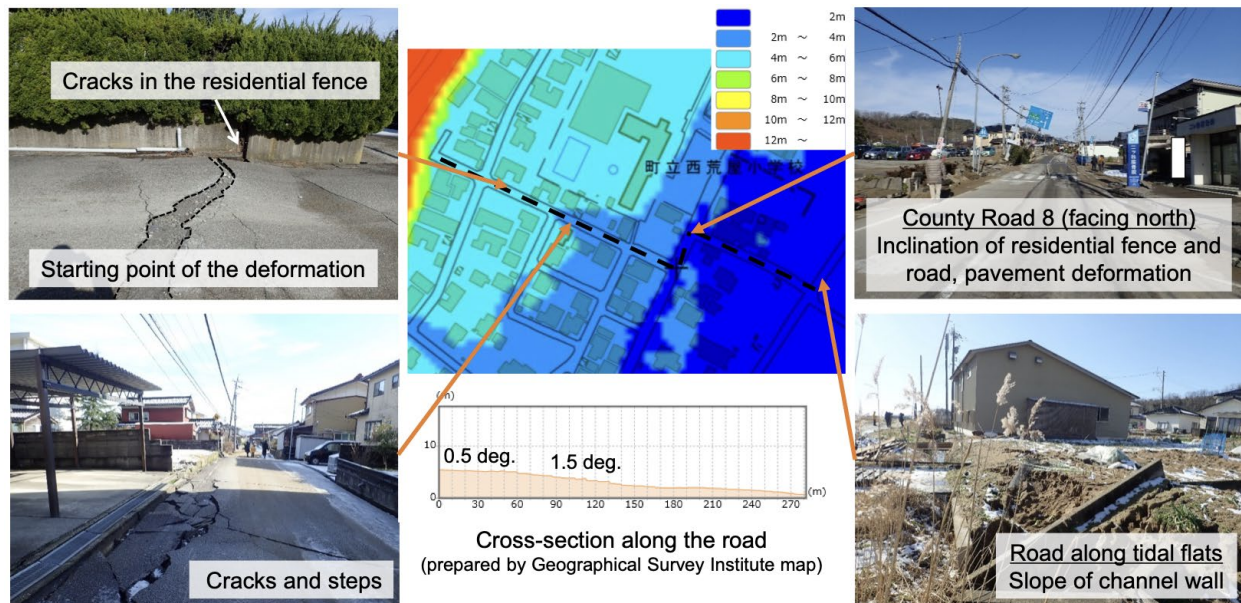
In Kahoku City and Uchinada Town, Ishikawa Prefecture, liquefaction damage such as sand boiling, tilting of utility poles and residential walls, and road deformation occurred on gently sloping ground from the foot of dunes in the west to tidal flats in the east. Several meters of lateral spreading occurred in some places due to liquefaction, and the roads on the lower elevation side were significantly deformed and uplifted due to this ground deformation. Figure 6.3 shows the liquefaction-induced damage in the Nishiaraya area of Uchinada Town (refer to Ueda et al. (2024) for liquefaction damage in other areas). Many areas where lateral spreading occurred in Kahoku City and Uchinada Town are topographically characterized by sand dunes on the west side and lagoons on the east side. It is thought that gently sloping ground was created by cutting the foot of the dunes and filling the tidal flats. Although the dune itself is not susceptible to liquefaction, groundwater is easily supplied from the base of the dune toward the gently sloping ground, likely contributing to liquefaction. The gently sloping ground is also composed of sand with a relatively uniform grain size, which may have contributed to increased liquefaction damage. However, considering that the JMA seismic intensity levels in Kahoku City and Uchinada Town are 5 upper and 5 lower, respectively, and that the ground formed by cutting sand dunes is relatively firm against seismic shaking, the detailed mechanism of lateral spreading on the scale of several meters is not fully understood at this time.

Figure 6.3. Ground deformation along the road (black dashed line) from the dune foot (west side) to the tidal flat (east side) in Nishiaraya, Uchinada Town, Ishikawa Prefecture.

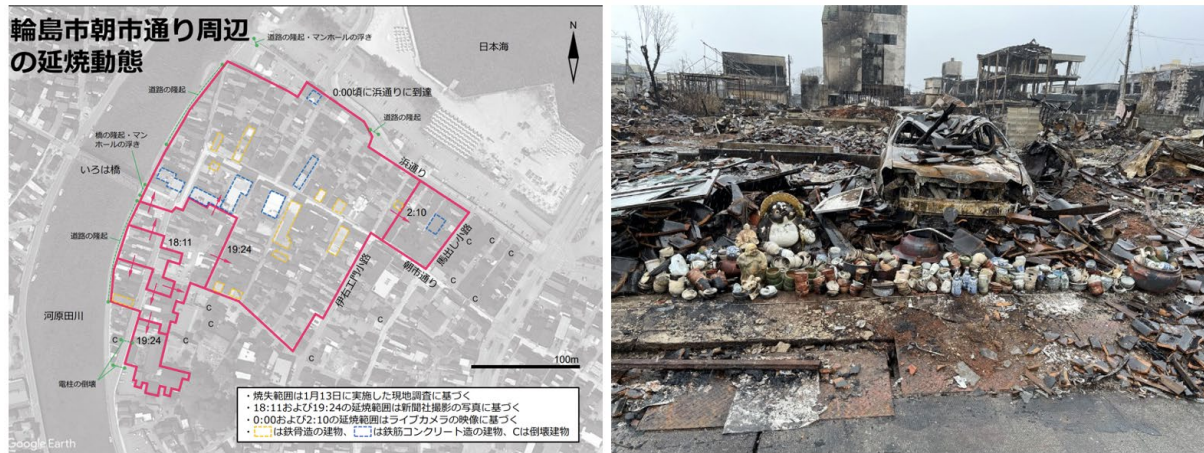
(a) Earthquake-triggered fire in Wajima city

Figure 7.3. Fire damage in Wajima and Suzu cities (Source: Nishino, 2024).

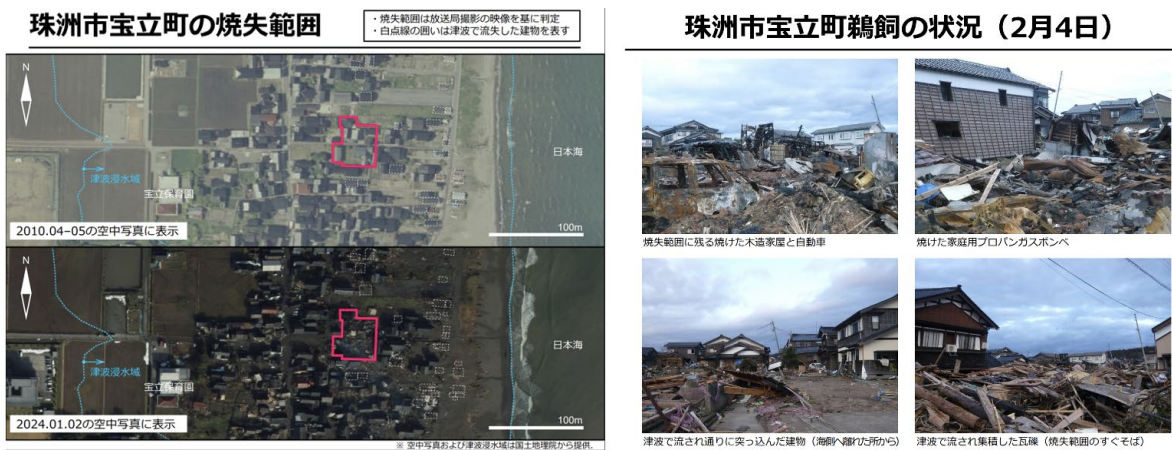
(b) Tsunami-triggered fire in Suzu city
