**EARTHQUAKE ENGINEERING  
RESEARCH INSTITUTE**

**StEER**  
**STRUCTURAL**  
EXTREME EVENTS  
RECONNAISSANCE

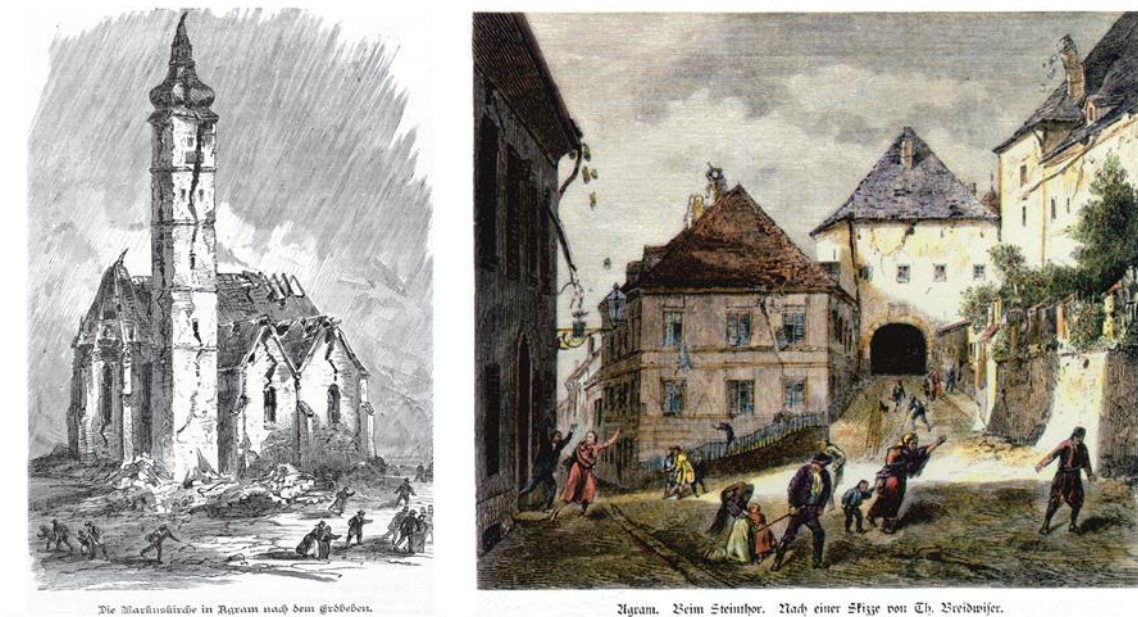
**Figure 1.1.** Lithographic illustration and hand colored xylographic illustration of the 1880 Zagreb earthquake (source: Kozák & Čermák 2010).

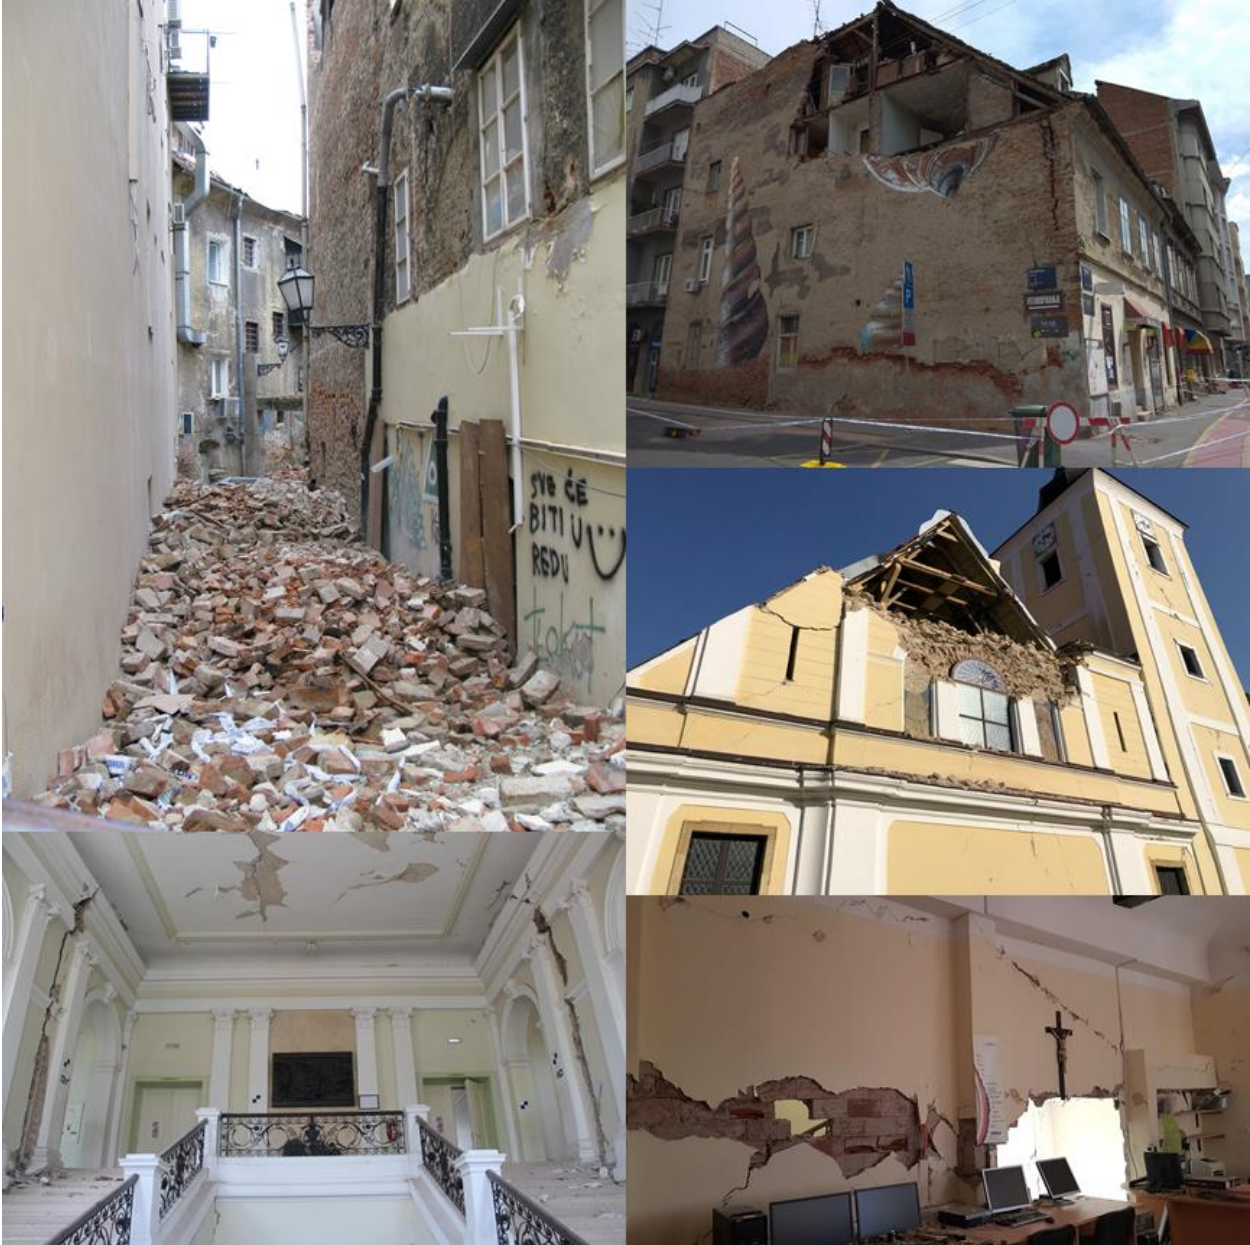
**Figure 1.2.** Photos of damage in Zagreb caused by the March 22, 2020 earthquake. (source: (1CroCEE 2021).

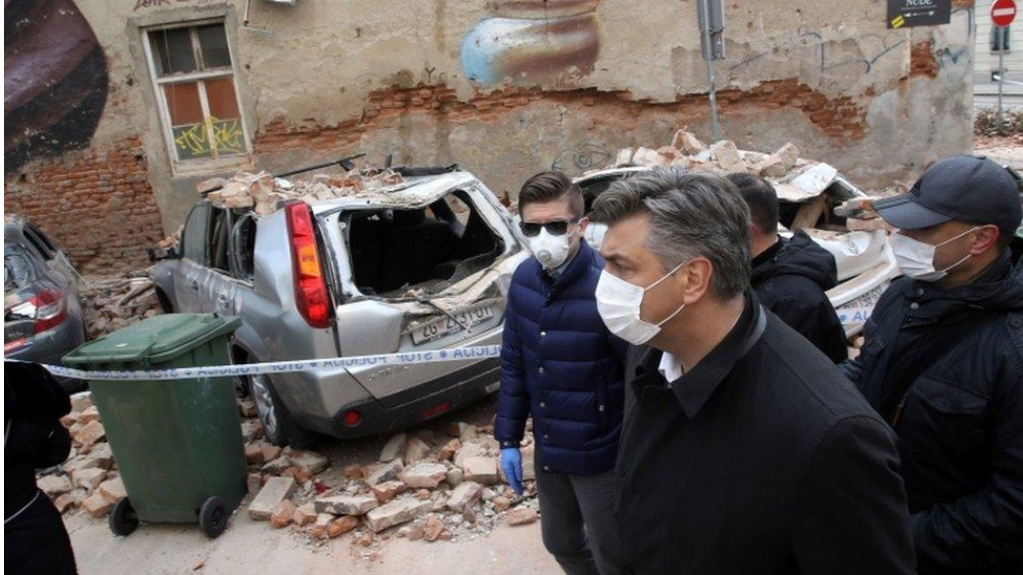
**Figure 1.3.** Croatian Prime Minister Andrej Plenković assesses the damage caused by the March 22, 2020 earthquake: (source: BBC News 2020e).

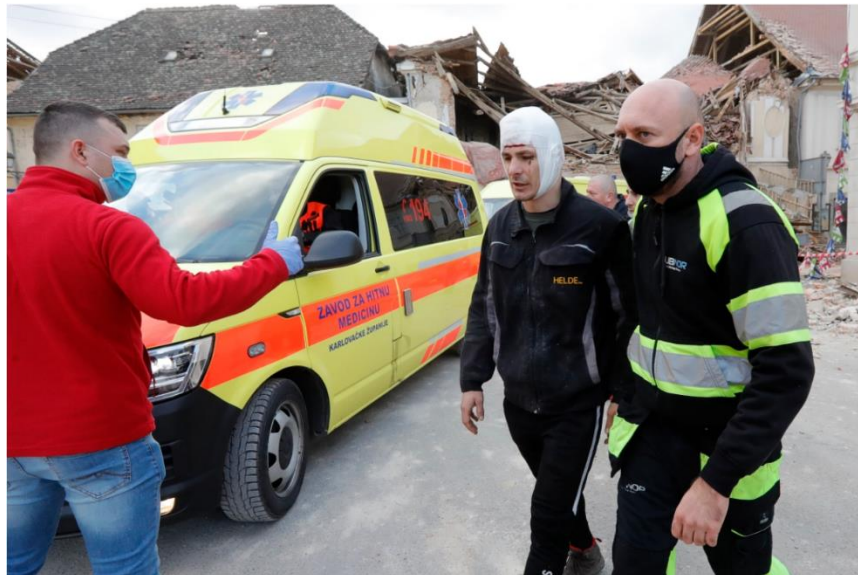
**Figure 1.4.** A man with a head injury is escorted away from buildings damaged in the earthquake in Petrinja. Photo by Antonio Bat (EPA).

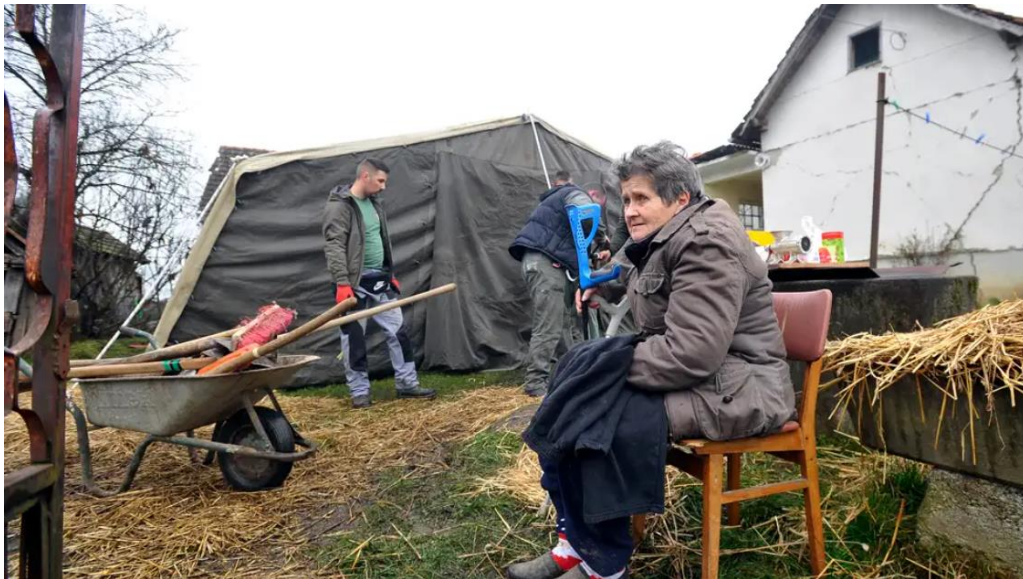
**Figure 1.5.** A woman sits in her yard as men erect a tent in front of a damaged house in the village of Majske Poljane. Photo by AP.

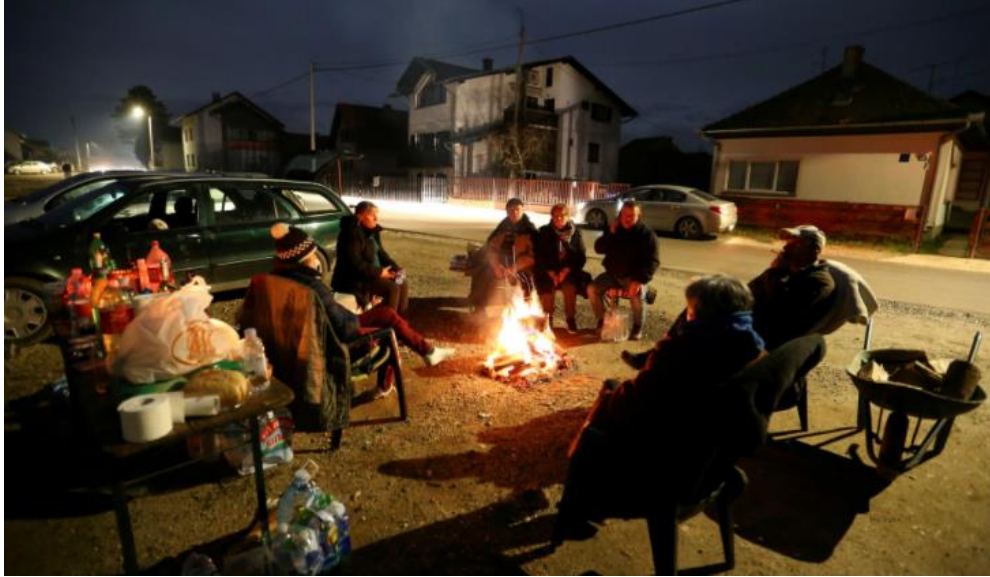
**Figure 1.6.** Displaced residents warm up around a fire after the earthquake in Petrinja. Photo by Antonio Bronić (Reuters).

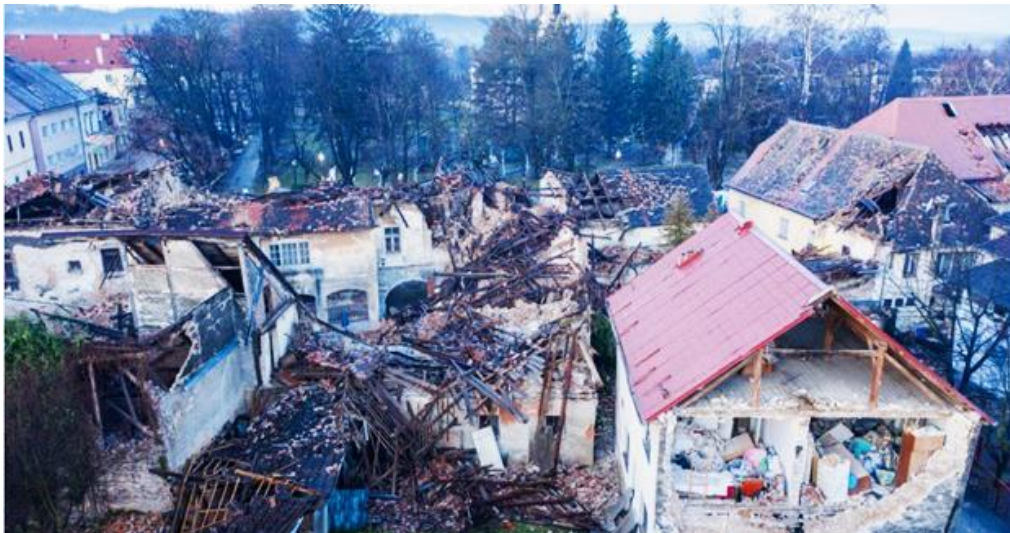
**Figure 1.7.** Aerial photo showing extent of damage in an area of Petrinja. Photo by Antonio Bronić (Reuters).

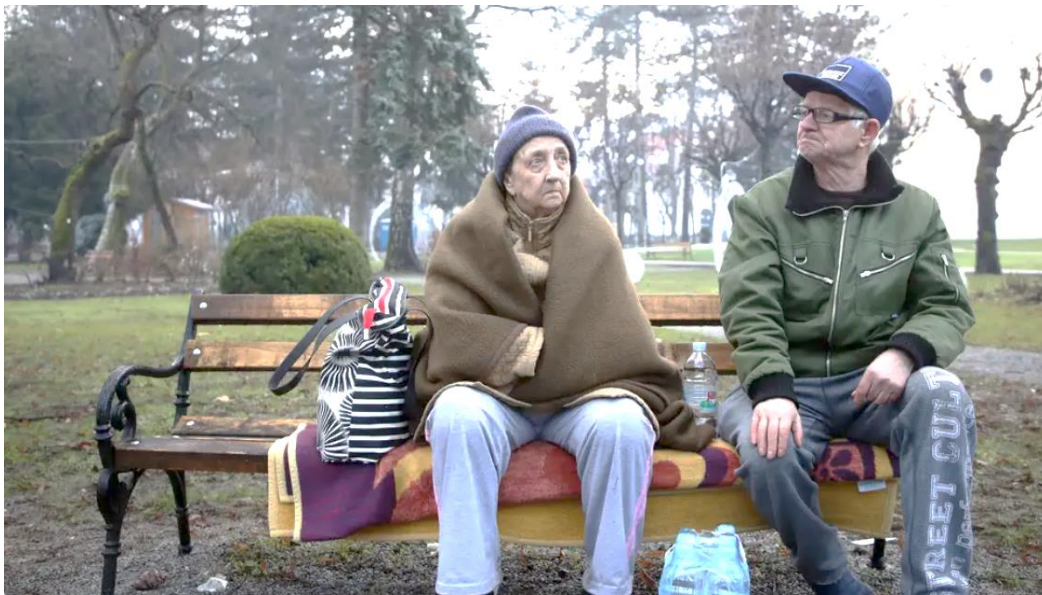
**Figure 1.8.** Maria Pavlović and her husband Tomislav, who were unable to return to their damaged home, sit on a bench in Petrinja. Photo by Damir Senčar (Getty Images).

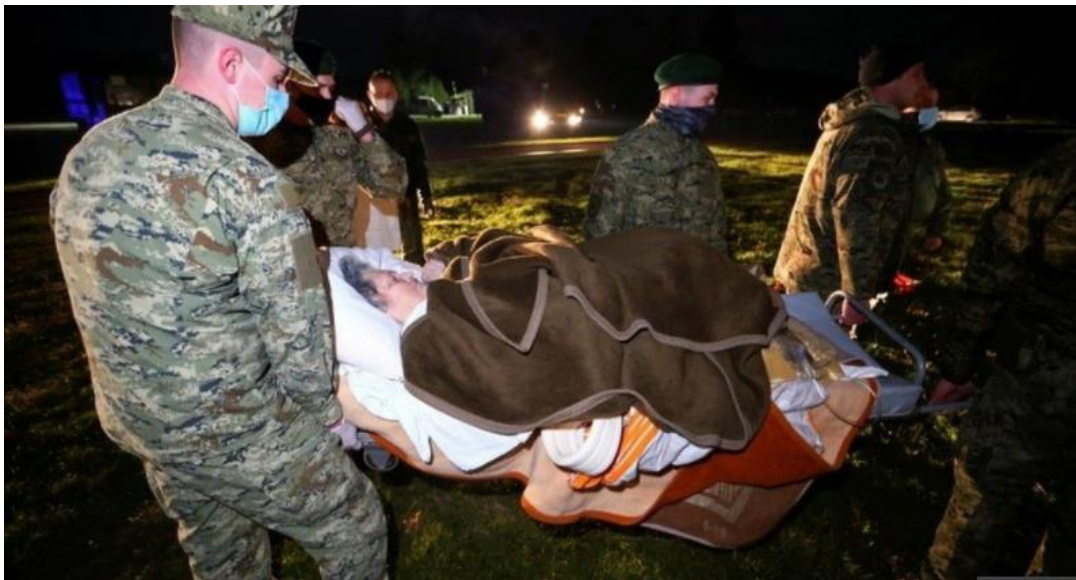
**Figure 1.9.** Croatian soldiers evacuating a woman from a local hospital. Photo by Antonio Bronić (Reuters).

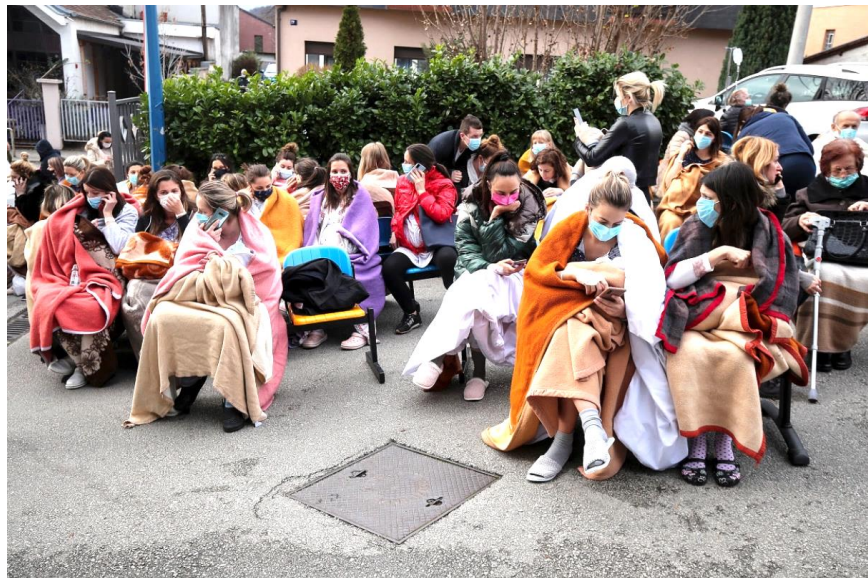
**Figure 1.11.** Patients and medical staff were evacuated from the Sveti Duh Hospital in Zagreb after the December 29 earthquake. Photo by Goran Stanzl (Reuters).

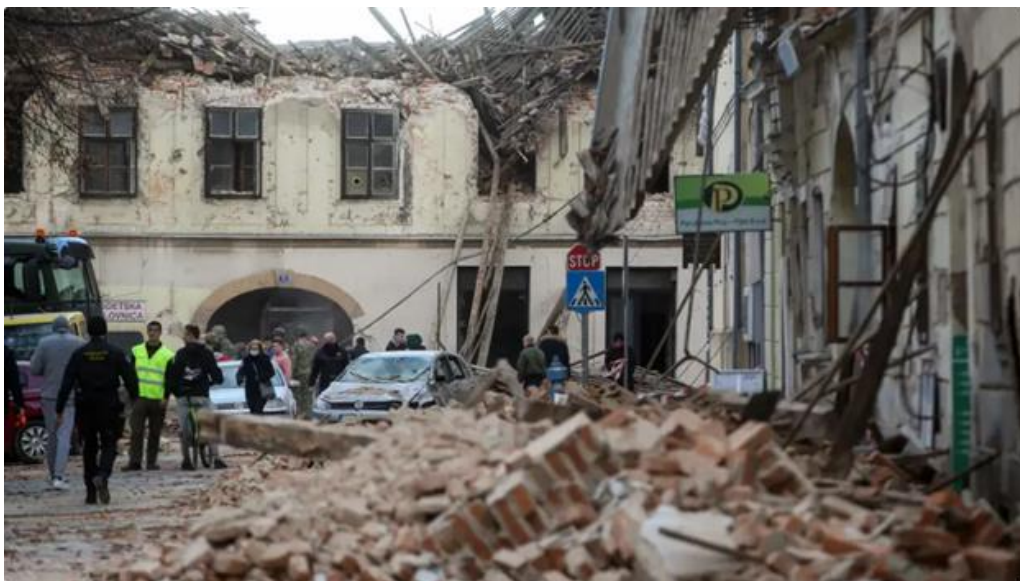
**Figure 1.12.** Croatian soldiers, firefighters, and residents next to heavily damaged buildings located in the center of Petrinja. Photo by Damir Senčar (Getty Images).

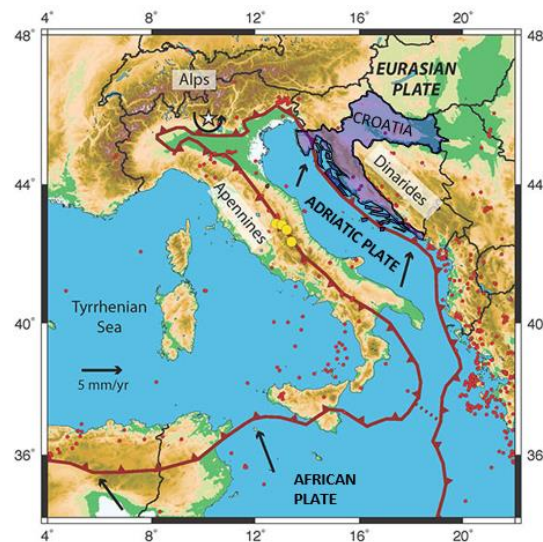
**Figure 2.1.** Tectonic plates in the Alpine-Mediterranean region (adapted from Physics Today 2016).

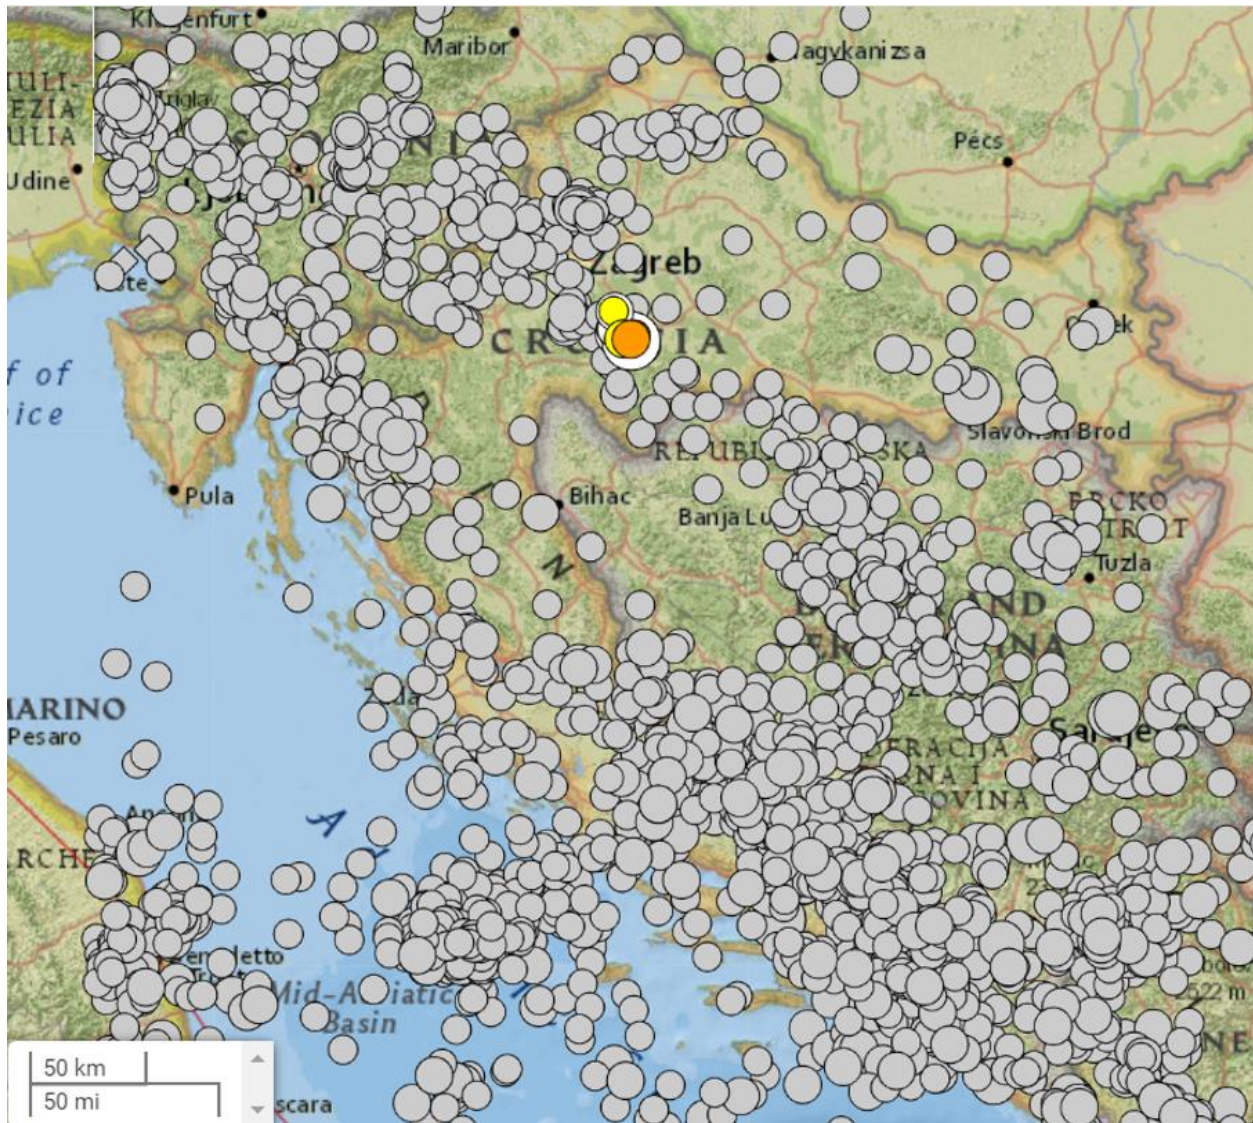
**Figure 2.5.** Epicenters of earthquakes with moment magnitudes  $M > 3$  in Croatia since 1950. Source: USGS ComCat. (USGS 2021).

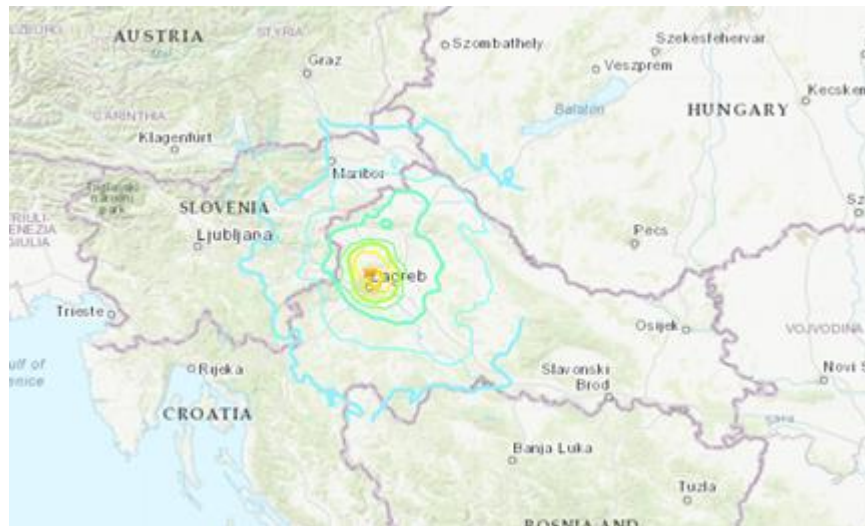
**Figure 2.8.** Epicenter of the Zagreb, Croatia earthquake on March 22, 2020 (USGS 2020b).

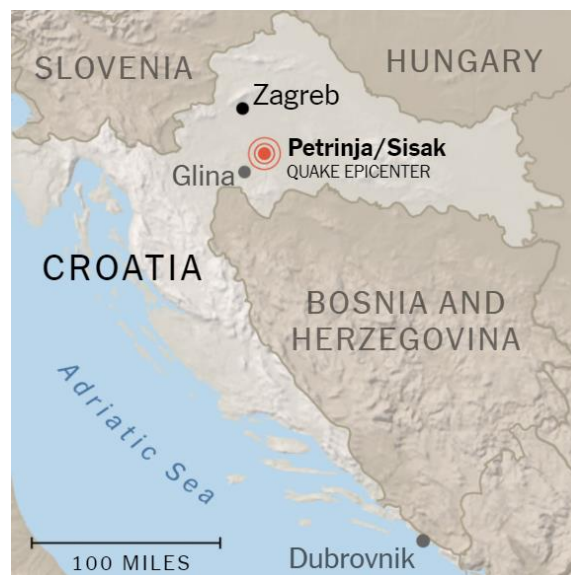
**Figure 2.11.** Location of the December 29, 2020 earthquake in Croatia (source: New York Times 2020).

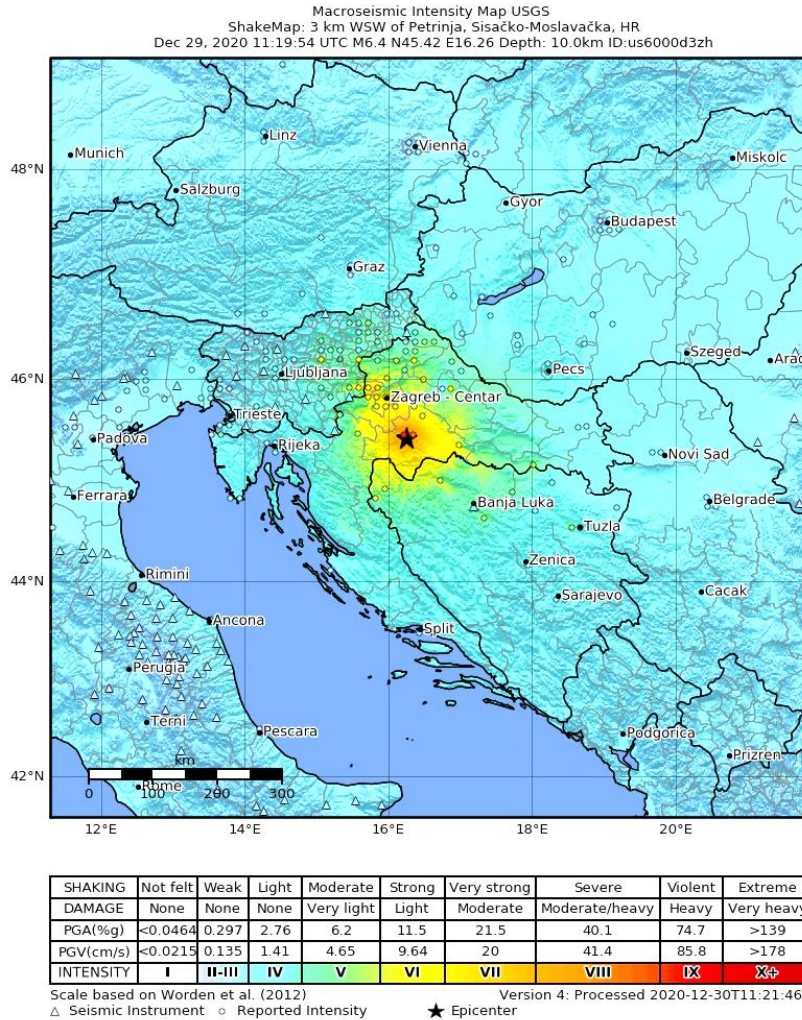
**Figure 2.16.** Intensity map estimated from ShakeMap. (source: USGS 2020).

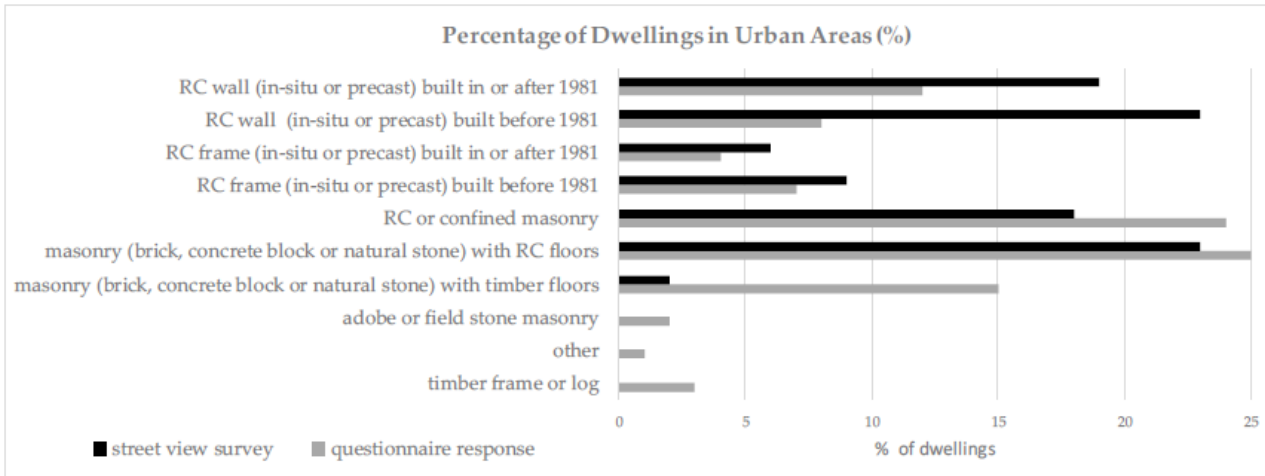
**Figure 3.4.** Classification of urban dwellings in Croatia according to project NERA (2011) (Pavić et al. 2020b).

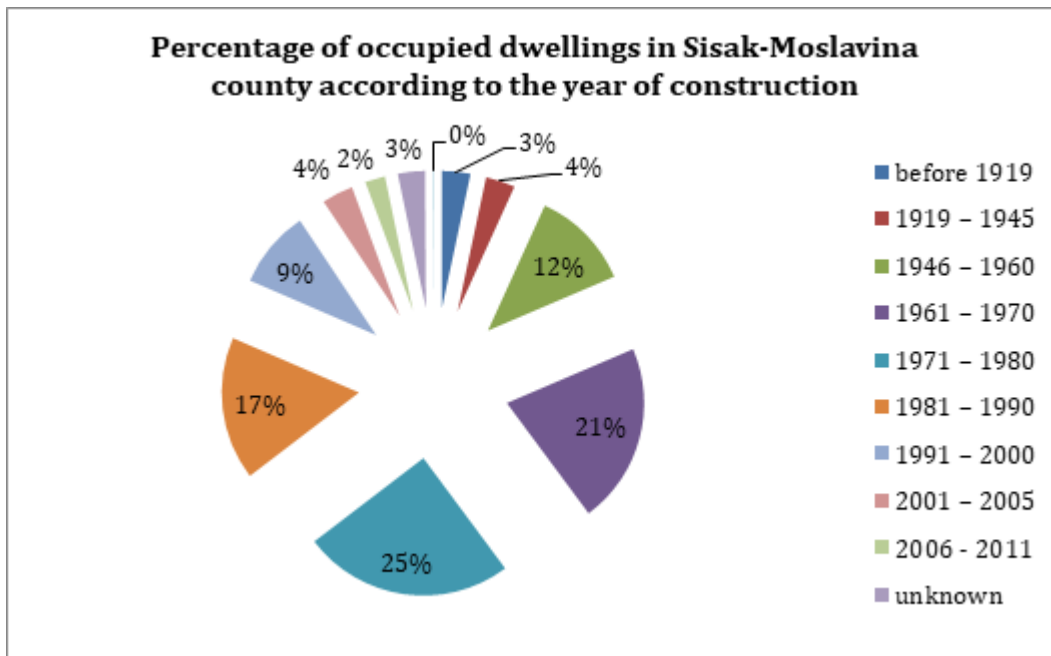
**Figure 3.5.** Classification of dwellings in Sisak-Moslavina County according to the year of construction (Croatian Bureau of Statistics 2011).

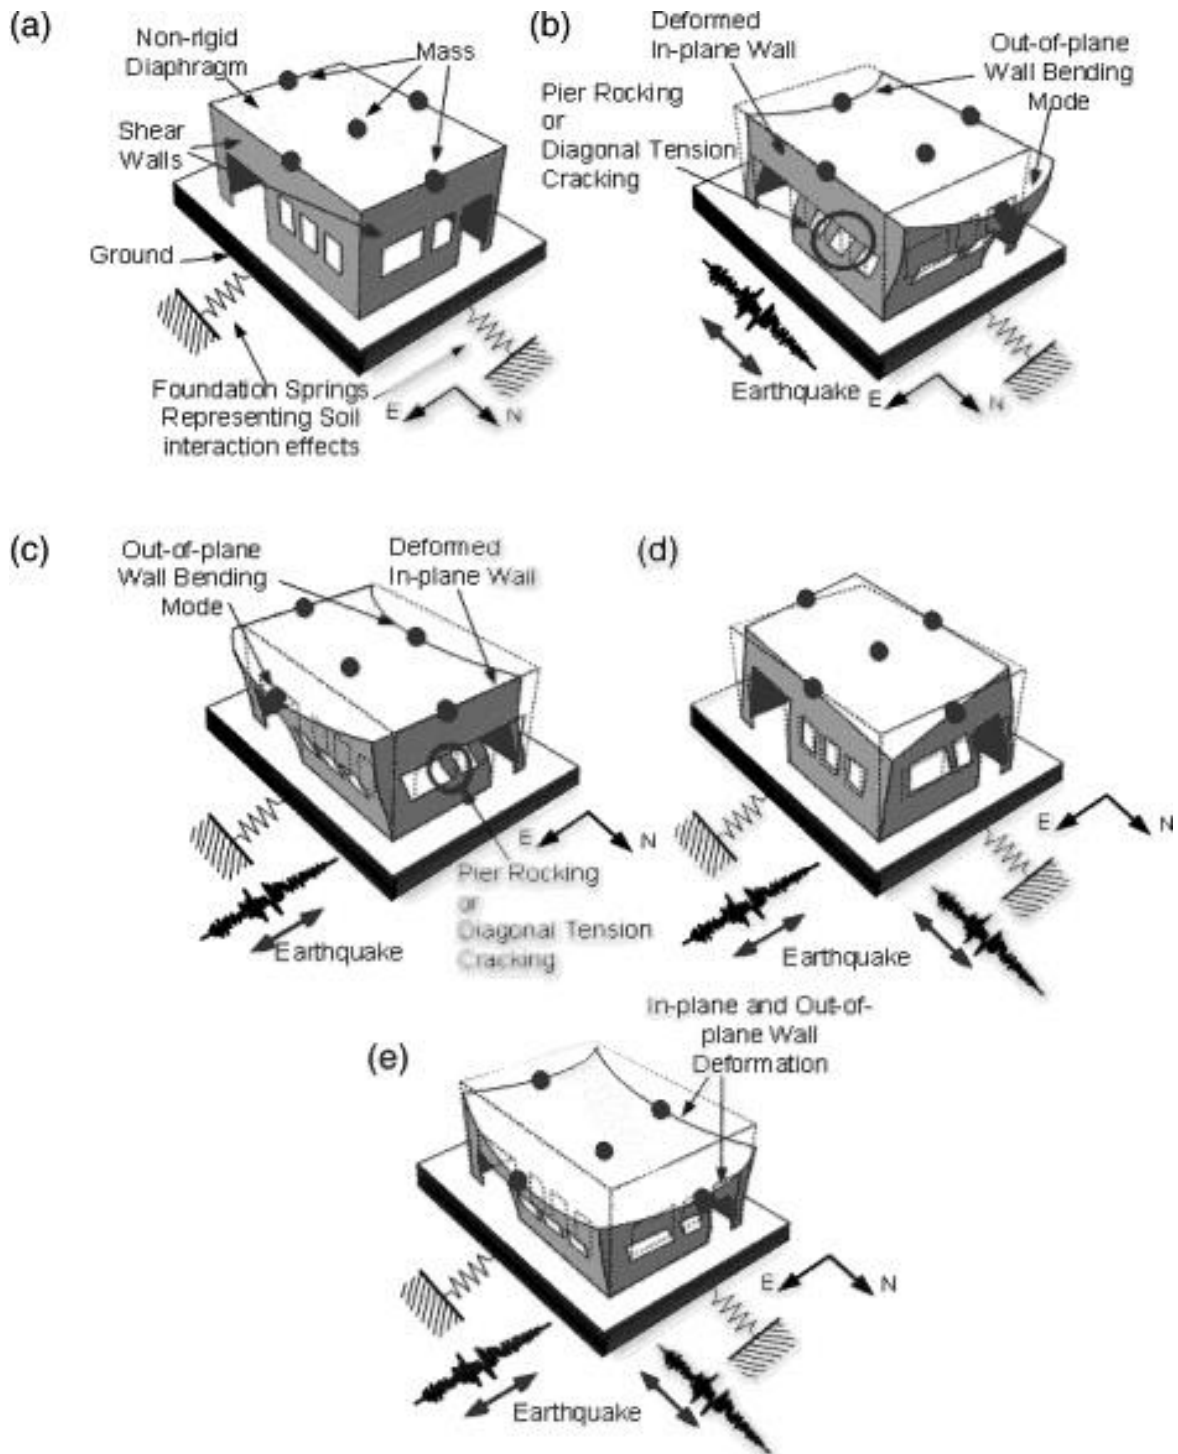
**Figure 3.6.** Schematics of a single-story URM building with a flexible diaphragm: (a) structural components and undeformed shape, (b, c) bending in two orthogonal directions, (d) shear racking in both directions, and (e) combined bending and shear racking (Kim and White 2004).

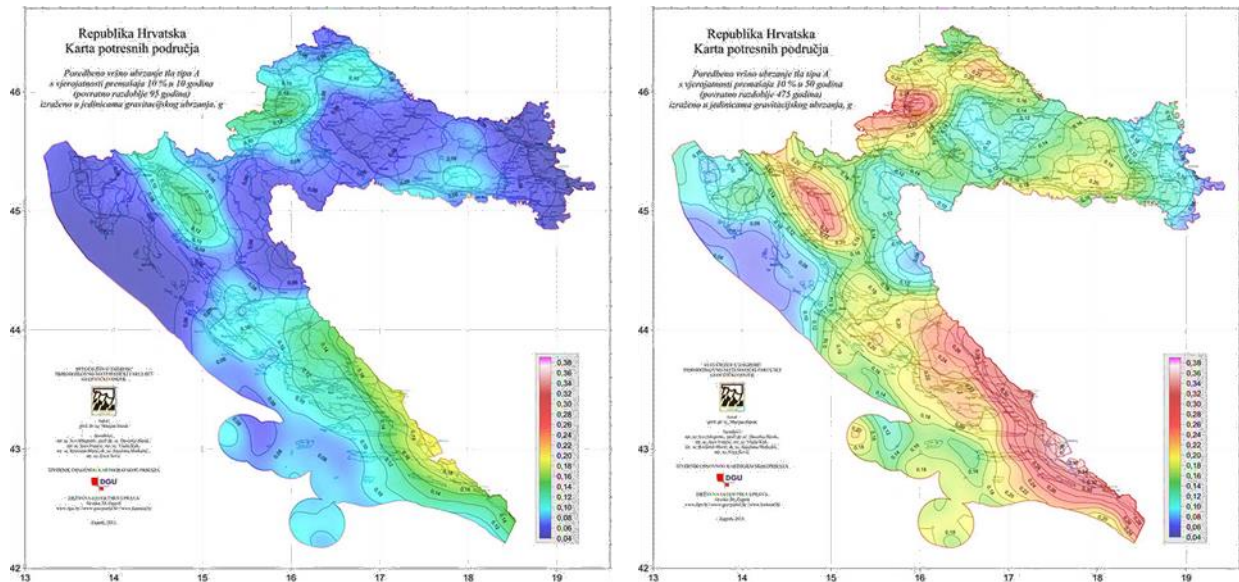
**Figure 3.8.** Seismic hazard maps of Croatia for 95-year (left) and 475-year (right) return period events (Herak 2011).

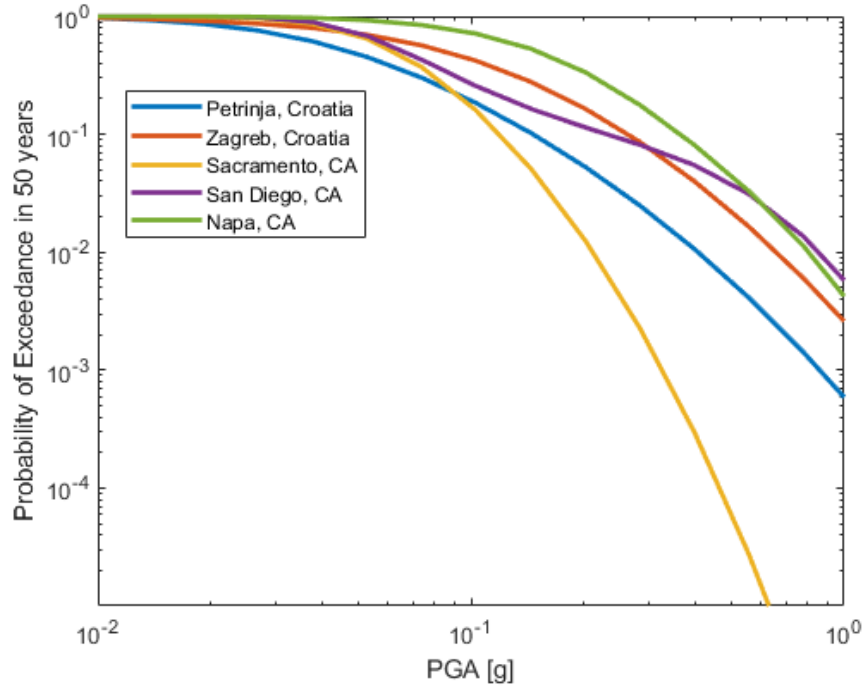
**Figure 3.9.** PGA hazard curves at Petrinja and Zagreb for a span of 50 years compared with those at three locations in California.

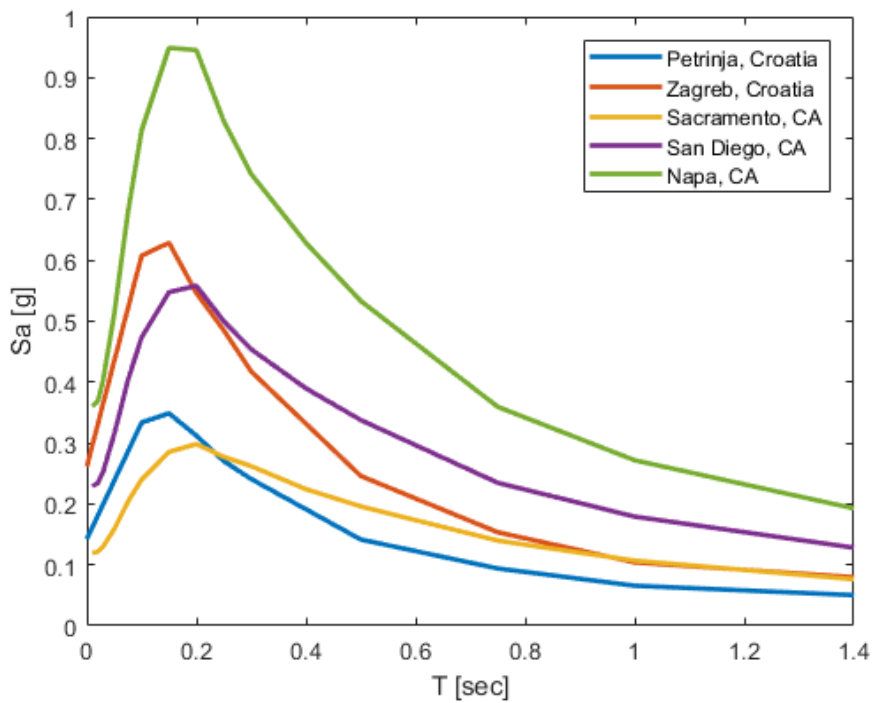
**Figure 3.10.** Comparison of uniform hazard spectra at Petrinja and Zagreb with several locations in California for the 475-year return period event.

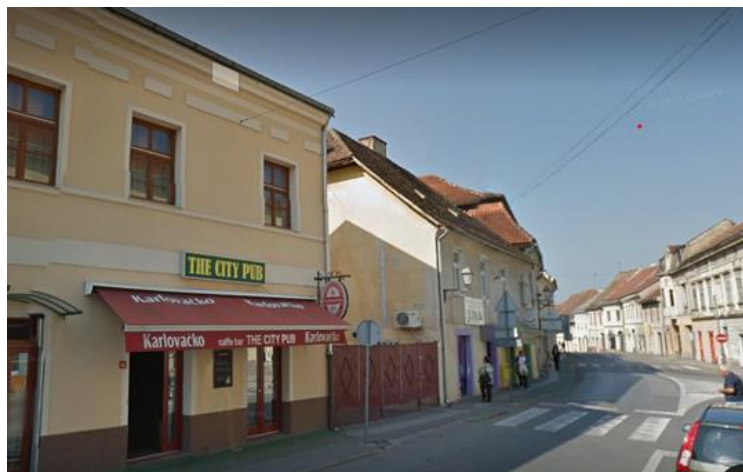
**Figure 4.2.** Typical older URM buildings in Petrinja (source: Google Earth).

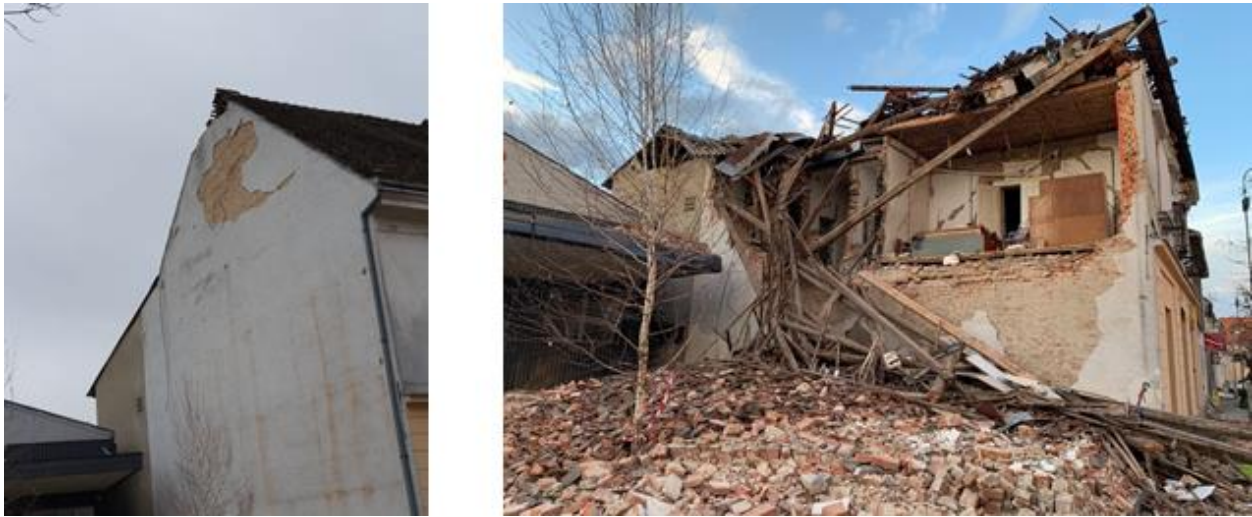
**Figure 4.3.** Typical wall and floor construction in older URM buildings, characterized by thick clay brick masonry walls, timber floors, and roofs. This building in Petrinja (adjacent to the KTC supermarket) was not significantly damaged in the December 28  $M_w$  5.2 earthquake but experienced gable wall and roof collapse in the December 29  $M_w$  6.4 earthquake (source: Joško Krolo).

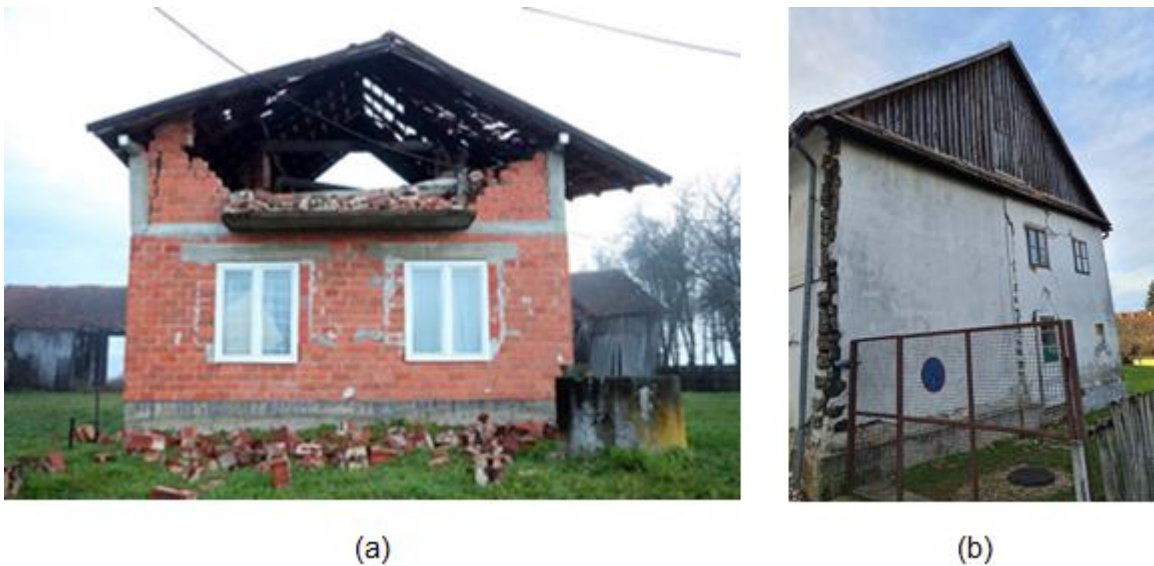
**Figure 4.9.** Performance of gable walls: (a) collapsed gable wall in a partially confined masonry building (with discontinuous RC tie column) and without a RC ring beam along the wall-to-roof interface (source: Sanjin Strukic/Pixel) and (b) good performance of a gable wall in a form of light-weight wooden panel (source: Nenad Bijelić).

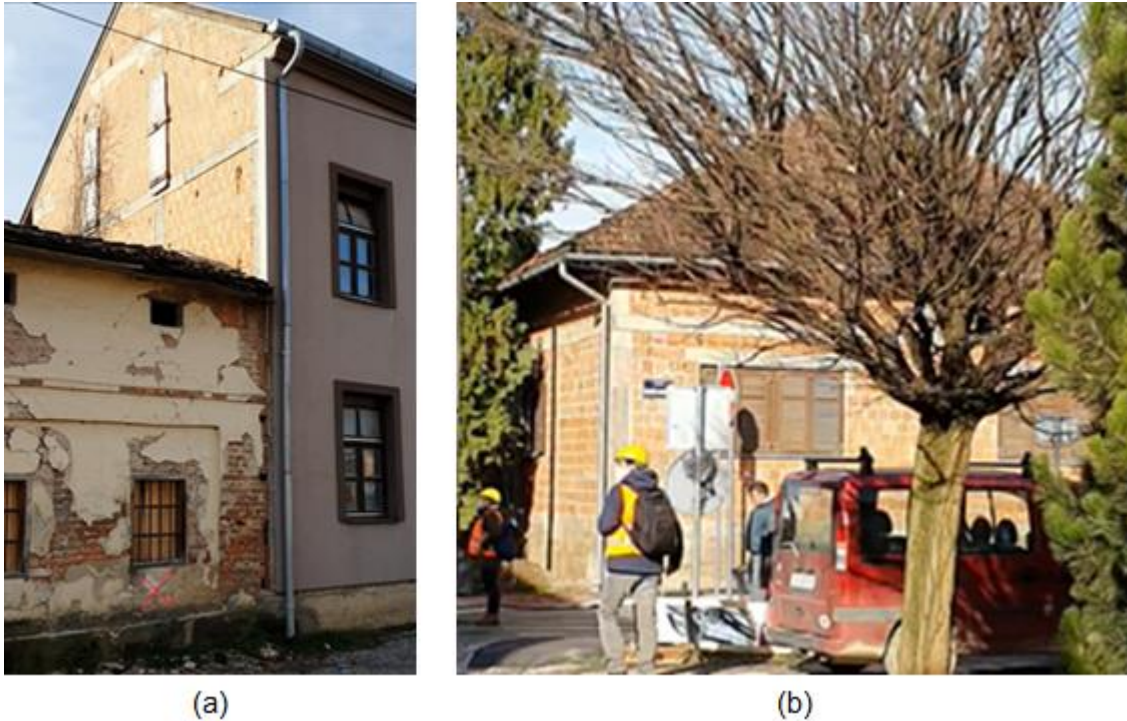
**Figure 4.10.** Examples of good performance of confined masonry buildings in Petrinja: (a) a two-story confined masonry building remained undamaged while an adjacent older URM building experienced severe damage; and (b) an undamaged single-story confined masonry building (source: Marko Bartolac).

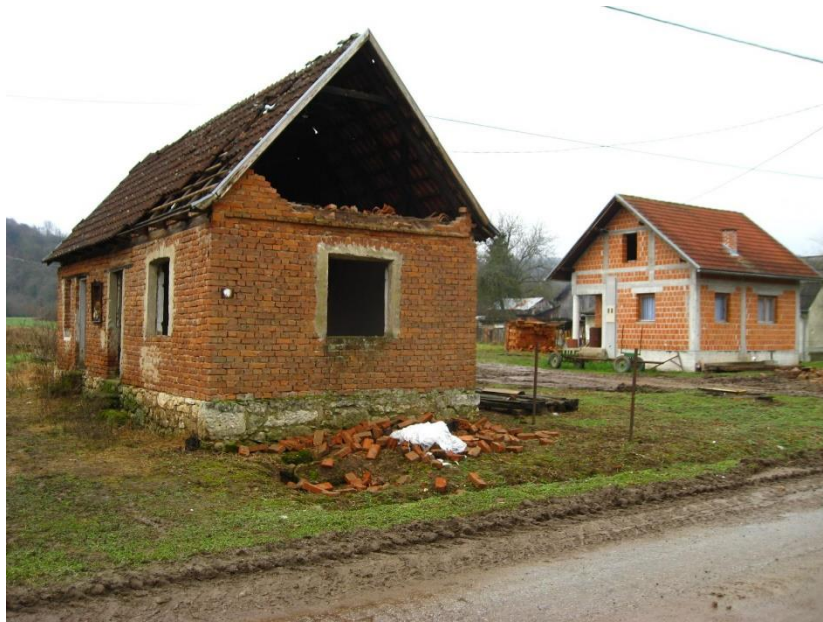
**Figure 4.11.** Performance comparison between confined masonry and URM buildings in Mečenčani village. The URM building with brick masonry walls (left) experienced damage in the earthquake while a similar confined masonry building (right) remained intact (source: Sonja Zlatović).

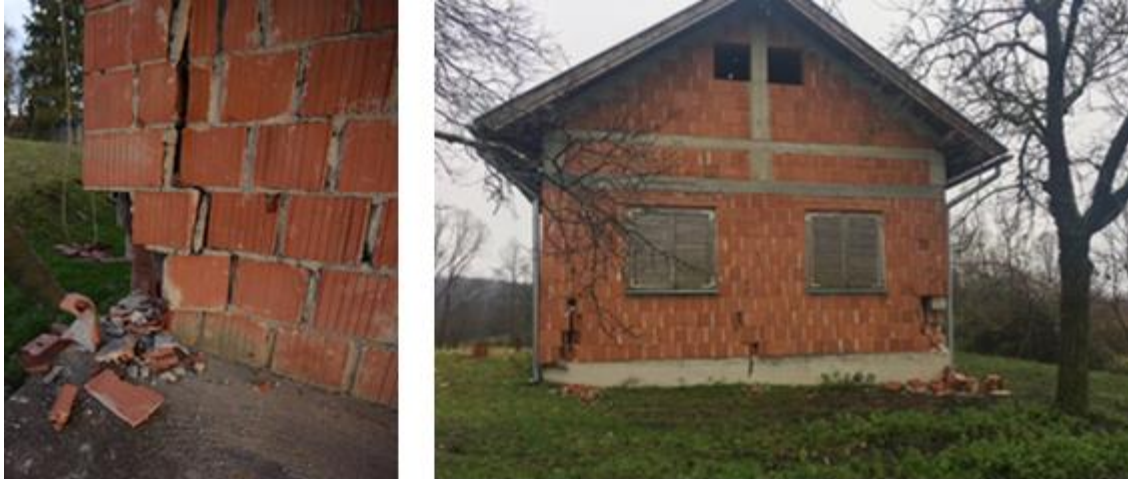
**Figure 4.12.** Damage of a partially confined masonry building due to the absence of RC tie-columns at the ground floor level (sources: J. Miskovic/Cropix (left) Hrvatska Danas 2021 (right)).

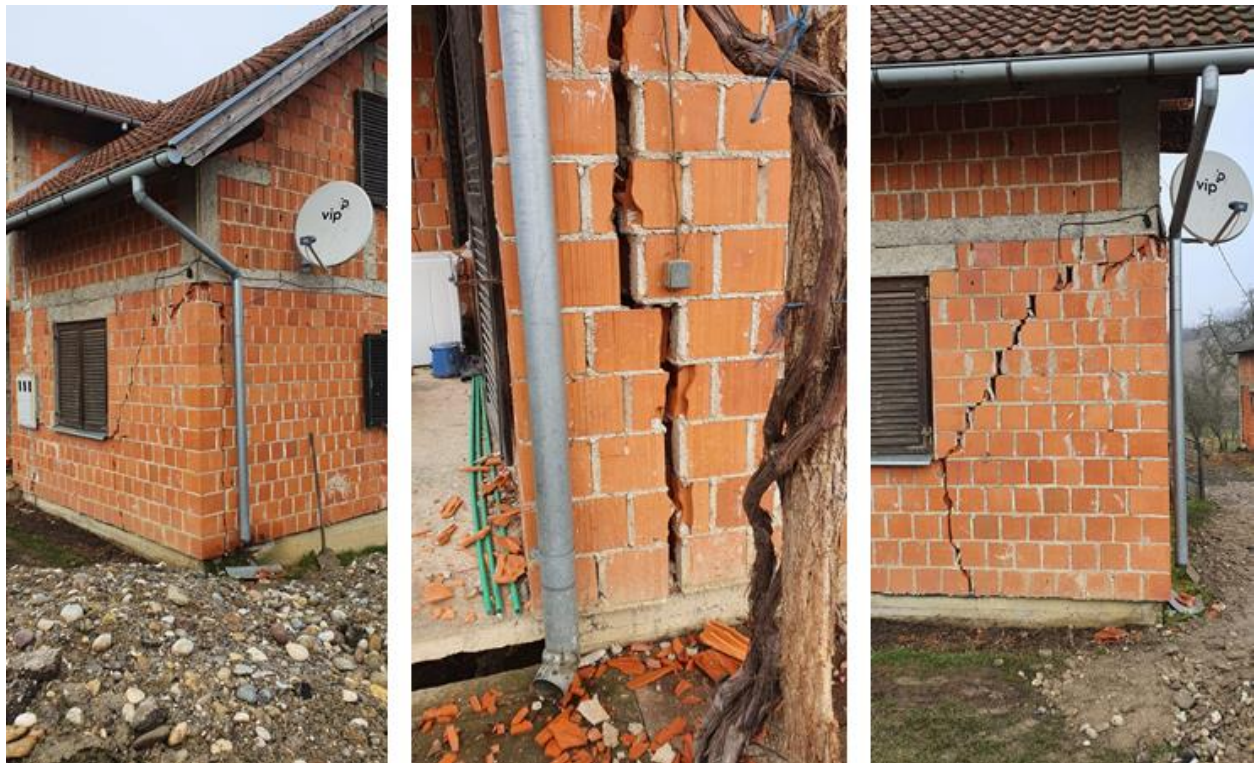
**Figure 4.13.** Damage of a partially confined masonry building in the Graberje village due to the absence of RC tie-columns at wall intersections. The damage is in the form of wide vertical cracks along the wall intersection and stepped shear cracks expanding from the ground to the second floor slab (source: Hrvoje Ljubojević, Tenzor d.o.o).

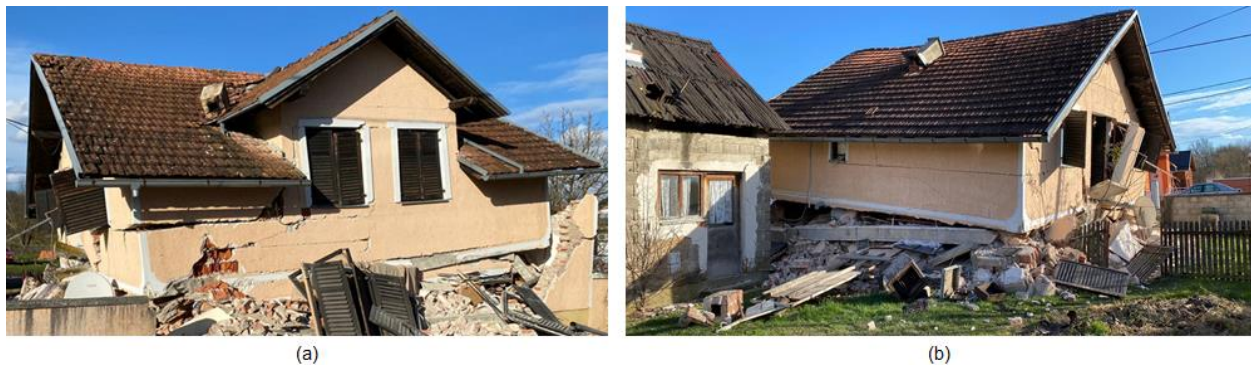
**Figure 4.14.** Collapsed partially confined masonry building in Prekope village, close to Glina (sources: (a) Damir Sencar AFP Getty and (b) Krešimir Micić).

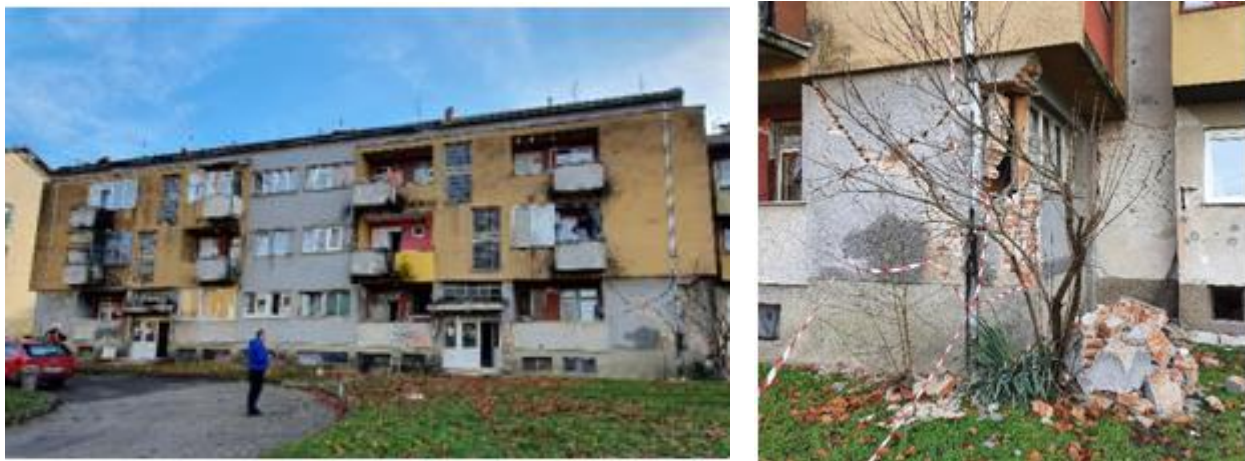
**Figure 4.16.** Damage in a 3-story residential building in Petrinja (source: Marko Bartolac).
