**EARTHQUAKE ENGINEERING  
RESEARCH INSTITUTE**

**StEER**  
**STRUCTURAL**  
EXTREME EVENTS  
RECONNAISSANCE

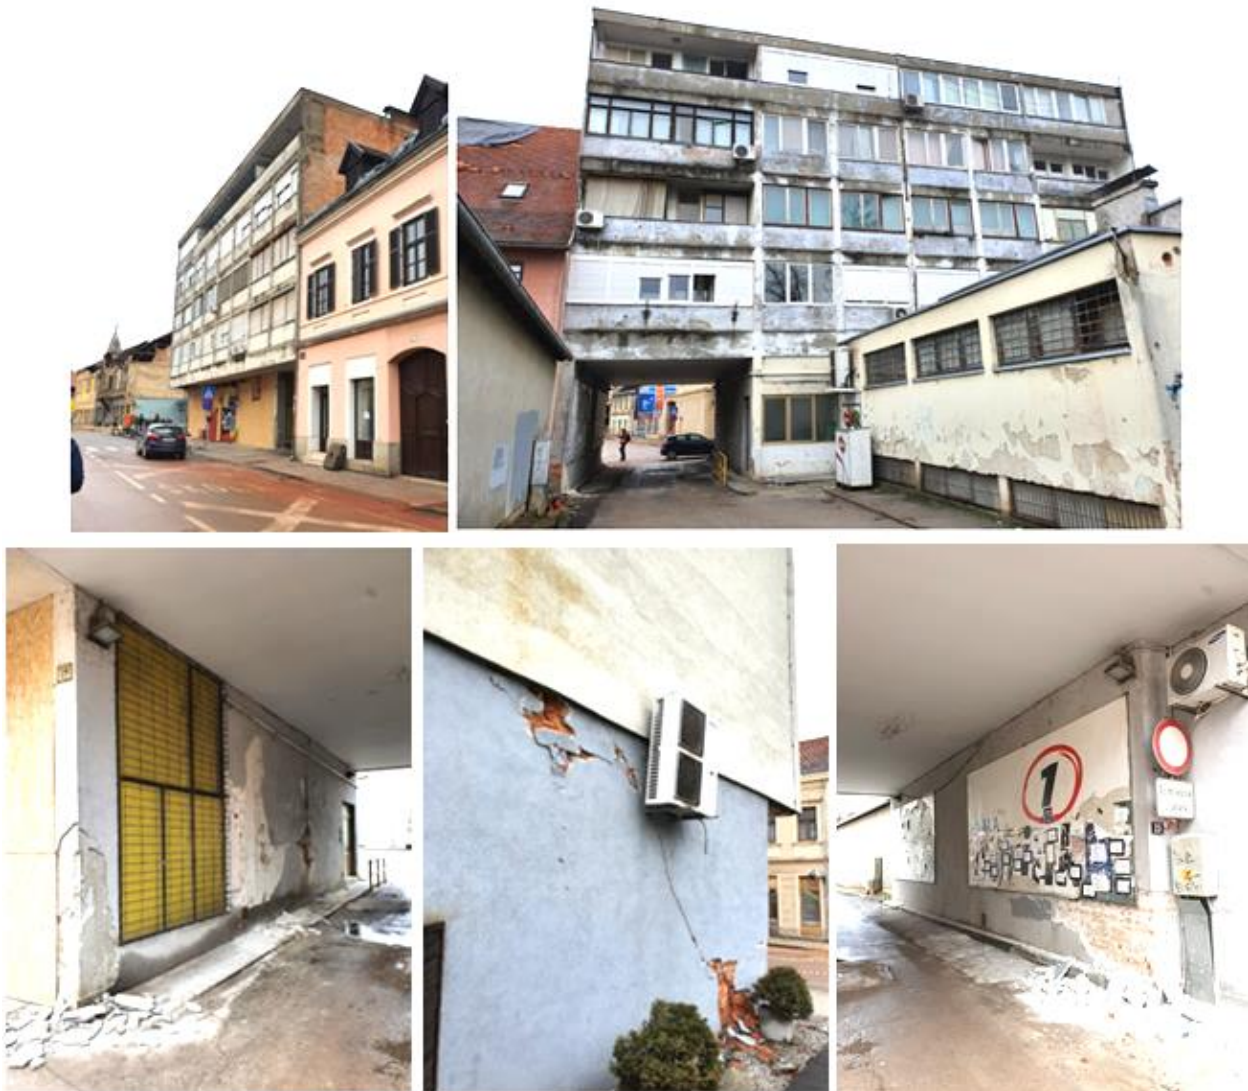
**Figure 4.17.** Five-story apartment building in the center of Petrinja (source: Nenad Bijelić and Marko Bartolac).

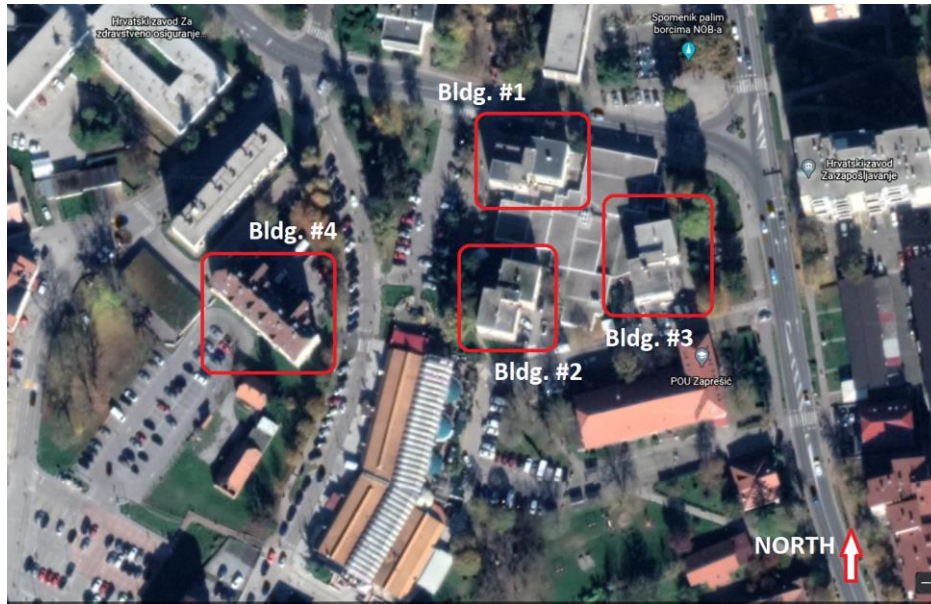
**Figure 4.18.** Map of four damaged buildings in Zaprešić (source: Google Earth).

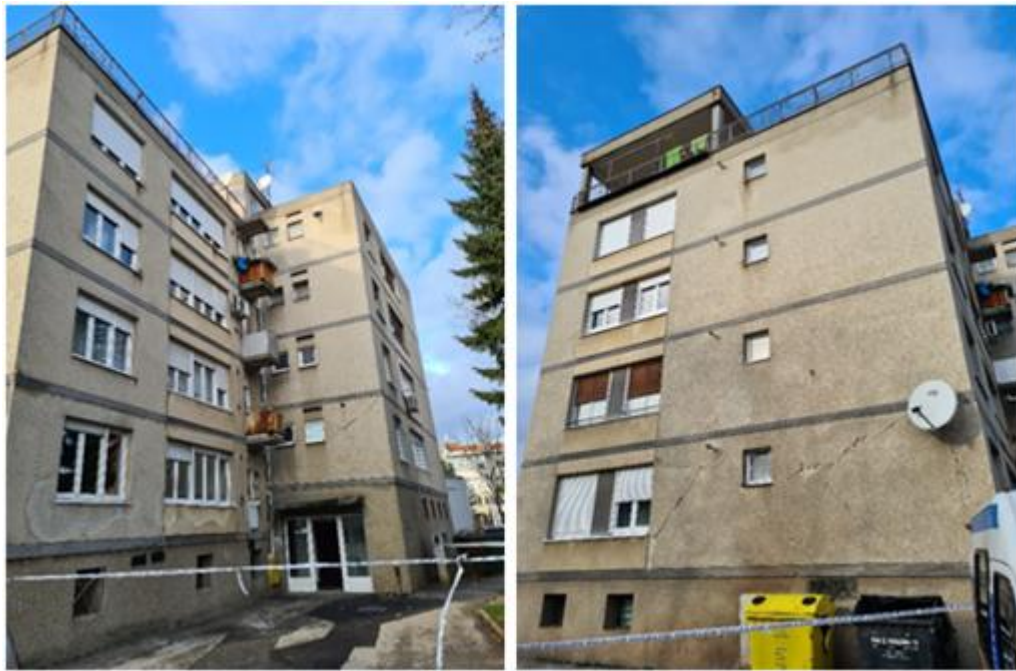
**Figure 4.19.** Damaged Building 3: exterior view and cracking pattern at the ground floor level (source: Nenad Bijelić).

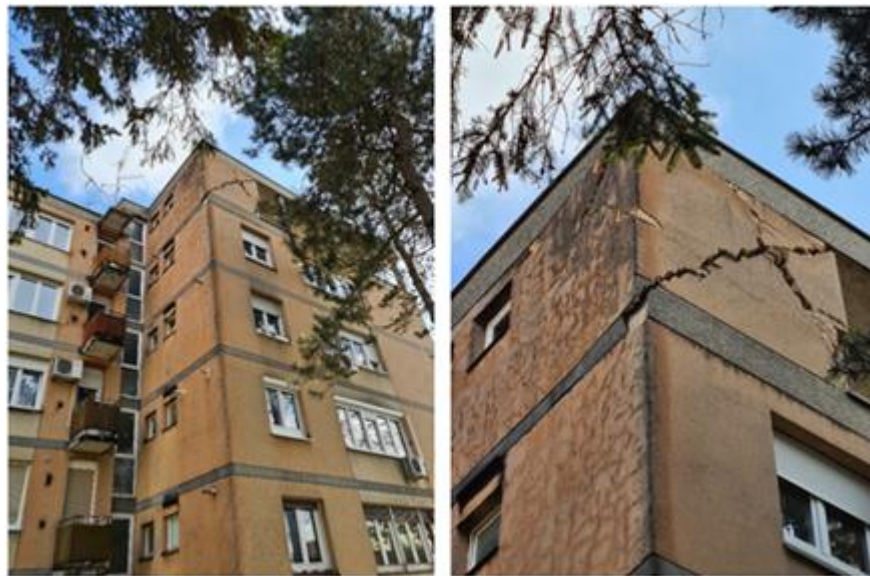
**Figure 4.20.** Extensive cracking experienced at the roof/terrace level of Building 2 (source: Nenad Bijelić).

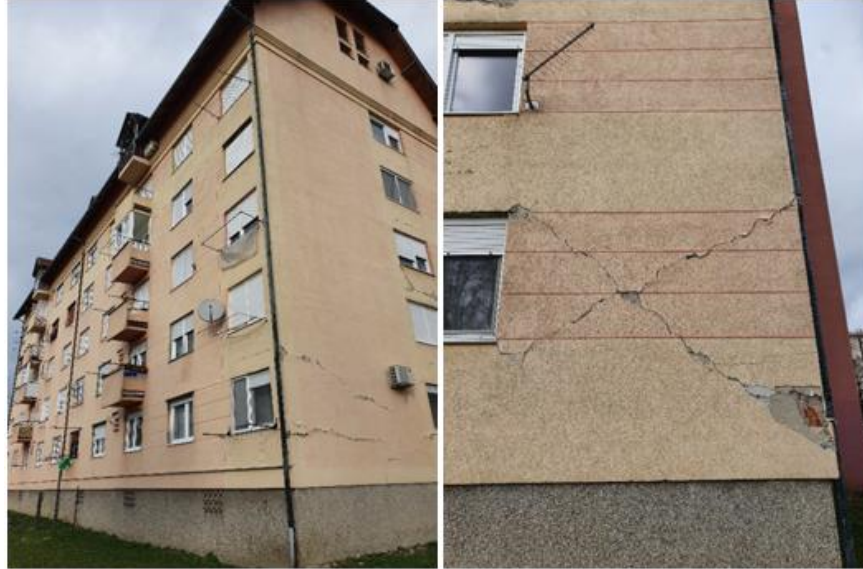
**Figure 4.21.** Damage to Building 4, a 5-story building with a vertical extension (source: Marko Bartolac).

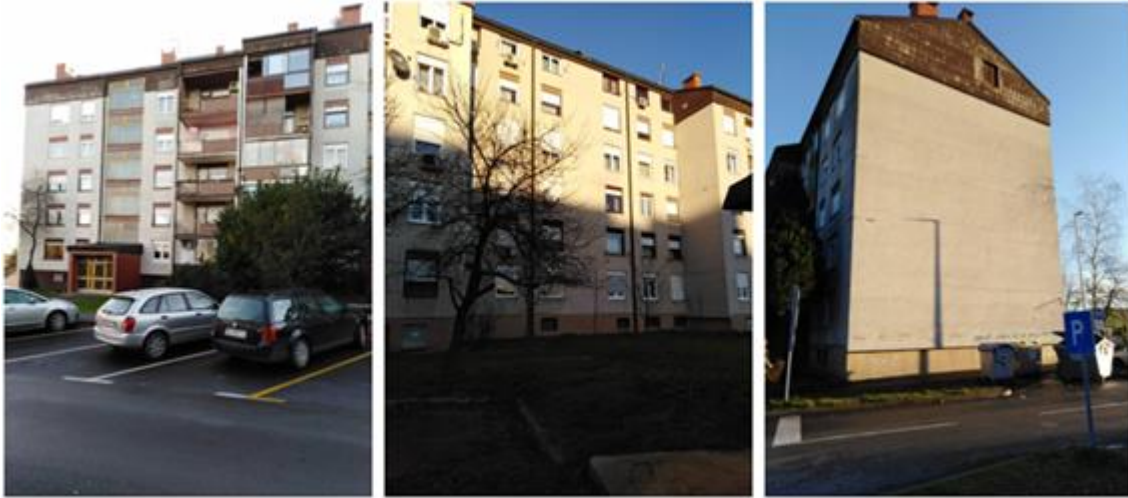
**Figure 4.23.** Buildings with RC structural walls that did not experience any damage, "Brzaj" settlement in Sisak (source: Maja Freiberger).

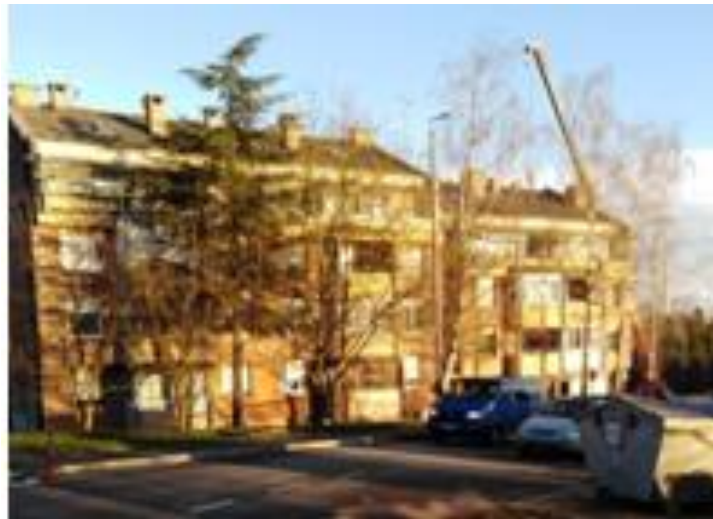
**Figure 4.24.** Removal of the chimneys from the roof of an RC building, "Brzaj" settlement in Sisak (source: Maja Freiberger).

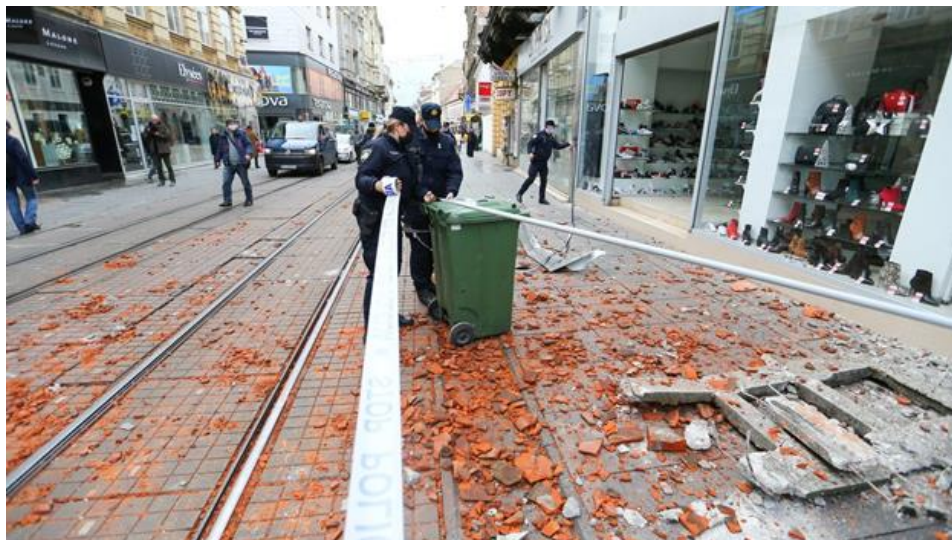
**Figure 4.25.** Photo taken looking east on Ilica Street in Zagreb showing fallen debris (source: Santora and Orovic, 2020).

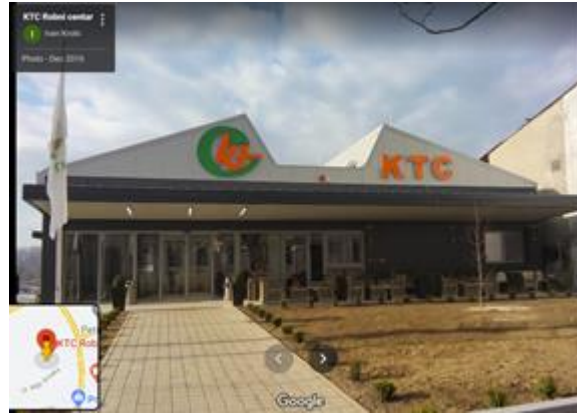
**Figure 4.26.** KTC supermarket in Petrinja before the earthquake (source: Google Maps).

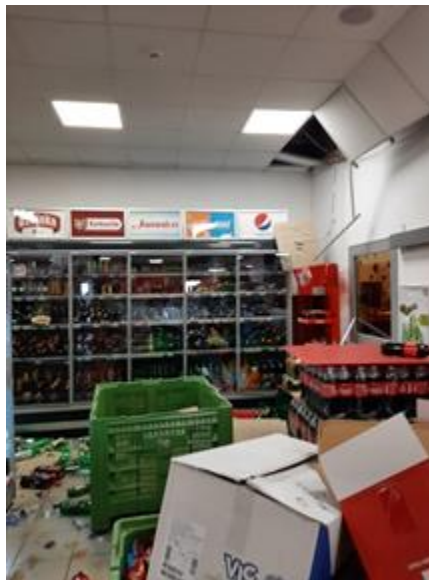
**Figure 4.27.** Damage to hung ceiling assembly in the KTC supermarket (source: Sonja Belovarac Radenovic).

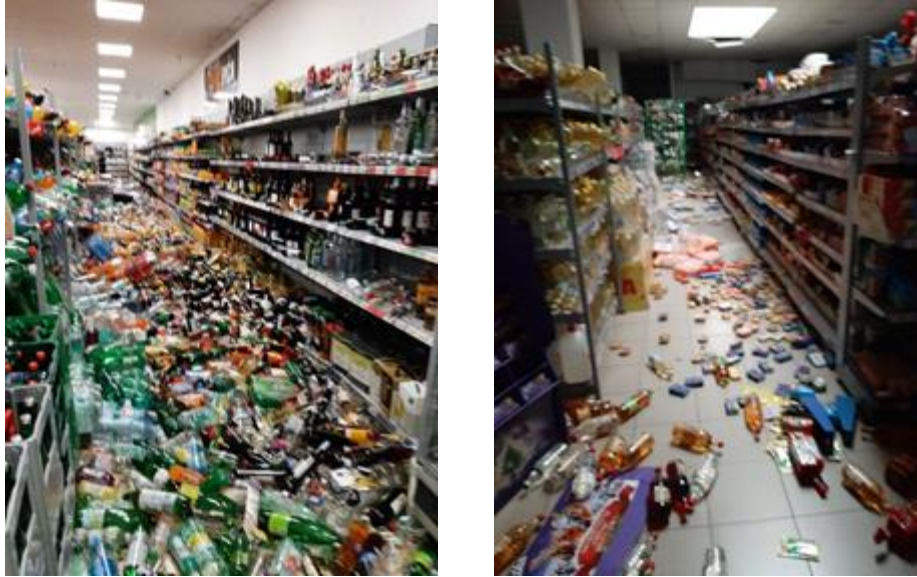
**Figure 4.28.** Products on the floor of the KTC supermarket due to the earthquake (source: Sonja Belovarac Radenovic).

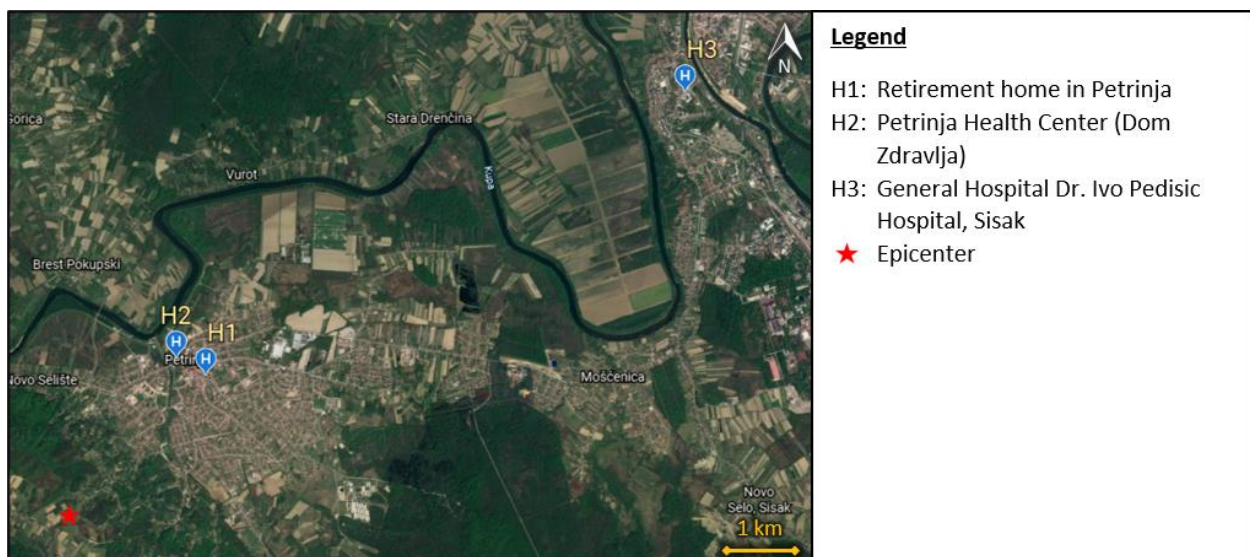
**Figure 4.29.** Location of the healthcare facilities discussed in this report (source: Google Earth).

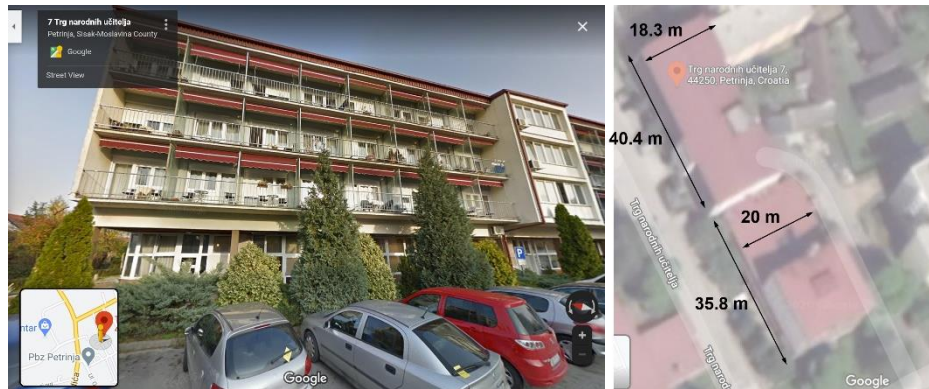
**Figure 4.30.** Retirement home in Petrinja: outside view (left) and dimensions in plan (right) (source: Google Earth).

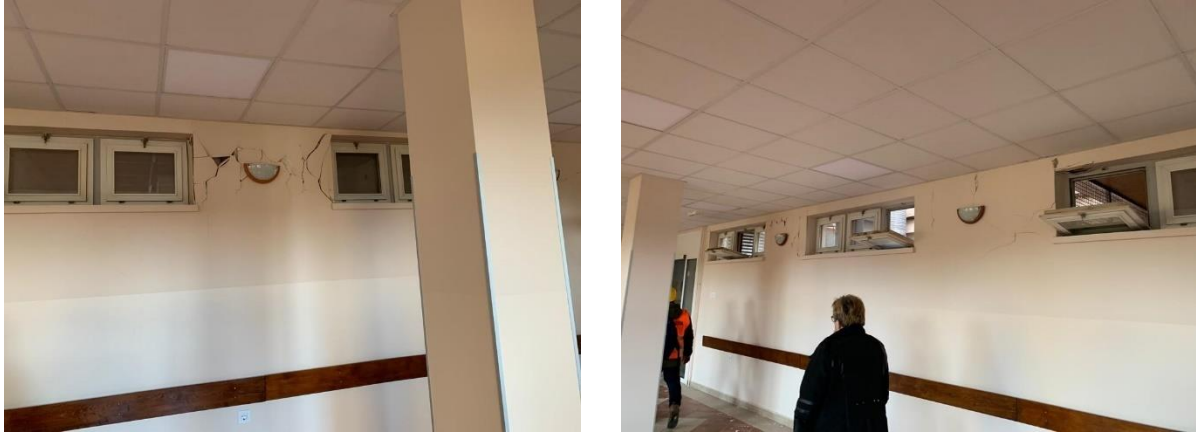
**Figure 4.31.** Shear cracks in infill masonry walls of the retirement home in Petrinja (source: Damir Lazarević).

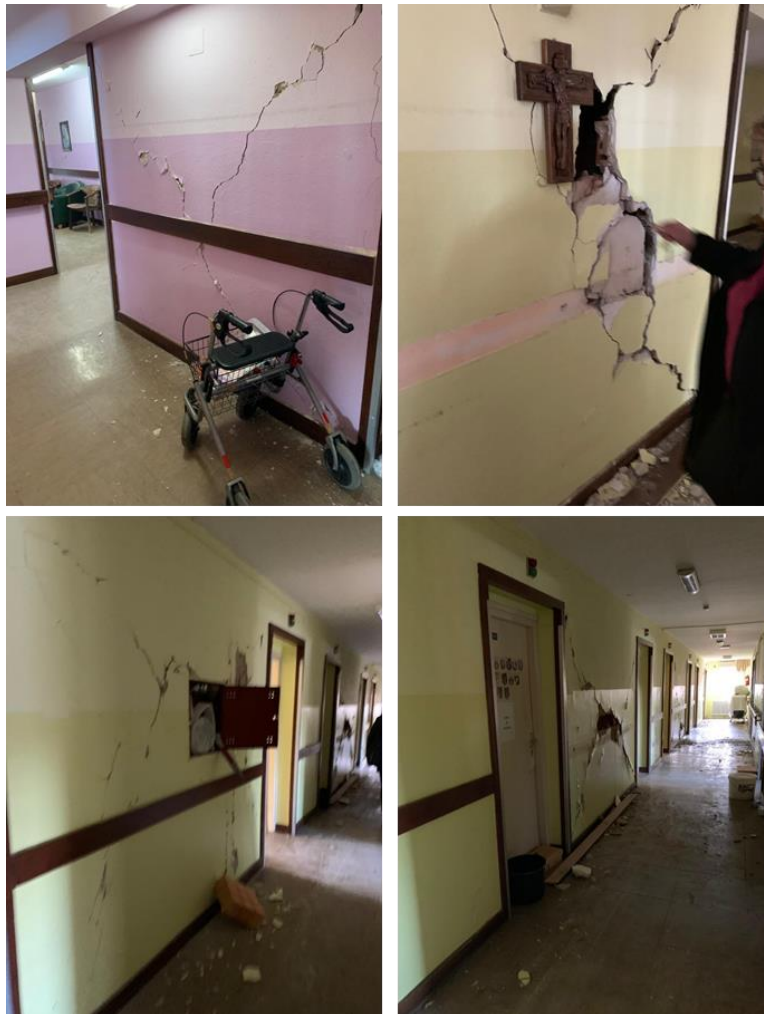
**Figure 4.32.** Damage to partition wall in the retirement home in Petrinja (source: Damir Lazarević).

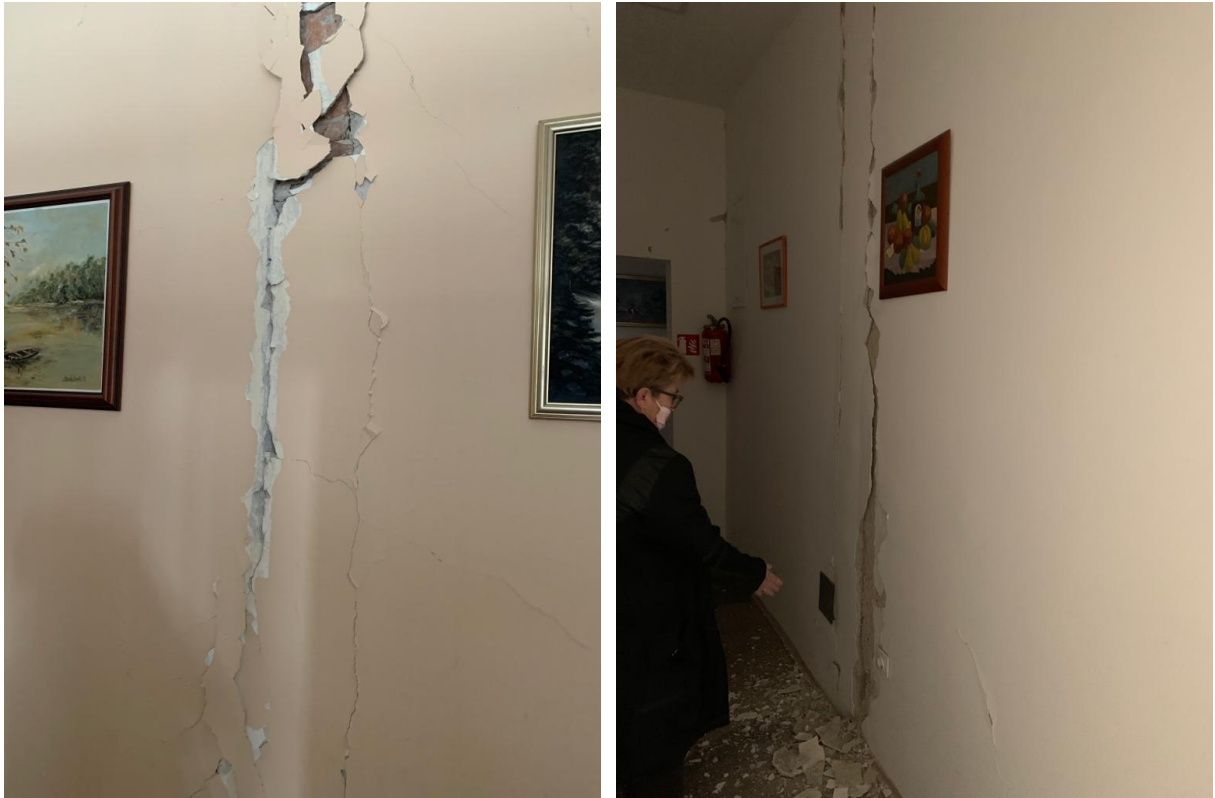
**Figure 4.33.** Cracks along the interface between a masonry infill and an RC column (source: Damir Lazarević).

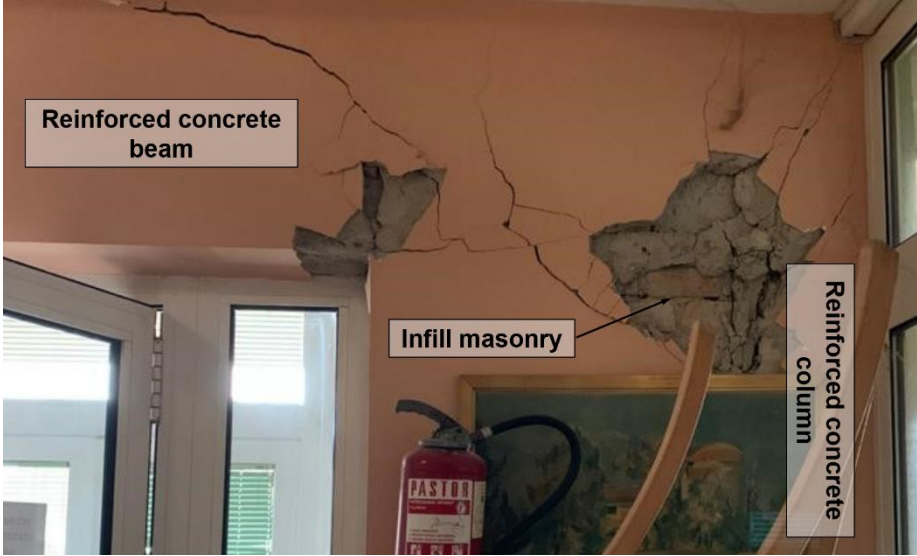
**Figure 4.34.** Damage to a reinforced concrete beam in the retirement home in Petrinja (source: Damir Lazarević).

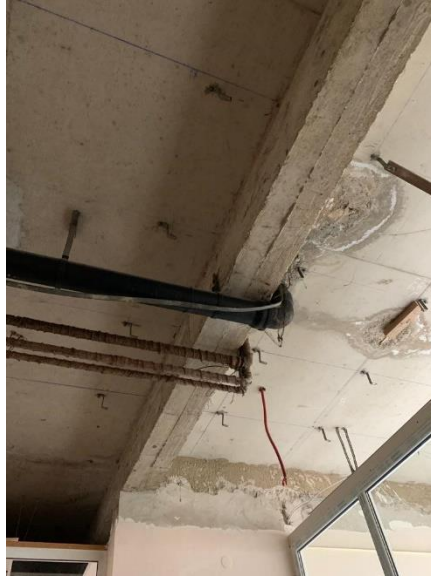
**Figure 4.35.** Exposed piping and fasteners for the hung ceiling (source: Damir Lazarević).

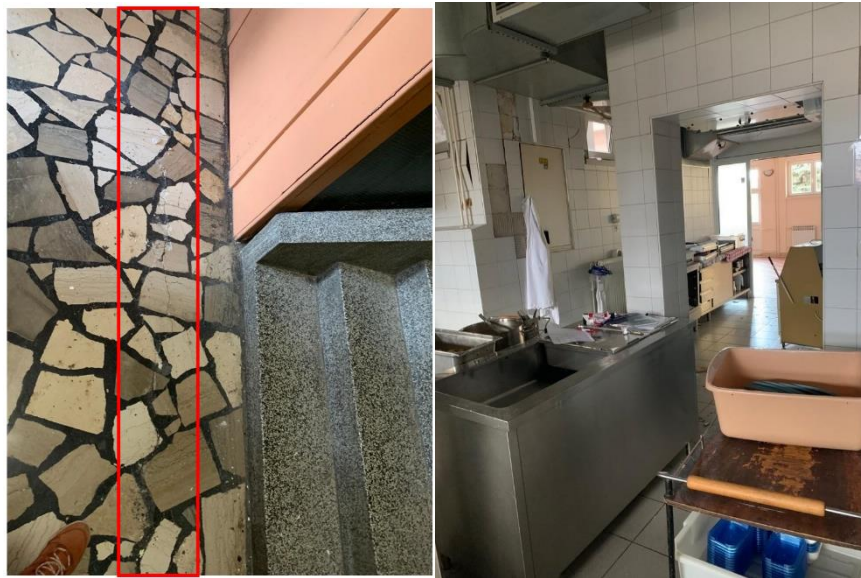
**Figure 4.36.** Cracks in the floor tiles (left) and tiles detached from the kitchen walls (right) (source: Damir Lazarević).

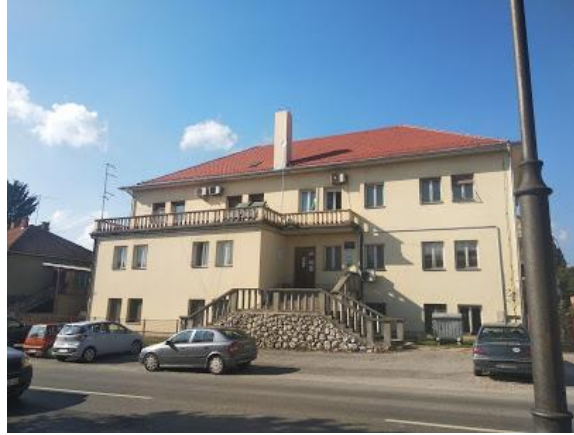
**Figure 4.37.** Outside view of the health center in Petrinja before the earthquake, showing its clay tile roof and stucco facade (source: Google Earth).

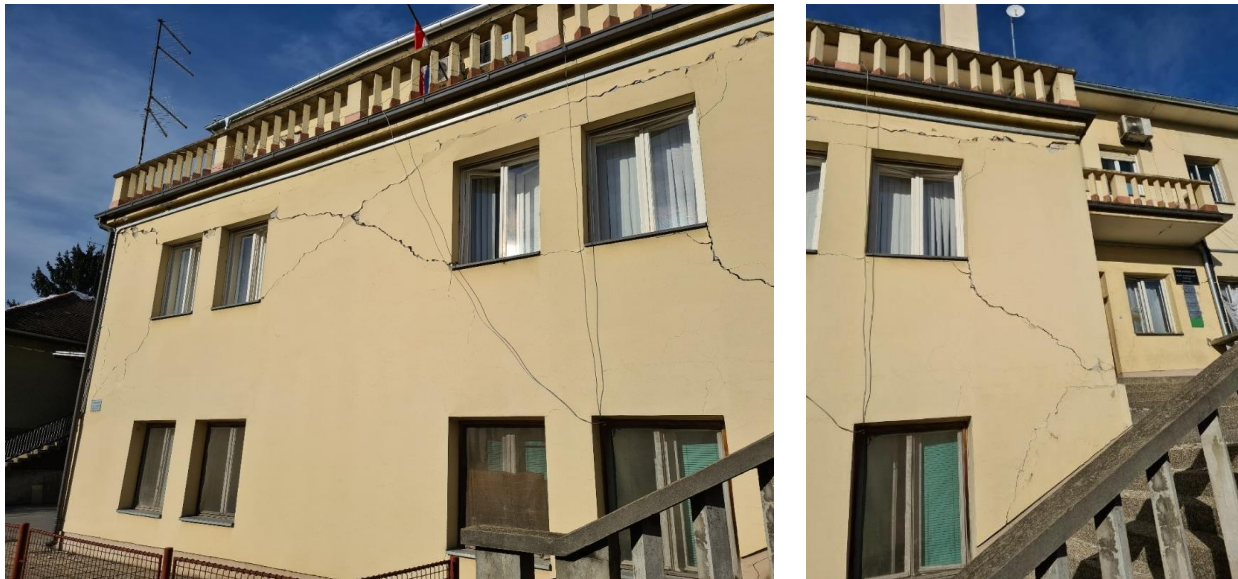
**Figure 4.38.** Photos showing the exterior of the health center in Petrinja with large shear cracks in the exterior walls (source: Domagoj Damjanović).

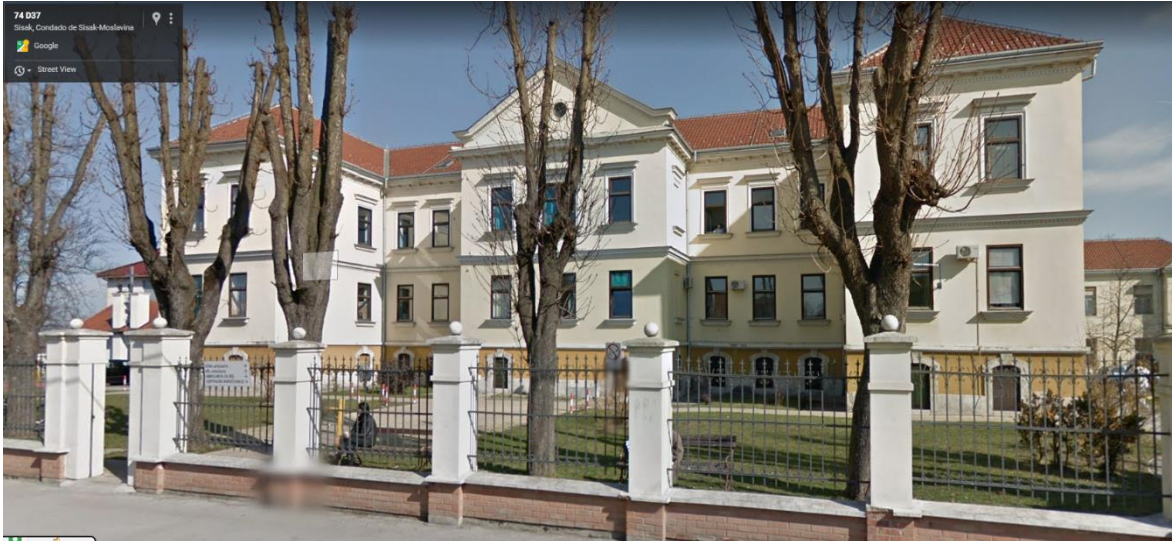
**Figure 4.39.** Internal Medicine building of the General Hospital Dr. Ivo Pedisic in Sisak before the earthquake (source: Google Earth).

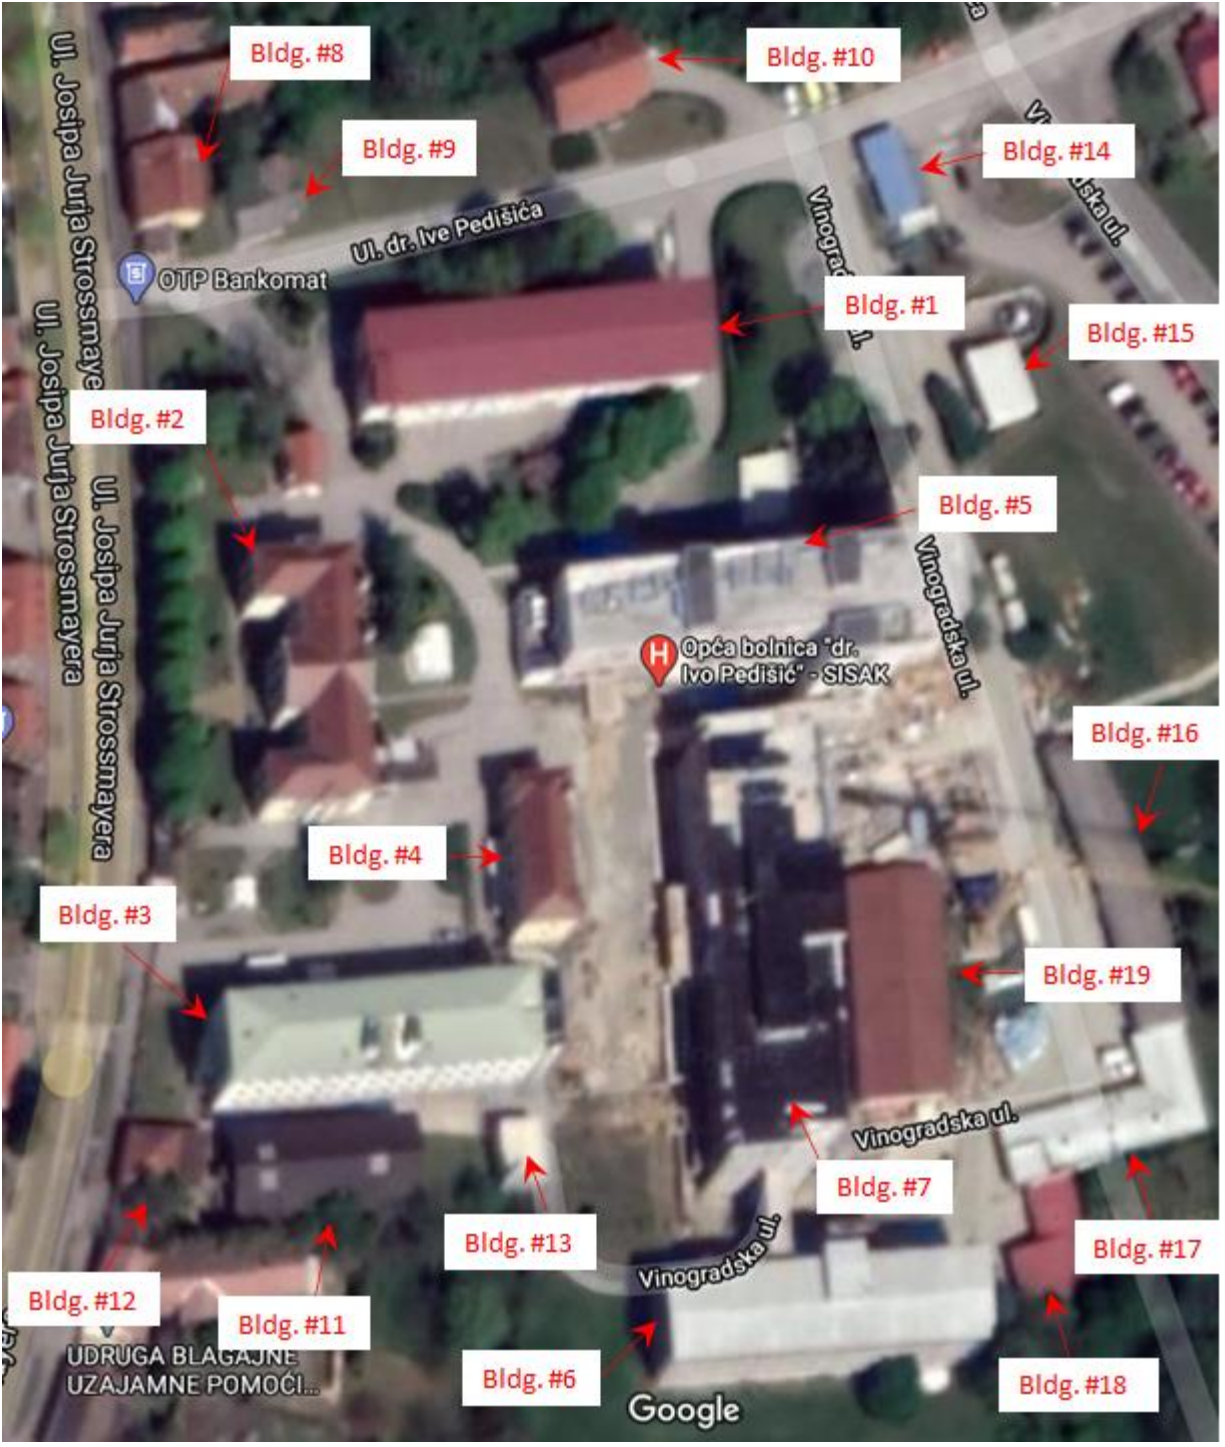
**Figure 4.40.** Plan view of the Dr. Ivo Pedisic General Hospital in Sisak. Buildings are enumerated for damage reporting purposes (source: Google Earth).

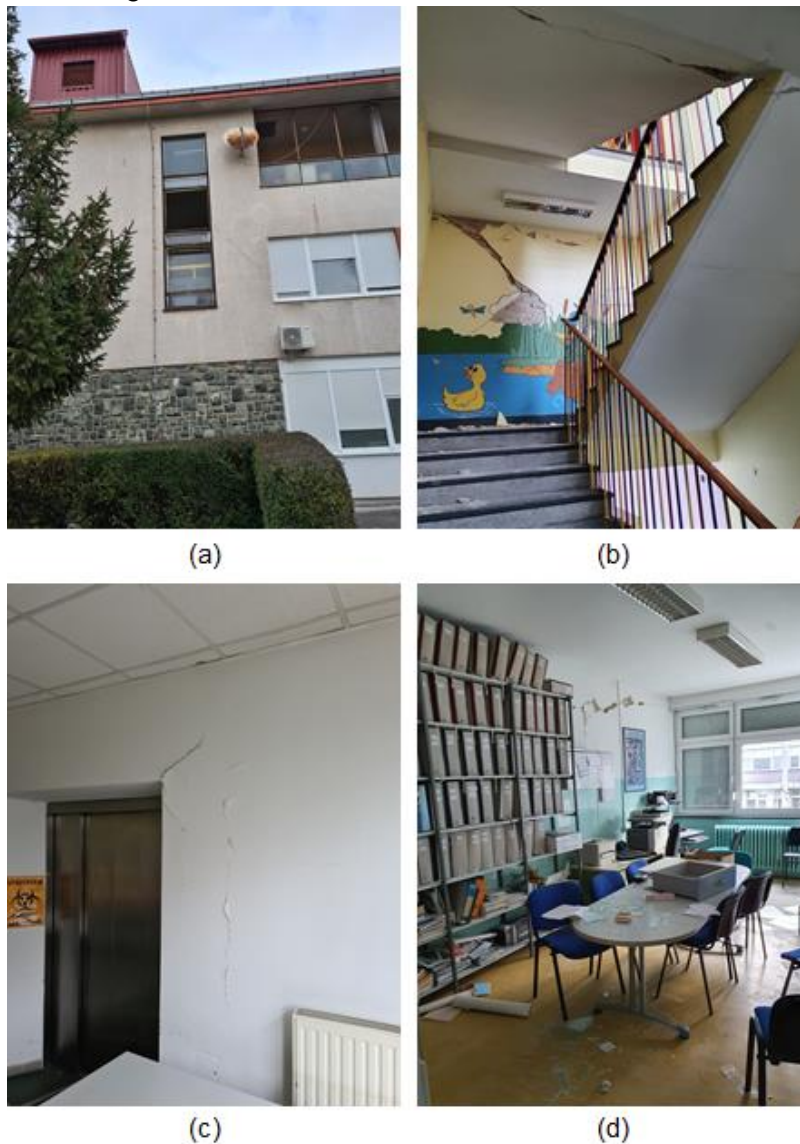
**Figure 4.41.** Building #1: (a) external view, (b) diagonal cracks in masonry infills, (c) cracks near elevator shafts, and (d) horizontal cracks along masonry-concrete joints (source: Nenad Bijelić).

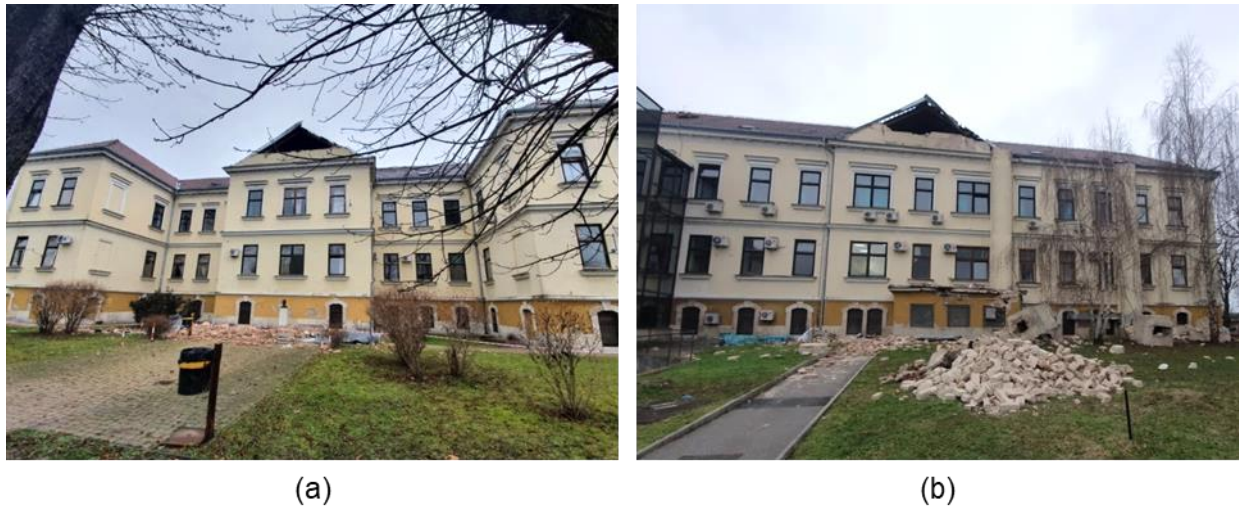
**Figure 4.42.** Building #2: (a) front view and (b) back view (source: Croatia Week 2021, Jan 5).

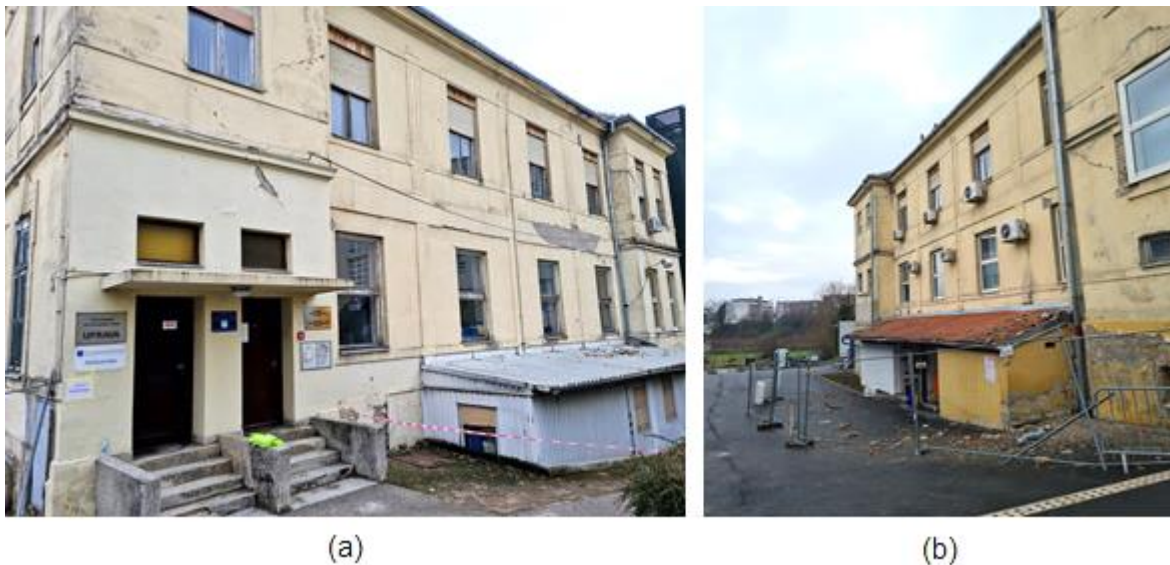
**Figure 4.43.** Building #4: (a) front view, and (b) back view (source: Nenad Bijelić).

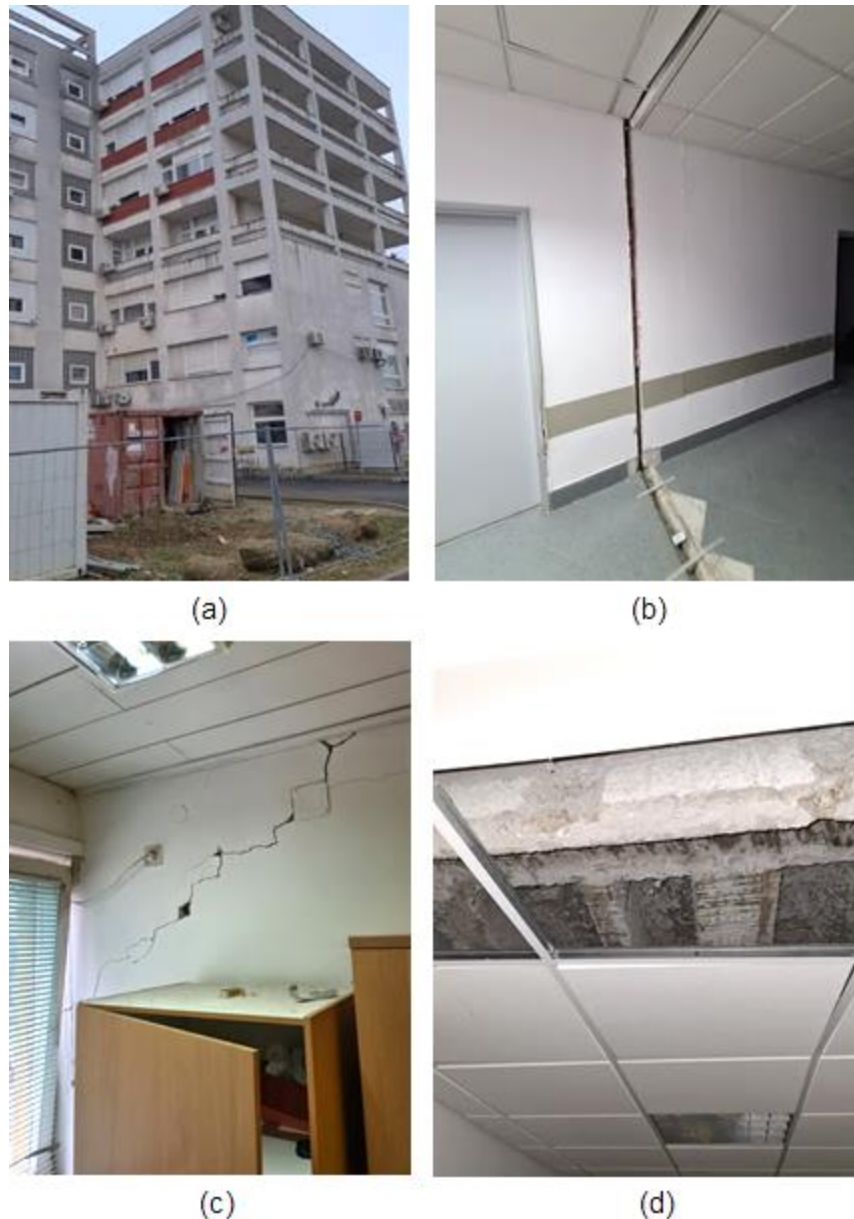
**Figure 4.44.** Building #5: (a) Outside view, (b) joint opening, (c) concrete wall cracking, and (d) fallen ceiling tiles (source: Nenad Bijelić).

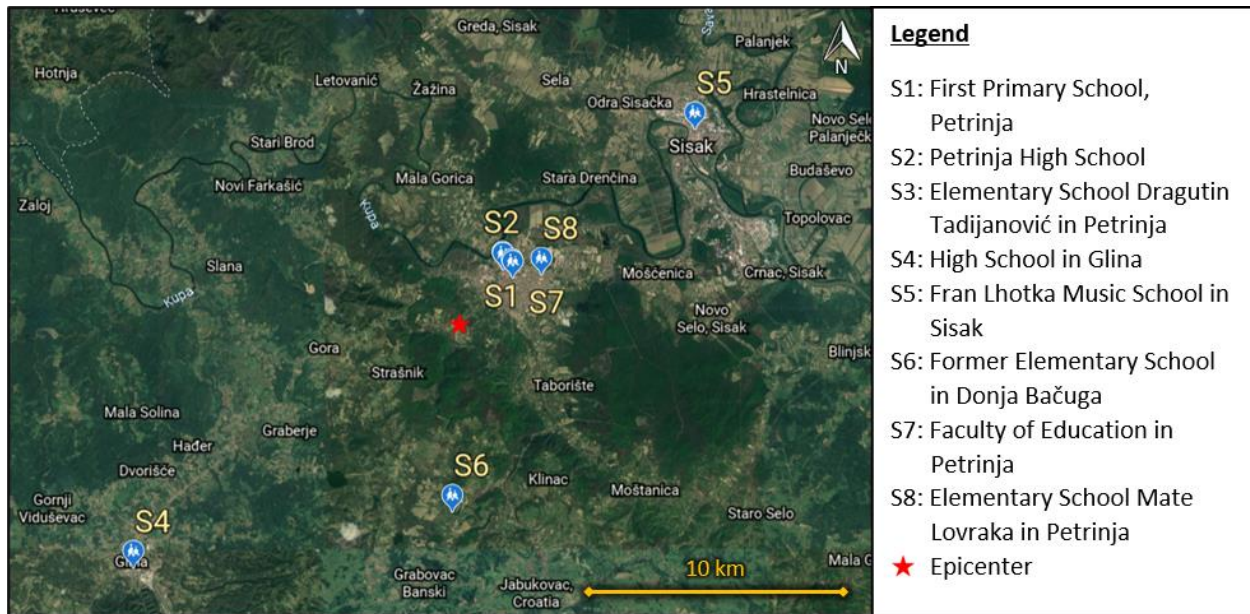
**Figure 4.45.** Location of schools discussed in this report (source: Google Earth).

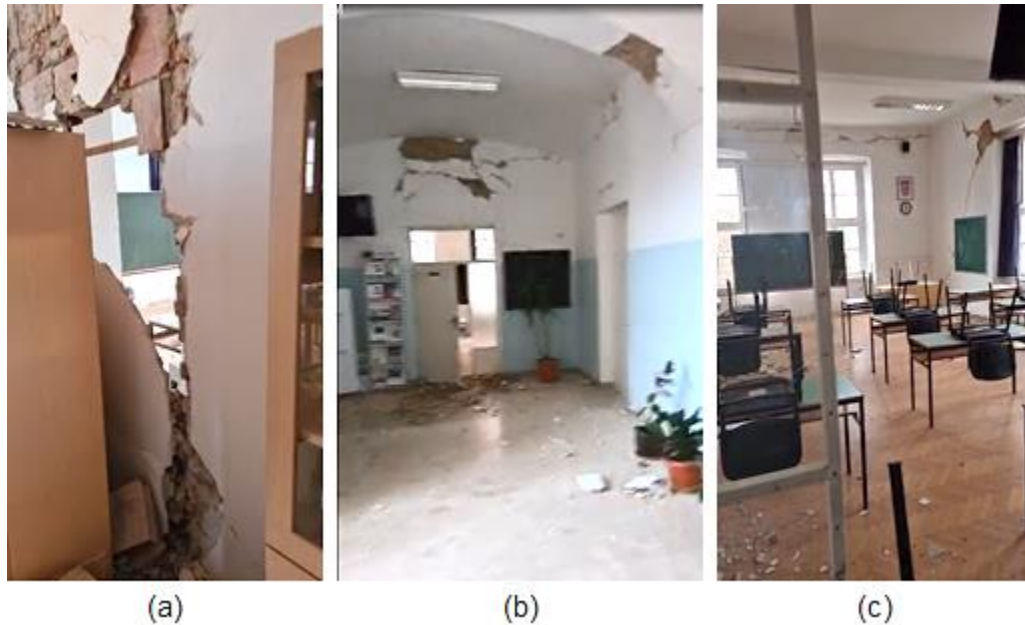
**Figure 4.48.** Interior damage to the First Primary School in Petrinja: (a) partial collapse of an interior partition wall showing its hollow clay tile construction, (b) damage to the interior walls, and (c) shear crack propagating from the corner of the window opening, highlighting the brittle nature of the construction (source: Nenad Bijelić).

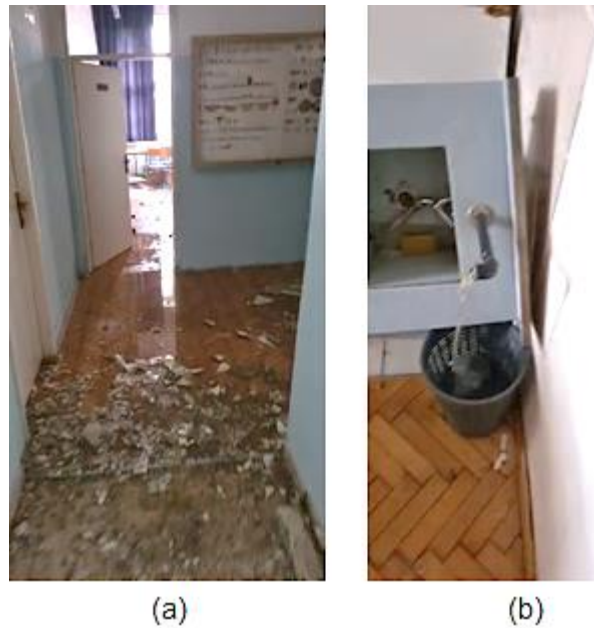
**Figure 4.49.** Leaking water pipe in the First Primary School in Petrinja: (a) water on the floor and (b) broken water pipe (source: Nenad Bijelić).

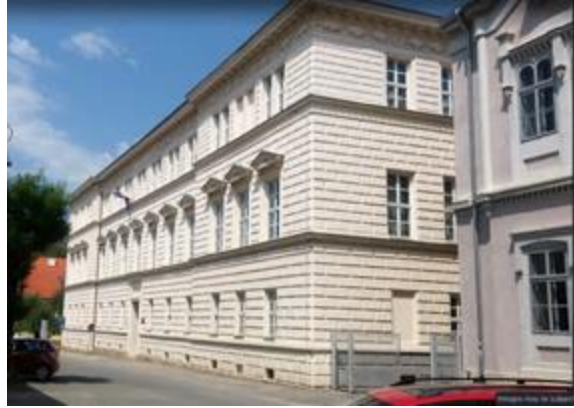
**Figure 4.50.** Petrinja High School before the earthquake (source: Google Maps).

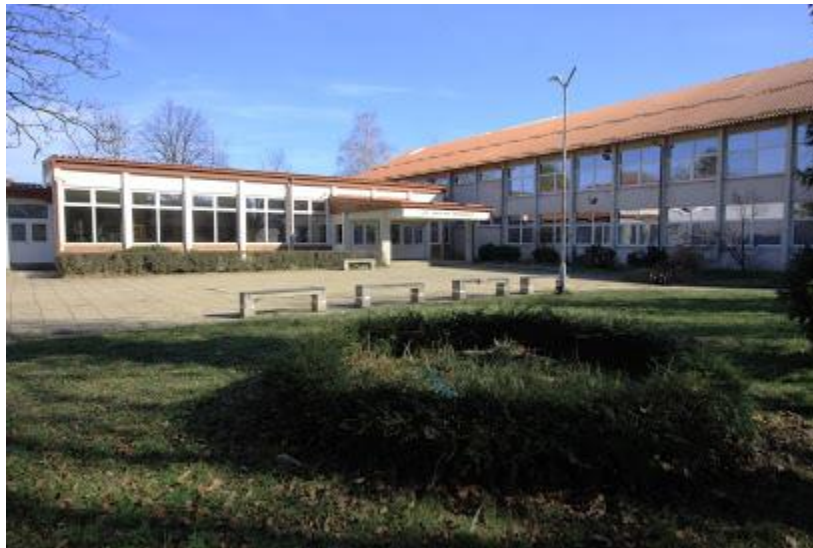
**Figure 4.54.** Elementary School Dragutin Tadijanović in Petrinja before the earthquake (source: Google Earth).

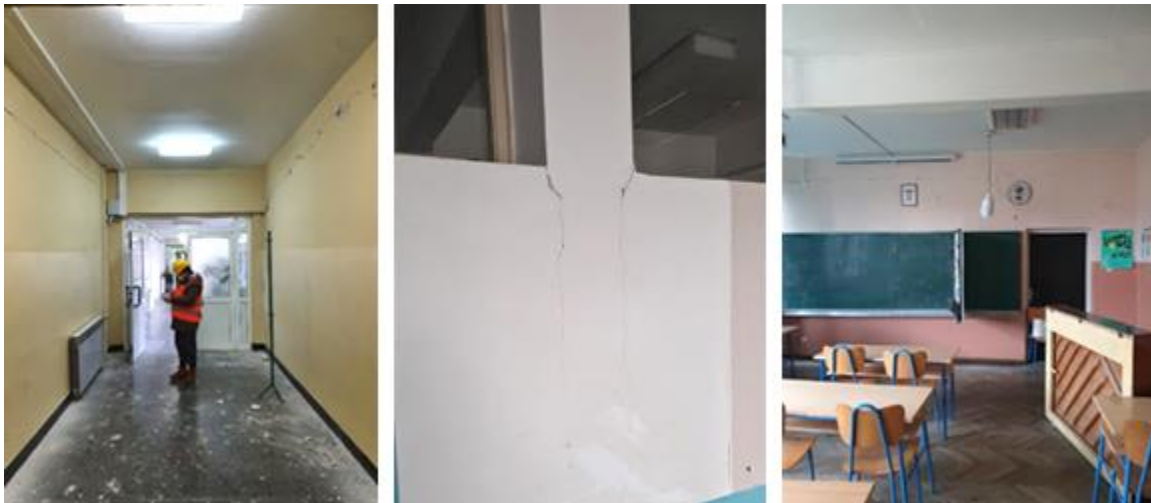
**Figure 4.56.** Cracks forming at the contact between reinforced concrete frames and masonry infills (source: Nenad Bijelić and Damir Lazarević).

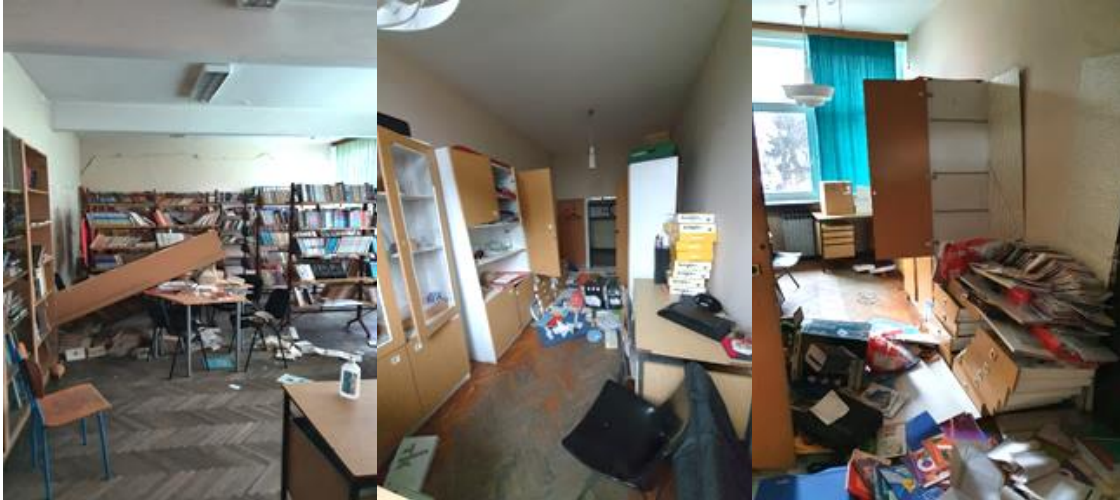
**Figure 4.57.** Items that fell off shelves and out of cabinets (source: Nenad Bijelić and Damir Lazarević).

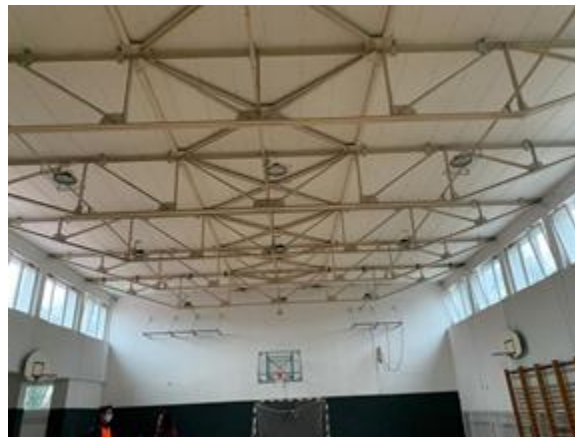
**Figure 4.58.** Sports hall at Elementary School Dragutin Tadijanović in Petrinja (source: Nenad Bijelić and Damir Lazarević).

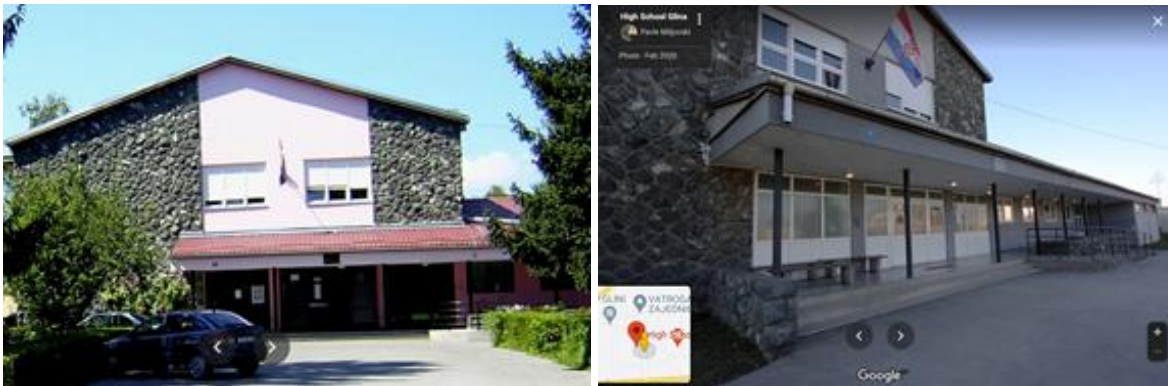
**Figure 4.59.** Glina High School before the earthquake (source: Google Maps).
