**EARTHQUAKE ENGINEERING  
RESEARCH INSTITUTE**

**StEER**  
**STRUCTURAL**  
EXTREME EVENTS  
RECONNAISSANCE

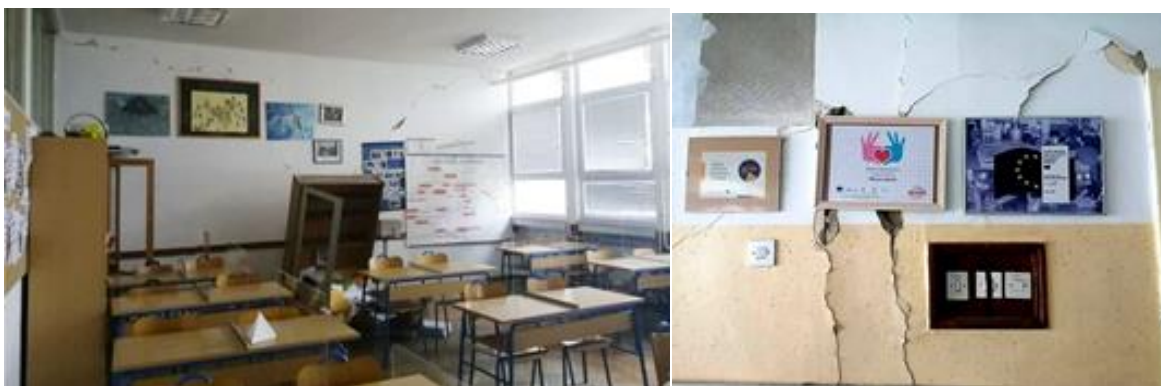
**Figure 4.60.** Earthquake damage in Glina High School (source: Facebook Page - Srednja škola Glina).

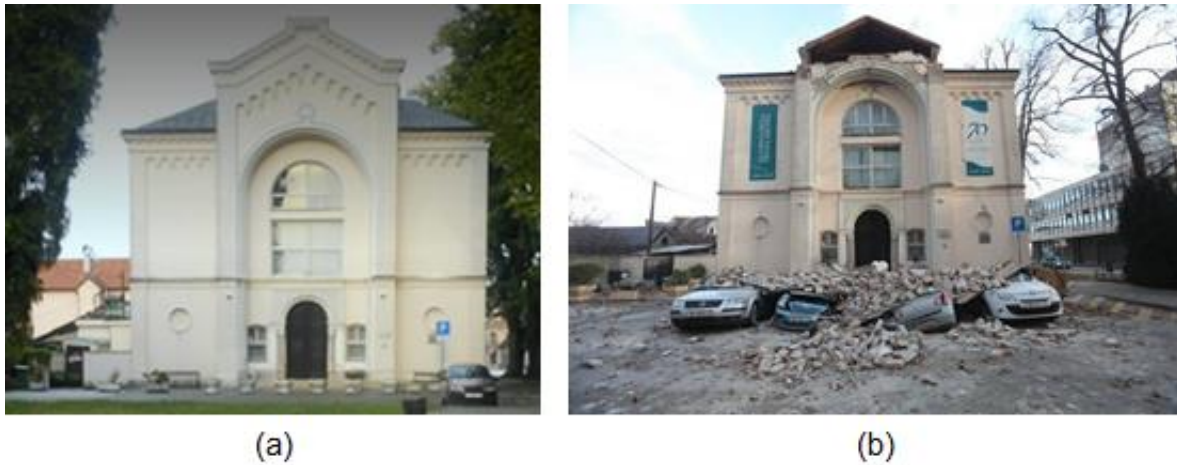
**Figure 4.61.** Fran Lhotka Music School (a) before the earthquake (source: Google Maps) and (b) after the earthquake (source: Facebook page - Glazbena škola Frana Lhotke, Sisak).

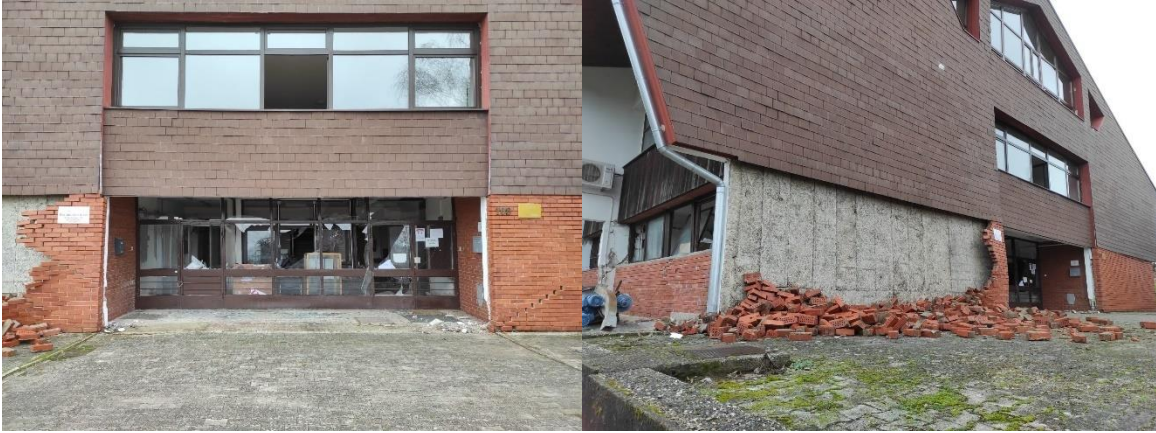
**Figure 4.63.** Brick facade detached from building (source: Nina Čeh).

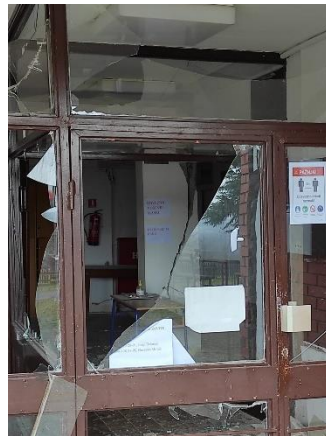
**Figure 4.64.** Broken glass in entryway door (source: Nina Čeh).

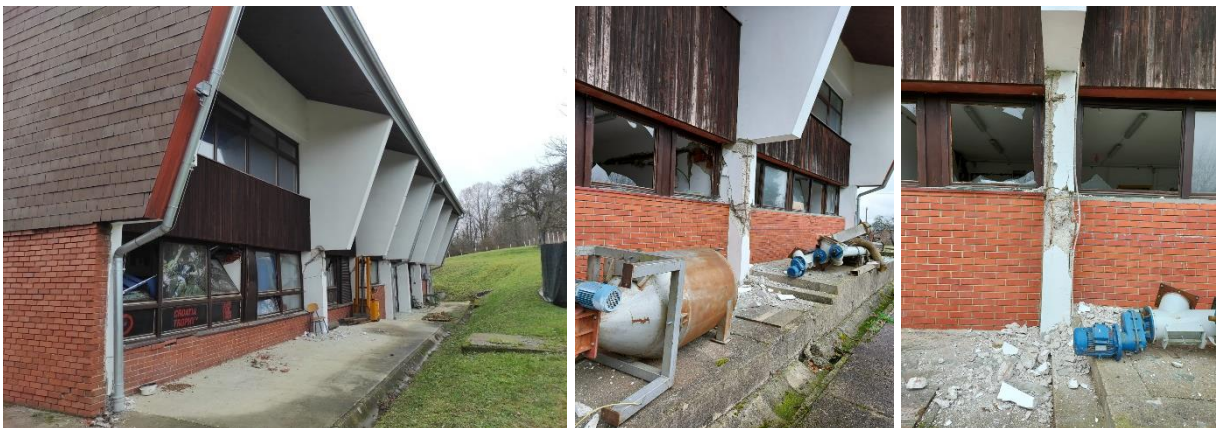
**Figure 4.65.** Shear cracks to exterior RC columns (source: Nina Čeh).

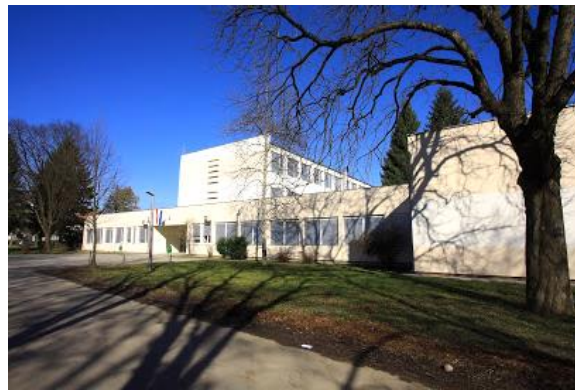
**Figure 4.66.** Faculty of Education before the earthquake (source: Google Earth).

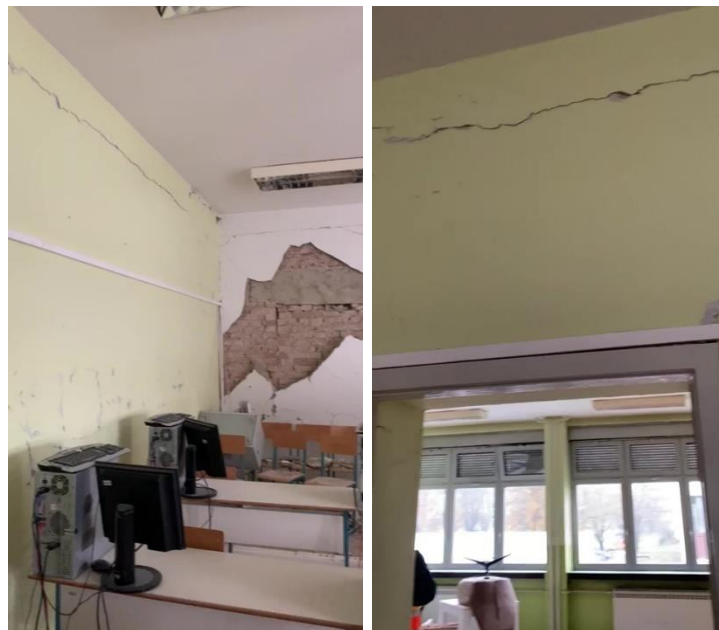
**Figure 4.69.** Horizontal cracks between the RC beams and the top of infill walls (source: Damir Lazarević).

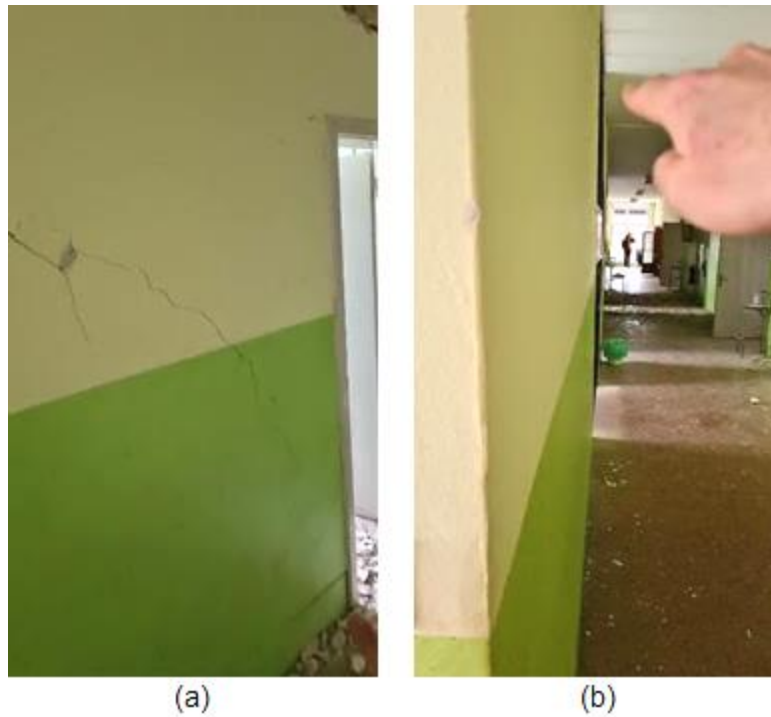
**Figure 4.70.** (a) Diagonal cracks due to in-plane loading and (b) out-of-plane infill failure due to in-plane/out-of-plane interaction (source: Nenad Bijelić and Damir Lazarević).

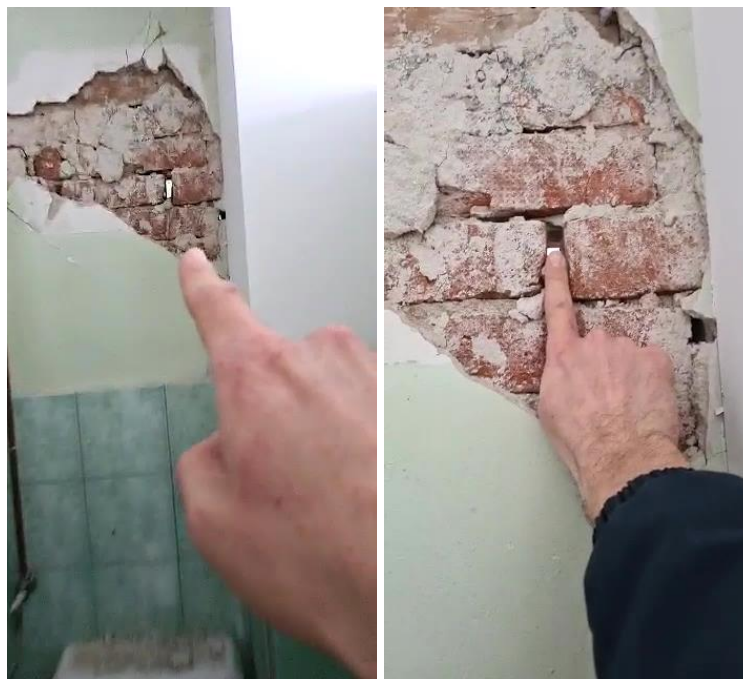
**Figure 4.71.** Gapping in head joints of infill walls (source: Nenad Bijelić).

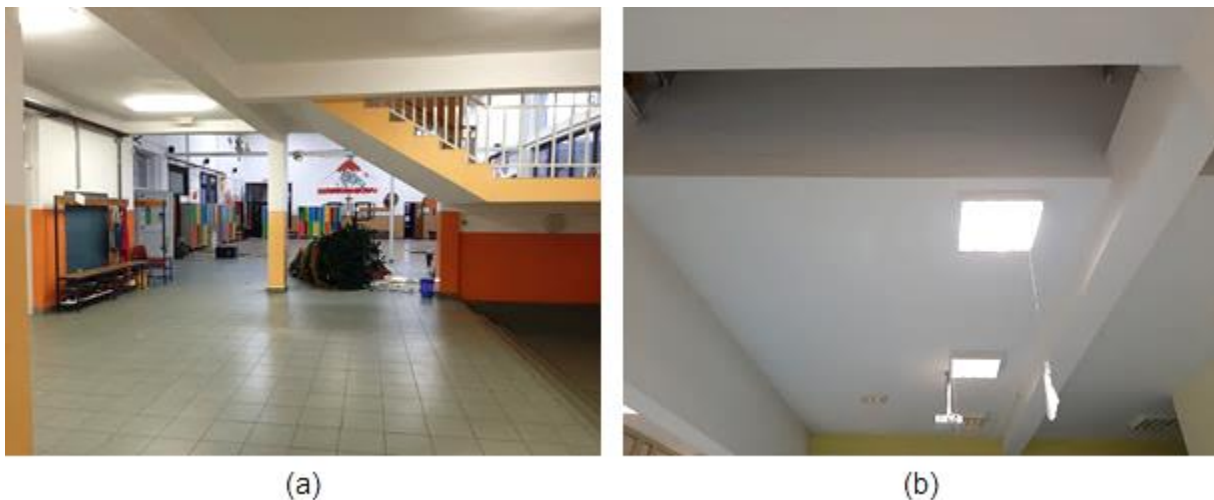
**Figure 4.73.** RC moment resisting frames of the northern part of the Mate Lovraka Elementary School in Petrinja (source: Susana Ereiz).

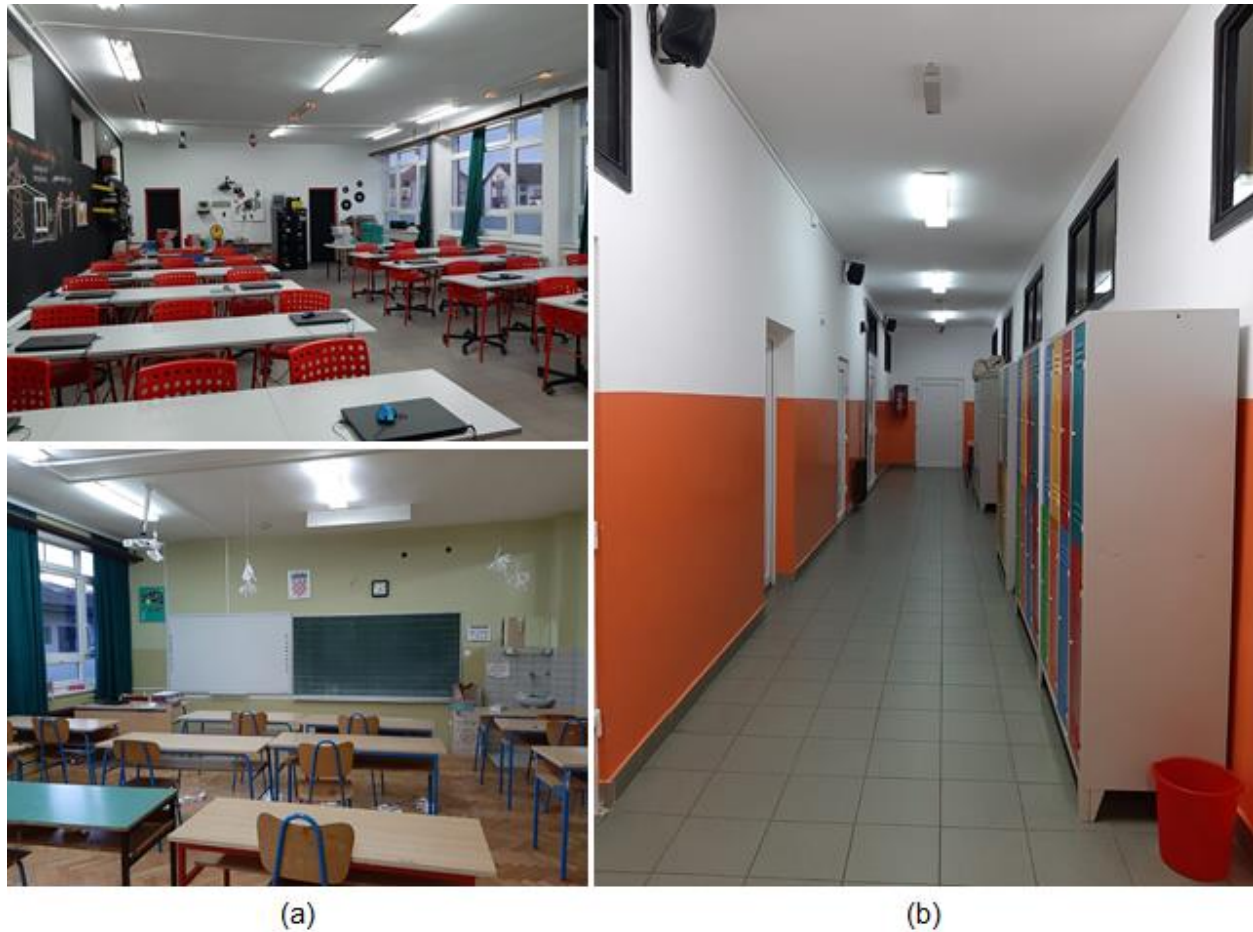
**Figure 4.74.** (a) Classrooms and (b) a corridor of the Mate Lovraka Elementary School in Petrinja (source: Susana Ereiz).

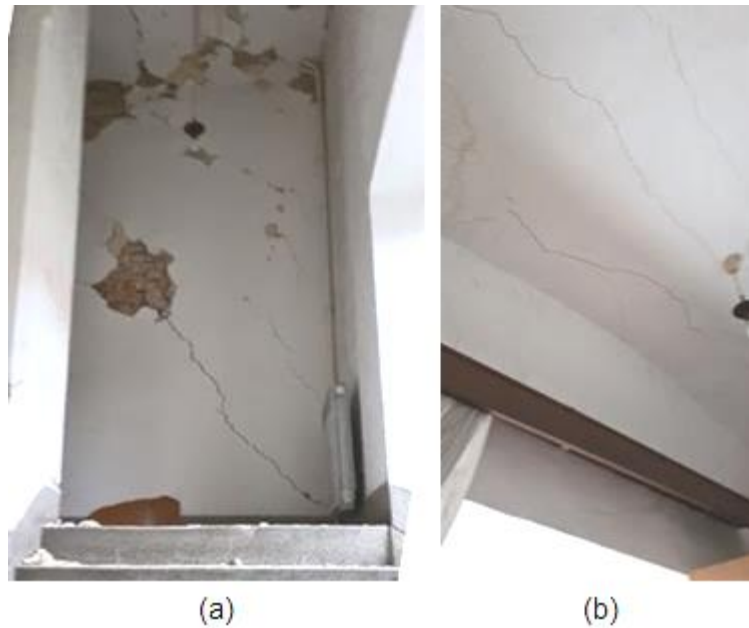
**Figure 4.77.** Details of Town Hall building damage: (a) In-plane shear crack in a load-bearing wall in the transverse direction (source: Nenad Bijelić) and (b) Cracking of a masonry vault, indicating a potential formation of an arch mechanism (source: Nenad Bijelić).

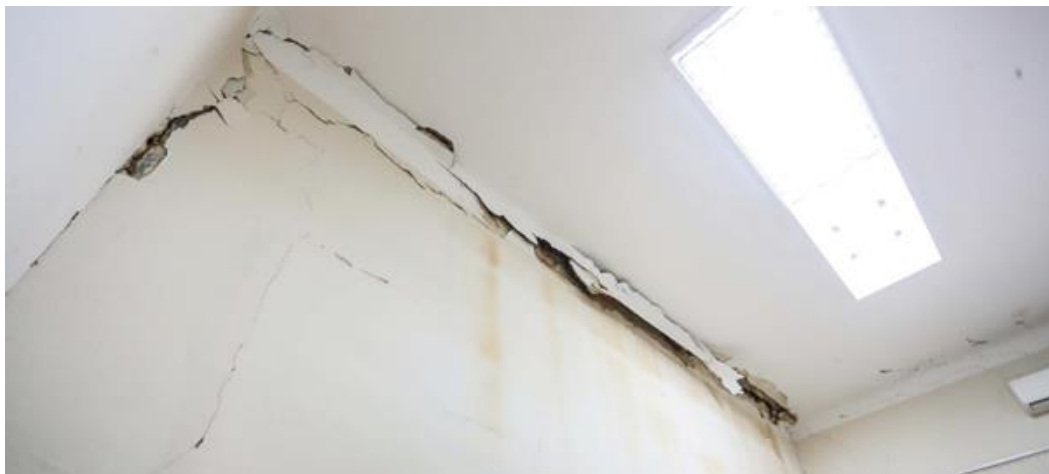
**Figure 4.78.** Damage at a floor-wall connection at the 2<sup>nd</sup> story. The crack at the connection is potentially a result of beam sliding at supports (source <https://www.index.hr/vijesti/clanak/video-pogledajte-kako-izgleda-petrinja-ogromna-steta-na-zgradi-gradske-uprave/2242131.aspx>).

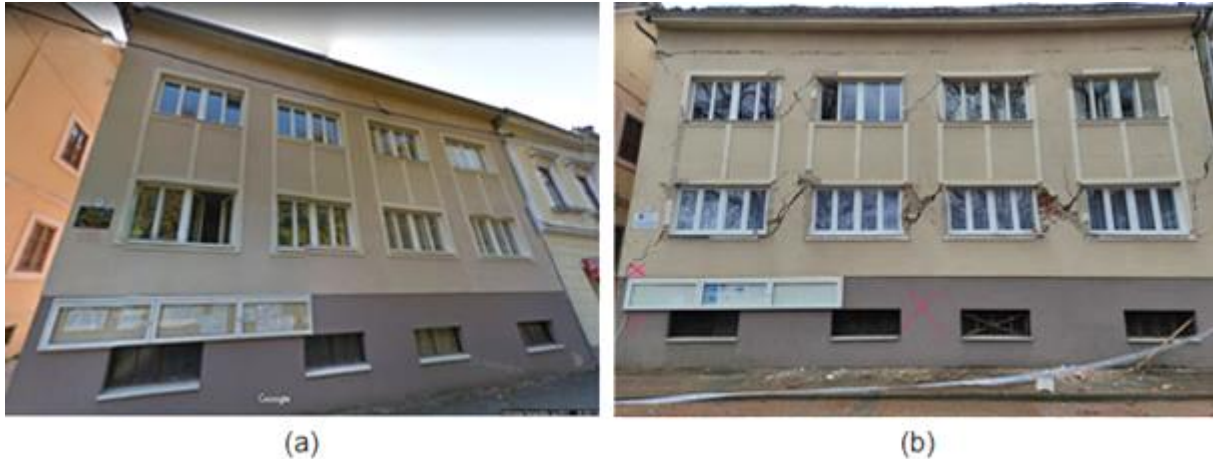
**Figure 4.80.** Chamber of Crafts building: (a) before the earthquakes (source: Google Maps) and (b) after the earthquakes. All central piers developed deep in-plane shear cracks. A wide continuous horizontal crack extends throughout the façade at the roof level (source: Nina Čeh).

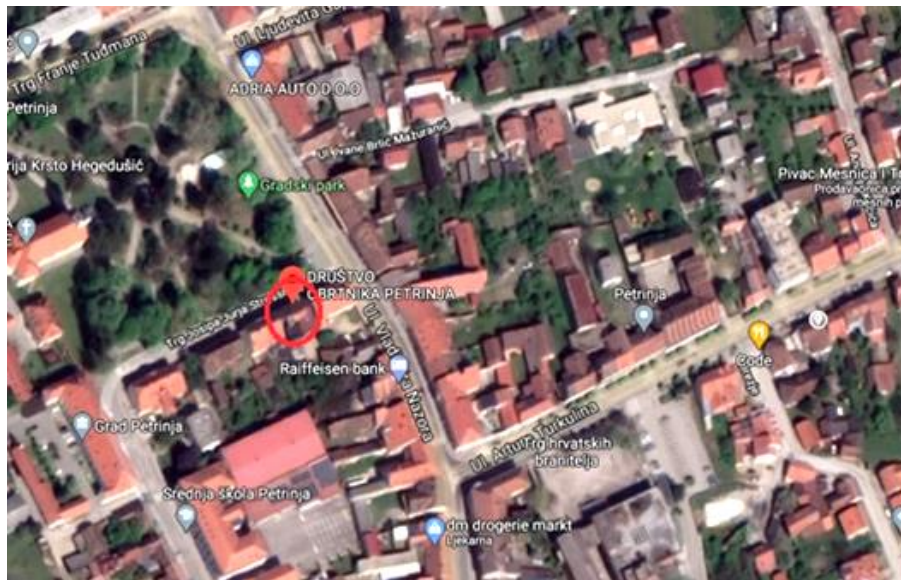
**Figure 4.81.** Chamber of Crafts building location. Considering that the building suffered predominately in-plane damage, it indicates a possibility of strong motion direction being the same as the building aggregate span direction (west-east) (source: Google Maps).

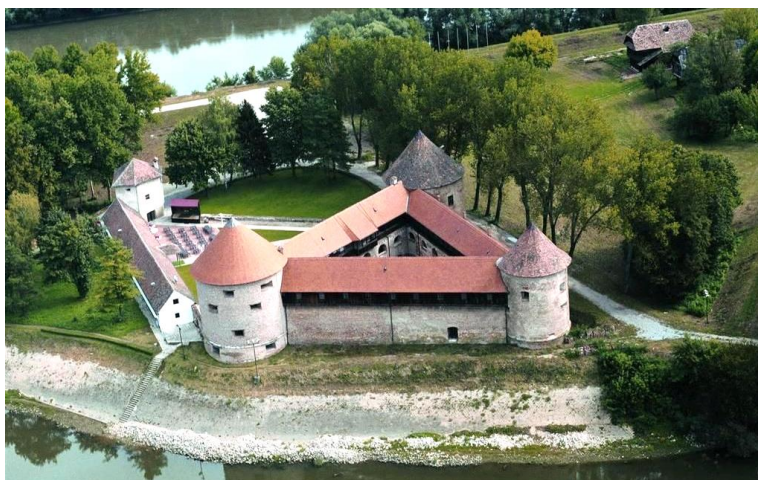
Figure 4.82. Aerial view of the Sisak Fortress (source: Pinterest 2021).

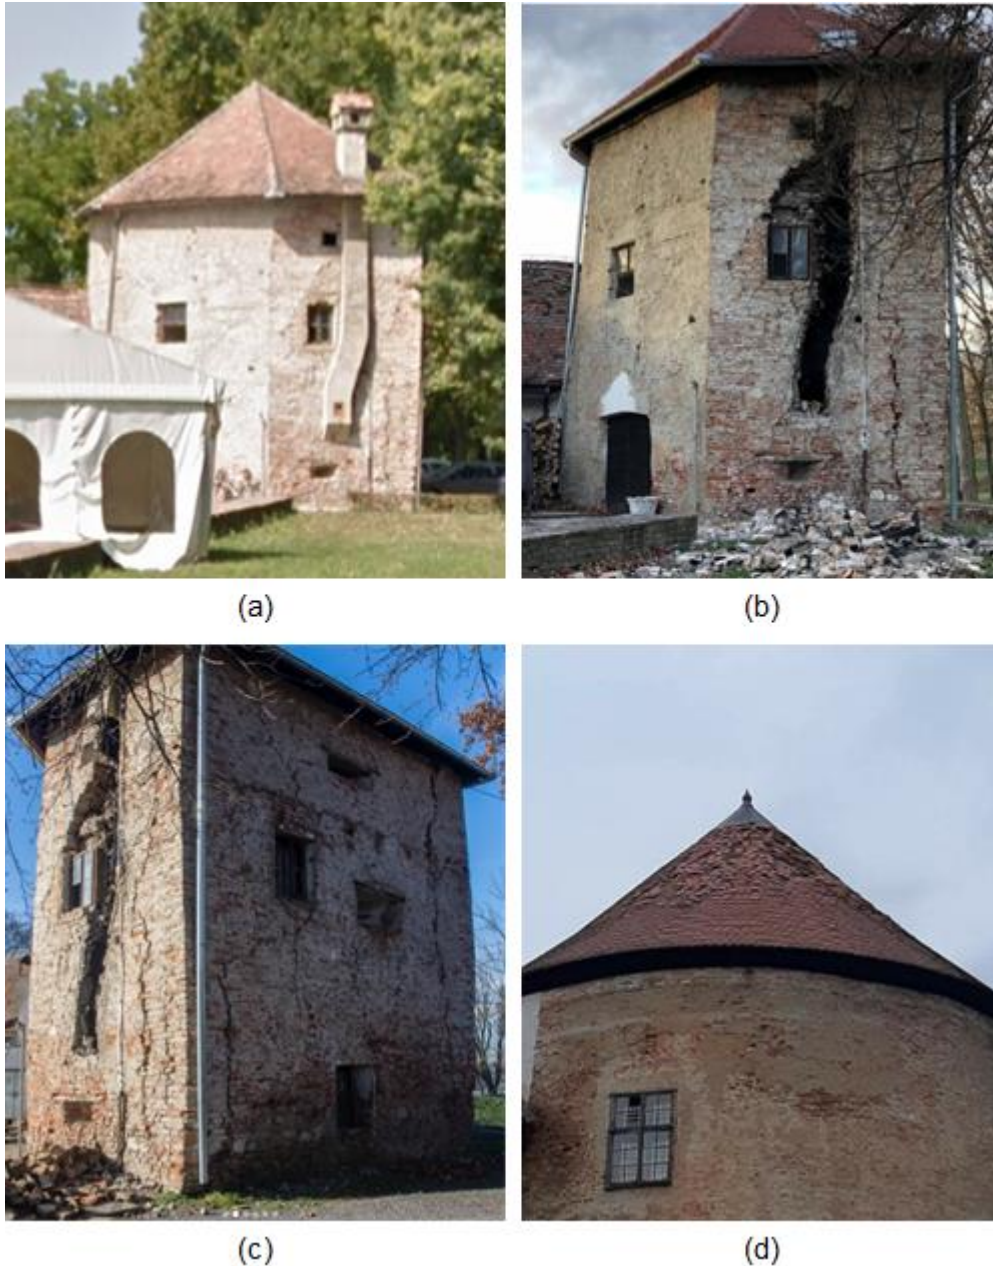
**Figure 4.83.** (a) Small tower connected to the Sisak fortress in 2011 (source: Google), (b, c) collapsed chimney in the small tower, and (d) damage to the tiles of the conical roof of one of the tower of the fortress (source: Instagram account starigradsisak and dvorcistarigardovi).

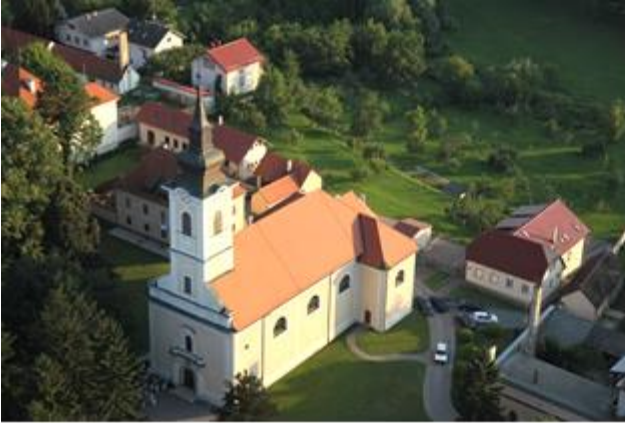
The dominating building on the main square in Petrinja is the Church of St Lovre, originally built in 1780 under the rule of Maria Theresa and Austro-Hungarian Empire. It was destroyed during the war in the 1990s. On its foundations, the new Church was built in 2000, replicating fully the original architectural design and the decorations. Figure 4.86a depicts that during the earthquake on December 29, 2020, it did not suffer any damage of structural elements mostly due to the good seismic behavior of confined masonry. However, the roof tiles are displaced, as indicated in Figure 4.85b, as well as the cross from the top of the Church. Plaster inside is cracked and statues are damaged. Cracks in the plaster are visible in the exterior of the bell tower.

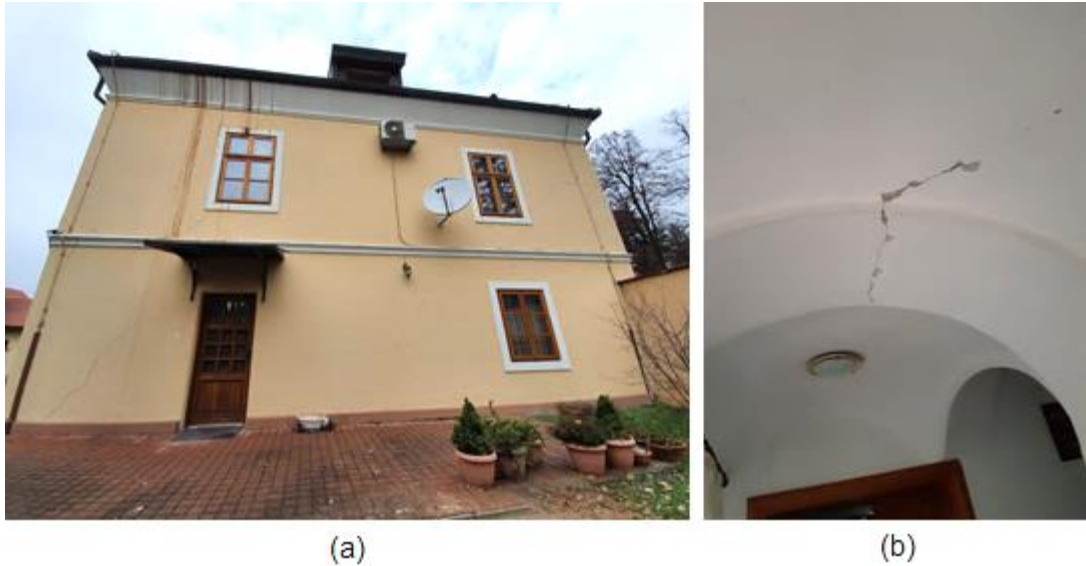
**Figure 4.87.** St. Lawrence parish church rectory that was built in 1783 in late Baroque style: (a) Façade shows diagonal cracks in the piers. Overall response was good. It is possible that small openings to the total area of walls had a beneficial effect. Chimneys collapsed. (b) Cracked vault inside the house (source: Marko Bartolac).

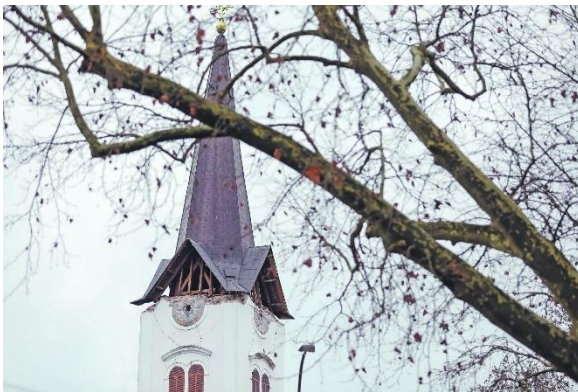
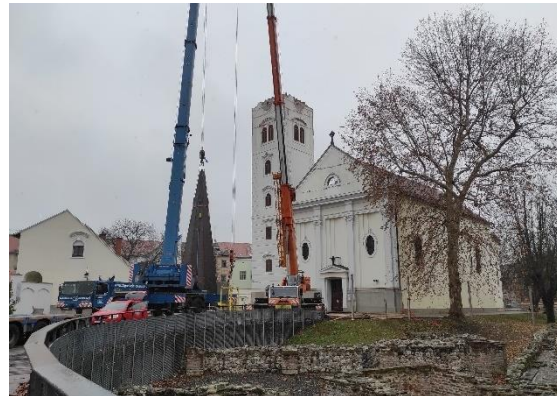
**Figure 4.89.** Sisak Cathedral after the earthquake in 2020: (a) a detail of the top of the bell tower showing local out-of-plane failure of gables (source: Marko Todorov/CROPIX) and (b) after the bell tower was removed (source: Nina Čeh)

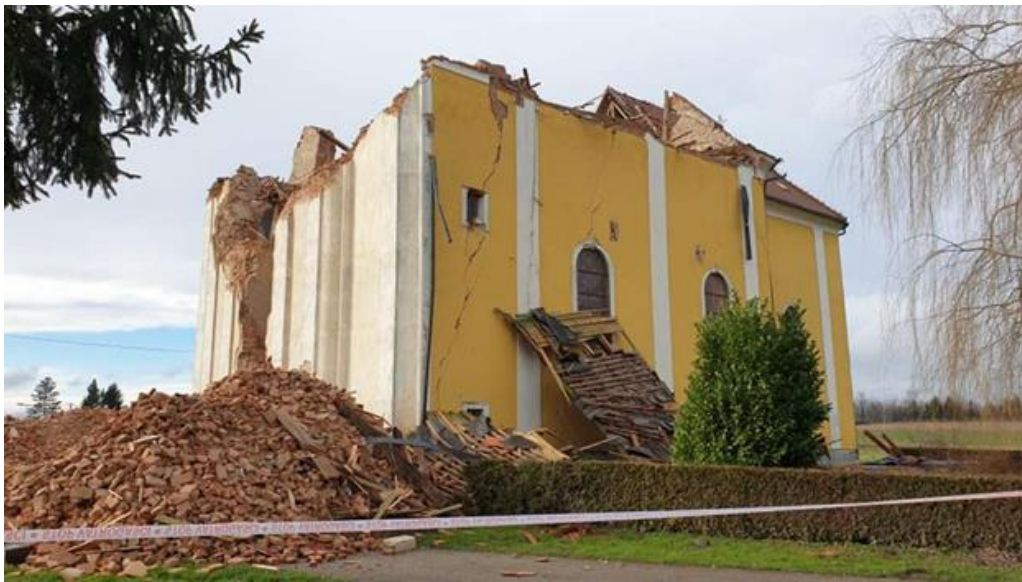
**Figure 4.90** Church of St. Nikola and Vida in the village of Žažina after the earthquake exhibited severe collapse of the bell tower and extensive cracking of load bearing walls (source: Total Croatia News 2021).

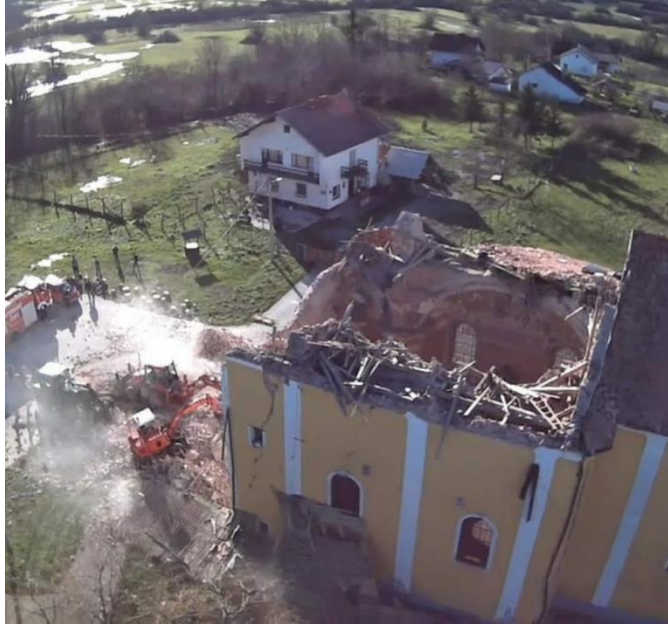
**Figure 4.91.** Aerial view of the Church of St. Nikola and Vid in the village of Žažina (source: Instagram account visitlekenik).

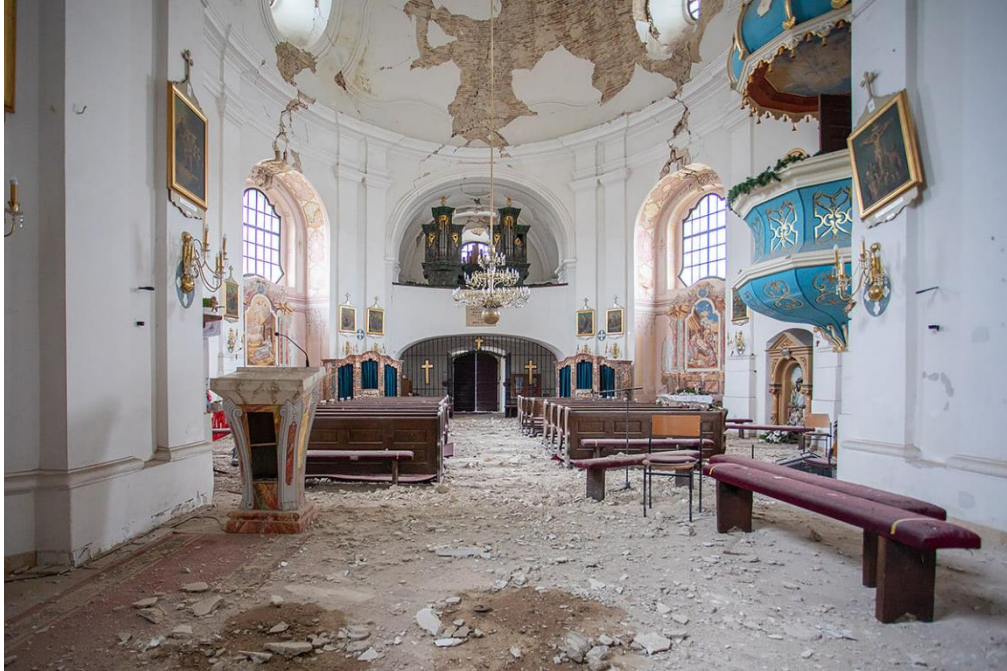
**Figure 4.94.** Interior of the Church of St. Marije Magdalene in Sela. Extensive cracking visible in the dome, as well as plaster detachment (source: Facebook Page Sisačka biskupija).

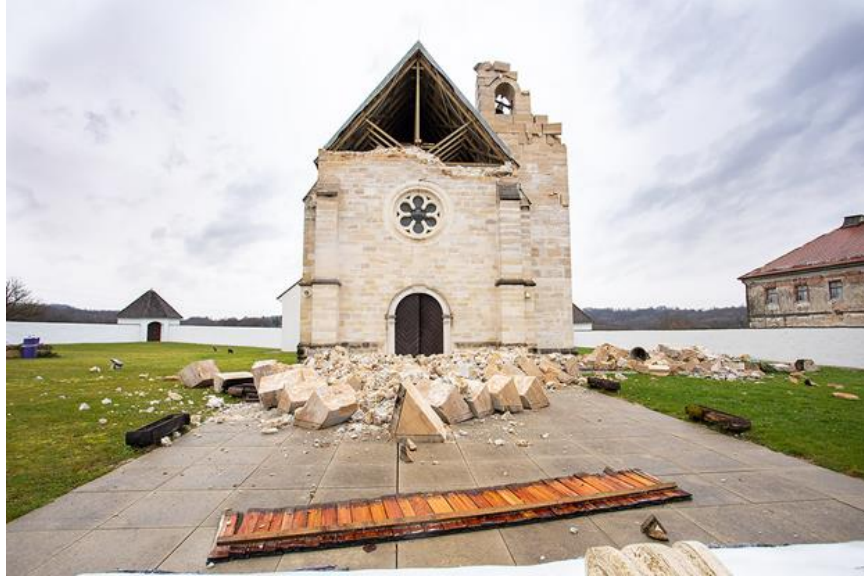
**Figure 4.95.** Church of Our Lady of the Mountain in the village Gora after its triangular gable suffered out-of-plane failure and the part of the bell tower collapsed (source: Facebook Page - Sisačka biskupija).

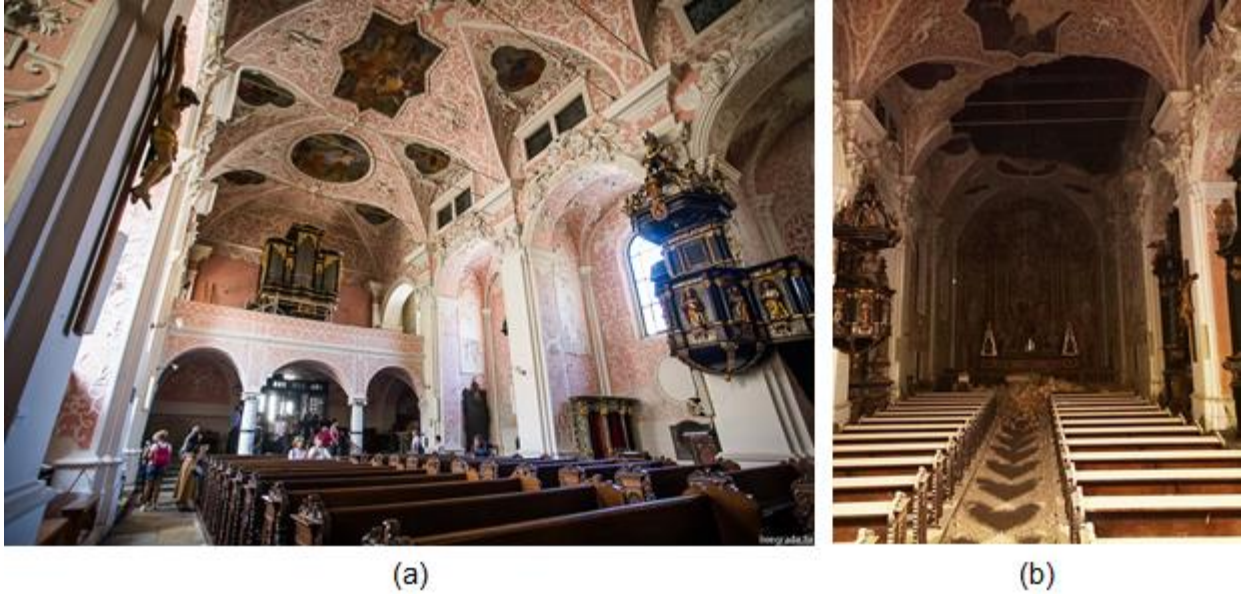
**Figure 4.96.** (a) Vault of the Church before the earthquake (source: Lice grada 2021) and (b) The collapse of the vault (source: Zagrebacka nadbiskupija).

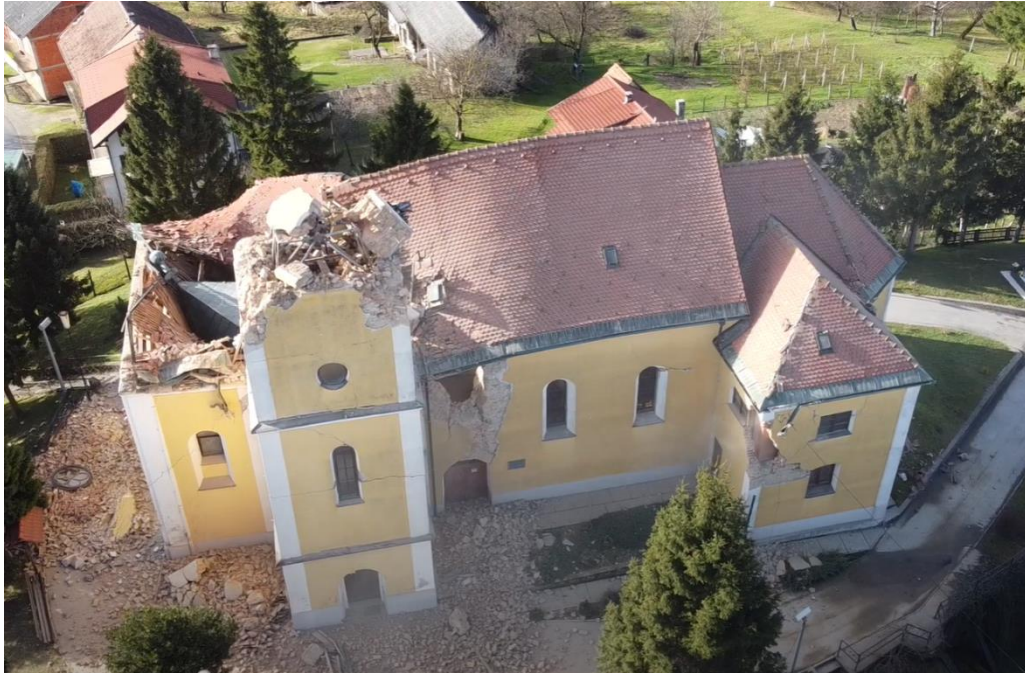
**Figure 4.97.** Aerial view of the Church of the Exaltation of the Holy Cross (Crkva Uzvišenja Sv. Križa) in Kravarsko (source: Youtube 2021).

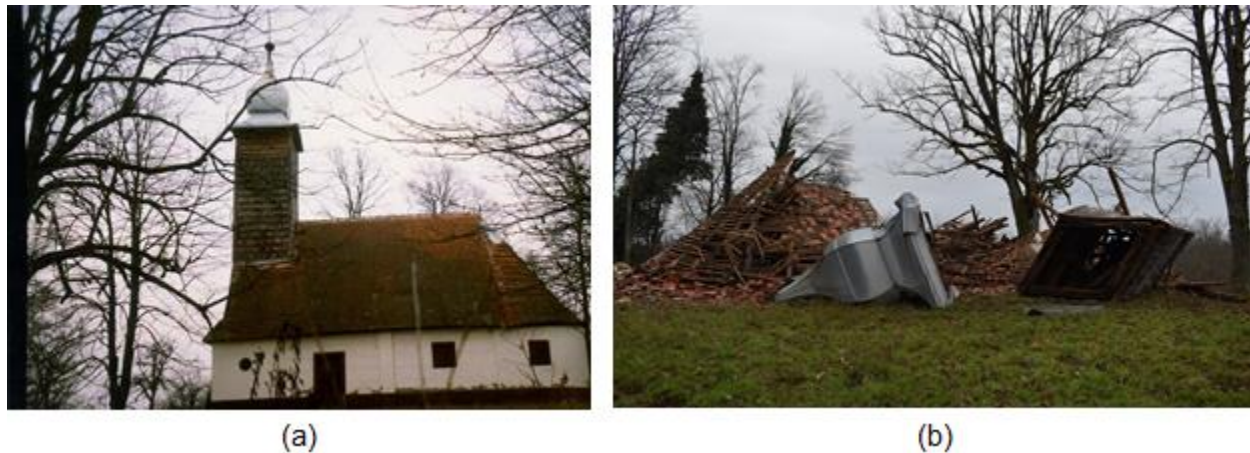
**Figure 4.99.** (a) Church in Majske Poljane (Hram Vaskrsenja Gospodnjeg) before the earthquake (source: Eparhija Gornjokarlovacka) and (b) Complete collapse of the Church (source: Eparhija Gornjokarlovacka).

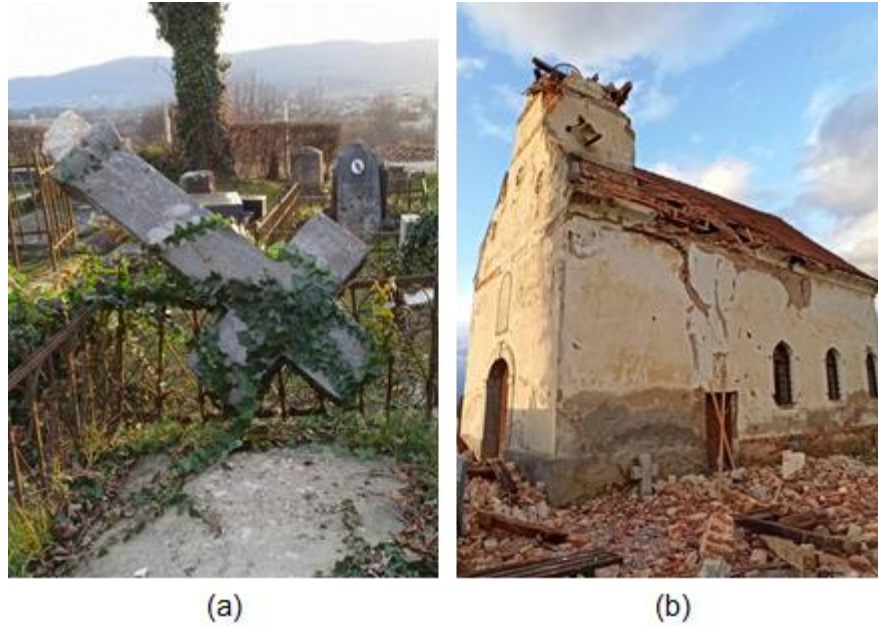
**Figure 4.100.** (a) Overturned cross at the cemetery in Petrinja and (b) St. Nicholas Chapel in Petrinja after severe damage due to the earthquake (source: Service of the Serbian Orthodox Church 2021).

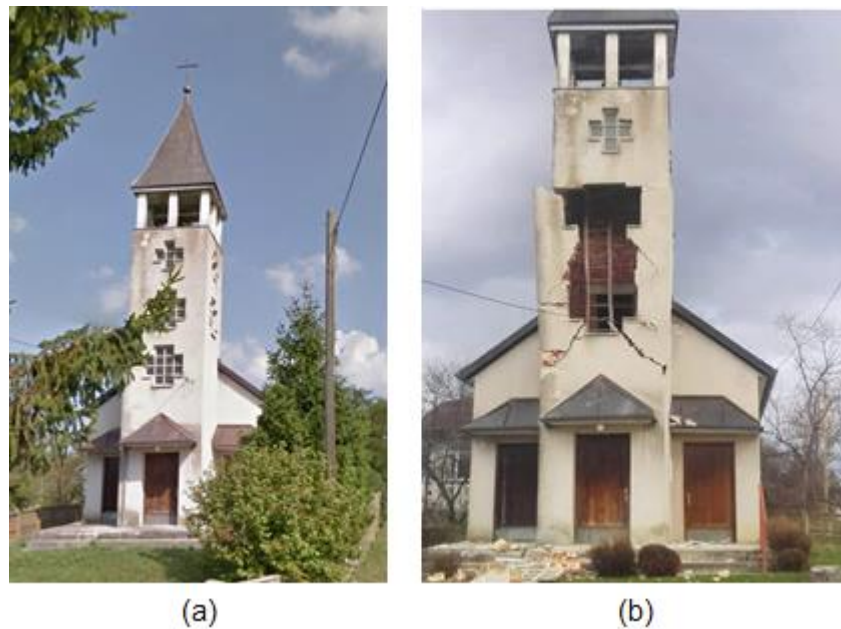
**Figure 4.101.** (a) Church St. Vid in Hotnja before the seismic event (source: Google); (b) Collapsed windows on the bell tower of the church (source: Facebook Page - Sisačka biskupija).

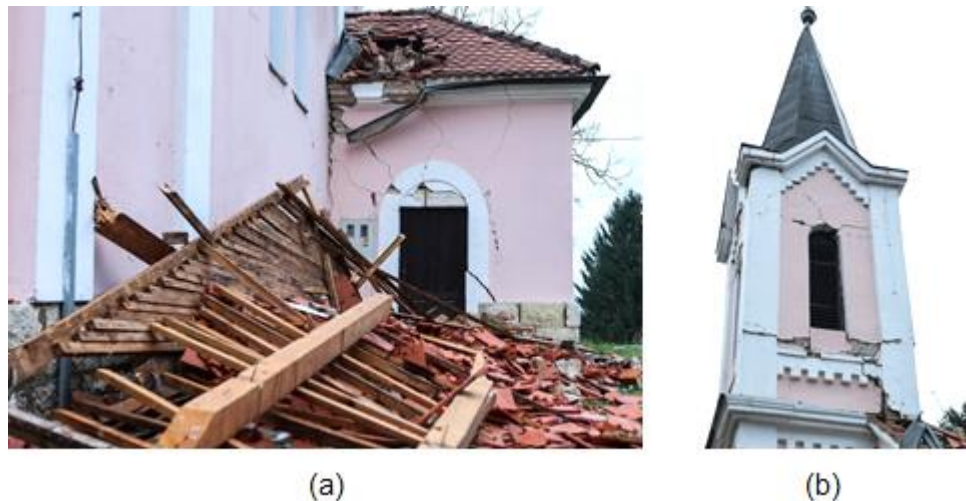
**Figure 4.103.** Church in Mračaj, near village Majur: (a) heavy cracking in the interface between adjacent shorter unit and the main nave (source: Marko Pripic/PIXSELL) and (b) severe cracking of the bell tower (source: Marko Pripic/PIXSELL).

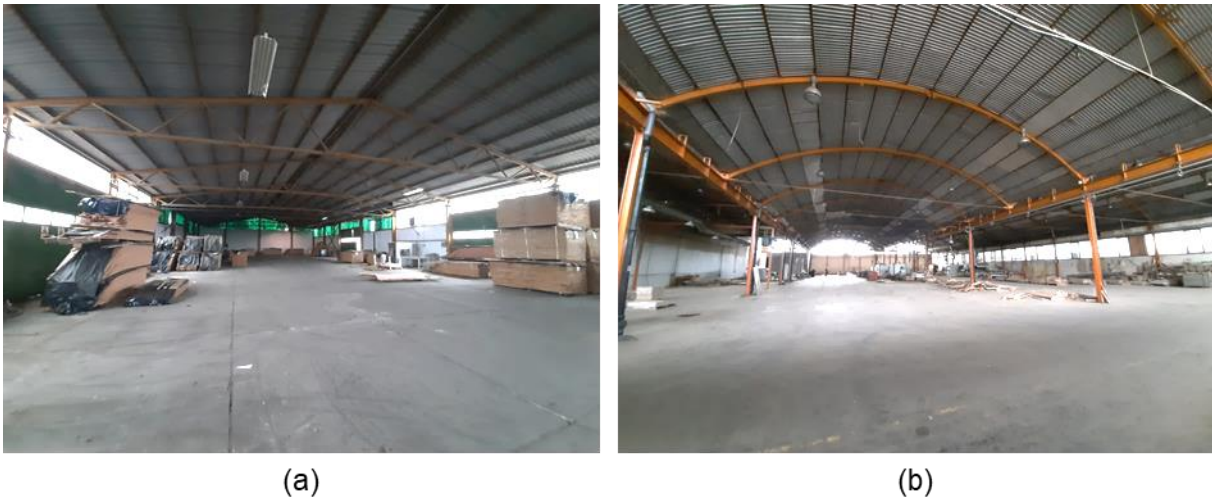
**Figure 4.106.** Storage areas within the industrial facility in Sisačka ul. 116, 44250, Petrinja (source: Marko Bartolac).

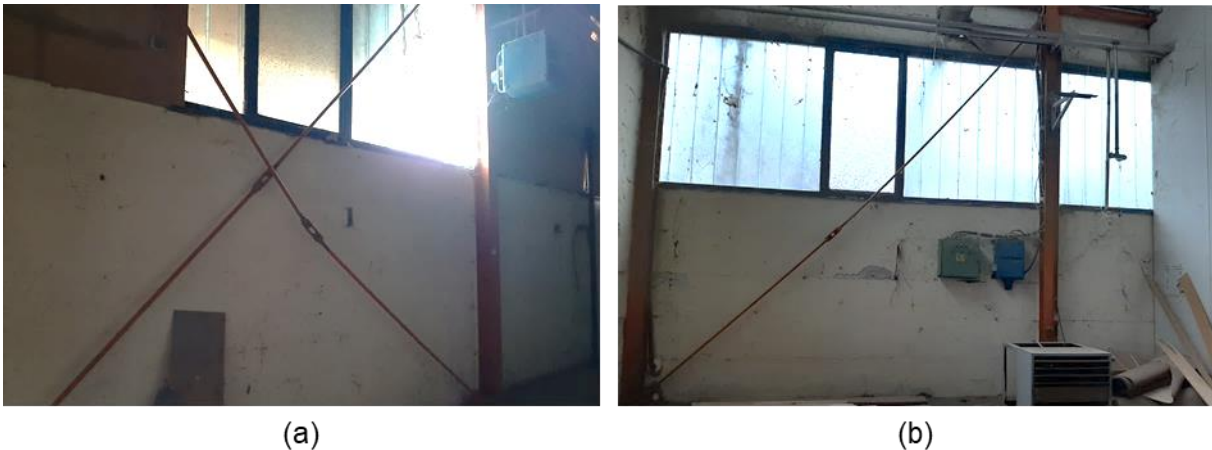
**Figure 4.107.** Fracture of tension-only steel bracings in an industrial facility in Sisačka ul. 116, 44250, Petrinja (source: Marko Bartolac).

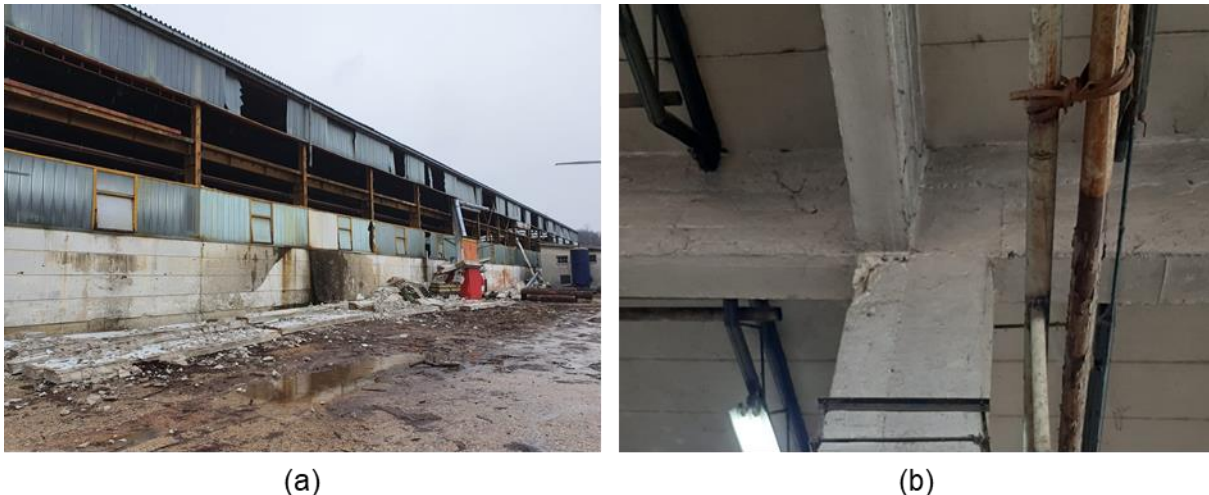
**Figure 4.108.** Damage to exterior cladding and concrete columns in an industrial facility in Sisačka ul. 116, 44250, Petrinja (source: Marko Bartolac).

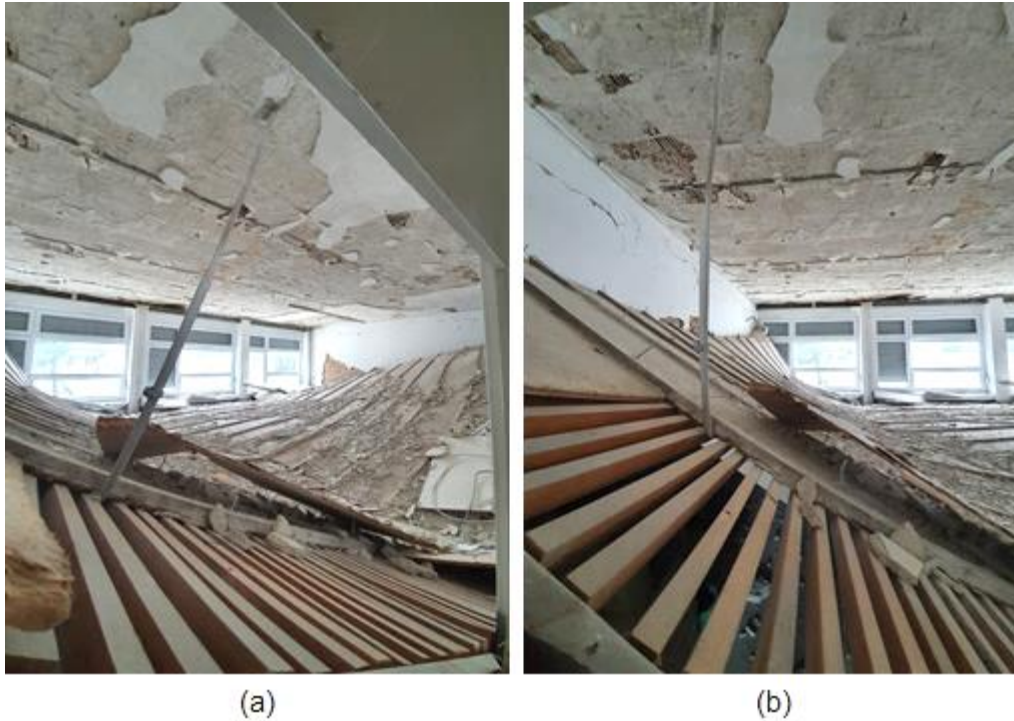
**Figure 4.110.** Ceiling collapse in 1962 university building (Učiteljski fakultet) (source: Marko Bartolac).

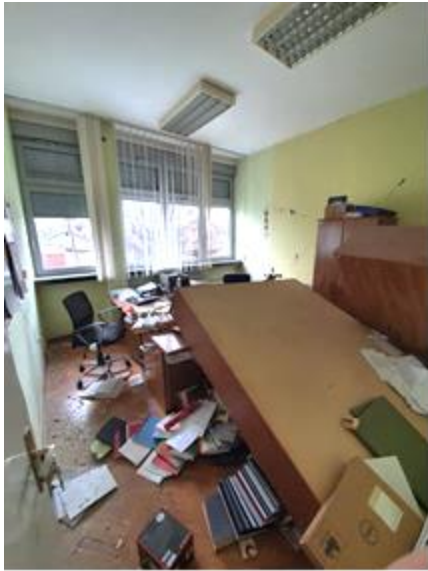
Overturning of unanchored slender contents often caused blocking of emergency exits in commercial stores, university buildings as well as residential houses as depicted in Figures 4.112. During the inspection of the building of the Faculty of Education (Učiteljski fakultet) in one classroom a detachment and collapse of the school board was observed (Figure 4.113).

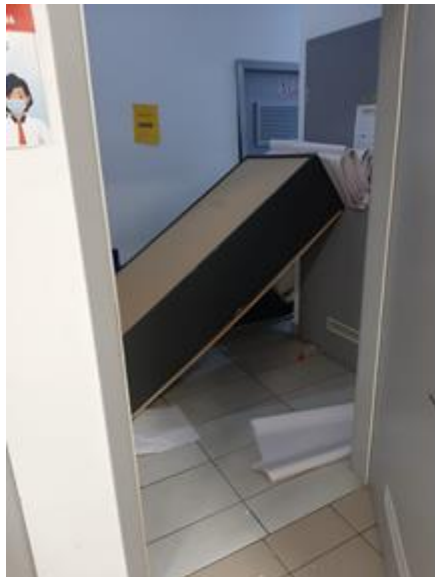
**Figure 4.111.** Comparisons of (a) inadequate and (b) sufficient (b) anchorage of building content in 1962 university building (Učiteljski fakultet) (source: Marko Bartolac).

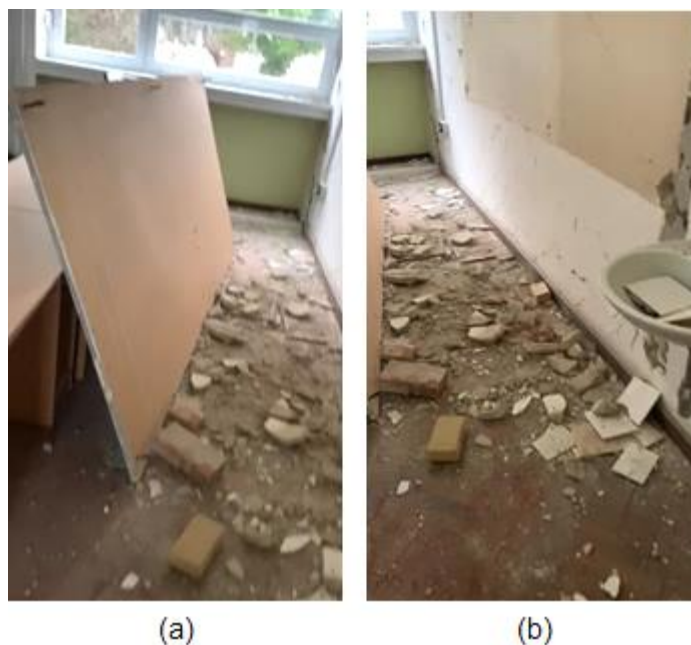
**Figure 4.113.** Detachment and collapse of the school board in one classroom (Faculty of Education - Učiteljski fakultet) (source: Marko Bartolac).

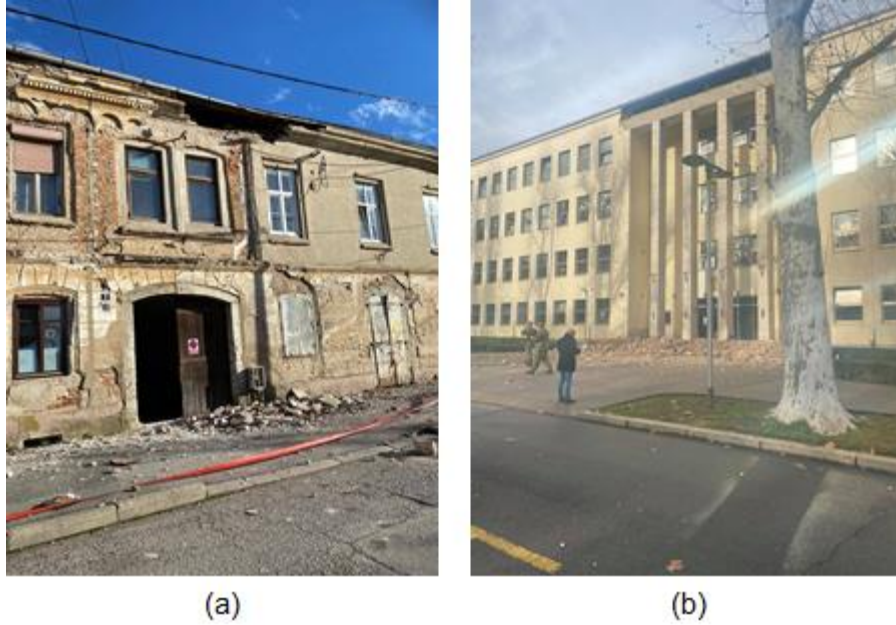
**Figure 4.115.** Fallen façades and parapets (source: 24sata.hr).

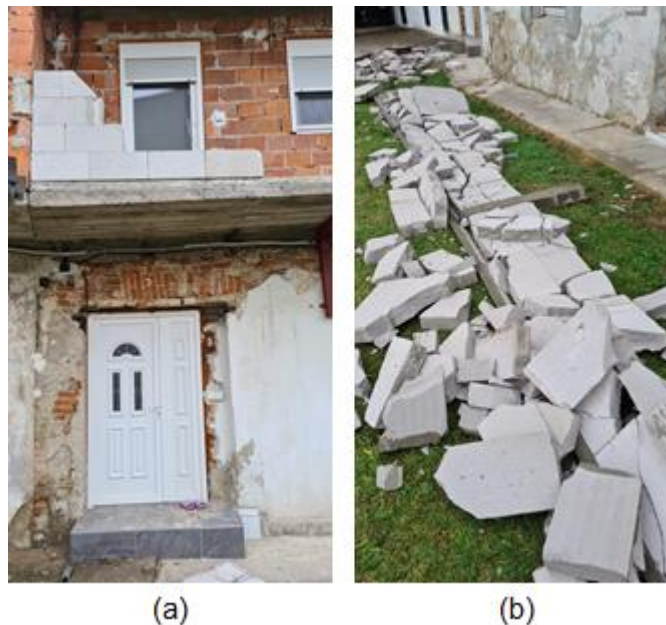
**Figure 4.116.** Collapsed unreinforced masonry balcony guardrail (source: Nenad Bijelić and Damir Lazarević).
