**EARTHQUAKE ENGINEERING  
RESEARCH INSTITUTE**

**StEER**  
**STRUCTURAL**  
EXTREME EVENTS  
RECONNAISSANCE

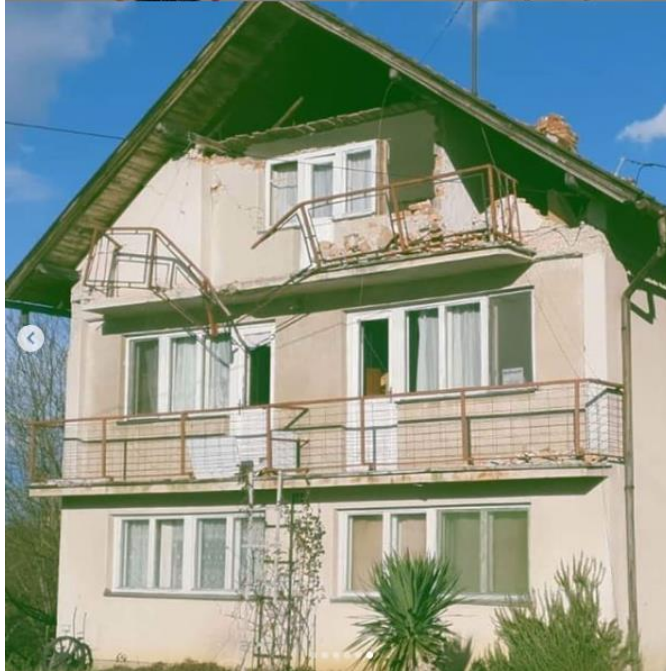
**Figure 4.117.** Damaged balcony guardrail in a family house in Sisak due to collapse of the gable end wall above (source: Instagram account on\_a\_binge\_art).

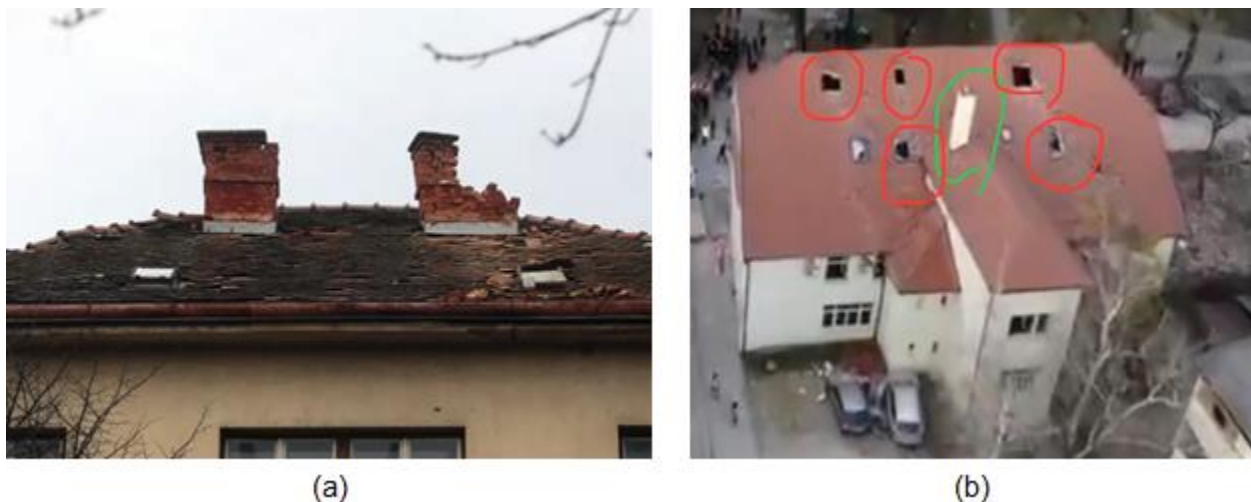
**Figure 4.118.** Damaged chimneys (source: (a) Getty and (b) Twitter 2021).

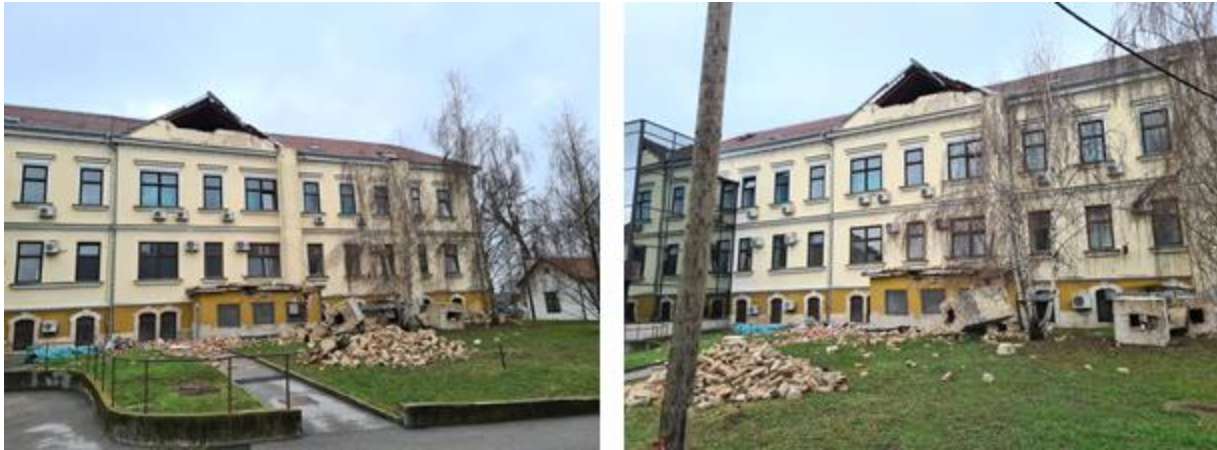
**Figure 4.119.** Fallen chimneys and gable end wall in hospital Dr. Ivo Pedišić in Sisak (source: Nenad Bijelić and Marko Bartolac).

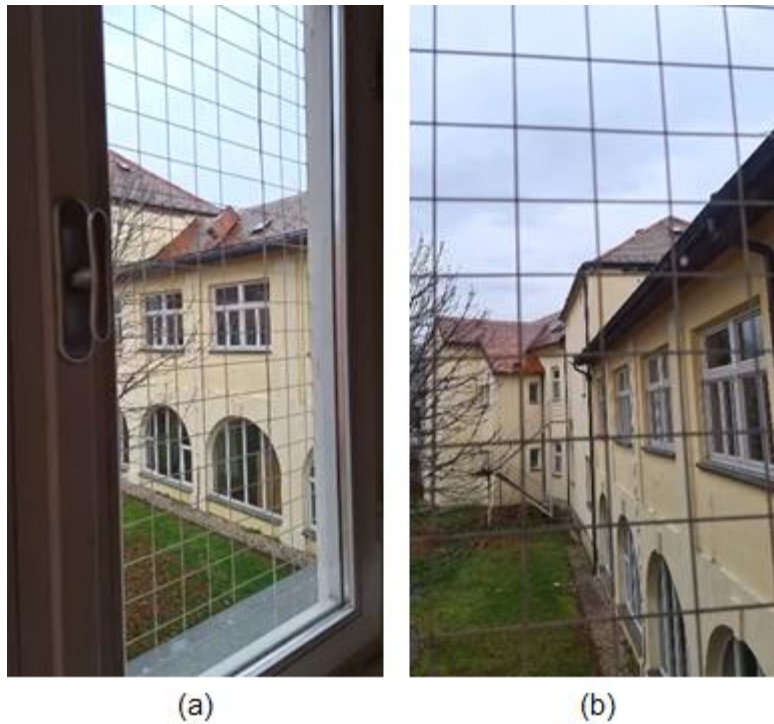
**Figure 4.121.** Collapsed chimneys (source: Nenad Bijelić and Damir Lazarević).

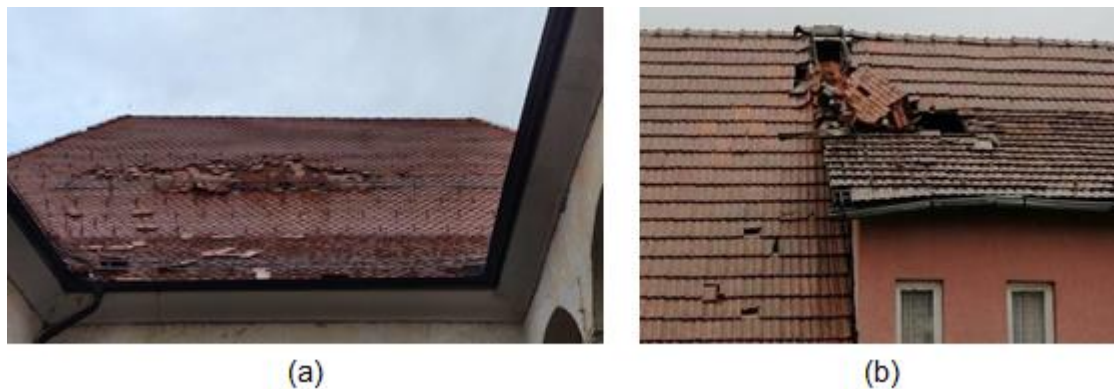
**Figure 4.122.** Damaged roof tiles (source: rtvslo.si).

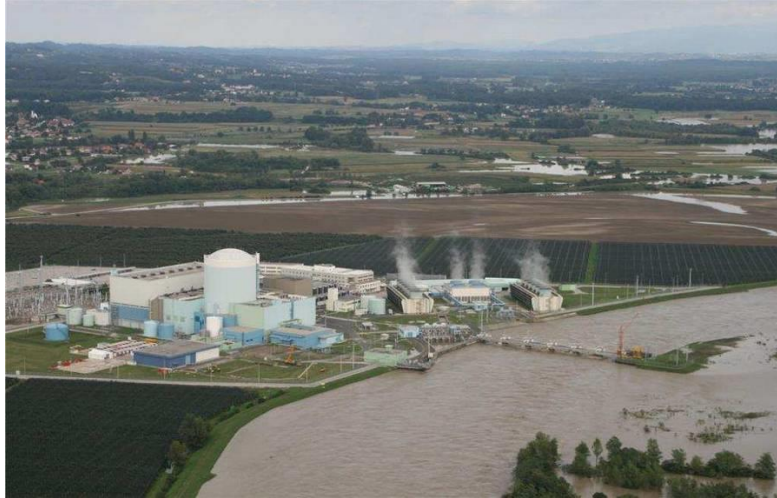
**Figure 5.1.** Krško Nuclear Power Plant (source: Stubelj 2018).

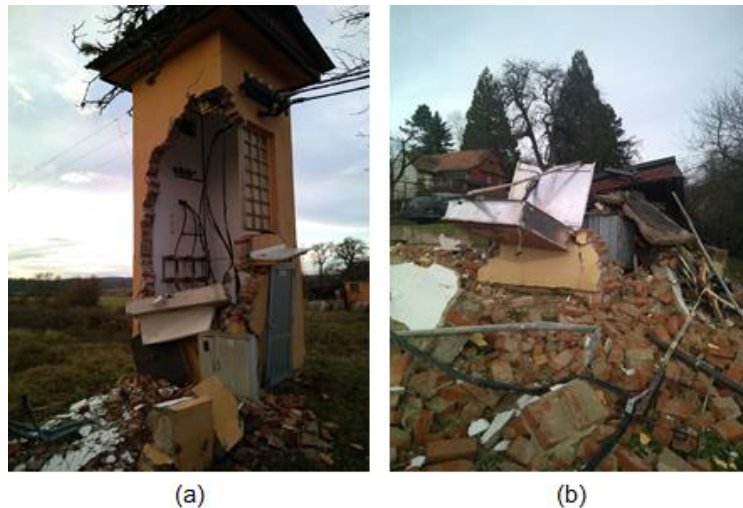
**Figure 5.2.** Severely damaged (a) and collapsed (b) substations in the Petrinja area. The size of substation structure on the left is 2.5 m square in plan and 8 m high (source: Mladen Štajdohar).

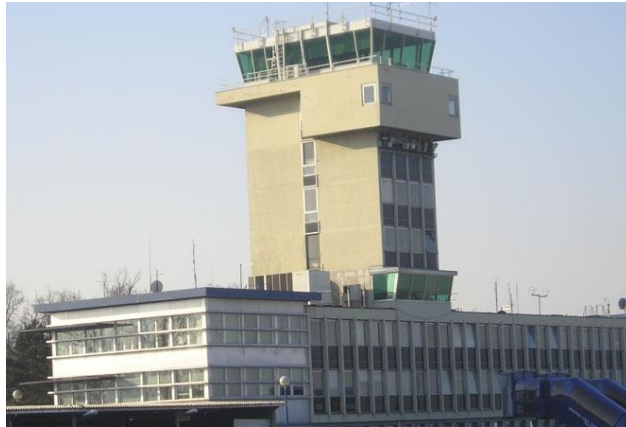
**Figure 5.3.** Control tower at the Zagreb International Airport experienced minor damage (source: DubrovnikTimes).

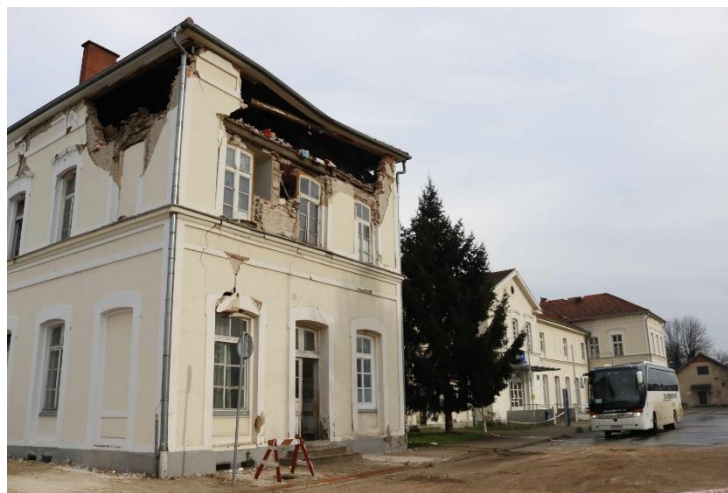
**Figure 5.4.** Significant damage of the Sisak Railway Station building (source: CroatiaWeek).

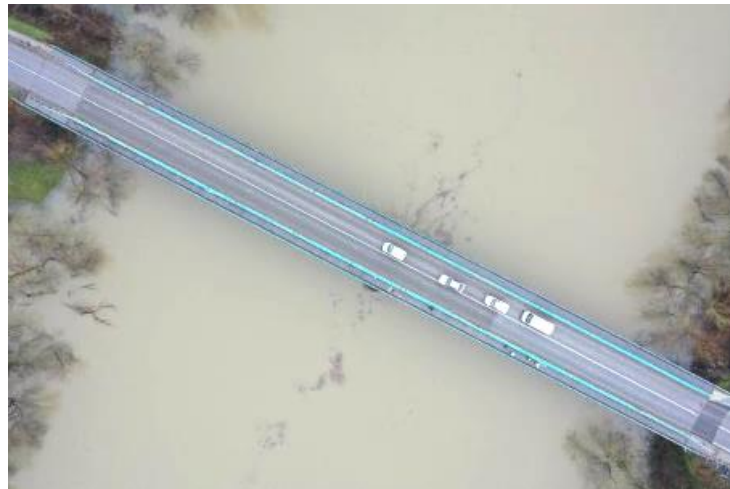
**Figure 5.5.** Satellite view of the Brest Bridge (coordinates 45.4486, 16.2604).

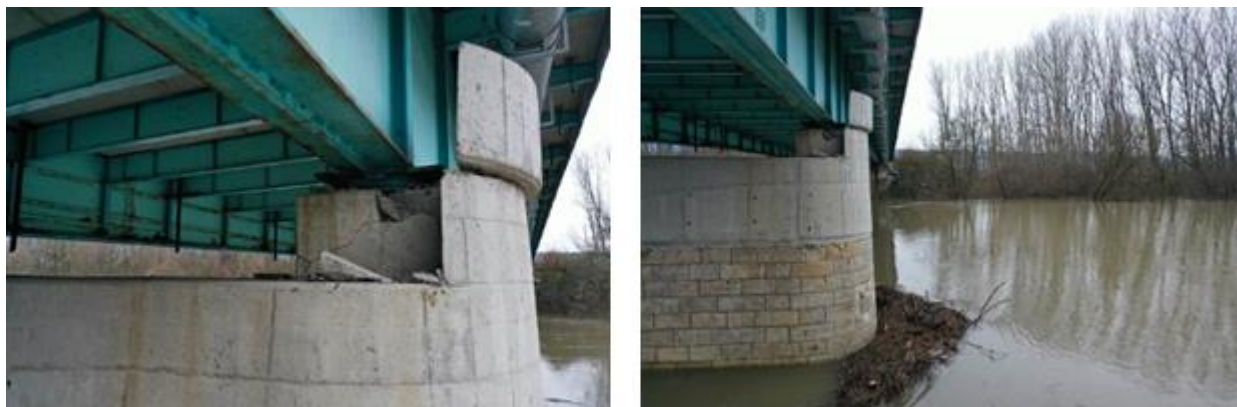
**Figure 5.6.** Damaged bearing supports of the Brest Bridge (source: Mate Baričević).

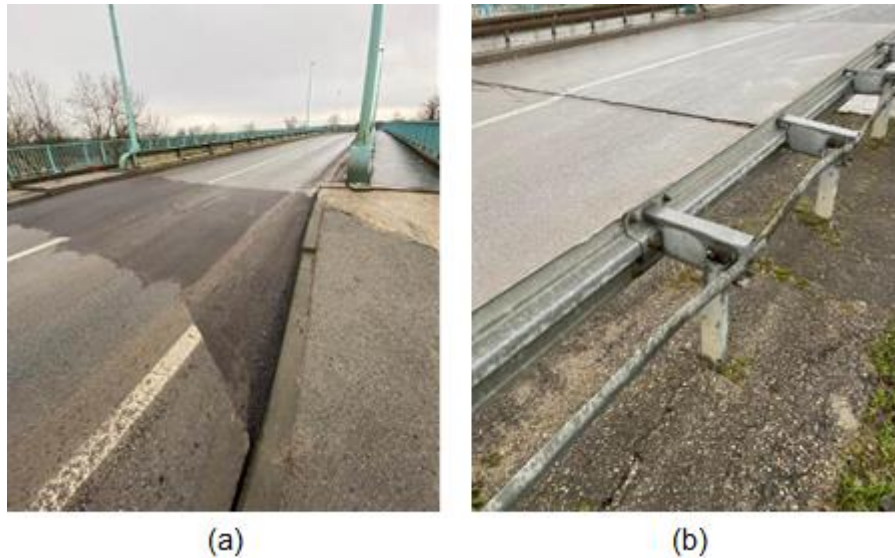
**Figure 5.7.** Asphalt at right-hand side abutment (a) and asphalt at left-hand side of abutment (b) of the Brest Bridge (source: Mate Baričević).

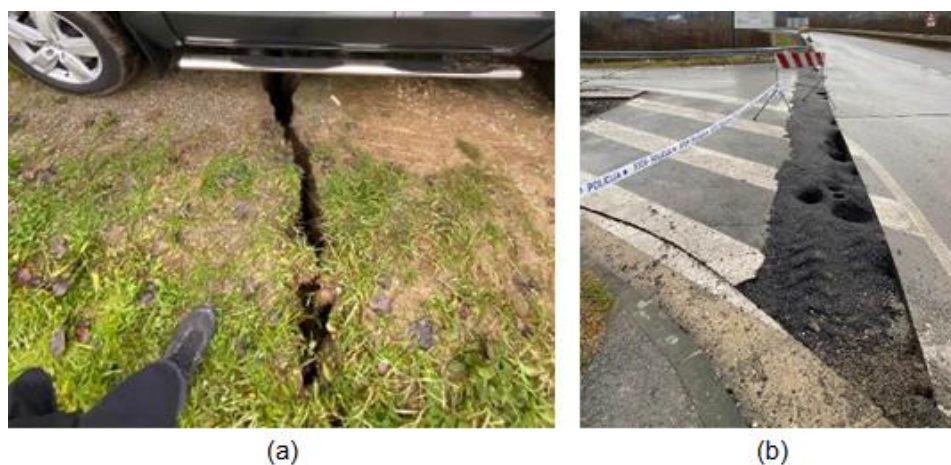
**Figures 5.8.** (a) Wide cracks at the bridge embankment and (b) collapsed portion of the asphalt curtain at the intersection with the access road to the center of Petrinja (source: Mate Baričević).

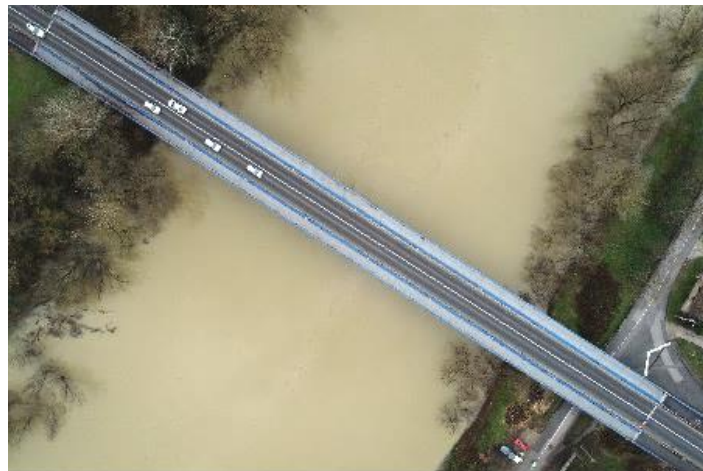
**Figure 5.10.** Satellite view of Galdovo Bridge (coordinates 45.4791, 16.3848).

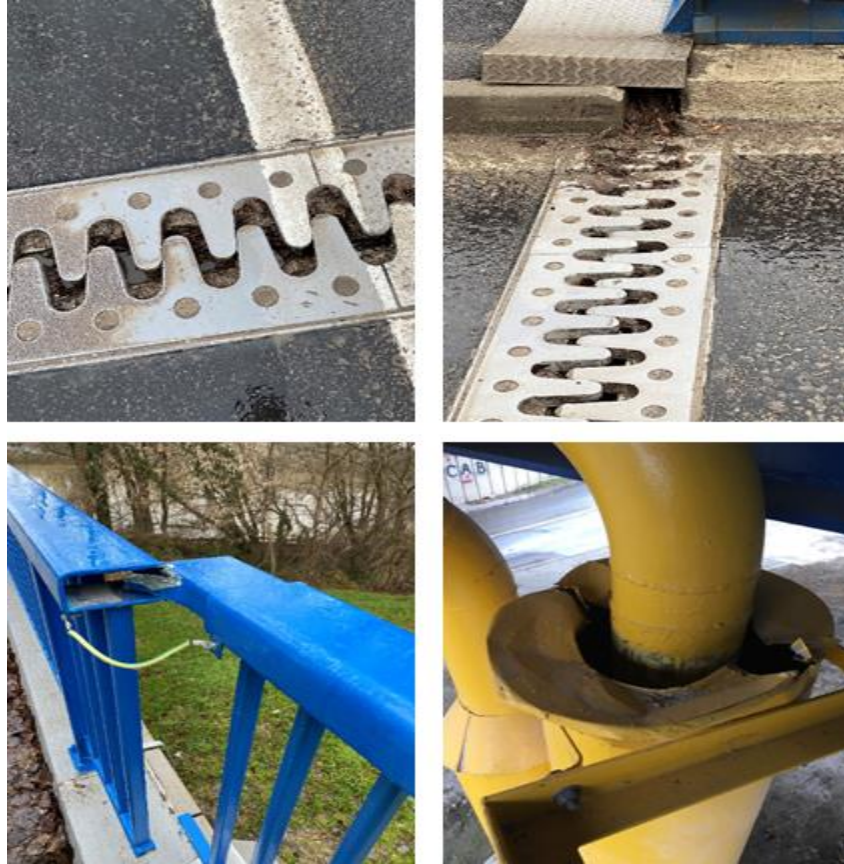
**Figure 5.12.** Damage due to lateral displacement of the bridge relative to the slab approach, Galdovo Bridge (source: Mate Baričević).

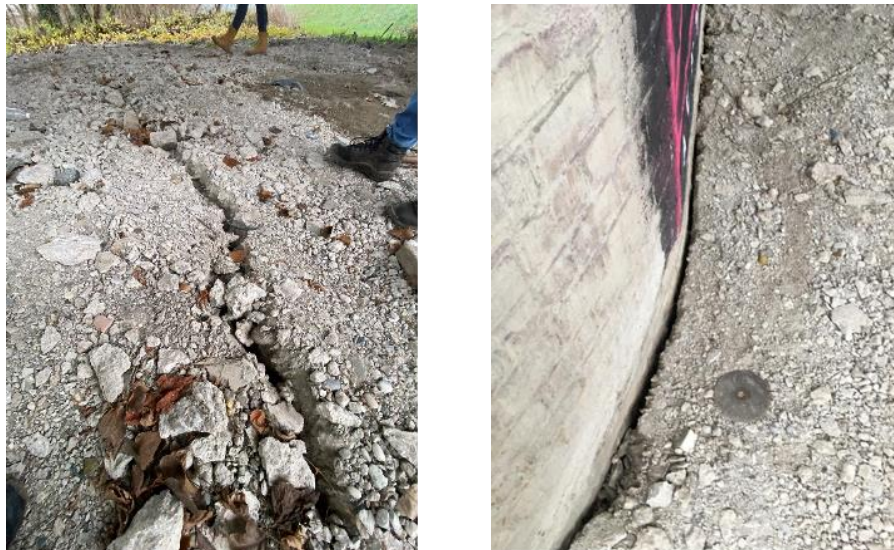
**Figure 5.13.** The displacement of the platform is visible on the ground, Galdovo Bridge (source: Mate Baričević).

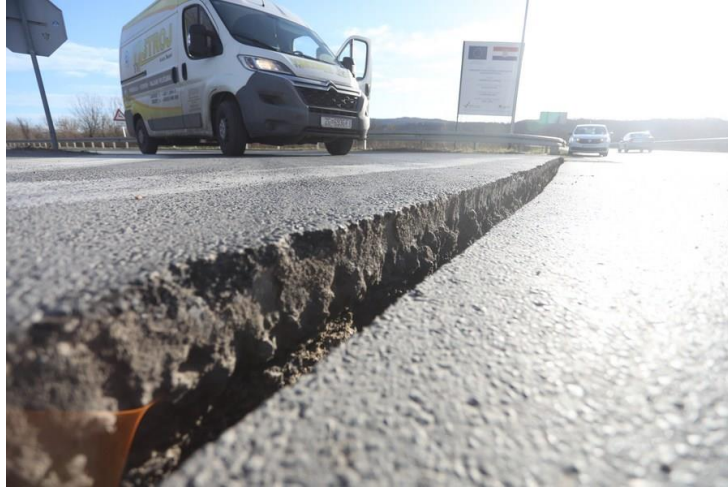
**Figure 5.14.** A major fissure in the road in Sisak was observed after the December 29, 2020 earthquake (source: Marin Tironi/Pixsell via Xinhua).

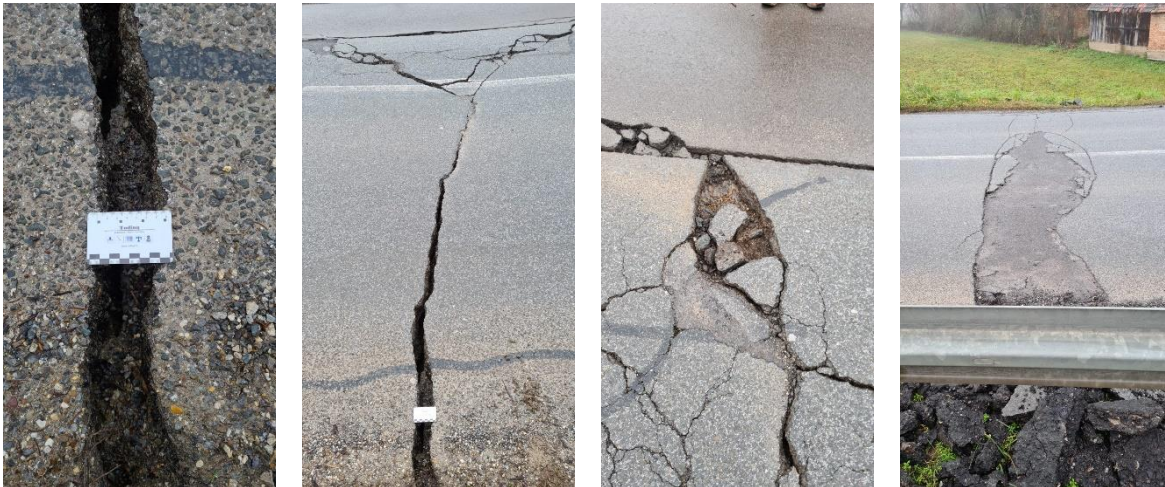
**Figure 5.15.** Damage to roads in Brest, north of Petrinja (source: Nenad Bijelić).

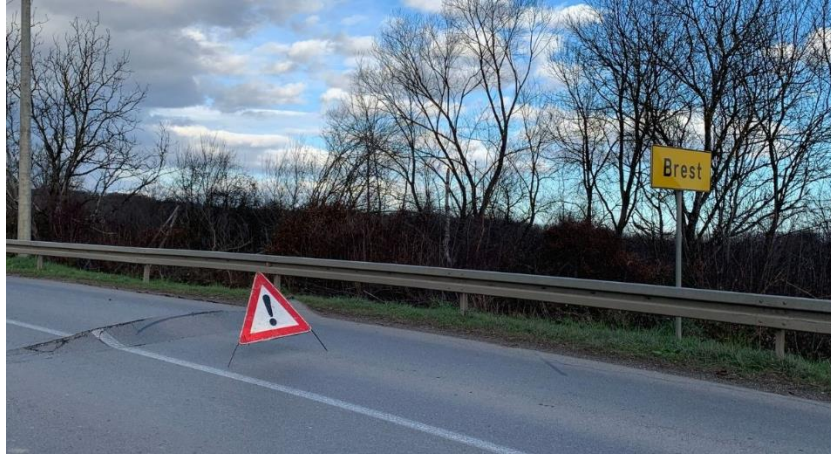
**Figure 5.16.** Ground failure of the road close to the Brest Bridge (source: Index.hr 2020d).

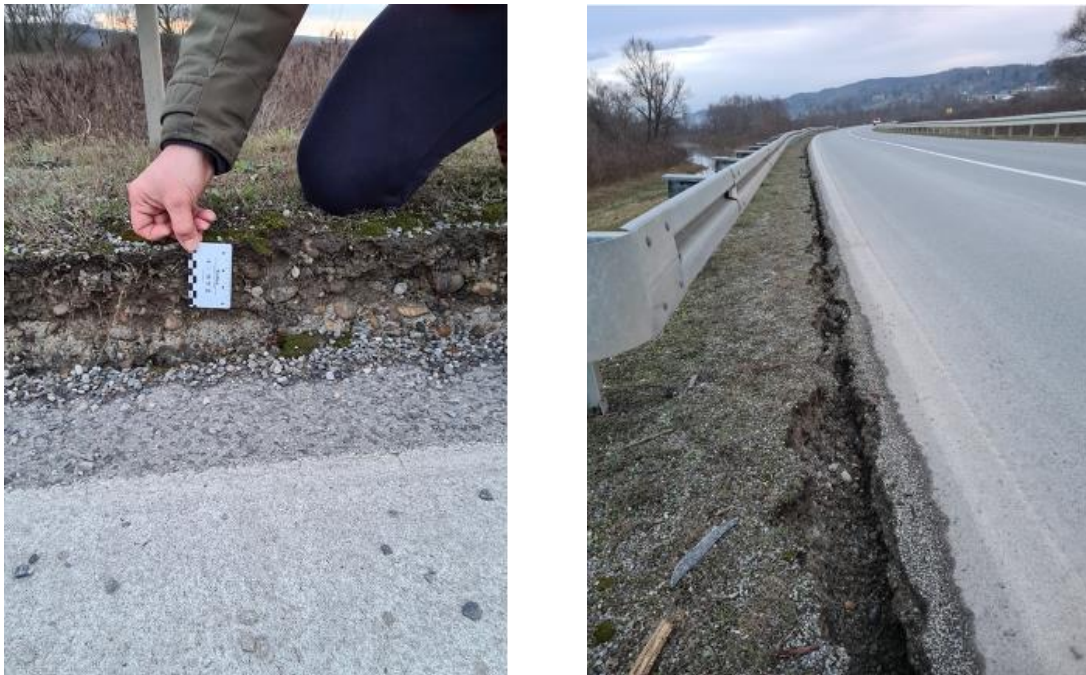
**Figure 5.17.** Ground failure of a road close to Brest Bridge (source: Nenad Bijelić).

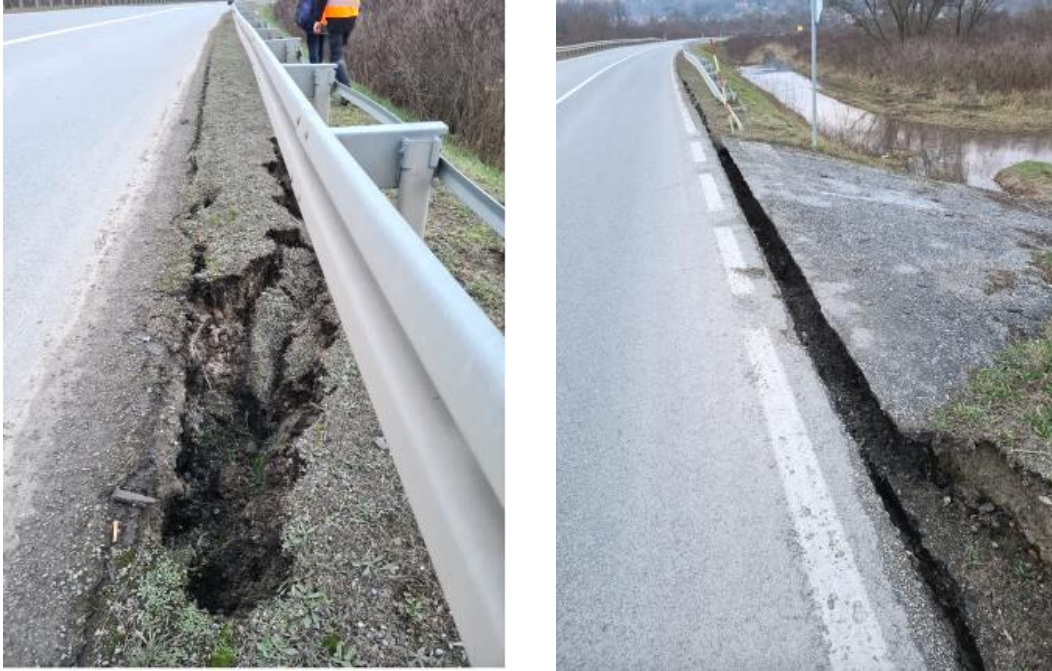
**Figure 5.18.** Partial ground slide due to reduced ground bearing capacity in the road close to Brest Bridge (source: Nenad Bijelić).

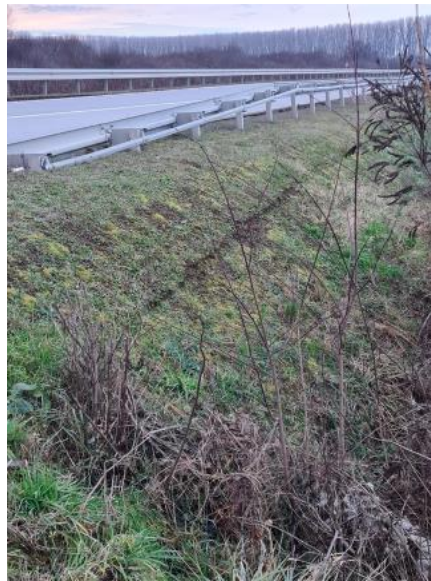
**Figure 5.19.** Partial lateral ground slide close to Brest Bridge (source: Nenad Bijelić).

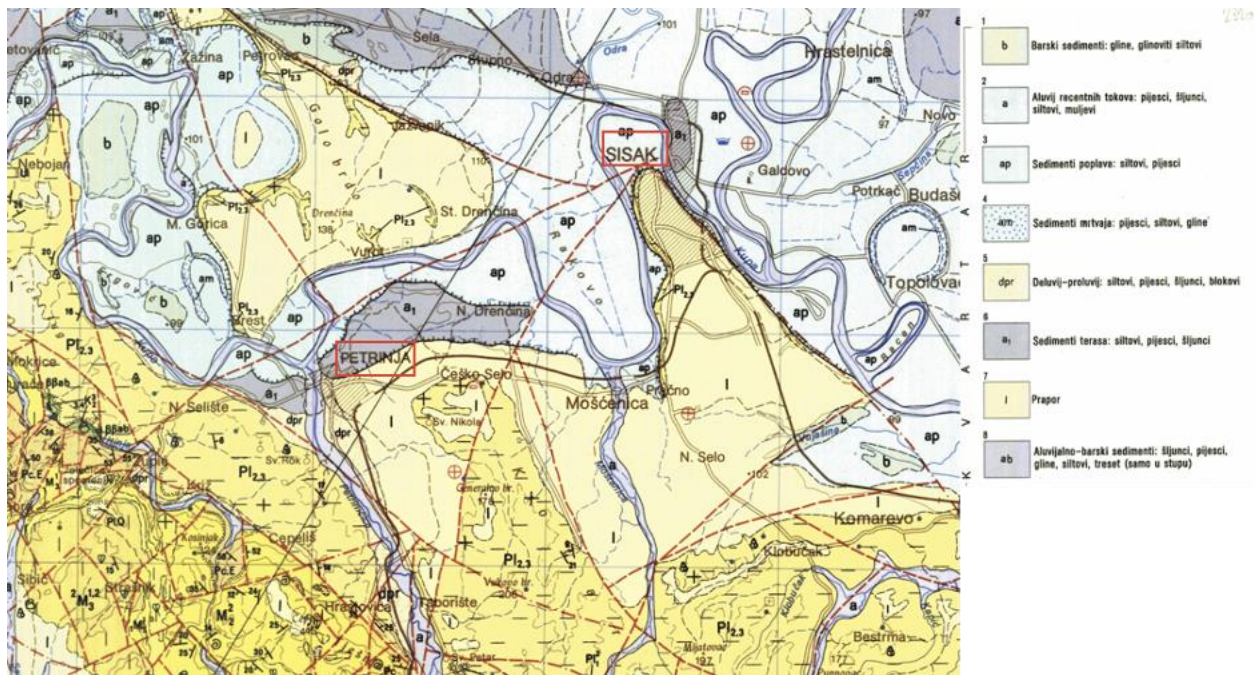
**Figure 6.1.** Geological map of the area around Petrinja and Sisak (after Pikija 1987). The light blue sediments are all shown to be fresh alluvial deposits consistent with what one would expect in this dense meandering river system. The darker zone north of Petrinja is characterized as Terasa sediments consisting of silts, sands, and gravels. The light-yellow area south of both locations is indicated as loess.

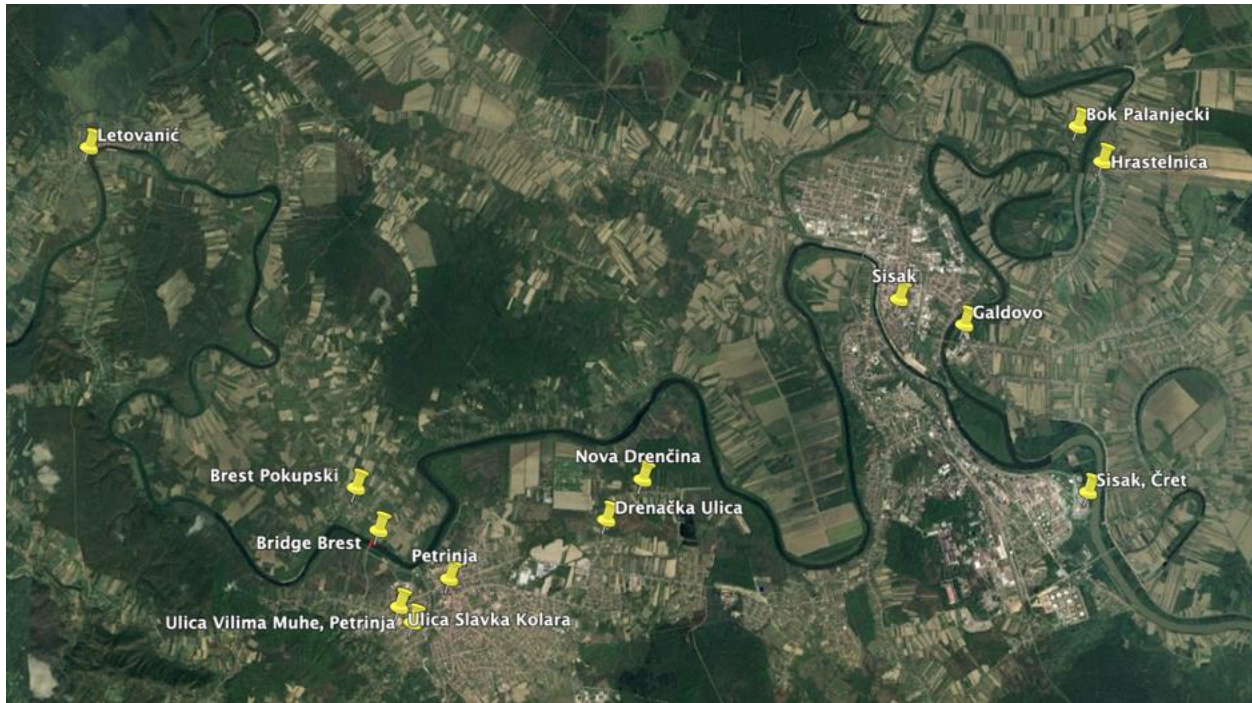
**Figure 6.3.** Google Earth imagery of the broader area with pins at locations with ground failures (referred to later in the corresponding subsections).

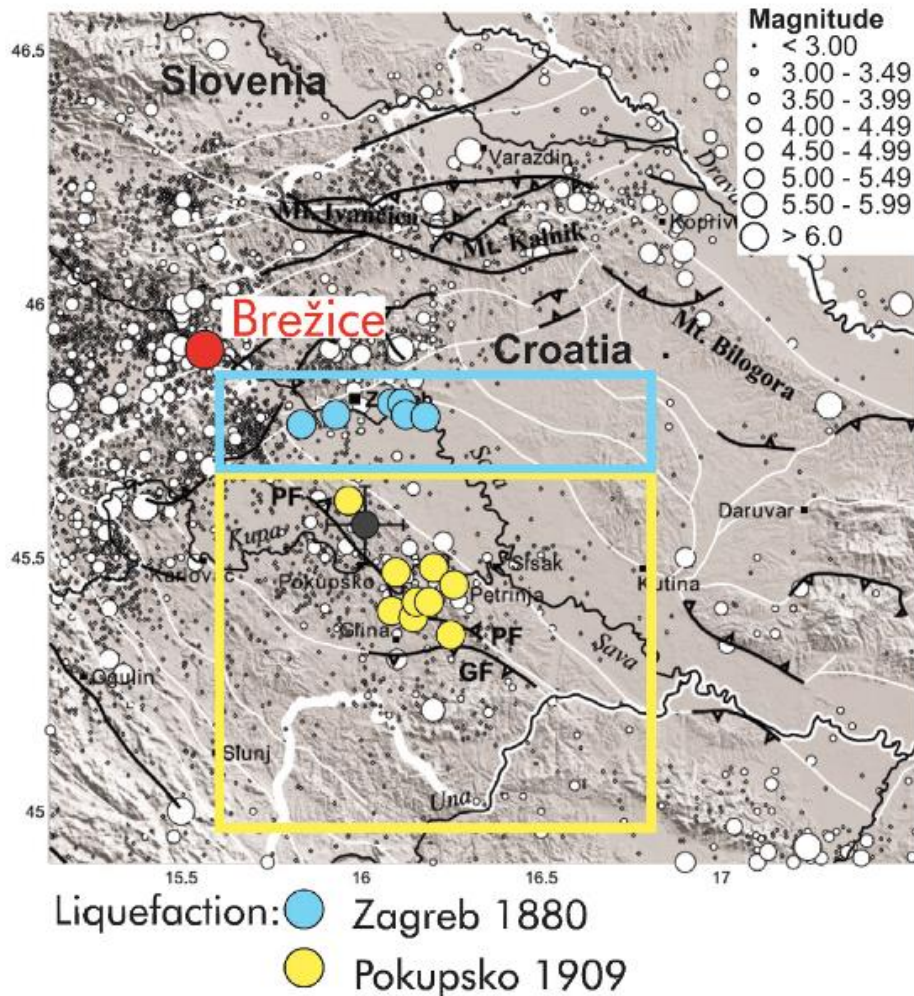
**Figure 6.4.** Epicenters of earthquakes at the Krško-Brežice field and in its close surroundings from 567 to 2007 AD, and the locations where liquefaction-related effects were observed during the Zagreb (blue dots) and Kupa Valley (yellow dots) earthquakes (Veinović et al. 2007, Herak et al. 2009, Herak & Herak 2010) (after Smolar et al. 2019).

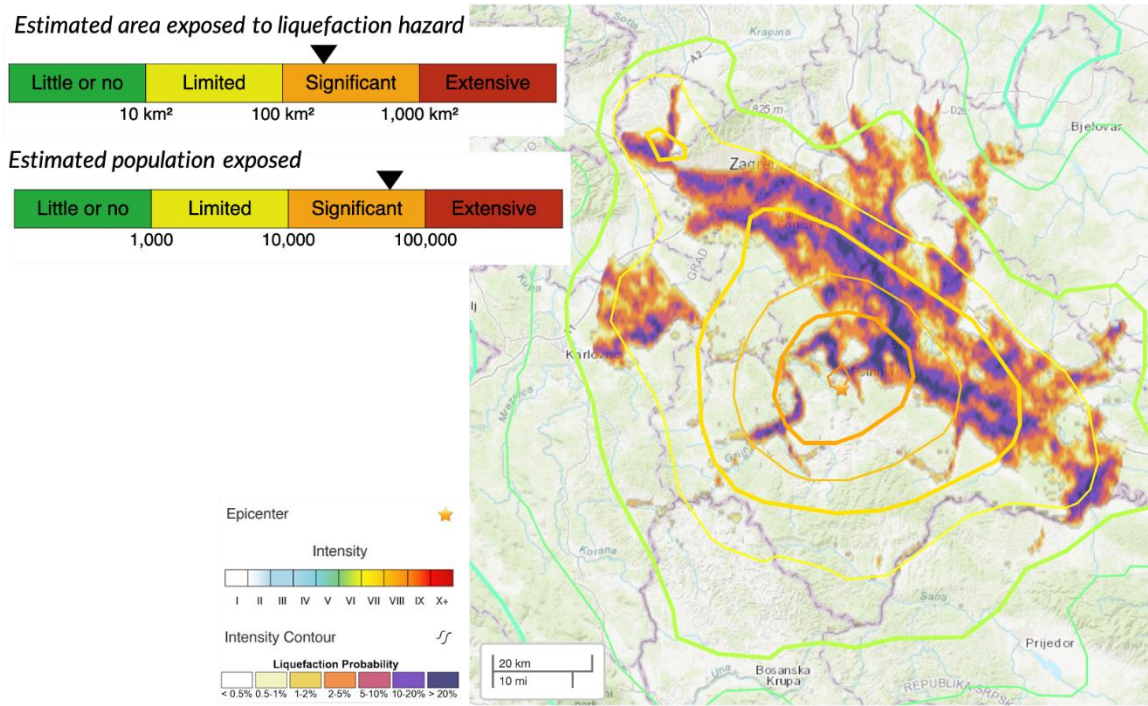
**Figure 6.6.** Liquefaction hazard map based on spatial extent and population exposure level (source USGS).

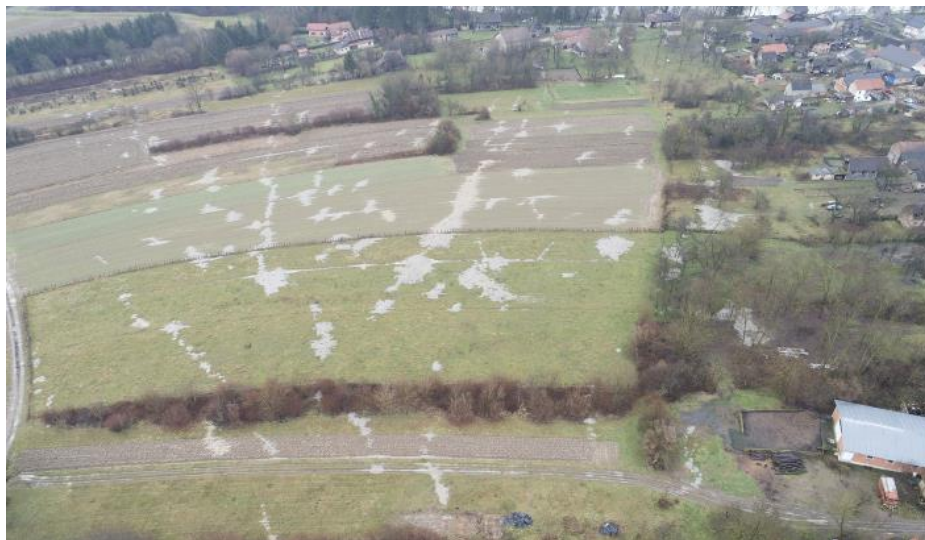
**Figure 6.7.** Aerial image of liquefaction ejecta at (45°30'41.988"N,16°24'37.632"E, source: Vedran Damjanović).

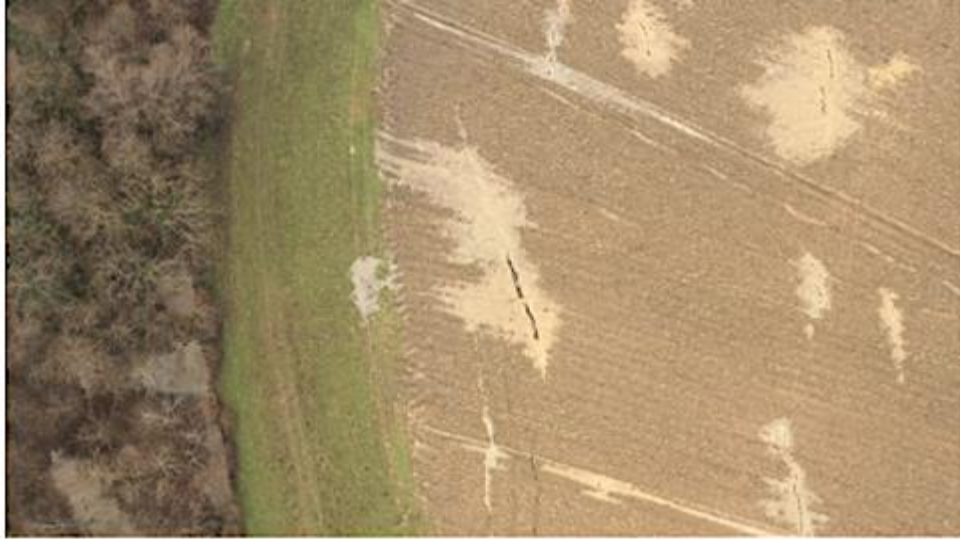
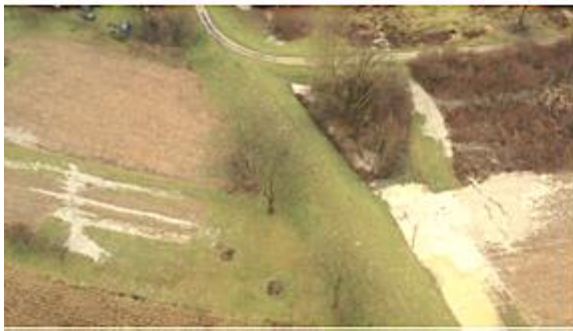
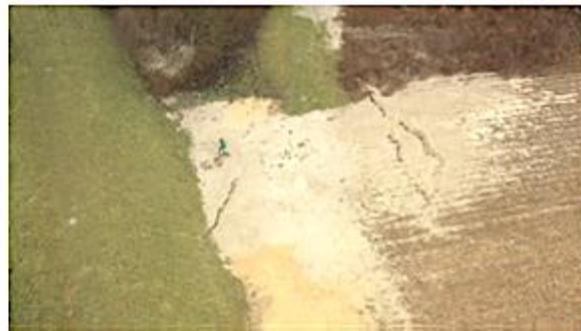
**Figure 6.8.** Liquefaction near Hrastelnica and Sisak. The proximity of these liquefaction surface manifestations to levees indicates that liquefaction was a definite mechanism contributing to the levee failures (see later subsection). The bottom right image is a close-up of the bottom left (source: Croatian Waters Archive).

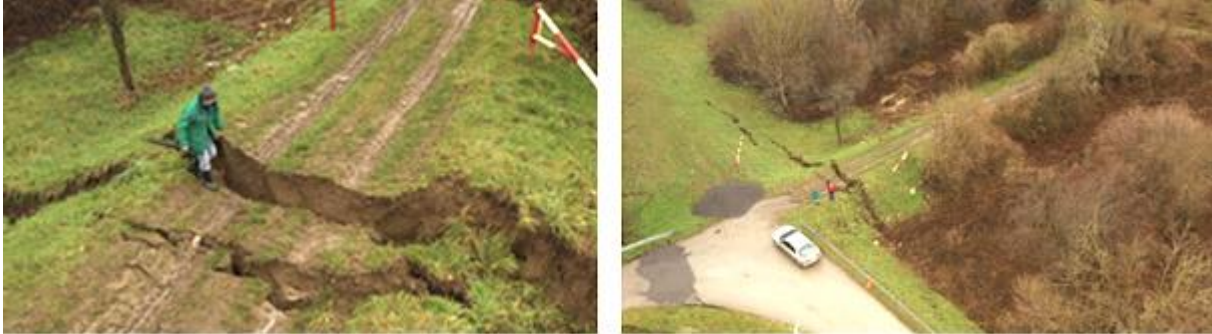
**Figure 6.13.** Rupture of the left riverbank of Sava (source: Croatian Waters Archive).

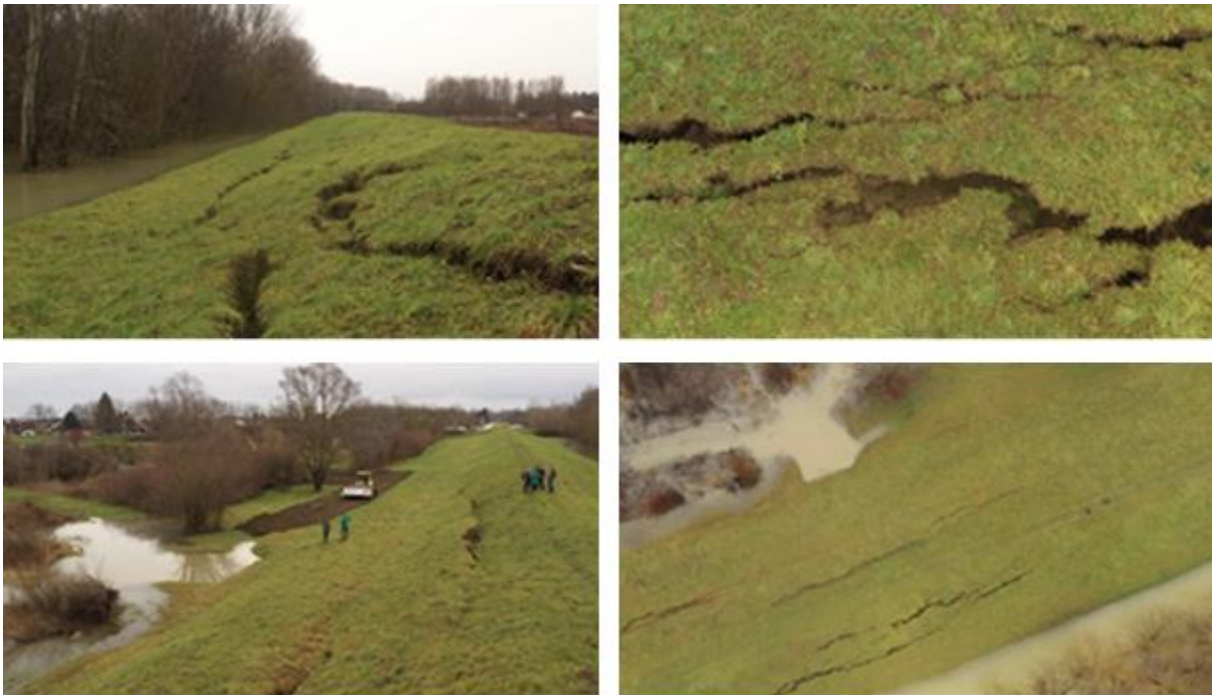
**Figure 6.14.** Embankment / levee failure by river Sava in Galdovo (source: Croatian Waters Archive).

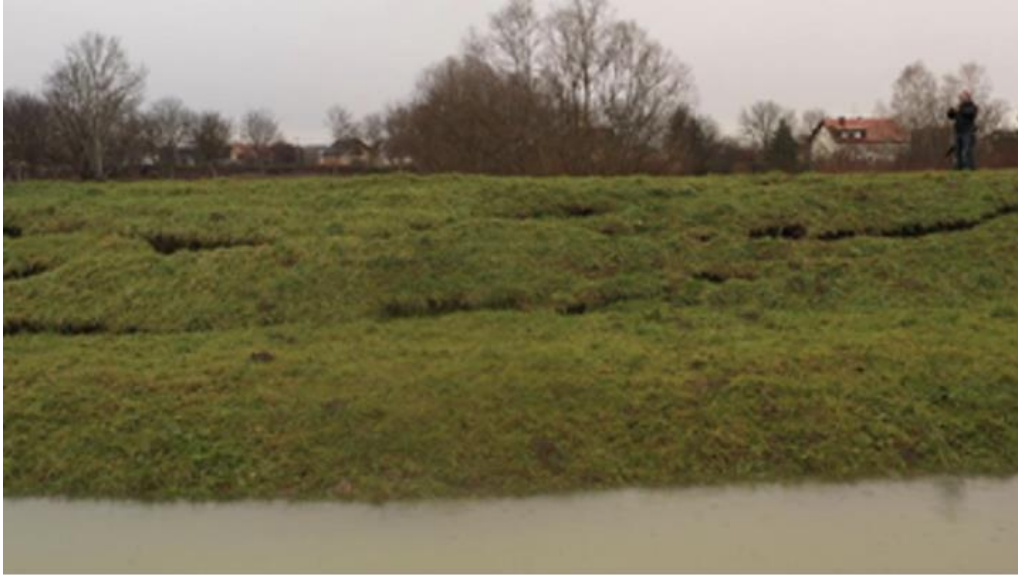
**Figure 6.15.** Embankment failure of river Sava near Hrastelnica (source: Croatian Waters Archive).

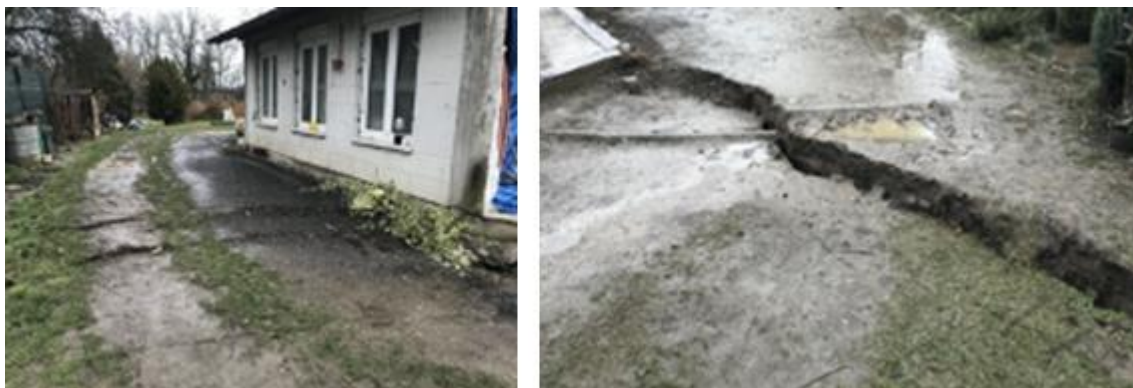
**Figure 6.17.** Building settlement due to lateral spreading, Bok Palanječki (photo: Vedran Jagodnik, 45°30'36.21"N,16°24'38.892"E).

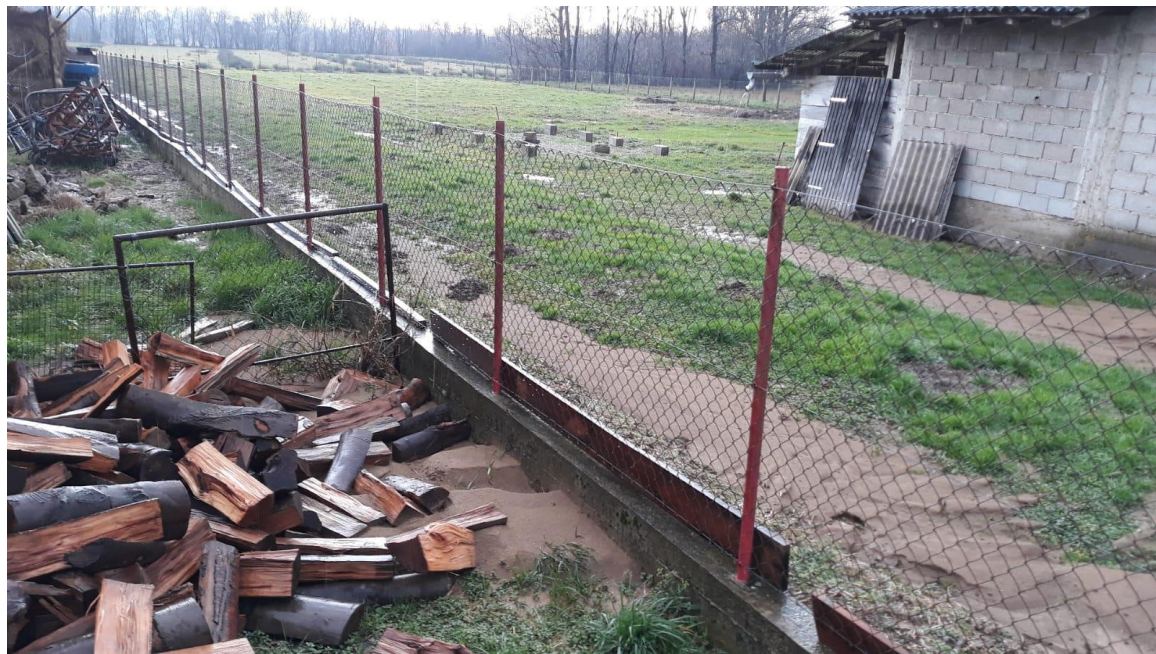
**Figure 6.18.** Crack between two houses due to liquefaction (45.4540, 16.2611). The line of liquefaction spreads through several yards and under houses, Brest Pokupski (source: Tomislav Ivšić, Sonja Zlatović, Igor Gukov).

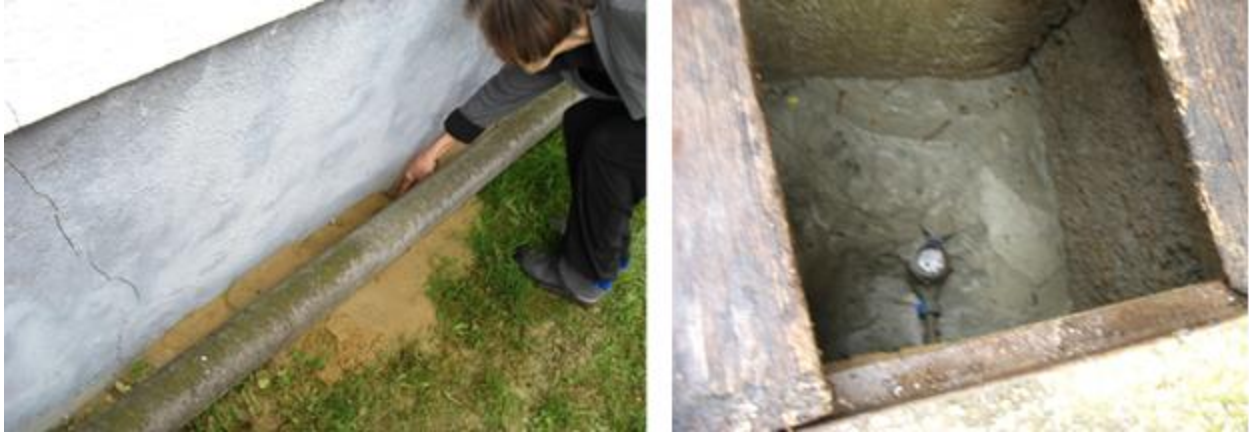
**Figure 6.19.** Liquefaction under a residential building with sandy soil ejected next to the structure and filling the underground space, Petrinja, Ulica Slavka Kolara (45.4349,16.2683, source Sonja Zlatović).

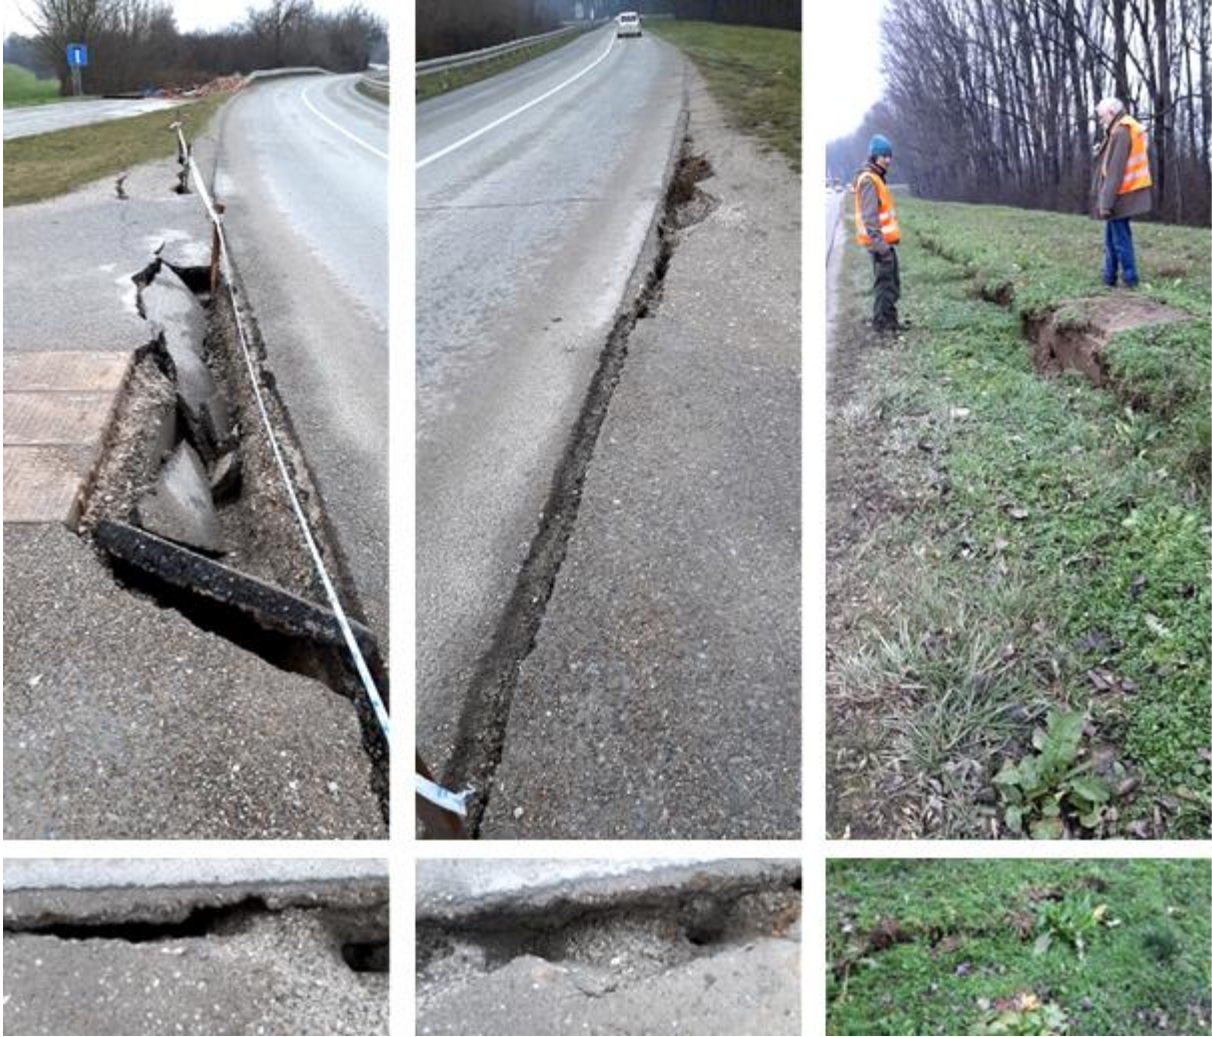
**Figure 6.21.** Settlement of the area between the embankment and the road between Petrinja and the bridge for Brest Pokupski (source Sonja Zlatović). The likely cause for the damage depicted in the left and middle photos, which is compatible with the extensive liquefaction that occurred in the broader area. The right photo shows a longitudinal subvertical crack of the embankment due to subsidence.

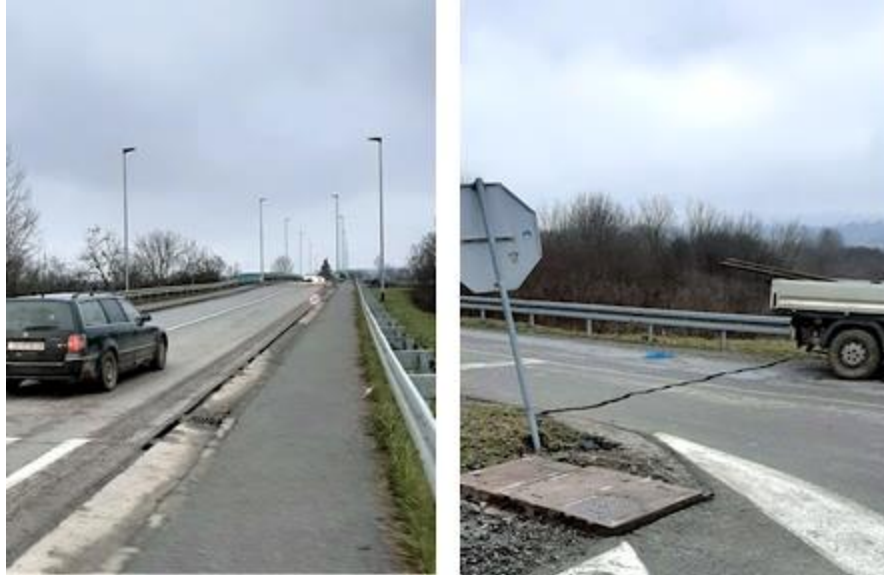
**Figure 6.22.** Bridge Brest, from Petrinja for Brest Pokupski (45.4461, 16.2628, source Sonja Zlatović).

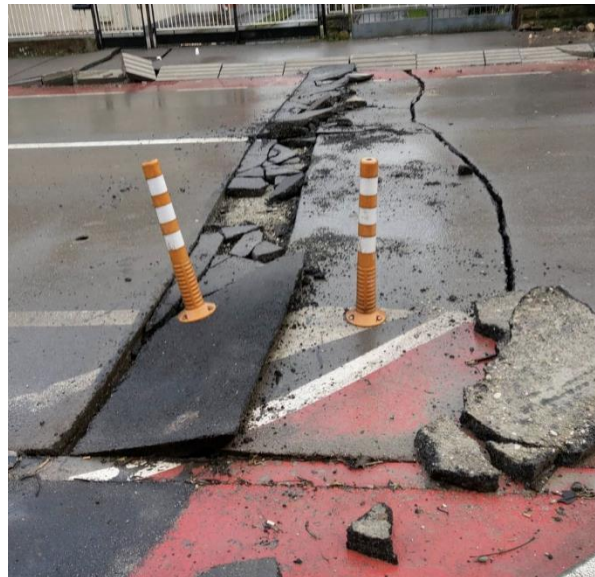
**Figure 6.23.** Road pavement cracking (45°29'45.108"N,16°22'36.888"E, source Zeljko Arbanas).

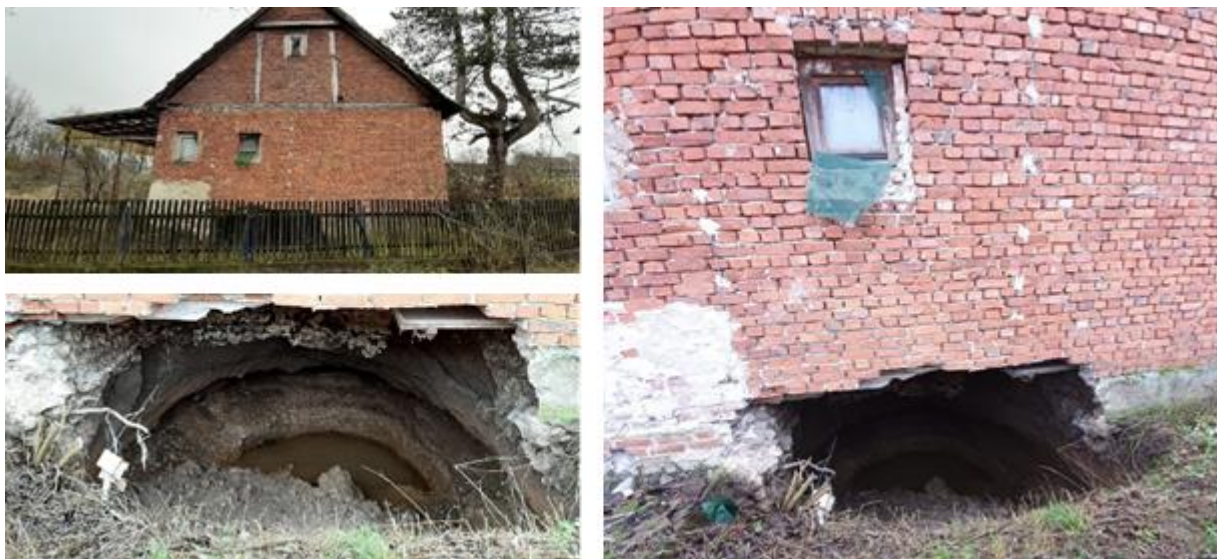
**Figure 6.25.** Sinkhole under a house with quite weak foundations (photos: left: Sonja Zlatović, right: Joško Krolo).
