**EARTHQUAKE ENGINEERING  
RESEARCH INSTITUTE**

**StEER**  
**STRUCTURAL**  
EXTREME EVENTS  
RECONNAISSANCE

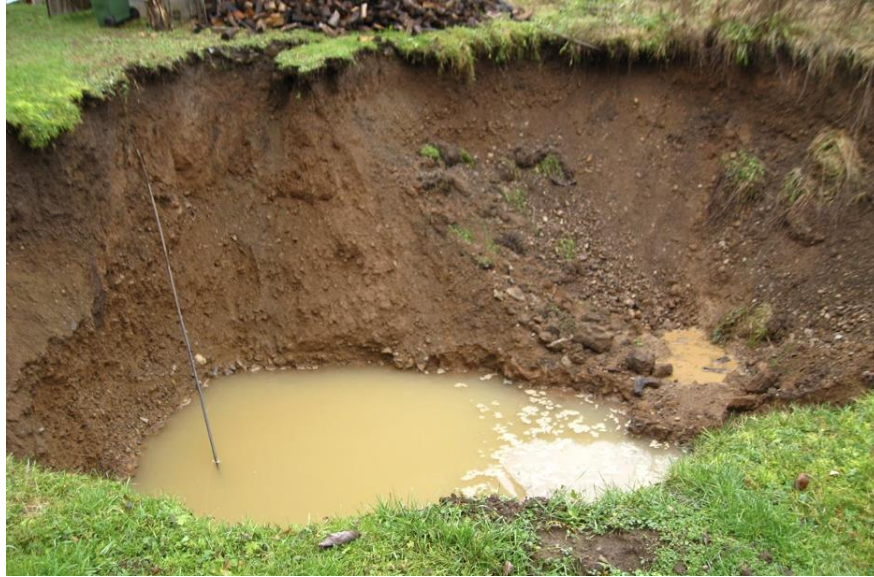
**Figure 6.26.** Sinkhole in Mečenčani (45.2829,16.4298, source Sonja Zlatović).

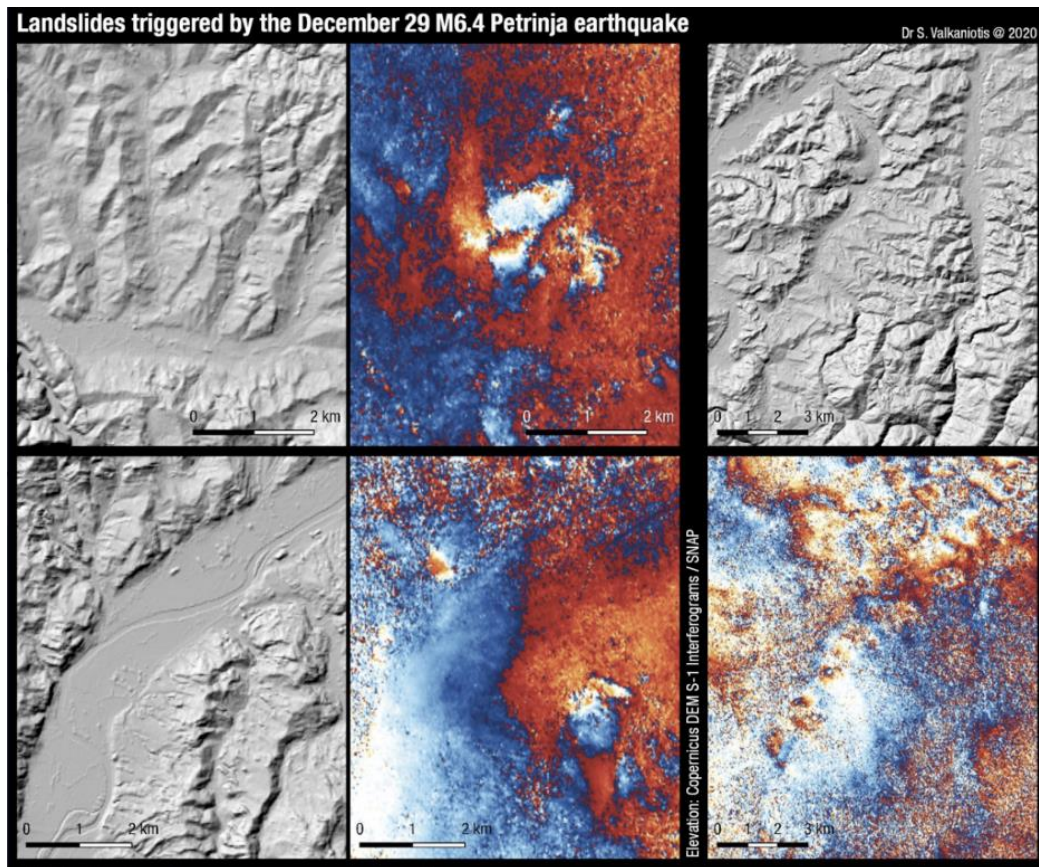
**Figure 6.28.** Sentinel1 interferogram showing the landslides triggered by the  $M_w$  6.4 Petrinja earthquake. Color images show the phase difference (displacement) for a pair of radar images. Each color fringe from blue to red represents 2.8 cm of ground displacement (relative to satellite position). Gray-scale images show topography (image source and explanation by Dr. Sotiris Valkaniotis 2020).

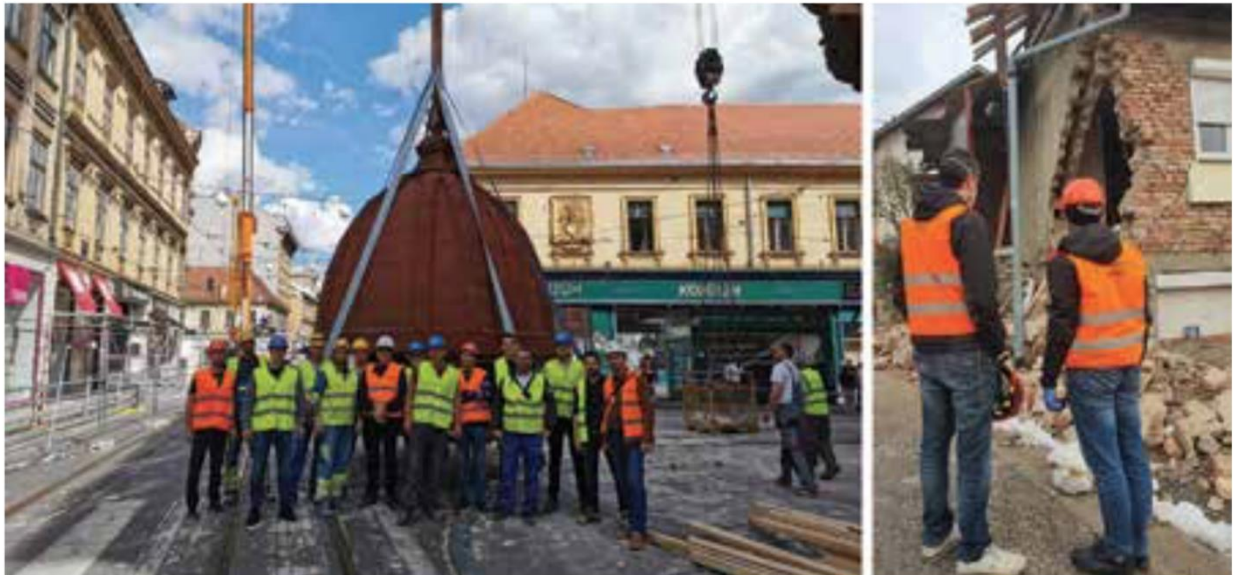
**Figure 7.2.** A group of engineers volunteered to conduct post-earthquake safety evaluations shown in Zagreb after the March 22, 2020 earthquake (source: Šavor Novak et al., 2020).

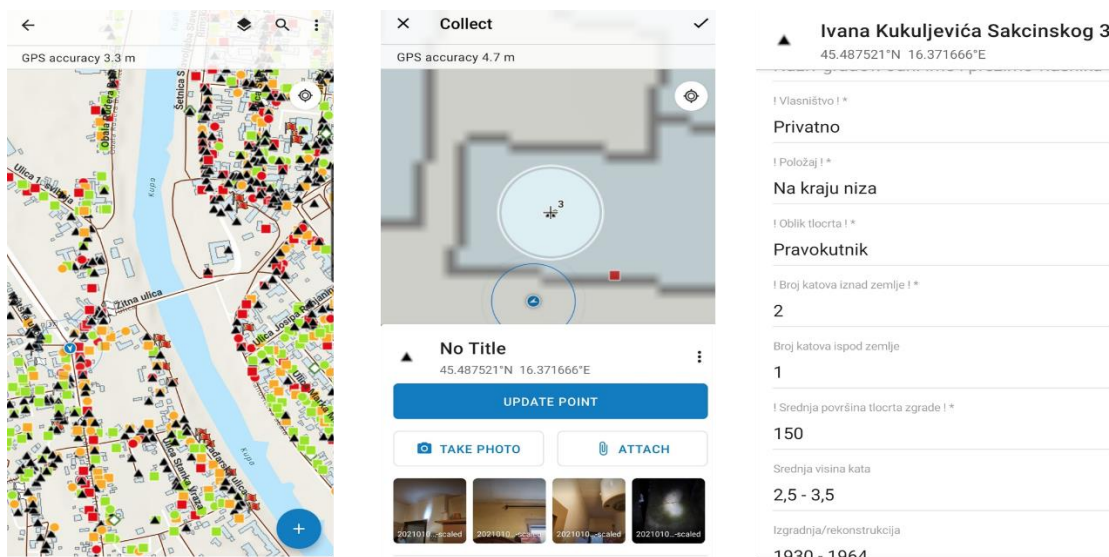
**Figure 7.4.** Screenshots of Collector for ArcGIS mobile app: (left) map indicating inspected locations where tags are color-coded as well as remaining locations indicated by black triangles, (middle) zoom in on a specific area and associated photos, (right) evaluation fields to be filled out by engineer on site (source: Marko Bartolac).

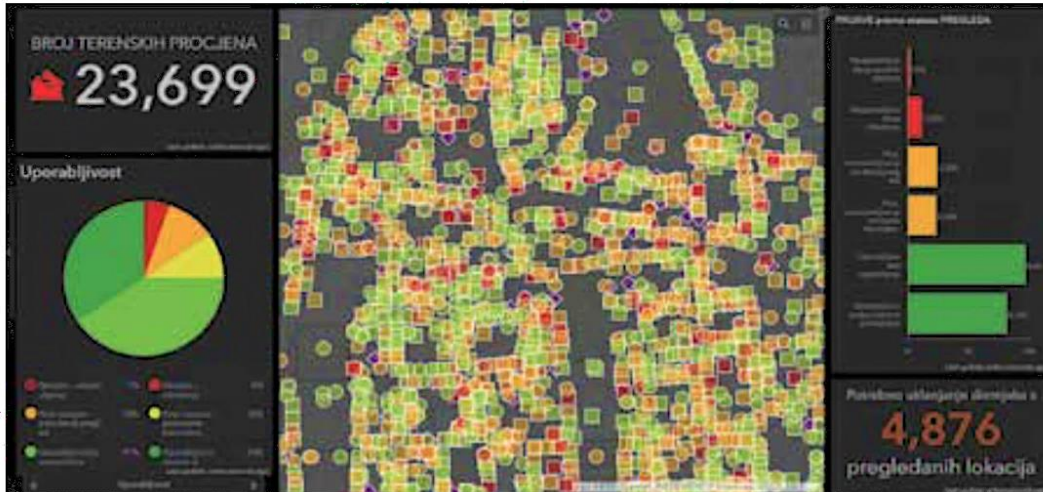
**Figure 7.5.** Example of the visualization of tagged buildings as of June 8, 2020, in the HCPI database (source: HCPI).

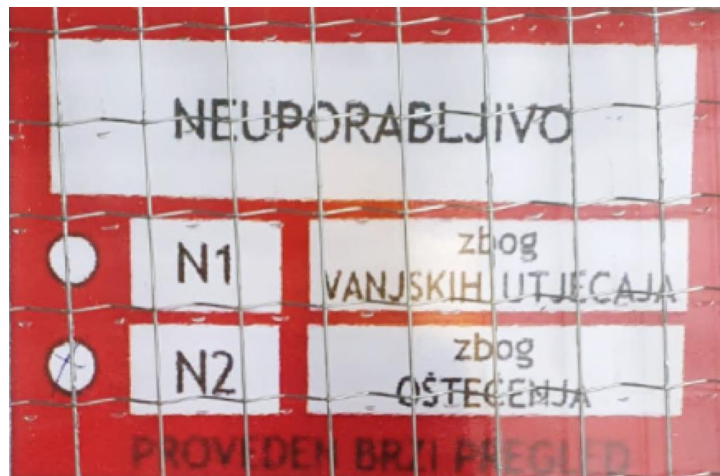
**Figure 7.6.** Example of red tags used by HCPI during their post-earthquake safety evaluations (Source: Damir Lazerevic).
