StEER
STRUCTURAL
EXTREME EVENTS
RECONNAISSANCE

HURRICANE IDALIA

PRJ-4123

PRELIMINARY VIRTUAL RECONNAISSANCE REPORT (PVRR)

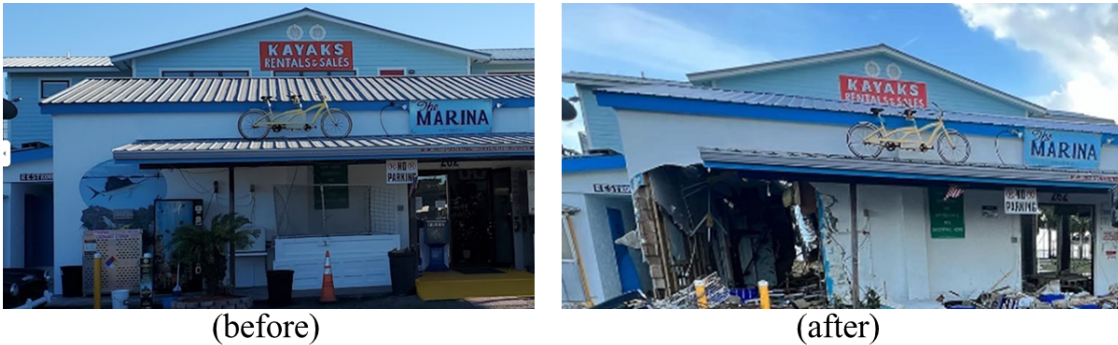
Multiple instances of failure of masonry or masonry-supported structures due to storm surge were observed and are summarized in Figures 4.1-4.3. Figure 4.1 shows a surge-induced out-of-plane collapse of a front masonry wall of a commercial building located in Horseshoe, FL.

Figure 4.1. Collapse of concrete masonry wall of commercial building in Horseshoe Beach, FL (Source: Vic Micolucci via [Facebook](#)).

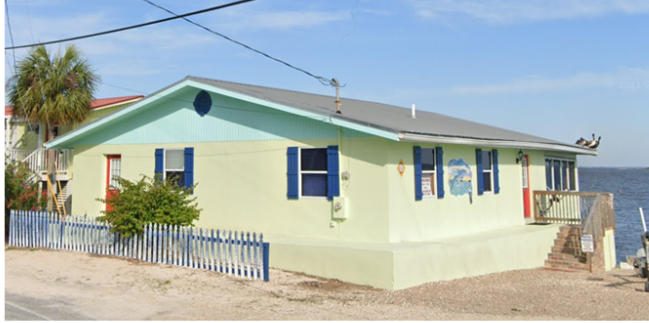
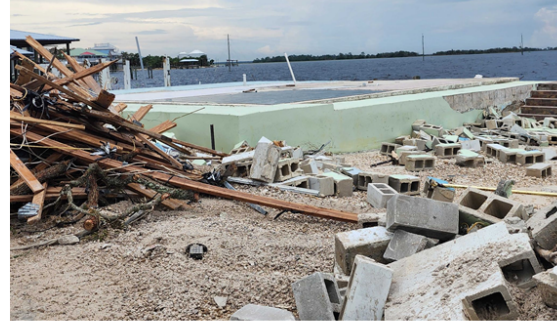
Figure 4.2 demonstrates the complete destruction of a nearshore single-story concrete masonry home constructed in 1970 at Horseshoe, FL. The photograph in the right panel of the figure shows that the home employed an ungrouted concrete masonry wall system with no evidence of positive anchorage to the concrete slab, which subsequently collapsed during the storm.

Figure 4.2. Complete loss of single-story unreinforced concrete masonry house in Horseshoe Beach, FL (Source: Nina Stark, Rutgers University via [DesignSafe-CI Slack](#)).

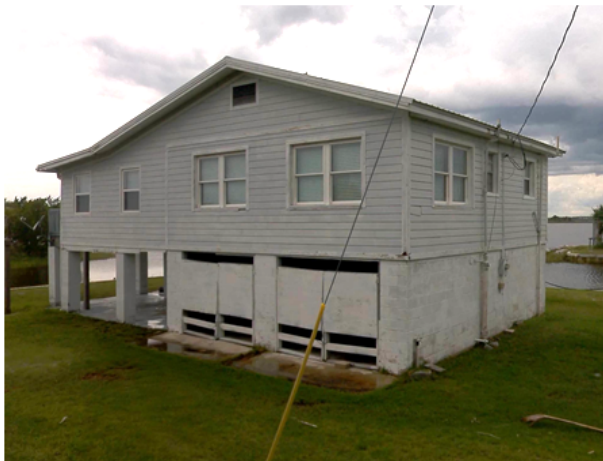
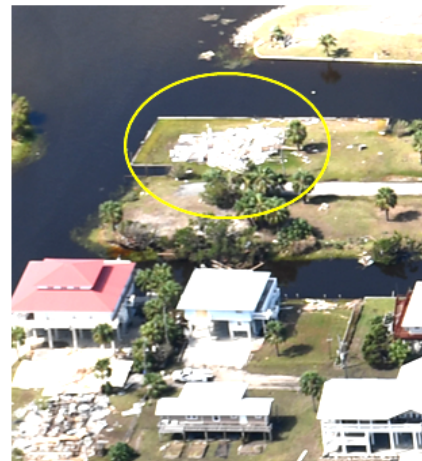
Figure 4.3. Complete loss of home elevated on masonry piers in Horseshoe Beach, FL (Sources: [Site Tour 360](#) (left) and [Civil Air Patrol](#) (right)).

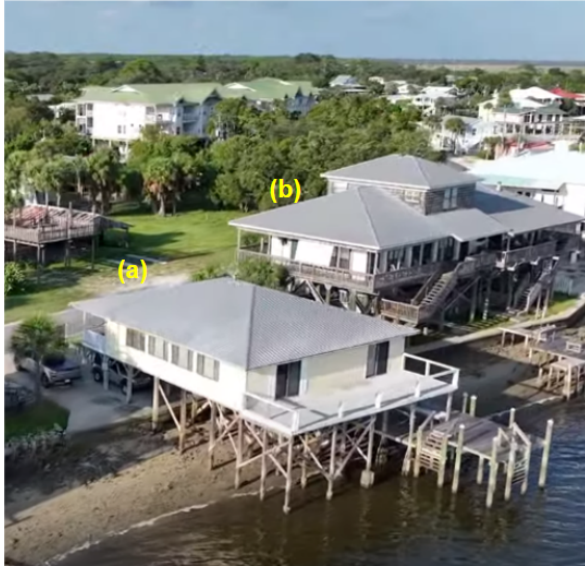
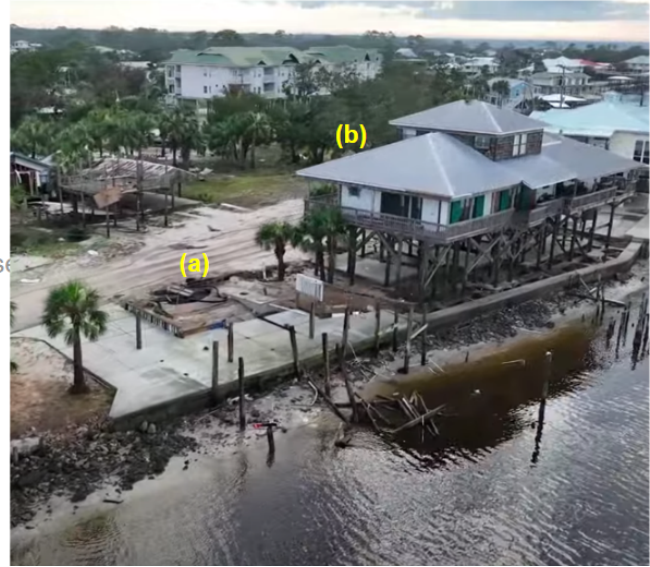
Figure 4.4 shows an elevated wood structure (labeled (a) in Fig. 4.4) that was washed away during Hurricane Idalia in Horseshoe Beach, FL. The structure was built in 1937 and elevated nearly 6 ft above grade. The structure was supported on wooden piles, many of which failed and lost connection to the superstructure during the storm. The pile system was supported by diagonal bracing in the direction of the surge flow. Failure may be attributed to insufficient elevation of the lowest horizontal structural member above grade and inadequate pile-to-superstructure connection detailing. An adjacent home constructed in 1994 (labeled (b) in Fig. 4.4) survived but lost some ground floor enclosures.

Figure 4.4. Before and after views showing disparate surge performance in Horseshoe Beach, FL. The elevated wood-frame home that was washed away (a), was constructed in 1937 and elevated approximately 6 ft above grade. The elevated home that is still standing was constructed in 1994 and was elevated approximately 10 ft above grade (Source: WXChasing [YouTube](#)).

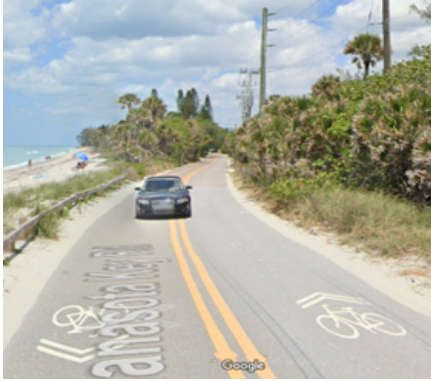
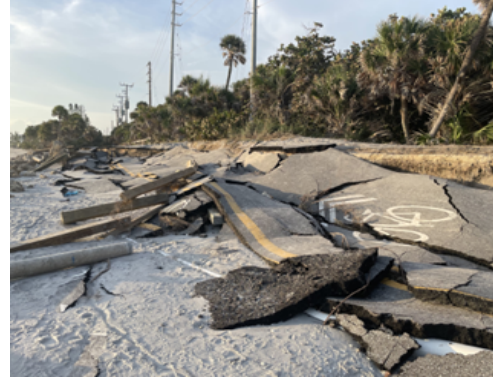
Hurricane Idalia-induced storm surge inundation around Englewood Beach caused a portion of the road to fail (Fig. 5.4). In South Carolina, the storm surge induced damage to nonstructural concrete slope protection panels installed on the sloping abutment below an overpass bridge on Highway 31. According to the South Carolina Department of Transportation, a portion of the bridge was closed to repair the damage (Benson, 2023) (Fig. 5.5).

Figure 5.4. Englewood Beachside Road, FL 34223, (26.96659, -82.38780) (Source: [Sun News](#))

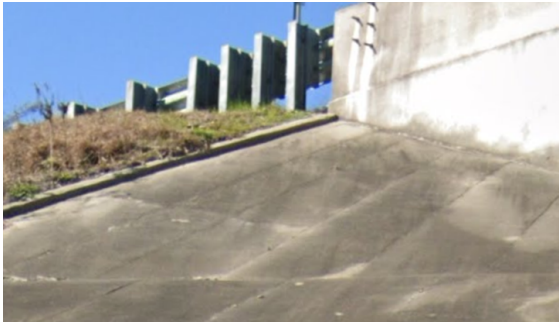
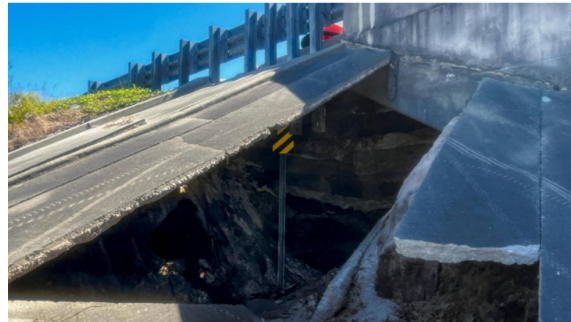
Figure 5.5. Highway 31, North Myrtle Beach, SC (33.844063, -78.701240) (Source: [Sarasota County Government via X \(formerly Twitter\)](#))

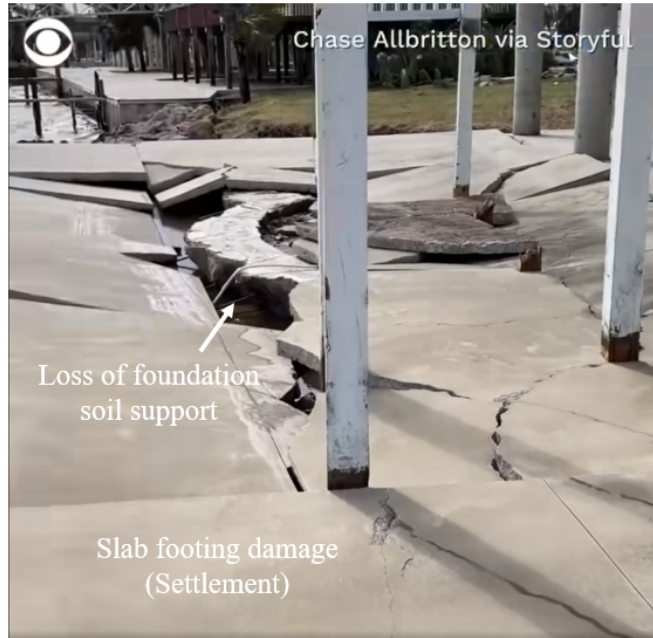
Geotechnical damage from Hurricane Idalia occurred throughout the area, including reports of scour-induced settlement and failure of column-to-footing connections at several locations (see [News report, CBS News](#) (CBS News, 2023); Fig. 6.1). A notable failure of an open shed structure on a peanut processing facility results from the pull out of 3-foot deep concrete foundations due to high wind uplift forces (Fig. 6.2). Many utility pole failures were also observed throughout the affected region.

Figure 6.1. View of Shallow foundation (slab footing) damage of residential structure showing severe washout (Source: [Chase Allbritton via Storyful](#)).

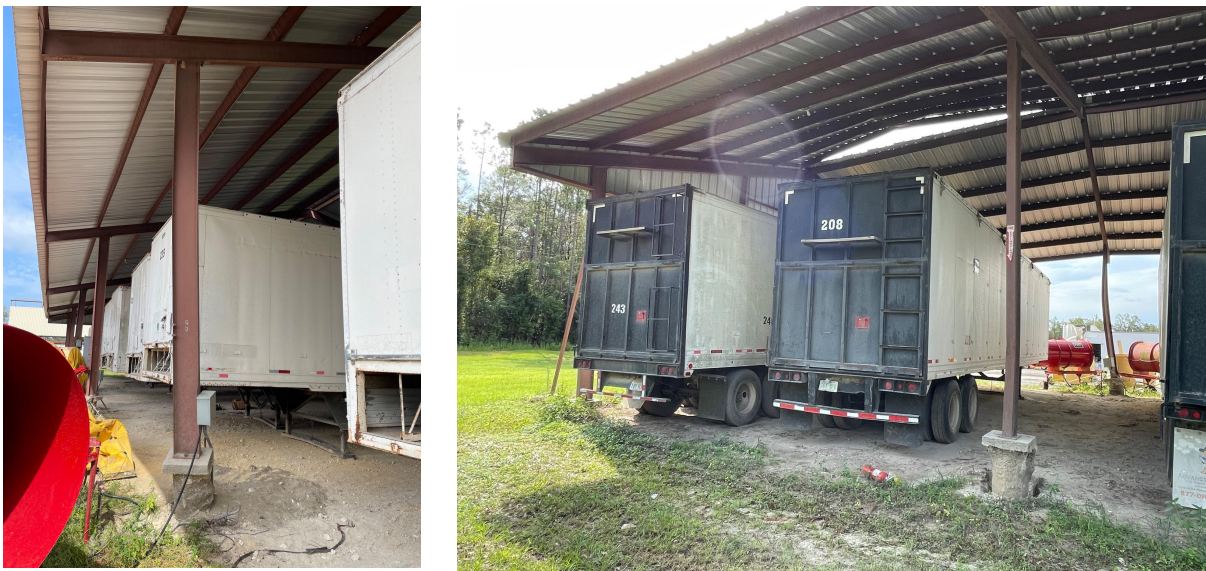
Figure 6.2. Column-foundation pull-out capacity failure. (Source: UF Building Performance Observation Survey on [2023-hurricane-idalia-vast design safe slack channel](#))
