<b>StEER</b> <b>STRUCTURAL</b> EXTREME EVENTS RECONNAISSANCE	<b>EVENT BRIEFING</b>		
	Event:	10.20.2019 Dallas, TX EF-3 Tornado	
	Region:	Dallas, TX	
Authors:	David Roueche, Auburn University Ian Robertson, University of Hawaii		
Editors:	David O. Prevatt, University of Florida Tracy Kijewski-Correa, University of Notre Dame		
DesignSafe Project #	PRJ-2600	Release Date:	October 24, 2019

10.20.2019 EF3 Dallas, TX Tornado | Released October 24, 2019

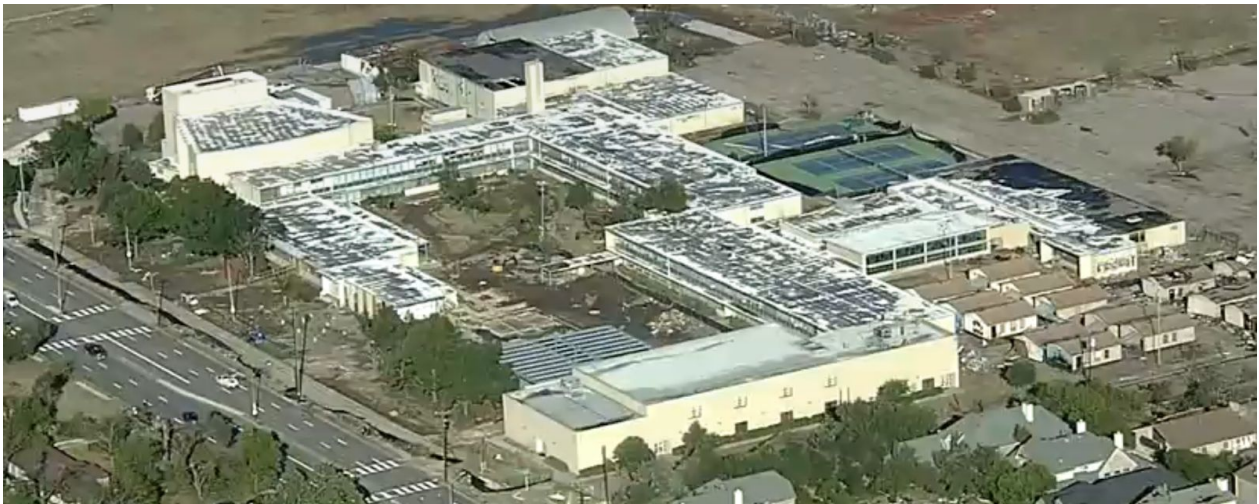
**Figure 3.** Thomas Jefferson High School with primarily envelope and cladding damage to the main facility (Source: [Fox 7 Austin](#)).

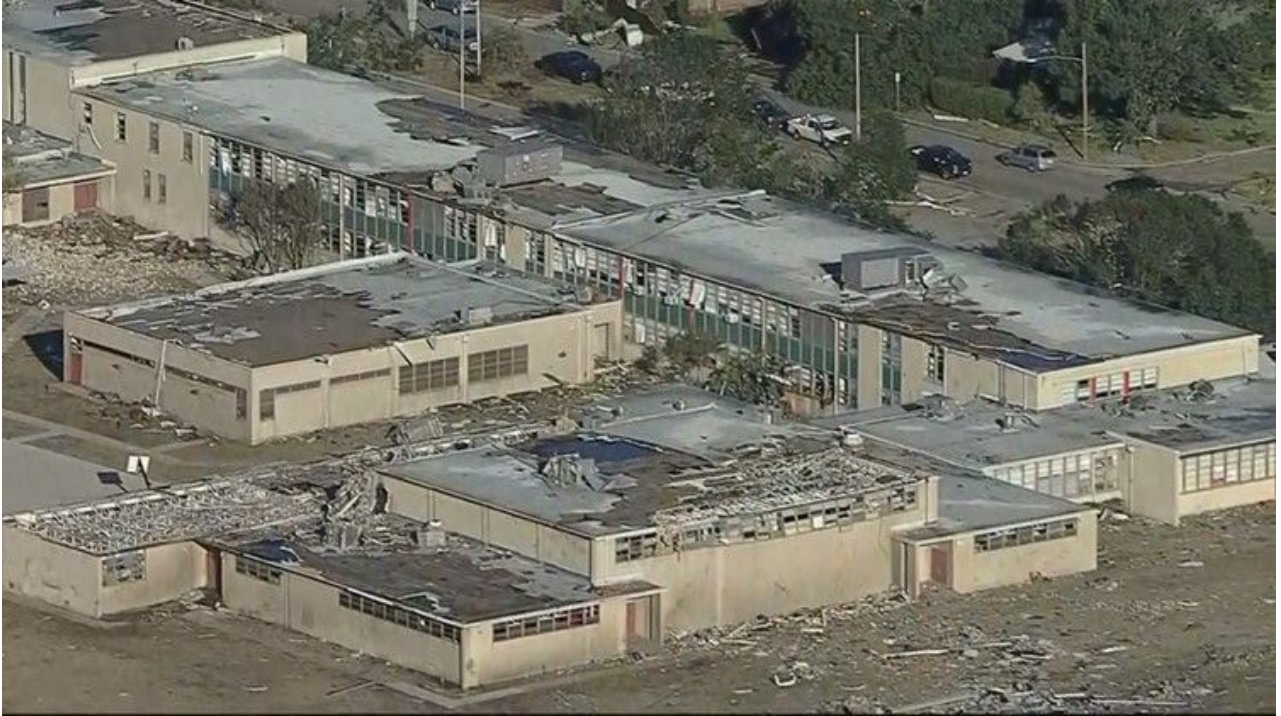
**Figure 4.** Cary Middle School with severe damage to cladding and fenestration and some structural roof damage (Source: [WFAA TV](#)).

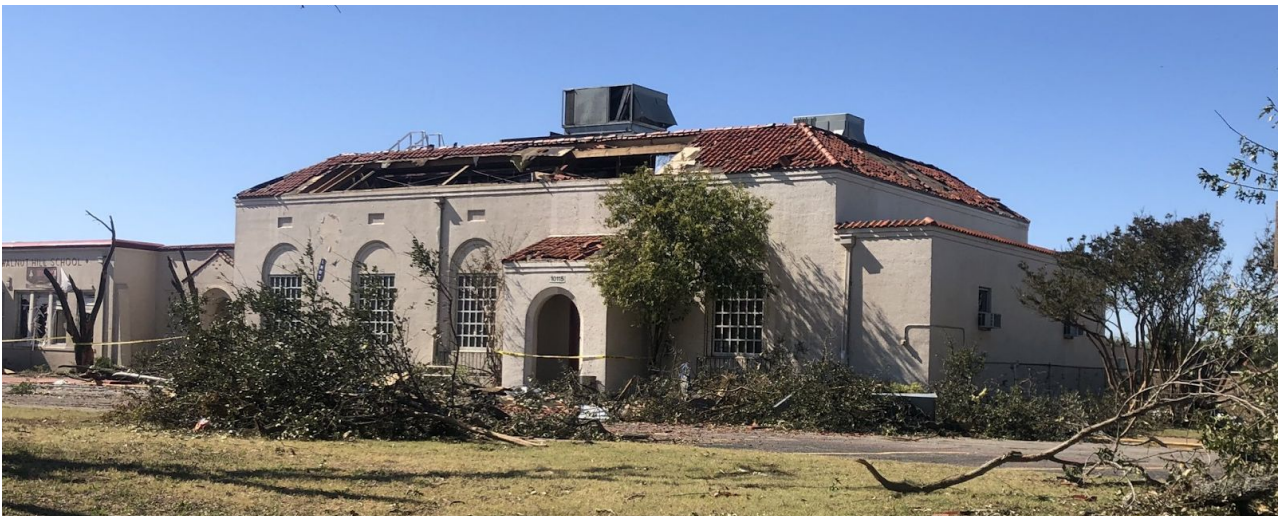
**Figure 5.** Walnut Hill Elementary School with structural roof damage (Source: [Fox 4 News](#)).

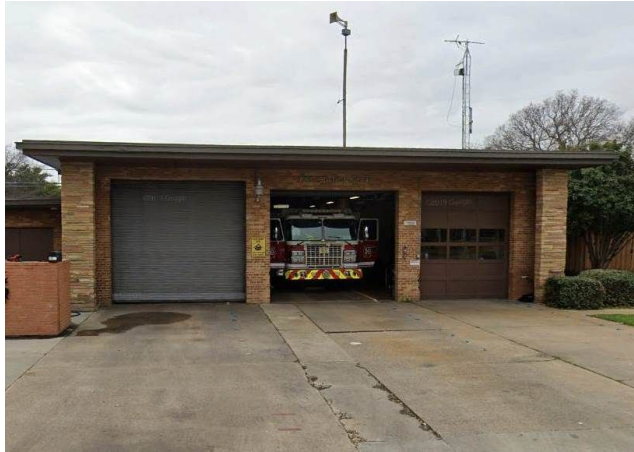
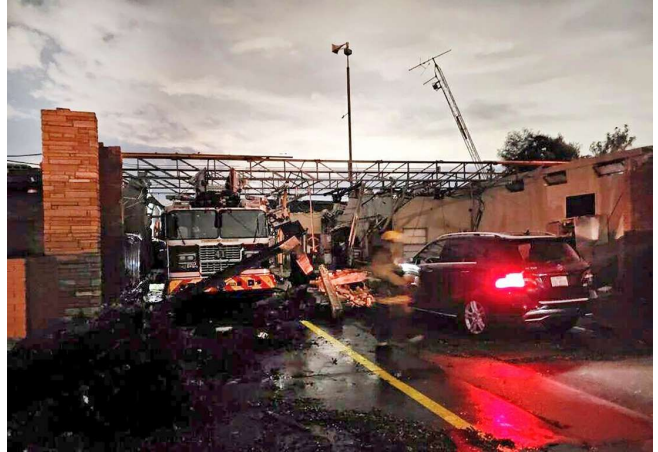
Figure 6 shows before and after images of Dallas Fire Station #41. The tornado damage to the roof and front doors of the fire station likely rendered the building and equipment unusable for recovery after the event. Figure 7 and 8 show before and after images of two church buildings with substantial to total structural damage. Figure 9 shows before and after images of a roof failure at Preston Royal shopping center. Figure 10 shows damage to the Home Depot near US HWY-75.

**Figure 6.** Google street view image of Dallas Fire Station #41 before the tornado (left) and photo taken after the tornado (right) (Lat: 32.8945N; Long: 96.8065W) (Sources: MSN 2019, DALLAS FIRE-RESCUE/HANDOUT/EPA-EFE/Shutterstock)

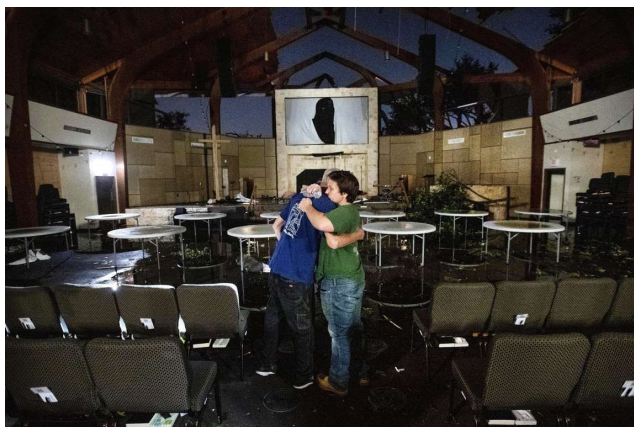
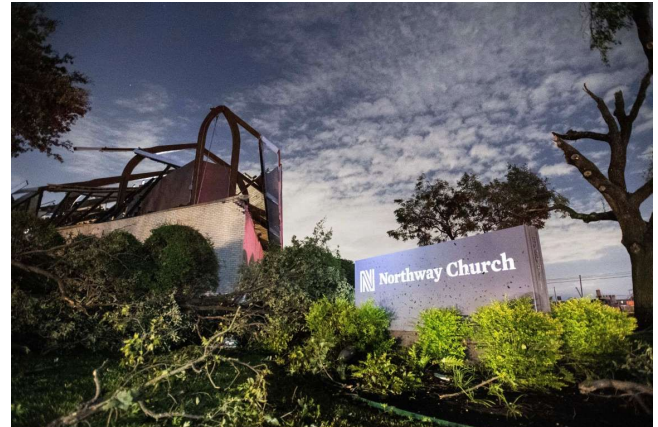
**Figure 7.** Tornado damage to Northway Church building (Lat: 32.8845N, Long: 96.8496W) (Sources: MSN 2019, Jeffrey McWhorter/AP Photo)

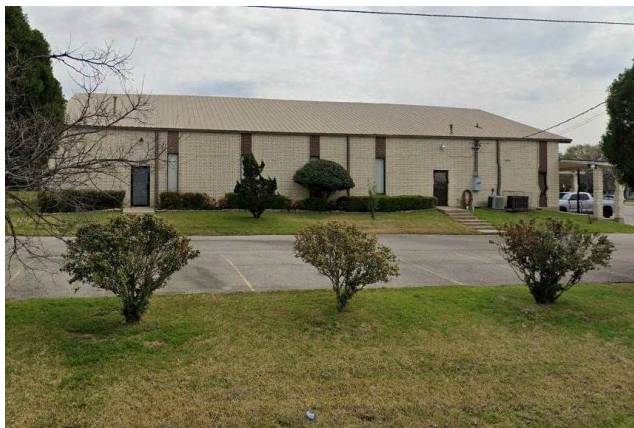
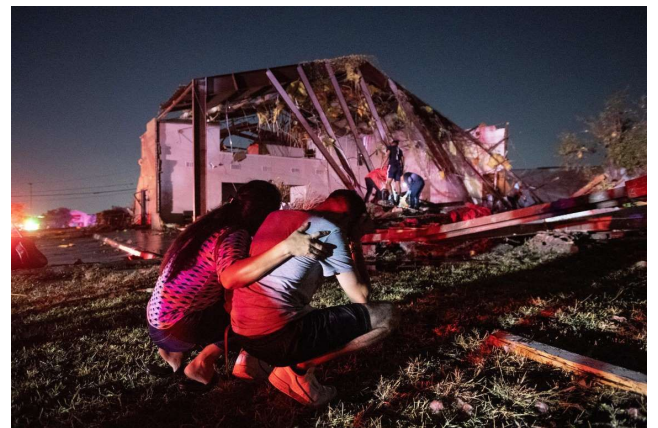
**Figure 8.** Google street view image of Primera Iglesia Dallas church before tornado (left) and photo

taken after the tornado (right) (Lat: 32.8811N; Long: 96.8536W) (Source: MSN 2019, Jeffrey McWhorter/AP Photo)

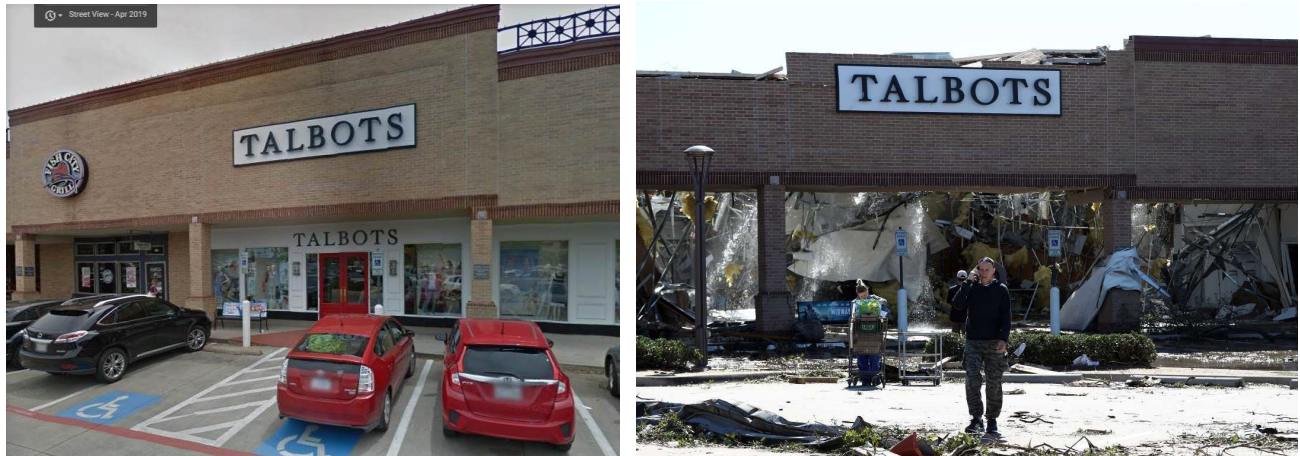
**Figure 9.** Google Street View before tornado and roof failure after tornado at Preston Royal Shopping Center (Lat: 32.8935N; Long: 96.8023W) (Sources: MSN 2019, Ronald Martinez/Getty Images)

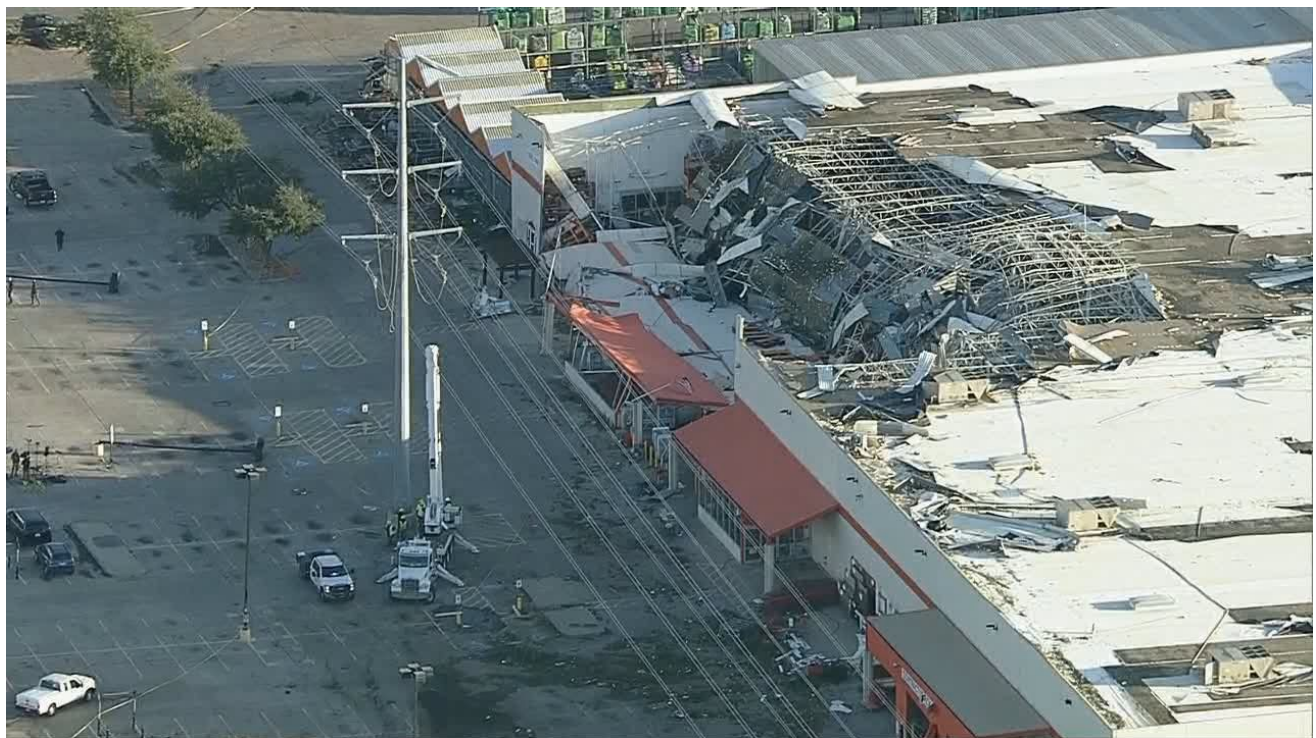
**Figure 10.** Aerial view of damage to the Home Depot (Lat: 32.906987; Long: -96.764696) (Sources: [Fox 4 News](#)).

A number of wooden power poles were snapped, causing power outages for over 150,000 customers. Several photos, such as Figure 10, showed main distribution lines still intact for at least portions of the tornado path. While the tornado crossed over several roadways and overpasses, no structural damage has been reported.

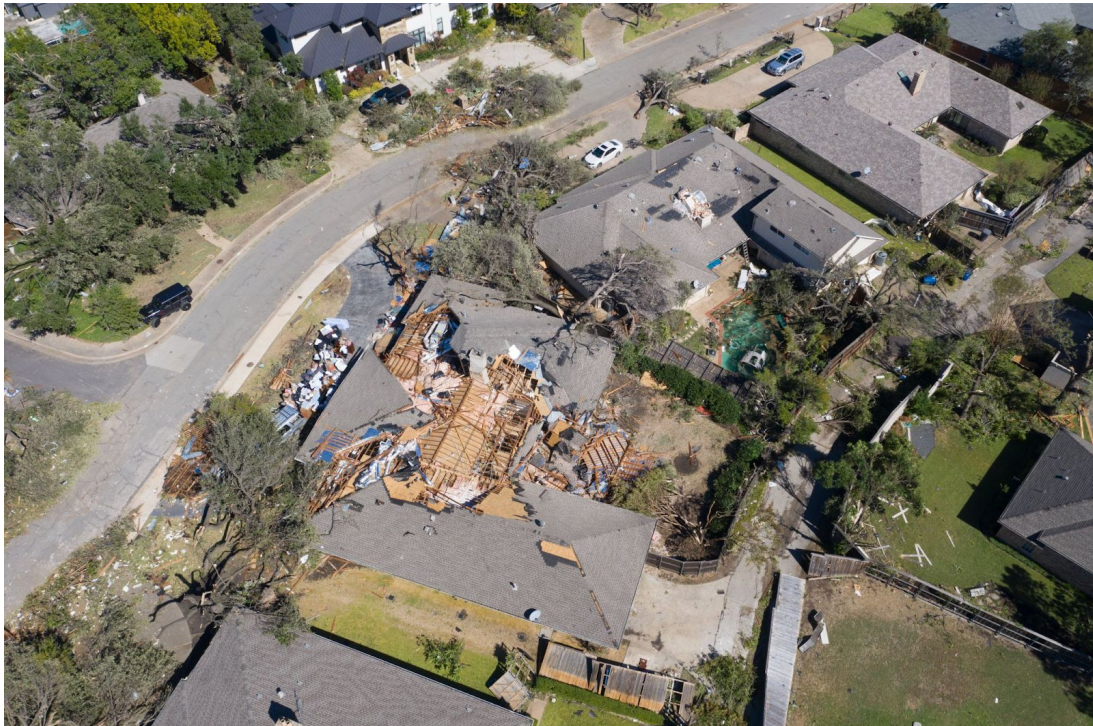
Damage to residential buildings was widespread, including both single-family homes and apartments, at both middle- and high-income levels. Figure 11 illustrates the intermittent nature of the damage, with the roof severely damaged in one home and little visible damage to adjacent homes. Figure 12 illustrates damage to a home in the more affluent Preston Hollows neighborhood in Dallas. Figure 13 shows roof and upper story wall damage to an apartment building in the Walnut Hill area. A field investigation of the 2015 EF4 tornado in nearby Garland and Rowlett found that residential structures were generally poorly constructed for wind resistance, with toe-nail roof-to-wall connections, presence of non-structural wall sheathing, and improper anchor bolt installation at the roof-to-wall connections (Prevatt and Roueche, 2017). Both high-income and middle-income-level homes were found to perform equally poorly.

**Figure 11.** Isolated roof damage to a single-family home with limited impacts to adjacent homes (Source: [Twitter via @Jberm236](#)).

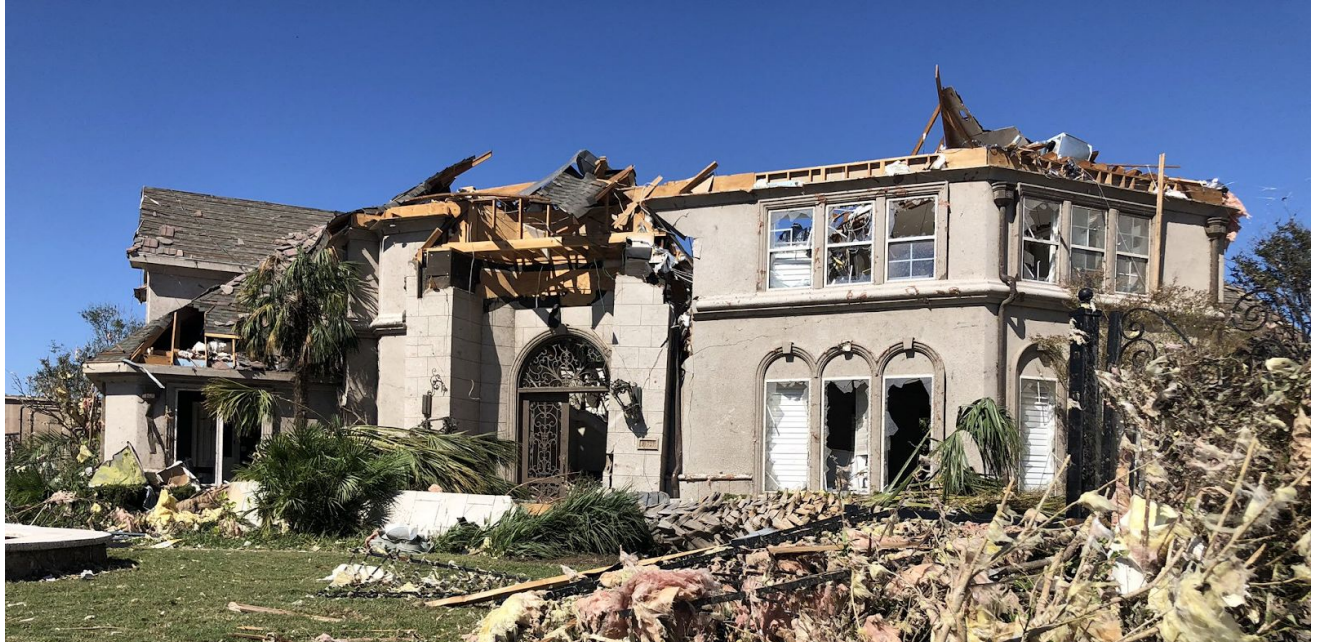
Figure 12. Damage to a single-family home in the Preston Hollows neighborhood (Source: [CBS 11](#)).

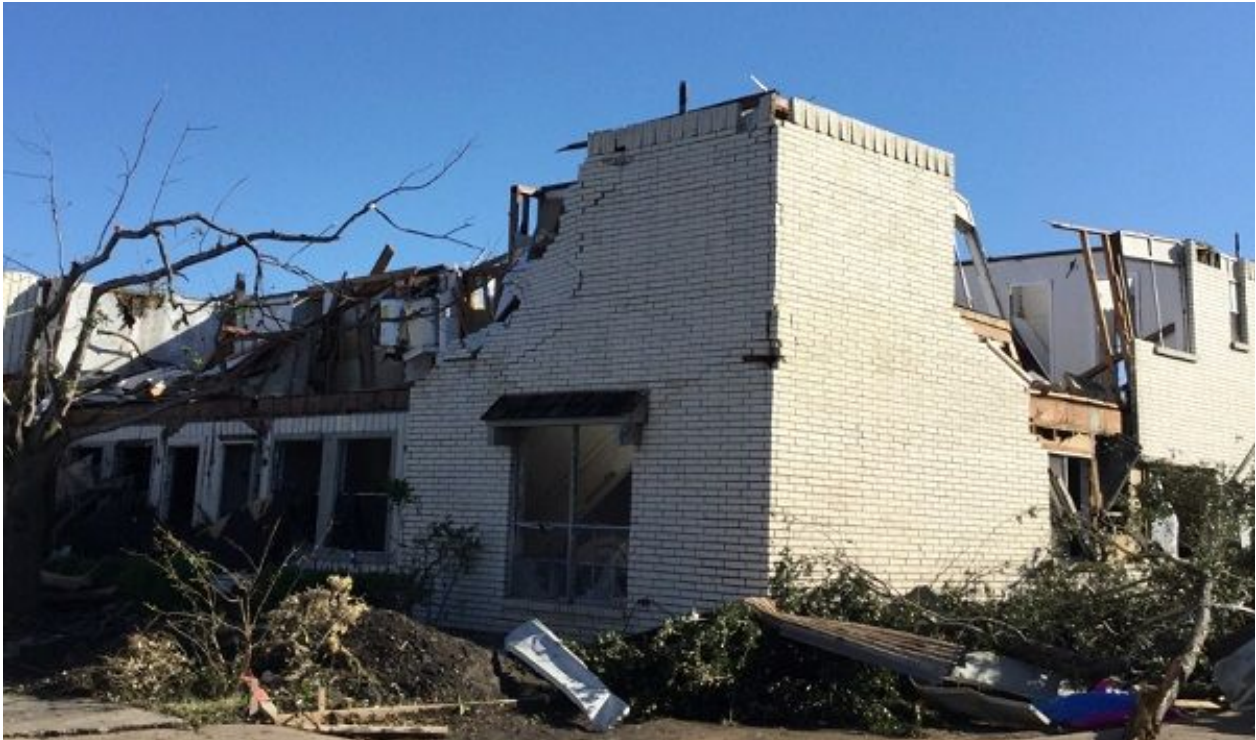
Figure 13. Damage to apartments located in Walnut Hill (Source: [NWS Fort Worth](#)).
