Mw 6.1 Duzce, Turkey Earthquake

November 23, 2022

PRELIMINARY VIRTUAL RECONNAISSANCE REPORT (PVRR)

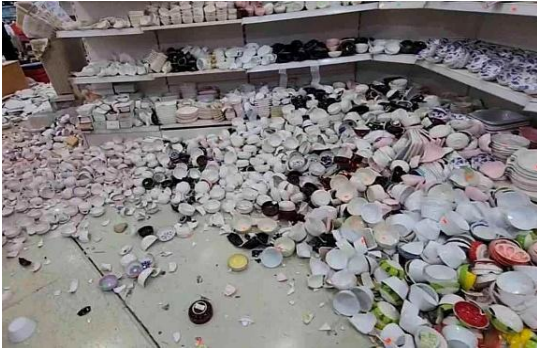
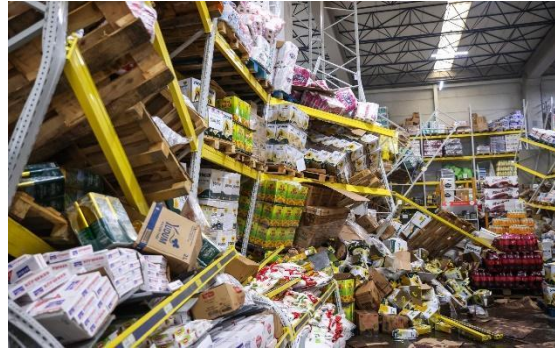
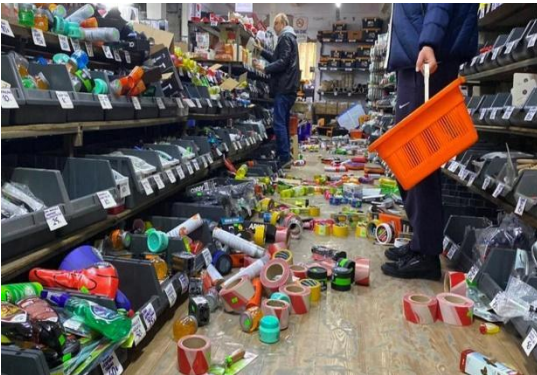
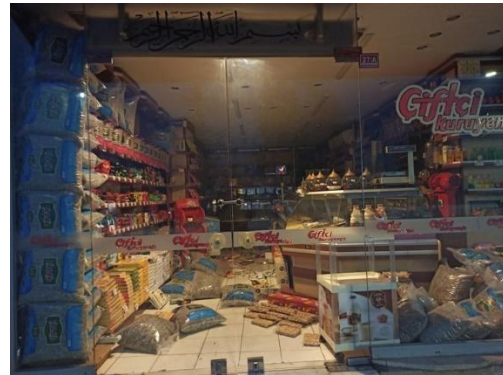
Significant loss was reported due to nonstructural damage in the commercial areas of Golyaka and Duzce. In most cases, shelves collapsed, or items fell in the stores during the strong shaking as shown in Figure 1.4. Although the commercial buildings did not experience severe structural damage during the earthquake, consistent with the nonstructural damage examples shown in Figures 1.4 to 1.7, the economic loss due to damage to the assets, goods, and

Figure 1.4. Nonstructural damage in stores (Sources: (a) T4Haber (2022), (b) Daily Sabah (2022), and (c) & (d) Tasdemir (2022)).

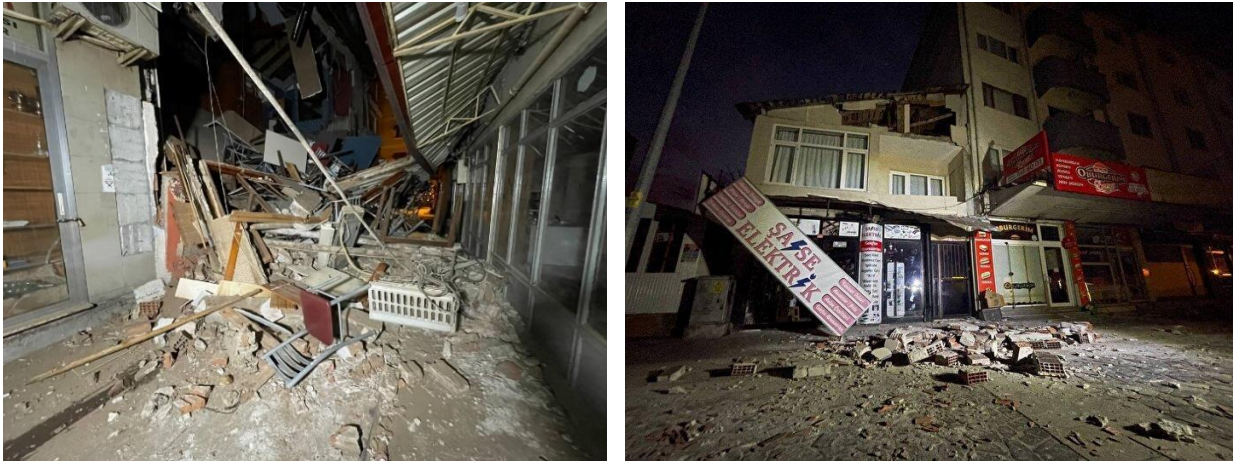
products appeared to be relatively high, such as the glass manufacturing factory in Figure 1.6. As shown in Figure 1.5, even if there was no damage in some shops and stores, due to nonstructural damage in the area, they had to be closed for a period of time until cleanup was complete. There was no report of structural damage in the Duzce Glass factory during the earthquake (Fig. 1.6). However, significant losses occurred as the vertical stacks of ready-to-ship glass products were shattered.

Figure 1.5. Damage in shopping areas and store fronts (Source: Yenisafak (2022)).

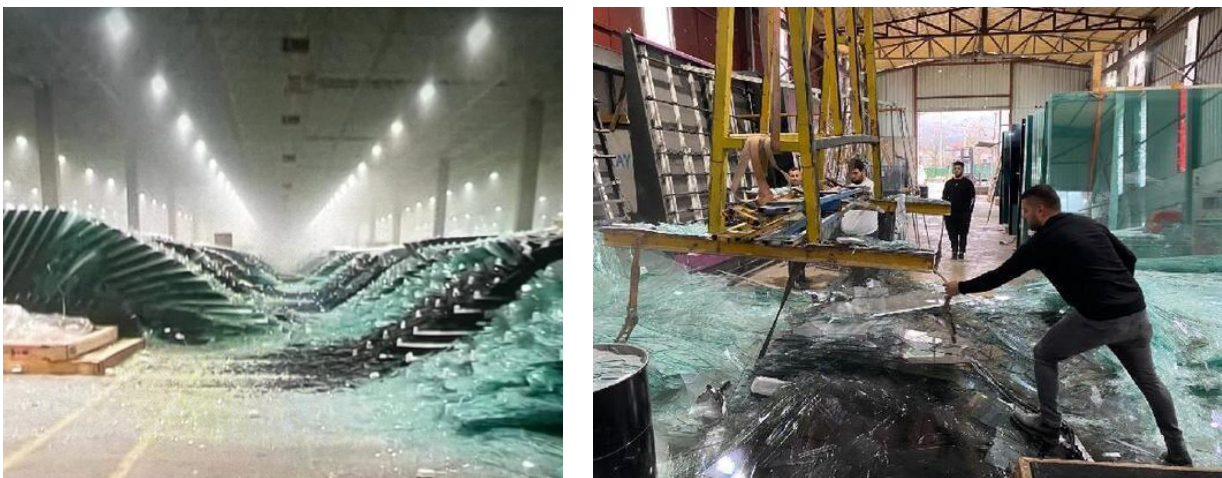
Figure 1.6. Damage in a glass manufacturing facility (Sources: Ensonhaber (2022) (left) & DHA (2022) (right)).

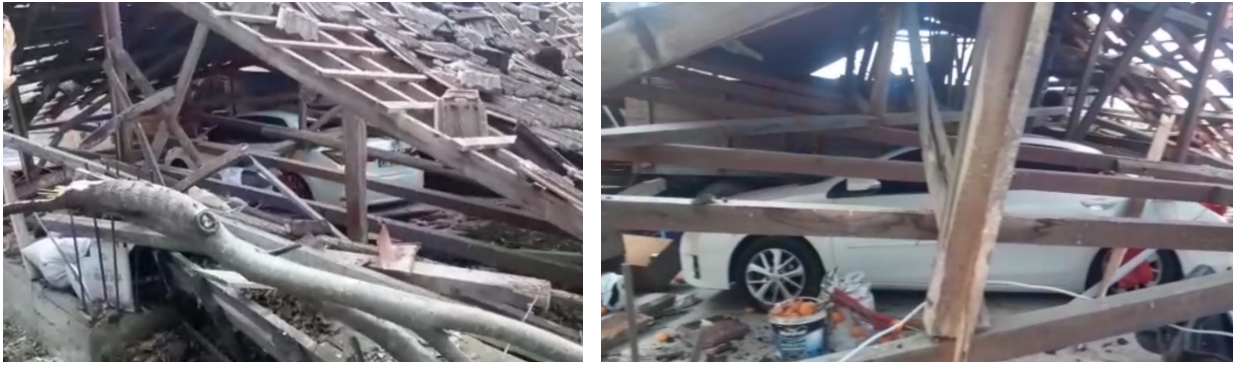
During the field investigation in Duzce after the earthquake, another example of economic loss was identified because of the collapse of a parking structure that was not engineered (Fig. 1.7). In this case, damage to a parked vehicle inside the parking structure was significant.

Figure 1.7. Damage to a parked vehicle due to damage to a non-engineered parking structure (Source: Arslan).

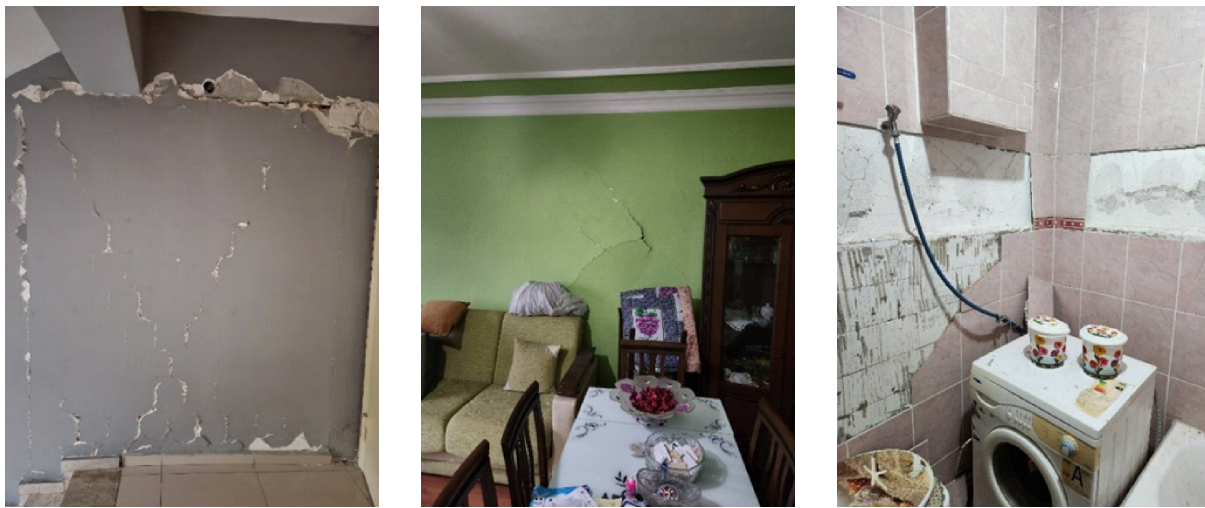
The reported damage was typically localized in the infill walls in the form of in-plane and out-of-plane separations or failures and damage to nonstructural components. Some examples of observed infill wall damage are shown in the next sequence of figures. Figures 4.1a and 4.2c show clear examples of diagonal shear failure of infill walls and wall separation from the RC beam-column frame system.

Figure 4.1. Examples of representative infill wall and tile damage in buildings at (a) 40.840°N, 31.144°E and (b) & (c) 40.838°N, 31.143°E. (Source: Demir).

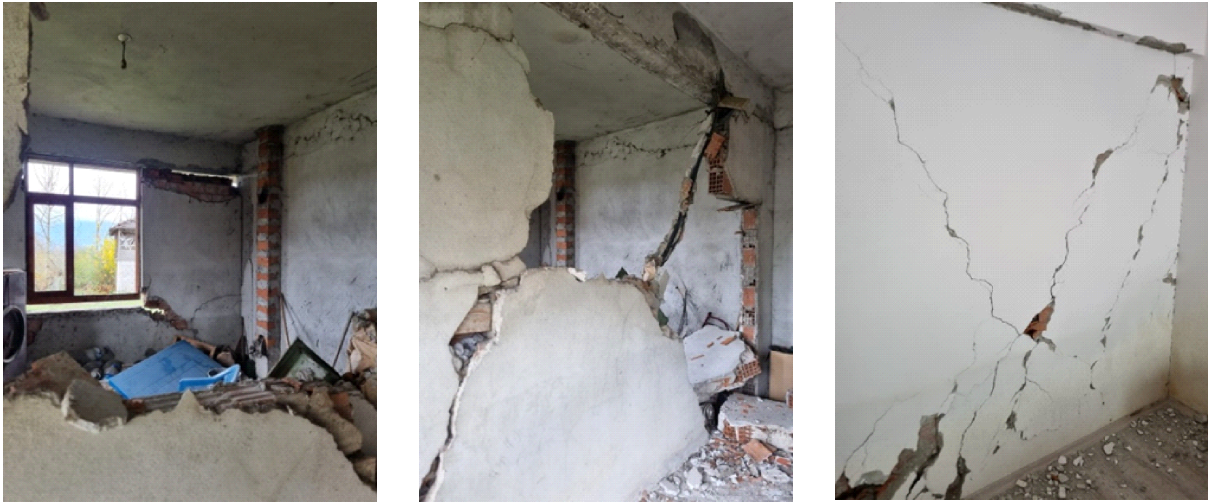
Figure 4.2. Examples of out-of-plane damage of infill and partition walls (coordinates: (a) & (b) 40.814°N, 31.014°E, and (c) 40.791°N, 30.994°E). [source: Arslan & Altunisik].

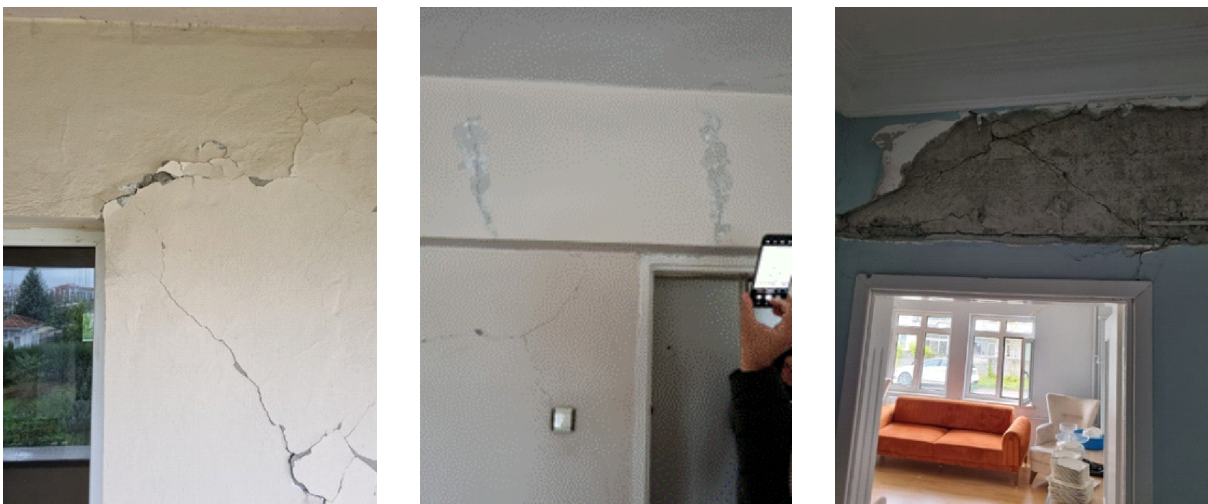
Some representative examples of observed damage in RC beams and columns are shown in Figures 4.3 and 4.4, respectively. Figures 4.4a and 4.4b show characteristic column shear failures, and Figure 4.4a presents typical short column damage. It should be noted that the sizes of the longitudinal and transverse steel in Figure 4.4c are almost equal. The exposed column in Figure 4.4c seems to have low concrete quality and a low amount of longitudinal steel.

Figure 4.3. Examples of RC beam damage observed as shear and flexural cracks in buildings at (a) & (c) 40.891°N, 31.049°E and (b) 40.891°N, 31.049°E. (Source: Arslan & Altunisik).

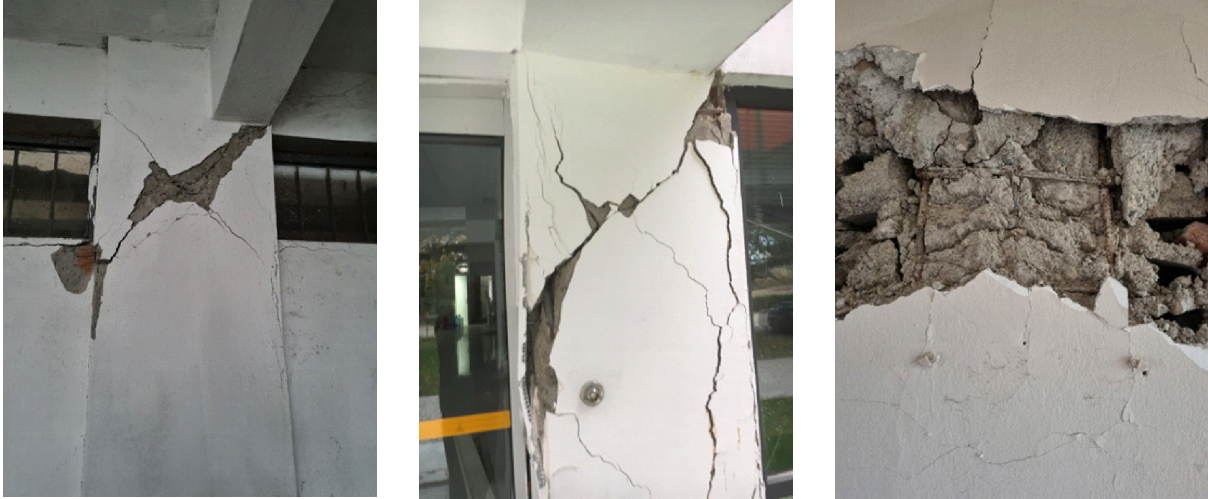
Figure 4.4. Examples of damage observed in RC columns in buildings at (a) 40.851°N, 30.947°E, (b) 40.809°N, 31.234°E, and (c) 40.810°N, 31.198°E. (Source: Arslan & Altunisik).

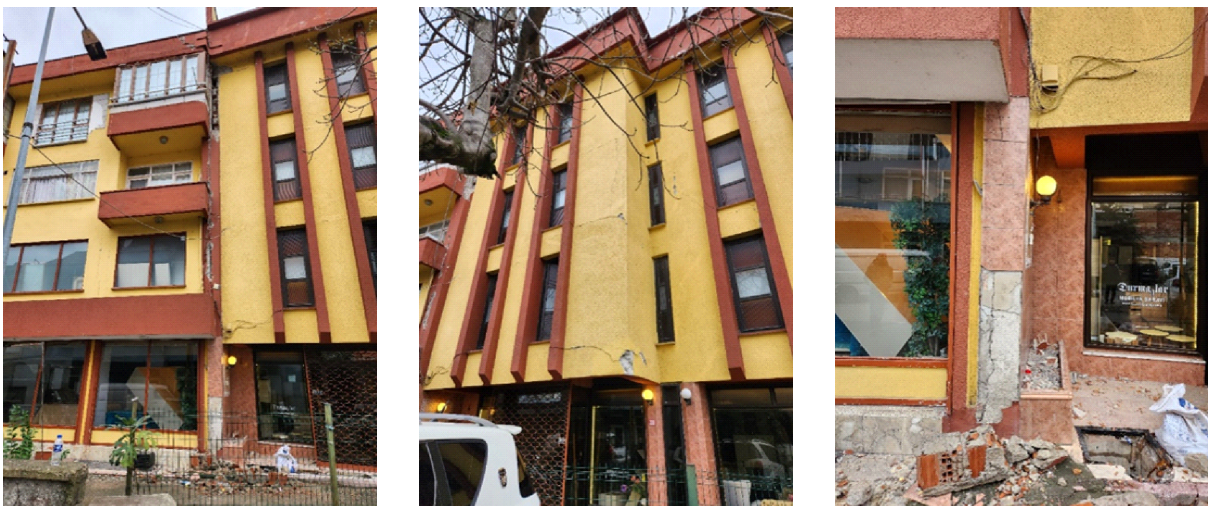
The four-story RC building shown in Figure 4.5b was built in 1988. This building pounded with the adjacent building on the left in Figure 4.5a during the earthquake. Due to insufficient gap between the two buildings, damage occurred in the load bearing concrete columns over the entire height of both buildings, including the parapet wall on of the building on the left in Figure 4.5a. The building in Figure 4.5b also experienced infill wall damage in the second and third stories above the overhangs (see Fig. 4.5c).

Figure 4.5. Damage to an RC apartment building at 40.838°N, 31.158°E (Source: Demir).

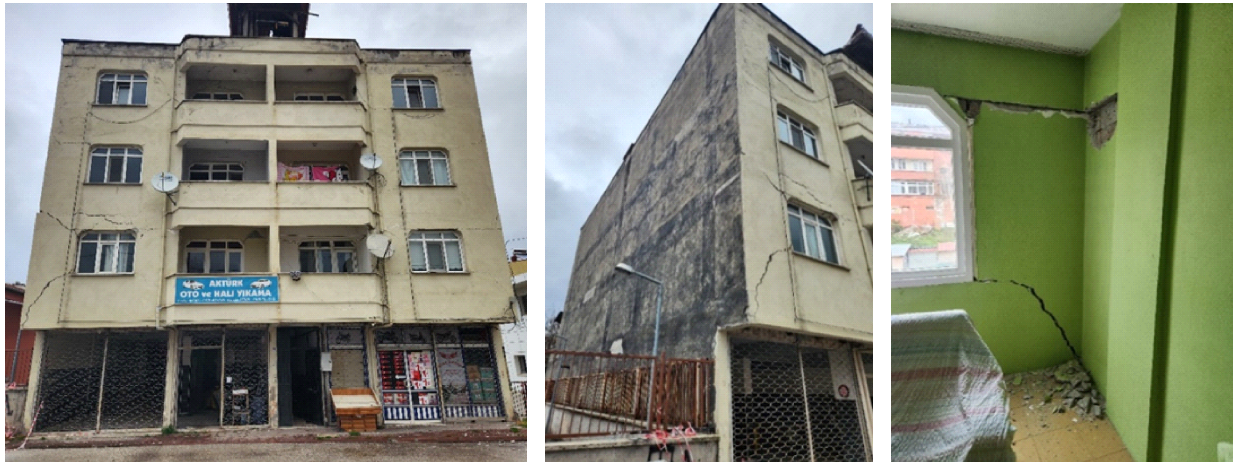
The four-story RC frame building shown in Figure 4.6 was built in 1992. Infill wall damage is visible on the left in the second story of the building. The wall damage occurred just above the approximately 0.5 m long overhang in that corner and spread around the window. The owner of the building said that it has not been designed or approved by an engineer. This is not unusual for the buildings constructed in this region before 1999. It should be noted that this building survived the 1999 M_w 7.6 Kocaeli and 1999 M_w 7.2 Duzce earthquakes with limited damage.

Figure 4.6. Damage to an RC apartment building in Golyaka at 40.779°N, 30.989°E (Source: Demir).

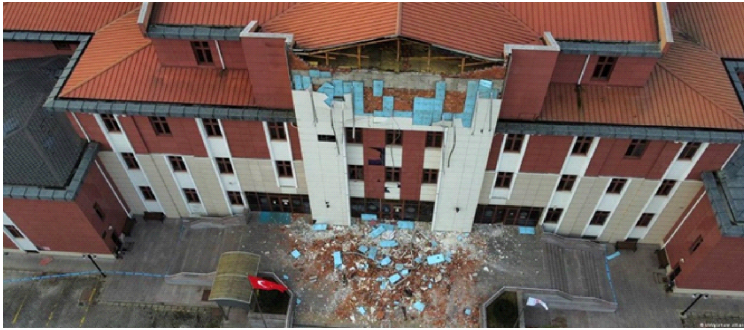
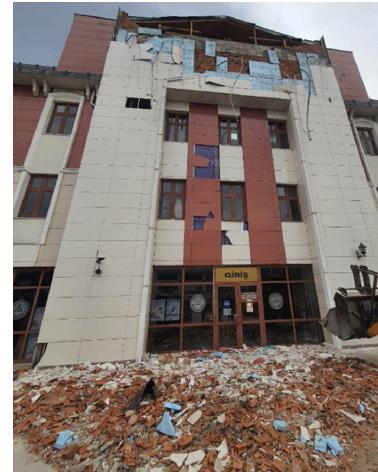
Figure 4.7. Facade damage in the Duzce courthouse located at 40.827°N, 31.189°E. (Sources: Deutsche Welle (2022) (left) & Demir (right)).

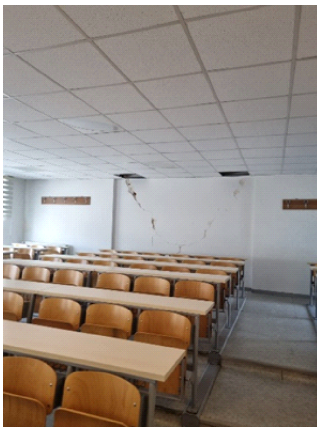
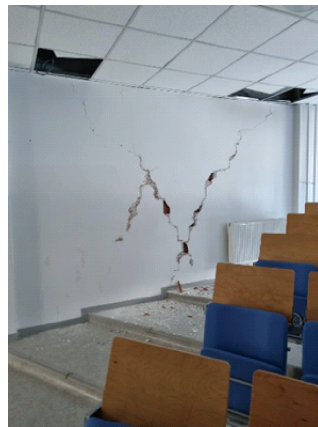
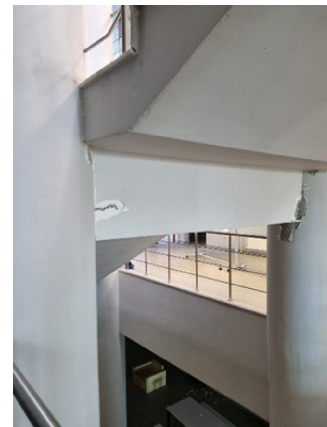
Figure 4.8 shows representative examples of observed damage in school buildings. Typical damage in these multi-story RC structures with unreinforced masonry infill walls include: (1) diagonal shear cracks in infill walls and separation from the surrounding beam-column frame (Figs. 4.8a,b), (2) cracks in the staircases (Fig. 4.8c), and (3) other nonstructural damage including damage to suspended ceilings (Fig. 4.8b).

Figure 4.8. Damage in school located at 40.903°N, 31.181°E (Source: Arslan & Altunisik).

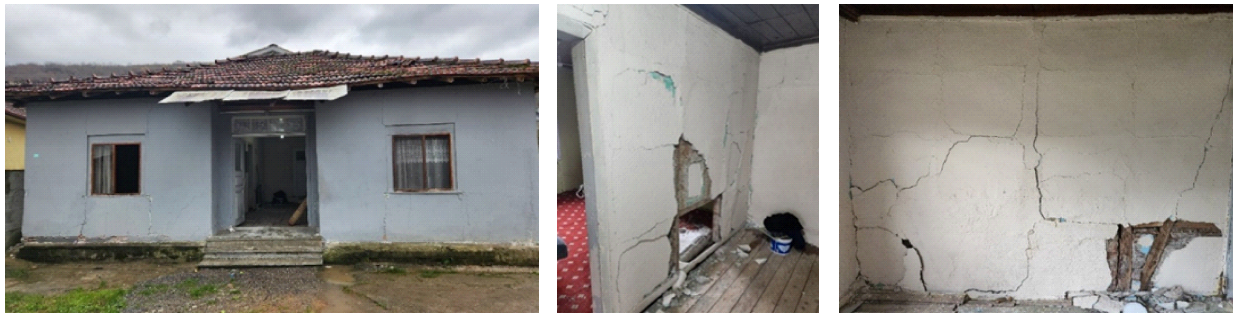
In rural areas or remote villages, there are older one- or two-story buildings with masonry or timber-masonry load bearing walls. Figure 4.9 shows a timber-masonry building that was built in the 1970s. This one-story building in Golyaka experienced significant cracking, but damaged

wall elements did not collapse (see large cracks and broken plaster on interior, as well as large vertical cracks on the exterior left of the building in Fig. 4.9).

Figure 4.9. Damage in timber-masonry load-bearing walls of a building in Golyaka (coordinates: 40.824°N, 31.001°E) (Source: Demir).

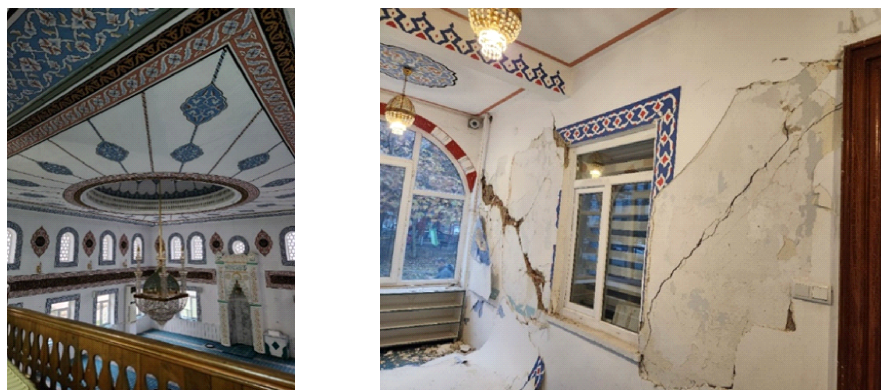
The November 23, 2022 Duzce earthquake caused substantial damage in multiple mosques, including Kiremitoğlu Mosque in downtown Duzce, Saridere Village Mosque in Golyaka (Duzce), Cedidiye Mosque in Duzce, Ayşe Metin Neighborhood Mosque in Cumayeri (Duzce), Yaka Neighborhood Mosque in Cumayeri (Duzce), and Saz Village in Kaynaşli (Duzce). Kiremitoğlu Mosque in downtown Duzce was built in 1968 and includes unreinforced brick masonry load bearing walls with many window openings. The mosque's central dome experienced a vertical displacement of approximately 100 mm. Major shear cracks were observed on the entrance walls around the windows as shown in Fig. 4.10.

Figure 4.10. Damage on the dome (left) and walls (right) of Kiremitoğlu mosque at 40.838°N, 31.145°E. (Source: Demir).

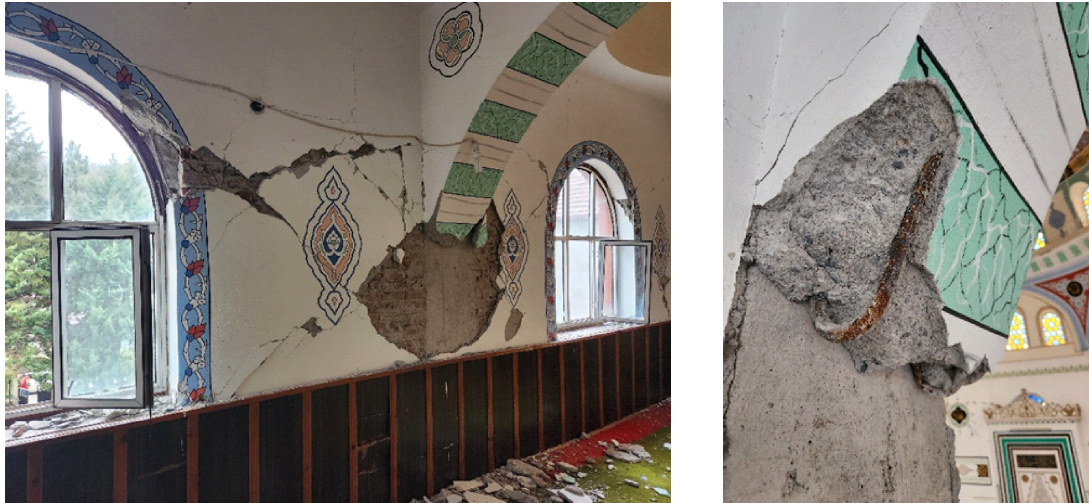
Another mosque that experienced significant damage due to the earthquake is the Saridere village mosque. The infill walls had diagonal cracks and separated from the RC beams (along horizontal cracks near the top in the left photograph in Fig. 4.11). The plaster also spalled off

(Fig. 4.11). This mosque was demolished a few days after the earthquake. It appears that the demolition decision was based on cost of repairs because there was no evidence of structural damage in the RC columns or beams.

Figure 4.11. Damage to Saridere village mosque in Golyaka at 40.819°N, 30.994°E. (Source: Demir).

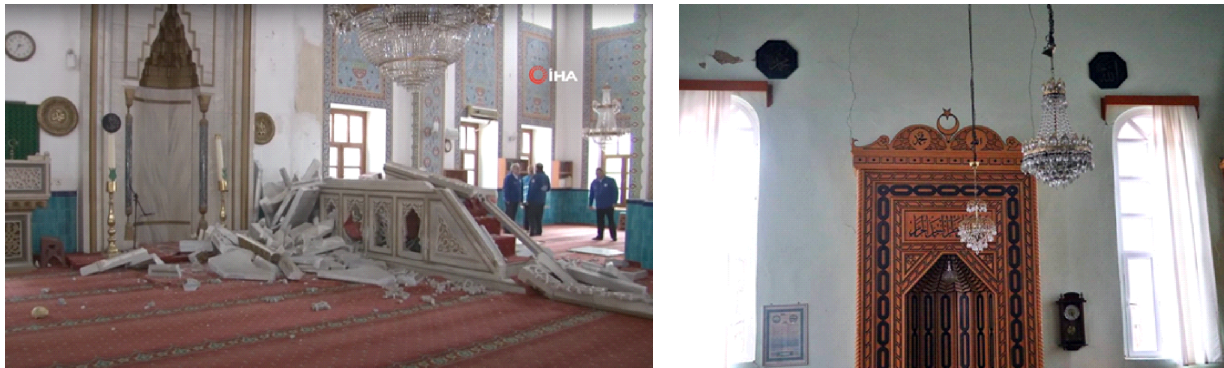
Two minarets of Cedidiye mosque in downtown Duzce had collapsed and were built after November 12, 1999 earthquake. Only the pulpit inside the Cedidiye mosque was destroyed during the November 23, 2022 earthquake, as shown in Figure 4.12a. Meanwhile, horizontal and vertical cracks developed in the front walls of the Saz village mosque in Kaynaşli, Duzce (Fig. 4.12b).

Figure 4.12. Damage to (a) Duzce Cedidiye mosque at 40.838°N, 31.163°E and (b) Saz village mosque in Kaynaşli, Duzce (Sources: (a) Anadolu Ajansi (2022), (b) KARAR.tv (2022)).

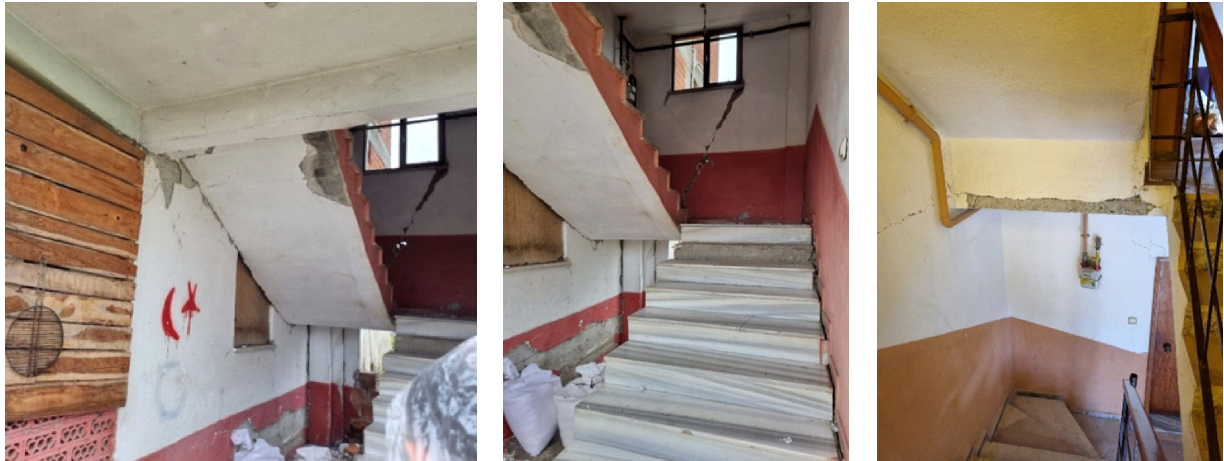
During the inspections of buildings, damage was reported in many staircases or stairwells. Structural walls on the perimeter of the stairwells tend to carry a large portion of the lateral loads and thus deform during earthquakes; such relative movement of the walls with respect to the staircases not monolithically connected may explain observed damages in Figures 4.13. A large diagonal shear crack below the window in Figures 4.13a,b is an indication of the large lateral shear demand on such walls.

Figure 4.13. Examples of the damage observed in stairwells of a building at 40.814°N, 31.014°E. (Source: Arslan & Altunisik).
