StEER STRUCTURAL EXTREME EVENTS RECONNAISSANCE	EVENT BRIEFING		
	Event:	Hurricane Delta	
	Region:	Louisiana, Mexico	
FAST Authors:	David Roueche, Auburn University (Lead FAST-1) Sabarethinam Kameshwar, Louisiana State University (Lead FAST-2) Justin D. Marshall, Auburn University Sai Aditya Bandaru, Louisiana State University (Graduate Student) Trung Do, University of Louisiana at Lafayette		
VAST Authors:	Tracy Kijewski-Correa, University of Notre Dame (Lead) Maria D. Cortes Delgado, University of Puerto Rico at Mayaguez Shane Crawford, National Institute of Standards and Technology Sajad Javadinasab Hormozabad, University of Kentucky Stephen Strader, Villanova University		
Editors:	David O. Prevatt, University of Florida		
DesignSafe Project #	PRJ-2933	Release Date:	October 19, 2020

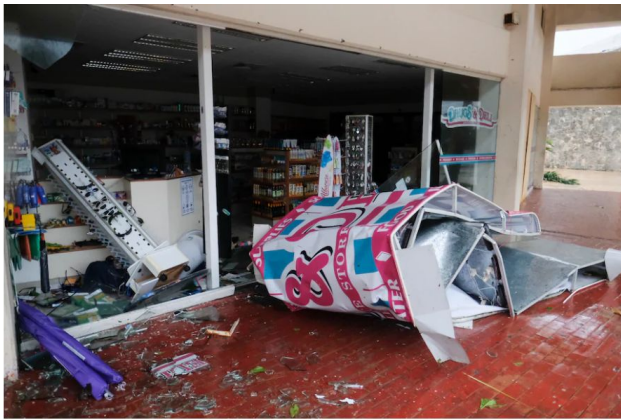
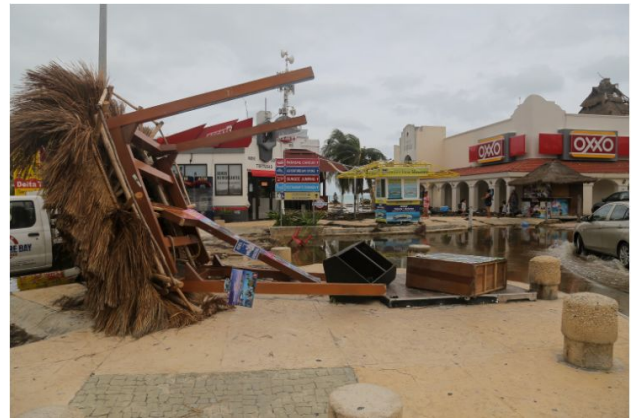
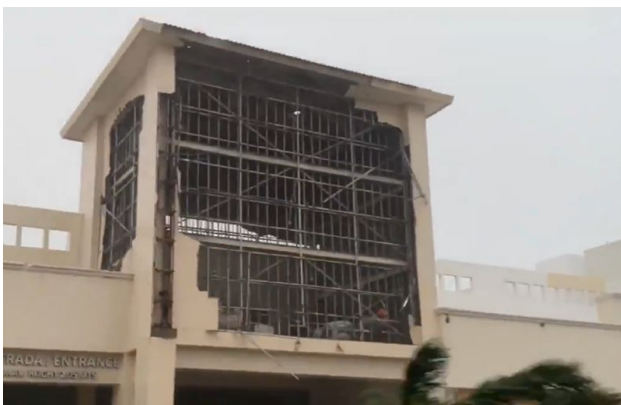
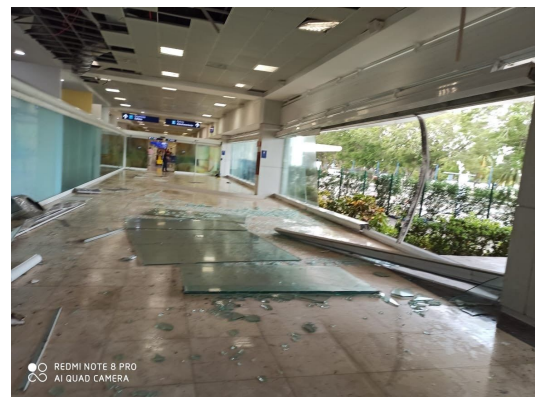
Figure 3.1. Damage in Cancún, Mexico: (a) storefront glass damage (Source: [Washington Post](#)); (b) light structure damage (information kiosk) (Source: [CNN](#)); (c) facade damage to resort (Source: [@RadarOmega_WX Reed Timmer, Oct. 7 Twitter](#)); (d) shattered windows at Cancun Airport (Source: [@RadarOmega_WX Reed Timmer, Oct. 7 Twitter](#))

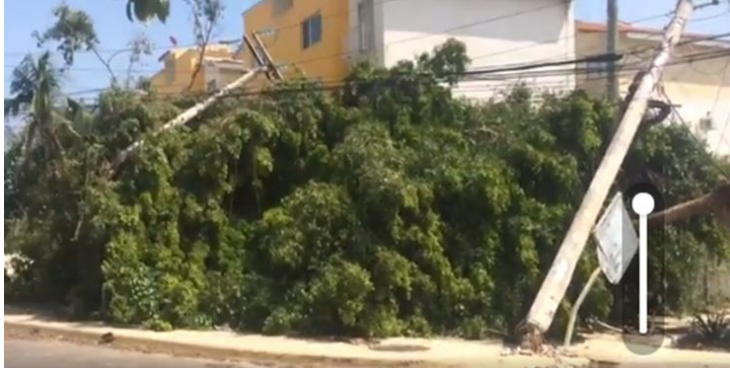
Hurricane Delta primarily affected the areas/sectors of Playa del Carmen and Quintana Roo at the Yucatan Peninsula. The official Twitter page of the Mexican government stated that there were 40,000 people evacuated across the Yucatan Peninsula prior to the landfall of Hurricane Delta. The most impacted structures were from the hospitality and tourism industry reporting damages including broken storefront windows (Fig. 3.1a), damage to light structures (Fig. 3.1b), and failure of facade elements (Fig. 3.1c). Entire panes of glass were also dislodged at the Cancun airport (Fig. 3.1d). Power outages were reported at Playa del Carmen on 7 October, with widespread reports of damage to the power grid. A notable recurring failure was the hinging of reinforced concrete electrical poles at their base, as noted in Figure 3.2a (the [video](#) of the failure in Fig. 3.2a zooms in

further on the hinging of these poles). Flooding also caused widespread disruptions (Fig. 3.2b). However, according to reports by the Mexican government, Playa del Carmen and Quintana Roo were already returning to normal operations as soon as 8 October, with ongoing collection of debris.

Figure 3.2. (a) Concrete electrical poles failed by hinge at base in Cancún, Mexico (Source: [@MirandaMonaco.Camila Miranda, Oct. 8 Twitter](#)) and (b) flooding in Cozumel ([@vivecozumel, Cozumel, Oct 7](#)).

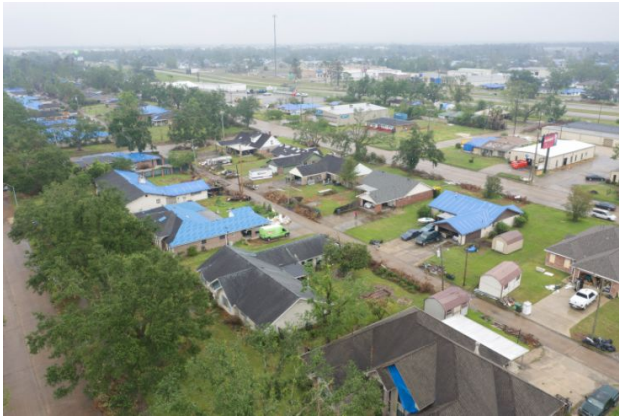
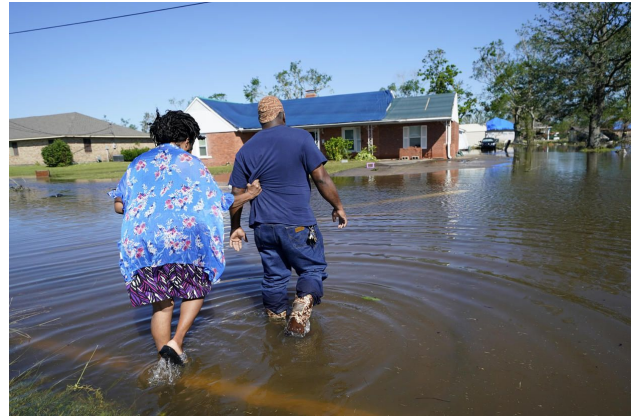
Figure 3.3. Damage in Lake Charles: (a) tarped roofs in a residential area (Source: [CNN](#)); (b) flooding in neighborhood where homes have unrepaired roof damage sustained in Hurricane Laura ([Gerald Herbert/AP](#))

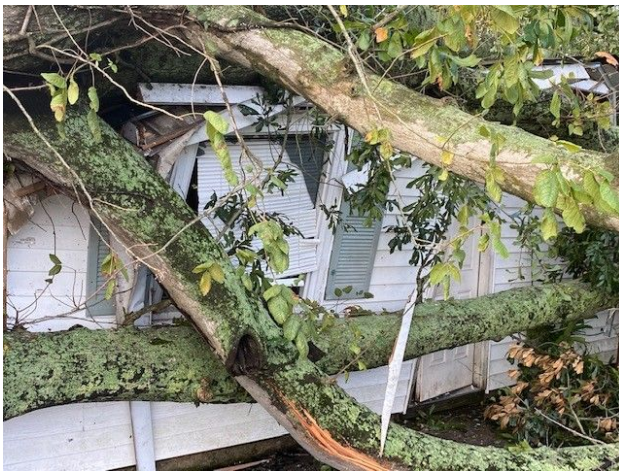
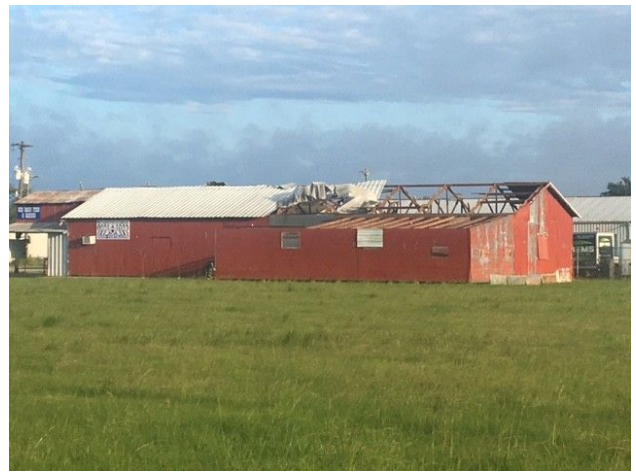
Figure 3.4. Damage in Lafayette: (a) tree falls causing significant structural damage, (b) CGI roof on agricultural building (Source: [KATC](#))

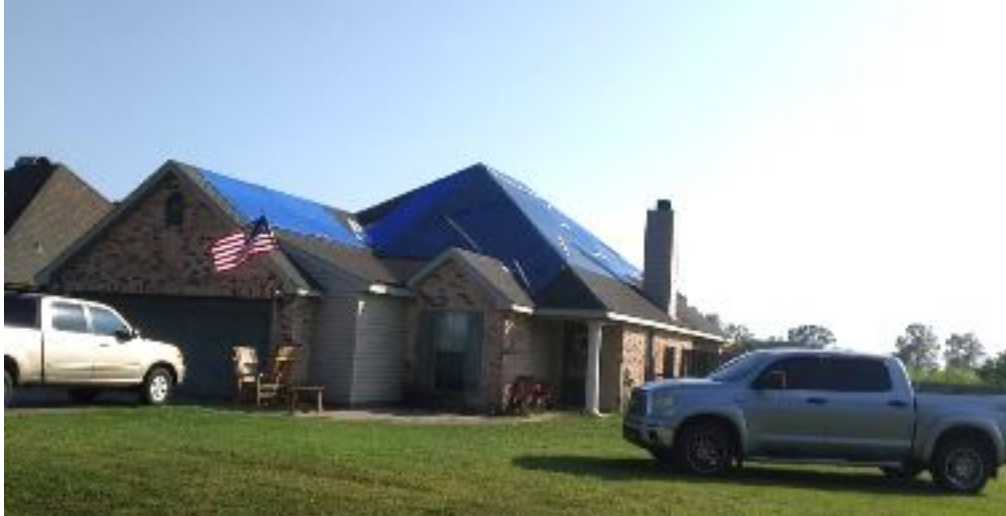
FAST-2 surveyed areas to the east of those impacted by Laura on 15 October, noting Insignificant damage on the way from Lafayette to Youngsville, with no considerable damage in residential communities in Lafayette. However, in Youngsville, which was impacted primarily by Hurricane Delta, some houses (approximately 2-5%) had tarps on the roofs; damaged fences were also observed. Notably, in several residential communities, houses at the end of blocks and thus not shielded by other properties had more frequent and substantial loss of roof cover and/or chimney damage (Fig. 4.2-4.3). This trend was mainly observed in developments bounded by open terrain,

and it did not seem to be affected by the age of the buildings (both new and established communities exhibited this trend). Even within suburban developments (such as Sugar Mill Pond), a similar trend was observed: houses adjacent to large open areas were damaged more frequently than houses in the interior of the subdivision.

Figure 4.2. Example of roof damage to house at end of block in Youngsville (Coordinates: 30.102928, -92.056204) (Credit: FAST-2).

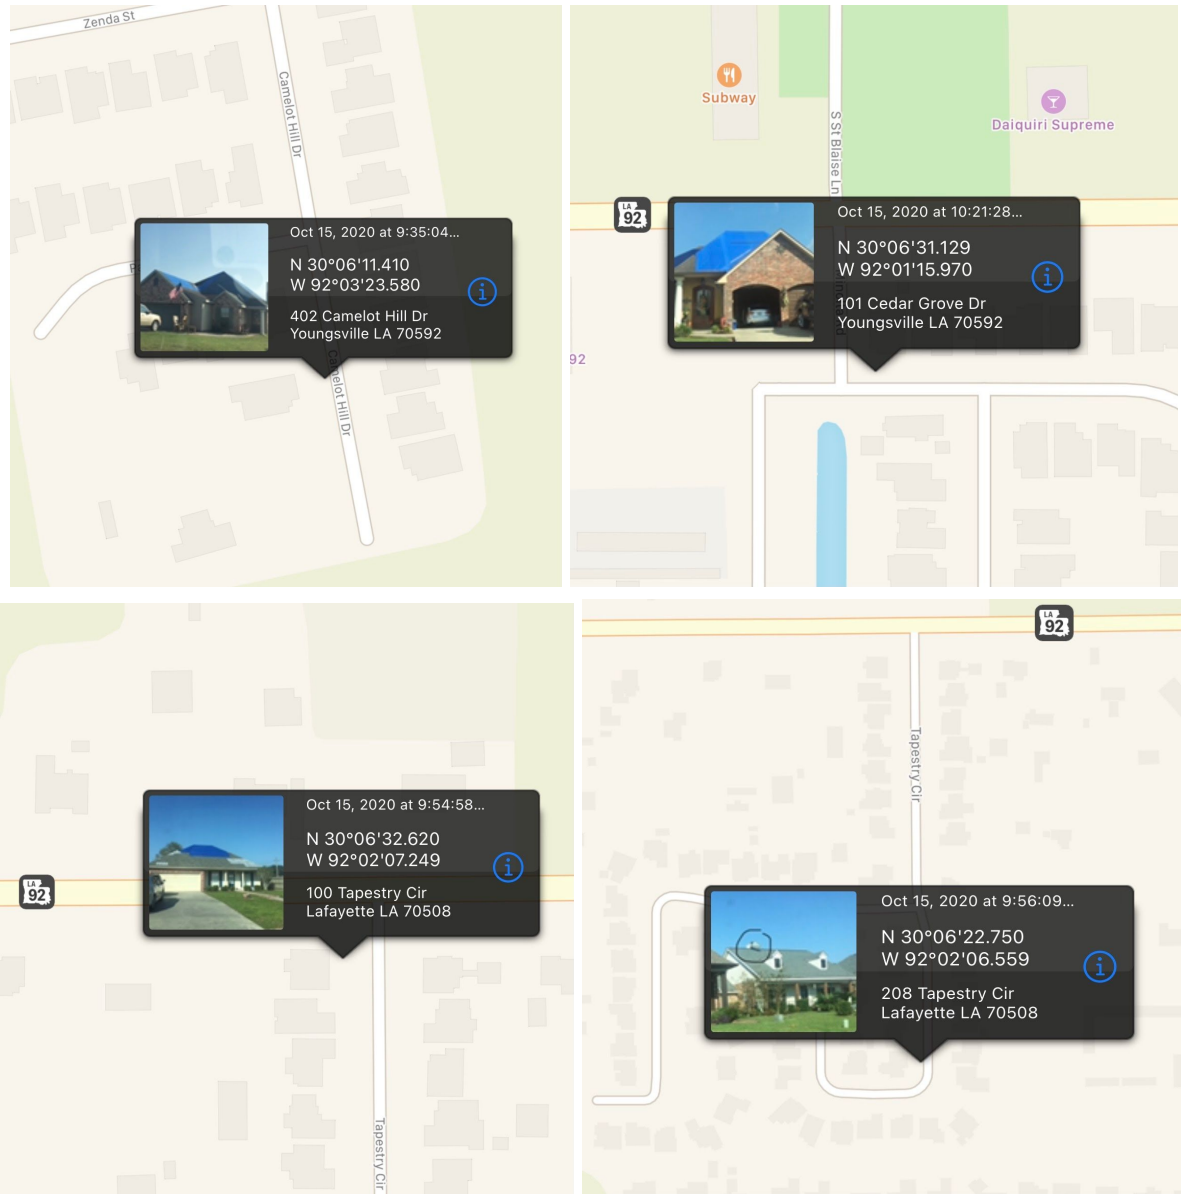
Figure 4.3. Locations of houses with roof cover loss or chimney damage at end of blocks in Youngville (Credit: FAST-2).

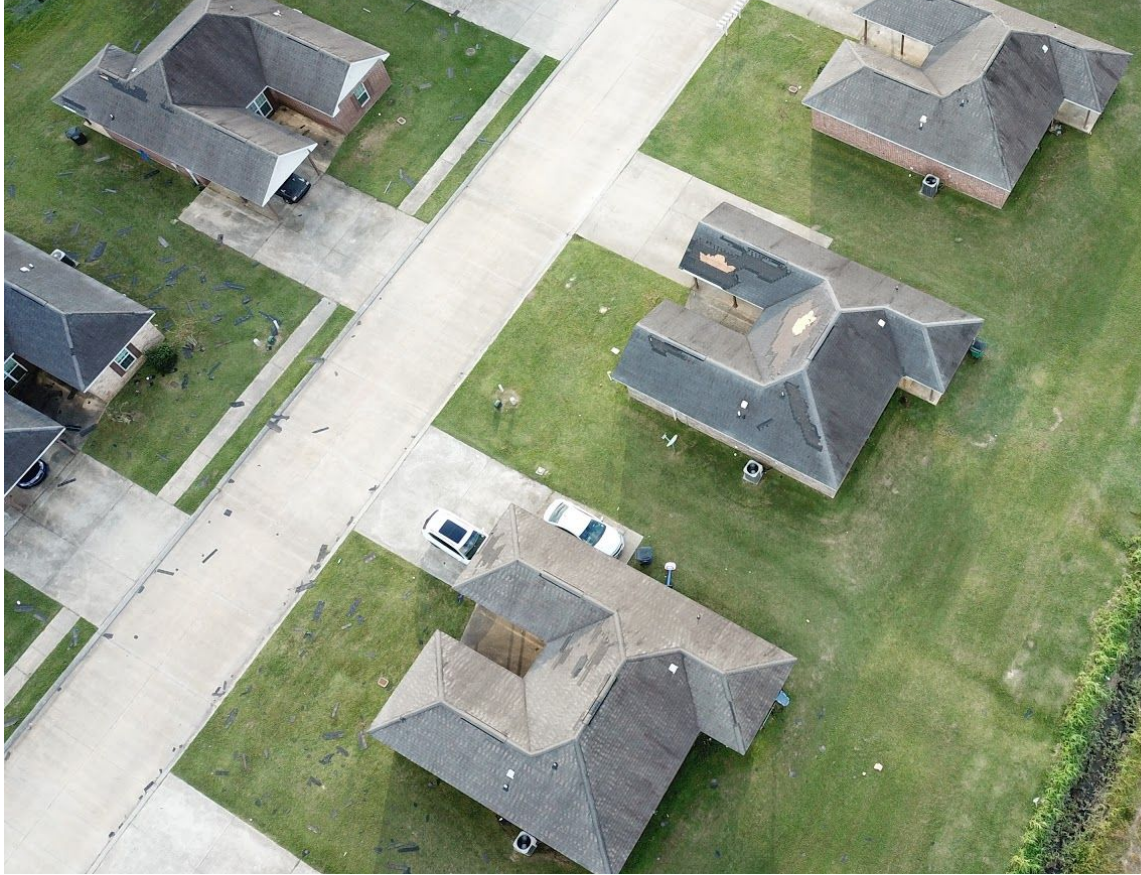
In communities impacted primarily by Hurricane Delta, FAST-1 rarely observed structural damage and those cases were confined to very old structures. Roof cover loss was common, though a damage gradient was not evident, with similar frequency and severity of damage across LA-14 communities (including Abbeville, Kaplan, Gueydan, Lake Arthur, and Bell City). Roughly 30% of buildings had observable wind damage to roof cover, and severity was generally less than 20% (see example in Fig. 4.4). Wall cladding damage was more isolated (~5% of buildings with wall cladding damage, skewed by the frequent use of brick veneer, which in only a few cases had observed damage). Notably many older buildings (approximate vintage 1940s) sat on concrete piers with no positive attachment (gravity connection only) but FAST1 did not observe any shifted off foundations (Fig. 4.5). As a proxy for the intensity of the wind field, most power poles in that area were still intact, with some leaning.

Figure 4.4. Typical roof cover damage levels in older (~2005) residential cluster in Abbeville (Credit: FAST-1).

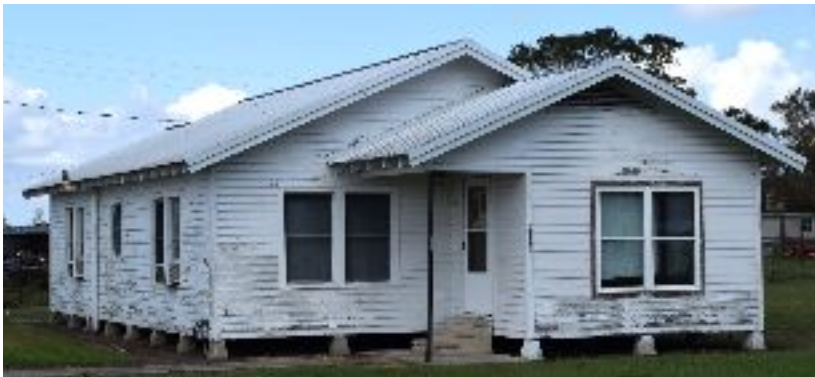
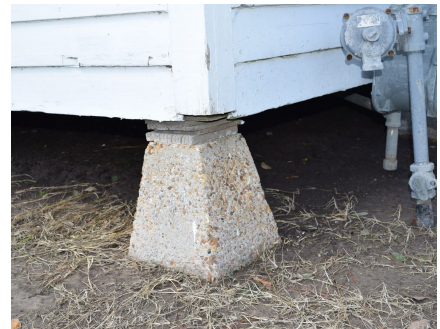
Figure 4.5. Typical older home (approximately 1940s construction) in communities along LA-14. Inset photo shows that such homes are elevated on concrete piers of various heights with no positive attachment (Credit: FAST-1).

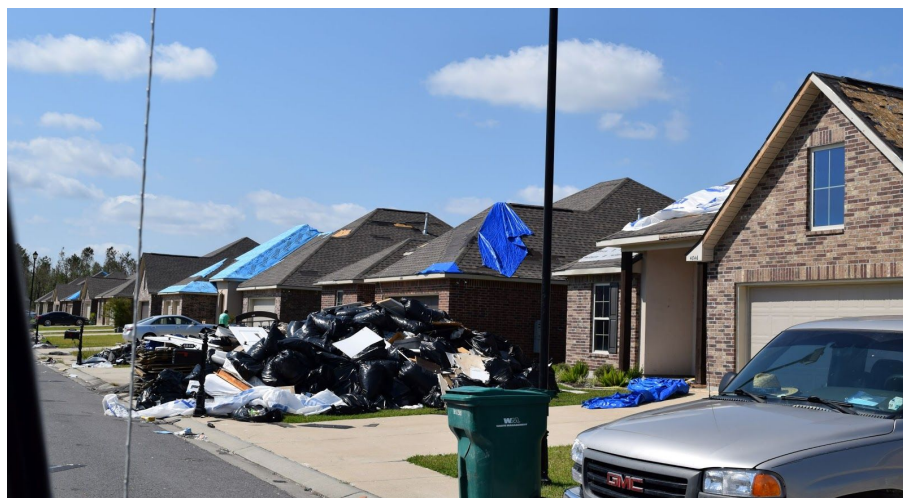
FAST-1 and FAST-2 surveyed a few clusters within the Lake Charles metro, capturing additional damage from Delta and status of recovery efforts. Many tarps, covering damaged roofs from Laura, were damaged by Hurricane Delta, exposing the structure to additional water damage. Very little rebuilding efforts were evident and most properties still had large piles of interior contents outside from Hurricane Laura, some of it scattered by Hurricane Delta winds (Fig. 4.6). A few cases of additional damage caused by Hurricane Delta were observed (Fig. 4.7).

Figure 4.6. Typical scene in regions of Lake Charles visited by FAST-1 (Credit: FAST-1).

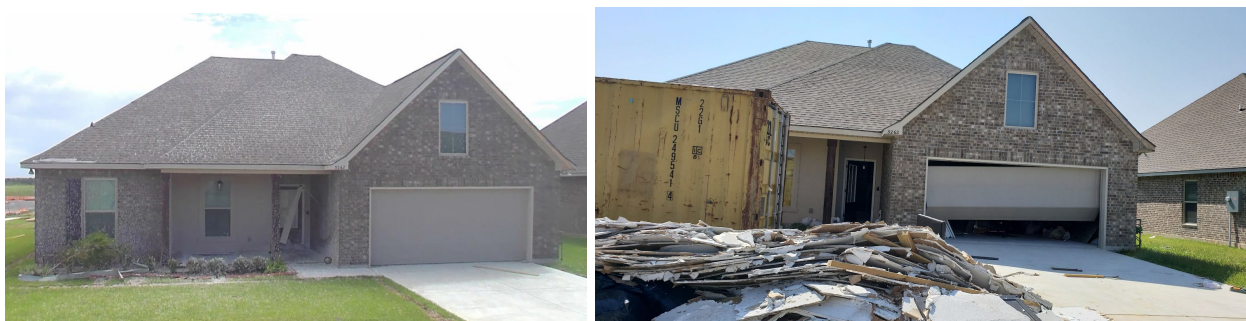
Figure 4.7. Progression of garage door damage on a home near the Chennault International Airport between hurricanes: (left) undamaged following Hurricane Laura and (right) buckled following Hurricane Delta, also note interior damages from Hurricane Laura as evidenced by debris pile at curb (Credit: FAST-1).

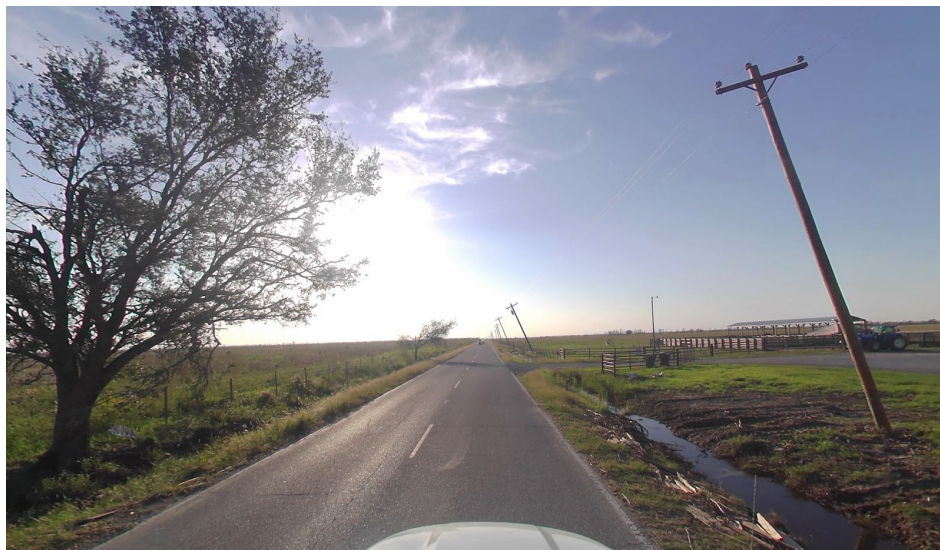
As of the FAST-1 survey on 12 October, power infrastructure had been mostly restored throughout the region, although many replaced poles were severely leaning (Fig. 4.9), possibly due to Hurricane Delta impacts. There was very little evidence of repair/recovery activity, with most surviving buildings appearing untouched from their post-Laura condition. During this time, flooding was still notable along portions of LA-82 with up to 24 inches of standing water on the roadway (observed around 3 PM, 12 October).

Figure 4.9. Power poles installed after Hurricane Laura already leaning severely along LA-27 (Credit: FAST-1; GPS: 30.0722, -93.1192). This location was subjected to approximately 85 mph peak gust wind speeds and 15-20 inches of rainfall.
