**Balao, Ecuador Mw 6.8
Earthquake of March 18, 2023**

Released: 4/14/2023
NHERI DesignSafe Project ID:
PRJ-3891

PRELIMINARY VIRTUAL RECONNAISSANCE REPORT (PVRR)

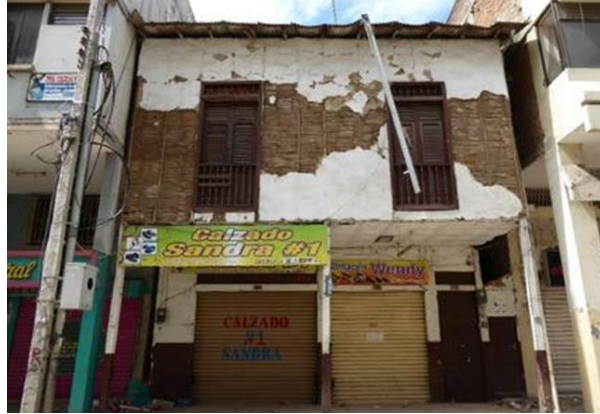
Figure 3.3. Non-engineered Bahareque House with substrate exposed by crumbled stucco ([Kaminsky 2023](#)).

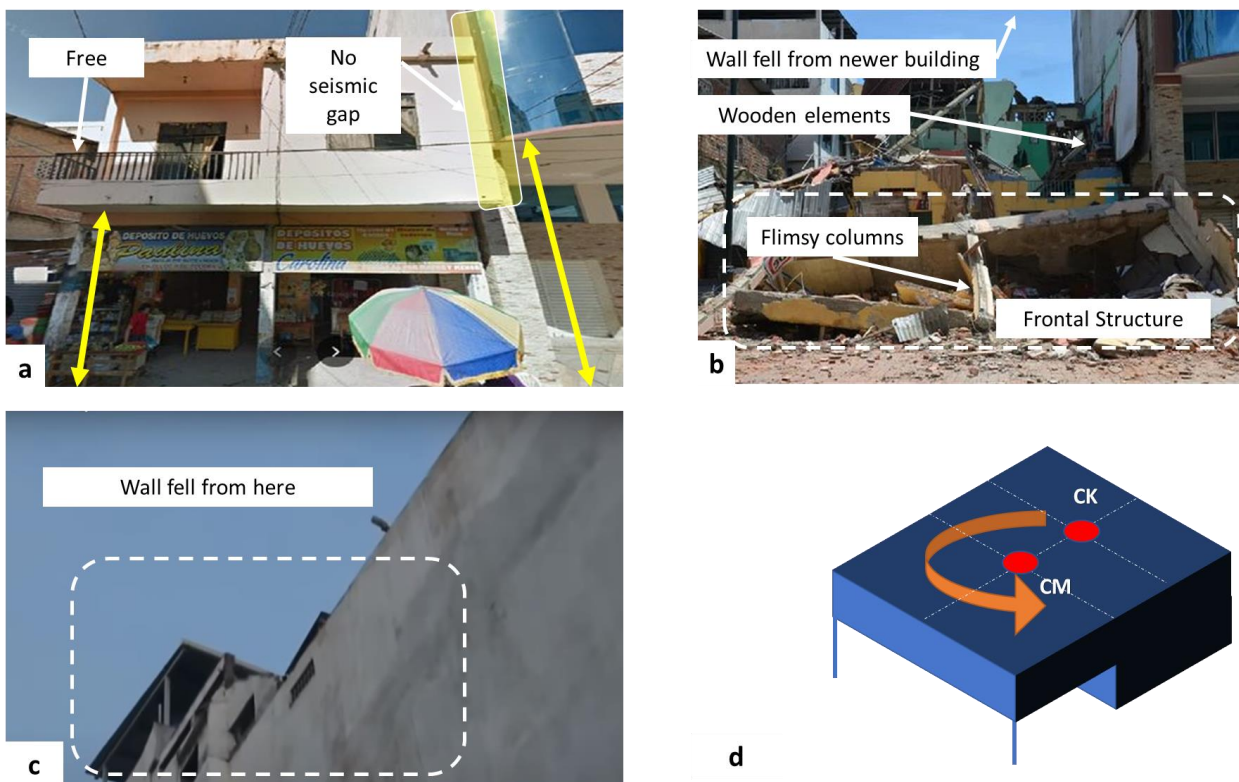
Figure 4,1 shows a non-engineered building located in Machala, El Oro, Ecuador near the intersection of Boyaca and Paez streets, located approximately 50 km from the epicenter of the 6.8Mw Balao Earthquake. The structure was at least 50 years old according to local sources (Primicias 2023a), and it featured a mixed structural system with wooden frames and beams on the back side, and flexible RC columns and beams on the front side. There was also stiff clay brick masonry, wooden floors, and concrete slabs. It is obvious from the pictures that there is a commercial shop at the first floor while the upper floor was residential.

Figure 4.1. Total collapse of a single-family residential building in Machala. (a) Structure before the collapse ([El Comercio 2023b](#)) (b) Collapsed structure ([Suarez 2023](#)) (c) According to local reports the partial collapse of a brick wall from the fifth story of the neighboring building triggered the collapse of this two-story structure (Primicias 2023a, Endara, A. B. 2023, [Arias 2023](#)). The fall of the wall from the neighboring building in combination with stiffness irregularities like the open ground story in the front of the building inducing torsion, lack of seismic gap generating pounding, flexible frames with stiff brittle infill walls that allow large drifts contributed to the collapse of this building. (d) Schematic demonstration of torsional effect induced by stiffness irregularities causing the collapse of a two-story building shown in (a) and (b).

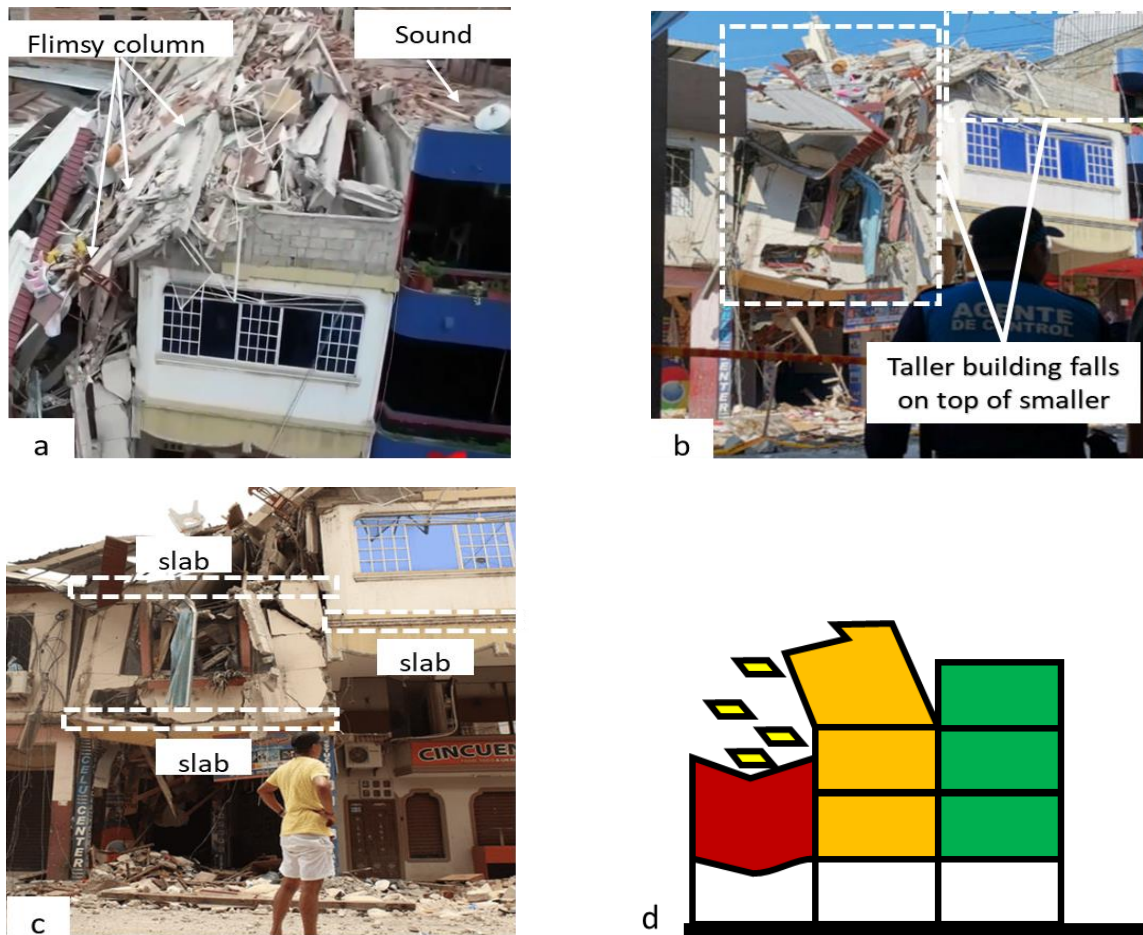
Figure 4.2 shows three buildings located side by side in Pasaje, El Oro, Ecuador, approximately 50 km from the epicenter of the 6.8Mw Balao Earthquake. The partial collapse of the flexible structure of the building in the middle triggered the full collapse of the smaller non-engineered structure while the building on the right side remains sound. The building in the center exhibits different architectural finishes in the upper stories and the structural system seems discontinuous. This suggests that the upper stories were part of an extension to the original structure. The reinforced concrete building on the right side remains sound.

Figure 4.2. Total collapse of a single-family residential building in Machala. (a) Partial collapse of flexible upper stories in the taller building ([Ecuavisa 2023](#)). (b) Full collapse of the smaller non-engineered building ([García 2023](#)) (c) Slabs at different levels could have hit columns in the smaller building around mid height ([El Universo 2023a](#)). (d) Scheme of the interaction among these three buildings.

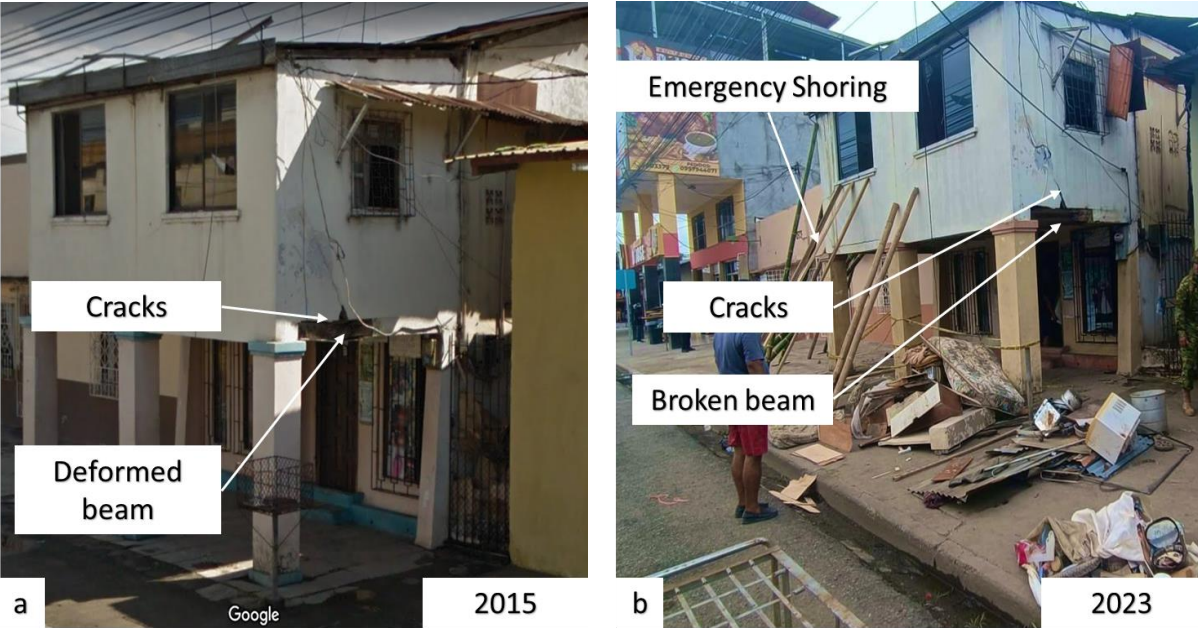
Figure 4.3 shows a non-engineered single-family building located in Machala, El Oro, Ecuador. While most of the structure is a combination of wooden frames and clay-bricks, the frontal overhang is sitting on top of what looks like reinforced concrete columns. Besides stiffness irregularities, lack of seismic gap and stiff masonry, this building attracts attention due to the pre-existing damage that was captured by google street view in 2015 and remains to date. Apparently, this structure already survived the 7.8Mw Muisne earthquake (400 km from the epicenter) in 2016 which was felt around the country. However, this time (50 km from the epicenter) there were concerns regarding its integrity which prompted the use of emergency shoring whose efficacy could be questioned judging by the picture.

Figure 4.3. Building with pre-existing damage. (a) There is a permanent deformation in one of the beams of the floor system that seems to be the reason for that masonry crack in the right side of the building ([Google 2015](#)). (b) There are signs of attempting to fix the crack, but part of the exterior beam seems to be missing / broken [Twitter \(2023c\)](#). However, it appears that the beams' redundancy of the floor system has enabled a redistribution of the loads.

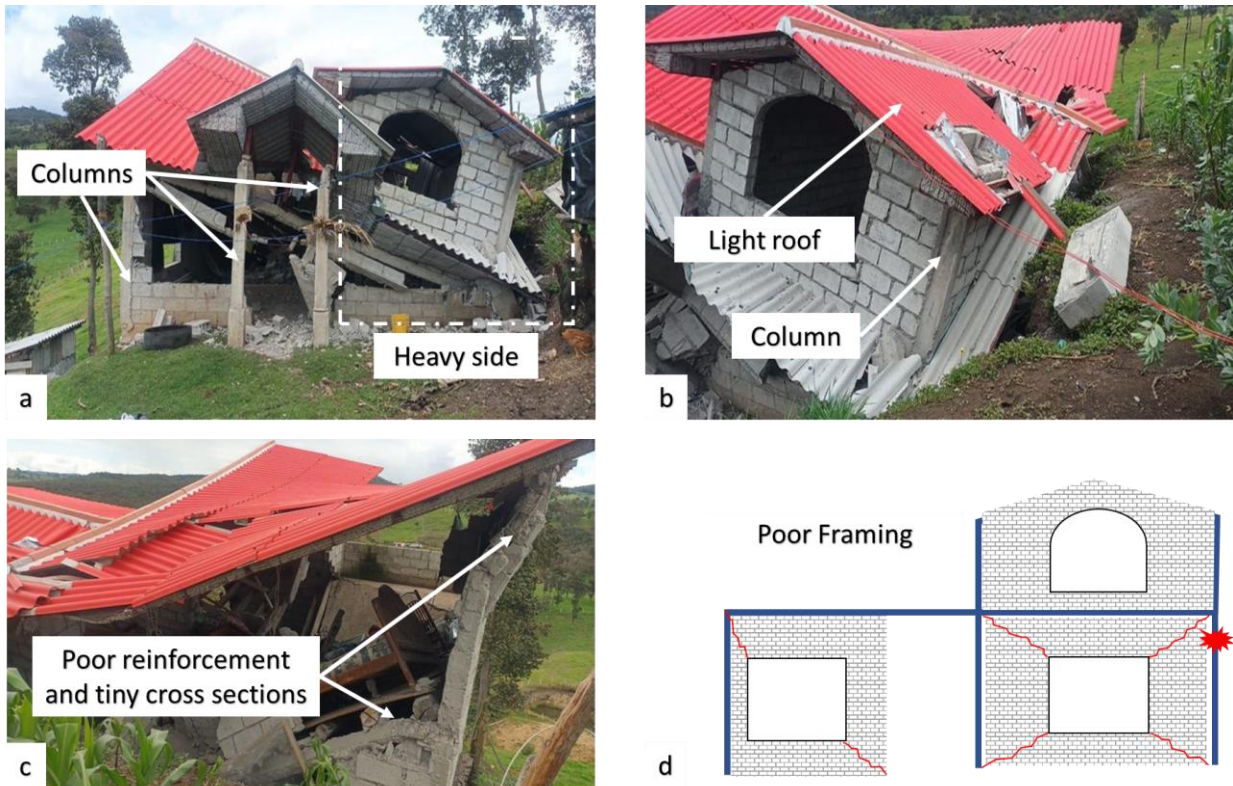
Figure 4.4 shows a non-engineered single-family building located in Baños, Azuay, Ecuador, approximately 64 km from the epicenter of the 6.8Mw Balao Earthquake. The structure is a combination of very slender columns and cement blocks. This building displays a combination of structural deficiencies such as discontinuous load paths, small cross sections in frames, poor reinforcement in the elements that are intended to work as columns, concentration of the second story mass in one side of the building even when all vertical elements are about the same size.

Figure 4.4. Single-family building collapse. (a) Front view shows slender columns and lack of a proper load path with a concentration of mass on the right side of the building ([Twitter 2023d](#)). (b) Second floor collapses on top of the first floor even using a relatively light roof ([Twitter 2023d](#)). (c) Poor reinforcement, tiny cross sections, and incorrect framing ([Twitter 2023d](#)). (d) Sketch of deficient framing leading to collapse.

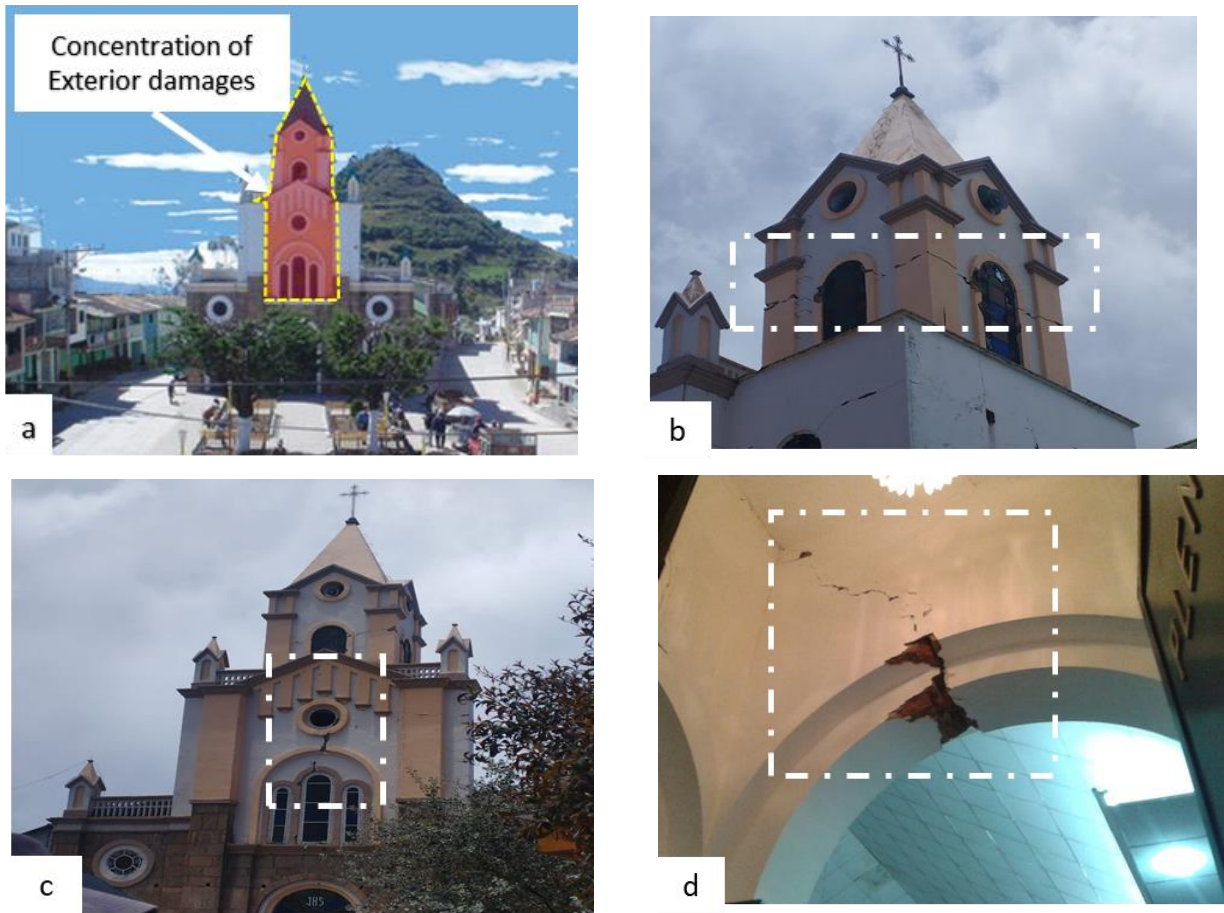
Figure 4.5 shows a church located in Pucará, Azuay, Ecuador, approximately 75 km from the epicenter of the 6.8Mw Balao Earthquake. The church is one of several churches in need of rehabilitation in Azuay. Many of these churches namely, Baños, Sinicay, San Fernando, Santo Domingo and the Catedral present deficiencies in structural components such as arches, domes, and the structures that hold roofs and towers.

Figure 4.5. Deficiencies at Pucara church. (a) Original structure ([Avilés 2023](#)). (b) Cracks in the vertical elements supporting the tower ([Twitter 2023e](#)). (c) Cracks in arches at the facade ([Twitter 2023e](#)). (d) Interior cracks in arch ([Twitter 2023f](#)).

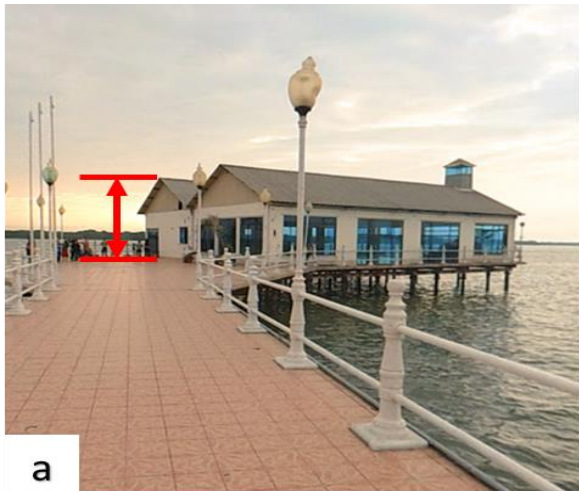
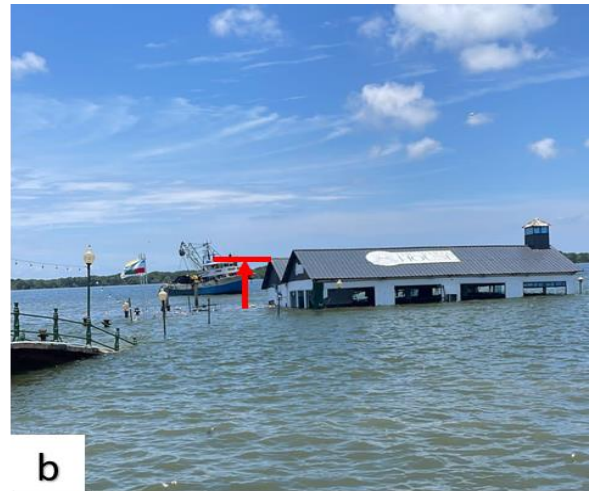
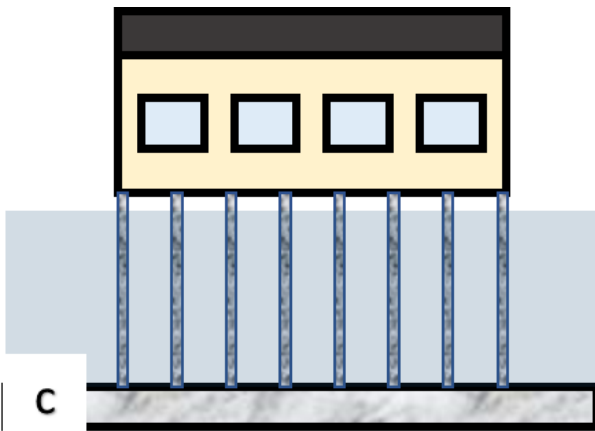
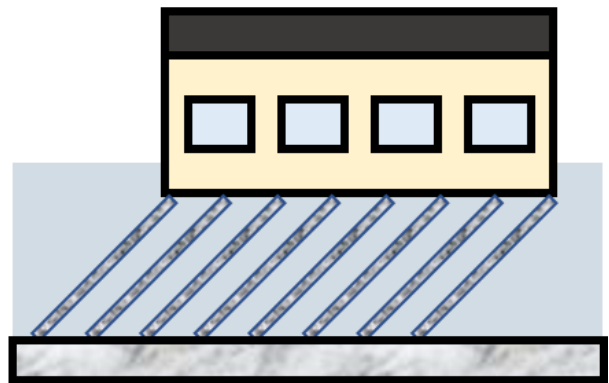
Figure 4.6 shows the marine museum located in Puerto Bolivar, El Oro, Ecuador, approximately 50 km from the epicenter of the 6.8Mw Balao Earthquake. Local news, Primicias (2023b), reported that the steel piles bent and collapsed due to the lateral motion induced by the 6.8M Balao earthquake.

Figure 4.6. Piles Failure at the Maritime Museum and Dock. (a) Marine museum before the 6.8Mw Balao earthquake ([Jimenez 2021](#)). (b) Marine museum after the 6.8M Balao earthquake ([Twitter 2023h](#)). (c) Sketch of the failure.

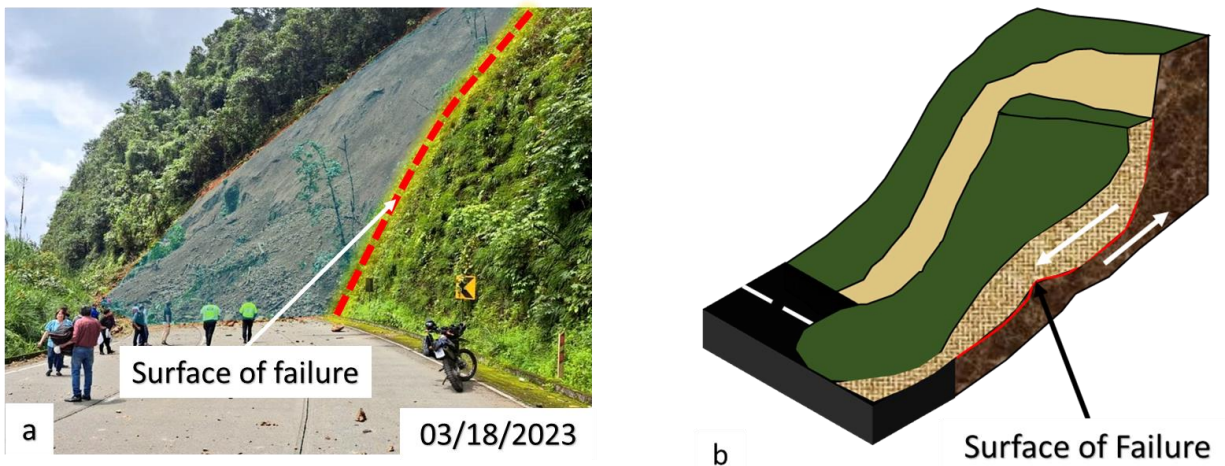
There were thirteen reports of landslides along this route. The more significant ones were at the 74, 93, and 98 kilometer marks. Large rocks and soil filled the road in several locations (Fig. 5.1). A person was reported killed due to a landslide on this route (El Universo 2023b). The Ecuadorian government declared a state of emergency in Azuay.

Figure 5.1. Landslide on Cuenca-Molleturo Route (a) Cuenca-Molleturo Route landslide closing 30 m of road ([Twitter 2023g](#)). (b) Sketch of the surface of failure generated during the seismic motion.

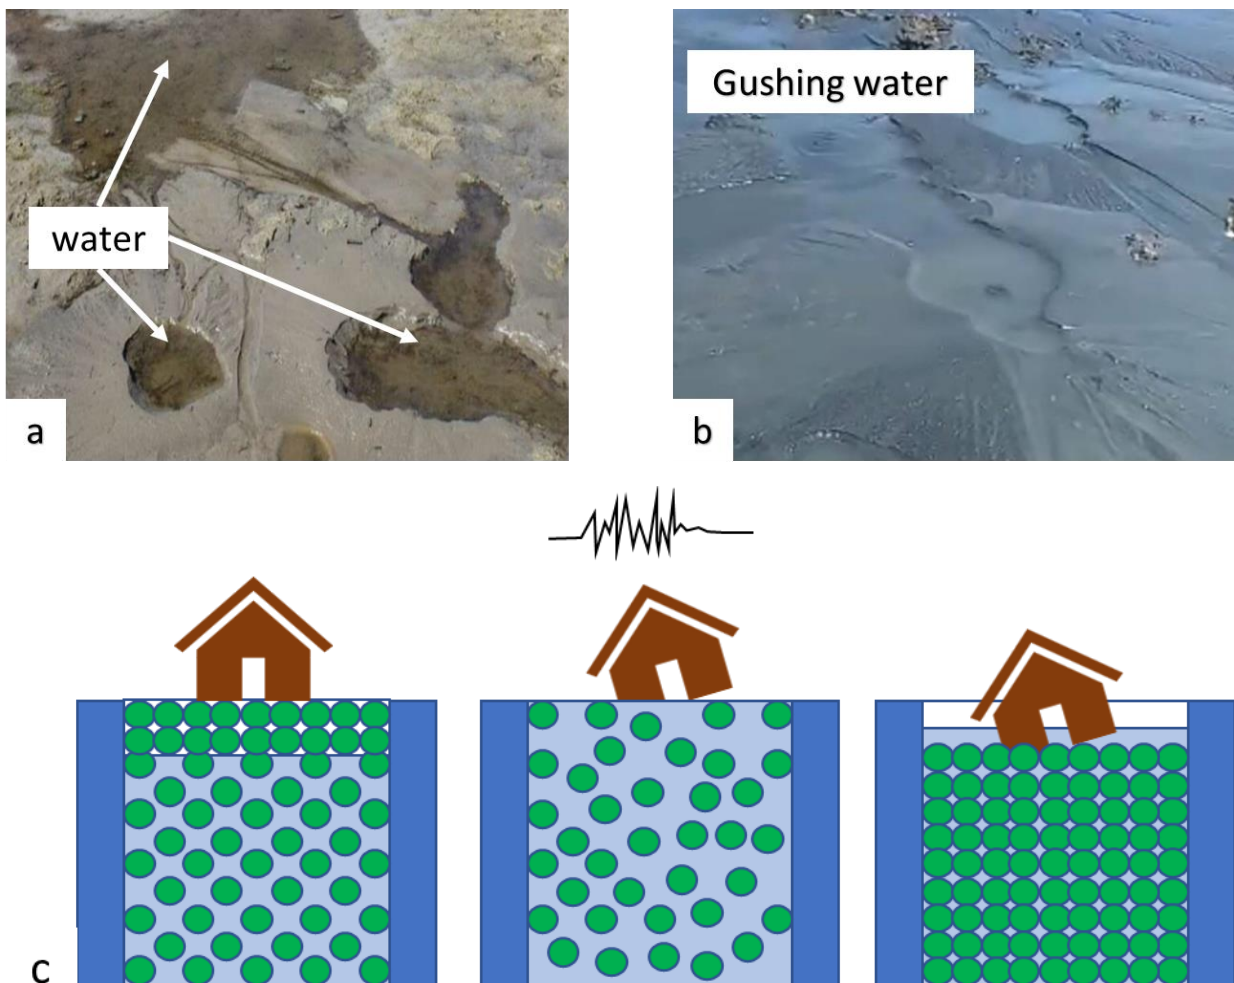
There were several reports of liquefaction from Isla Puná, Guayaquil, Guayas which is located in the Gulf of Guayaquil, right next to the location of the epicenter of the Balao Earthquake (Fig 6.1). The community describe it as small water volcanoes. There were no total collapses, but there were at least ten partial collapses reported by Dirección de Monitoreo de Eventos Adversos (2023).

Figure 6.1. Liquefaction at Isla Puná: (a) Water pools due to liquefaction ([El Comercio 2023c](#)). (b) Soil fractures surrounding foundations ([El universo 2023c](#)). (c) Liquefaction phenomenon sketch.

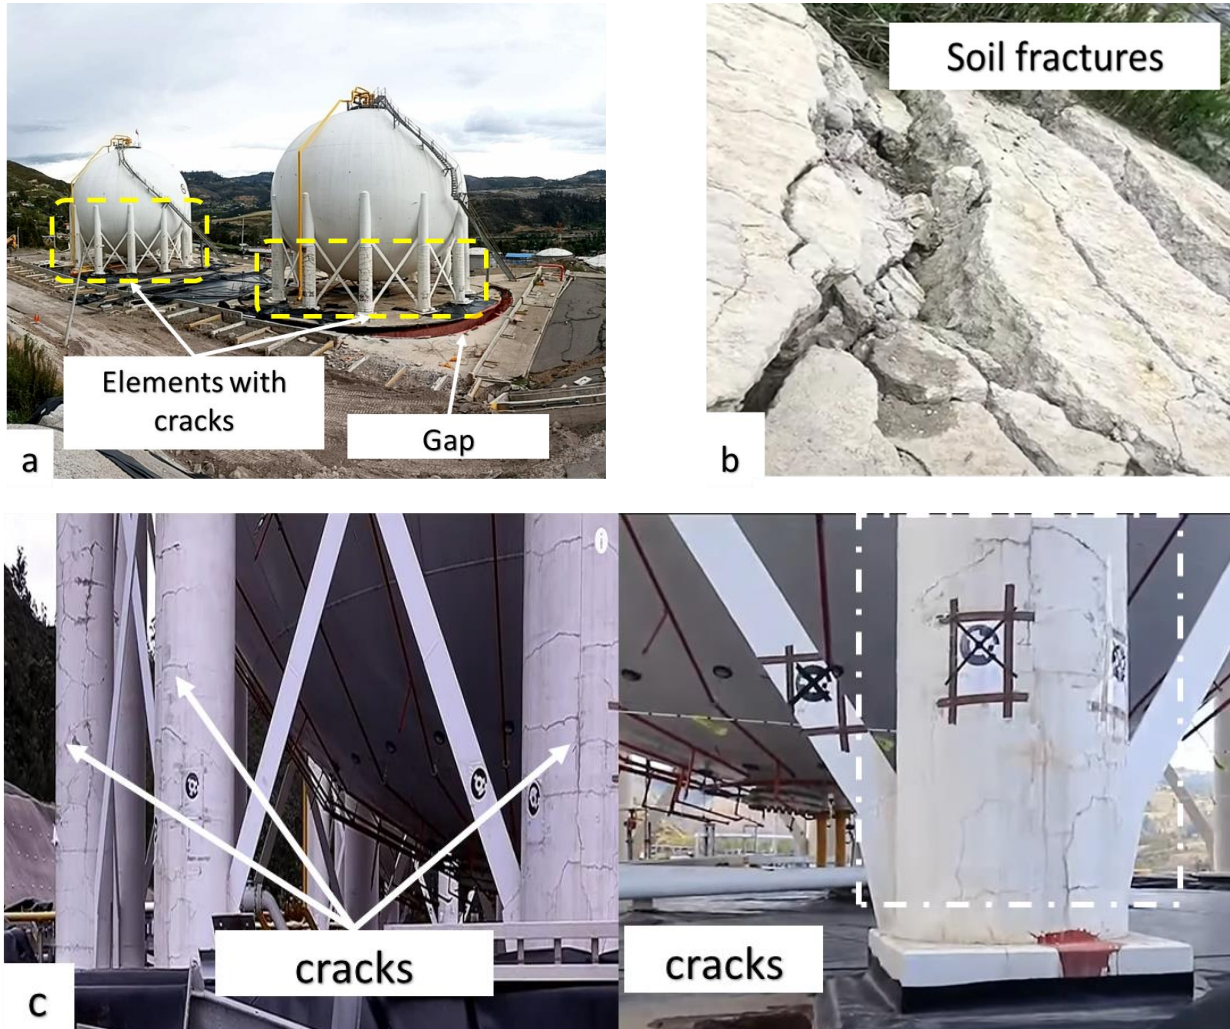
Figure 6.2 shows spherical storage tanks of 3,238 m³ each for petroleum liquid gas, located in Cuenca, approximately 70 km from the epicenter of the 6.8Mw Balao earthquake. According to government representatives (Transport Manager of Petroecuador), these structures already had settlement issues which were exacerbated by the 6.8Mw Balao earthquake reaching settlements of about 3 cm. The spheres are scheduled to be disassembled and transported to Chorrillos Terminal in Guayas where they will be reassembled.

Figure 6.2. Foundation Settlement of Storage units: (a) Spherical Storage unit site ([Twitter 2023i](#)). (b) Soil fractures surrounding foundations ([Twitter 2023i](#)). (c) Distress in supporting columns due to relative settlements ([Twitter 2023i](#)).
