**NASHVILLE TORNADES**

**MARCH 3, 2020**

**NHERI DesignSafe Project ID:  
 PRJ-2723**

**EARLY ACCESS VIRTUAL RECONNAISSANCE REPORT (EARR)**

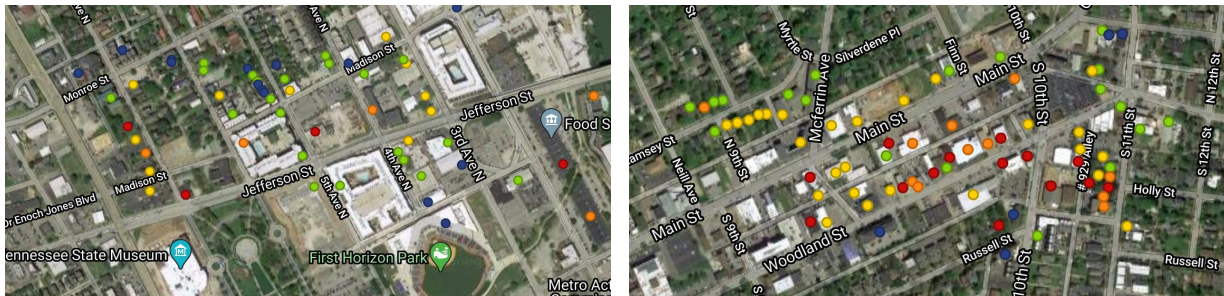
**Figure 2.2.** Scattered damage levels within a relatively narrow tornado damage path through Germantown (left) and Five Points (right).

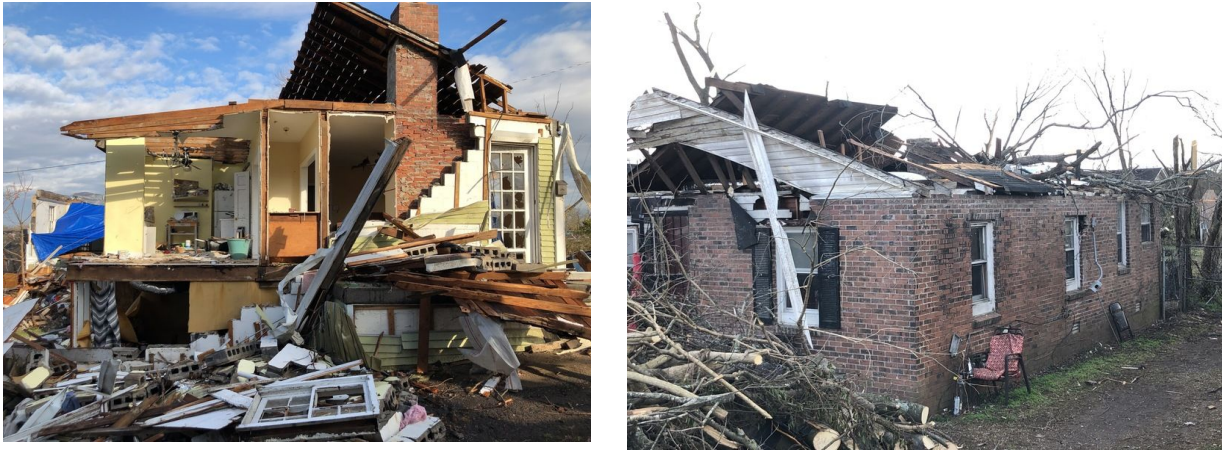
**Figure 6.1.1.** (left) 2-story hollow CMU residential structure with horizontal 1X wood planks for roof sheathing in Lockeland Springs; (right) single-story wood-frame home (constructed in 1945) in the Osage/North Fisk neighborhood in north Nashville with wood rafters and plywood sheathing.

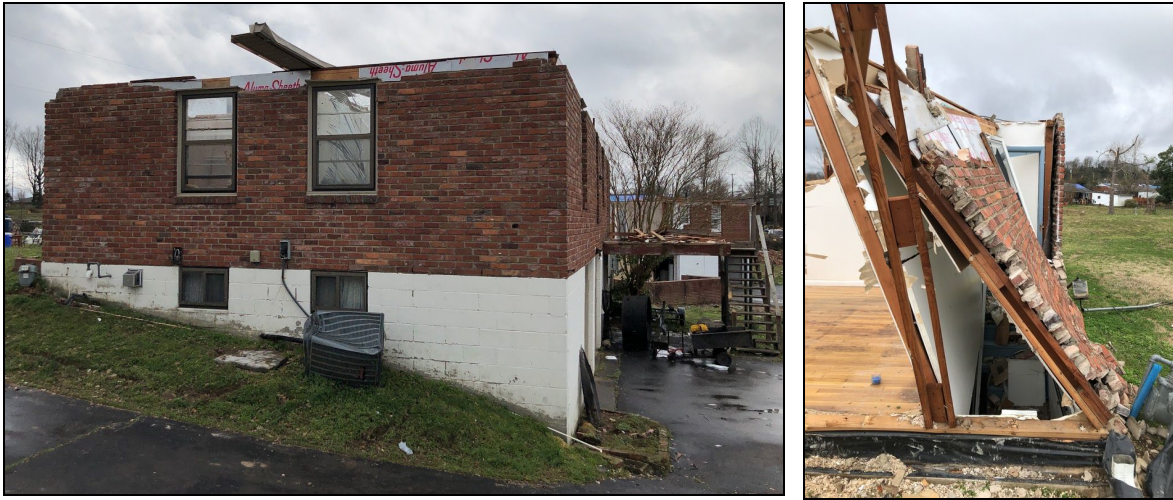
**Figure 6.1.2.** Typical construction and common failures in Donelson, with (left) a roof entirely removed, and (right) partial collapse of a wood-frame wall.

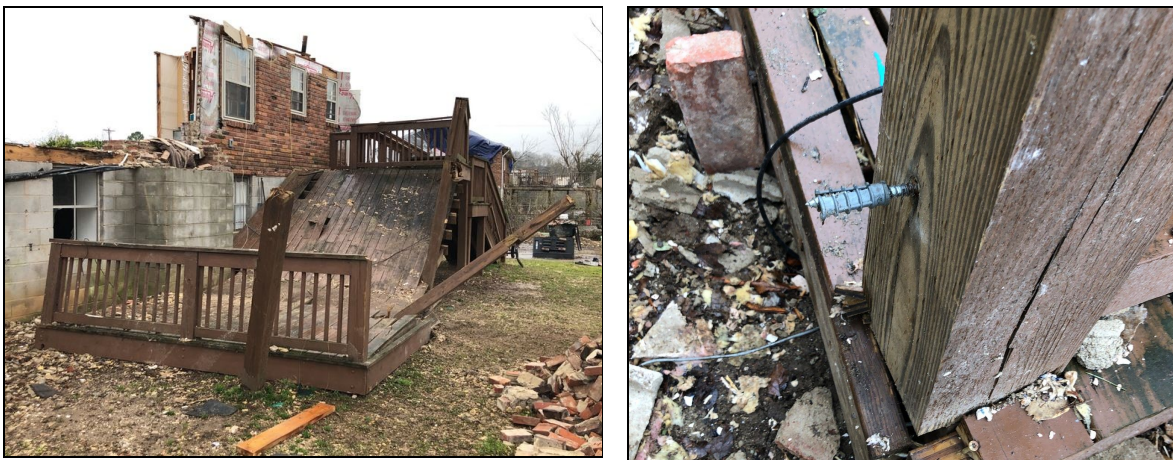
**Figure 6.1.3.** Several decks in Donelson that collapsed were fastened only to the brick veneer at the 2nd floor level.

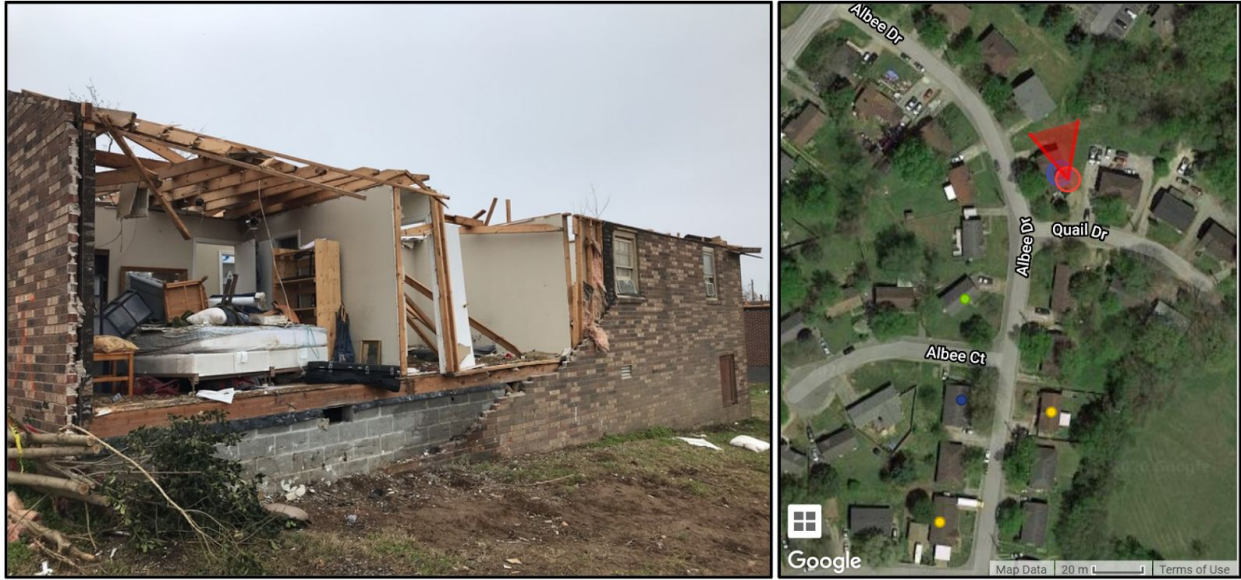
**Figure 6.1.4.** Single-story gable-roofed structure destroyed in Hermitage. Single-wythe brick facade on wood stud wall with Celotex wall sheathing. Home built in 1980. Photo taken March 12.

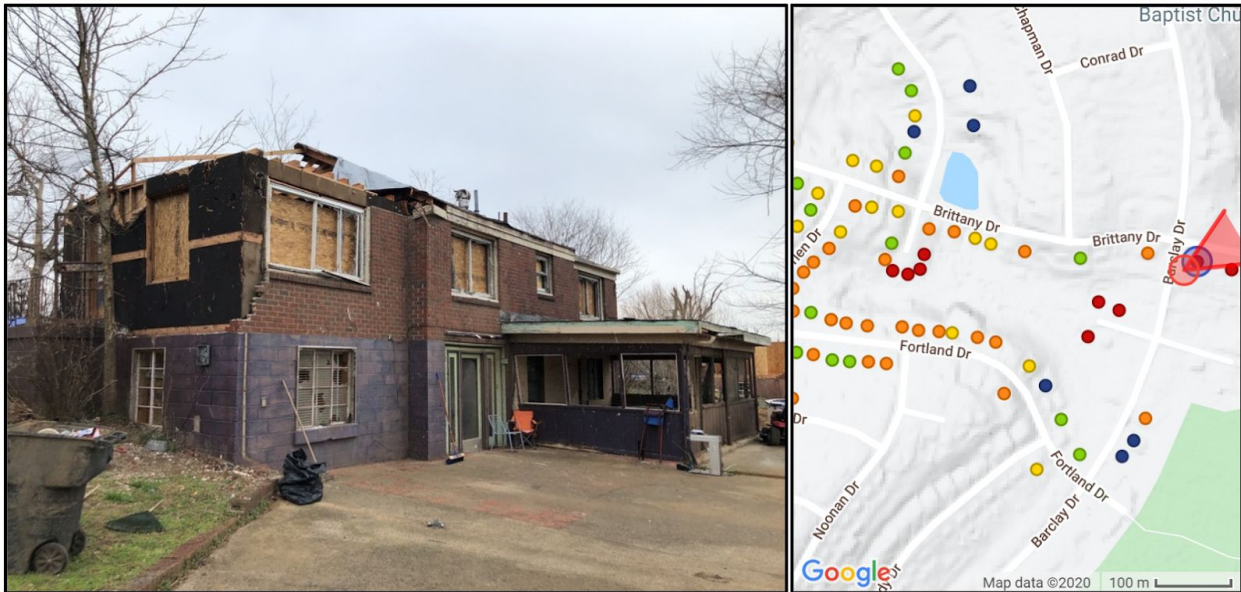
**Figure 6.1.5.** Typical 1980's construction in Barclay subdivision, with wood rafters, non-structural wall sheathing, and unreinforced masonry stem wall foundations with walk-out basements. Damage may have been enhanced by topographic features, with heaviest damage colocated with a valley that ran East-West through the area.

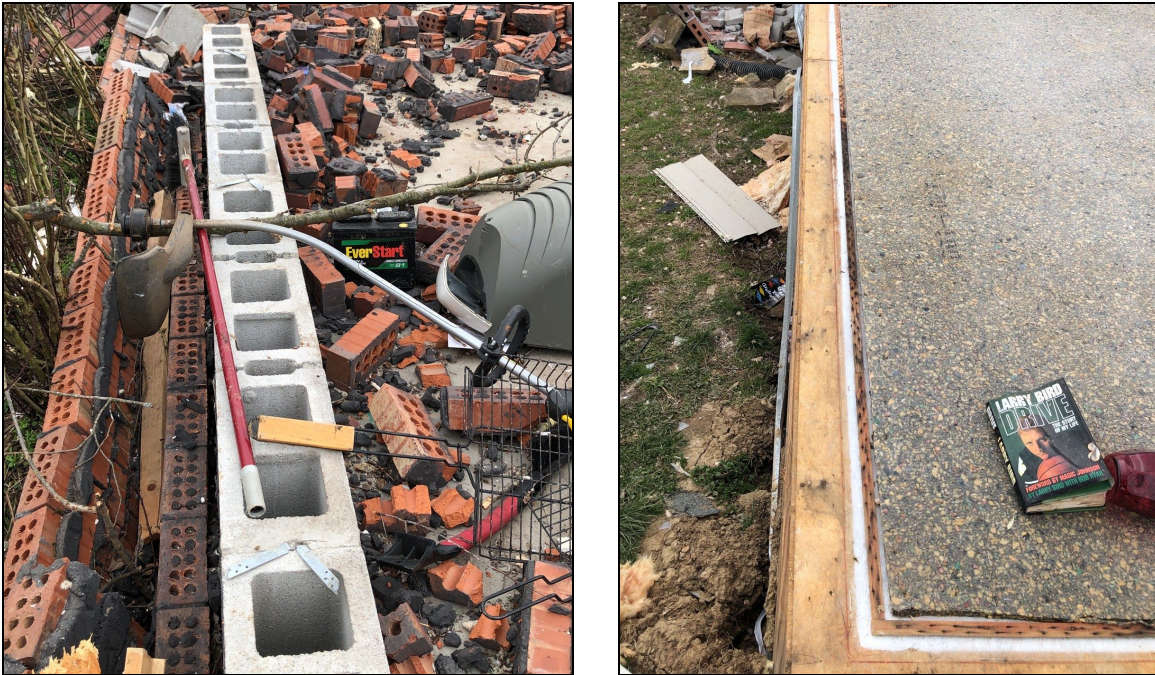
**Figure 6.1.6.** Common failures in Triple Crown subdivision with (left) foundation anchor straps installed into primarily ungrouted CMU block stem wall and (right) nailed sill plate attachment to floor system (two nails at 16-inches on-center).

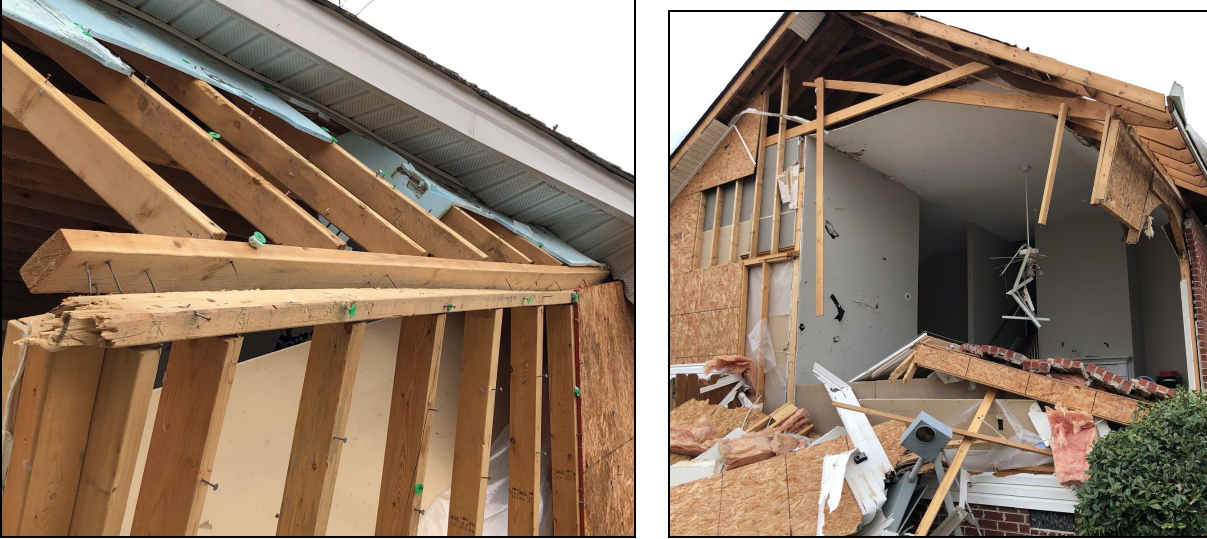
**Figure 6.1.7.** Gable end (left) and tall wall (right) failures occurring at the intersection of upper gable frame bottom plate and lower wall frame top plate, where sheathing is not overlapped and no lateral support is present.

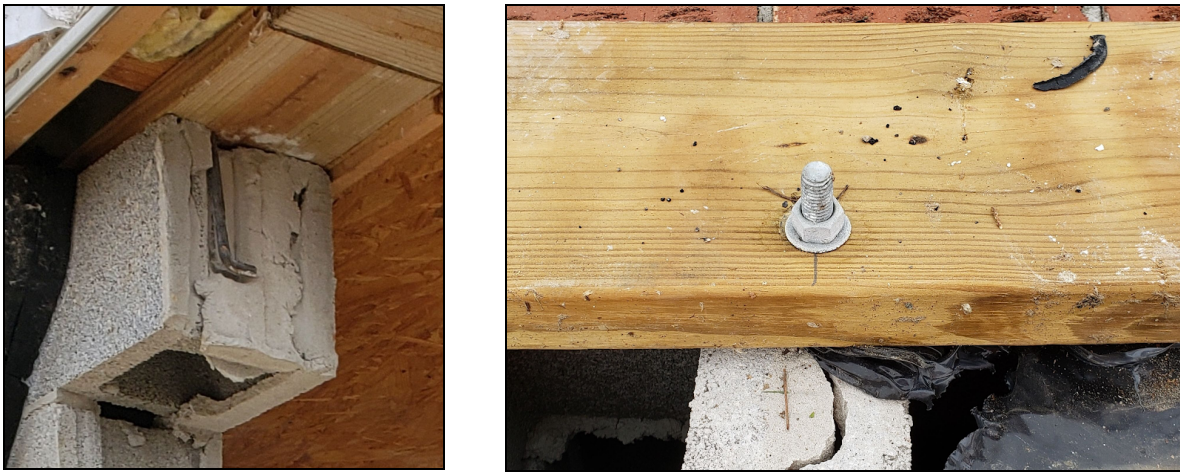
**Figure 6.1.8.** Bottom and top views of the typical sill plate to masonry stem wall connection. Here the sill plate is fastened to the stem wall with a j-bolt embedded in the head joint between adjacent empty CMU blocks.

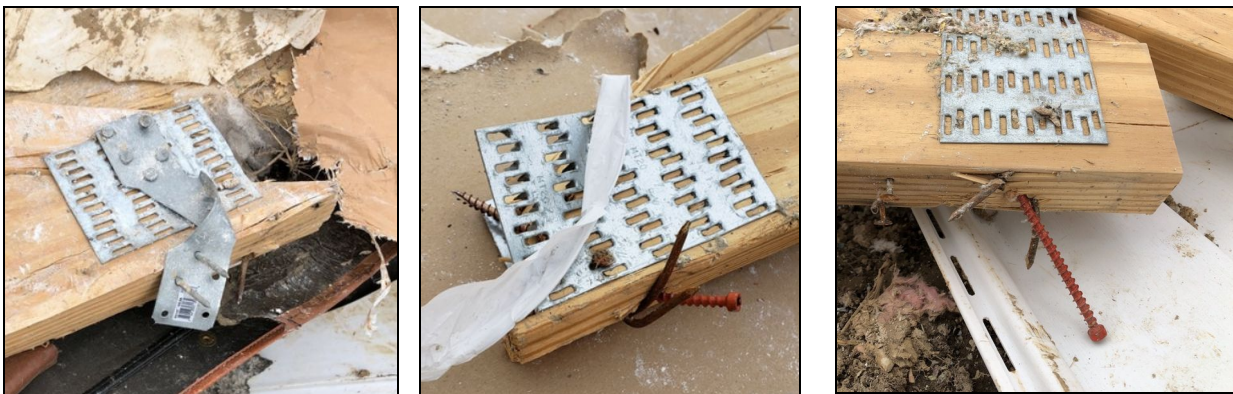
**Figure 6.1.9.** Observed roof-to-wall connections in newest homes, including (left) a hurricane strap, (middle) an incorrectly installed fully-threaded truss screw (0.15 in x 6 in; insufficient embedment in the wall double top plates) in the Hensley Dr. neighborhood, and (right) fully-threaded truss screw used in a raised heel truss.

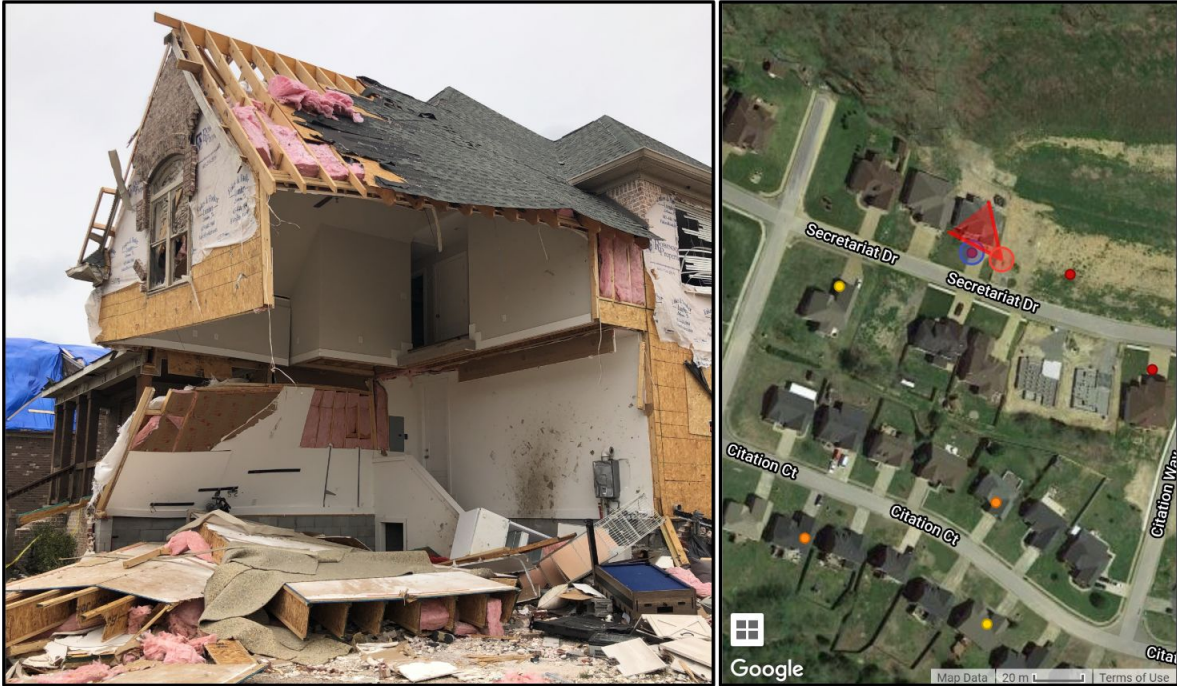
**Figure 6.1.10.** Garage wall failures were commonly observed, typically due to failure of garage doors, positive internal pressurization of the garage, and separation of walls at story joints, where discontinuities in the vertical load path exist.

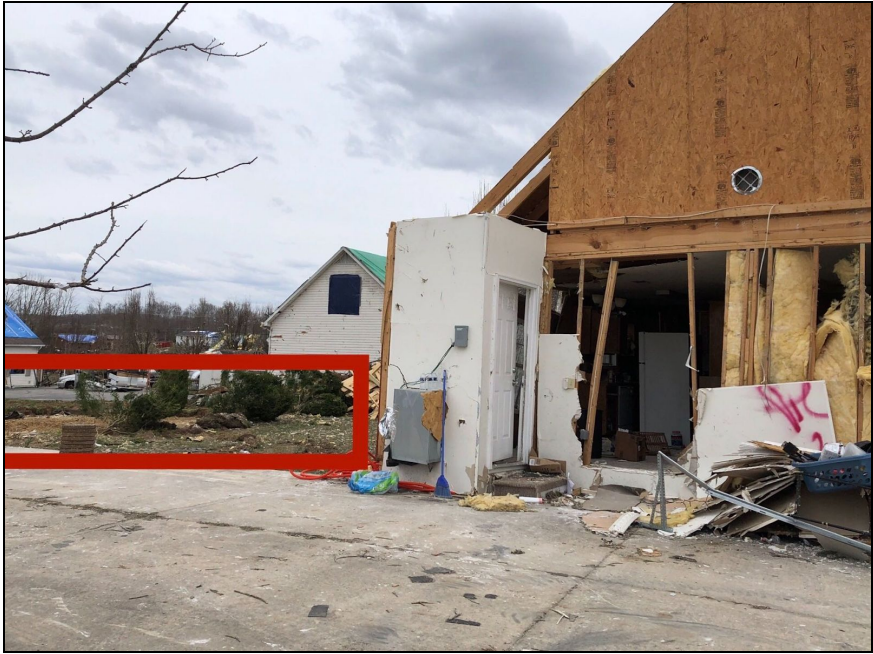
**Figure 6.1.11.** Anchorage failures were widespread, even when the majority of the home remained intact. This home slid approximately 50 ft off its foundation, and lofted over bushes. Red box indicates the original location of the home. The anchorage system present was the same as described previously - unreinforced masonry stem wall.

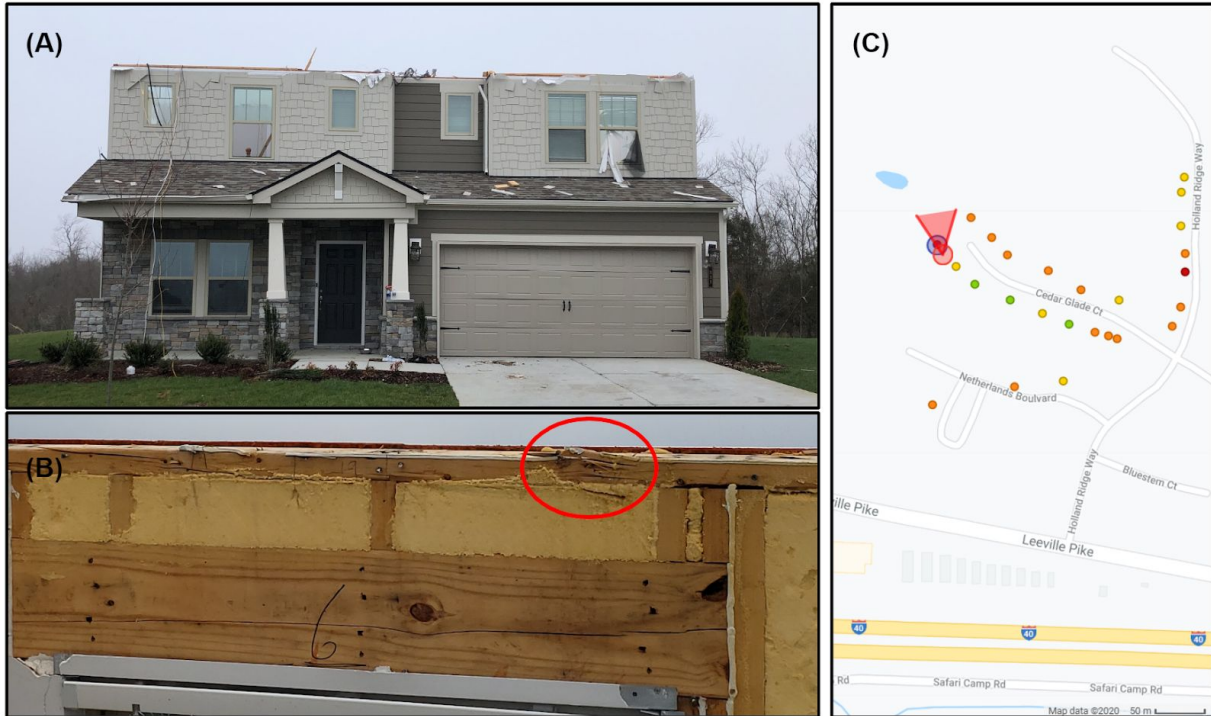
**Figure 6.1.12.** (a) New construction of single-family residential building structure in Lebanon with entire roof failure; (b) although hurricane straps were used to fasten the roof trusses to the walls (located on the inside of the wall), the lower nails of the hurricane strap barely caught the lower of the two top plates (highlighted by red oval), while the wall sheathing was stapled only to the lower top plate. The vertical load path at this connection therefore relied upon the withdrawal capacity of the nails connecting the upper and lower top plates to transfer loads to the walls.

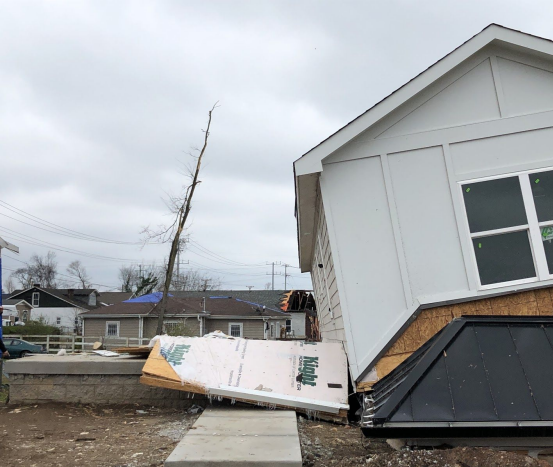
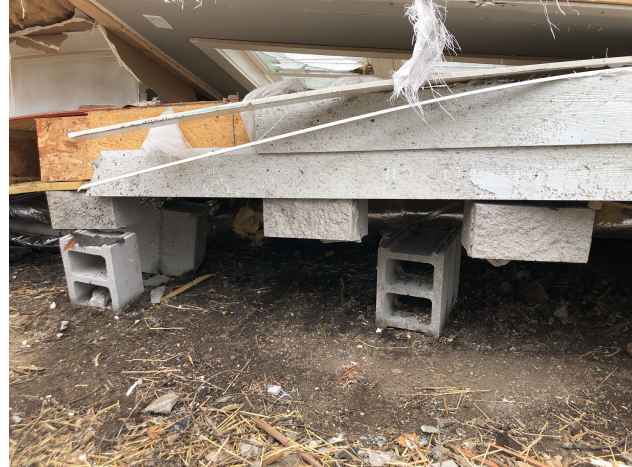
**Figure 6.1.13.** (left) Collapse of lower level in newly built “tall and skinny” home in North Nashville on 14th Ave.; (right) pictured is the 2nd floor with the left-hand 1st story wall laying flat. Single grouted blocks in the top course of the stem wall were still attached to the sill plate.

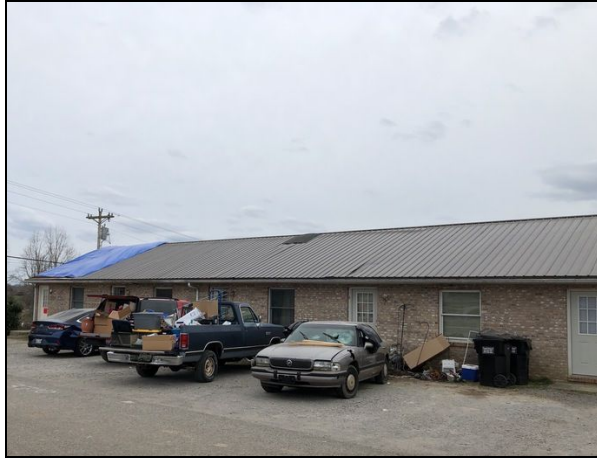
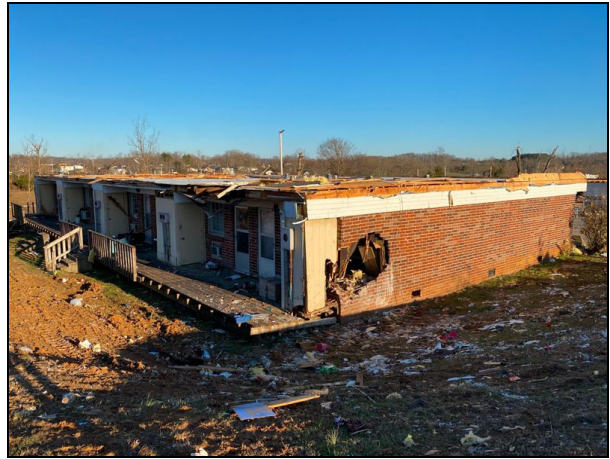
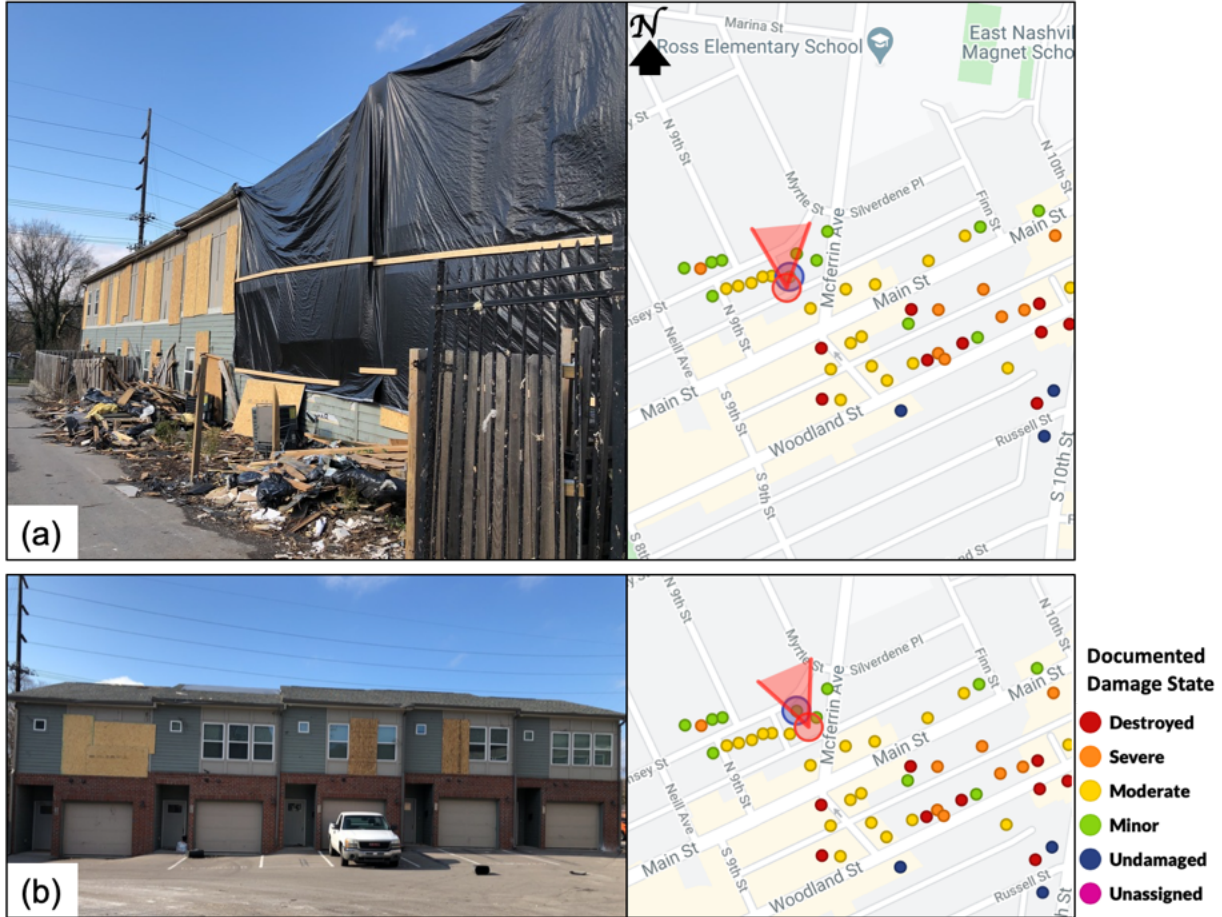
**Figure 6.2.2.** Cluster of townhome structures where (a) eastern exterior structure sustained moderate damage and (b) northern interior structure sustained minor damage. Photos taken March 10, 2020. Photo with map available on Fulcrum App.

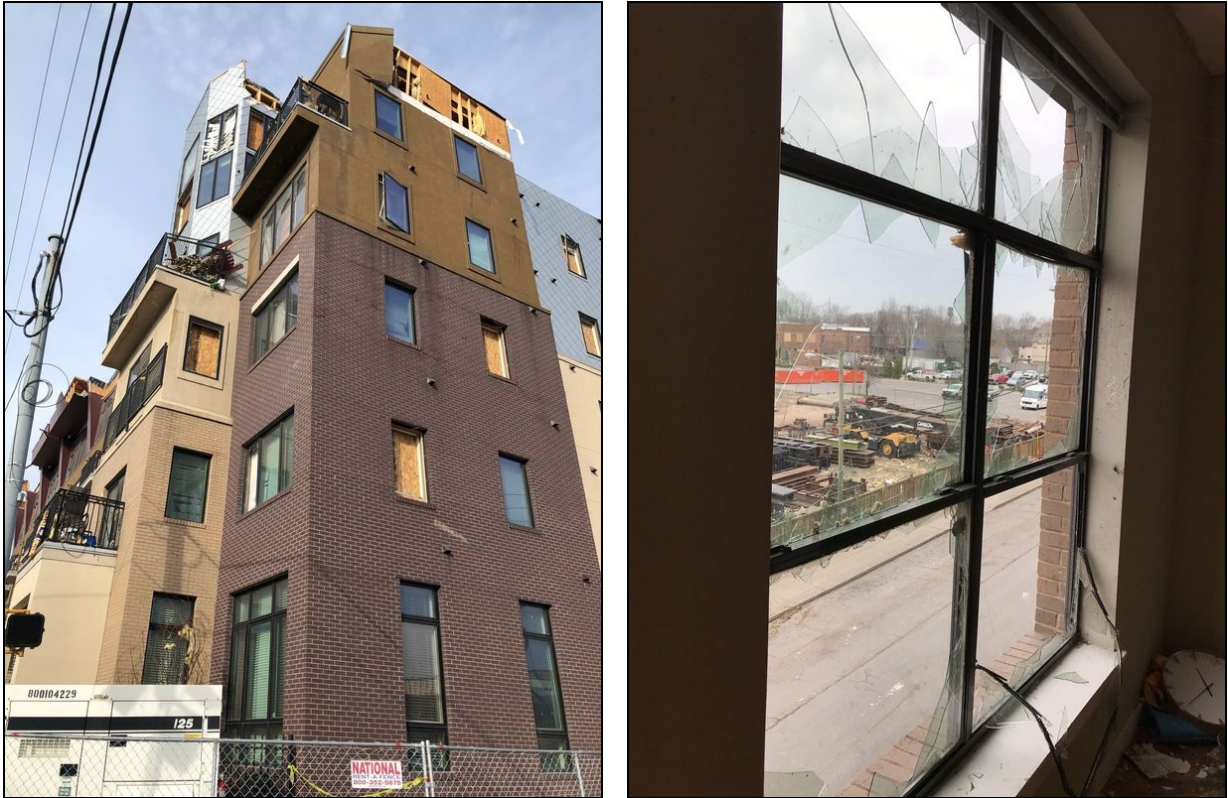
**Figure 6.2.3.** Typical residential structure in Germantown (Apartments >10 units). Damage primarily to windows and roofing/ top floor.

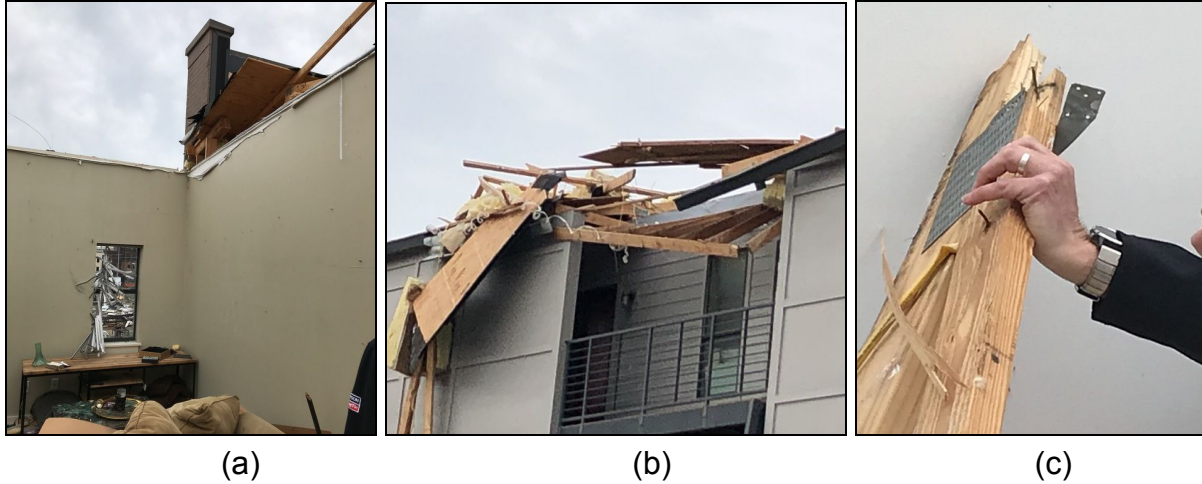
**Figure 6.2.5.** Documented (a) roof failure, (b) initiated at overhang, with (c) evidence of metal ties in a 3-story apartment building in Germantown.

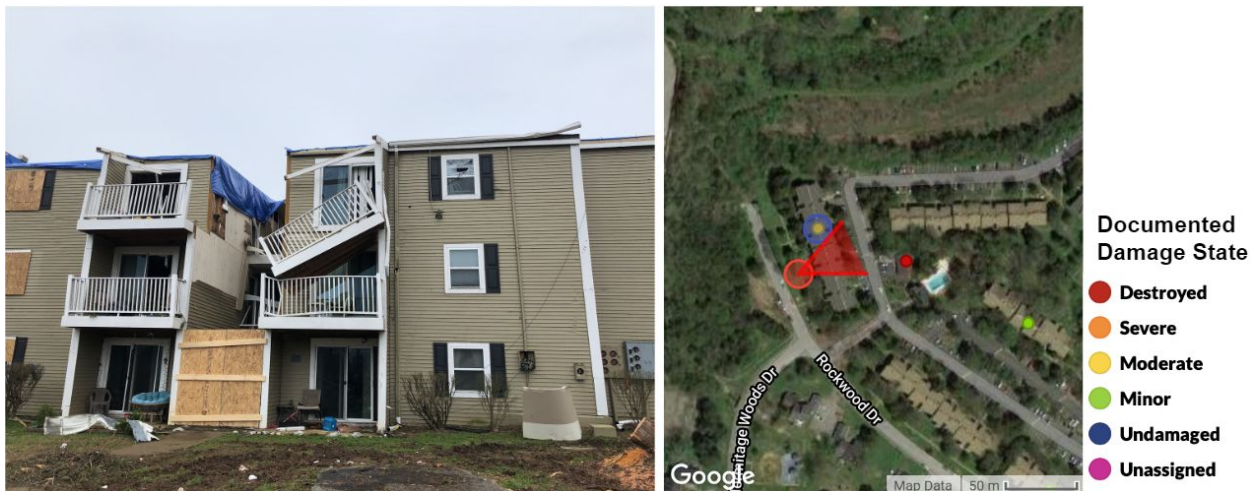
**Figure 6.2.6.** Balcony failure observed in a three-story apartment complex at Hermitage. Photo taken March 12, 2020.

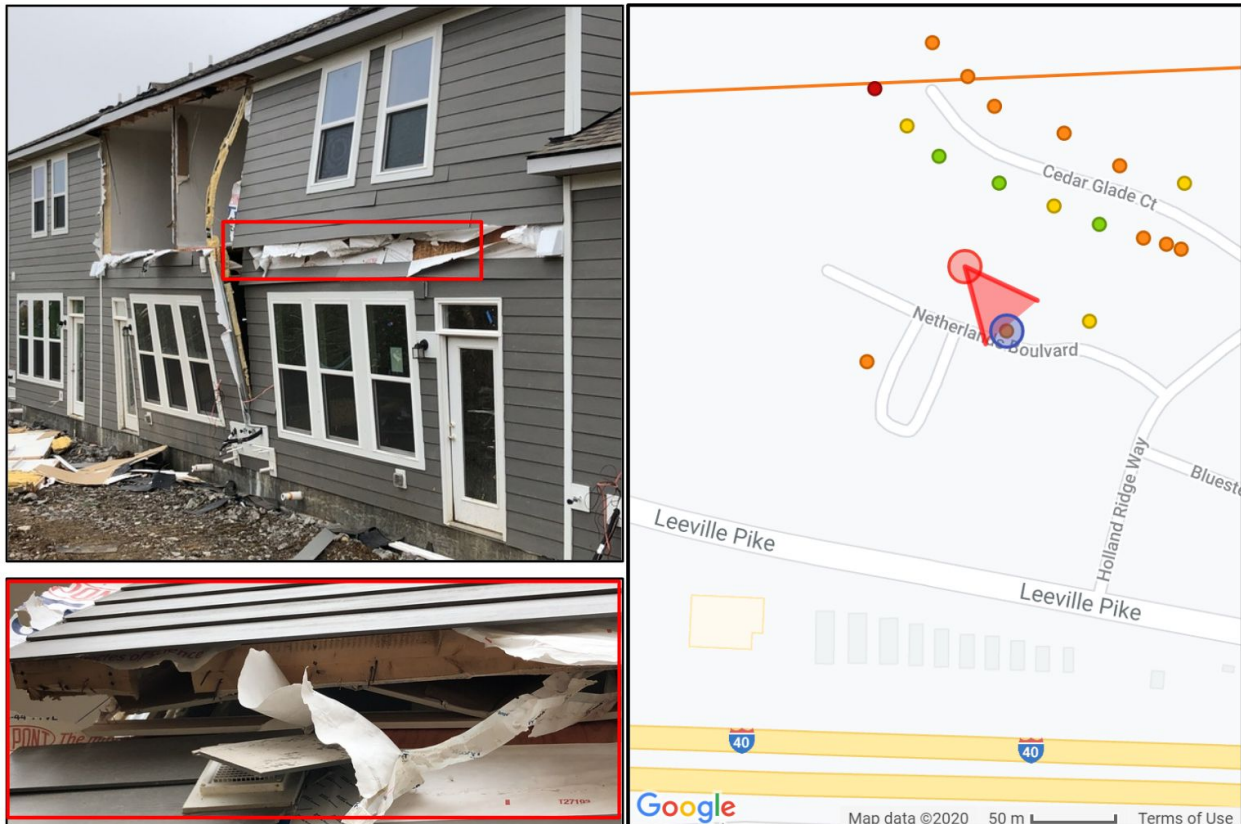
**Figure 6.2.7.** A multi-family complex near Lebanon constructed in 2019/2020 with blowout of the leeward wall. Connection between floors relied upon the shear capacity of nails into the bottom plate of the upper story. Sheathing was not continuous across the story joint. Open cell spray foam insulation was used in the walls and roof. The orange line in the right figure shows the NWS-estimated tornado centerline.

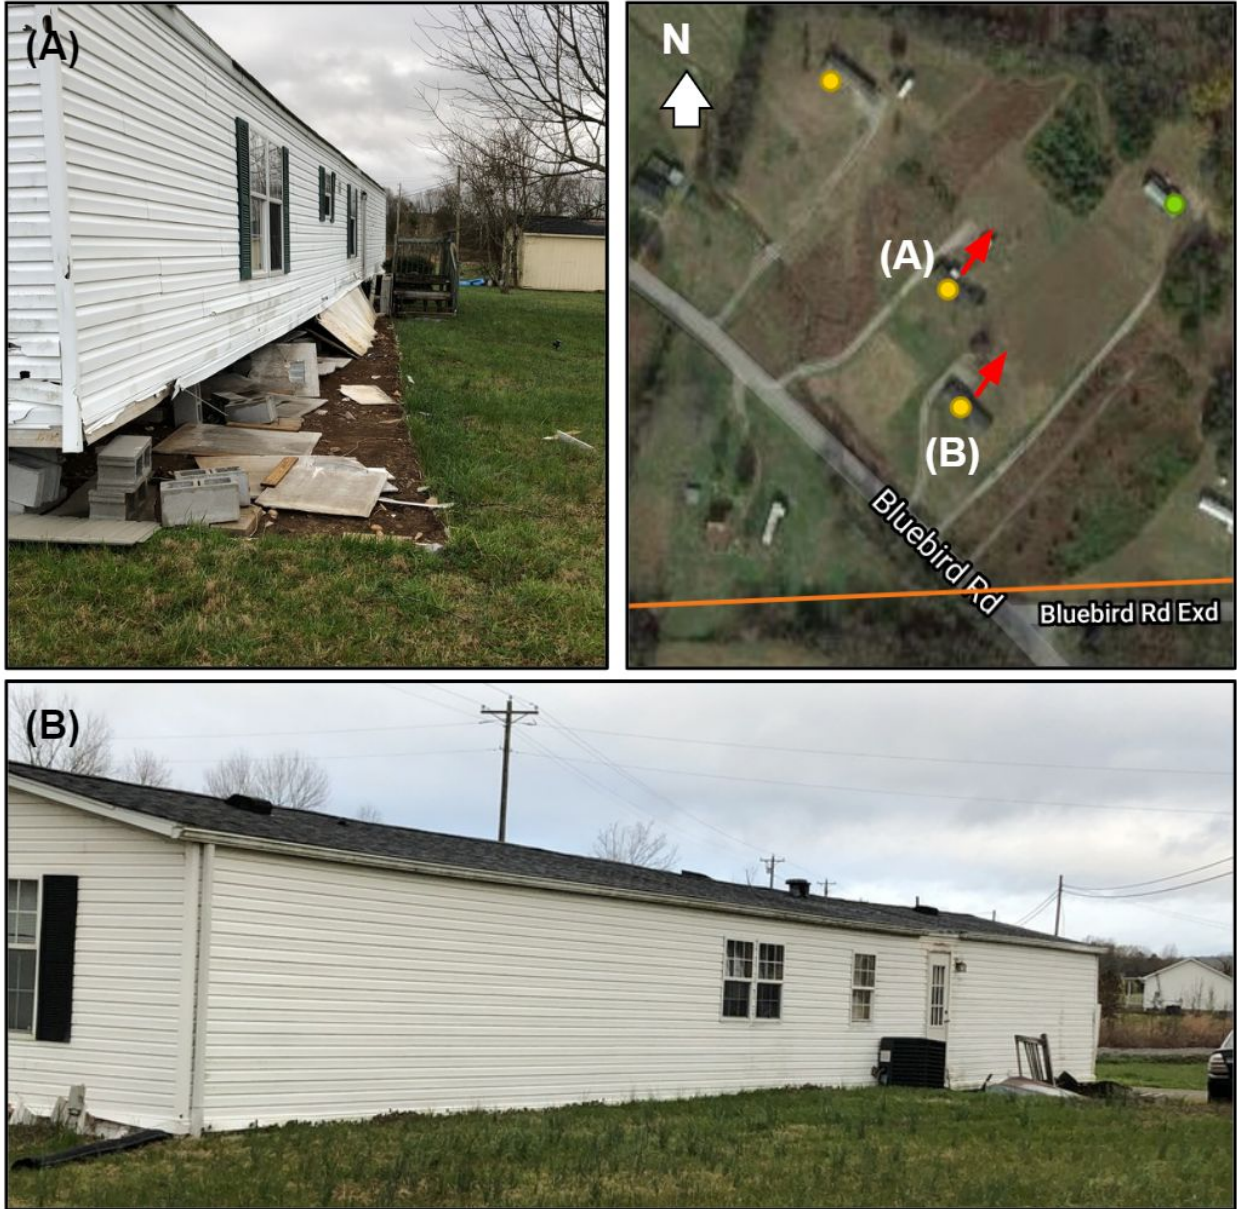
**Figure 6.3.1.** Typical sliding behavior observed in MMH, demonstrating that the anchorage system is often the weakest link in the structural load path.

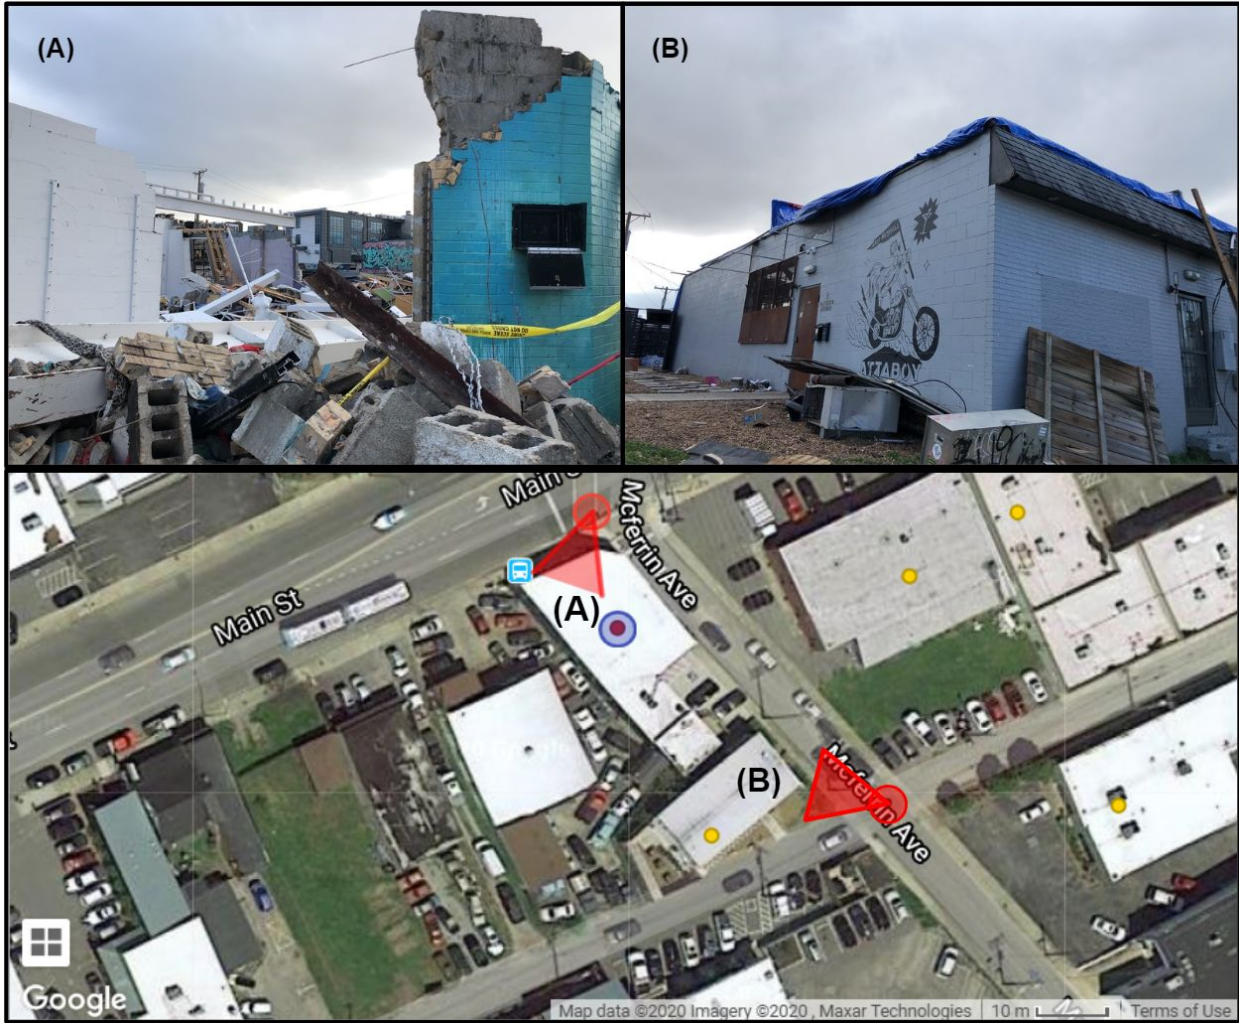
**Figure 6.4.1.** Damage to two adjoining buildings in the Five Points area of Nashville demonstrating the typical variability in performance observed in retail and office buildings. (a) a destroyed brick and concrete masonry block building with some steel framing members (built in 1950). Minimal reinforcement visible in the rubble, primarily existing in the bond beam; (b) a brick and concrete masonry block building with moderate damage to the roof cover (built in 1970).

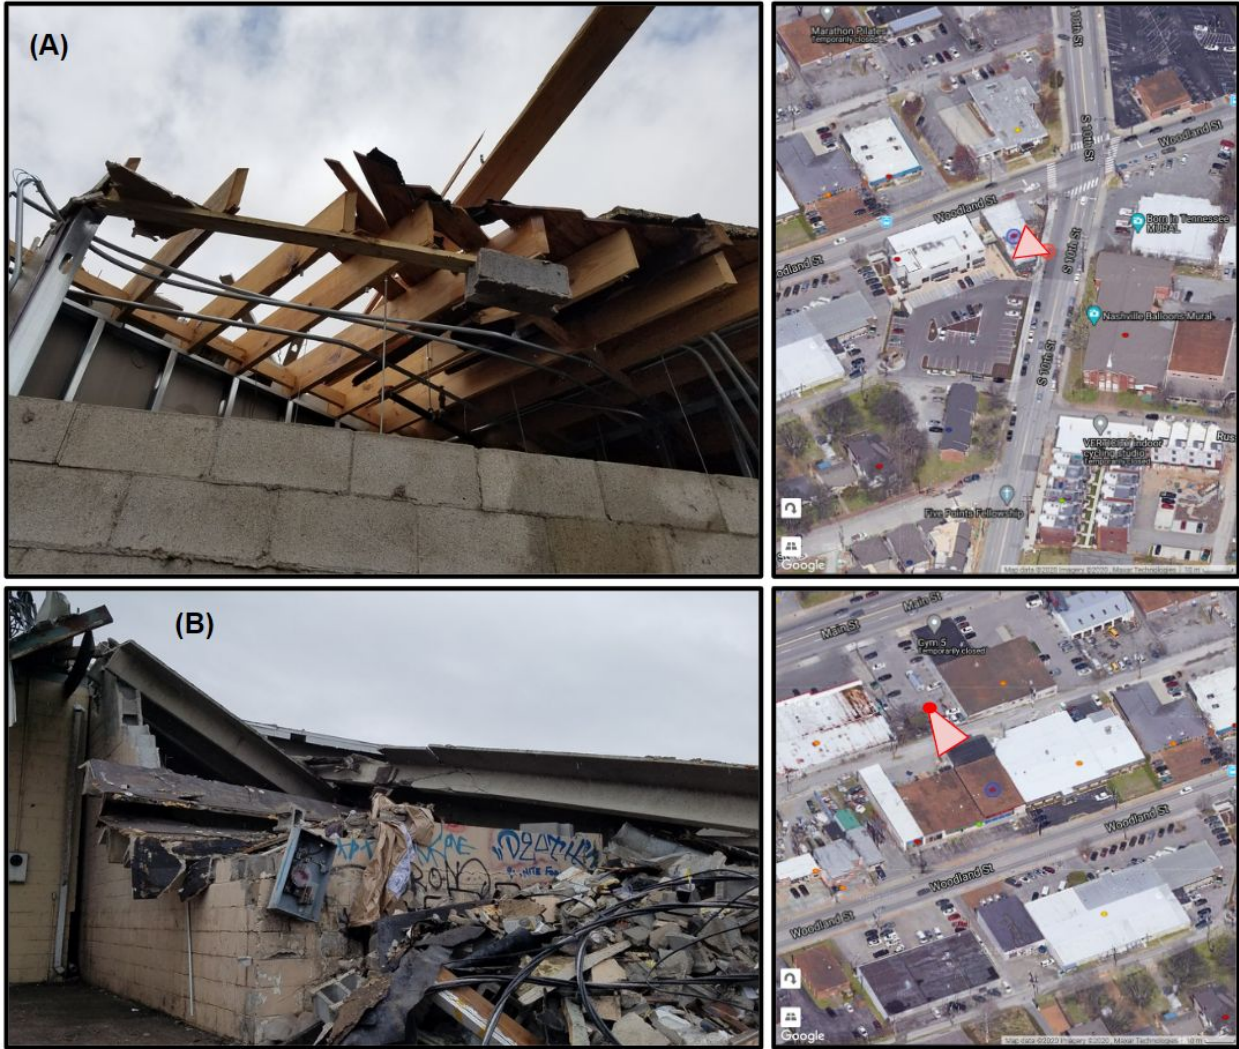
**Figure 6.4.2.** Additional failures noted in the Five Points area of Nashville: (a) Remnants of the bond beam and the wood top plate at a restaurant building originally constructed in 1935 with masonry block exterior walls, wood rafters, and cold-form steel interior walls; (b) Failure of prestressed concrete beams used in a small warehouse building constructed in 1962.

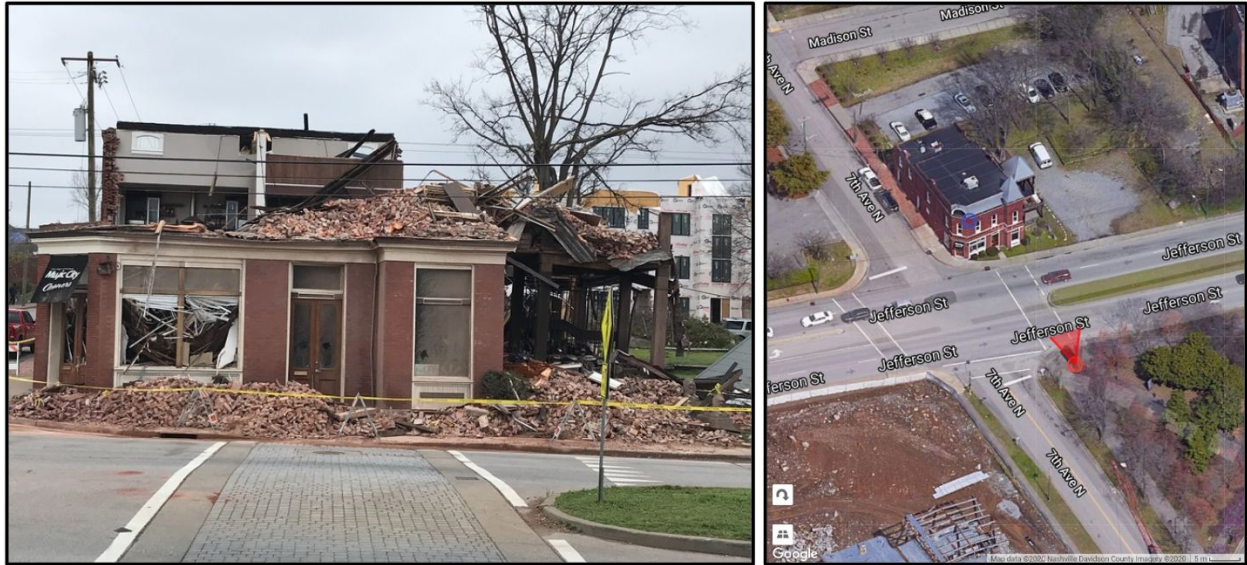
**Figure 6.4.3.** Destroyed office space in Germantown. Structure was built in 1910 and consisted of solid brick wythe walls (4 units thick) and heavy timber roof members.

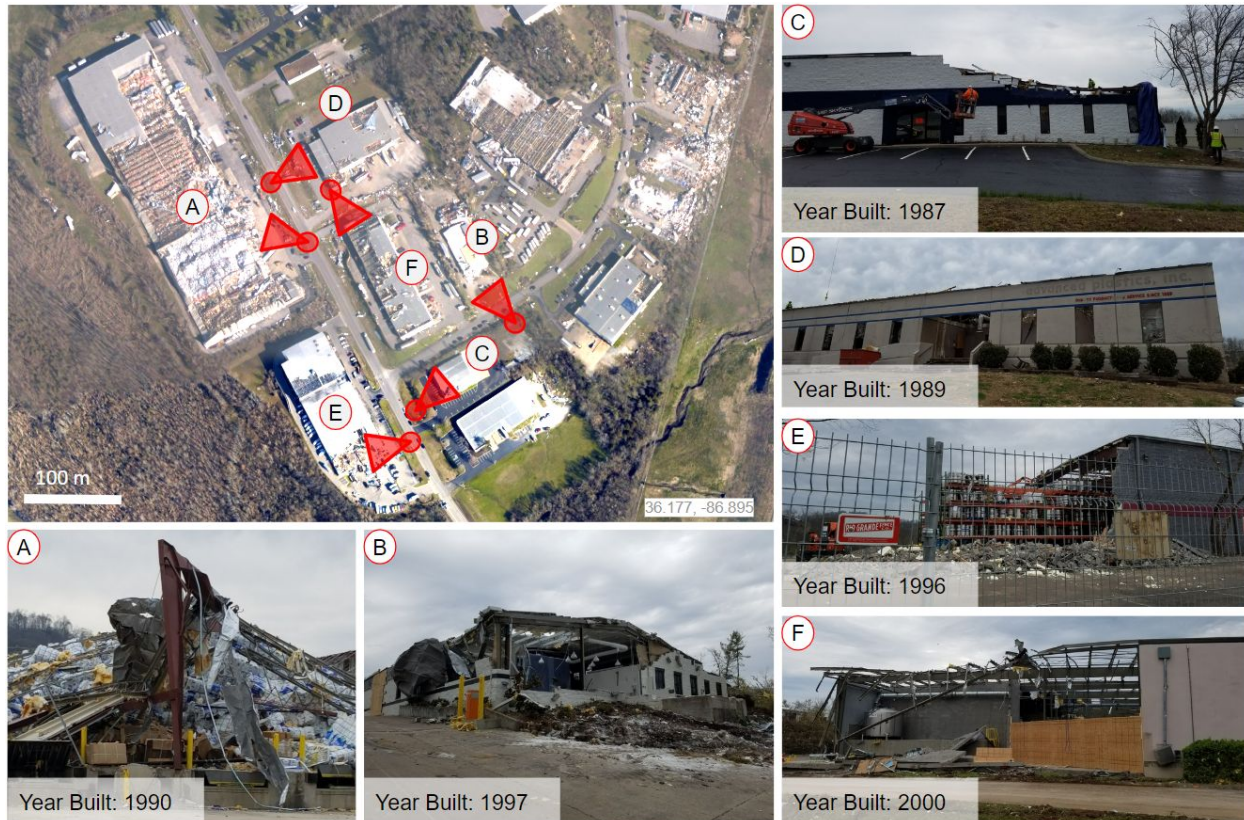
**Figure 6.4.4.** Cluster of damaged, large-volume industrial buildings west of the John C. Tune Airport sampled by FAST. Damage ranged from structural collapse of multiple bays (e.g., Building A) to moderate loss of metal roofing panels and insulation. Structural systems were steel-frame buildings with primarily CMU in-fill walls, steel roof joists or purlins, and corrugated metal deck.

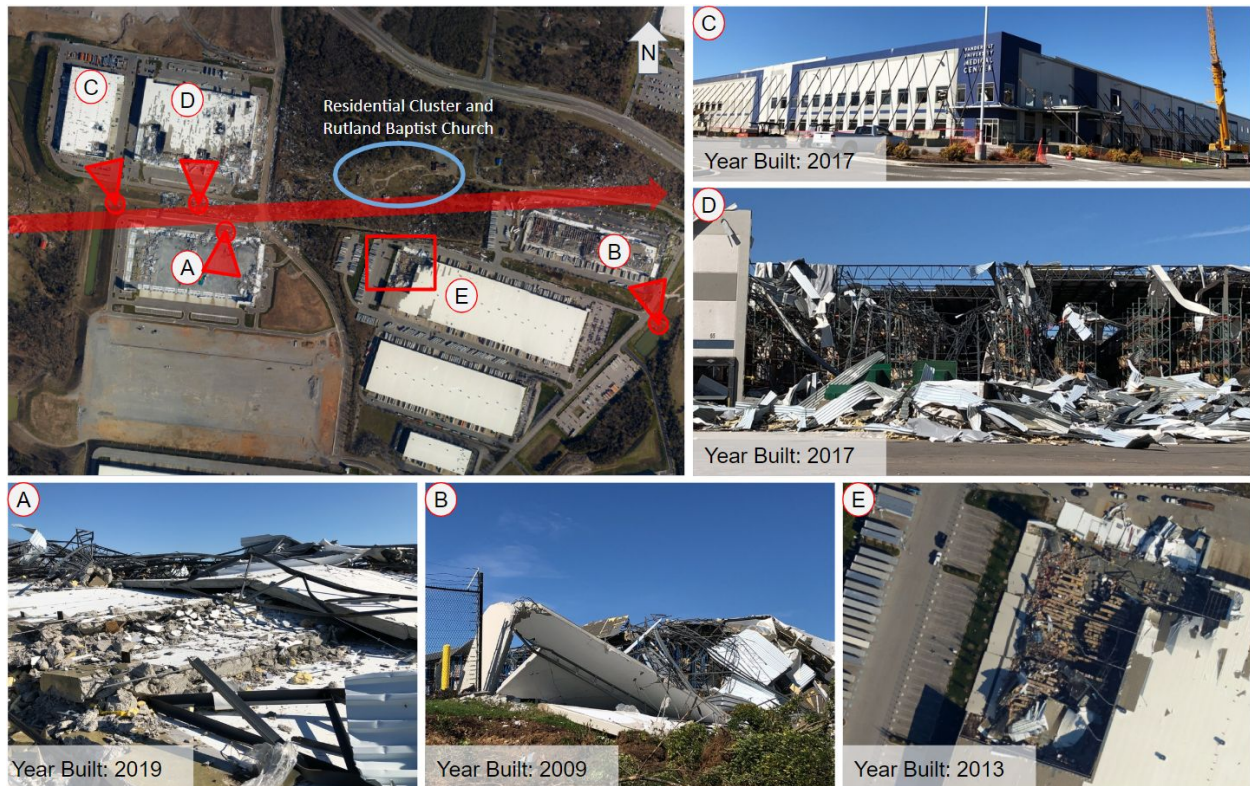
**Figure 6.4.5.** Damage to a cluster of modern industrial buildings between Mt. Juliet and Lebanon. All buildings were tilt-up precast concrete construction with steel roof joists and joist girders. FAST captured aerial imagery via UAV of this cluster to develop densified point clouds to facilitate measurements and further analysis. A residential cluster in the same area experienced a mixture of failures, from complete destruction of a mobile/manufactured home, removal of the roof structure of a single-family home built in 1936, minor damage to a single-family home built in 1949, and moderate damage to Rutland Baptist Church.
