**NASHVILLE TORNADES**

**MARCH 3, 2020**

**NHERI DesignSafe Project ID:  
 PRJ-2723**

**EARLY ACCESS VIRTUAL RECONNAISSANCE REPORT (EARR)**

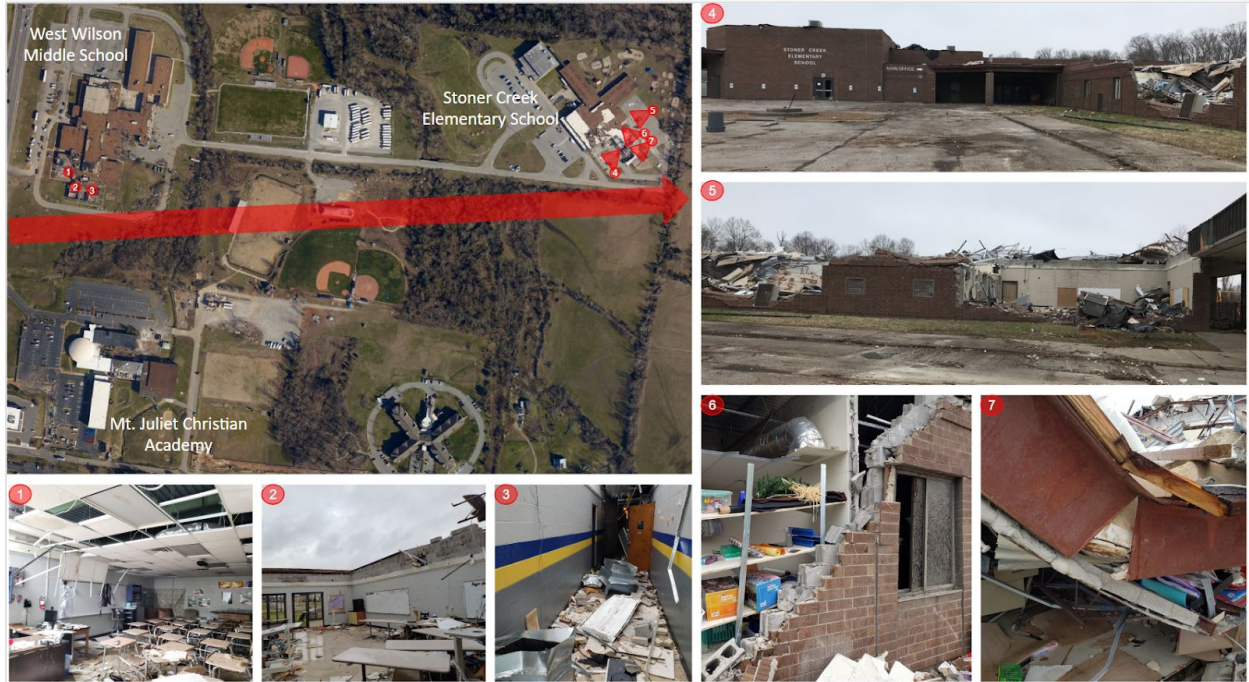
**Figure 6.5.1.** Overview of damage to West Wilson Middle School and Stoner Creek Elementary School in relation to the approximate tornado path (red arrow). Mt. Juliet Christian Academy sustained less severe damage but was not investigated by FAST.

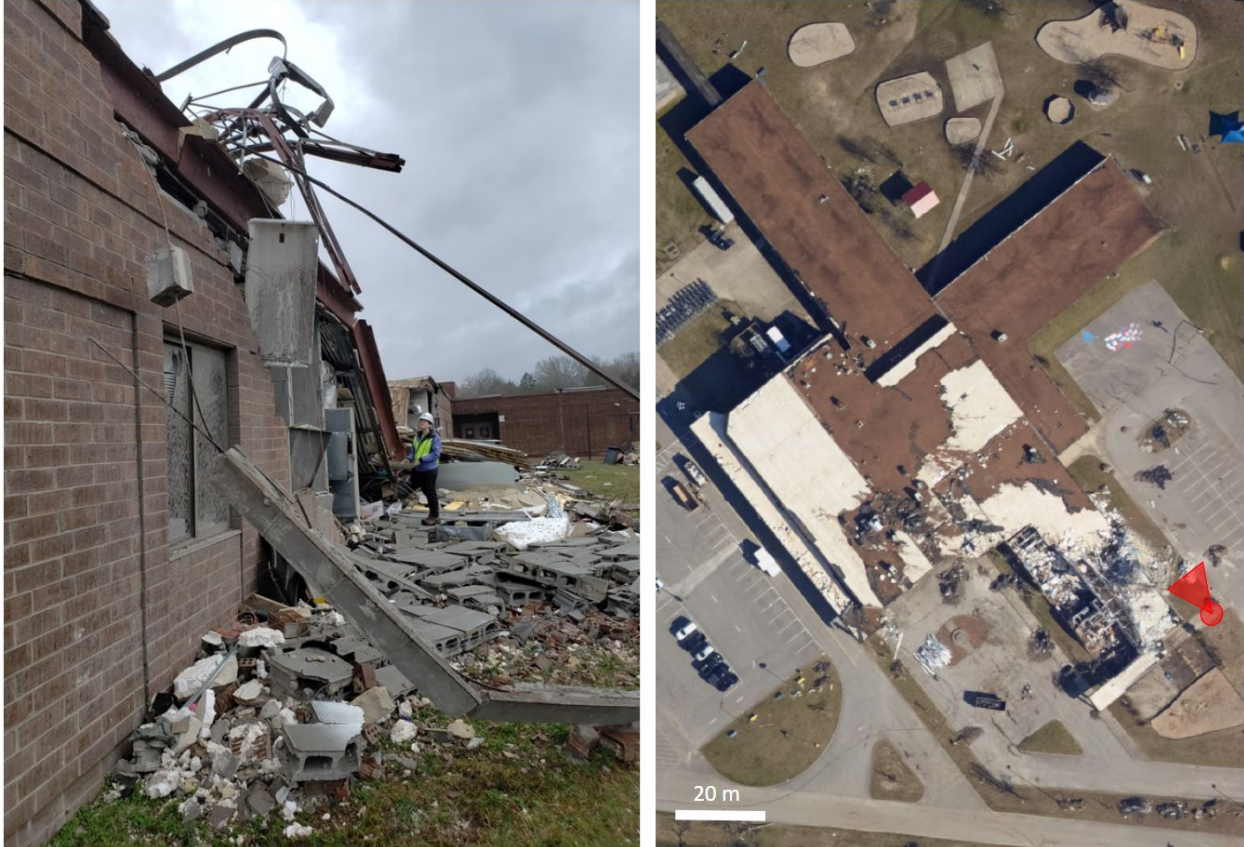
**Figure 6.5.2.** Collapsed CMU wall and roof beams at the south wing of Stoner Creek Elementary School. Steel I-beams and evidence of grouted and reinforced masonry were observed.

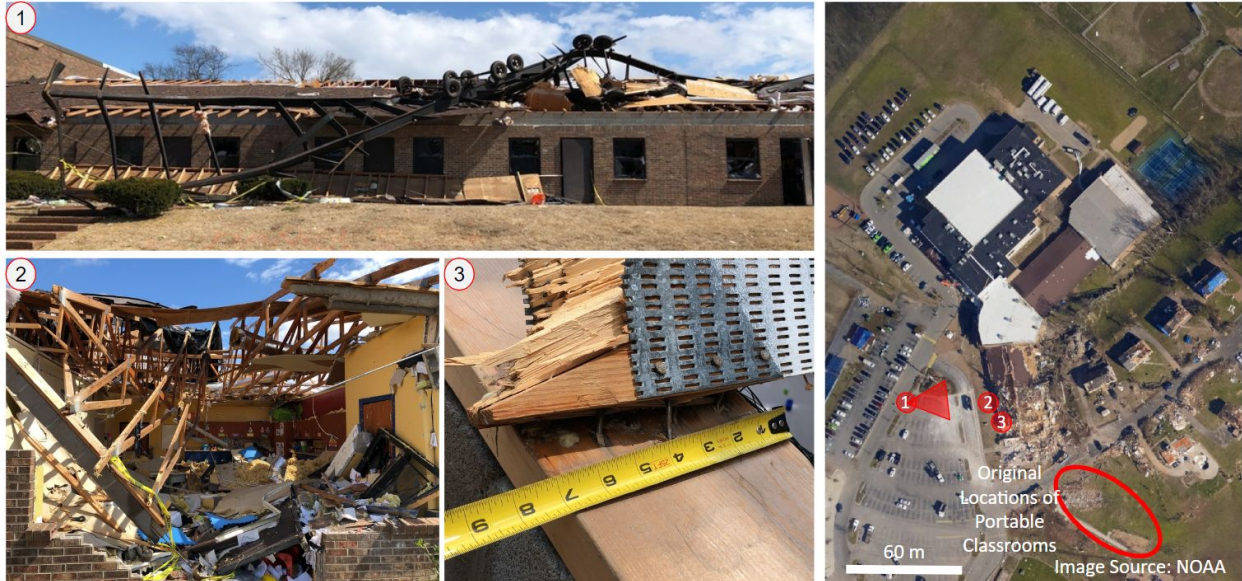
**Figure 6.5.3.** Representative images showing damage to the Donelson Christian Academy. (1) shows the frame of a portable classroom atop the south wing of the academy; (2) shows roof trusses still attached to the CMU bond beam with portions of the wall below collapsed. (3) shows a toe-nail connection between roof trusses and the 2x8 sill plate.

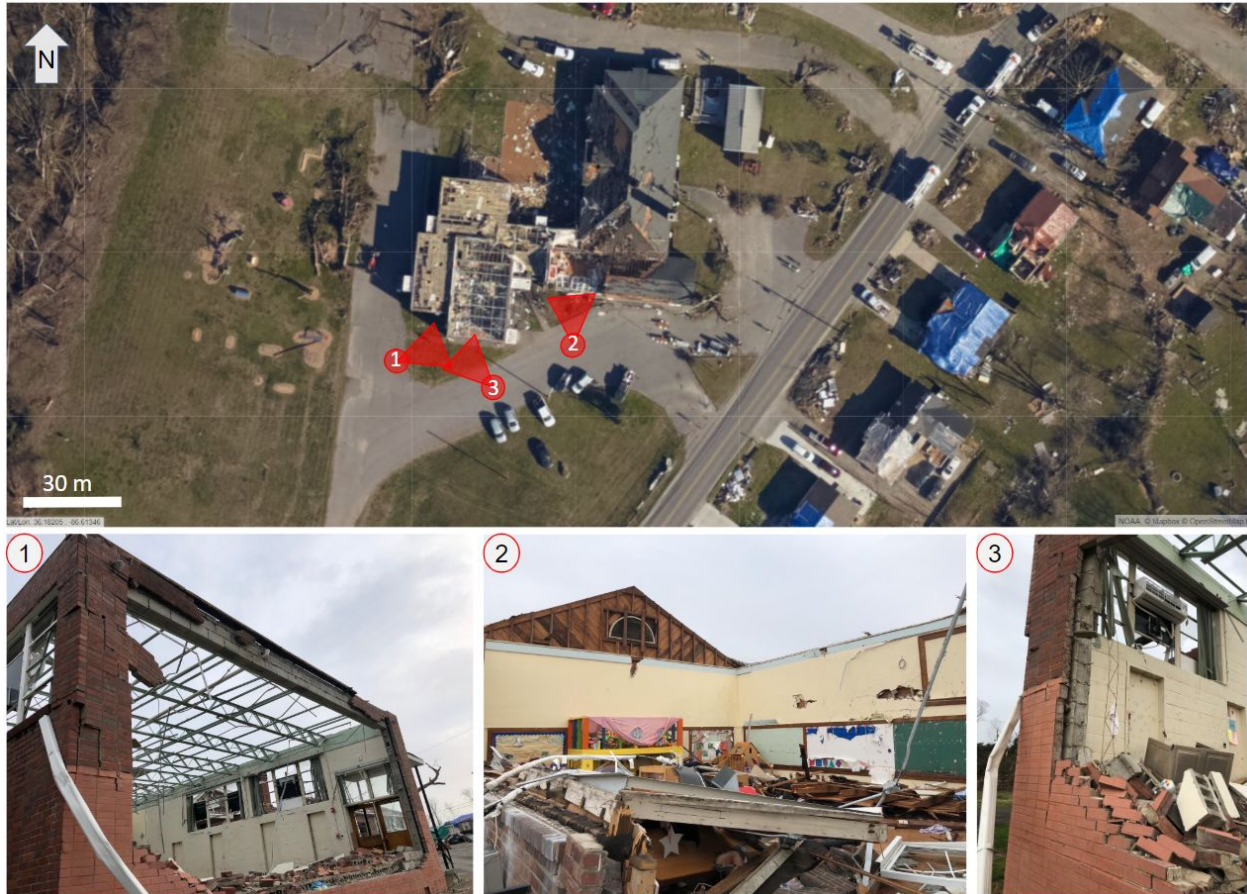
**Figure 6.5.4.** Observed damage sustained by the Donelson Chapel United Methodist Daycare Center, including (1) collapse of the end wall of the gymnasium with evidence of torsional racking of the building; (2) collapsed walls and complete roof removal in a classroom on the south side of the building; (3) clean failure of the CMU blocks near the corner of the gymnasium with no evidence of reinforcement or fully grouted cells in the wall below the bond beam. FAST noted very little fenestration damage on the east and north walls of the building.

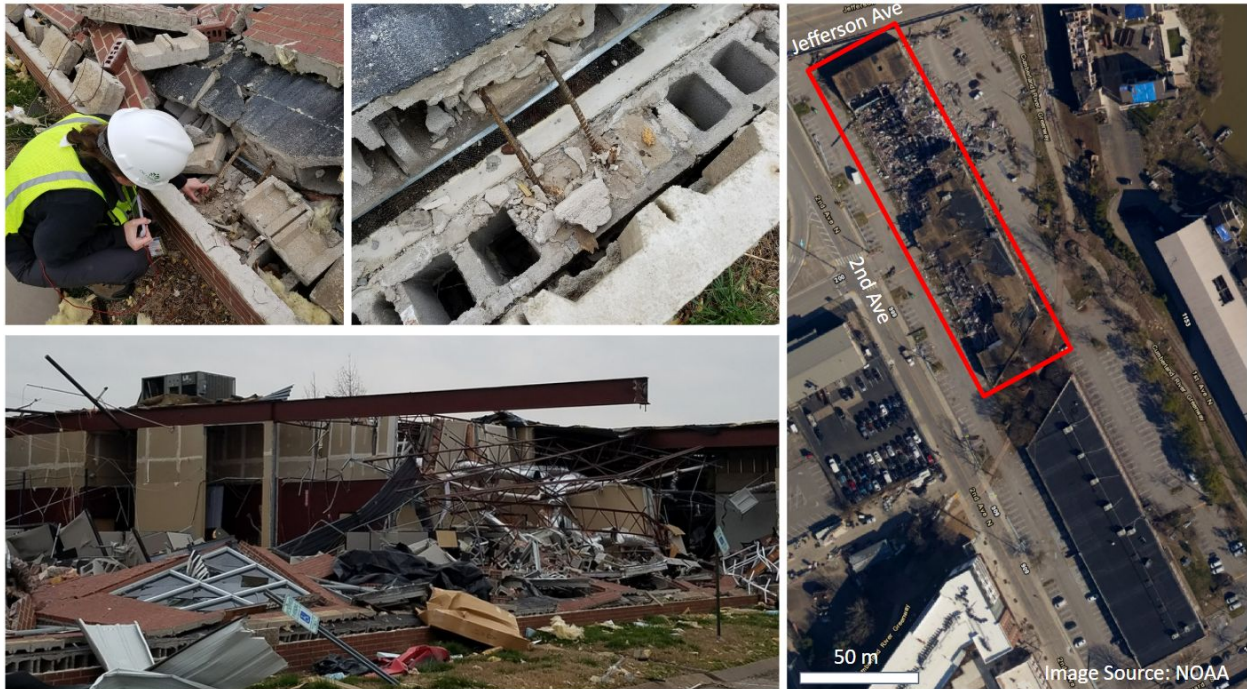
**Figure 6.6.1.** Total collapse of a government building in Germantown (GPS: 36.1740, -86.7822). The steel frame structure had infill CMU walls and brick veneers. Bent and snapped rebars were observed at the anchorage points.

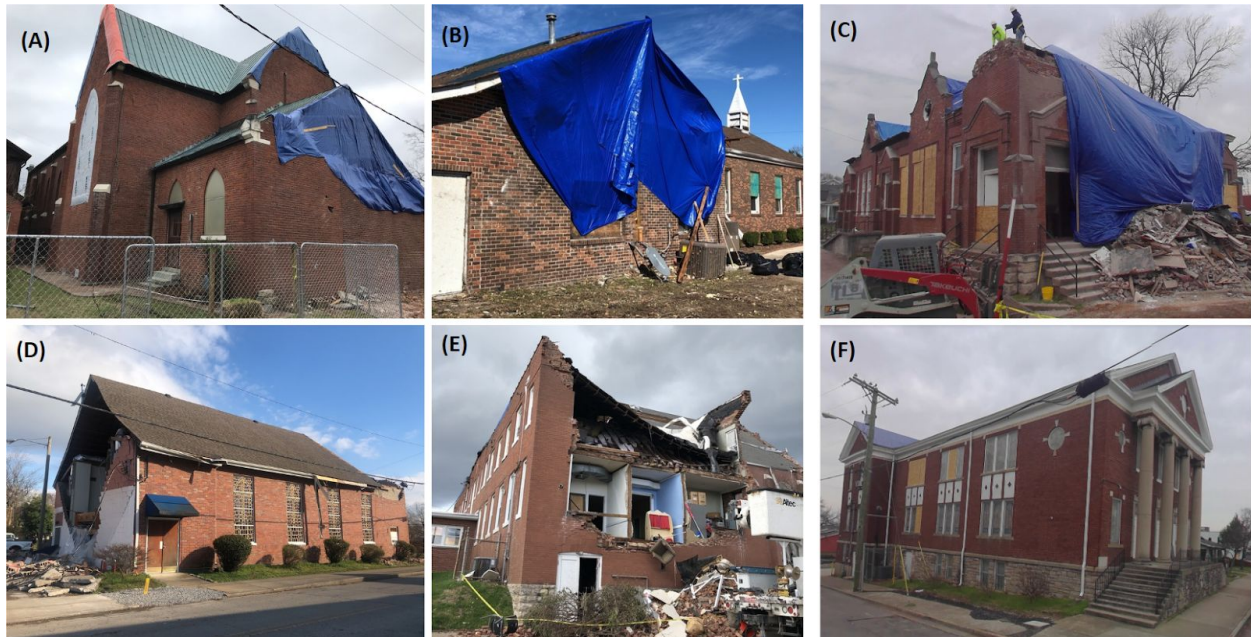
**Figure 6.81.** Damage to six heritage churches: (a) East End United Methodist Church, with partial removal of the roof structure and collapse of some walls; (b) Assumption Church, with minor damage to edges of the metal roof and partial collapse of the gable wall on the northwest corner of the building; (c) Hopewell Baptist Church, with collapse of the brick steeple, damaging the roof and walls below; (d) the Church at Lockeland Springs, with only component and cladding damage visible; (e) St. John A.M.E. Church with collapse of the front foyer (Note the roof of this building is nominally flat with a small parapet and the roof structure did not experience observable damage); (f) First Baptist Church of East Nashville, with roof cover damage and broken windows.

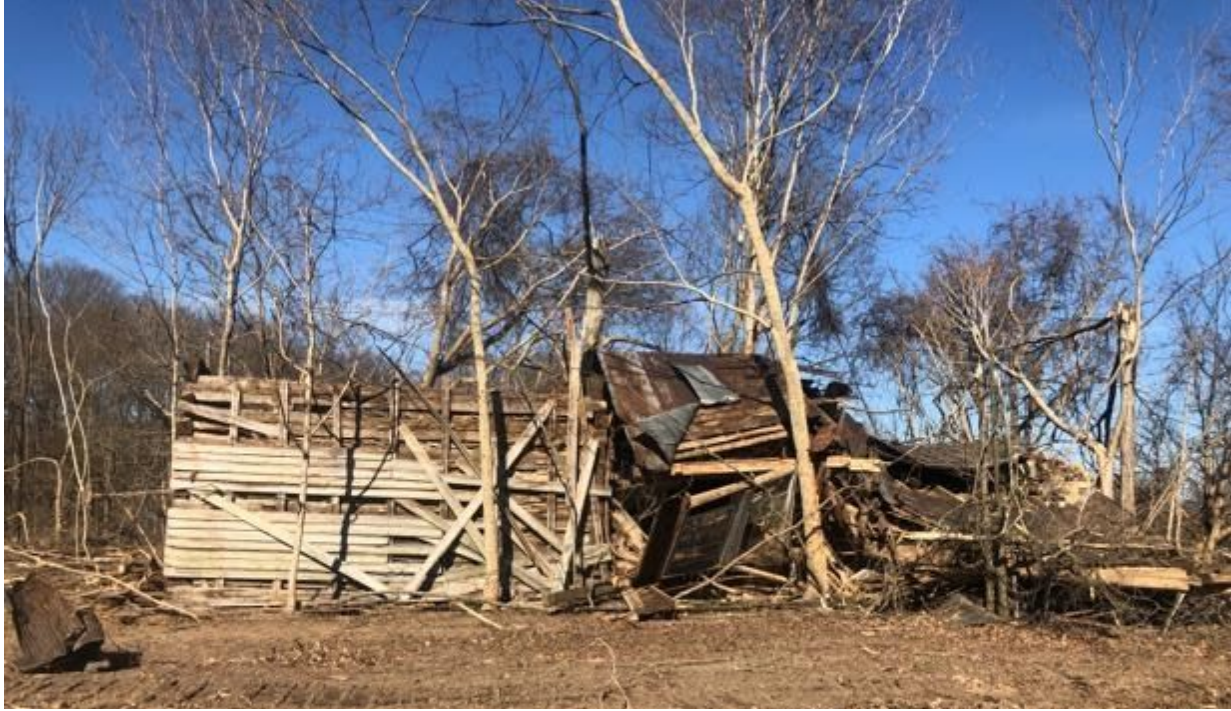
**Figure 6.9.1.** Destroyed wood-framed farm structure (36.854049, -86.295355) with a few fallen trees, but most still standing.

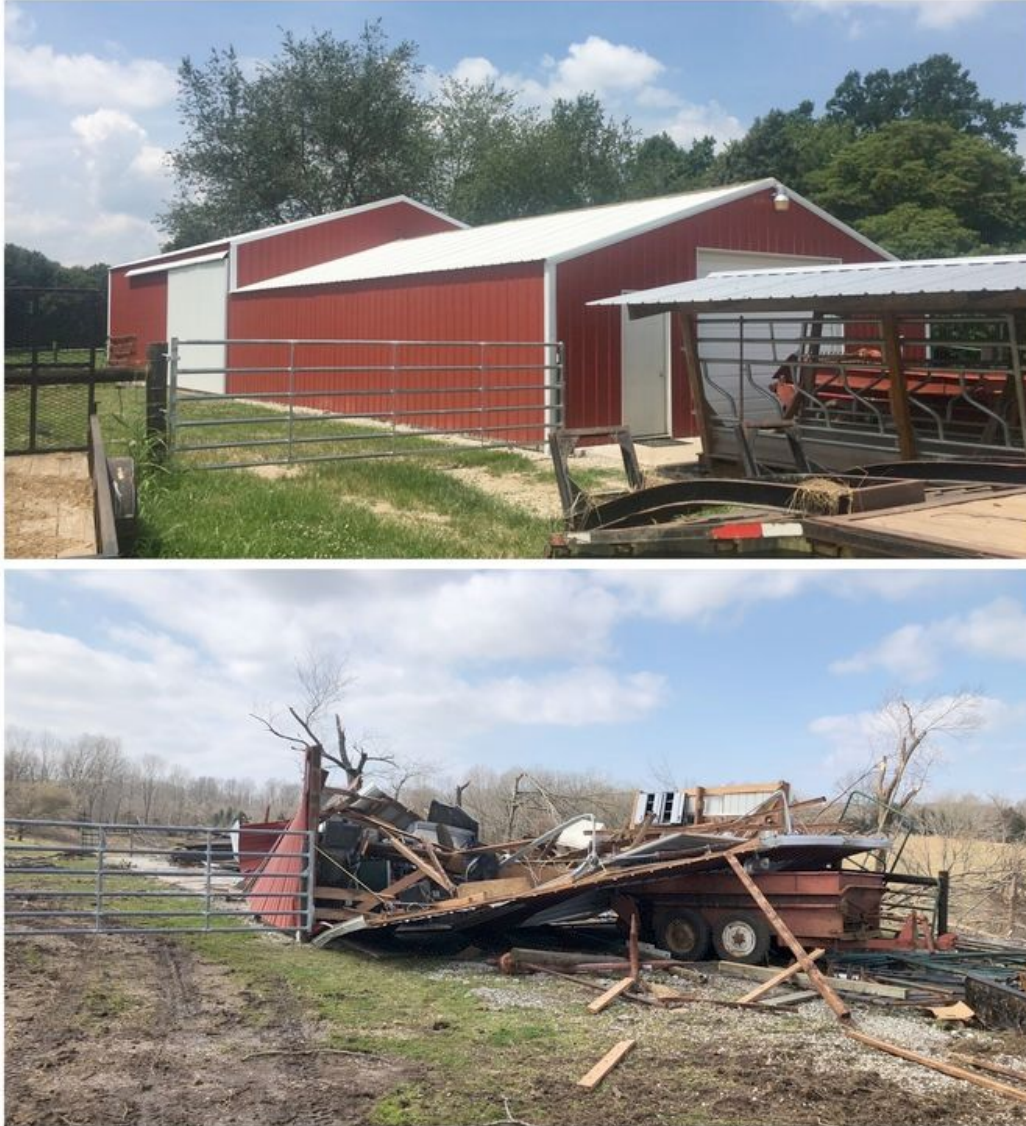
**Figure 6.9.2.** Before (top) and after (bottom) total collapse of metal barn (36.852421, -86.302735). Wood posts were set in the ground with no positive connection to the 4" thick concrete slab. Wind resistance would have been minimal. A few felled trees nearby.

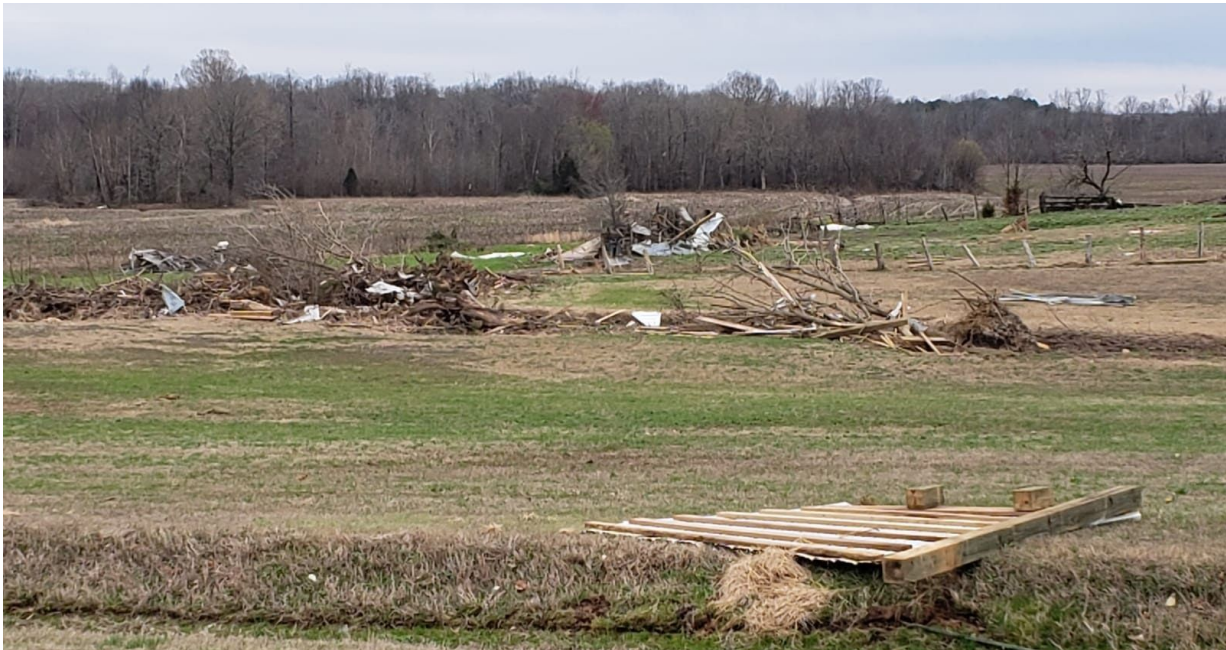
**Figure 6.9.3.** Debris field in rural/agricultural areas (36.087824, -88.340024) including corrugated steel from failed silos.

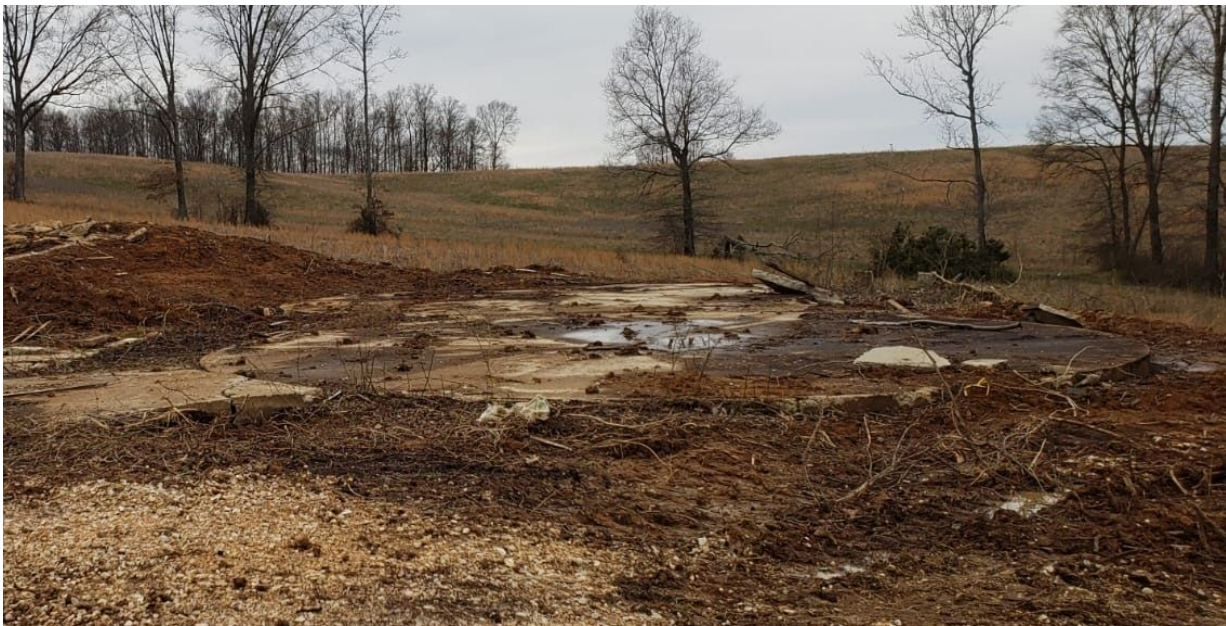
**Figure 6.9.4.** Steel silo failure (36.091628, -88.372416). Failure due to grouted or epoxy connection at base.

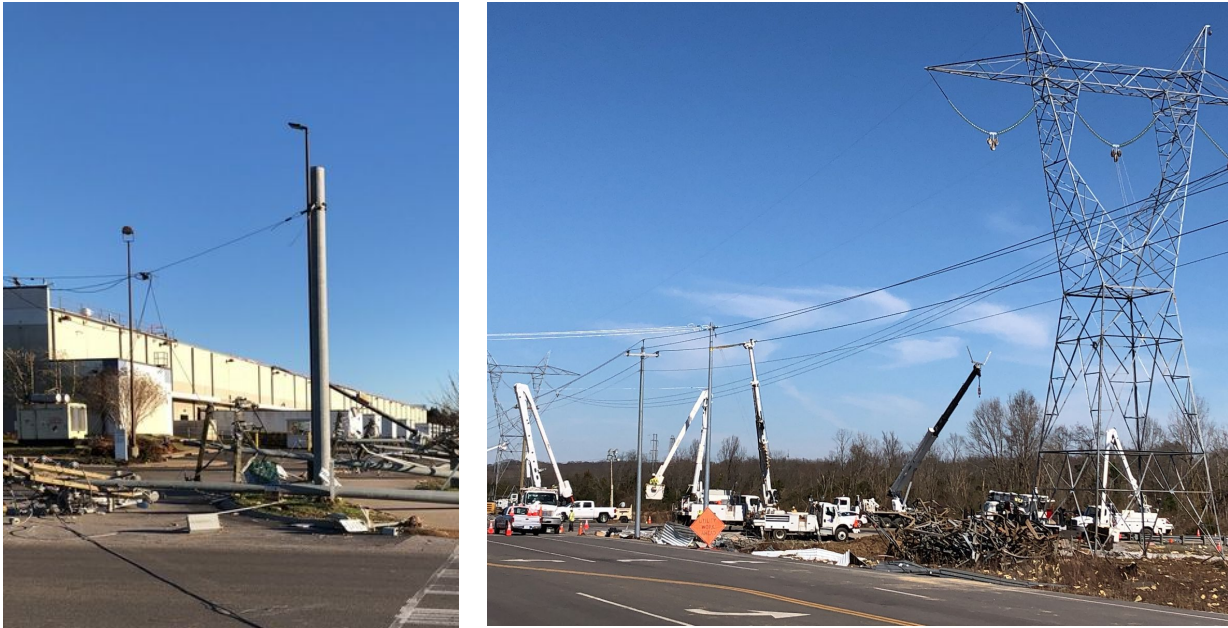
**Figure 7.1.1.** Illustrative damage to power infrastructure observed by FAST: (left) damage to power poles and traffic signal structure in Mt. Juliet (36.186894, -86.41586); (right) lattice towers in Mt. Juliet (Location: 36.184661, -86.464333) supporting 500 kV high-voltage transmission lines replaced after being damaged in the tornado, per the [TVA](#).

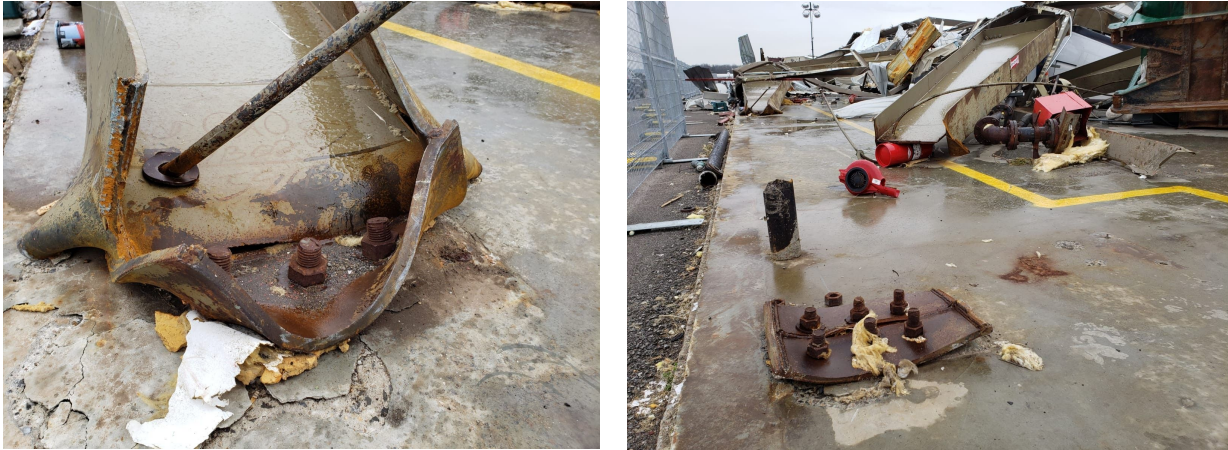
**Figure 7.2.1.** Baseplate damage and steel tension rupture in a collapsed hangar at the John C. Tune Airport.

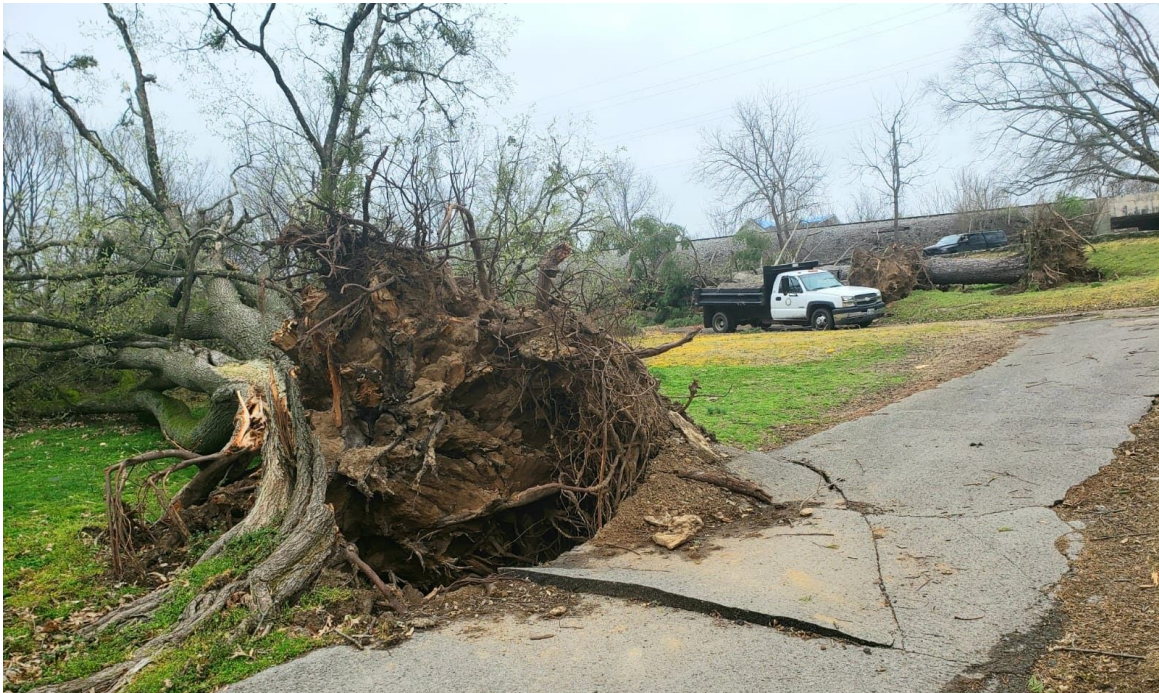
**Figure 8.1.** Treefall (in NE direction) at Shelby Golf Course just east of Lockeland Springs.

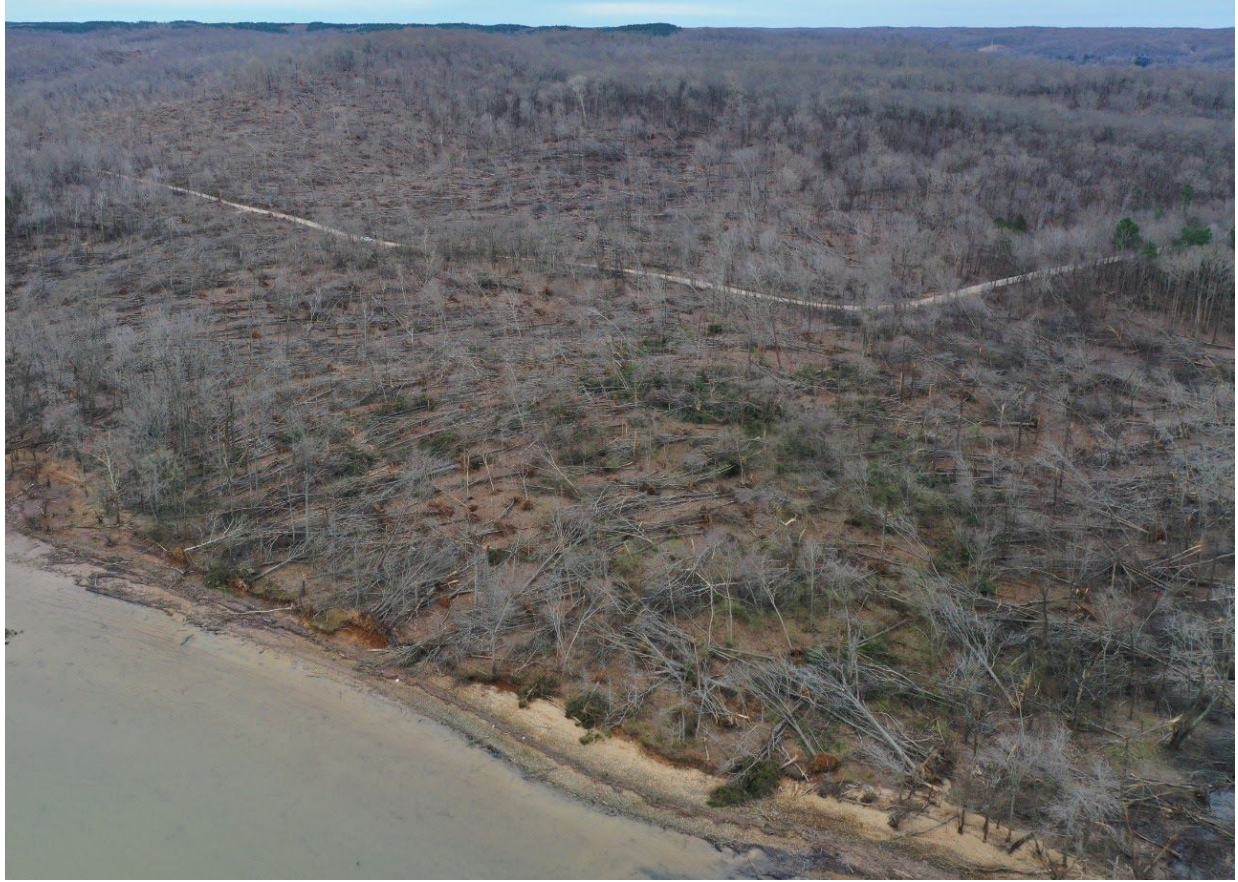
**Figure 8.2.** Tree fall damage near Waverly, TN documented by Wood and Liao. Aerial view from approximately 250 ft above ground level.
