# StEER: Structural Extreme Event Reconnaissance Network & Earthquake Engineering Research Institute (EERI)

## ALASKA EARTHQUAKE PRELIMINARY VIRTUAL ASSESSMENT TEAM (P-VAT) JOINT REPORT

**Released:** December 6, 2018

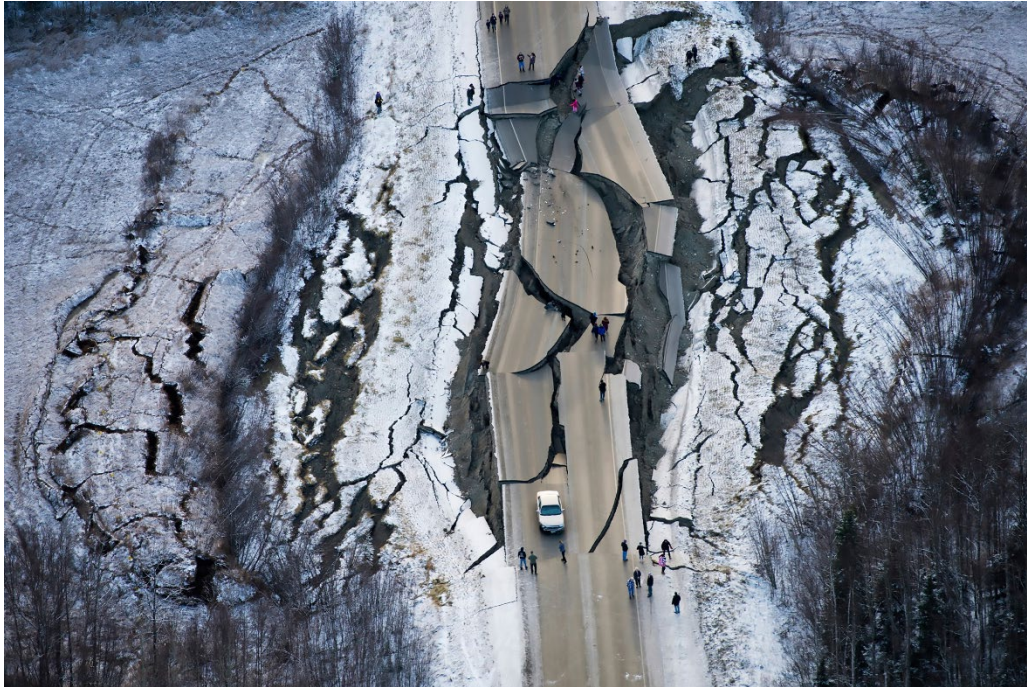
Earthquake damage on Vine Road, near Wasilla, Alaska, on Nov. 30, 2018.  
(Source: Time Magazine, Image Credit: Marc Lester - *Anchorage Daily News/AP*)

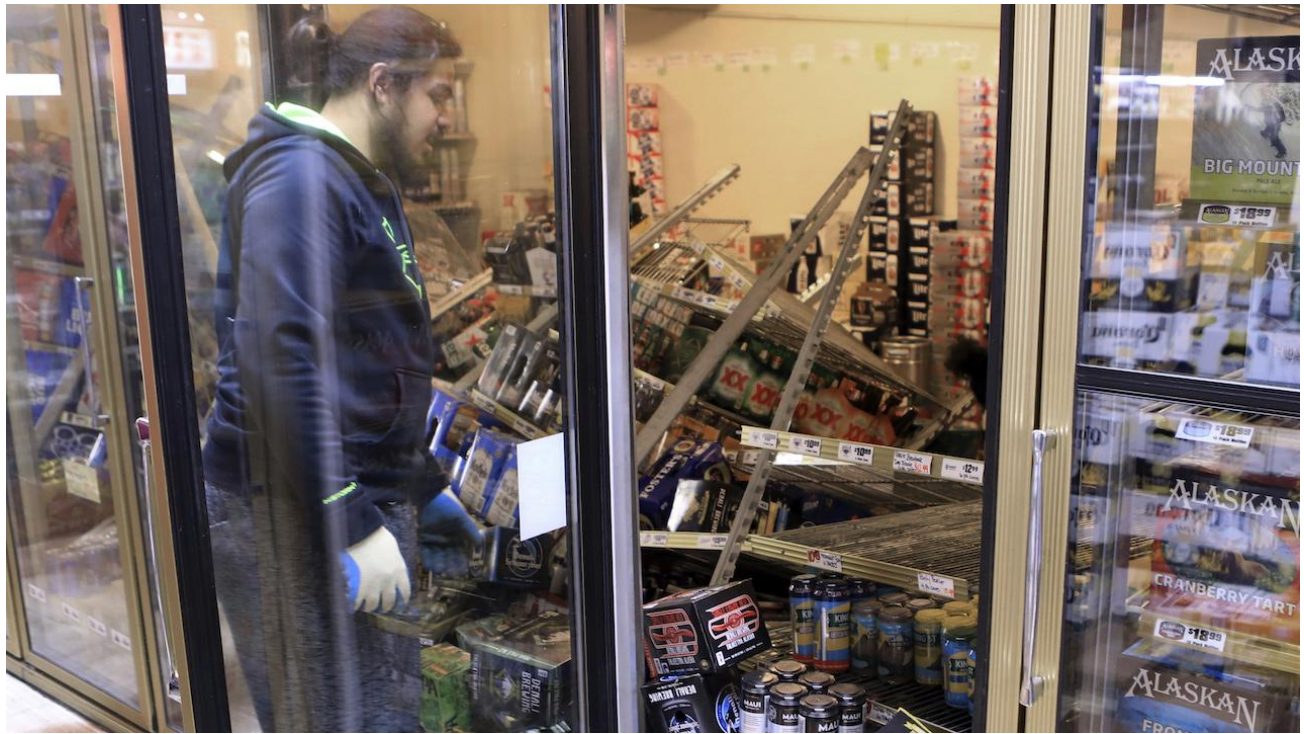
**Figure 10:** Aisoli Lealasola prepares to clean up fallen cases of beer in a cooler at Value Liquor in Anchorage, Alaska. (Source: AP Photo/Dan Joling<sup>8</sup>)

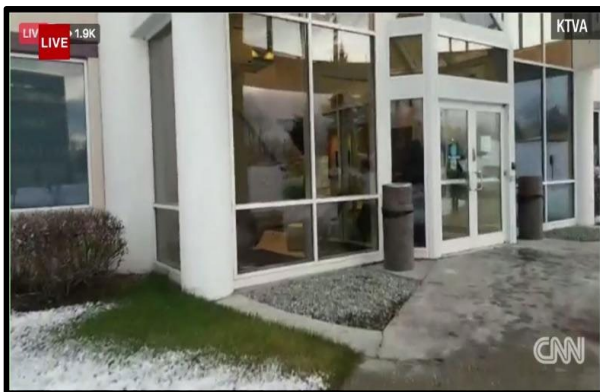
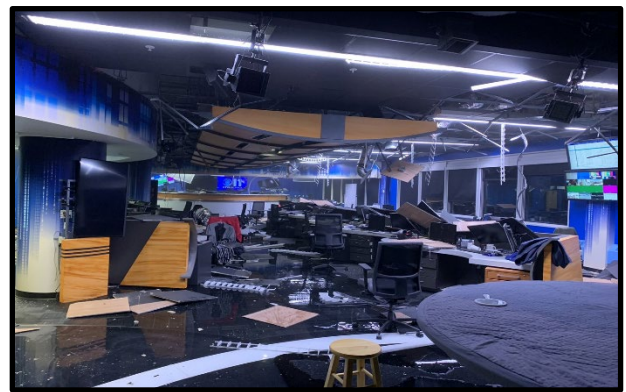
Widespread non-structural damage was reported in commercial construction. KTVA office, shown in Figure 11, was reported to have window pane, ceiling, and office equipment damage. Window damage, equipment and inventory damage were also reported in stores and local businesses (Fig. 12). Many stores had to suspend operations to deal with clean up and assessment, after shelves of merchandise toppled to the ground. Most of the grocery stores resumed business in Anchorage on Saturday, December 1, 2018; however, stores at Eagle River and Wasilla remained closed on Saturday. The US Federal Building and courthouse located on the Seventh Avenue in downtown Anchorage suffered boiler damage. The building was later found to be structurally sound, but federal officials closed it December 4 for ongoing clean up. Significant cracks were also observed in Anchorage Grand Hotel (Fig. 13).

**Figure 11:** Window and ceiling damage at the CNN affiliate KTVA's offices<sup>9</sup>

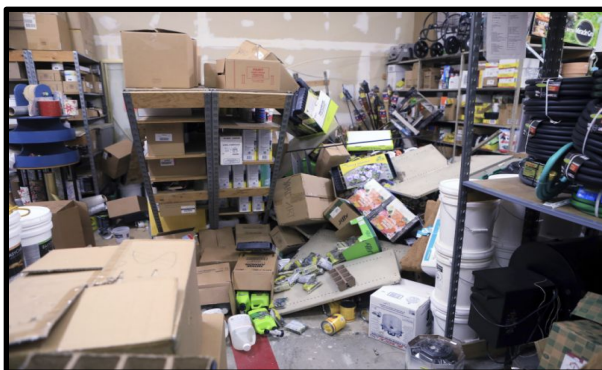
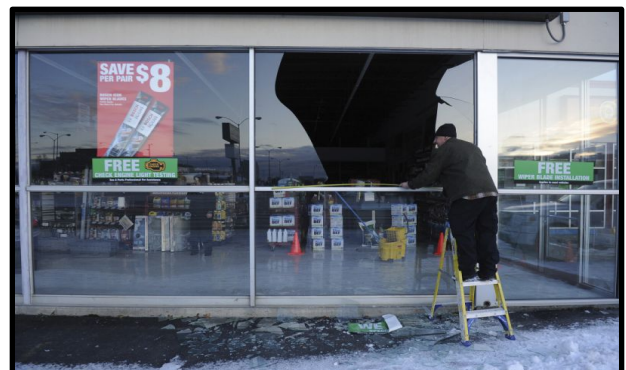
**Figure 12:** Inventory and window damage at stores following the earthquake<sup>10</sup>

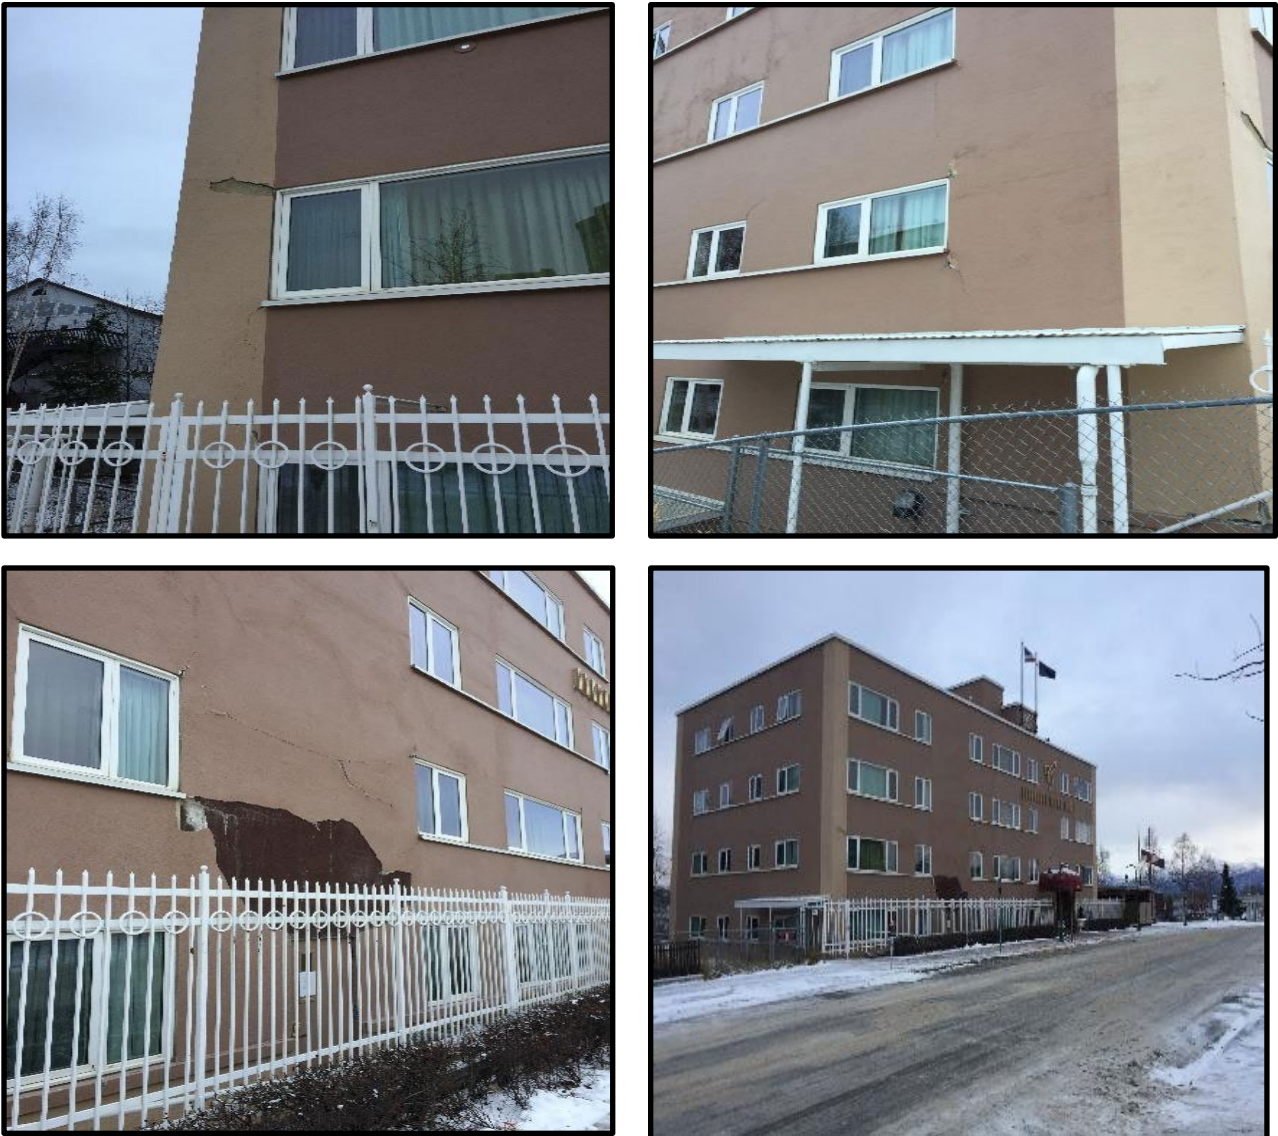
**Figure 13:** Major cracks observed in Anchorage Grand Hotel, Downtown Anchorage, Alaska<sup>11</sup>

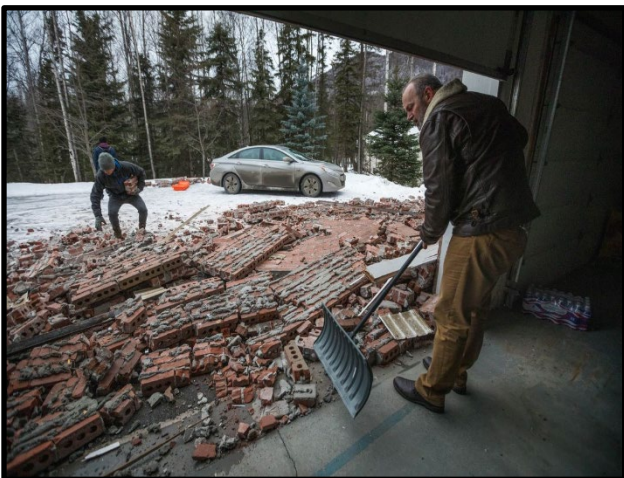
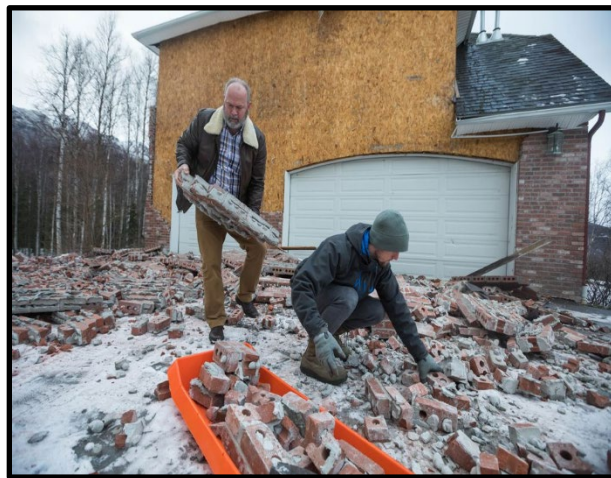
**Figure 17:** Brick veneer damage at residence in Eagle River<sup>13</sup>

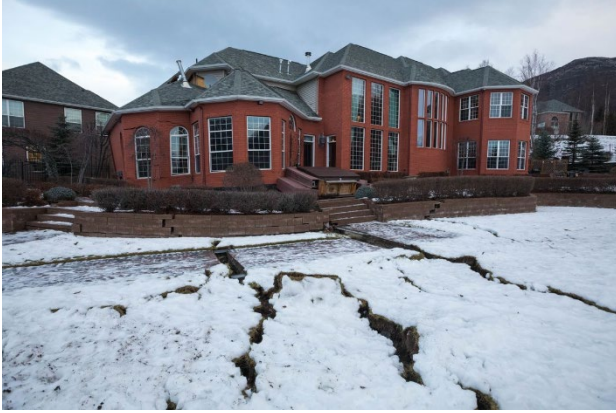
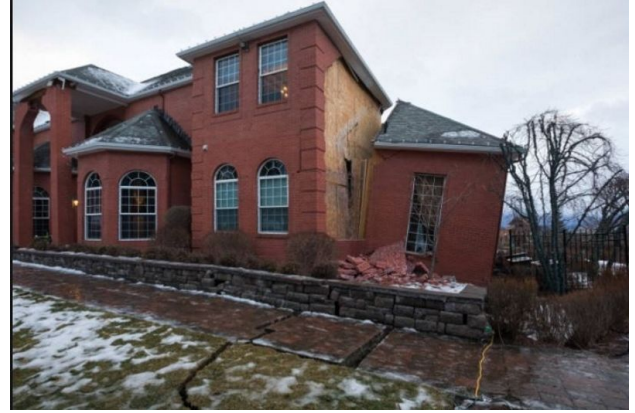
**Figure 18:** Home in Eagle River with significant structural damage due to geotechnical failure<sup>14</sup>

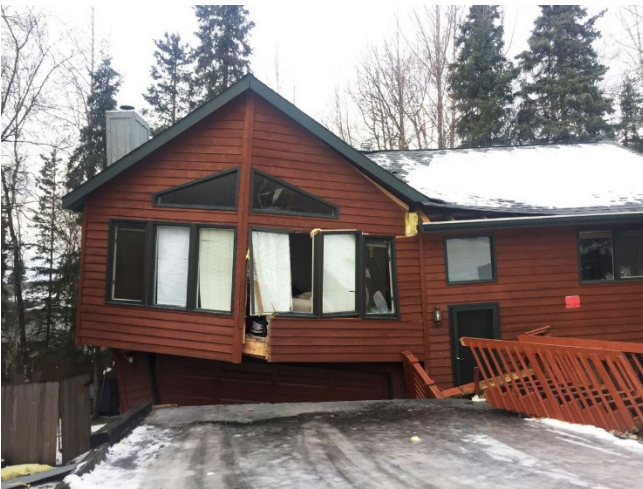
◀ **Figure 19:** Partially collapsed two-story home on Dome Circle in Eagle River<sup>15</sup>

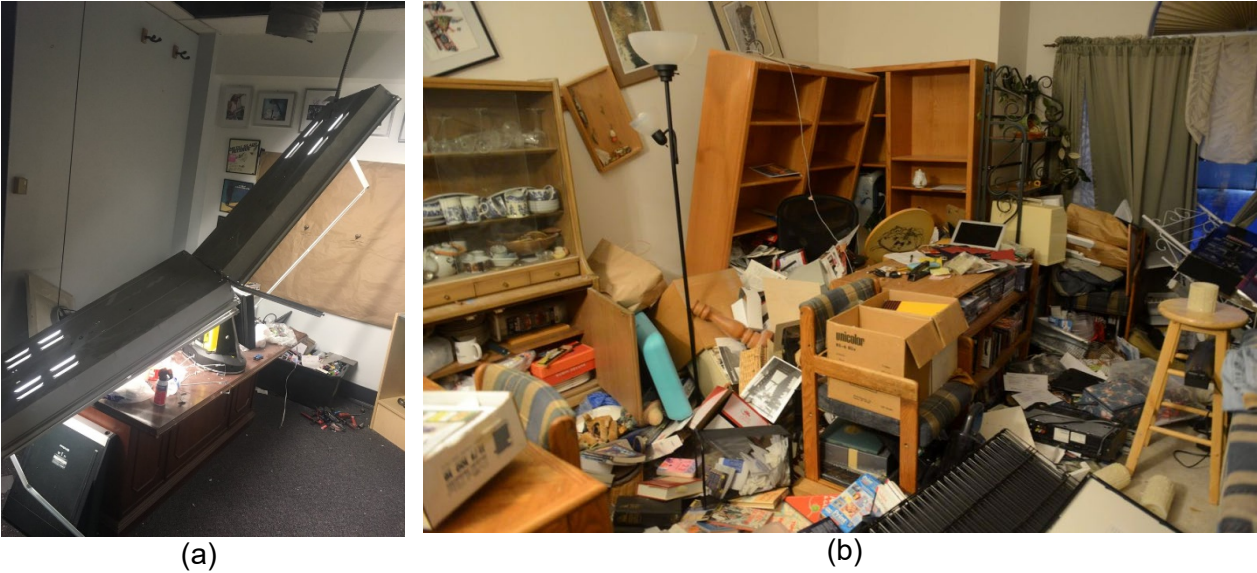
**Figure 21:** Typical residential contents losses such as (a) detached lighting fixtures<sup>17</sup> and (b) disrupted home office with toppled bookcases in west Anchorage<sup>18</sup>

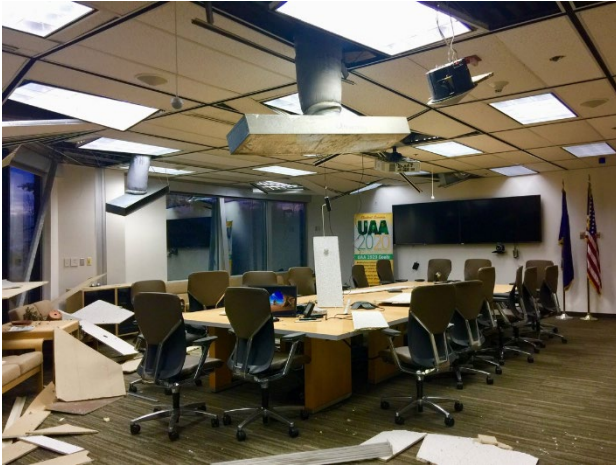
(a) Ceiling tiles that had fallen down in one of the rooms on The University of Alaska Anchorage<sup>19</sup>

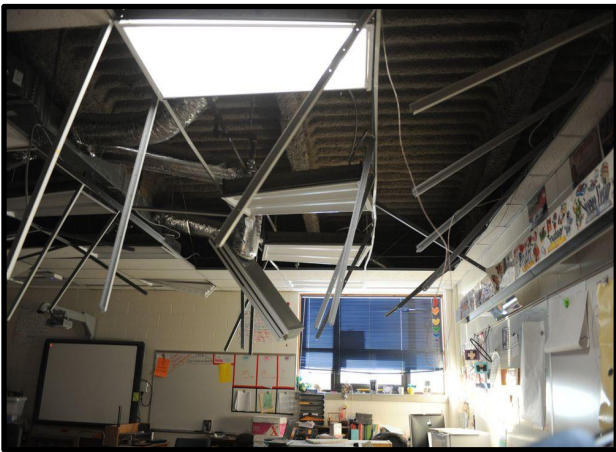
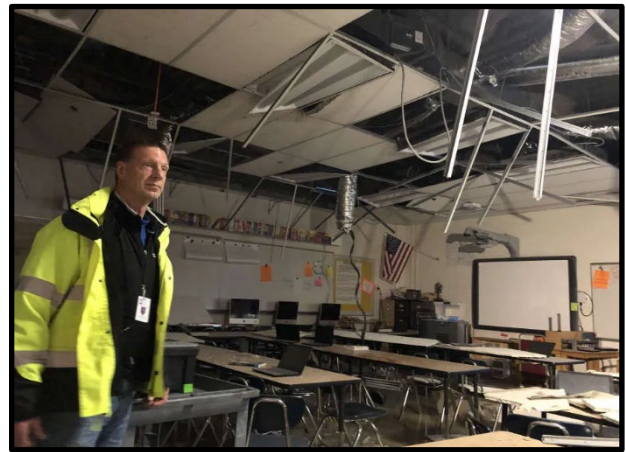
(c) Damaged classrooms ceilings at Hanshew Middle School<sup>21</sup>

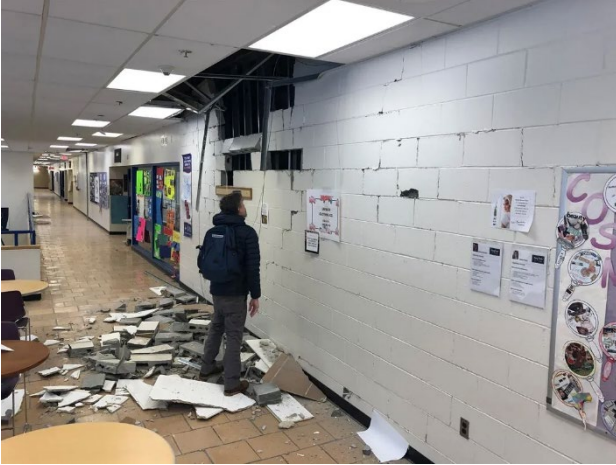
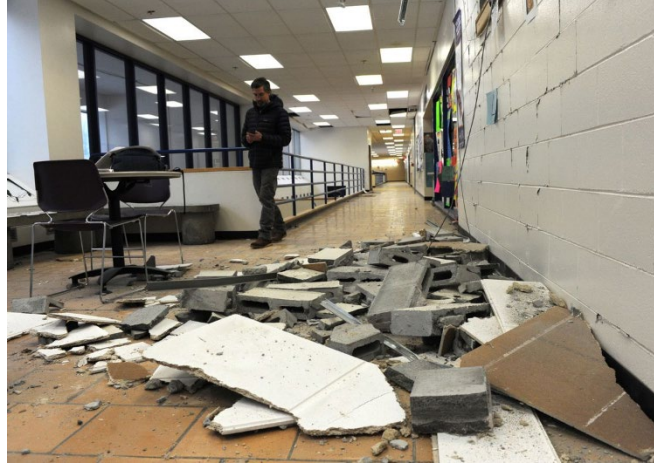
(a) Damage to masonry infill wall at King Tech High School<sup>22</sup>

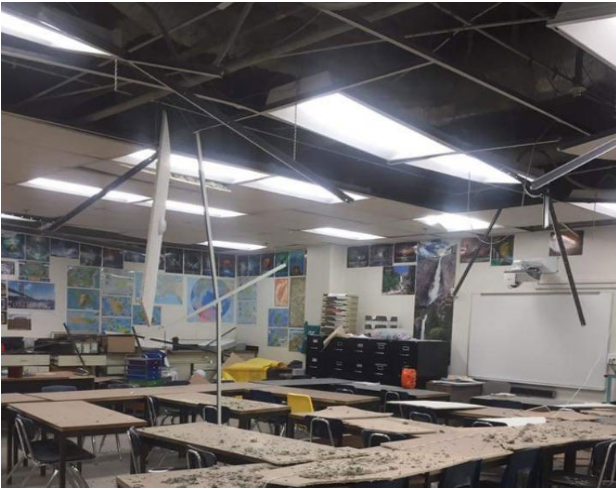
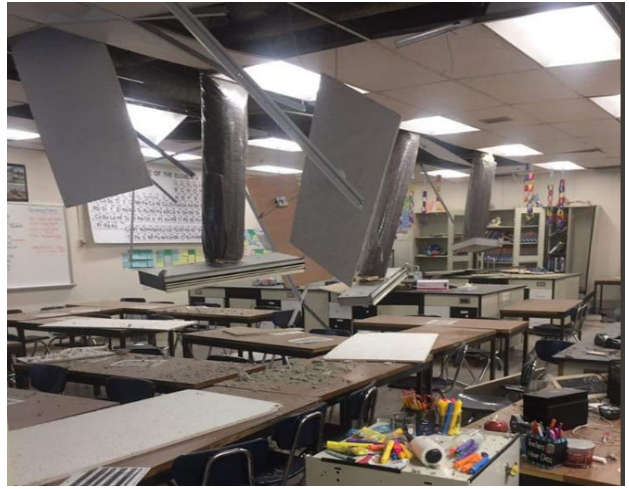
(b) Damaged suspended ceilings and Light fittings at Bartlett High School<sup>23</sup>

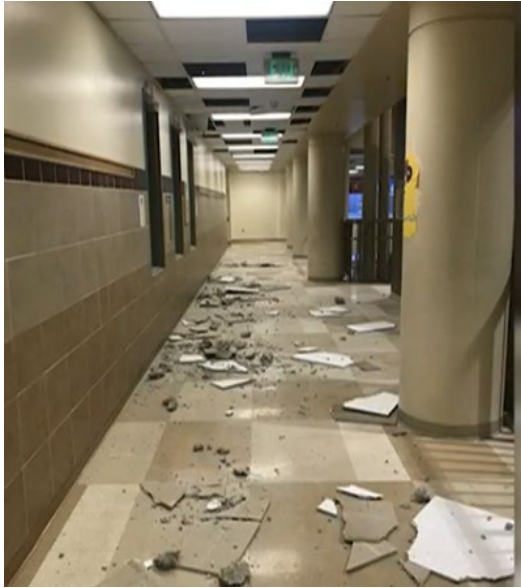
(a) Damaged ceilings at Diamond High School<sup>24</sup>

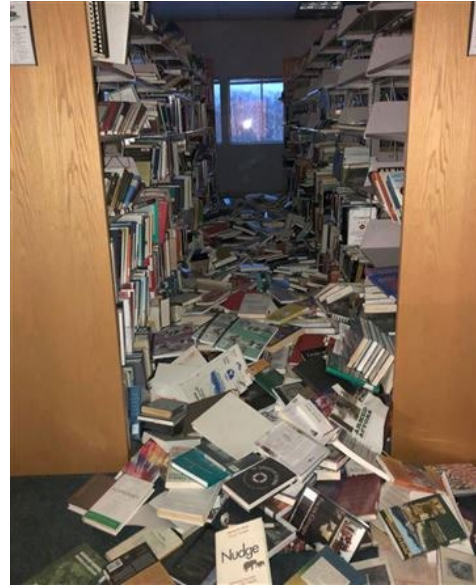
(b) Books and ceiling tiles litter the floor at the Mat-Su College library in Anchorage<sup>25</sup>

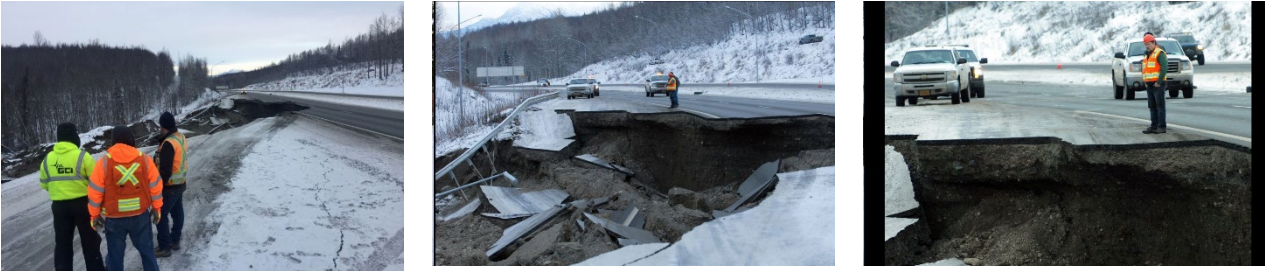
(a) Damage to Glenn Highway southbound lanes between Eklutna and Mirror Lake<sup>27</sup>

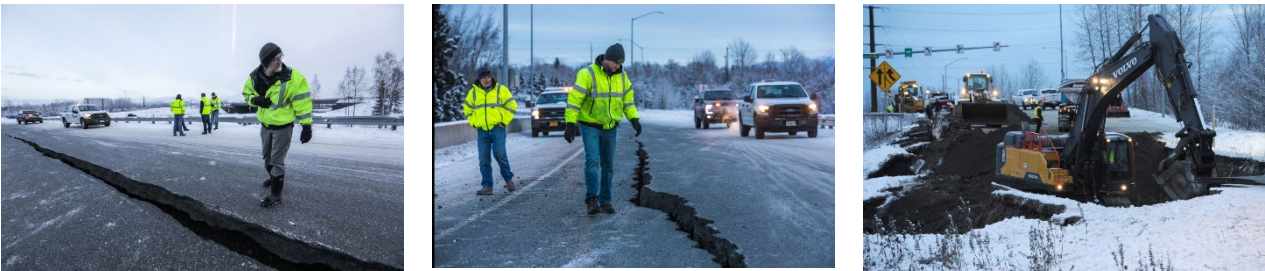
(b) A crack occurred in the road at the International Airport Road off-ramp on southbound Minnesota Blvd.<sup>28</sup>

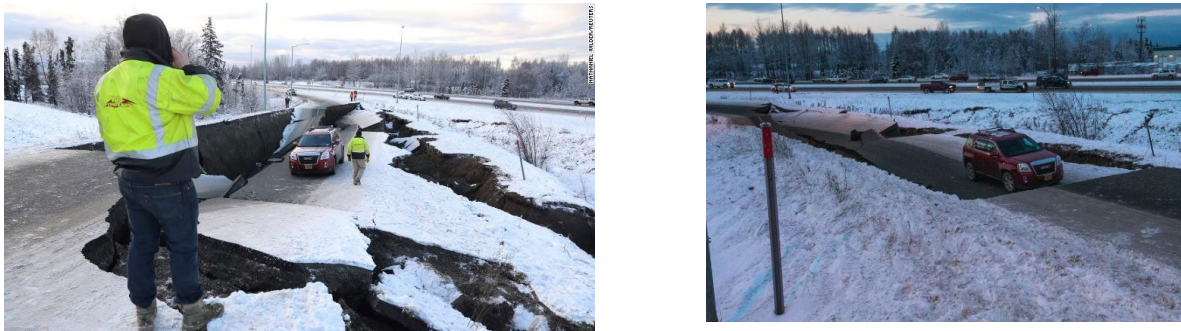
(c) Collapsed northbound onramp for International Airport Rd. at Minnesota Blvd with stranded vehicle<sup>29</sup>.

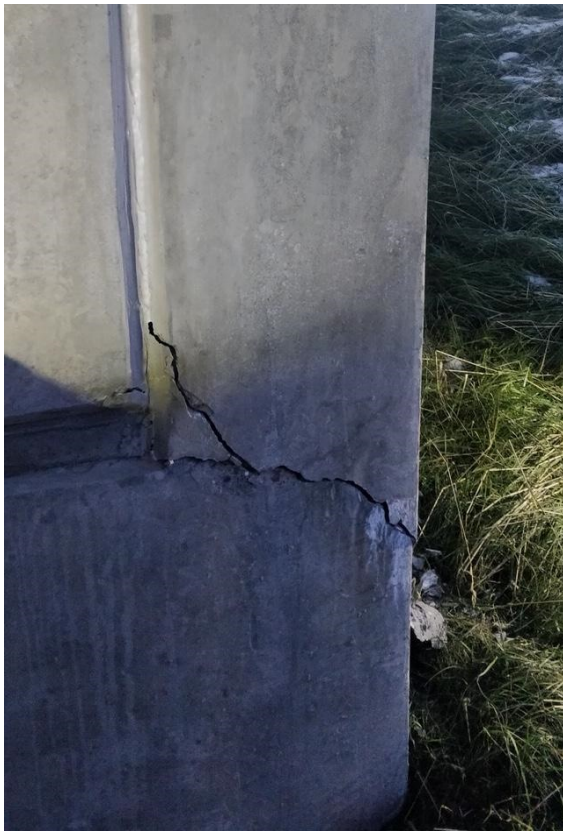
**Figure 26:** (a) Cracking of shear key on the bridge at the intersection of Glenn Highway and Muldoon Road, (b) Abutment spalling on the bridge on Seward Meridian Road over Parks Highway (Courtesy of Elmer Marx, AKDOT)

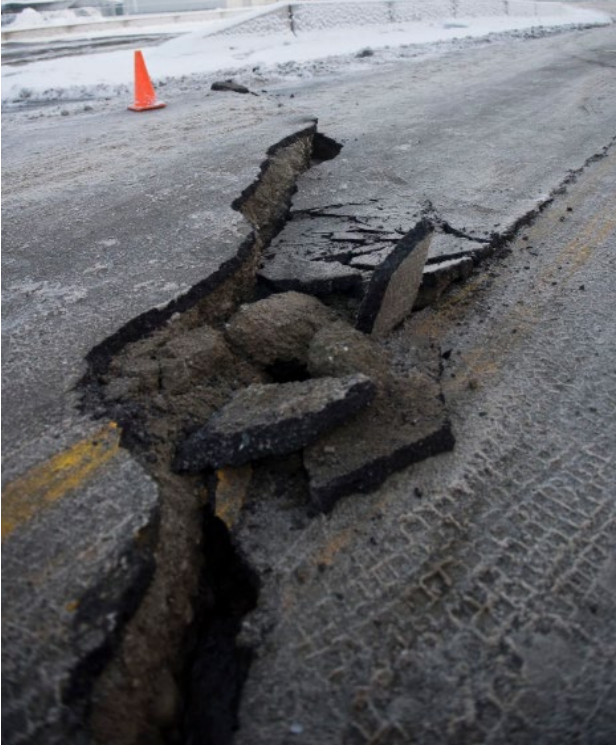
**Figure 27:** Cracks in Aircraft Drive near Lake Hood<sup>30</sup>

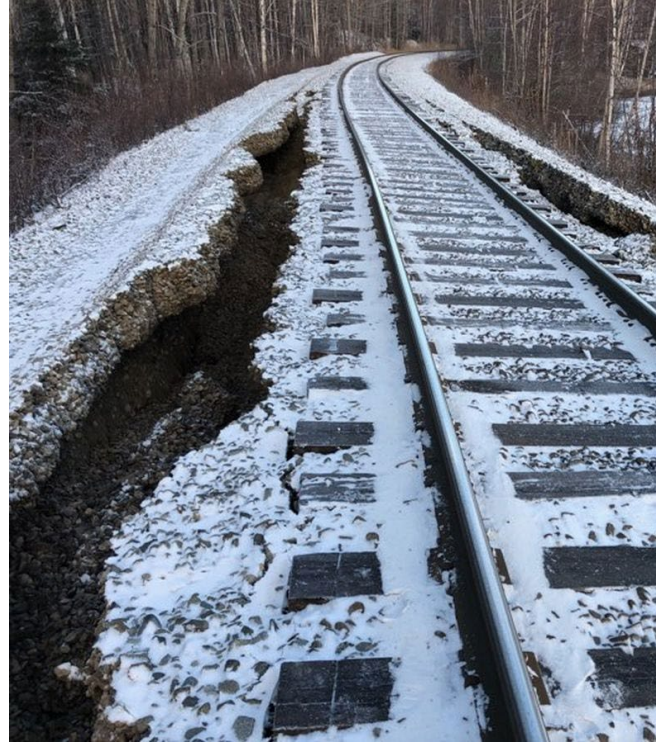
**Figure 28:** Cracks along parts of Alaska Railroad system<sup>31</sup>

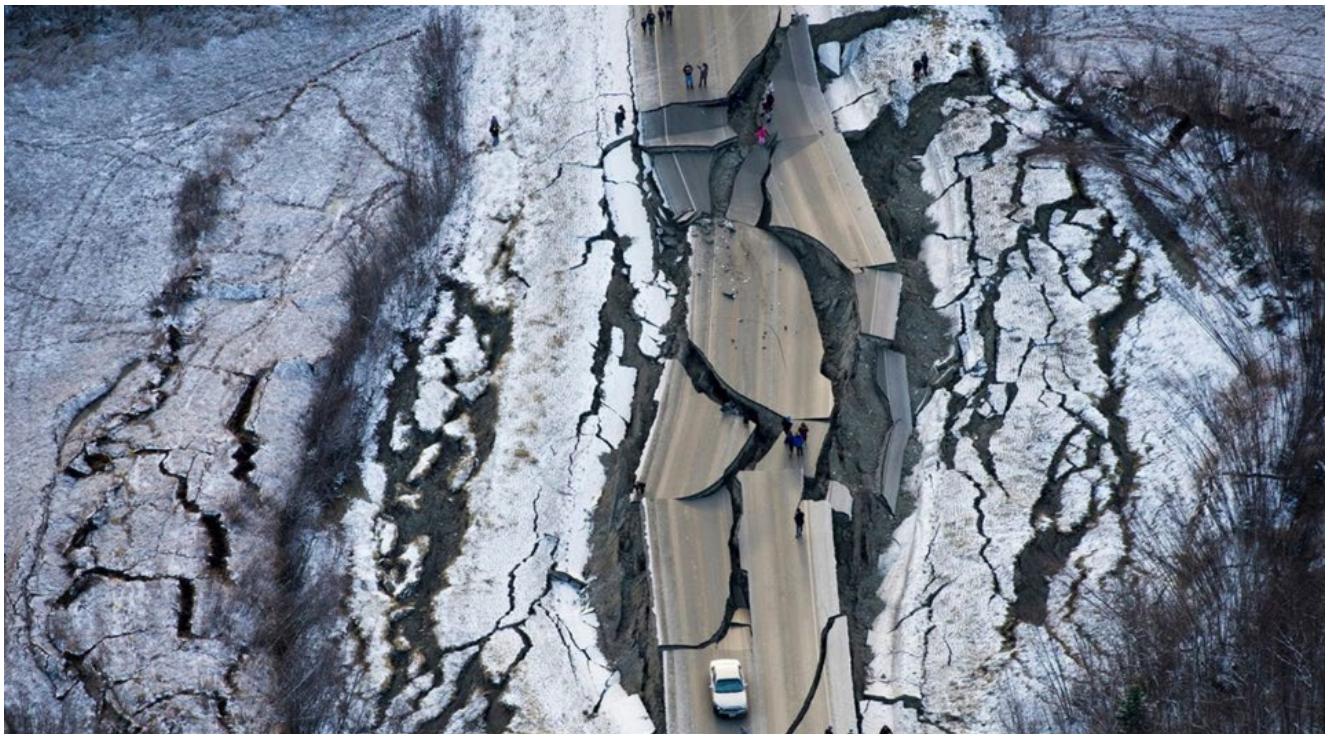
**Figure 30:** Aerial photo of damage on Vine Road, south of Wasilla<sup>35</sup>

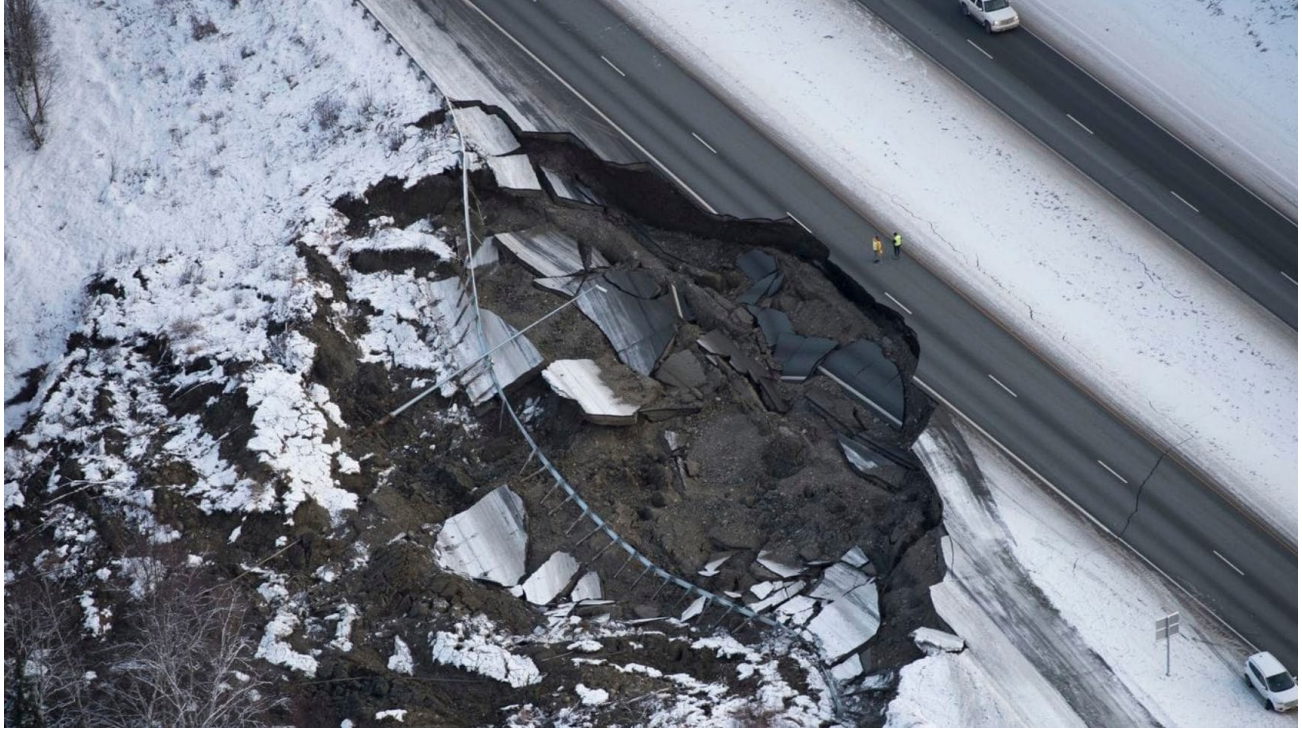
**Figure 31:** Aerial photo of the damage on the Glenn Highway near Mirror Lake in Anchorage, approximate location: 61.42° N, 149.42° W<sup>36</sup>

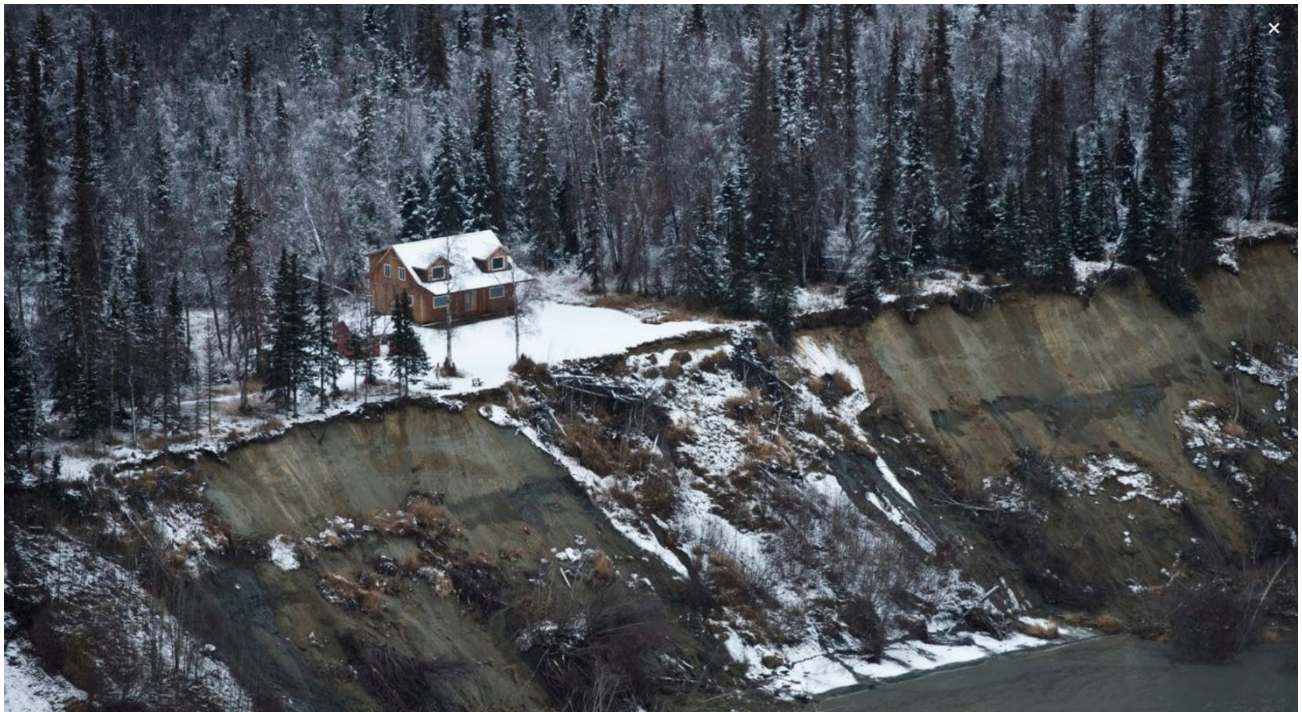
**Figure 32:** Landslide occurred after the earthquake, on the northwest side of Knik Arm in the Anchorage area<sup>37</sup>

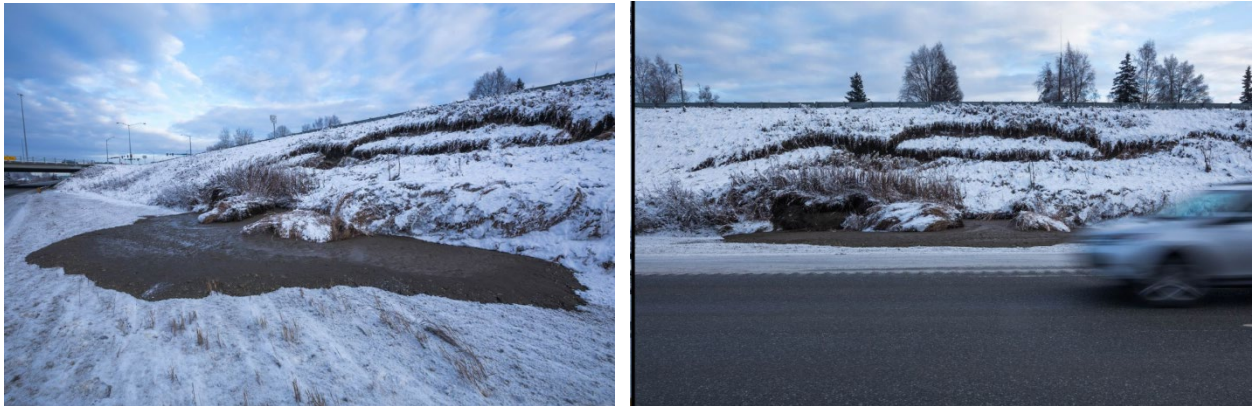
**Figure 36:** Mudslide along Minnesota Blvd. near Diamond<sup>41</sup>

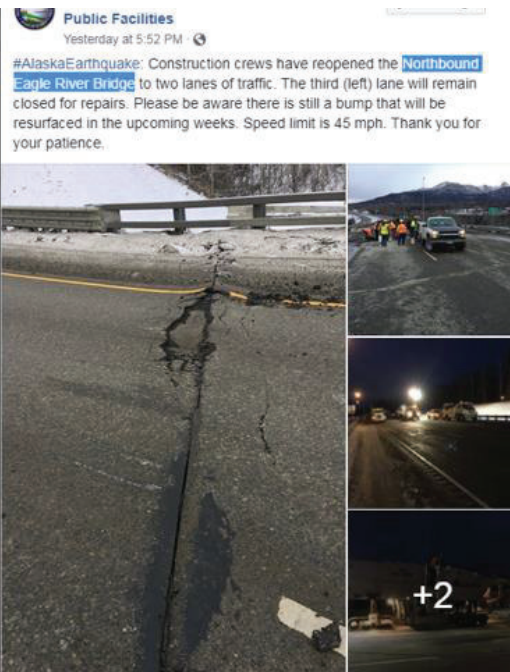
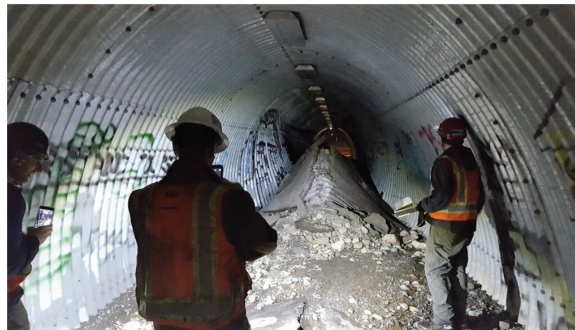
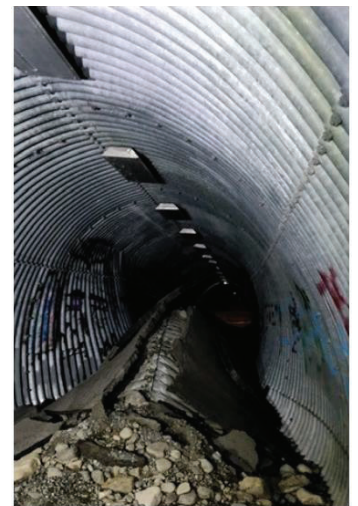
Water main that failed under the pedestrian tunnel just to the north of Briggs Bridge over Eagle River [Source1](#), [Source2](#)

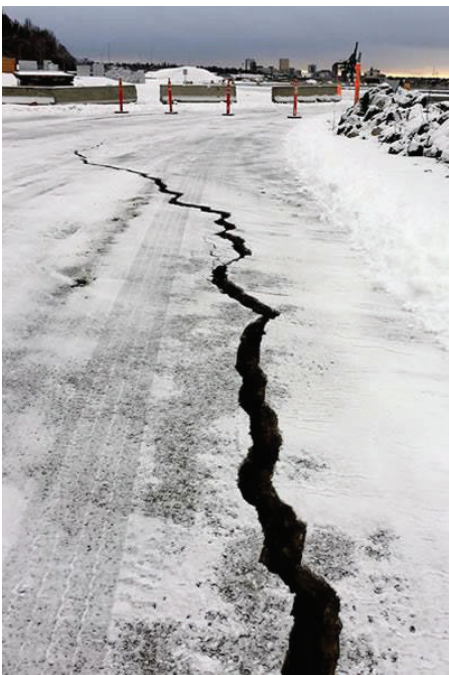
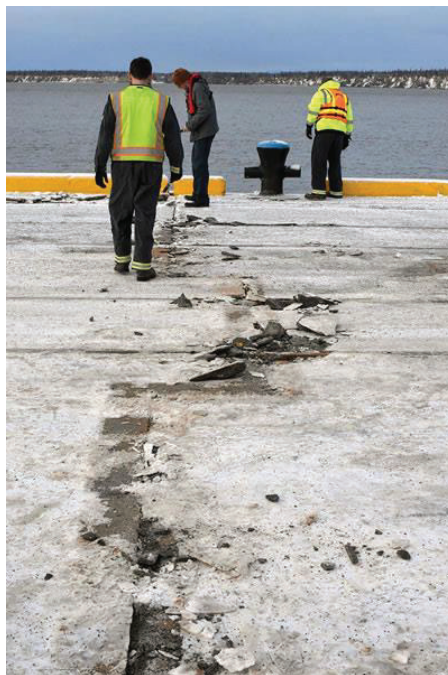
Minor Damages in [Port of Alaska](#)

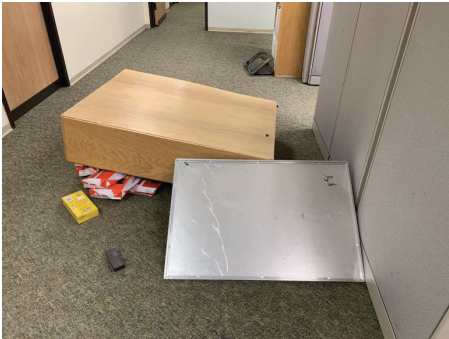
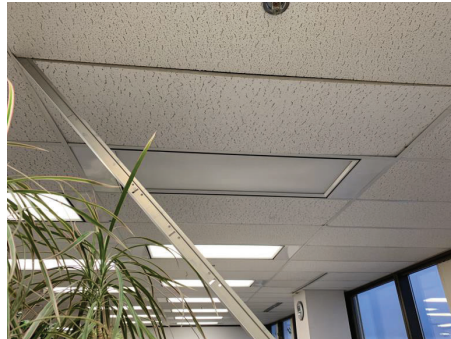
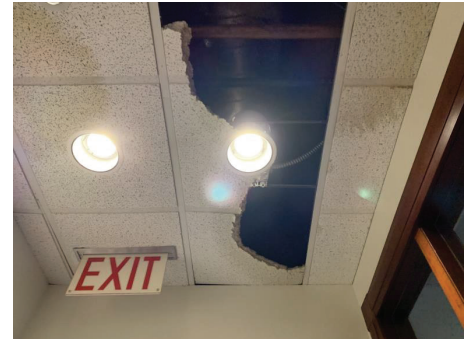
Primarily non-structural. Building is yellow tagged.

There was also some water pipe failure and limited flooding on one of the floors

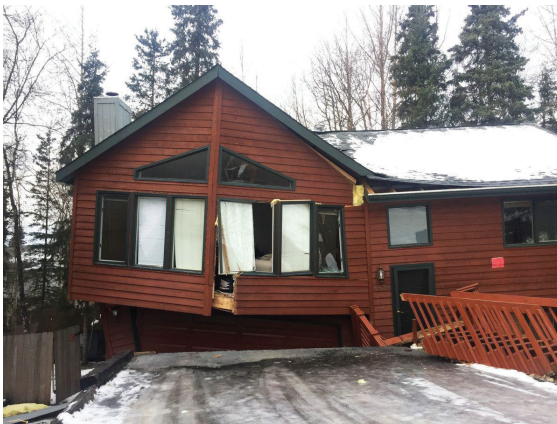
Partial collapse

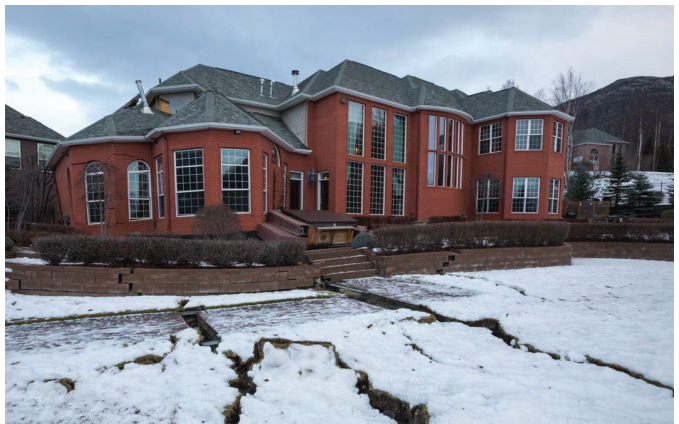
Severe structural damage

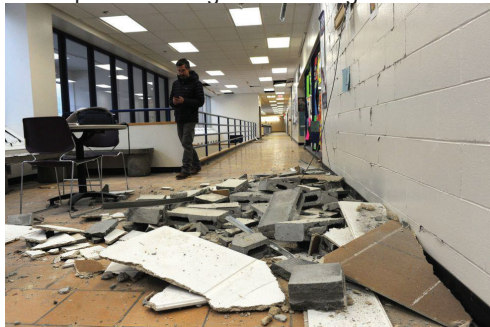
([Anchorage Daily News](#)) Damage to cinder block wall (non-weight bearing) and ceiling at King Tech High School

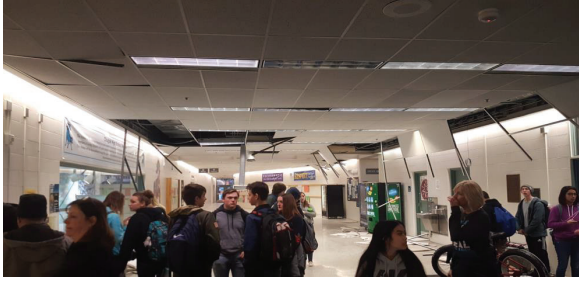
([Twitter](#)) Chugiak High School - damage to suspended ceilings

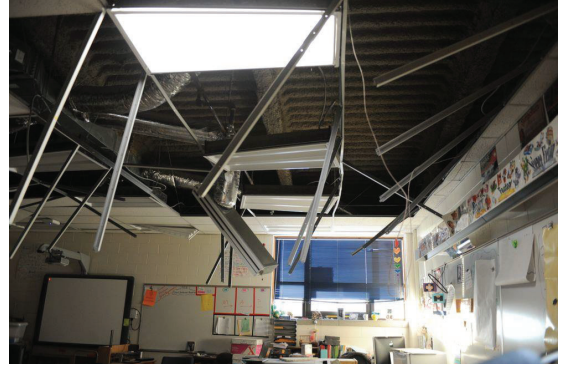
([Anchorage Daily News](#)) Failure of ceilings in some classrooms at Hanshew Middle School

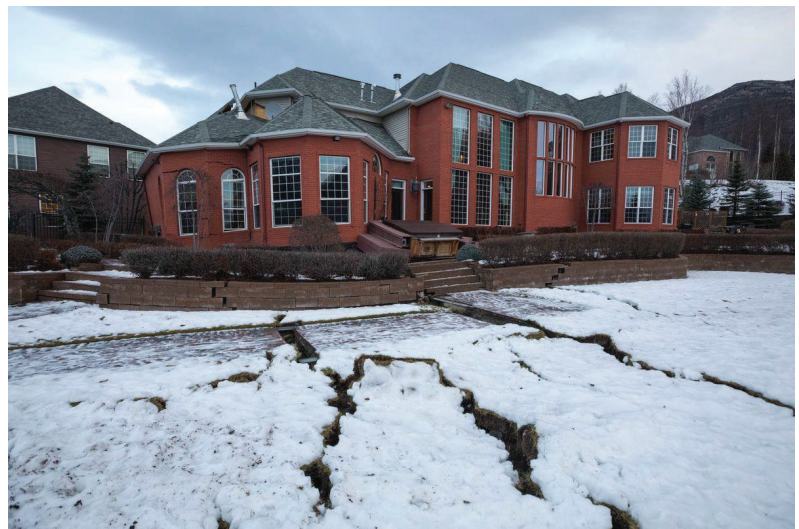
Residential Building in Eagle River damaged due to earthquake  
<https://www.adn.com/alaska-news/2018/12/01/anchorage-fire-chief-how-to-look-for-serious-structural-damage-at-home/>

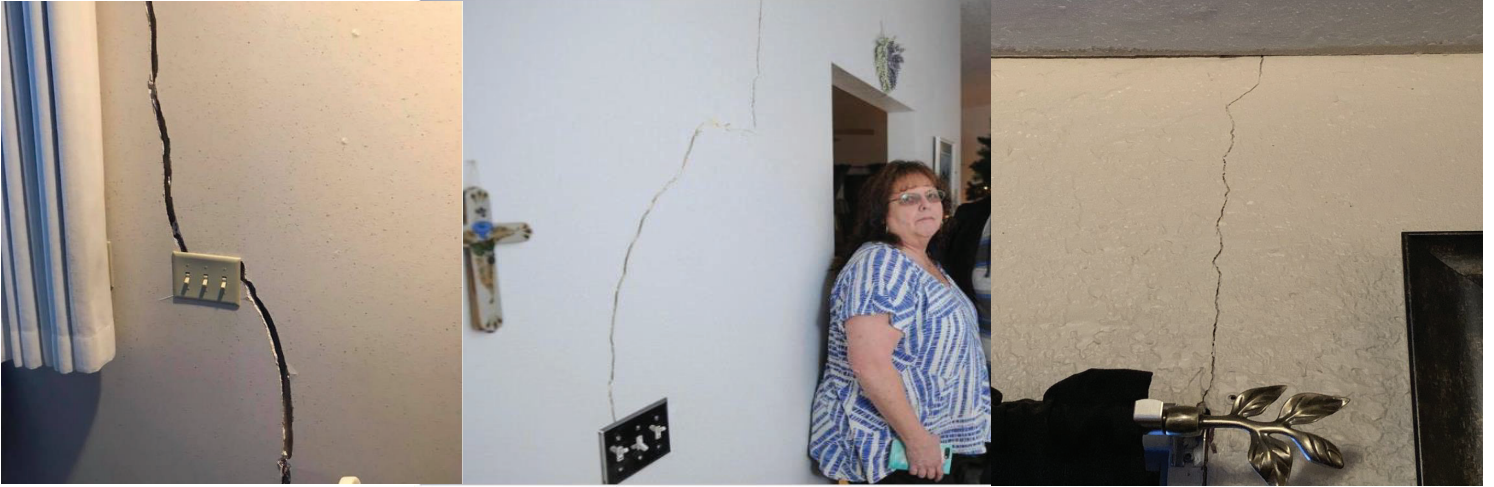
Both Major and Minor cracks were reported by residents at different locations
