StEER: Structural Engineering Extreme Event  
Reconnaissance Network  
PALU EARTHQUAKE AND TSUNAMI, SULAWESI, INDONESIA  
PRELIMINARY VIRTUAL ASSESSMENT TEAM (PVAT) REPORT

Collapsed Roa-Roa Hotel in Palu

**Released:** October 2, 2018

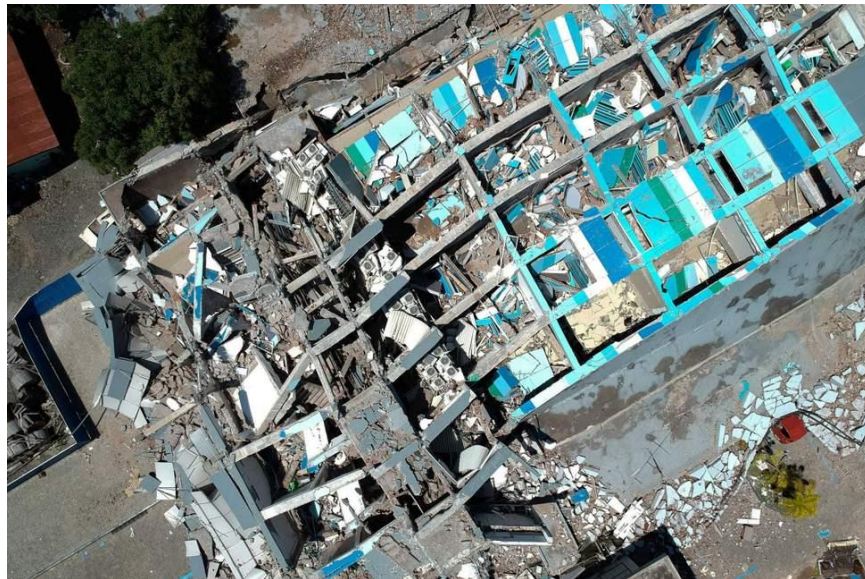
A number of multi-story reinforced concrete buildings are reported to have collapsed during the earthquake. Most notable was the eight-story Roa-Roa Hotel (0.90290 S, 119.86869 E) which collapsed resulting in multiple deaths (Figure 10 and Figure 11). The building lateral force resisting system appears to be a reinforced concrete moment frame structure (Figure 12 and Figure 13). Details of the beam-column framing are visible in Figure 14.

**Figure 12: Collapsed Roa-Roa Hotel after earthquake**

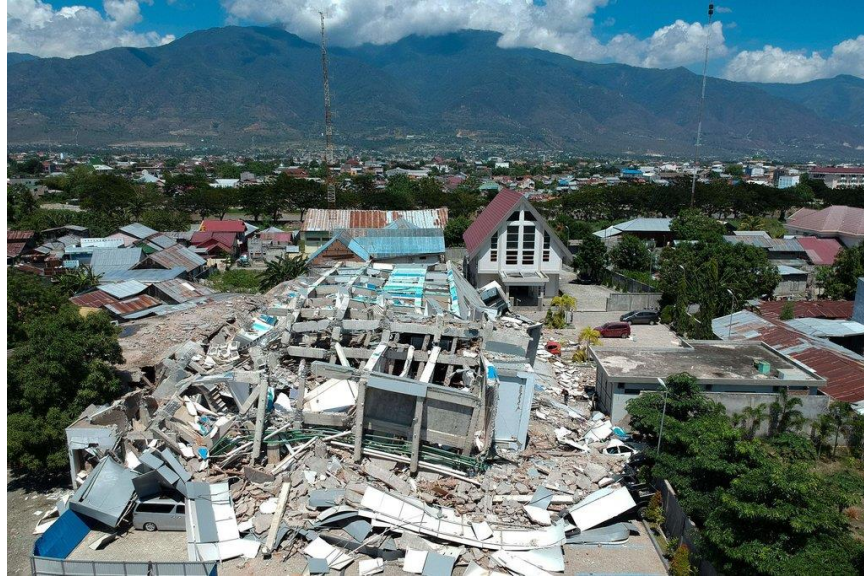
**Figure 13: Collapsed Roa-Roa Hotel after earthquake**

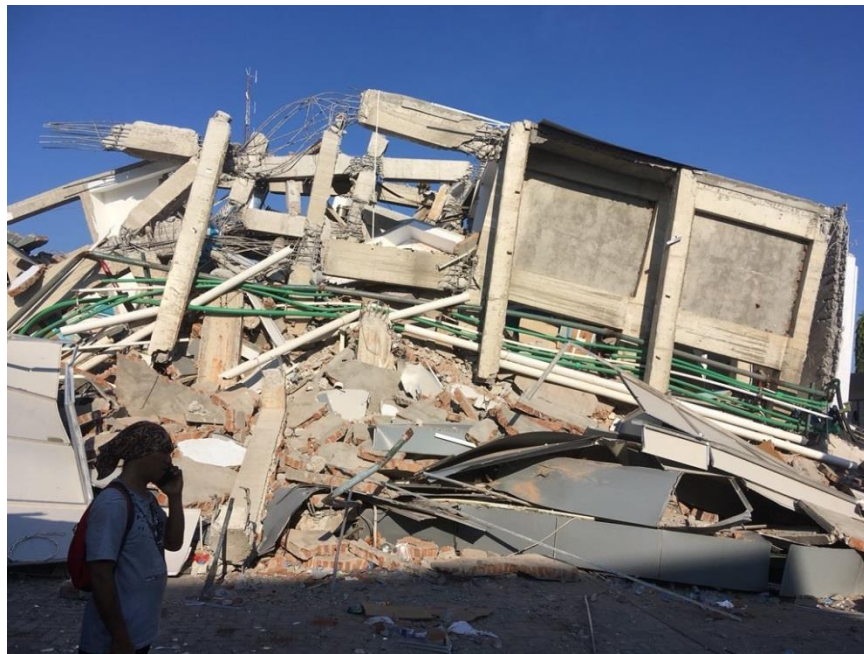
**Figure 14: Lower levels of Roa-Roa Hotel after collapse due to earthquake**

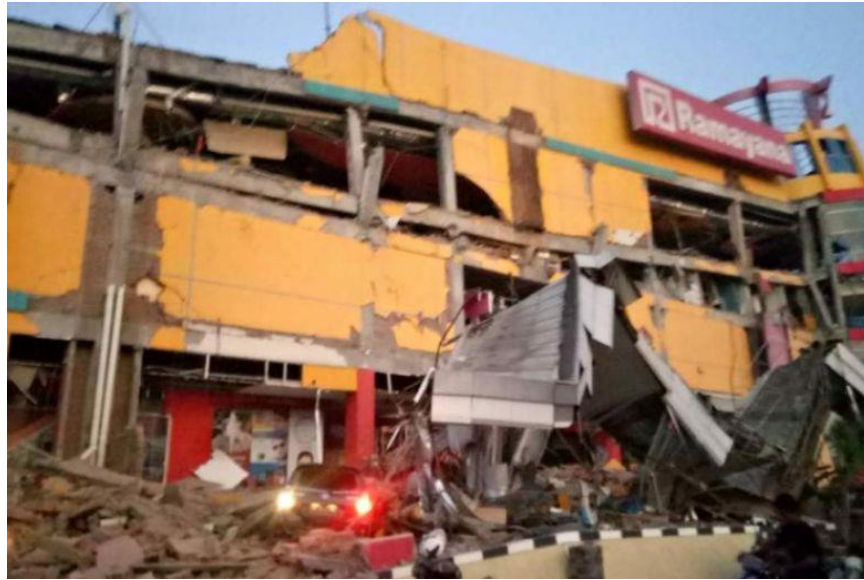
A reinforced concrete shopping center in Palu experienced partial collapse during the earthquake (Figure 15). A number of mosques also suffered severe damage or even collapse (Figure 16 and Figure 17). The Baiturrahman Mosque experienced both the earthquake shaking and the subsequent tsunami. It appears that the partial collapse of the roof dome can be attributed to the earthquake shaking, while the extent of tsunami damage is unknown at this time (Figure 18). The Apung Palu Mosque located on piles slightly off-shore from the Palu coastline suffered severe damage apparently due to significant settlement or damage to the supporting piles (Figure 19). The bridge that provides access to the mosque has collapsed. It is not known whether this damage was the result of the earthquake or tsunami, or a combination of the two.

**Figure 15: A reinforced concrete Shopping Center in Palu experienced partial collapse during the earthquake (Photo: AFP/BNPB)**

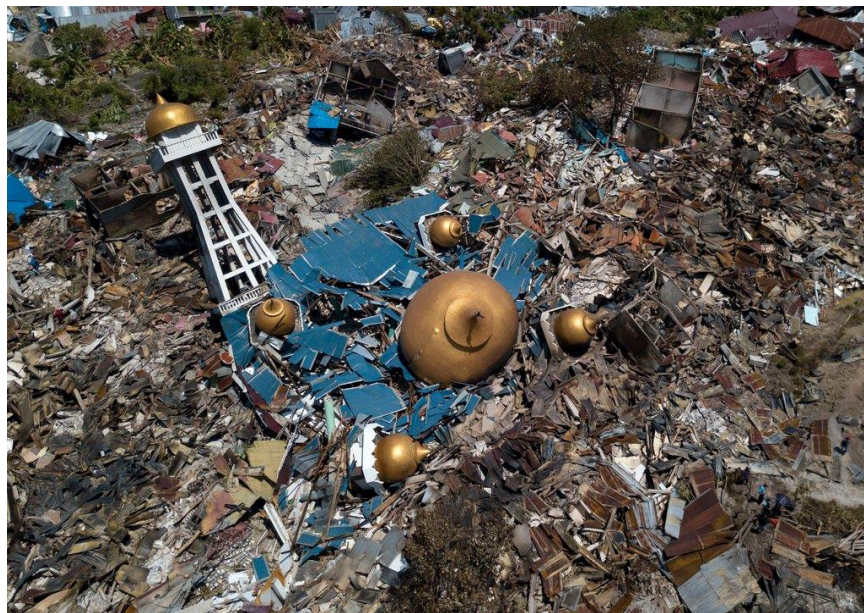
**Figure 16: Collapse of mosque (location unknown)**

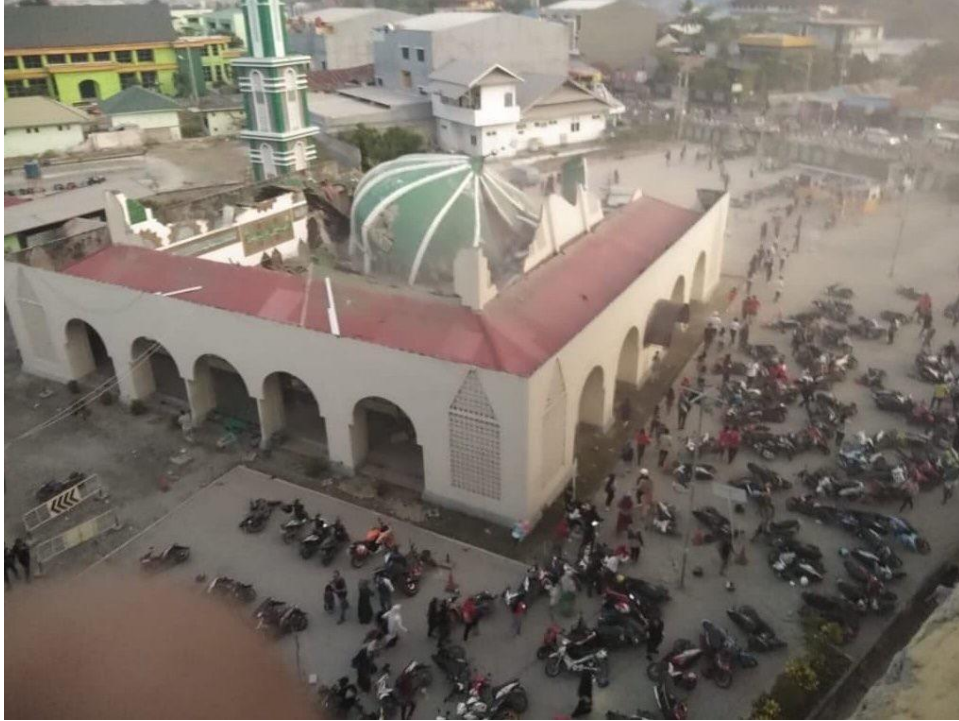
**Figure 17: Damage to Baiturrahman Mosque**

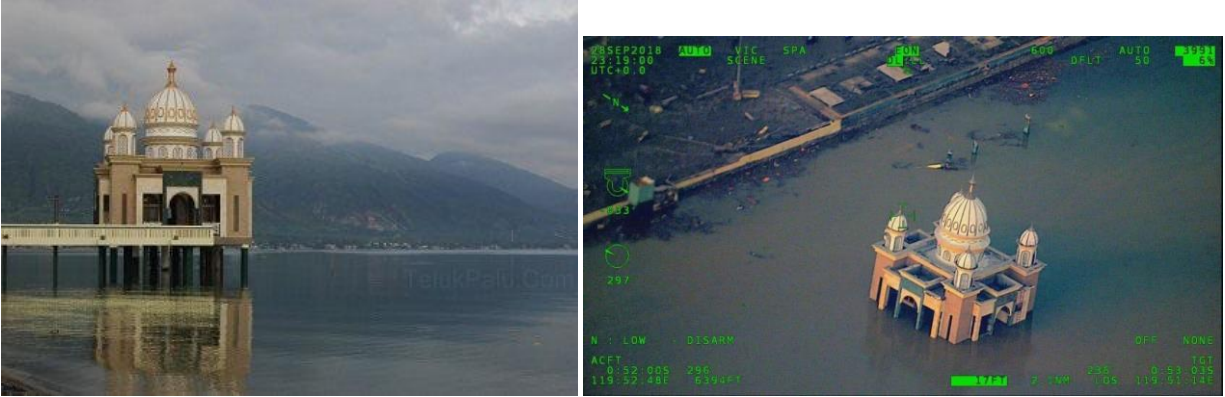
**Figure 19: Apung Palu Mosque before (left) and after (right) the earthquake and tsunami. Exact cause of damage not yet established but could be due to earthquake shaking prior to the tsunami, or possibly a combination of both events.**

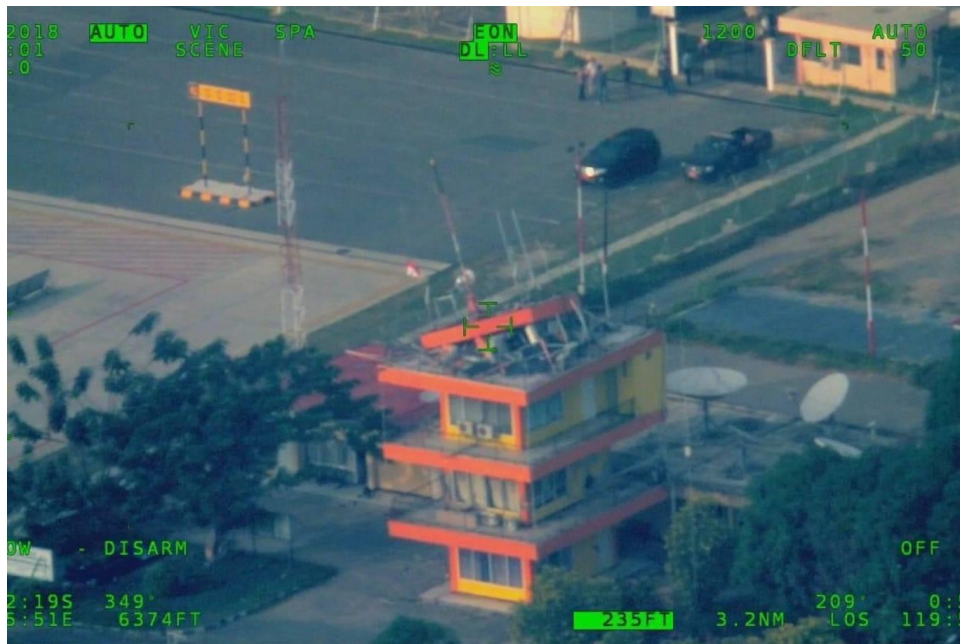
The top level of the Palu Mutiara Sis Al Jufri Airport control tower collapsed during the earthquake (Figure 20 and Figure 21). This is a common occurrence for airport towers because of the large window openings generally required at the control room, and the frequent lack of adequate lateral framing system supporting the roof. One air traffic controller, twenty-one-year-old Anthonius Gunawan Agung, was reportedly on duty in the tower and continued to assist a Batik airplane during take-off, even as the earthquake occurred. He apparently leaped from the control tower just before it collapsed, but died due to injuries suffered in the fall (Times of Isreal, 2018). Damage also occurred in the main terminal building (Figure 22).

**Figure 20: Airport Control Tower after earthquake with top level collapse (0.91670 S, 119.90654 E)**

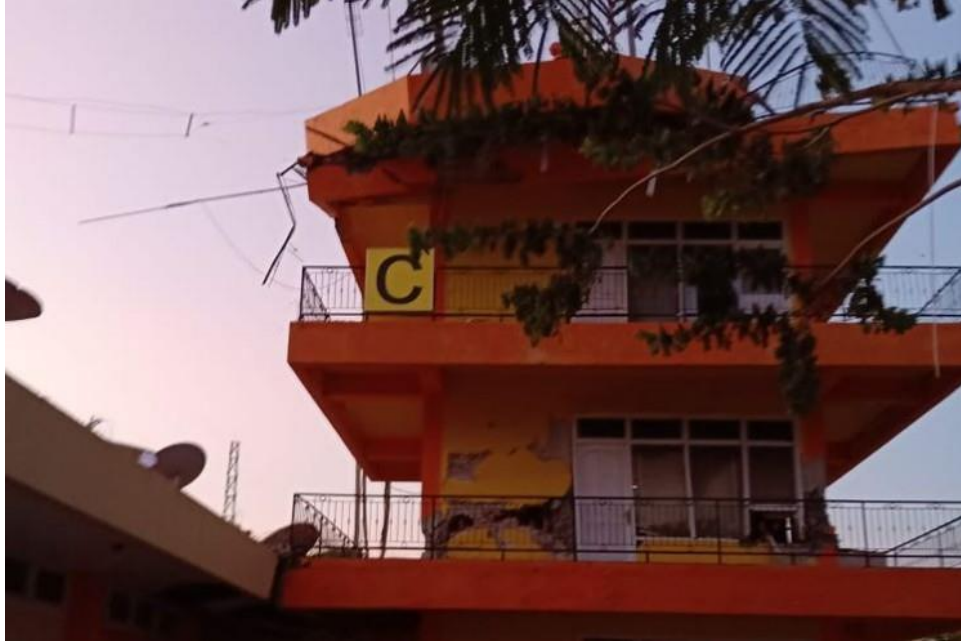
**Figure 21: Earthquake damage to airport control tower.**

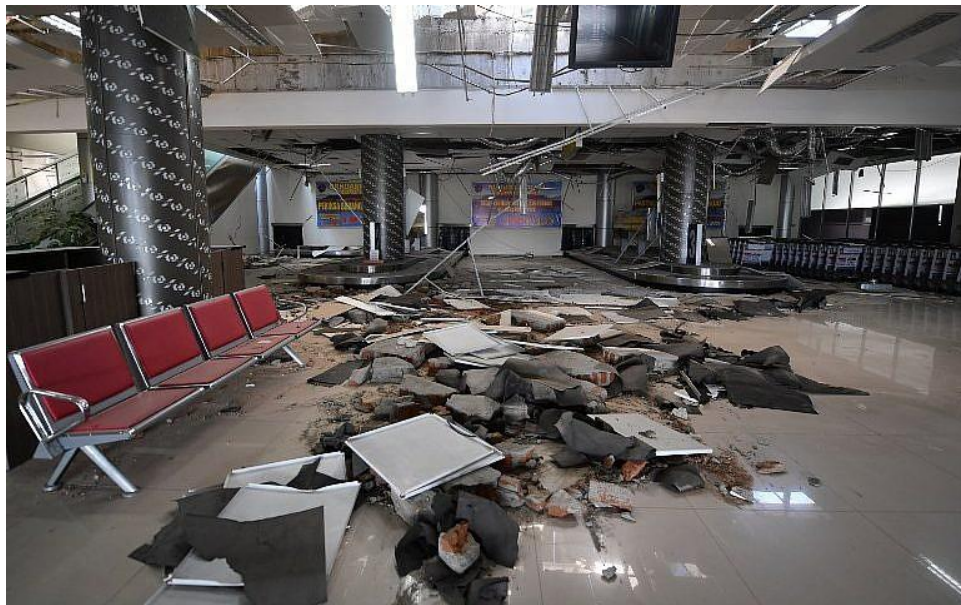
**Figure 22: Damage inside airport terminal building (AFP Photo/Adek Berry)**

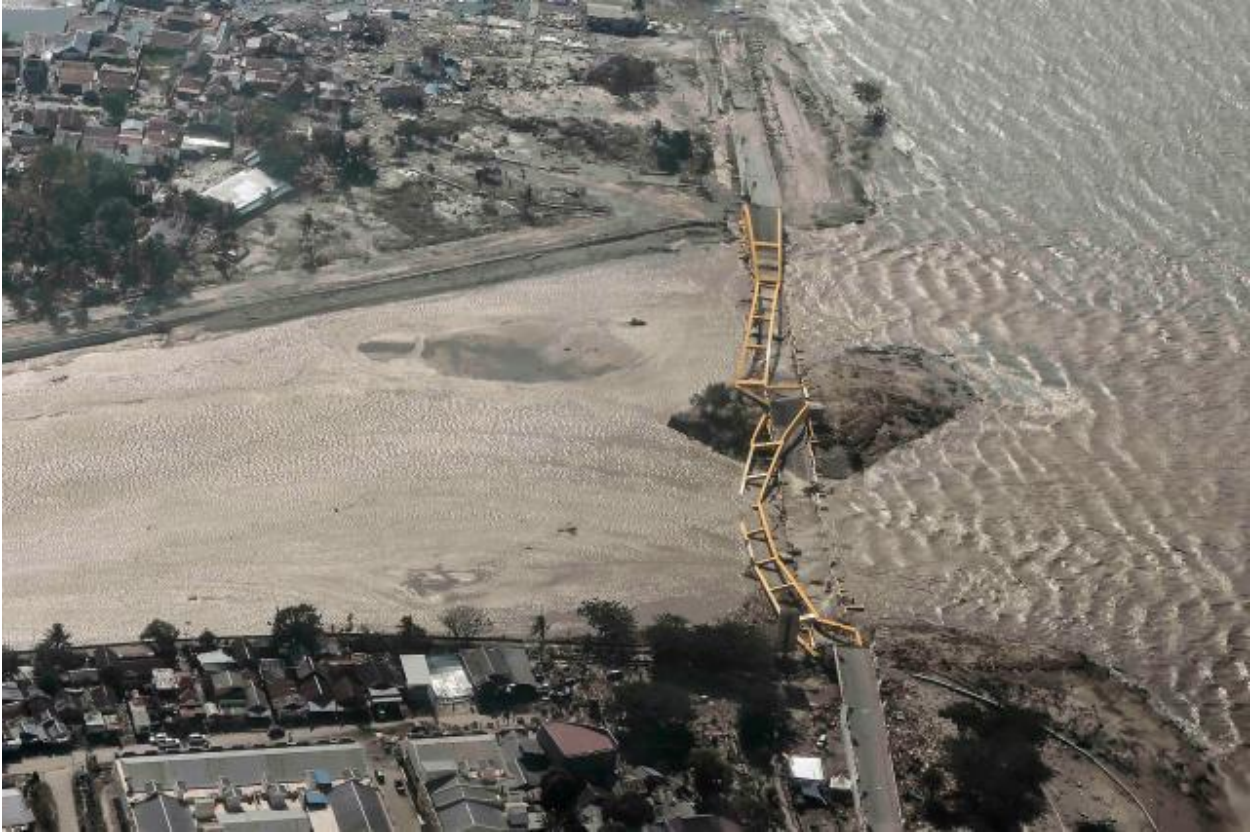
The iconic twin steel arch cable-suspended Palu Bridge IV over the mouth of the Palu River (Figure 23 and Figure 24) collapsed, presumably during the earthquake (though this needs to be confirmed) (Figure 25 and Figure 26). The bridge had a total span of 250 meters and the steel box arches were 20 meters tall. A number of other bridges are reportedly damaged, hampering road traffic in and around the city.

**Figure 25: Palu Bridge IV after earthquake and tsunami**

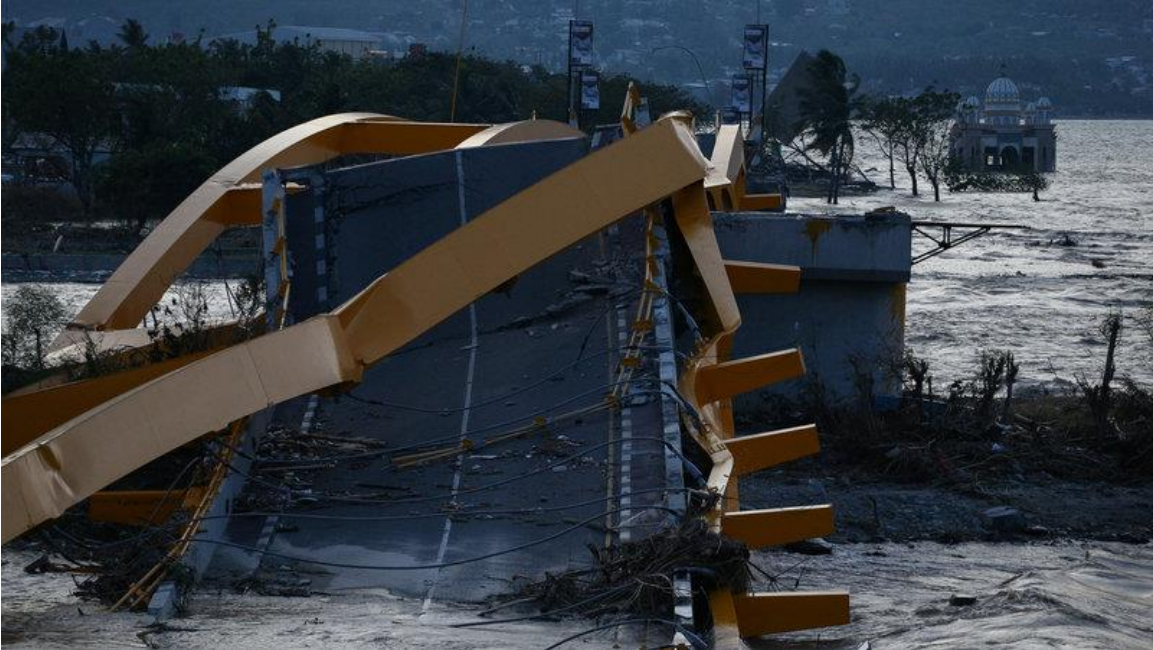
**Figure 26: Palu Bridge IV after earthquake and tsunami (Photo: Athit Perawogmetha/Reuters)**

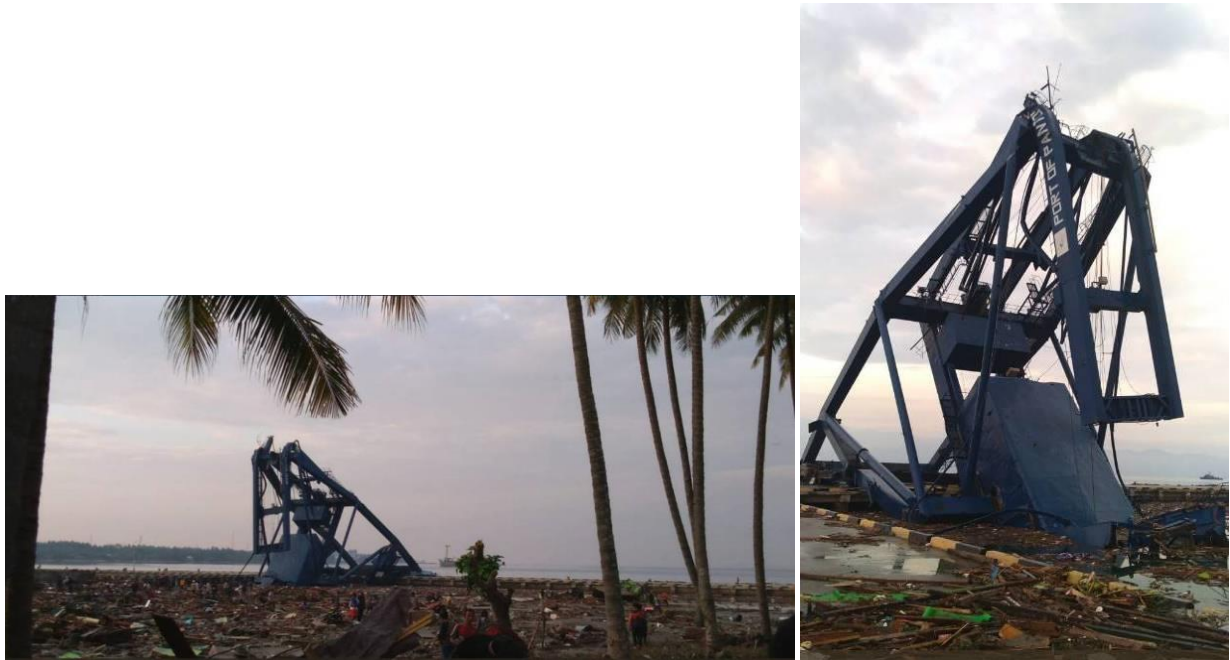
A gantry crane at a port facility to the Northeast of Palu (exact location not yet confirmed) appears to have collapsed during the earthquake, though the exact timing of failure is unknown (Figure 27). Damage is also evident to a port facility further to the North, probably also attributable to earthquake shaking (Figure 28).

**Figure 27: Failure of gantry crane (possibly at 0.710899 S, 119.85577 E)**

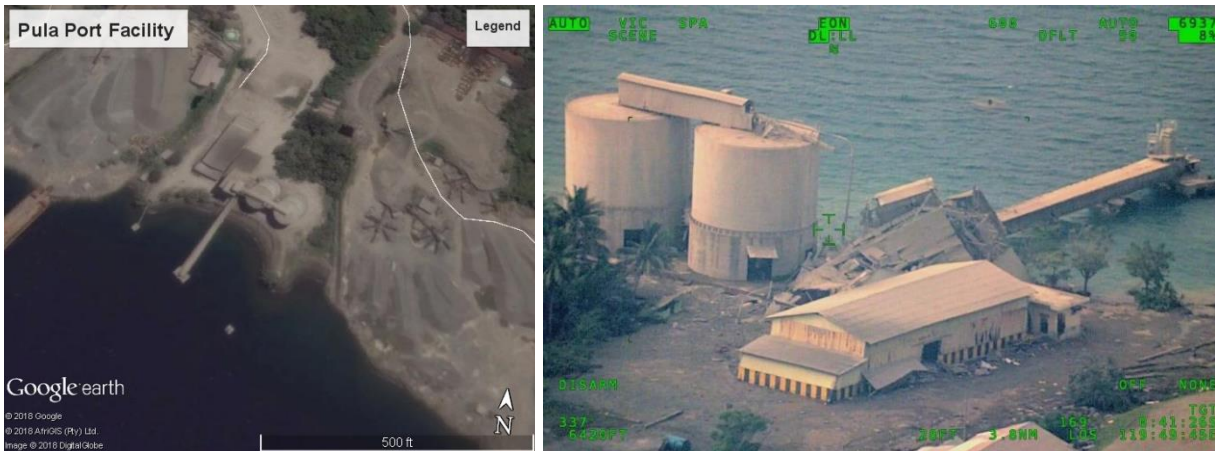
**Figure 28: Damage to port facility (0.690718 S, 119.82923 E)**

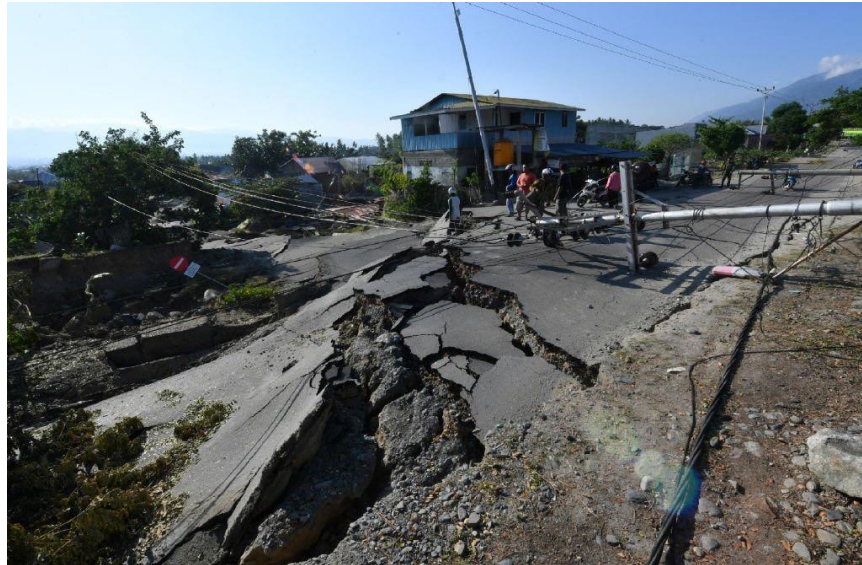
Substantial damage has occurred to roadways in the Palu area (Figure 29, Figure 30 and Figure 31). It appears that some of this damage is due to surface rupture, liquefaction and lateral spreading, while other damage is due to landslides and rockfalls triggered by the earthquake.

**Figure 29: Significant damage to roadways due to fault rupture and liquefaction.**

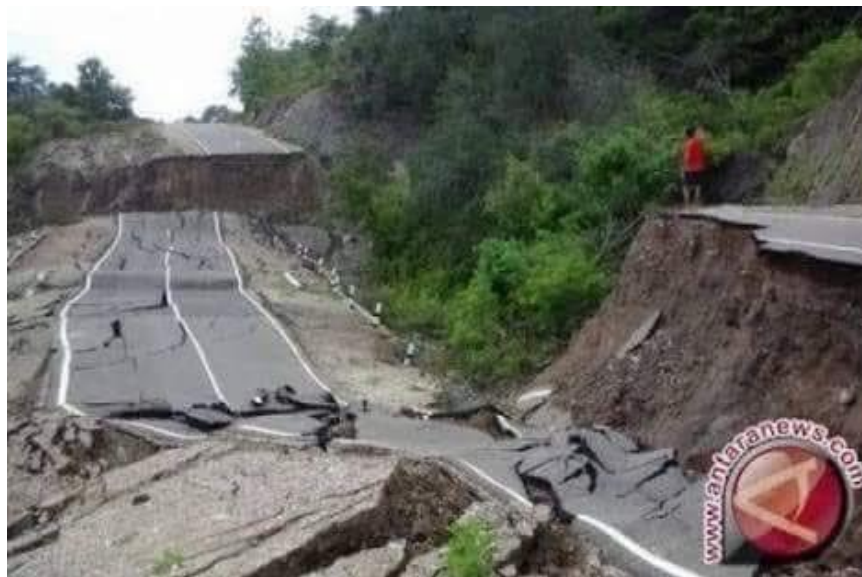
**Figure 30: Failure of roadway due to landslide induced by the earthquake.**

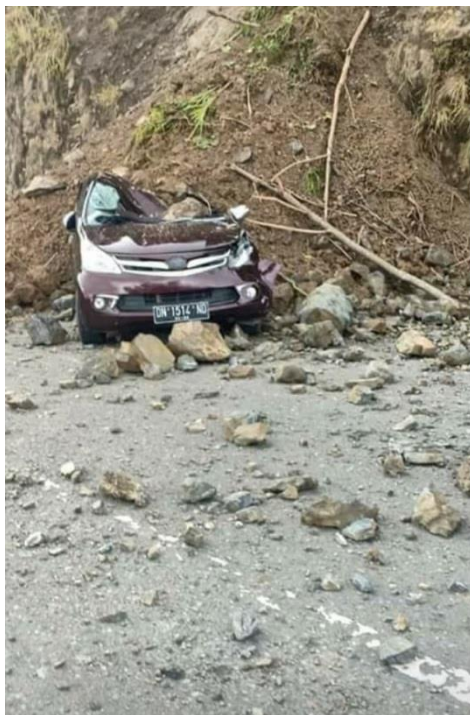
**Figure 31: Landslide damage to car and roadway (location unknown)**

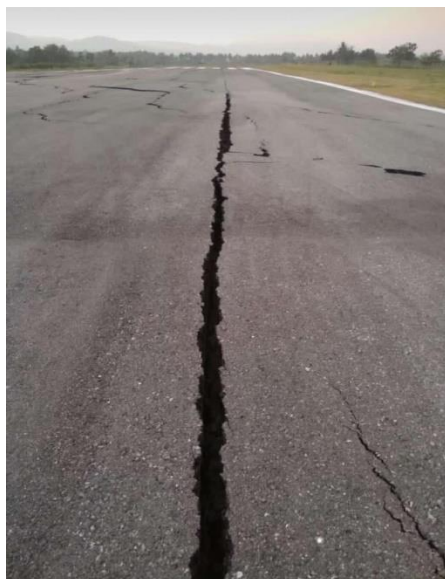
Similar damage due to earth movement has resulted in large cracks in the asphalt paving on the runway at the Palu Mutiara Sis Al Jufri Airport (Figure 32).

**Figure 32: Damage to Palu's Mutiara Sis Al Jufri Airport runway due to ground movement.**

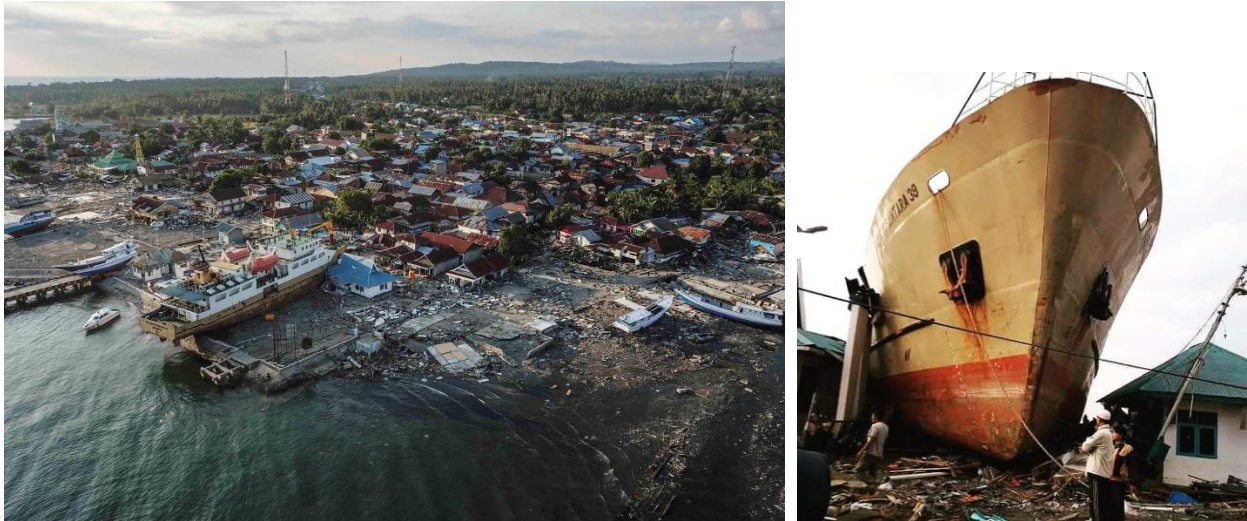
**Figure 33: Ship and boats washed onshore by tsunami (Sources: Left image – NYT, 2018c; Right image – phys.org, 2018) (0.69482 S, 119.8403 E)**

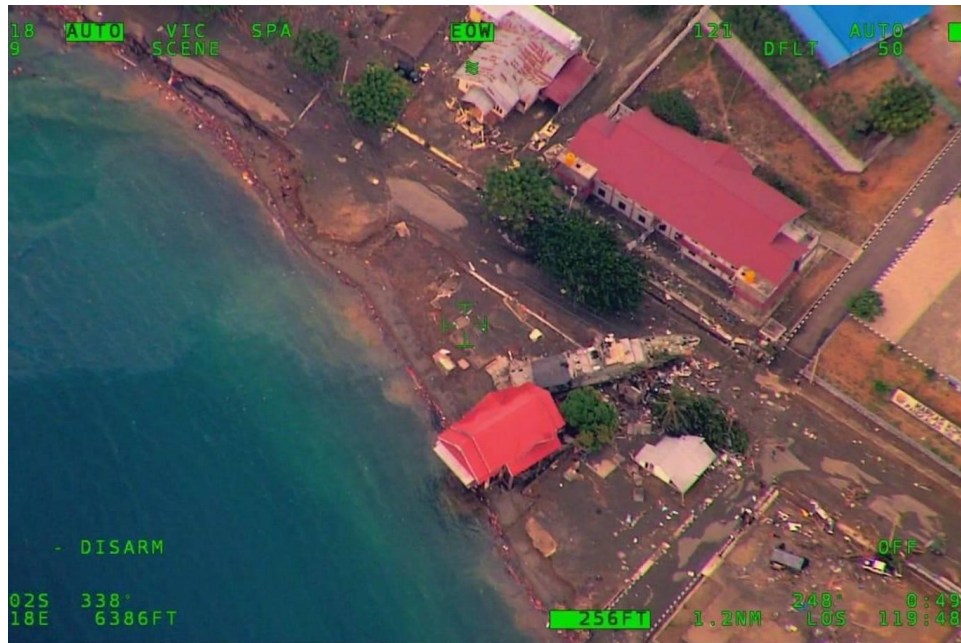
**Figure 34: Ship washed onshore adjacent to Watusampu Naval Base (0.821631 S, 119.81086 E)**

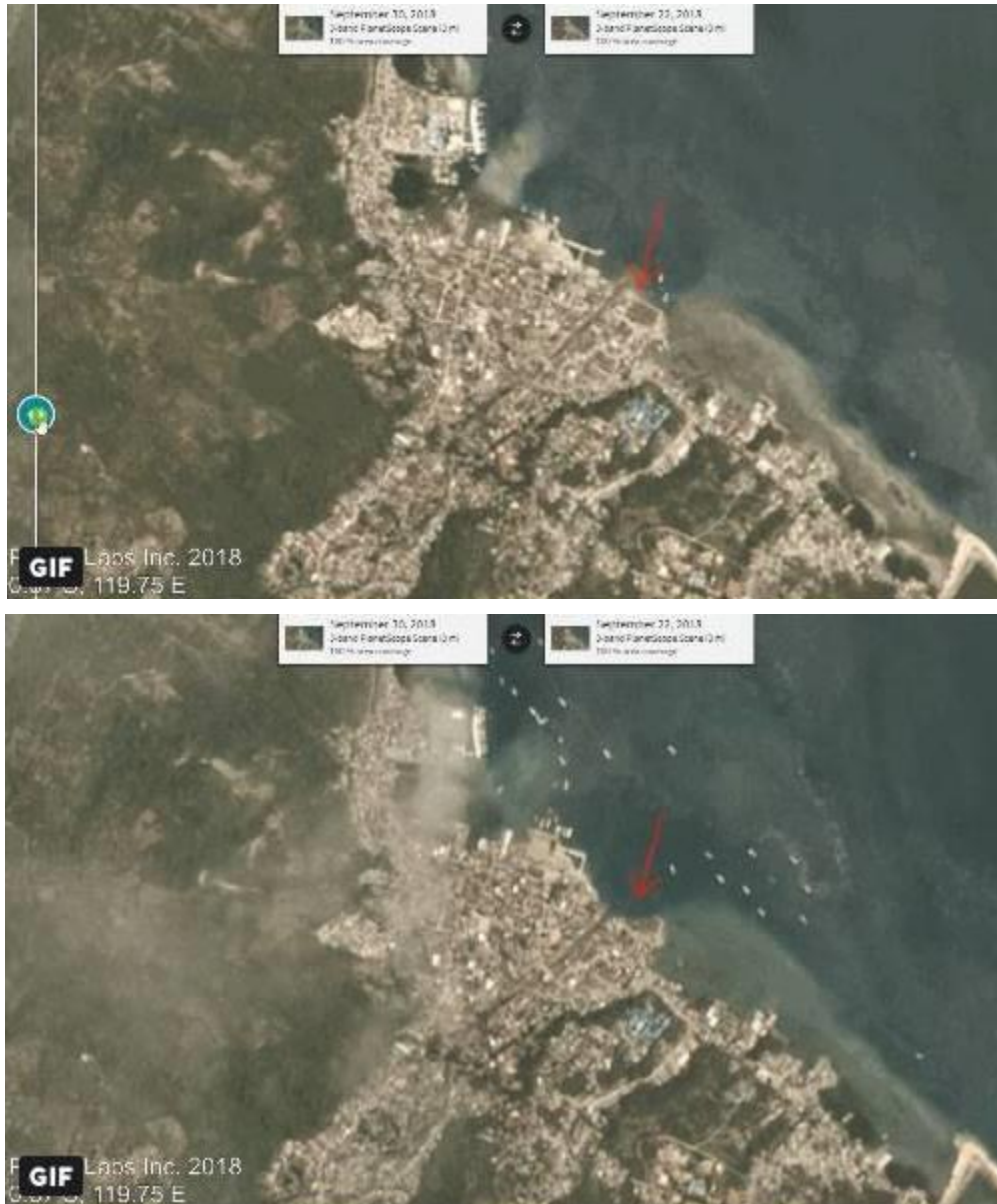
**Figure 35: Before (top) and after (bottom) images of ships washed from their moorings by the tsunami. Port damage and erosion evident along coastline. (Source: Murray Ford twitter feed @mfordNZ)**

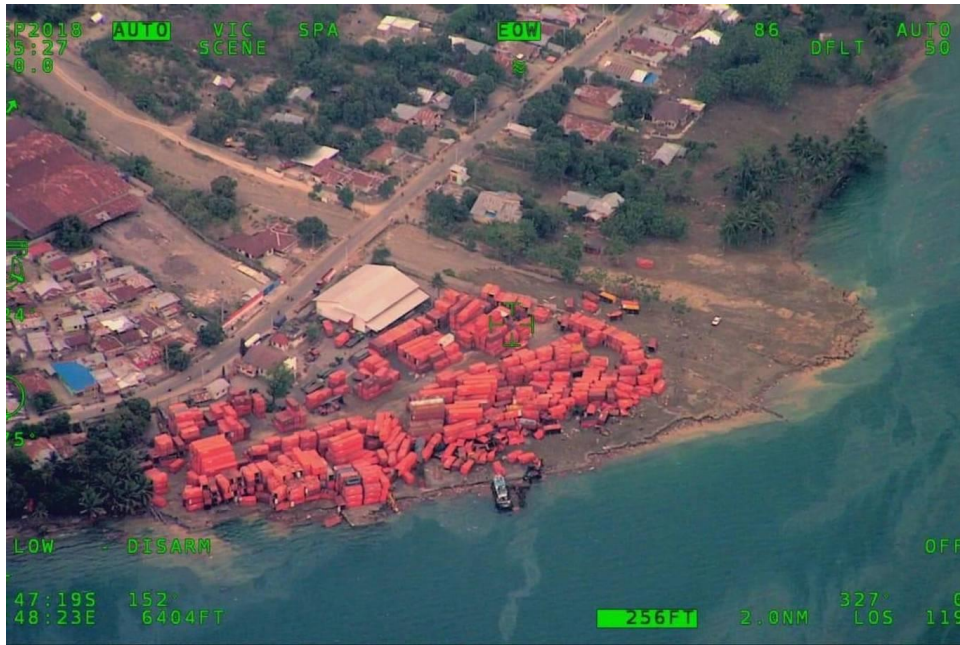
Shipping containers stored at the shoreline along the West edge of Palu Bay were only affected at the shoreline (Figure 36). This is likely due to the limited tsunami inundation at this location as evidenced by the lack of damage to adjacent buildings.

**Figure 36: Shipping container yard after tsunami (0.76477 S, 119.7905 E)**

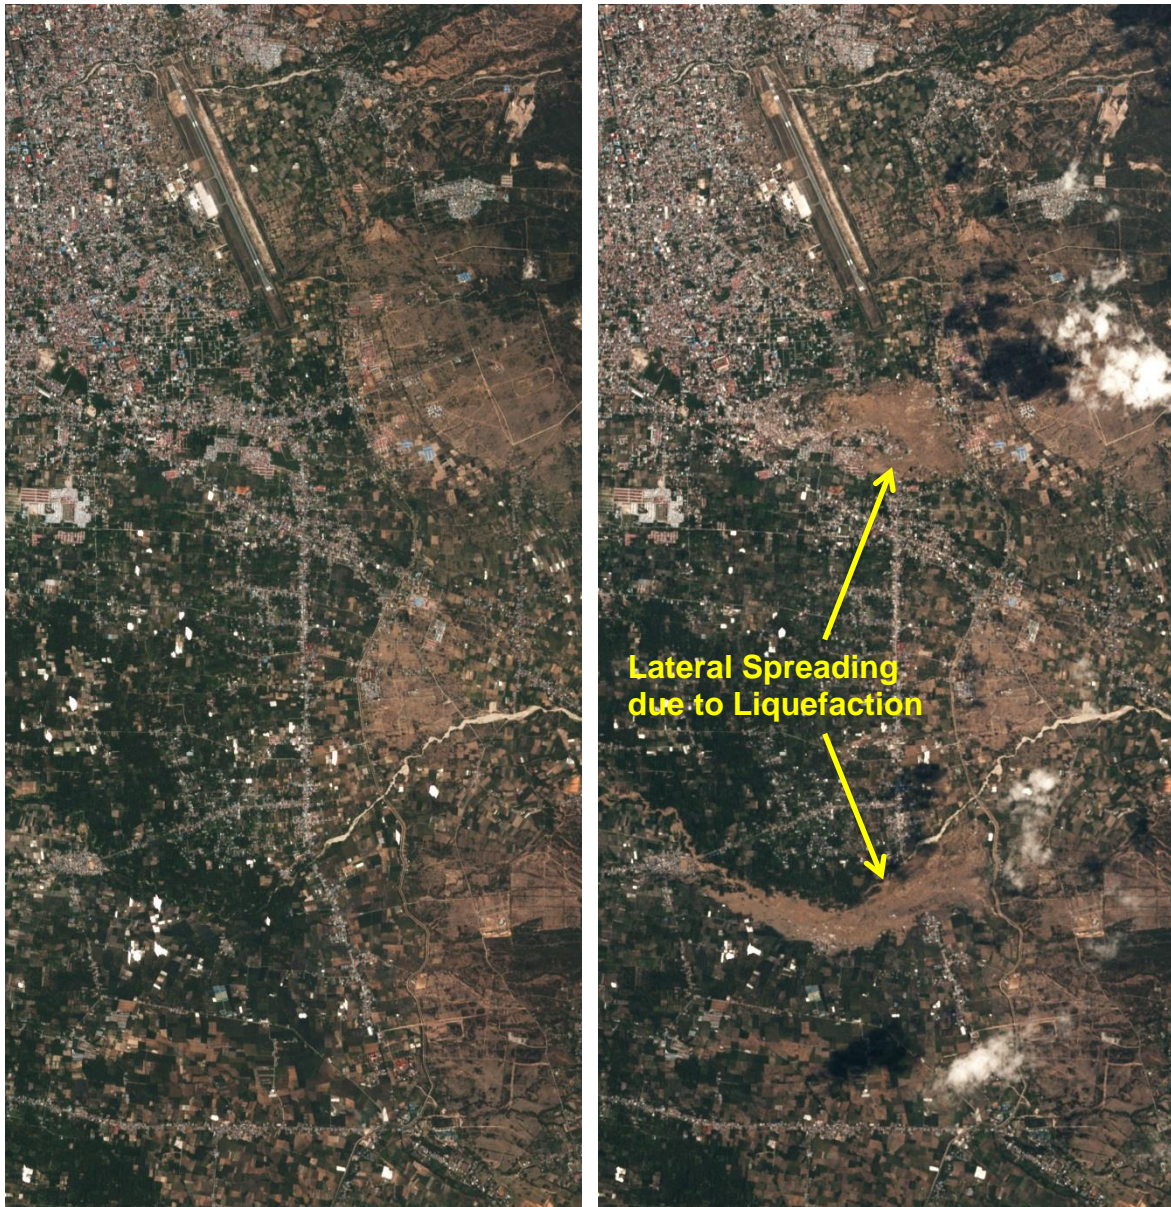
Liquefaction and significant lateral spreading appear to have occurred at a number of locations in Palu (Figure 39). Video evidence of lateral spreading and resulting ground failure and damage to structures can be viewed in the following videos, some of which were posted by Sutopo Purwo Nugroho, Head of Information Data and Public Relation Center, BNPB - National Agency for Disaster Management, Indonesia (Twitter feed: [@Sutopo\\_PN](https://twitter.com/Sutopo_PN)):

**Figure 39: Aerial images of Palu before (left) and after (right) the earthquake. Severe lateral spreading due to liquefaction is evident in two large areas leading to total destruction of buildings and infrastructure in those areas (Source: New York Times, NYT, 2018b)**
