StEER
STRUCTURAL
 EXTREME EVENTS
 RECONNAISSANCE

Midwest Tornado Outbreak
10 December 2021
 Released: 29 December 2021
 NHERI DesignSafe Project ID:
 PRJ-3349

**JOINT PRELIMINARY VIRTUAL RECONNAISSANCE REPORT AND
 EARLY ACCESS RECONNAISSANCE REPORT (PVRR-EARR)**

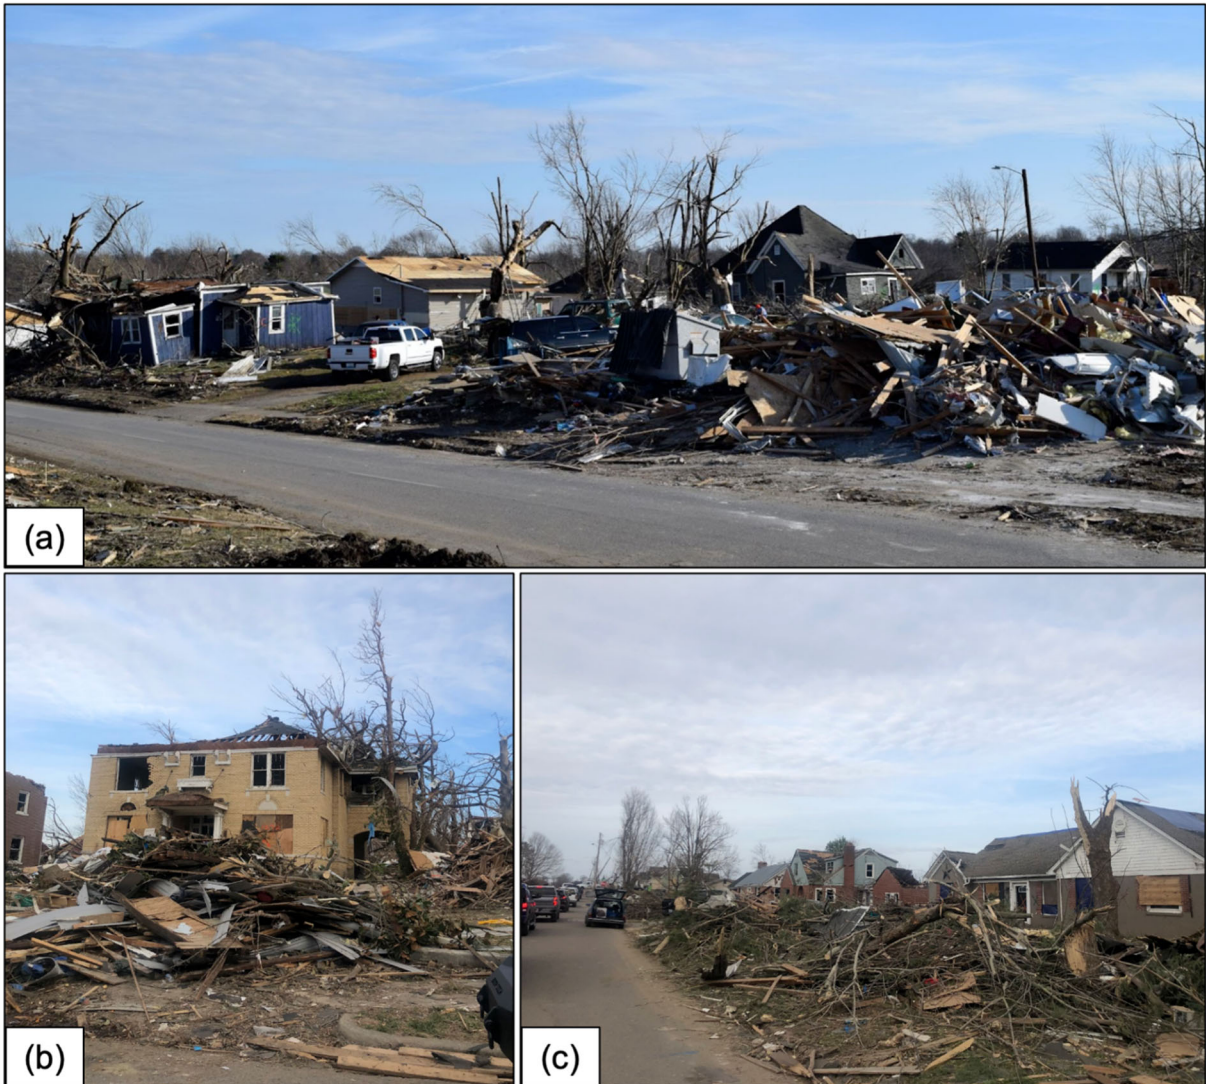
In Mayfield, Princeton, Dawson Springs, and Bremen, the FAST noted that the majority of the homes were older building stock with little to no wind uplift load path. Figures 6.1.3-6.1.4 offer representative images of FAST-observed performance of single family residences in Princeton and Mayfield. Most homes were wood-frame, constructed atop unreinforced masonry piers and stem walls, with wood platforms forming the substructure.

Figure 6.1.3. Representative residential damage and debris found in Mayfield, KY, including (a) varying damage levels, from no visible damage to complete collapse, evident in a cluster of wood-frame homes in close proximity to each other; (b) loss of the roof structure and windows blown out in a two-story home with a large pile of debris in front of it; and (c) debris piles in front a row of homes that suffered primarily building envelope damage. (Images acquired by the FAST).

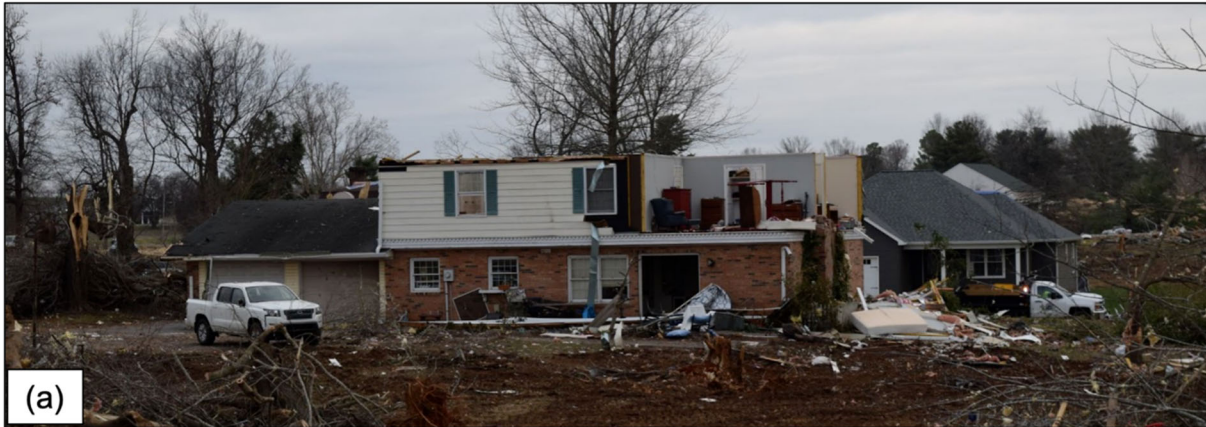
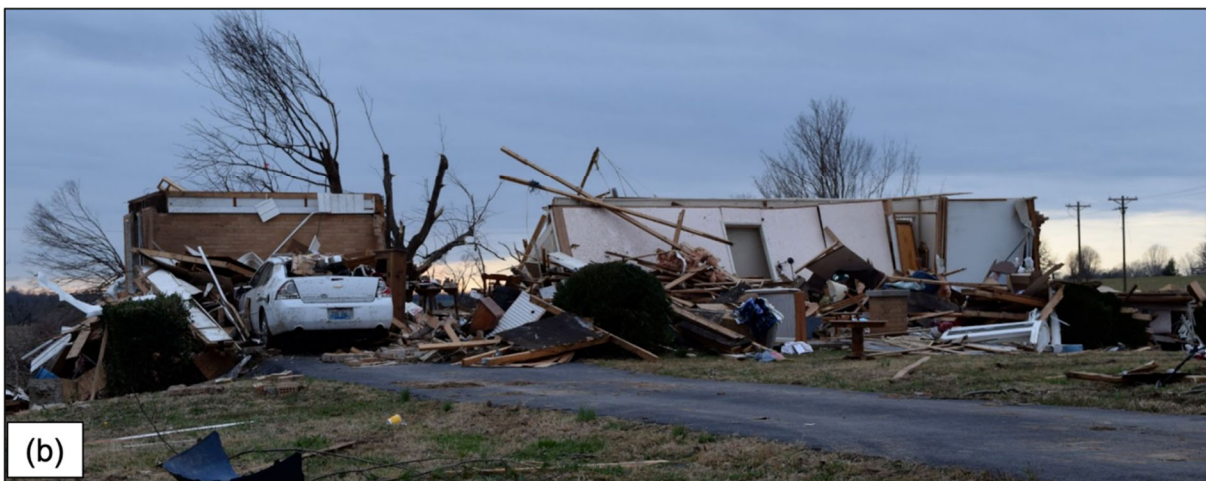
Figure 6.1.4. Representative damage to single-family homes in Princeton, KY along (a) Dogwood Ln (Lat: 37.0808, Long: -87.8984), and (b) Country Club Ln (Lat: 37.0781, Long: -87.9052), showing wood-frame structures with roof structure failures and subsequent wall collapses. (Images acquired by the FAST).

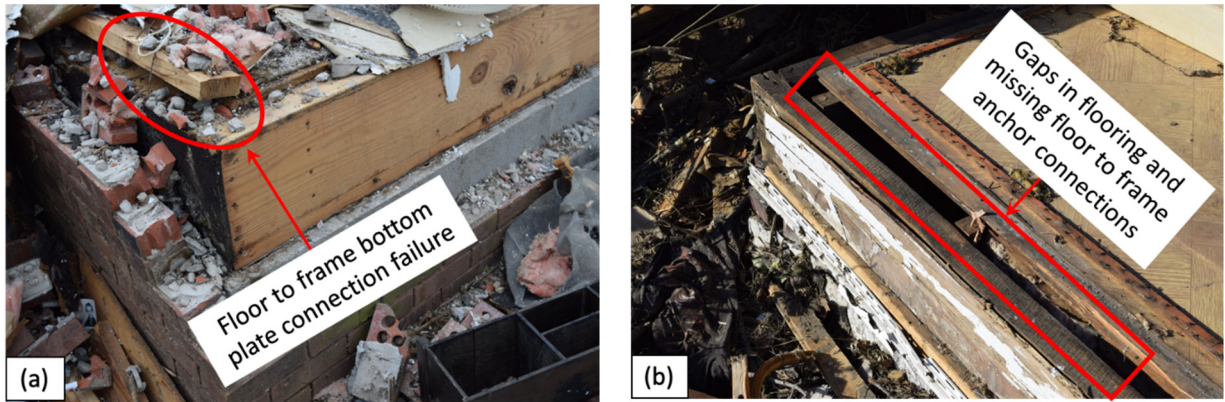
Figure 6.1.5. Common wall-to-foundation connection failures; (a) removal of the bottom plate from subfloor and wall studs from bottom plate in a Princeton home due to reliance on nailed connections in withdrawal; (b) removal of the bottom plate and stud walls from the wood-frame floor platform in a downtown Mayfield home due to reliance on nailed connections. (Images acquired by the FAST).

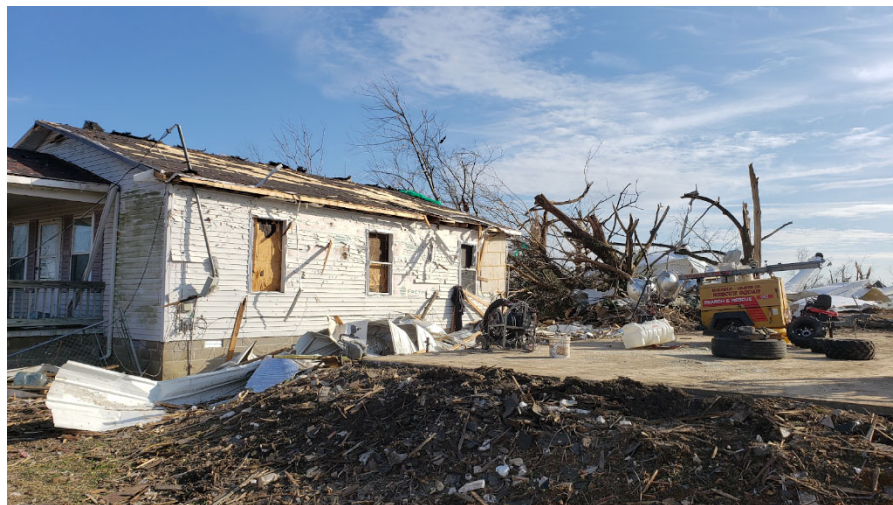
collapsed water tower), this home only suffered damage to the building envelope, with ~50% of the roof cover removed, multiple windows blown out, and wind-borne debris impacts to the walls. The collapsed water tower and severe structural damage to the buildings surrounding this home suggest that the enhanced load path used in this home was key to its comparatively successful performance, but further analysis is needed to reveal whether any other factors (e.g., micrometeorological) played a part.

Figure 6.1.6. Single-family residence with building envelope damage 200 ft down-path of the collapsed water tower in Mayfield. The home had been constructed with hurricane straps that wrapped over the top of the wood trusses and connected them to the wood-frame walls. (Images acquired by the FAST).

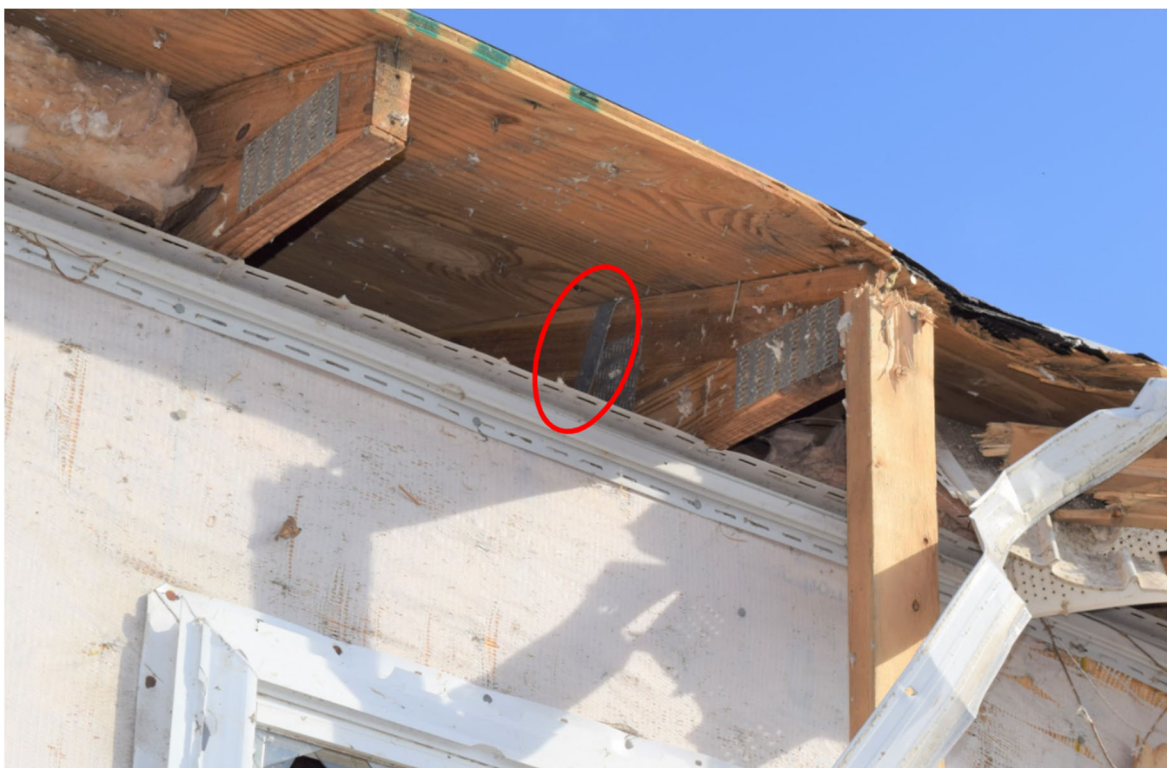
Figure 6.1.7. Steel strap wrapping around a truss to secure it to the wood-frame wall in a home adjacent to the collapsed water tower in Mayfield, KY. (Photo taken by the FAST).

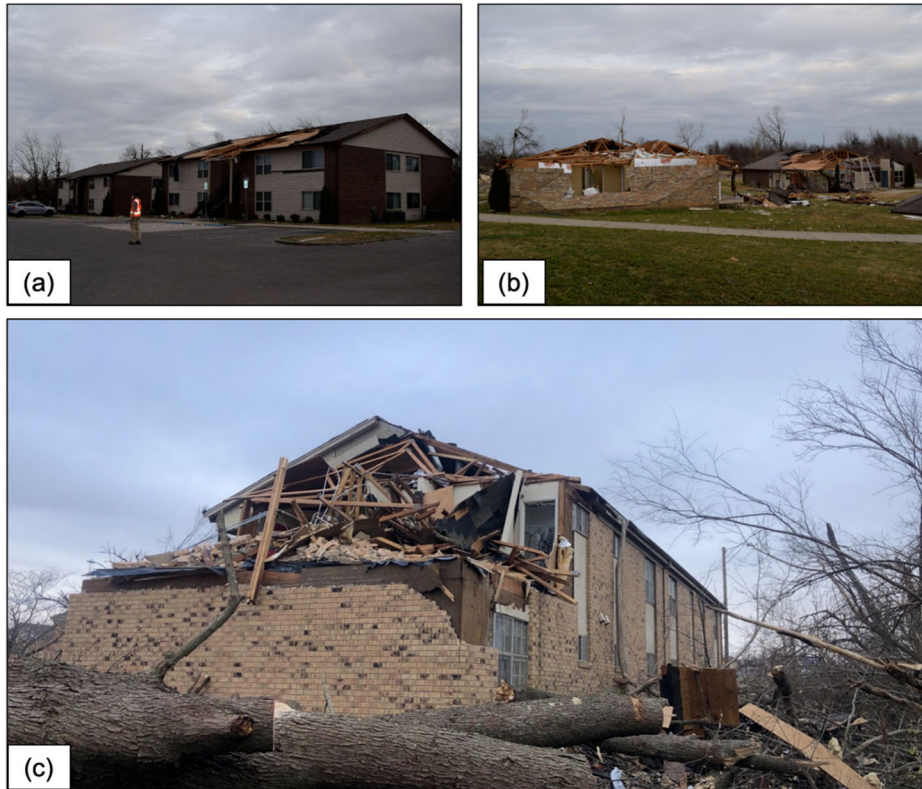
Figure 6.2.2. Examples of damage to multi-family residential structures in Mayfield: (a) Windhaven Apartments (two-story units) (Lat: 36.7447, Long: -88.6297), (b) Windhaven Apartments (one-story units), (c) Tree impact on the Mayfield Garden Apartments (Lat: 36.7350, -88.6436). (All images acquired by the FAST).

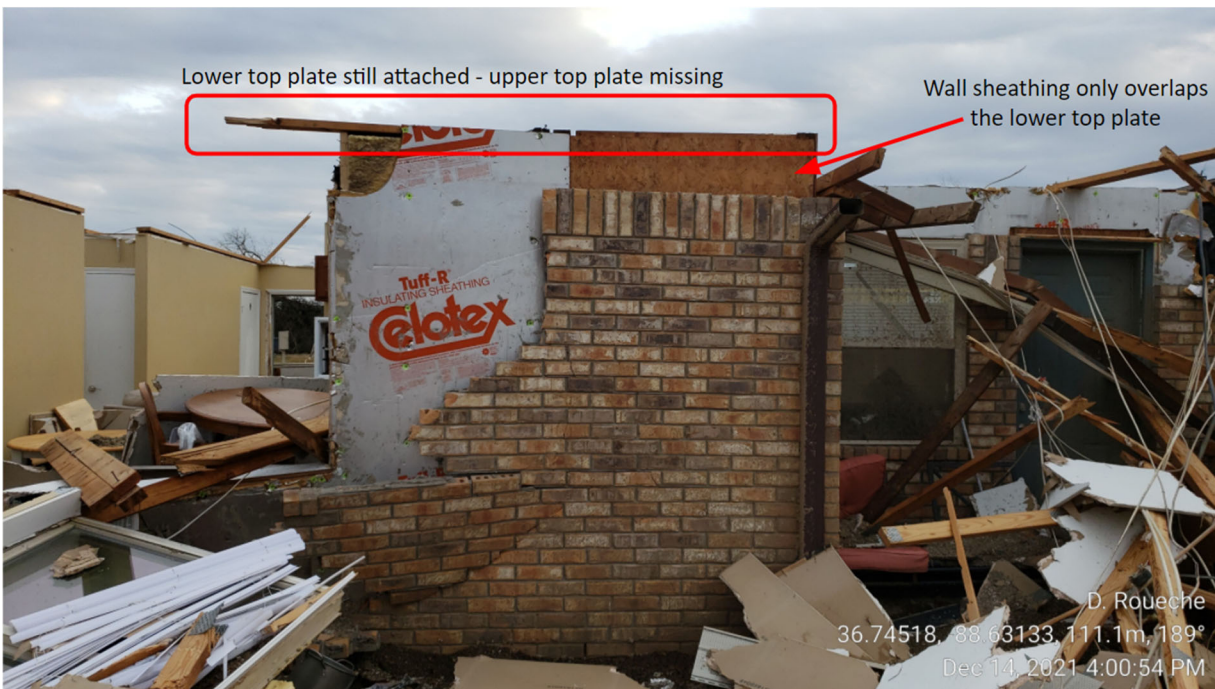
Figure 6.2.5. Roof-to-wall failure occurring via separation of the upper and lower top plates of the stud wall of a unit at the Windhaven Apartment complex (Lat: 36.7452, Long: -88.6313). Removal of the upper of the two top plates was observed around the perimeter of the structure (Image acquired by the FAST).

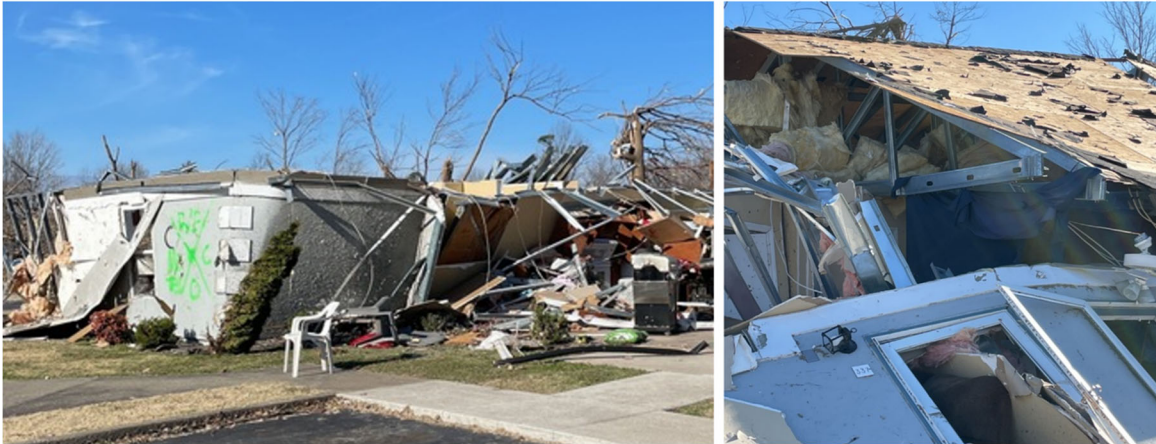
The Mayfield Manor Apartments, which were constructed with light steel framing performed well as a whole. One building in the complex, shown in Figure 6.2.6, was destroyed (roof uplifted and several exterior walls collapsed). However, buildings in the same apartment complex across the street (approximately the same distance to the tornado center as the damaged building -- see Fig. 6.2.3 and Fig. 6.2.4), and presumably with the same construction, performed well structurally. Presuming these buildings all had the same load path and detailing, the causal factors may be non-structural, with site features suggestive of the role of tree falls or debris from adjacent damaged buildings, and warrants further analysis.

Figure 6.2.6. Collapse of a cold-formed steel framed unit at the Mayfield Manor Apartments in Mayfield, KY (All images acquired by the FAST).

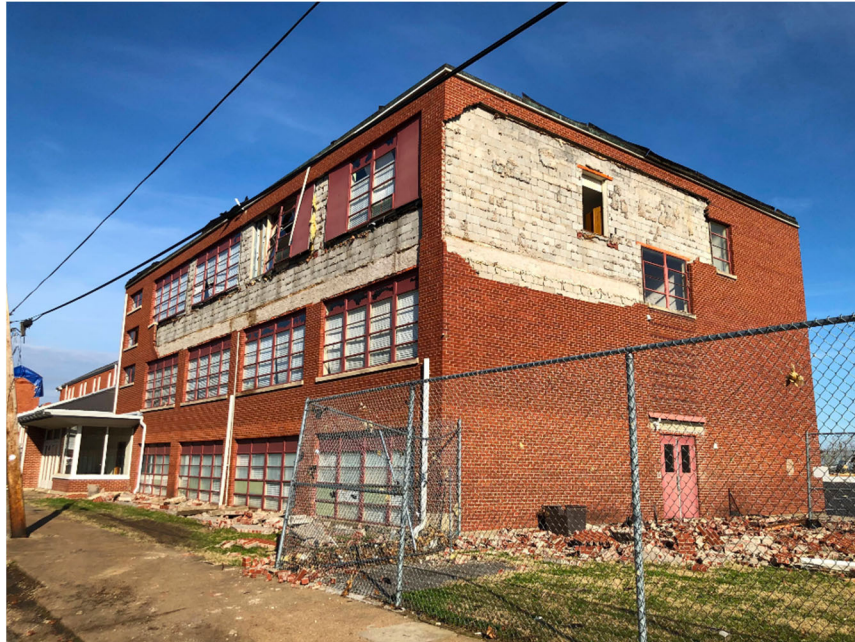
Figure 6.3.4 St. Joseph Catholic School at 702 W Broadway (Lat: 36.7411, Long: -88.6442), Mayfield with failure (or lack) of brick veneer ties to the backup CMU (Photo taken by the FAST).

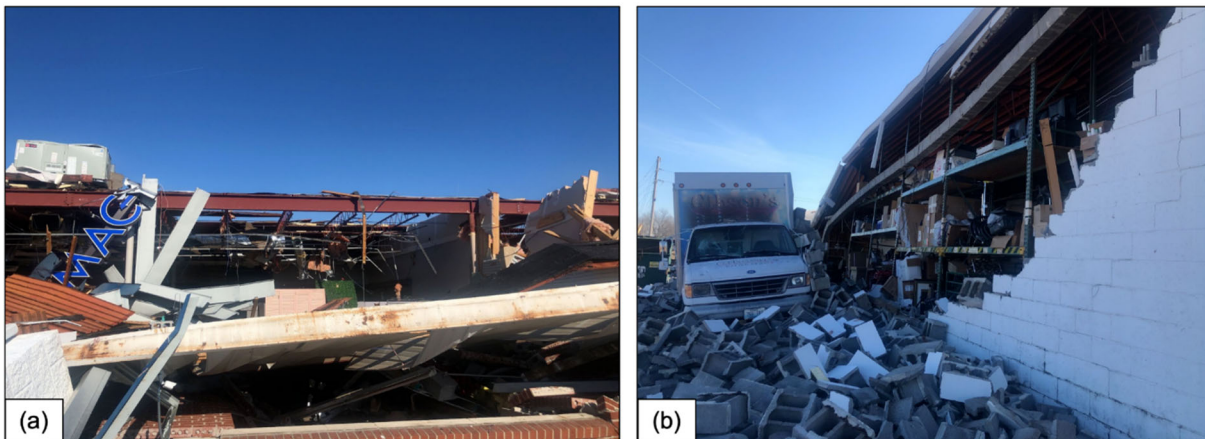
Figure 6.3.5. Examples of failure modes in commercial structures located at 715 E Broadway (Lat: 36.7442, Long:-88.6278) in Mayfield (All images acquired by the FAST).

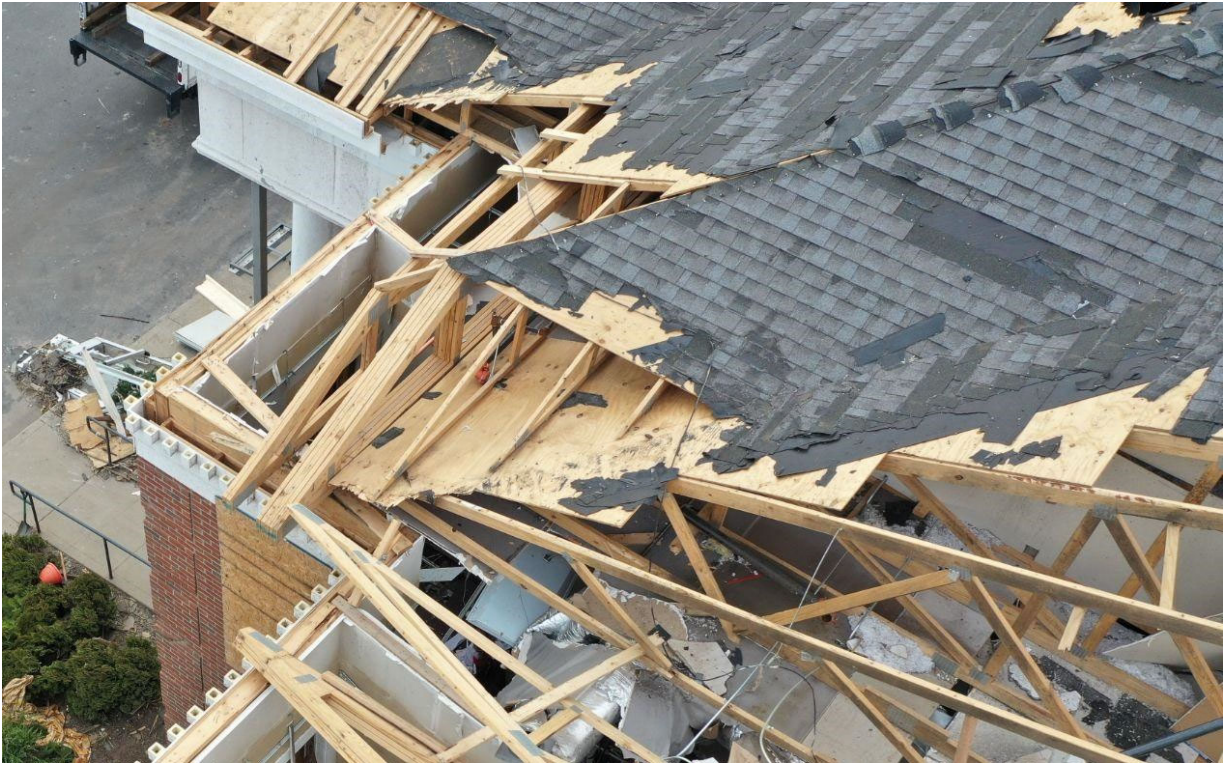
Figure 6.3.6. Roof-to-wall connection failures at the FNB bank (Lat: 36.7419, Long: -88.6350) in downtown Mayfield (Photo taken via UAV by the FAST).

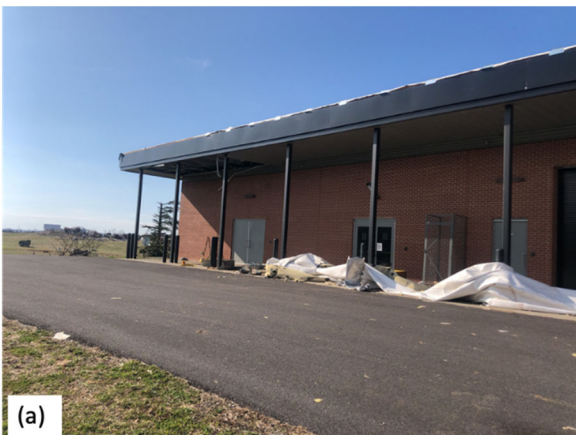
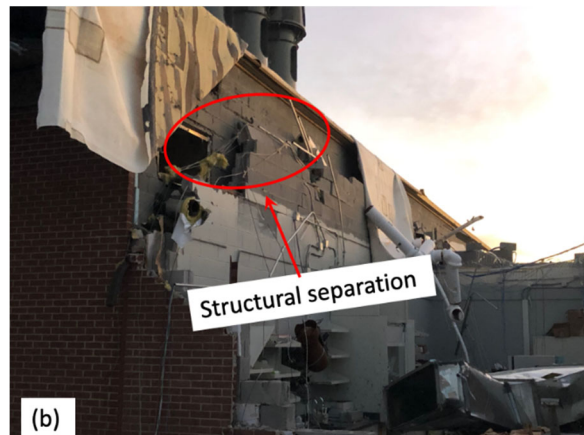
Figure 6.3.8. (a) Undamaged new addition (Lat: 37.1003, Long: -87.8530), which is the left-most building in Figure 6.3.7, and (b) structural separation of the new addition from the collapsed existing structure of the University of Kentucky Grain and Forage Center of Excellence in Princeton (Images acquired by the FAST).

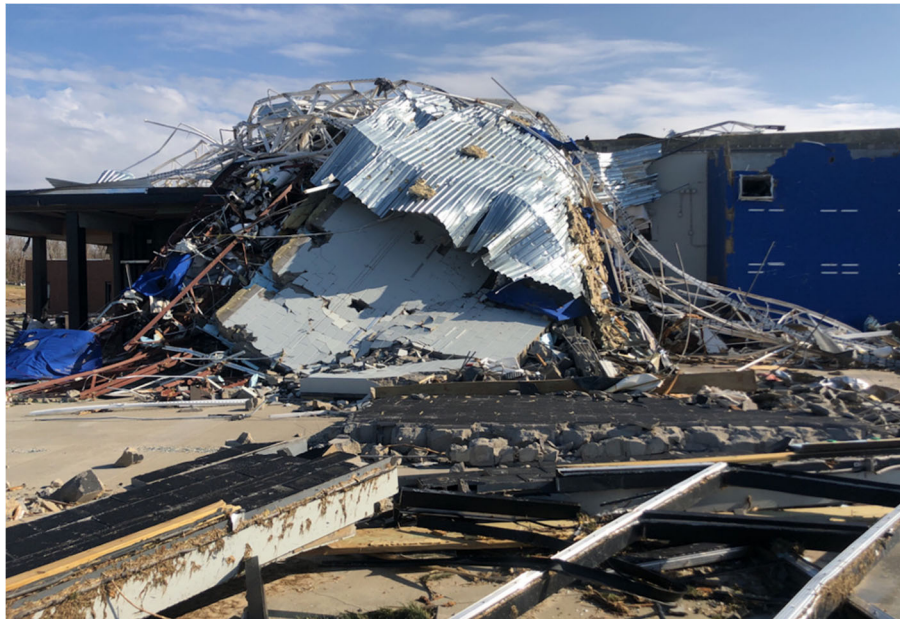
Multiple buildings on the campus of the University of Kentucky (UK) Research and Education center in Princeton were damaged, the most notable being the Grain and Forage Center of Excellence. This multi-story combination of steel frame and concrete masonry unit (CMU) block building was originally constructed in the 1980's, but underwent a significant expansion in September 2019, including the addition of several new wings and a two-story multipurpose space with large equipment access (20,000 square feet) (see [designer site](#) and [construction photos](#)). Located directly in the path of the tornado, this building was destroyed, with the roof and exterior walls in all but two wings severely damaged or collapsed (see aerial view in Fig. 6.3.7). One of the newly added corner buildings survived. This may be attributed to the adoption of modern codes and structural separation of the new addition from other existing buildings (see Fig 6.3.8b). However, the other new additions at the opposite side of the existing building suffered severe damage or collapse. A sharp wind speed gradient was likely present across the width of the building, evidenced by the standing trees and light poles on the left side of the image, aligned with the still standing new wing of the building. Detailed investigation will be needed to ascertain the factors behind better performance of this new addition compared to its collapsed neighbors and StEER LiDAR scans can assist in this regard. Figures 6.3.9-10 provide a closer view of damage and collapse of the industrial roof trusses of the structure, respectively.

Figure 6.3.10. Collapse of light metal industrial roof trusses of UK Research and Education Center in Princeton, new building (Image acquired by the FAST).

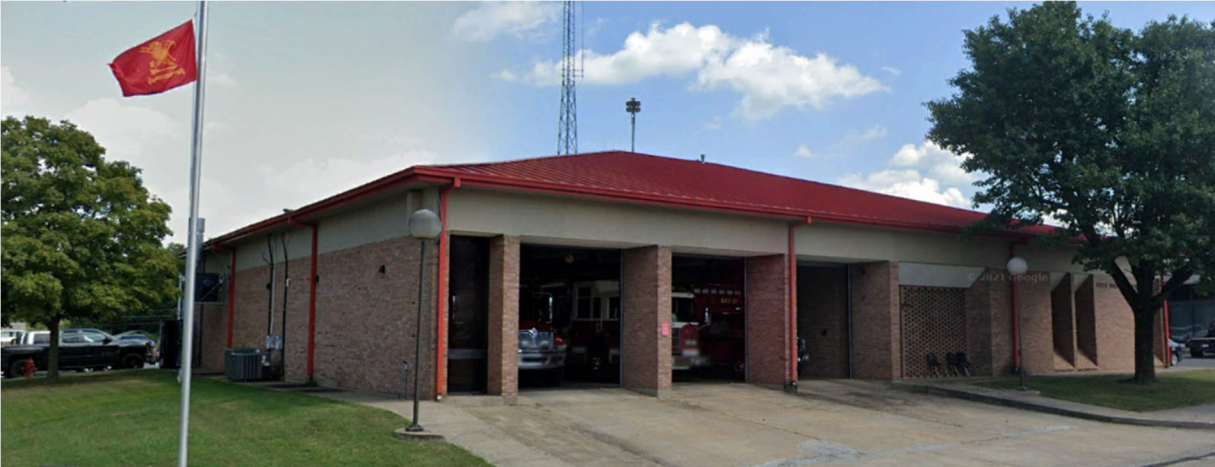
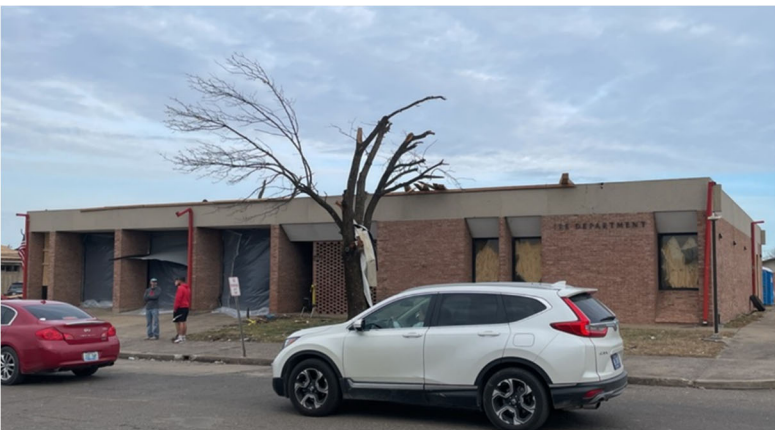
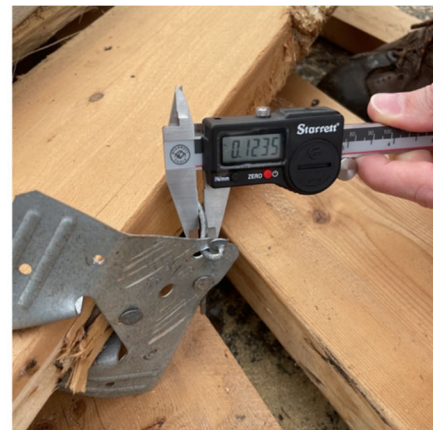
Figure 6.4.3. Mayfield Fire Department Station 1 at the corner of E. North Street and N. 6th Street in Mayfield (Lat: 36.7424, Long: -88.6342). (Top) Pre-tornado view of the building from Google Streetview; (Bottom Left) post-tornado view of the structure taken by the FAST and (Bottom Right) details of the hurricane clips used to tie the roof structure to the walls captured by the FAST.

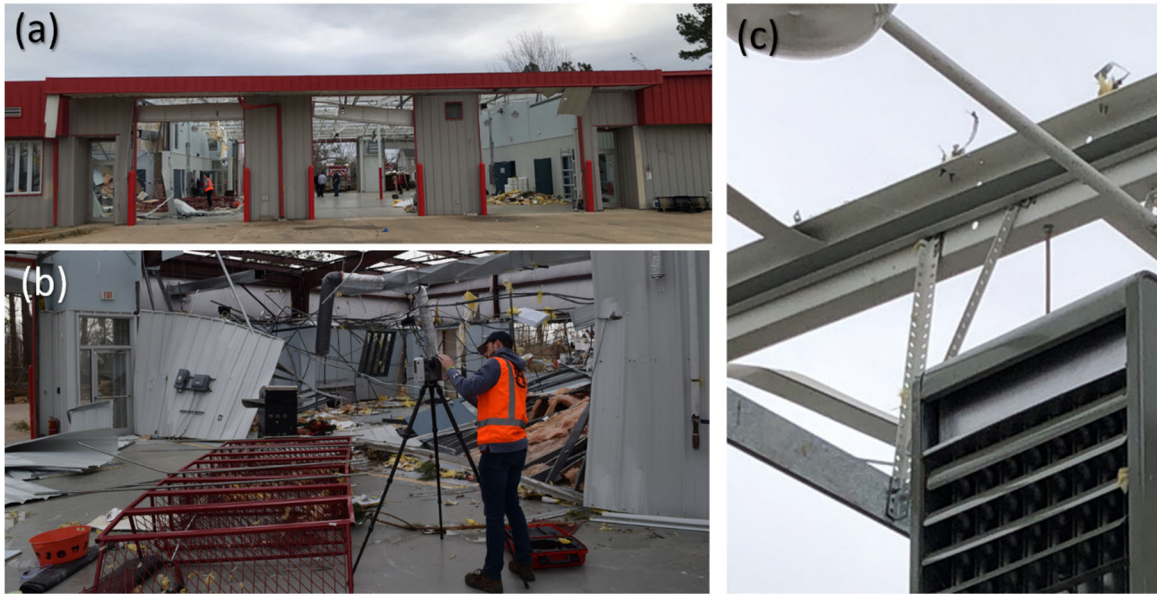
Figure 6.4.4. East Marshall District Station 1 (Lat: 36.9232, Long: -88.2476). (a) Exterior doors were blown in and all roof cladding uplifted; (b) LiDAR scans were collected inside and outside the building; (c) roof panels were attached to the roof structure through flexible ties that were fastened to the top flange of the z-purlins. Failure occurred at the connection between the flexible tie and the roof panel. All images acquired by the FAST.

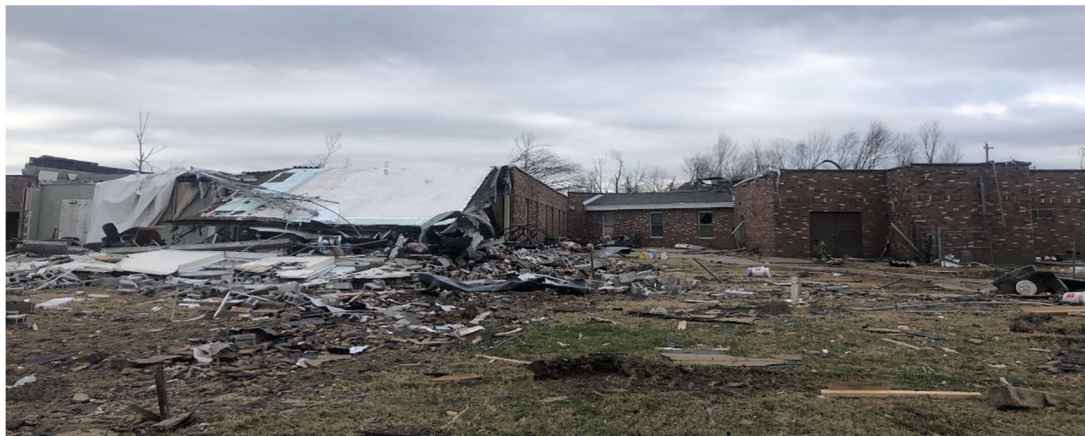
Figure 6.4.6. Damage to one wing of the Mayfield Health and Rehabilitation Center (Image acquired by the FAST).

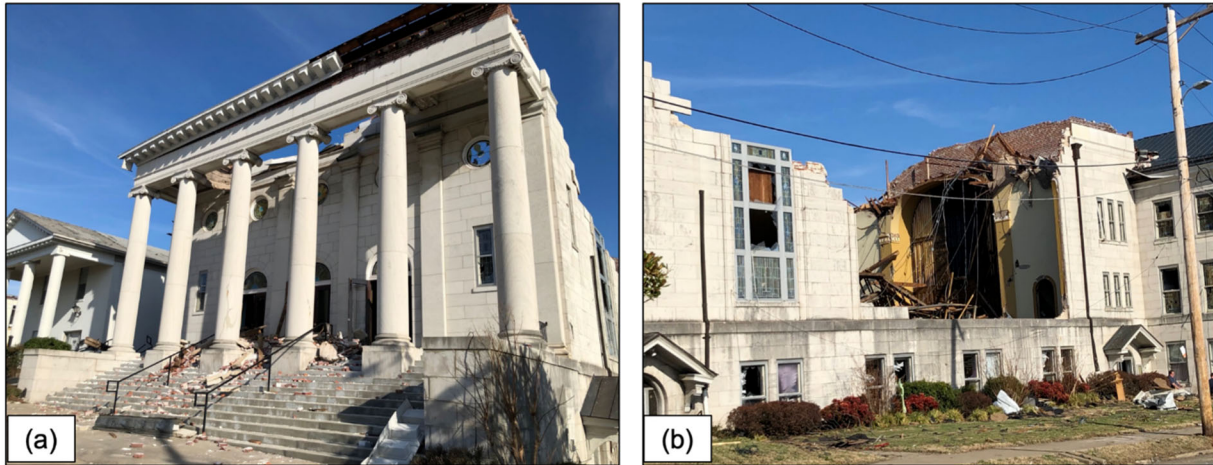
Figure 6.5.2. Damage to First United Methodist Church (Lat: 36.7399, Long: -88.6366) in Mayfield, KY. Images acquired by the FAST.

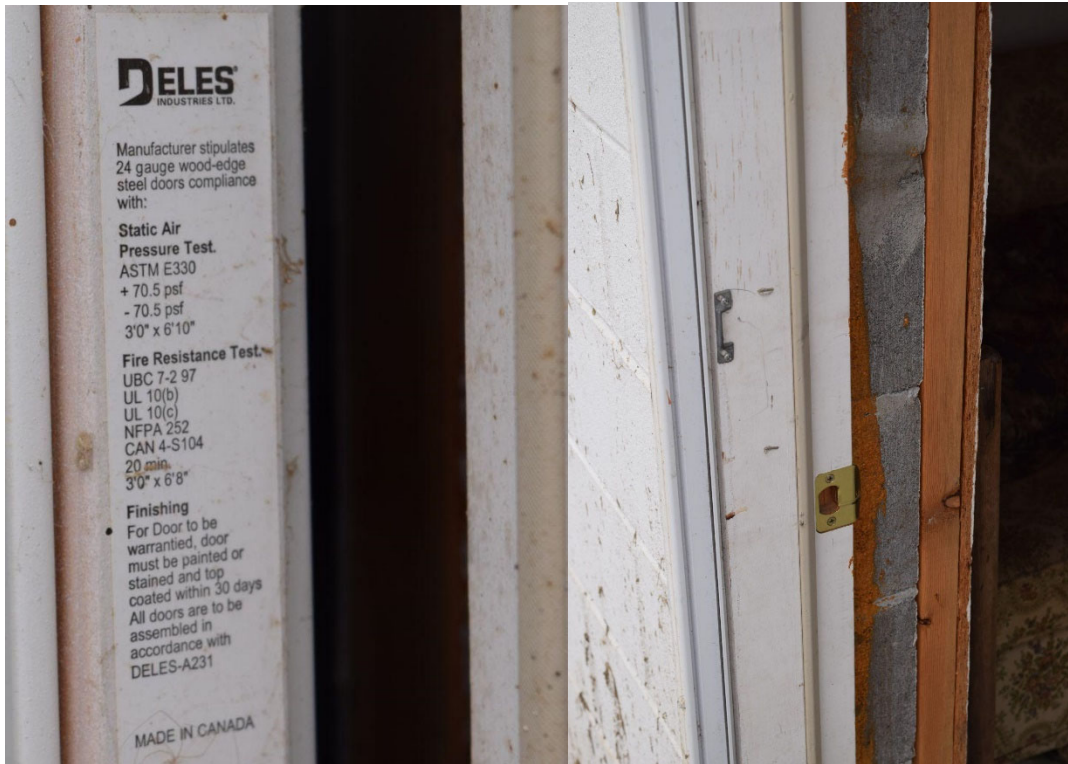
Figure 6.6.2. Door and hardware for the “home-built” shelter in Bremen shown in Figure 6.6.1(a) (Photos acquired by the FAST).

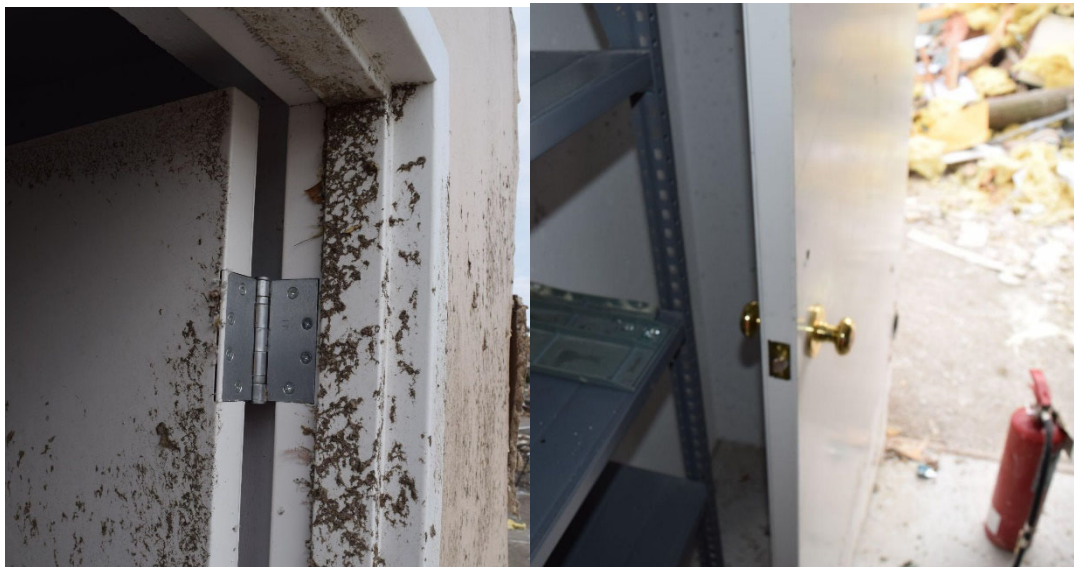
Figure 6.6.3. Door hardware for safe room in attorney’s office building shown in Figure 6.6.1(b) (Photos acquired by the FAST).

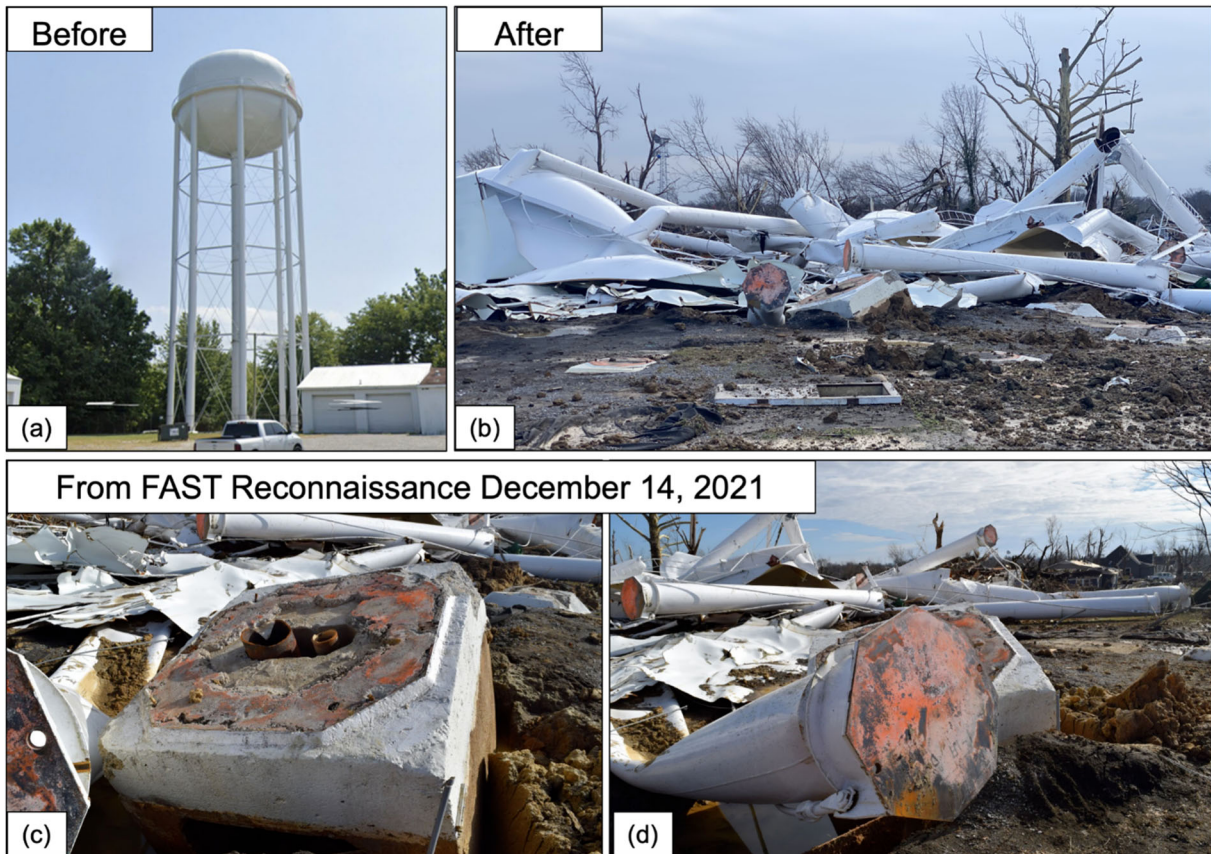
Figure 7.2.1. (a) Water tower in Mayfield (Lat: 36.7389, Long:-88.6425): (a) before and (b) after 10 December tornado (source: Chris Jackson on [Twitter](#)) with a closer evaluation of footings during the FAST assessment (c & d).

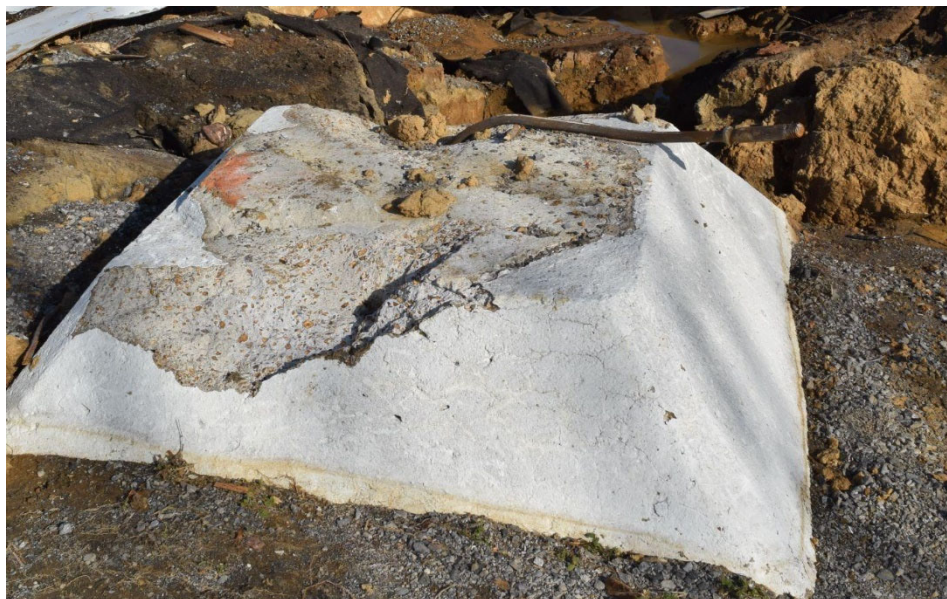
Figure 7.2.2. Shearing of one anchoring rod and pullout of another at one of the eight support footings for the Mayfield water tower (Image acquired by the FAST).
