EVENT BRIEFING		
	Event:	15 January 2021, Mamuju-Majene Earthquake, West Sulawesi	
	Region:	Indonesia	
Authors:	Selim Günay, University of California Berkeley Wael M. Hassan, University of Alaska Anchorage Eduardo Miranda, Stanford University Ian Robertson, University of Hawaii at Manoa Hartanto Wibowo, Iowa State University		
Editors:	Tracy Kijewski-Correa, University of Notre Dame		
DesignSafe Project #	PRJ-3015	Release Date:	18 January 2021

15 January 2021 Mamuju-Majene Earthquake

Sulawesi, Indonesia | Released 18 January 2021

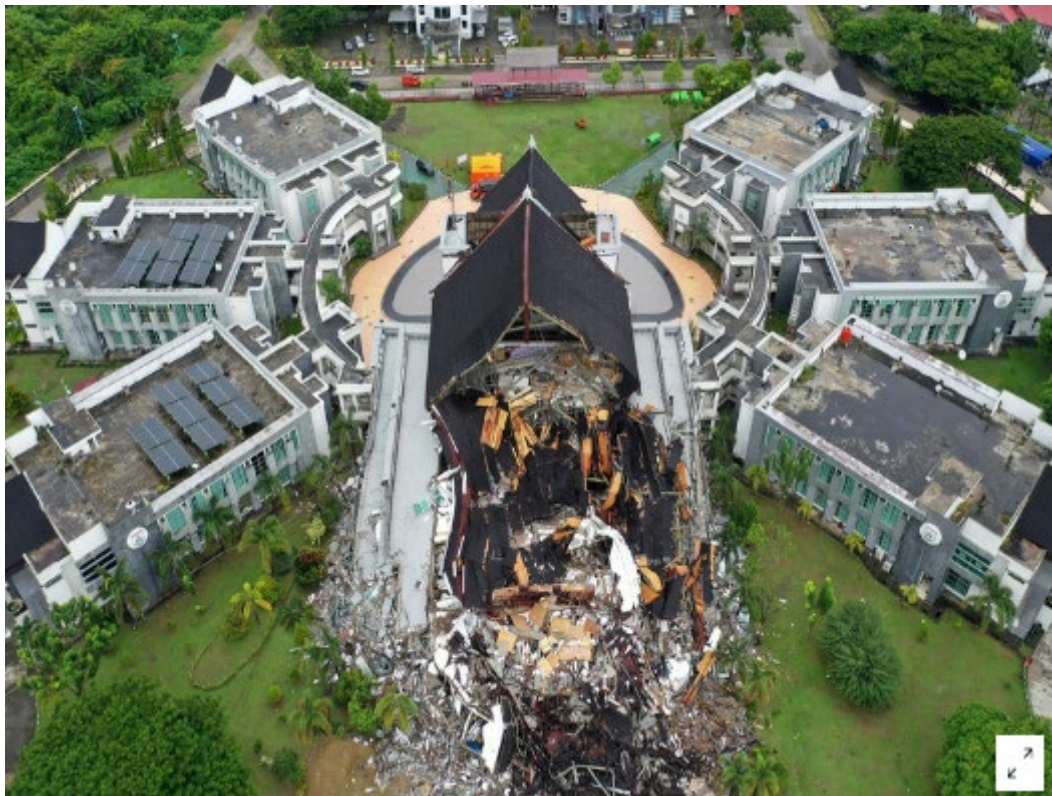
Partially collapsed West Sulawesi Governor's office in Mamuju, Sulawesi, Indonesia

- ❑ Collapse of the West Sulawesi Governor's office building, a government structure constructed in 2010 in Mamuju, may indicate a need for revisiting the definition of seismic hazard and the currently employed seismic design methods and construction practices in Indonesia.

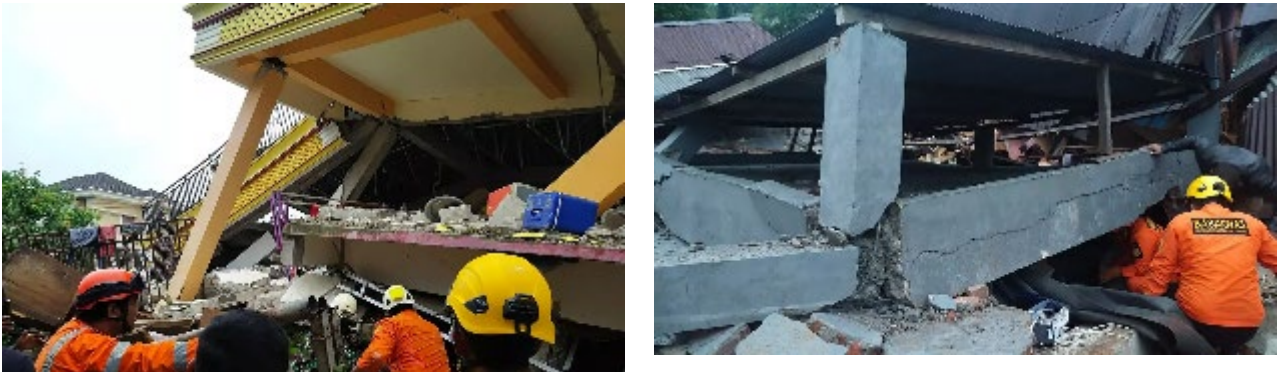
- ❑ Several photographs capturing intact columns and beams with damaged joints of collapsed buildings suggest that beam-column joint failures initiated some of these collapses.

Collapses of reinforced concrete (RC) residential buildings were especially prominent in this earthquake. It is noted that most low-rise residential buildings in Indonesia are made of reinforced concrete (RC), but many are non-engineered. Examples of typical global collapse and component failures are provided in Figures 3.1-3.2. It is apparent that the collapsed buildings are in the category of non-ductile RC buildings, lacking seismic details such as proper confinement in the plastic hinge regions, lack of transverse reinforcement in the beam-column joints, weak columns supporting strong beams, plain reinforcing bars (see Fig. 3.2 top left), etc. Numerous buildings suffered failures because of significant damage at the beam-column connections. Several photos capturing intact columns and beams of collapsed buildings suggest that beam-column joint axial failures initiated the collapse; which is particularly susceptible with joints having large beam to column depth ratios, (Fig. 3.1 right), and is consistent with experimental evidence of joint axial failures (Hassan 2011).

Figure 3.1 Photos of collapsed buildings suggesting the initiation of collapse from failed beam-column joints (Indiatimes, 2021).

4. The seismic resistance of reinforced concrete structures, particularly non-ductile concrete structures without seismic details, should be carefully assessed in light of the regional seismic hazard in Indonesia. Concrete buildings where beam depth is larger than 1.5 times column depth and lacking proper transverse reinforcement in beam-column joints are susceptible to collapse in even moderate shaking. Several buildings are believed to have collapsed during this event due to shear/axial failure of insufficiently reinforced concrete beam-column joints. Experimental and strength models of seismic vulnerability of such joints experiencing axial failure leading to collapse are presented in (Hassan and Moehle 2012 a, b).

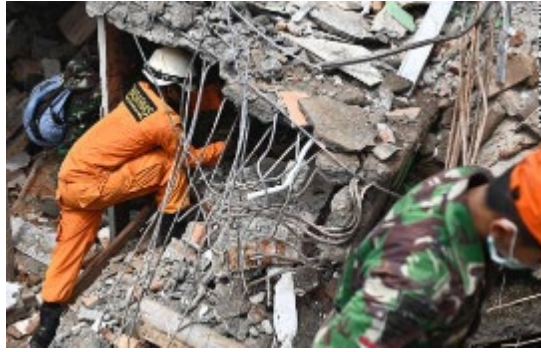
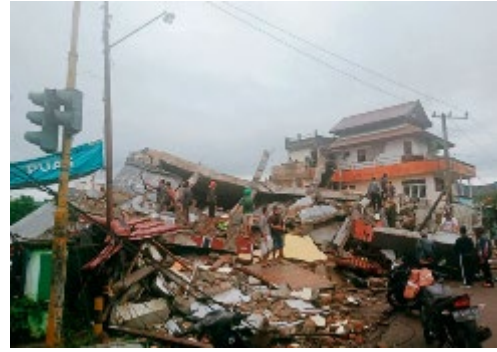
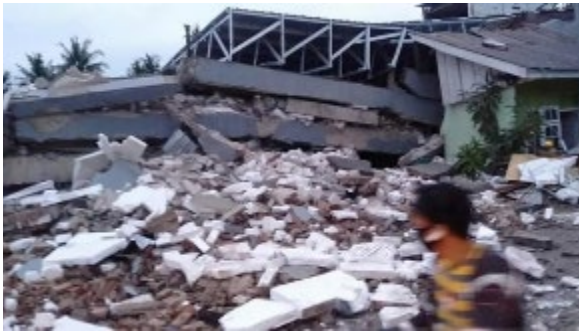
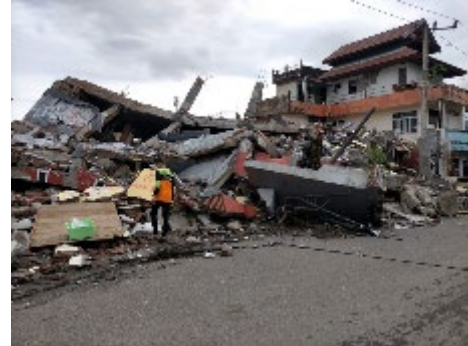
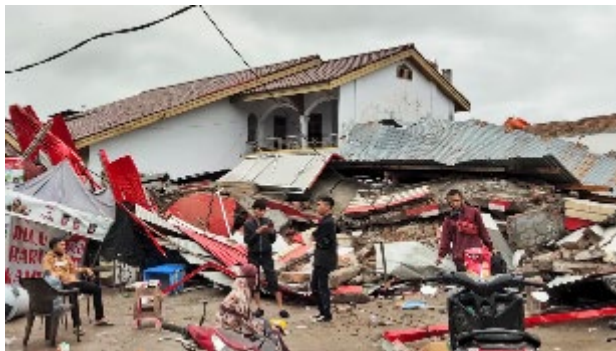
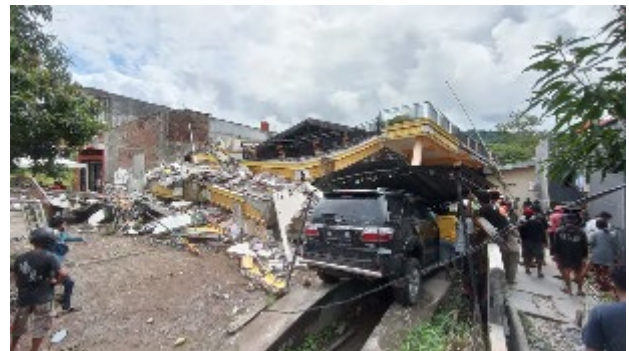
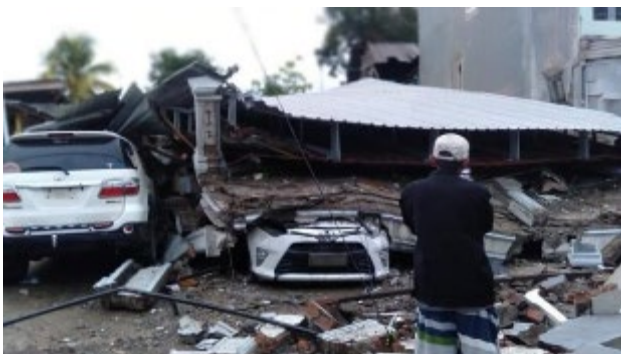
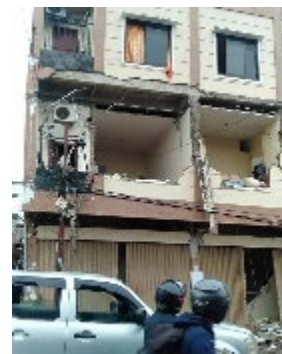
The bottom right photo in Fig. 3.2 shows failed exterior walls of a residential building. The failures occurring at a mid-story point to the role of in-plane (IP) and out-of-plane (OOP) interaction in these failures. This type of mid-story infill wall failures has also been observed in other previous earthquakes (Mosalam and Günay, 2015).

Figure 3.2 Images of collapsed RC residential buildings and one with a failed exterior wall (lower right) located in Mamuju (Sources: CNN 2021b, GettyImages 2021, AP 2021, AP Photo/Rudy Akdyaksyah, Kumparan, 2021, <https://pbs.twimg.com/media/Er1PSQuU0AIPcnw.jpg>).

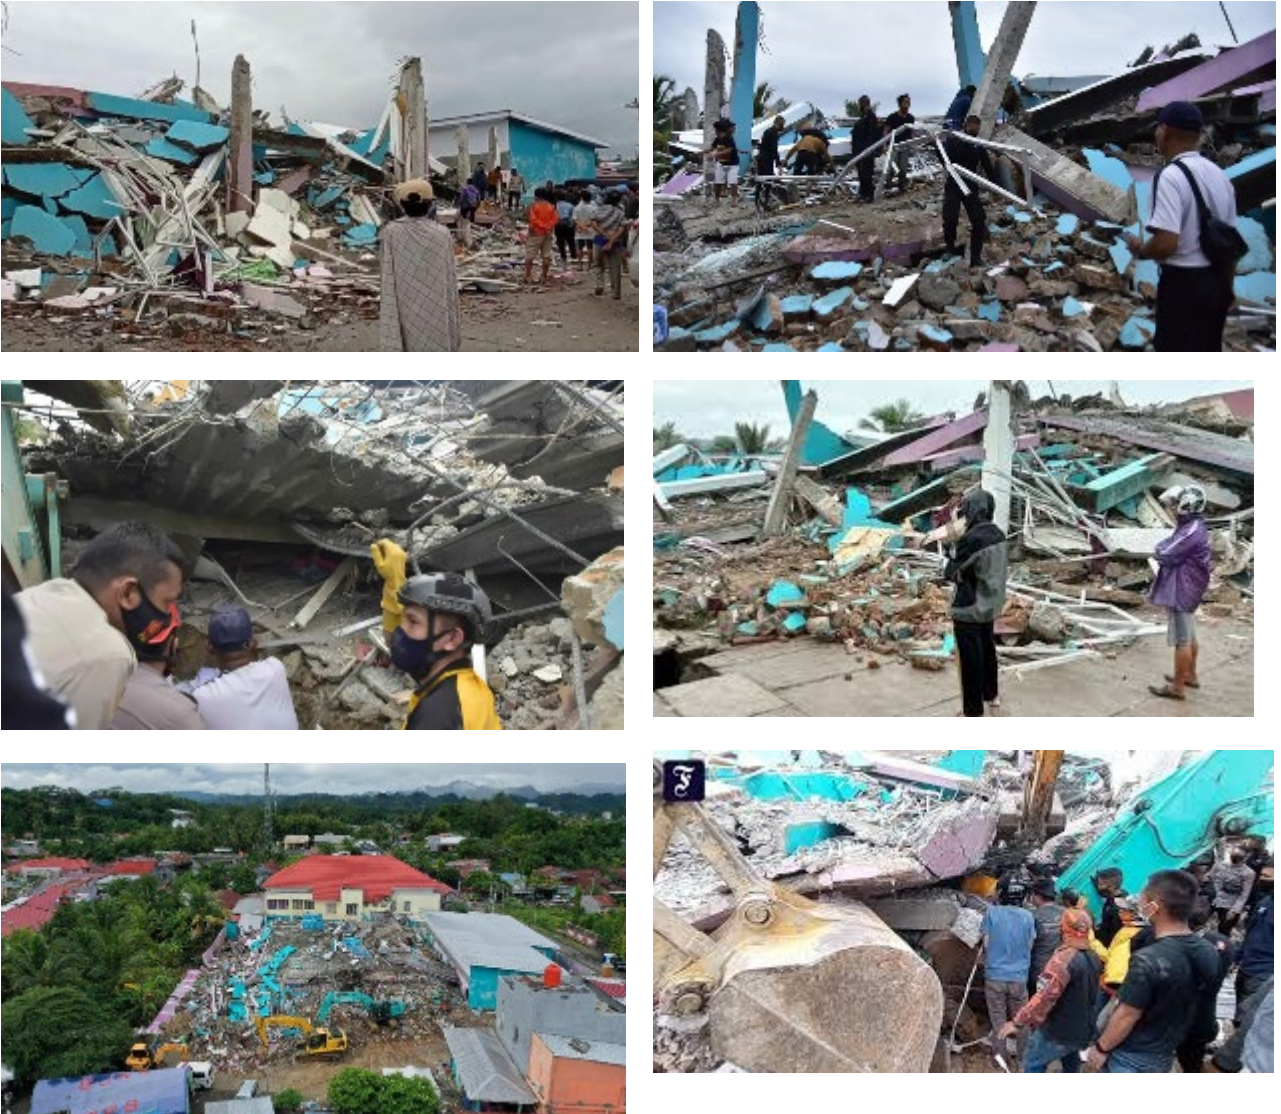
Collapse of and heavy damage to several critical buildings have been reported in the city of Mamuju. The five-story Mitra Manakarra Hospital (Fig. 3.3) collapsed and trapped a number of people inside. Several images of collapse suggest non-ductile concrete details of the Hospital (Fig. 3.4). Similar to the residential buildings described in the previous section, intact columns in the photos in Figure 3.4 indicate that beam-column joint failures might have led to the building collapse. However, more details are required to determine the actual collapse mechanism.

Complete collapse of a hospital structure during an earthquake is a clearly undesirable failure, jeopardizing those in the hospital as well as those injured in the community, for whom this hospital is no longer available. The details behind this collapse should be studied to learn whether there are similar deficiencies in other hospitals in the region and elsewhere in Indonesia. Retrofit of similarly susceptible structures, especially hospitals and school buildings, should be a priority to avoid similar consequences during future earthquakes.

Figure 3.4 Collapsed Mitra Manakarra Hospital in Mamuju (Sources: Reuters, 2021; Weather, 2021; Gettyimages, 2021; Antara, 2021)

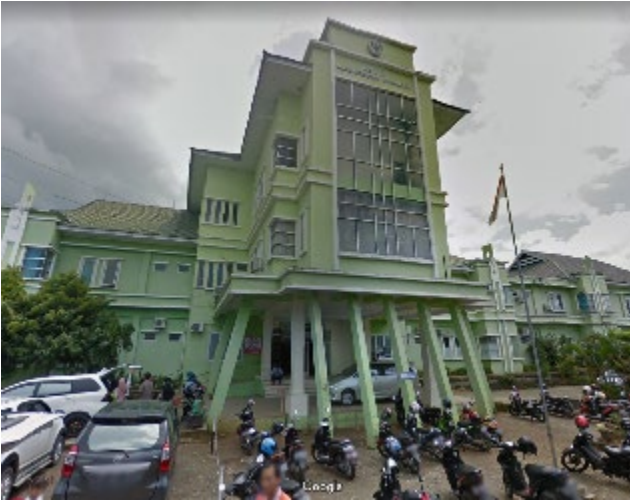
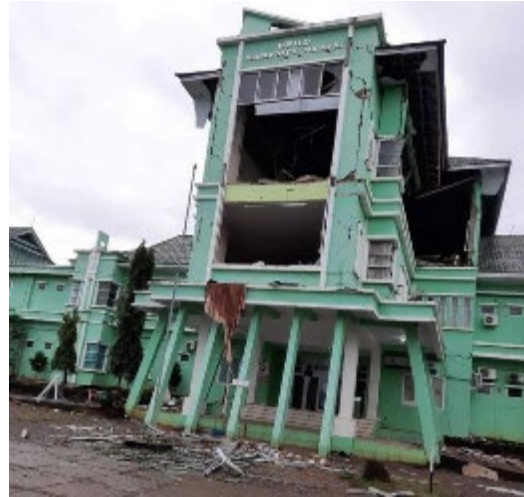
Another government hospital in Mamuju was heavily damaged (Fig. 3.5), with most of the damage in unreinforced masonry walls and the glass facade. A community health center also sustained damage (Reliefweb, 2021).

Figure 3.5 Glass façade and unreinforced masonry walls of a district hospital in Mamuju (2.685S, 118.889E) intact before the earthquake (left) and broken after the earthquake (right) (Sources: Left: Google Street view; Right: <https://suryakepri.com/2021/01/16/update-jumlah-korban-gempa-majene-bertambah-jadi-42-orang-meninggal-dunia/>).

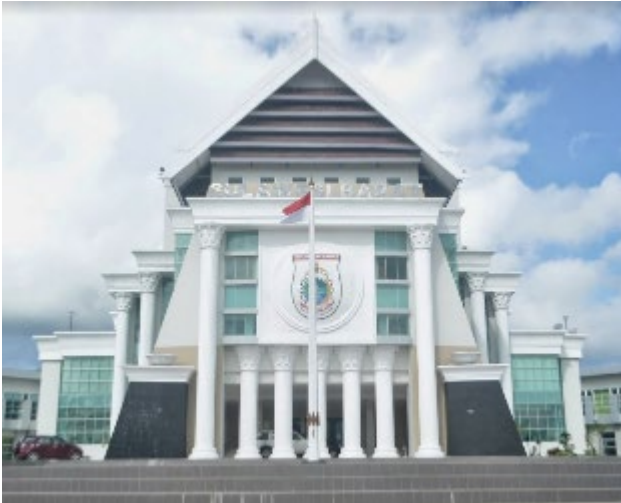
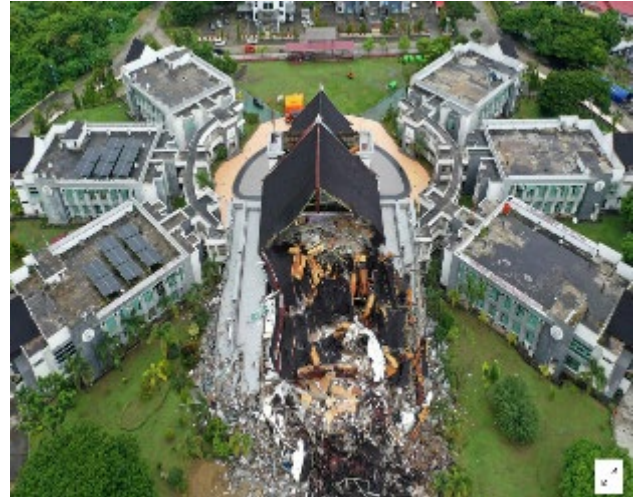
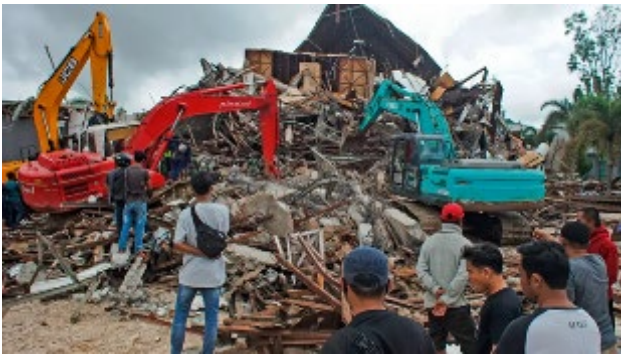
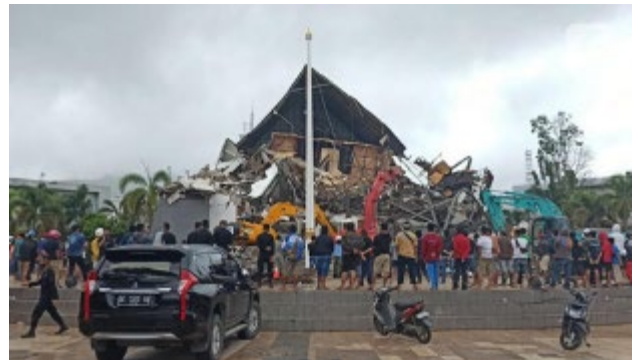
Another notable collapse was observed at the West Sulawesi Governor's office (Fig. 3.6). The building was built in 2010 (Rakyat Demokrasi, 2021) and has many concrete pillars/columns. Two people were reportedly trapped underneath the collapsed structure (Berita Nasional, 2021). It is difficult to draw conclusions about the observed collapse without much information about the details of the building geometry and material characteristics; however, the relatively heavy roof and/or potential weak first or second stories might have contributed to the collapse. Because of the differences in plan, number of stories and framing system, the natural periods of vibration of this building would be different from those of the six adjacent buildings that remained intact. If the dominant frequency of the ground motion were closer to one of the periods of the Governor's office, that could have led to collapse, while the neighboring buildings remained intact. Other government buildings were also reported as collapsed in Mamuju (Fig. 3.7-3.9). Based on the presence of the observed openings, the first story of the local Power Utility Office building in Fig. 3.8 is a potential soft story by visual inspection, however there is not significant damage in this story, the reasons of which may be worth exploring with further numerical simulations.

Figure 3.6 Collapsed Office of the Governor of West Sulawesi, located 21 miles NNW of the epicenter (2.665S, 118.853E); before the earthquake (top left), aerial image after the earthquake (top right) and surface imagery of search for survivors (bottom left, right) (Sources: Google Earth Images, 2021; Reuters, 2021).

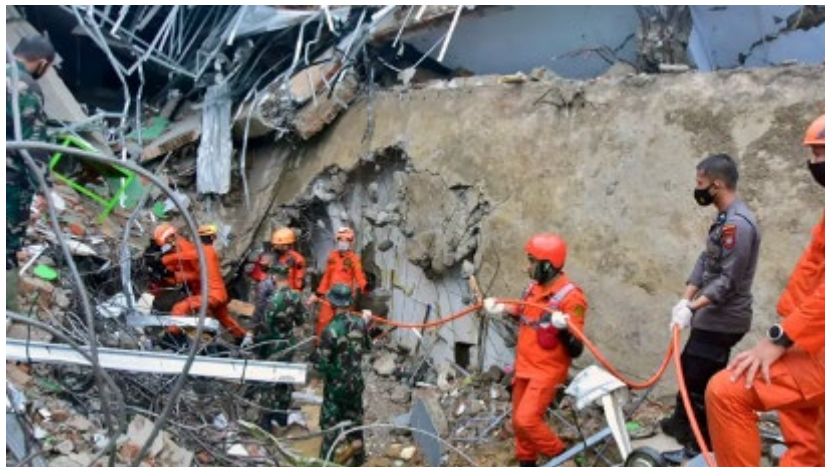
Figure 3.7 A collapsed government building in Mamuju (Source: AP Photo/Daus Thobelulu).

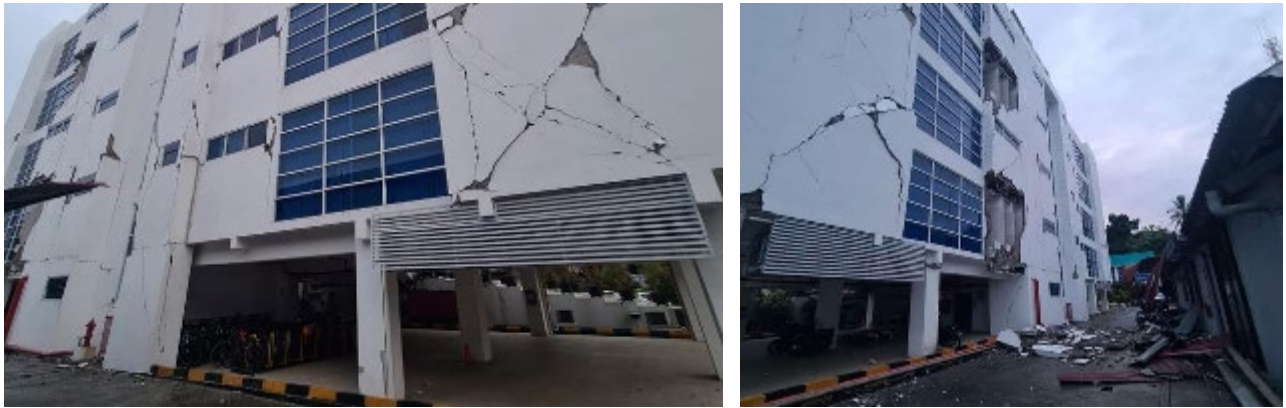
Figure 3.8 Local Power Utility Office built in 2017 with significant facade damage. (2.6771S, 118.895E) (Source: PLN/State Electricity Company Documentation, via detikNews, 2021)

5. Reasons for the relatively good performance of the Mamuju local power utility office building with a seemingly soft story (Fig. 3.8) can be further explored with numerical simulations.

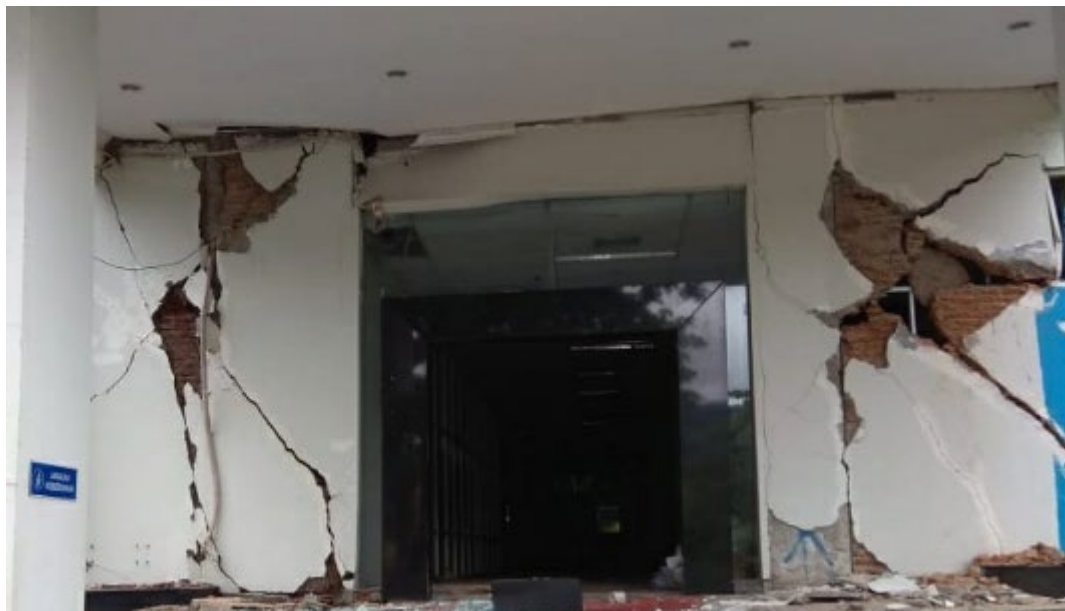
Damage experienced by the frame members and infill walls of the Mamuju Tax Office is shown in Fig. 3.9. The infill wall on the right experienced a complex damage mechanism, probably due the presence of openings. The infill wall on the left experienced less damage and the lateral forces transferred from this infill wall to the adjacent column led to the observed shear crack on the column. This is a good example of a strong column / weak beam proportion, where flexural damage is observed at the beam ends with no or less damage observed at the top of the columns. Therefore, the observed damage by the frame members is adequate according to modern seismic codes. However, heavy damage experienced at the beam end is likely to warrant downtime of the building and a closure to occupancy for a certain time due to the required repairs. This observation highlights the need to start considering functionality objectives in seismic design beyond the currently required life safety objective.

Figure 3.9 Damage experienced by the frame members and infill walls of the Mamuju Tax Office (Twitter, 2021a).

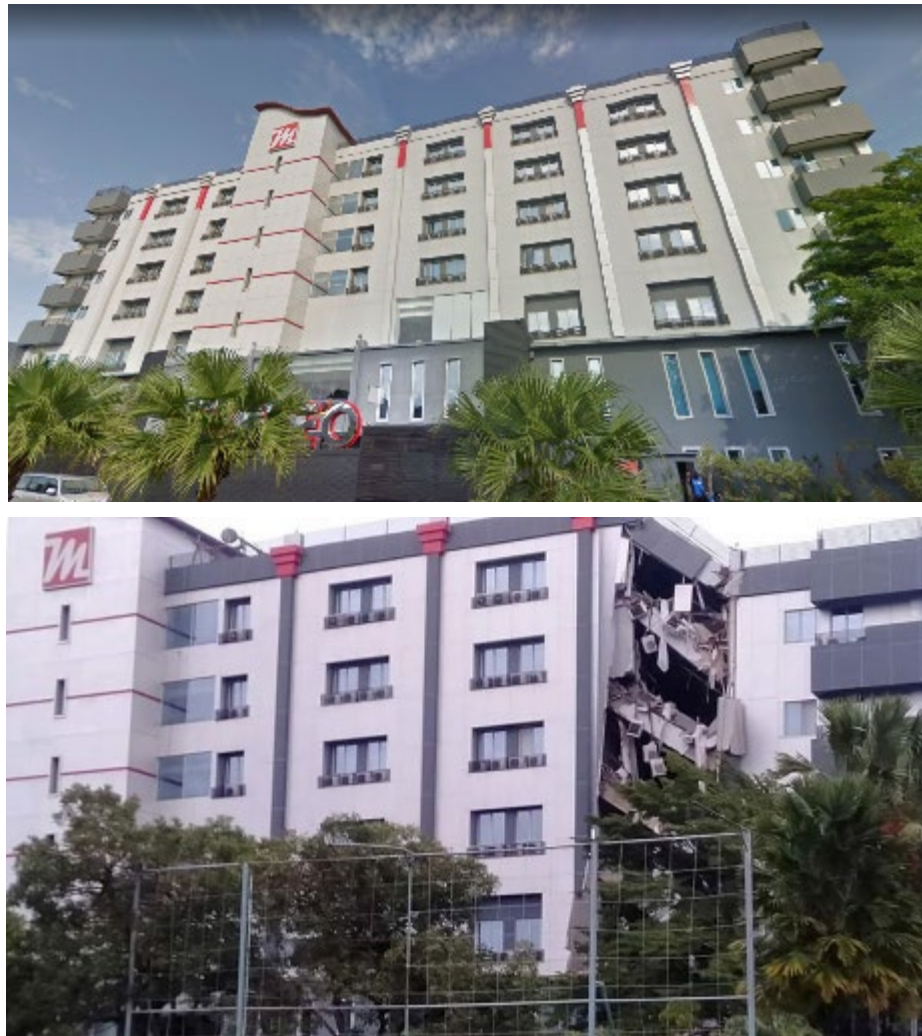
The d'Maleo Hotel (Fig. 3.10) sustained damage in Mamuju (Reliefweb, 2021). Not visible in Fig. 3.10, it is possible that a partial collapse of a story could have taken place on the lowered side of the building. External walls of the Matahari Shopping Center in Mamuju experienced significant damage (Fig. 3.11). Beyond the structural damages reported herein, nonstructural suspended ceiling damage was also documented (Fig. 3.12).

Figure 3.10 Google Street view image (top) and partial collapse (bottom) of the d'Maleo Hotel in Mamuju. (2.6728S, 118.8867E) (Source: Arman/a Majene resident, <https://kumparan.com/paluposo/foto-bangunan-rusak-dampak-gempa-majene-sulawesi-barat-1uysWeg3YSB>)

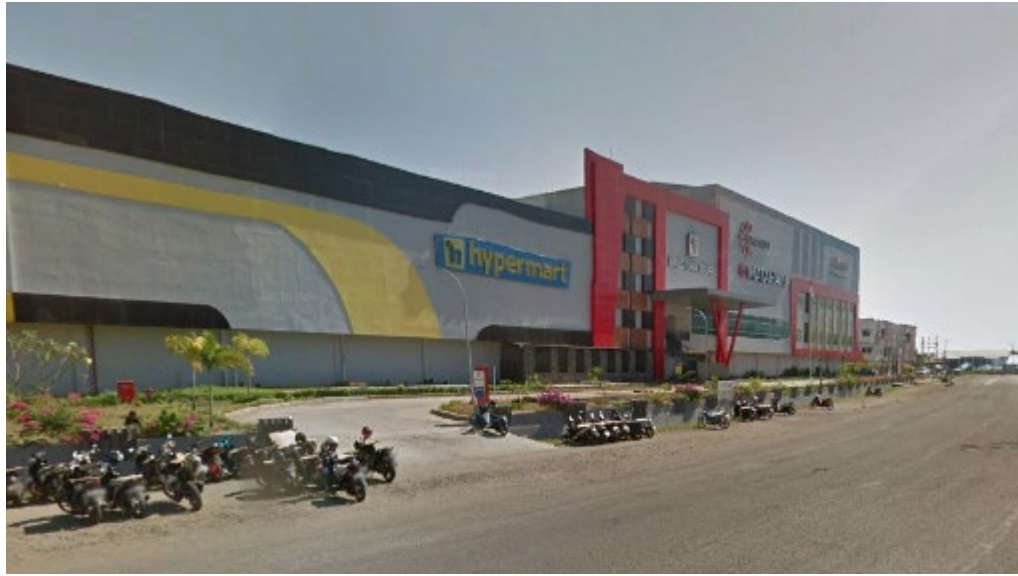
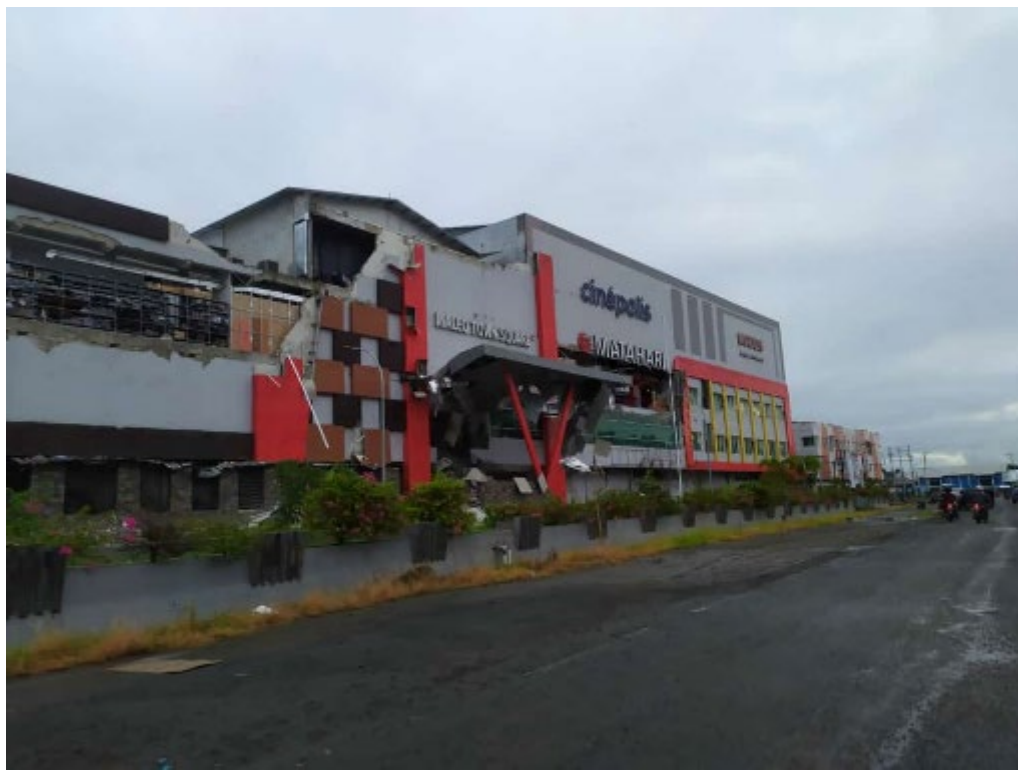
Figure 3.11 Photographs of the Matahari Shopping Center in Mamuju taken from Google Street view (top) and a video frame taken after the earthquake (bottom) (2.6694S, 118.8918E) (Source: https://twitter.com/fad__id/status/1349863151873925120?s=09)

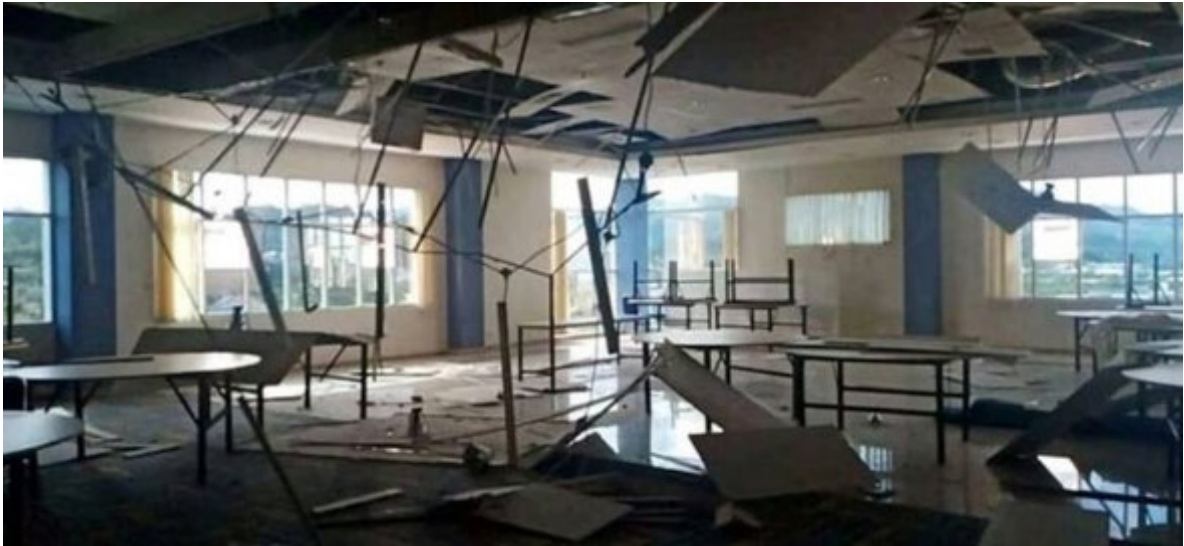
Figure 3.12 Non-structural suspended ceiling damage observed in a building (Reuters, 2021).

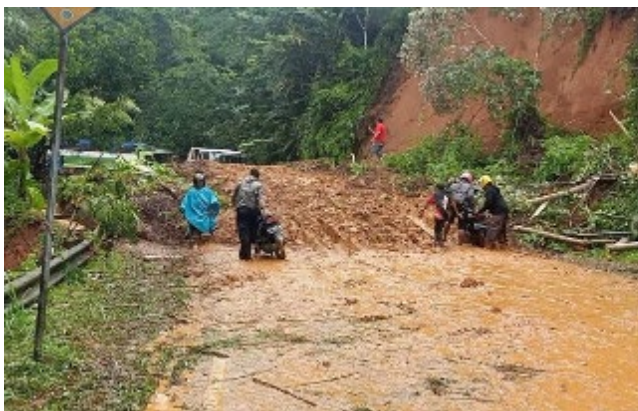
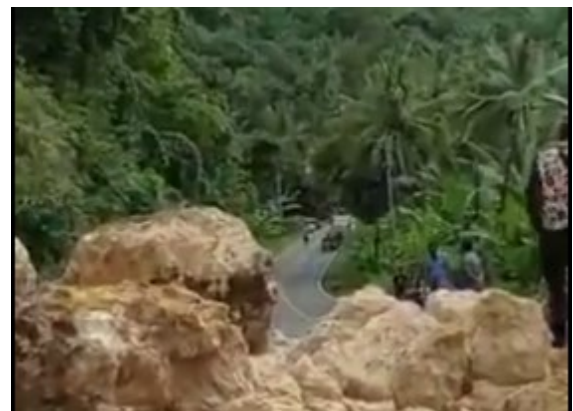
In addition to the extensive building damage, the flight control tower at Mamuju’s commercial airport was damaged. At least one route into Mamuju has been lost due to a damaged bridge; and at least two other roads were damaged (Twitter, 2021b). Indonesia’s disaster agency reported a series of aftershocks that caused at least three landslides, blocking other roads (Twitter, 2021b) (Fig. 3.13). Communications and power infrastructure have been affected leading to disruptions and outages (The Straits Times, 2021). The Indonesian Ministry of Information said that at least 122 BTS (Wireless communication antenna), out of 651 in the region, has lost functionality due to the earthquake (Tempo, 2021). The severity of the BTS damage is still under further investigation, with the possible cause ranging from a power outage to structural damage.

Figure 3.13 Road closures due to landslides (Left source: Liptan.com 2021; Right source: Twitter 2021b)

7. Regional scale simulations (e.g., Xu et al., 2020) should be conducted for identifying critical transportation routes and making it a priority to ensure their post-earthquake functionality or to develop alternative routes.
