# HURRICANE DORIAN

September 1, 2019

NHERI DesignSafe Project ID:  
 PRJ-2555

## EARLY ACCESS RECONNAISSANCE REPORT (EARR)

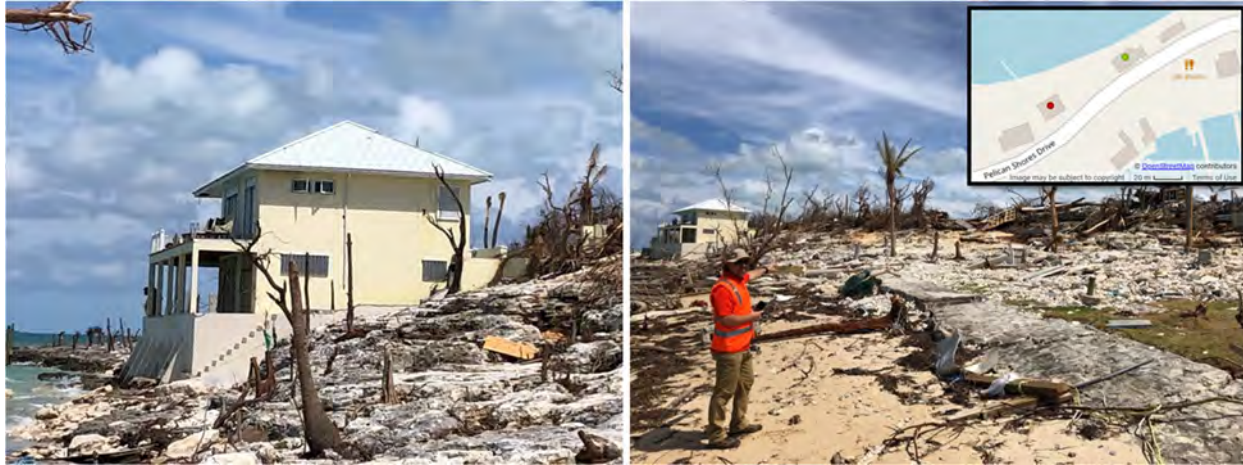
The variation of damage to residential buildings in these areas ranged from total destruction up to the exterior of the building being essentially undamaged. For example, Figure 6.1 contrasts two homes located along Pelican Shores Drive. One home (left) appeared undamaged by Dorian, although significant interior damage due to water infiltration from surge did occur, located on the eastern coast (green dot on the inset map), while the other home (right) was completely destroyed (red dot on the inset map). The home on the left was constructed in 2007 out of concrete masonry, with hurricane shutters over openings and a hipped metal roof, while the home on the right pre-dates 2005 (exact date of construction unknown) and details of its structural load path were not discernible in the debris.

**Figure 6.1.** Contrast between the performance of two homes located along Pelican Shores Drive exposed to the worst of Dorian's wind, storm surge and waves. The home on the left is located at [26.552164, -77.055065], and the home on the right at [26.551852, -77.055599].

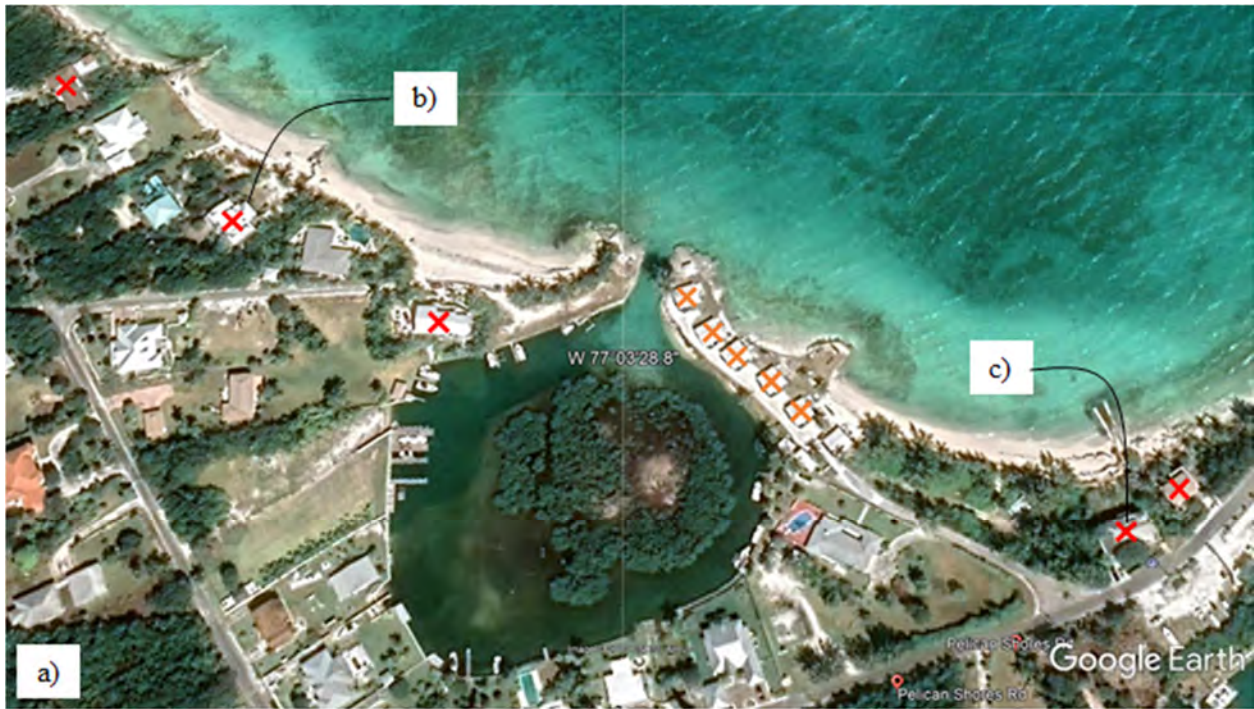
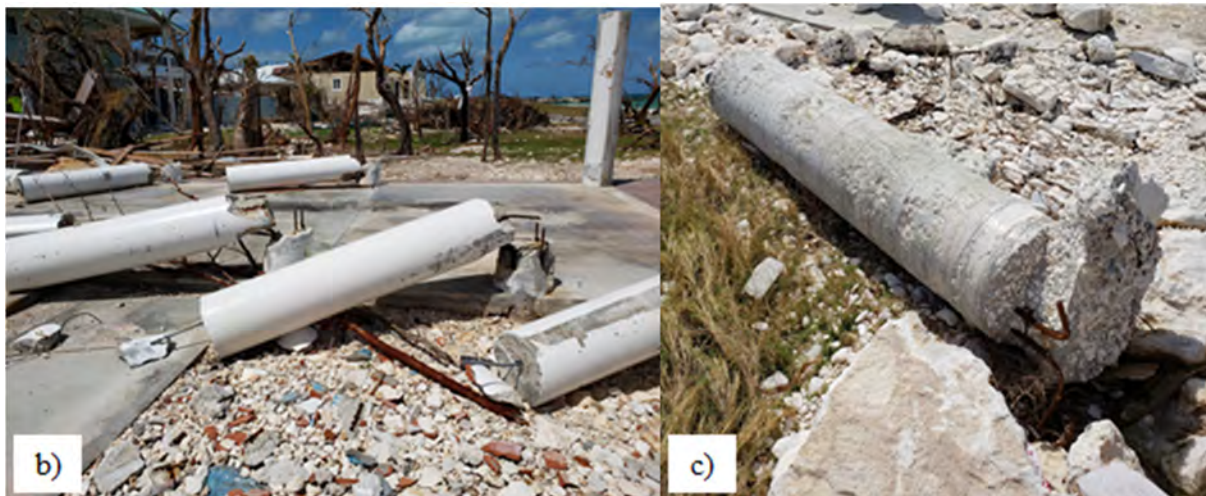
Along Pelican Shores there were a number of homes that were elevated above grade using lightly reinforced concrete columns while others were elevated on masonry walls 3 to 4 ft above grade; still others were slab on grade. The significant wind and surge essentially completely demolished several of these homes. The small cottages that were constructed with slab on grade foundations as indicated in Figure 6.2a by orange markers, had only their foundations remaining. Other structures, marked by red markers, which were elevated at heights from 4 ft up to approximately 8 to 10 ft on concrete columns, were also washed away. Some noteworthy structural observations:

1. the amount of reinforcing steel in the concrete columns was very low (four #4 or #5 longitudinal bars for a 12"-16" diameter column)
2. the foundation and anchorage was insufficient to resist lateral forces
3. only a single anchor bolt attached the structure to the column.

Figure 6.2b and 6.2c show examples of these columns in their final position.

**Figure 6.2.** (a) Google Earth map indicating structures that collapsed due to wind and surge along the coast. The structure on the far left with a red marker is located at [26.55363, -77.06072]. (b) Topped concrete columns showing minimal corroded reinforcement and a single anchor bolt to attach to the supported structure located at [26.44297, -77.05980]. (c) Topped concrete column showing minimal reinforcing and anchorage into a footing located at [26.55174, -77.05588].

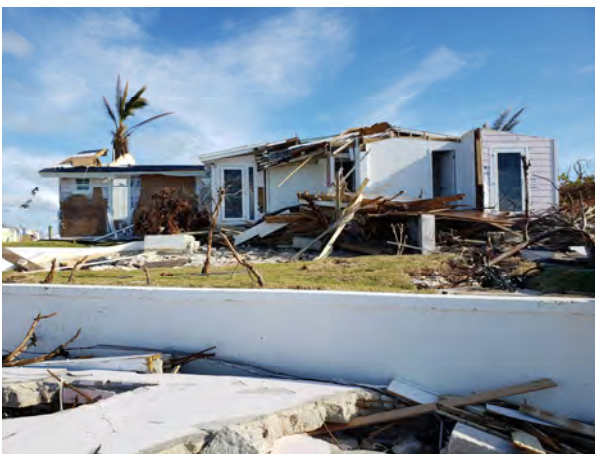
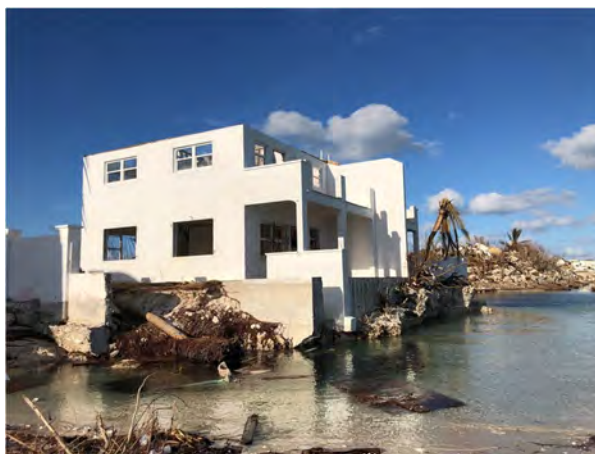
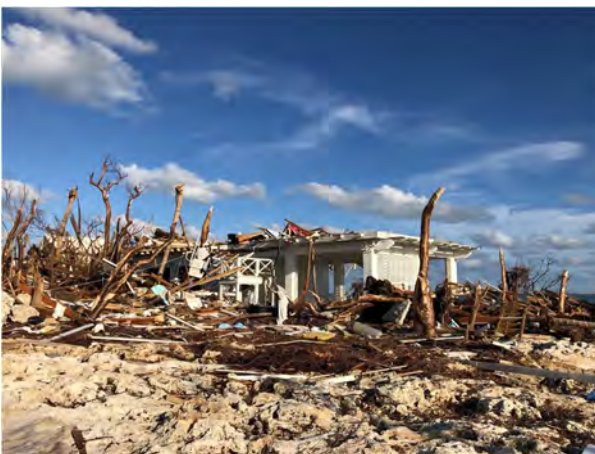
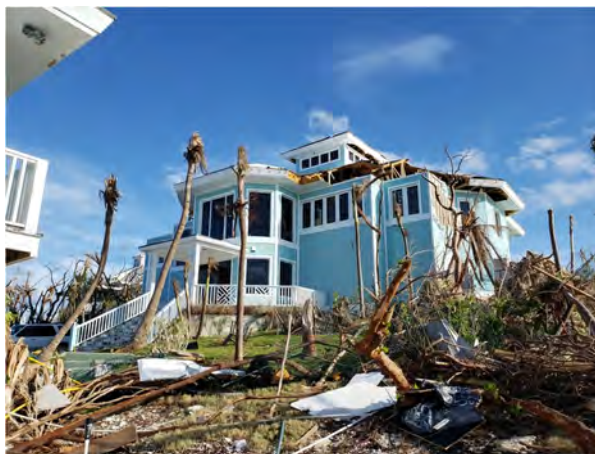
Homes along Eastern Shores Road generally appeared to belong to more affluent households, but the damage that was accessible to the FAST-1 was some of the worst observed in Great Abaco. Due to road washout, the team was not able to extend assessments along the full length of the road, but where they were able to assess, all buildings were at least severely damaged if not completely destroyed. As shown in the PVRR (Kijewski-Correa et al. 2019), there were some homes in the far eastern portions that did perform well based on exterior views. Figure 6.3 shows a sample of typical single-family residential performance along the accessible portions of Eastern Shores Road. Some of the structures that were totally destroyed but were constructed with concrete had very light to no reinforcing and minimal connection between the elevated structure and the concrete podium structure below.

**Figure 6.3.** Typical performance of single-family residences along Eastern Shores Drive.

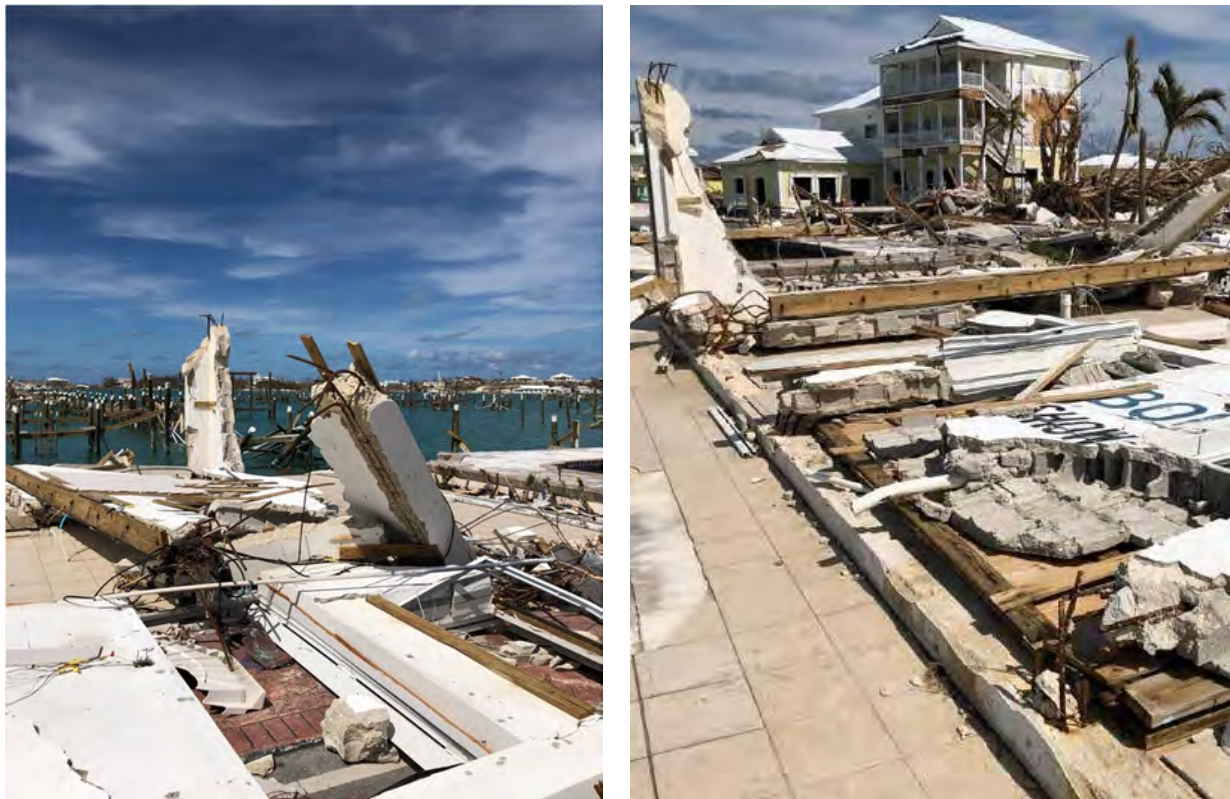
Commercial buildings along the eastern shore of Marsh Harbour (mostly along Bay Street) exposed to high winds, waves and storm surge did not fare well, with most completely destroyed. Figure 6.4 shows the Harbour View Marina, which was completely destroyed. The marina was only reinforced at approximately 7 ft on center, with unreinforced and ungrouted cells in between.

**Figure 6.4.** Destroyed marina in Marsh Harbour constructed with masonry block, unreinforced between grouted, reinforced columns located approximately 7 ft on center.

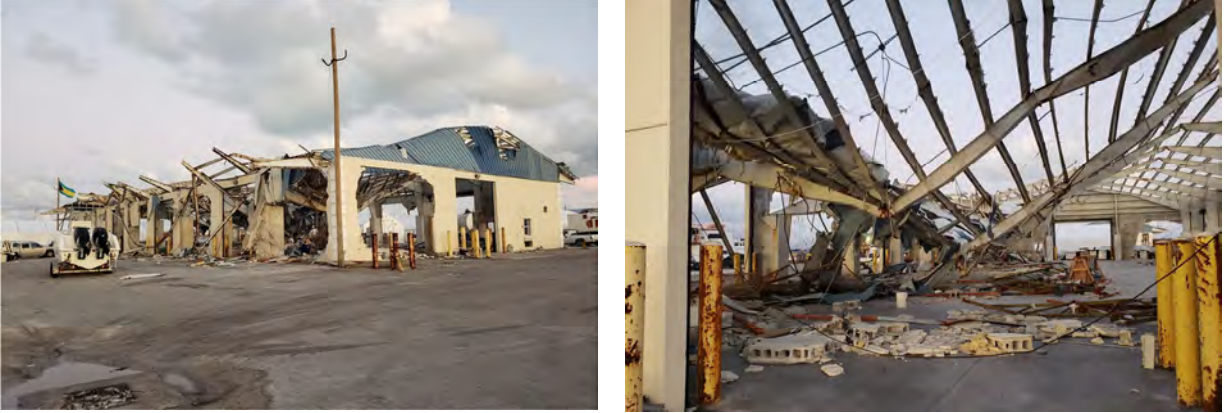
FAST-1 also investigated buildings in the International Port Area, including what appeared to be the main receiving warehouse, a metal building with steel moment frames, X-bracing, unreinforced masonry block in-fill walls and a standing seam metal roof (Fig. 6.5). The building was gutted by the hurricane, with only the structural frame remaining, albeit partially collapsed on the coastward side of the building (north-facing). The building pre-dates 2005 imagery but exact year of construction is unknown. Surface corrosion was visible during the on-site inspection, but it is unlikely that it was a significant performance factor.

**Figure 6.5.** Metal building at the International Port Area destroyed by high winds, waves and storm surge.

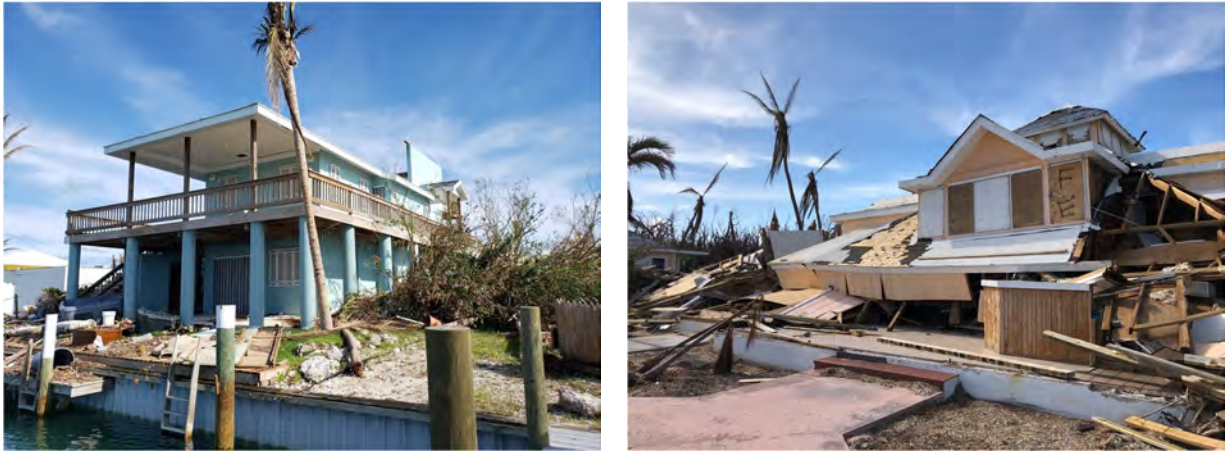
A variety of damage modes were observed in residential buildings. Destroyed homes typically experienced the loss of the roof structure (e.g., Fig. 6.6 (left)) and sometimes also the elevated wood-frame structure, although at least one wood-frame home experienced a failure mode akin to soft story collapse, apparently due to storm surge (Fig. 6.6 (right)). A number of wall-to-foundation failures were noted, despite the presence of anchor bolts, as illustrated in Figure 6.7. FAST-1 observed only isolated instances, if used at all, of metal straps connecting wood stud walls to sill plates, which would have left a critical weak link in the structural load path.

**Figure 6.6.** Severe damage to residential buildings, including loss of roof over top story (left) and collapse of bottom story in wood-frame building (right).

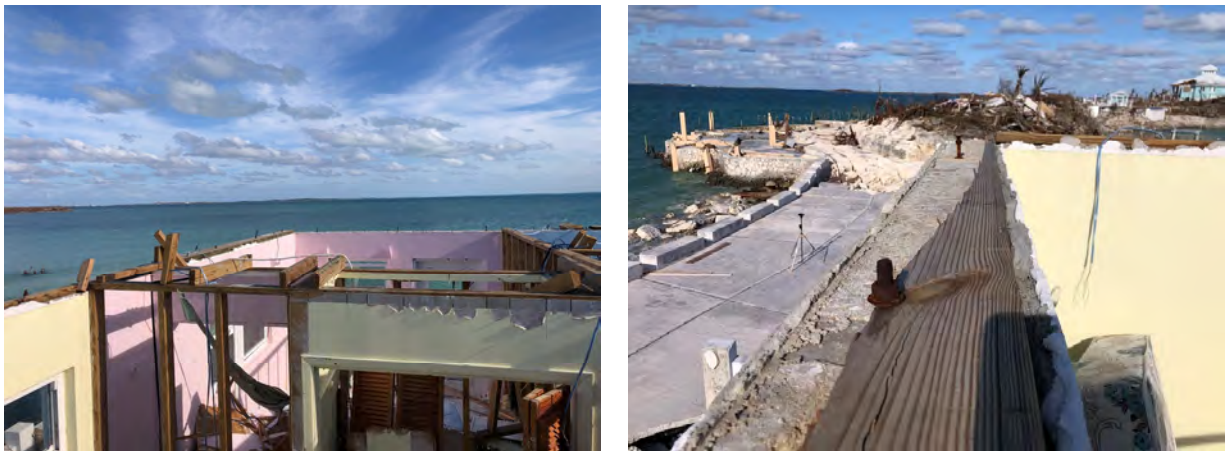
**Figure 6.7.** Typical connections of elevated wood-frame construction atop reinforced masonry ground floor construction. Anchor bolts were commonly observed anchoring the sill plates (shown above) but in failed buildings, straps were not utilized to provide a strong positive connection between the studs and the sill plate.

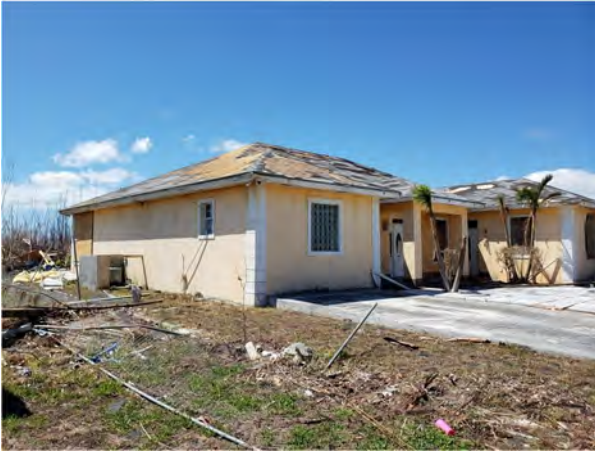
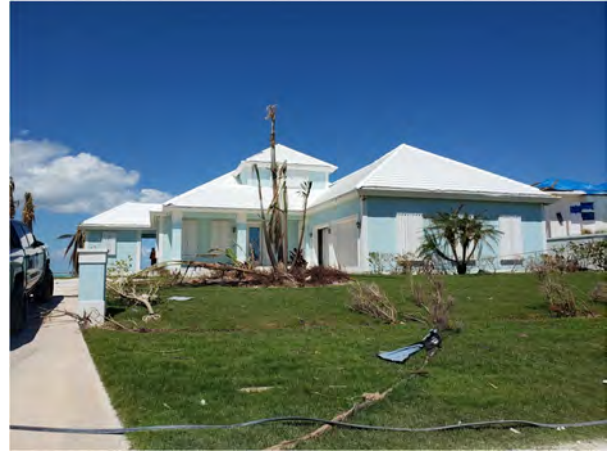
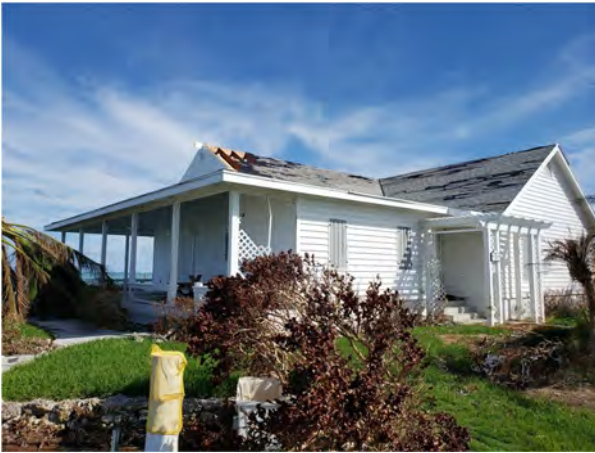
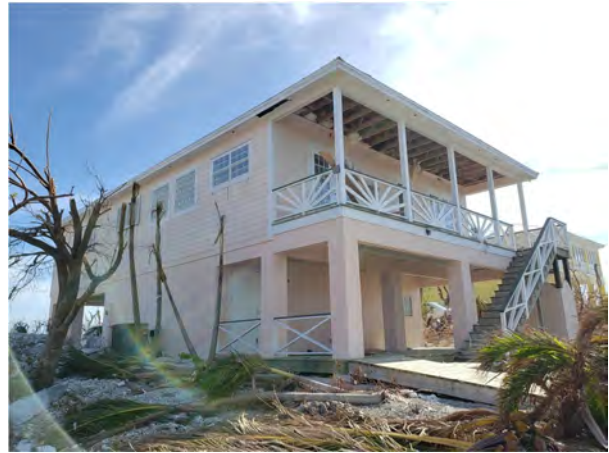
As noted elsewhere, there were a number of residential buildings that performed well structurally, although surge and rainwater ingress likely compromised interiors. Figure 6.8 shows a collection of such well-performing single-family homes in regions subjected to high wind and surge. Note the single story masonry block home (unknown reinforcement) with a hip/gable roof, windows protected by plywood panels, and an asphalt shingle roof that performed reasonably well structurally (Fig. 6.8a). A high water mark here was measured at ~6 ft above ground level. While many of these homes were higher-end construction, at least one, shown in Figure 6.8c, appeared to be a more modest older home, yet survived with just 1.5 roof sheathing panels removed and approximately 40% roof cover loss. The interior damage in this case may result in a total loss, but given the wind speed estimates, and the older style of construction, the lack of structural damage

**Figure 6.8.** Sampling of performance under wind and storm surge across residential construction at various tiers of property value.

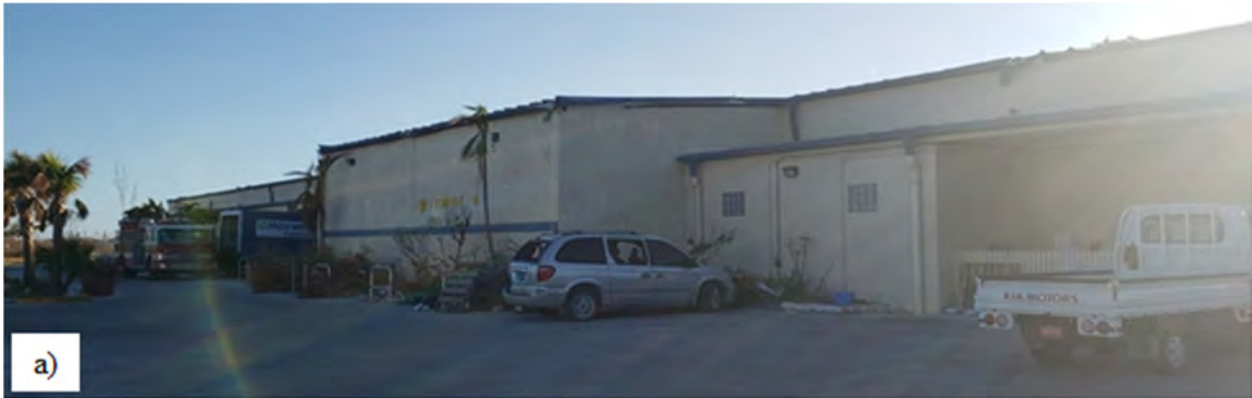
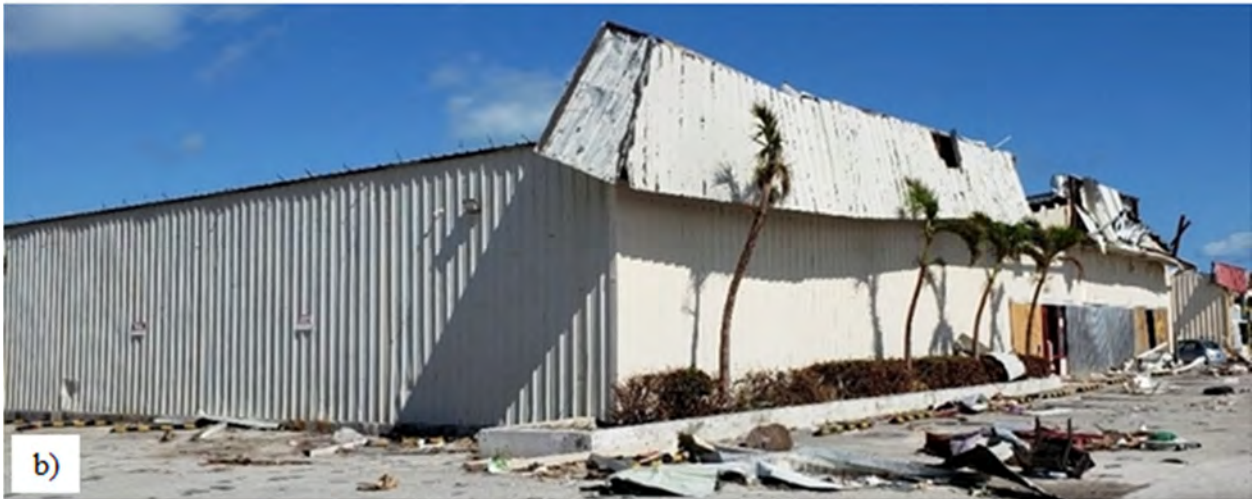
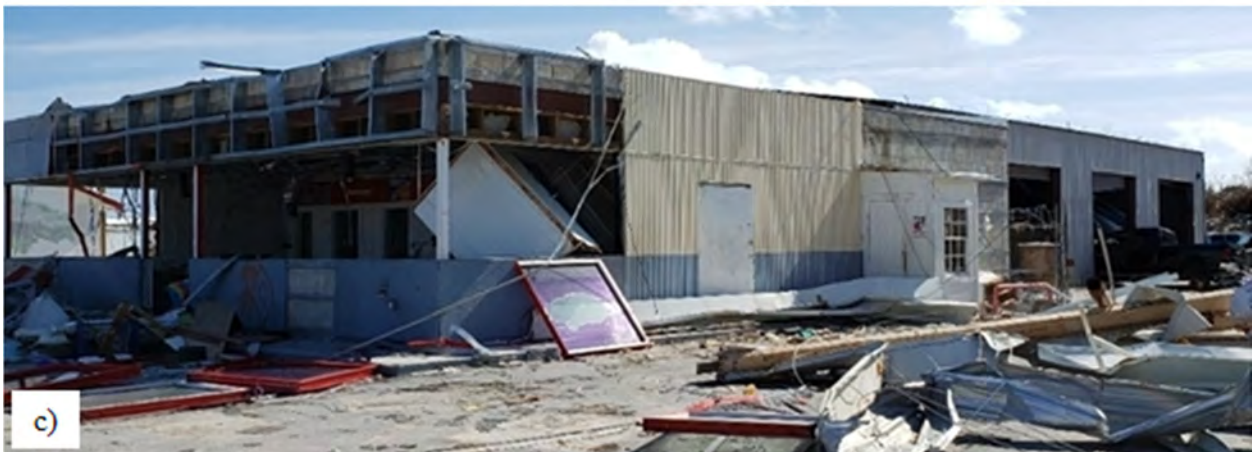
The primary commercial district in Abaco is along Don Mackay Boulevard, which is generally south of the Marsh Harbor Government Port. FAST-1 assessed 10 buildings in the region. The breakdown of damage statistics for this region is shown in Table 6.1. This region was affected by both wind and surge but was far enough inland that the wave action would not have been significant. It was clear from several buildings and boats displaced from the marina that water ingress and flooding occurred. While a clear waterline indication was not found in any of the buildings, FAST-1 estimated that flooding was likely in excess of 5 ft above grade. The one building that was classified with “minor” damage was Maxwell’s grocery store (Fig. 6.9a), which is the main supermarket for Marsh Harbour. It was not operational but the damage was primarily to the building envelope. The solar panels on the roof survived the high winds and according to reports were undamaged. Figure 6.9b shows a metal building (Ace Hardware) that was classified with “moderate” damage, primarily loss of building envelope, which resulted in significant damage

due to water ingress. Figure 6.9c shows a gas station that was classified as destroyed. It is apparent in the photo that the surge caused one of the refrigerators to float from its original position.

**Figure 6.9.** Variation of damage to commercial buildings in Marsh Harbour: (a) Minor damage to Maxwell’s grocery store [26.53773, -77.05638]; (b) Moderate damage to Ace Hardware (metal building) which also showed significant water ingress damage [26.536398, -77.06132]; (c) Destroyed gas station with evidence of significant flooding due to the refrigerator that has been lifted and moved [26.53677, -77.06014]

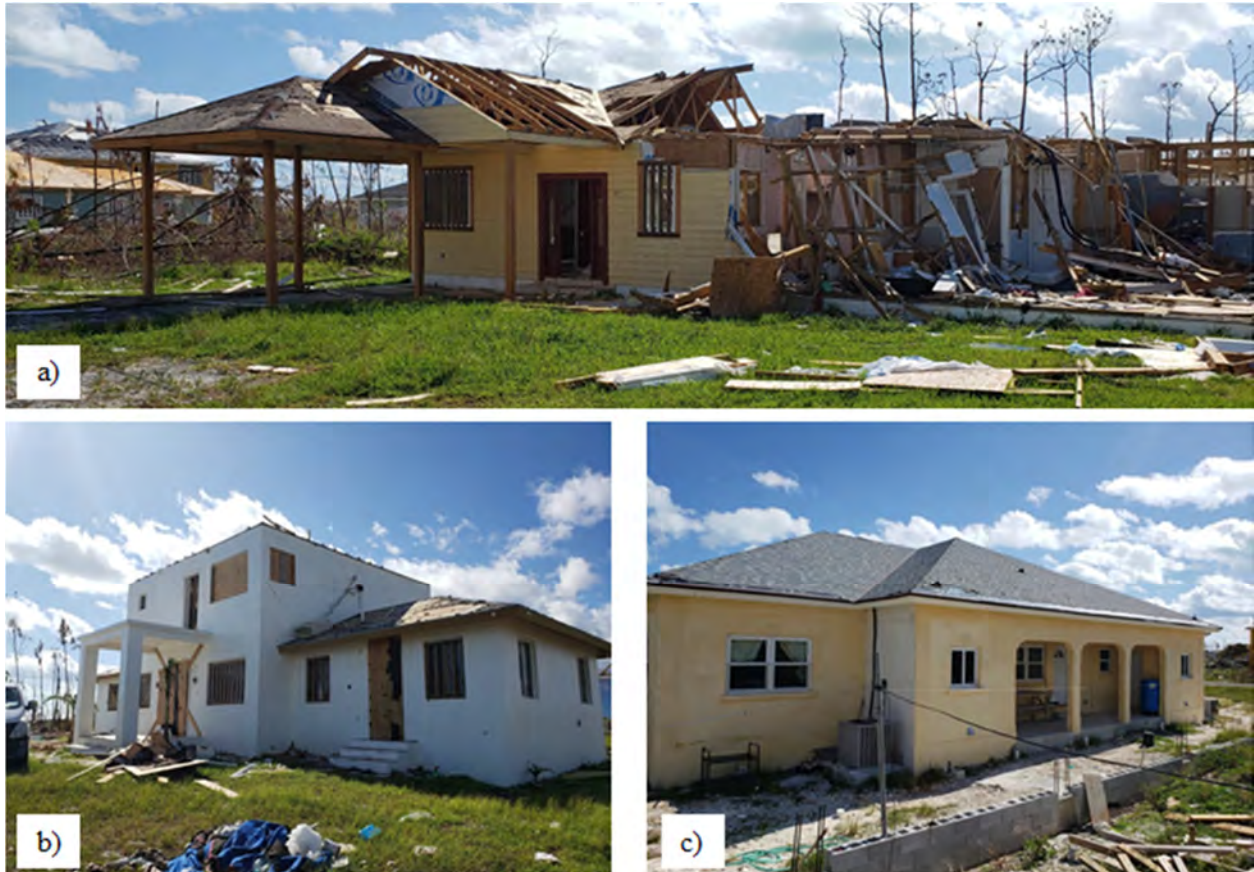
Figure 6.11 shows examples of the variation in damage states in the Central Pines neighborhood. Figure 6.11a shows a “Destroyed” wood-frame home that was built between 2007 and 2012. Figure 6.11b shows a home that was built around 2005 with severe damage due to a partial loss of the roof structure over the two-story portion of the home. Figure 6.11c shows a residence that experienced only minor damage. This was the newest of the three structures based on historical imagery that suggests it was constructed in 2018.

**Figure 6.11.** (a) Example of “Destroyed” wood-frame residence in Central Pines [26.53908, -77.08815]; (b) Example of “Severe” damage in Central Pines [26.53713,-77.08815]; (c) Example of “Minor” damage in Central Pines [26.63991, -77.08816].

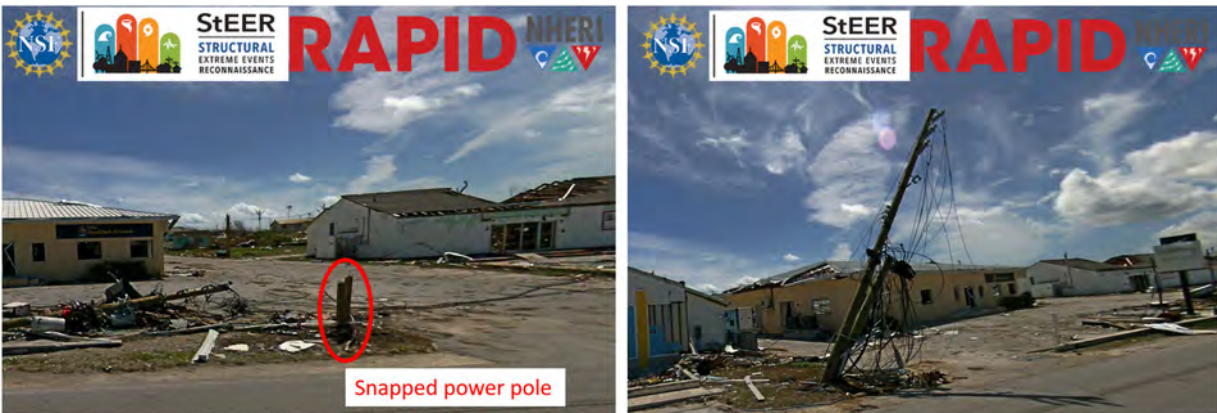
**Figure 7.1.** Snapped and leaning power poles in the business district of Marsh Harbour captured by the NHERI RAPID EF Applied StreetView camera.

A number of snapped power poles and light posts were observed by the D2D team and are documented in the previous StreetView images in Figure 7.1. A detailed analysis has not been conducted to date, but the data could be used to assess the relative hazard intensity across the impacted regions in Marsh Harbour and Treasure Cay.

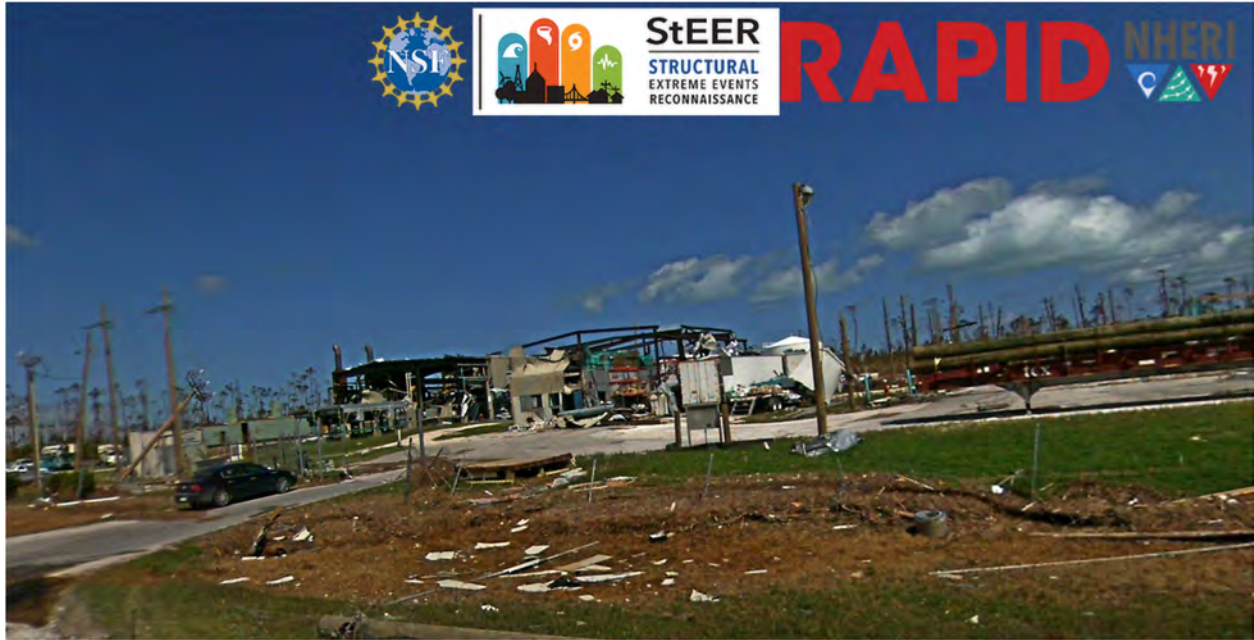
Limited cell service was available on the island during the FAST-1 deployment, but without a reliable data connection. Power was not available due to damage to the power lines and poles. Great Abaco relied upon a network of power poles and distribution lines that was heavily damaged by Dorian with most power poles in Marsh Harbour snapped or collapsed (Fig. 7.1). In Treasure Cay, many power poles were downed, but it was more common to see intact poles and distribution lines, especially along the main highway (Treasure Cay Drive). In addition, the Marsh Harbour power station [26.53466, -77.09566] was severely damaged by Dorian's winds. While the team did not do any assessments of the power plant buildings, the damage, primarily to the cladding elements, is clearly visible in the StreetView imagery in Figure 7.2 and from high-resolution satellite imagery.

**Figure 7.2.** Applied StreetView image of damaged Marsh Harbour power plant facility [26.53466, -77.09566].

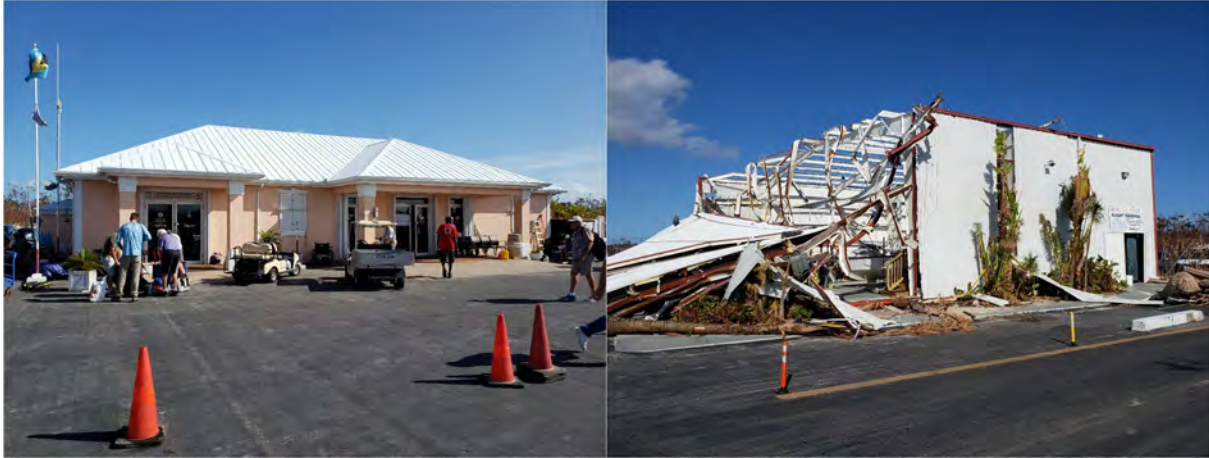
**Figure 7.3.** Examples of structures assessed by the D2D team at the Leonard Thompson International Airport: (a) Flight Base of Operations (FBO) Jet Center, assessed as “Undamaged” [26.51362, -77.08426]; (b) Cherokee Aviation hangar building, assessed as “Severe” damage [26.51353,-77.08483].

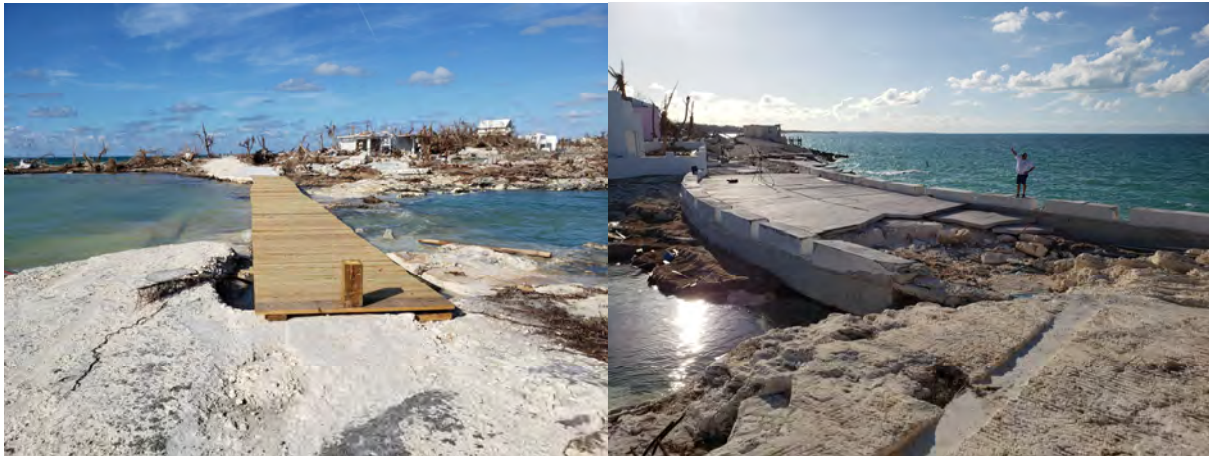
Several examples of damage to roadways were observed due to the surge effects of Hurricane Dorian. Within Marsh Harbour, the damage was primarily evident in Pelican Shore and Eastern Shore, with the two most significant examples on Eastern Shore. The first location was a complete washout of the roadway, which prevented access to Eastern Shores (small pedestrian walkway was erected to allow for some access of personnel) (Fig. 7.4a). Not much further down the road from the complete washout was a section of the roadway with concrete pavement and a partial concrete guardrail that was significantly damaged by the effects of surge (Fig. 7.4b). This was the region of Marsh Harbour where some of the highest surge levels were reported.

**Figure 7.4.** Examples of roadway surge damage: (a) Complete roadway washout of Eastern Shores road which has been temporarily replaced with a pedestrian bridge [26.55190, -77.03761]; (b) Roadway erosion of concrete pavement and guardrail on Eastern Shores Road [26.55313,-77.03569].

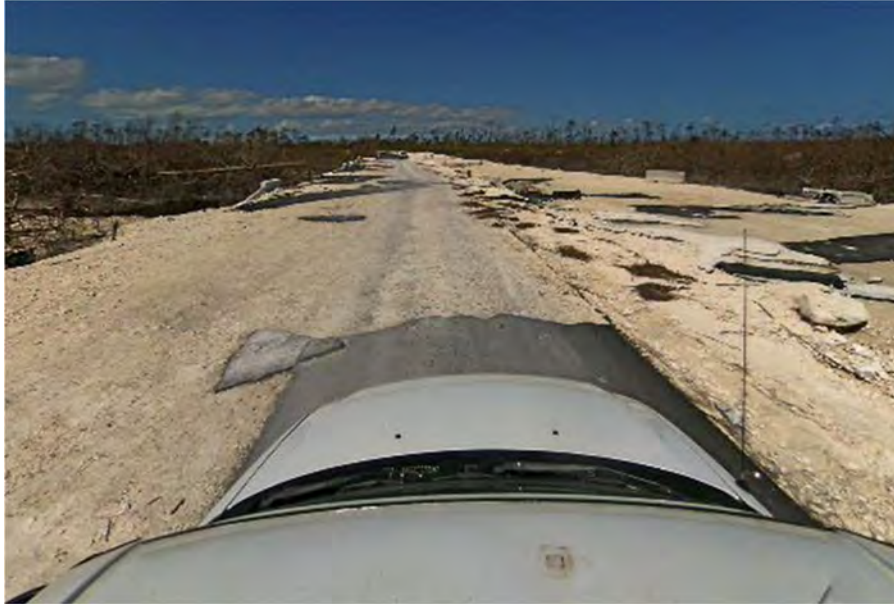
Another example of significant damage was the road to Treasure Cay from Marsh Harbour. This section of the roadway was recently reconstructed with a number of concrete culverts due to the fact that this was a low-lying thoroughfare adjacent to a small waterway. The location of the roadway is on the western side of the island, indicating that in this area the surge was moving from the eastern coast along this waterway to the western side of the island. The damage from the StreetView camera is evident in Figure 7.5.

**Figure 7.5.** StreetView image of damage to a recently reconstructed roadway on the road from Marsh Harbour to Treasure Cay [26.58216, -77.16946].

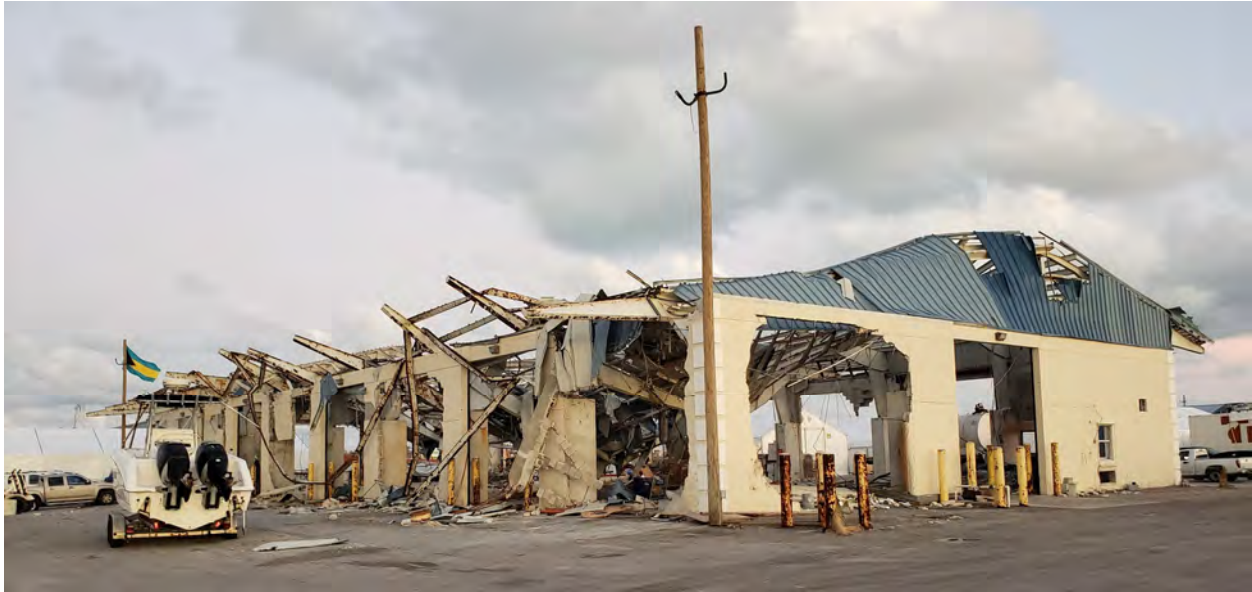
**Figure 7.6.** Image of damage to warehouse building at Marsh Harbour Government Port [26.54332, -77.06435].

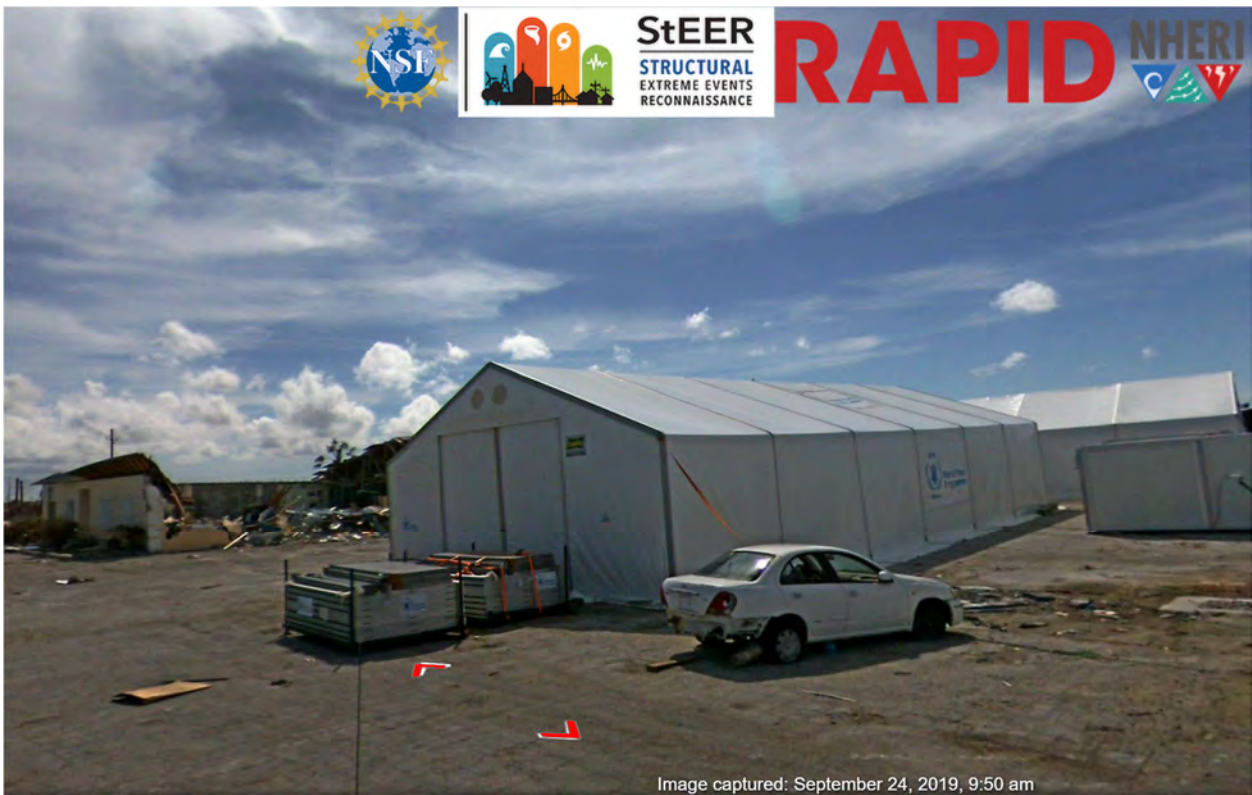
The Marsh Harbour Government Port [26.54276, -77.06433] was operational during the time FAST-1 was on the ground. It was serving as a water and food distribution point although these operations were moved to Abaco Primary School during the time the team was on the ground. The team assessed only one of the buildings, a metal building that was used for storage and was classified as “Severe” damage. Figure 7.6 shows the warehouse building that was damaged by Hurricane Dorian and would have experienced both high winds and surge. StreetView imaging captured the current status of the port as well. Figure 7.7 shows some of the temporary facilities supporting aid operations at the port, with a view of the destroyed administration building visible in the background.

**Figure 7.7.** StreetView imagery of the temporary structures set up at the port facility, with view of the destroyed Administration building in the background.
