EVENT BRIEFING

Event: 13 July 2019: Hurricane Barry

Region: Southern US Gulf Regions

Released: July 16, 2019 (DesignSafe Project: PRJ-2451)

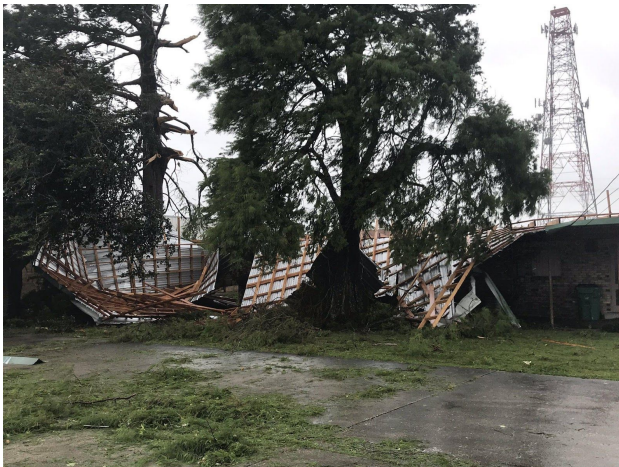
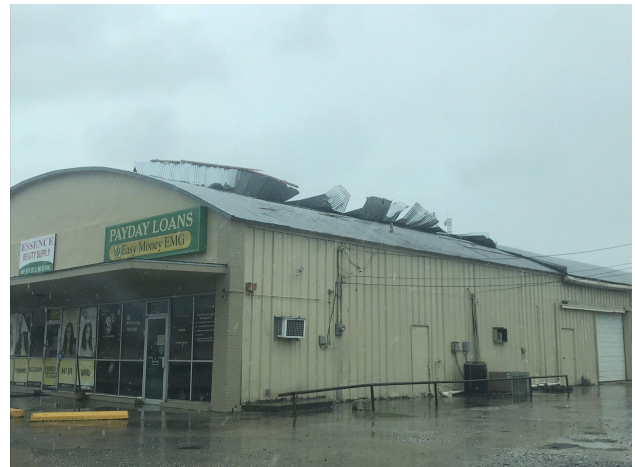
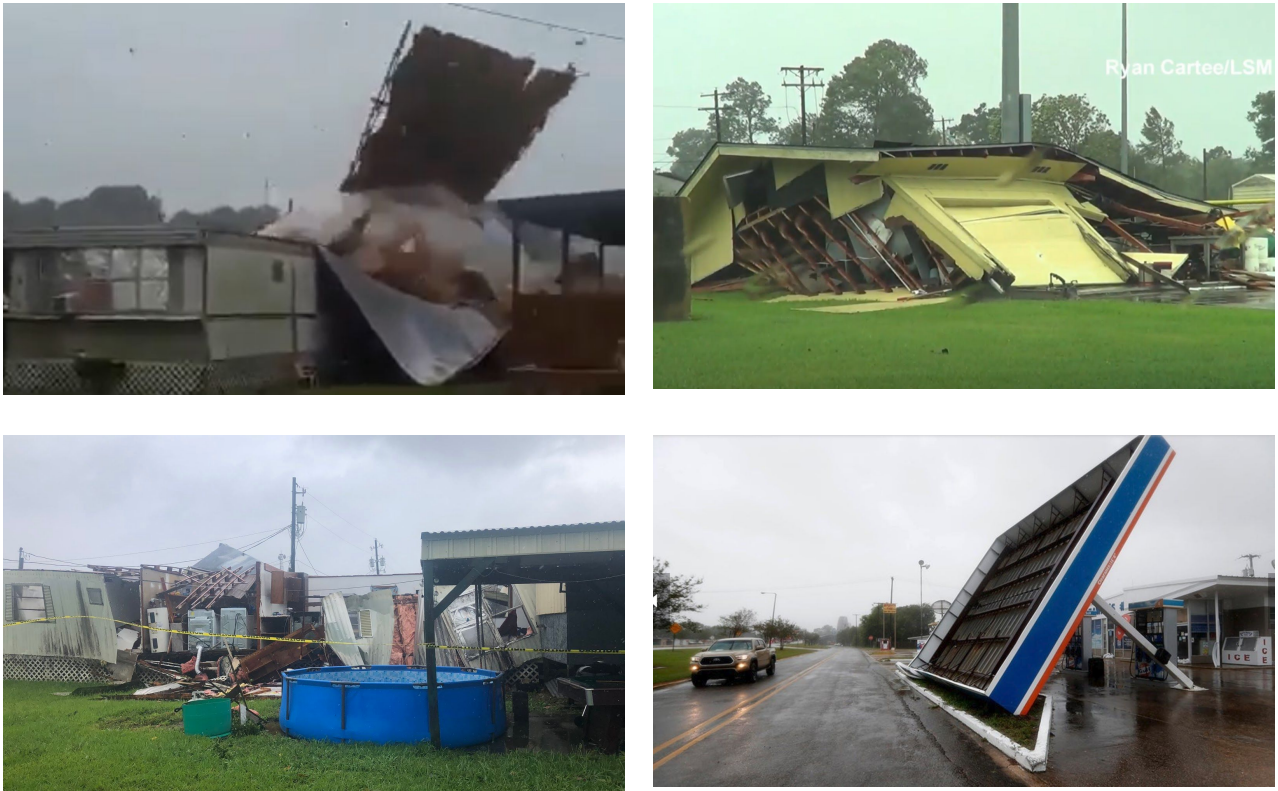
With maximum reported wind gusts no more than 60% of design, relatively minor wind damage is expected from Hurricane Barry. Early reports appear to confirm this expectation, as only scattered reports of damage are available. Figure 3 shows a selection of the most significant reported damage. The reports of damage are generally restricted to a handful of older, vulnerable buildings, including a mobile home that lost its roof. A couple reports of shingles being lost on a roof were also noted. A number of trees were also downed, impacting transmission lines and roadways. Overall however, wind damage appears to be minimal beyond these isolated cases.

Figure 3. Reports of wind damage from Hurricane Barry. (a) A corrugated metal roof and framing torn off a building in Morgan City, LA ([Courtesy of MadWxChasing](#)); (b) Corrugated metal roof sheeting uplifted on an arched roof building in downtown Morgan City, LA (Courtesy of [Trey Greenwood](#)); (c) still frame from video showing the roof of a mobile home in Morgan City, LA blowing off due to Hurricane Barry winds (Courtesy of [Scott Pilie](#)); (d) Collapsed storage shed at a baseball park in Patterson, LA (Courtesy of [Ryan Cartee / Live Storms Media](#)); (e) A back view of the damaged mobile home shown in (c), courtesy of [Trey Couvillion](#); and (f) a toppled single column gas station canopy near Morgan City, LA (Courtesy of the [Weather Channel](#)).

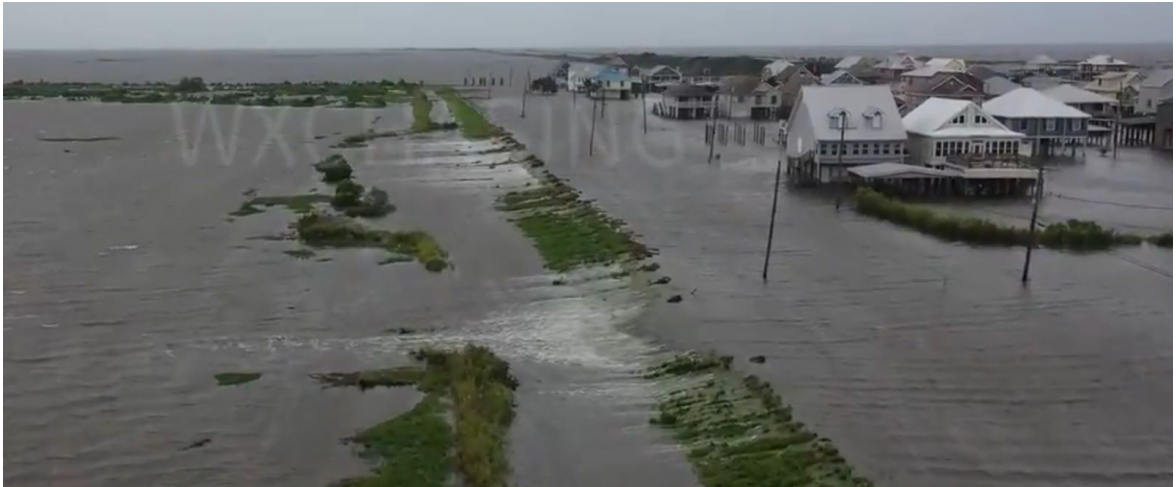
Parish), the storm surge inundation peaked at 6.6 ft above the normal high tide level⁴ as shown in Figure 4. With the storm surge, one of the concerns was flooding overtopping levees and cutting off access to evacuation routes for residents. Figure 5 shows levees overtopping in Plaquemines Parish. There are no reports of failed levees at this time.

Figure 5. Levee overtopping in Plaquemines Parish near Myrtle Grove. Still shot taken from video by [WXChasing](http://WXChasing.com).
