EVENT BRIEFING	
	Event:	21 Sept., 2019 Albania, Mw 5.6; 24 Sept., 2019 Kashmir, Mw 5.6 and 26 Sept., 2019 Turkey, Mw 5.7 Earthquakes
	Region:	Europe / West Asia
	Authors:	Selim Günay, Pacific Earthquake Engineering Research Center, University of California, Berkeley Khalid M. Mosalam, Pacific Earthquake Engineering Research Center, University of California, Berkeley
	Released:	2 October, 2019

Albania-Kashmir-Turkey Earthquakes | Released October 2, 2019

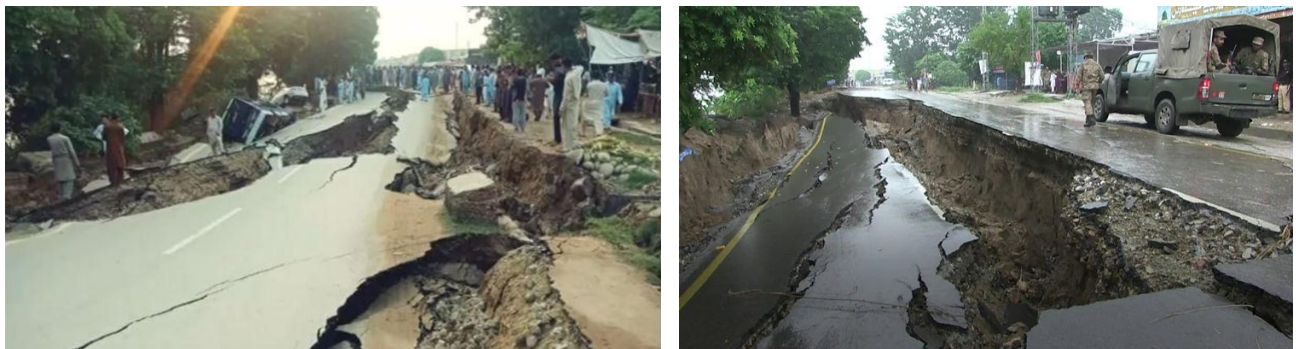
Two bridges were reported damaged and parts of several roads were severely affected (Fig. 4). Pakistan's major water reservoir Mangla Dam located near Mirpur remained safe (the Hindu, 2019). However, the officials indicated that Mangla dam power house has been closed, cutting off 900 MW power supply to the national grid. Upper Jhelum canal was damaged and water inundated various villages. Pakistan-occupied Information Minister indicated that the breach in the Upper Jhelum Canal was fixed due to timely intervention of officials (the Hindu, 2019). Mobile phone towers, and electricity poles in the area were damaged interrupting communications and power supply (the Guardian, 2019).

Figure 4. Damage to roads in Kashmir earthquake

There are two potential reasons for the relatively large extent of damage experienced in a moderate earthquake. The first is the inadequate quality of construction and lack of earthquake resistant design in the damaged houses and bridges. This earthquake occurred in the intensity zone with maximum Peak Ground Acceleration (PGA) in the range of 0.35g (Government of Pakistan Cabinet

Secretariat, 2019). Therefore, if the structures were designed according to the seismic code, they should not have experienced significant damage in this earthquake. The second reason is the shallow nature of the earthquake leading to increased levels of shaking. This highlights the importance of reporting other factors to the public, such as the focal depth, and ground shaking levels (as compared to using only earthquake magnitude) to describe the level of earthquakes.

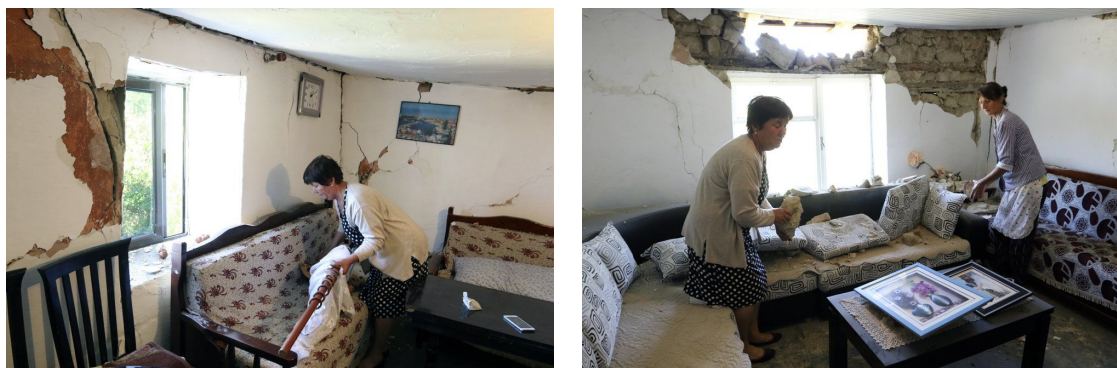
Although only 5.6 in magnitude, the Albania earthquake was the strongest earthquake in the country in the last 30 years (Japan Times, 2019). In the region of Tirana, 48 houses and three apartment buildings experienced cracks (Fig. 5), while in Durres region, 42 houses and four apartment buildings were damaged, along with 20 buildings damaged in other areas (Euro News, 2019). One apartment building in Durres was heavily damaged (Fig. 6), with a crack running down it from the sixth floor all the way to the ground (Euro News, 2019; AP News, 2019). As shown in Figure 6, Debris falling from the collapsed roof of a building crushed several cars (Euro News, 2019).

Figure 5. Severely damaged houses in a village near Tirana, Albania quake (AP News, 2019)

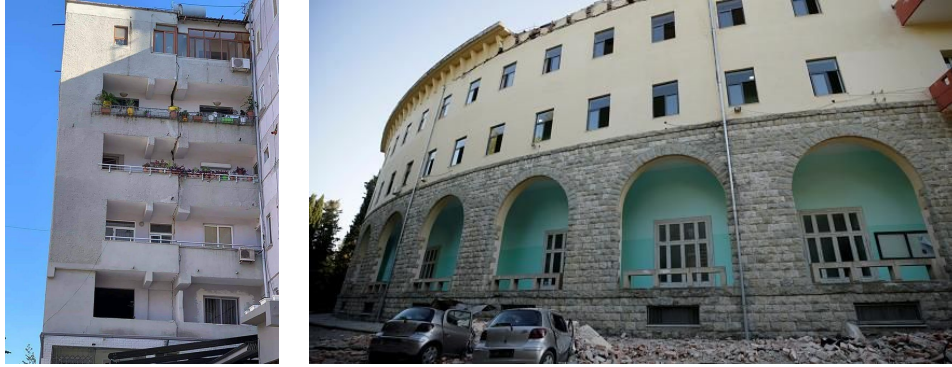
Figure 6. Heavily damaged building with a big crack running all along the height (left); Cars crushed by debris fallen from the collapsed roof a building; Albania quake (Euro News, 2019)

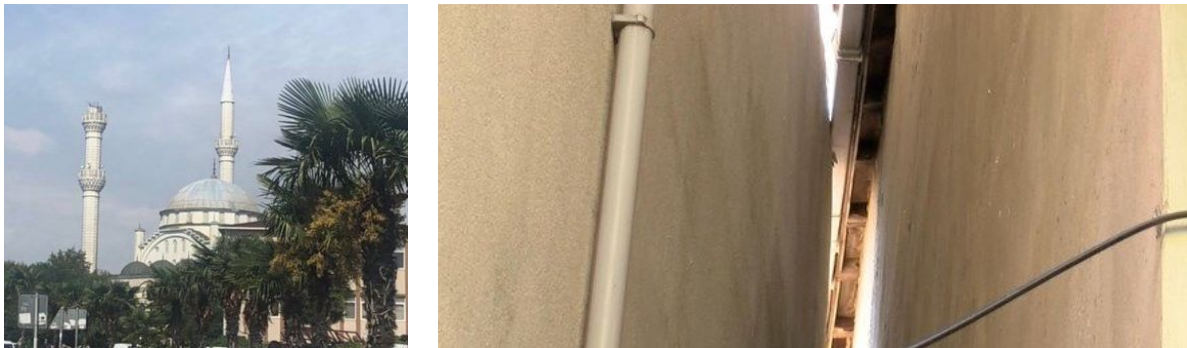
Due to the low level of accelerations in urban areas ($< 0.1g$), there was not significant damage experienced in the Turkey earthquake. The most significant damage was the broken minaret of a mosque in the Avcilar district of Istanbul, shown in Figure 7 (USA Today). This damage is probably due to some structural deficiency of this minaret, considering the one next to it did not experience any damage (Figure 7). Regardless, this damage demonstrates the effect of far field ground motions and the ground motion amplification due to local soil conditions, considering that the distance between the epicenter of the earthquake and Avcilar is around 70 km.

Figure 7. Broken minaret of a mosque in Avcilar, Istanbul (left), building in Istanbul leaning on the adjacent building due to tilting (right) (NTV, 2019a)

Another important case study is a building in Istanbul that tilted and is leaning on an adjacent building (NTV, 2019a), possibly attributed to soil liquefaction underneath the building. This tilting also demonstrates the effect of far field ground motions and the ground motion amplification due to local soil conditions.
