<b>StEER</b> <b>STRUCTURAL</b> EXTREME EVENTS RECONNAISSANCE	<b>EVENT BRIEFING</b>		
	Event:	24 January, 2020 Turkey, Mw 6.7 Earthquake	
	Region:	West Asia	
Authors:	Selim Günay, UC Berkeley; Abdullah Dilsiz, Ankara Yildirim Beyazit University; Khalid M. Mosalam, UC Berkeley		
Editors:	Ian Robertson, University of Hawaii at Manoa Tracy Kijewski-Correa, University of Notre Dame		
DesignSafe Project #	PRJ-2684	Release Date:	January 26, 2020

24 January 2020 Mw 6.8 Earthquake in Turkey | Released January 26, 2020

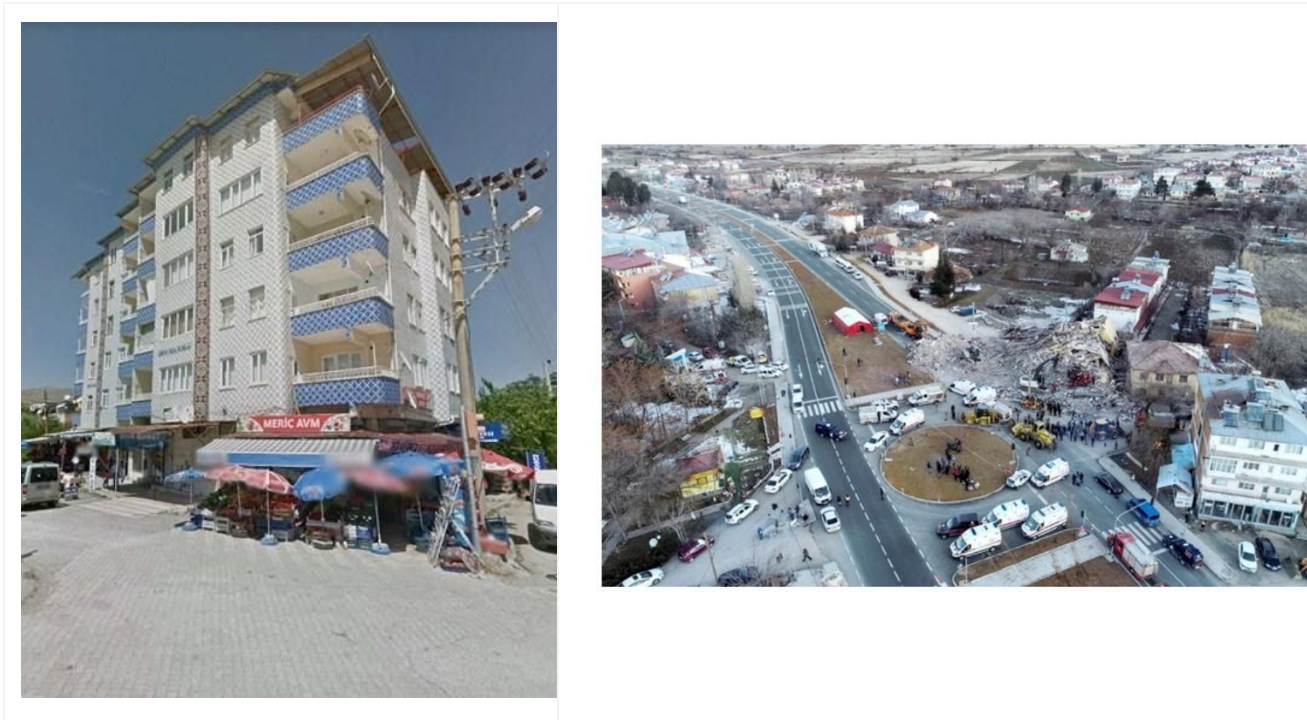
The earthquake led to the collapse of 72 buildings, including reinforced concrete, masonry and adobe construction (Hurriyet, 2020). Collapsed reinforced concrete buildings were low to mid-rise (up to 6 stories), whereas collapsed masonry and adobe buildings were low-rise. Figures 5-7 show photos of three collapsed buildings. Specifically, Figure 5 shows the photo of a 6-story reinforced concrete building in Elazig before the earthquake and the rubble due after the collapse of the building in the earthquake (NTV, 2020). There is no particular plan or elevation irregularity observed from the pre-earthquake photo, except some potential for torsional irregularity. However, information is not available about the structural system, member sizes, reinforcement ratios/detailing, and material characteristics, therefore it is difficult to provide any explanations about the collapse of the building. It is observed from this figure that other buildings around this building are low rise, therefore, there is a chance that the experienced ground motions had larger spectral accelerations at the natural frequency of this collapsed building.

**Figure 5.** Collapsed six-story building in Elazig (right) along with a photo of the building before the earthquake (left) (NTV, 2020).

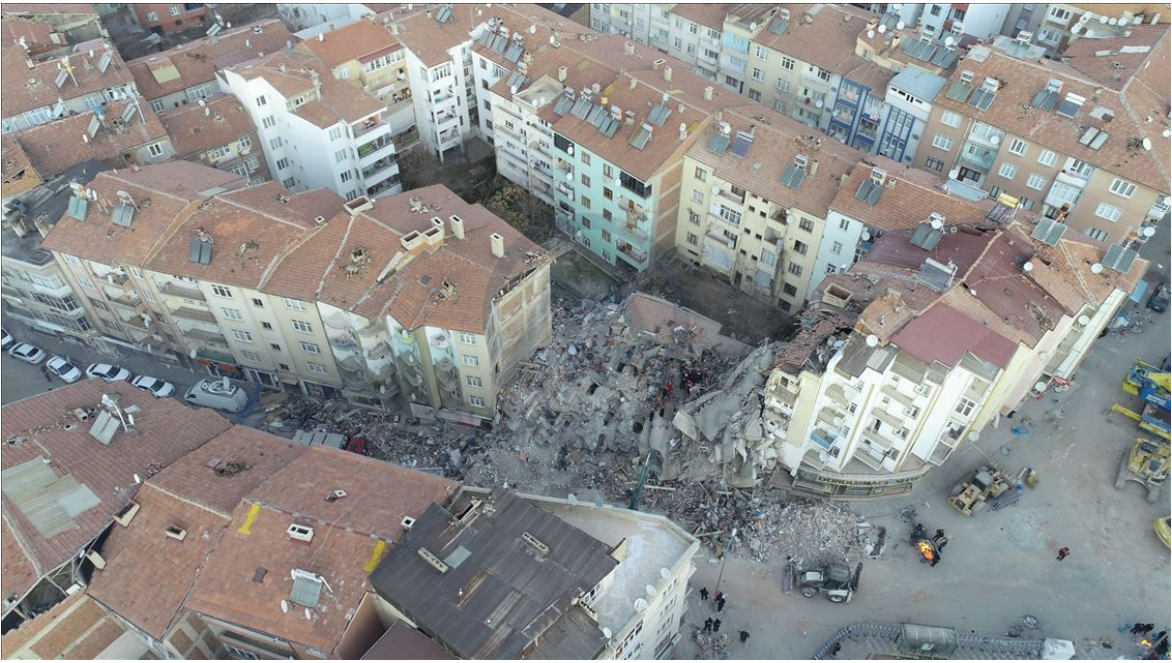
The buildings in Figures 6 and 7 have several surrounding buildings with a similar number of stories and structural systems that remained intact, though experiencing damage; therefore observed collapses could be due to several deficiencies, low construction quality and any damage experienced in a prior earthquake. It is known that there is a very narrow boundary between collapse and survival for non-ductile reinforced concrete buildings, which could potentially explain why only a few of these possibly non-ductile buildings collapsed and others remained standing. However, information is not available about the seismic detailing of these buildings at the time this briefing was authored. Other than the collapsed buildings, there are buildings that experienced varying levels of damage, including severe damage in Doganyol, which is 9 km away from the epicenter.

**Figure 6.** Collapsed reinforced concrete building among a block of buildings in Mustafa Pasa neighborhood of Elazig (Anadolu Agency, 2020).

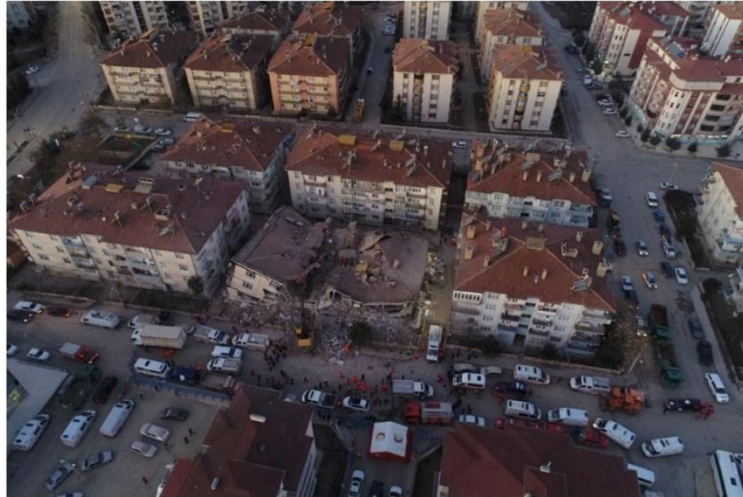
**Figure 7.** Collapsed reinforced concrete building in Sursuru neighborhood of Elazig with similar intact buildings around (NTV, 2020).
