**StEER: Structural Extreme Event Reconnaissance
Network**
**PALU EARTHQUAKE AND TSUNAMI, SULAWESI,
INDONESIA**
FIELD ASSESSMENT TEAM 1 (FAT-1)
EARLY ACCESS RECONNAISSANCE REPORT (EARR)

Released: January 15, 2019
NHERI DesignSafe Project ID: PRJ-2128

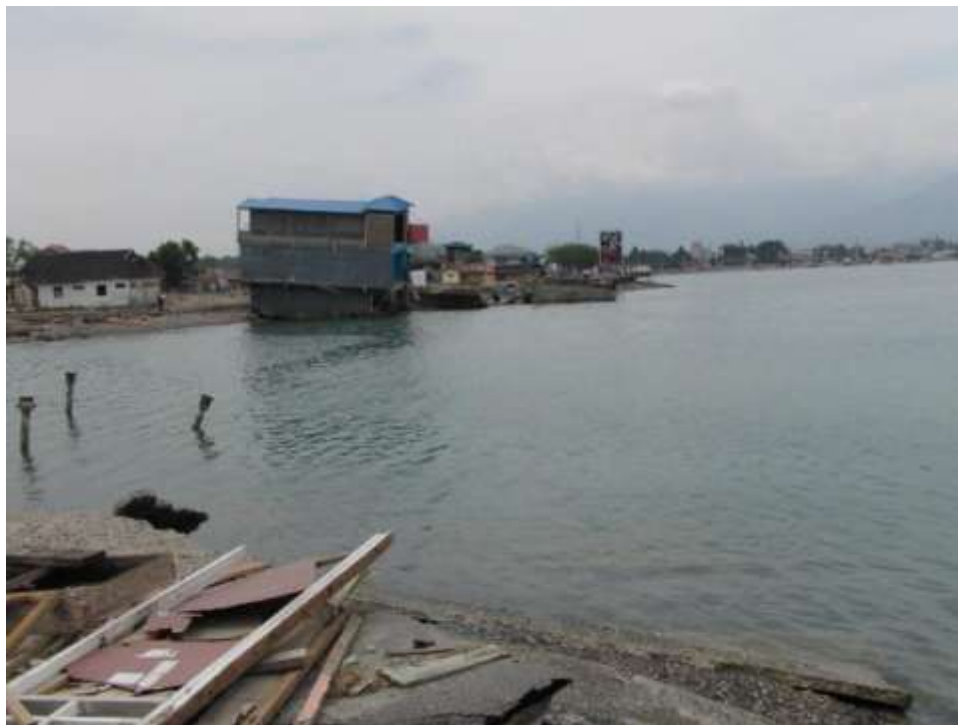
Figure 22: View along original alignment of coastal highway (See Figure 21) that is suspected to have been part of landslide 11 in Talise.

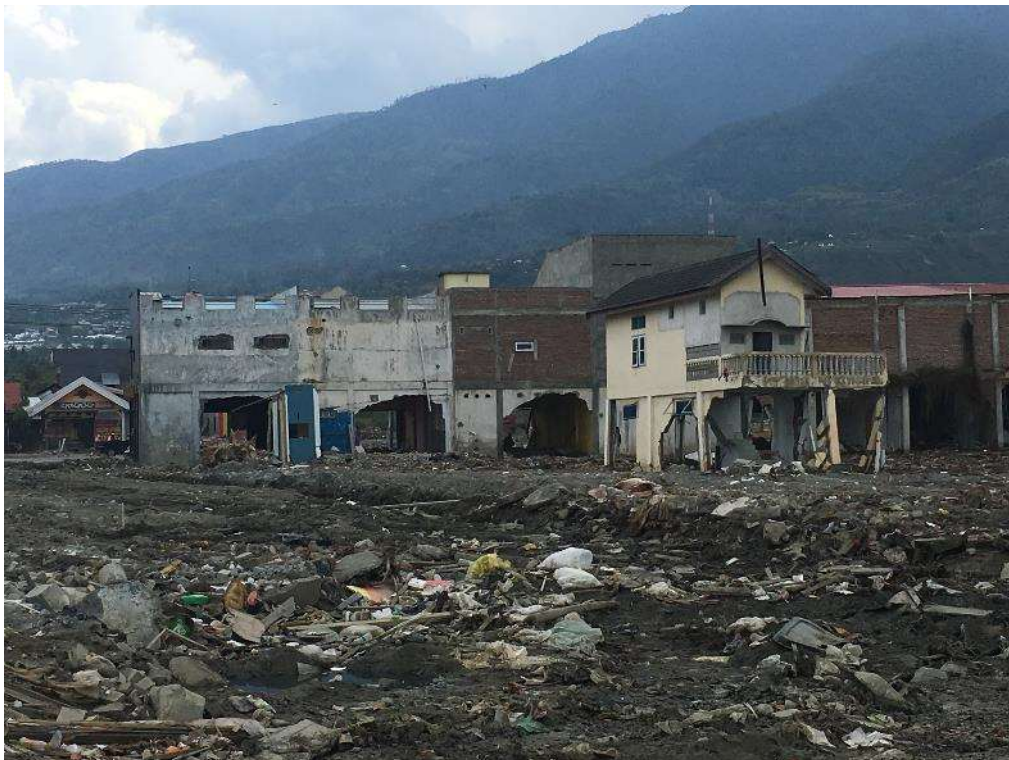
Figure 34: Low-rise reinforced concrete frame structures with unreinforced masonry infill wall panels damaged by tsunami loads (Credit: Ian Robertson).

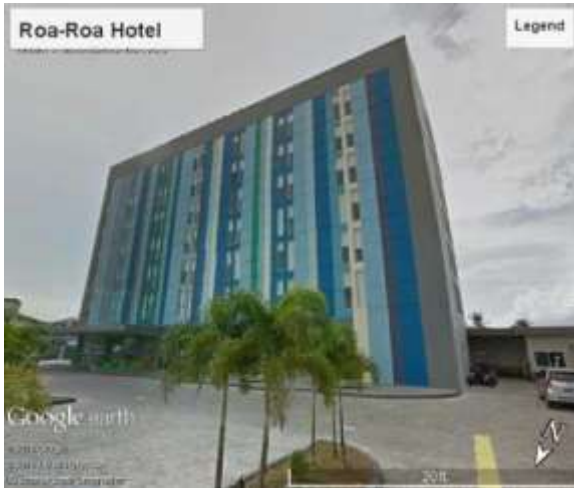
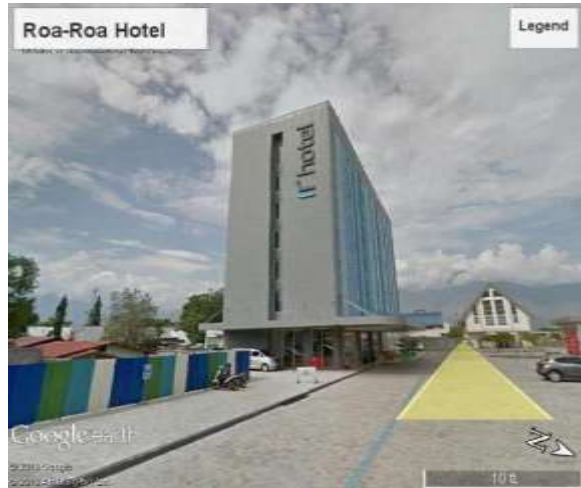
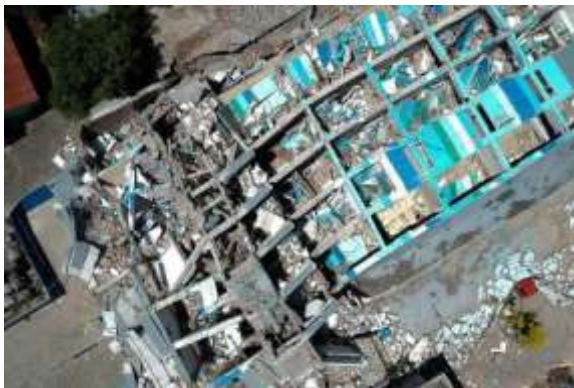
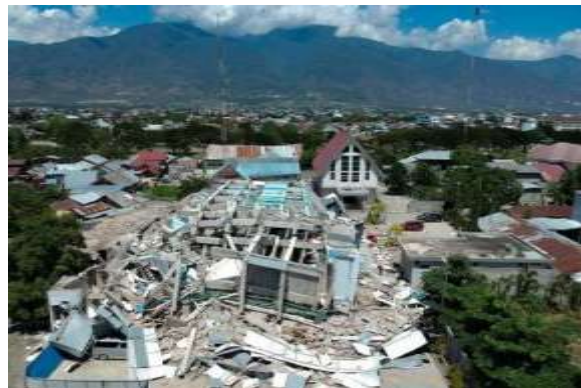
One of the more dramatic structural failures was the eight-story Roa-Roa Hotel (0.90290 S, 119.86869 E), which collapsed resulting in multiple deaths (Figure 43). Approximately 60 residents were in the hotel at the time of the collapse, but the final number of casualties is unknown. Based on Google Earth historical images, the building was under construction in June 2013, making it only 5 years old at the time of the earthquake. The building’s lateral force resisting system appears to be a reinforced concrete moment frame structure with infill reinforced concrete wall panels on portions of the building perimeter. Details of the framing are evident from Figure 44.

Figure 43: Google Earth Streetview images of Roa-Roa Hotel before the earthquake (top) and collapsed Roa-Roa Hotel after the earthquake (bottom).

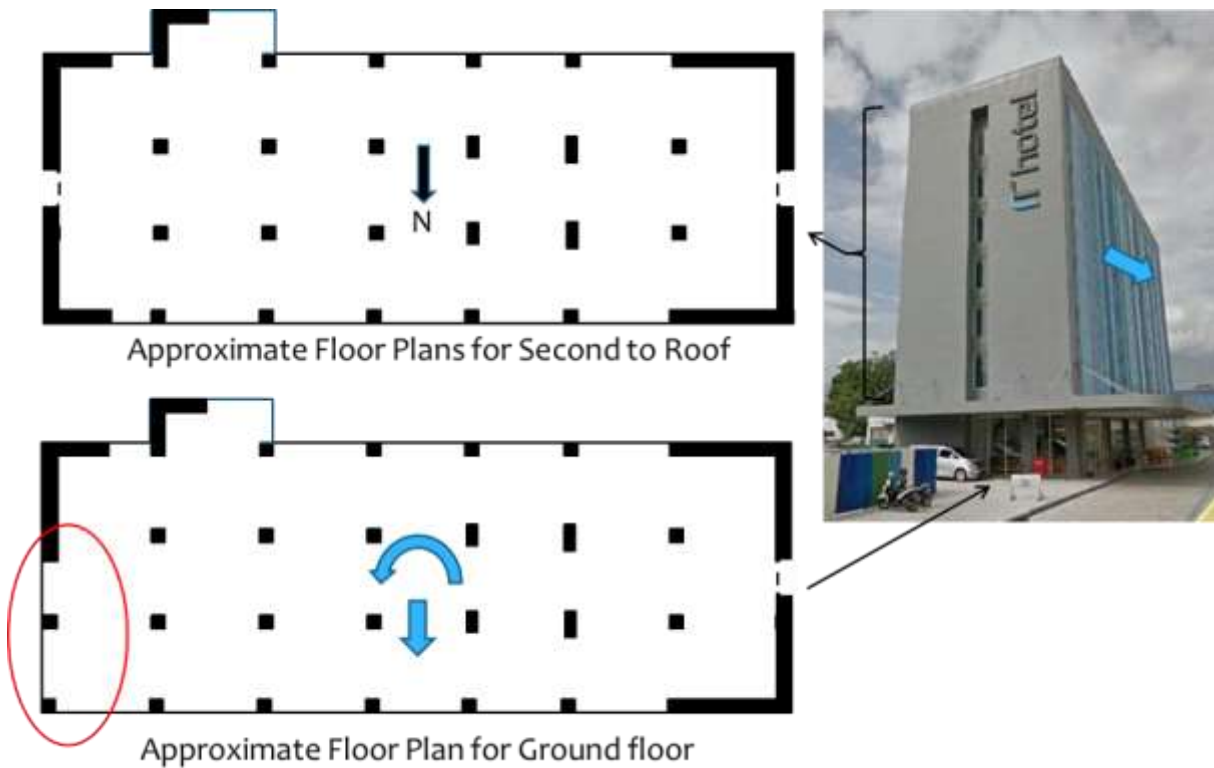
An approximate structural layout for columns and walls on the ground floor and the upper floors was developed based on field observations and Google Earth StreetView images (Figure 46). Efforts are underway to obtain structural drawings for this building. It would appear that the transition from wall to individual columns at the ground level on the NE corner of the building could have led to significant torsional effects and considerable displacement demand on those columns. Failure of these columns would explain the collapse of the building towards the North.

Figure 46: Approximate floor plans and presumed failure mode for Roa Roa Hotel.

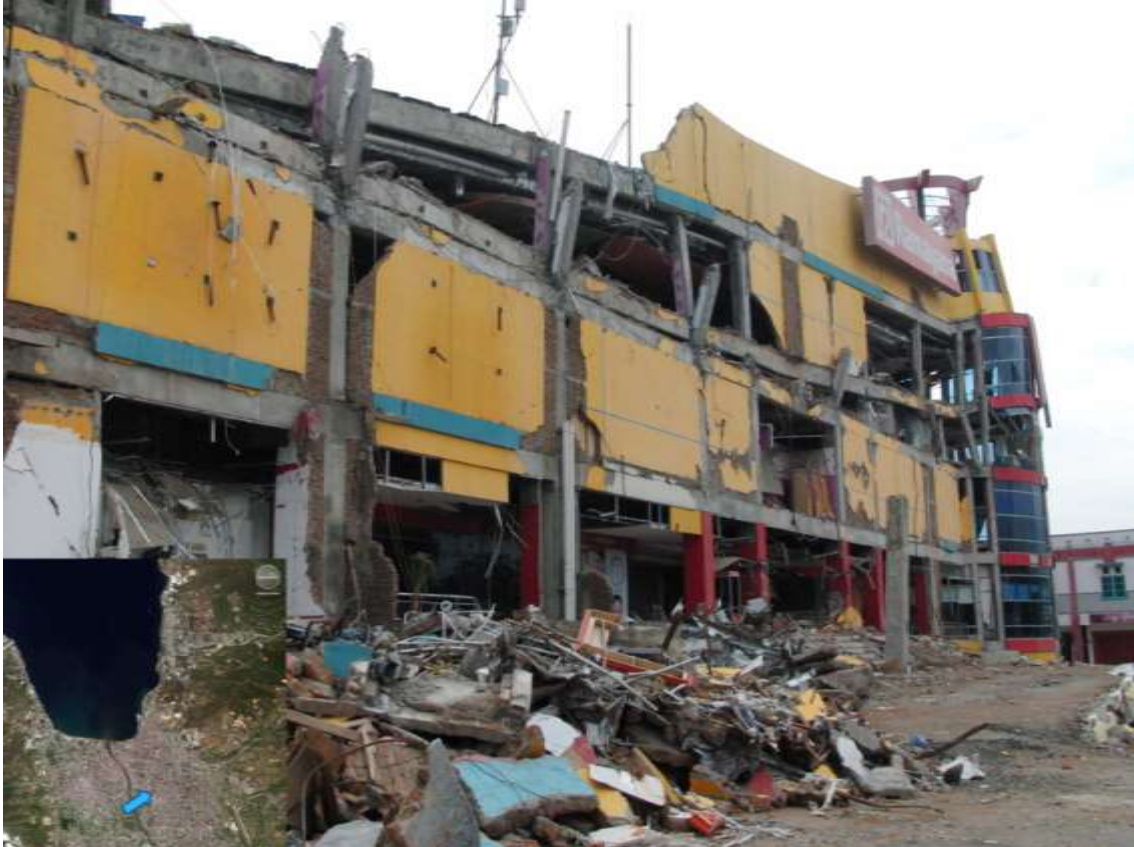
The Tatura Shopping Mall (0.908287 S, 119.87627 E) suffered partial collapse during the earthquake. This four-story shopping mall experienced multiple column and beam-column joint failures, resulting in partial collapse of the roof and third floor. Based on Google Earth historical images, the foundations for this building were under construction in March 2005, making the building approximately 13 years old. Figure 47 shows a 3D rendering of the mall generated by “Structure-from-Motion” software Pix4D using 1500 drone images. The DJI Phantom 4 Pro+ quadcopter drone was flown by Yuta Nishida from Waseda University and Ryota Nakamura

Figure 48: West elevation of Tatura Shopping Mall showing column and joint failures resulting in collapse of the third level and roof.

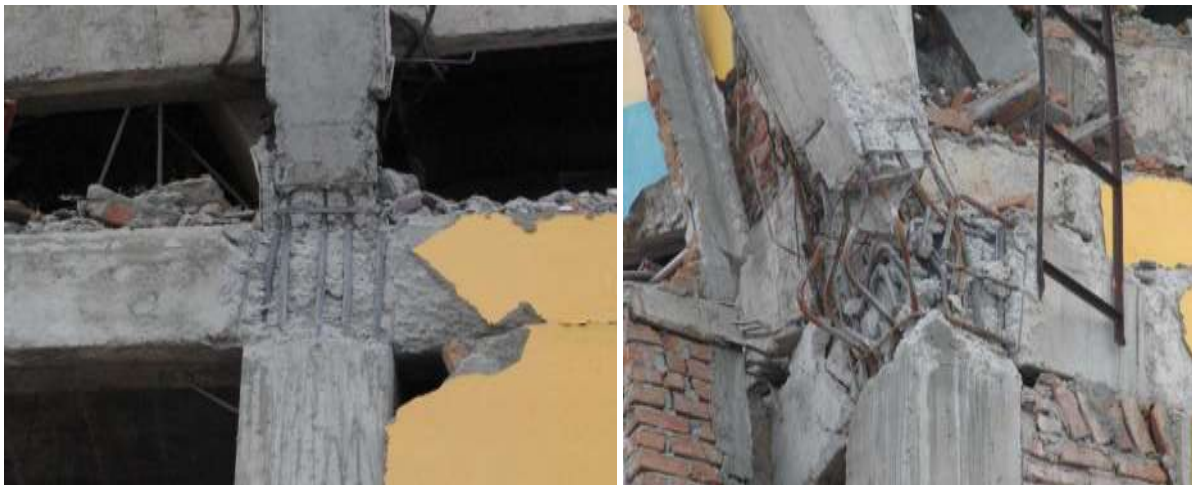
Figure 49: Lack of ties in the beam-column joints probably resulted in buckling of column vertical reinforcement and failure of the unconfined concrete in the joints.

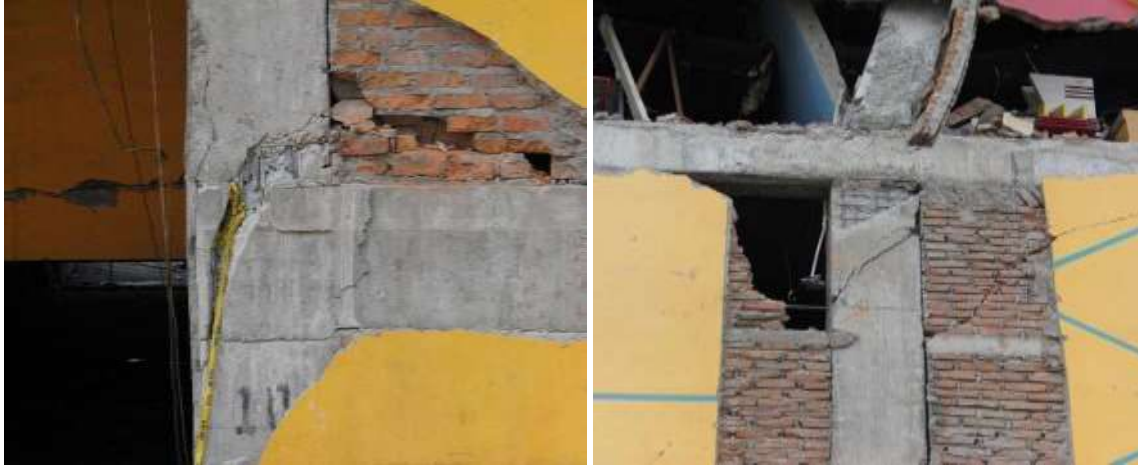
Figure 50: Column shear cracking, possibly exacerbated by presence of masonry infills

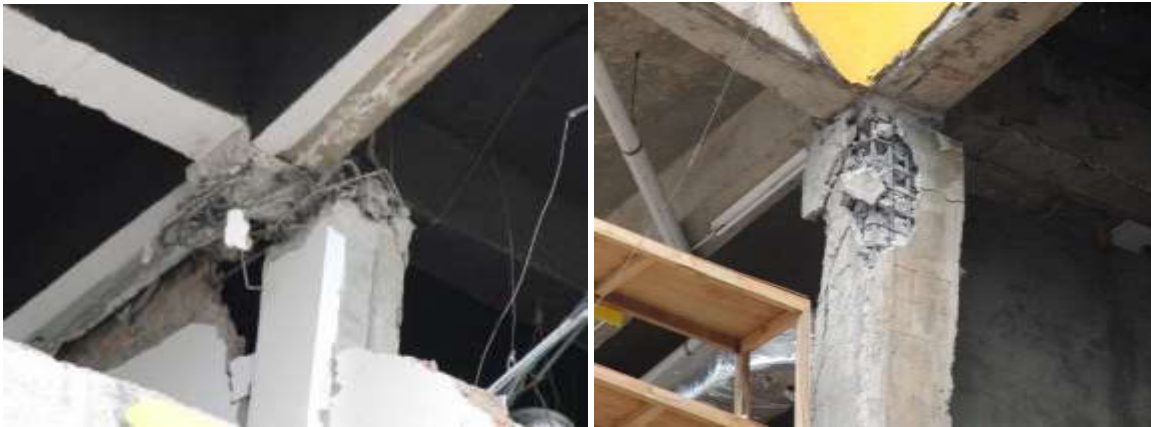
Figure 51: Partial collapse of two interior columns due to shear or flexural failure in the hinging region. Note the lack of damage in the beams framing into these columns.

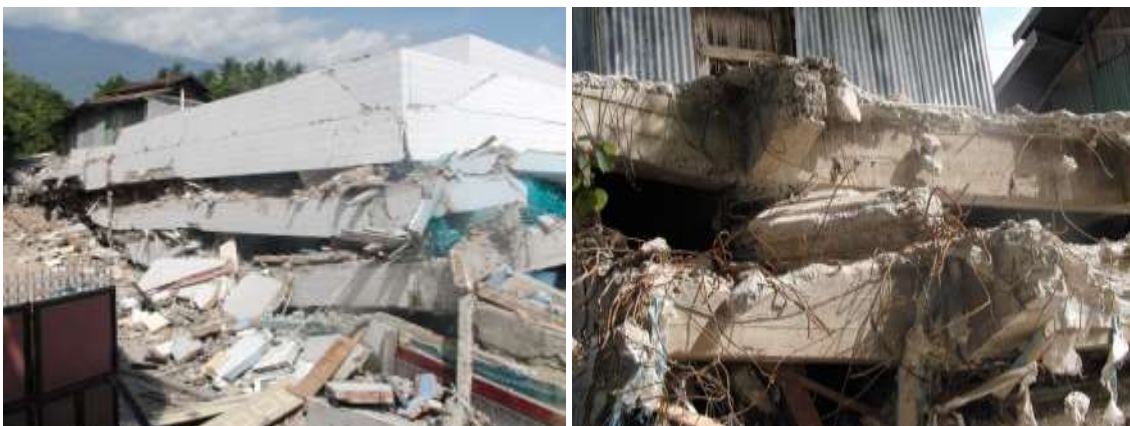
Figure 54: Column failures resulting in complete collapse of the three-story Dunia Baru Restaurant

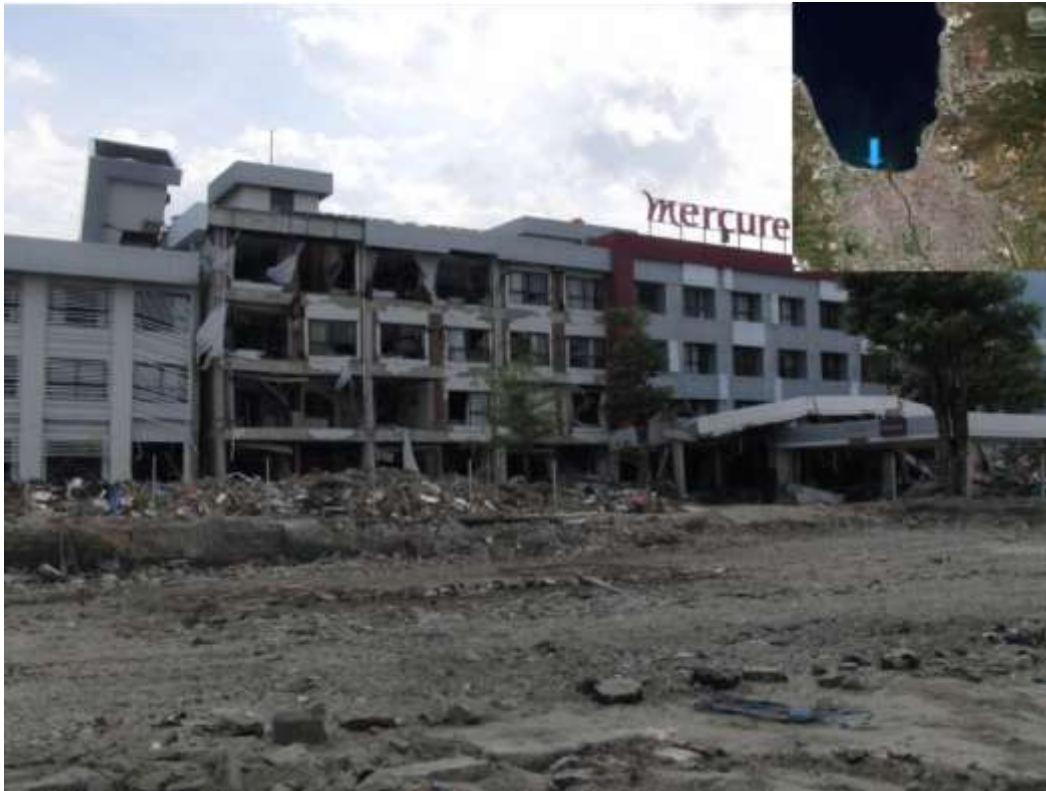
Figure 55: The five story Mercure Hotel experienced a complete collapse of the ground floor.

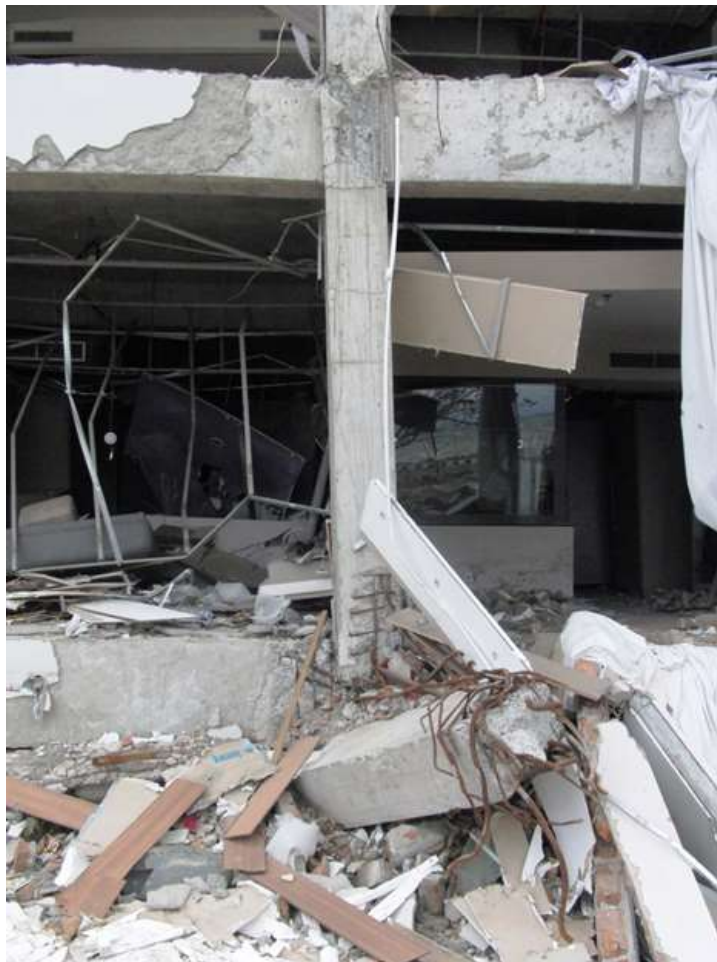
Figure 58: Failed first floor column and damaged joints at second and third floors of Mercure Hotel.

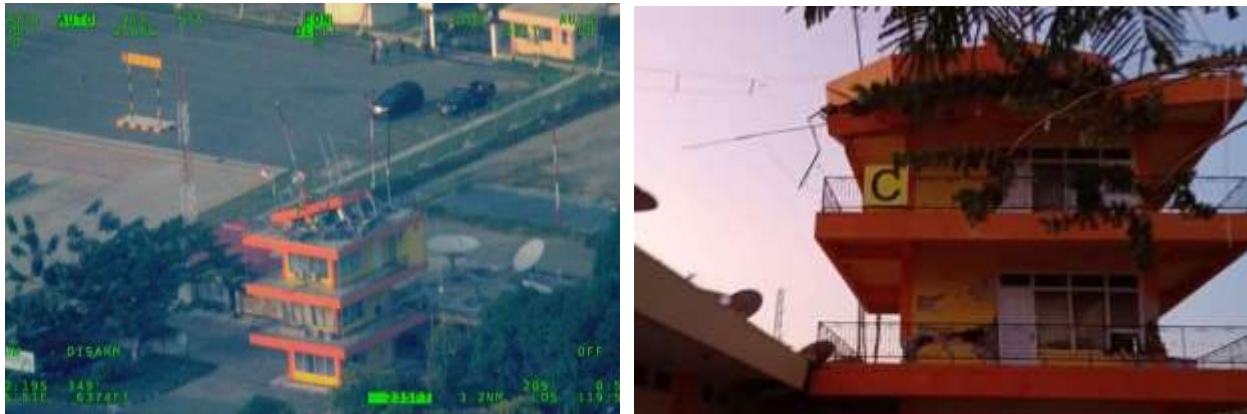
Figure 60: Collapse of the roof of the air traffic control tower at Palu Airport. Structural damage is also evident in walls and columns at the second level of the tower (right).

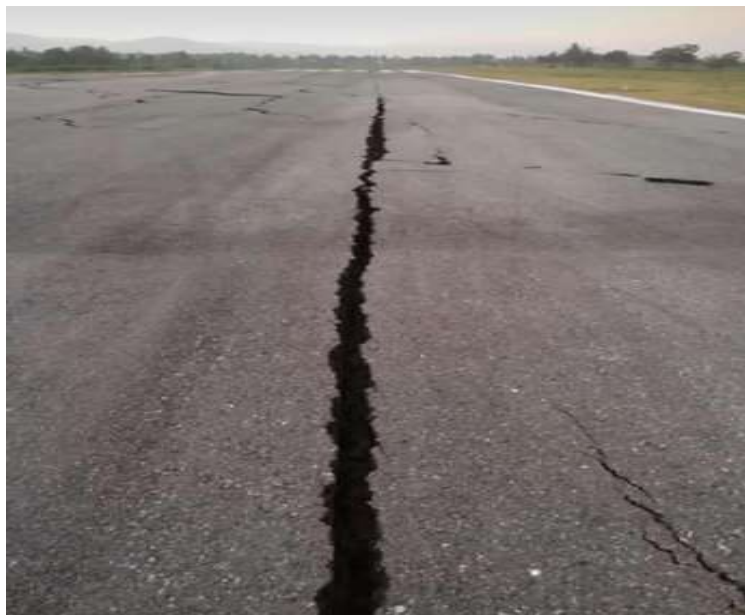
Figure 61: Earthquake damage to Palu airport runway.

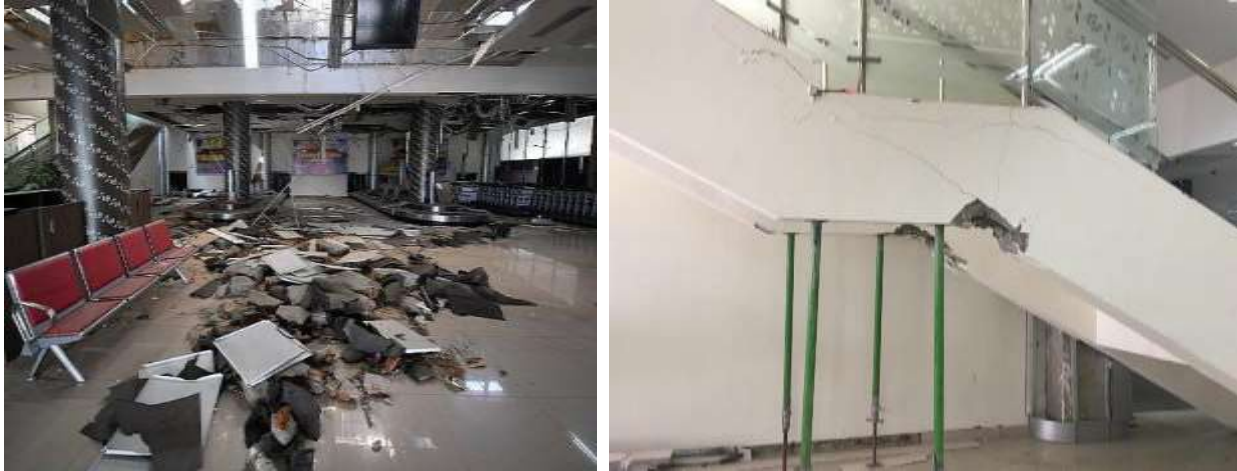
Figure 62: Earthquake damage at Palu airport terminal building: non-structural elements (left) and escalator connecting ground and second floors (right).

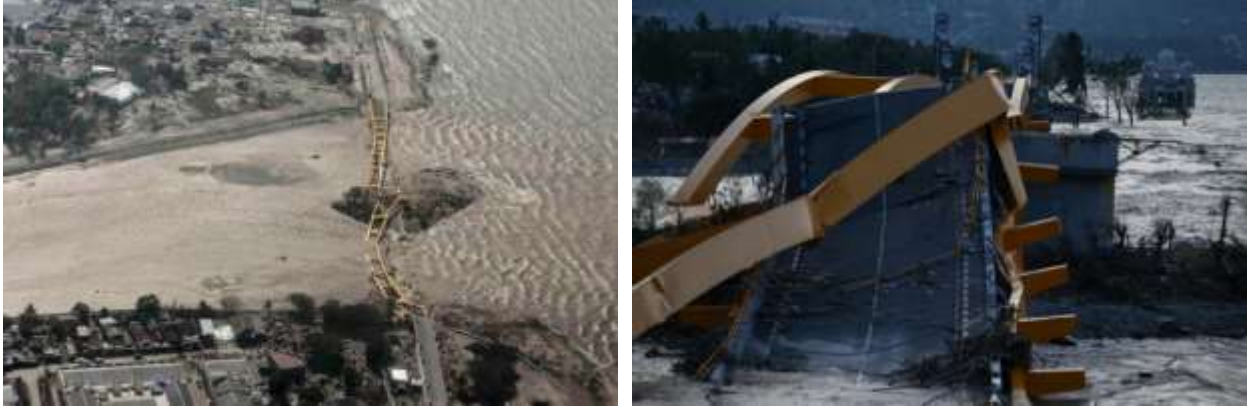
- **Bridges:** The iconic twin steel arch cable-suspended Palu Bridge IV over the mouth of the Palu River collapsed, presumably during the earthquake. The bridge had a total span of 250 meters and the steel box arches were 20 meters tall. A number of other bridges are reportedly damaged, hampering road traffic in and around the city.

Figure 64: Palu Bridge IV after the earthquake and tsunami.

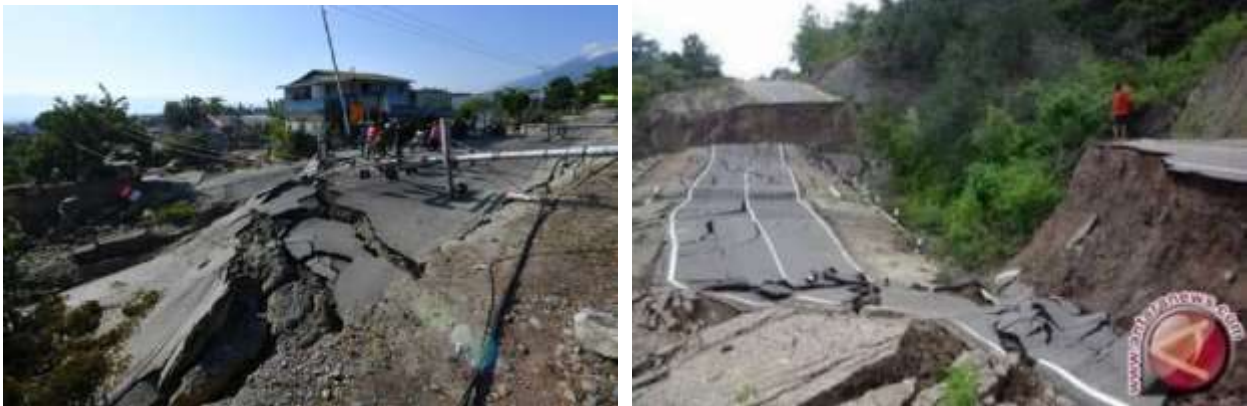
Figure 65: Road failures due to the earthquake.

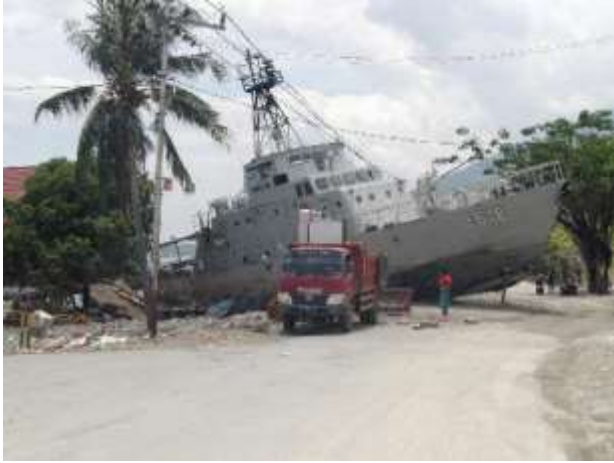
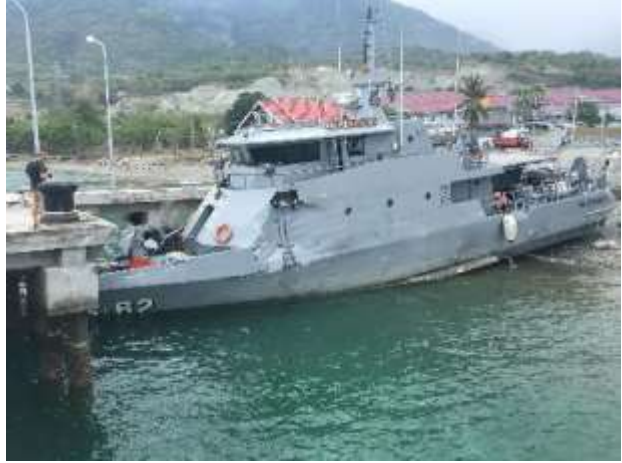
Figure 70: Naval ships in Watusampu Naval Base beached (left) and damaged from pounding against piers (right) because of tsunami waves.

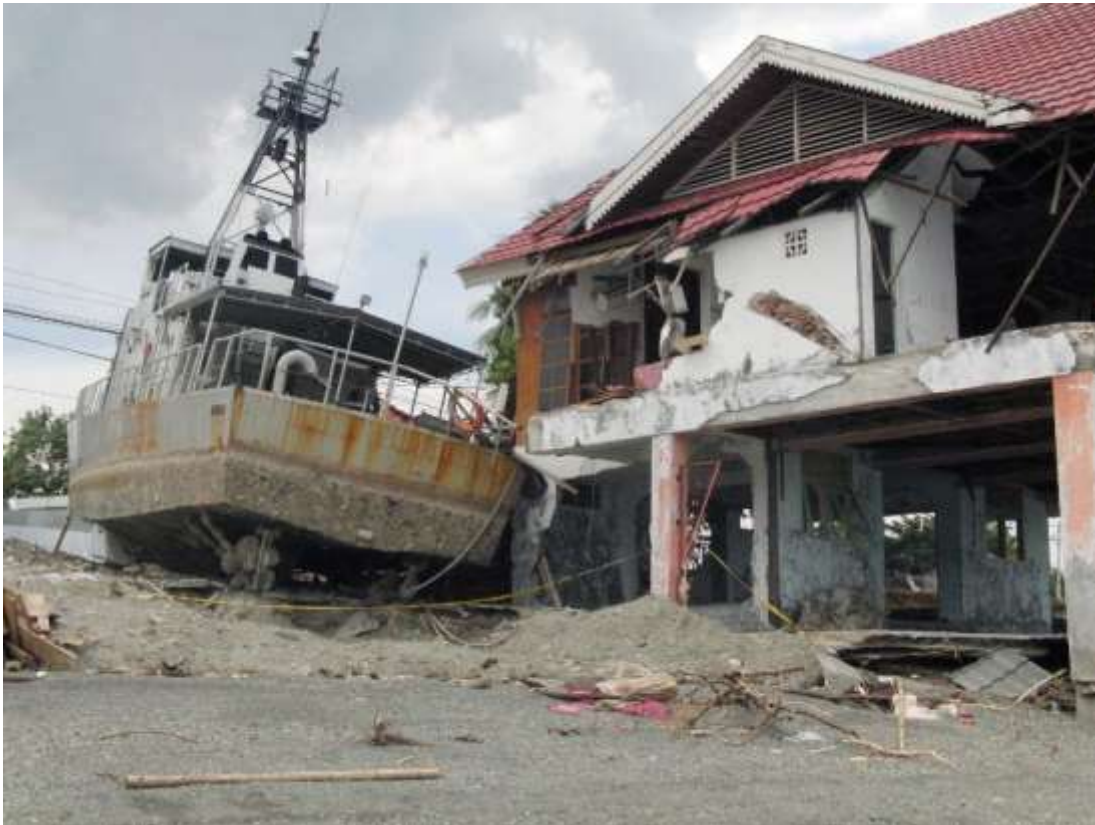
Figure 71: Naval ship adjacent to building with evidence of impact damage.

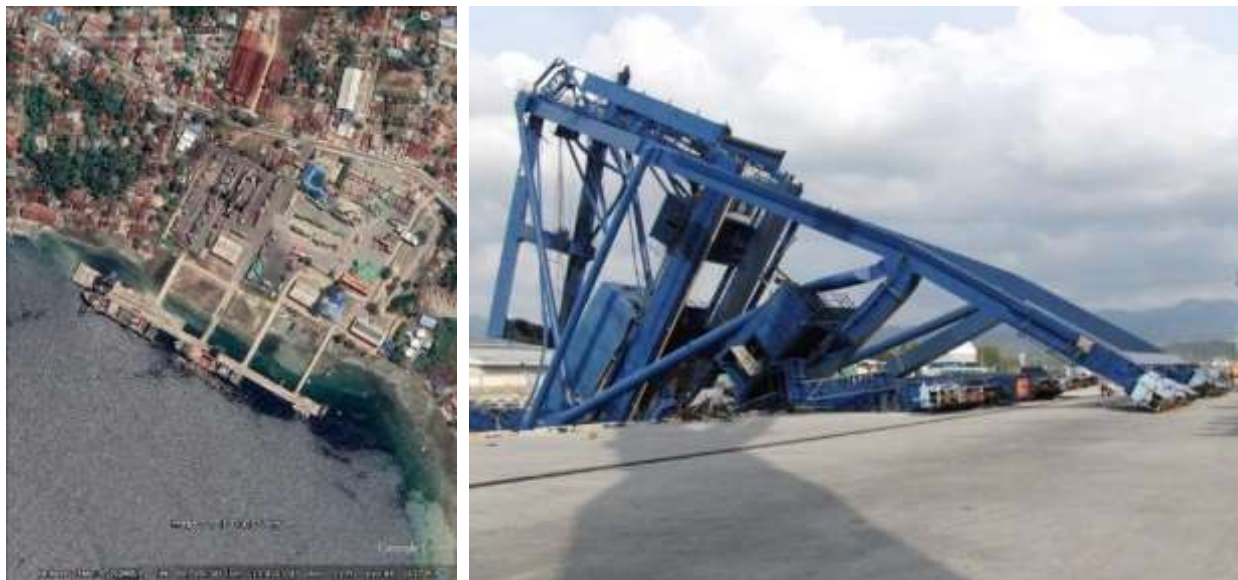
Figure 73: Google Earth image of the Port of Pantoloan before the earthquake and tsunami (left) and the collapsed gantry crane after the earthquake (right).

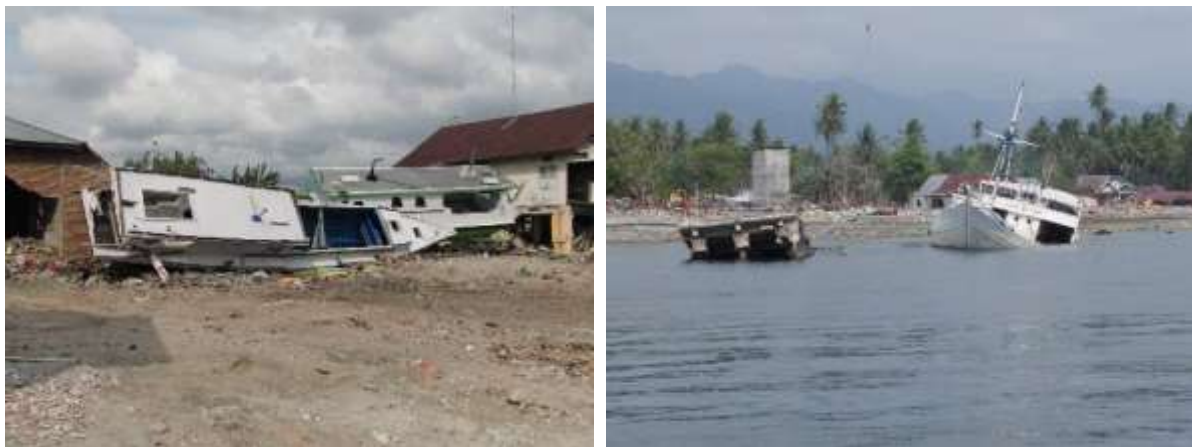
Figure 76: Ship impact with buildings (left) and broken pier and sunken ship (right) at Wani Port.

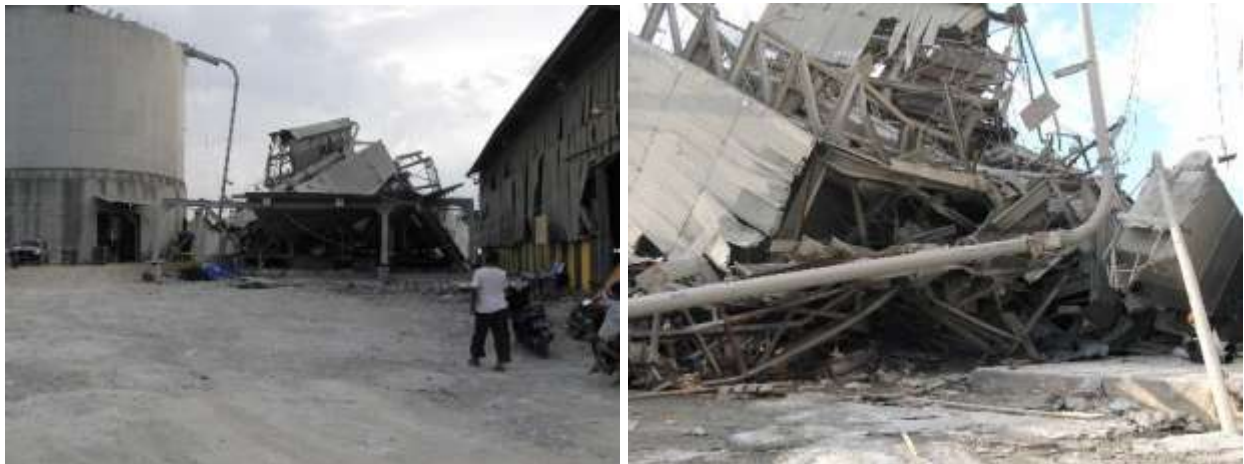
Figure 78: Collapse of steel-framed cement packaging building during earthquake.

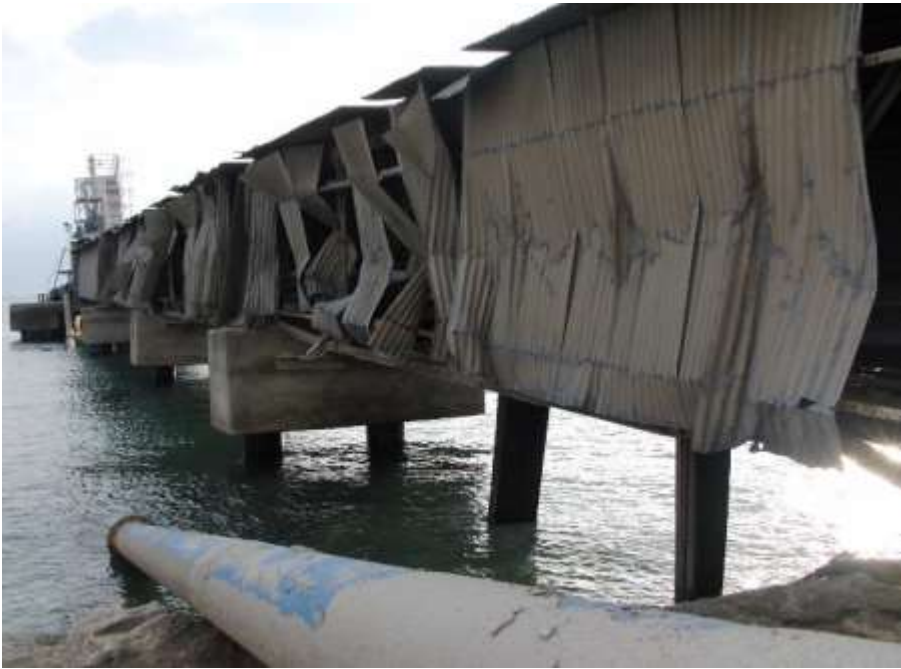
Figure 80: Hydrodynamic damage to sheet metal cladding on the pier supporting a conveyor belt for cement transport from ships to the silos.
