# StEER: Structural Extreme Event Reconnaissance Network

28 MAY 2019 EF4 TORNADO IN LINWOOD, KANSAS:  
FIELD ASSESSMENT STRUCTURAL TEAM (FAST)  
EARLY ACCESS RECONNAISSANCE REPORT (EARR)

**Released:** June 12, 2019  
**NHERI DesignSafe Project ID:** PRJ-2396

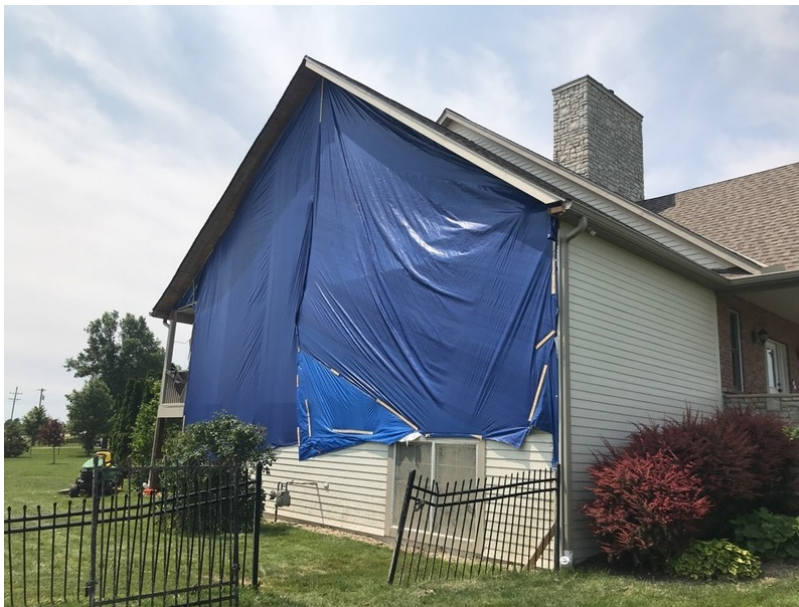
One interesting two-story single-family house was situated about 0.1 mile south of the tornado path in the Bear Lake neighborhood west of Bonner Springs, Kansas, where the tornado intensity was on the order of EF-2 or EF-3 ratings. The most striking aspect of the damage was that the structure was missing its easternmost wall (Figure 14). The westernmost wall of the home, which was oriented parallel to the roof trusses, was also bowed outward. Such damage implied that although walls perpendicular to roof trusses were laterally braced by the trusses, walls parallel to the trusses may not have been braced laterally along their lengths. It was also reported that the ceiling of a porch on the south wall of the house was bowed upward and that 2x4 framing supporting the porch ceiling exhibited shear-type failures.

**Figure 14.** Single-Family house missing east side of the wall.

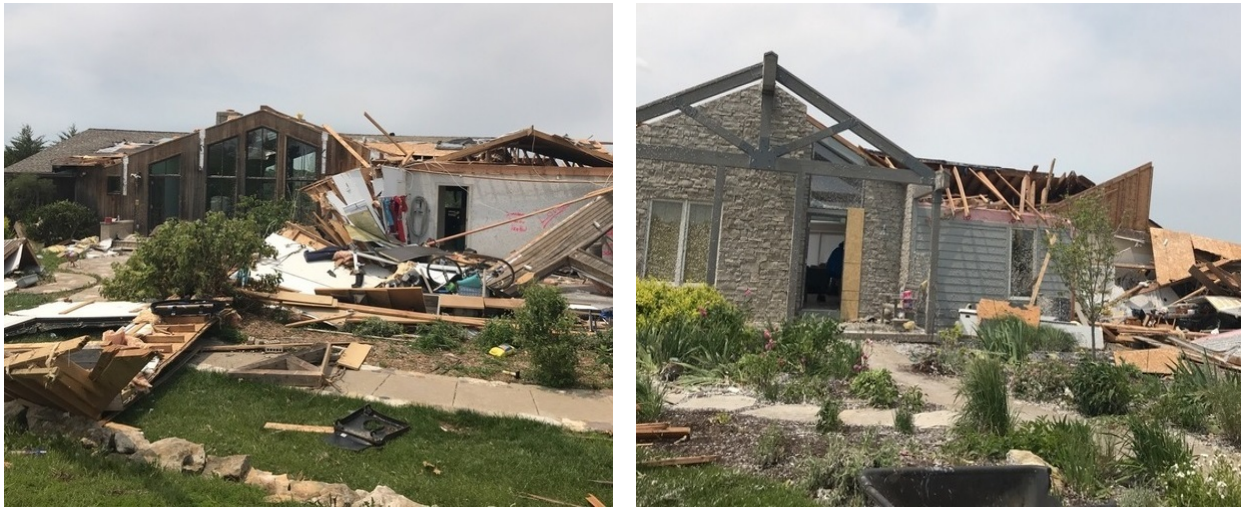
Figure 15 shows two other destroyed single-family wood-frame structures located in the Bear Lake neighborhood west of Bonner Springs, Kansas. The damage to these homes was attributed to wind damage. Roof structures, attached garages, and porches were the most severely damaged features of these homes. Photos in Figure 16 illustrate the effects of wind pressures on doors. One photo shows a bowed garage door, the other shows missing exterior and interior doors. The exterior door was dislodged with the door frame fractured and the interior door was dislodged with the entire frame separated from the surrounding wall. Residents survived the

tornado sheltering in the back of their walk-out basement. Incredibly, it was reported that a 20-lb barbell was found 25 feet from its original location.

**Figure 15.** Views of two destroyed single-family wood-frame structures in the Bear Lake neighborhood west of Bonner Springs, Kansas.

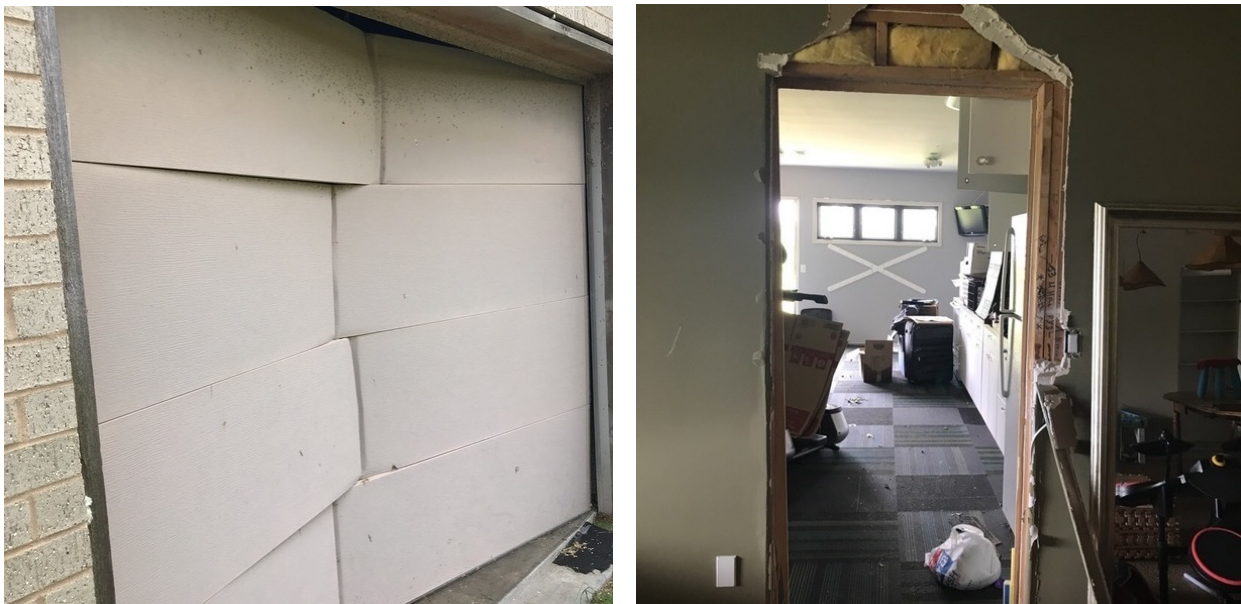
**Figure 16.** Damage to garage door (left) and interior house door (right).

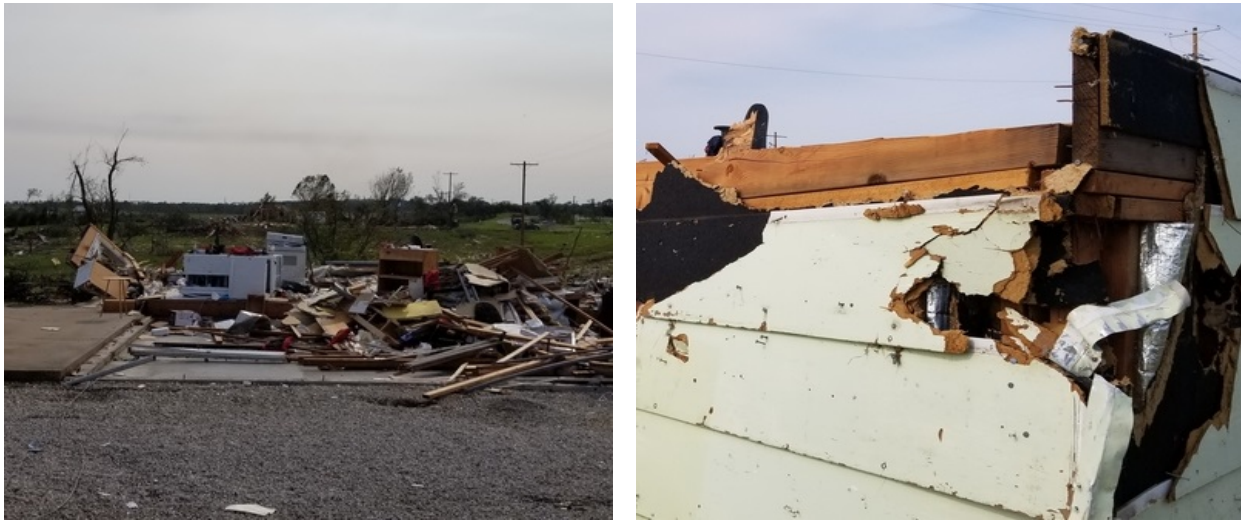
The most acute damage to structures occurred near Linwood, Kansas, where numerous structures sustained catastrophic damage. An example is shown in Figure 17, which provides photos of what was the front of a home and a close-up image taken of the back-side of the home where the first floor wall (missing) rested on the wall of the walk-out basement (shown). There was no evidence of anchors used to tie the framing of the first floor to the basement walls. Given the catastrophic nearby damage, it is not discernable whether proper anchorage of wall framing would have saved this home from destruction. However, lack of anchorage and roof-to-wall straps

were observed consistently with damaged wood-frame structures. Nailed connections were clearly not sufficient in resisting the uplift and lateral loads experienced by these structures.

**Figure 17.** Catastrophically damaged single-family structure in Linwood, Kansas. Photos of the front of the home (left) and the joint where the first-floor walls (missing) rested on the basement walls (right).

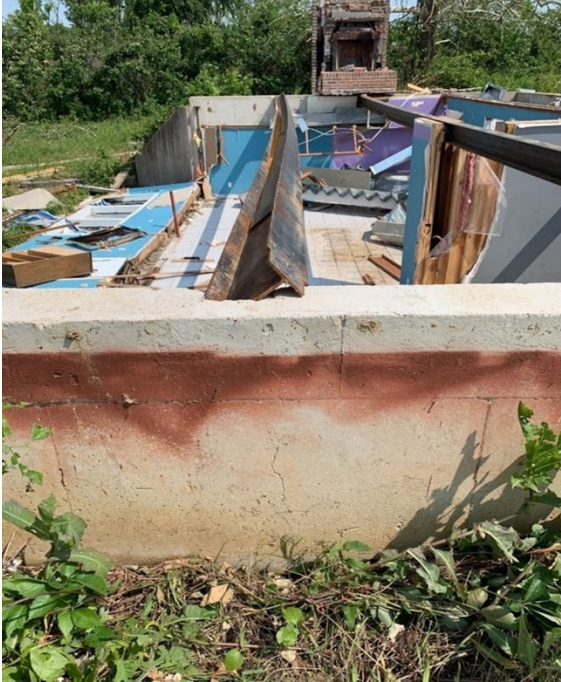
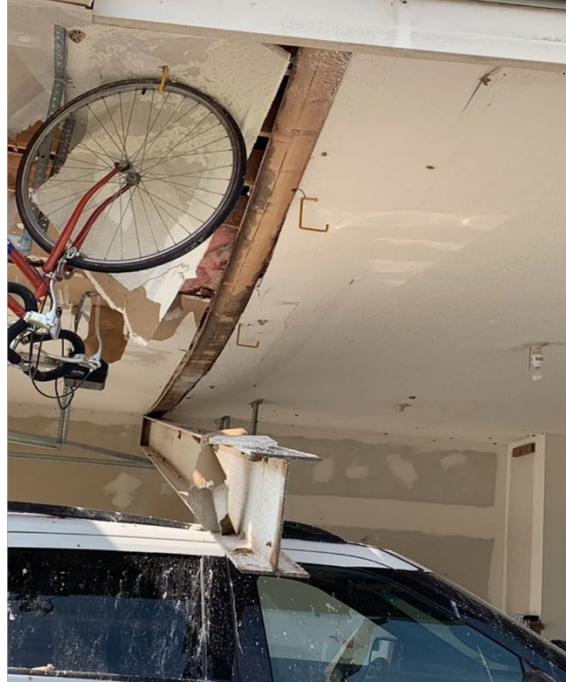
In addition to the lack of engineered connections and anchorage impacting the connection of wood members, several homes used steel beams for longer spans. Figure 18 depicts two cases where these steel beams were unrestrained and resting on the structure with no connection. The weight and additional gravity load on top of these steel beams is sufficient for typical gravity-load purposes, but was not sufficient in resisting the uplift and lateral loads experienced during the tornado. In the right image of Figure 18, the fallen steel beam resulted in vehicular damage. Following the topic of restraints, exterior columns, often on the front porch or on the front side of homes, often shifted during the tornado (see Figure 19).

**Figure 18.** Unrestrained steel beams.

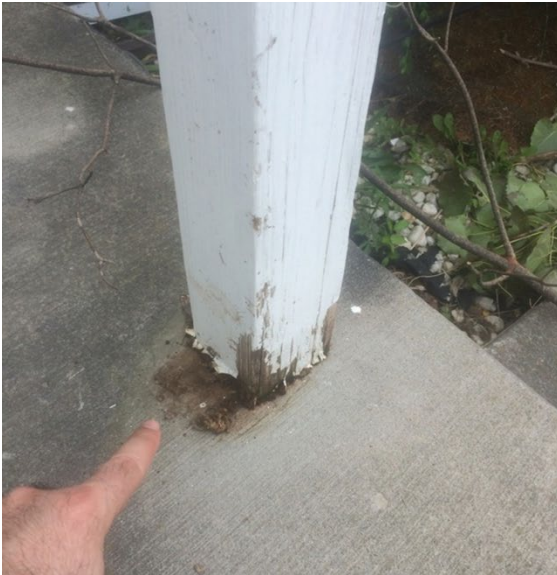
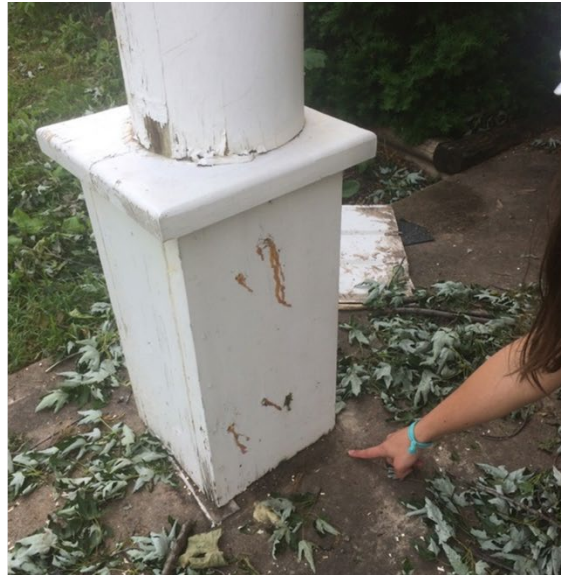
**Figure 19.** Shifted columns.

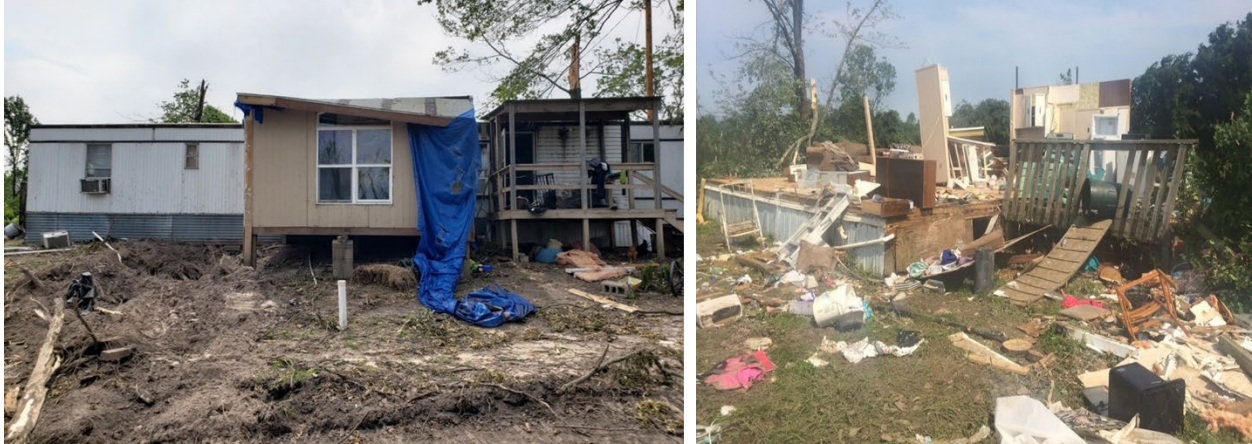
Fortunately there were not many manufactured (mobile) homes along the tornado's path as these structures are particularly known for high physical vulnerability. Of the manufactured homes captured in the study, severe to complete damage was observed as shown in Figure 20.

**Figure 20.** Severely damaged manufactured home (left) and completed destroyed manufactured home (right).

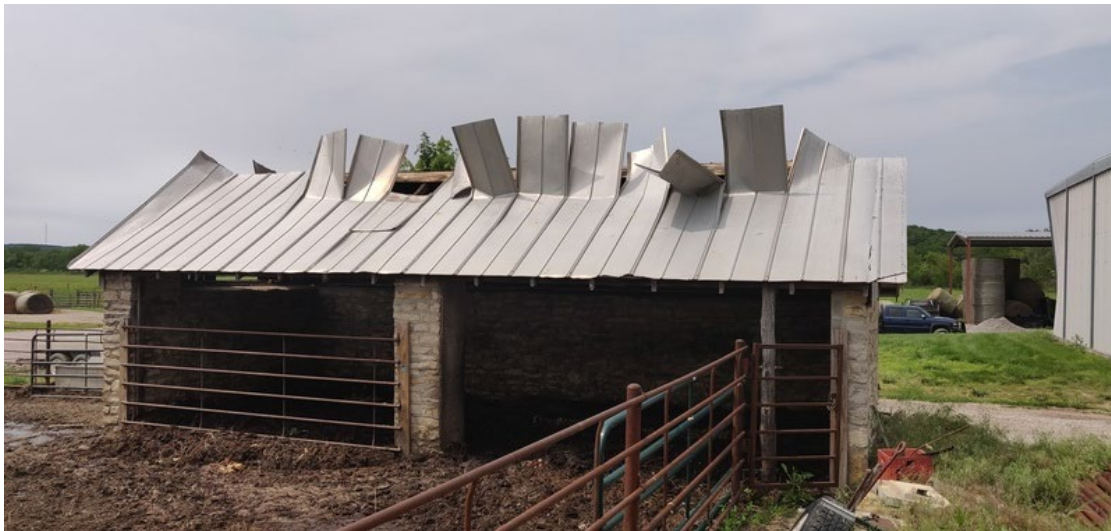
Some common types of damage to auxiliary structures include uplifting of metal roofs (Figure 22), bending of metal walls (Figure 23), damage to doors (Figure 24), and loss of roof shingles. Damage due to tree-fall on the structure was also observed.

**Figure 22.** Metal roof exhibiting uplift damage.

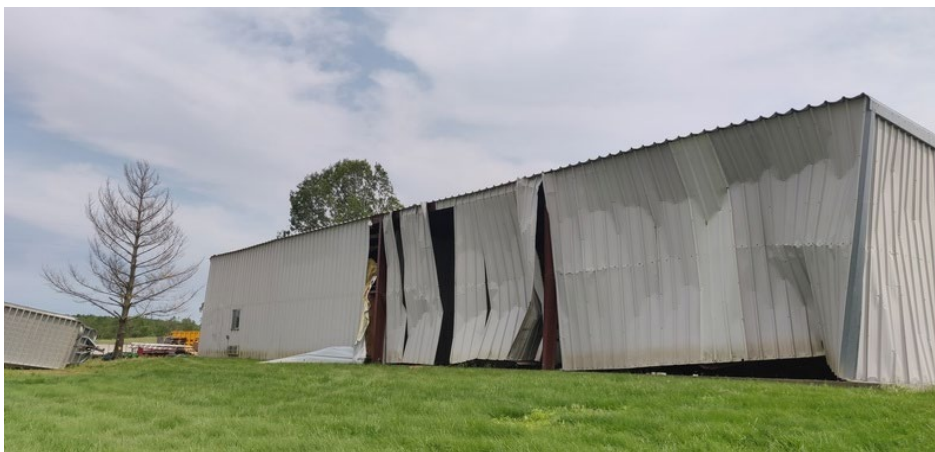
**Figure 23.** Damaged metal building envelope.

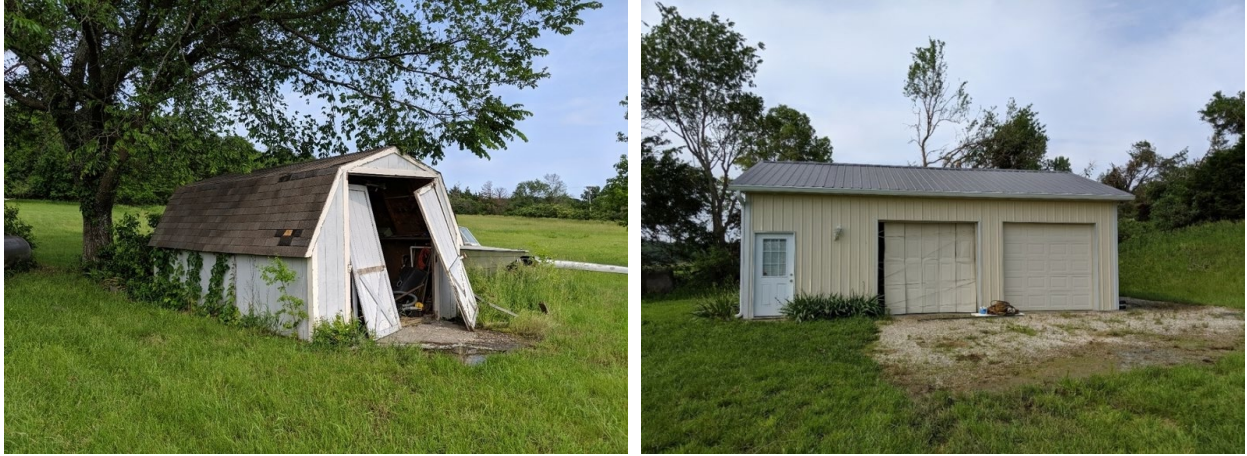
**Figure 24.** Damaged shed door (left) and garage door (right).

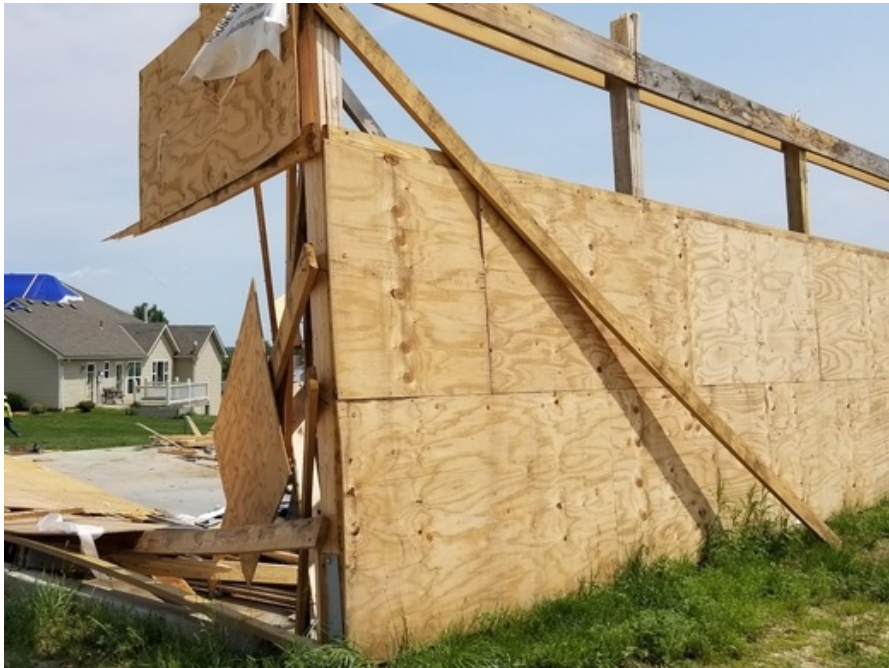
Although several damaged structures showed evidence of sub-optimal construction, some well-constructed buildings were also damaged. Figure 25 shows the remains of a well-constructed (and recently completed) detached structure serving as a barn and garage. The photo shows what remains of the western-most wall, which consisted of sandwiched 2x6 columns anchored to a concrete foundation and well-attached plywood sheathing. This structure, located between Linwood and Bonner Springs, Kansas, was directly in the path of the tornado.

**Figure 25.** Remains of a relatively well-constructed barn located between Linwood and Bonner Springs, Kansas.

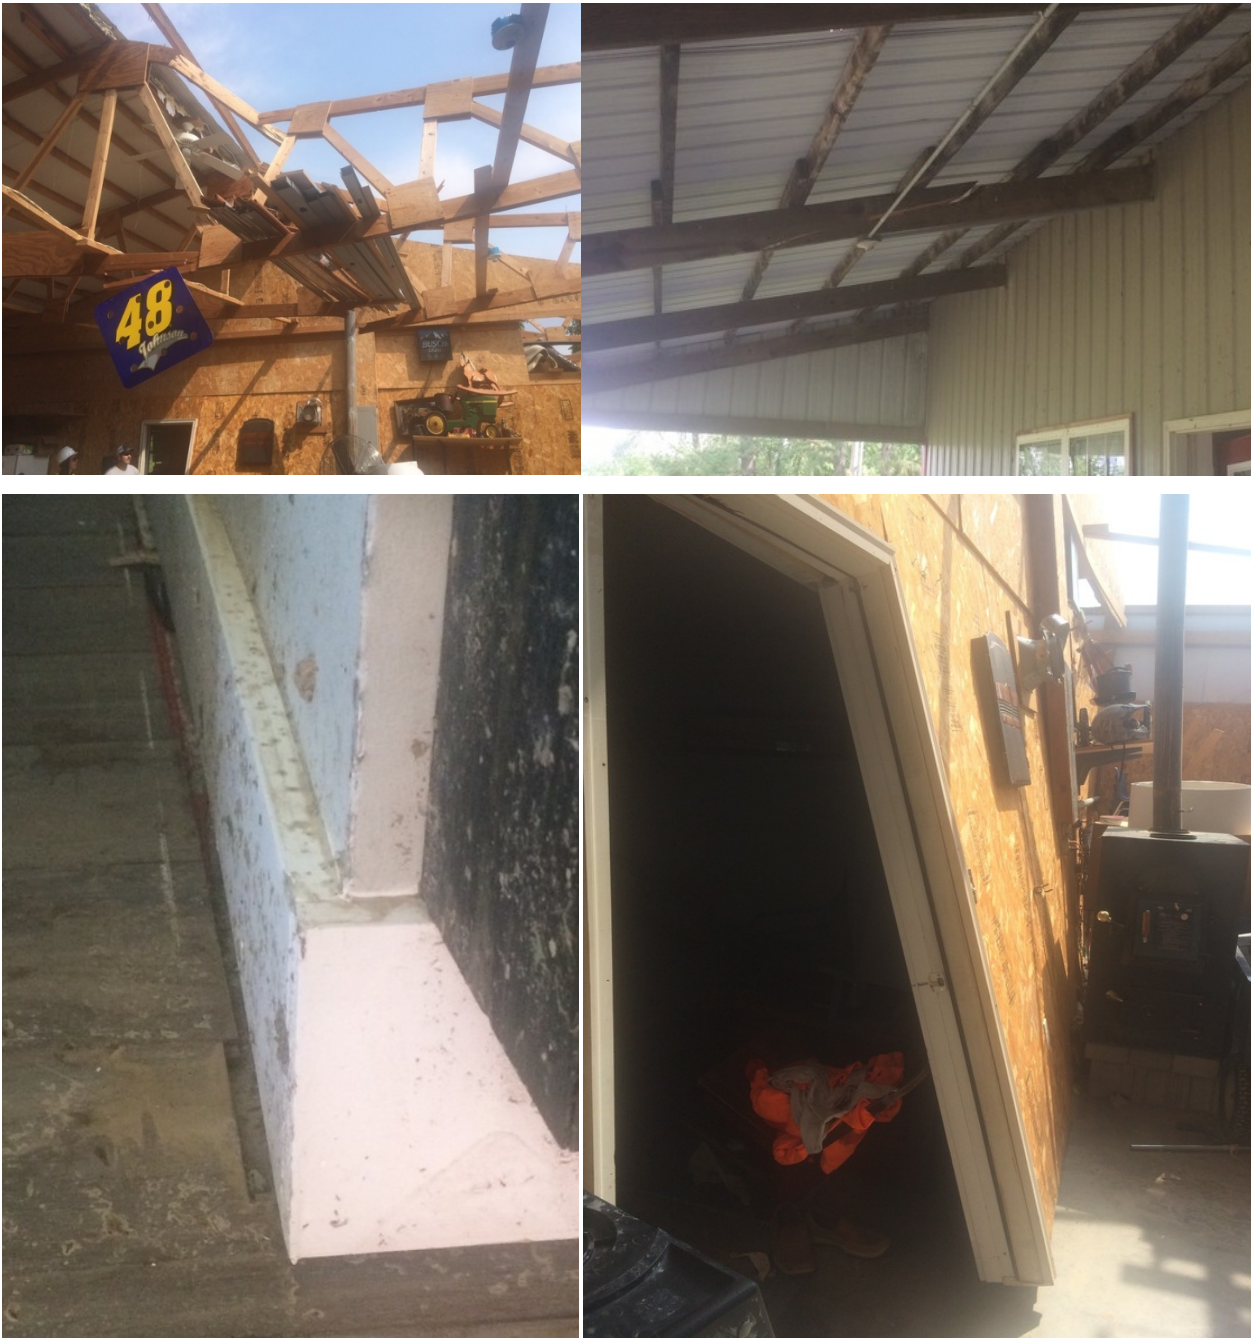
wider support spacing and weaker exterior sheathing likely led to the catastrophic damage that included large holes in the roof, split roof rafters, and severely moved interior walls.

**Figure 26.** Residential auxiliary structure with severe roof loss (top left), split roof rafters (top right), shifted interior walls (bottom left), and uplifted and released interior walls (bottom right).

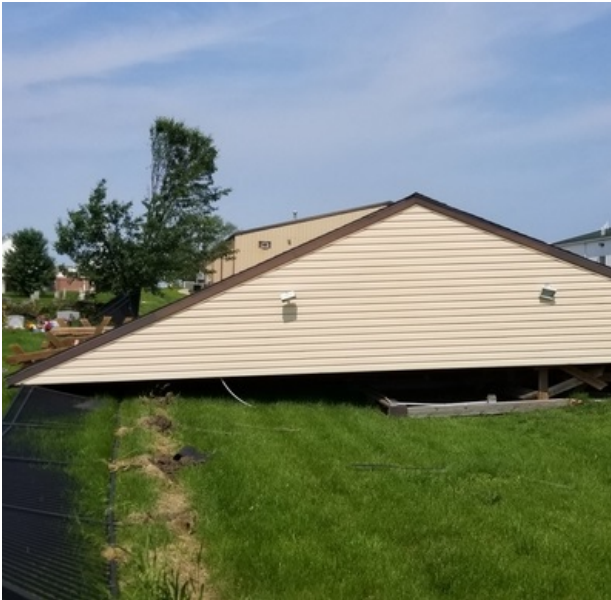
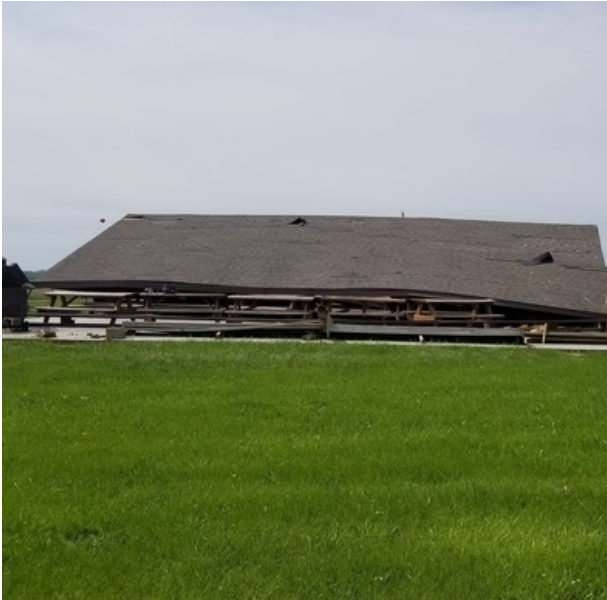
**Figure 27.** Picnic shelter at Elm Grove Baptist Church.

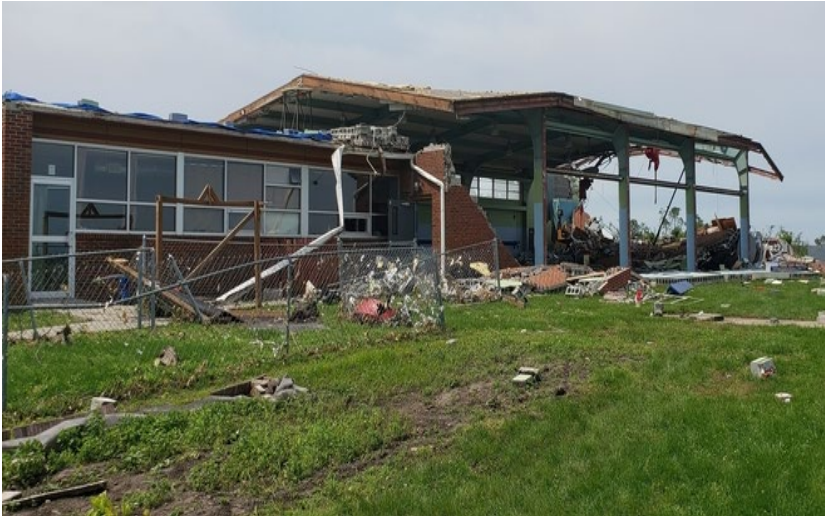
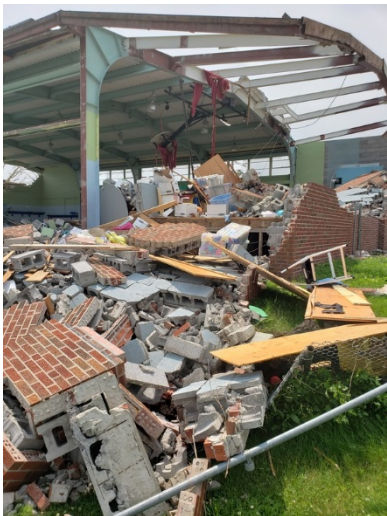
5. Unreinforced masonry buildings also continue to be particularly vulnerable. The Building Blocks Day Care was completely destroyed; should the tornado have occurred during typical workday hours, this structural failure could have resulted in injury and death for many small children.

**Figure 28.** Building Blocks Day Care.

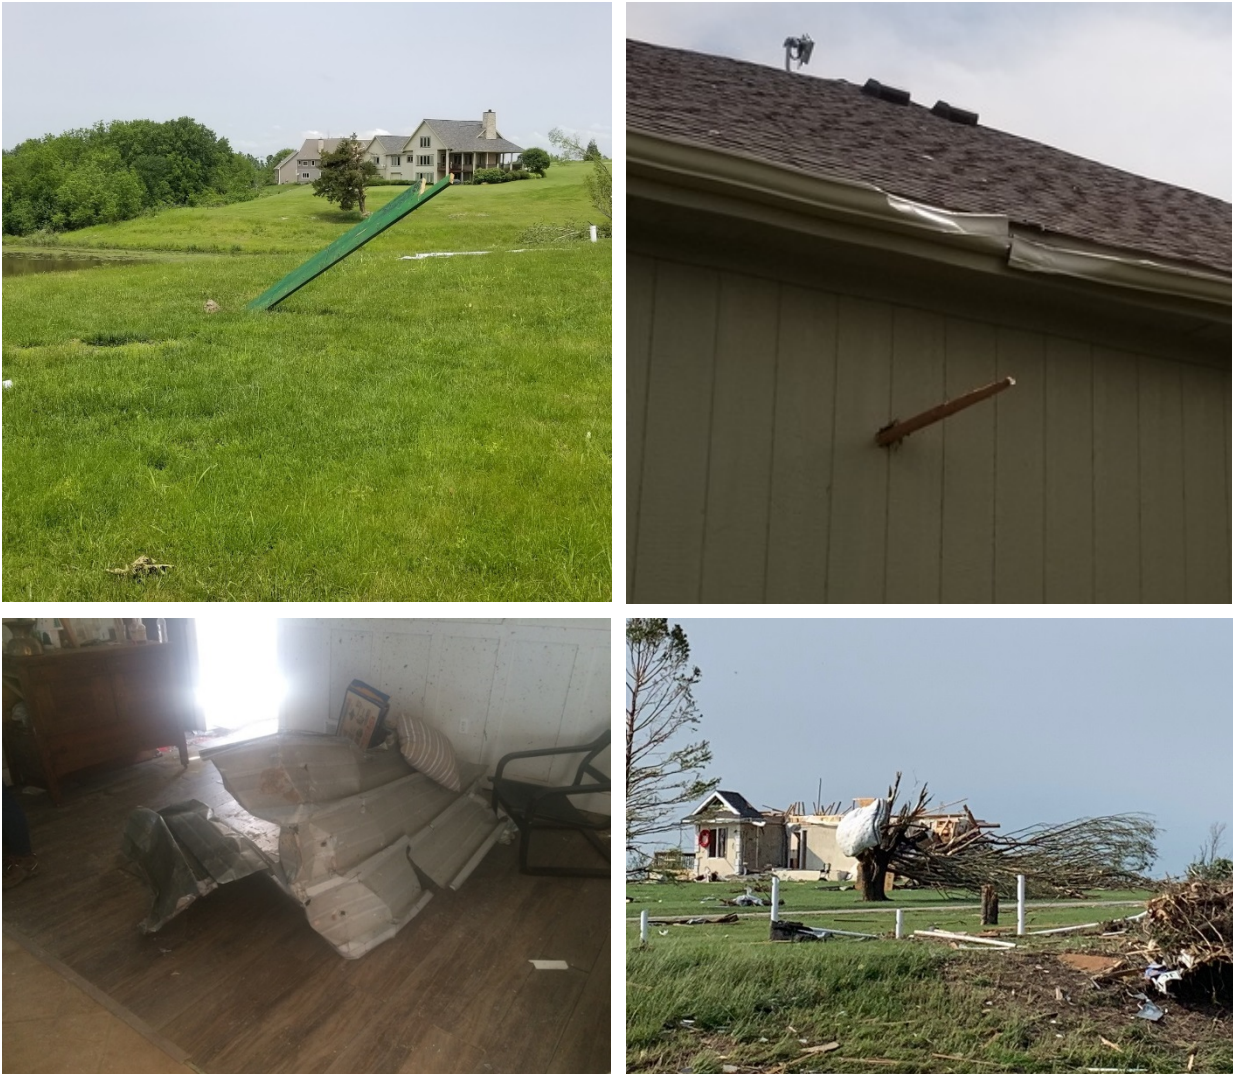
Considerable evidence of wind-borne debris was observed throughout the area affected by the tornado, with debris reportedly being found 50 miles from path of the tornado. Examples of large missiles impacting the ground or structures are shown in Figure 29.

**Figure 29.** Wind-borne debris: 2 x 18 in. lumber embedded in soil (top left), 2 x 4 in. lumber embedded in exterior wall of wood-frame home (top right), siding from auxiliary structure inside neighbor's residential structure (bottom left), mattress stuck in tree (bottom right).

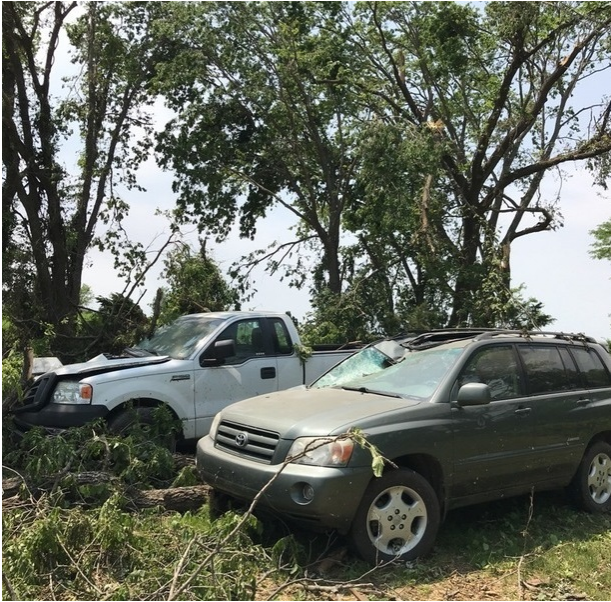
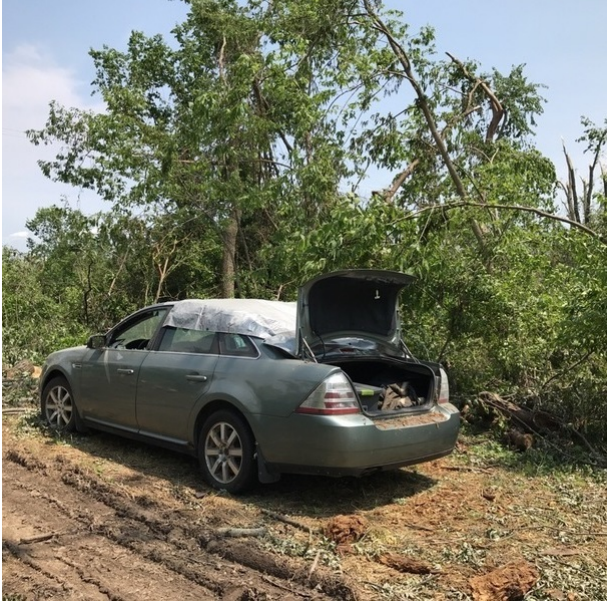
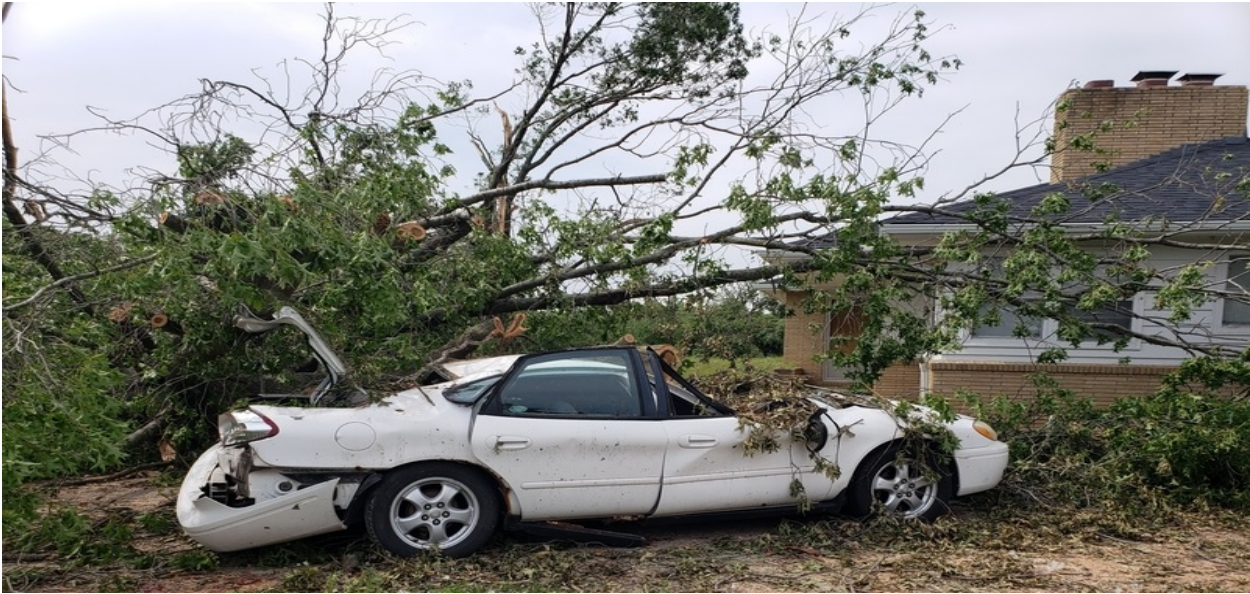
A number of tree-damaged vehicles were found parked near single-family wood structures that experienced major to severe destruction (Figure 30). Most tree-damaged vehicles had shattered windshields or other evidence of wind-borne debris damage, parts of trees resting on the vehicle, or completely collapsed roofs. Several vehicles overturned or relocated by the tornado were also

**Figure 30.** Tree-damage to vehicles.

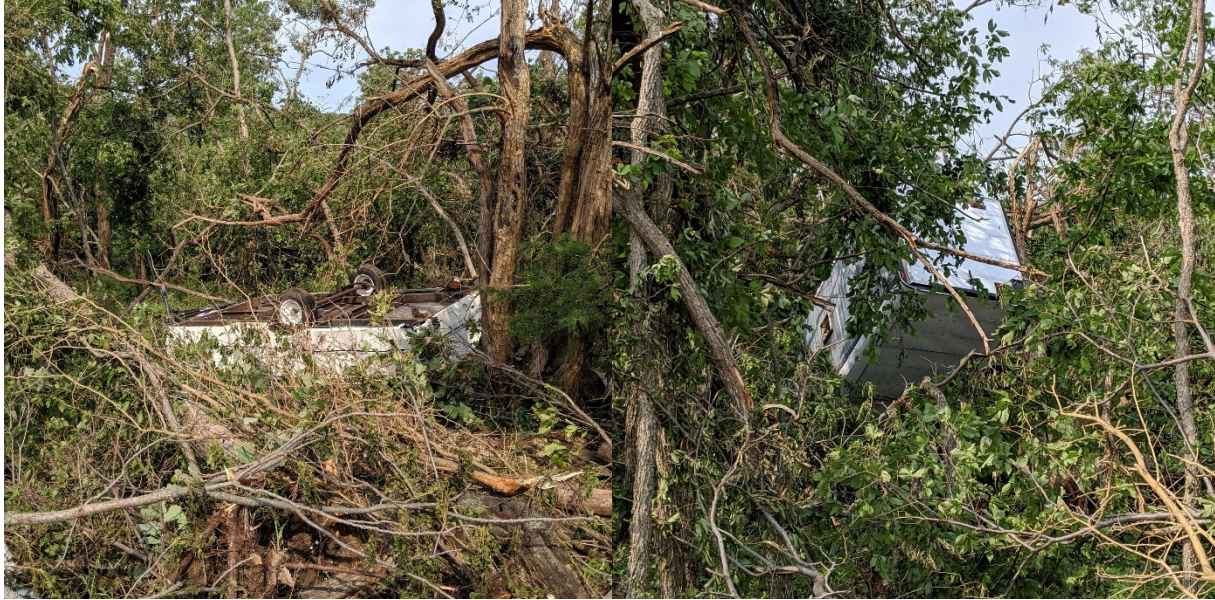
**Figure 31.** Vehicles overturned or relocated by the tornado.

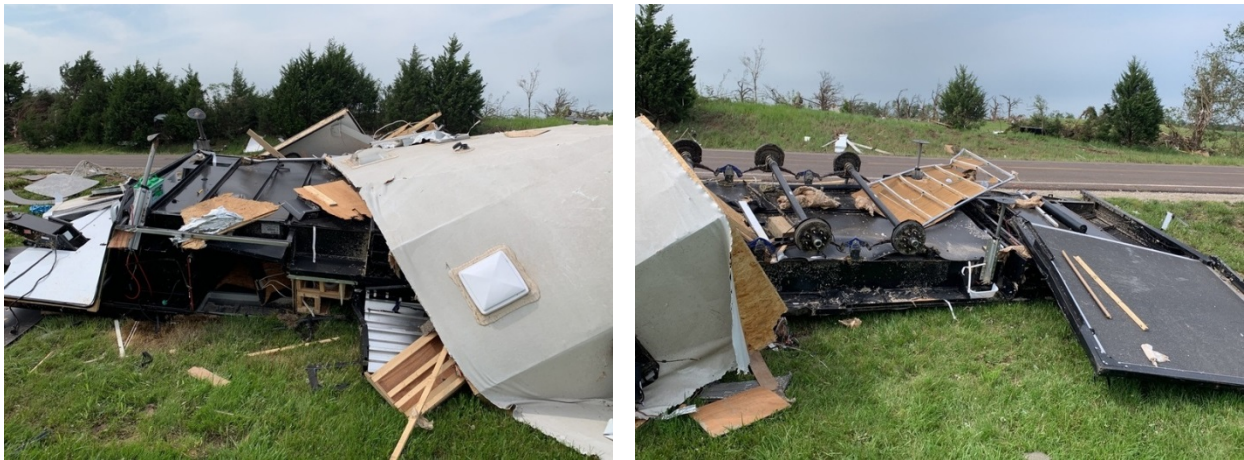
observed (Figure 31). In one case, a recreational vehicle had exploded, similarly to damage observed to older manufactured homes (Figure 32).

**Figure 32.** Exploded recreational vehicle (RV).

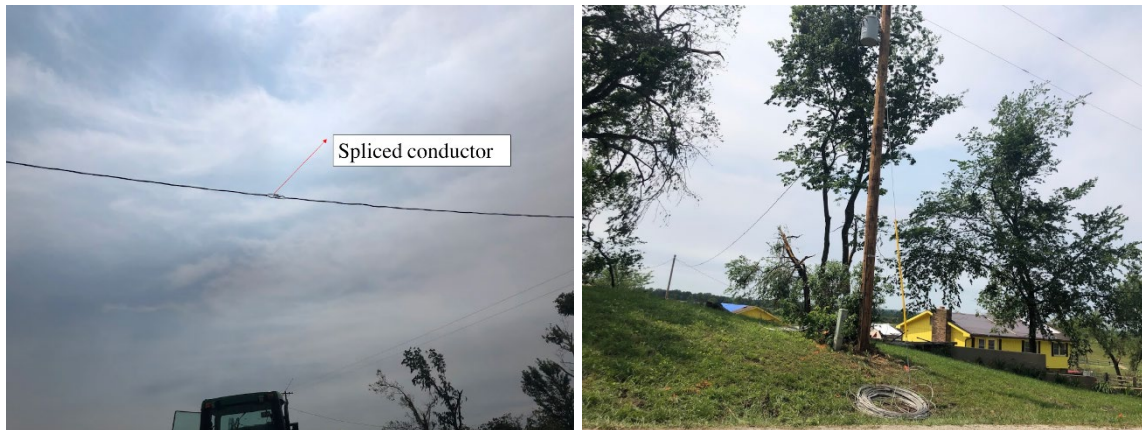
**Figure 33.** Recovered local power distribution structures: repaired conductor lines (according to the resident) (left); and a reinstalled power pole (right).

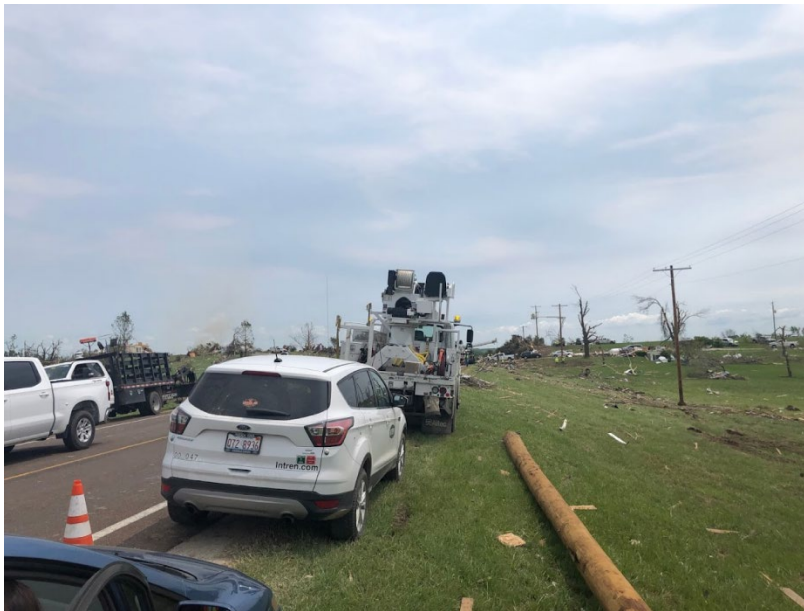
A limited number of failed electric power structures were documented during the survey. As mentioned earlier, this survey was performed three days after the tornado, and notably, repair on the electric power network (EPN) infrastructure was on-going. Figure 33 provides an image of two types of EPN failures, namely a repaired conductor and pole structure that failed during the tornado near Lawrence. A brief conversation with the residents indicated that the power was restored in one day near that location. Figure 34 illustrates a timber pole that was to be installed near Linwood, KS. Based on a short discussion with repair crew, the wood pole was chemically processed to prevent decay in service.

**Figure 34.** An electric wood pole in-place ready for reinstallation. Also captured in this photo is the linear array of poles, which were all destroyed during the tornado and reinstalled rapidly by Kansas City Power and Lights (based on information from crew member).
