**StEER**  
**STRUCTURAL**  
 EXTREME EVENTS  
 RECONNAISSANCE

**Aegean Sea Earthquake**  
 30 October 2020  
 Released: November 14, 2020  
 NHERI DesignSafe Project ID:  
 PRJ-2953

## PRELIMINARY VIRTUAL RECONNAISSANCE REPORT (PVRR)

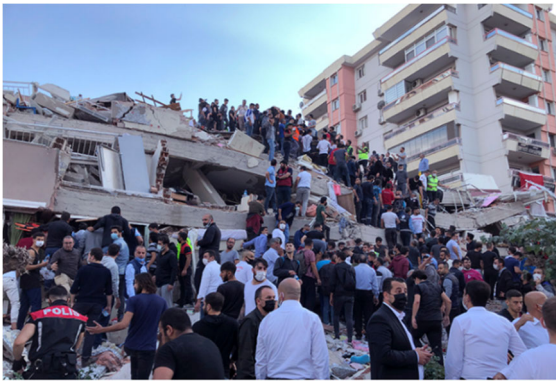
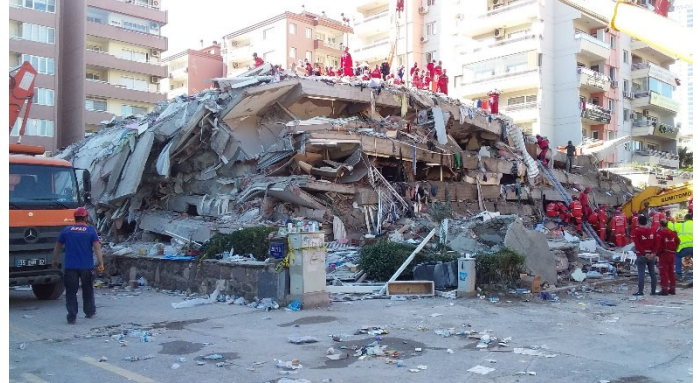
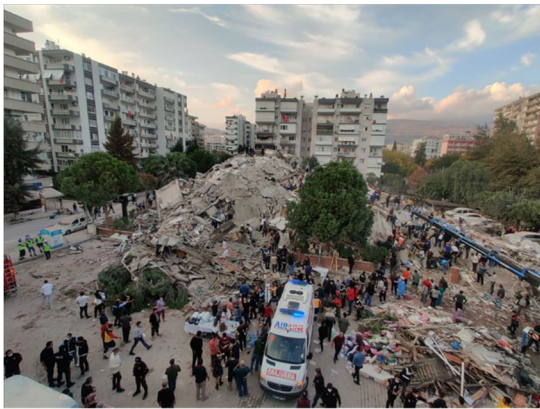
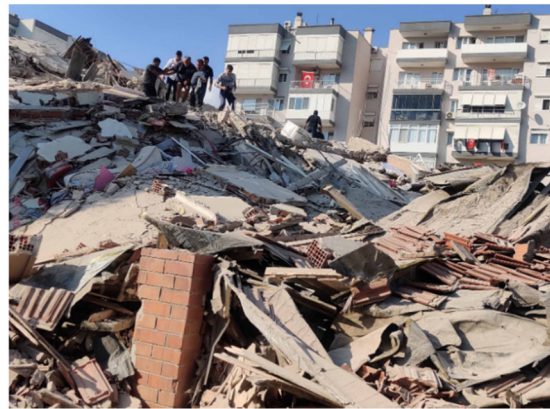
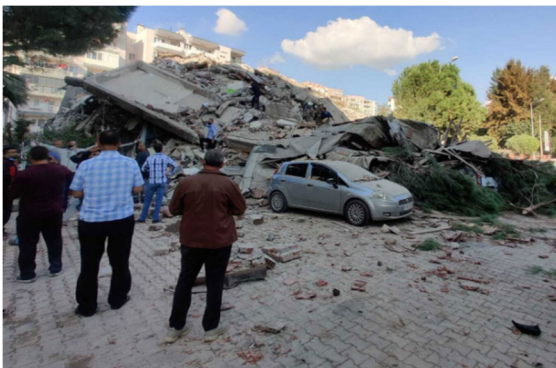
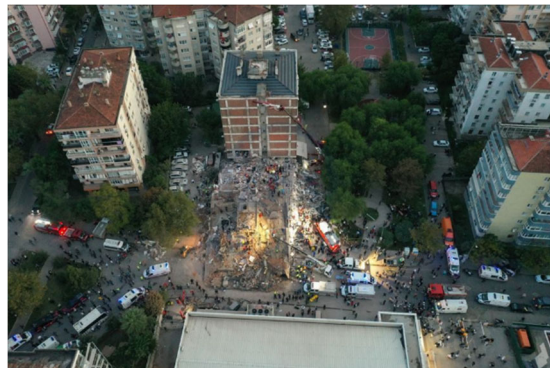
**Figure 15.** Images from collapsed buildings in Bayrakli district of Izmir (CNN, 2020; AA, 2020).

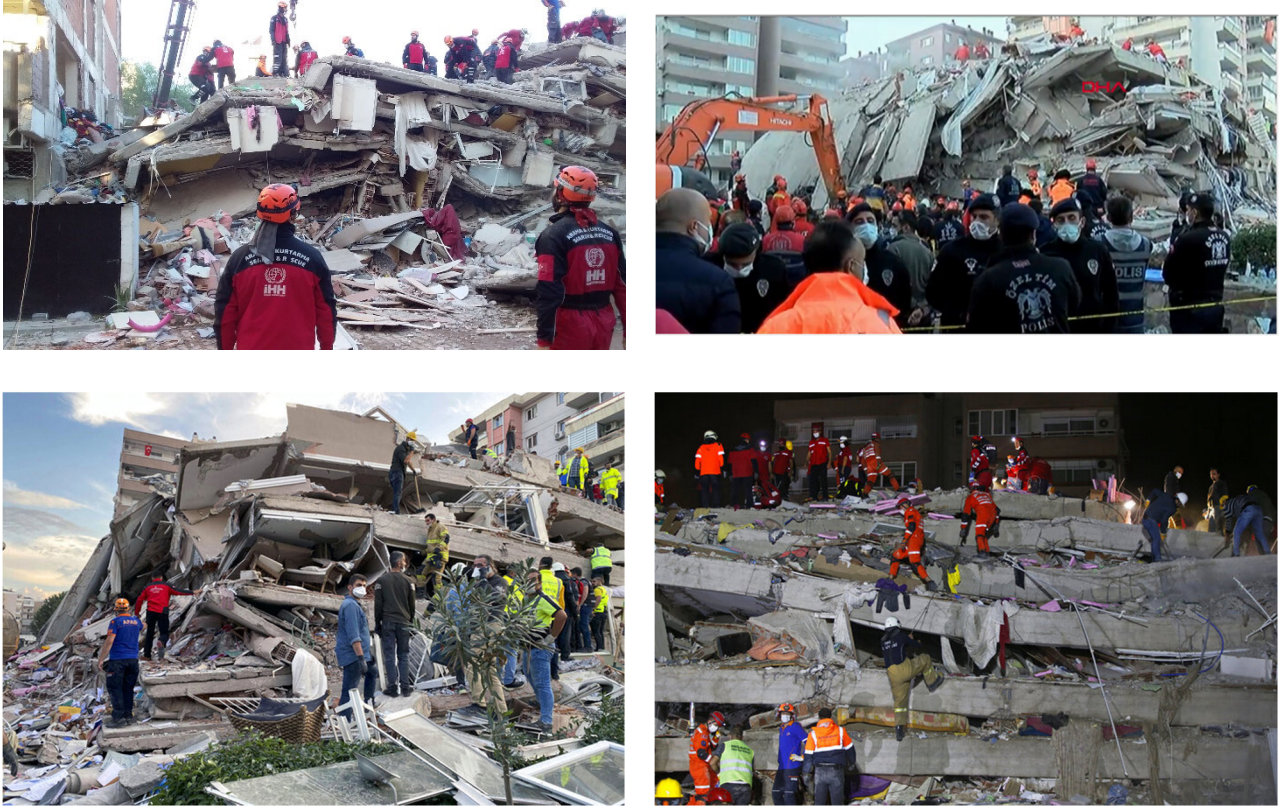
**Figure 16.** Images from gravity (pancake) collapse of buildings in Bayrakli district of Izmir (CNN, 2020; AA, 2020; AP, 2020; BBC, 2020).

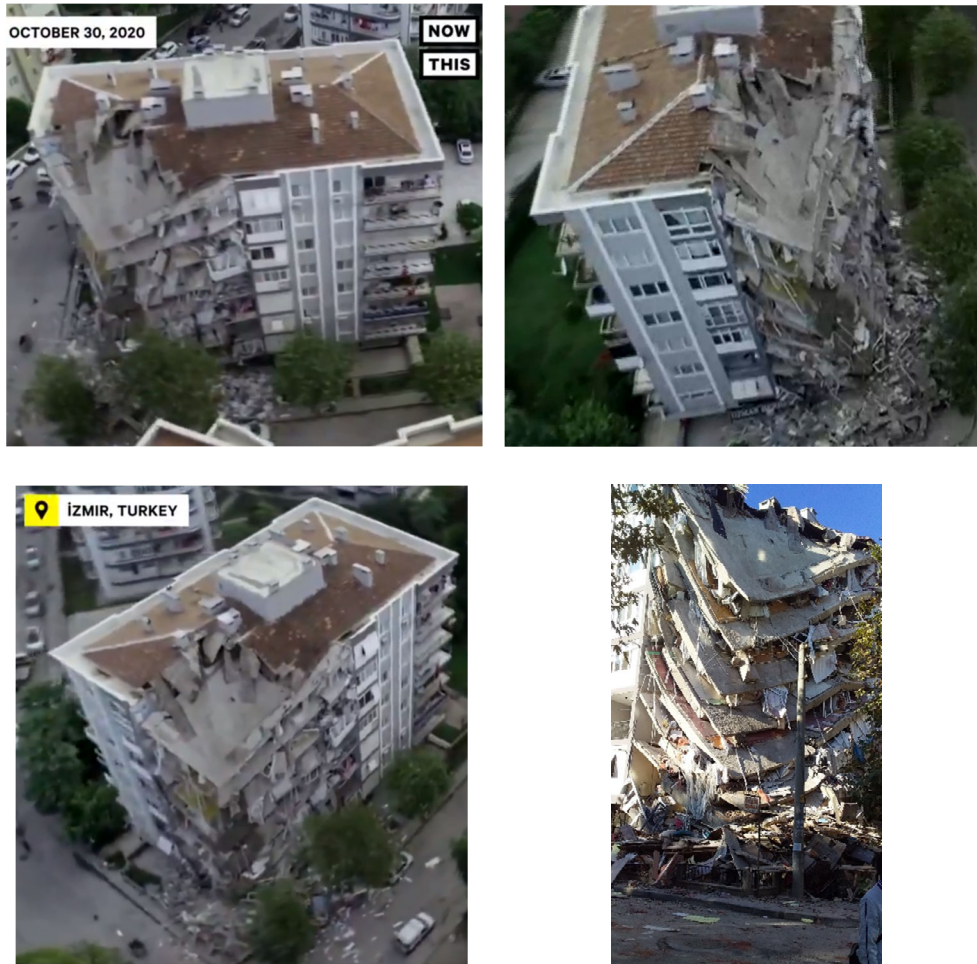
Several partial collapses were also observed as shown in Figures 17-20. In one of these examples (Fig. 17), a quarter of an eight-story building with a rectangular plan collapsed. It is likely that this failure started from the corner columns at the collapsed location because of the increased axial forces due to the overturning moments acting along both horizontal axes of the building. These large axial forces' interaction with biaxial bending could have started a partial collapse initiated by one of the lower story corner columns. Although there is no visible plan irregularity, it is also possible that the increased shear failures due to accidental torsional eccentricity or any other torsion irregularity not visible from the photographs in Figure 17 could have led to a column failure. Fortunately, the collapse progressed along only a quarter of the building and did not lead to a full collapse, which indicates the presence of sufficient redundancy and redistribution capacity in the structural system. Figure 18 illustrates a similar partial collapse of one side of a building. Figure 19 documents another partial collapse, which led to failure of the bottom three stories, resulting in a rigid body tilting of the remaining

**Figure 17.** Eight-story building partial collapse in Manavkuyu area, Bayrakli district, Izmir (Twitter, 2020; Fox19, 2020).

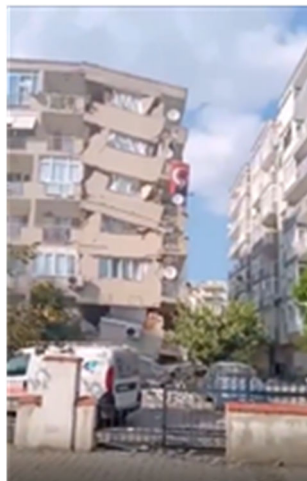
**Figure 18.** Partially collapsed Karagul building in Manavkuyu area, Bayrakli district, Izmir (Hurriyet, 2020).

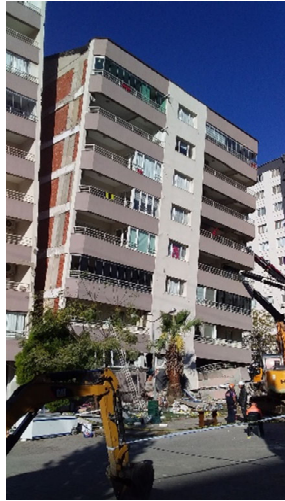
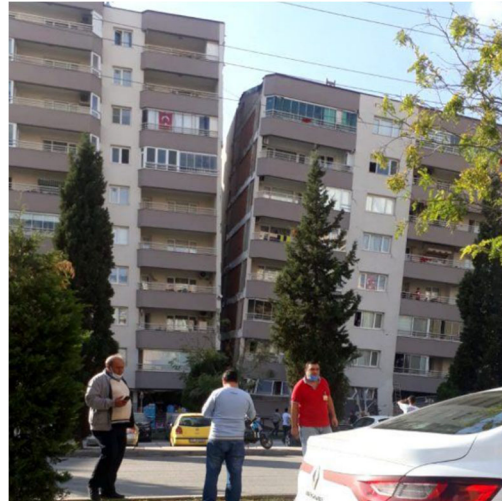
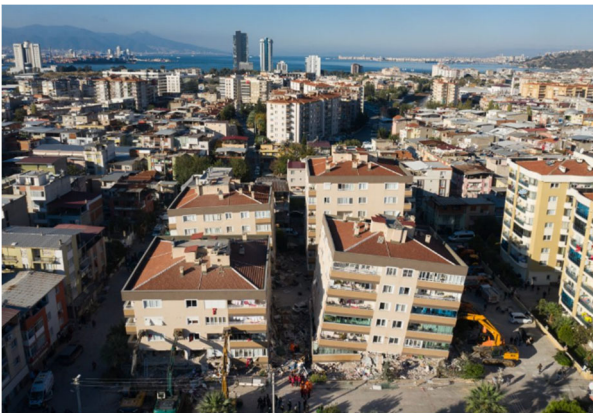
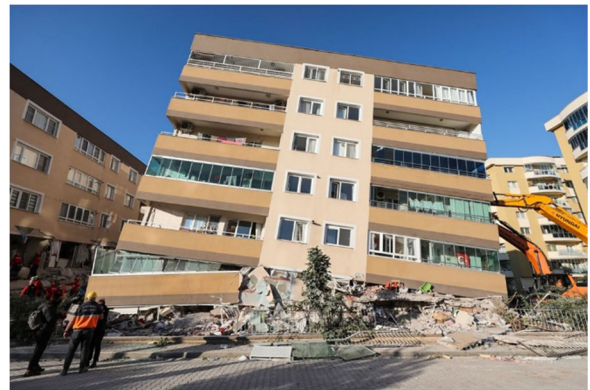
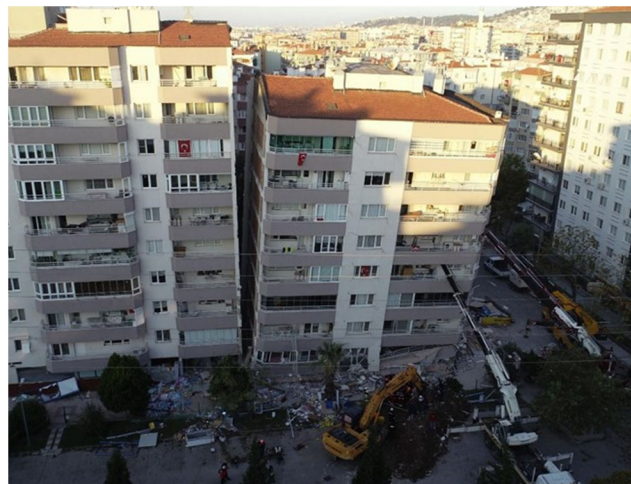
**Figure 19.** A partially collapsed building in Bayrakli district of Izmir, where first three floors above the ground collapsed (Twitter, 2020b; Haber7, 2020; Fanatik, 2020).

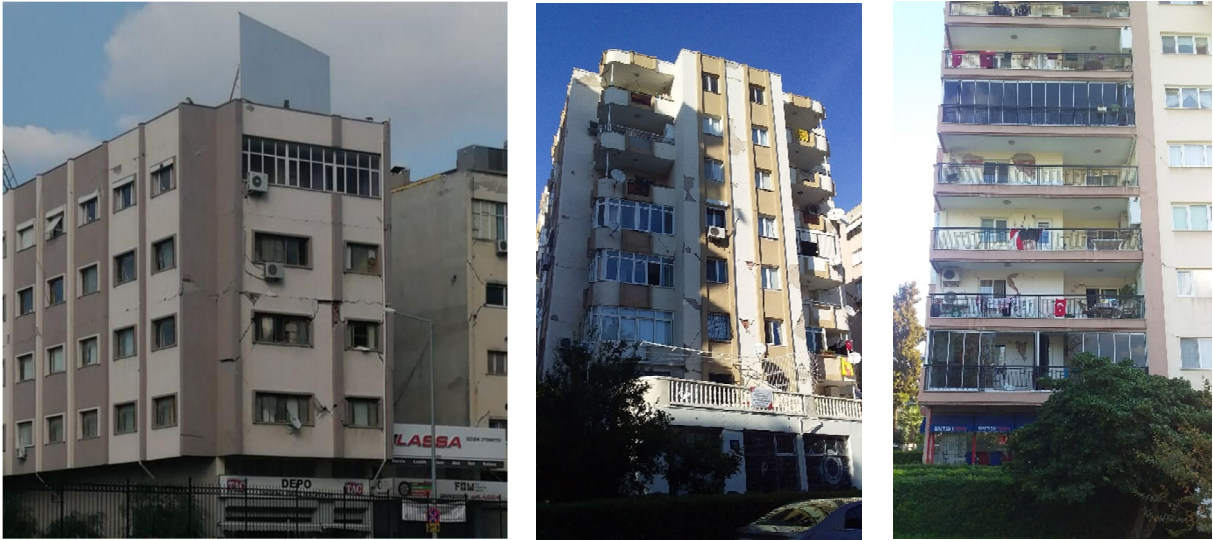
In those buildings that did not collapse, common reported damage included in-plane diagonal and horizontal cracking of hollow clay masonry infill walls (Fig. 20). It is noted that several tall buildings, designed according to the current TBSC (2018) and currently under construction, performed well.

**Figure 20.** Damage in building façades (CNNTurk, 2020).

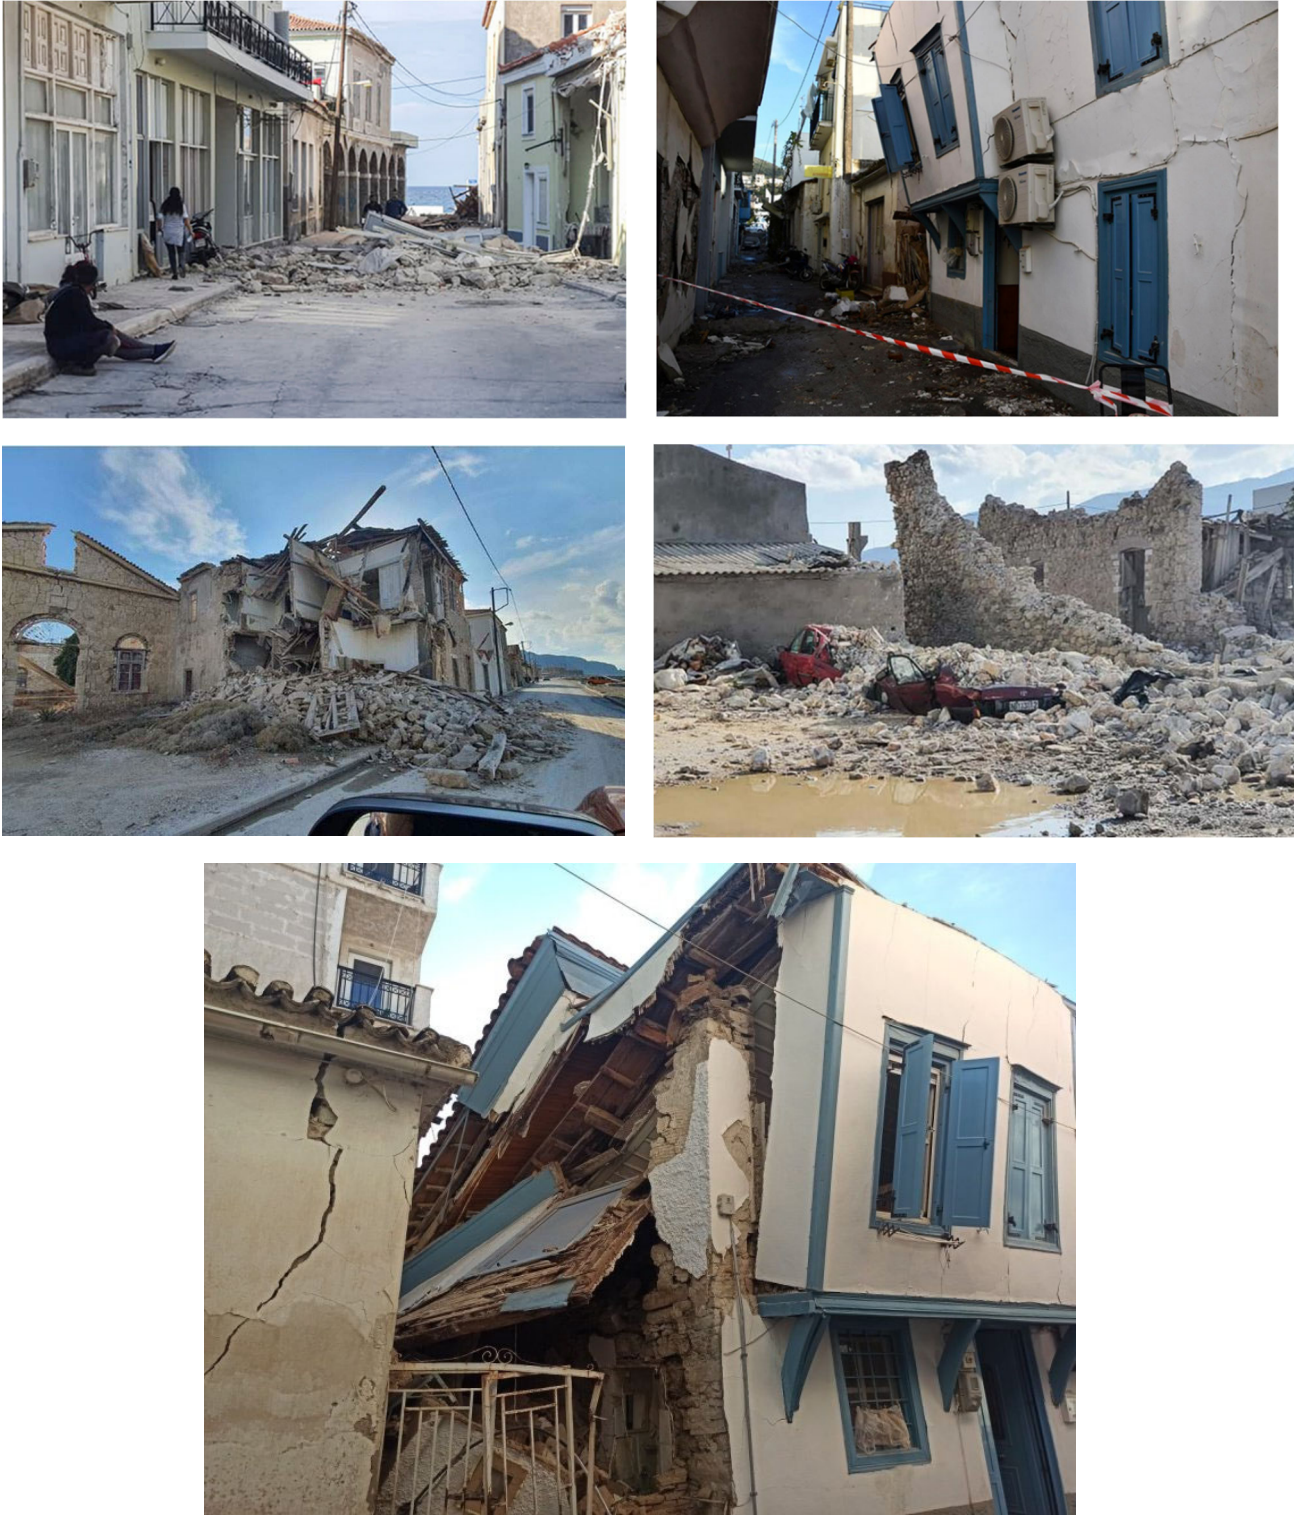
Most damage in Greece was reported in older masonry and adobe houses in the towns of Pythagorio, Karlovasi and Vathy on Samos island (Fig. 21). Well-maintained masonry buildings generally performed in an acceptable way, with minor to moderate damage resulting from expected modes of failure. Part of the Church of the Assumption of the Virgin Mary in Karlovasi also collapsed, fortunately while no one was inside. Reinforced concrete buildings demonstrated satisfactory structural performance.

**Figure 21.** Damage to masonry and adobe houses on Samos island, Greece (CNN, 2020).

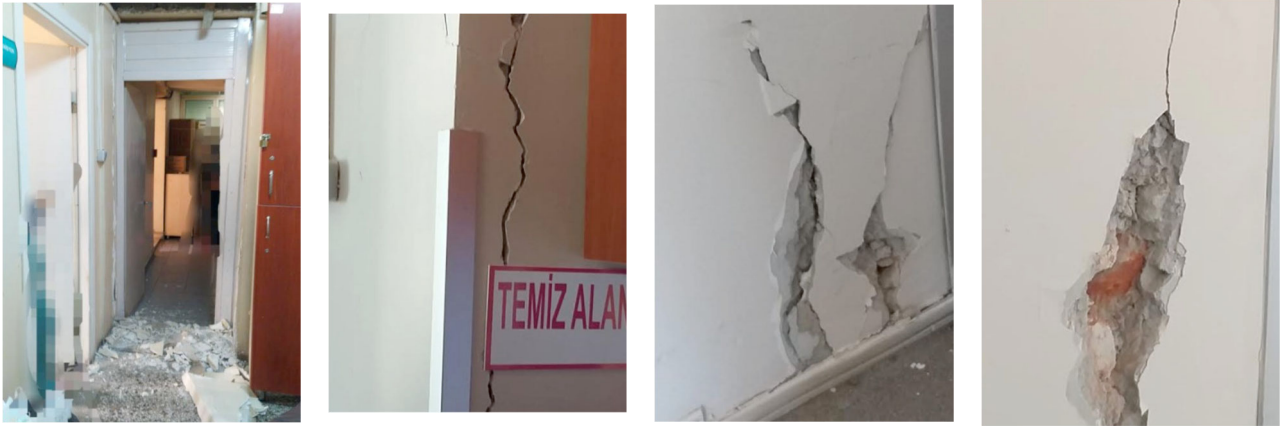
Patients in Buca Seyfi Demirsoy hospital in Izmir (Fig. 22) were evacuated because of damage to the hospital (GlobalNews, 2020). Similar damage was observed in several other hospitals around Izmir. Base isolation of hospitals in seismic regions is required by law in Turkey to provide functionality and continued operation after earthquakes. Notably, base-isolated Turkish hospitals performed well during the 6.7 Mw Elazig earthquake in 2020 (Günay et al., 2020). Unfortunately, the hospitals damaged in this earthquake were designed and built before this law came into effect. Damage and evacuation of the Buca Seyfi Demirsoy hospital thus demonstrated the importance of requiring base isolation for hospitals.

**Figure 22.** Fallen debris and damage observed in the interior walls of the Buca Seyfi Demirsoy hospital in Izmir (Haberek, 2020; Oda TV, 2020).

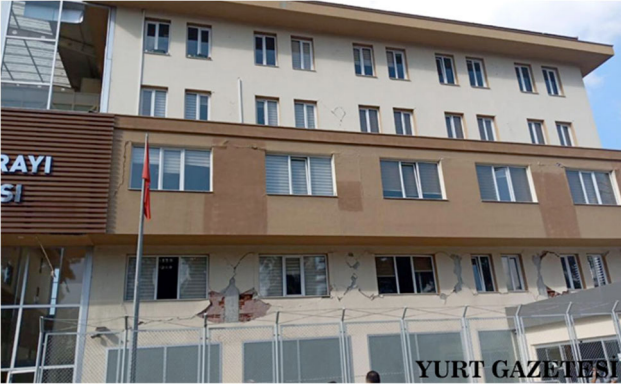
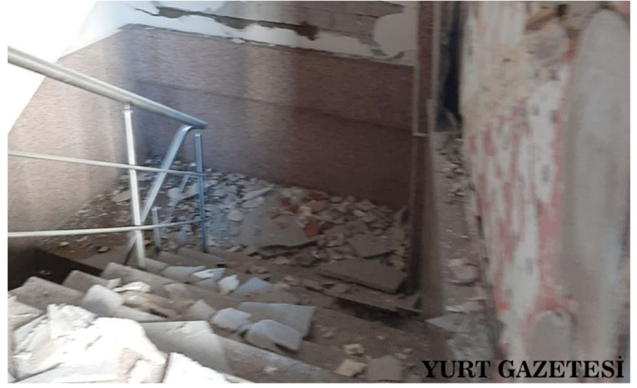
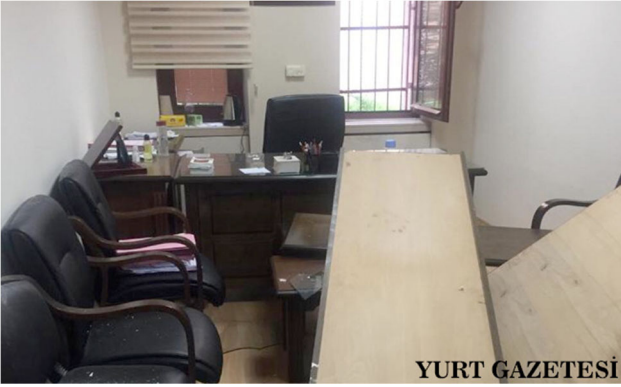
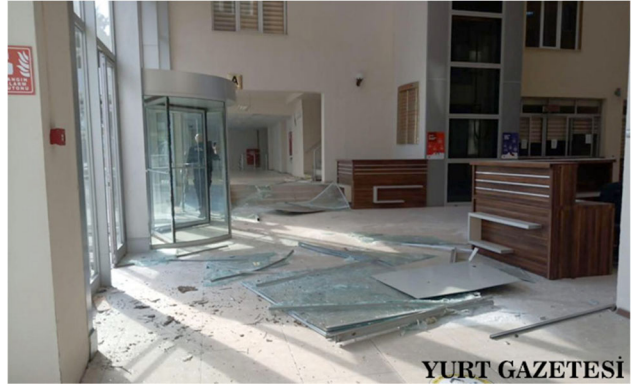
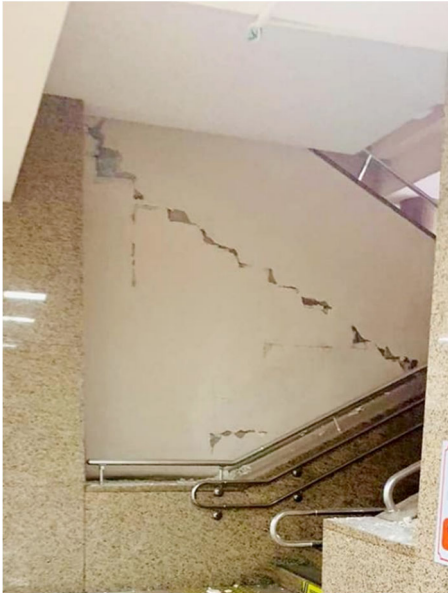
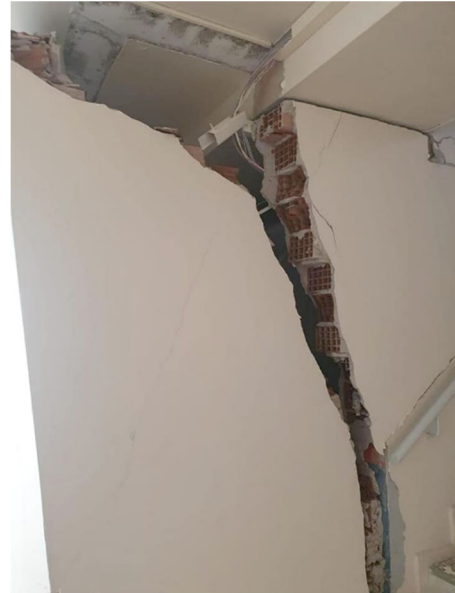
Nonstructural damage was observed in the windows, exterior and interior infill walls and staircases of the Courthouse in Izmir. Several of these nonstructural damages are shown in Figure 23 (Yurt Gazetesi, 2020). Although such damage is not significant from structural point of view, they cause significant disruption to operation and functionality of the facility.

**Figure 23.** Nonstructural damage observed in windows, exterior and interior infill walls, and staircases of the Courthouse in Izmir (Yurt Gazetesi, 2020).

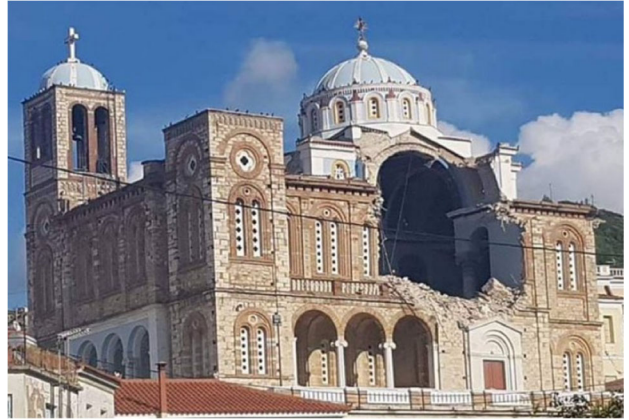
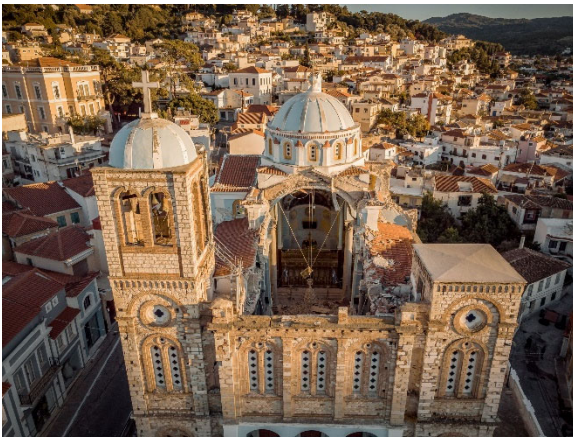
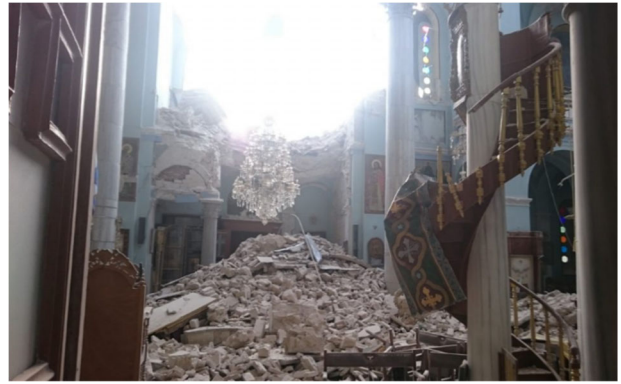
The roof and a wall of the Orthodox Church of Kimisi Theotokou (also known as the Church of Dormition or the Assumption of the Virgin Mary Church) in Neo Karlovasi on the Greek Island of Samos collapsed during the earthquake (Fig. 24). The two bell towers of the Agios Nikolaos Orthodox Church, also in Neo Karlovasi, were damaged in the earthquake (Fig. 25), as well as the Orthodox Church of Agios Nikolaos in Kokkari on the Island of Samos (Fig. 26) (MSN, 2020). All three churches were designed by the architect Angelos Angelidis in the late 19th to early 20th century. There were also reports of damage to the Orthodox Chapel of Agia Anna in Chora, Samos (Orthodoxia, 2020).

**Figure 24.** Façade of the Karlovassi Church on the Greek island of Samos: (a) before the earthquake (MBP, 2020a), and (b) frontal (Liferight, 2020), (c) lateral, and (d) interior views of the partial collapse after the earthquake (Orthodoxia, 2020).

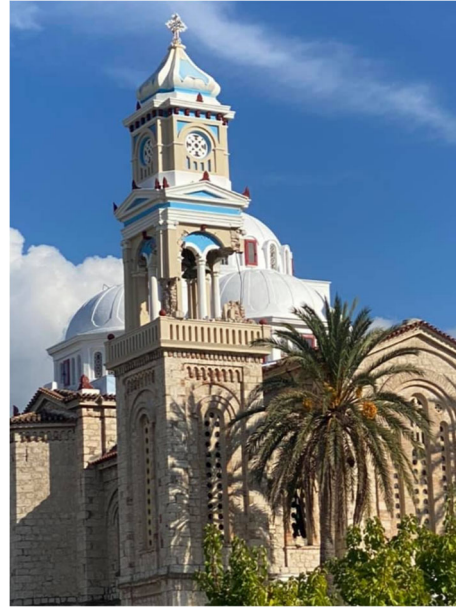
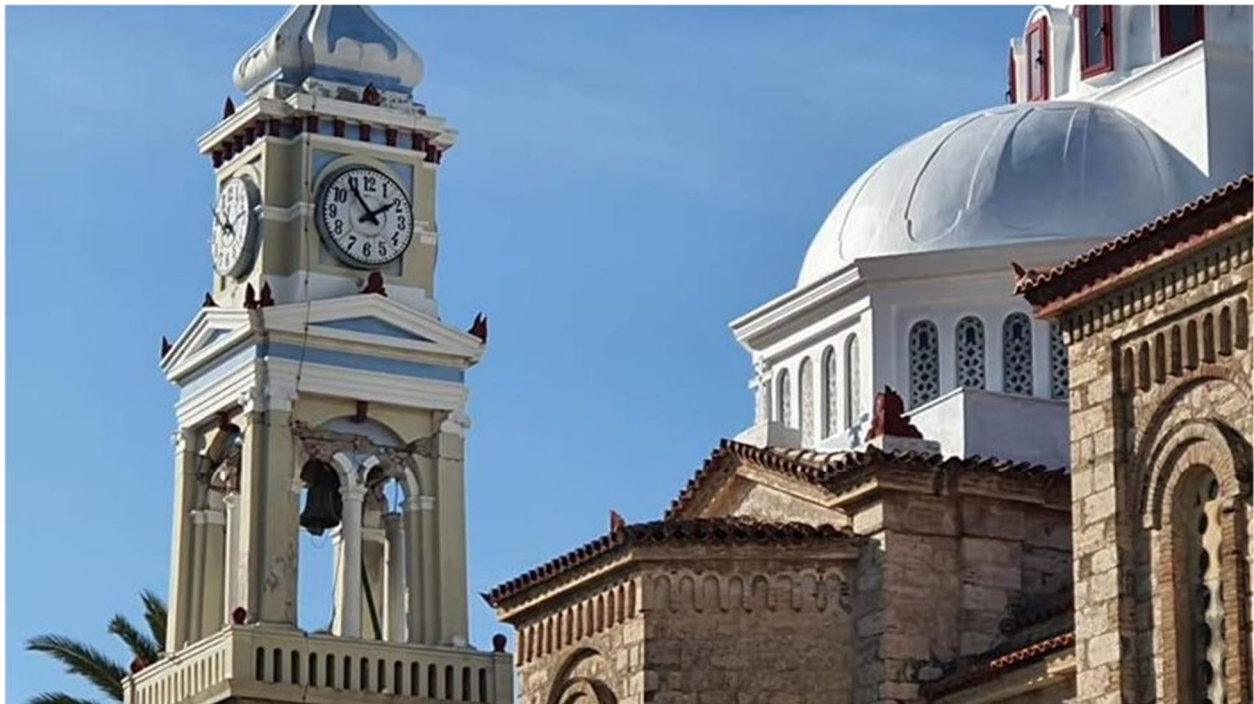
**Figure 25.** Agios Nikolaos Orthodox Church on the Greek island of Samos: (a) before the earthquake (WC, 2020), (b) view of the left-side damaged bell tower after the earthquake (Orthodoxia, 2020), and (c) view of the right-side damaged bell tower after the earthquake (Protothema, 2020a).

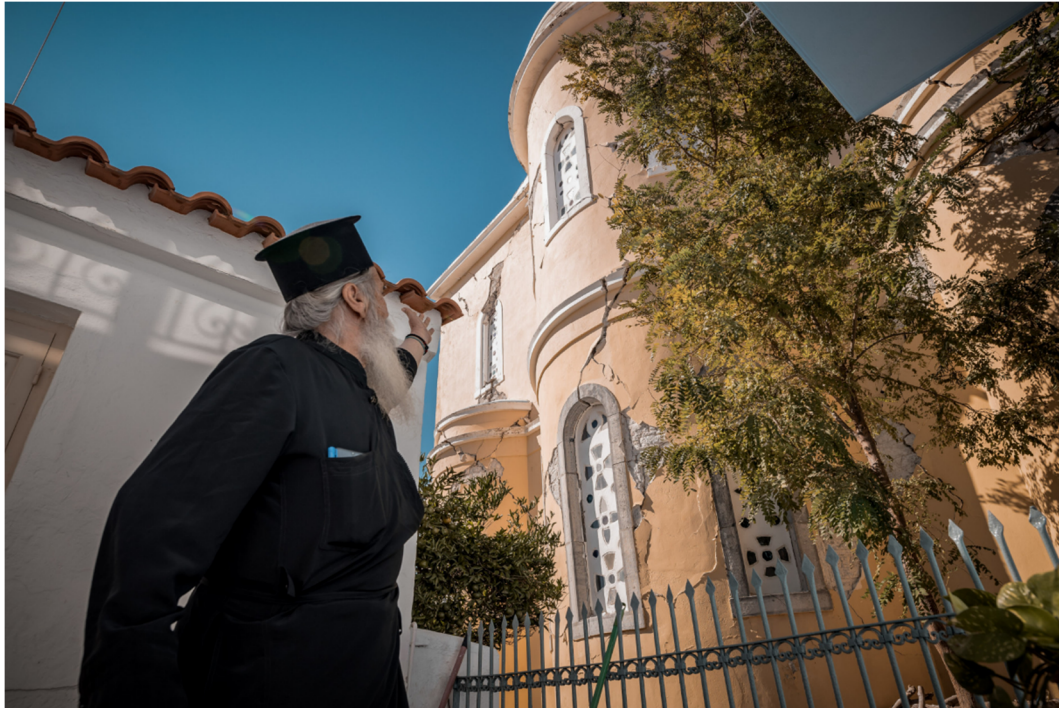
**Figure 26.** Damage to the Orthodox Church of Agios Nikolaos in Kokkari on the Greek island of Samos (MSN, 2020).

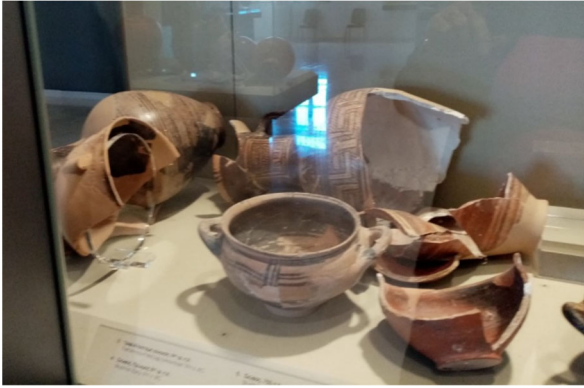
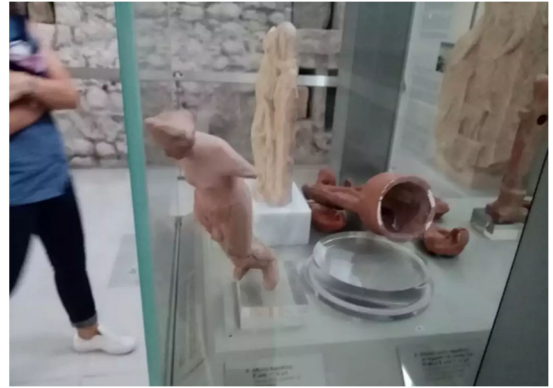
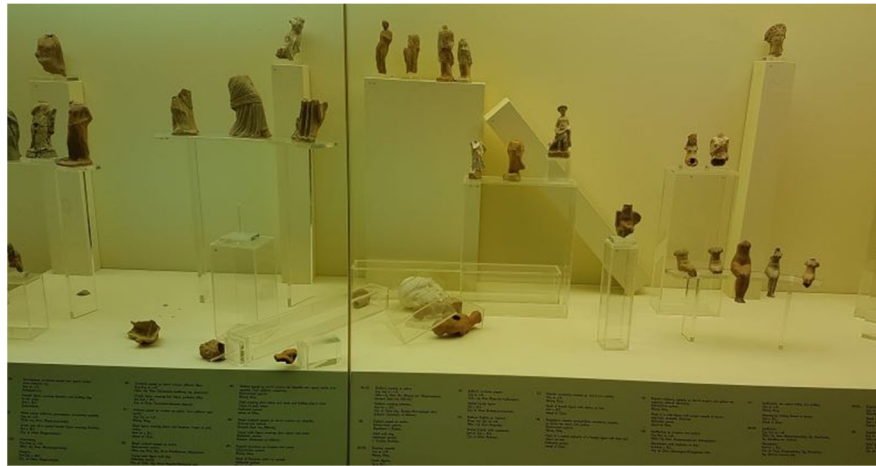
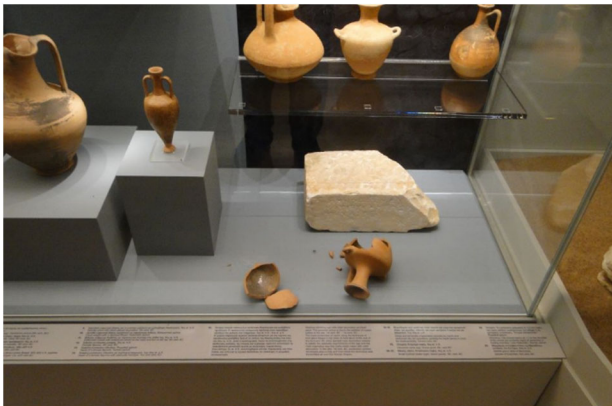
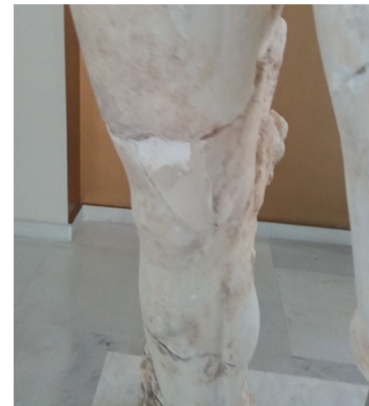
Damage to pottery collections was reported at the Archaeological Museum of Pythagorion, on the Greek island of Samos (Fig. 27a-b) and at the Archaeological Museum of Agios Kirykos, Ikaria, Greece (Fig. 27d); the latter museum also reported cracks to the museum walls. The Archaeological Museum in Chios, Greece similarly documented damage to its terracotta and ceramics collections (Fig. 27c). At the Archaeological Museum of Vathy on the Island of Samos in Greece, developed a crack in the leg of a large statue of a kouros (Fig. 27e).

**Figure 27.** Damage to: (a, b) pottery collection of the Archaeological Museum of Pythagorion (AVGI, 2020), (c) terracotta and ceramics collection of the Archaeological Museum in Chios (AVGI, 2020), (d) pottery collection of the Archaeological Museum of Agios Kirykos (AVGI, 2020), and (e) leg of the kouros at the Archaeological Museum of Vathy (ATHENS9.84, 2020).

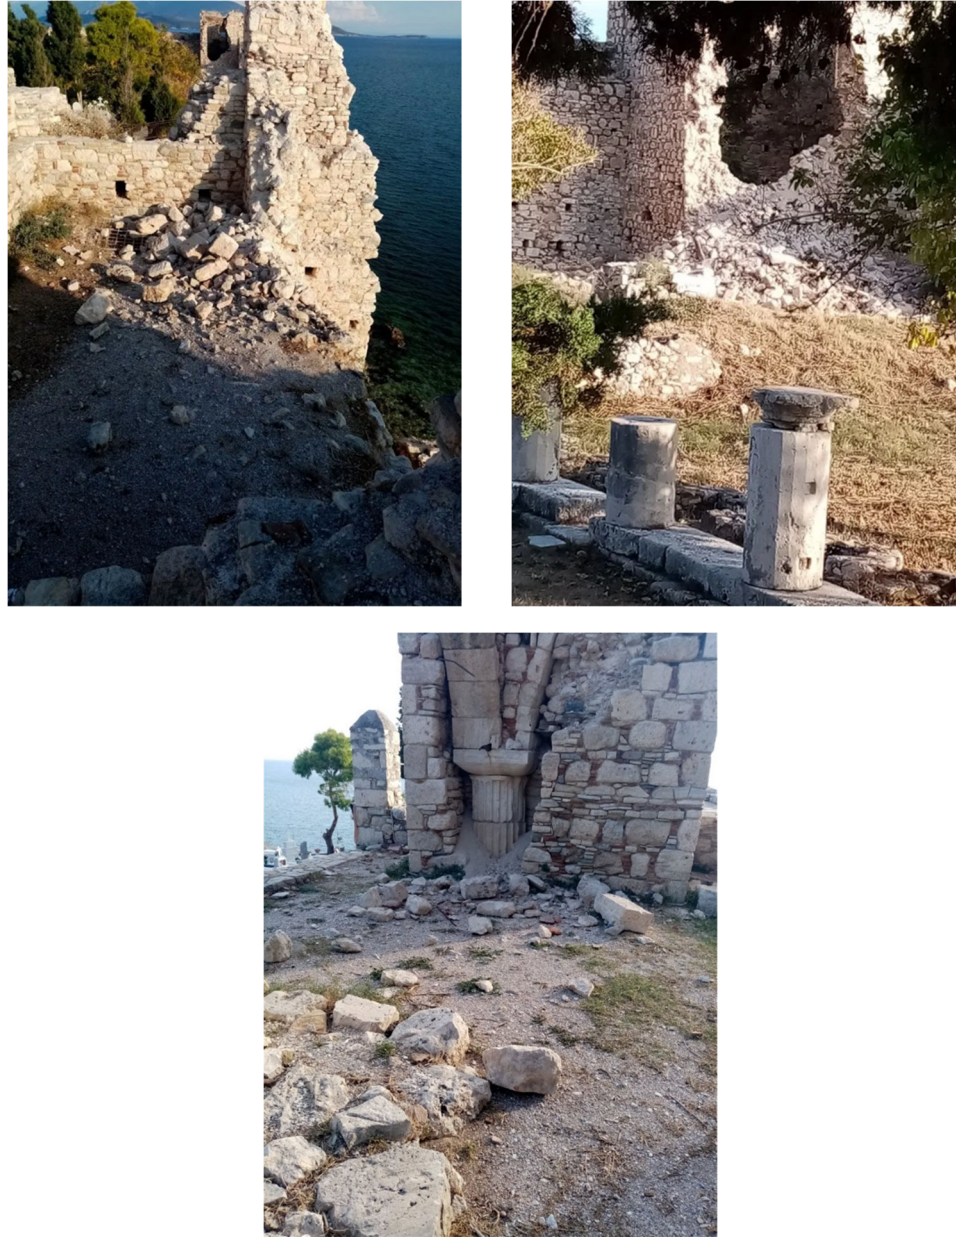
Parts of the wall of the Castle of Lykourgos Logothetis in Pythagorion on the island of Samos in Greece collapsed (Fig. 28). At the archaeological site of Heraion of Samos, minor damage to the building that supports the activities of the site was also reported (Protothema, 2020b).

**Figure 28.** Damage to the wall of the Castle of Lykourgos Logothetis in Pythagorion (Dikastiko, 2020; Protothema, 2020b).

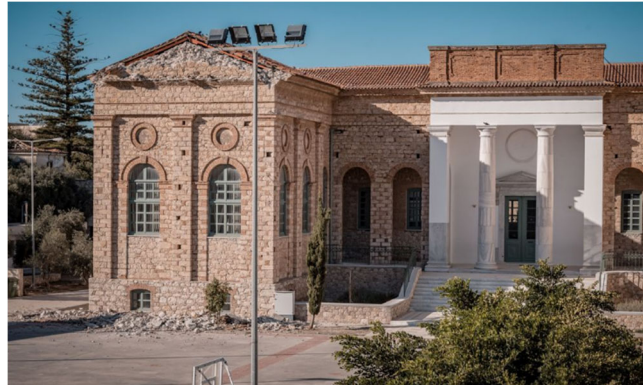
**Figure 29.** Damage to the Porphyriada school in Karlovasi (Documentonews, 2020).

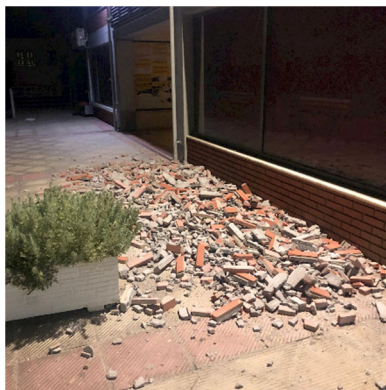
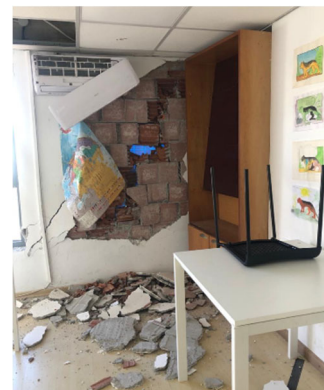
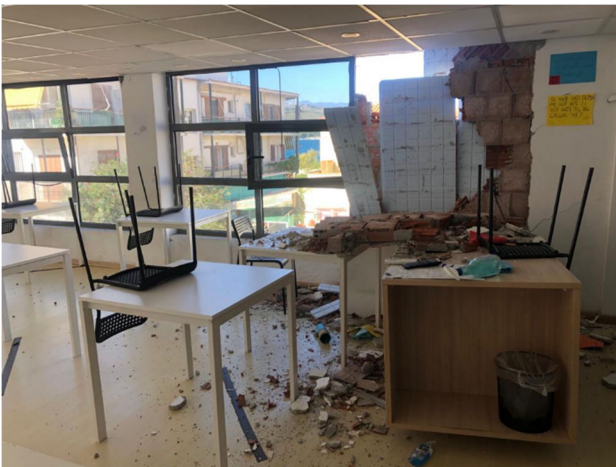
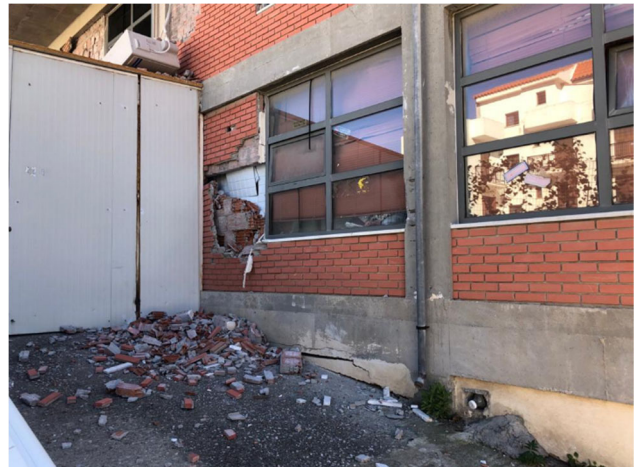
and the Evening High School-Unified Special Vocational High School - Lyceum (efsyn, 2020). In addition, damage was also reported to the Mazí Educational Centre (Fig. 30), which supports children and adolescents living in the Samos refugee camp located in the island (Still I Rise, 2020).

**Figure 30.** Damage to the Mazí Educational Centre (Still I Rise, 2020).

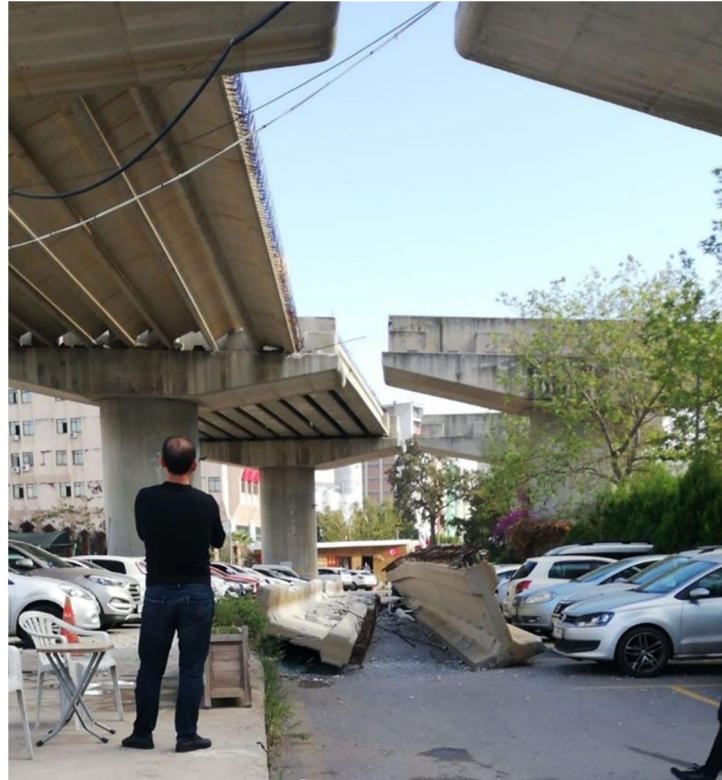
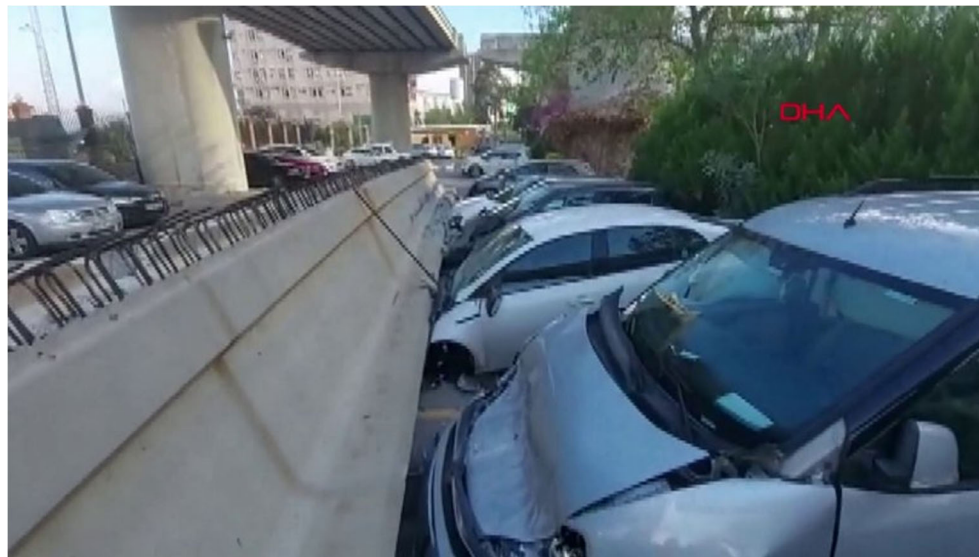
A few highway bridges in Izmir experienced damage, including the precast girders of a bridge under construction, which fell to the ground and crushed several parked cars (Fig. 31).

**Figure 31.** A collapsed girder of a bridge under construction fell to the ground and crushed parked cars in Alsancak district of Izmir, Turkey (HaberTurk, 2020).

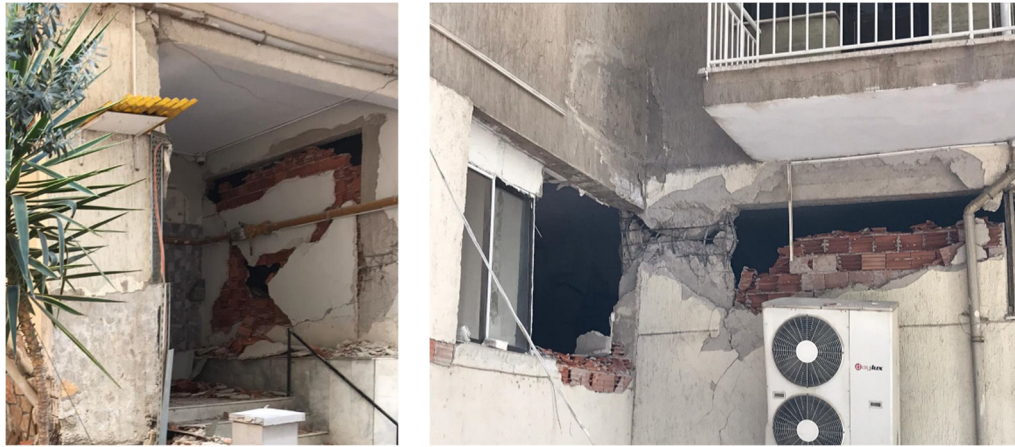
**Figure 36.** Heavy damage in a RC frame building with URM infills (Credit: Ozgur Ozcelik).

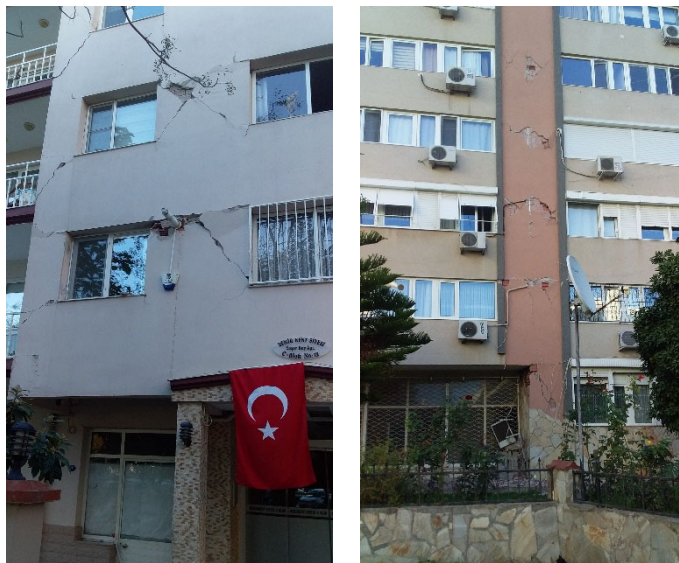
**Figure 37.** Diagonal cracks in exterior infill walls (Credit: Mauricio Morales-Beltran).

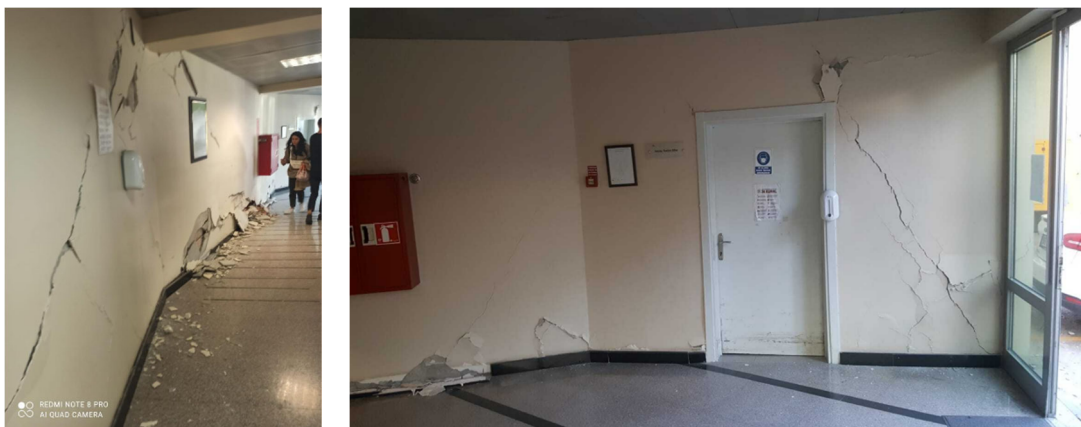
**Figure 38.** Diagonal cracks in interior infill walls of a building (Credit: Ahmet Dindar).

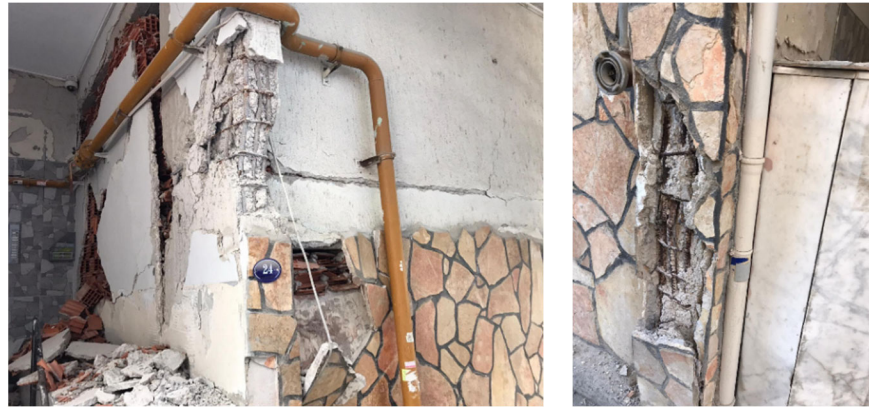
Typical structural and material deficiencies that could have played a role in the damages observed in different districts of Izmir are shown in Figure 39: relatively large spacing of transverse reinforcement and potential corrosion of the longitudinal reinforcing bars.

**Figure 39.** Large transverse reinforcement spacing (left) and corrosion of reinforcing bars (right) (Credit: Ozgur Ozcelik).

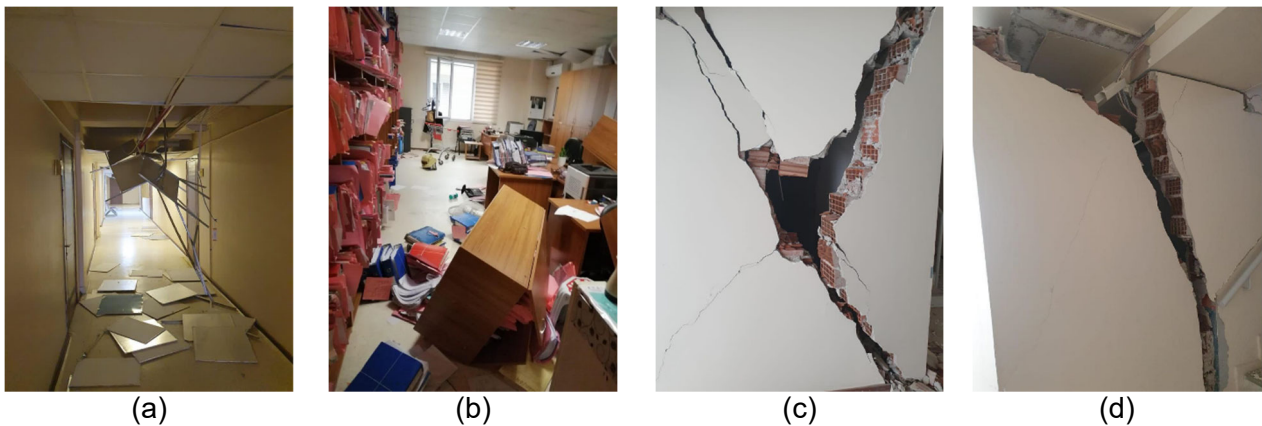
StEER members also documented damage to nonstructural components and infill walls of the Courthouse in Izmir (Fig. 40), discussed previously in Section 5.3 of this report.

**Figure 40.** Damage observed in the Courthouse in Izmir: (a) fallen suspended ceiling, (b) toppled shelves, and (c, d) extensive damage to infill walls (Credit: Ozgur Ozcelik).
