StEER: Structural Extreme Event Reconnaissance Network

HURRICANE MICHAEL PRELIMINARY VIRTUAL ASSESSMENT TEAM (P-VAT) REPORT

Released: October 15, 2018
NHERI DesignSafe Project ID: PRJ-2112

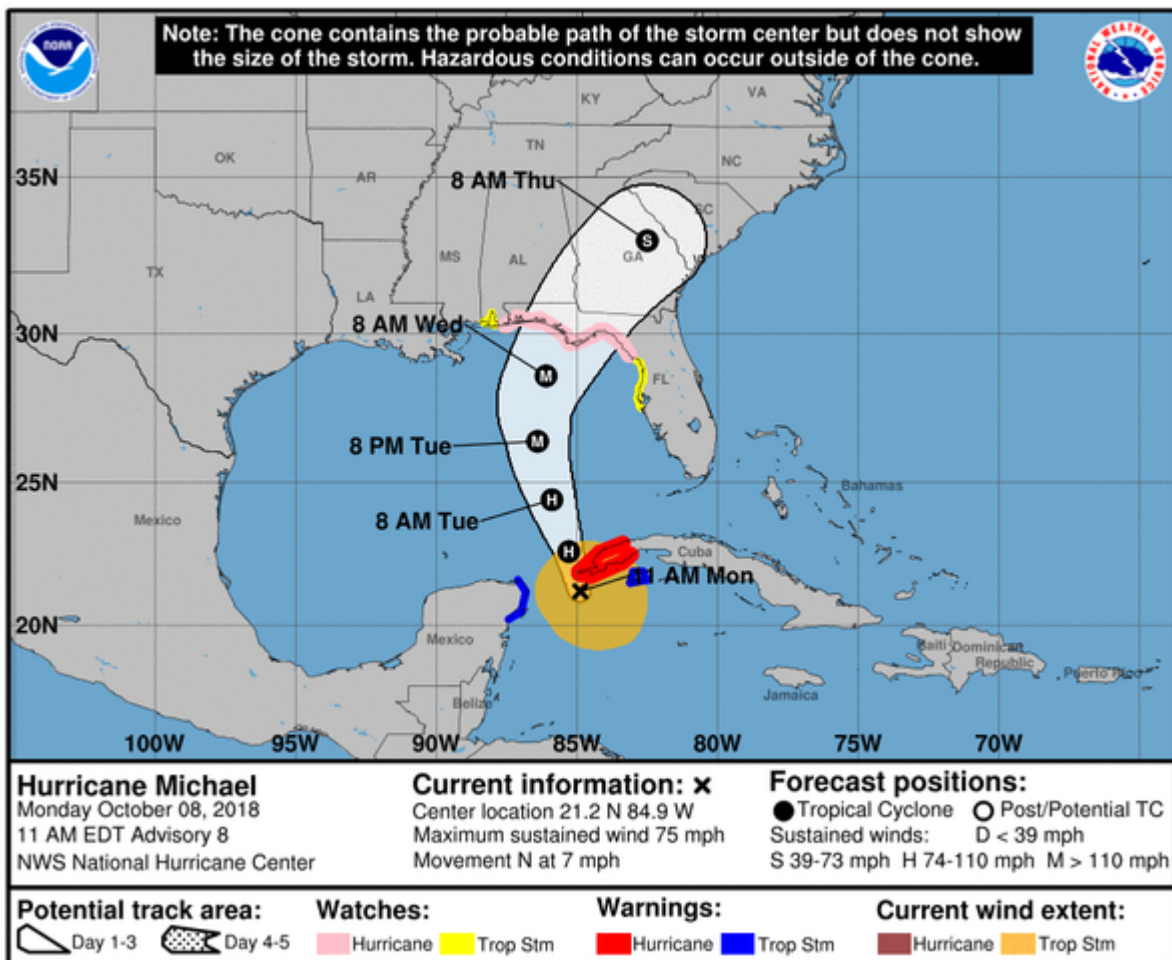
Figure 1: Hurricane Michael track (Source: National Hurricane Center)

The National Hurricane Center (NHC) issued its first notice for this event at 4:00 pm on Saturday, Oct. 6, 2018 indicating a potential tropical cyclone was forming in the northwestern Caribbean Sea. Heavy rainfall and flash flooding were expected over portions of Central America, western Cuba, and the northeastern Yucatan Peninsula. Within 12 hours, the storm increased to a tropical depression with 50 mph sustained winds, and a predicted trajectory to accelerate across the southeastern United States over the next few days. By 4:00 pm Sunday, the storm advanced to tropical storm classification with models forecasting Michael to reach hurricane strength within two days, and to reach the Gulf of Mexico in three days. Michael strengthened to a Category 1 hurricane by mid-morning on Monday (Fig. 1).

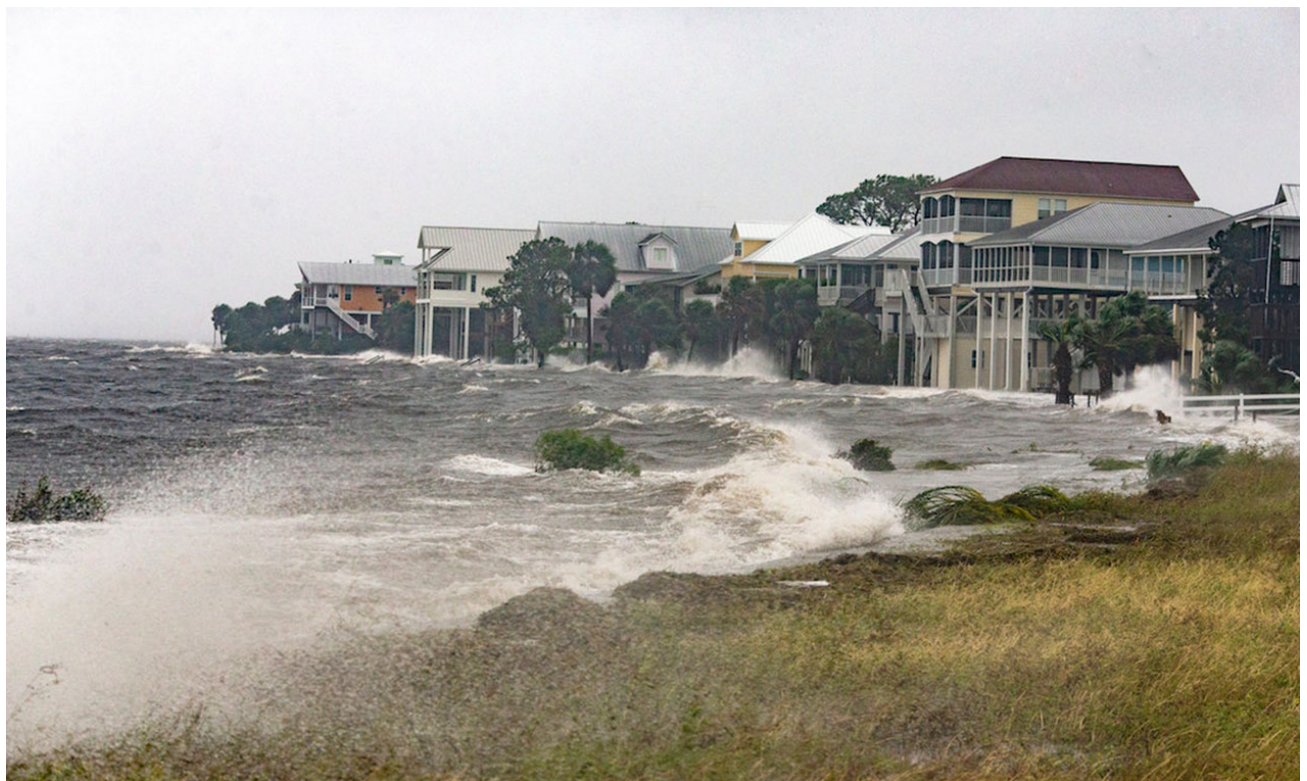
Figure 7: Storm surge and waves on October 10 in Shell Point Beach. (Source: Berke 2018)

The area from the Aucilla River to the Tyndall Air Force Base was forecasted to experience high storm surge of 9 to 14 ft (Berke 2018). The *Independent* referenced the National Hurricane Center in reporting that the actual storm surge ranged from 8 to 14 ft in areas from Mexico Beach to Apalachee Bay, a location noted for storm surge potential even from less-intense tropical cyclones. There in Apalachee Bay, Michael’s storm surge produced a peak inundation of 7.72 feet above ground level, easily surpassing the previous record of 6.43 feet above ground set during Hurricane Dennis in July 2005. The peak inundation of 5.31 feet above ground recorded at Panama City, Florida, was second only to Hurricane Opal in 1995. Cedar Key, Florida, experienced peak inundation of just over 4 feet during the afternoon of Oct. 10. Predicted storm surge levels based on ADCIRC (ADvanced CIRCulation) simulations by the Coastal Emergency Risk Assessment (CERA) are visualized in Figure 6. The depth of inundation with strong waves riding on this storm surge (Fig. 7) completely destroyed many homes with insufficient freeboard, making storm surge a particularly damaging hazard in this hurricane.

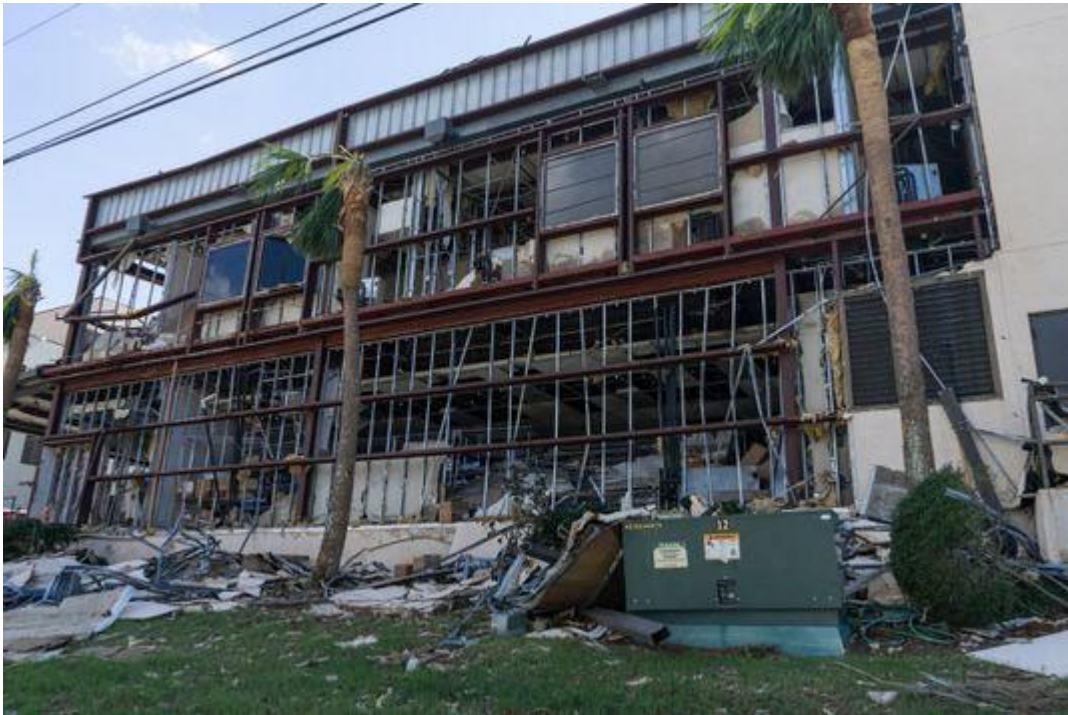
Figure 12: Bay Medical Center Sacred Heart: The hospital sustained roof, structural and water damage (Source: Pensacola News Journal -- www.pnj.com/news/)

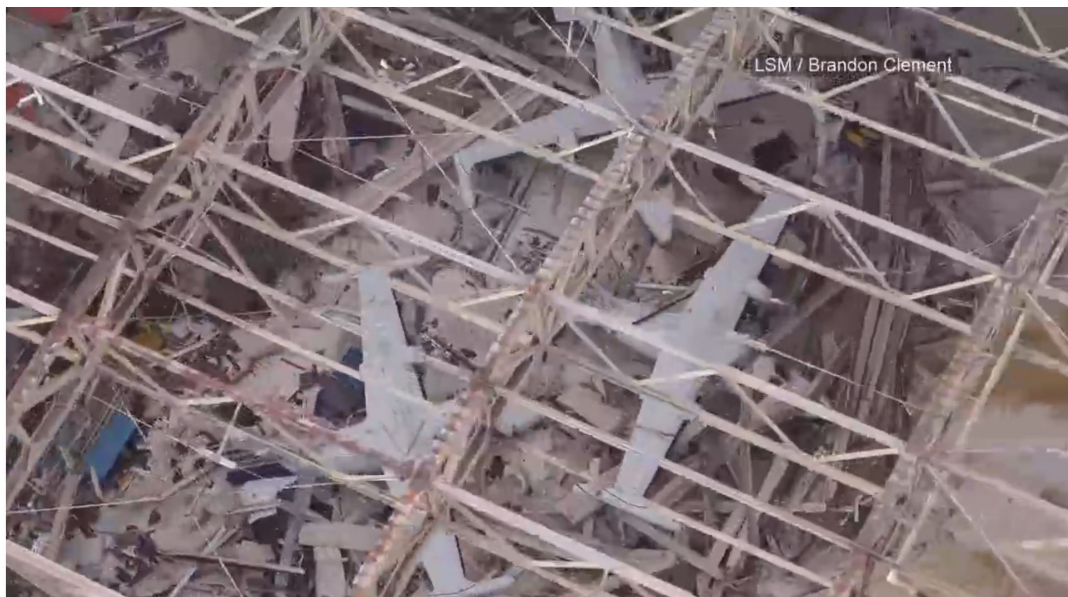
Tyndall Air Force Base, built in 1941, is located 12 miles east of Panama City, Florida. According to the base commander, every structure suffered roof damage, in addition to other structural damages. Of particular note were the damages to the envelope of the aircraft hangars (Fig. 13). Moreover, water, power and sewer facilities were also damaged making the base uninhabitable.

Figure 13: Catastrophic damage at Tyndall Air Force Base with fighter jets exposed inside of roofless hangars (Source: First Coast News -- www.firstcoastnews.com)

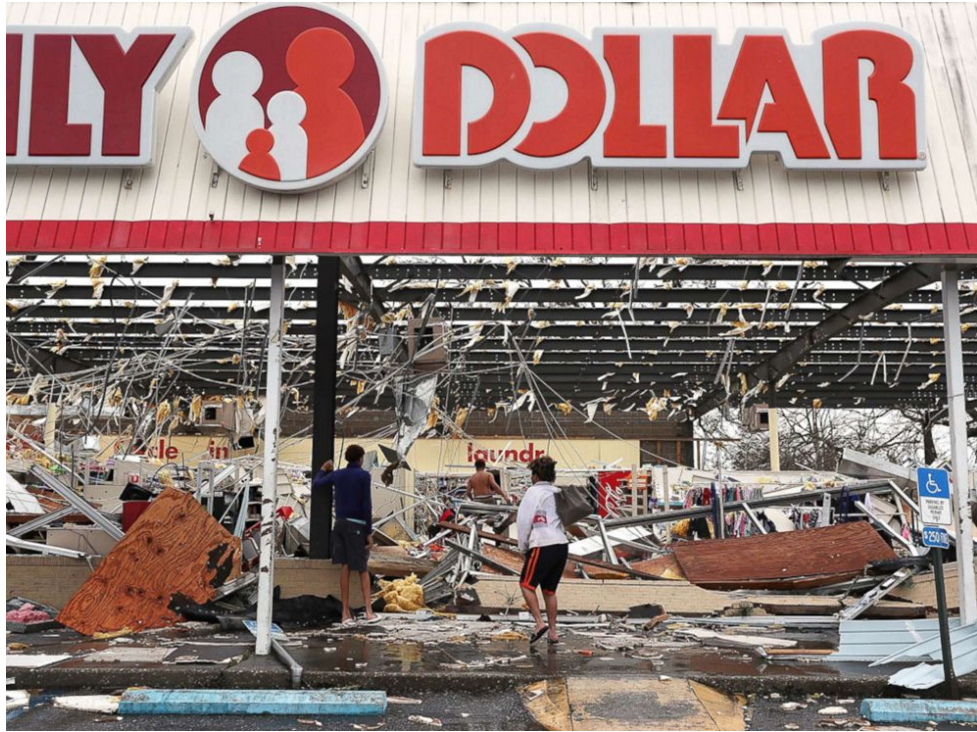
The following case studies illustrate the performance of common commercial typologies. The first illustrates the performance of metal frame and joist systems, where the building envelope has been completely detached from the primary structural system, as was the case with the Dollar General in Panama City shown in Figure 14 (see <https://www.youtube.com/watch?v=E7zSfWTjqlg>). While the failure sequence cannot be known with certainty, the loss of the glass curtain wall resulted in

exposure of all contents of this retail store, which became a target of significant looting. Another noteworthy example is the First Federal Bank in Panama City, which suffered a complete loss of its cladding system resulting in significant damage to contents and interior finishes (Fig. 15).

Figure 14: Family Dollar damaged by hurricane Michael (Source: First Coast News -- <https://www.circa.com/story/2018/10/11/nation/family-dollar-looted-in-the-aftermath-of-hurricane-michael>)

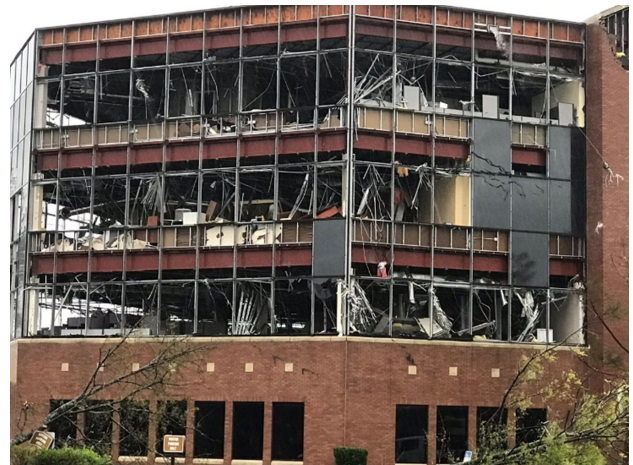
Figure 15: First Federal Bank of Florida: (a) before Hurricane Michael, image from google maps June 2017; (b) after Hurricane Michael (Source: <https://twitter.com/StormVisuals/status/1050118658717040640/photo/1>)

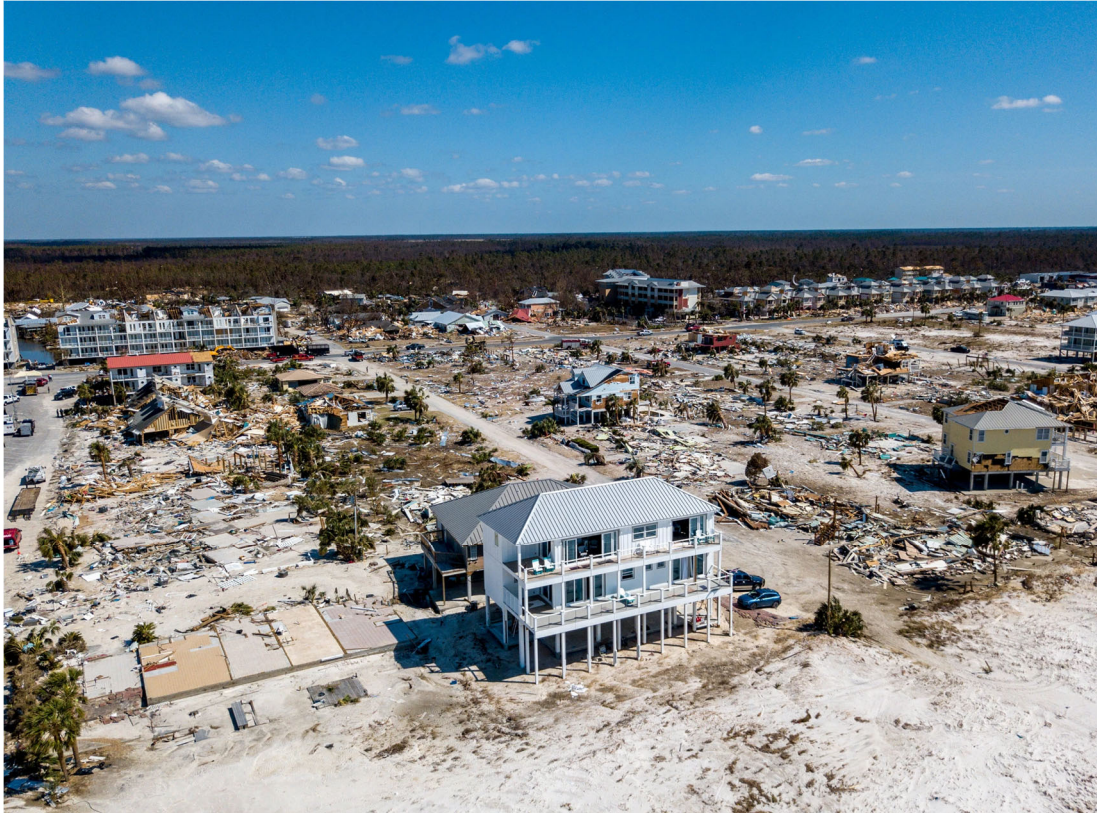
Hurricane Michael caused the full spectrum of damage scenarios in residential construction in the affected area, from wind-induced damages to the building envelope such as loss of roof and wall cover, to more substantive structural damage to the roof system (loss of sheathing and framing) to the complete destruction of the main force resisting system. However, some of the most staggering damage was noted in the regions experiencing large storm surge, e.g., Mexico Beach, FL, where

homes were completely wiped from their foundations. While not surprising for homes that were not elevated or were of older construction not built to the latest Florida codes (such as the 1970s-era homes common to Mexico Beach), the loss of homes with elevated living spaces and concrete piers designed to the latest code provisions were particularly disconcerting for homeowners. In many cases, the lack of sufficient freeboard resulted in homes that had robust load paths being crushed under the force of breaking waves riding on the significant storm surge. Damage characteristic of that observed in Hurricane Ike in Texas and Superstorm Sandy in New Jersey was observed. Figure 16 shows one of the few exceptions on Mexico Beach, a home built above code minimums for Bay County, at a cost of roughly double per square foot. The home is reinforced concrete elevated on concrete pilings and lost only its stairs and breakaway walls, with some minor water damage.

Figure 16: Widespread devastation to wood-framed single and multi-family residences in Mexico Beach as noted by the bare slabs with few survivors in the areas with highest inundation, including the concrete “Sand Palace” (Source: New York Times)

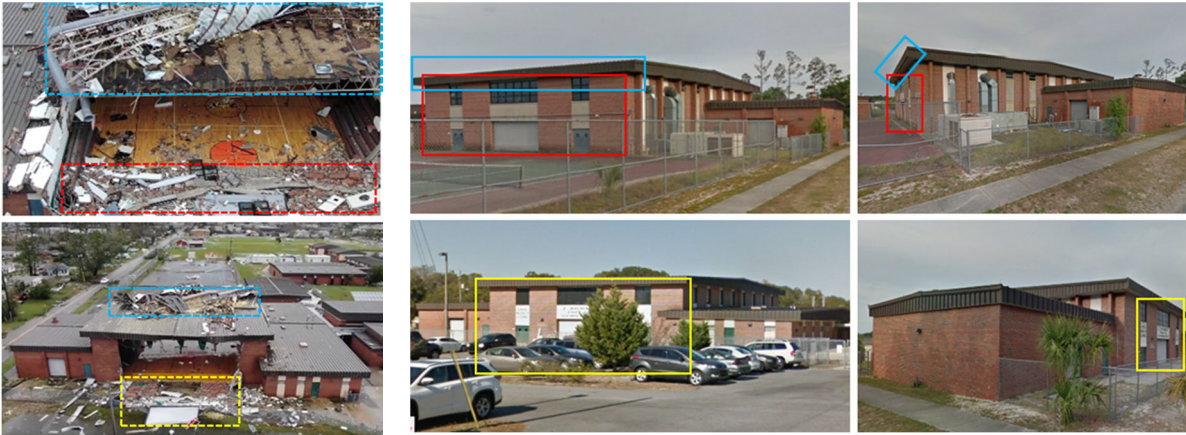
Figure 17 provides an example of damage to long-span roof system in the gymnasium of the Jinks Middle School in Panama City, Florida. It is suspected that failure instigated with the breach of the roof, which is peeled back, followed by the failure of the windward and leeward masonry walls.

(a) After hurricane Michael

(b) Before hurricane Michael (Nov 2017)

Figure 17: Jinks Middle School (Panama City) gym destroyed by Hurricane Michael ([source](#): WMBB). (a) Post-storm imagery documenting failure of end wall adjacent to parking lot (yellow dashed boxes) and tennis court (red dashed boxes). Roof at the tennis court side (blue dash boxes) is completely peeled back. (b) Multiple views of building before Hurricane Michael from Google StreetView (captured Nov 2017). Each damaged element in (a) is boxed using the same colors but solid line in (b).

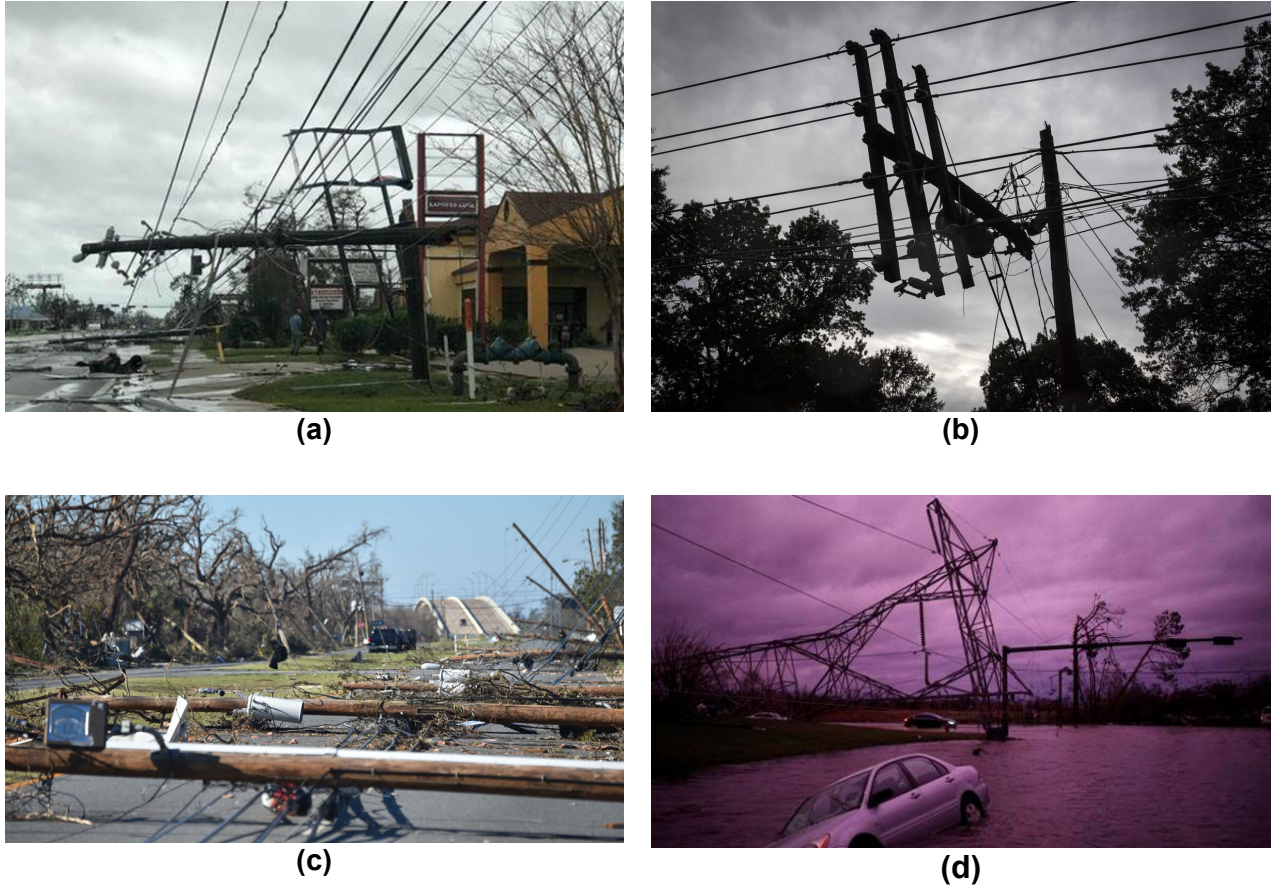
The electric power network suffered losses to physical infrastructure, such as wooden and concrete distribution poles, lattice-type transmission towers, and substations. The damage to the distribution system is observed to be mostly due to a combination of high winds and fallen trees and the domino-like failure of tens to hundreds of distribution poles (Fig. 20 a-c). The damage to the transmission towers is more limited (Fig. 20 c-d), but considering the high voltage load carried by these towers, it is expected to have more lasting effects with widespread blackouts. There are reports of damage to the raised structures of substations due to high winds in addition to a number of flooding events that have hampered the operation of the substations.

Figure 20: (a) Failed wooden power poles in Mexico Beach. (Source: Tallahassee Democrat); (b) Downed power lines in Winston-Salem, NC (Source: Winston-Salem Journal); (c) Fallen electrical poles block a road in the aftermath of Hurricane Michael on Oct. 12, 2018 in Panama City, FL representing a cascade failure in multiple poles that could be initiated either by fallen trees, extreme wind effects, or both (Source: Hector Retamal/AFP/Getty Images); (d) Vehicle sits partially submerged in floodwaters as a fallen electricity transmission tower lays on the ground in the background after Hurricane Michael hit in Panama City, FL on Wednesday, Oct. 10, 2018. (Source: Luke Sharrett/Bloomberg).

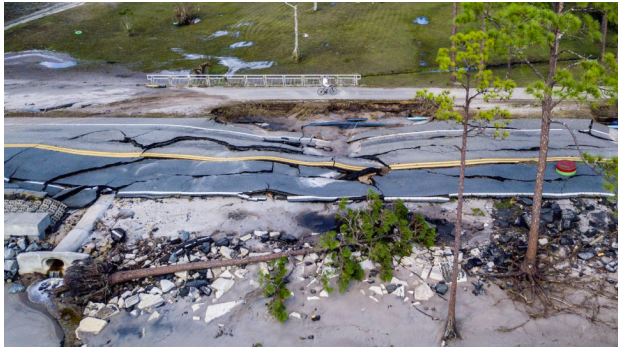
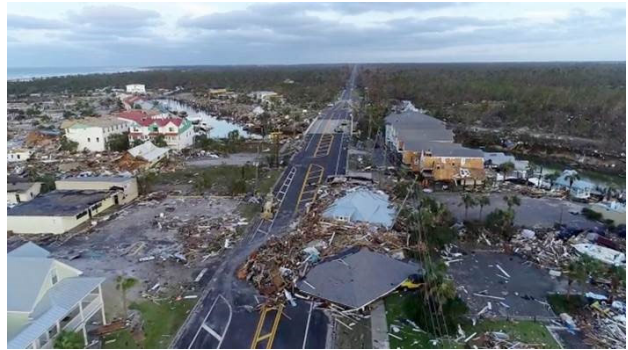
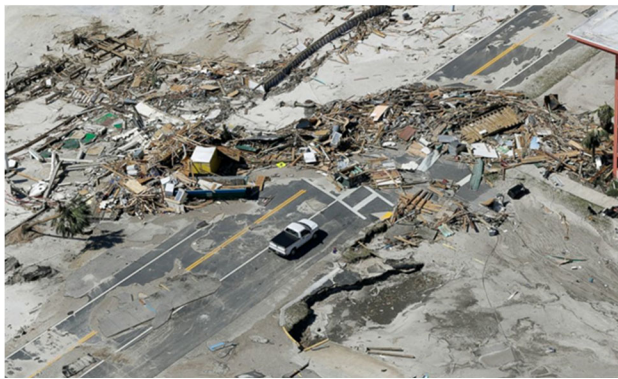
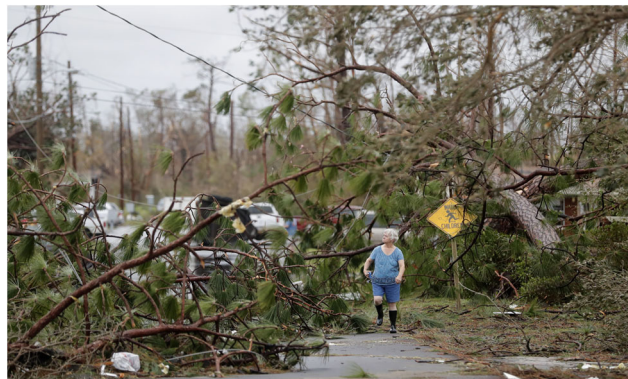
Some of the hardest-hit areas were near impossible to reach because the roads were buried beneath either water, debris or both, e.g., Mexico Beach. Downed trees, power lines, and debris were the main cause of road closures. In coastal areas, this was amplified by the significant damage to buildings and other coastal infrastructure and their transport by storm surge (Fig. 22 b,c). At one point, an estimated 200 roads in Tallahassee were blocked by fallen trees. Ground saturation from previous rain events made trees particularly vulnerable to uprooting (Fig. 22d). The main east-west road across the Panhandle, Interstate 10, was closed for an 80-mile stretch. U.S. Highway 98 was the only reported roadway with damage due to washout (see Fig. 22a). Multiple bridges in states as far as South Carolina were closed along the coast for safety during high winds, but no sustained damage has been disclosed due to high winds thus far. The Georgia Department of Transportation had cleared its interstate highways, but were still working to clear over 100 state routes at the time this report was authored. Twenty-eight state roads were closed due to downed trees and other debris in South Carolina, where the interchange of I-85 and 385 had 3 ramps closed due to flooding. Appendix B lists specific road and bridge closures in Florida, Georgia and North Carolina as of October 12, 2018.

Figure 22: (a) Damage to Highway 98 near Carrabelle (Source: The New York Times); (b) road obscured by debris in Mexico Beach, FL on Thursday, Oct. 11, 2018 (Source: CTV News); (c) debris from homes destroyed by Hurricane Michael and sand deposition block road on Oct. 11, 2018, in Mexico Beach, FL (Source: Lincoln Journal Star); (d) Trees blocking roadway in Panama City, FL (Source: Gerald Herbert, AP)
