Hurricane Ian

Released: November 16, 2022

NHERI DesignSafe Project ID: PRJ-3709

PRELIMINARY VIRTUAL RECONNAISSANCE REPORT (PVRR)

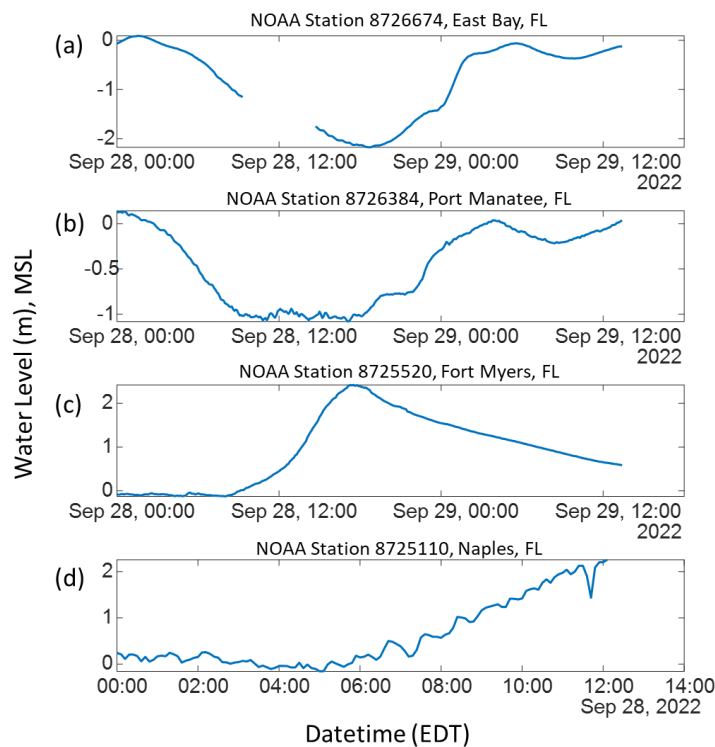
Figure 2.6. Preliminary water levels (m) during Hurricane Ian from 28-29 September, 2022 referenced to MSL at NOAA Stations (a) 8726674, East Bay, FL near City of Tampa; (b) 8726384, Port Manatee, FL near mouth of Tampa Bay; (c) 8725520, Fort Myers, FL; and (d) 8725110, Naples, FL (Data Source: NOAA Tides and Currents).

Nearby tide buoys similarly recorded impacts of the hurricane on tides and water levels. Figure 2.6 shows water levels in meters recorded with respect to MSL at NOAA stations located at (a) East Bay, near the City of Tampa, (b) Port Manatee, near the mouth of Tampa Bay, (c) Fort Myers, and (d) Naples. The hurricane caused a negative storm tide in Tampa Bay, with water levels receding to -2 m (6.5 ft) with respect to MSL at East Bay (Fig. 2.6). The storm tides recorded at the Fort Myers and Naples locations were significant, with peak water levels (referenced to MSL) reaching 2.42 m (8 ft) at the Fort Myers station. Peak water levels at the Naples station reached 2.26 m (7.41 ft) with respect to MSL before the buoy malfunctioned.

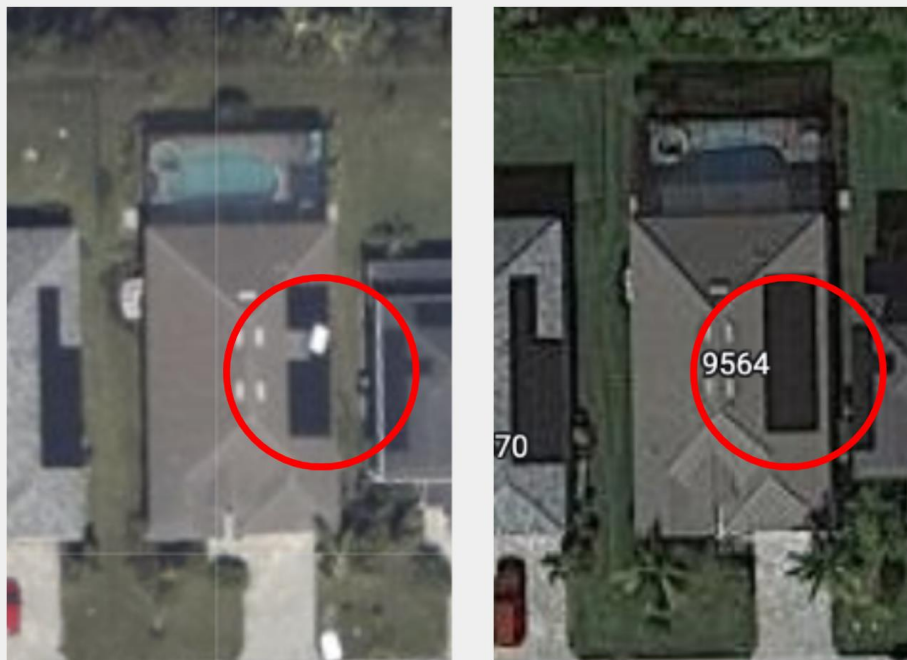
Figure CS5.2. Evidence of roof solar panel damage by comparing (left) a damaged panel visible in the post-storm NOAA imagery, and (right) pre-event imagery showing the undamaged panel.

Beyond Babcock Ranch, however, aerial imagery from NOAA revealed damage to roof solar panels in areas that observed higher peak wind gusts. A preliminary assessment conducted in multiple neighborhoods in Cape Coral and Fort Myers identified 30 rooftop panel installations with severe damage (Fig. CS.5.1). An example of typical damage is shown in Fig. CS.5.2. Field inspections can reveal less visible damage to the panels ([Burgess & Goodman, 2018](#); [Ceferino et al., 2022](#)), identify specific failure mechanisms (e.g., cracks and local failures in the rack, panel connection, or roof attachment), and evaluate the impacts on continuous power access and building functionality.

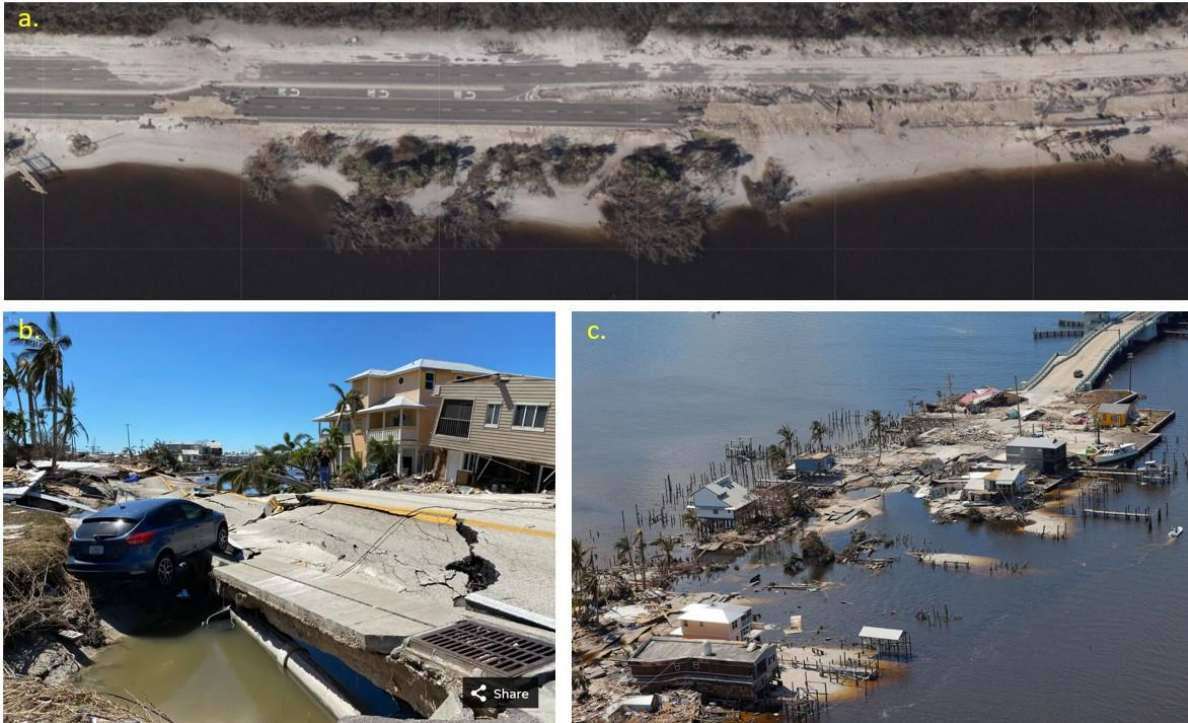
Figure 5.3. Observed damage coastal roadways, including (a) the McGregor Blvd in Fort Myers (source: NOAA Hurricane Ian Imagery), and (b), (c) the Pine Island Rd (Source: ABC news (2022) and Levy (2022) respectively).

Figure 5.2 summarizes the progression of road closures during the landfall of Hurricane Ian, initiating with coastal roadways and causeways in Lee County inundated by storm surge, which in several cases caused structural damage. This includes all the bridges to Pine Island (Gallman, 2022), the roadway connecting Captiva and Sanibel Islands, the Sanibel Causeway connecting Sanibel Island to Fort Myers (Levy, 2022), the Big Hickory Bridge, and Little Hickory Bridge (fl511.com). Damage was also observed to coastal highways in Fort Myers, with the most characteristic case being McGregor Blvd. The most common pattern of failure was the severe coastal erosion near the causeways and roads that led to scour and partial damage (e.g., differential settlements) or washout of pavements and causeways, and the damage to approach slabs, as shown in Figure 5.3.

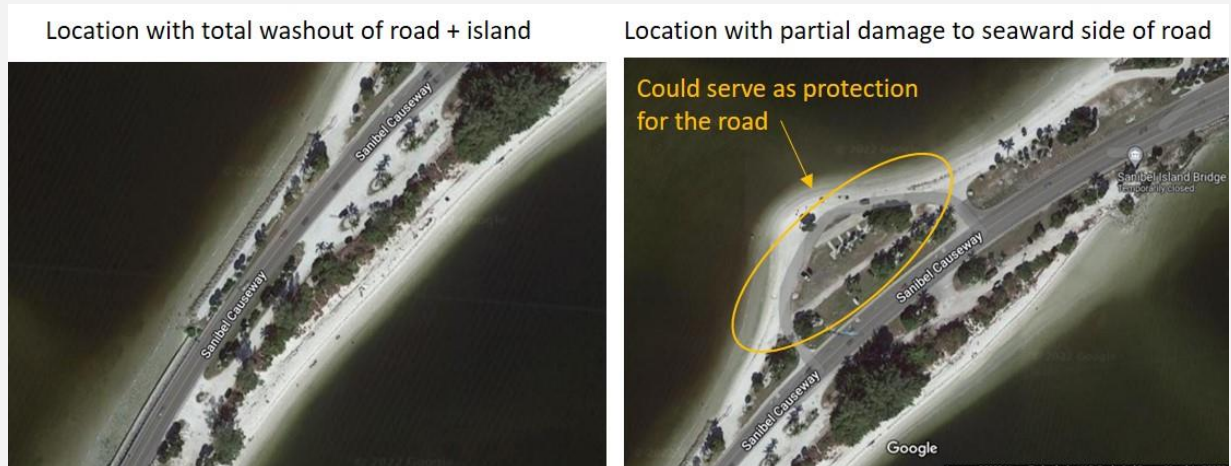
Figure CS.5.4. Selected locations of Causeway Island Park A before Hurricane Ian (modified from Google Maps).

Two other types of damage were also observed in the Sanibel Causeway, particularly ‘at the two islands. The first type was the partial damage of the pavements on the seaward side, which was caused by the erosion of the soil below the roads, and the second type was the total washout of the road with the island below it (see Fig. CS.5.3). Interestingly, for both island A and B, the first type of damage occurred towards the north side of the island and the second type (total washout) occurred towards the south end. As shown in Figure CS.5.4, for island A at the location where a total washout was observed, the road was very close to the shore, which means that it could be exposed to surge and direct impact from the waves. On the other hand, at the location with partial damage and scour of the pavement, the road was located further from the shore. This would consequently imply that while in the former case the road would be subjected to hydrodynamic effects (e.g., scour) immediately after the instant at which the surge and waves reached the elevation of the road, in the latter case the road would be subjected to the same effects only after the sandy beach (on the seaward side) would have been eroded. Apart from this hypothetical explanation, other potential reasons that could have contributed to the different levels of damage are (i) differences in road elevations, (ii) directionality effects which may be important in the case of skewed bridge superstructures subjected to extreme
