StEER STRUCTURAL EXTREME EVENTS RECONNAISSANCE		EVENT BRIEFING	
		Event:	Typhoon Hagibis and Oct. 12, 2019 Earthquake
		Region:	East Asia
Authors:	Selim Günay, Pacific Earthquake Engineering Research Center, University of California, Berkeley David O. Prevatt, Engineering School of Sustainable Infrastructure & Environment Ian N. Robertson, University of Hawaii at Manoa Khalid M. Mosalam, Pacific Earthquake Engineering Research Center, University of California, Berkeley		
Editors:	Tracy Kijewski-Correa, University of Notre Dame David Roueche, Auburn University		
DesignSafe Project #	PRJ-2577	Release Date:	October 17, 2019

Typhoon Hagibis + Earthquake | Released October 17, 2019

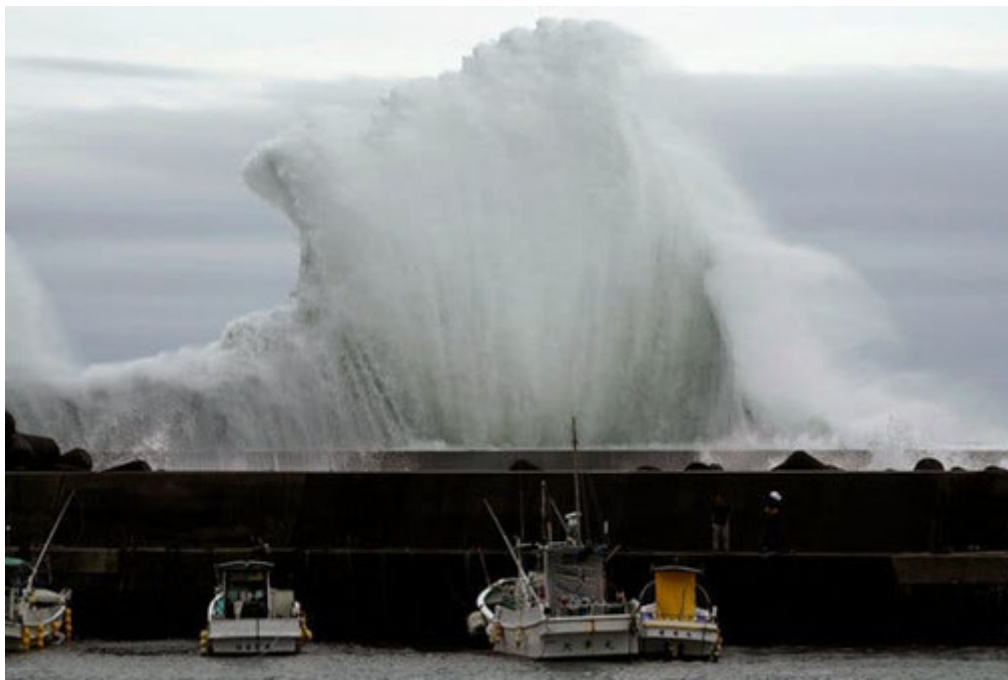
Figure 3: Wave striking breakwater in Kiho, Japan (Source: Toru Hanai/Associated Press; New York Times, 2019).

In addition to hurricane force winds, Hagibis brought storm surge and waves to the South and East shores of Honshu Island. Because Japan has a history of typhoons and tsunamis, many shorelines and river estuaries are protected by breakwaters and concrete walls or earthen levees. These appear to have been effective at limiting damage to coastal ports and harbor facilities (Fig. 3); however, the storm also brought extremely high rainfall (Fig. 4). The combination of elevated sea level and wave runup, plus extreme riverine flow due to the heavy rainfall may have contributed to some river channels being overtopped. Extensive flood damage resulted in a number of river valleys, impacting homes (Figs. 5 and 6). According to the Fire and Disaster Management Agency of Japan, 9,962 houses had been flooded across the country (CNN, 2019a). The heavy rain also caused 146 landslides across the country.

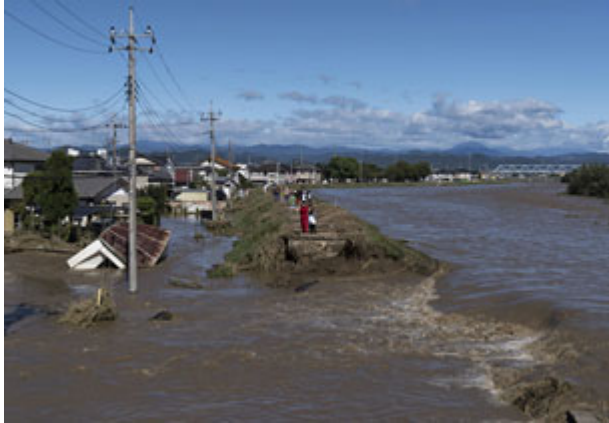
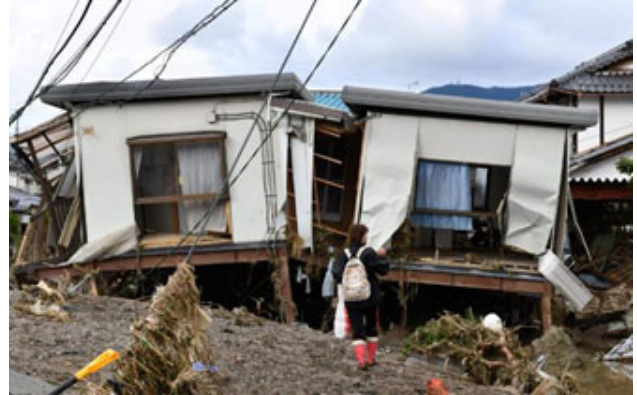
Figure 6: Floodwater flow through a break in the riverbank of the Akiyama River in Sano, Tochigi (left, The Atlantic, 2019), flood-damaged homes in Nagano (right, CNN, 2019a).

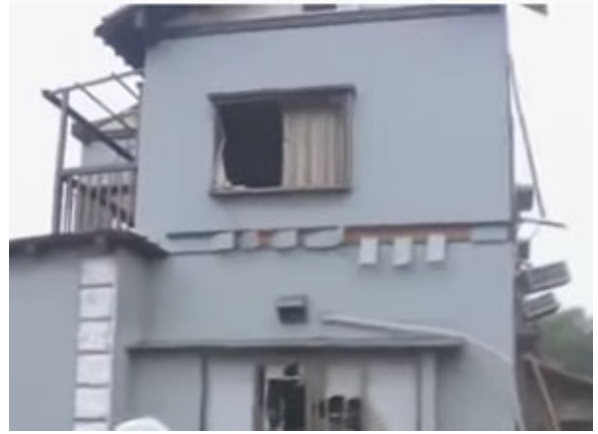
Figure 8: Buildings with damaged façade (Source: Forbes, 2019; CBS News, 2019).

There was significant wind damage to structures, both to the nonstructural components, such as façades and glazing, and to the structural components, including complete collapse (Figs. 8 and 9).

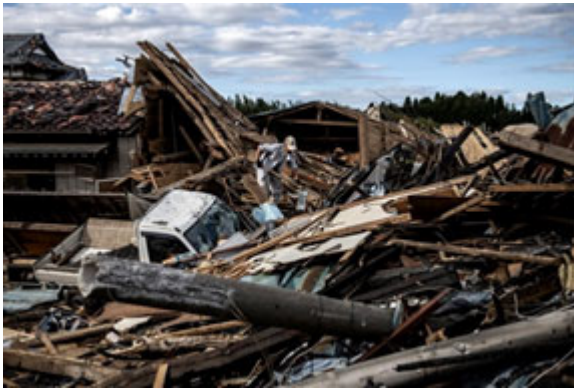
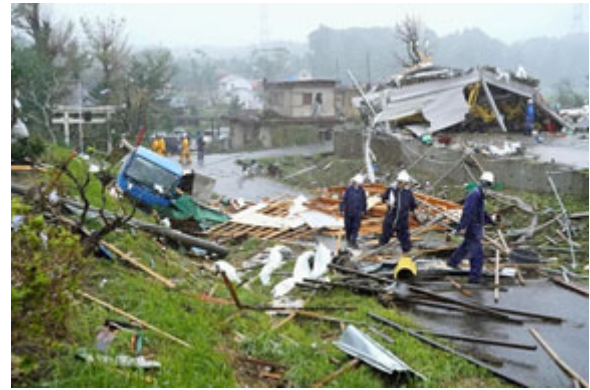
Figure 9: Significantly damaged/collapsed buildings; image on the right may have been due to a tornado spawned by the typhoon (Source: CNN, 2019b; ABS-CBN, 2019).
