**M7.2 Nippes Earthquake,  
 Haiti**

14 August 2021

**PRELIMINARY VIRTUAL RECONNAISSANCE REPORT (PVRR)**

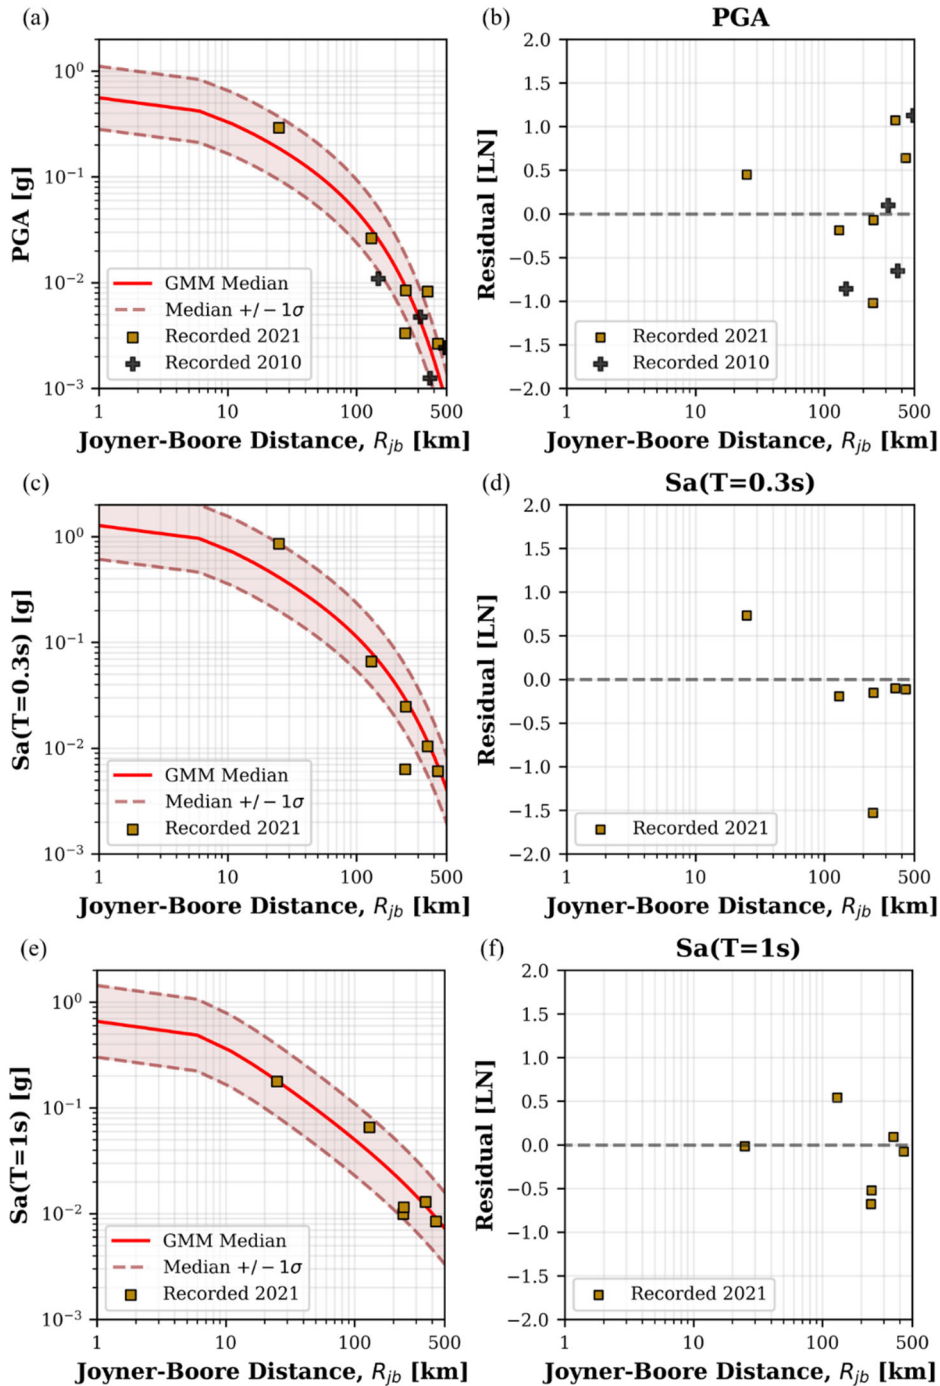
Frankel et al. (2011) selected the Next Generation Attenuation (NGA) Ground-Motion Models (GMM) by Boore and Atkinson (2008), Campbell and Bozorgnia (2008), and Chiou and Youngs (2008) to develop seismic hazard maps for Haiti. Figures 2.7a,c,e compare the recorded PGA,  $Sa(T=0.3s)$  [Spectral acceleration at  $T=0.3$  sec] and  $Sa(T=1.0s)$  [Spectral acceleration at  $T=1.0$  sec] values, respectively, at six strong-motion stations located in Haiti, Dominican Republic, Cuba, and Jamaica during the 2021 Mw 7.2 Haiti Earthquake (Appendix C), against the estimation of the Boore et al. (2014) GMM, an update to the previously used model for the island. Estimates are for stiff soil ( $V_{S30} = 360$  m/sec) conditions, and the Joyner-Boore distance of the stations is approximated here with the epicentral distance. Further, PGA recorded values at 4 strong motions stations during the 2010 Mw 7.0 Haiti Earthquake are included in Figure 2.7a for comparison. Note that most PSA recorded values for both 2021 Mw 7.2 and 2010 Mw 7.0 events fall within the median  $\pm 1$  standard deviation of the GMM estimates, indicating that the observed PSA values are not particularly rare. Figures 2.7b, d, f present the residuals at PGA,  $Sa(T=0.3s)$  and  $Sa(T=1.0s)$ , respectively, to the Boore et al. (2014) GMM versus Joyner-Boore distance. The 2021 Mw 7.2 event, recorded PGA and  $Sa(T=0.3s)$  at the closest station, located at around 25 km, are respectively about 60% and 107% higher than the GMM estimate.

**Figure 2.7.** Comparison of recorded (a) PGA, (c)  $Sa(T=0.3s)$  and (e)  $Sa(T=1.0s)$  from established ground motion models with observations from 6 strong motion stations located in Haiti, Dominican Republic, Cuba, and Jamaica during the 2021 Mw 7.2 Haiti Earthquake (Appendix C), with respective residuals in (b), (d) and (f). Comparisons with the 2010 Haiti Earthquake are also provided in (a) and (b).

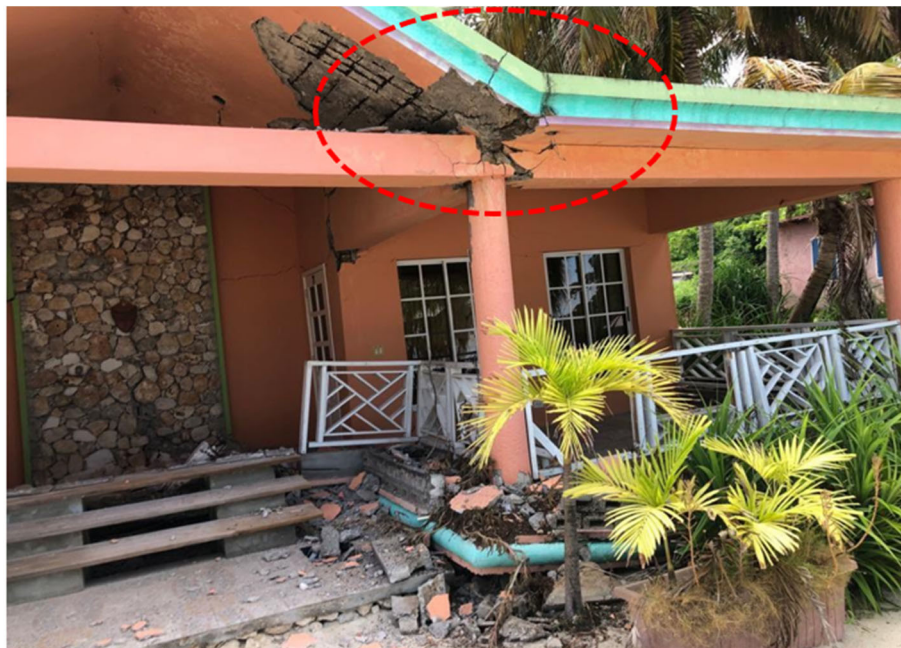
**Figure 4.2.** Example of damaged slab and beam-column connection in Abaka Bay Resort hotel, on the beachfront in Jeremie in Grand'Anse Department of Haiti. (Source: Jesus Chris' Twitter account; Journalist and broadcaster).

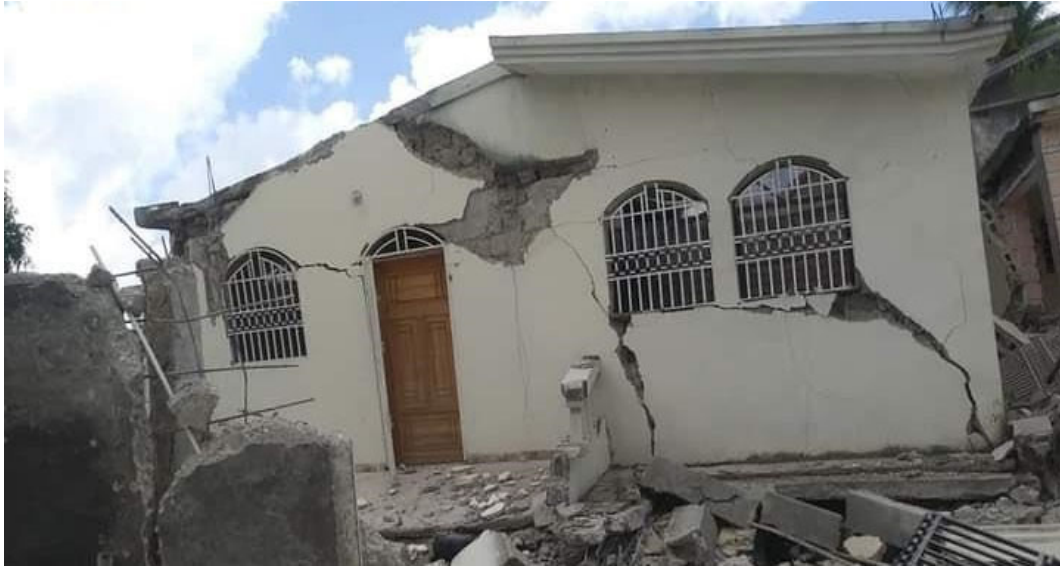
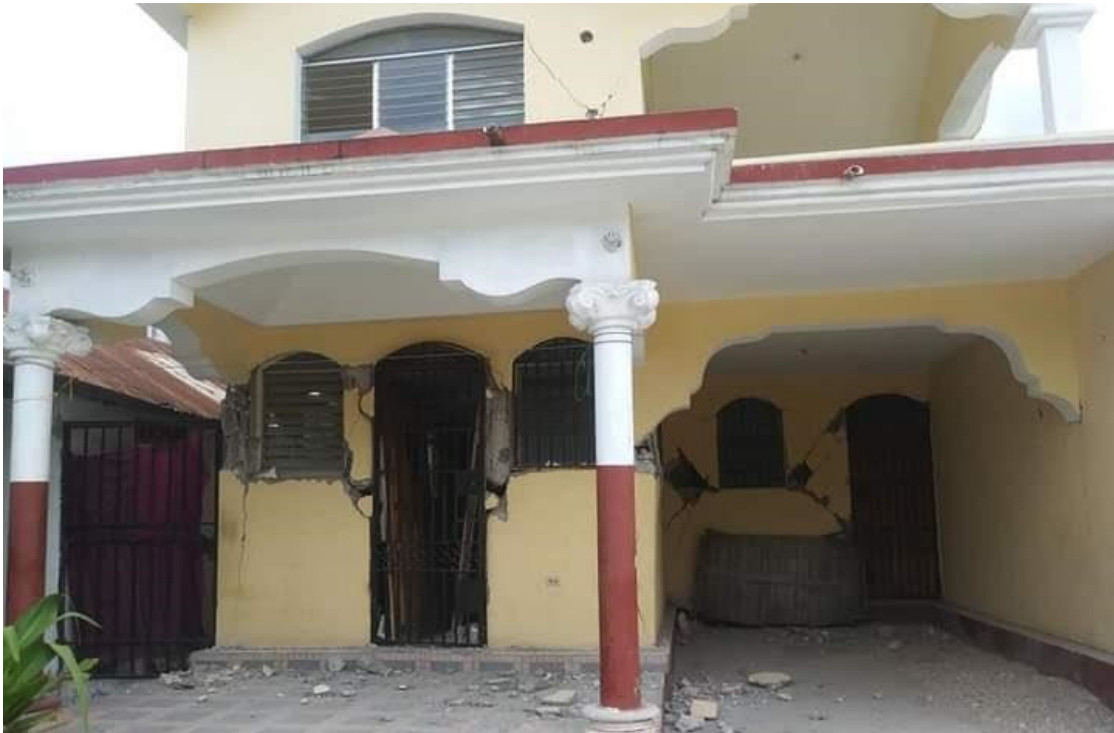
A common characteristic in Haitian urban construction is iron security bars on windows and doors; shear cracking is commonly visible in URM walls framing these stiff elements, as demonstrated in damaged homes in Figure 4.3 in Les Cayes Arrondissement. Figure 4.3a is a representative example of a single-story construction. On the other hand, Figure 4.3b is representative of the multi-story construction common in urban centers like Les Cayes and Jeremie. In many cases, high shear demands at the ground floor of these heavy, weakly-confined, multi-story masonry homes resulted in soft-story failures (Figure 4.4) and complete pancake collapses with the heavy concrete slab floors/roofs often intact. Exposed reinforcement at the roofline of one such pancake collapse in Figure 4.5 indicates the location of tie columns in this weakly-confined building.

**Figure 4.3.** Shear cracks adjacent to stiff security barred windows in (a) single- and (b) multi-story weakly confined masonry homes in the commune of Maniche in the Les Cayes Arrondissement of Sud Department (Source: [Twitter](#)).

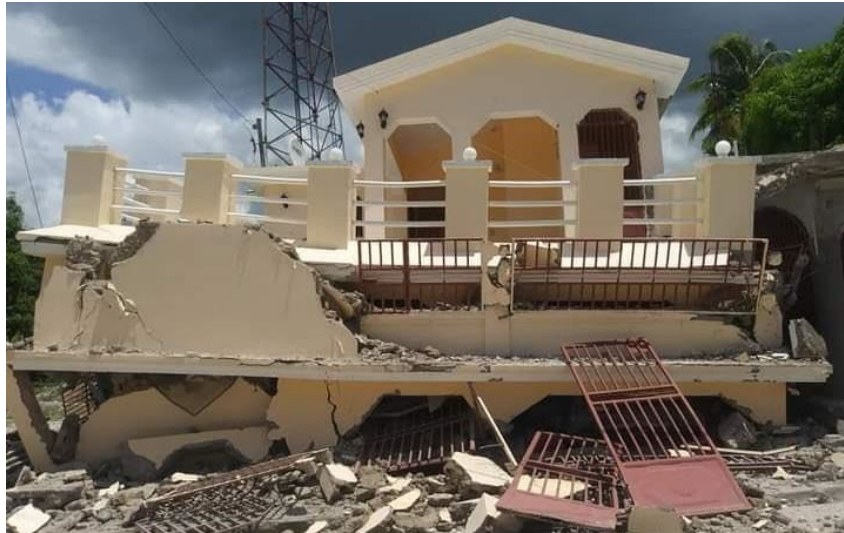
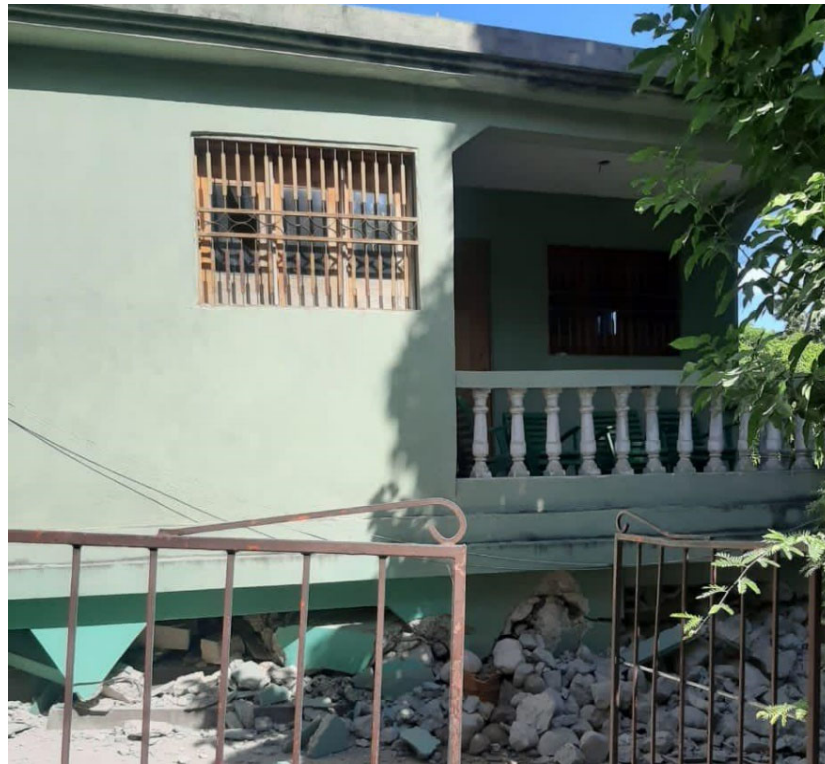
**Figure 4.4.** Soft story failures in single family homes in the communes of (a) Maniche (Source: [Twitter](#)) and (b) Camp-Perrin (Source: [Twitter](#)), both in Les Cayes Arrondissement of Sud Department.

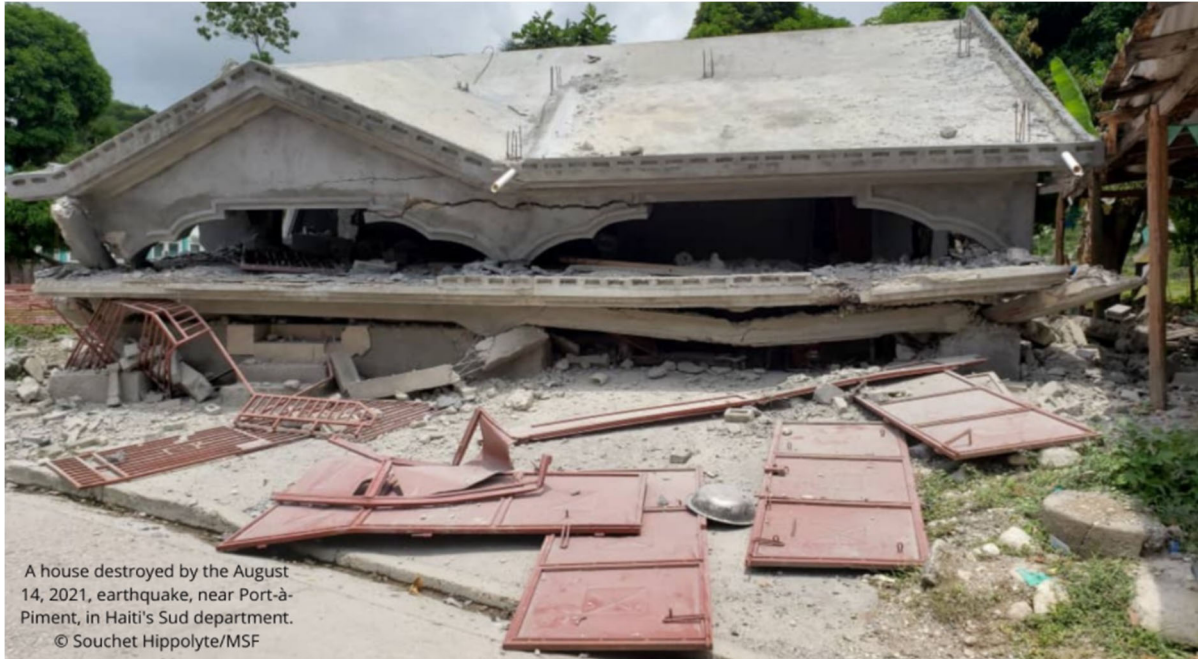
**Figure 4.5.** Pancake collapse of a weakly-confined masonry house destroyed in Port-à-Piment in the Sud Department (Source: [Twitter](#)).

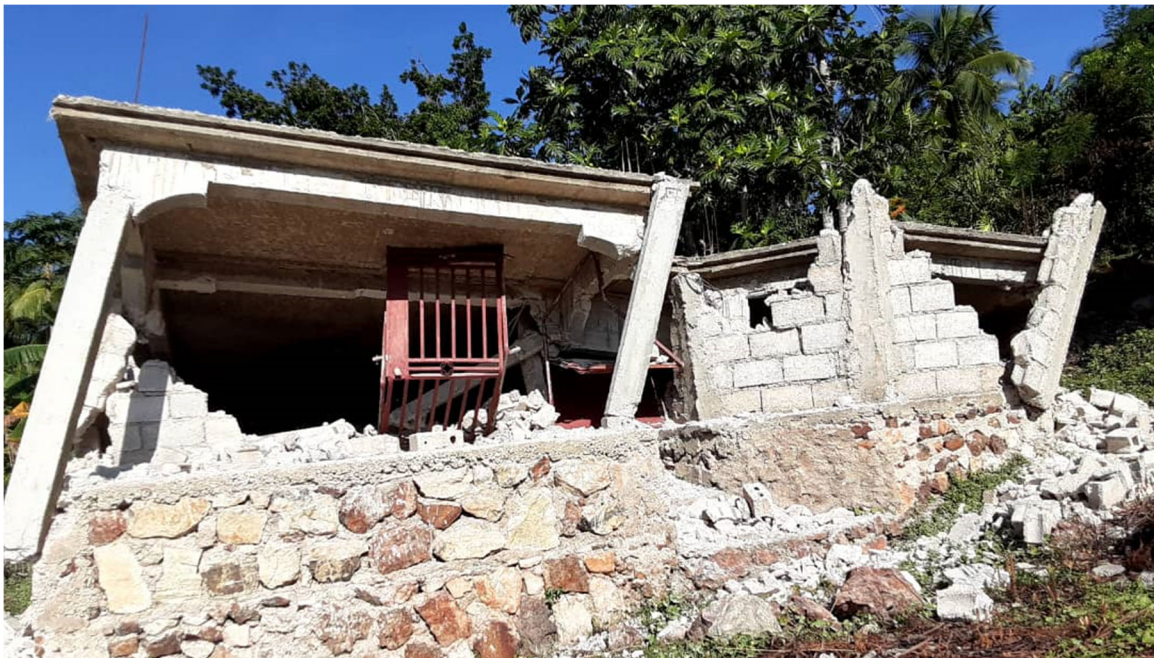
While multi-story URM and weakly confined masonry residences were the most vulnerable, the racking failure in Figure 4.6 demonstrates a number of the common vulnerabilities shared by single-story masonry residential construction in Haiti: (1) heavy concrete slab roof supported by weakly confined load-bearing CMU masonry walls, (2) covered porches supported by concrete columns not tied into the larger structural system, (3) lack of ring beam, relying solely on the slab to engage the system laterally, and (4) openings unconfined but possibly stiffened by security doors and windows. These structural system vulnerabilities are further amplified by the poor quality of the material frequently used in construction. It is also to be noted in Figure 4.6 the elevated stone masonry foundation, which is common in flood-prone areas.

**Figure 4.6.** Damage of a single-story home in Anse-a-Veau (Credit: Gefthé Dévilme, GeoHazards International).

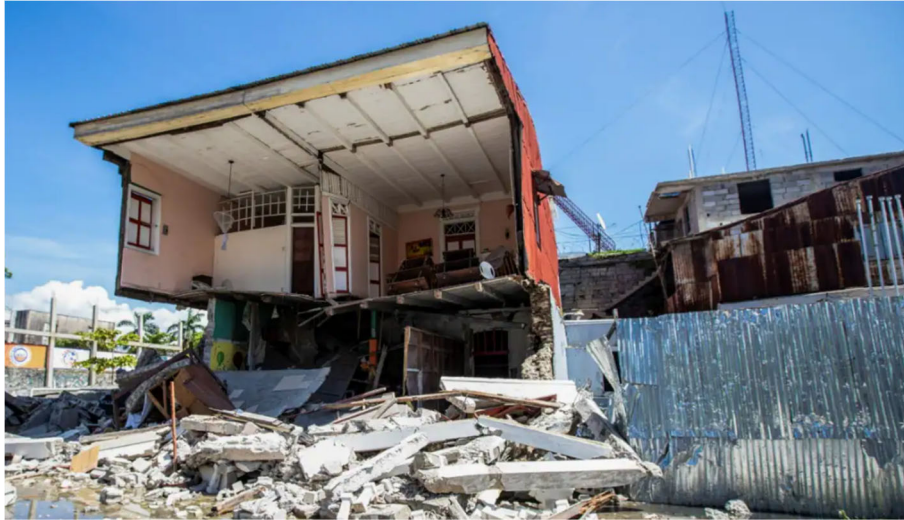
**Figure 4.7.** Example of an OOP failure in blended stone masonry and timber home in Les Cayes (Note poorly confined masonry construction in the background) (Source: [Reuters](#)).

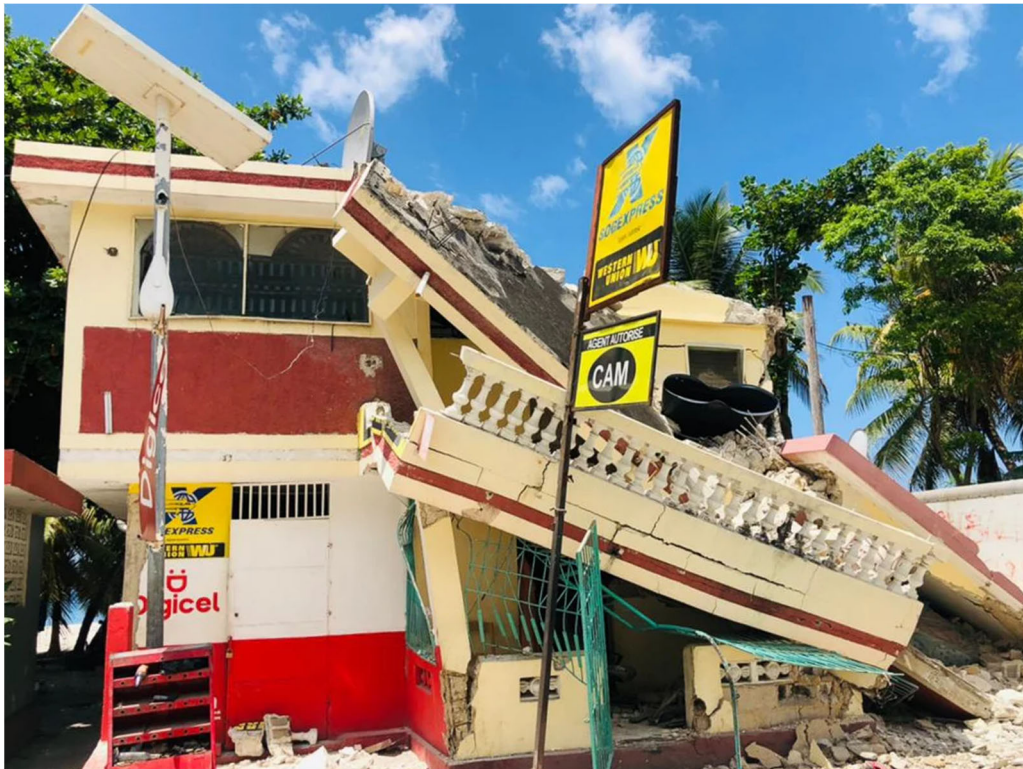
Figure 4.13. Collapse of small business in Petite-Rivière-de-Nippes (Source: [npr](#)).

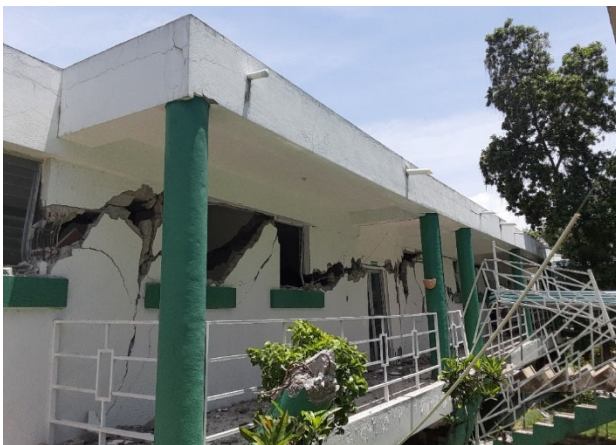
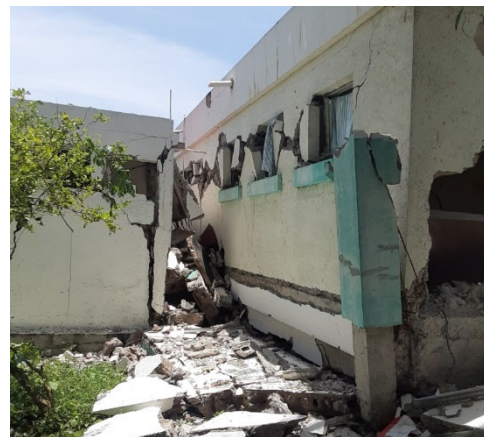
**Figure 4.16.** Severe damage of Hopital de l'Azile in Nippes (Source: Gefthe Devilme, GeoHazards International).

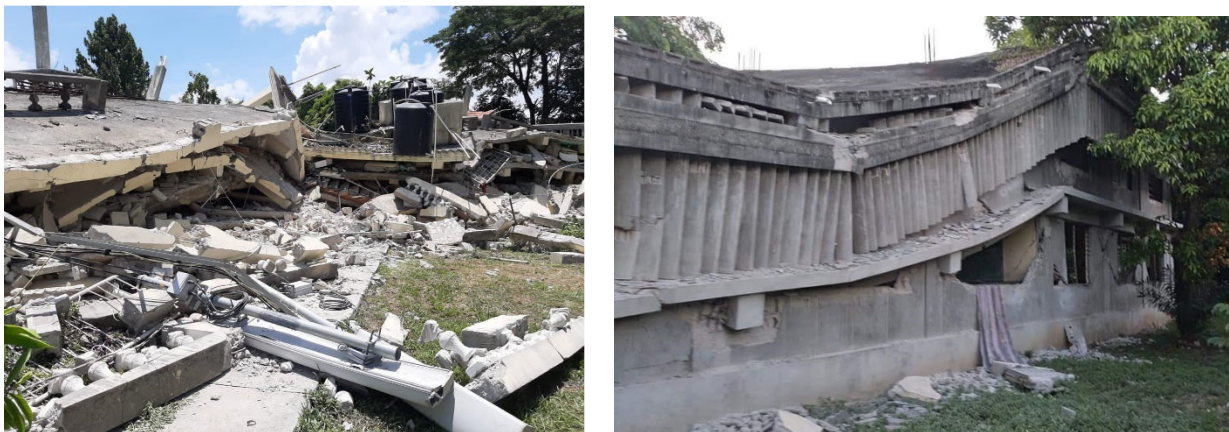
**Figure 4.17.** Views of the collapsed seminary school of the Missionary Oblates of Mary Immaculate in Mazenod, Camp-Perrin, Sud Department (Source: [Twitter](#)).

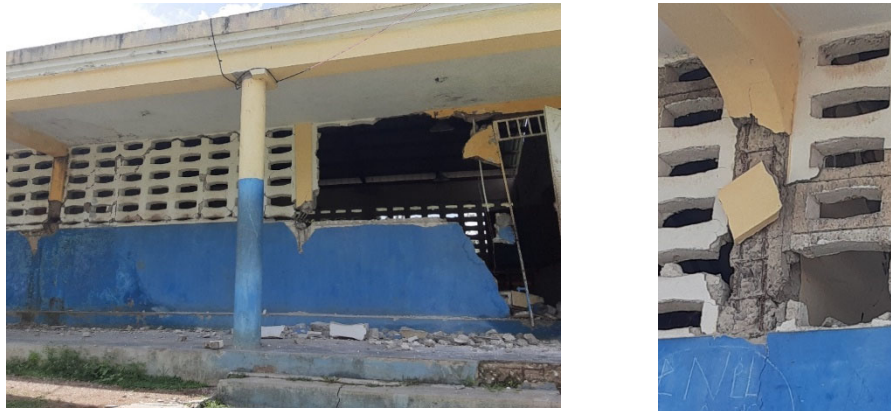
The use of vented CMU block or louvered windows over a partial height of CMU infill or load bearing walls is common practice to ventilate classrooms in these buildings; this can create captive/short column effects that resulted in shear failures in the 2010 Haiti Earthquake (Mix et al., 2010). This practice resulted in similar “short column” failures in Sinai National School (Figure 4.18). The same extensive shear cracks in infill walls as well as in RC columns are observed in Boisrond Tonnerre School in Anse-a-Veau (Figure 4.19).

**Figure 4.18.** Short column effect due to partial height infill walls in Sinai National School in Miragoane (Source: Gefthe Devilmé, GeoHazards International)

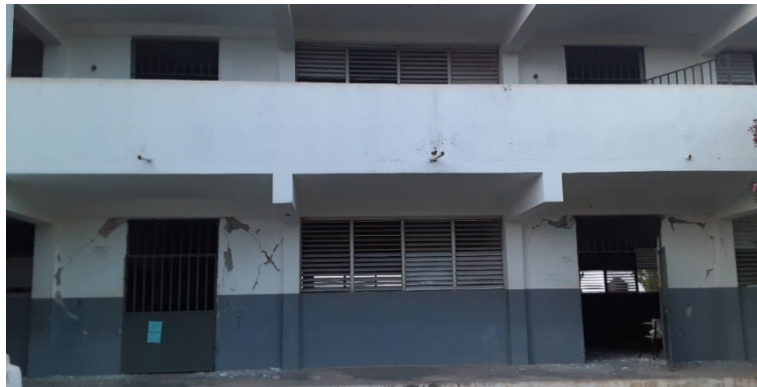
**Figure 4.19.** Infill wall damage and short column shear cracks at Boisrond Tonnerre school, Anse-a-Veau, Nippes Department (Source: Gefthe Devilmé, GeoHazards International)

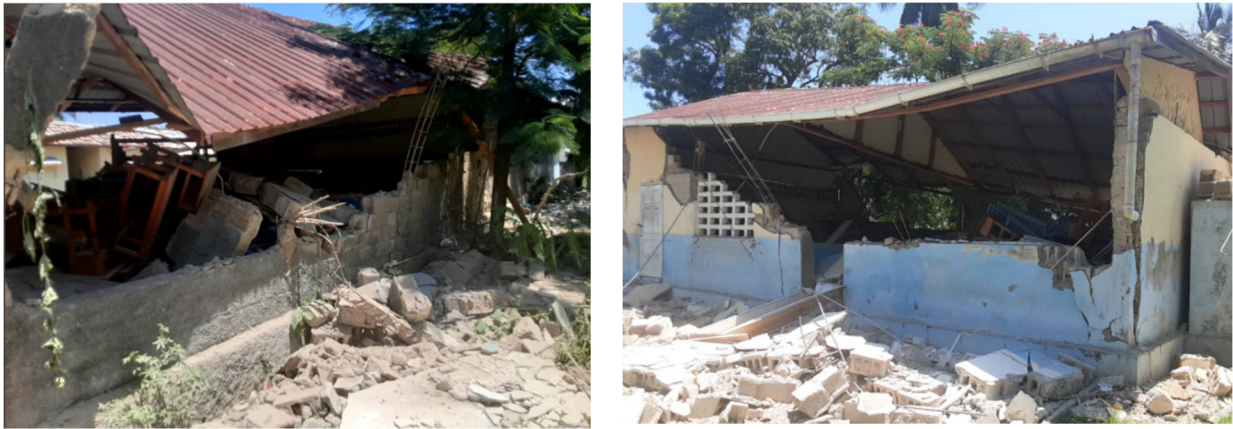
**Figure 4.20.** Public secondary school collapsed in Petit Trou de Nippes (Source: [Twitter](#)).

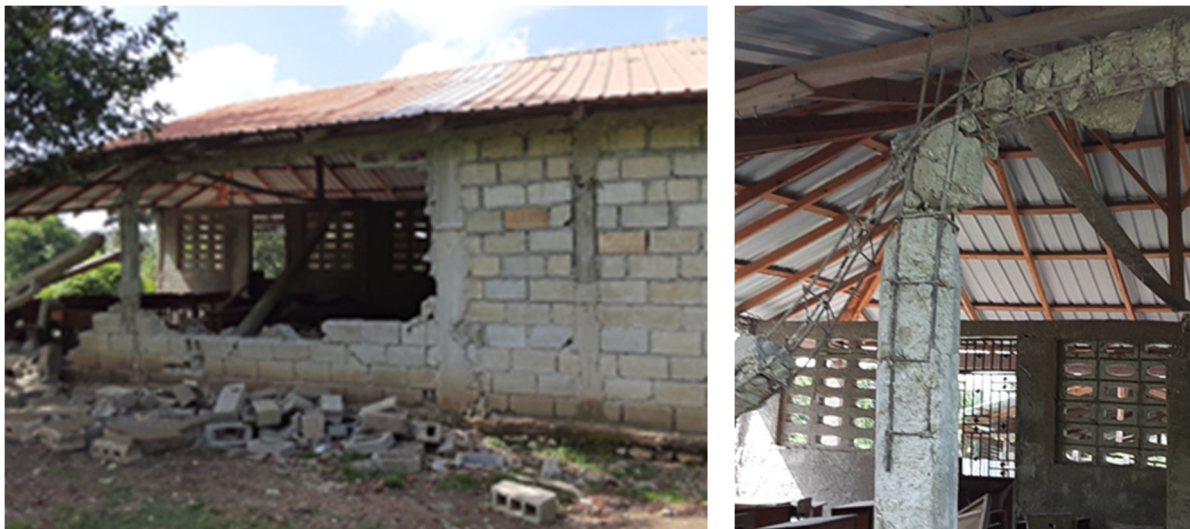
**Figure 4.21.** Severe damage of school in Baltazar (Source: Gefthe Devilmé, GeoHazards International).

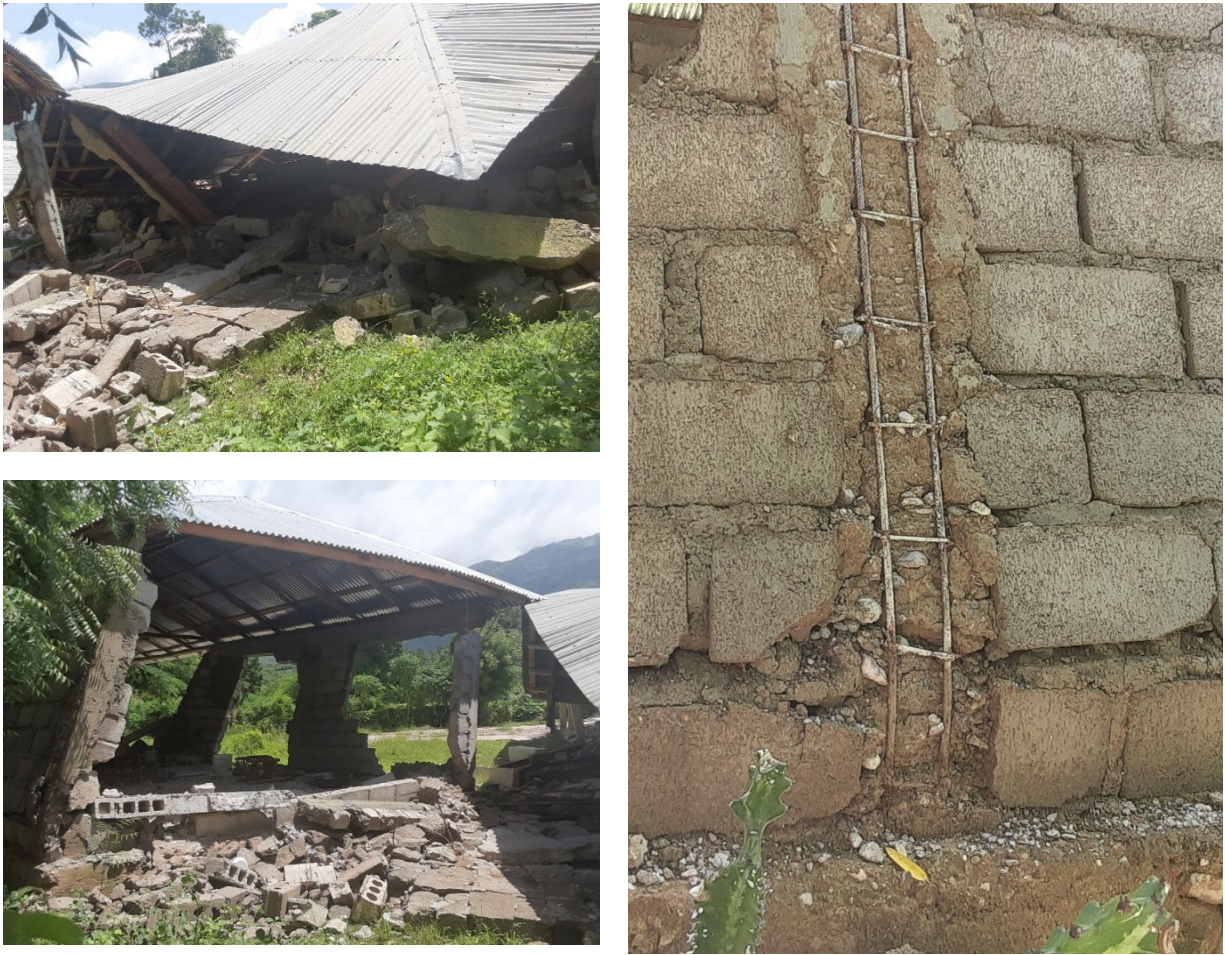
Alternatively, classrooms in the more rural areas may be a single-story version of the previously discussed layout, with similar design features. More humble schools may adopt a more open floor plan with weakly confined masonry or URM topped by a CGI-roof. A failure of one such school in Petit Trou de Nippes is shown in Figure 4.20, 13.5 km from the epicenter. Note shear cracking around vented CMU blocks observed in school in Baltazar (Fig. 4.21), where cracking and collapse of weakly confined CMU walls are combined with damage of horizontal and vertical confining elements. Another example of inadequate confinement of a masonry wall in open-plan schools is demonstrated in Figure 4.22 in L'Asile showing poor quality of tie columns.

**Figure 4.22.** Collapse of weakly confined masonry school in L'Asile, Nippes Department (Source: Gefthe Devilme, GeoHazards International).

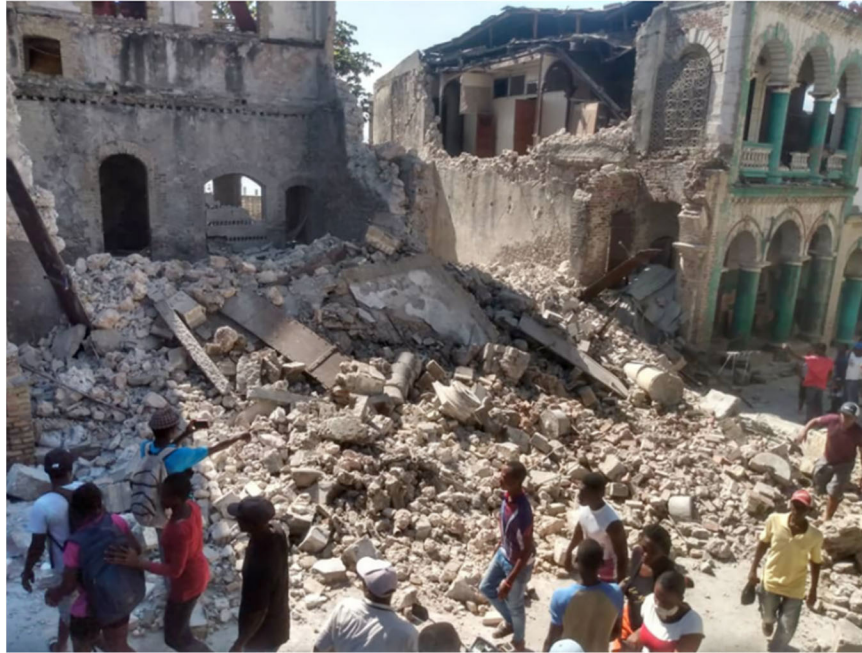
The downtown of the major city centers of Jeremie and Les Cayes are characterized by 2 to 3 story historical load bearing stone masonry buildings with elongated floor plans perpendicular to the street. Major damage was reported in this class of construction, as evidenced in Figure 4.23.

**Figure 4.23.** Collapse of stone masonry historical buildings, downtown Jeremie (Source: [CNN](#)).

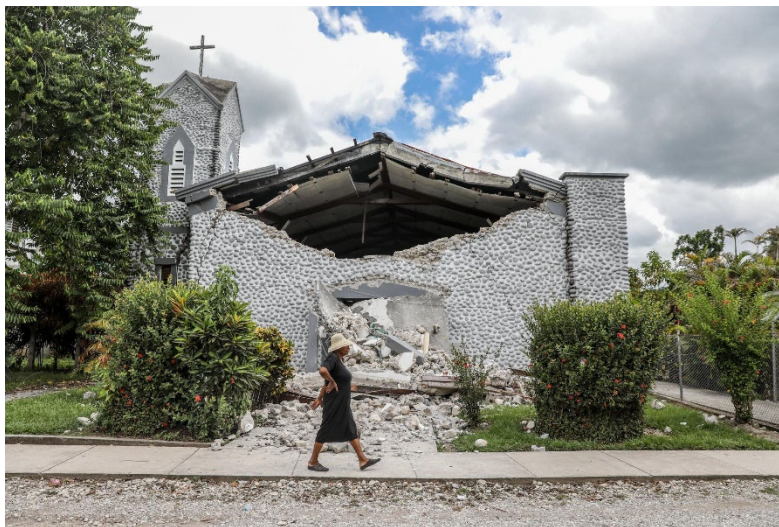
**Figure 4.26.** View of the damage to the Chapel of Saint Eugene, which is part of the seminary school of the Missionary Oblates of Mary Immaculate in Mazenod, Camp-Perrin (Source: [NYTimes](#)).

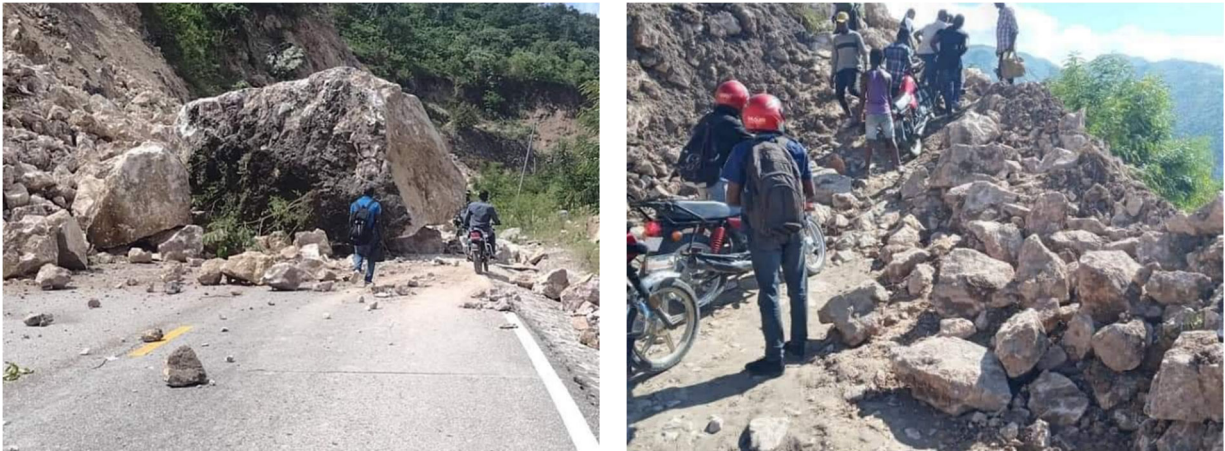
**Figure 5.1.** Rockslides restrict RN7 (National Route 7) from Les Cayes to Grand'Anse (Source: [W10news - Facebook post](#)).

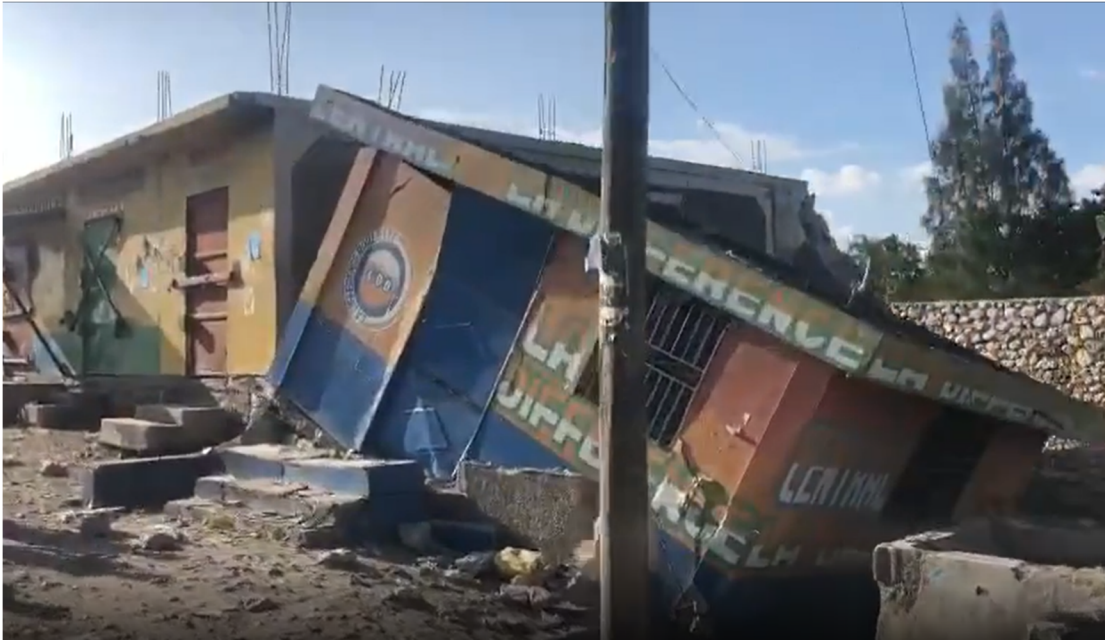
**Figure 6.4.** Foundation failure under small business in Saint George area in southwest Haiti (Source: [Twitter](#)).

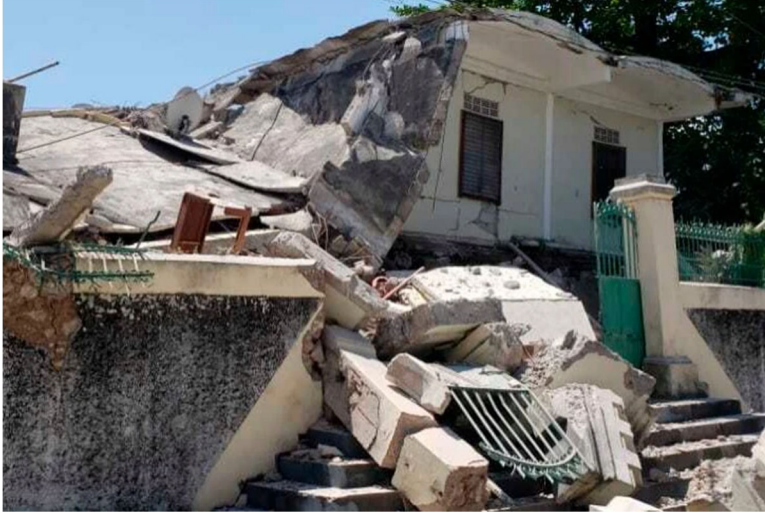
Multi-unit residential collapse in Les Cayes, Sud Department (Source: [NYTimes](#), August 14)

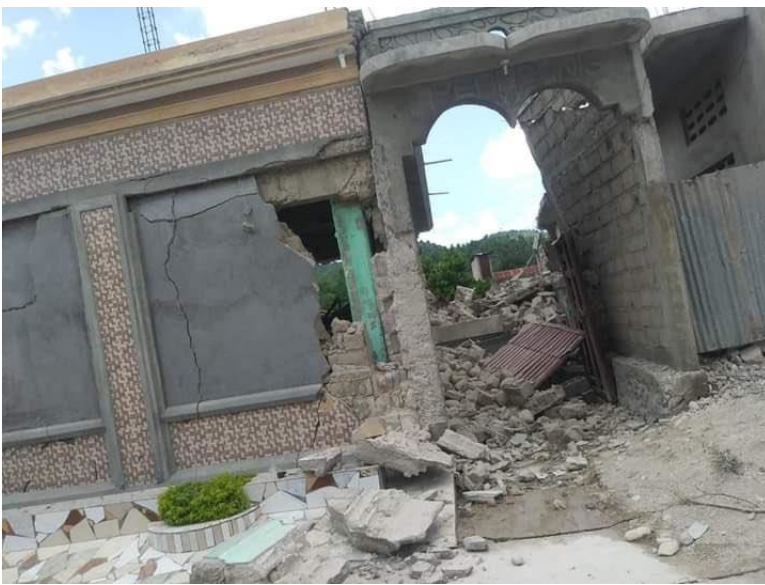
Damage to masonry in the commune of Maniche, Les Cayes, Sud Department  
(Source: [Twitter](#))

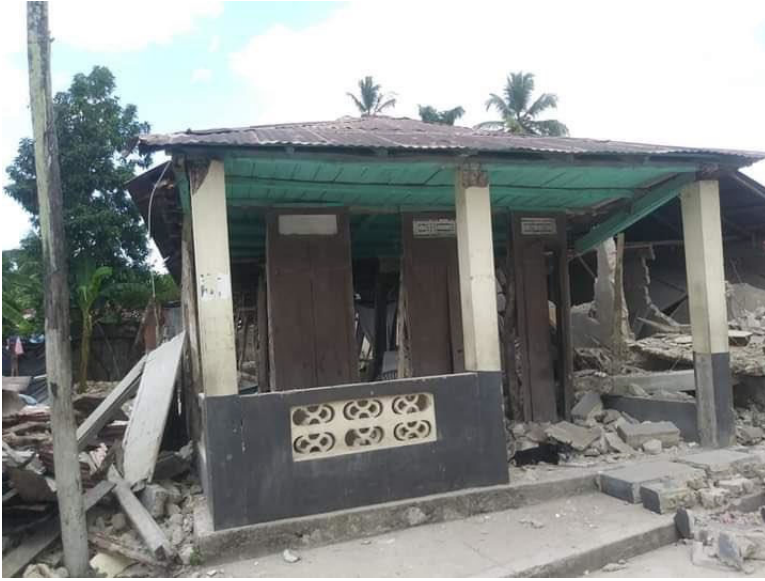
Damage to infill walls in homes in the commune of Maniche, Cayes, Sud Department (Source: [Twitter](#))

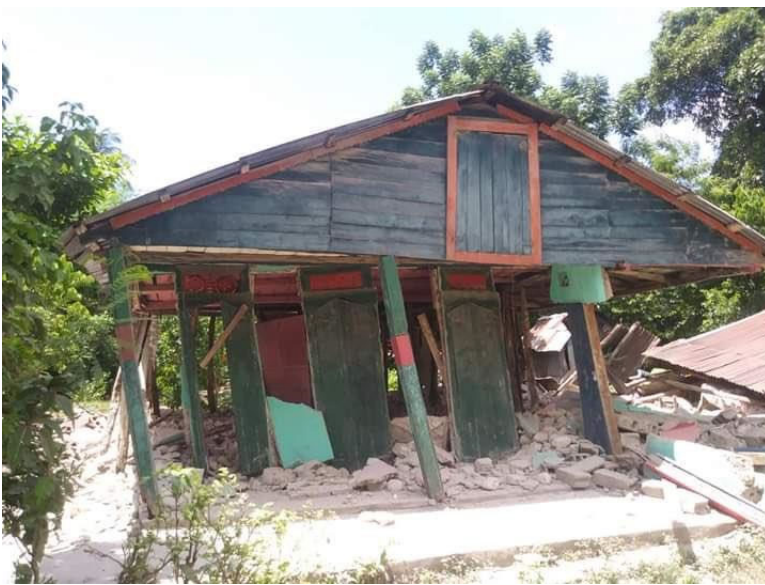
Damage to infill walls in homes of the commune of Maniche, Cayes, Sud Department (Source: [Twitter](#))

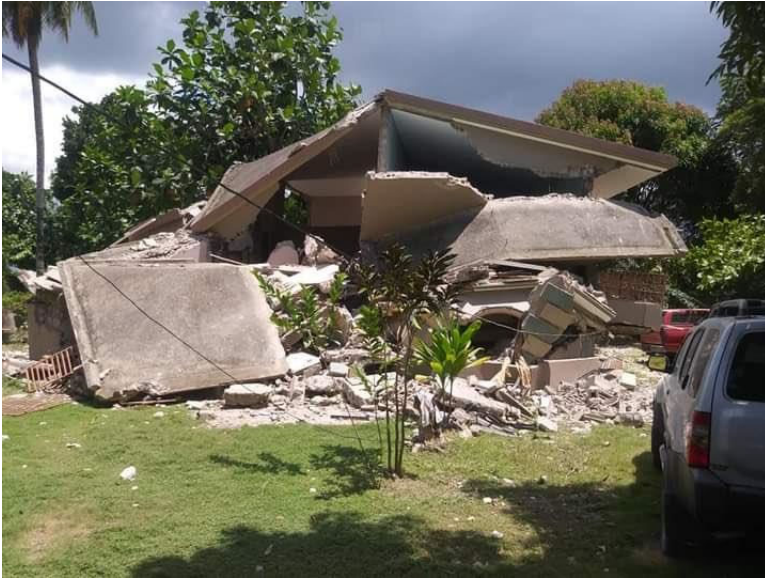
Collapse of a multi-story house in commune of Maniche, Cayes, Sud Department (Source: [Twitter](#))

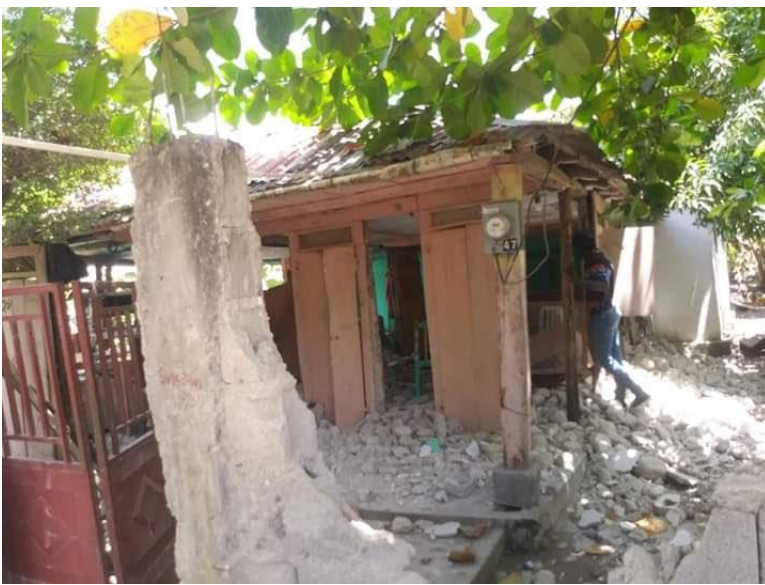
Damage to infill walls in house in commune of Maniche, Cayes, Sud Department (Source: [Twitter](#))

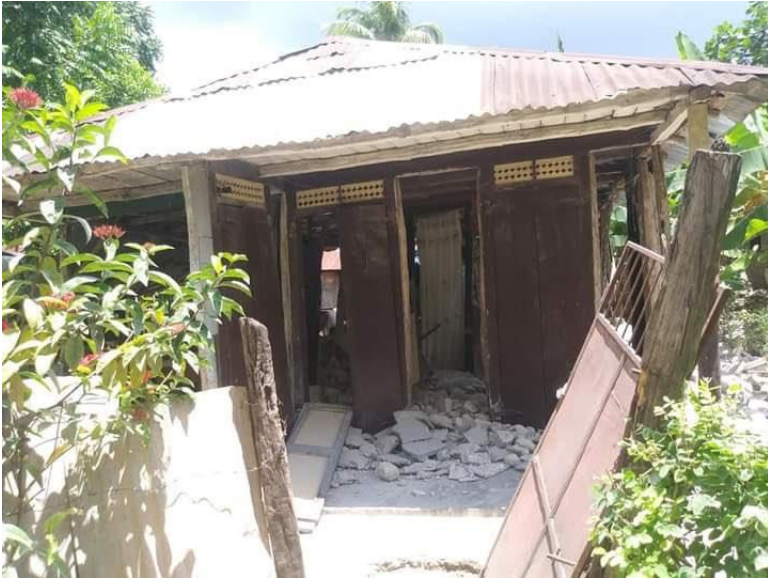
Damage to infill walls in house in commune of Maniche, Cayes, Sud Department (Source: [Twitter](#))

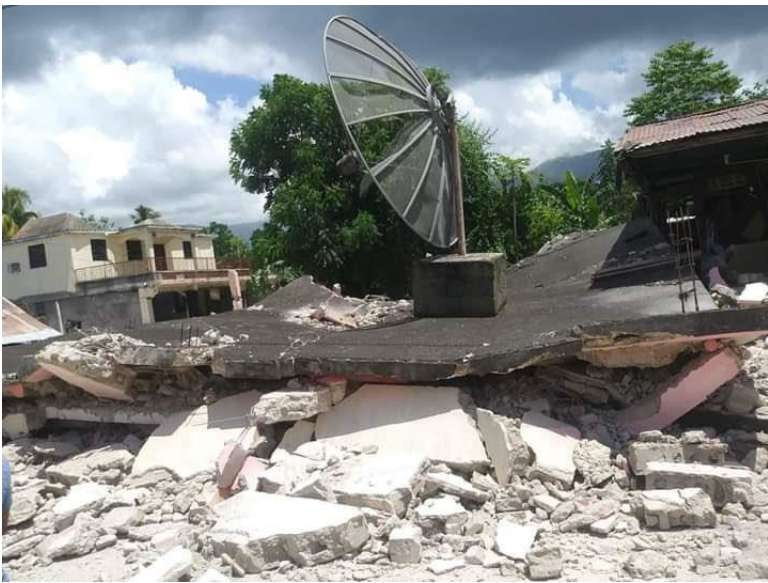
Collapse of masonry building in the commune of Maniche, Cayes, Sud Department (Source: [Twitter](#))

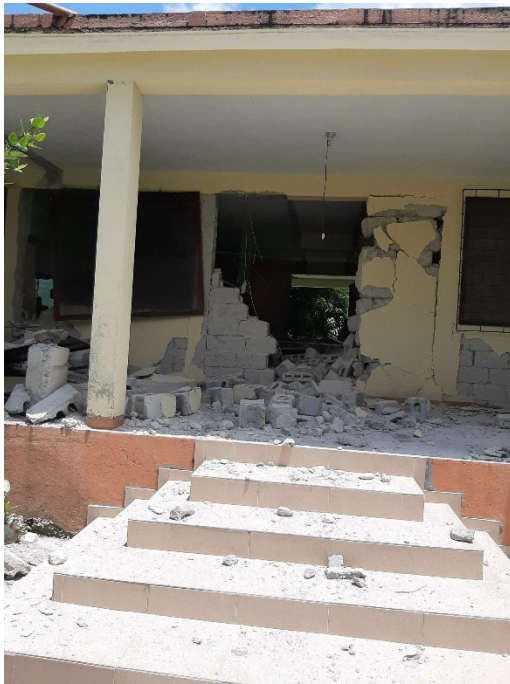
Damaged houses in the commune of Camp-Perrin, Cayes, Sud Department (Source: [Twitter](#))

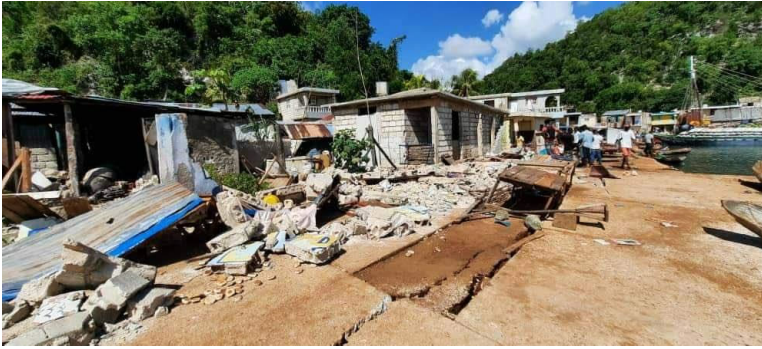
Damaged houses in the commune of Pestel, Corail Arrondissement, Grand'Anse Department (Source: [Twitter](#))

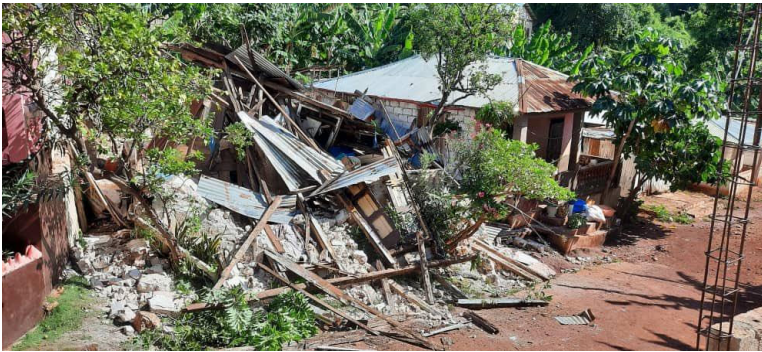
Collapsed house in the commune of Pestel, Corail Arrondissement, Grand'Anse Department (Source: [Twitter](#))

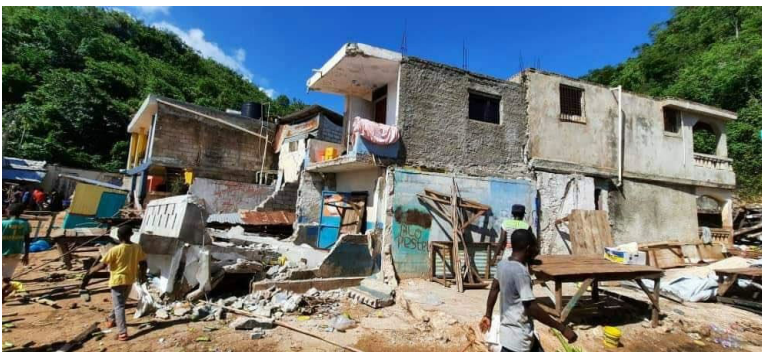
Damaged houses in the commune of Pestel, Corail Arrondissement, Grand'Anse Department (Source: [Twitter](#))

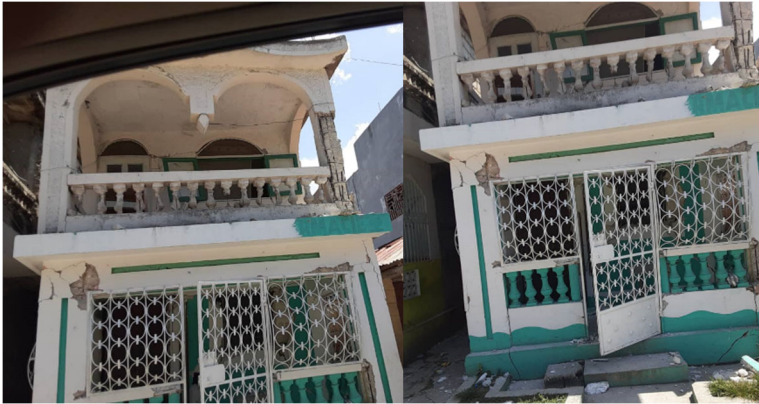
Damage of single-family houses in Petite Riviere de Nippes (Credit: Gefthé Dévilmé, GeoHazards International)

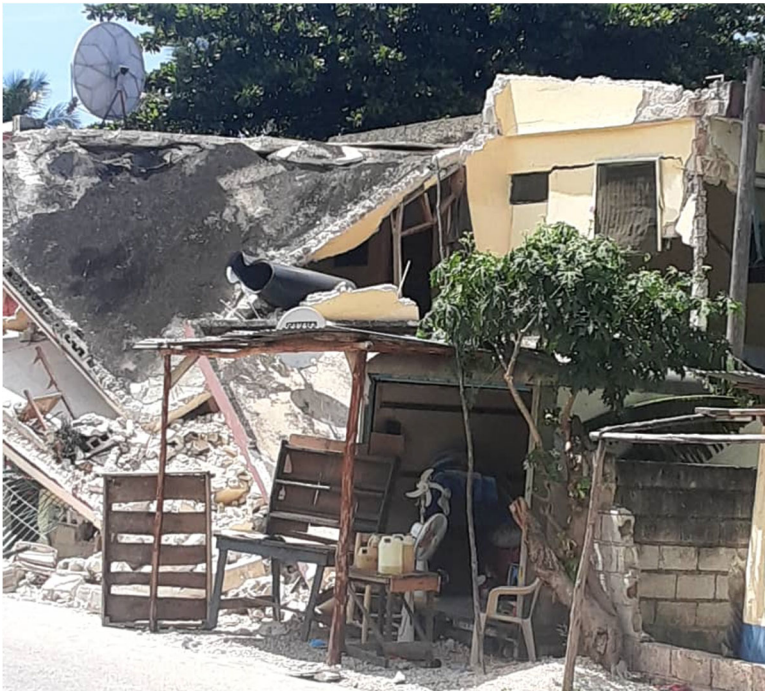
Damage of single-family houses in Petite Riviere de Nippes (Credit: Gefthé Dévilmé, GeoHazards International)

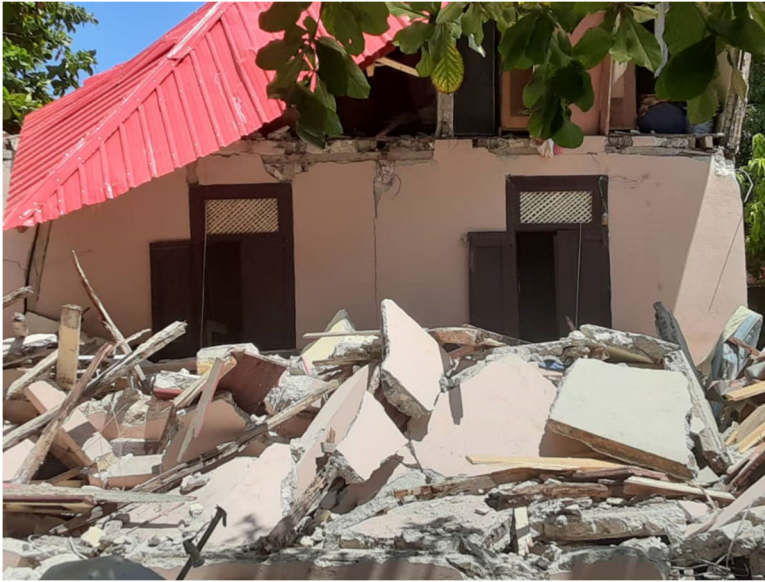
Damage of single-family house in Anse-a-Veau (Credit: Gefthé Dévilmé, GeoHazards International)

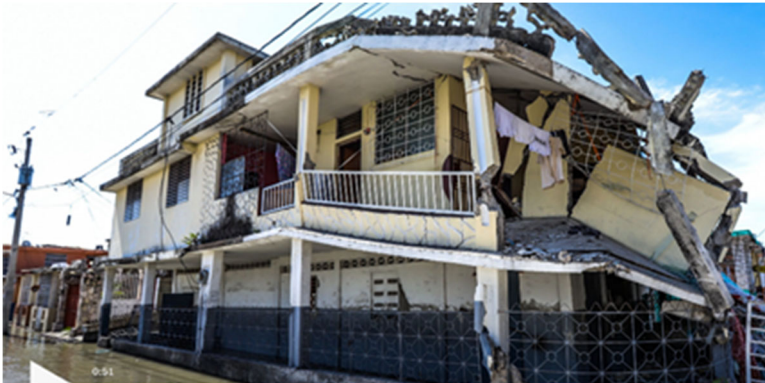
Partial collapse of a multi-family RC residential building (Still photo of a footage by Ralph Tedy Erol/AP, Source: [NY Times](#))

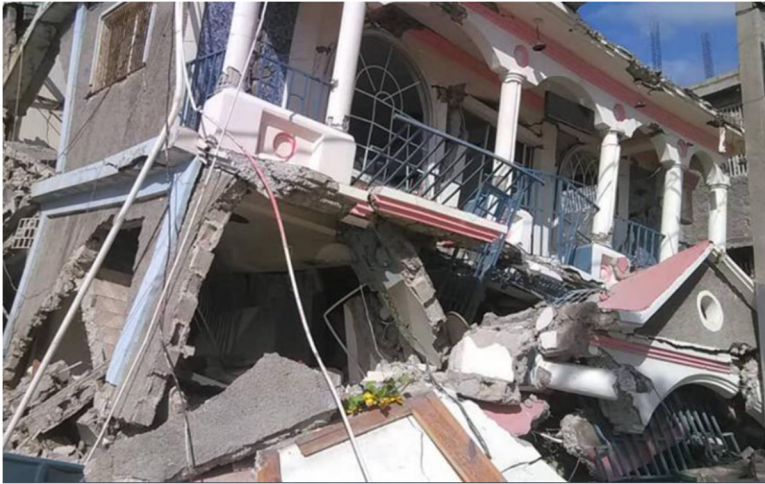
Collapsed hotel in Les Cayes (Source: [Twitter](#))

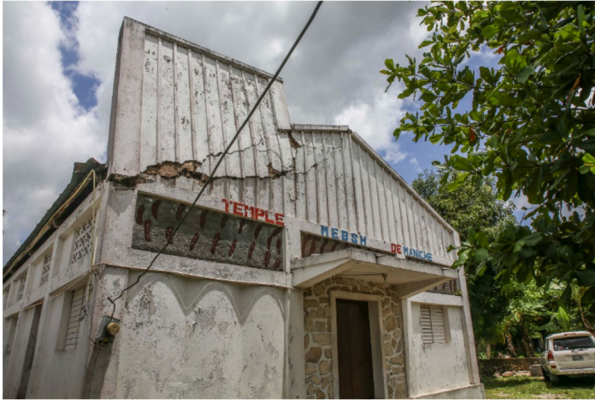
Damaged Baptist MEBSH church of Maniche  
(Source: [Le Nouvelliste](#))
