**M7.2 Nippes Earthquake,  
 Haiti**

14 August 2021

**PRELIMINARY VIRTUAL RECONNAISSANCE REPORT (PVRR)**

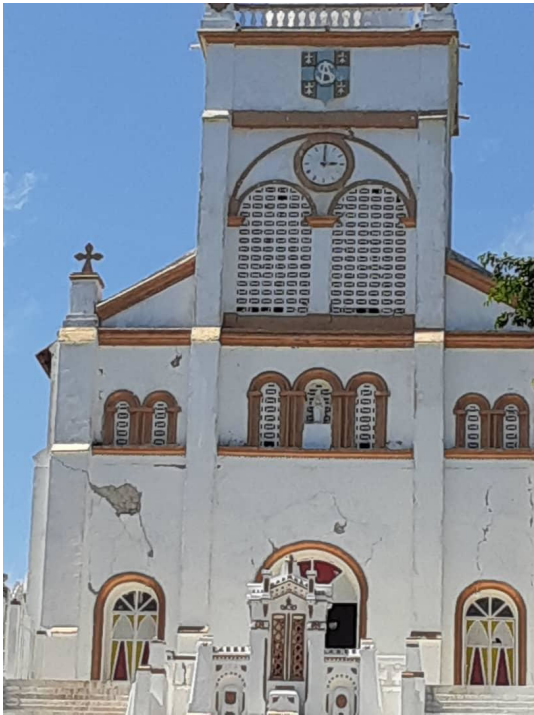
Damage to the cathedral of Saint Anne in the  
commune of Anse-à-Veau (Source:  
GeoHazards International).

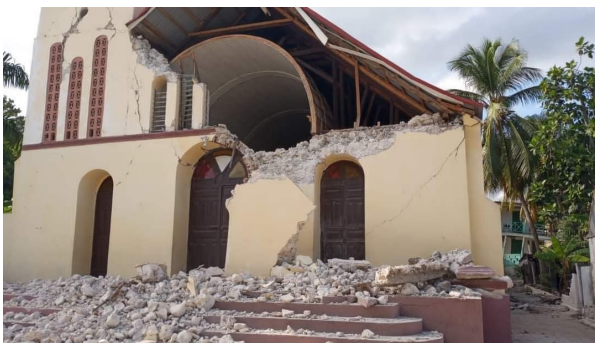
Partial collapse of the parish church in the  
commune of Corail, Grand d'Anse Department  
(Source: [Twitter](#))

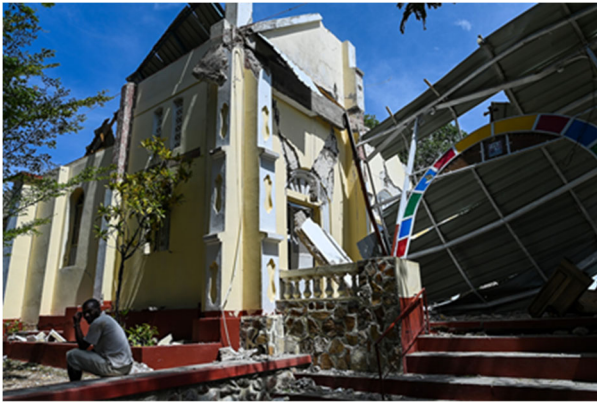
Damage to the church of Saint Joseph in the commune of L'Asile (Source: [Washington Post](#))

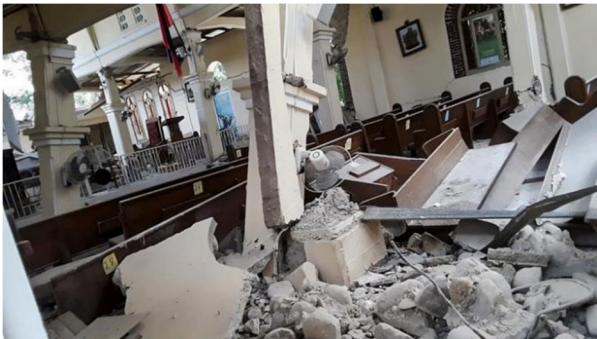
Damage to the church of Saint Joseph in the commune of L'Asile (Source: [Boston Pilot](#))

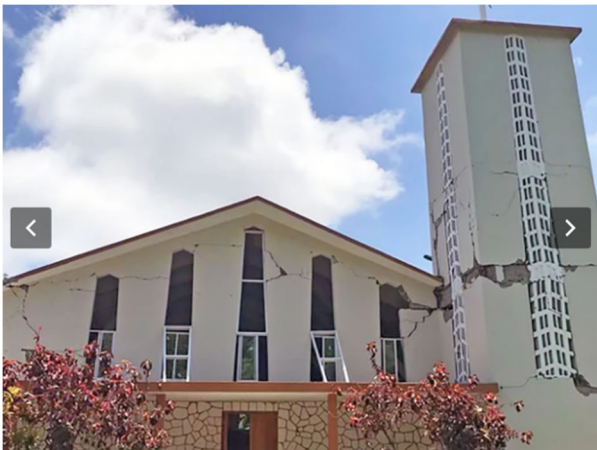
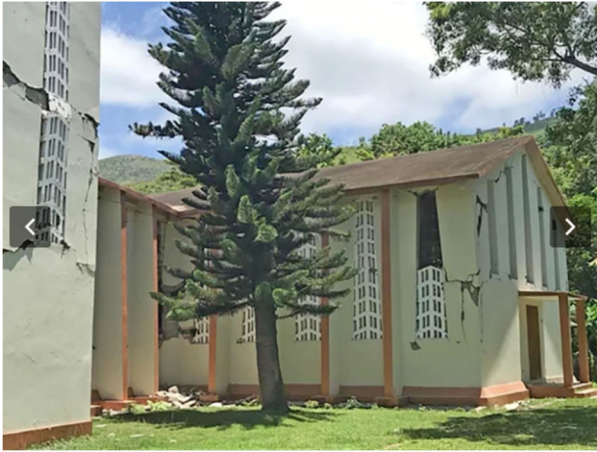
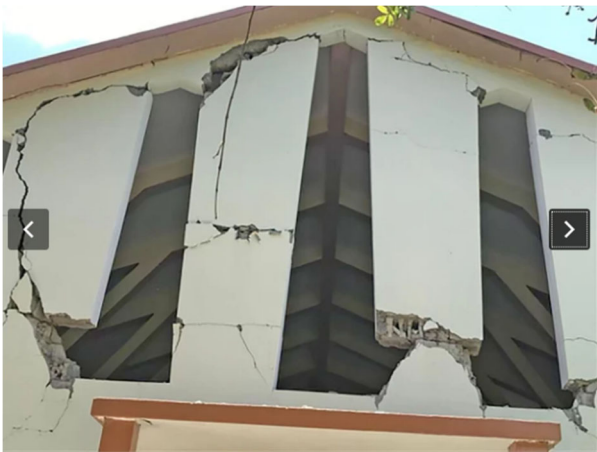
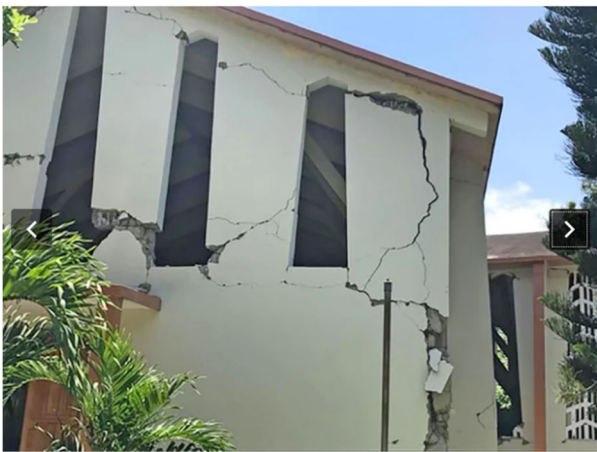
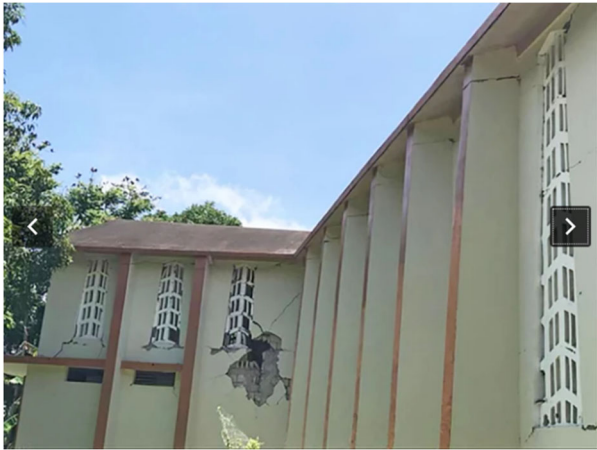
Damage to the church of Saint Anne, in La Sucrerie Henry, commune of Aquin, Sud Department (Source: [Mona Lisa Lives Here](#))

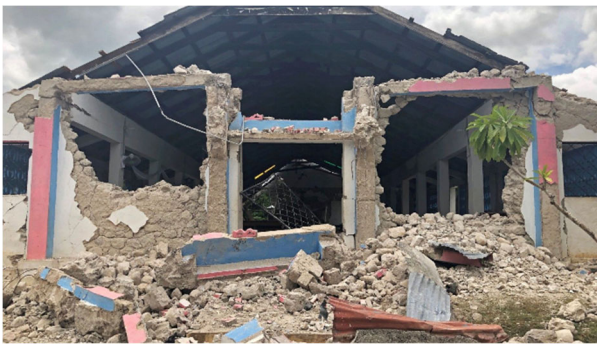
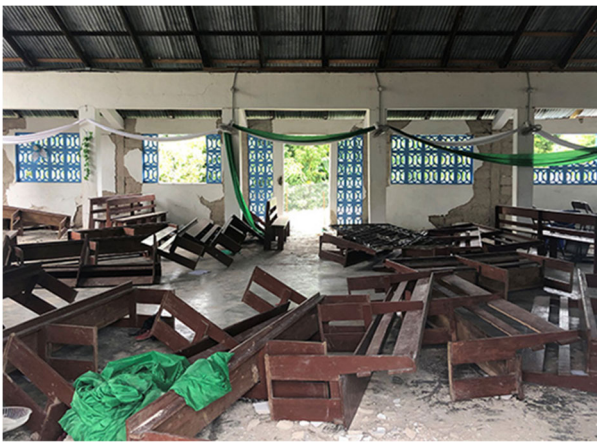
Damage to the church of the Sainte Famille du Toirac, in Toirac, commune of Camp Pérrin (Source: [Boston Pilot](#))
