EVENT BRIEFING

Event: Cyclones Idai and Kenneth

Region: Southeast Africa

Released: June 4, 2019 (DesignSafe Project: PRJ-2399)

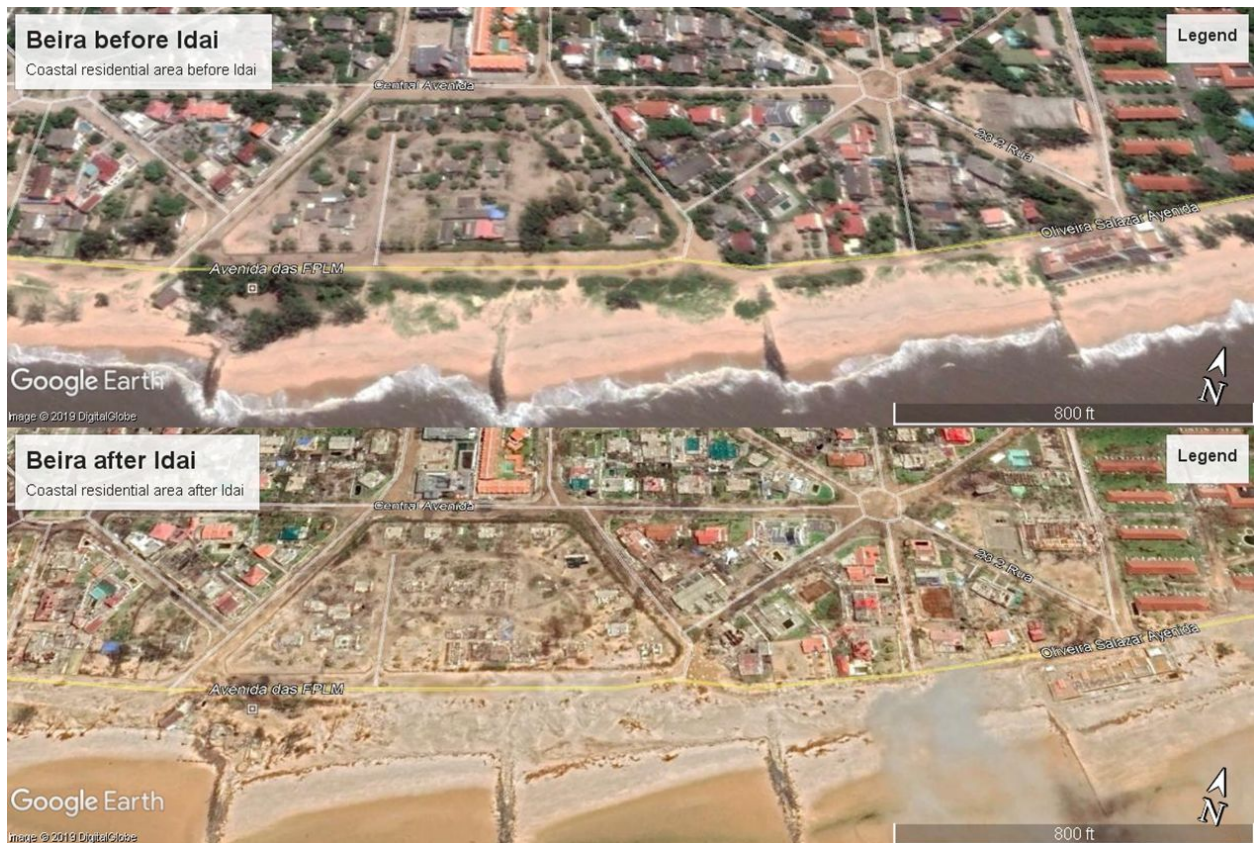
Damage to coastal structures resulted from a combination of high wind and storm surge. Figure 4 shows a typical stretch of coastline in Beira both before and after Cyclone Idai. Buildings and roadways exposed to storm surge suffered significantly more damage than those subjected to high winds only.

Figure 4: Google Earth images before (top, 3/12/2019) and after (bottom, 3/21/2019) Cyclone Idai

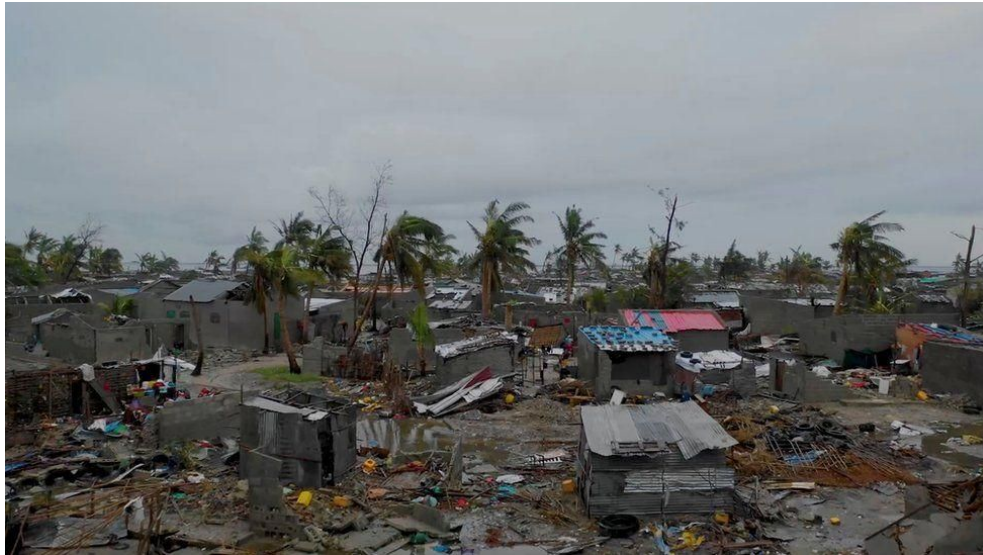
Most of the buildings damaged by these two cyclones was confined to non-engineered housing units (Fig. 5). The lack of effective load path to resist uplift forces on the roofs led to failure of many of these dwellings. Subsequent flooding due to the heavy rainfall and proximity to large river deltas, particularly along the Pungwe River, resulted in extensive flooding damage to additional damage and displacement of occupants, compounding the existing wind damage (Fig. 6).

Figure 5: Damage to non-engineered housing units consisting of adobe/timber walls and sheet metal roofing (Photo Credit: Reuters)

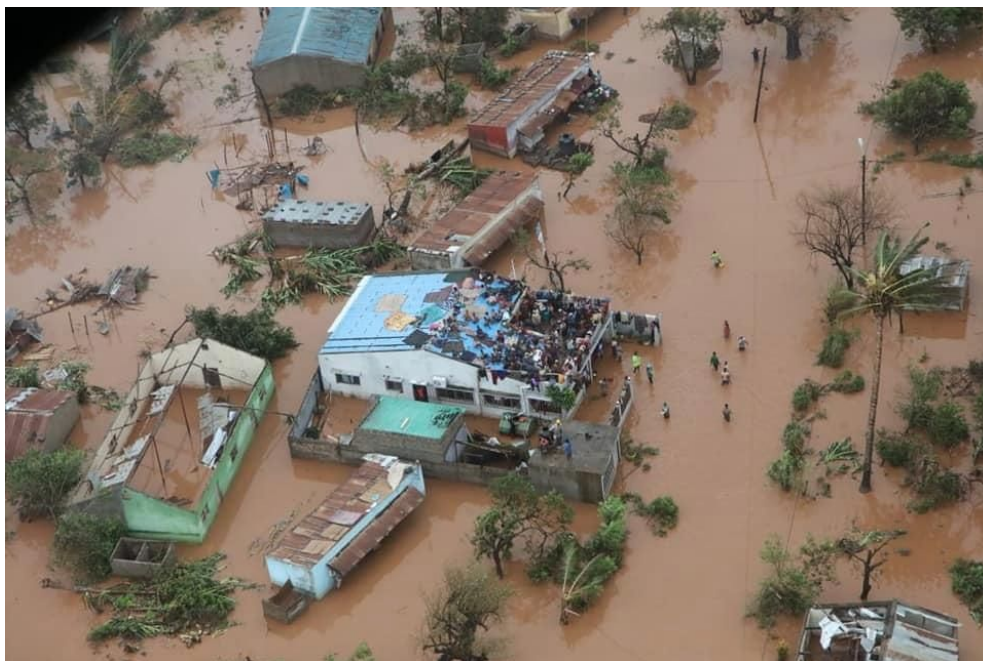
Figure 6: Residents seek refuge from flood waters on second level of damaged building (Photo Credit: National Institute of Disaster Management – INGC, Mozambique)

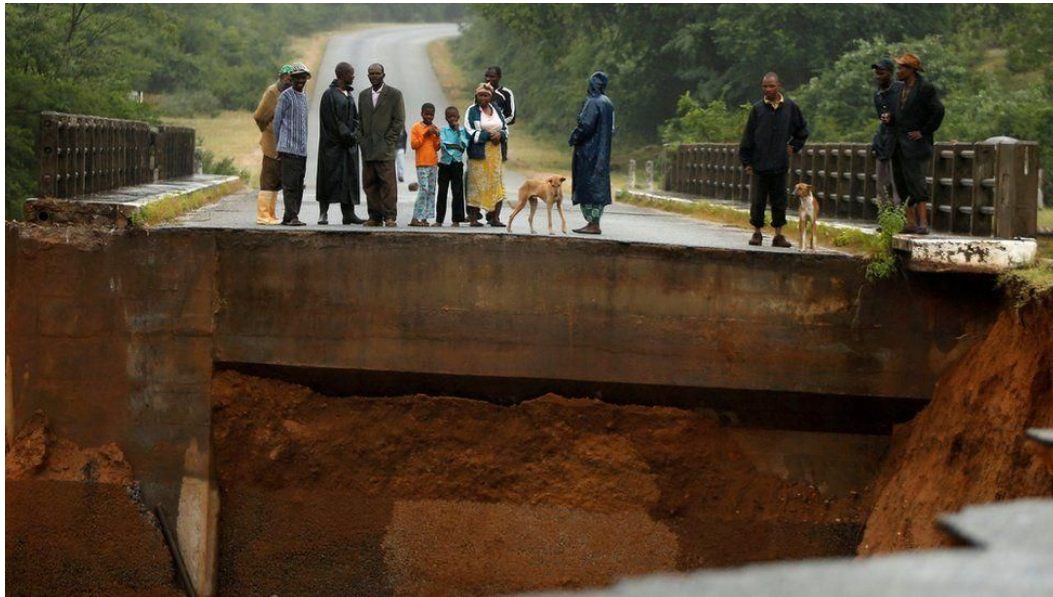
A number of roads and at least one bridge were washed away by the flood waters, most likely due to scour (Figs. 7 and 8). The authors are not aware of any major failures of bridges due to structural damage caused by the wind or flooding.

Figure 7: Abutment to bridge span crossing the Umvumvu river washed away following Cyclone Idai in Chimanimani (Photo Credit: Reuters)

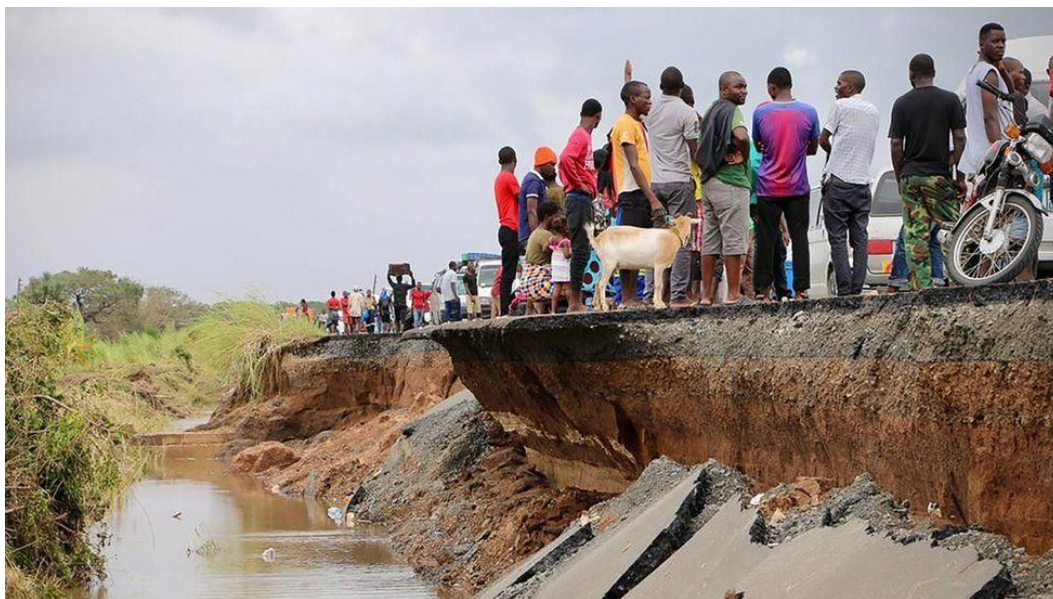
Figure 8: Damaged section of the road between Beira and Chimoio in Nhamatanda District in Central Mozambique after the area was hit by Cyclone Idai.
