StEER: Structural Engineering Extreme Event
Reconnaissance Network
2018 HAITI EARTHQUAKE
PRELIMINARY VIRTUAL ASSESSMENT TEAM (P-VAT)
REPORT

Collapsed School Building in Gros-Morne, Haiti

Released: October 10, 2018
NHERI DesignSafe Project ID: PRJ-2104

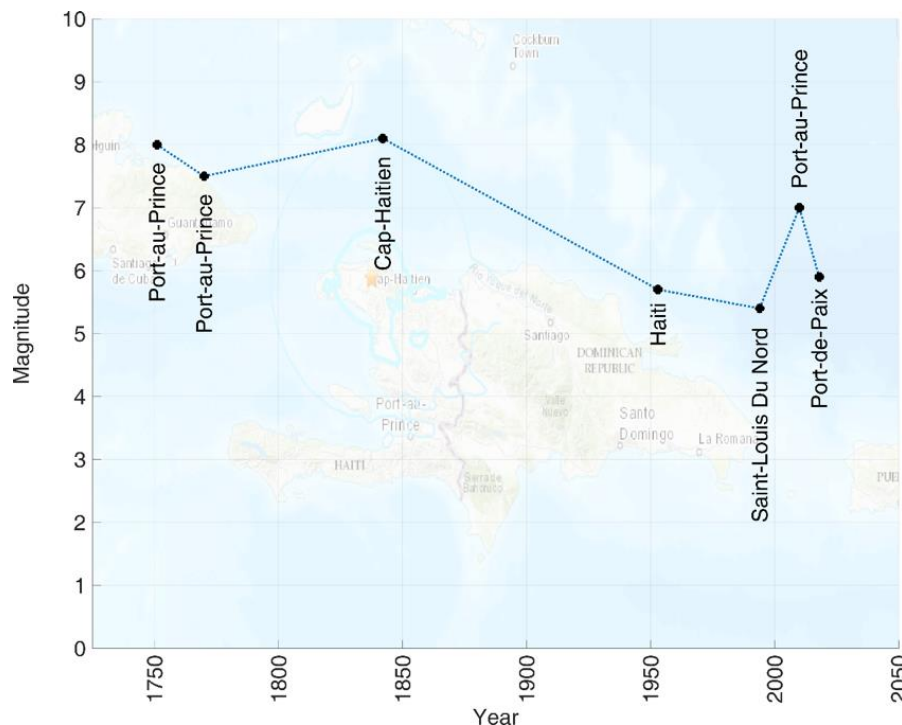
Figure 1: Timeline of major earthquakes in Haiti (primary data source: <http://bit.ly/usqs-sig-eg>).

The first objective of StEER’s response is the compilation of information available immediately after the event, to improve our understanding of the performance of constructed facilities during a moderate earthquake in a country that was devastated by a 7.0 magnitude earthquake 8 years ago and has gone through a series of mitigation measures. Although buildings and structures in the US may perform better during the earthquake than those in Haiti, this earthquake still provides good lessons to learn in the form of hazard mitigation for a country that has a history of strong earthquakes (see Fig. 1).

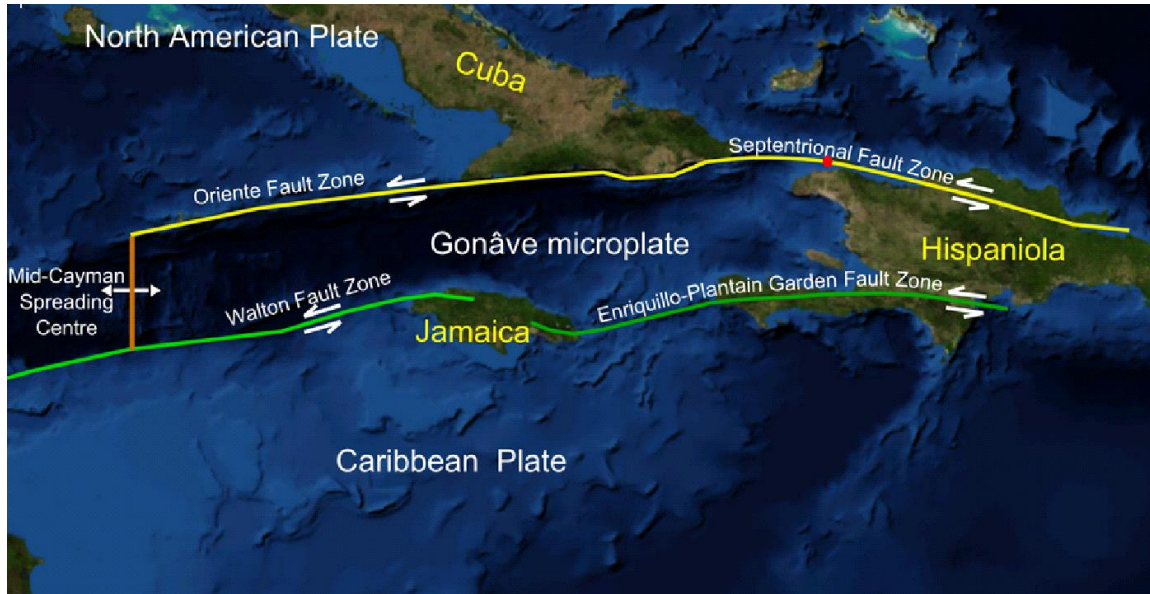
Figure 3: Septentrional-Oriente fault zone with the epicenter of the earthquake marked on the Septentrional fault (Wikipedia, 2018)

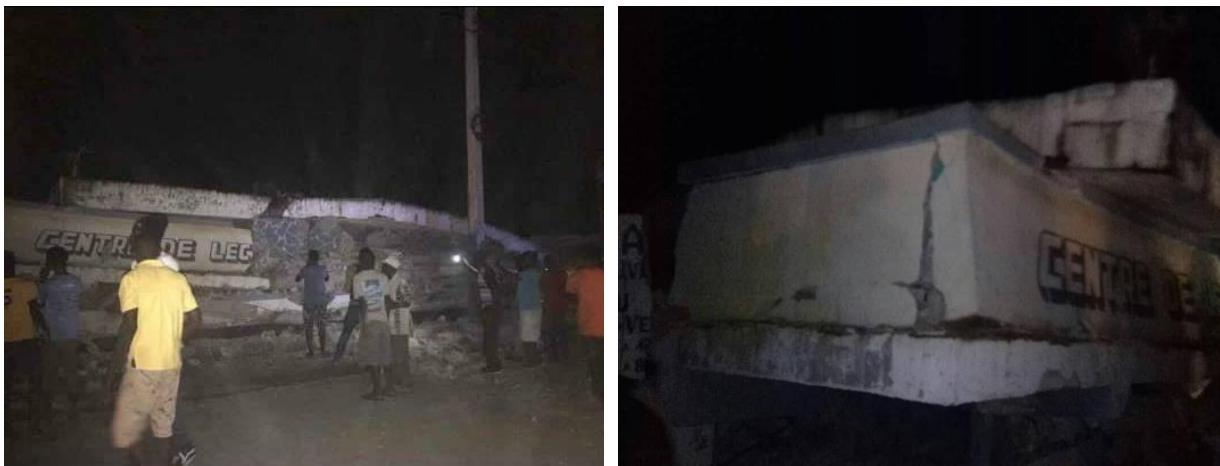
First story of a reinforced concrete auditorium in the town of Gros-Morne collapsed during the earthquake on October 6 2018 (Fig. 6), killing one person. By the morning of October 7 2018, it was entirely cleared and debris was removed (Fig. 7). A video of the clearance of the collapsed auditorium can be found at:

Figure 6: The collapsed auditorium after the 2018 Haiti Earthquake

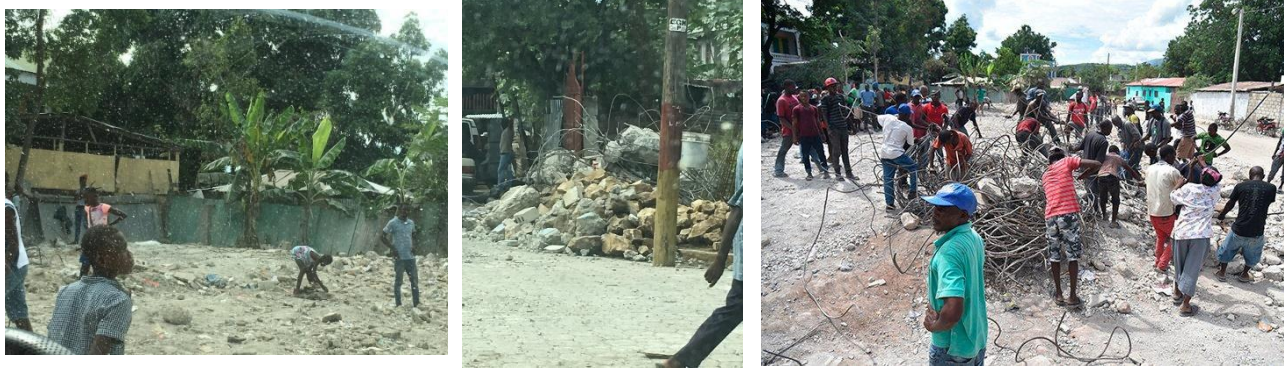
Figure 7: The debris of the collapsed auditorium after the 2018 Haiti Earthquake

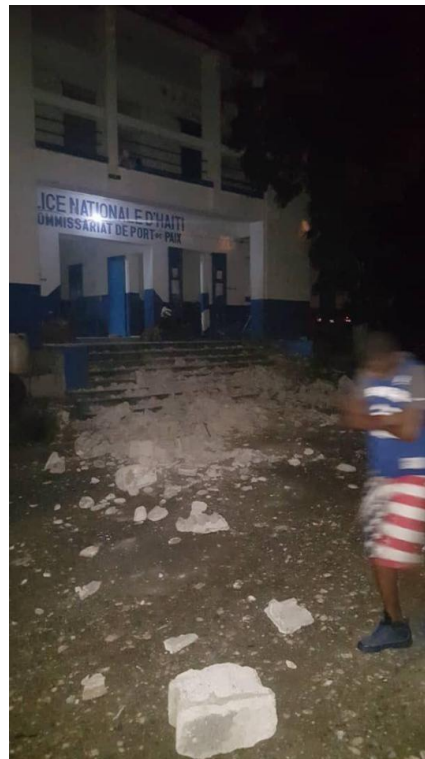
A police station, named Police Nationale d'Haiti Commissariat de Port-de-Paix, in Port-de-Paix was damaged (Fig. 8), allowing several detainees to escape.

Figure 8: The damaged police station after the 2018 Haiti Earthquake

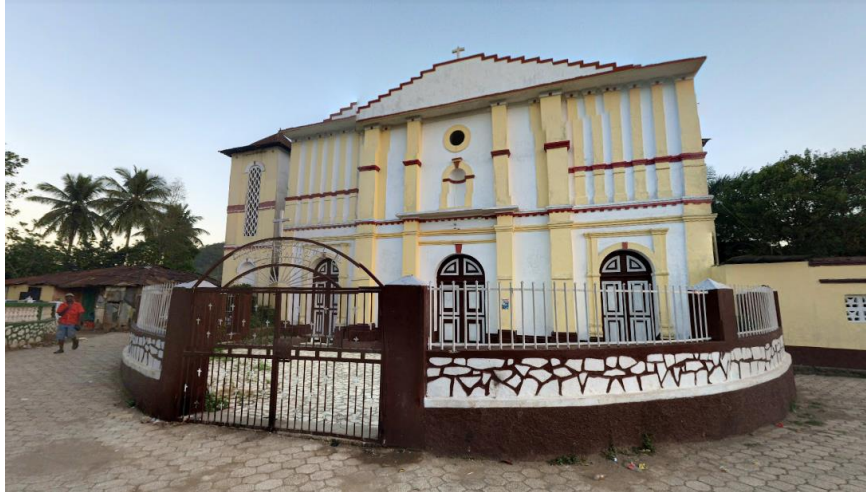
Figure 9: Google Map Street View image of Paroisse Saint Michel Archange de Plaisance church before the 2018 Haiti Earthquake

The front facade of the Catholic church, Paroisse Saint Michel Archange de Plaisance collapsed (Figures 9-11). A house next to the church also collapsed, according to Lemoine Bonneau from Haitian newspaper *Le Nouvelliste*.

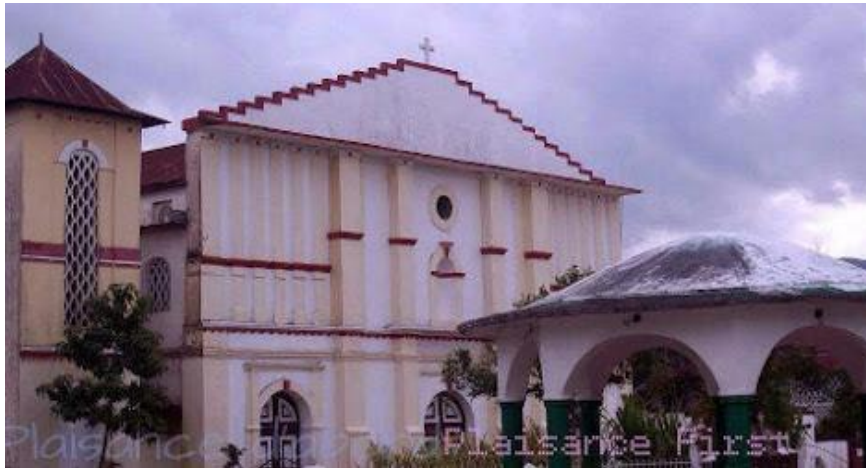
Figure 10: Google Map Street View image of Paroisse Saint Michel Archange de Plaisance church before the 2018 Haiti Earthquake

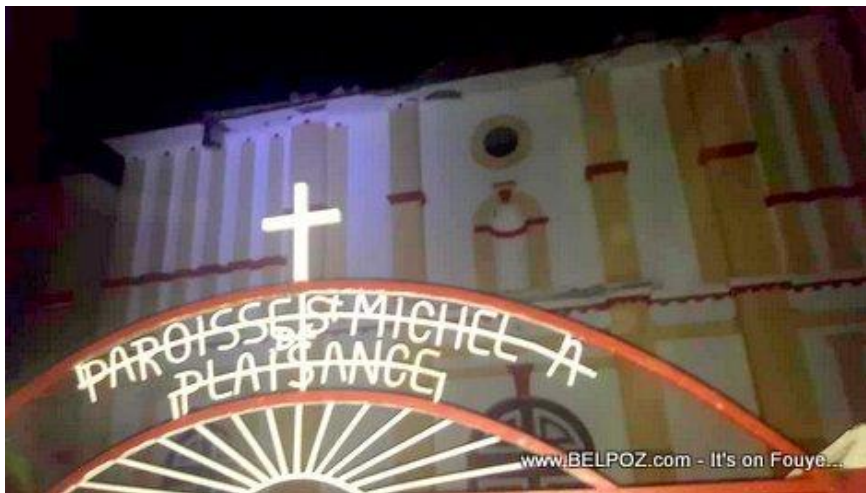
Figure 11: Damaged Paroisse Saint Michel Archange de Plaisance church after the 2018 Haiti Earthquake, note the decorative gable atop the front face in Figures 8 and 9 detached in the earthquake.

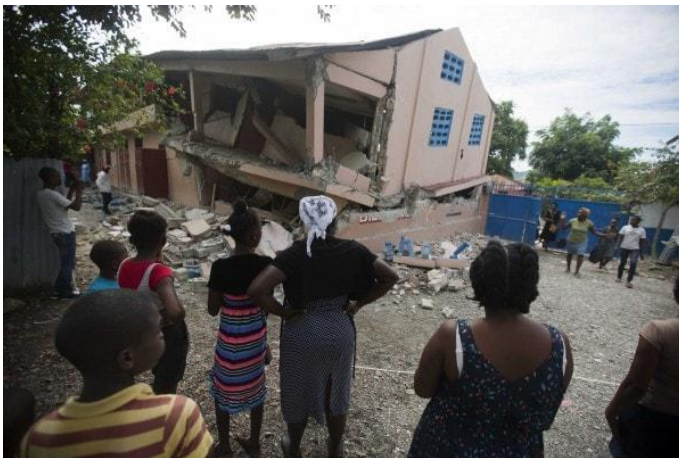
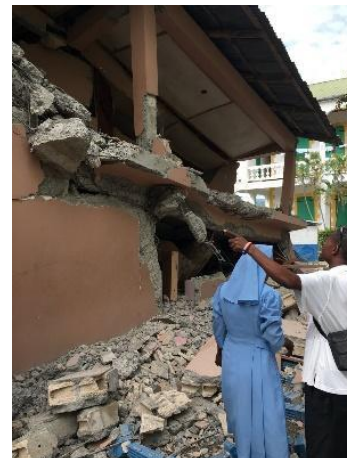
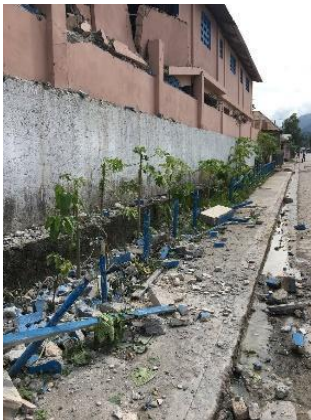
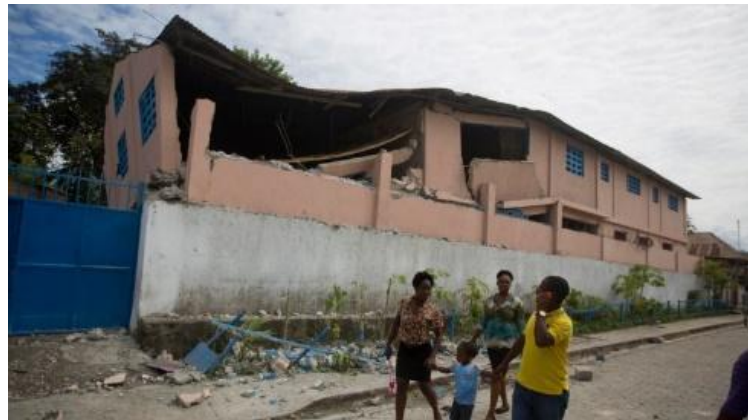
San Gabriel National School in Gros-Morne is a 2-story RC moment resisting frame that collapsed due to the damage of the first-story columns (Fig. 12). Some beams on the second floor and some external walls were also destroyed, severely damaging several classrooms. The block of classrooms was just built in 2016. The construction materials shown in Figure 11b possibly seem to be easily crushed, which suggests questionable material quality and levels of confinement.

Figure 12: Collapsed San Gabriel National School in Gros-Morne after the 2018 Haiti Earthquake

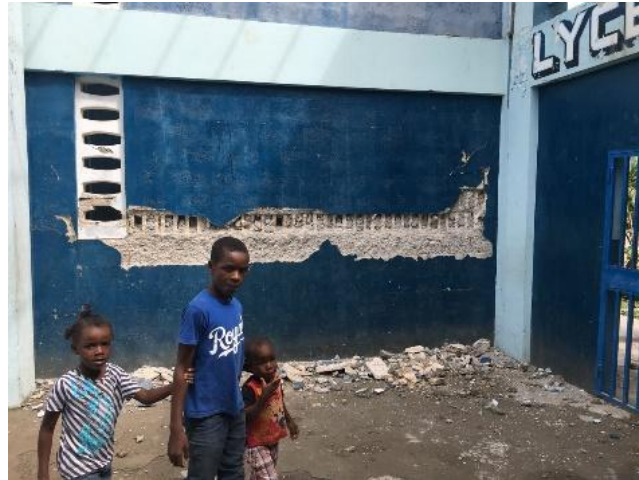
Moderate damage was observed at the Lycee Jacques Roumain Educational Center in Gros-Morne (Fig. 13).

Figure 13. Damaged infill wall of the Lycee Jacques Roumain Educational Center in Gros-Morne after the 2018 Haiti Earthquake

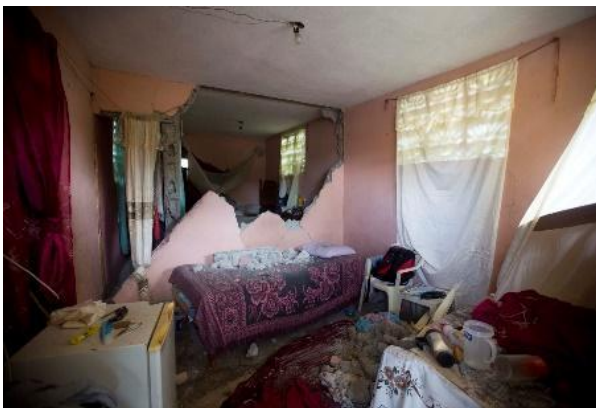
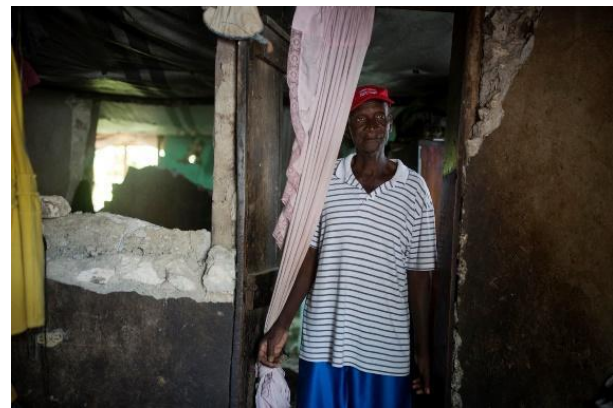
Some residential houses collapsed and others experienced moderate to heavy damage. A bed is covered by rubble from a CMU wall that collapsed in Figure 14a (AP Photo/Dieu Nalio Chery), representative of the weakly confined load bearing masonry construction common in modern Haitian residential construction. A Haiti citizen, Marcorel Maurice, stands inside his wooden post and beam home, a more traditional residential typology, which suffered damage to the stone infill (AP Photo/Dieu Nalio Chery) in Figure 14b.

Figure 14. (a) A bed is covered by rubble from a CMU wall that collapsed, and (b) A Haitian man stands inside the failed infill wall in his damaged home

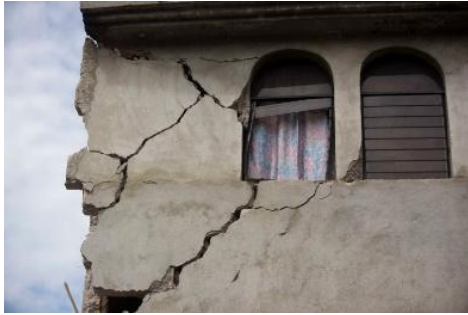
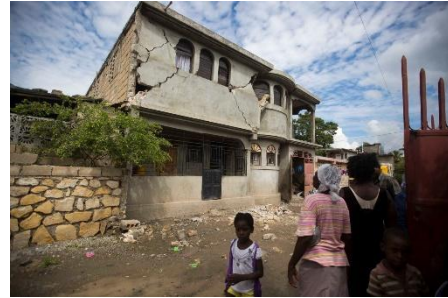
Figures 15 and 16 provide other examples of damage to CMU load bearing masonry homes, with shear cracks adjacent to louvered and vented block windows. Note the absence of any confining elements at the corner of the upper floor of the damaged home in Figure 15. In Port-de-Paix, Haiti, residents are asking for temporary shelter after their homes were destroyed by the earthquake; many were frightened to return to homes that survived the first earthquake for fear they would collapse in the subsequent aftershocks. Videos of some damaged houses can be found at <https://twitter.com/esteelavoie>.

Figure 15. Large cracks observed in the walls of a masonry house after the 2018 Haiti Earthquake (Dieu Nalio Chery/Associated Press)

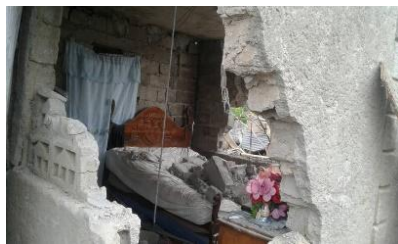
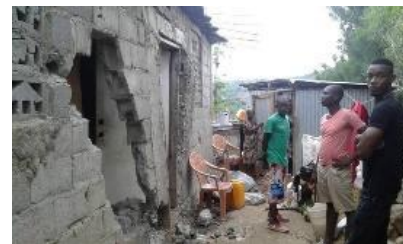
Figure 16. Heavily damaged homes in Port-de-Paix after the 2018 Haiti Earthquake
