StEER: Structural Extreme Event Reconnaissance  
Network  
SUNDA STRAIT TSUNAMI (INDONESIA)  
PRELIMINARY VIRTUAL ASSESSMENT TEAM (P-VAT) REPORT

**Released:** December 30, 2018

**NHERI DesignSafe Project ID:** PRJ-2175

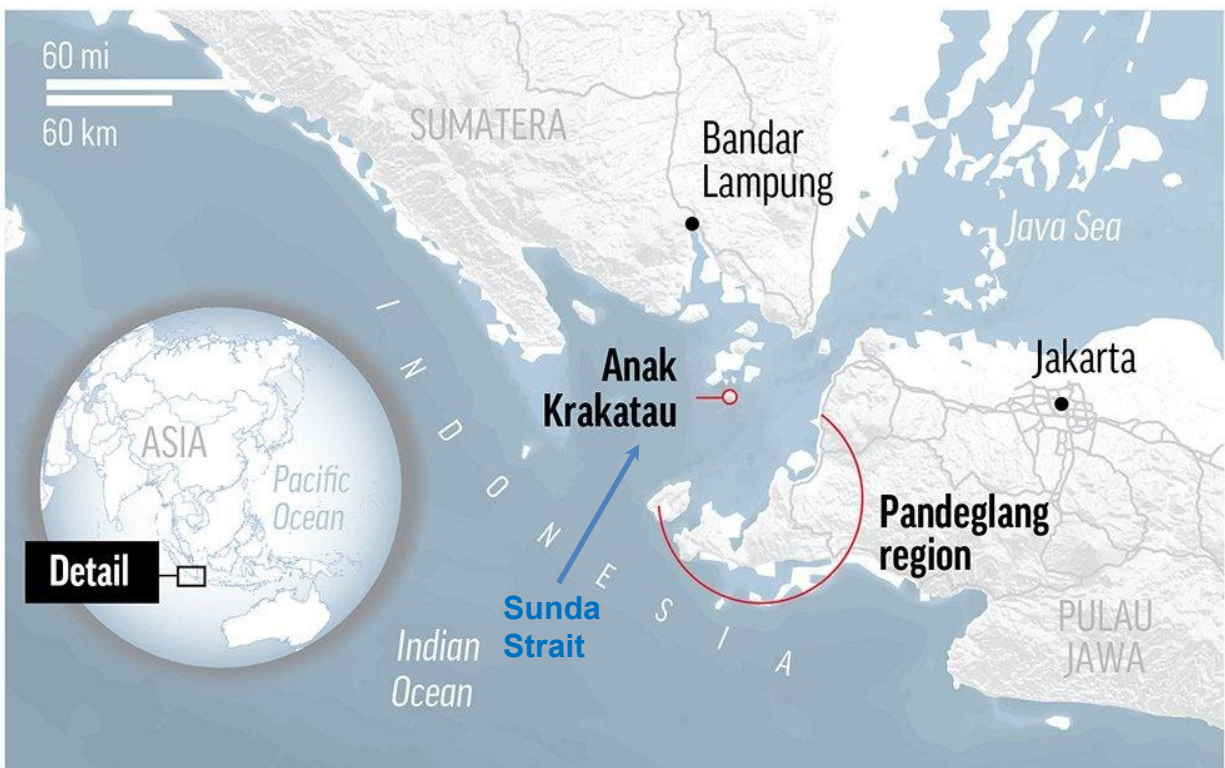
**Figure 1: Map showing location of Anak Krakatau in the Sunda Strait between Sumatra and Java Islands, Indonesia (Credit: Associated Press)**

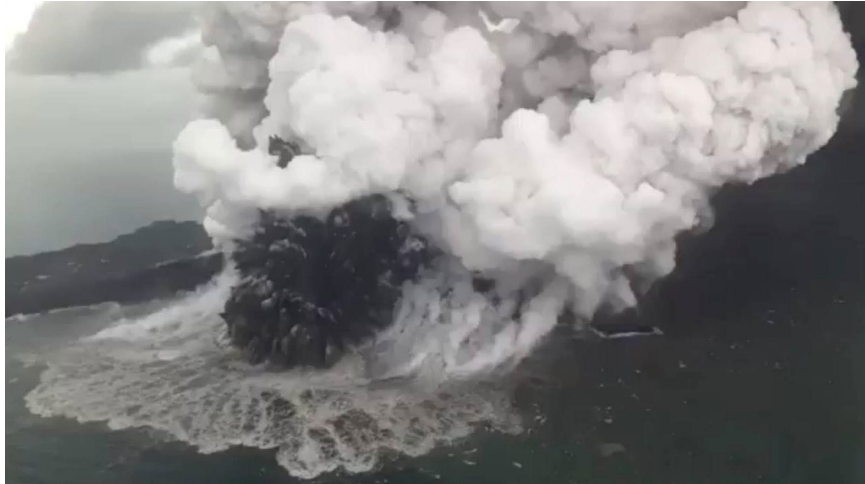
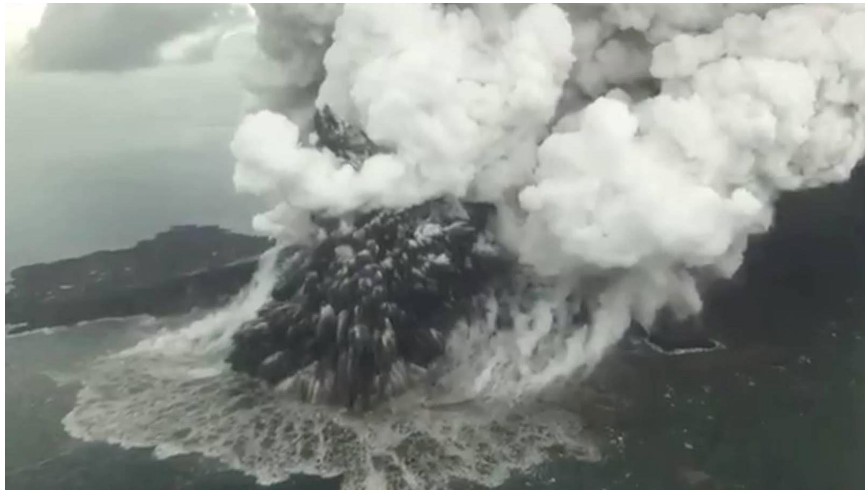
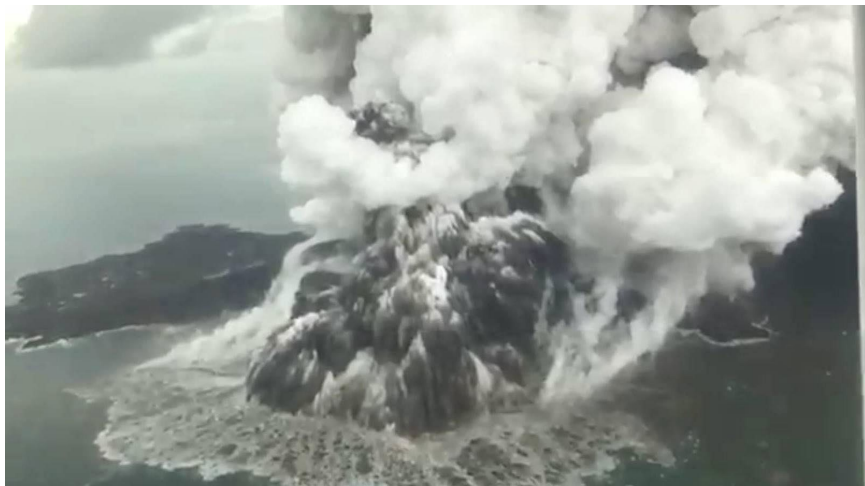
**Figure 5: Three sequential images (top to bottom) from video of violent explosion of Anak Krakatau at around 4pm on December 23<sup>rd</sup>, 2018, the day after the damaging tsunamis (Credit: Capt. Mykola from Susi Air)**

The volcano is still very active as illustrated by a video captured by Captain Mykola of Susi Air at around 4 PM local time during a reconnaissance flight to observe tsunami damage on December 23<sup>rd</sup>, 2018 (see [https://twitter.com/Sutopo\\_PN/status/1077045675290812416](https://twitter.com/Sutopo_PN/status/1077045675290812416)). Figure 5 shows three images captured from this video showing a large explosion at Anak Krakatau, potentially leading to additional smaller tsunami waves. The volcanic ash was also reported to affect the surrounding areas up to 12 km radius.

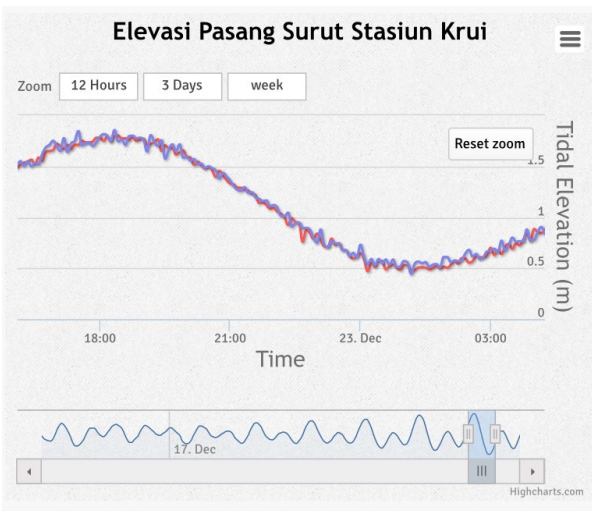
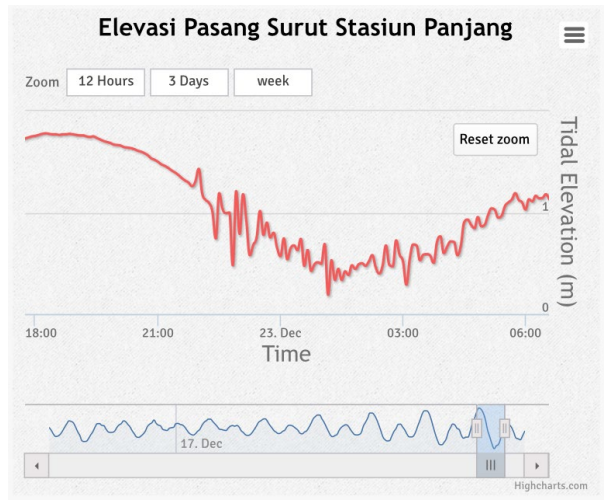
**Figure 6: Tide station records on south end of Sumatra Island during time of tsunami (Source: Jason Patton / tides.big.go.id)**

The tide gage records at sites outside of the Sunda Strait (Krui in Figure 6 and Binuangeun in Figure 7) show almost no signal from the tsunami waves. Similarly, the tide gage at Bengkuntat (Figure 6) does not appear to show a tsunami wave signal; the long spike at 1:00 am on Dec. 23<sup>rd</sup> is likely an errant reading.

Tide gages inside Sunda Strait, not directly exposed to tsunamis generated by a Southwest flank collapse on Anak Krakatau, show disturbance from the tsunami waves, but they do not exceed the spring tide level experienced earlier that evening (Kota Agung and Pelabuhan Panjang in Figure 6).

Tsunami wave arrival times are all approximately 21:30 as reported by eyewitnesses at various locations. All records start with an initial positive wave, which is typical of landslide-generated tsunamis and confirms the eyewitness accounts that the water did not recede prior to the first wave.

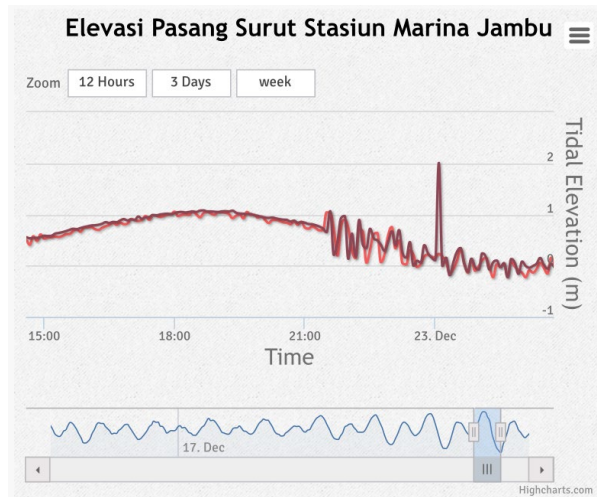
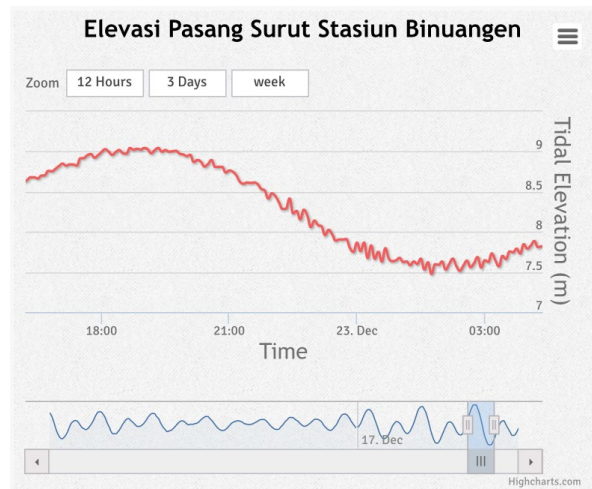
Figure 7: Tide station records on west end of Java Island during time of tsunami (Source: Jason Patton / tides.big.go.id)

Although located North and East of Anak Krakatau, the tide gages at Ciwandan, Banten, (Figure 7) and Marina Jambu (Figure 7) registered more significant tsunami wave heights that just exceeded the prior spring tide elevations. The single spike in the Marina Jambu record is assumed to be an errant reading.

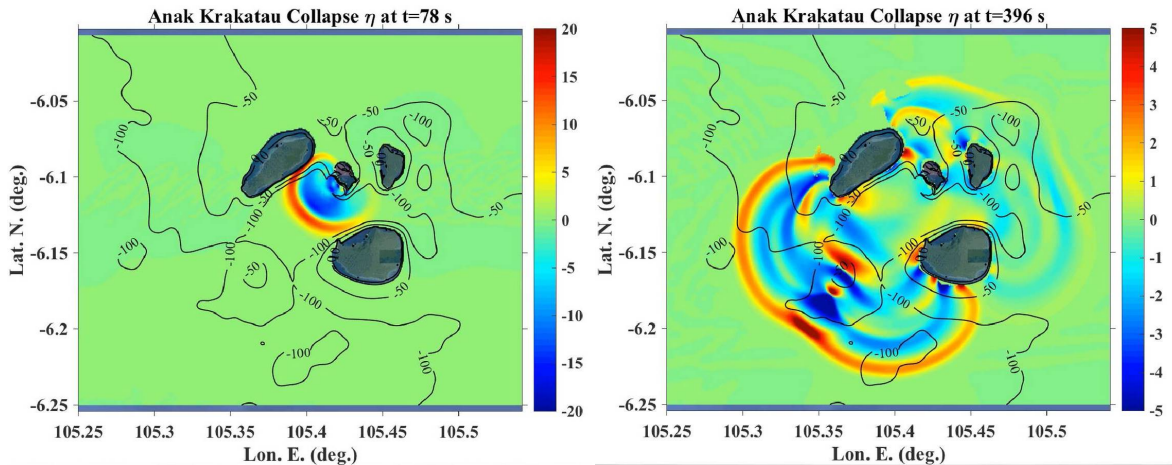
Figure 12: Images captured from simulation by Grilli, et al. (2018) as landslide-generated tsunami waves travel between islands surrounding Anak Krakatau (Note amplitude scale varies)

By performing inverse ray tracing from tide gage records, Grilli et al. (2018) were able to identify the source as the SW side of Anak Krakatau. They estimate the shape and volume (about 0.20 cubic km) of the flank collapse as a viscous flow with an assumed relative density of 1.9. The resulting wave propagation is visualized in Figures 13 and 14. It is evident that wave gauges installed on the three uninhabited islands surrounding Anak Krakatau would be able to provide advance warning of the volcanic initiation of any future tsunami waves.

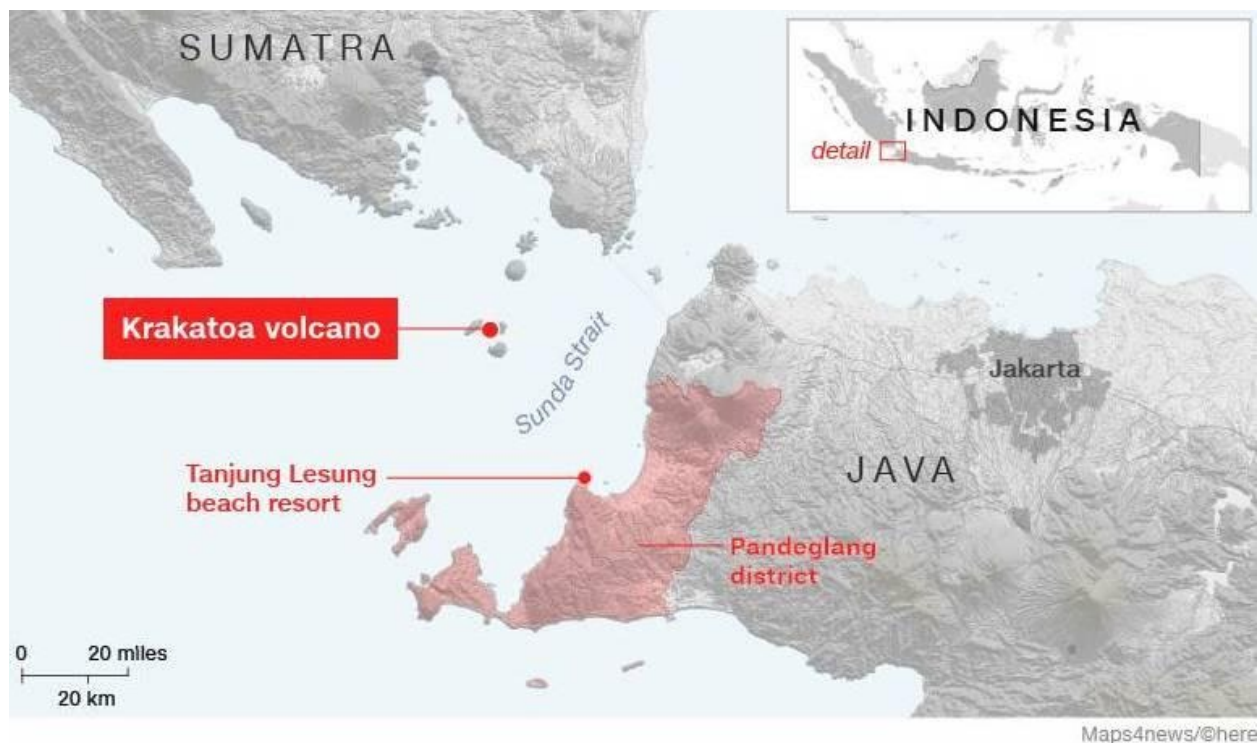
Figure 14: Map showing location of Tanjung Lesung beach resort (CNN, 2018)

Figure 14 depicts the location of Tanjung Lesung beach resort where many locals and tourists were enjoying the long Christmas weekend. Based on the simulations by Grilli et al. (2018), it would have been the first location on West Java to experience the tsunami waves. A video posted at numerous outlets shows the moment the tsunami wave strikes a beach party where a rock band “Seventeen” was playing on stage. (A copy of this video is available at Nowthisnews: <https://twitter.com/nowthisnews/status/1076931197362679808>).

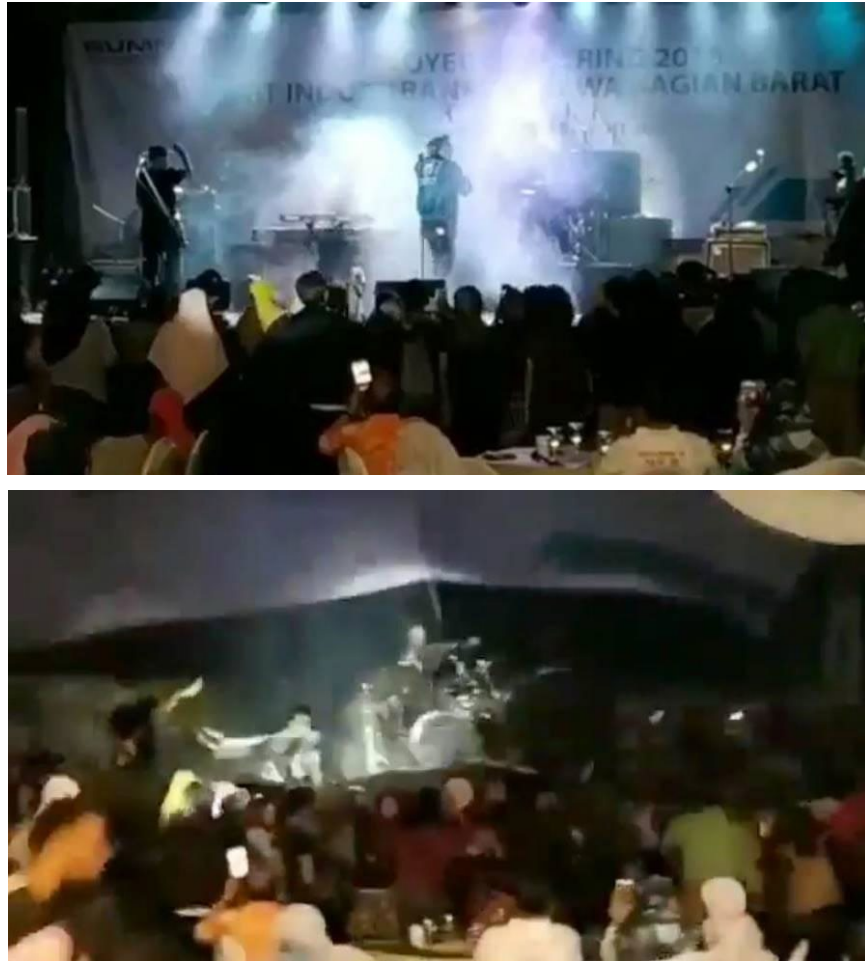
**Figure 15: Rock band “Seventeen” playing on stage at a beach concert in Tanjung Lesung beach resort (left) and the stage overturned by the tsunami wave (right) (Images from video posted by nowthisnews)**

Figure 15 shows a frame from this video shortly before the tsunami wave strikes the beach party, while the second frame shows the wave overturning the stage. The wave continued through the audience resulting in at least 31 deaths. The lead singer survived but the band’s bassist and road manager were found dead. Three other band members were still missing at the time this report was authored, while at least 29 party attendees died and another 13 were still missing (Nowthisnews, 2018).

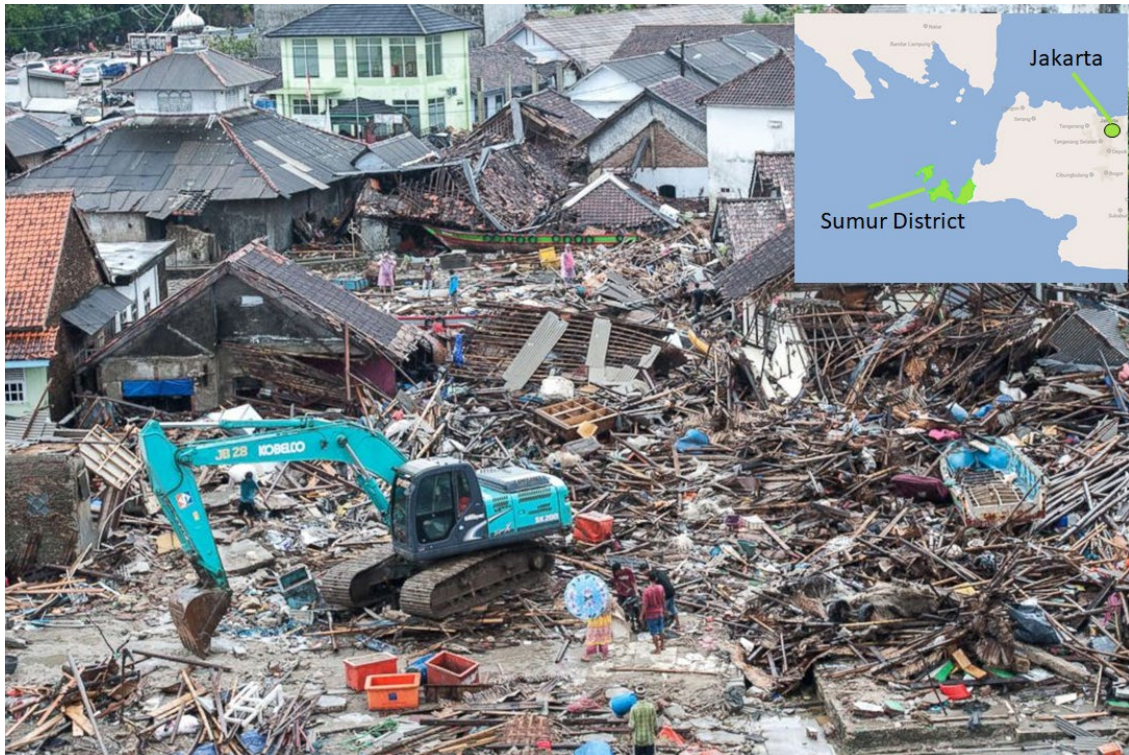
**Figure 19: Debris clean-up underway in the Sumur district of Pangdeglang, Banten Province, Indonesia. Photo by Veri Sanovri/Xinhua via Newscom and [ABC News](#).**

Most of the damage was limited to the first few rows of buildings along the shoreline exposed to the tsunami waves. The wave amplitudes and periods were not large enough to result in extensive inland inundation. Figures 19 and 20 show cleanup operations along the West coast of Java, consisting mainly of debris from bamboo, timber and masonry single story structures. Figures 21 and 22 illustrate damage to masonry structures immediately adjacent to the shoreline, presumably due to hydrodynamic wave loading. Figure 23 depicts the contribution of floating debris, including vehicles, to enhanced hydrodynamic loads due to debris damming, and impact loads.

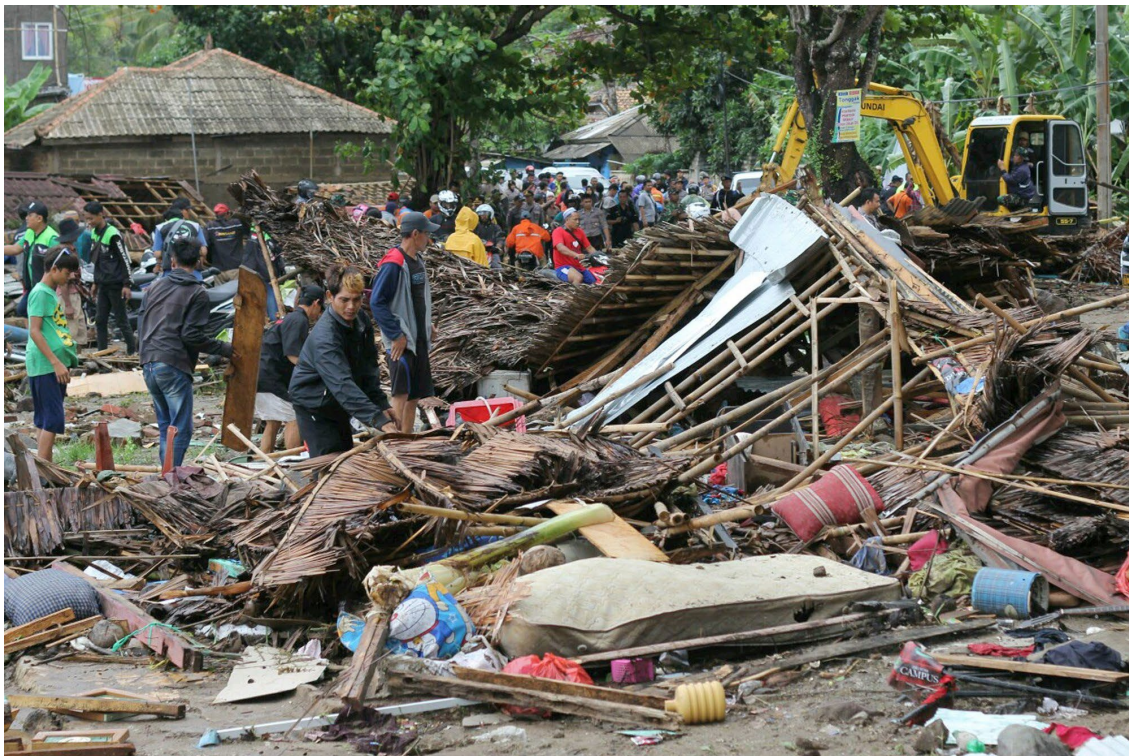
**Figure 20: Clean-up efforts underway along the coastline of Carita district, West Java (Credit: Associated Press / Fauzy Chaniago)**

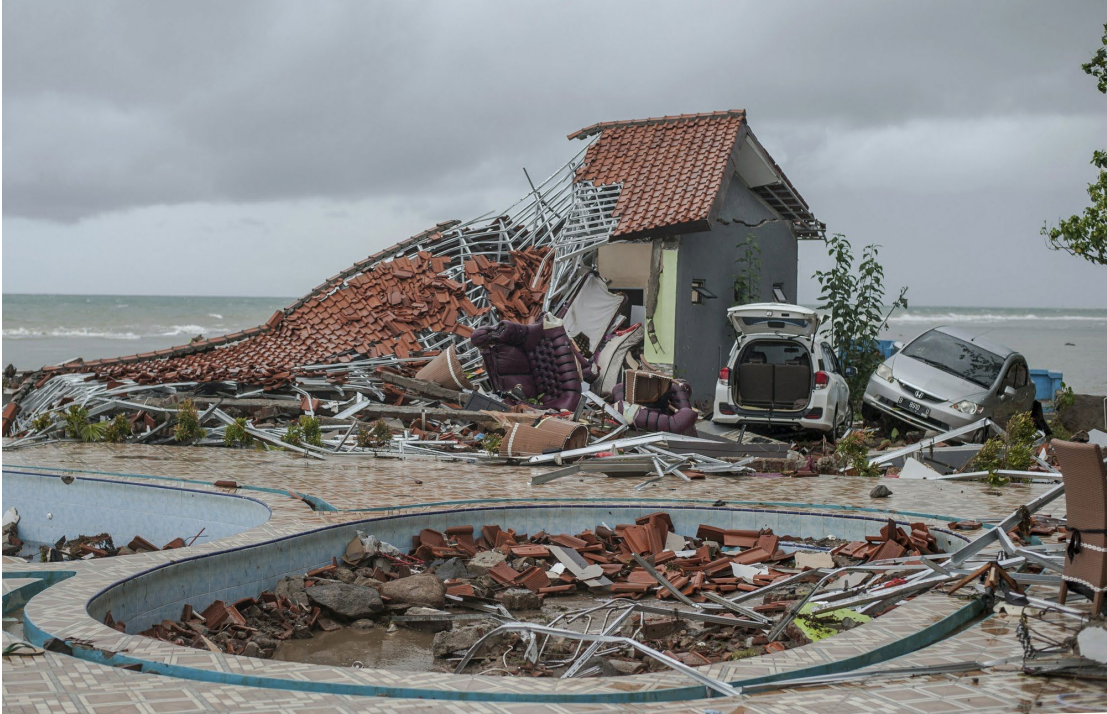
**Figure 21: Damage to masonry structure on the shoreline (Credit: Associated Press / Fauzy Chaniago)**

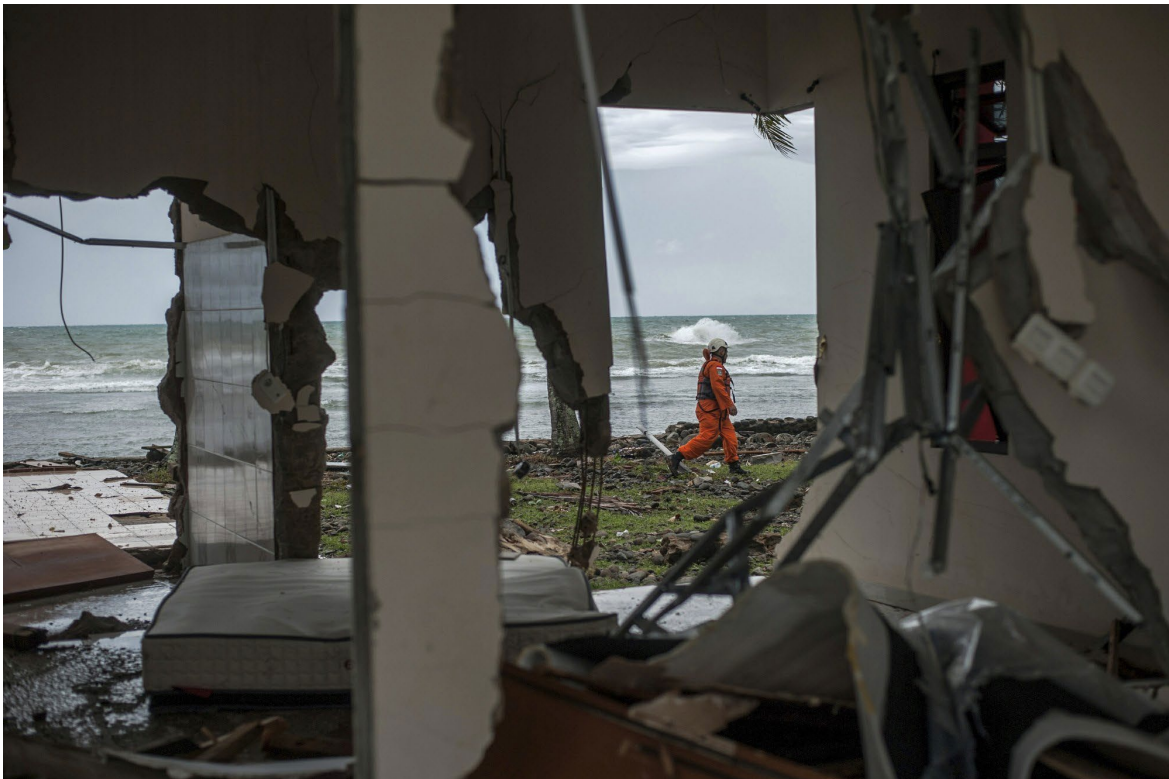
**Figure 22: Damage to masonry structure on shoreline (Credit: Associated Press / Fauzy Chaniago)**

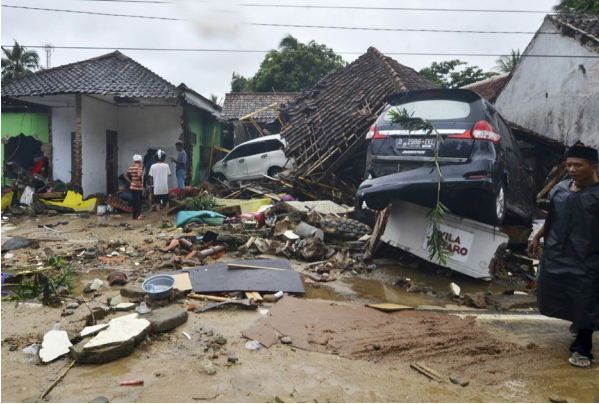
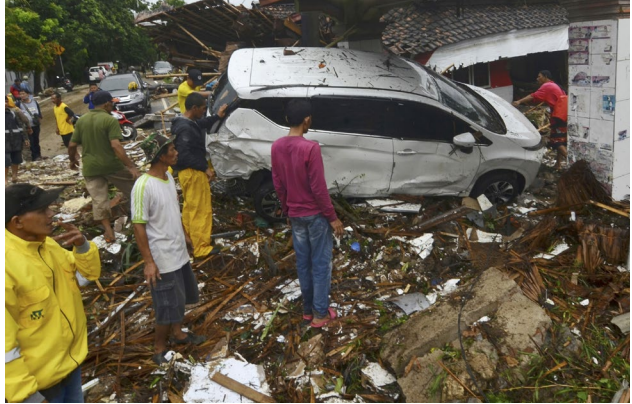
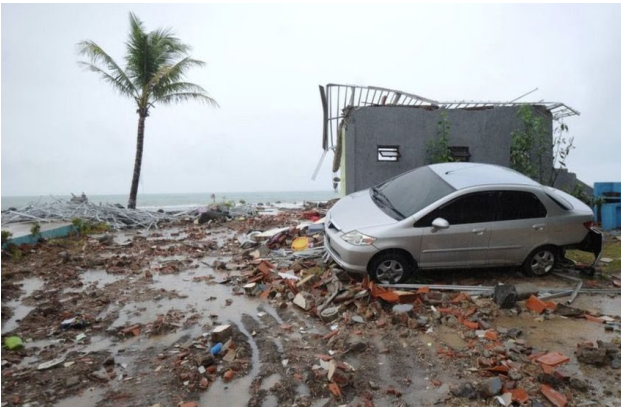
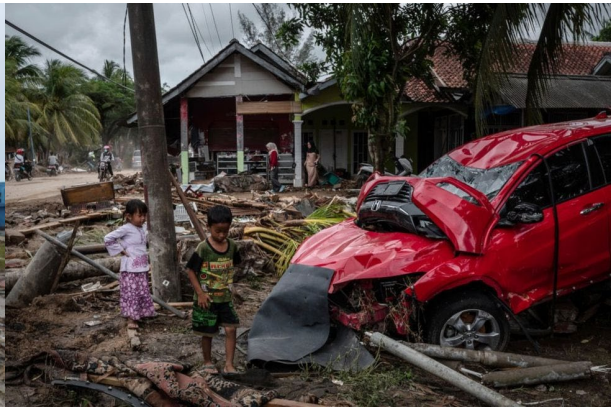
**Figure 23: Floating debris, and particularly vehicles, appeared to enhance the hydrodynamic and impact loading on structures.**

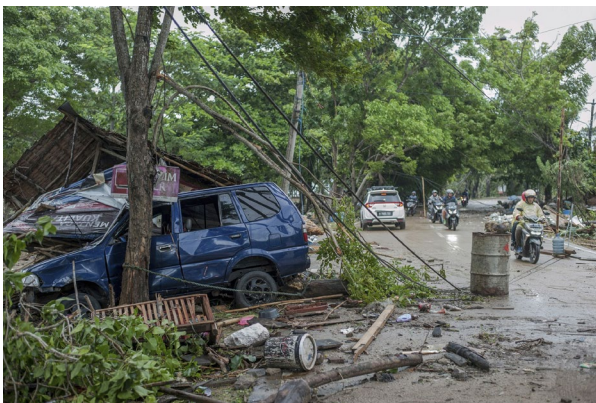
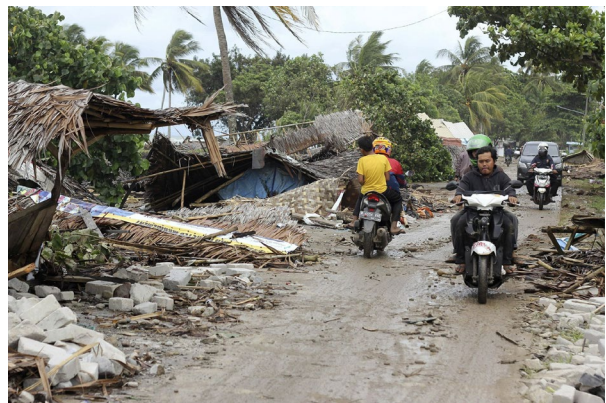
**Figure 24: The coastal roadway along the West edge of Java was obstructed by debris and fallen utility lines, but was cleared quickly to allow access to most communities along the coast.**

The coastal roadway along the West coast of Java was obstructed by fallen utility lines and debris deposits (Figure 24). This roadway was cleared soon after the event to allow emergency responders to access communities along the shoreline. A video showing the debris from building damage in Pandeglang is available at

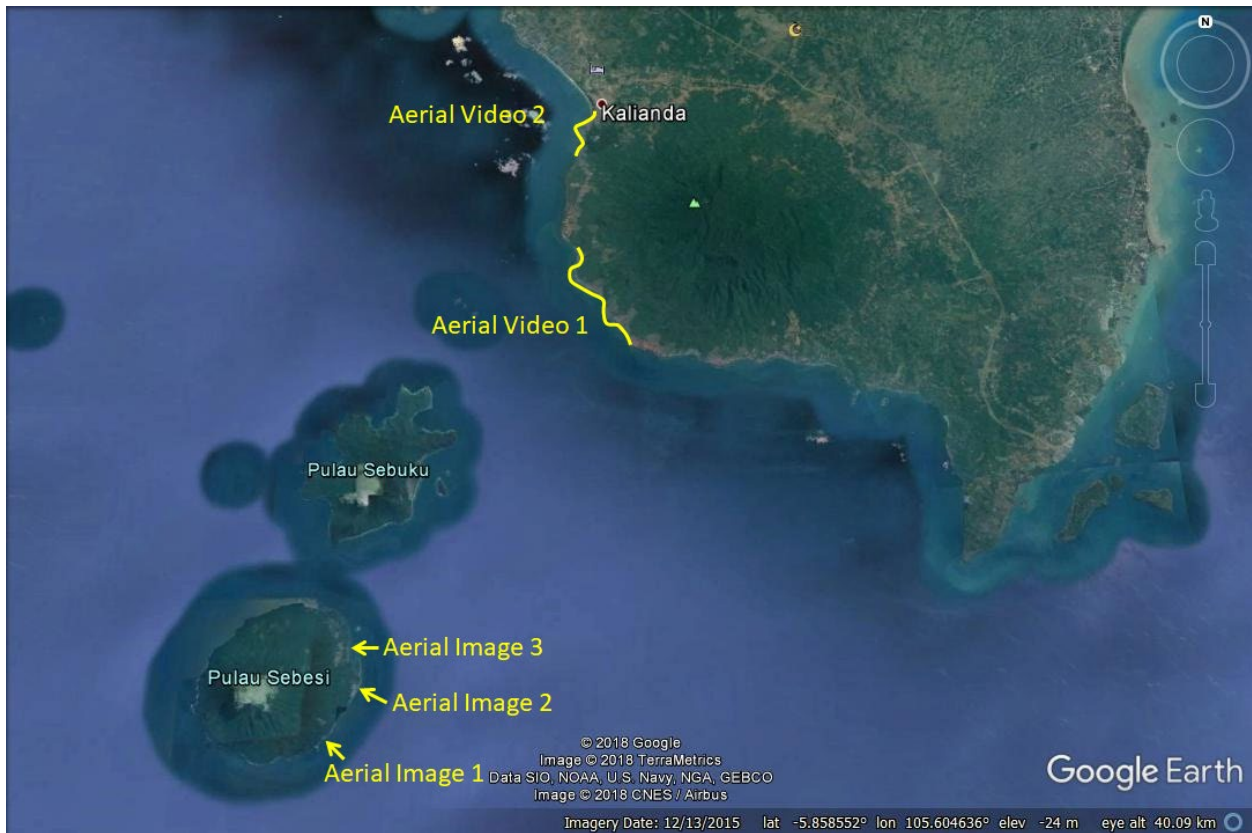
**Figure 25: Extent of aerial videos surveying damage on the South shore of Sumatra, and aerial photos taken of communities on Sebesi Island.**

Two aerial videos along the South shore of Sumatra, posted by P.N. Sutopo, document only limited damage to buildings directly on the shoreline (the first video is available at: [https://twitter.com/Sutopo\\_PN/status/1077741487645806593](https://twitter.com/Sutopo_PN/status/1077741487645806593)). The coastal roadway does not appear to be damaged or blocked over the region covered by the videos, which is shown in Figure 25. Figures 26 through 29 isolate various locations along with shoreline both in Google Earth and with stills captured from this video.

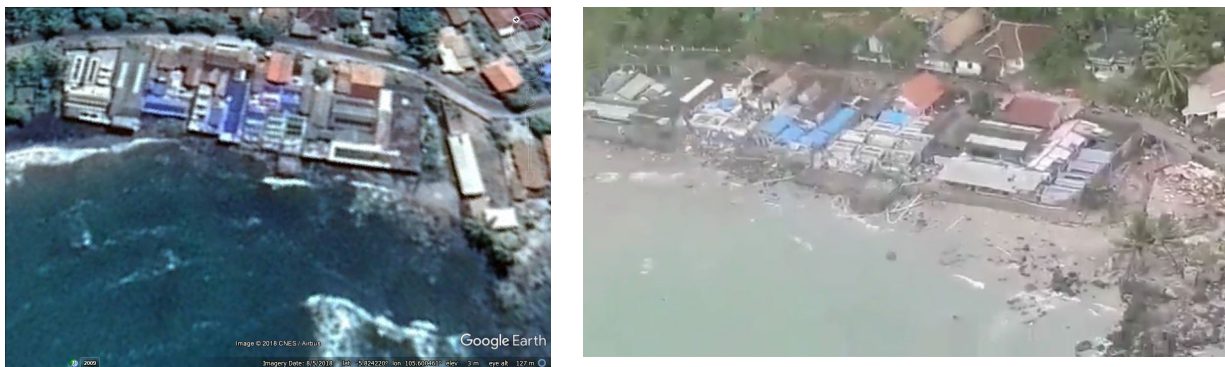
**Figure 26: Google Earth (left) and aerial video (right) images of damage to coastal buildings on the South shore of Sumatra (5.82414S, 106.600E)**

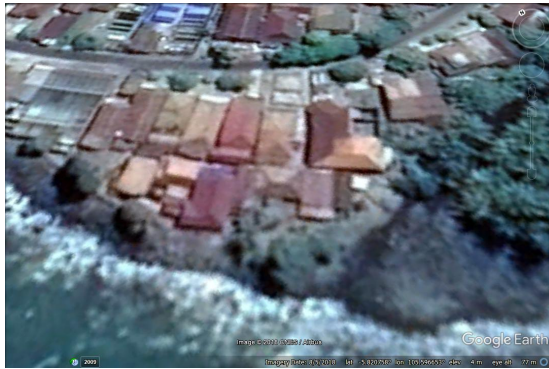
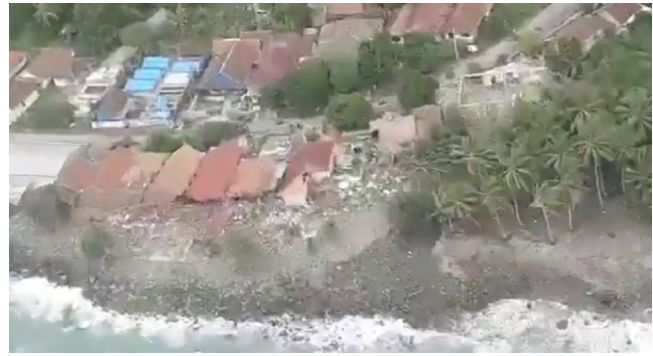
**Figure 27: Google Earth (left) and aerial video (right) images of damage to coastal buildings on the South shore of Sumatra (5.8208S, 105.5967E)**

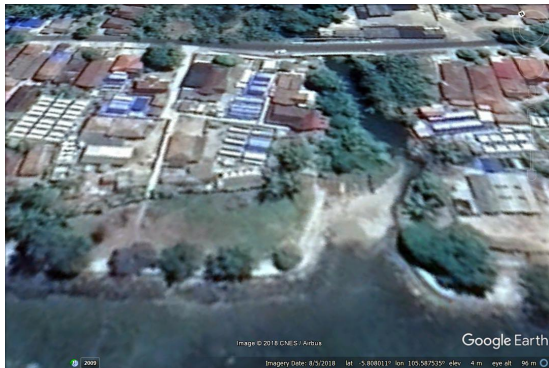
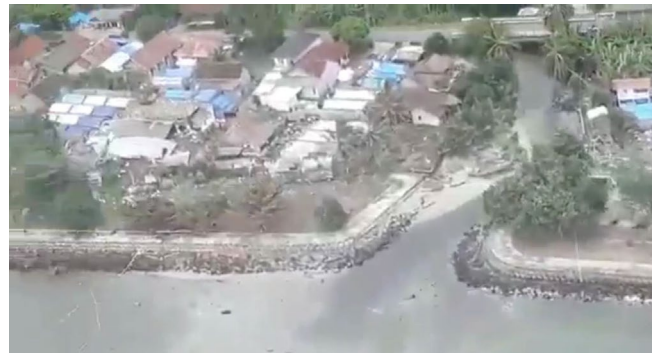
**Figure 28: Google Earth (left) and aerial video (right) images of damage to coastal buildings on the South shore of Sumatra (5.80825S, 105.58756E)**

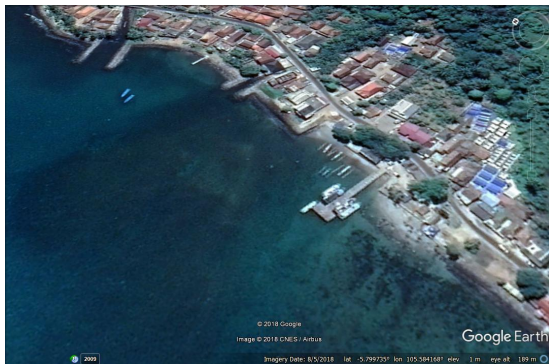
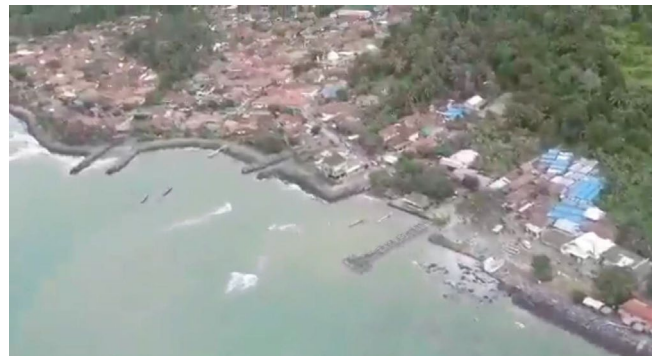
**Figure 29: Google Earth (left) and aerial video (right) images of damage to the timber decking on Canti Pier and boats in a small harbor in Kalianda on the South shore of Sumatra (5.800S, 105.5844E)**

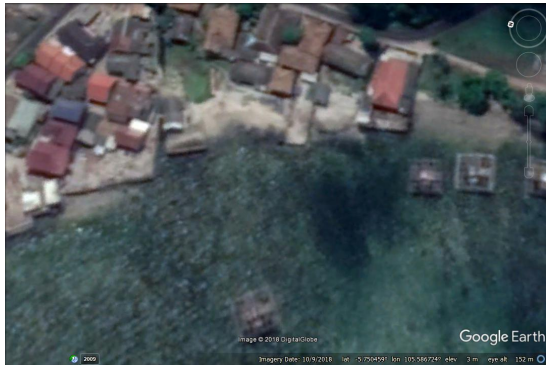
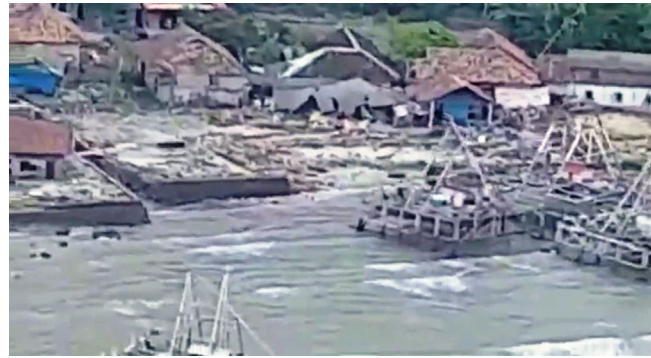
**Figure 30: Google Earth (left) and aerial video (right) images of damage to coastal buildings and coastal platforms in Kalianda on the South shore of Sumatra (5.7506S, 105.587E)**

The second aerial video (see [https://twitter.com/Sutopo\\_PN/status/1076721942437085184](https://twitter.com/Sutopo_PN/status/1076721942437085184)) features an adjacent stretch of shoreline along the Kalianda coast of Sumatra. Figure 30 depicts damage to coastal structures, while Figure 31 focuses on the Kalianda Bawah harbor with some boats intact but others washed on shore or sunk in the harbor.

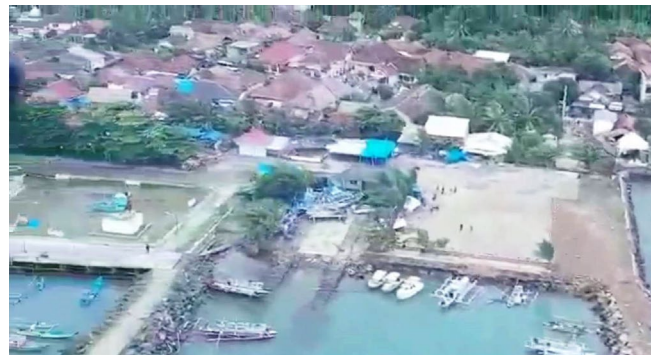
**Figure 31: Google Earth (left) and aerial video (right) images of damage to boats in Kalianda Bawah harbor on the South shore of Sumatra (5.744S, 105.588E)**

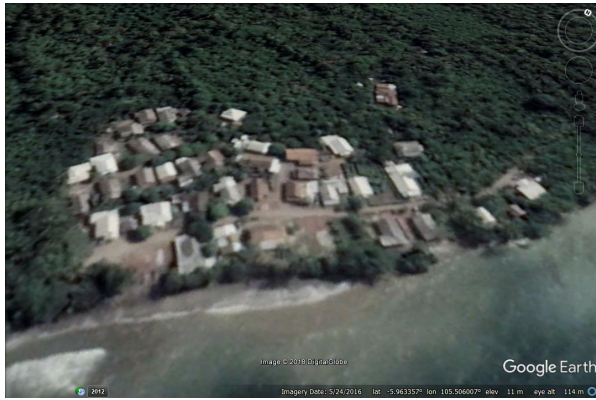
**Figure 32: Google Earth (left) and aerial photo (right) of damage to coastal buildings on the Southeast shore of Sebesi Island. Image 1 location in Figure 25 (5.9635S, 105.50607E)**

P.N. Sutopo reports that two people died and 40 houses were damaged by the Sunda Strait tsunami on Sebesi Island ([https://twitter.com/Sutopo\\_PN/status/1077762078121684992](https://twitter.com/Sutopo_PN/status/1077762078121684992)). Aerial images captured some of this damage to coastal homes (Figure 32) and a pier (Figure 33). Two new buildings (with blue roofs) that were not evident in Google Earth images from August 2017, along with a modified pier (Figure 34) appear to have survived without damage.

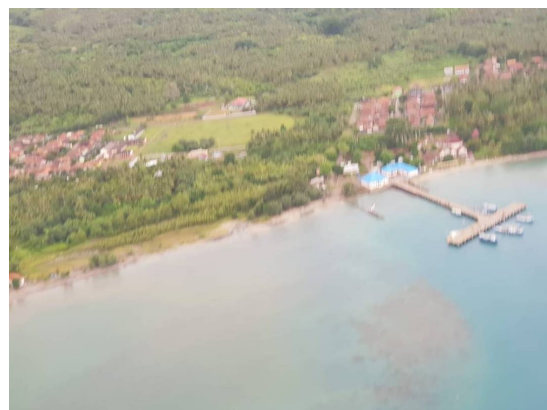
**Figure 34: Google Earth (left) and aerial photo (right) showing undamaged pier and new buildings (with blue roofs) built since August 2017 (Date of latest Google Earth image) on the East shore of Sebesi Island. Image 3 location in Figure 25 (5.93615S, 105.51168E)**

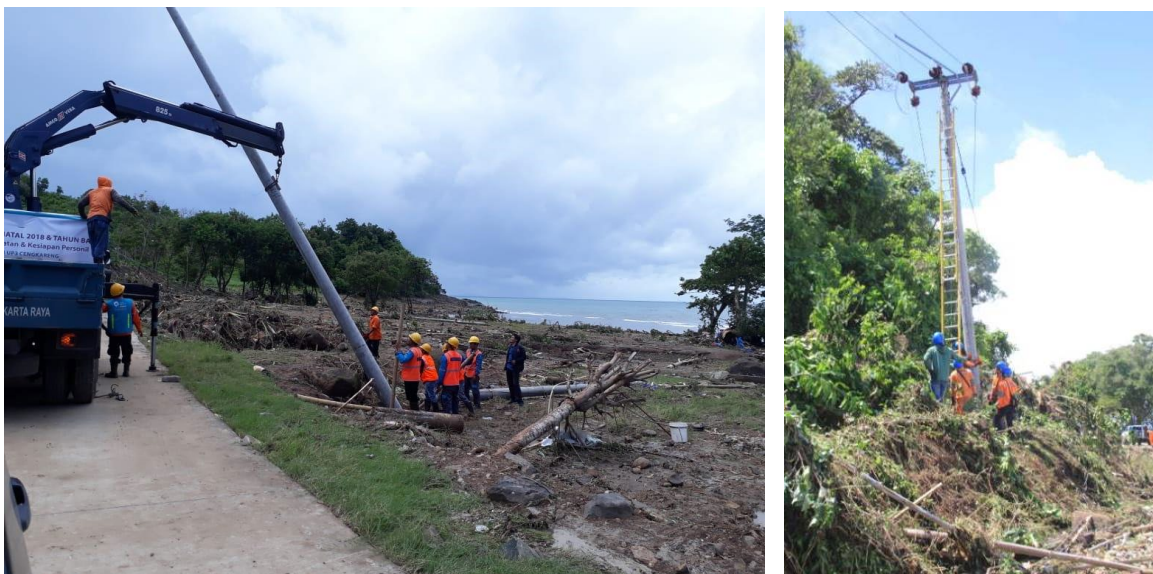
**Figure 35: Crews installing new power transmission line poles the day after the tsunami**  
(Source: [https://twitter.com/Sutopo\\_PN/status/1077091875448737792](https://twitter.com/Sutopo_PN/status/1077091875448737792))

Damage to power distribution poles and lines occurred along stretches of the coastal road on West Java. Crews were quick to replace poles and reinstate the transmission lines. P.N. Sutopo posted images of this repair work on December 23rd, the day after the tsunami (Figure 35).
