StEER STRUCTURAL EXTREME EVENTS RECONNAISSANCE	EVENT BRIEFING		
	Event:	18 March, 2020 Utah, Mw 5.7 Earthquake	
	Region:	USA	
Authors:	Selim Günay, Alicia Tsai, Khalid M. Mosalam, UC Berkeley		
Editors:	Tracy Kijewski-Correa, University of Notre Dame David Prevatt, Auburn University Ian Robertson, University of Hawaii at Manoa David Roueche, University of Auburn		
DesignSafe Project #	PRJ-2733	Release Date:	March 20, 2020

18 March, 2020 Utah, Mw 5.7 Earthquake | Released March 20, 2020

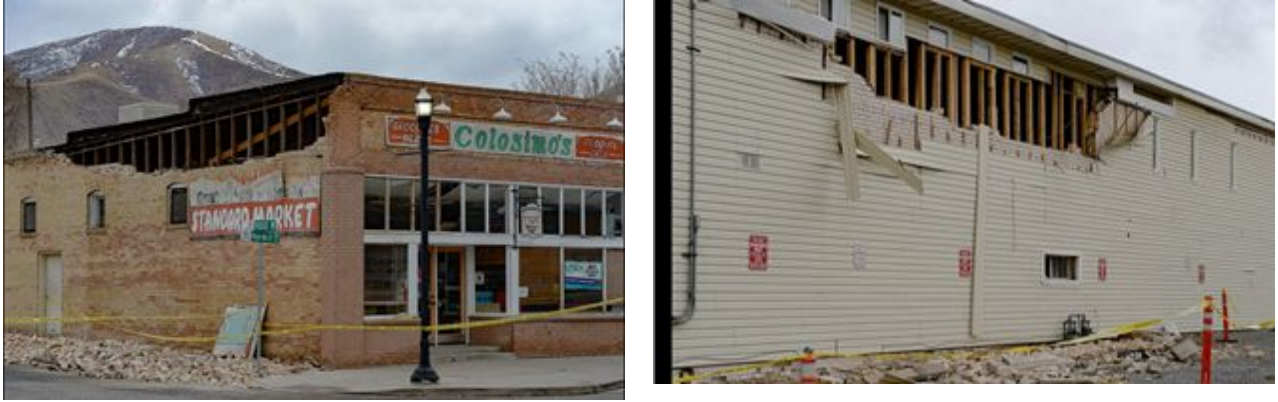
Buildings, including historical structures, experienced damage during the earthquake. A commonly observed damage is the out-of-plane failure of the brick veneer walls of wood frame buildings (Fig. 5). A new school building in Herriman, Silver Crest Elementary, experienced similar damage to its front façade, where pieces of masonry fell to the ground (Fig. 6). Such masonry wall and façade failures present a high risk of injury or death due to falling rubble. Furthermore, debris can significantly increase the evacuation time in densely populated areas (Lu et al., 2019). If the earthquake occurred at a different time of day and the schools were not closed due to COVID-19 concerns, fallen masonry in this earthquake could have injured or killed people.

Figure 5. Brick veneer wall damage in Magna (The Salt Lake Tribune, 2020)

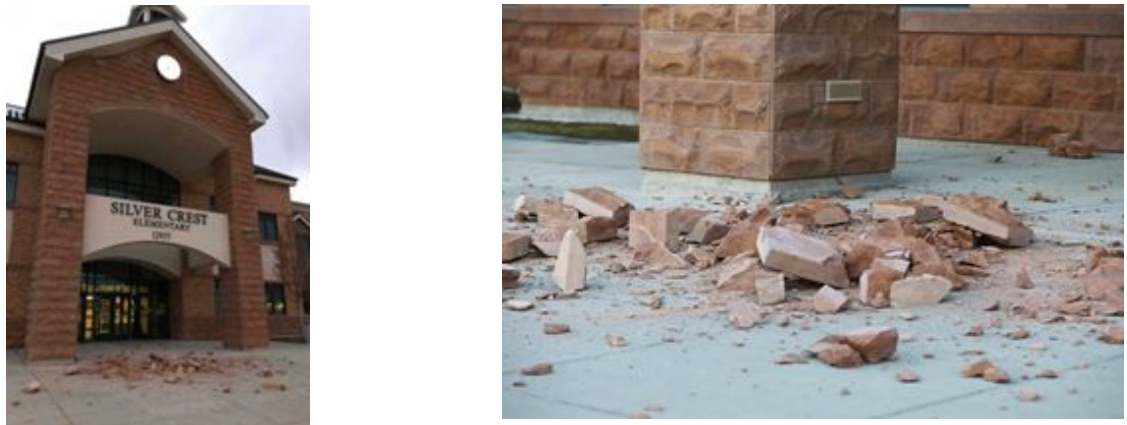
Figure 6. Front façade damage experienced in Silver Crest Elementary resulting in masonry debris striking the ground in front of the main entrance (Valley Journals, 2020; Deseret News, 2020)

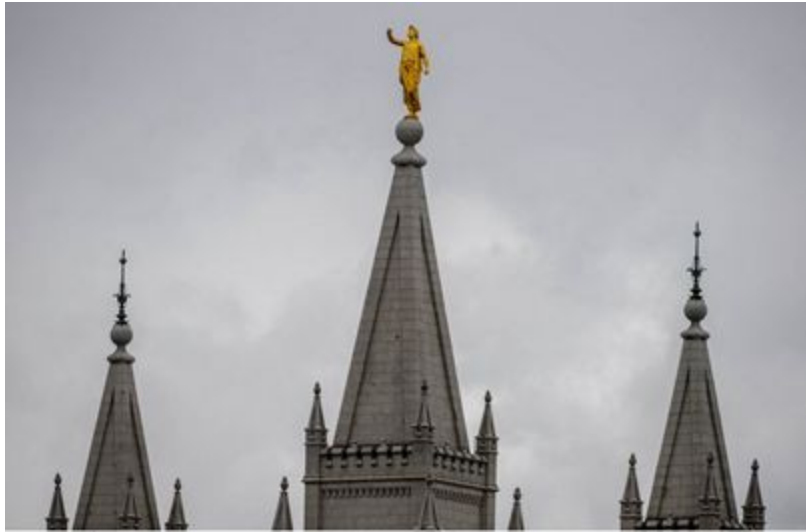
The University of Utah’s Browning Building was closed due to cracks and nonstructural damage, including damage to suspended ceilings. The historic Rio Grande Depot, a brick building constructed in 1910 and housing historical artifacts, sustained minor damage. At the time of the earthquake, the iconic Salt Lake Temple of The Church of Jesus Christ of Latter-day Saints was in the early phases of a four-year upgrade, including a seismic retrofit. The golden Angel Moroni statue of the church was damaged and lost a trumpet (Fig. 7), and some of the temple’s smaller spire stones shifted. In West Valley City, 48 mobile/manufactured homes were shifted off their foundations and experienced significant nonstructural utilities and contents damage (Fig. 8).

Figure 7. The statue of Moroni at the top of the Salt Lake temple damaged during the earthquake (The Salt Lake Tribune, 2020)

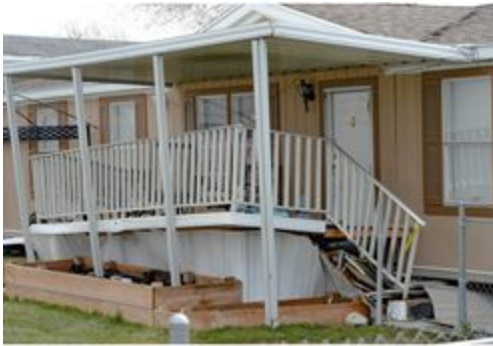
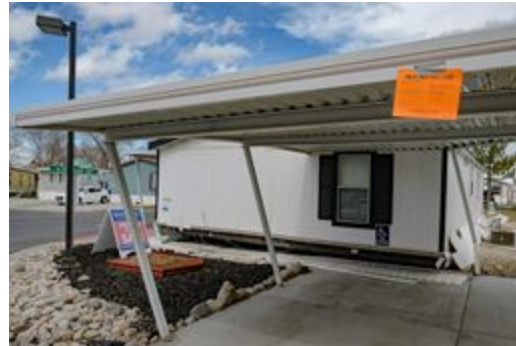
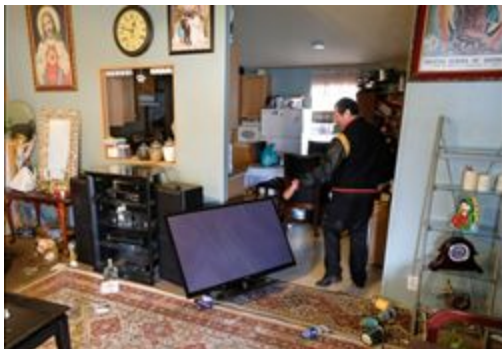
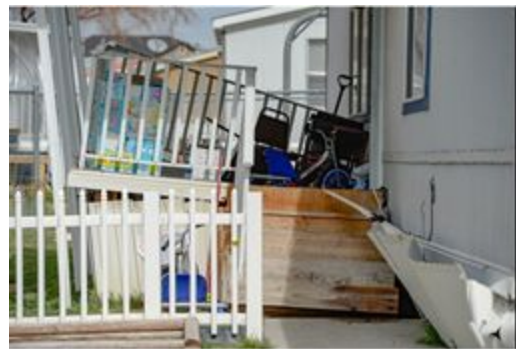
- ❑ The most significant damage was experienced by mobile/manufactured homes in the form of foundation sliding and nonstructural component damage.
- ❑ Transportation, electricity, water, and other infrastructure systems were restored in less than a day, suggesting good community resilience to this event.

Figure 8. Structural and nonstructural damage experienced by mobile/manufactured homes in West Valley City (The Salt Lake Tribune, 2020)

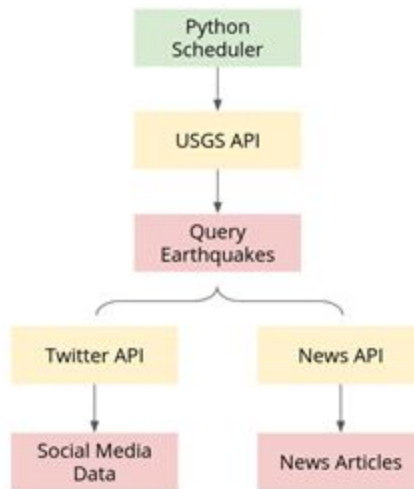
StEER has previously used Natural Language Processing (NLP) to initiate reconnaissance reports in a rapid manner (Tsai et al., 2019). To increase the automated nature of this process and expand the usage of this technique to extract other information related to the consequences of earthquakes and other hazards, an automated data collection process has been developed (Fig. 10). The automatic data collection script used in this process is written in Python and utilizes U.S. Geological Survey Earthquake Hazard Program API (Application Programming Interface) (USGS, 2020b). The program is scheduled to run every day on the server of the PEER (Pacific Earthquake Engineering Research) Center and to query new earthquakes from the USGS API. Only earthquakes that have magnitudes greater than or equal to 5 and USGS PAGER alert levels in either yellow, orange, or red are recorded. When such a new earthquake is detected, the program starts collecting related social media data from Twitter and related news articles from News API (2020). Tweets are collected over a period of two weeks or more using the keyword “earthquake” and the earthquake location name (Utah in this event). Tweets are also collected in local language (English in this case) to capture local changes more precisely. News articles related to the earthquake are collected for a duration of a week or less. The news article data is then used in the automatic text summarization and the social media data is used for extracting information related to the consequences of an earthquake, such as the recovery time.

Figure 10. Automatic data collection workflow

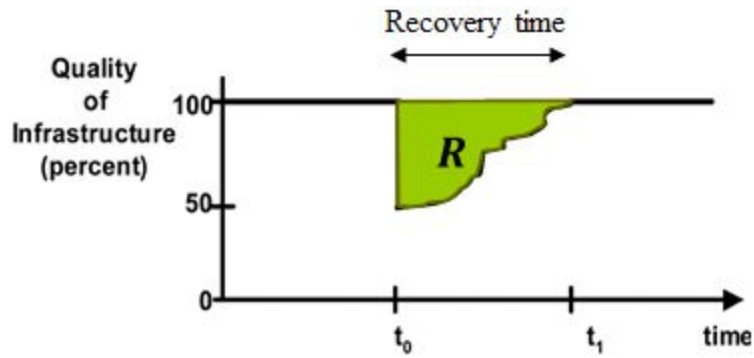
In the context of extreme events, recovery time, conceptually illustrated in Figure 11, is the time needed after the extreme event to restore the functionality of a structure, an infrastructure system (e.g. water supply, power grid, or transportation network), or a community to a desired level wherein it can operate or function the same, close to, or better than the condition before the extreme event (Bruneau et al., 2003).

Figure 11. Conceptual illustration of recovery time (Bruneau et al., 2003)
