StEER
STRUCTURAL
 EXTREME EVENTS
 RECONNAISSANCE

NASHVILLE TORNADOES

MARCH 3, 2020

PRELIMINARY VIRTUAL RECONNAISSANCE REPORT (PVRR)

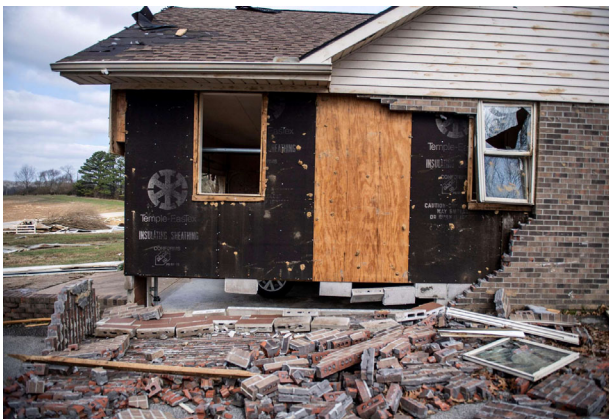
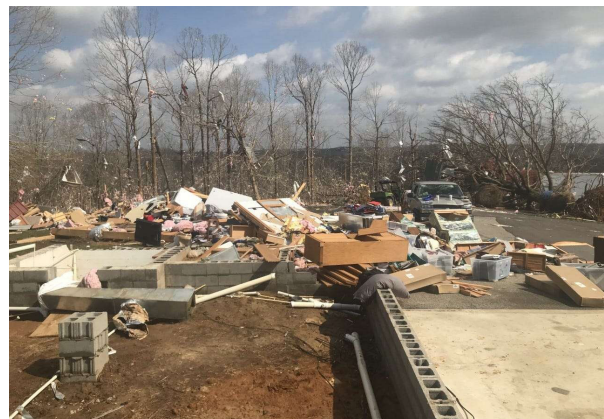
Representative damage from the EF2 tornado in Benton County northeast of Camden, TN is shown in Figure 4.1. A site-built and a mobile/manufactured (MH) home were destroyed, while other homes in the area sustained more minor damage. The destroyed site-built home shown in Figure 4.1(a) exemplifies the lack of a continuous vertical load path common in many homes in non-hurricane prone regions, with the wood-frame structure built atop unreinforced masonry stem walls and piers.

(a) Home near Bradford, TN partially lifted off of foundation (GPS: 36.045426, -88.743747). Source: [Stephanie Amador / The Jackson Sun](#)

(b) Destroyed site-built home (GPS: 36.095, -88.057). Source: [Brandon Shields](#).

Figure 4.1. Severe damage in Gibson County near Bradford, TN (a) and Benton County near Camden, TN (b). Both homes exhibit the lack of foundation anchorage common to many homes in non-hurricane prone regions.

Related to Topic 1.1, the VAST observed that the majority of collapsed structures for which early data was available were constructed on unreinforced masonry stem wall foundations. Unreinforced masonry piers are highly vulnerable weak points in the structural load paths of residential structures and are well-documented as contributors to failures in previous tornadoes (Tuscaloosa, AL and Joplin, MO in 2011). Documentation of the vulnerability of these foundations in this event should be used as an opportunity to emphasize the vulnerability of this foundation class relative to other elements of the structural load path, and more importantly to highlight the importance of reinforcing foundation load paths in existing construction potentially subjected to high wind events.

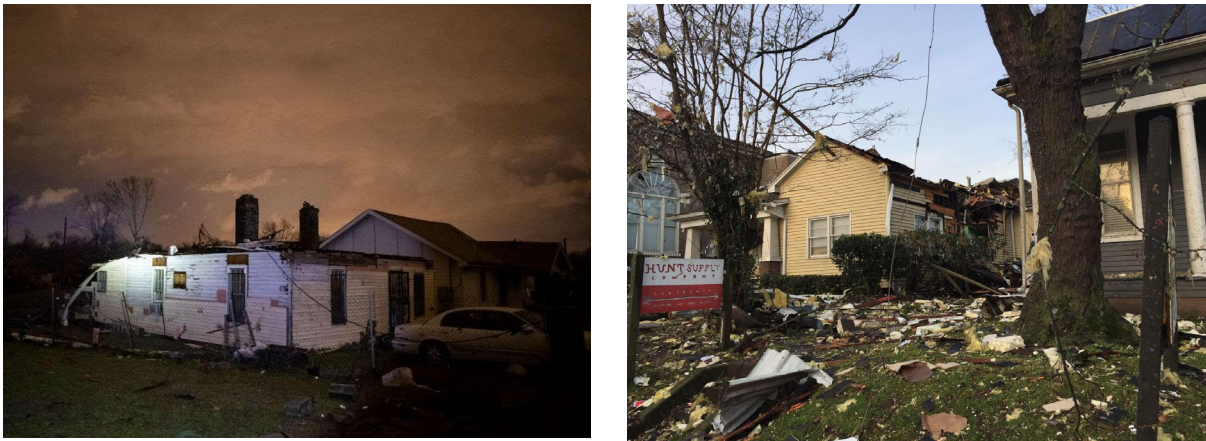
In East Nashville, the path tracked through a region of mostly small, 1930-1950s wood-frame homes constructed on stem walls with crawl spaces underneath the home, according to property records. Homes from this era tend to be heavier, using larger structural members, than more modern homes (see Prevatt and Roueche, 2015). Roofs are typically the most vulnerable as the roof-to-wall connections are minimal (toe-nails), as illustrated in Figure 4.2. Some examples of damage in Donelson are shown in Figure 4.3. Roof structure damage was common, with subsequent wall collapse also noted in several images.

Figure 4.2. Roof structure damage to (left) a single-family house located in Underwood St. (Source: [Brett Carlsen/Getty Images](#)); (right) roof damage to a single-family house located on Russell St. in East Nashville (GPS: 36.176342 -86.750374; Source: [Ruth Ann Cox](#)).

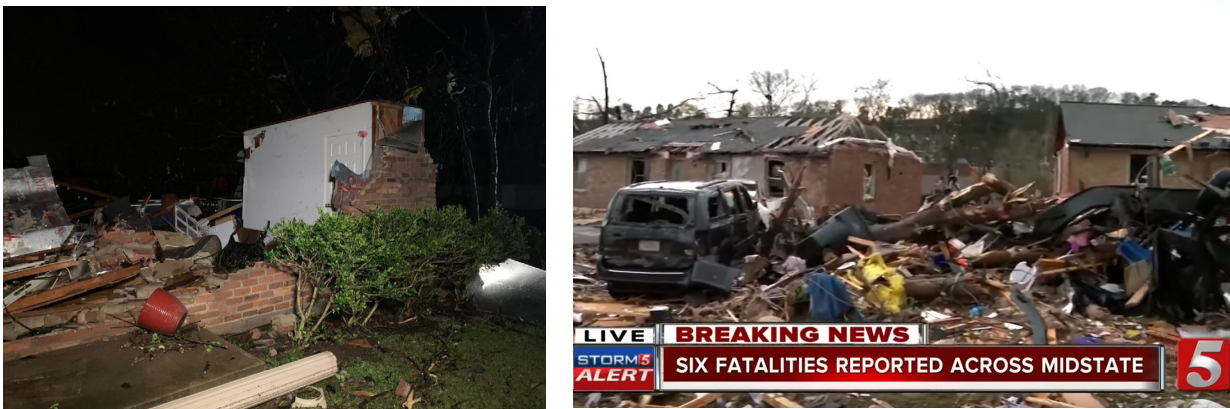
Figure 4.3. (Left) Collapsed walls in a 1960's single-family house on Edgemont drive in Donelson, TN. Source: [WTMJ-TV](#). (right) roof structure damage to single-family homes near Donelson Christian Academy (GPS: 36.184046, -86.648980). Source: [NewsChannel5 Nashville](#).

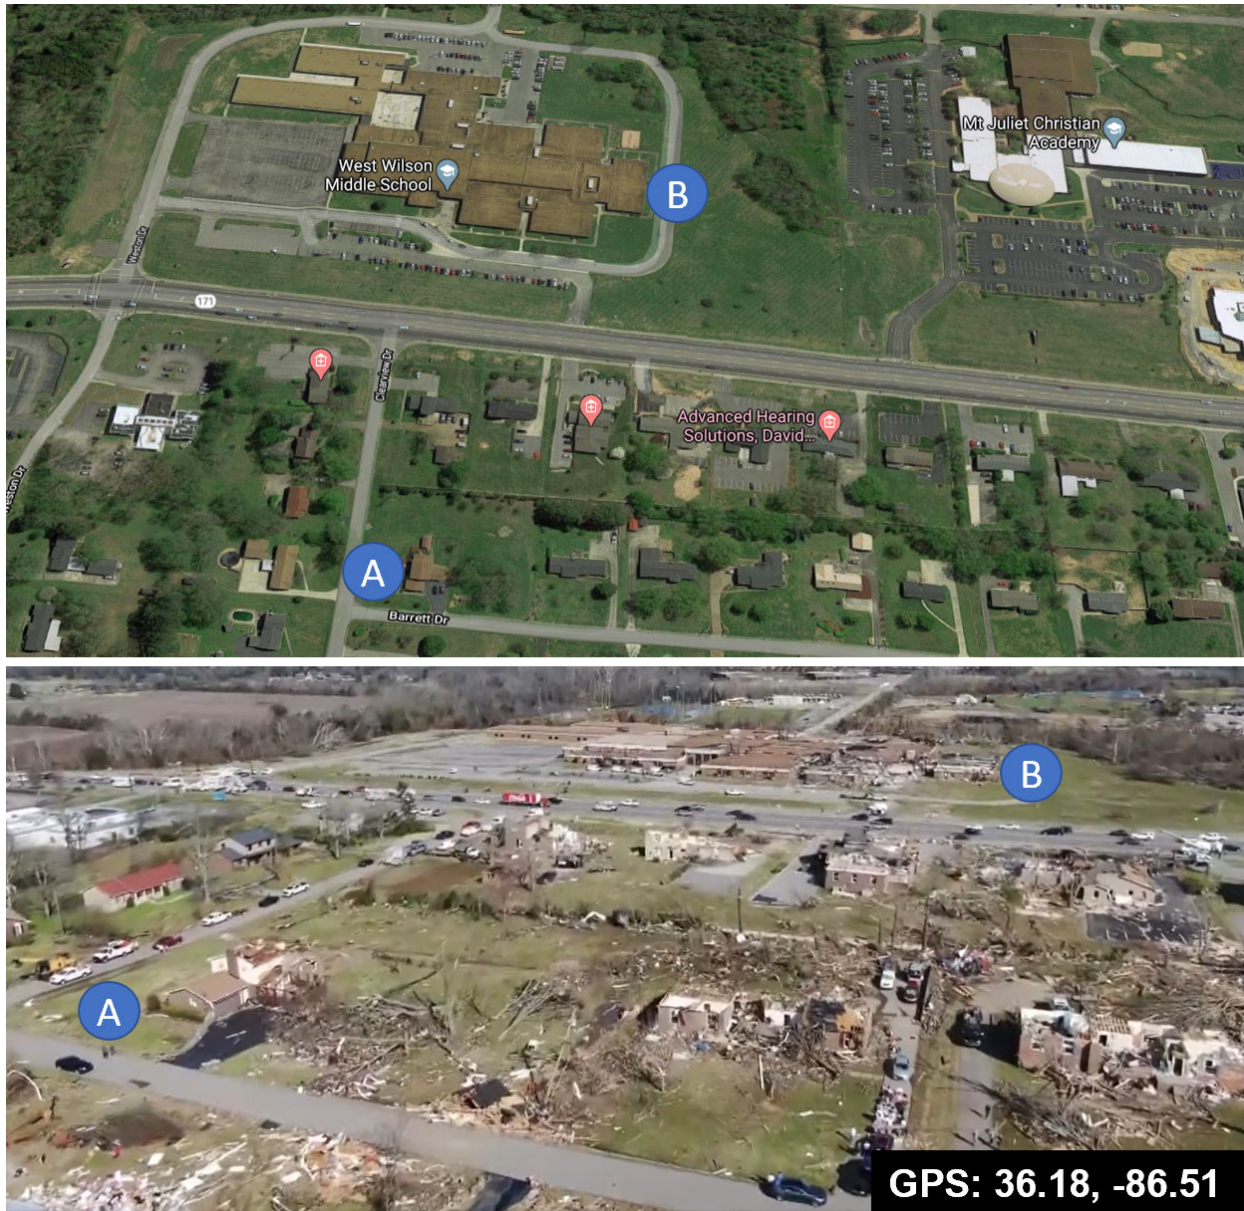
An aerial view of damage to single-family homes in Mt. Juliet is provided in Figure 4.4. The most severe damage here primarily consists of complete roof failure and partial wall collapse based on the available imagery thus far. The damage path was approximately 1500 ft wide at this point based on available imagery.

Figure 4.4. Before and after aerial view (looking east) of the tornado path through Mt. Juliet, TN near West Wilson Middle School. Structural damage for residential buildings primarily consists of complete roof failure and partial wall collapse.

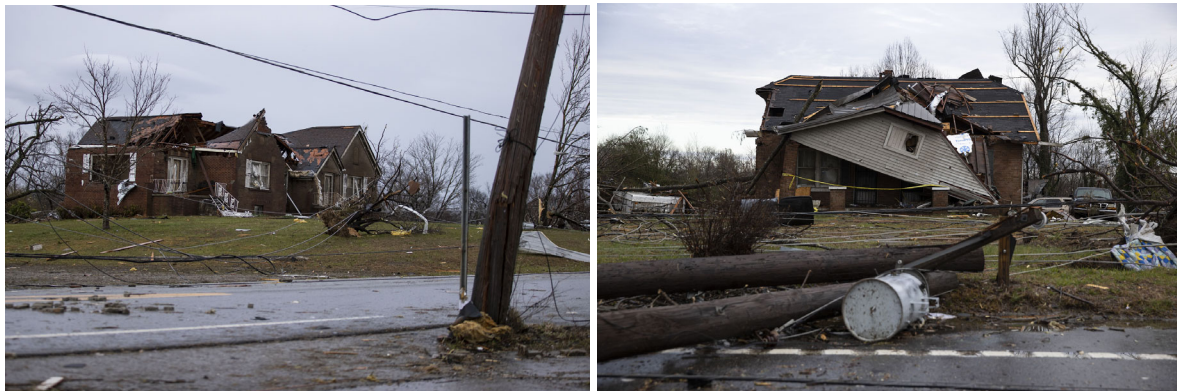
Figure 4.5. Single-family home damaged by the tornado in Cookeville, TN ([House Cookeville](#))

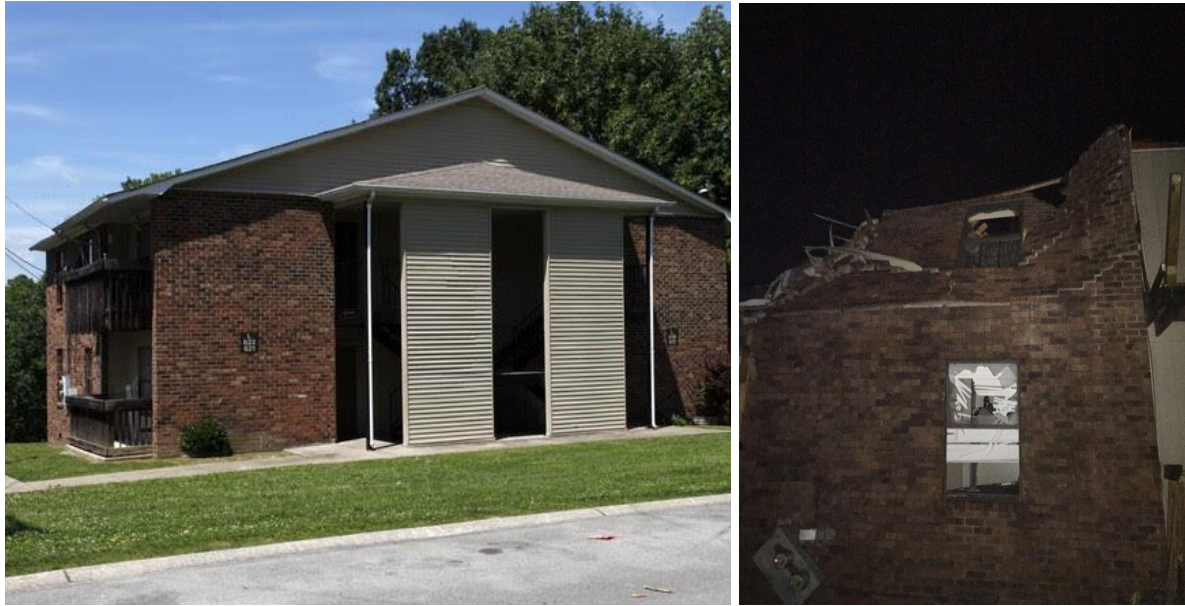
Figure 4.8. Margaret Robinson Apartments before and after the tornado (GPS 36.178388 -86.597882; source: [tmj4](#)).

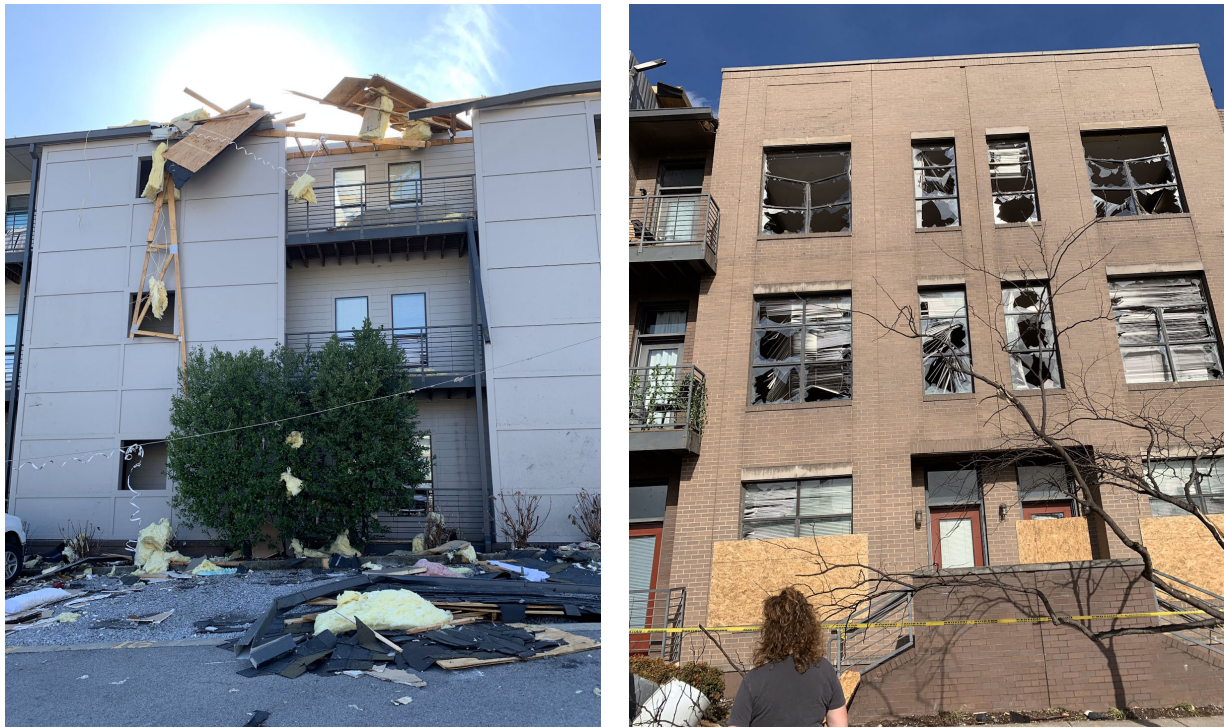
Figure 4.9. A sampling of damage to apartments in the Nashville metro. Exact location unknown. Source: [Twitter user @melaninsings](#).

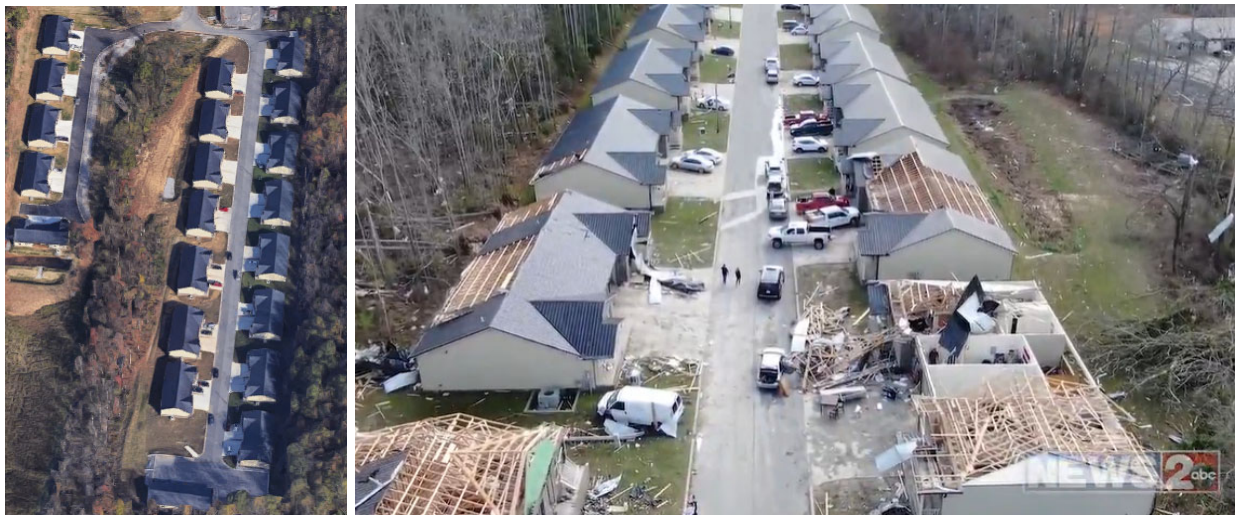
Figure 4.11. Damage to multiple duplex residential buildings near Broad St. (Cookeville, TN) (GPS: 36.170992 -85.537113): before and after the tornado (source: [wkrn news](#)), looking North.

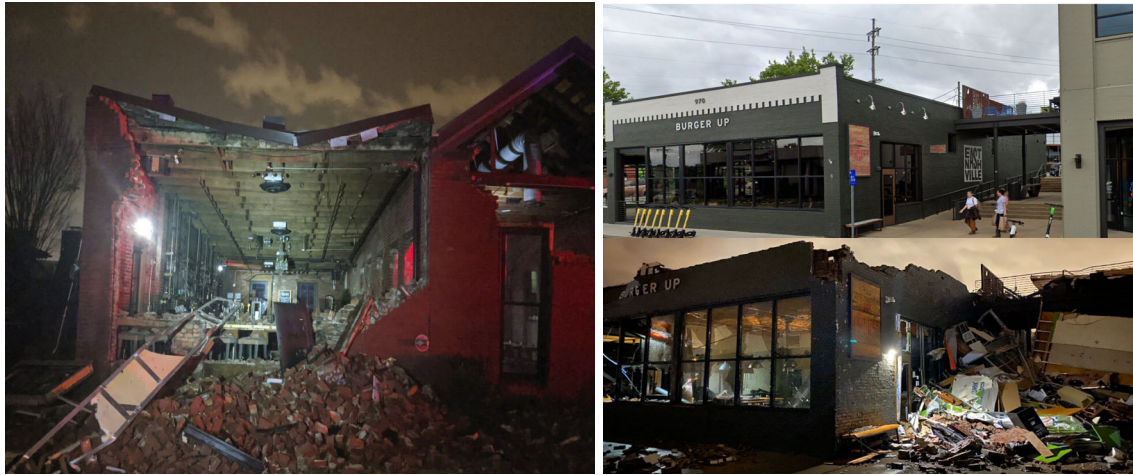
Figure 4.12. Damage to restaurants caused by the tornado: (left) Geist restaurant (Nashville) (Alex [Carlson via AP](#)); (right) Burger up (Source: [@LuluLady](#)).

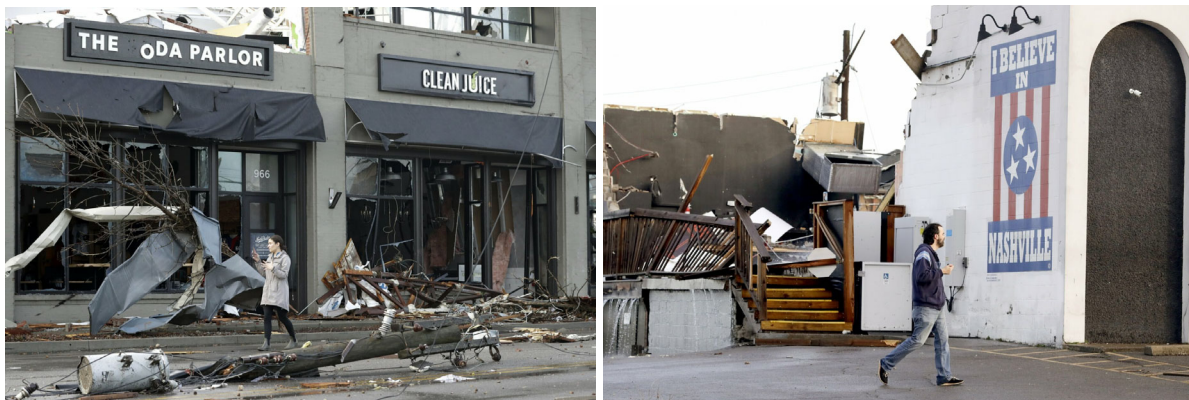
Figure 4.13. Damage to buildings caused by the tornado in downtown Nashville: (left) commercial buildings in Nashville ([Parlor Nashville](#)); (right) live music venue “Basement East” ([Basement East](#)).

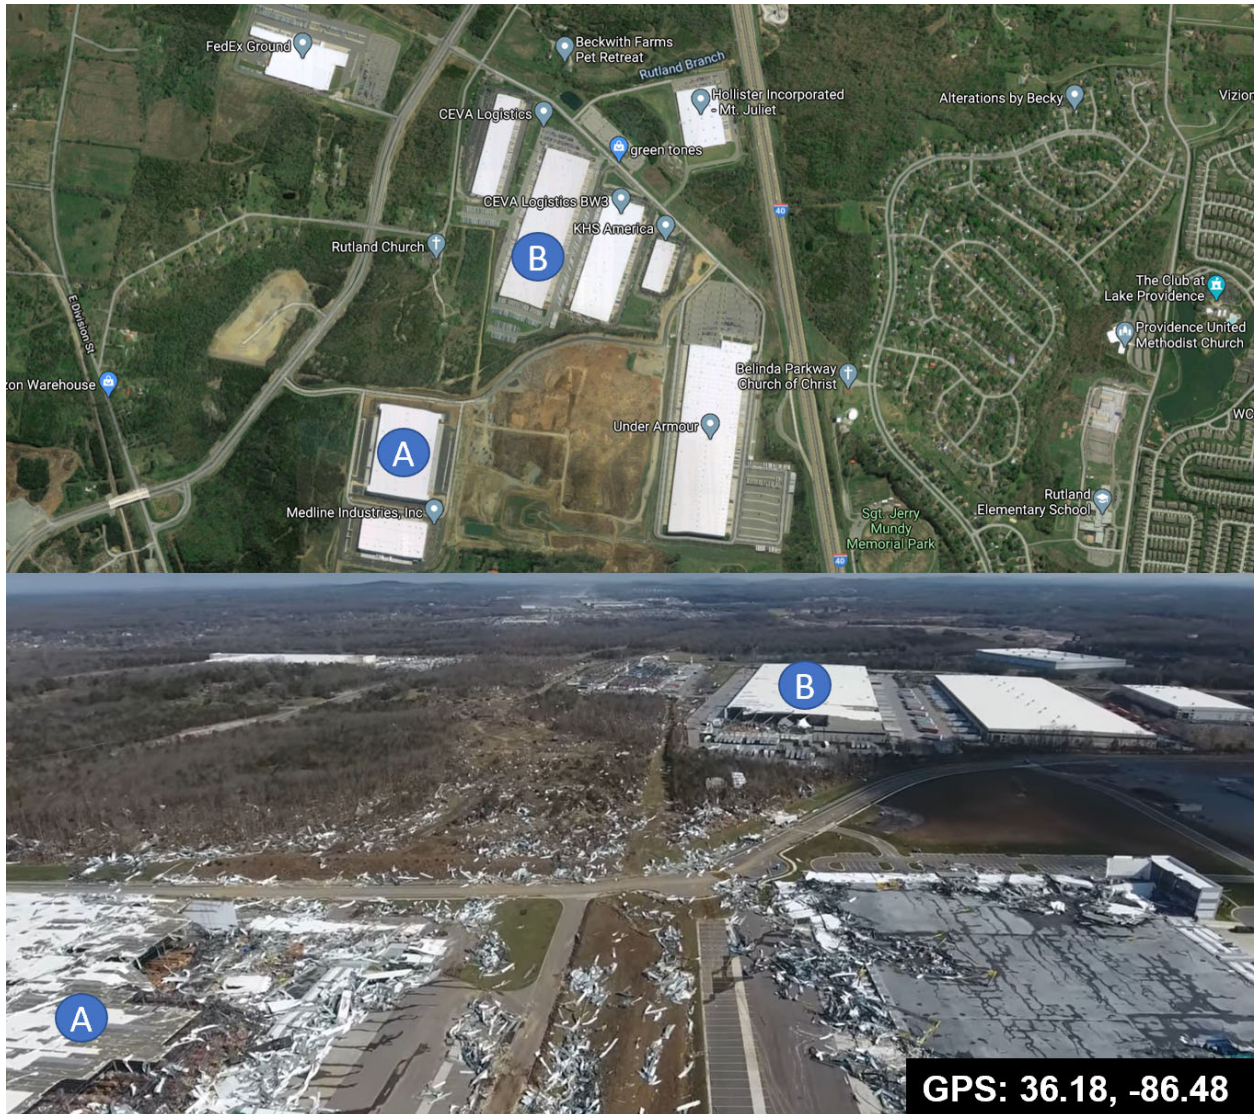
Figure 4.14. Before and after aerial views of damage to an industrial complex in Mount Juliet, TN that contained distribution/manufacturing centers for a variety of retailers. Post-tornado imagery was captured by [Brady Turner](#).

High-fidelity captures (e.g., lidar, SfM) of the performance of big box buildings, particularly the large industrial buildings in Mt. Juliet. These are of similar size to buildings damaged in Hurricane Michael. The contrast or similarities between the failures under hurricane and tornado-induced loads could improve our understanding of tornado-induced wind loads.

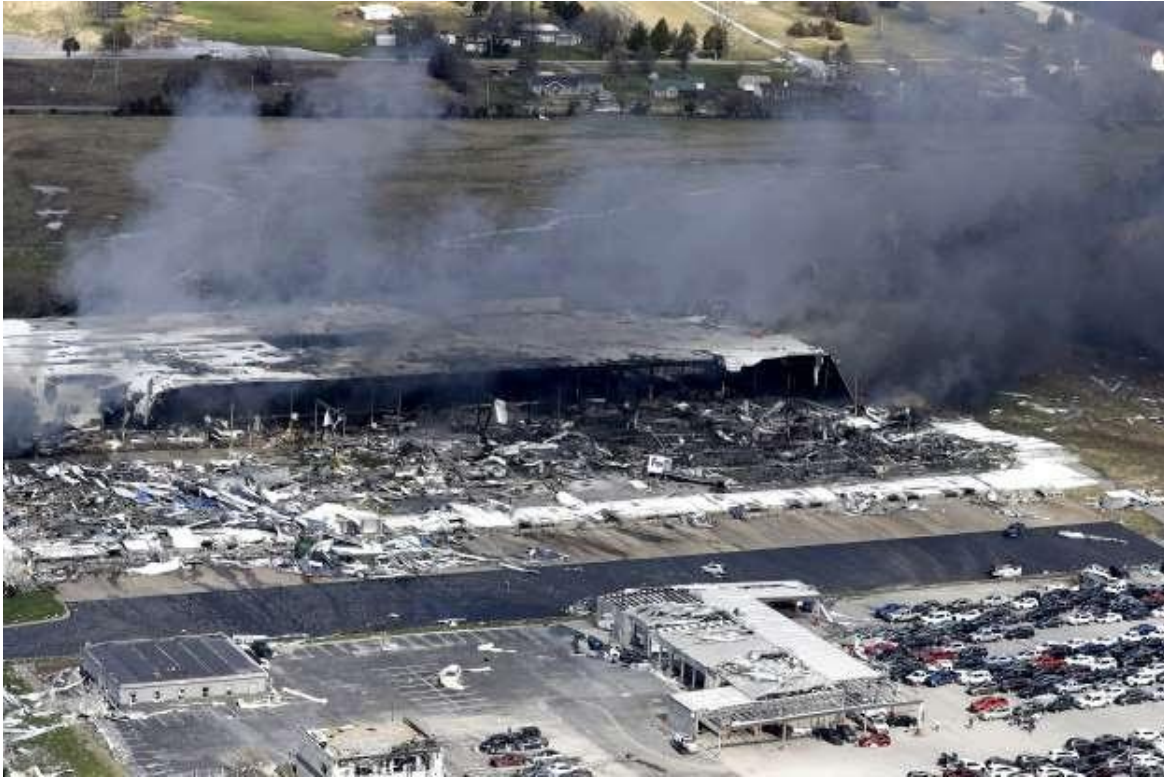
Figure 4.15. Precast tilt-up concrete building with approximately 50% of the building footprint collapsed. Photos indicated the facility caught on fire during/after the tornado. (Source: [Mark Humphrey / AP Photos](#)). GPS: 36.187, -86.434.

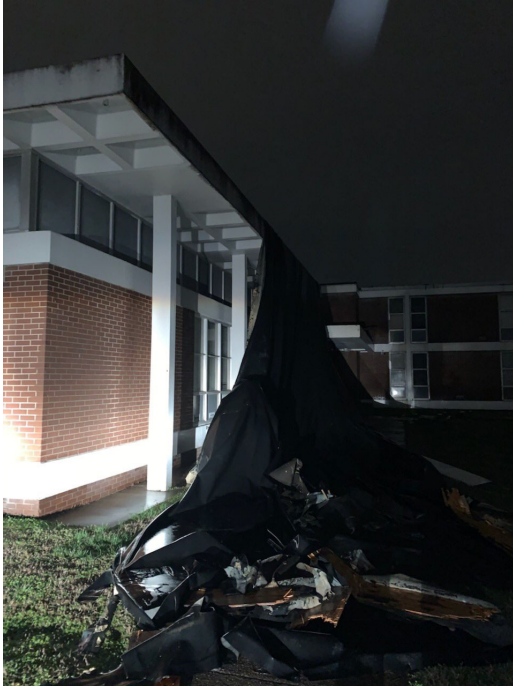
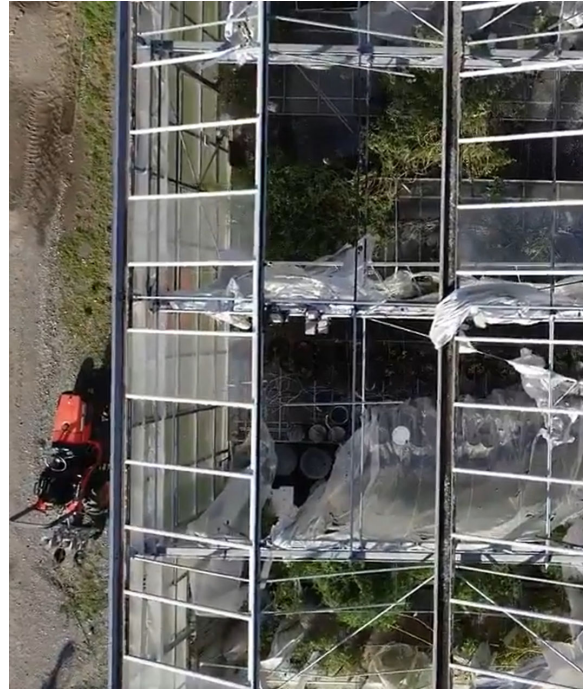
Figure 4.16. (Left) building damage (exact building unknown) on Tennessee State University campus. Source: [Tennessee State University](#); (right) damaged greenhouses at the Tennessee Sate University Agricultural Research Farm (Source: [TSU Ag. Extension](#)).

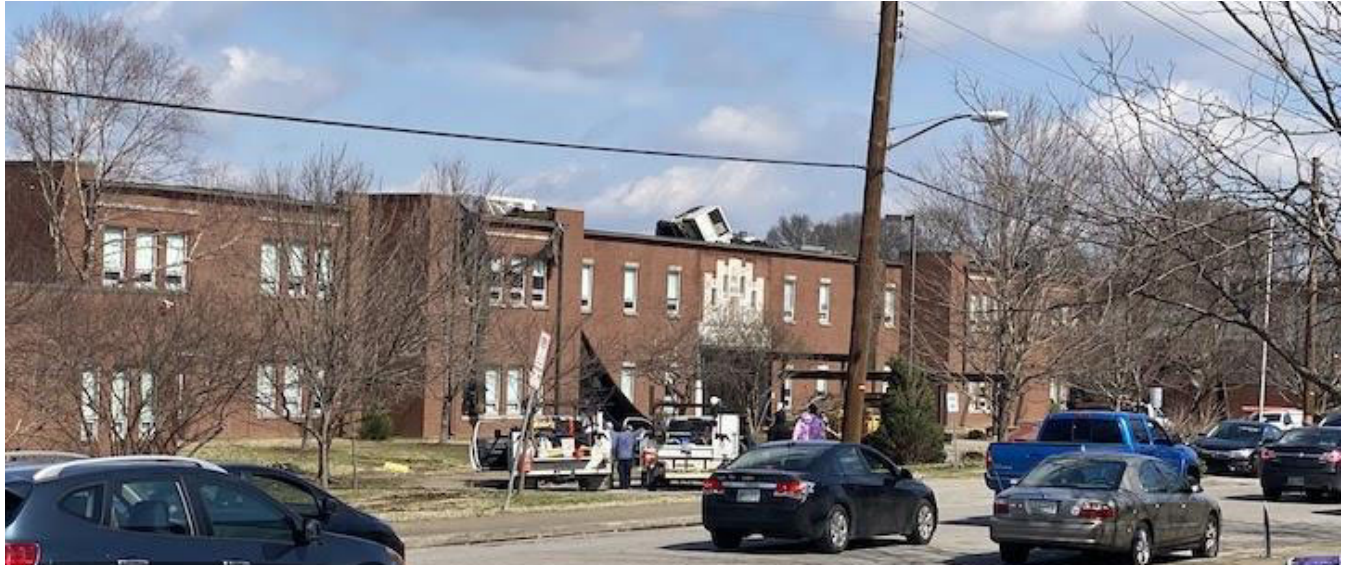
Figure 4.17. Meigs Middle Magnet School Damage (GPS: 36.176388, -86.760729). Source: [Nashville Metro Schools](#).

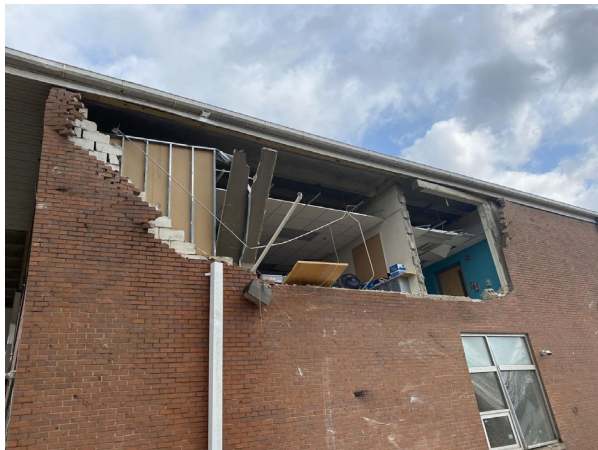
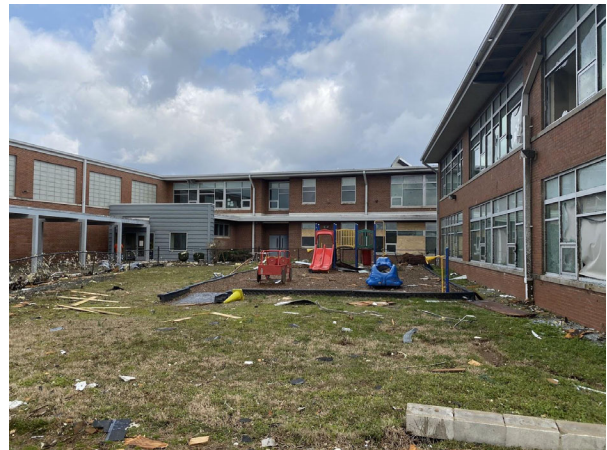
Figure 4.18. Robert Churchwell Museum Magnet Elementary School Damage (GPS: 36.175469, -86.810060). Source: [Nashville Metro Schools](#).

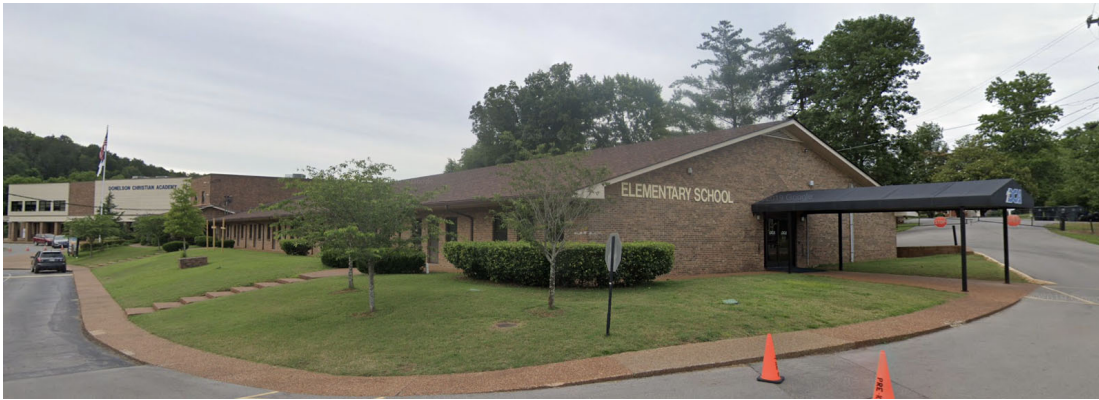
Figure 4.19. Donelson Christian Academy [Google Street View of School Before the Tornado Impact](#) and damage after the impact (GPS: 36.184433, -86.650141). Source: [Eric Hilt NewsChannel 5](#).

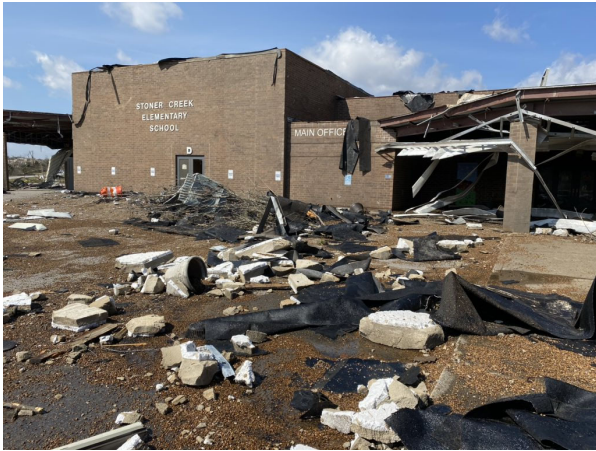
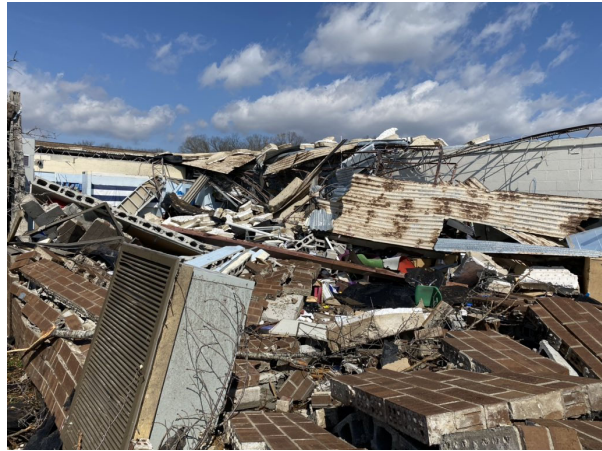
Figure 4.20. Building and Roof Damage to Stoner Creek Elementary School in Mt. Juliet (GPS: 36.184852, -86.502176). Source: [Stoner Creek Elementary School](#).

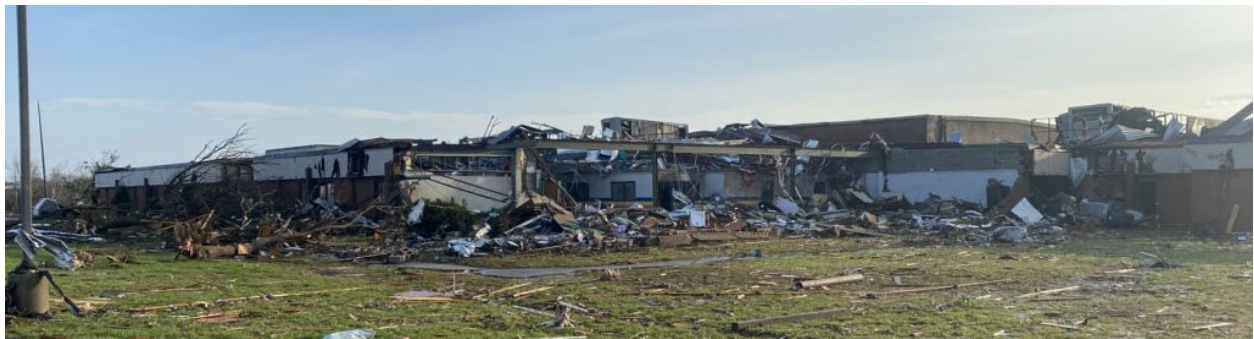
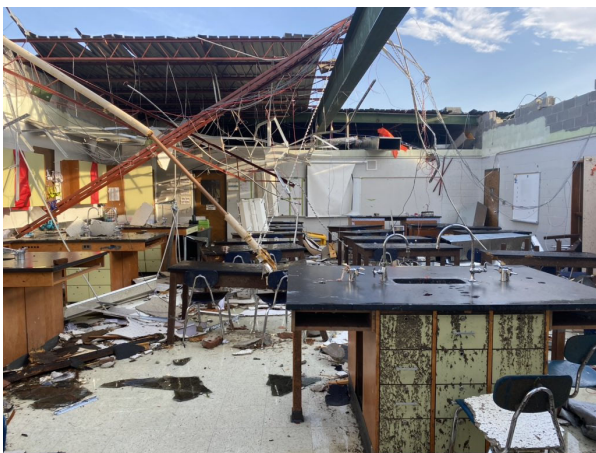
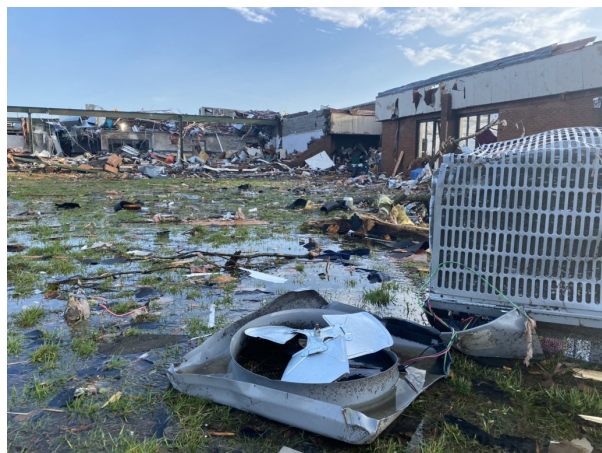
Figure 4.21. Damage to the West Wilson Middle School in Mt. Juliet (GPS: 36.184785, -86.510193). Source: [West Wilson Middle School](#).

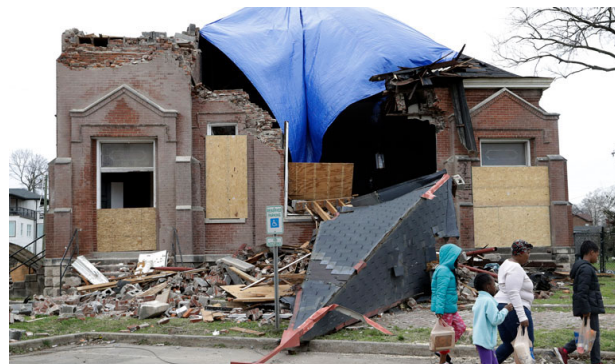
Figure 4.22. Damaged churches in Germantown. (Left) Assumption of the Blessed Virgin Mary Church, which suffered collapse of a wall and damage to the roof. The church was built in 1859. (Source: [The Catholic World Report](#)); (right) damage to historic Hopewell Missionary Baptist Church.

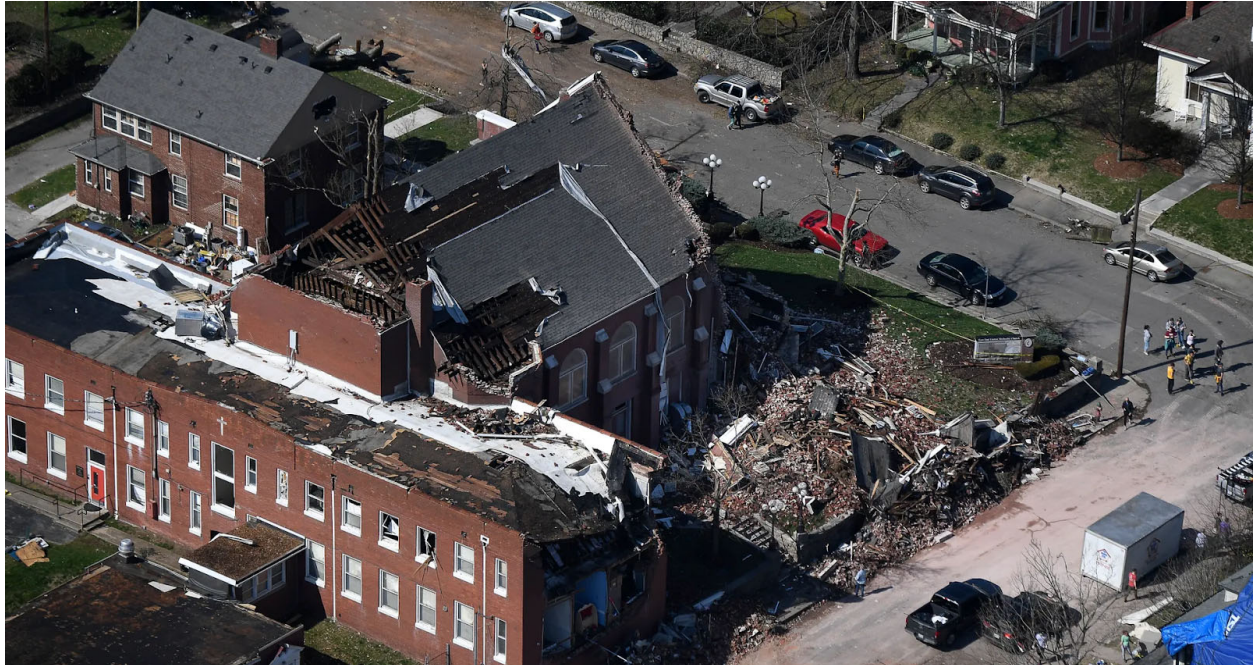
Figure 4.23. Heavy damage to the East End United Methodist Church at 1212 Holly in East Nashville (Source: George Walker IV / Tennessean.com).

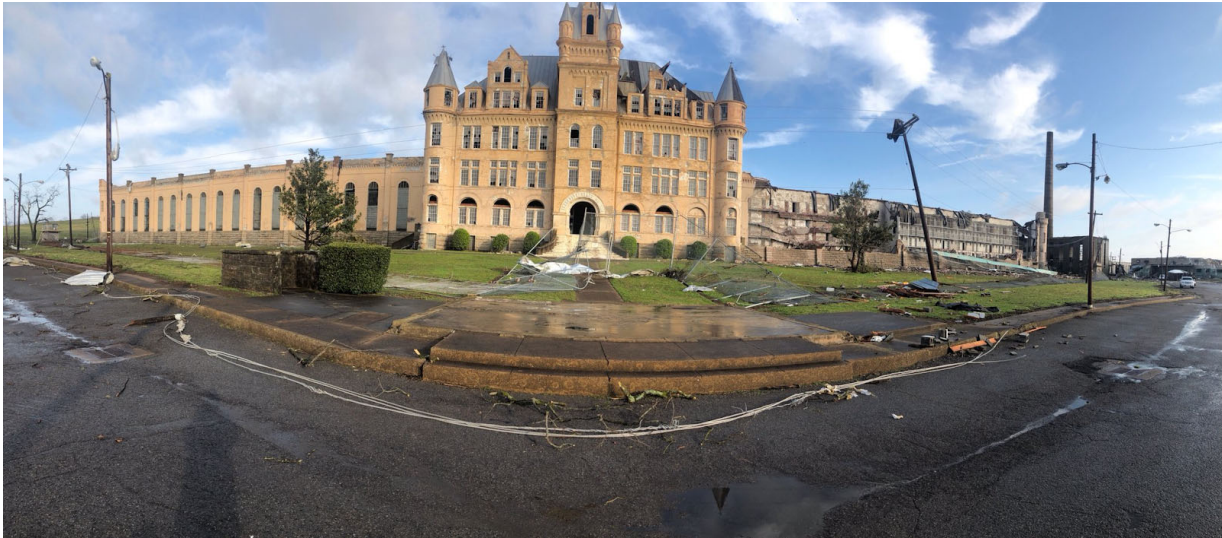
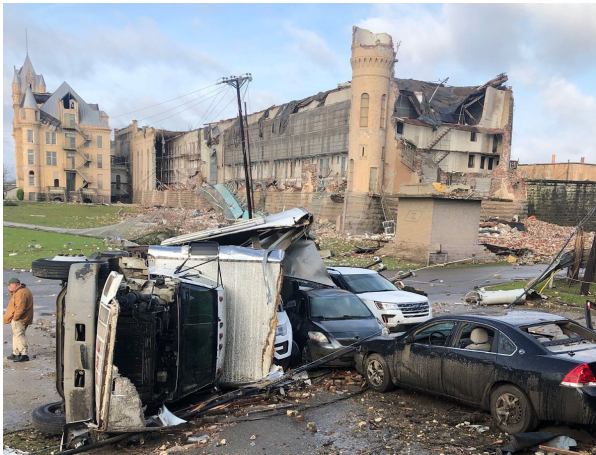
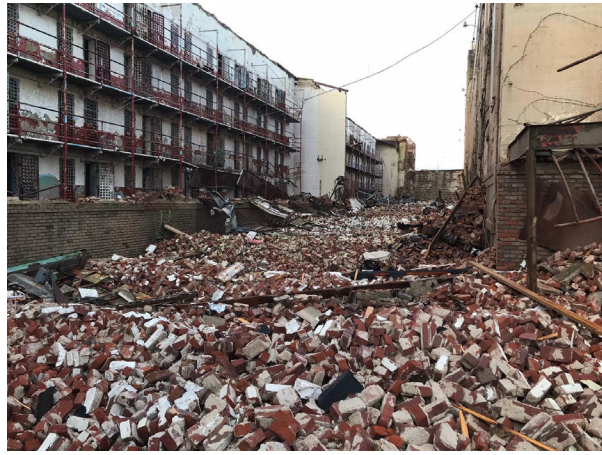
Figure 4.22. Tennessee Department of Corrections Historical State Prison. (GPS: 36.177011, -86.865586). Source: [TN DOC](#).

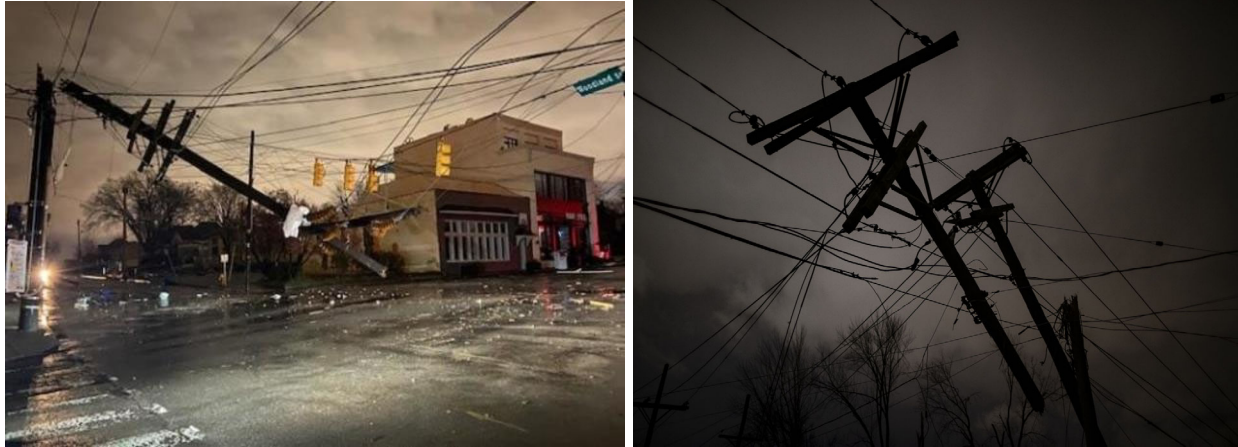
Figure 5.1. (a) Power pole damaged by the tornado in Nashville (Source: wlf.com via WTVF-TV, CBS News). (b) Damage to utility poles in Underwood St. (Nashville) (Source: Yahoo News).

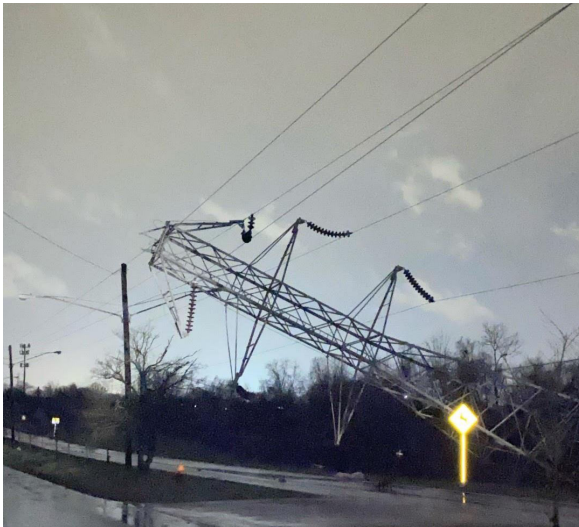
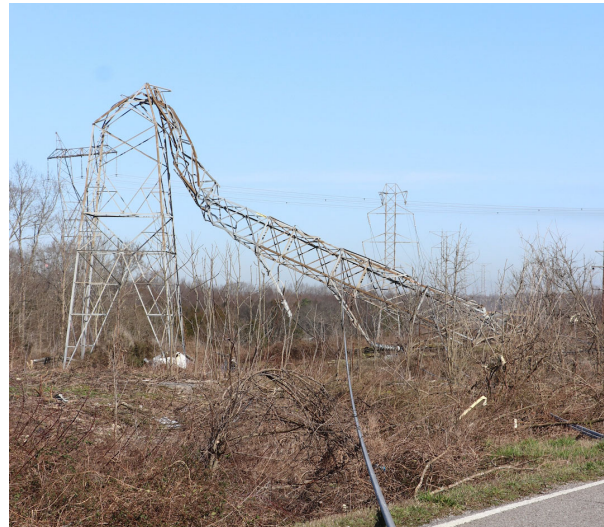
Figure 5.2. Transmission tower damage on Riverside Drive in Nashville, TN (Source: TMJ4); (right) Transmission tower damaged near the Cumberland River (Source: Tennessee Valley Authority).

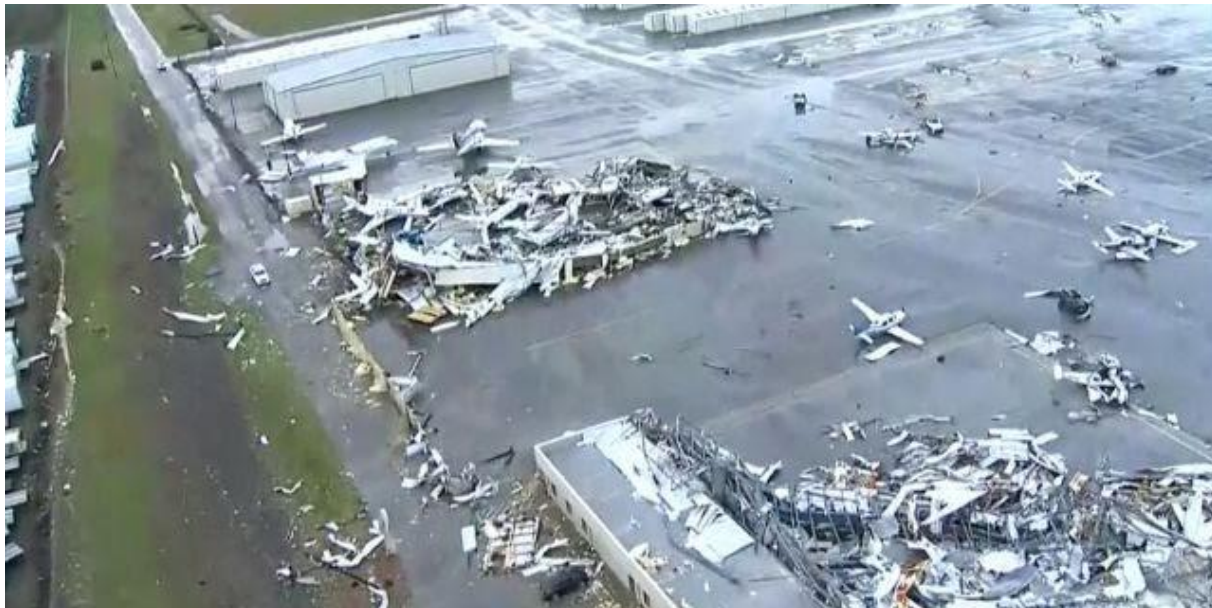
The John C. Tune airport was located near the beginning of the Nashville tornado path and was severely damaged by the tornado (Figs. 5.3 and 5.4). The Class E airport is owned by the Metropolitan Nashville Airport Authority and averages 230 aircraft operations per day⁶, primarily serving corporate and private aircraft needs. It underwent extensive renovations in 2015, mostly to the runway and taxiways. The airport contains 134 different hangar buildings.

Figure 5.3. Damage to John C. Tune Airport, Nashville International's sister airport in West Nashville (Source: [Fox News](#))

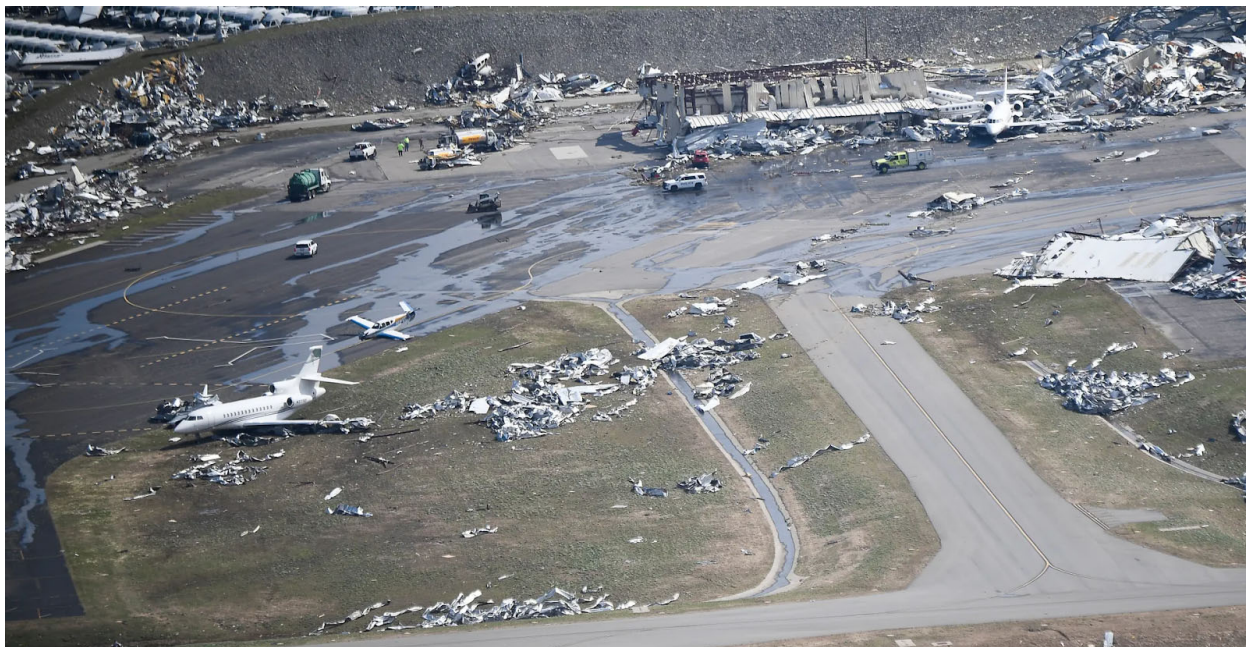
Figure 5.4. An aerial view of John C. Tune Airport showing collapsed hangars and other buildings and damaged aircraft (Source: [George Walker IV / Tennessean.com](#)).
