EVENT BRIEFING

Event: 17 June, 2019 Yibin City, Sichuan, China Earthquake

Authors: Xinzheng Lu, Department of Civil Engineering
Tsinghua University, Beijing, PR China
Selim Günay, Pacific Earthquake Engineering Research
Center, University of California, Berkeley

Released: June 22, 2019 (DesignSafe Project: PRJ-2428)

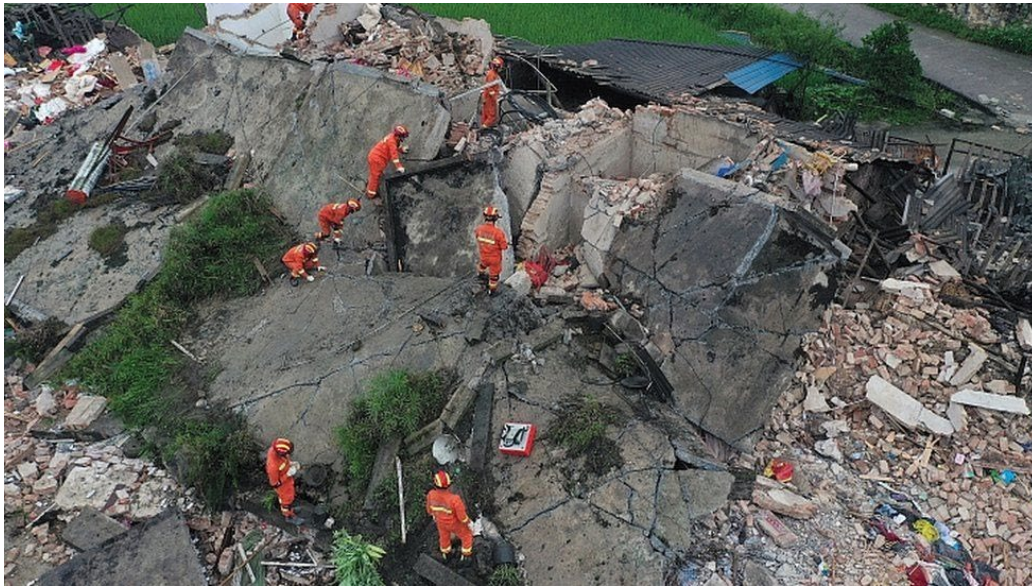
Figure 4. Rescuers searching for people in the rubble of a collapsed building (BBC News, 2019).

Over 20,000 houses were damaged with several collapses, e.g., Figure 4 (China Plus, 2019). Around 243,880 people were affected, and more than 52,000 people were displaced from impacted areas. Similar to previous earthquakes, these numbers highlight the social consequences of earthquakes, such as population displacement, highlighting the need for more regional-scale simulations of building and infrastructure performance in collaboration with social science experts.

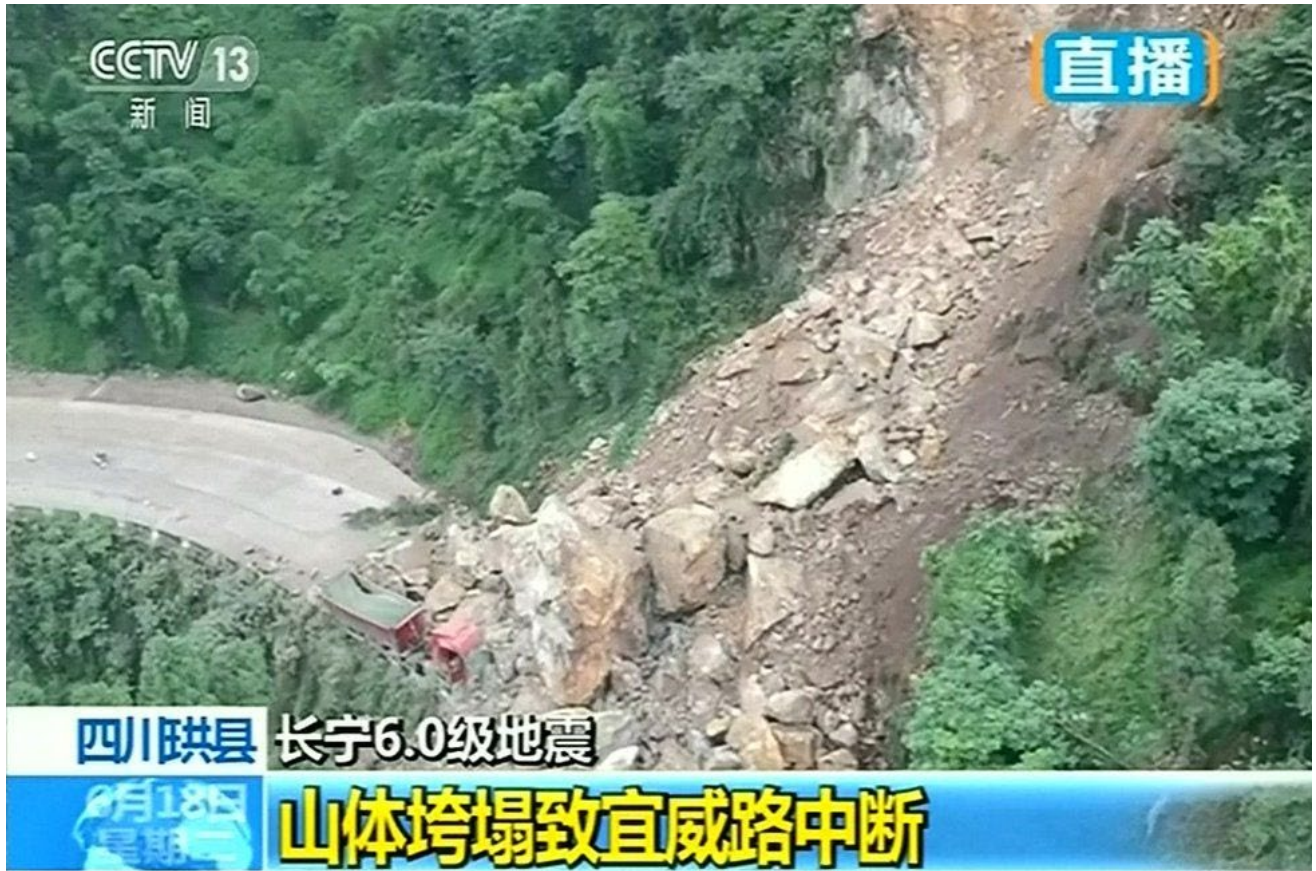
Figure 7. Aftermath of a landslide that had blocked a road and left a lorry engulfed in debris (BBC News, 2019).

On-the-ground reports documented several landslides after the earthquake. Figure 7 shows the aftermath of a landslide that had blocked a road and left a lorry engulfed in debris (BBC News, 2019).
