StEER
STRUCTURAL
 EXTREME EVENTS
 RECONNAISSANCE

Hurricane Helene
 September 29, 2024
 Released: December 16, 2024
 NHERI DesignSafe Project ID: PRJ-5669

PRELIMINARY VIRTUAL RECONNAISSANCE REPORT (PVRR)

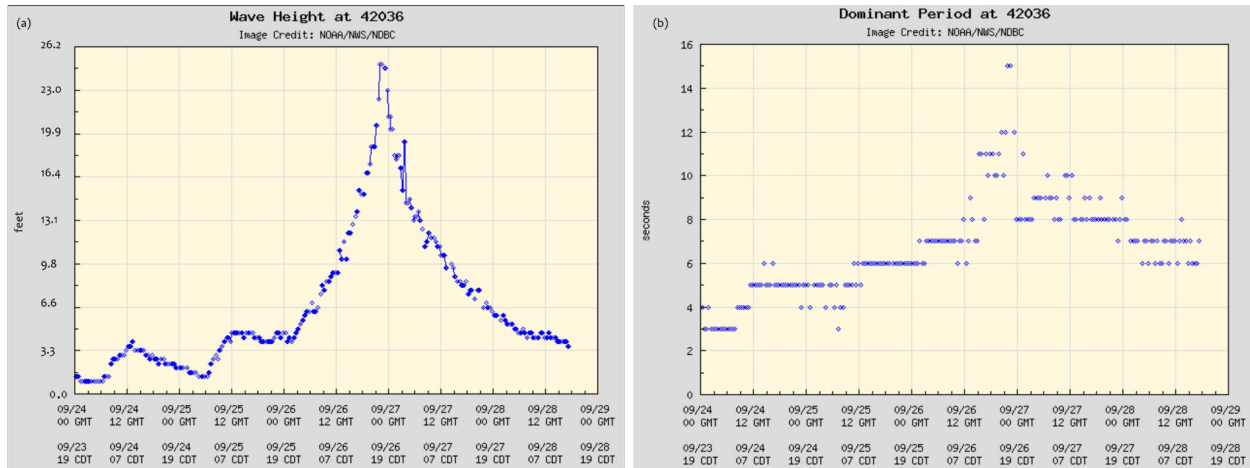
The large wind field of Helene generated the significant wave heights and dominant wave periods shown in Figure 2.7, measured during the passage of Hurricane Helene from September 24 to 29, 2024 at National Data Buoy Center (NDBC) Station 42036, located 112 nautical miles WNW of Tampa, Florida. Offshore wave heights reached over 24.6 ft (7.5 m), with peak periods up to 16 seconds during the storm. The significant depths of water above ground as indicated in Figure 2.6 likely allowed for large breaking waves to develop over land that led to significant damage to coastal construction.

Figure 2.7. (a) significant wave heights (ft) and (b) dominant wave periods (s) measured at NDBC Station 42036, located 112 nautical miles WNW of Tampa, FL (Source: NDBC, 2024).

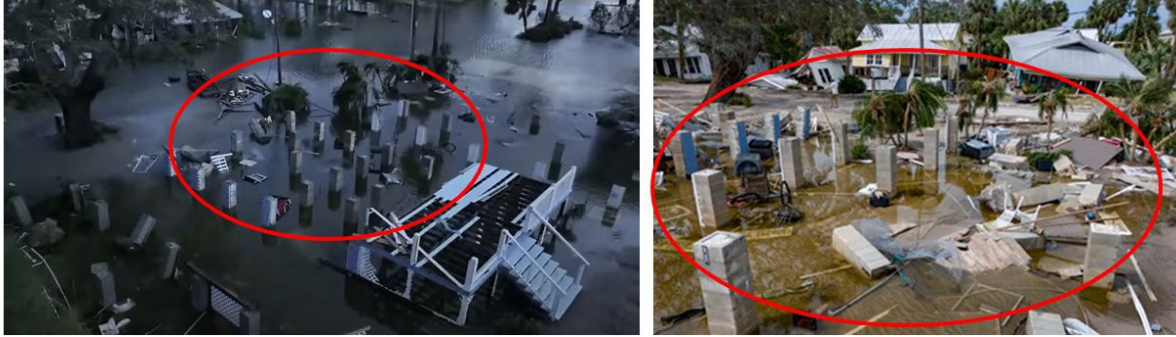
Single-Family Residential Buildings	Storm surge and wave load caused building damage in several coastal towns in the Florida Big Bend coast. Older slab-on-grade residences and elevated ones were destroyed. Newer elevated constructions survived where their lowest occupied floors were above the storm surge and wave height. Elevated houses that had intermediate wood decks (some expanded staircase landings) raised the likelihood of total structural failure of the house. There was evidence of inadequate column foundations, particularly in concrete columns built on shallow foundations that failed due to scouring. Wind damage to roof cover and wall cladding systems was also observed.
Multi-Family Residential Buildings	Damage to multi-family residential buildings were also observed where lowest floor levels were impacted by storm surge and waves.

Figure 4.1.1. Elevated structures washed away by storm surge and wave loads in Cedar Key, FL (Source: [Greg Lovett](#)).

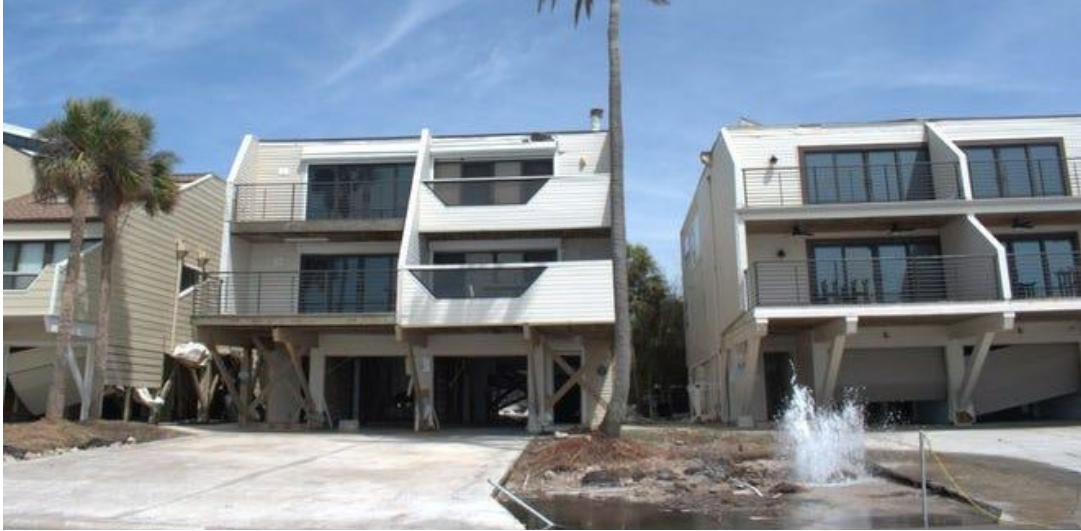
Elevated structures in other areas near Sarasota and Tampa also suffered damages due to surge and wave loading, but the damage was primarily limited to the ground floor: damage to garage doors and other break-away components (Fig. 4.1.3). Readers should recall, the storm surge levels were far less severe southwards from Tampa (2 m or less see Figure 2.6). Several nearshore elevated structures also suffered severe erosion, but did not experience collapse (Fig. 4.1.4).

Figure 4.1.3. Damage to non-structural elements at ground floor of elevated buildings in Siesta Keys, FL (Source: [Christian Casale](#)).

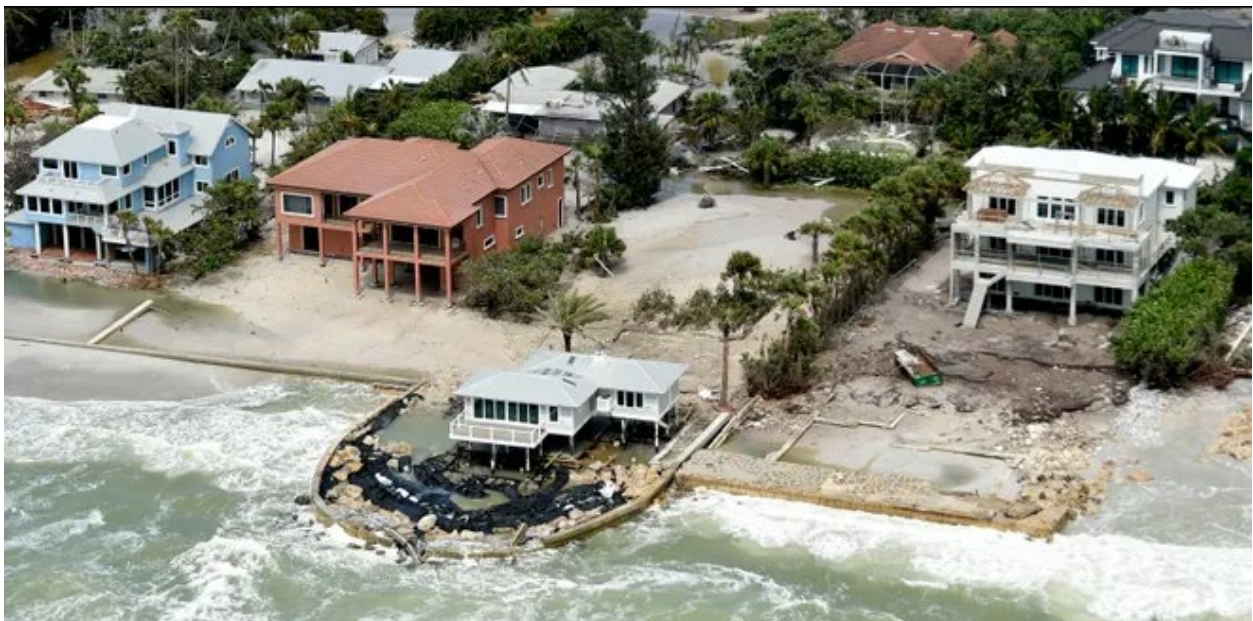
Figure 4.1.4. Beach erosion and wind-induced damage to the building on the right of the image in Longboat Key, FL (Source: [Thomas Bender](#)).

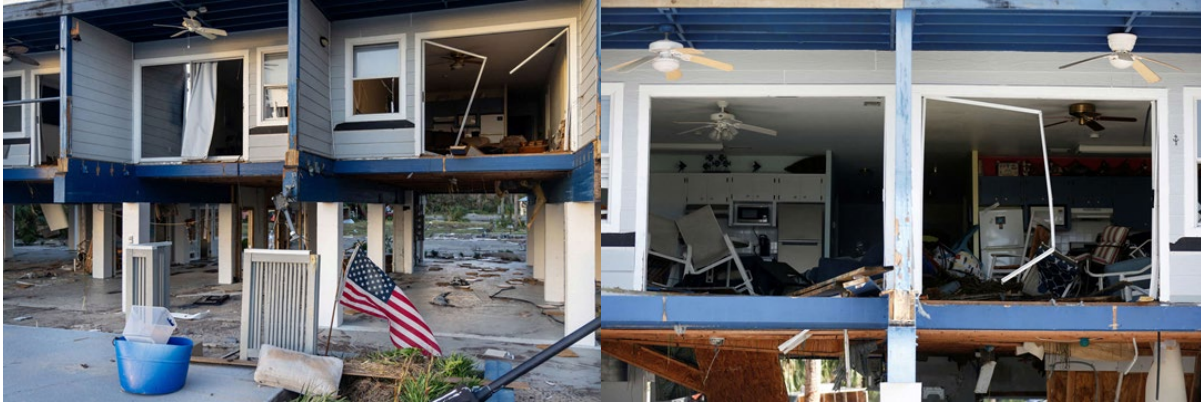
Figure 4.1.5 shows damage to the lower level of a multi-story wood-frame building located next to the Steinhatchee Marina. Surge- and wave-generate slamming-induced uplift forces dislocated the balconies. Surge level reaching above the first floor caused extensive damage to the facades and other non-structural components. The building was elevated on a pile system anchored to a concrete slab; no damage was observed to the piles or the slab.

Figure 4.1.5. Damage to balconies, facades and other non-structural elements of elevated buildings in Steinhatchee, FL (Source: [Kathleen Flynn, Reuters](#)).

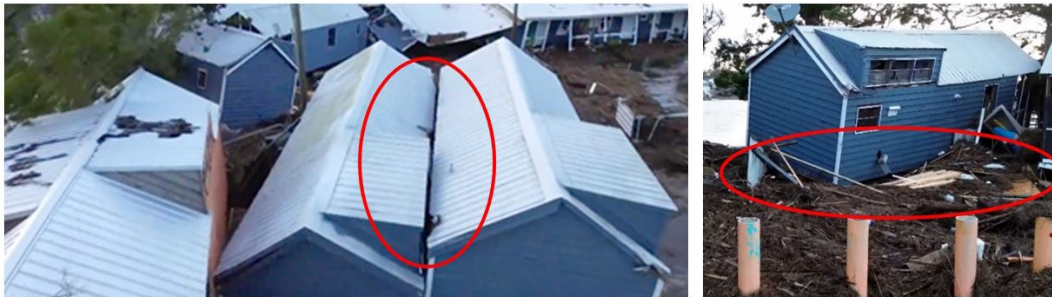
By comparison, non-elevated structures along the Gulf Coast of Florida were severely damaged, displaced, or destroyed by the storm surge and wave action. Figures 4.1.6-4.1.8 present examples of these failures, which include complete dislocation from the foundation (Fig. 4.1.6) with corresponding structural damage (Fig. 4.1.7) as well as damage to exterior walls with foundation scouring (Fig. 4.1.8).

(a) Multiple dislocated homes damming against each other

Figure 4.1.6. Manufactured homes dislocated from their foundation in Steinhatchee, FL (Source: [Aaron Rigsby](#)).

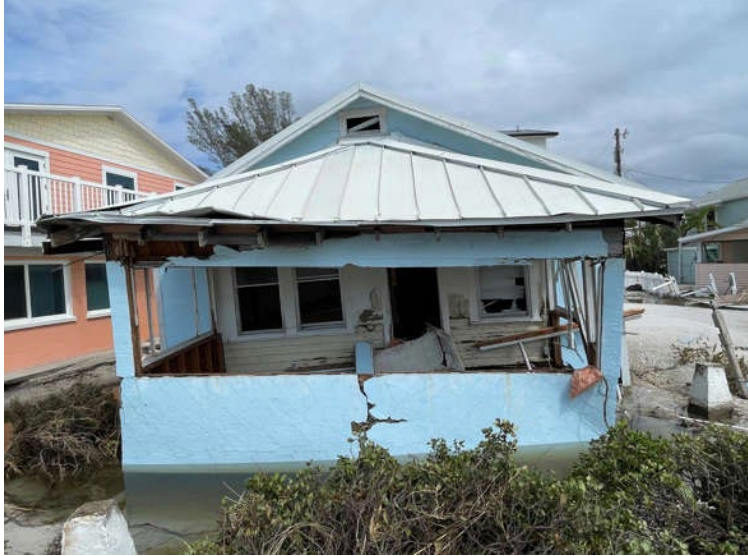
Figure 4.1.7. Dislocated non-elevated structure in Bradenton Beach on Anna Maria Island, FL (Source: [Thomas Bender](#)).

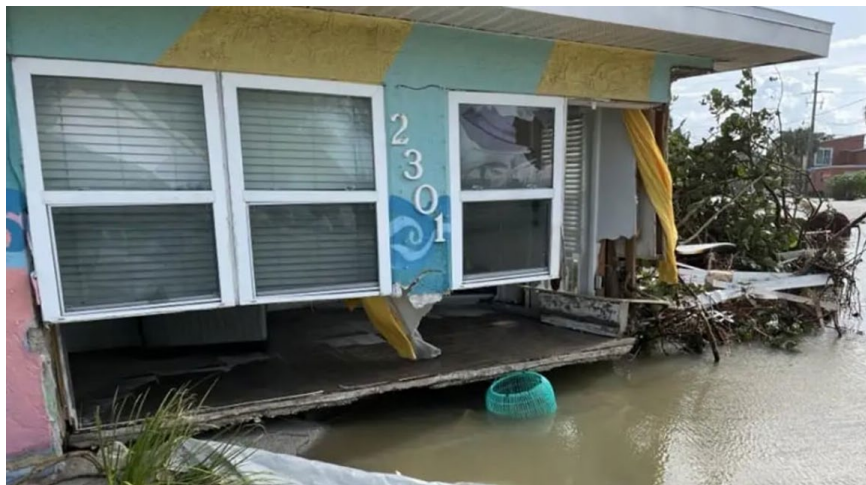
Figure 4.1.8. Non-elevated building with damaged exterior walls and foundation scouring in Manatee County, FL (Source: [Manatee County Government](#)).

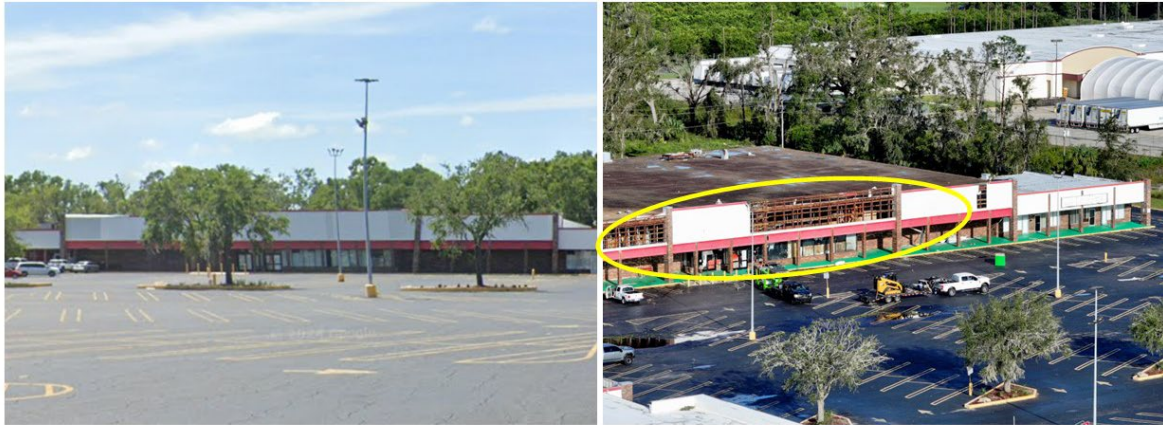
While Helene’s wind speeds were well below the design wind speed for this region, some wind damage was observed across the landfall areas. Figure 4.1.9 shows one such example, a commercial building in Perry, constructed in 1980 per property assessor records, with extensive loss of the cladding attached to its parapets. Preliminary wind field estimates suggest the building likely experienced peak wind gust speeds of about 110 mph, which is below the current design level of 120 mph for typical structures at this location. Another observed mode of wind-induced damage was due to tree falls impacting structures (Fig. 4.1.10) -- a source of both structural damage and loss of life.

Figure 4.1.9. Wind damage to cladding of a commercial building in Perry, FL, (a) before and (b) after the storm (Source: [Mark Bello, Reuters](#)).

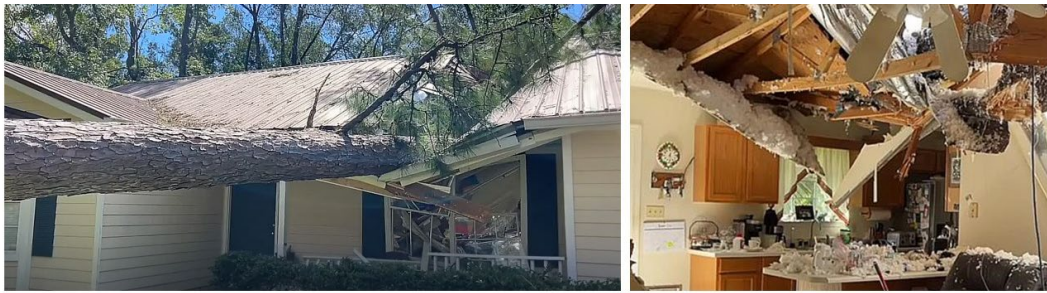
(a) Fallen tree on wooden roof structure

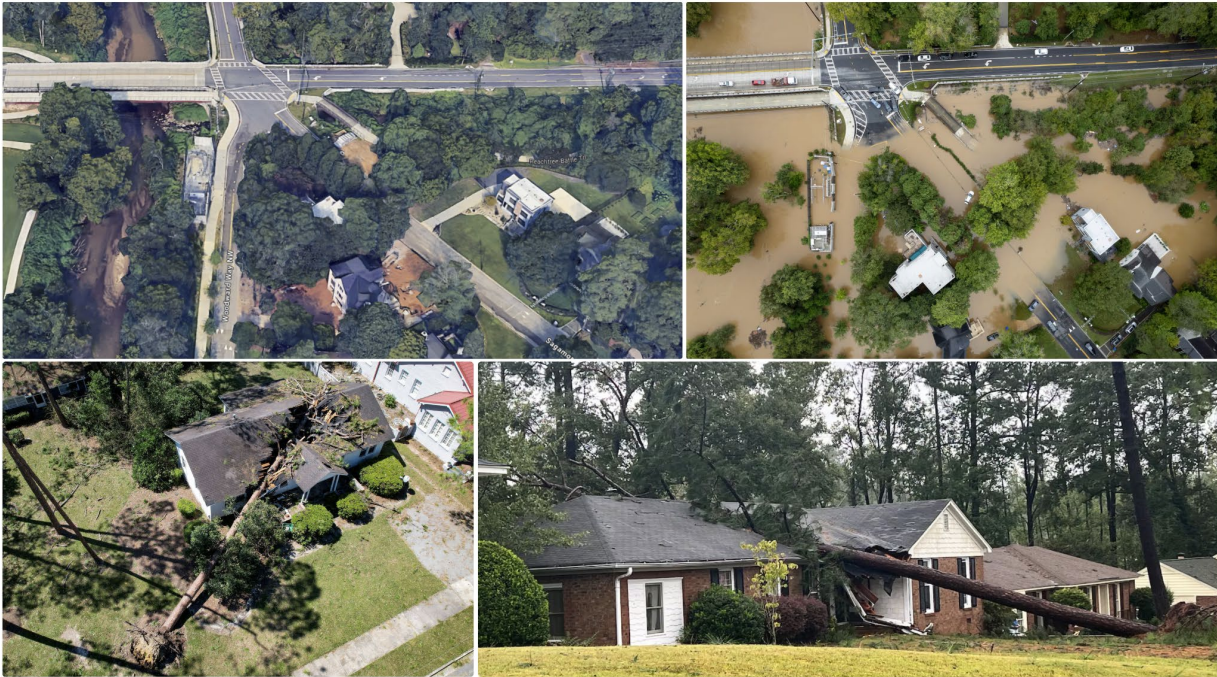
Table 4.2.1 provides a summary of impacts in the state of Georgia, mainly due to flash flooding and tornadoes spawned by Hurricane Helene. Areas in central and northern Georgia experienced severe riverine flooding, with the cities of Macon and Augusta particularly hard hit (Insurance Business Magazine, 2024). Wind damages included severe roof and structural failures, with evidence of debris impacts and tree falls into structures. Flooding compounded the damage in low-lying areas, leading to extensive property damage, with reports of partial collapse due to flood-induced damages (Fig. 4.2.1).

Figure 4.2.1. Peachtree Creek in Atlanta before (top left) and (top right) after heavy rains; aerial (bottom left) and ground-level (bottom right) post-tornado views (Source: [Ben Gary from the Atlanta Journal-Constitution](#)).

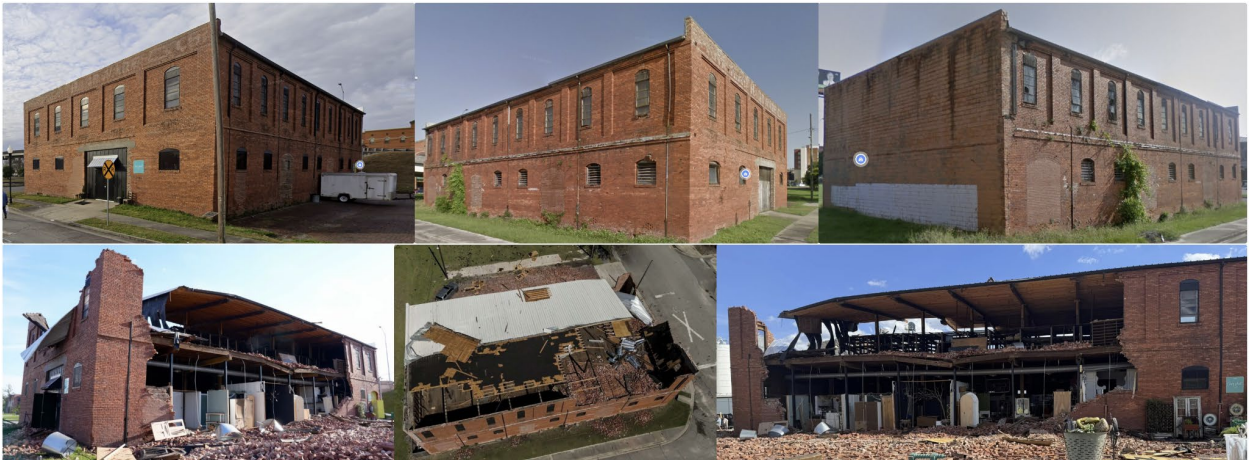
Multi-wythe brick buildings sustained significant damage due to strong winds and flying debris. Older brick structures, particularly those not designed for high wind resistance, experienced partial wall cracking, separation of brick facades, and out-of-plane failures of load bearing masonry walls, as well as roof damage. Damages were compounded by floodwaters. Figure 4.2.2 provides one example, showing partial wall collapse of the Chez What building before and after hurricane Helene in Valdosta, GA.

Figure 4.2.2. Chez What building before (top) and after (bottom) Hurricane Helene in Valdosta, GA (Source: [Dominick Del Vecchoi](#), [FEMA](#), [Thedesck.net](#)).

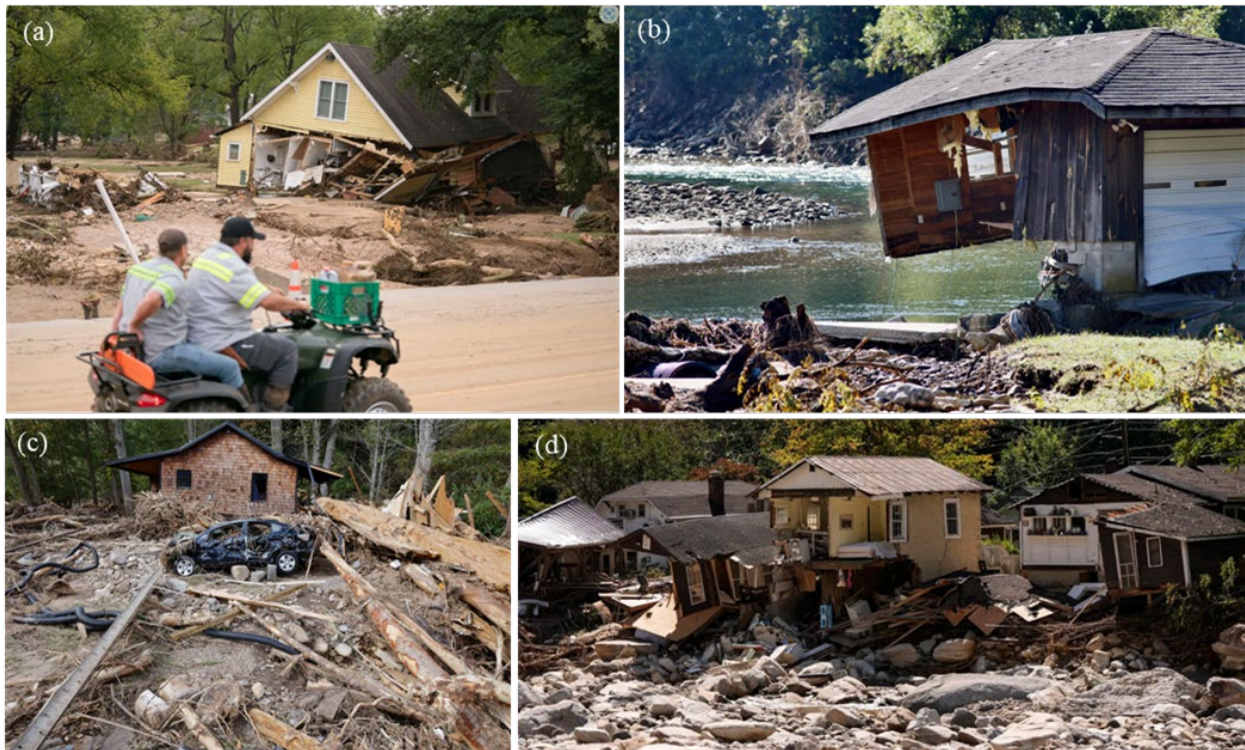
Figure 4.3.1. Outstanding examples of ravaged buildings across different regions in North Carolina: (a) Mill Creek in Old Fort, a timber residential house has been detached from foundation and carried several feet away, has sustained out-of-plane damage and debris can be seen around it (Source: [Sean Rayford—Getty Images](#)), (b) house in Cruso at a close distance to the riverbank has been swept away due to severe scouring that compromised its structural integrity (Source: [Reuters, Jonathan Drake](#)), (c) Barnardville, a house and other debris was found downstream hundreds of feet from its original location (Source: [Reuters, Jonathan Drake](#)), (d) Chimney Rock Village, houses made of timber have been completely destroyed and displaced by strong currents (Source: [Associated Press, Mike Stewart](#)).

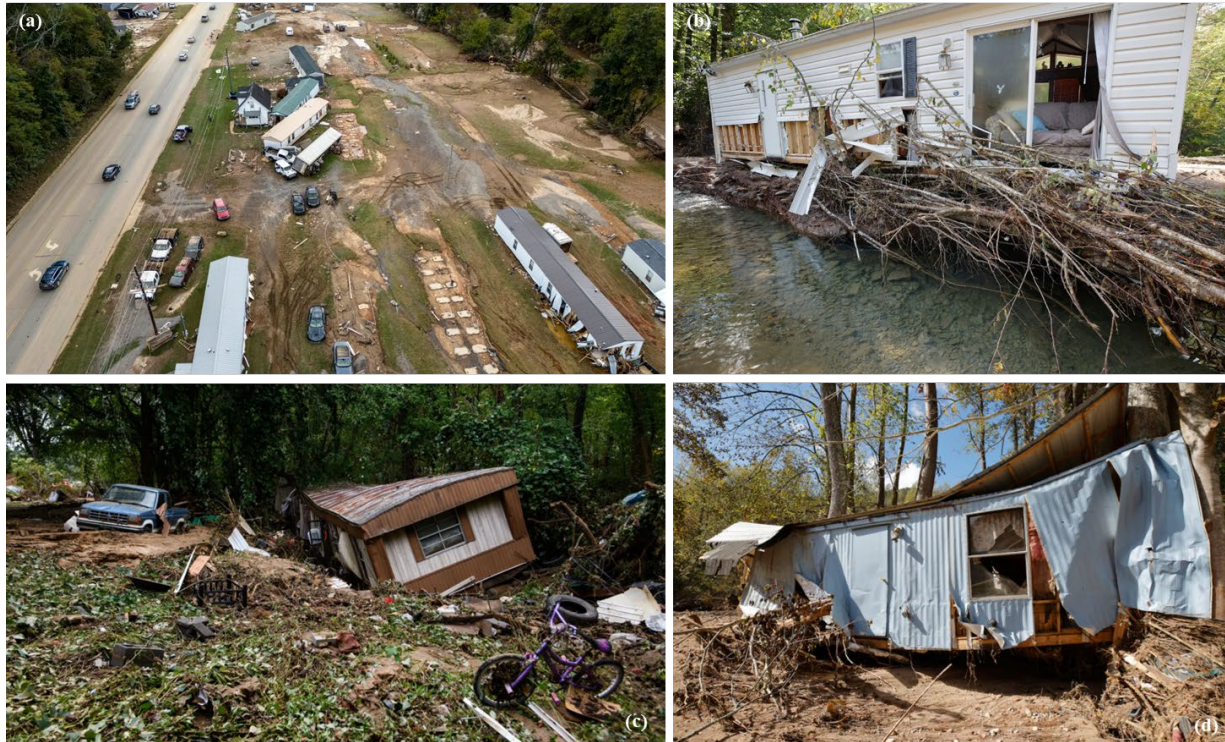
Figure 4.3.2. Examples of impacts to mobile homes in North Carolina: (a) in Swannanoa, mobile homes and vehicles displaced by flood waters, the footing structure for one of the mobile homes can be seen in the bottom right of the picture (Source: [Associated Press Photo, Mike Stewart](#)), (b) mobile home in Cruso, swept away by surging creek (Source: [Reuters, Jonathan Drake](#)), (c) in Old Fort, vehicle and mobile home pushed into tree line (Source: [Getty Images, Melissa Sue Gerrits](#)), (d) in Barnardsville, a trailer home completely deformed and destroyed by the impacts of flooding (Source: [Reuters, Jonathan Drake](#)).

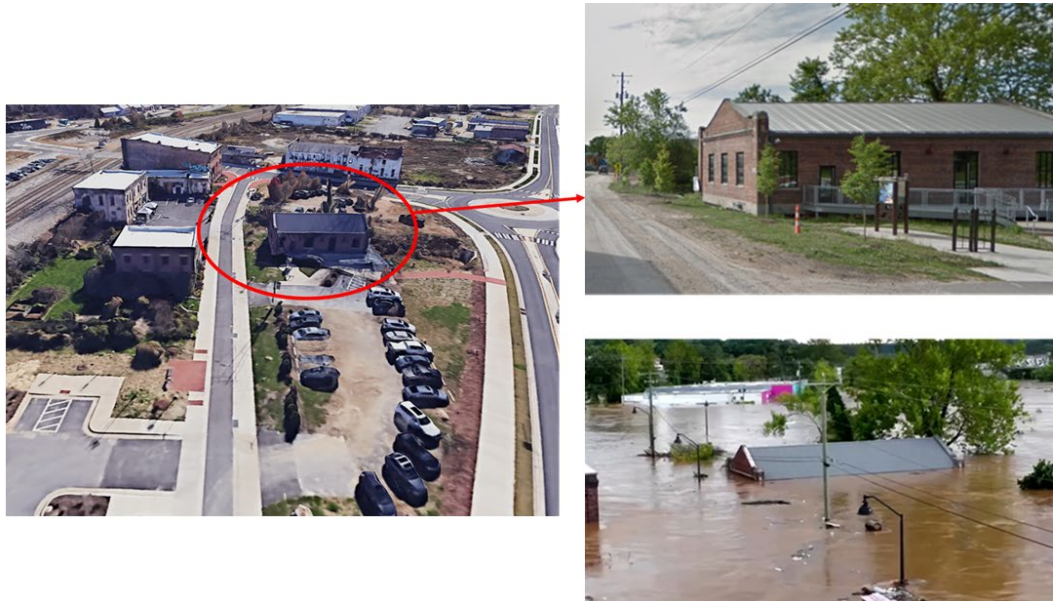
Figure 4.3.3. Flooded region before and after in the River Art District, Asheville, North Carolina (Source: Google Street View (before) and [@nctradlines / Reuters](#) (after)).

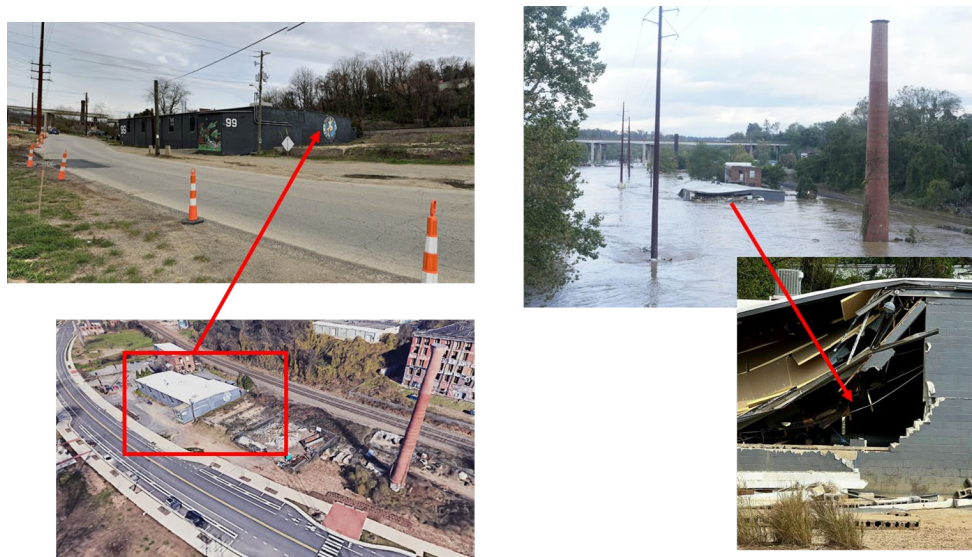
French Broad River (Coffey, 2024). Figure 4.3.4 shows the flood level at a one-story brick bearing wall building located within the River Arts District, and its condition before, during and after the flood.

Figure 4.3.4. The images on the left focus on a specific building (building 99 - Second Gear and Sugar and Snow Gelato, Asheville, North Carolina) within the district, that was repurposed to host commercial stores. The water levels reaching close to the roof can be seen in the upper right image and out-of-plane failure for one of the walls is visible in the bottom right photo. (Source: Google Street View (pictures before) and [Citizen Times, Jacob Biba](#) and detail of damage from [Glen Miska](#) (pictures after)).

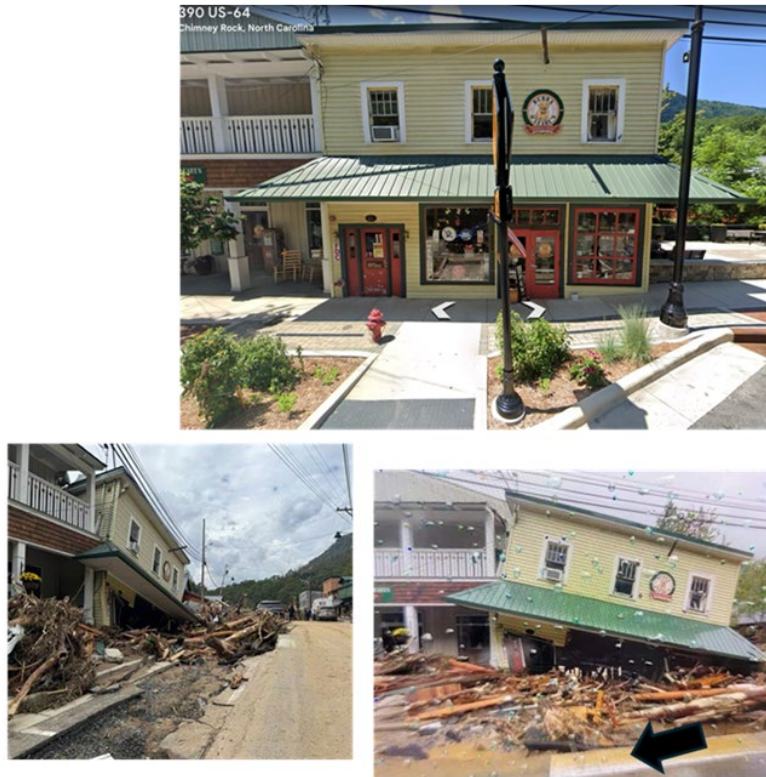
The small communities of Chimney Rock and Bat Cave, located in Rutherford County within the Hickory Nut Gorge of the Blue Ridge Mountains along the Rocky Broad River, experienced severe flooding due to the region's steep terrain and proximity to rivers. Structural failures due to fast-moving flood waters (Fig. 4.3.5) were observed; more prominent was the scouring of foundations and unseating of buildings located on river banks (Fig. 4.3.6-4.3.7).

Figure 4.3.5. Two-story timber structure in downtown Chimney Rock collapsed due to fast-moving flood waters. The flow of the water along the graded road in front of the damaged building is also indicated with a black arrow (Source: Google Street View (top), bottom right from [James Spann via Threads](#), bottom left [WSOC-TV](#)).

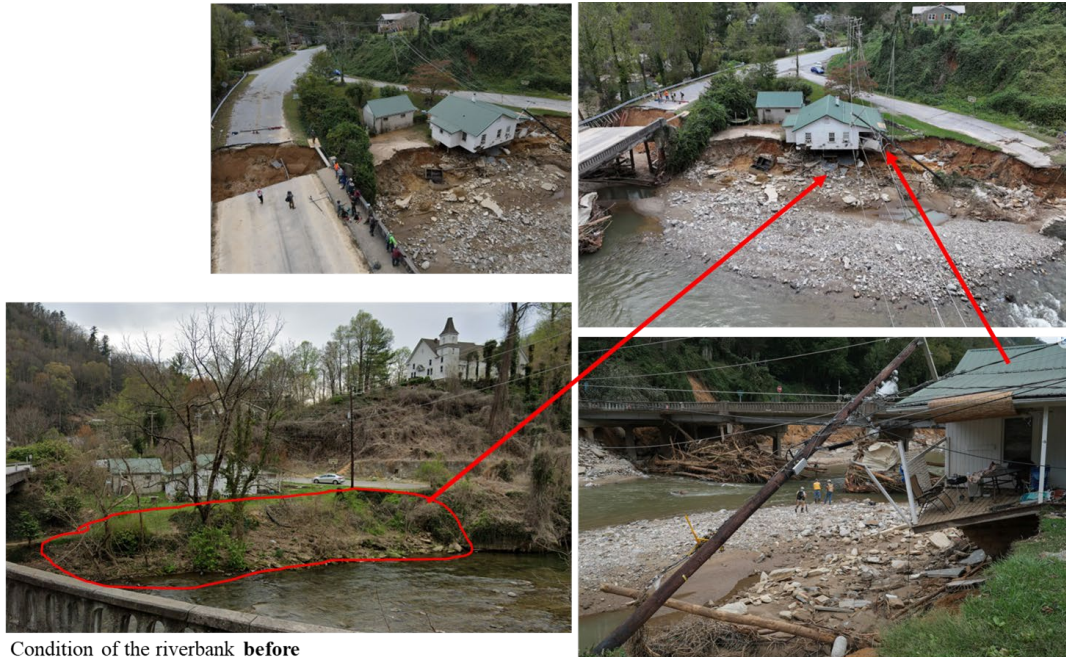
Figure 4.3.6. Severe scouring effects on the riverbanks of Rocky Broad River in Bat Cave, North Carolina. (Source: Google Street View (before) and starting from top left and going clockwise: [New York Times](#), [Christian Monterrosa](#), and the right two from [Reuters](#), [Marco Bello](#)).

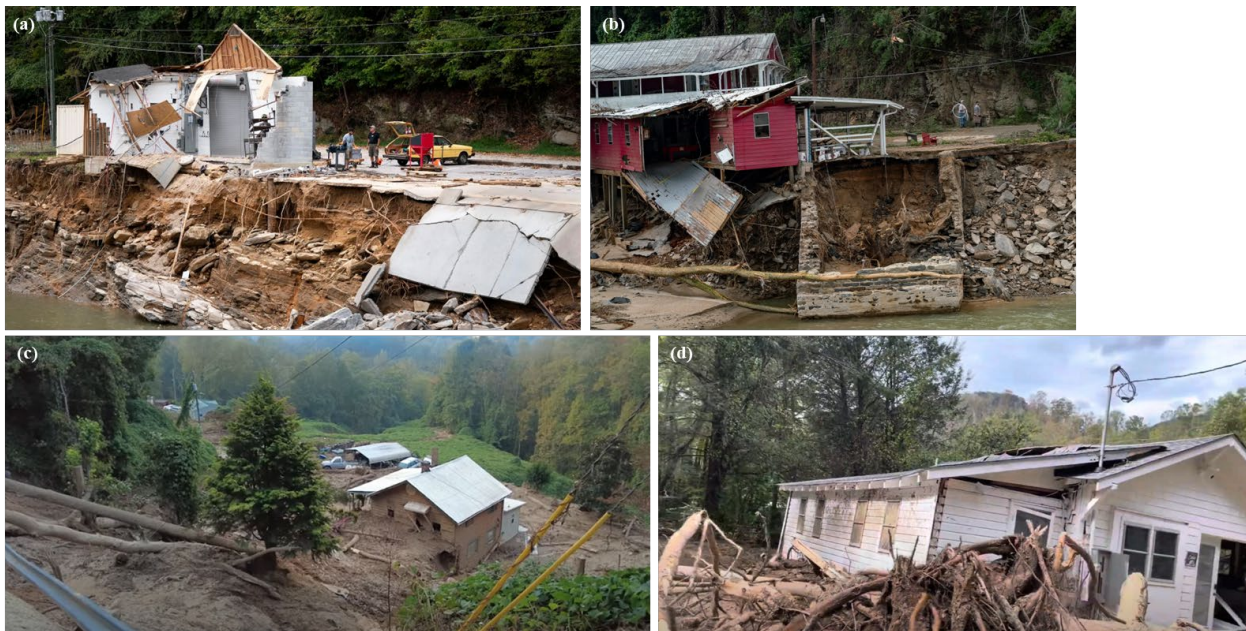
Figure 4.3.7. Four different locations in Bat Cave, North Carolina: (a) (Source: [Sean Rayford/Getty Images](#)) and (b) (Source: [New York Post](#), [Ben Hendren](#)) are locations along the Rocky Broad River area that experienced unprecedented flood levels that resulted in extreme scouring/erosion that swept entire houses made of timber, (c) landslides also caused damages to houses like the one shown here (Source: video from [Forbes Breaking News](#)) and (d) houses were also detached from foundations and were found stranded several feet away ([YouTube video by Blaine Chappell](#)).

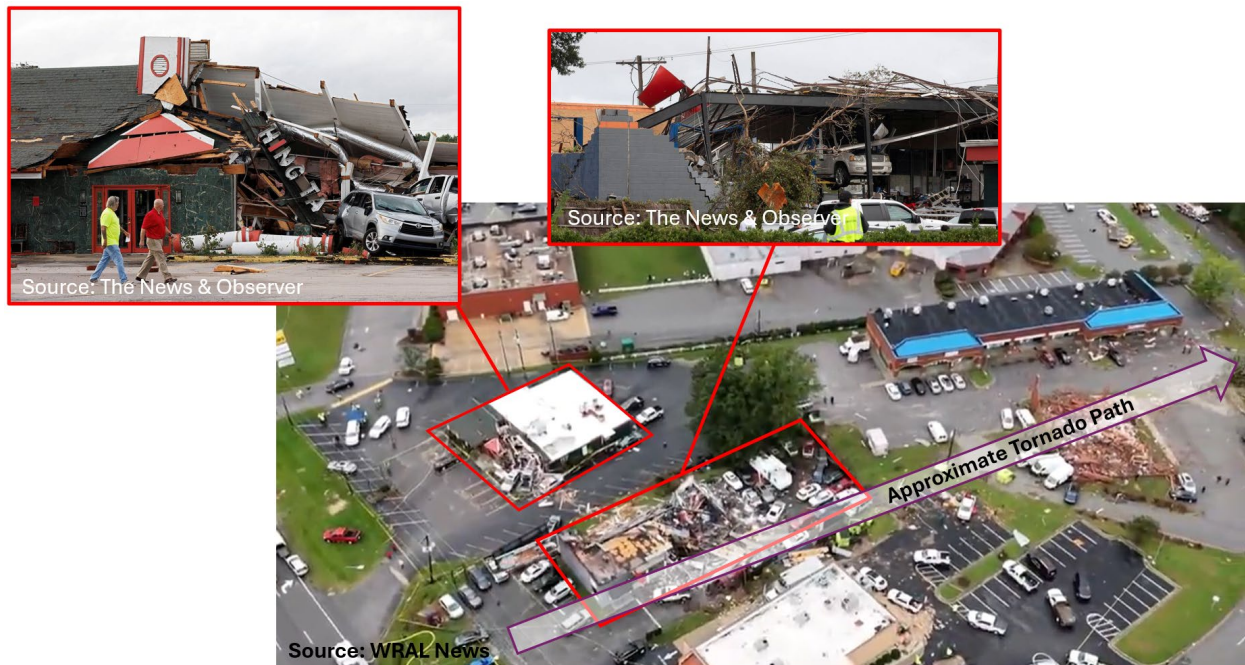
An EF1 tornado was reported in Blowing Rock, NC that caused roof damage and failures due to flying debris, falling trees and aerodynamic loads. Another short-lived tornado struck the city of Rocky Mount, in Nash County, causing up to EF-3 damage along a 0.1-mile path through the downtown region (Fig. 4.3.8). The tornado struck multiple occupied restaurants, resulting in 15 reported injuries, but fortunately no fatalities (Moore & Adam, 2024). The National Weather Service estimated peak wind speeds of 140 mph.

Figure 4.3.8. Several commercial structures were destroyed in downtown Rocky Mount, NC by an EF-3 tornado (Sources: inset photographs from [Raleigh News & Observer](#), base aerial image from [WRAL News](#)).

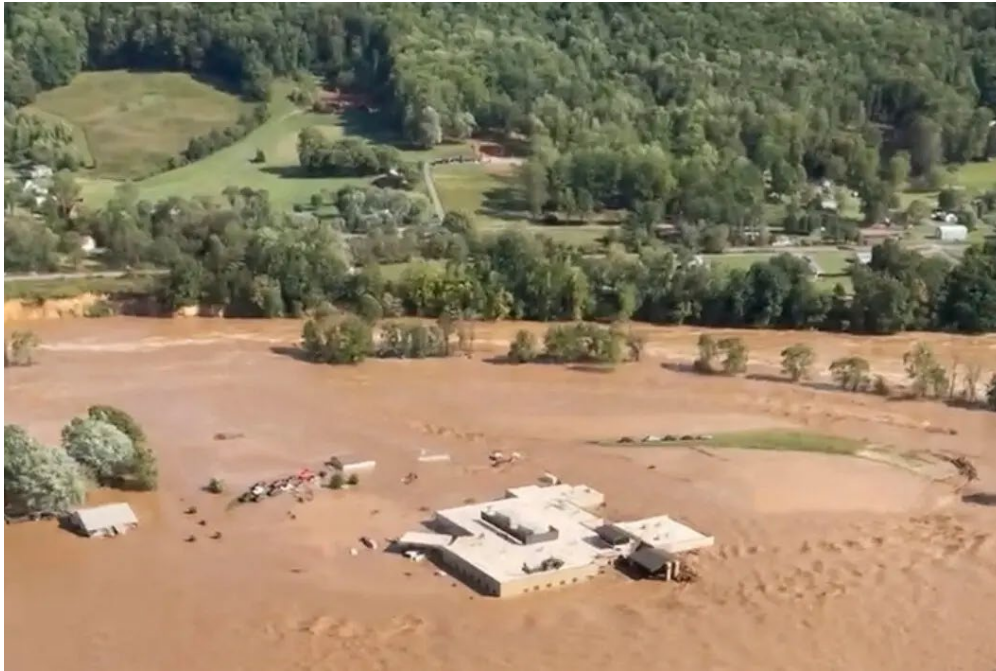
Figure 4.4.1. Unicoi County hospital impacted by flooding along the French Broad River in Erwin, TN (Source: [Wade Payne/Associated Press](#)).

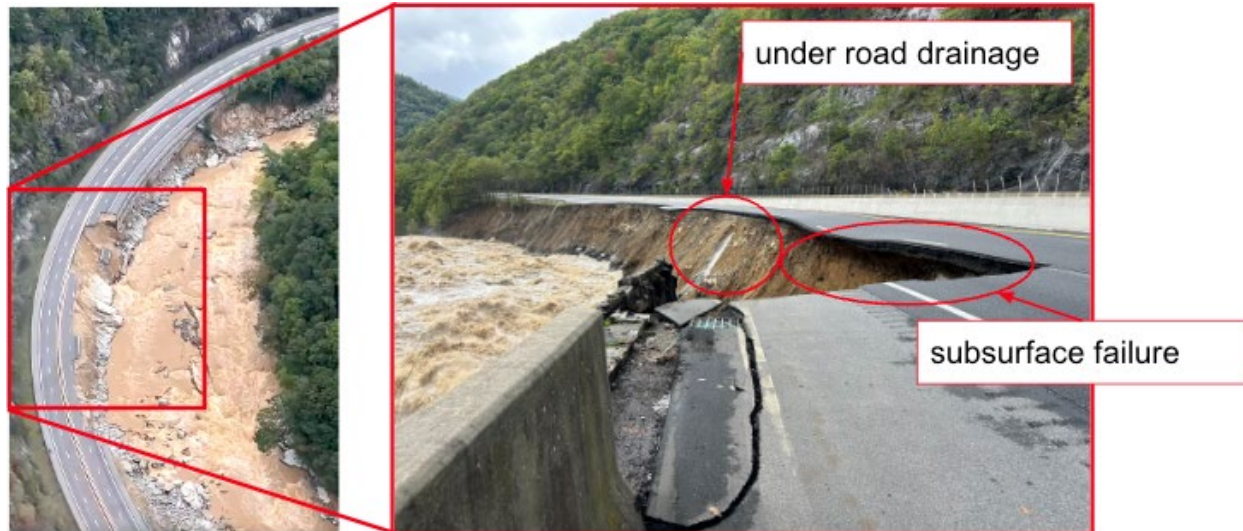
Figure 5.5. Damage to I-40 near the TN/NC border (photos from helicopter [video posted to X](#), and photos posted to [Threads](#)).

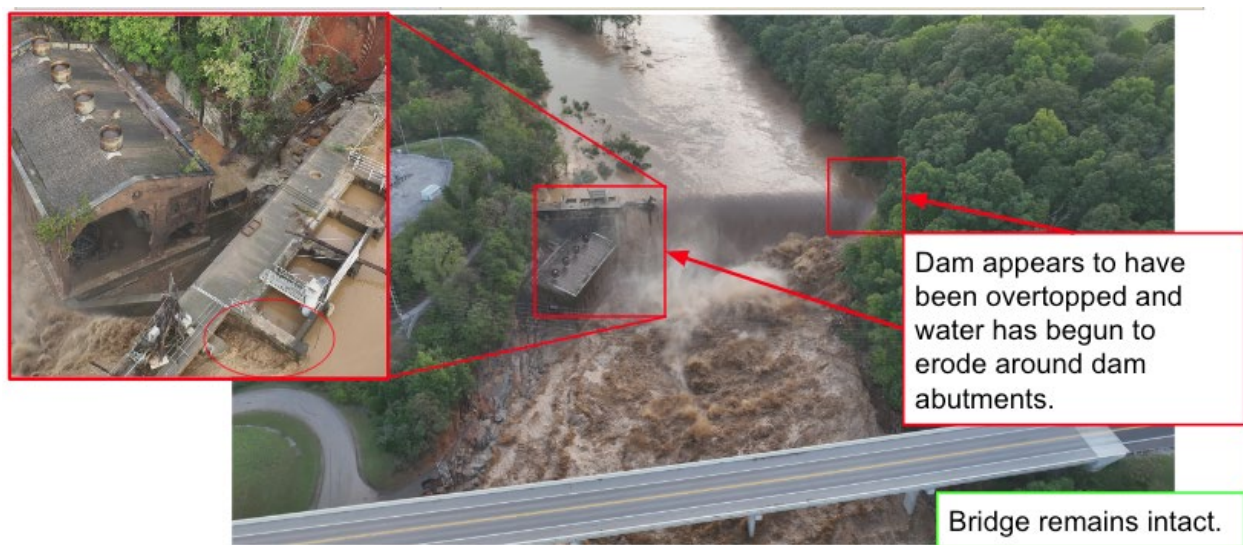
Figure 5.6. Overtopping of the Nolichucky Dam with erosion damage (Photos from Tom [Satkowiak via X](#)).

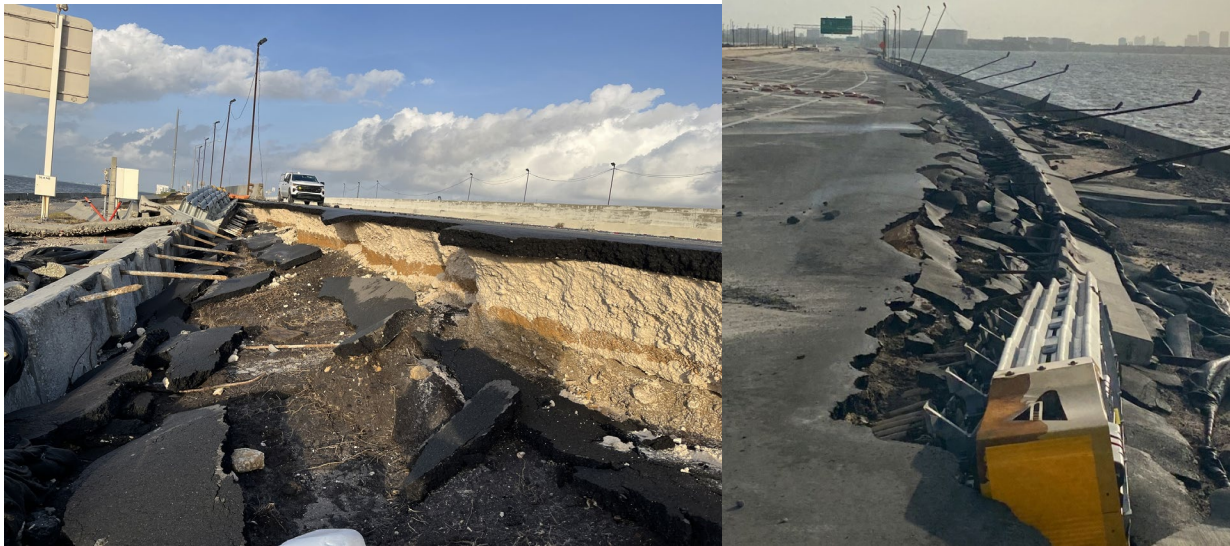
Figure 6.1. Asphalt pavement and soil subgrade washed away by Hurricane Helene storm surge (Source: [FDOT West Central - Tampa Area](#)).

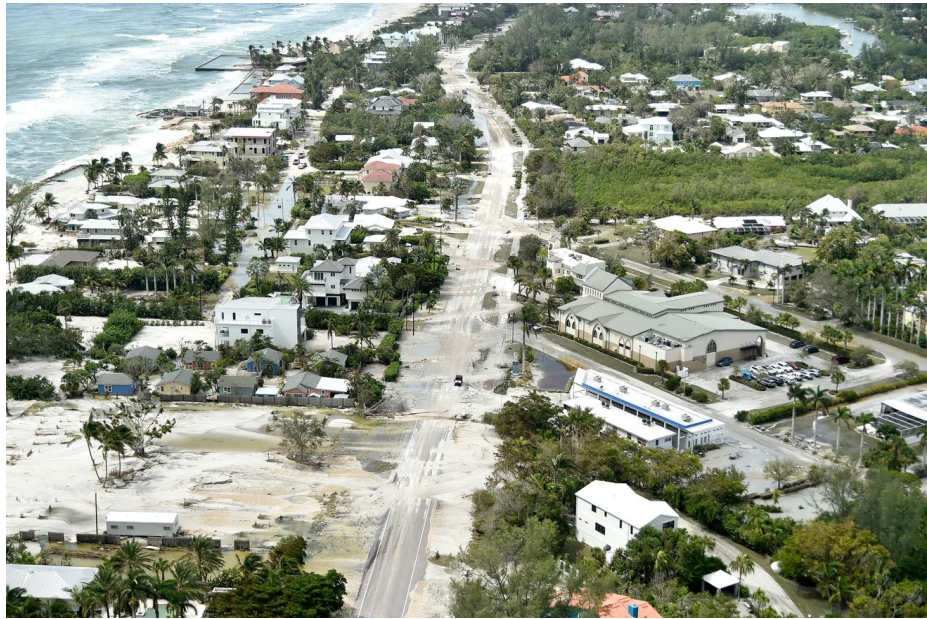
Figure 6.2. Gulf of Mexico Drive on Longboat Key (Source: [Thomas Bender/Sarasota Herald-Tribune](#)).

Coastal areas in Georgia and Florida reported erosion issues along the shoreline (Fig. 6.1). Sand deposition was also significant along the Florida Gulf Coast, e.g., along Gulf of Mexico Drive on Longboat Key and roadways on Anna Maria Island (Figs. 6.2 and 6.3, respectively). Gulf Boulevard (FL-699) in the Tampa Bay area experienced similar levels of sand deposition, where Florida Department of Transportation (FDOT) crews removed nearly 50,000 cubic yards of sand

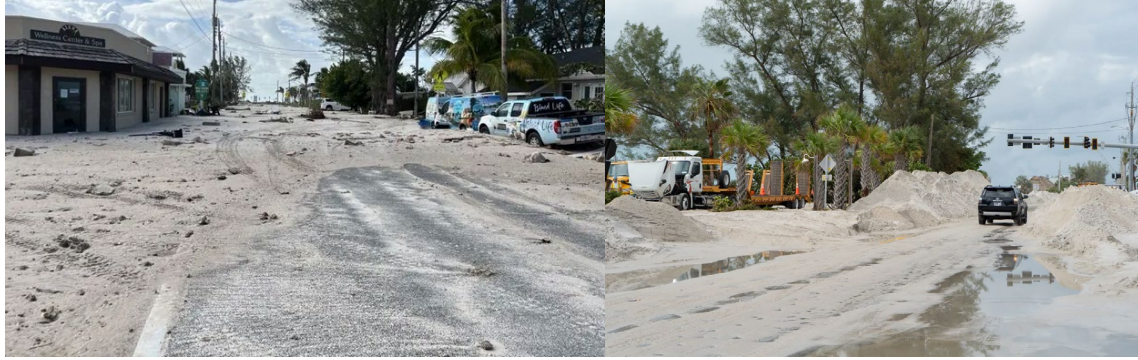
Figure 6.3. Roadways on Anna Maria Island (Source: [Jesse Mendoza/Sarasota Herald-Tribune and Manatee County Government](#)).

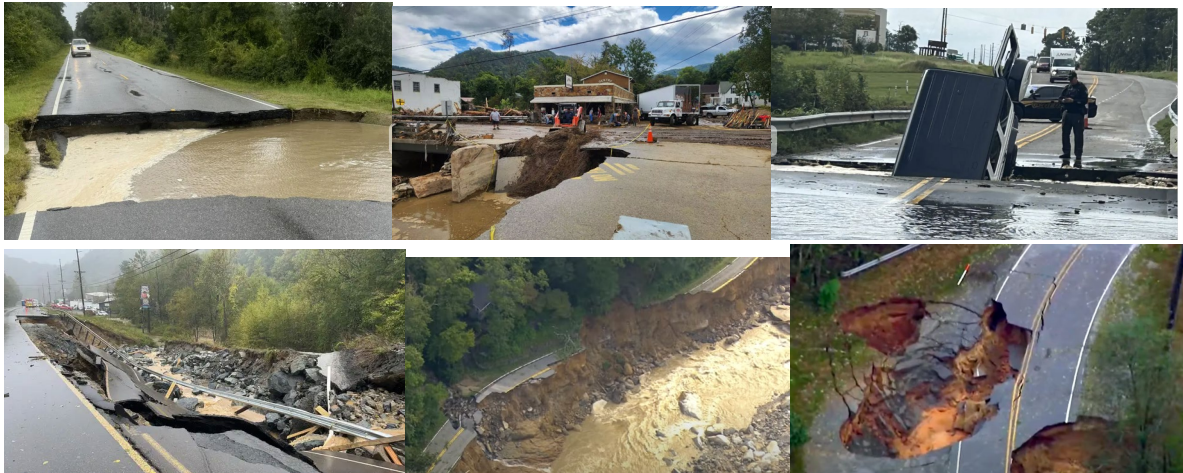
Figure 6.4. Geotechnical failures of roadways in North Carolina: (a) East Moore Street, (b) Hot Springs, (c) N.C. 211, (d) Hwy 105, (e) Rutherford County, (f) sinkhole (Source: [CBS17](#), [RBP](#), [Foxweather](#), [11Alive](#)).

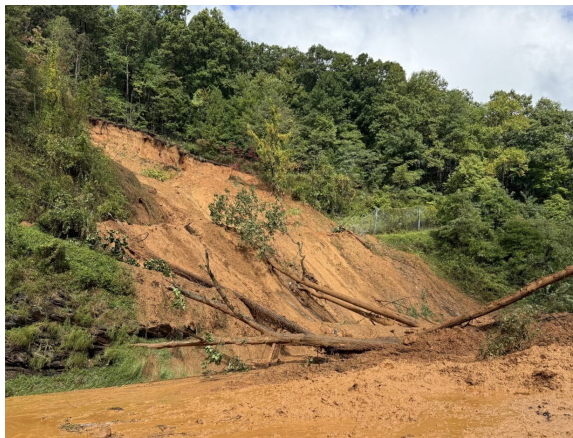
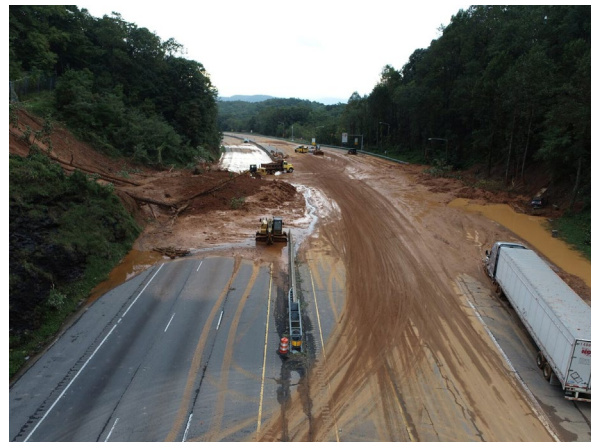
(a)

(b)

Figure 6.6. Example of Landslides in North Carolina: (a) I-40 near Old Fort and (b) I-40 near Black Mountain (Source: [Clayton Henkel on NC newsline](#)).

Across multiple states, bridges and roadways were undermined by floodwaters, with scouring around bridge abutments or erosion of underlying unbound granular layers of roadways diminished their load-bearing capacity, resulting in widespread failures. A cross-section of such failures in North Carolina is presented in Figure 6.4 depicting failures in Southport, Hot Springs and Rutherford County, as well as impacts to NC 211, NC 105 in Watauga County, and US 17 in Brunswick County. Similar failures were observed in Tennessee (Fig. 6.5). Railways, particularly in North Carolina, were extensively damaged by similar mechanisms (Fig. 6.6). Landslides and mudslides also played a considerable role in road closures, particularly in North Carolina, where an estimated 626 landslides were reported. Notable among these were the multiple landslides and mudslides in McDowell County along I-40, examples of which are provided in Figure 6.7.

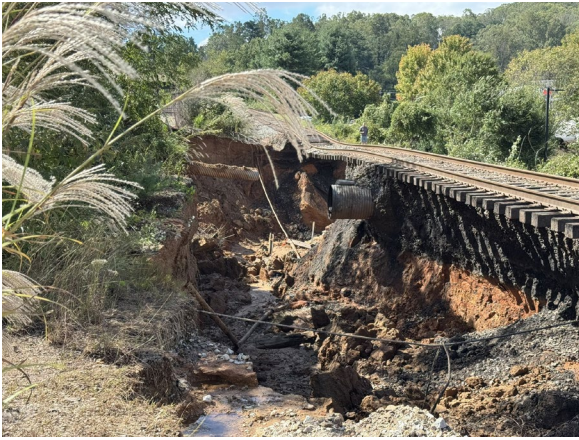
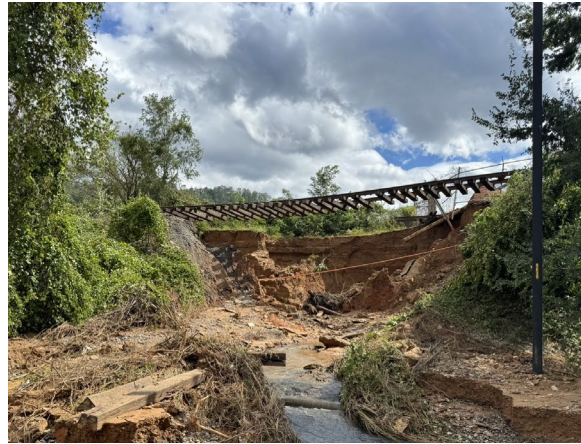
Figure 6.7. Undercutting of railway tracks in Asheville, NC (Source: [Nate on X.com](#))
