StEER
STRUCTURAL
EXTREME EVENTS
RECONNAISSANCE

Typhoon Merbok
17 September, 2022
Released: 31 October, 2022
NHERI DesignSafe Project ID:
PRJ- 3737

PRELIMINARY VIRTUAL RECONNAISSANCE REPORT (PVRR)

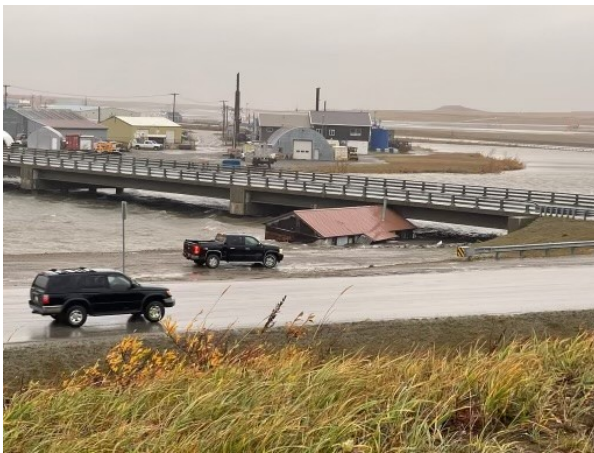
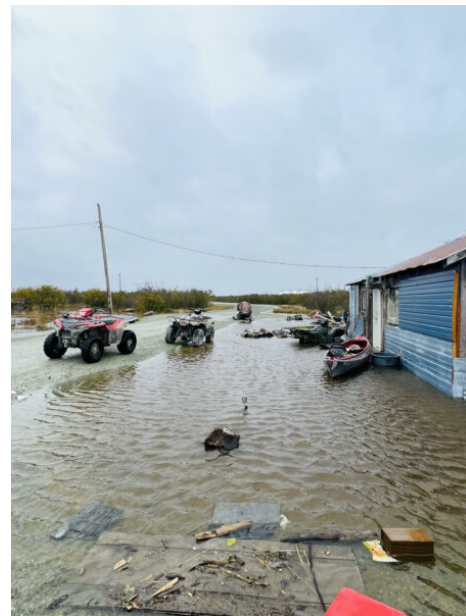
Figure 1.2: (a) Building washed against the Snake River Bridge, Nome (source: [Alaska DOT & PF 2022](#)) and (b) surging water flooded several structures and vehicles in Napakiak on Saturday, September 17, 2022 (source : [Alaska Public Media 2022](#))

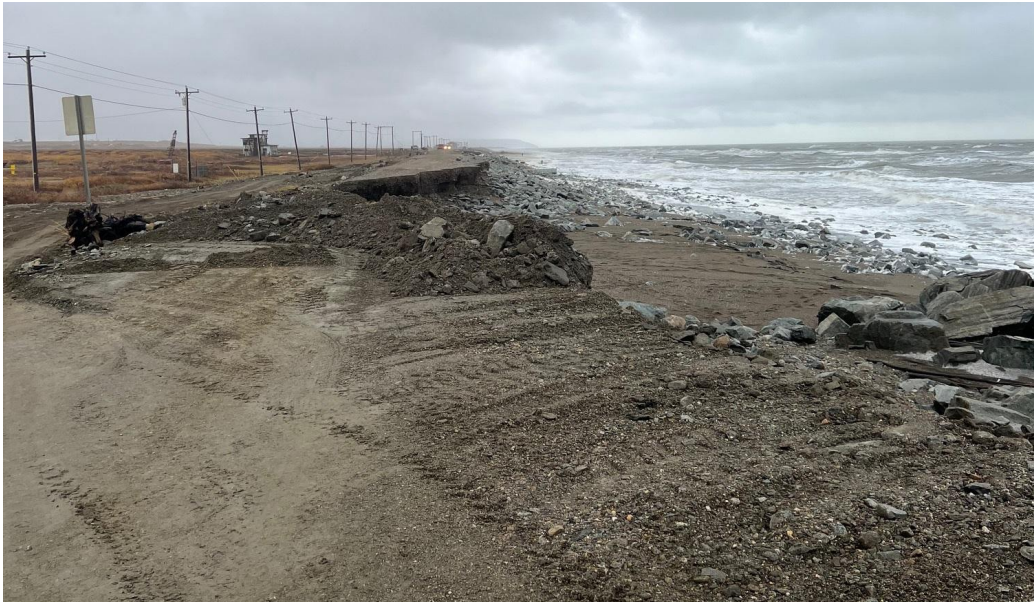
Figure 6.2: Coastal erosion along Nome-Council Highway (source: Bering Strait School District, [Alaska DHS & EM 2022b](#))

Erosion affected airport runways (Scammon Bay), and roadway embankments and bridge abutments of Nome-Council Highway ([Alaska DOT&PF 2022](#)). The section of the 70 mile long Nome-Council highway (see **Figure 6.1, 6.2**) that runs along barrier islands separating Safety Sound from Norton Sound was heavily damaged, with up to 10 miles of the highway totally destroyed ([Mark Thiessen 2022](#)). Per DOT&PF, crews checked the Safety Sound bridge on the Nome-Council Road and determined the bridge itself (**Figure 6.3**) is intact despite abutment damage. Shaktoolik's protective berm was also significantly eroded, as discussed under coastal protective systems. Severe coastal erosion was also observed in Golovin (**Figure 6.4**) and Elim (**Figure 6.5**).

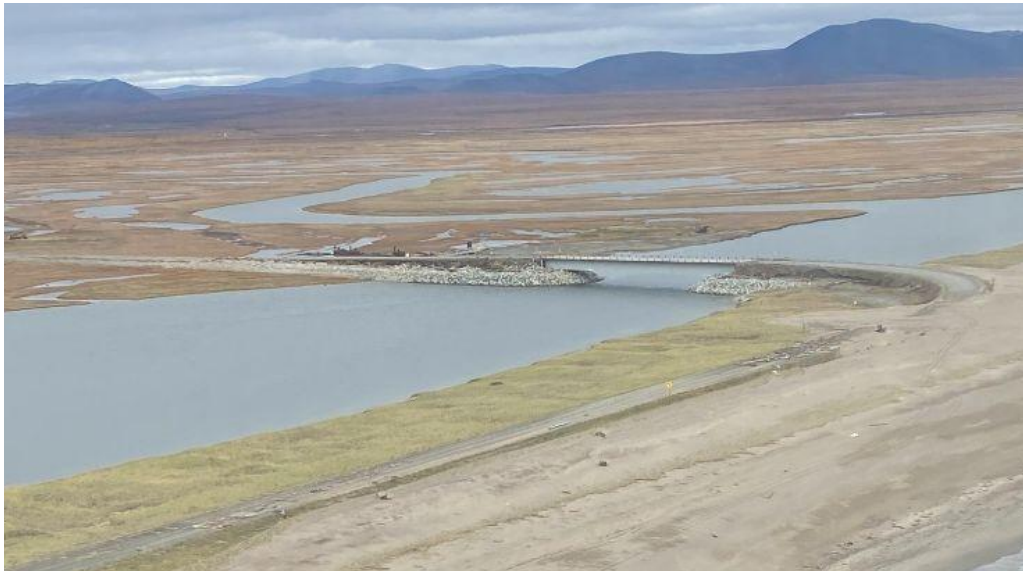
Figure 6.3: Bridge on Nome-Council Highway with some apparent abutment damage (source: [Alaska DOT&PF 2022](#))

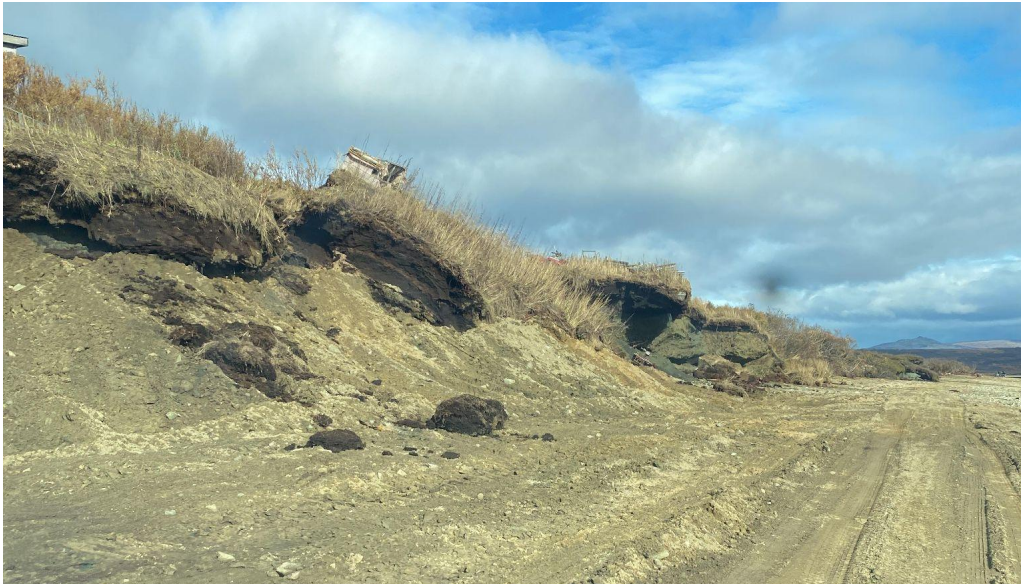
Figure 6.4: Coastal erosion in Golovin area (source: [Alaska DOT&PF 2022](#))

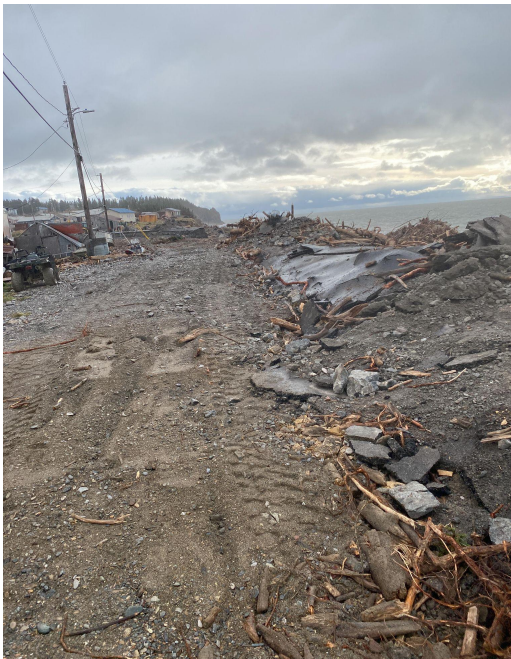
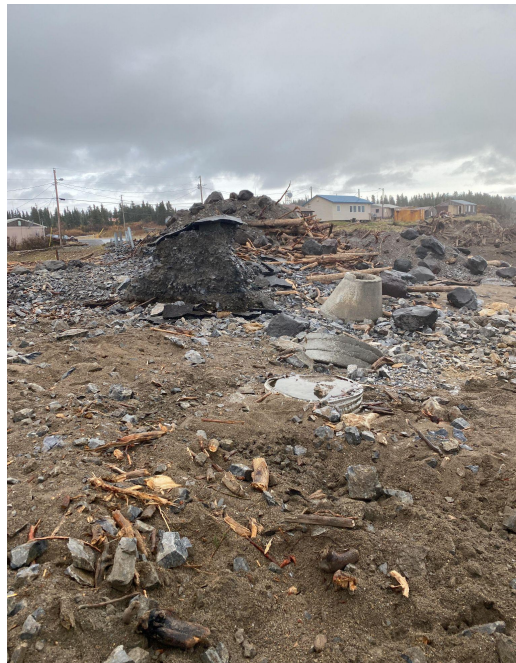
Figure 6.5: Coastal erosion in Elim (source: [Alaska DOT&PF 2022](#))

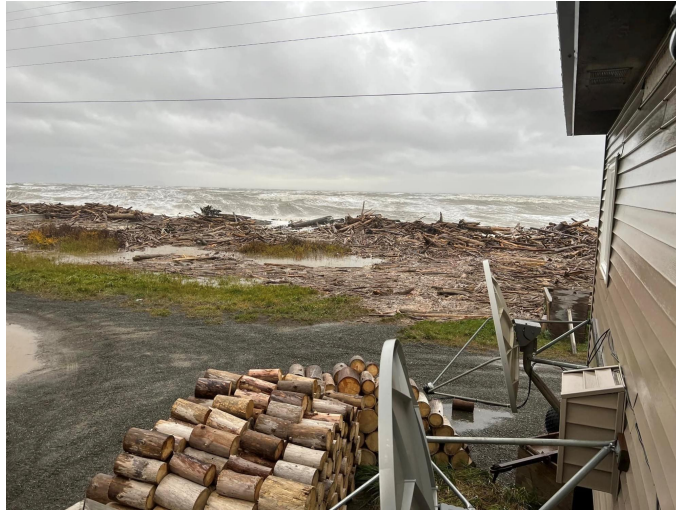
Figure 6.7: Remnants of the Shaktoolik berm (source: Bering Strait School District, [Alaska DHS & EM 2022b](#))

The Shaktoolik berm (**Figures 6.6** and **6.7**), which protected the community from the sea, was eroded significantly by the storm ([Stremple and Juneau 2022](#)). The Shaktoolik community of 210 residents, opted against a relocation plan a year ago, estimated to cost \$290 million, and opted in favor of a beach-protection berm ([Adapt Alaska](#)) constructed with gravel and driftwood at an estimated cost of under \$1 million ([Yereth Rosen 2022](#)). At the time of writing, United States Army Corps of Engineers (USACE) Engineers were evaluating the Nome Seawall and Shishmaref Bank Protection projects ([Office of Governor MIKE DUNLEAVY 2022b](#)).

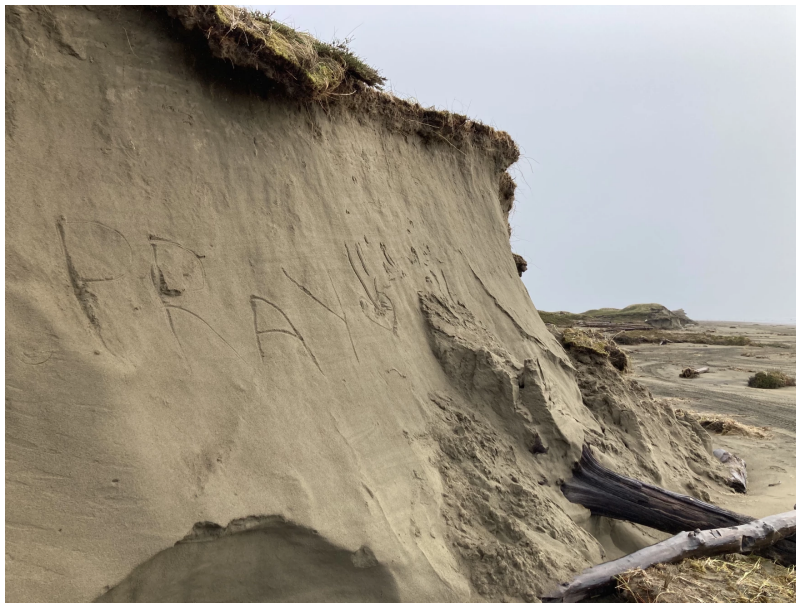
Figure 6.8: A partially eroded dune in Hooper bay(source: [Will McCarthy 2022b](#))

Hooper Bay lost to coastal erosion a significant amount of the rows of natural dunes (**Figure 6.8**) that protect the village. According to a local estimate the community lost approximately 300 feet of coastline ([Will McCarthy 2022b](#)).
