StEER STRUCTURAL EXTREME EVENTS RECONNAISSANCE	EVENT BRIEFING		
	Event:	Hurricane Eta	
	Region:	Central America, SE United States	
Lead:	Tracy Kijewski-Correa, University of Notre Dame		
Authors:	Maria D. Cortes Delgado, University of Puerto Rico Mayaguez Campus Mariantonieta Gutierrez Soto, University of Kentucky Sajad Javadinasab Hormozabad, University of Kentucky David Roueche, Auburn University		
Editors:	David O. Prevatt, University of Florida Ian Robertson, University of Hawaii at Manoa		
DesignSafe Project #	PRJ-2954	Release Date:	November 14, 2020

Hurricane Eta | Released November 14, 2020

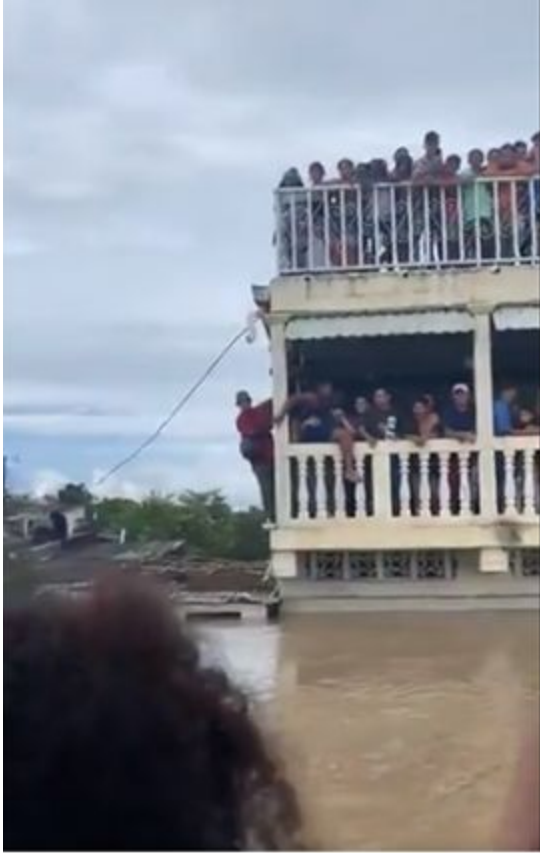
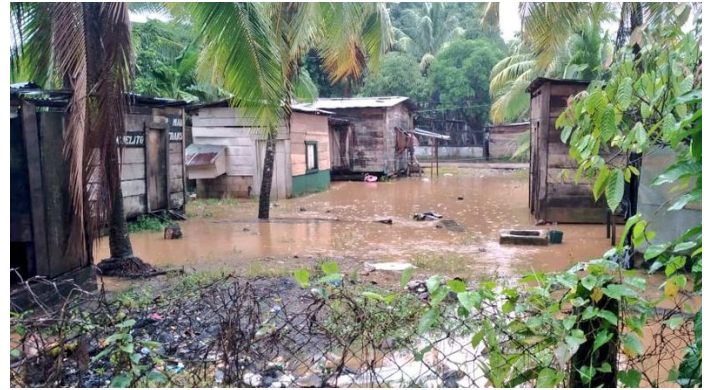
Figure 1.1. Rising floodwaters in (a) urban residential areas in Honduras, with residents vertically evacuating as waters reach the first story of a concrete building (Source: [Twitter](#) - click link for full video) and (b) rural residential areas like Sol de Libertad in Rosita, Nicaragua which lack such evacuation options (Estrada Galo, 2020b).

Figure 1.1a illustrates the implications for flood resilience across the rural-urban divide: multistory concrete and masonry structures were inherently more resilient to flood damage and supported vertical evacuation, which was vital to stemming life loss and enabling ongoing high-water rescues. Whereas Figure 1.1b demonstrates the wood-framed homes in rural communities more vulnerable to flood hazards and lacking proper water and sanitation, creating additional flood-induced health risks. Notably such challenges facing Hondouran communities vulnerable to climate-driven hazards have been previously underscored following Hurricane Mitch (McSweeney & Coomes 2011; Guill and Shandera 2001) and are sadly reiterated again during Hurricane Eta.

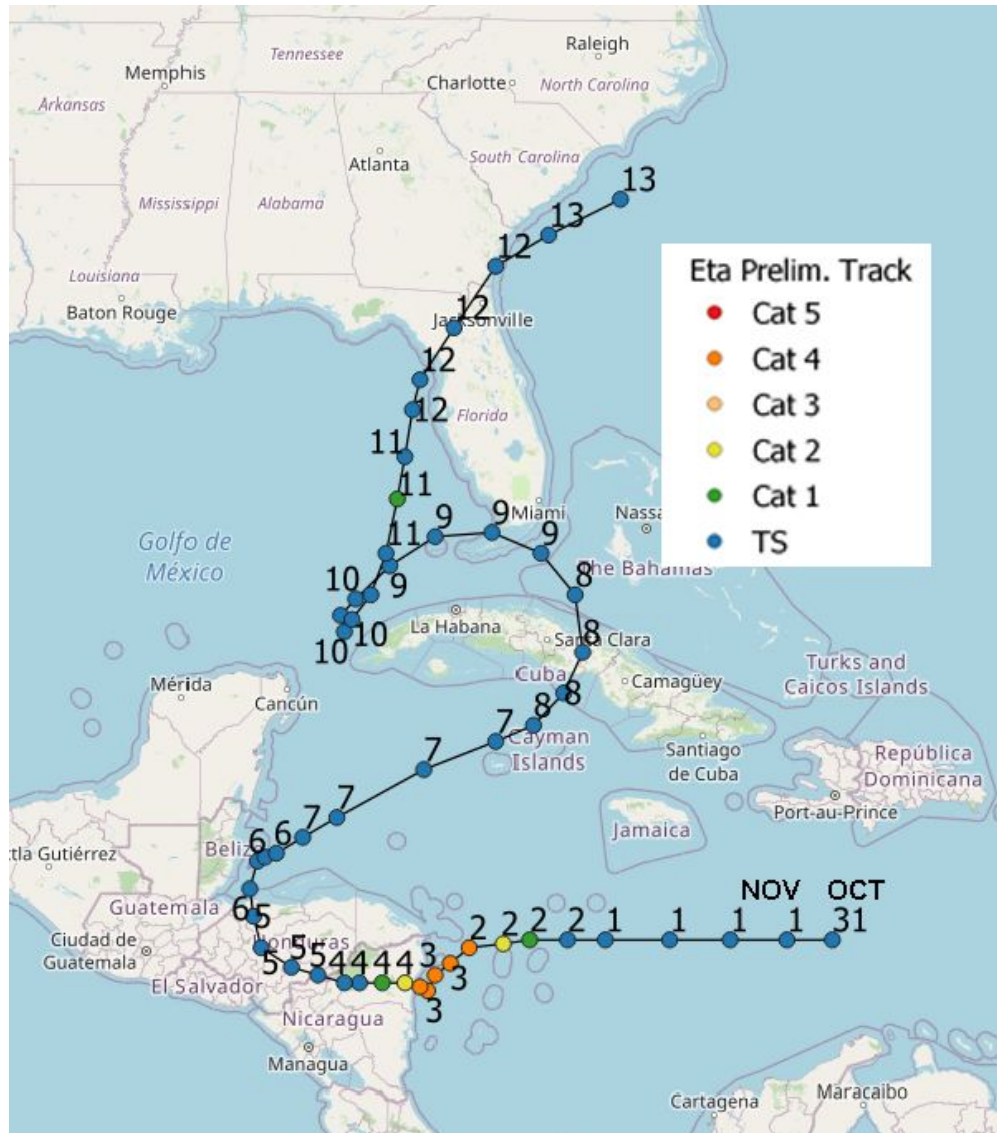
Figure 2.1. Track of Hurricane Eta over multiple landfalls. Numbers on track indicate the date of track location while colored symbols reflect intensity (Data source: [NHC](#)).

Figure 2.1 shows the evolution of Hurricane Eta through its landfalls in Central America and the United States, with subsections for each region. The lack of reported measurements of storm surge, rainfall and wind speeds in Central America limit the hazard description to largely forecasted values in briefings from the National Hurricane Center (NHC).

As shown by Figure 2.1, by 6 November Tropical Storm Eta moved back over water headed toward the United States, landfalling first in Cuba, before making its first US landfall on 8 November 2020 as a tropical storm with sustained winds of 65 mph on Florida's Lower Matecumbe Key. Eta produced 18 inches of rain in South Florida from 8-9 November, causing widespread flooding in Miami and Fort Lauderdale. The tropical storm then moved back into the Gulf and as shown in Figure 2.1, briefly regained hurricane force on 11 November, but weakened before making its second US landfall near Cedar Key, FL around 4:00 AM EST on 12 November with maximum sustained winds of 50 mph. A storm surge of 3-4 feet was reported in Tampa Bay, which received between 4 and 8 inches of rain as of the morning of 12 November. Eta's pattern of heavy rainfall continued as it moved across Florida and back over water, inching along the Atlantic Coast of the Carolinas, delivering 3 to 7 inches of rain that resulted in flash flooding conditions.

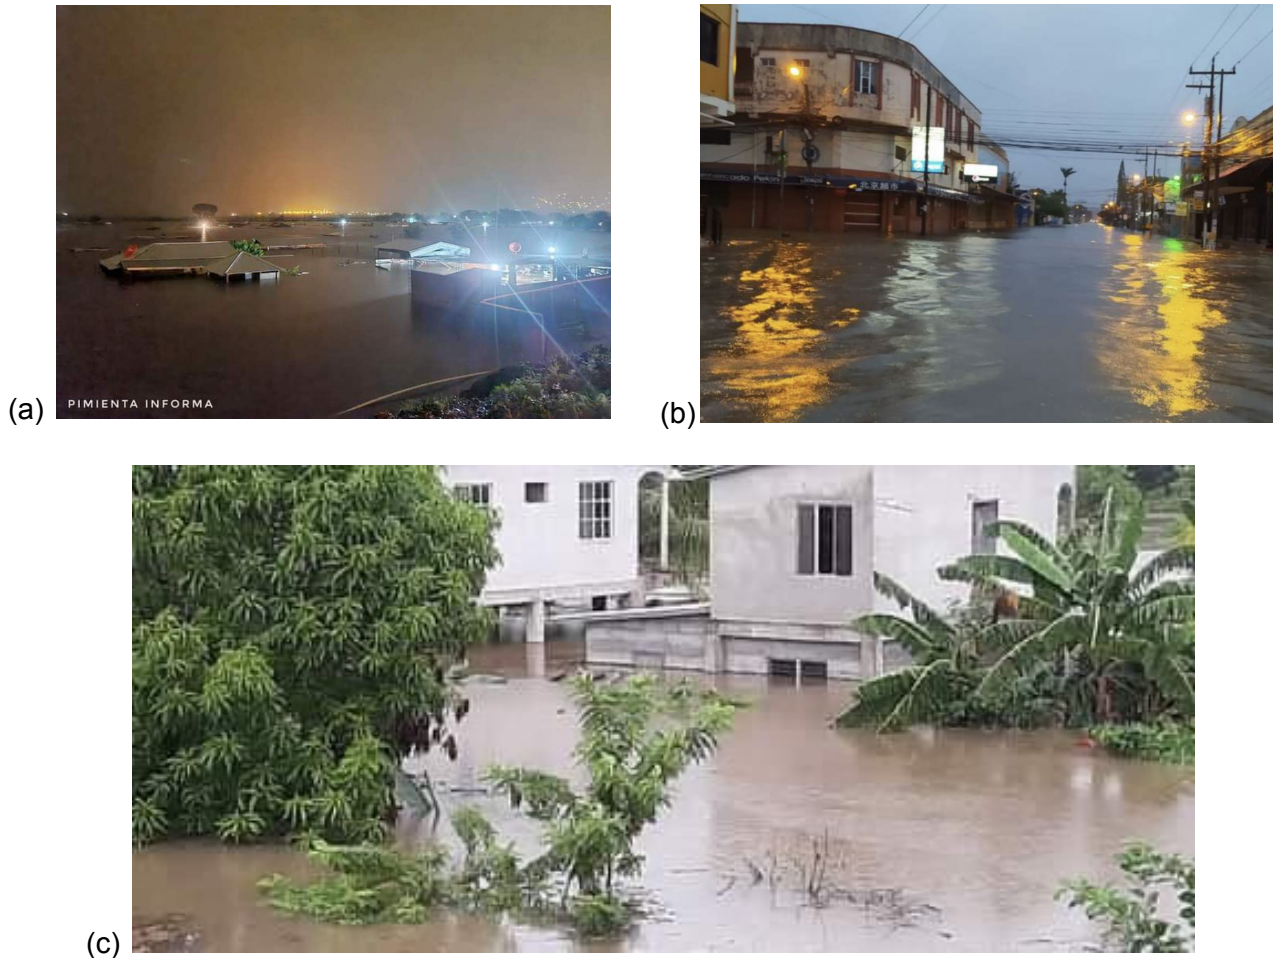
Figure 3.1. Floodwaters in Honduras reached the first story of buildings (a-b) as illustrated by examples in Puerto Cortes (Source: La Prensa, 2020a); (c) illustrates the typical multi-story urban residential concrete and masonry typologies in Honduras that are inherently more resilient to flood losses in comparison with wood or other light-framed/clad construction (Source: <https://twitter.com/brianarrubi/status/1325225824182657025/photo/2>).

Given the negligible damage to structures in the US, this section will focus on structural damages to buildings in Central America and specifically Nicaragua, with an emphasis on the potential impacts of wind and storm surge (damage in other Central American countries is confined to flood-related losses). It is important to contextualize these reports within the typologies and construction practices in the region. In more urban and peri-urban areas, residential and commercial construction employs variations of unreinforced masonry and confined masonry. The engagement of reinforced concrete and confined masonry construction in these regions at minimum minimized the potential for structural damage from the expansive flooding in Eta (see Fig. 3.1), though content losses are still

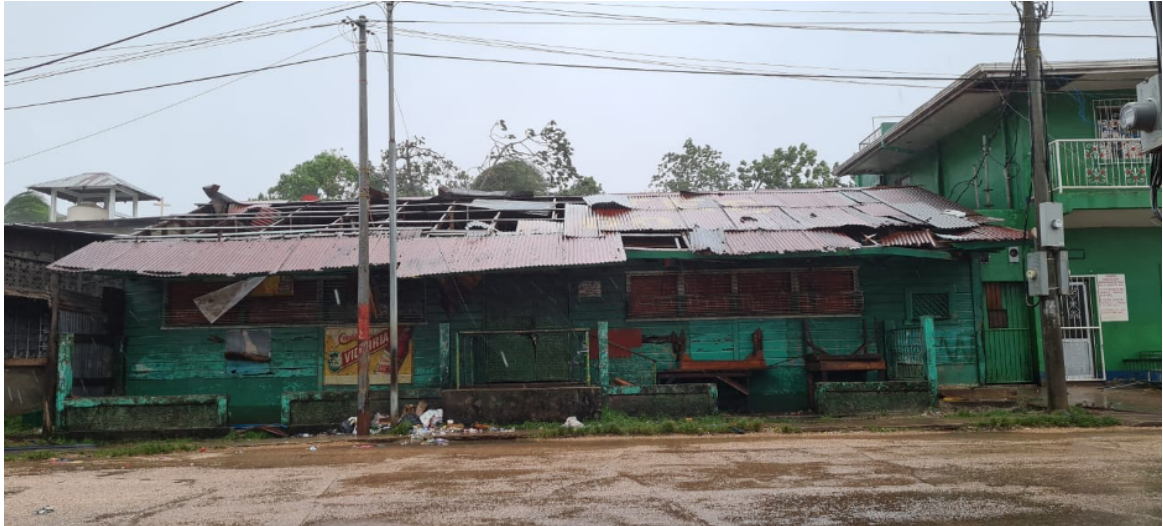
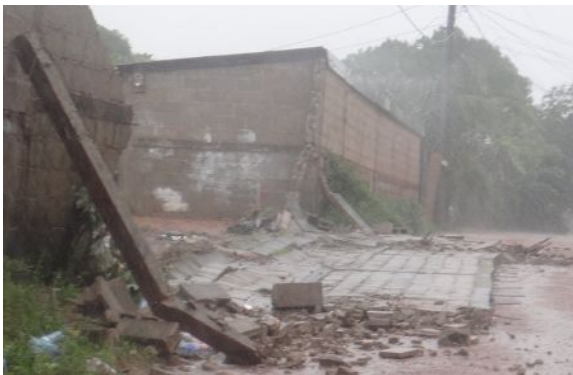
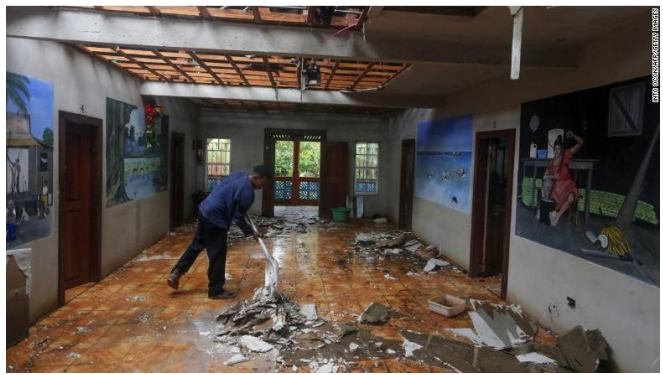
Figure 3.2. Eta-related damages in Puerto Cabezas, Nicaragua: (a) representative loss of roof CGI roof cover on single-story building in adjacent to a multi-story building with concrete slab roof (Source: Estrada Galo, 2020b); (b) example of inadequately confined masonry wall failure under lateral loads (Top left, Estrada Galo, 2020b); (c) interior losses due to water-damaged roof (Source: [CNN](#))

significant. Concrete and masonry typologies may employ two possible roof systems: concrete slab roofs or corrugated galvanized iron (CGI) roofs framed by timber, prefabricated open web steel joists or steel-hollow section trusses/purlins (both of which are exemplified later in Fig. 3.2a). The use of timber framing for CGI roofs is more prevalent in lower income/rural areas and that lumber is generally hand-processed and nailed (no use of straps or plates) to lightly frame these roof systems; however, wood species in Nicaragua can provide excellent hardwood for framing. In both settings, CGI attachment is often weak: CGI sheets themselves are commonly corroded or thin gauge and umbrella nails are rarely employed. The styles of construction in this region are consistent with those throughout Latin America and the Caribbean (LAC); the study by Kijewski-Correa et al. (2018) illustrates the vulnerabilities common in these systems as observed in Hurricane Matthew in Haiti.

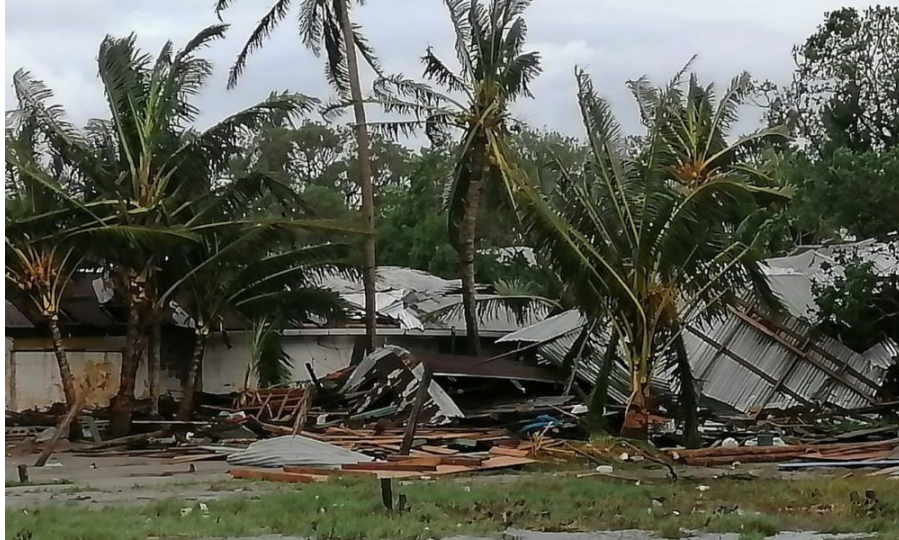
Figure 3.3. Structural collapse of residential building in Managua (Davila, 2020)

The potential for wind-damage was concentrated in Nicaragua over approximately a 100-mile radius, as noted in Section 2.1. Rural areas affected by Hurricane Eta include El Muelle, Nueva Jerusalen and Peter Ferrara neighborhoods of Bilwi, Nicaragua. The 100,000+ people living in Bilwi and the adjacent Caribbean communities are mostly indigenous, and this pair of videos ([1](#) and [2](#)) from the indigenous coastal community Wawa Bar in the municipality of Bilwi provides an indication of impacts to the coastal areas, as well as some of the local residential construction practices. These communities reported damage to residential and school buildings with most losses concentrated in the roof system, and specifically the loss of CGI roof cover. As these roof systems have weak cover attachment, loss of metal roof cover was anticipated, in contrast to concrete slab roofs (Fig. 3.2a), a system accessible to those with higher economic capacity and inherently more resilient to the strong winds and heavy rainfalls associated with hurricanes and tropical storms common in LAC. However, roof cover loss is potentially beneficial as a fuse that avoids propagating uplift forces into more vulnerable wall systems (Kijewski-Correa et al., 2018). Such masonry wall system vulnerability (illustrated in Fig. 3.2b) is generally associated with inadequate confinement, lack of reinforcement or lack of system-level integration of the wall system through ring beams, or a combination thereof, where errors in detailing these critical reinforced concrete confining elements can lead to failure under lateral forces from wind, storm surge or floodwaters. While the loss of roof cover can be a beneficial fuse to avoid propagating more dangerous building-level failures, the resulting content losses due to rainwater infiltration still have significant impacts to building functions and its occupants (Fig. 3.2c). In some cases, roof failures did propagate to building-level collapse of light-framed wood construction in as far inland as the Nicaraguan capital of Managua (Fig. 3.3).

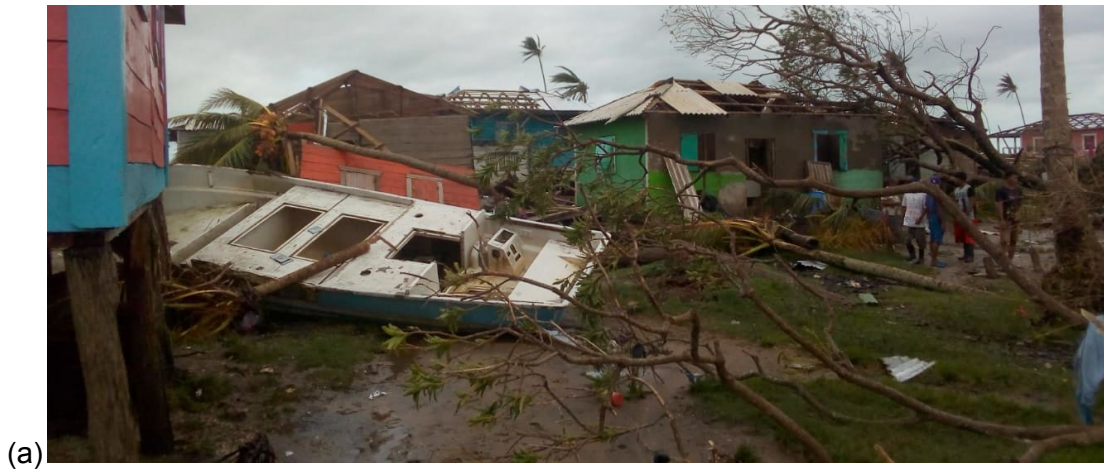
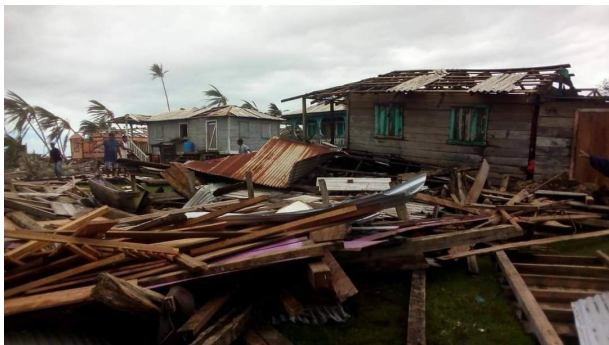
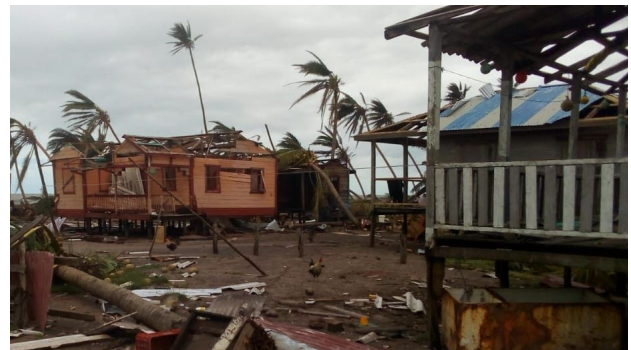
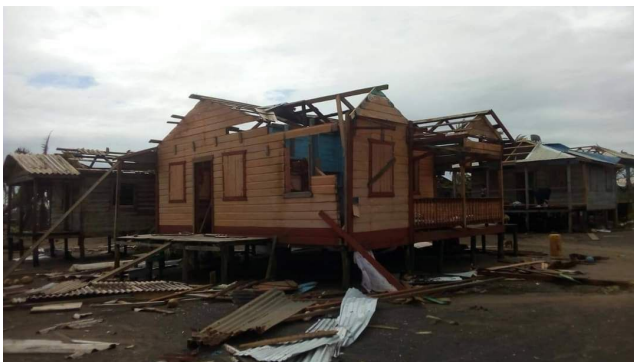
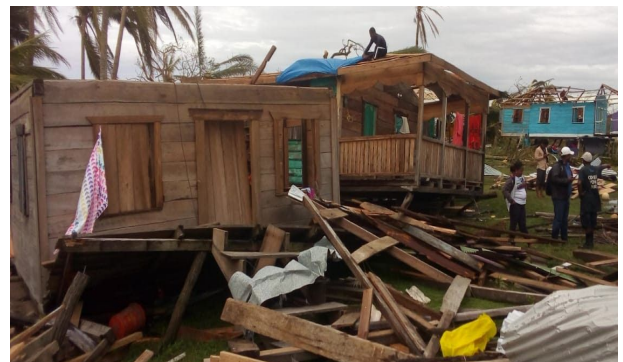
Figure 3.4. Damage to elevated wood-frame residential structures in the coastal community of Miskito, Nicaragua due to wind and storm surge impacts: (a-b) displaced boats and debris fields indicative of storm surge; (c-d) typical wind damage to CGI roofs; (e) houses unseated from foundation (Sources: Palmado via [Twitter](#) and Paul Cruz via [Twitter](#)).

Eastern Nicaraguan coastal communities like Wawa and Miskito were typified by modestly elevated wood-framed homes with losses primarily confined to the roof system, ranging from loss of roof cover to the complete detachment of the roof system (Fig. 3.4a-b), a potentially beneficial structural fuse, as mentioned previously. Some homes were unseated from their elevated foundations and debris evidence suggests this may have resulted from storm surge (Fig. 3.4c). The lack of concrete and masonry construction in some of these coastal communities left residents with few evacuation options.

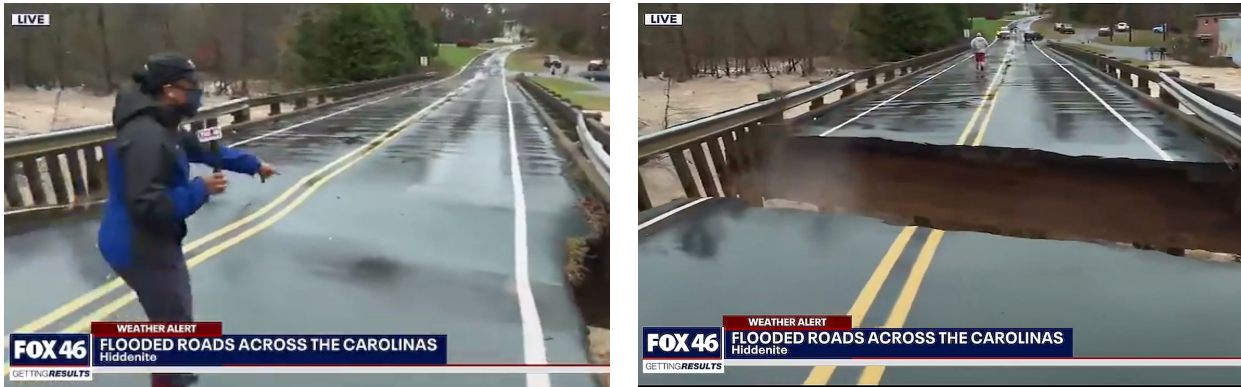
Figure 3.6. Just before and after the collapse of a portion of a bridge on Cheatham Ford Rd in Alexander County, NC (GPS: 35.896155, -81.054812) due to loss of freeboard from rising floodwaters (screen clips from [Fox46 Twitter](#) account).

The heavy tropical rainfall associated with Eta and an approaching cold front led to severe flash flooding in North Carolina that impacted a number of buildings and other structures. Structural damage appears to be mostly confined to transportation infrastructure. At least four bridges and 50 roadways were breached by the flood waters in Alexander County alone (Vigdor et al., 2020), 2020), as illustrated in Figure 3.6. Rising floodwaters caused evacuation of the Corvian Community Elementary School (WBTV, 2020) located just north of Charlotte, NC (GPS: 35.3228, -80.7565), but no structural damage was reported or expected.
