StEER
STRUCTURAL
EXTREME EVENTS
RECONNAISSANCE

Hurricane Otis
October 25, 2023
Released: September 18, 2024
NHERI DesignSafe Project ID:
PRJ-4231

EARLY ACCESS RECONNAISSANCE REPORT (EARR)

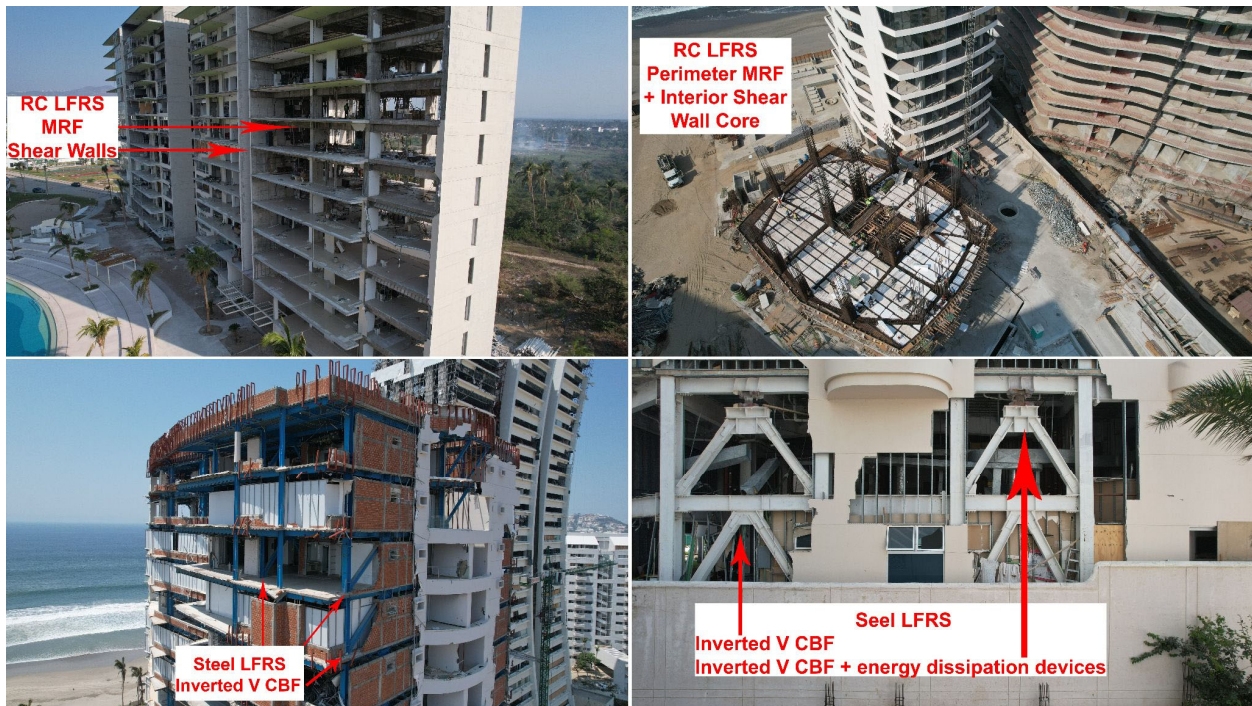
Damage to exterior wall cladding systems partially revealed components of the main structural systems in most buildings. Lateral force resisting systems (LFRS) observed in mid- and high-rise buildings assessed include a) reinforced concrete moment resisting frames and shear walls (Figure 4.1.1), b) structural steel moment resisting frames, braced frames, and buckling restrained braced frames (Figure 4.1.1), and c) composite systems (structural steel braced frames with composite columns, Figure 4.1.2). Several of the structural steel and composite systems implemented seismic dampers. The most common use of seismic dampers was metallic yielding energy dissipation devices in Concentric Braced Frames (CBFs, inverted Vs) with composite or plain steel columns; in some cases, the seismic dampers were discontinued on the top floors retaining only the CBFs as the LFRS of the upper levels of the building. A dominant structural system or construction material was not identified. Floor systems observed were either reinforced concrete joist systems lightened with expanded polystyrene blocks or composite corrugated steel deck; solid slabs were observed in some overhangs. The team was unable to identify whether interior bays used solid slabs or post-tensioned floor systems due to limited access and visibility. The FAST team did not detect damage to the floor structural systems and the LFRS of the assessed buildings.

Figure 4.1.1. Examples of Reinforced Concrete (RC) and Structural Steel LFRS in Acapulco (Source: FAST).

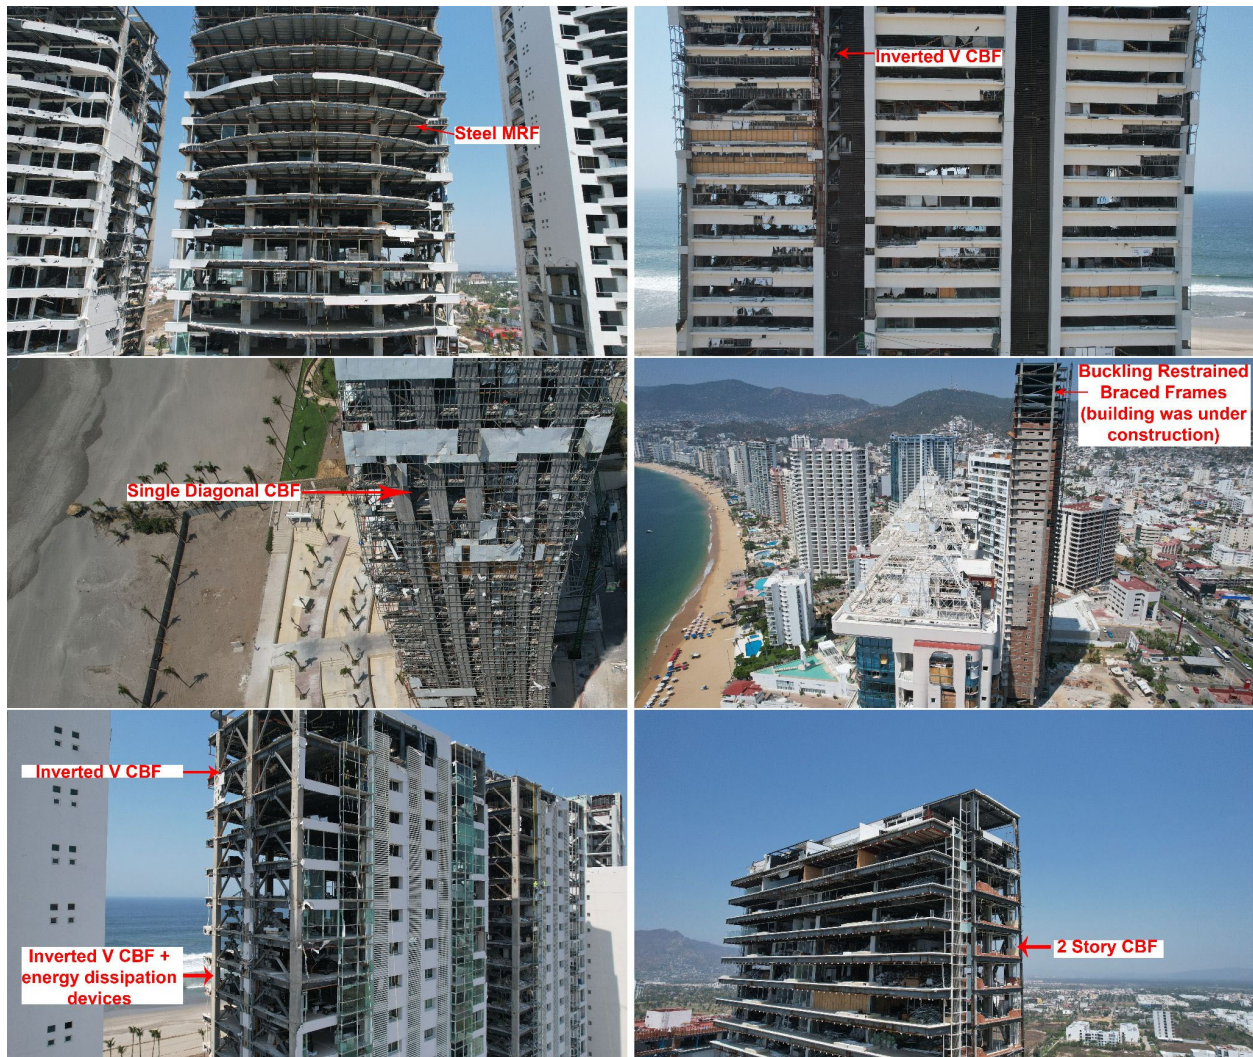
Figure 4.1.2. Examples of LFRS with Composite Columns in Acapulco (Source: FAST).

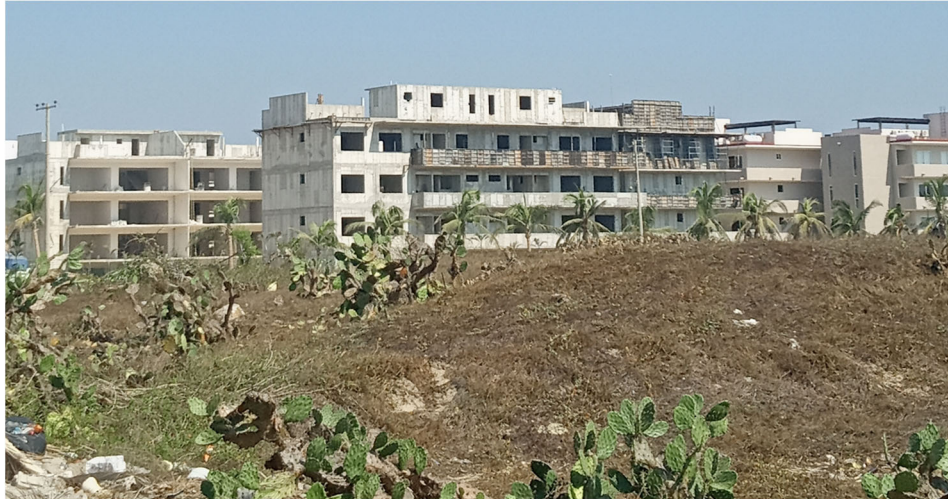
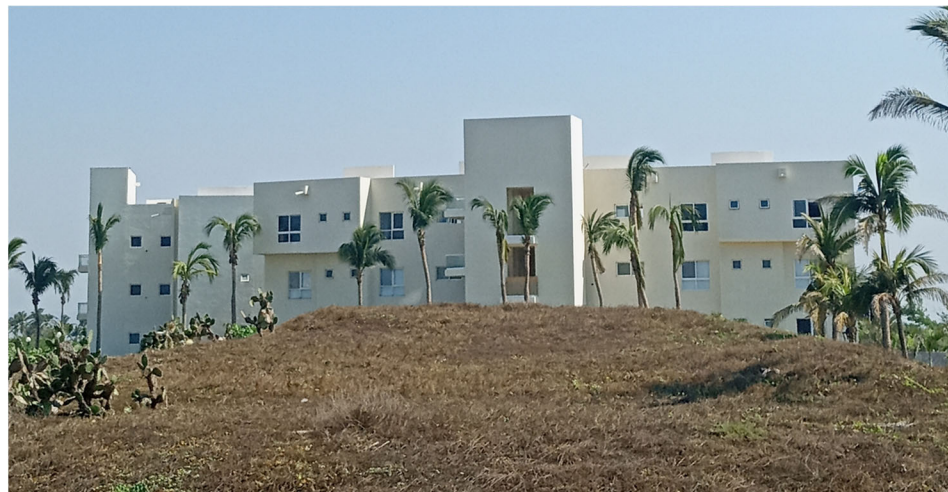
Figure 4.2.2 shows minor damage to the building envelope and components & cladding of the single family engineered homes in the Barra Vieja area. The minor damage was concentrated in the windows (likely due to impact of wind-borne debris) and roof tiles. Construction type and damage to low-rise residential single-family housing in the assessed areas (tourist areas of Diamante and Barra Vieja) is not representative of the lower income areas of the region that were severely affected by the hurricane but not accessible to the FAST. These observations also applied to multi-family low rise residential buildings (2-5 stories) with construction typology similar to that of buildings eligible for government mortgage sponsored programs (e.g., INFONAVIT). INFONAVIT-style construction, either single- or multi-family, implement reusable aluminum formwork to satisfy the demands of mass housing campaigns. The characteristic structural system of cast in place reinforced concrete bearing walls serves as both the LFRS and the building envelope (Figures 4.2.2 and 4.2.3 present examples of multi-family INFONAVIT style complexes with minor damage in the Diamante and Barra Vieja areas).

Figure 4.2.3. Examples of INFONAVIT-style construction utilizing reinforced concrete bearing walls as both the LFRS and the building envelope. Both the top and bottom images are representative of multi-family complexes just south of the airport (Source: FAST).
